J4I2337 – I-435 South Corridor Concept Study

Appendix B - Existing Bridge Assessments and Recommendations

Completed June 10, 2014

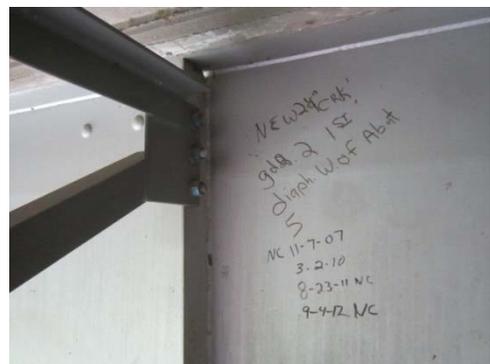
The superstructure is in fair condition (condition rating of 5) per the most recent MoDOT report. The superstructure contains several fatigue sensitive details near stiffeners, lateral bracing connections and longitudinal stiffener connections. The diaphragm connection stiffeners were not welded to the girder flanges and fatigue cracks have developed at the top of the stiffener. These cracks occur at three locations: in the girder web at the toe of the web to flange weld, in the stiffener to web weld, and in the web at the toe of the stiffener weld. Most of the cracks are in compression areas of the girder. Clip angles have been added between the connection stiffeners and the girder bottom flange to prevent cracks in those locations.

Figure 4. Typical crack in girder web

- Replace the east abutment strip seal joint system.
- Spot clean and paint areas with light rust or, alternatively, clean and paint all structural steel.
- Retrofit the lateral bracing gusset plate connections to the girder web.
- Retrofit the connections of the stiffeners to the girder top flange.
- Retrofit the longitudinal stiffener connections to the girder web in the tension areas.
- Replace the median barriers.
- Repair erosion damage at the north end of the west abutment for the eastbound Bridge.

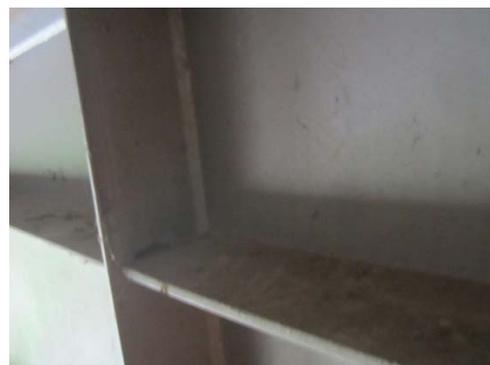
The longitudinal stiffeners are welded to the girder webs and either there is no weld gap to the stiffener welds or the weld gap is small allowing the potential for a concentration of stresses to form. The longitudinal stiffeners are located near the compression flange but areas near the girder splices may be in reversal zones. Therefore, the potential for fatigue cracks exists at those locations.

Figure 5. Small or missing gap at longitudinal stiffener

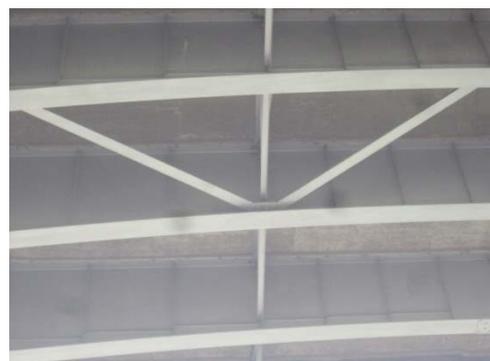
The lateral bracing gusset plates are also welded to the girder web in the interior spans near midspan where the web is in tension. Similar to the longitudinal stiffeners, the weld gaps are small allowing the potential for a concentration of stresses to form which could lead to cracking.

Figure 6. General view of lateral bracing connection

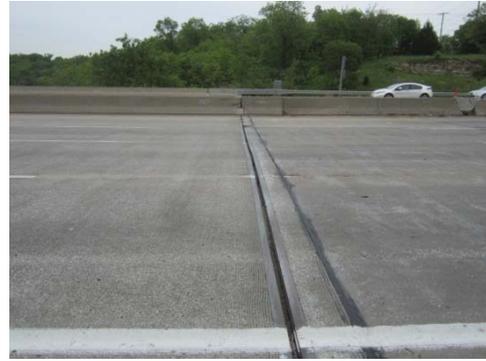
most recent MoDOT report. Isolated transverse cracks with light efflorescence were noted on the bottom of the deck. The east abutment expansion joint elastomer is worn and torn in several locations. Longitudinal cracks were noted at the top and bottom of the median barriers.

Figure 7. Deterioration in east abutment joint

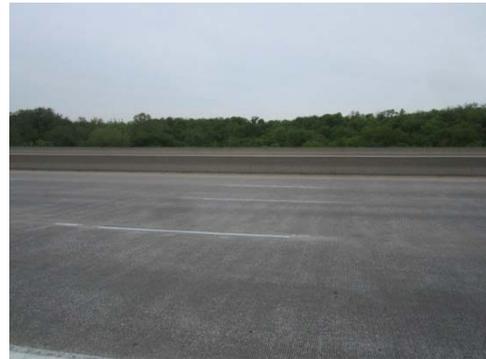
Figure 8. Cracks in median barrier

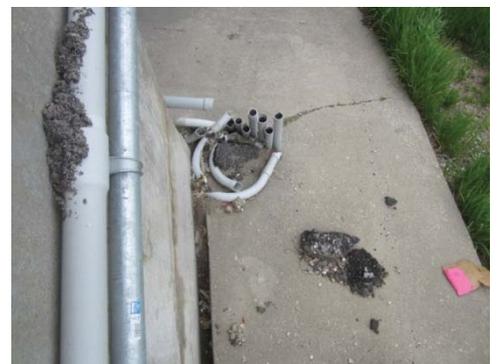
The deck is in satisfactory condition (condition rating of 6) and beams are in good condition (condition rating of 7) per the most recent MoDOT report. The wiring in the exposed conduits for the cathodic protection has been vandalized and the wiring is missing. Isolated areas on the underside of the deck have minor water staining. Several areas of patching were noted on the top of the deck generally near the expansion joints. The median barrier was damaged in one location and longitudinal cracks were noted at the top and near the bottom of the barrier. The bridge was painted in 1995 (System F) and isolated areas of rust were noted on the girders generally at the flange edges.

The deck over the existing girders is original concrete with uncoated reinforcing steel. The reinforcing steel was cathodically protected for a portion of the life of the structure but has not been protected since the wiring was disabled. Deterioration accelerates quickly in uncoated reinforcing steel and may pose problems in the near future.

Figure 11. Missing cathodic protection wiring

- Spot paint areas with light rust or, alternatively, clean and paint all structural steel.
- Remove and replace deck and strip seal joint systems.

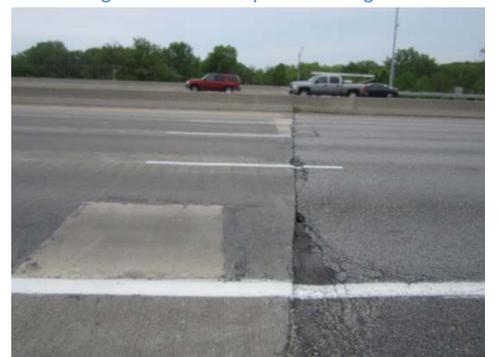
Figure 13. Deck patching at abutment

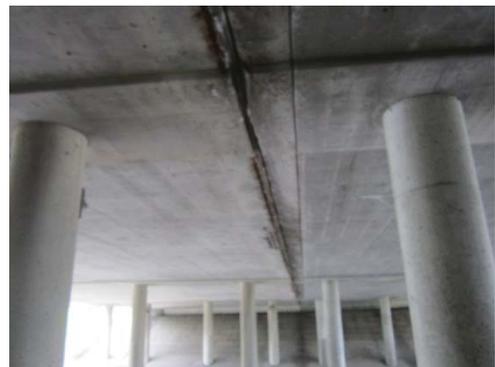
The superstructure and deck are in satisfactory condition (condition rating of 6) per the most recent MoDOT report. The longitudinal joints between the widening and the existing deck are deteriorated and had significant spalling. Water and rust stains were noted on the underside of the deck at the voided slab weep holes. Longitudinal cracks with rust stains were also noted near the east abutment. Areas of map cracking and deck patches were noted in the top of the deck. Significant erosion damage of the concrete slope protection at the west abutment was noted.

The numerous patches in the deck and water stains in the bottom of the slab indicate that water and chlorides have saturated the concrete. Generally, maintenance and repair costs accelerate rapidly when the chlorides have permeated the structure. An overlay would slow the deterioration of the slab, but uncertainty exists as to how much damage exists currently inside of the voids and significant deck repairs would be required prior to placing the overlay. Maintenance activities will escalate with time even with the deck repairs and new concrete may not participate fully in resisting the loads on the structure.

Figure 16. Spalls along longitudinal joint

- Remove and replace both bridges.

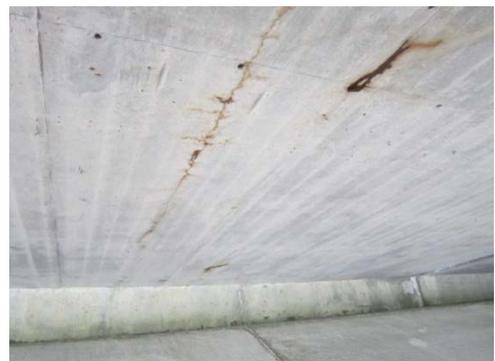
Figure 17. Cracks and rust stains on bottom of deck

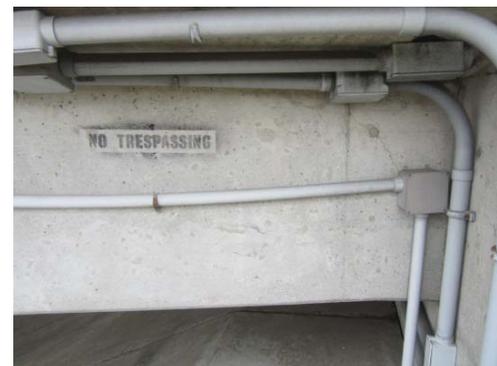
The superstructure and deck are in fair condition (condition ratings of 5) per the most recent MoDOT report. Shear cracks were noted in the box girder webs at the east abutment of the eastbound bridge and west abutment of the westbound bridge. Water stains were noted in the bottom of the box at both abutments as well as several isolated locations throughout the bridges. Patched and cracked areas were noted in the top of the deck along the longitudinal cold joints between the widening and the original deck for over 50% of the length. There are numerous additional patches in the top surface of the roadway. The substructure was in satisfactory condition (condition rating of 6) per the most recent MoDOT report. The concrete bents are in overall good condition although spalls were noted at the end of the abutments. The vertical clearance at the southeast corner is posted at 14'-6".

Figure 20. Shear cracks in box girder webs

- Remove and replace both bridges.

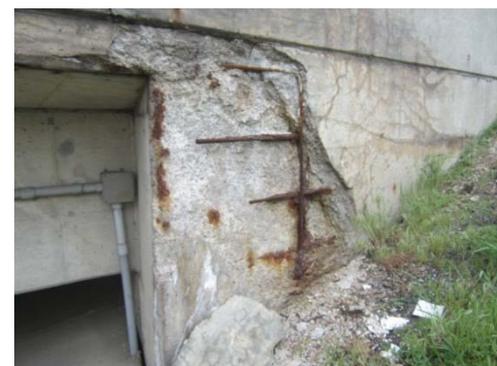
Figure 21. Spall with exposed reinforcing steel
