# I-55 West Outer Road At Rock Creek

## *Bridge Replacement Project*

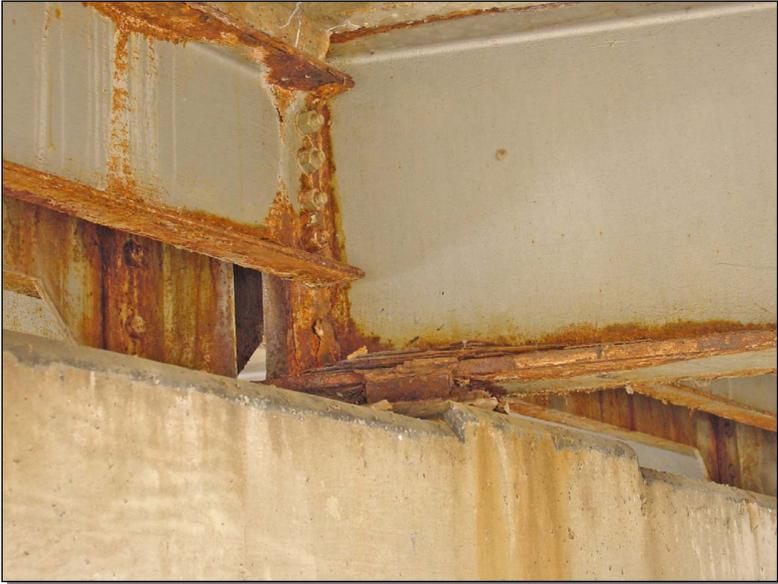
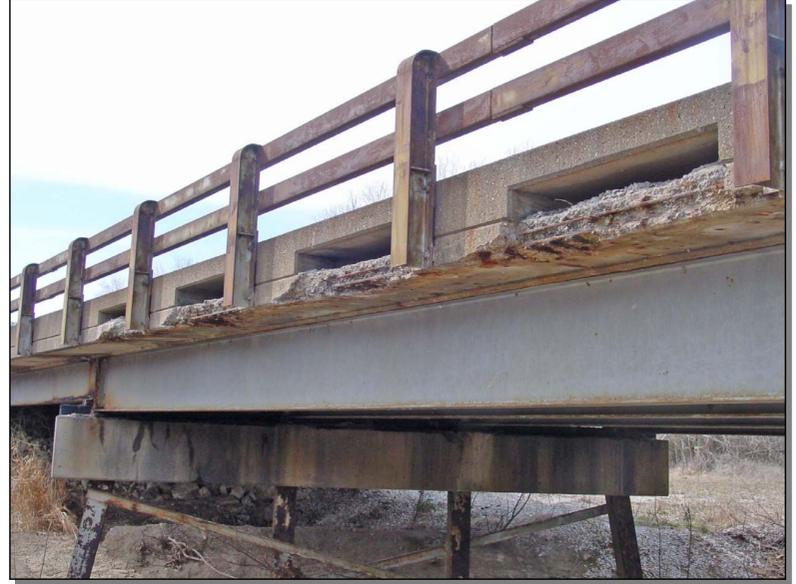
Years of moisture have caused extensive deterioration to the underside of the Rock Creek Bridge.

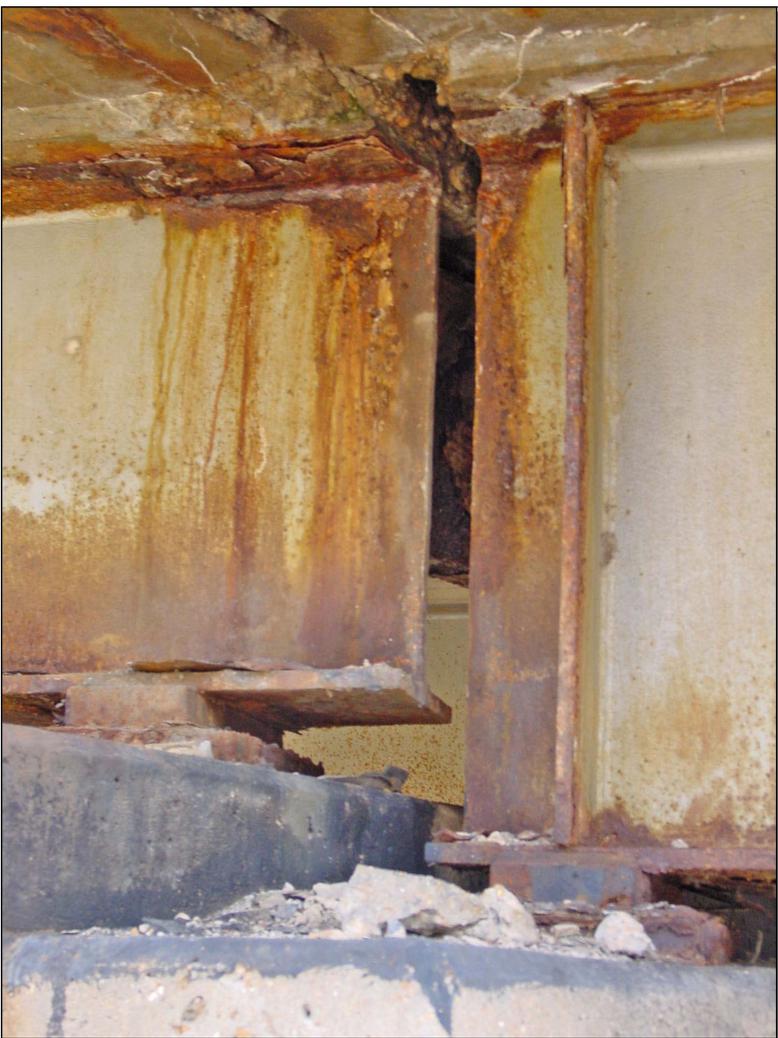
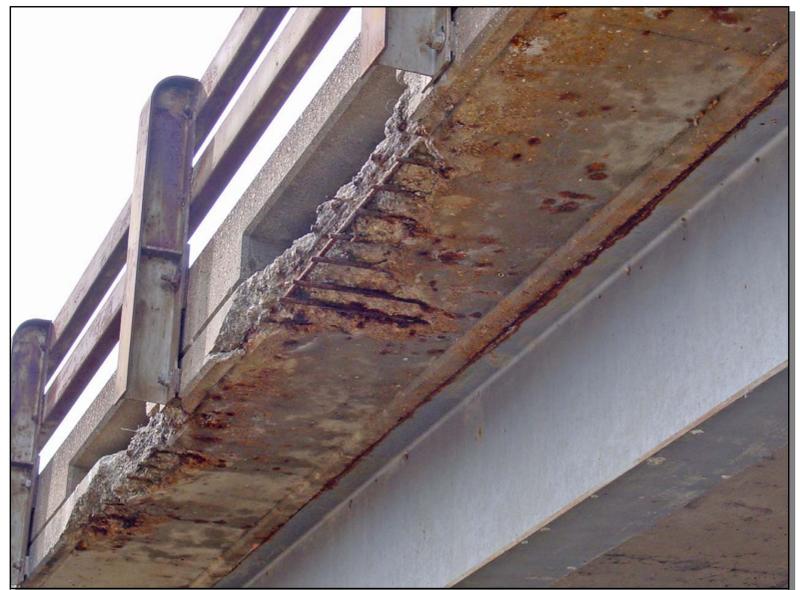
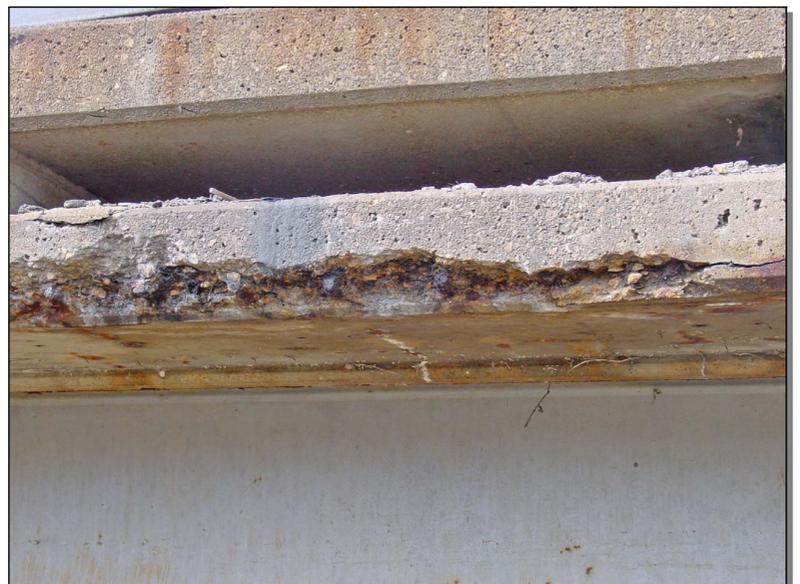
The concrete on the sides and under the bridge itself is cracking. Excessive rust has corroded the structural steel beams under the bridge.
