251 MISSOURI BRIDGES PROJECT

MoDOT Bridge Inspection Report

**Missouri Department of Transportation
Bridge Inventory and Inspection System
Structural Inventory & Appraisal Sheet**

COUNTY : COOPER	BRIDGE : L0962 2	REVIEW STATUS : REVIEW	NBI STATUS : T
RECORD TYPE : ROUTE CARRIED 'ON' STRUCT		RUN DATE : 11/28/2017	SUBMITTAL YEAR : 2017

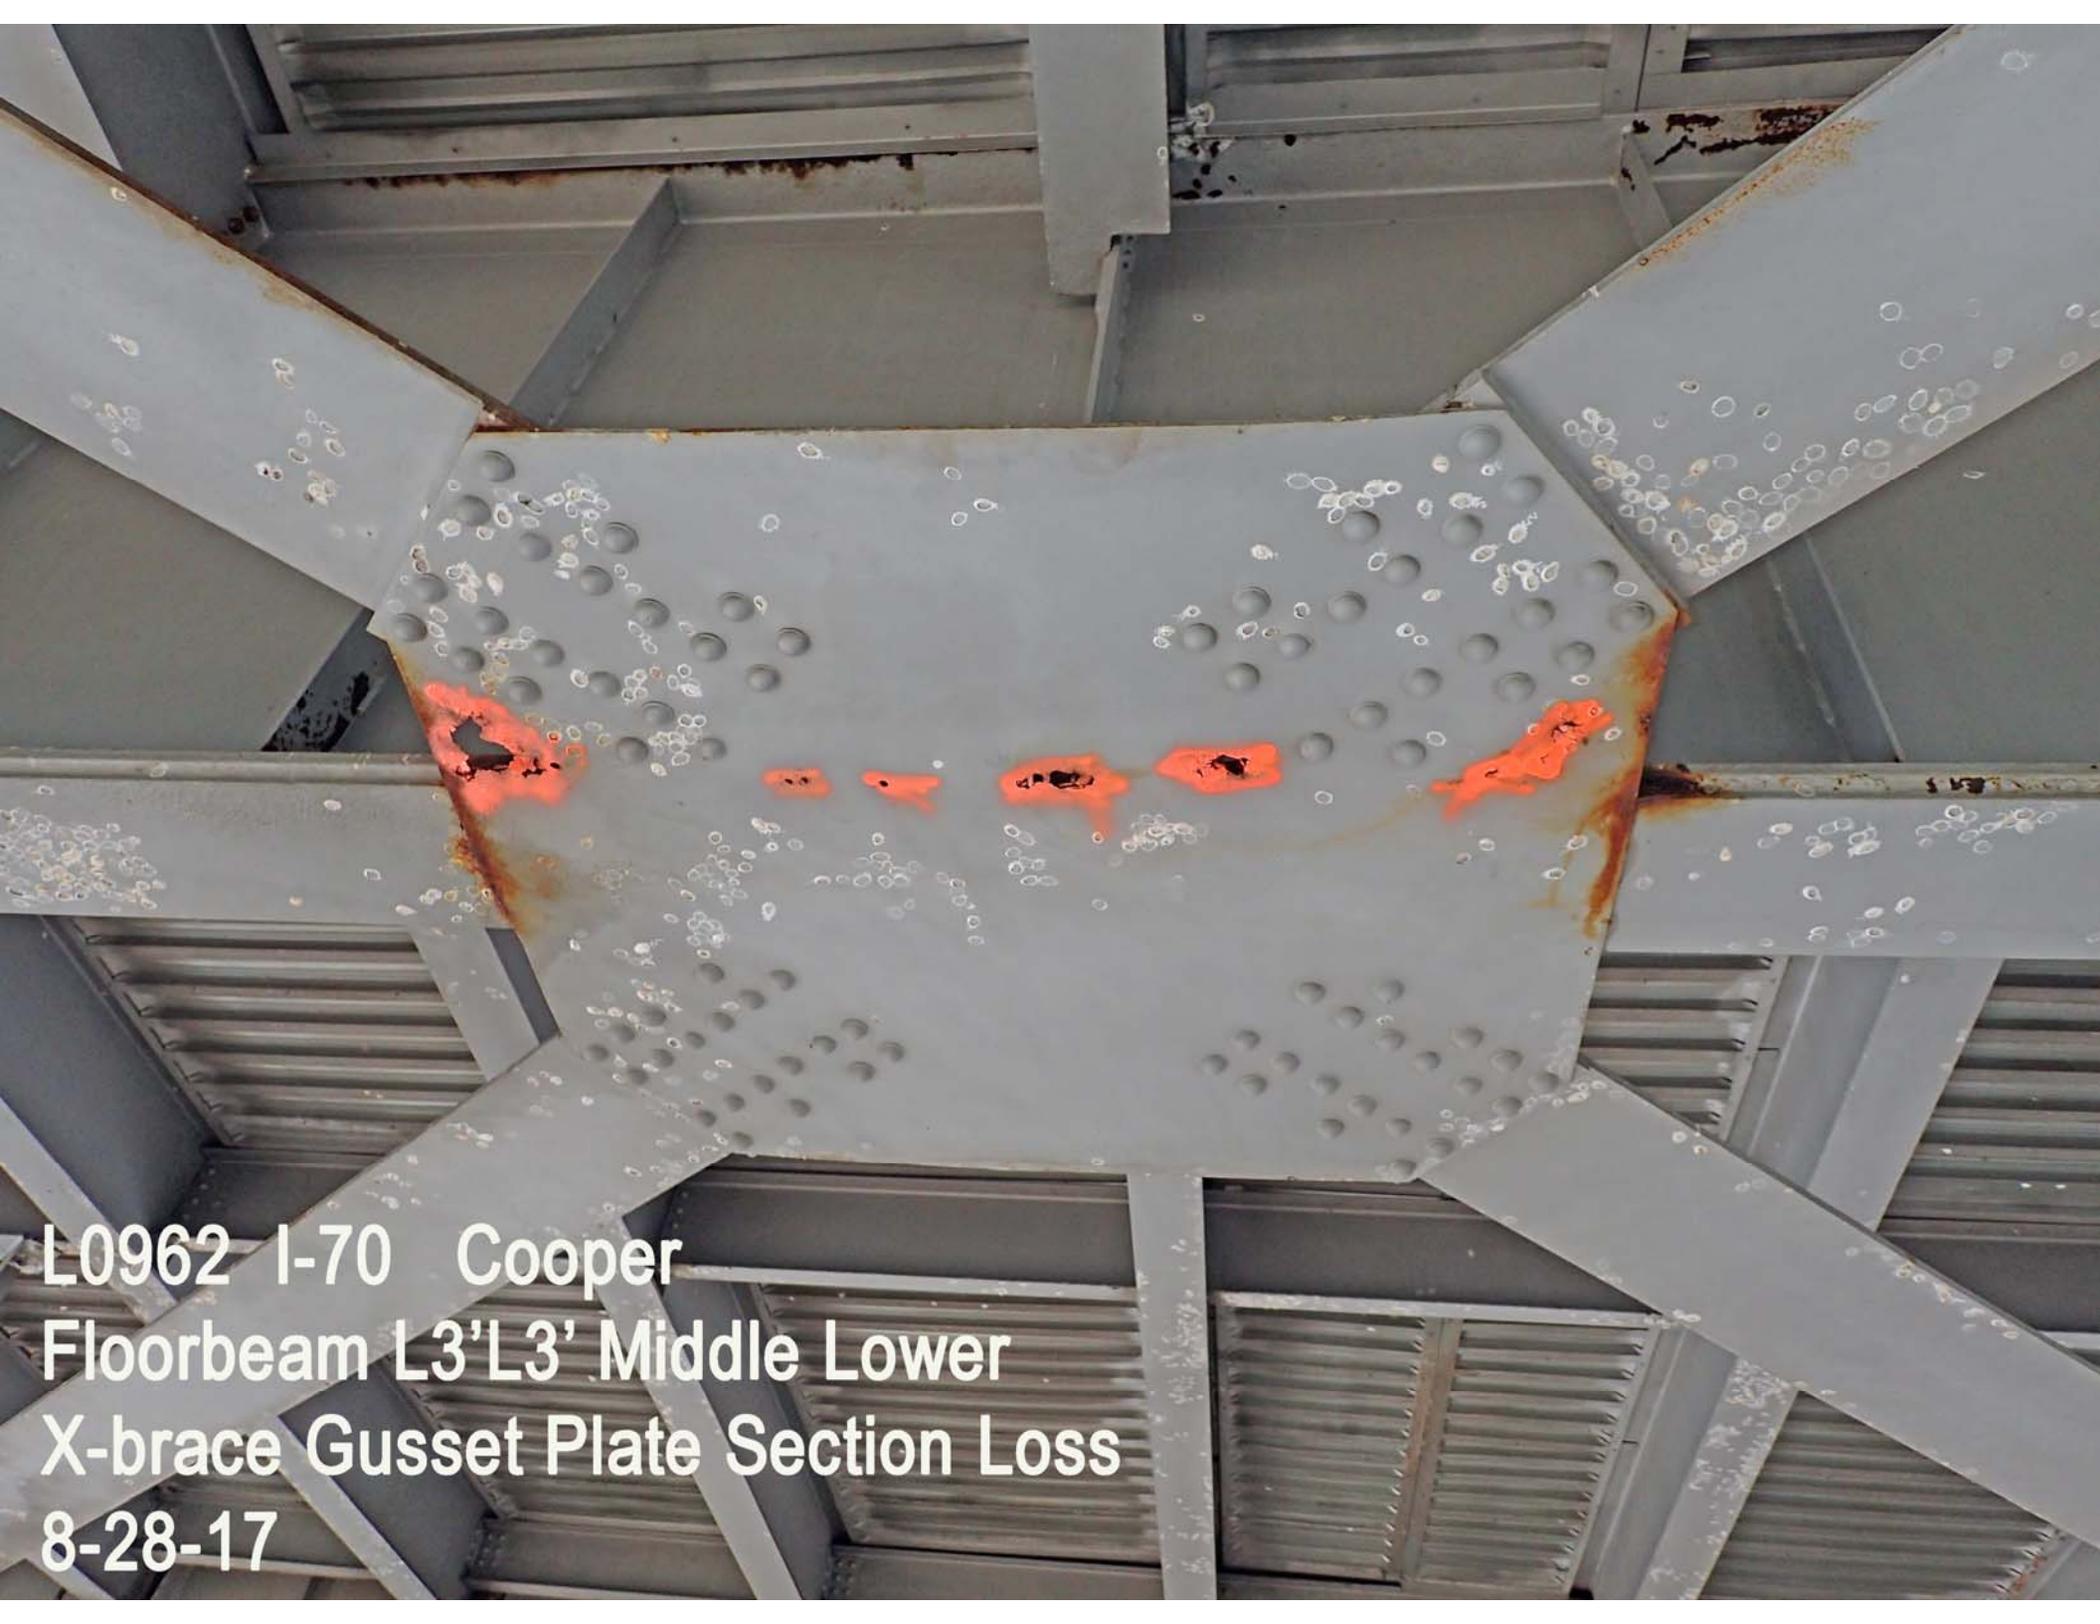
L0962 I-70 Cooper
Floorbeam L3'L3' Middle Lower
X-brace Gusset Plate Section Loss
8-28-17

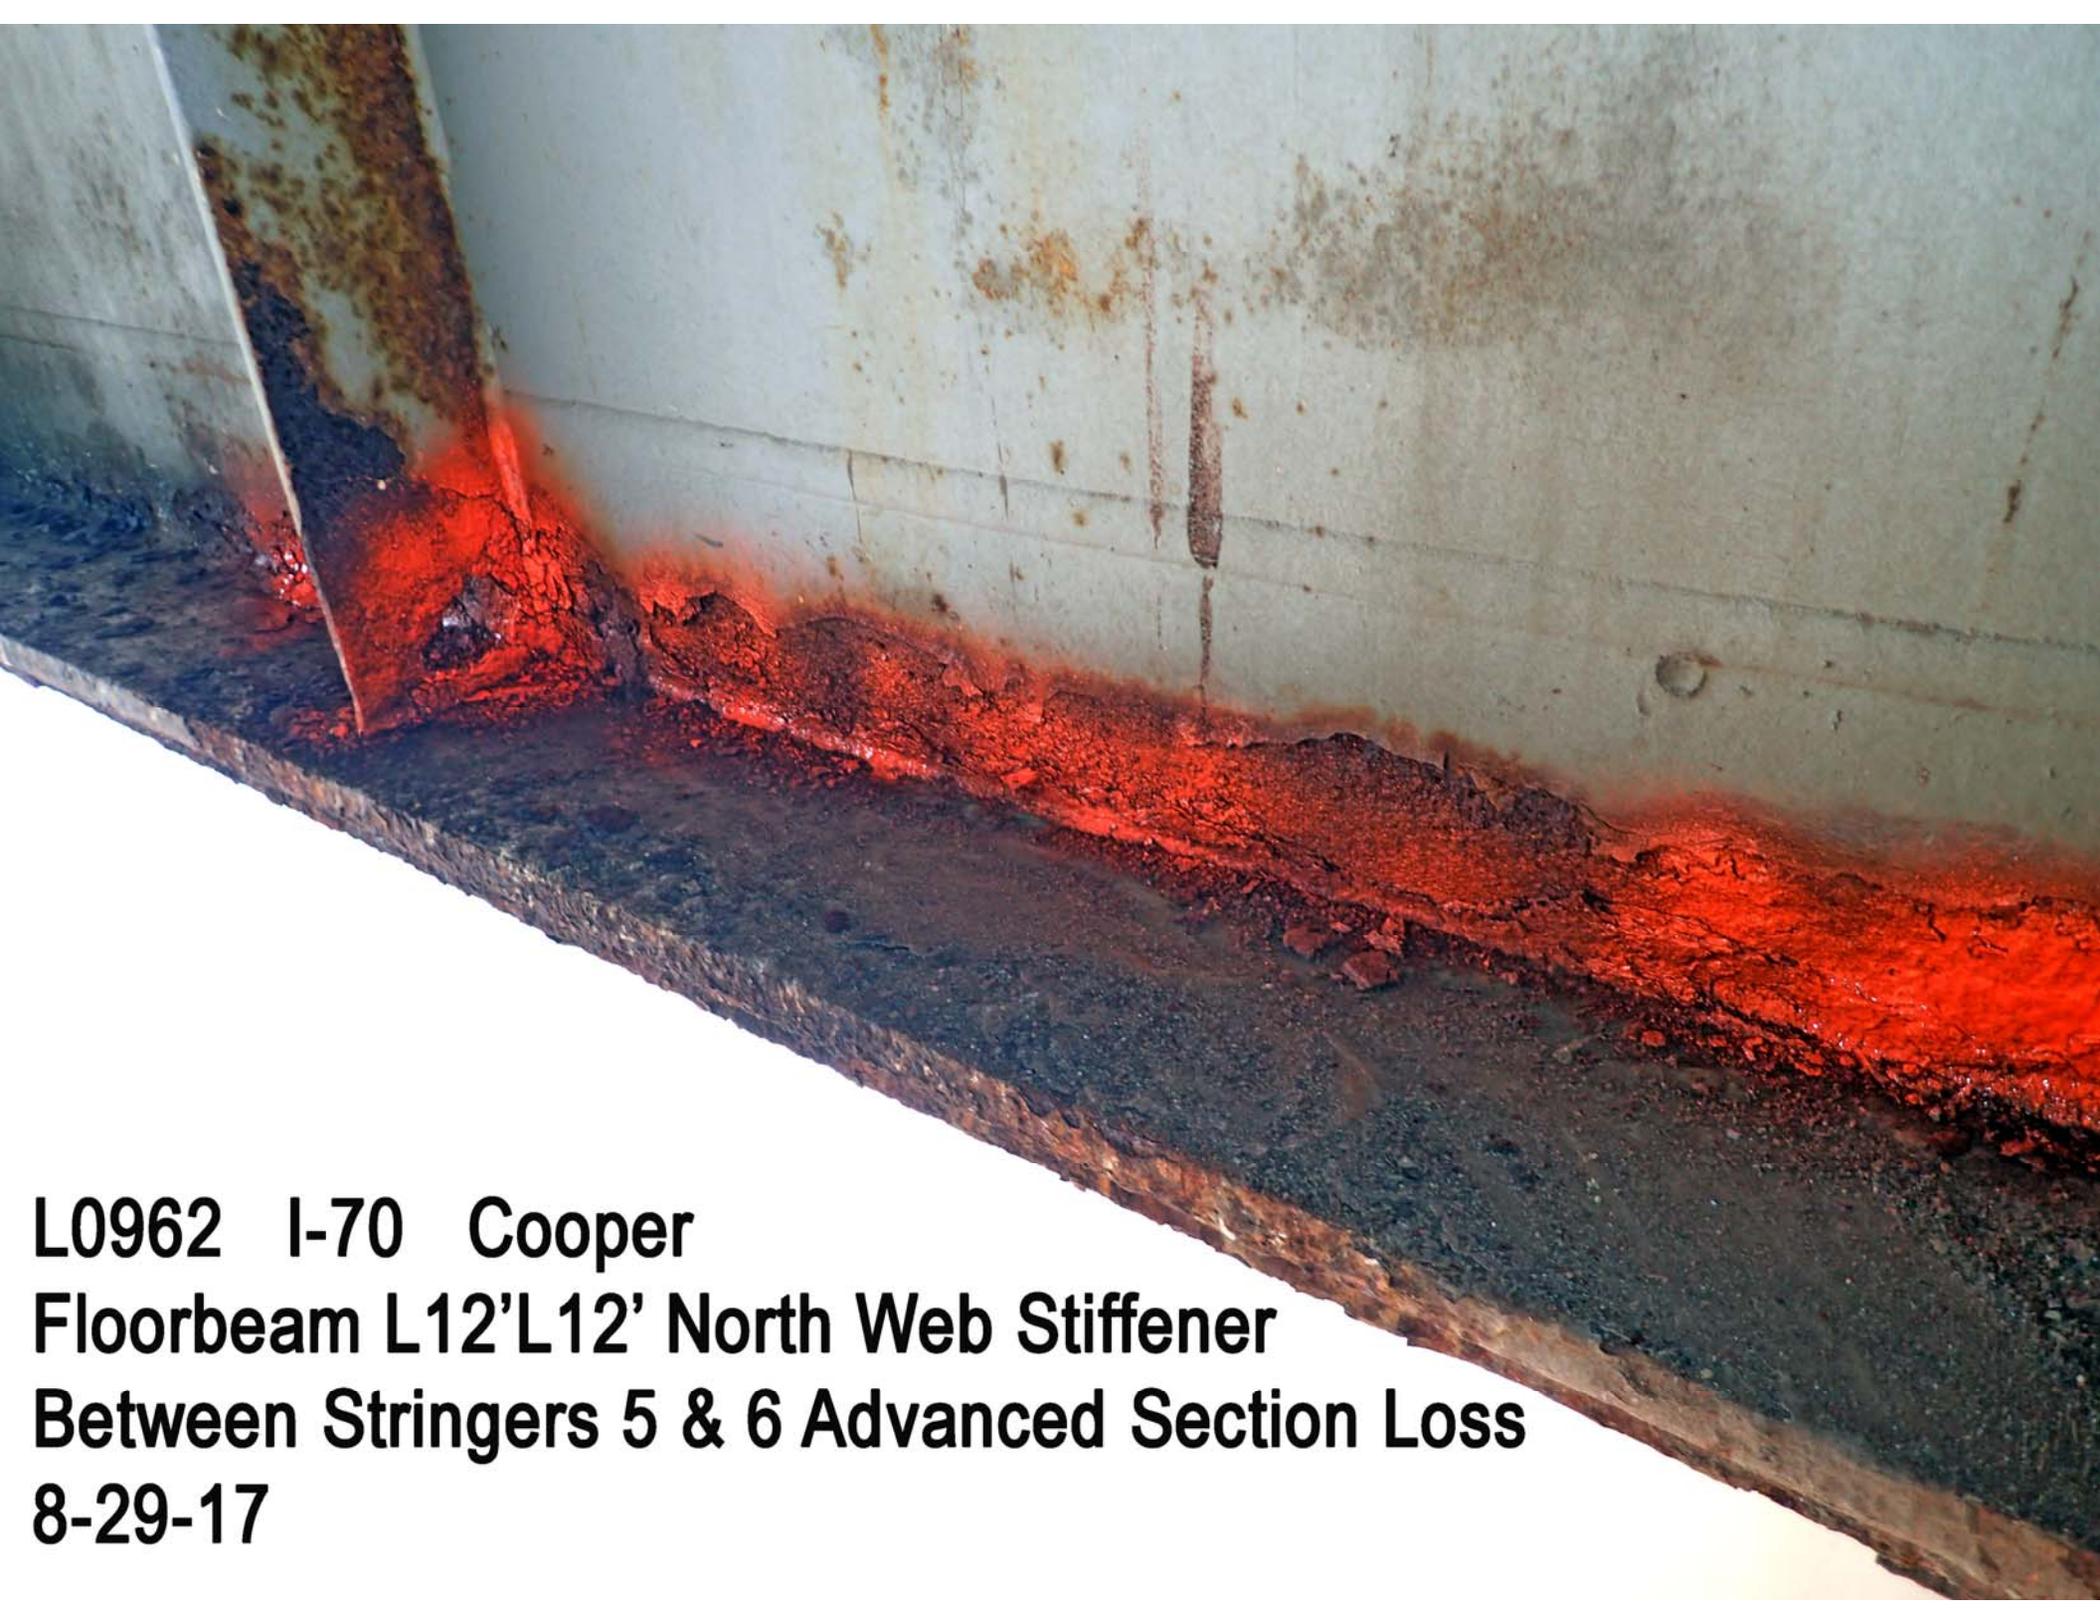
**L0962 I-70 Cooper
Floorbeam L12'L12' North Web Stiffener
Between Stringers 5 & 6 Advanced Section Loss
8-29-17**

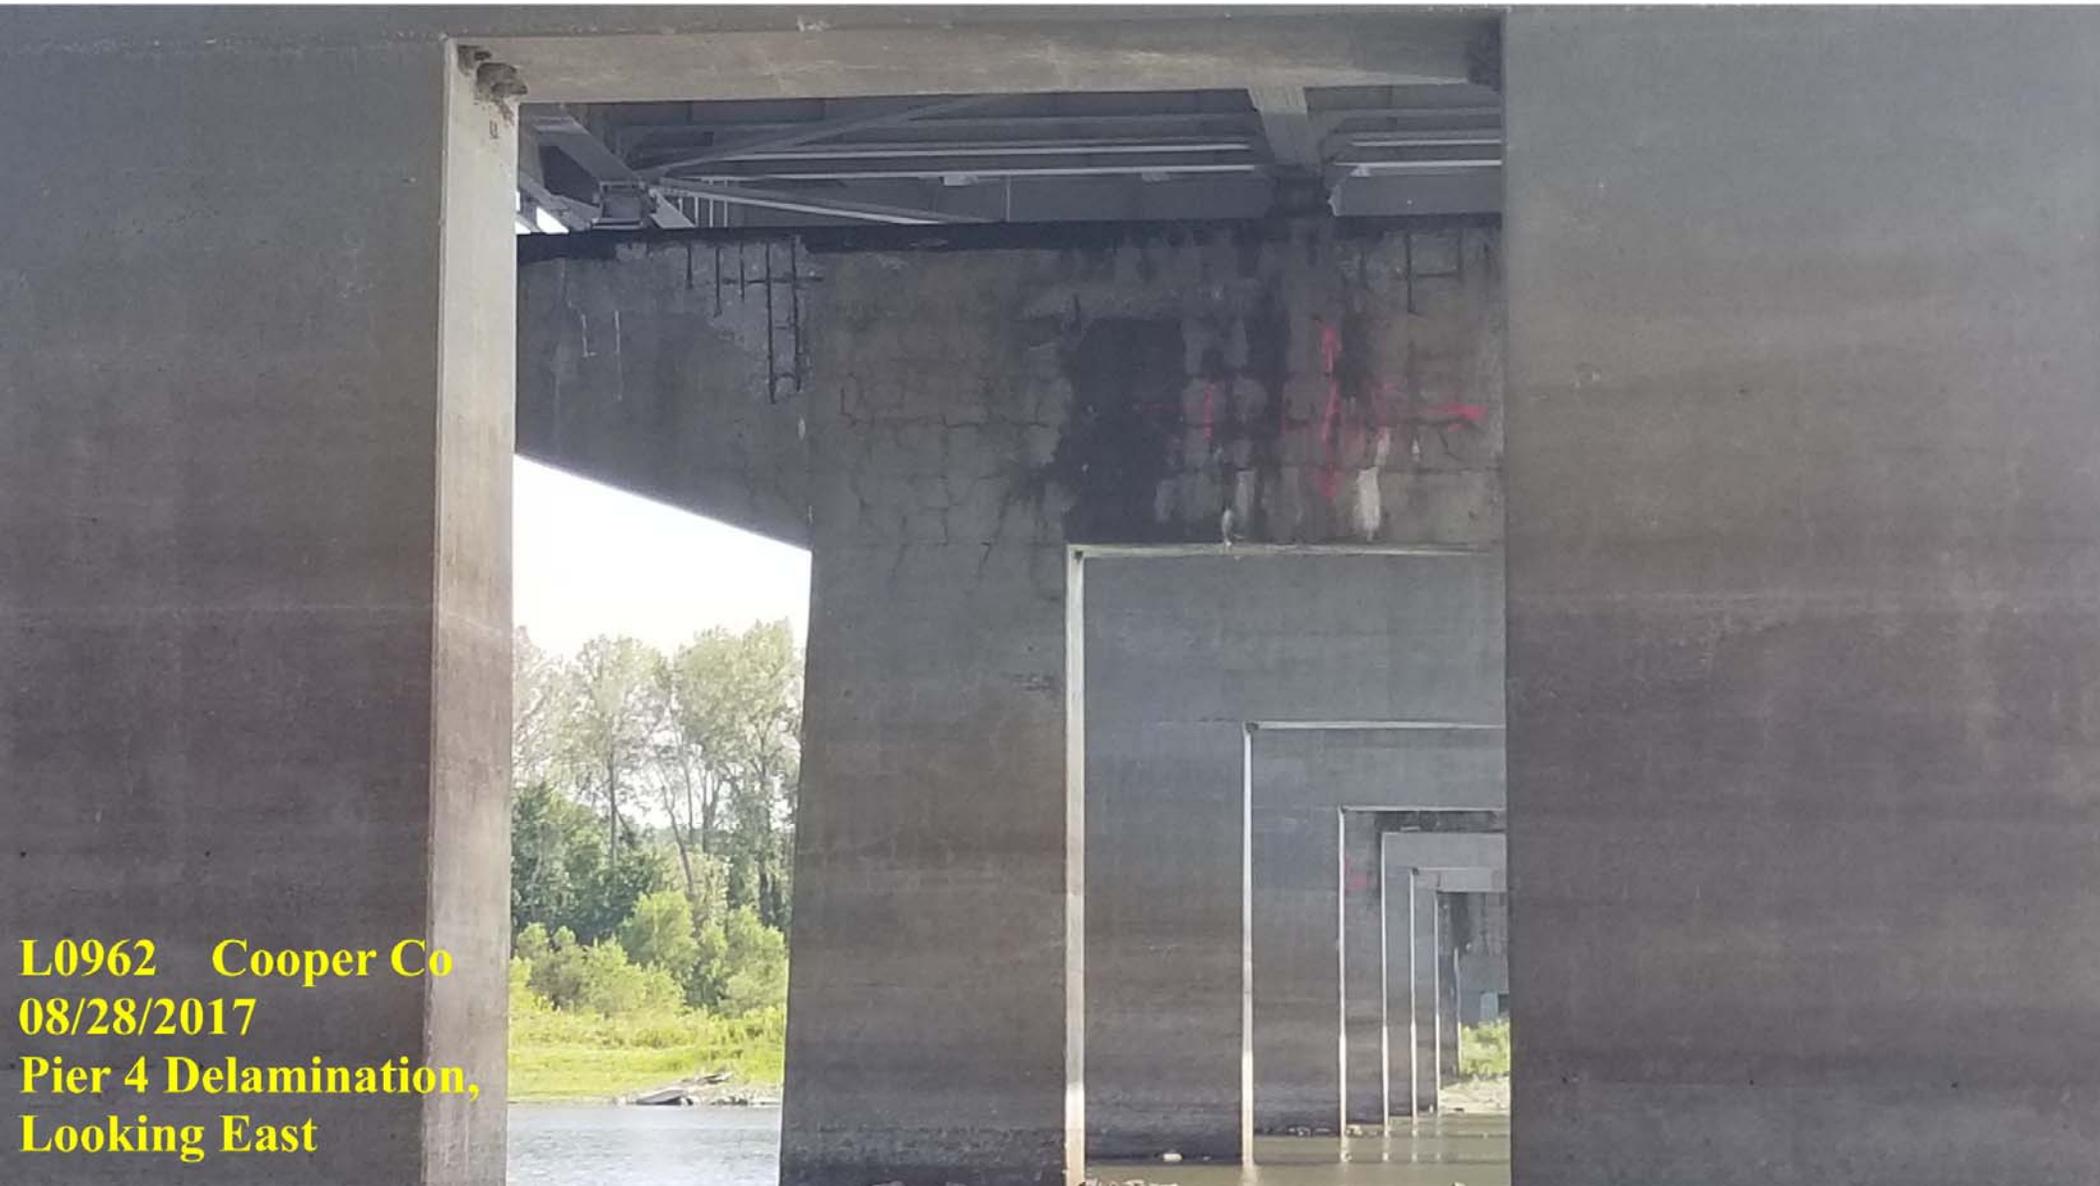
**L0962 Cooper Co
08/28/2017
Pier 4 Delamination,
Looking East**

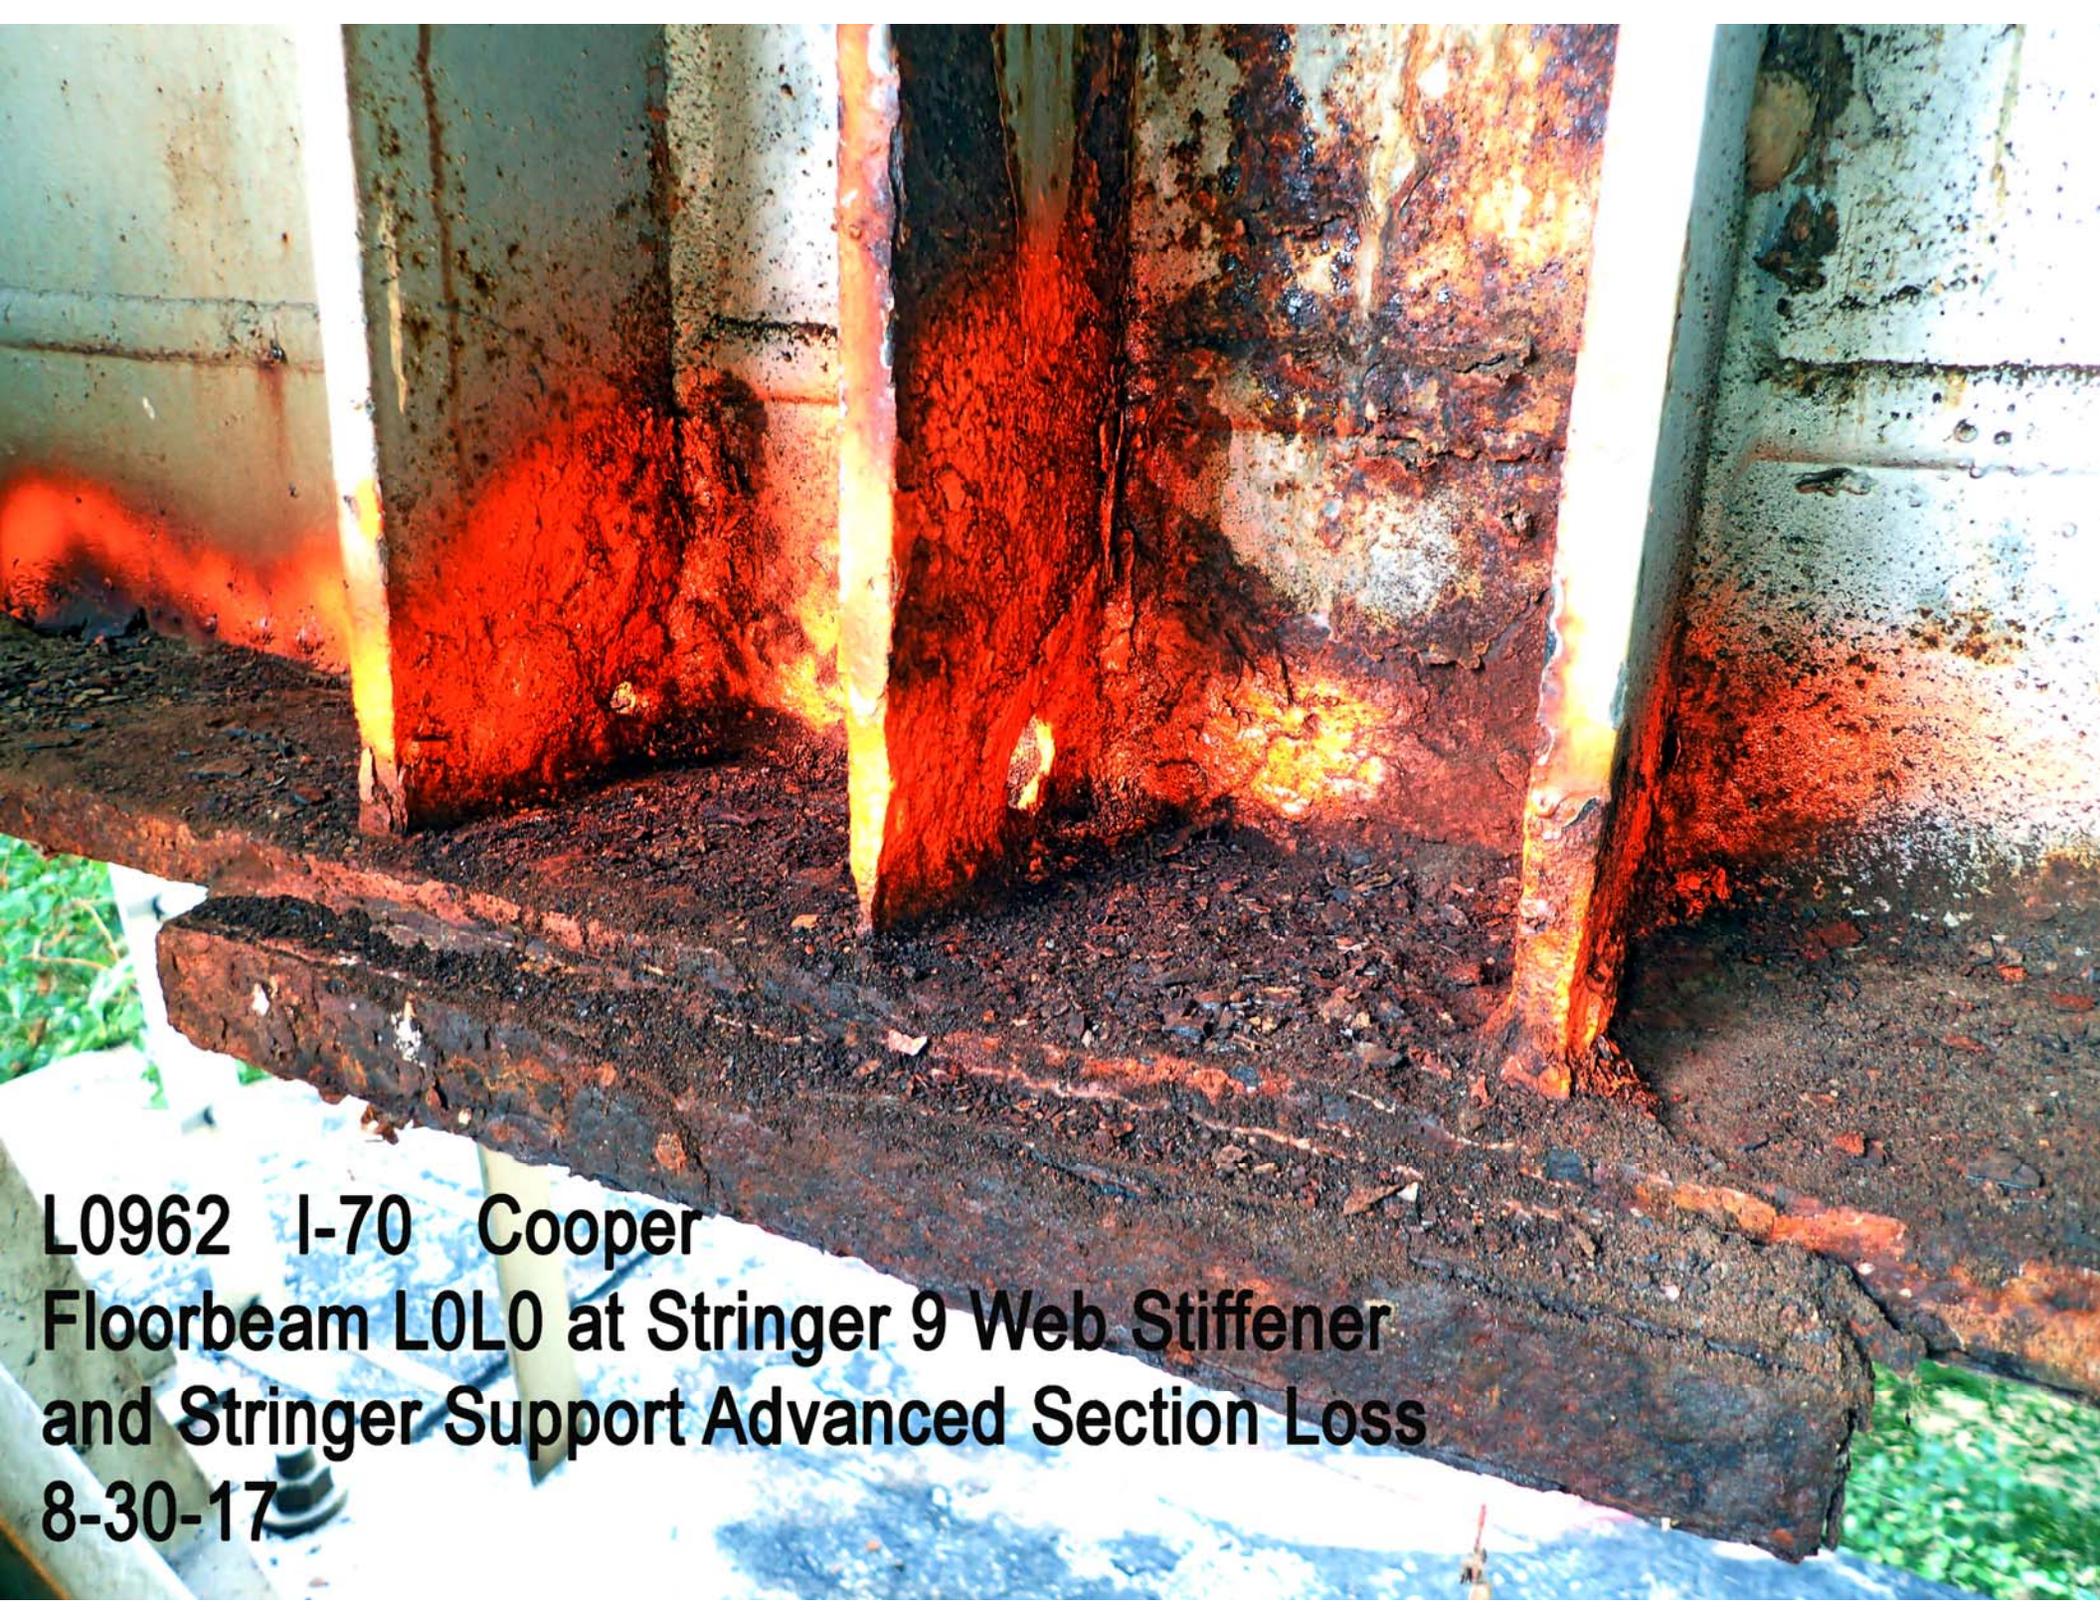
**L0962 I-70 Cooper
Floorbeam L0L0 at Stringer 9 Web Stiffener
and Stringer Support Advanced Section Loss
8-30-17**

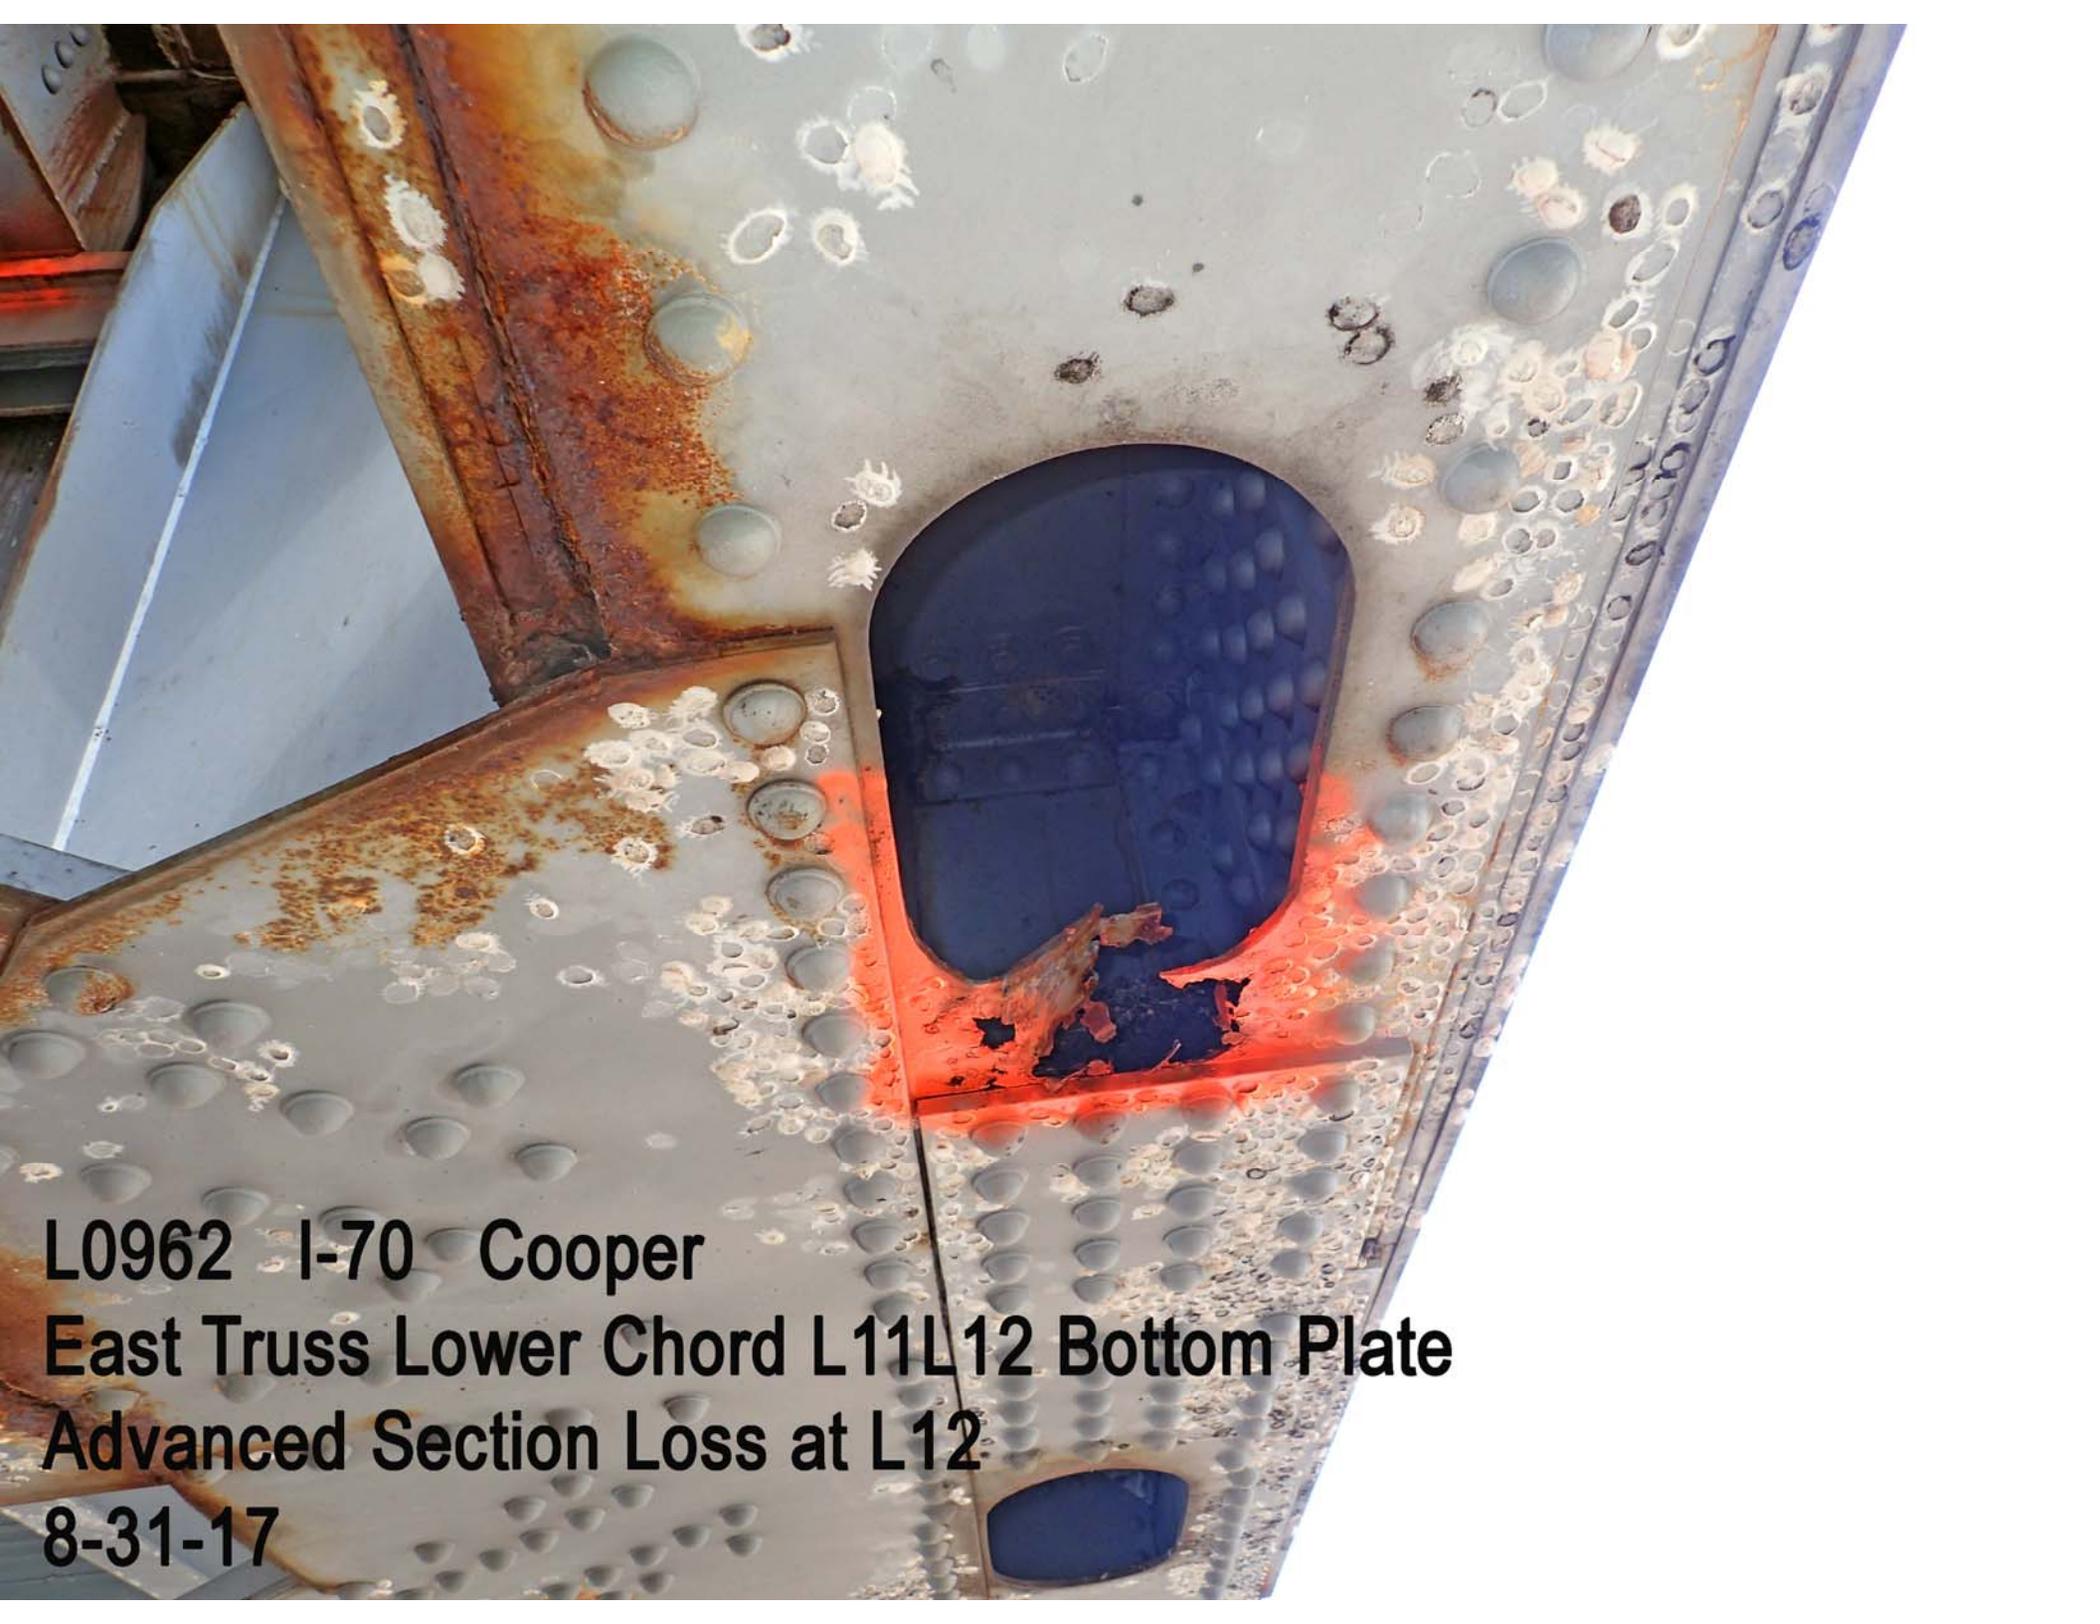
**L0962 I-70 Cooper
East Truss Lower Chord L11L12 Bottom Plate
Advanced Section Loss at L12
8-31-17**

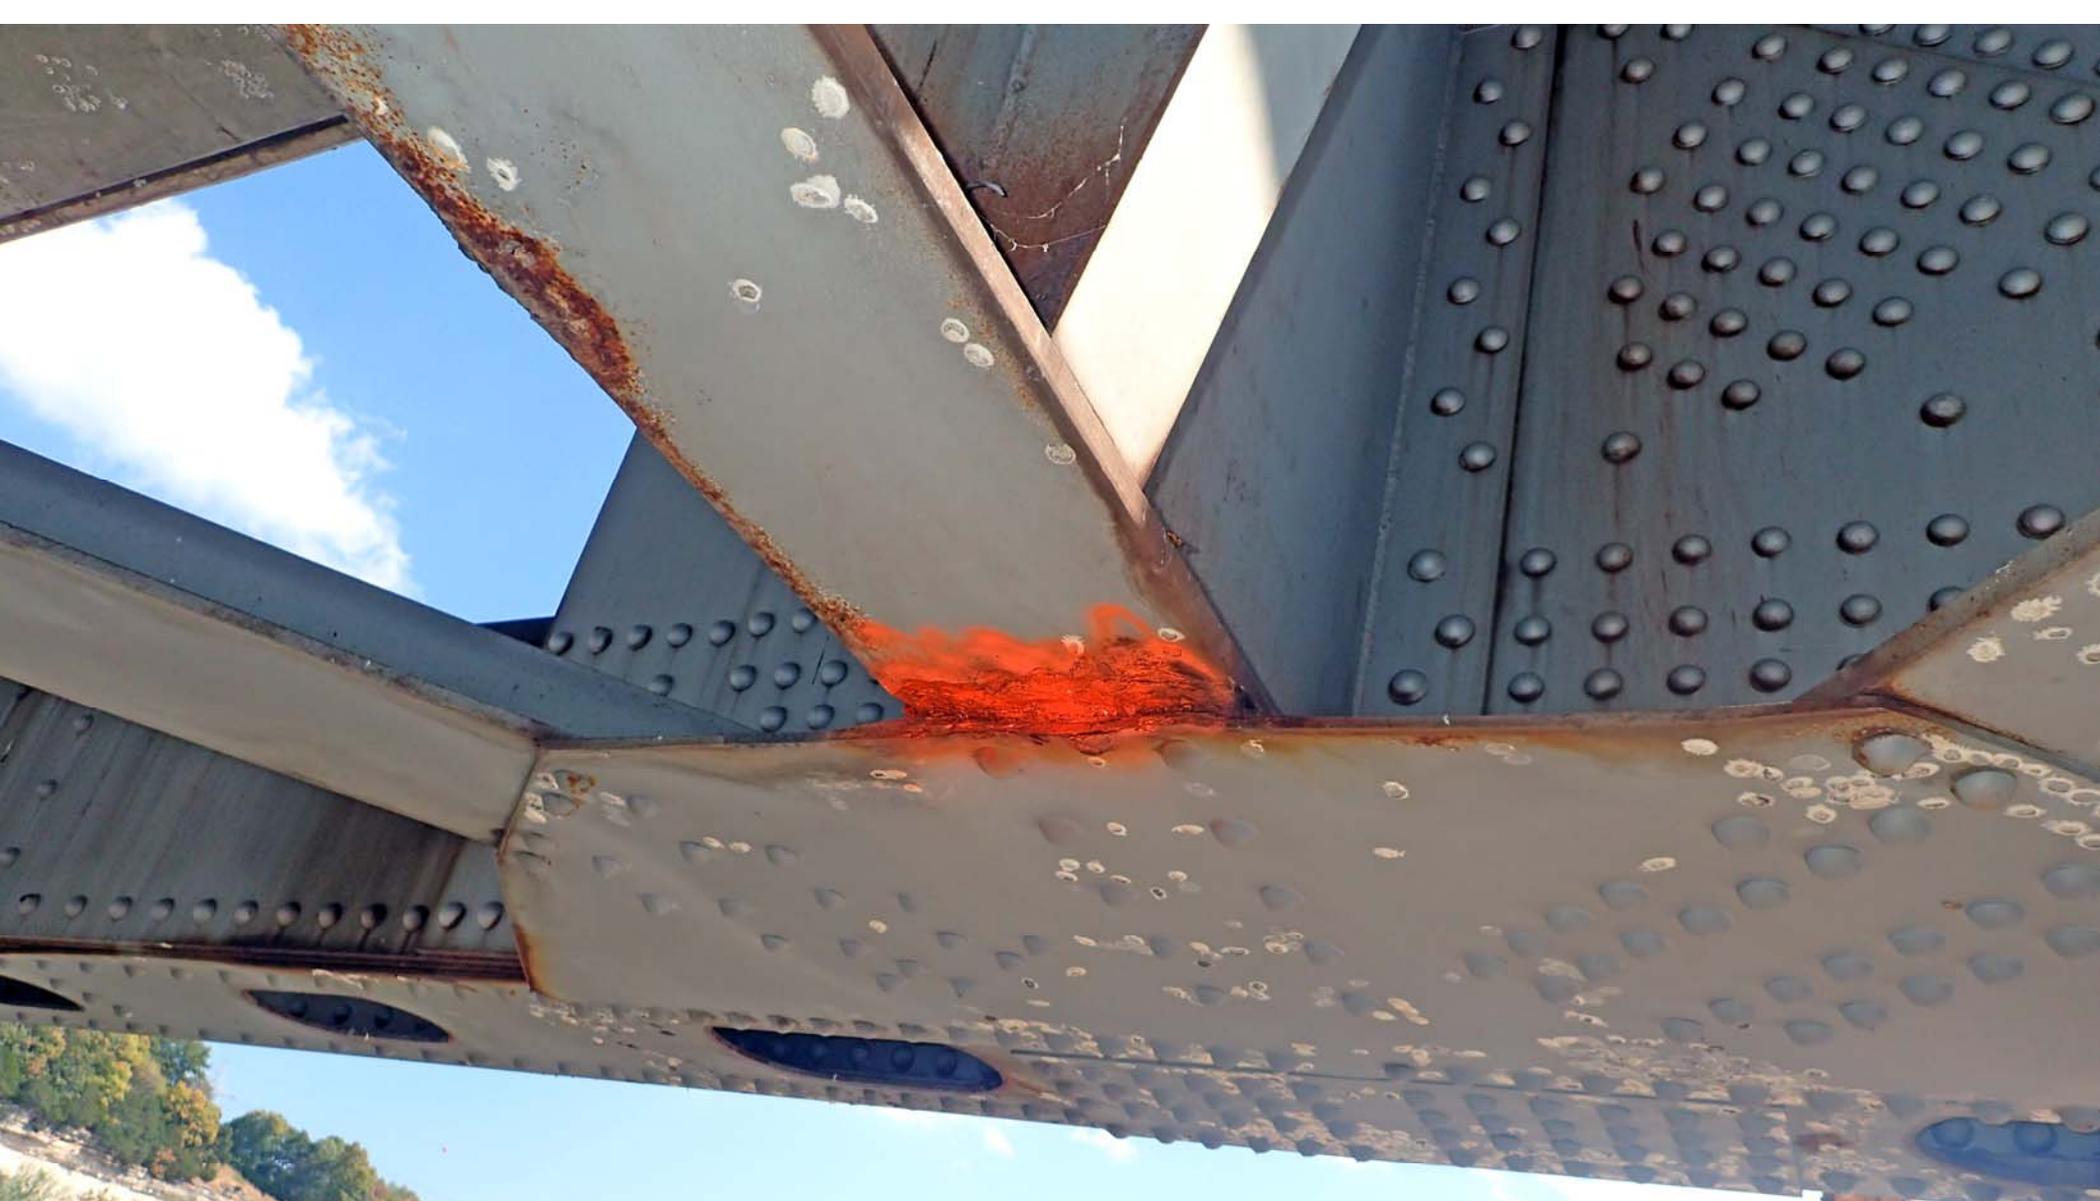
**L0962 I-70 Cooper
Floorbeam L16'L16' East End
Bottom Flange Heavy Section Loss
10-2-17**

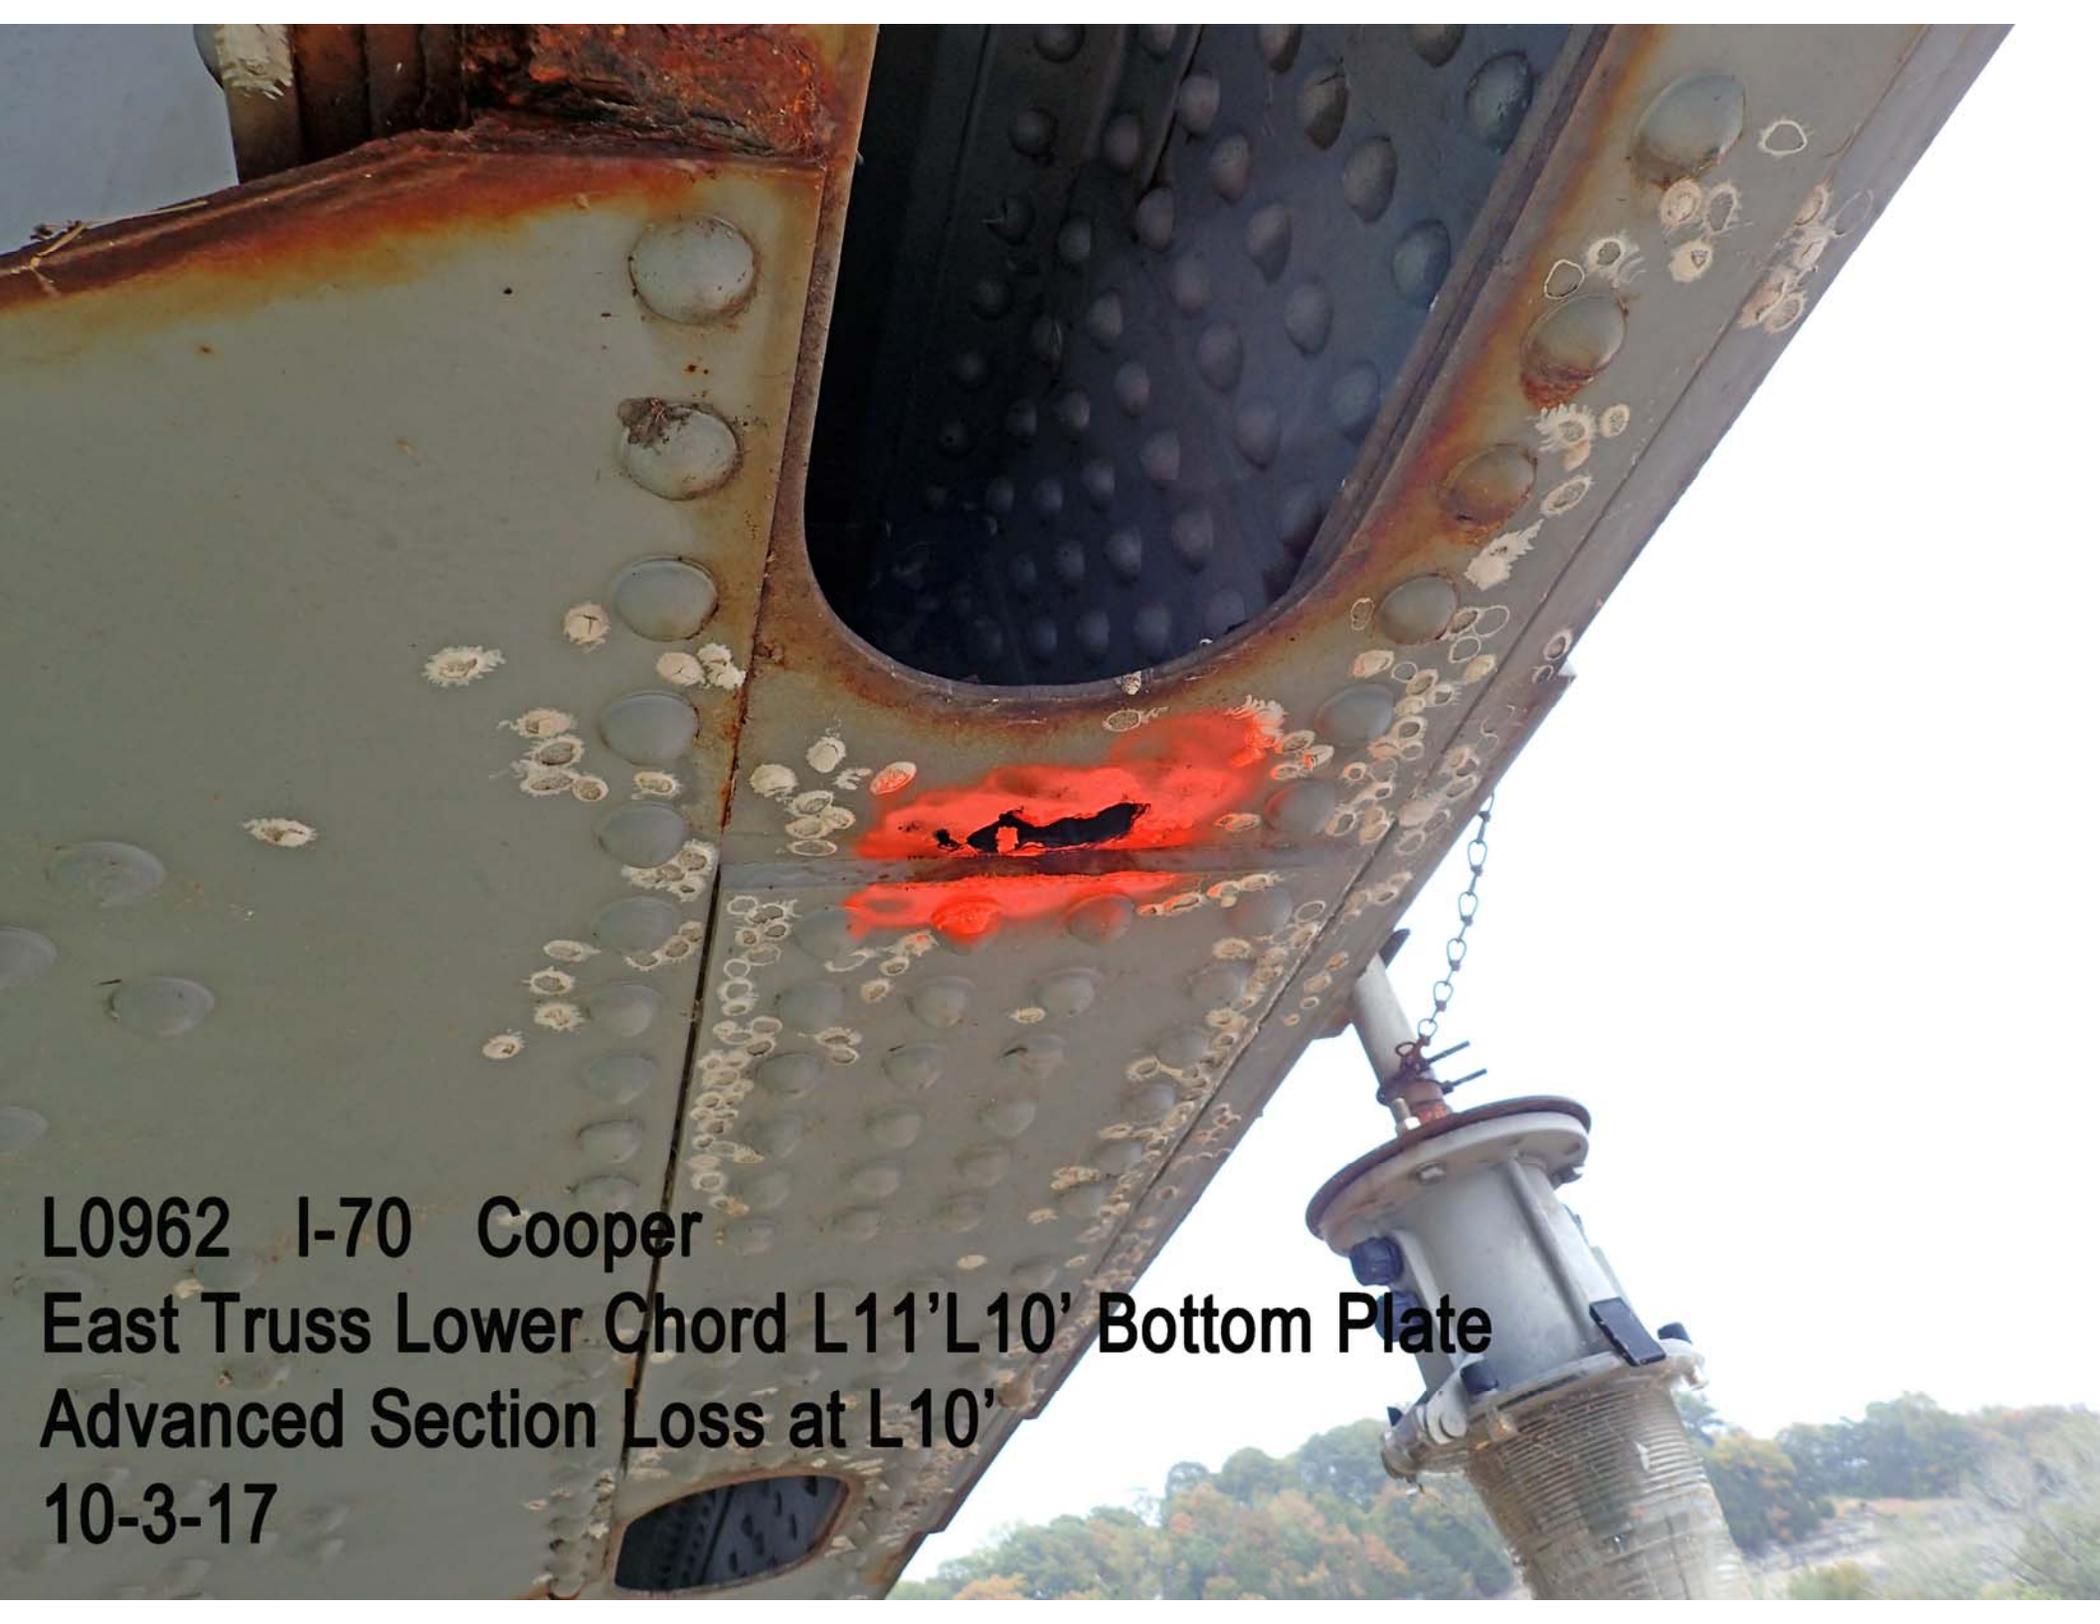
**L0962 I-70 Cooper
East Truss Lower Chord L11'L10' Bottom Plate
Advanced Section Loss at L10'
10-3-17**
