251 MISSOURI BRIDGES PROJECT

MoDOT Bridge Inspection Report

**Missouri Department of Transportation
Bridge Inventory and Inspection System
Structural Inventory & Appraisal Sheet**

COUNTY : COOPER	BRIDGE : L0962 2	REVIEW STATUS : REVIEW	NBI STATUS : T
RECORD TYPE : ROUTE CARRIED 'ON' STRUCT		RUN DATE : 11/28/2017	SUBMITTAL YEAR : 2017

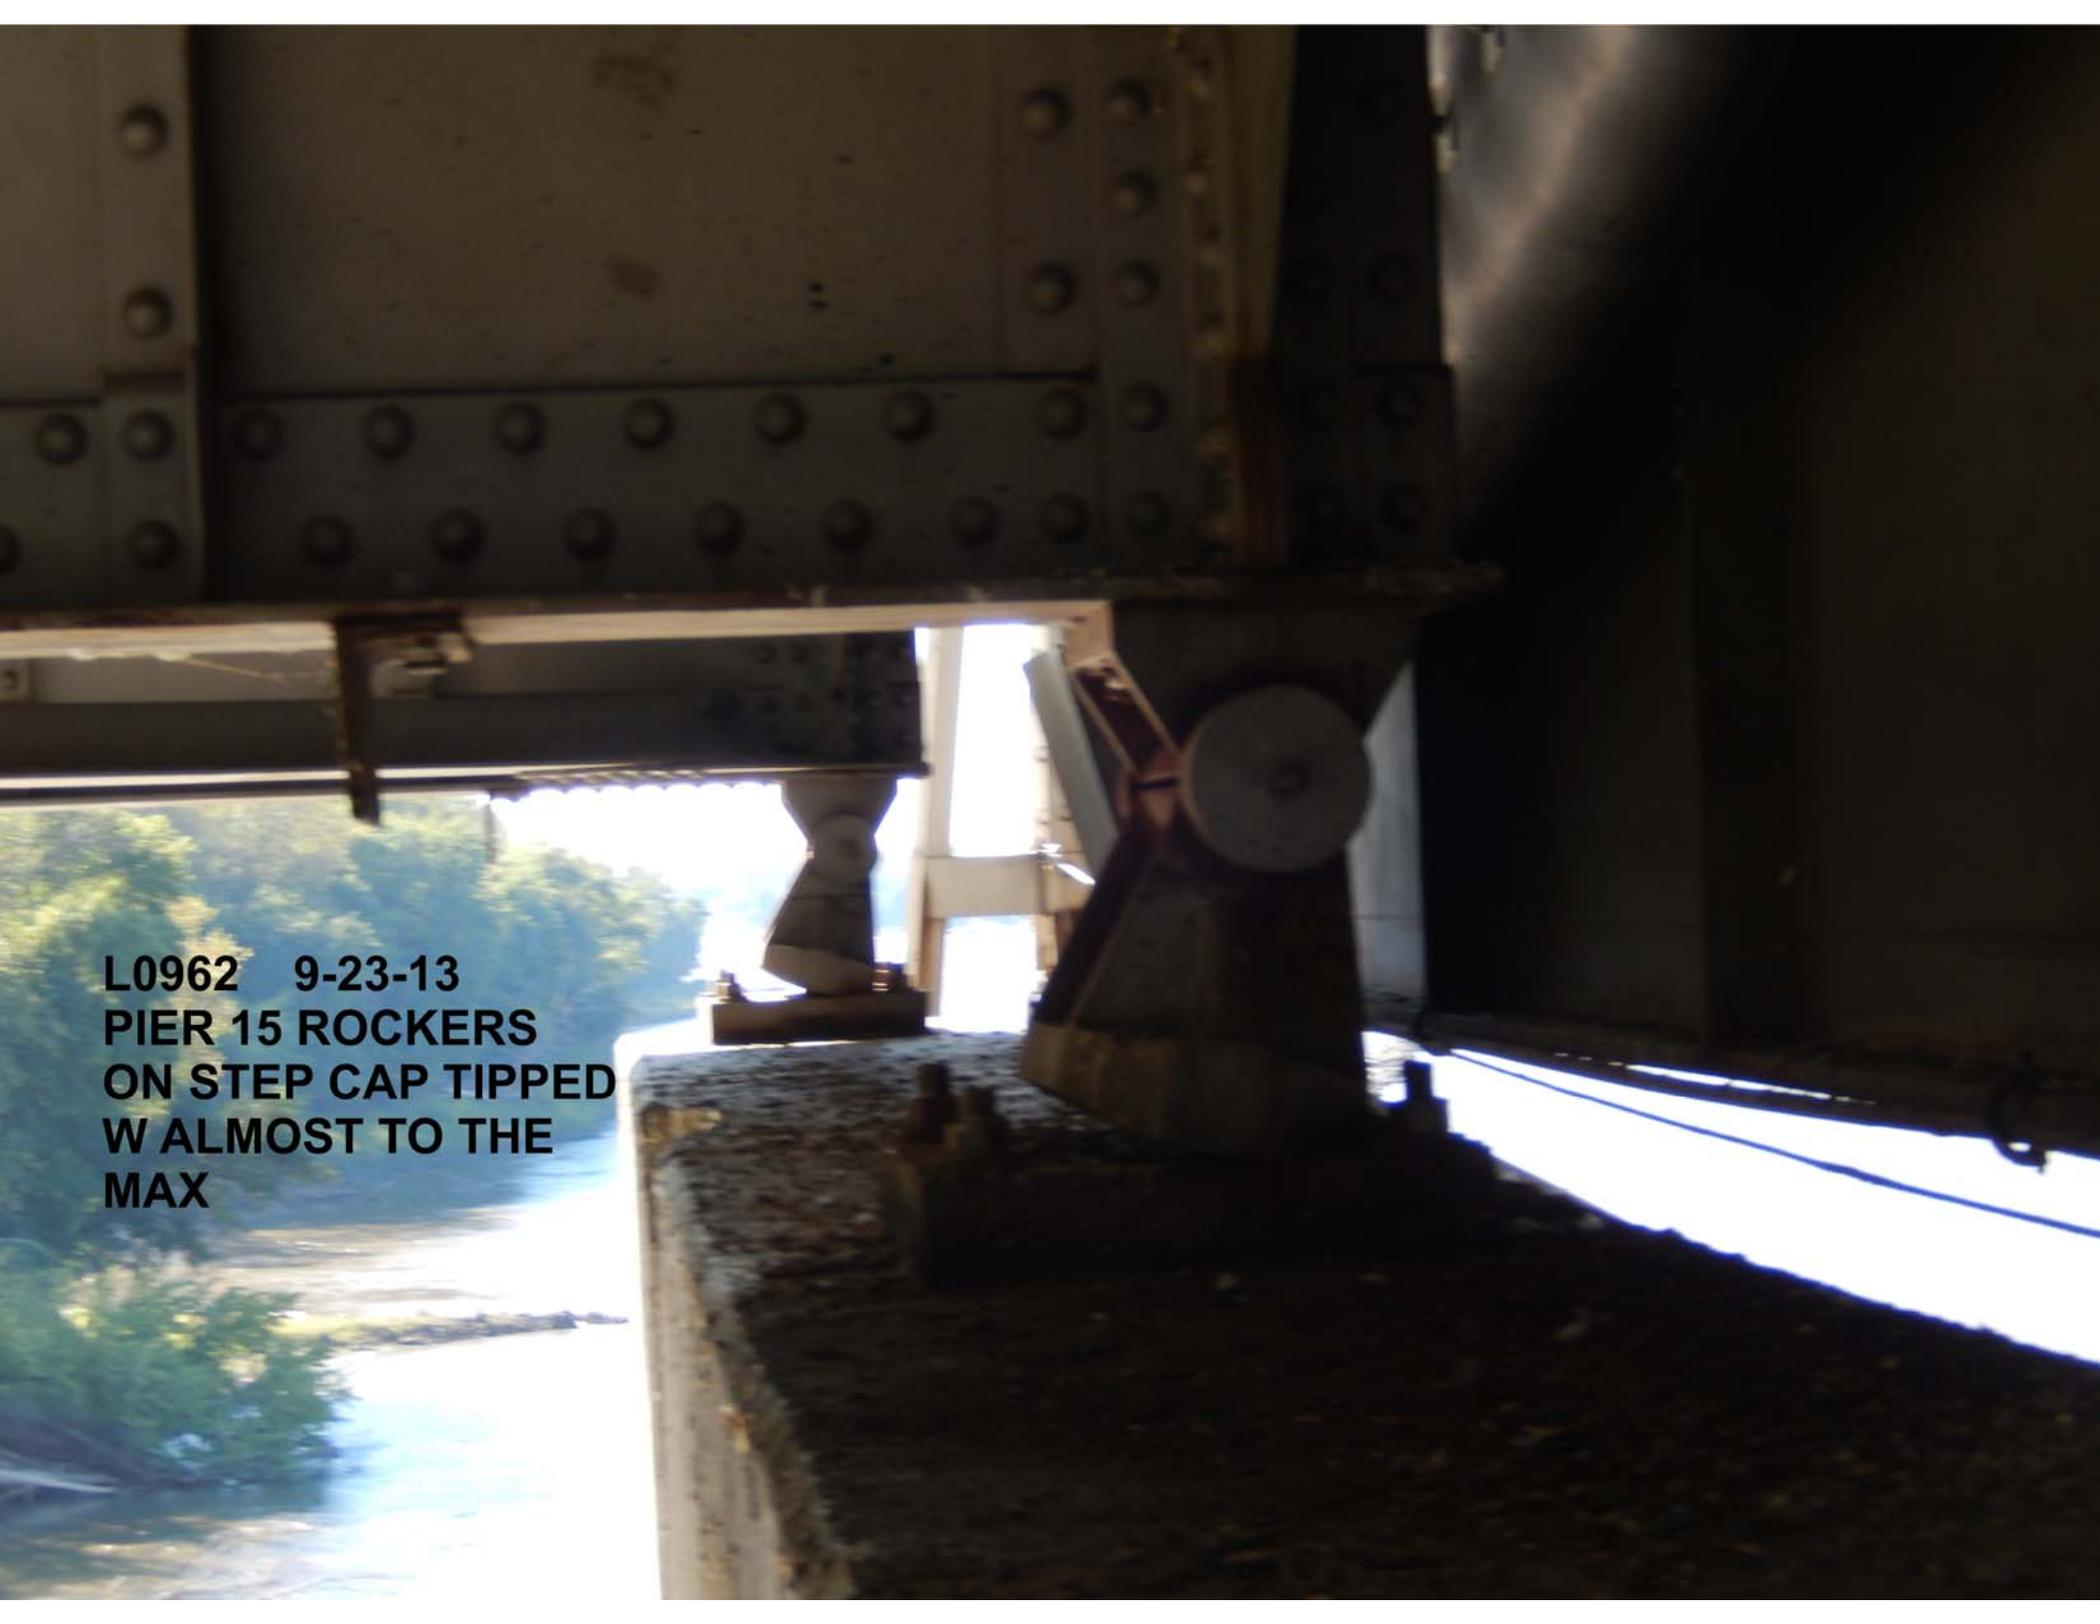
L0962 9-23-13
PIER 15 ROCKERS
ON STEP CAP TIPPED
W ALMOST TO THE
MAX

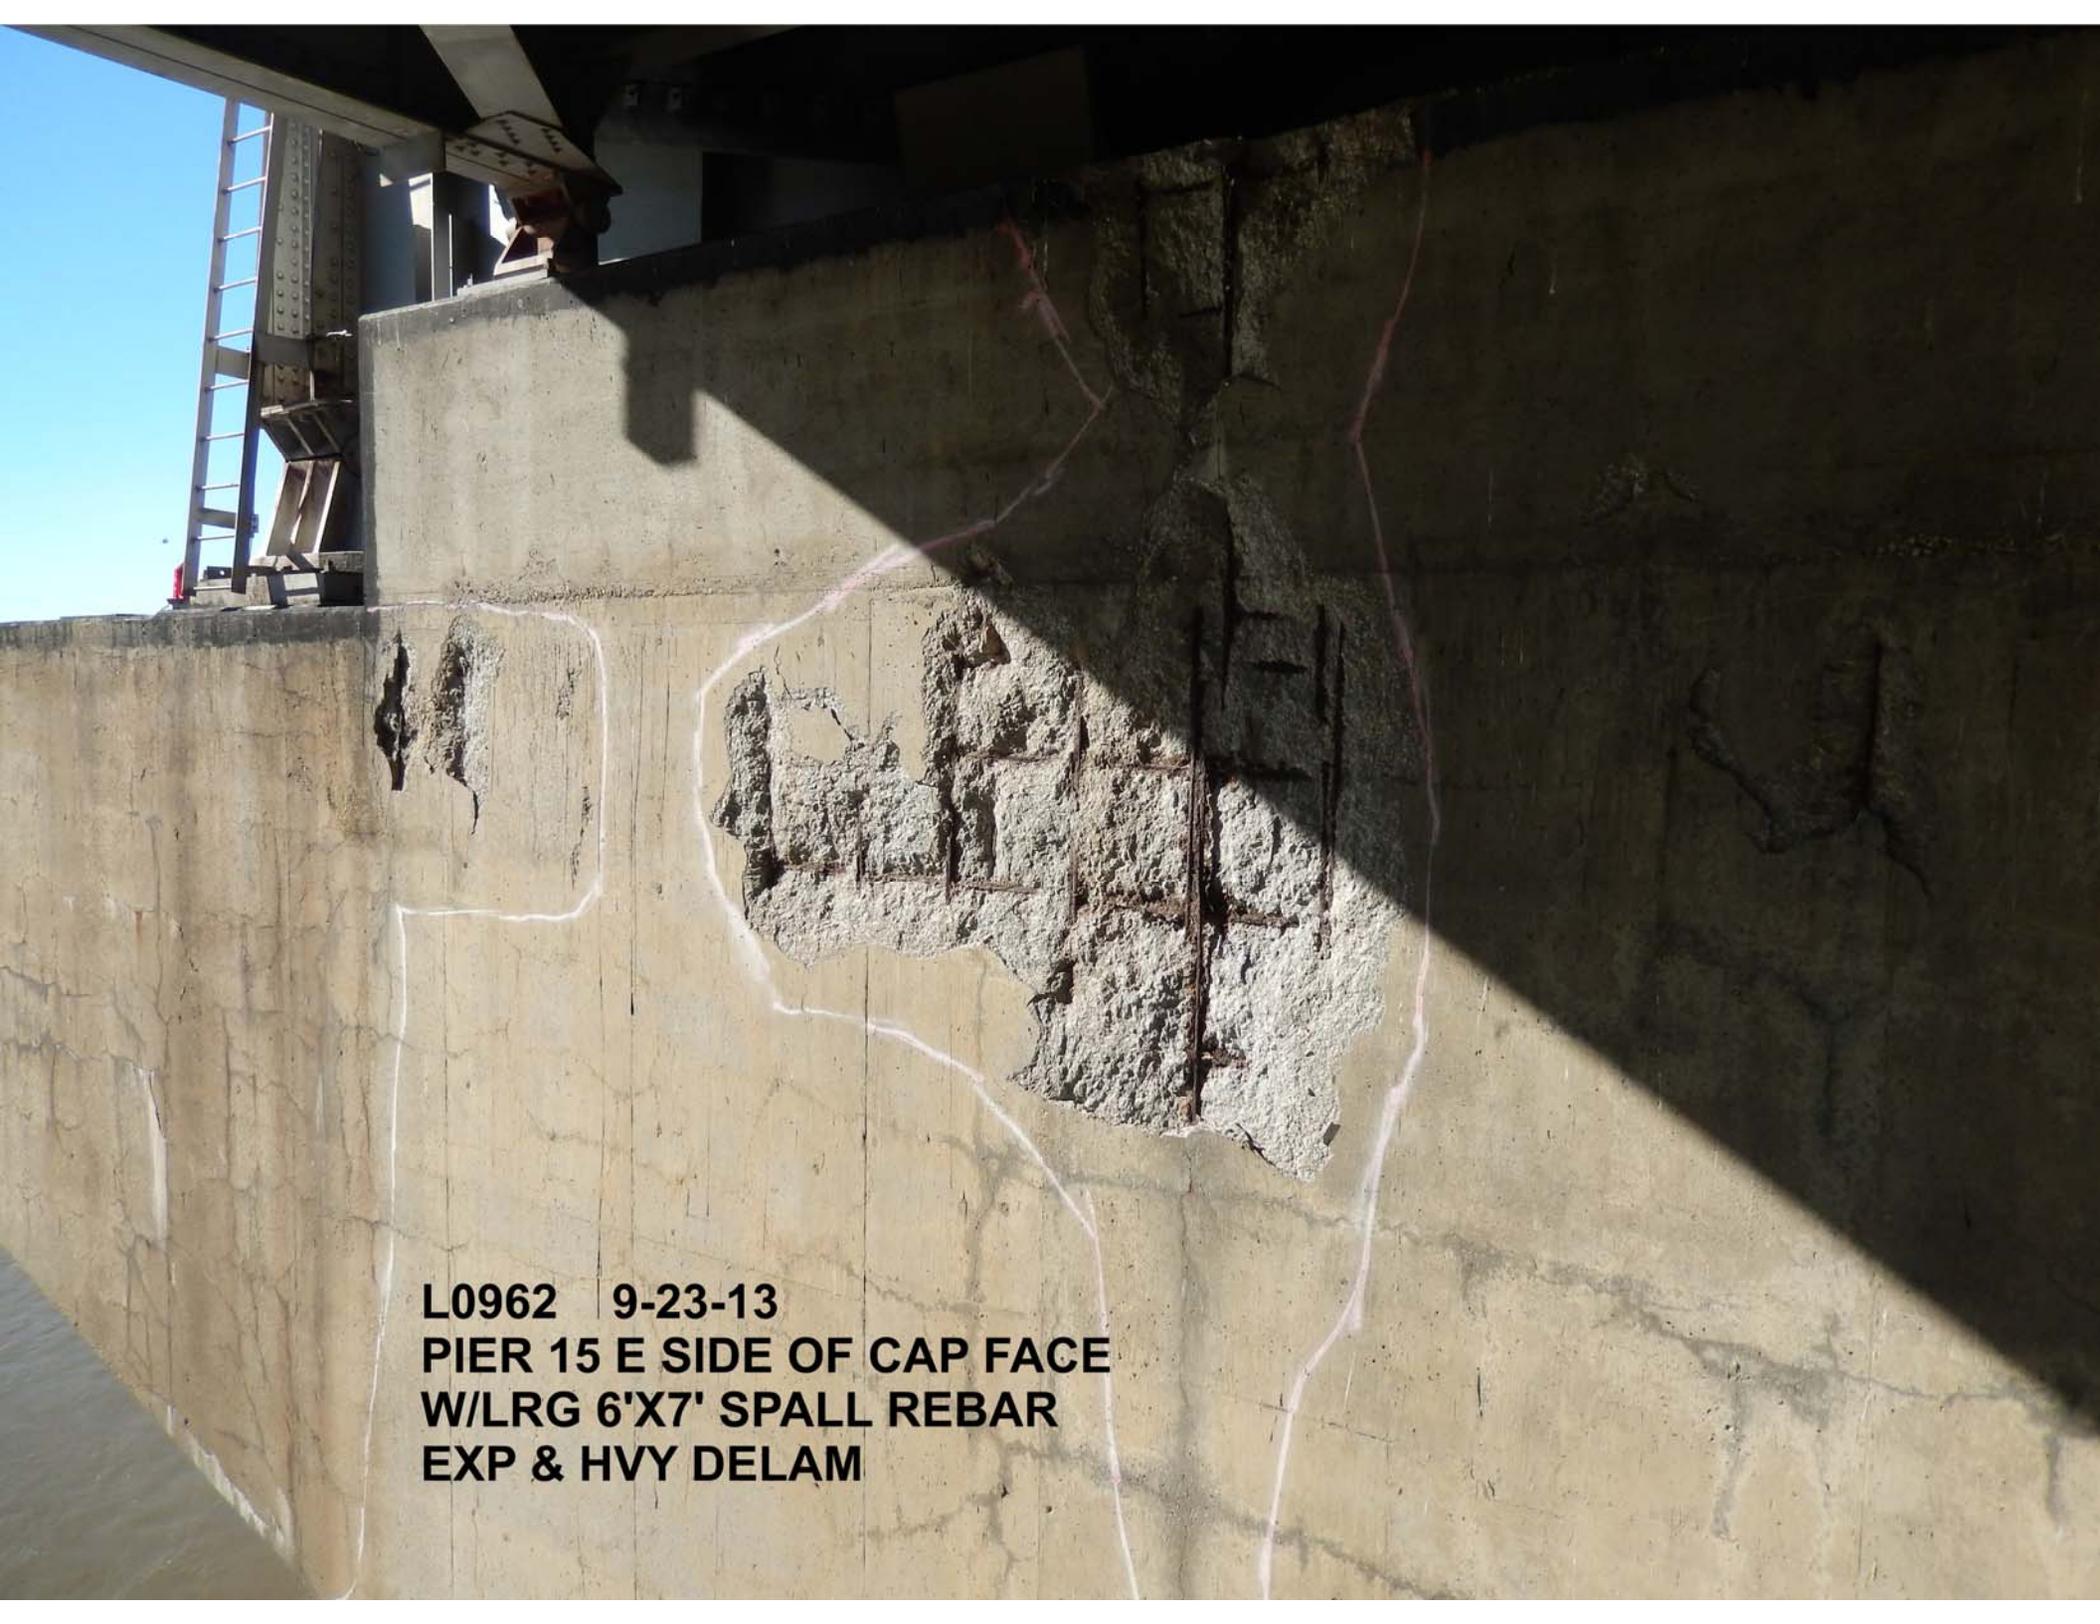
**L0962 9-23-13
PIER 15 E SIDE OF CAP FACE
W/LRG 6'X7' SPALL REBAR
EXP & HVY DELAM**

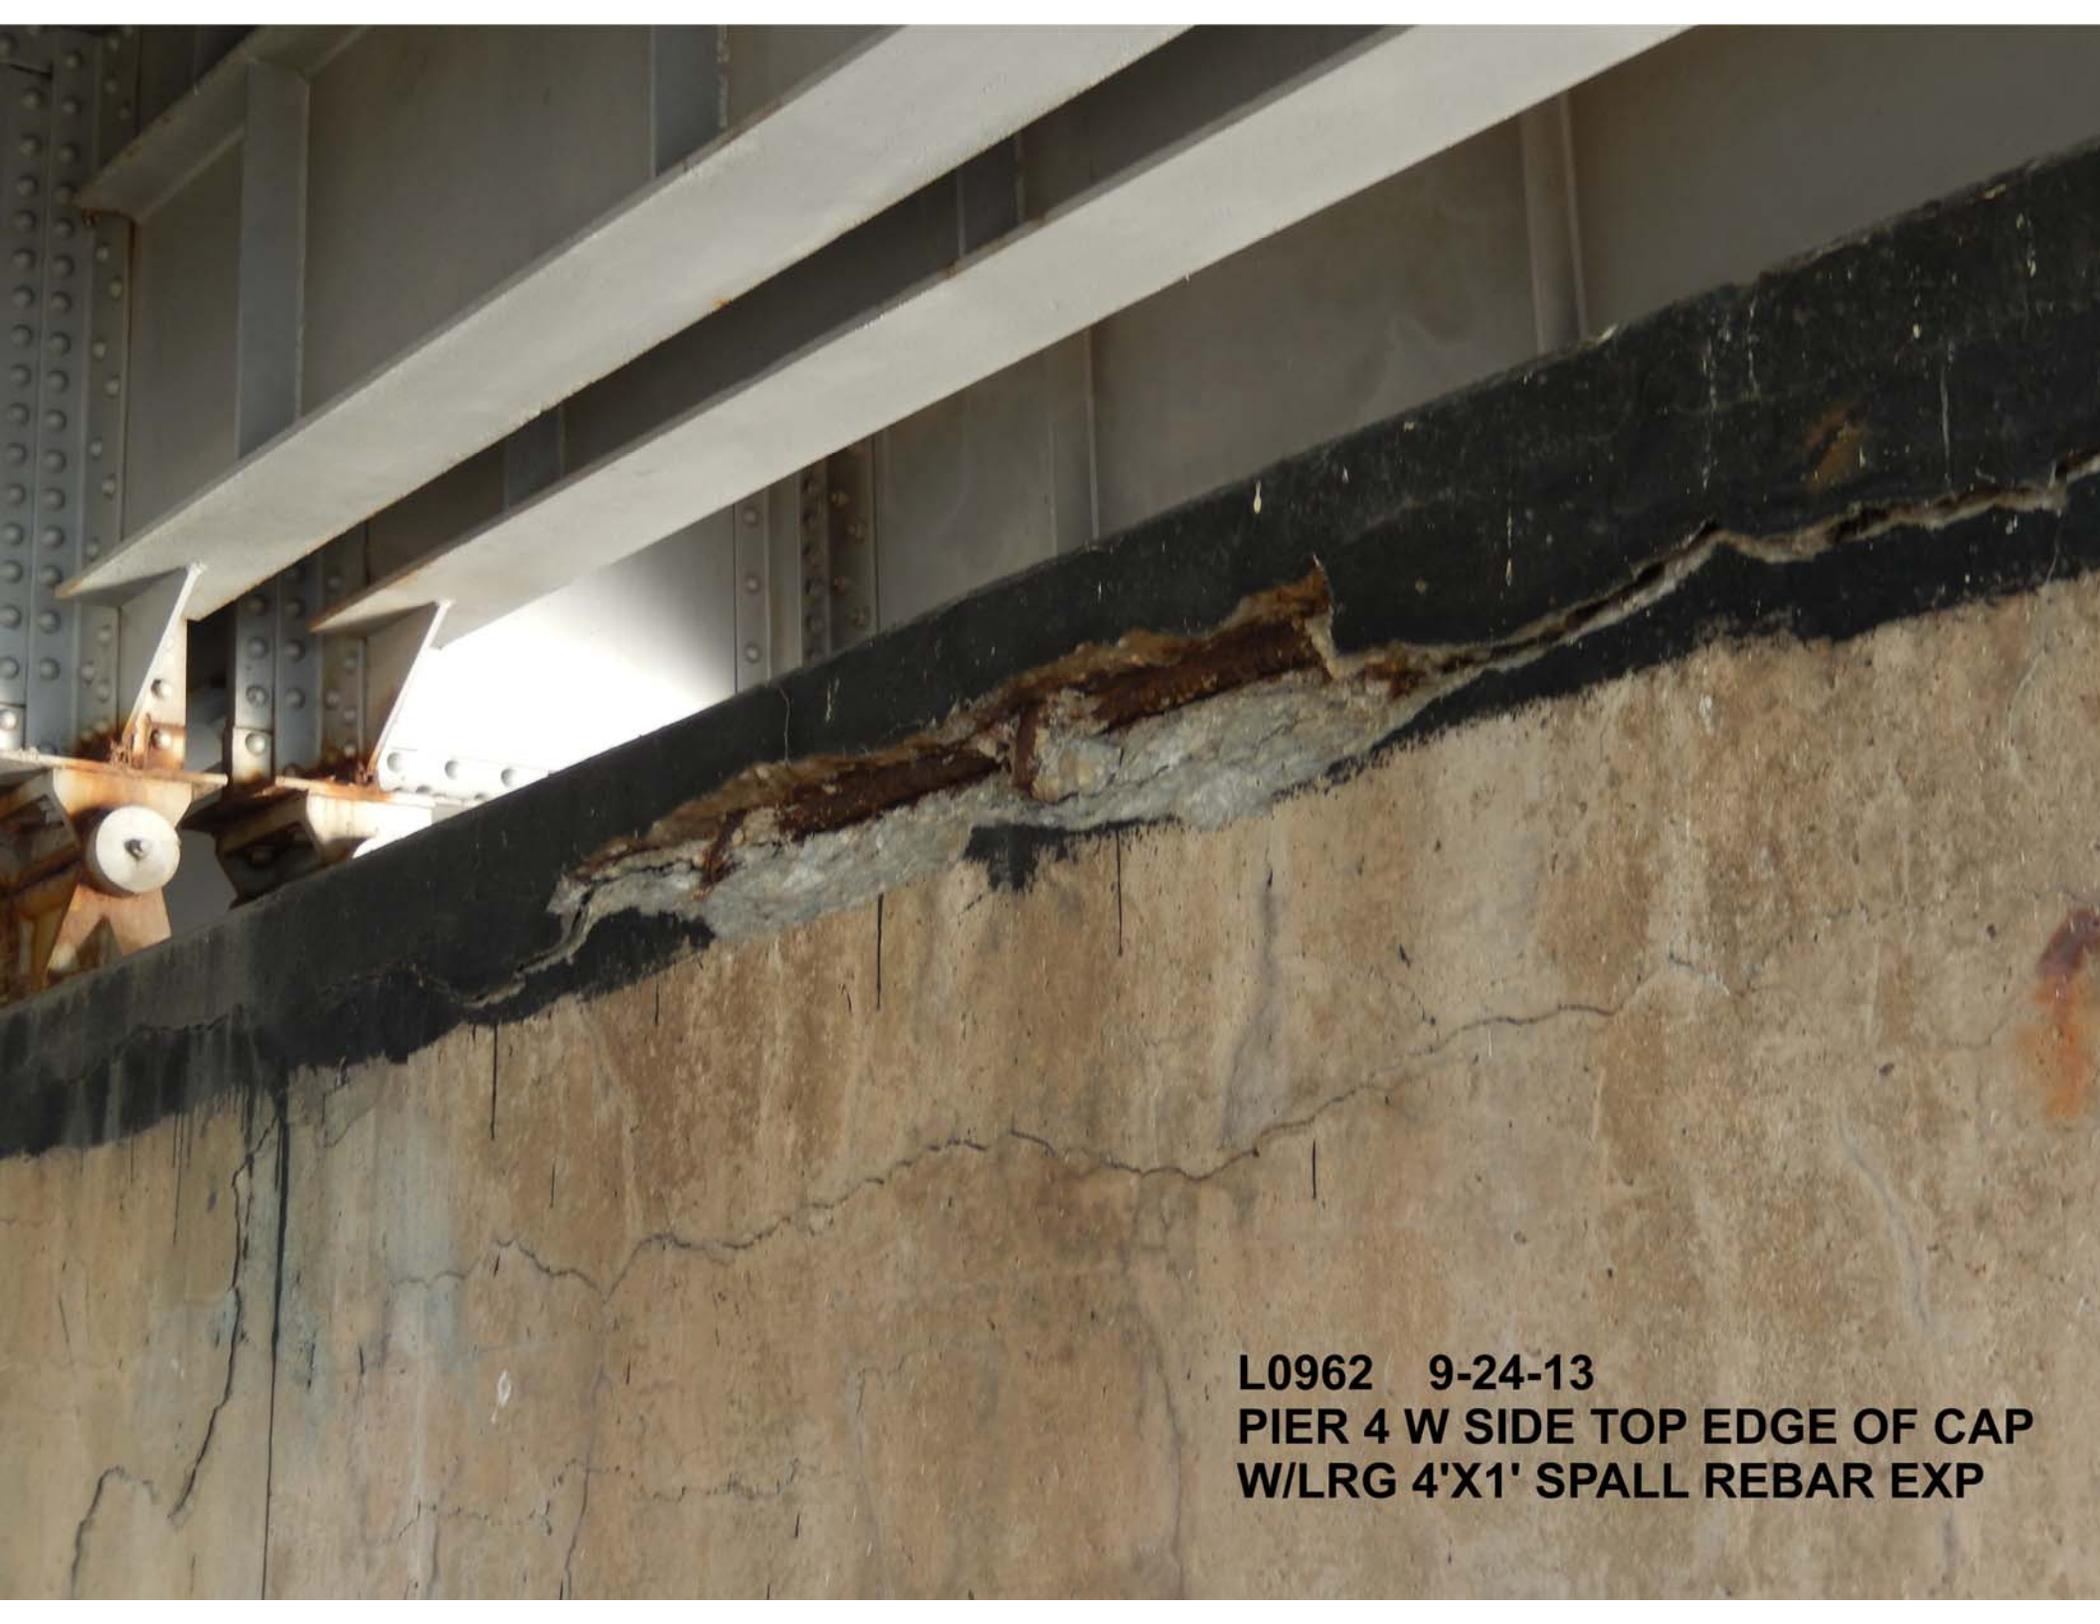
L0962 9-24-13
PIER 4 W SIDE TOP EDGE OF CAP
W/LRG 4'X1' SPALL REBAR EXP

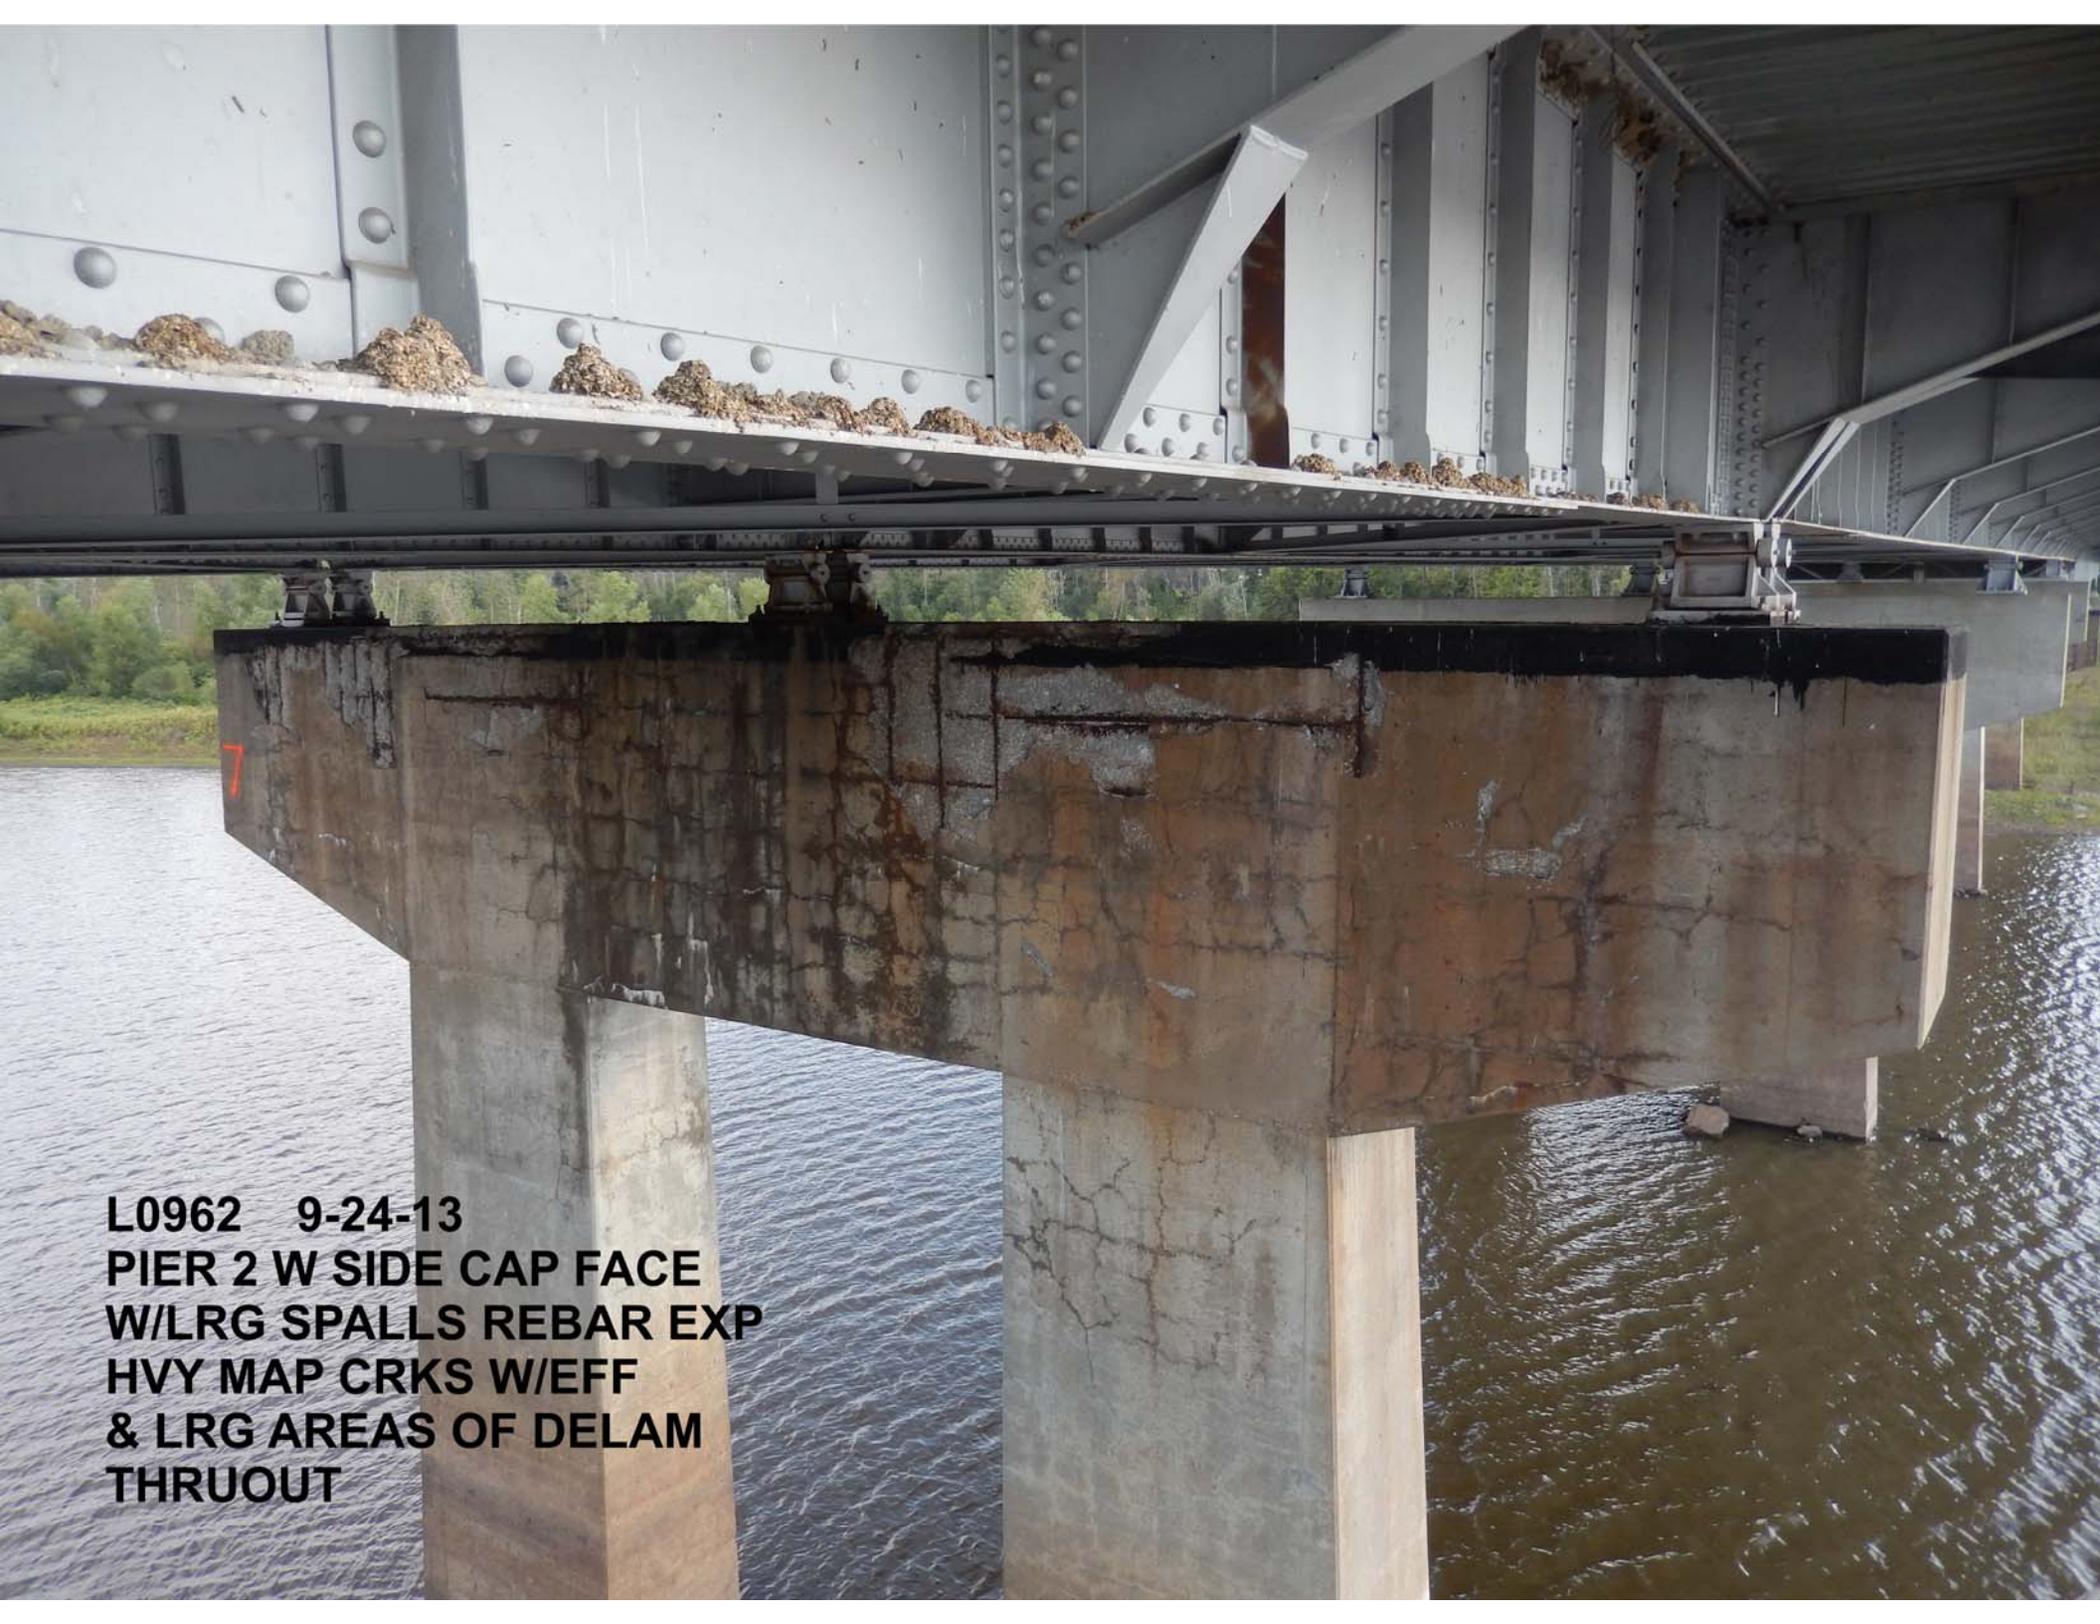
**L0962 9-24-13
PIER 2 W SIDE CAP FACE
W/LRG SPALLS REBAR EXP
HVY MAP CRKS W/EFF
& LRG AREAS OF DELAM
THRUOUT**

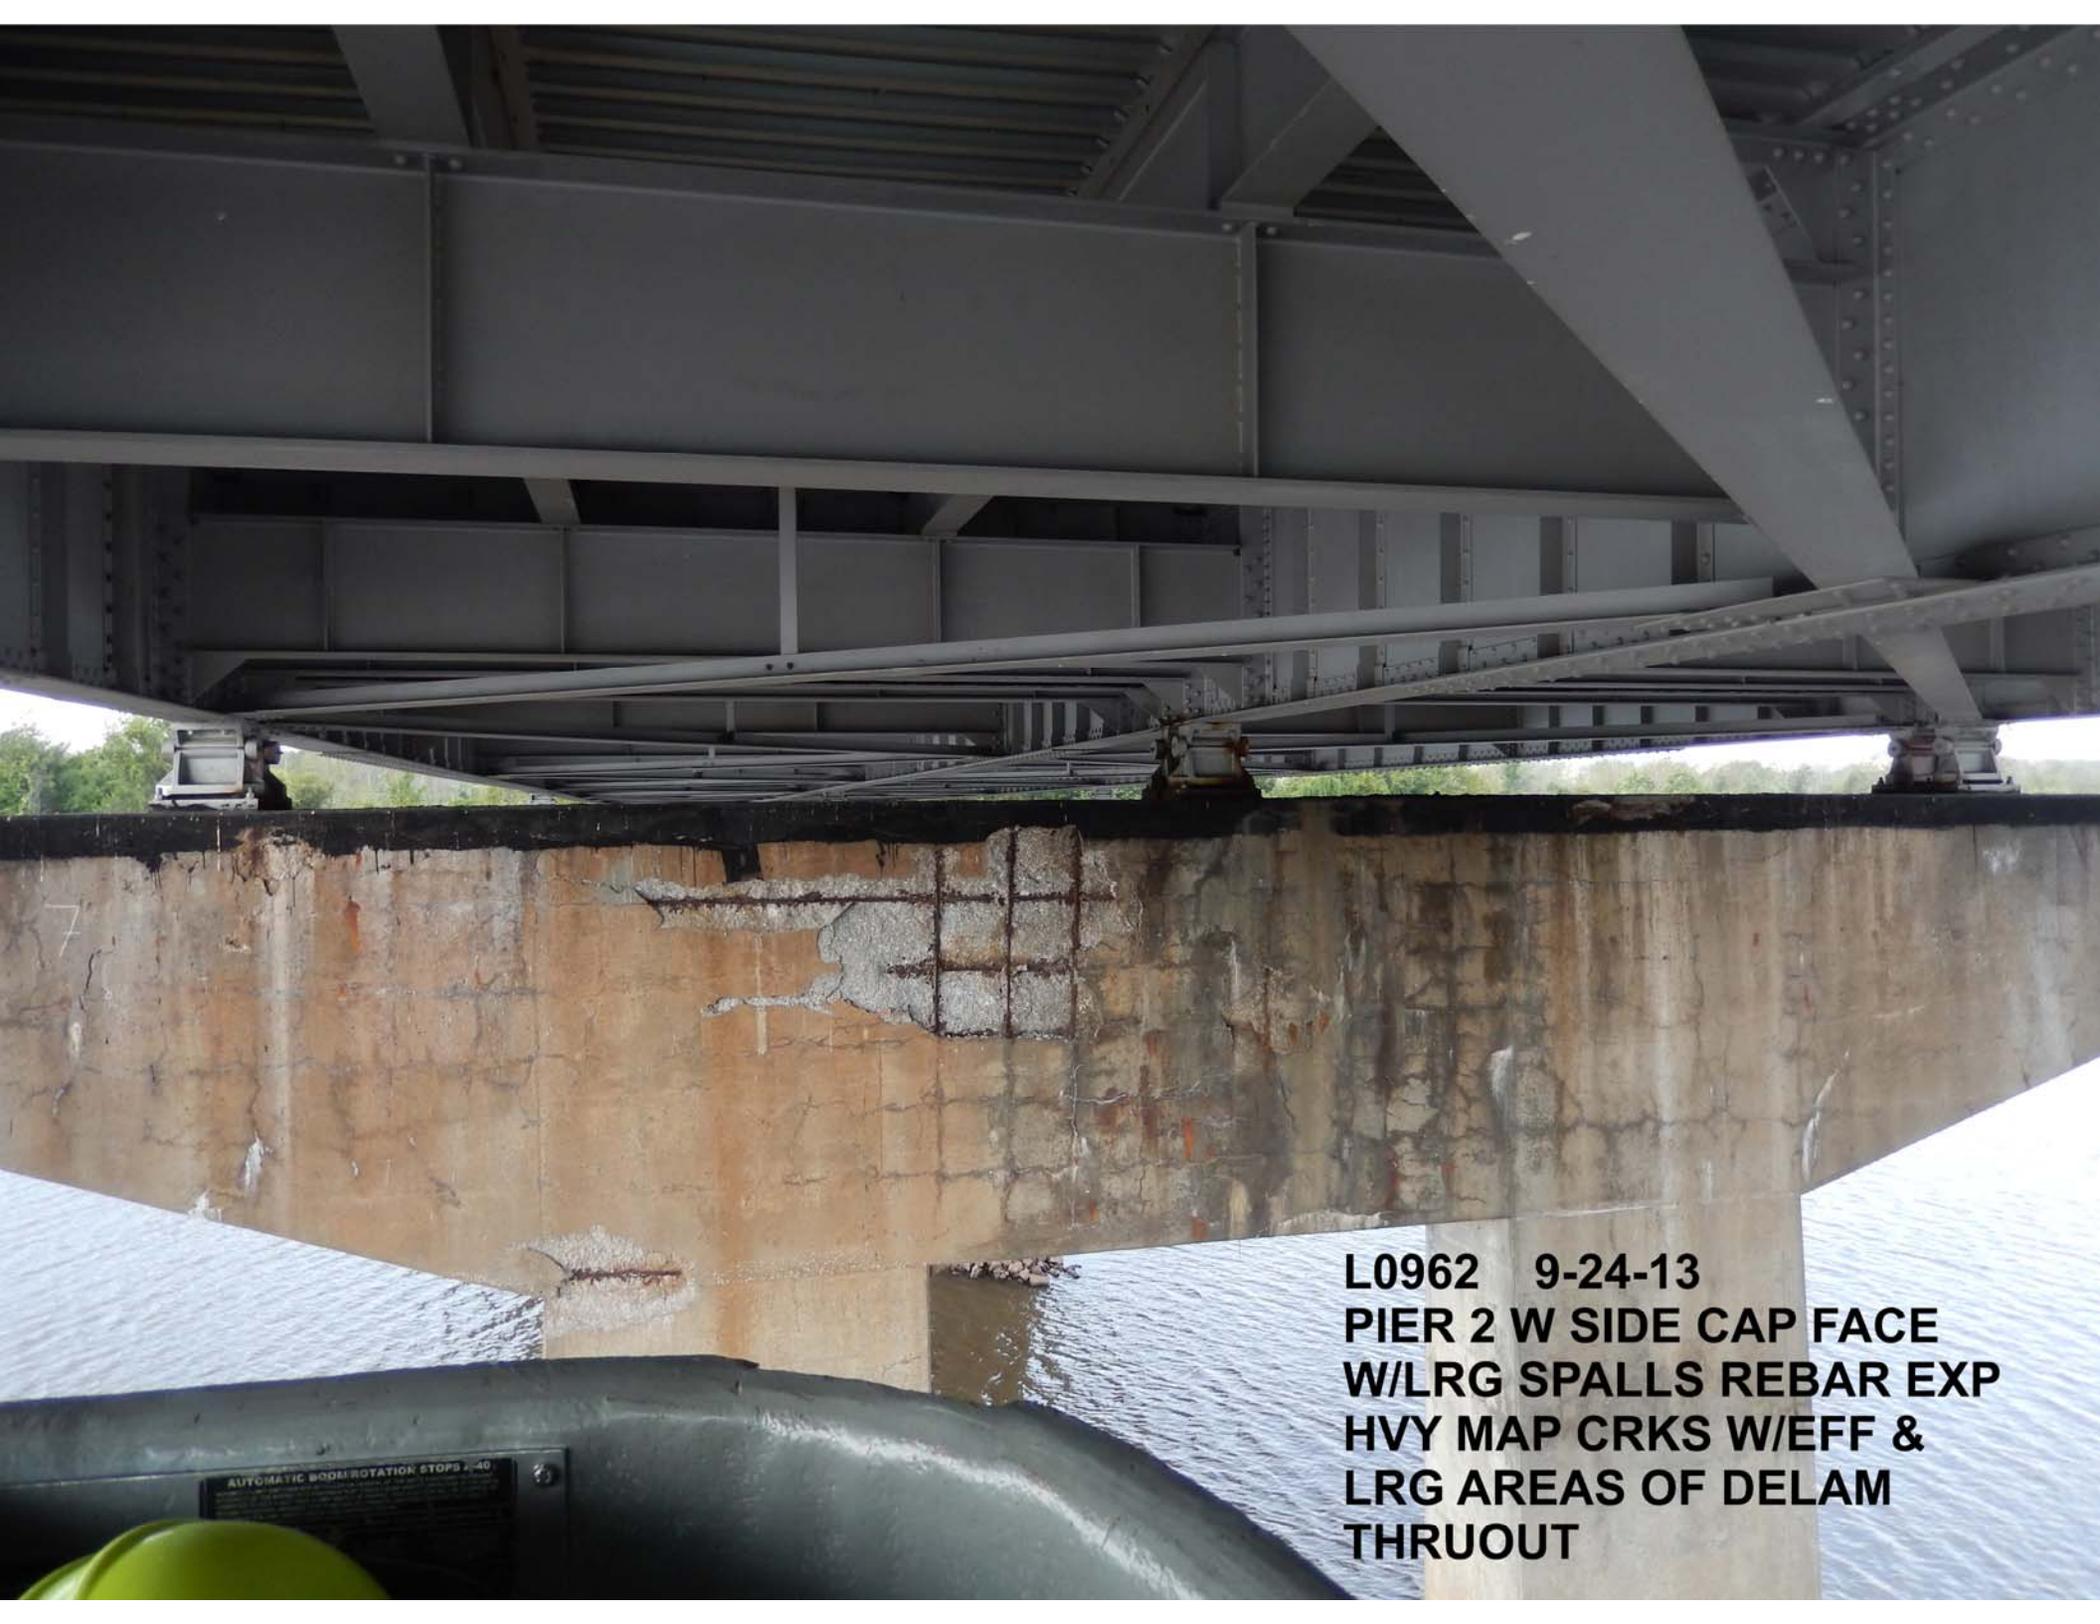
L0962 9-24-13
PIER 2 W SIDE CAP FACE
W/LRG SPALLS REBAR EXP
HVY MAP CRKS W/EFF &
LRG AREAS OF DELAM
THRUOUT

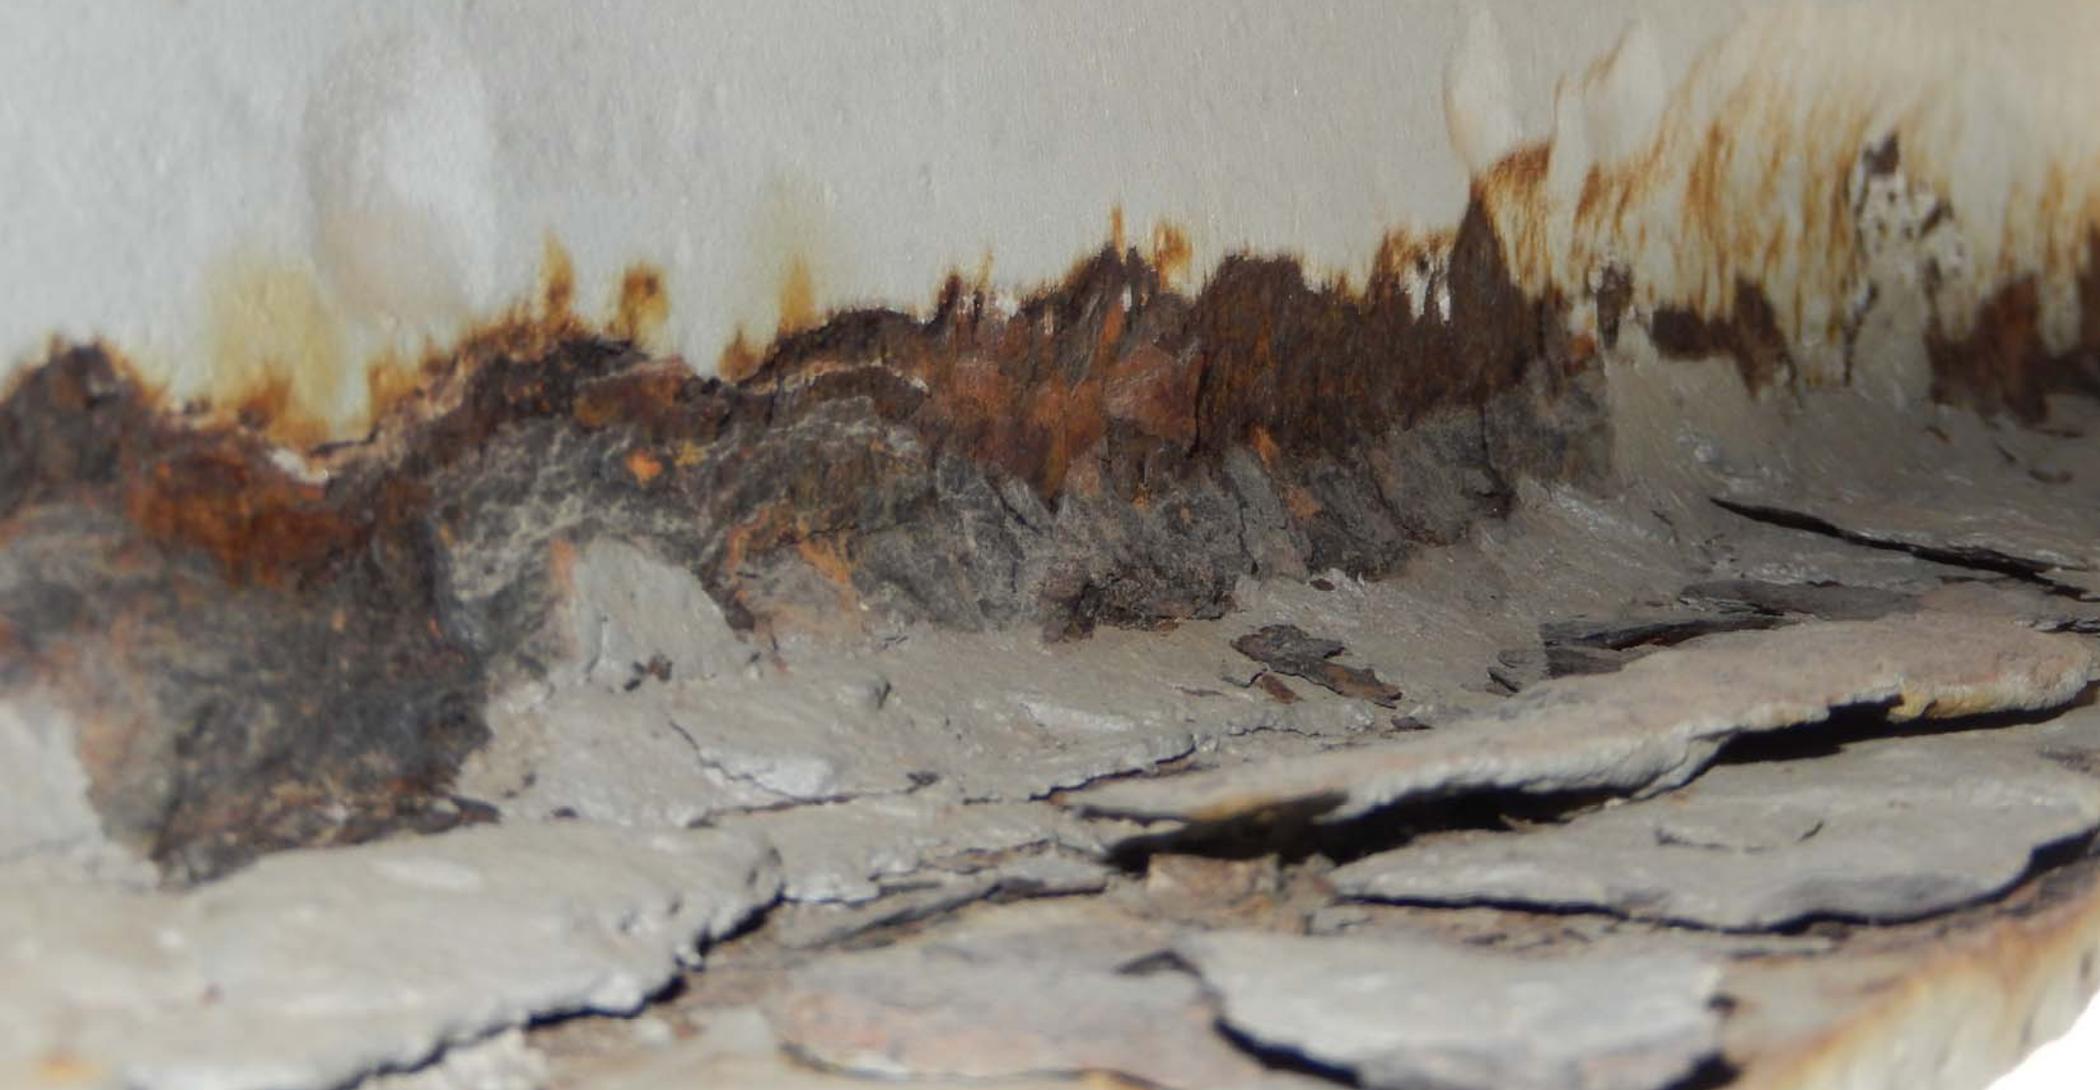
**L0962 9-24-13
PIER 7 FLBM W SIDE ALONG
BTTM FLNG W/SL 30%- 50%
REMAINING THRUOUT
ENTIRE MEMBER**

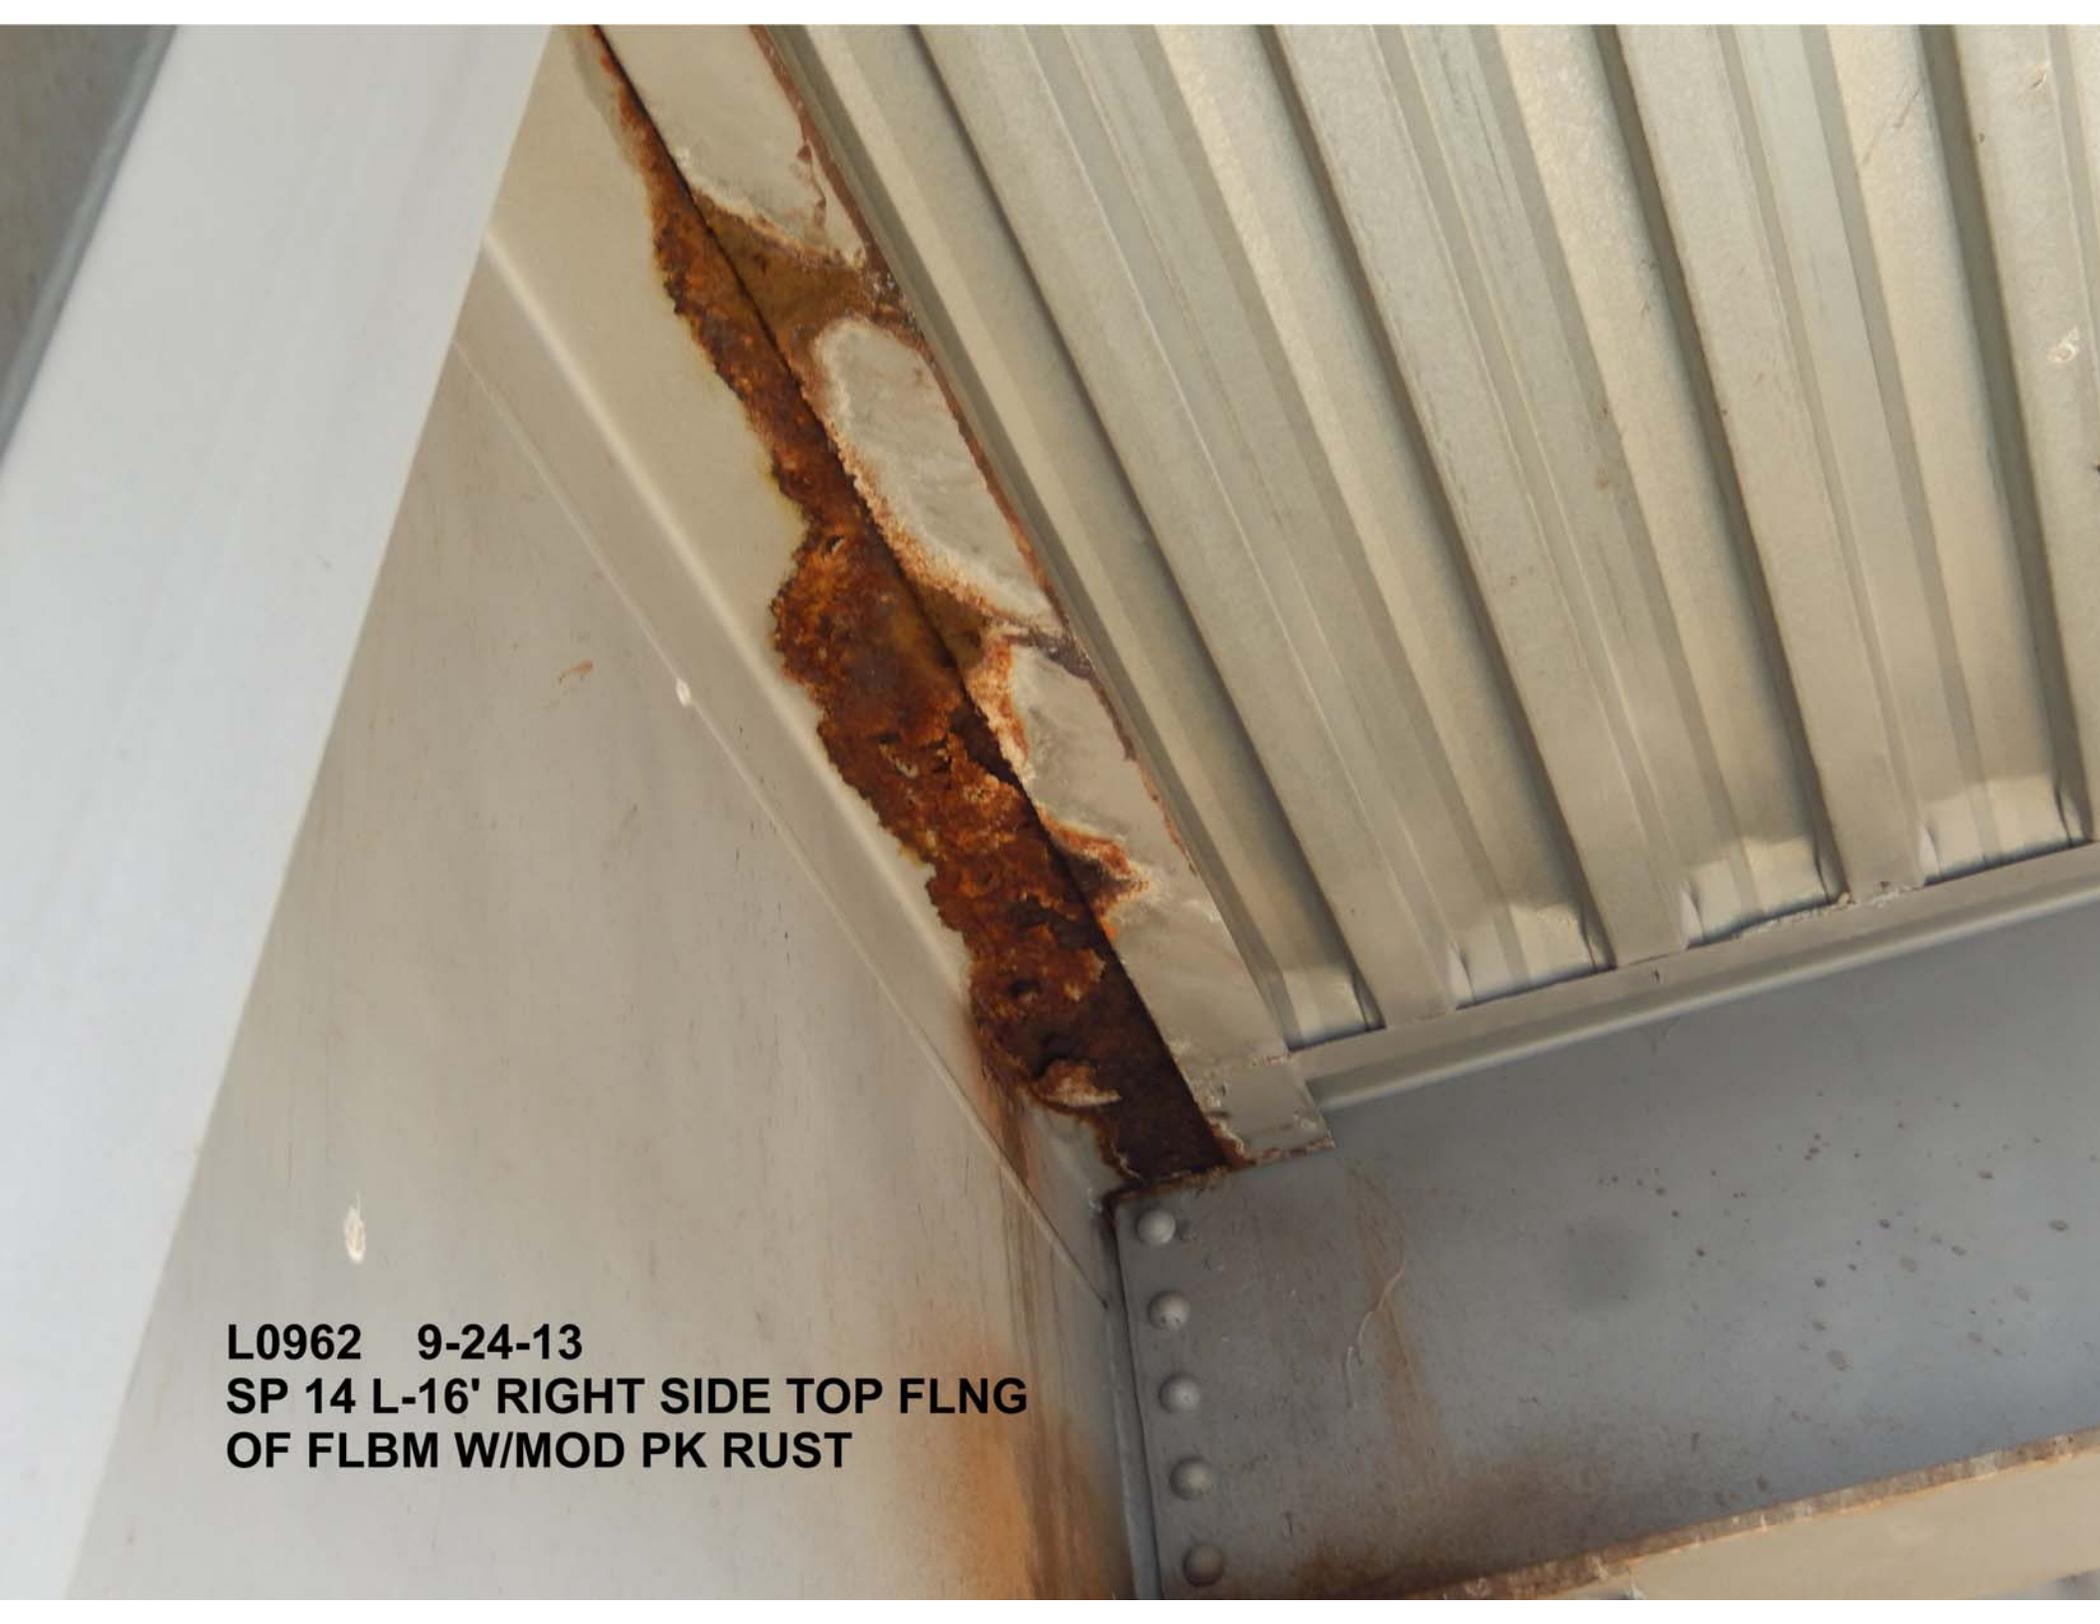
L0962 9-24-13
SP 14 L-16' RIGHT SIDE TOP FLNG
OF FLBM W/MOD PK RUST
