251 MISSOURI BRIDGES PROJECT

MoDOT Bridge Inspection Report

**Missouri Department of Transportation
Bridge Inventory and Inspection System
Structural Inventory & Appraisal Sheet**

COUNTY : COOPER	BRIDGE : L0962 2	REVIEW STATUS : REVIEW	NBI STATUS : T
RECORD TYPE : ROUTE CARRIED 'ON' STRUCT		RUN DATE : 11/28/2017	SUBMITTAL YEAR : 2017

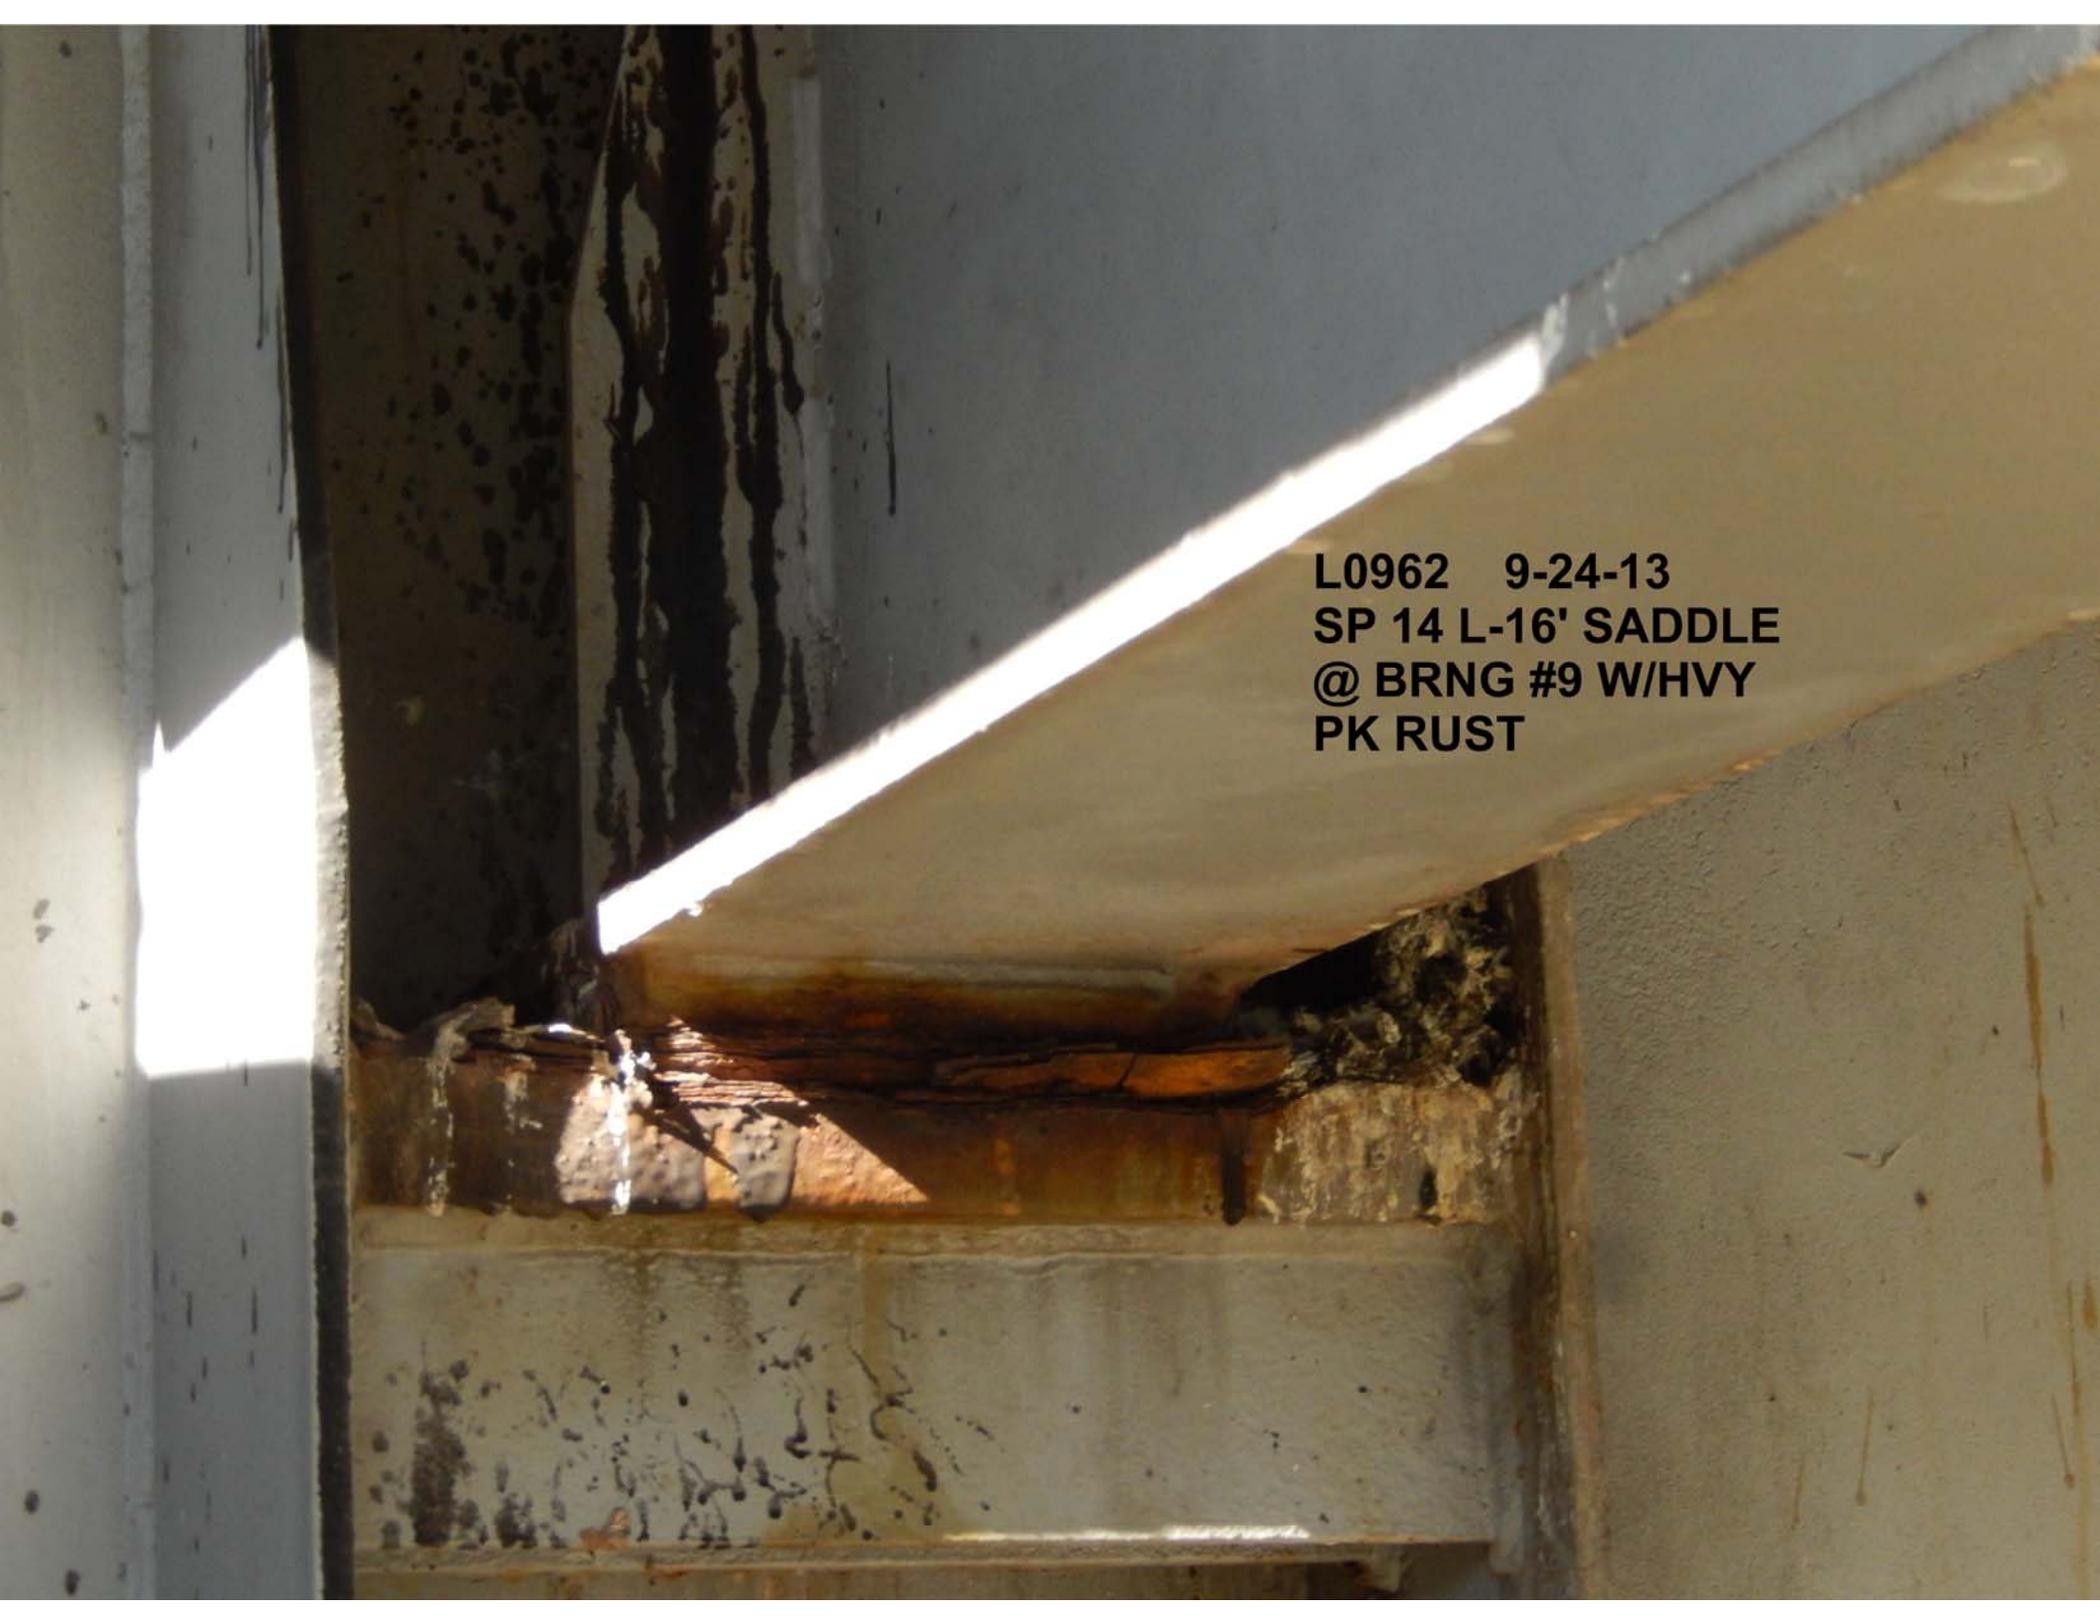
L0962 9-24-13
SP 14 L-16' SADDLE
@ BRNG #9 W/HVY
PK RUST

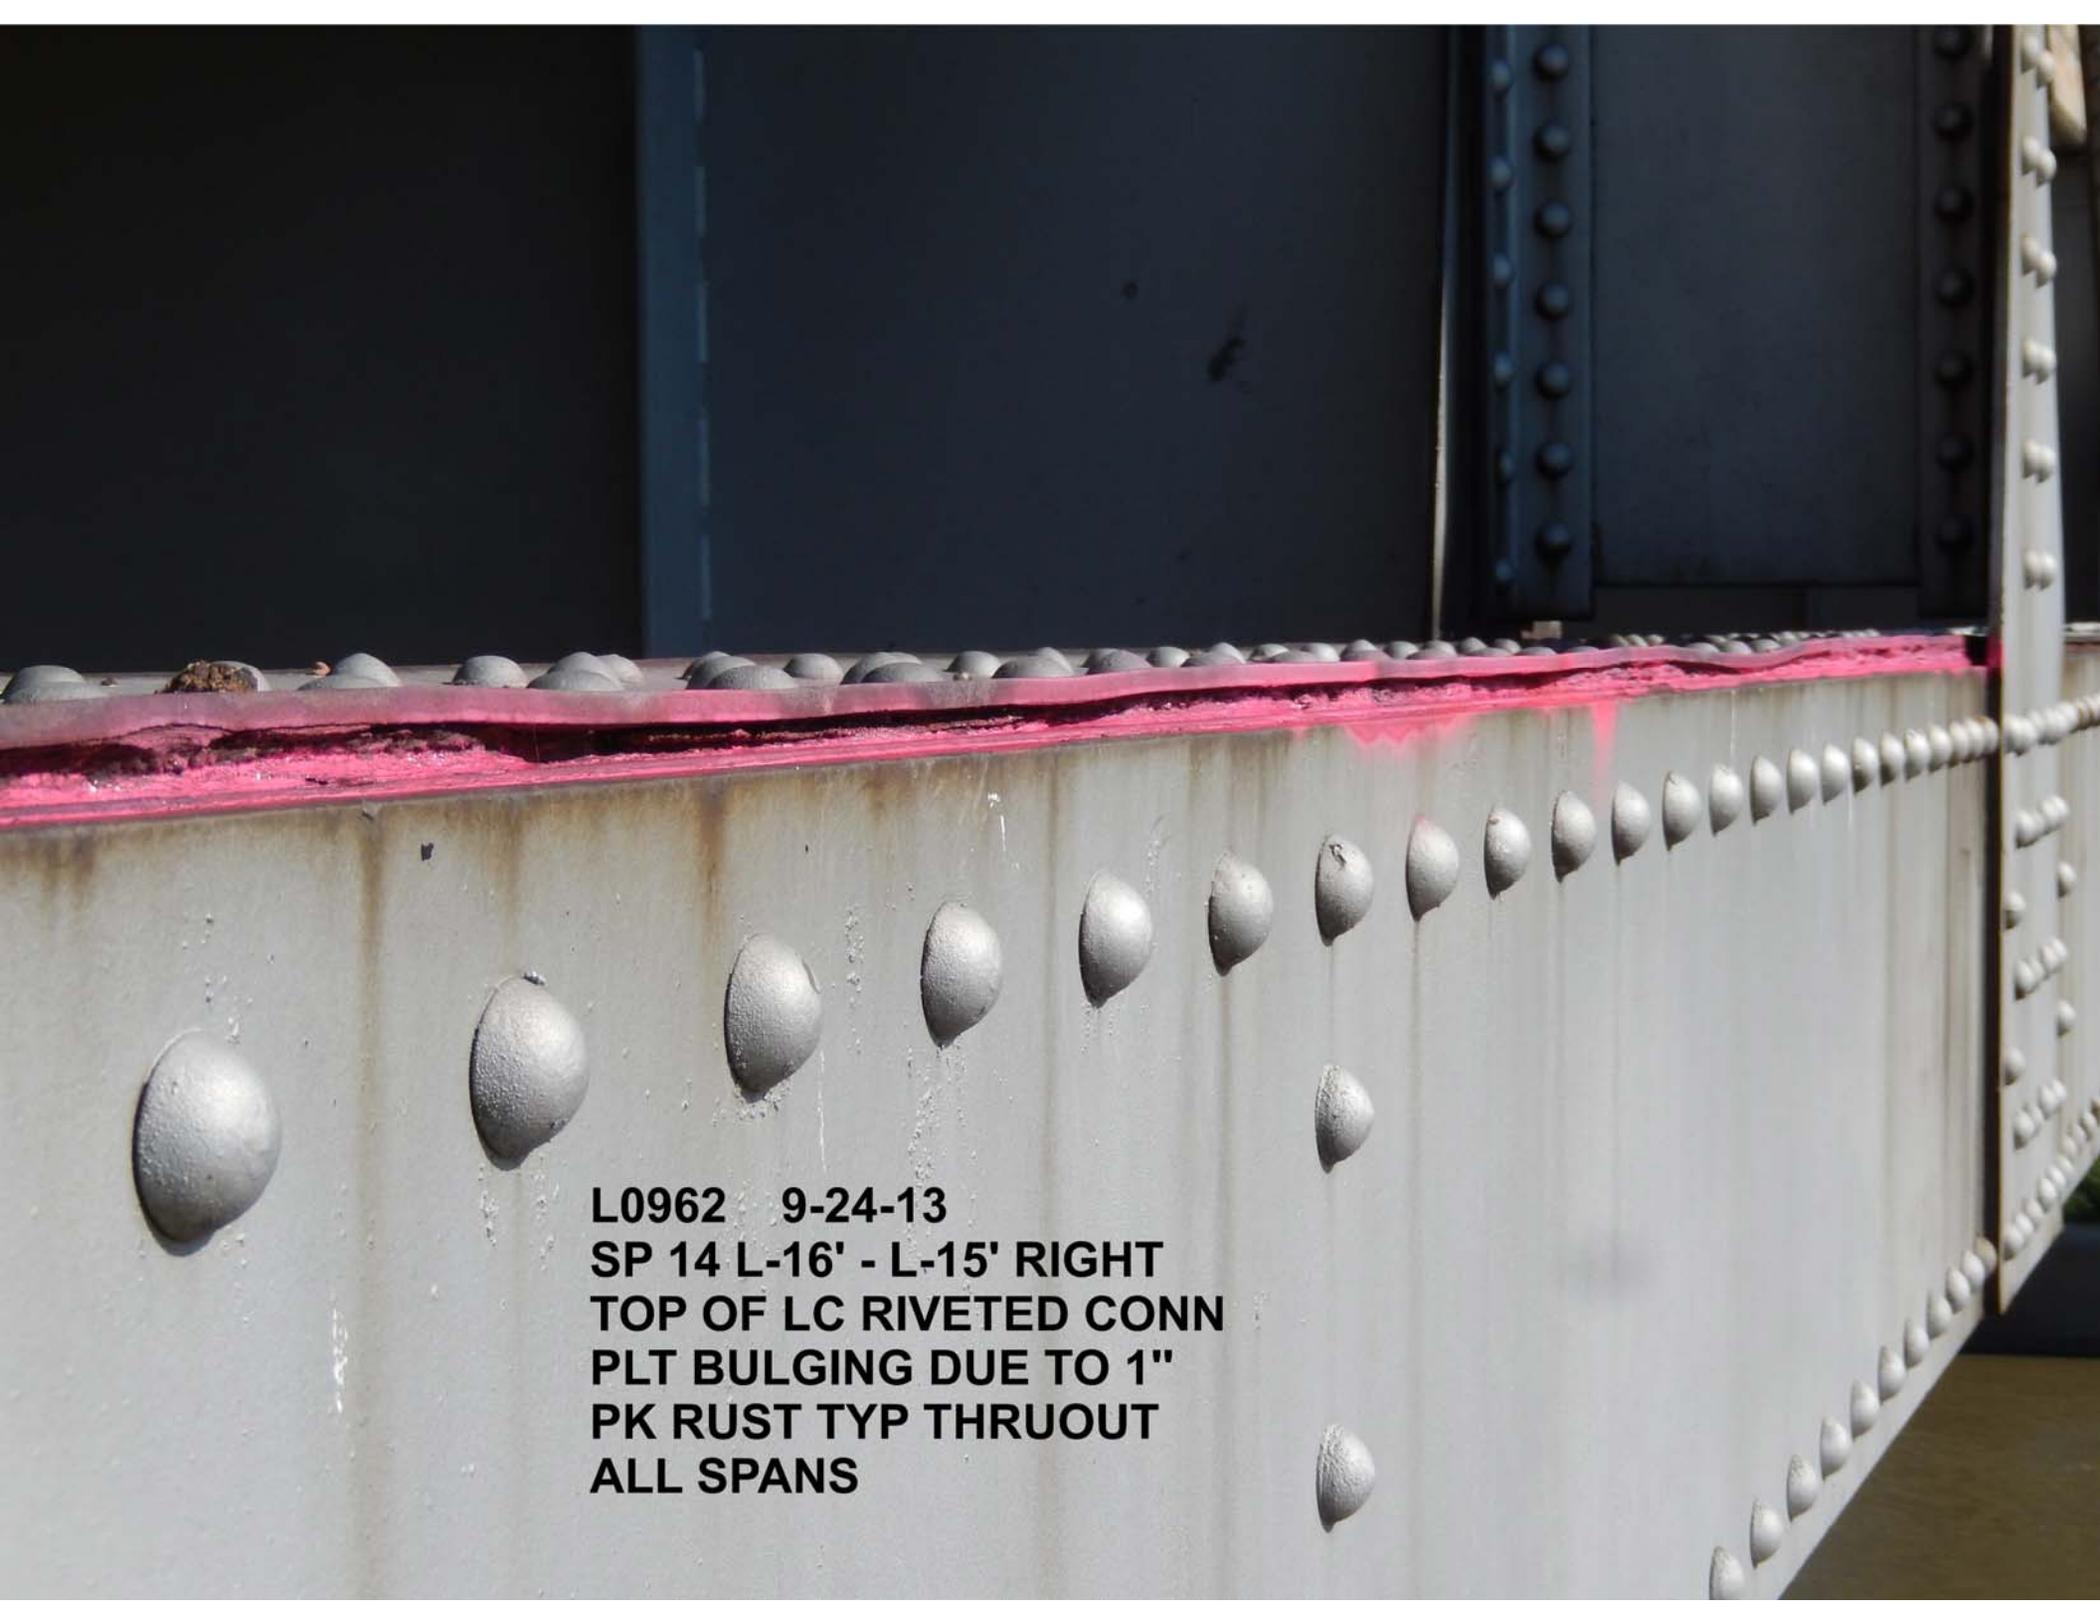
**L0962 9-24-13
SP 14 L-16' - L-15' RIGHT
TOP OF LC RIVETED CONN
PLT BULGING DUE TO 1"
PK RUST TYP THRUOUT
ALL SPANS**

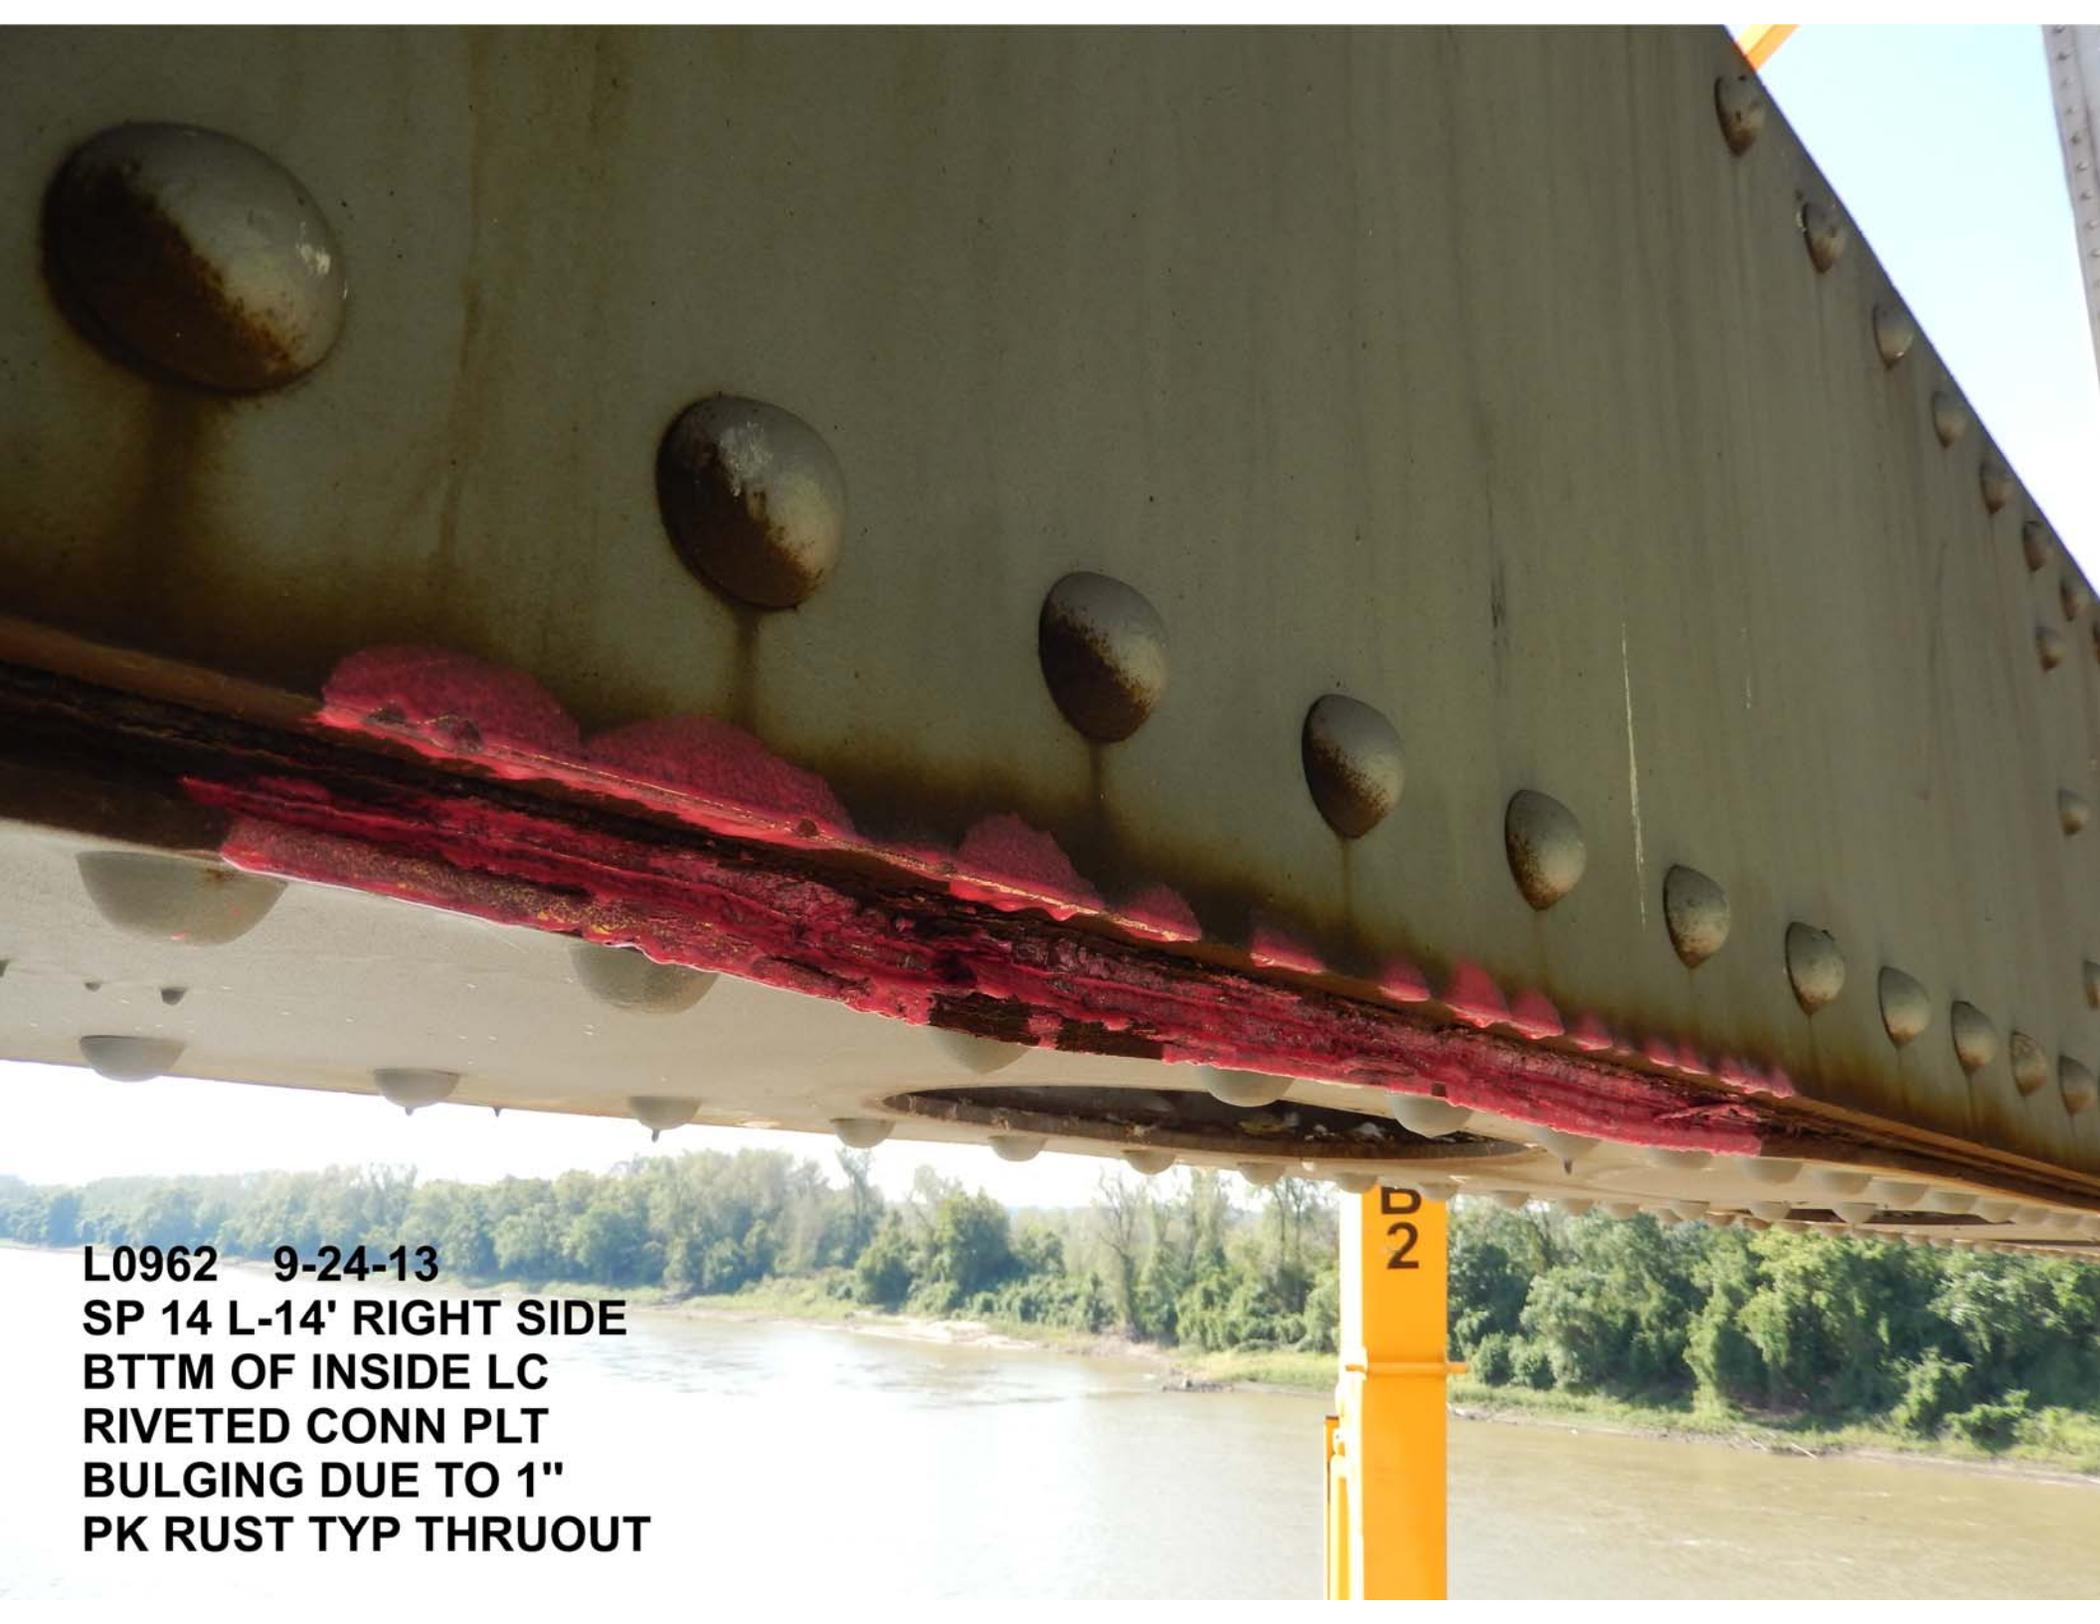
L0962 9-24-13
SP 14 L-14' RIGHT SIDE
BTTM OF INSIDE LC
RIVETED CONN PLT
BULGING DUE TO 1"
PK RUST TYP THRUOUT

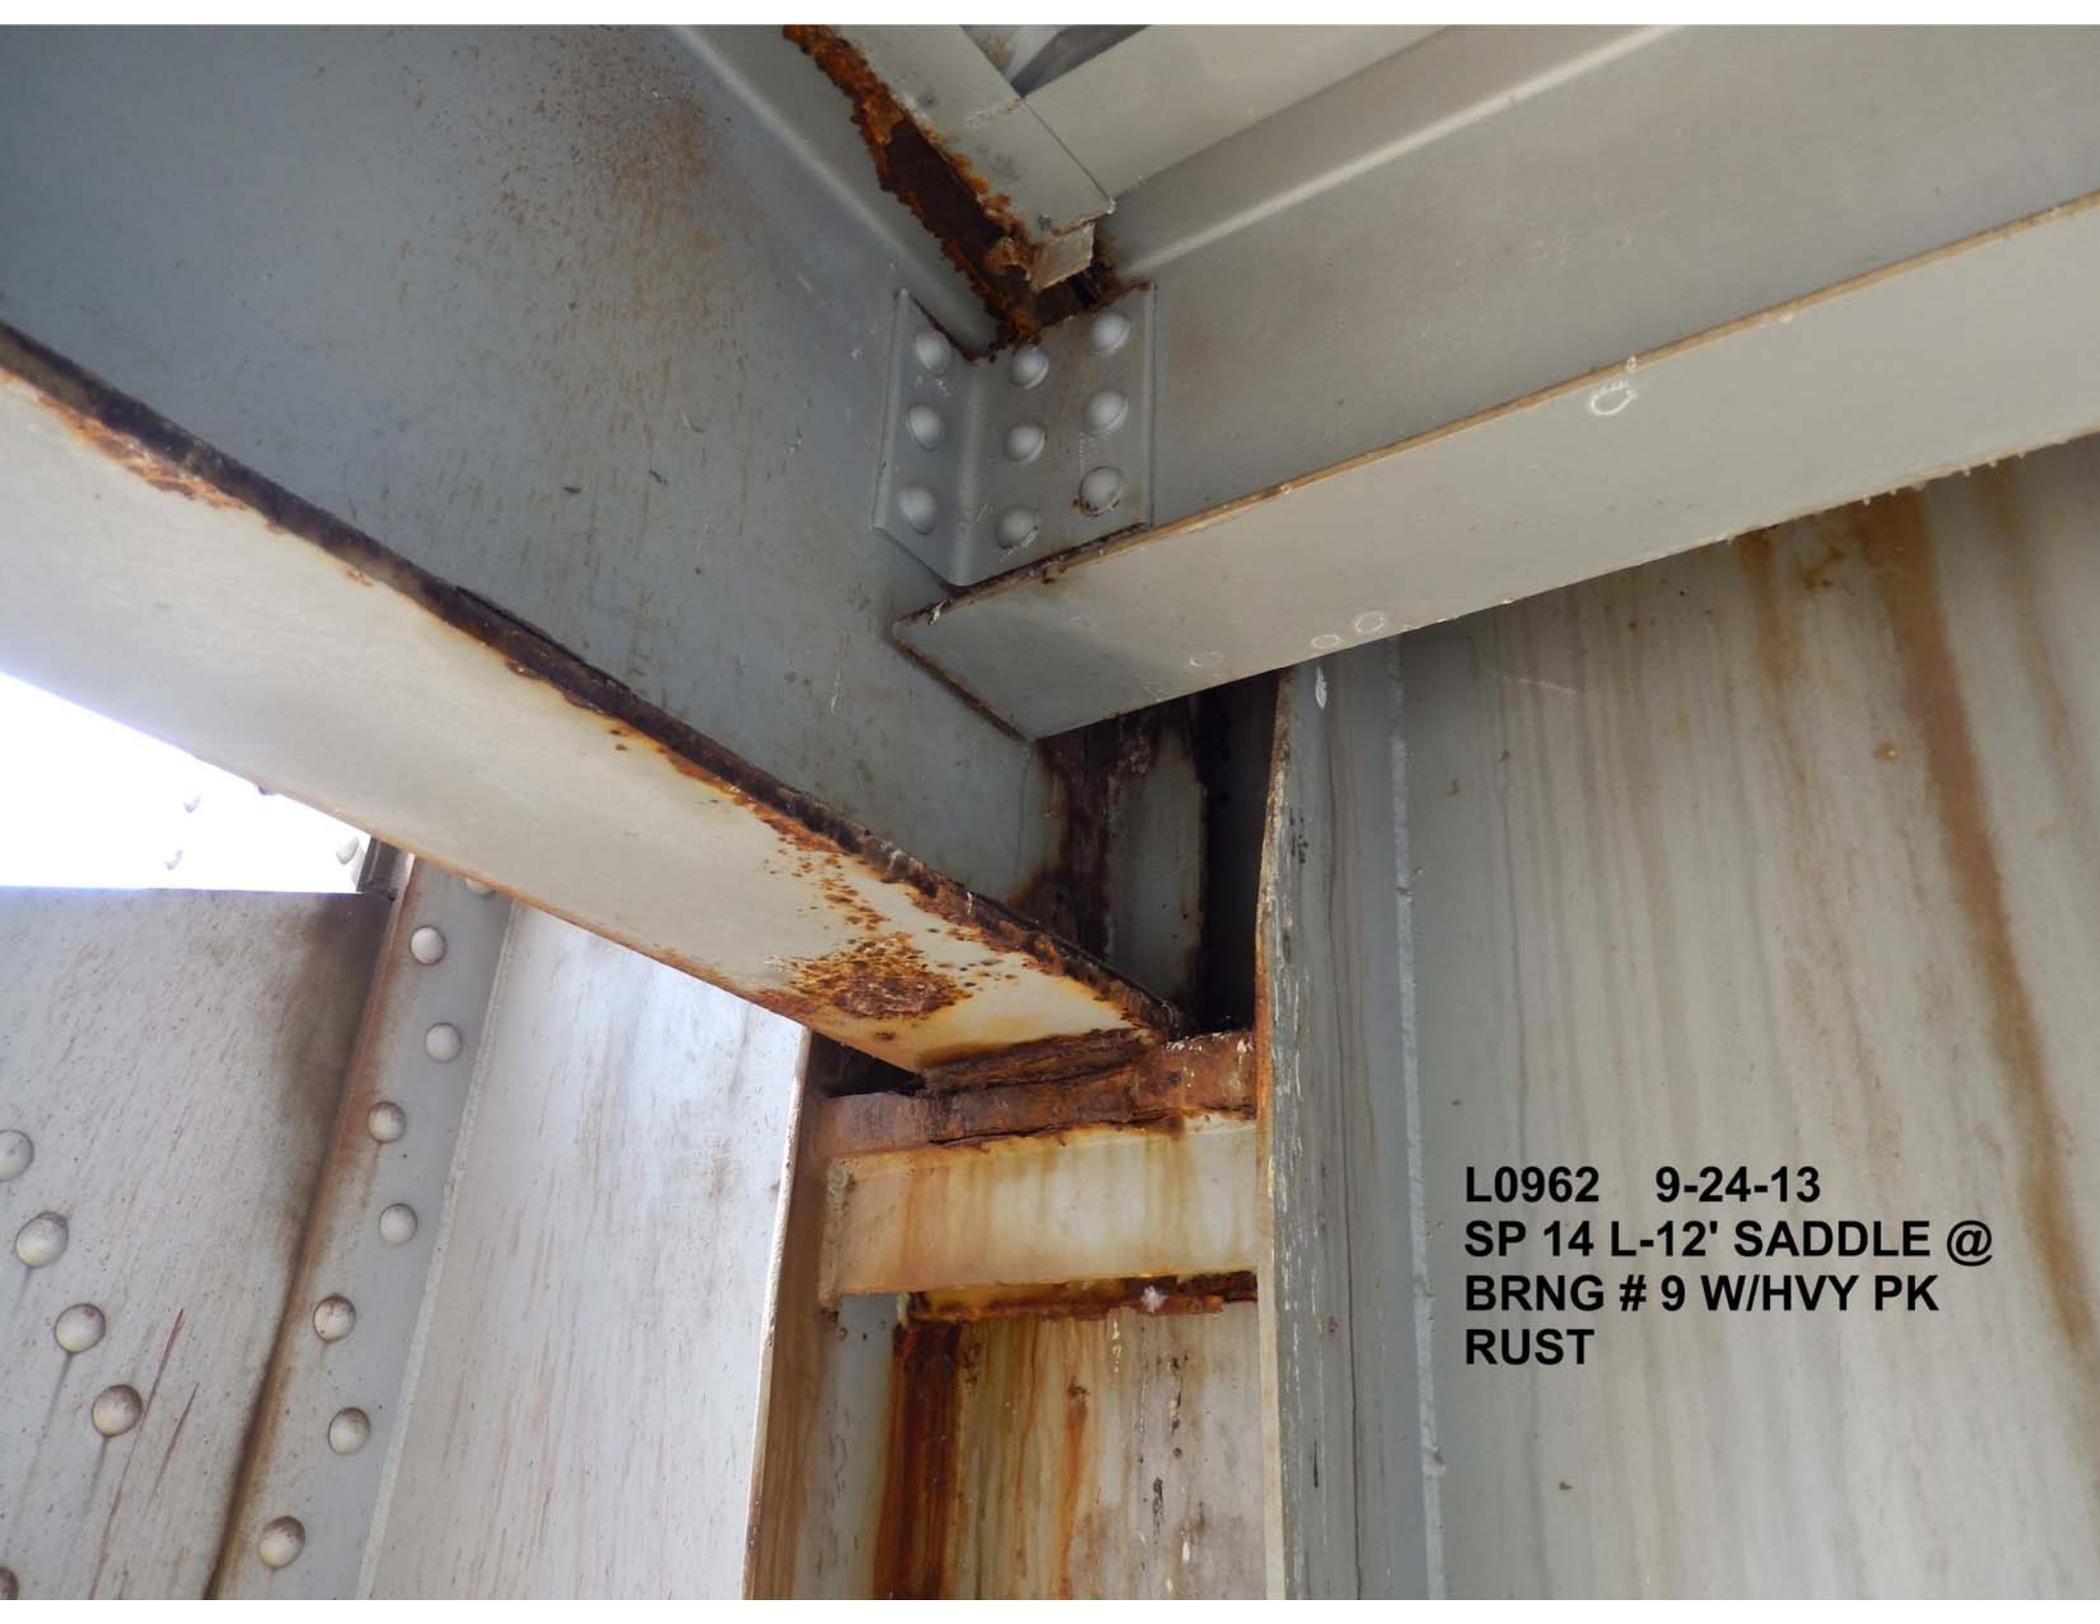
L0962 9-24-13
SP 14 L-12' SADDLE @
BRNG # 9 W/HVY PK
RUST

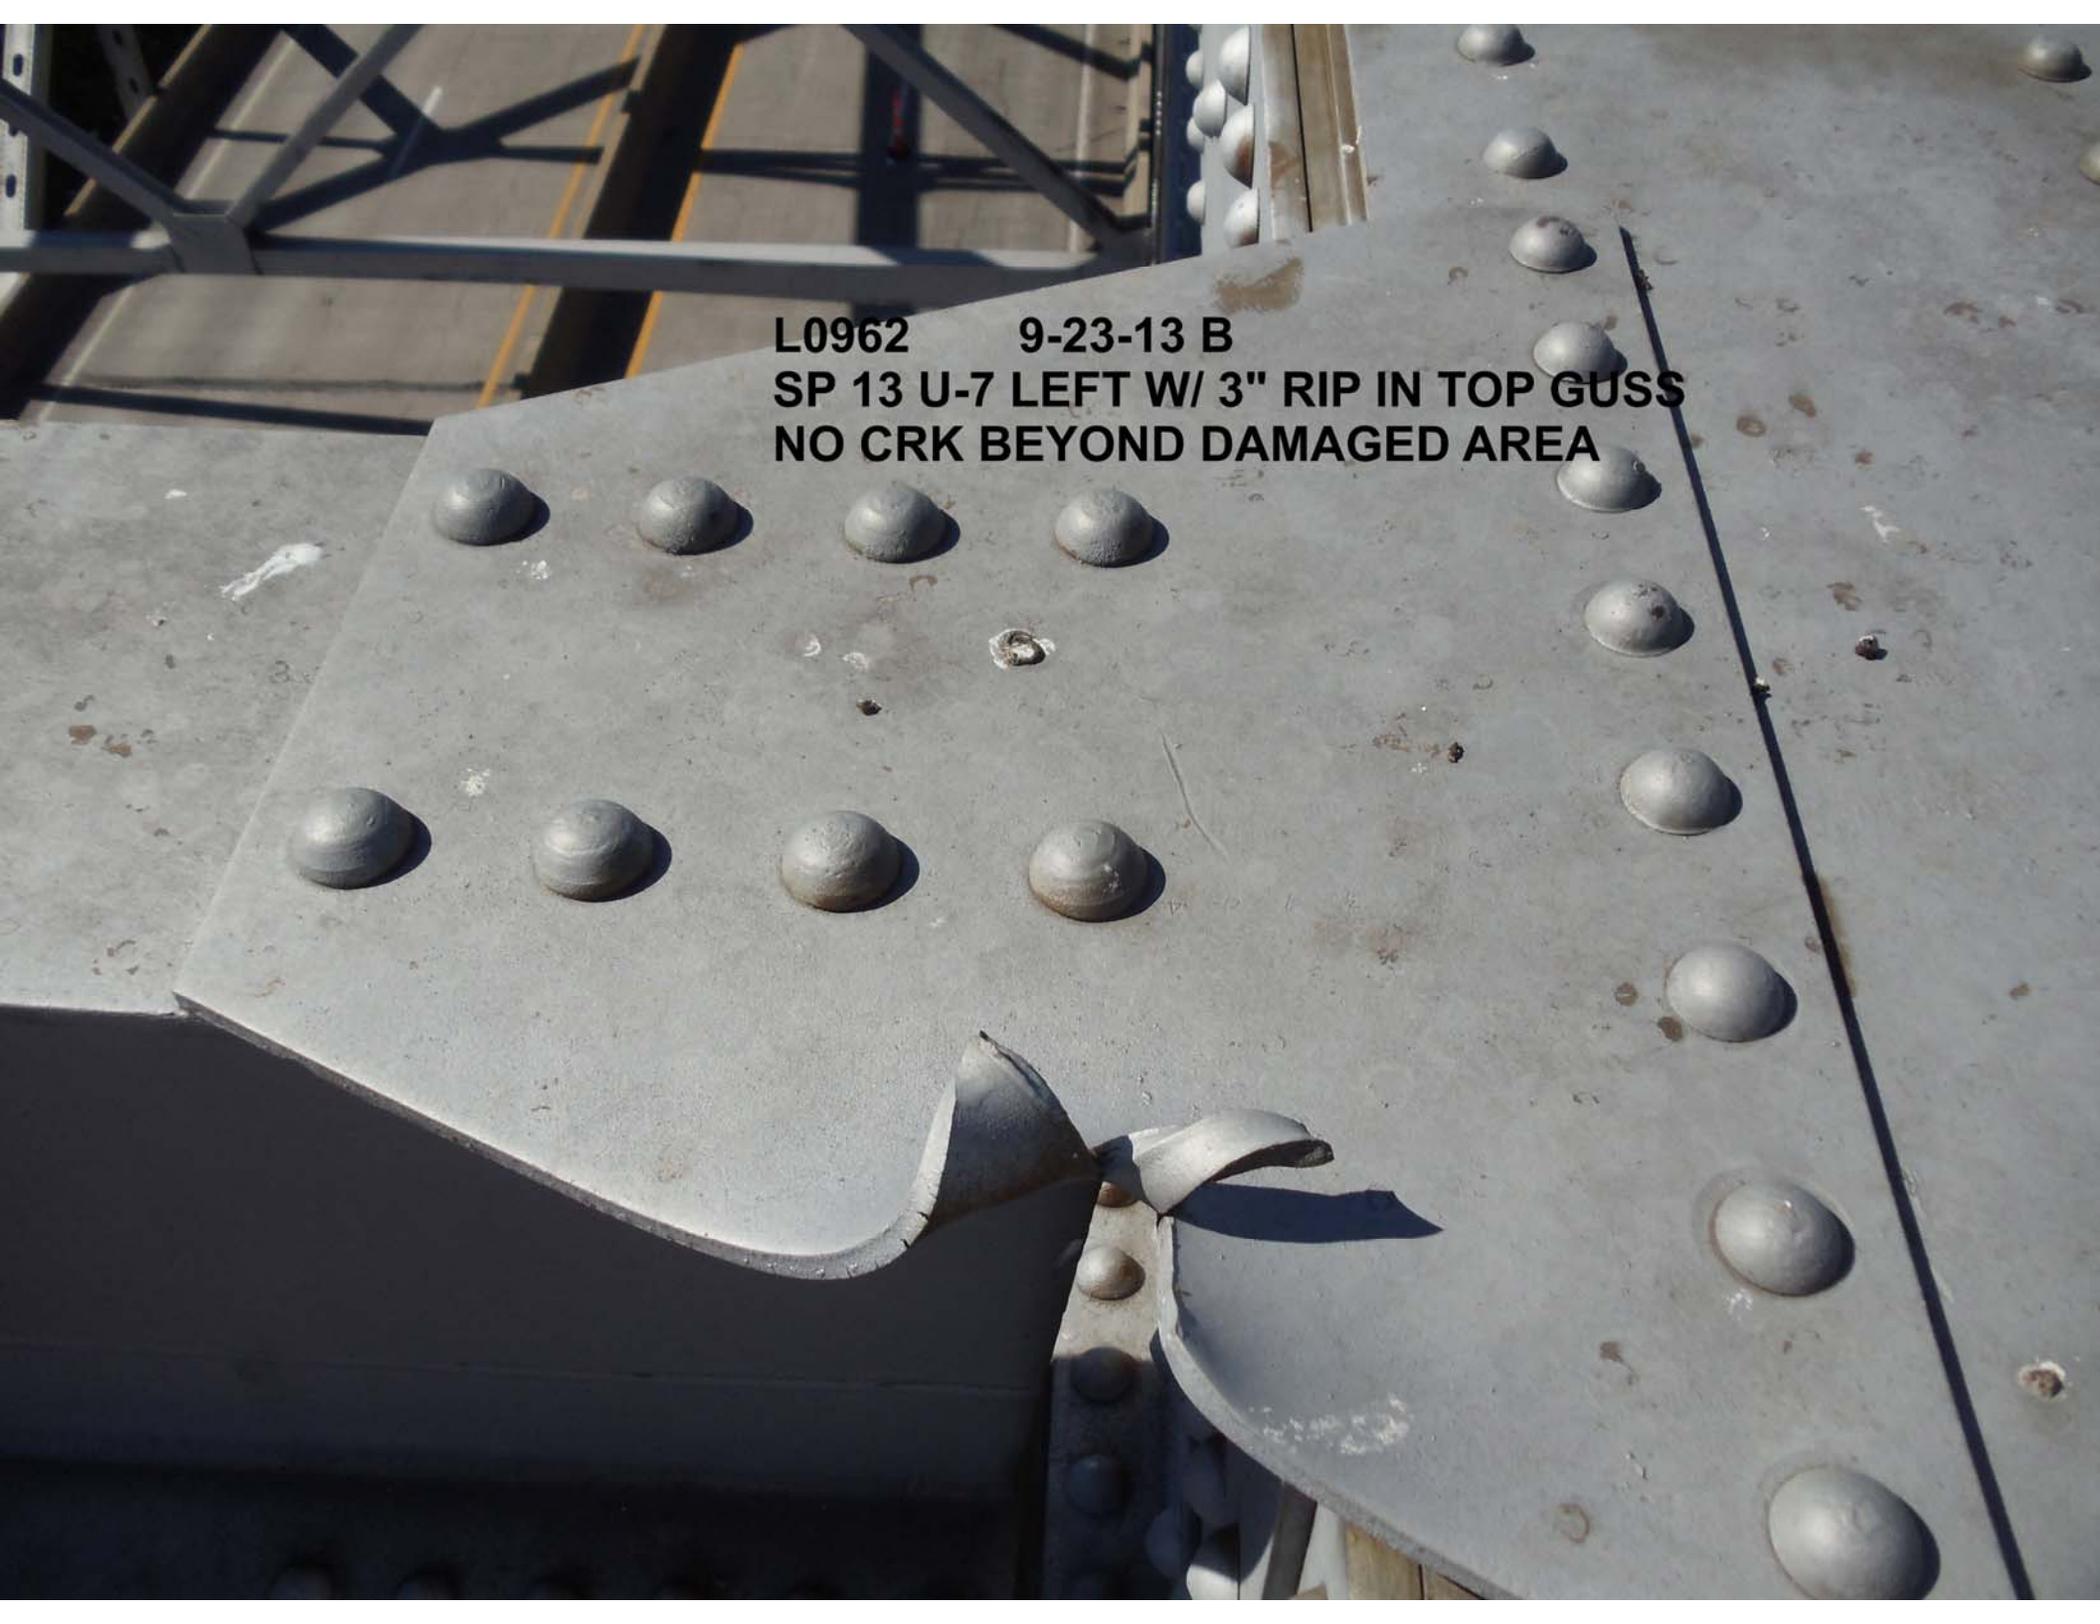
L0962 9-23-13 B
SP 13 U-7 LEFT W/ 3" RIP IN TOP GUSS
NO CRK BEYOND DAMAGED AREA

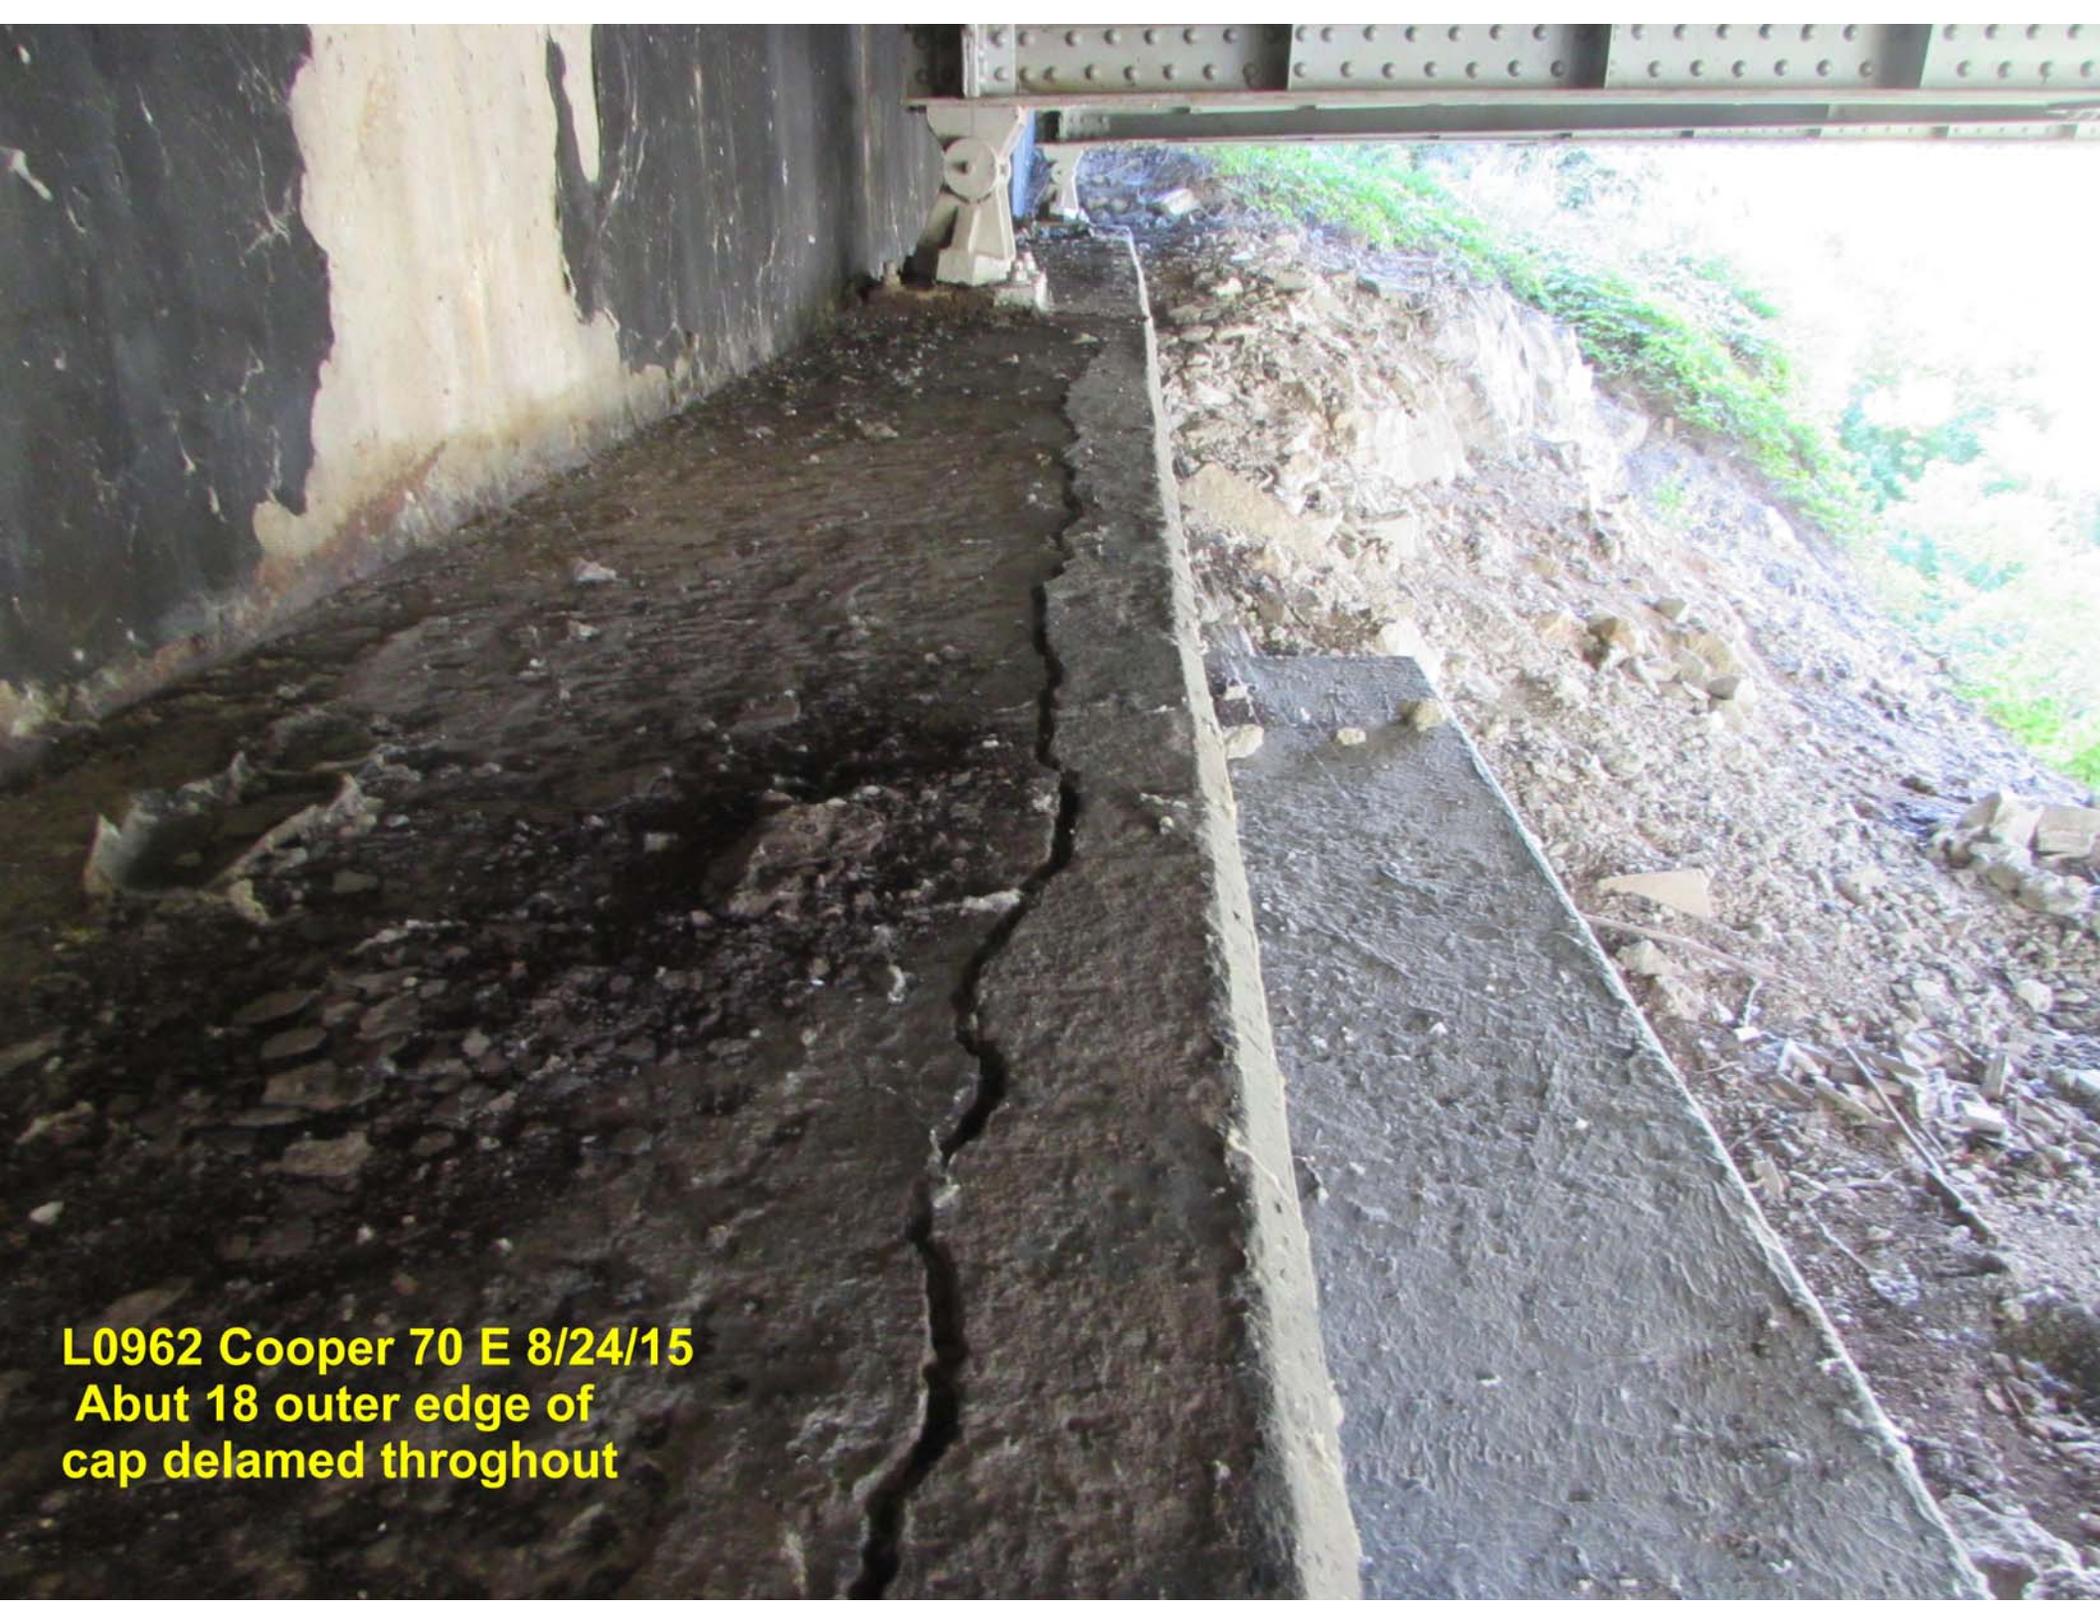
L0962 Cooper 70 E 8/24/15
Abut 18 outer edge of
cap delamed throughtout
