251 MISSOURI BRIDGES PROJECT

MoDOT Bridge Inspection Report

**Missouri Department of Transportation
Bridge Inventory and Inspection System
Structural Inventory & Appraisal Sheet**

COUNTY : COOPER	BRIDGE : L0962 2	REVIEW STATUS : REVIEW	NBI STATUS : T
RECORD TYPE : ROUTE CARRIED 'ON' STRUCT		RUN DATE : 11/28/2017	SUBMITTAL YEAR : 2017

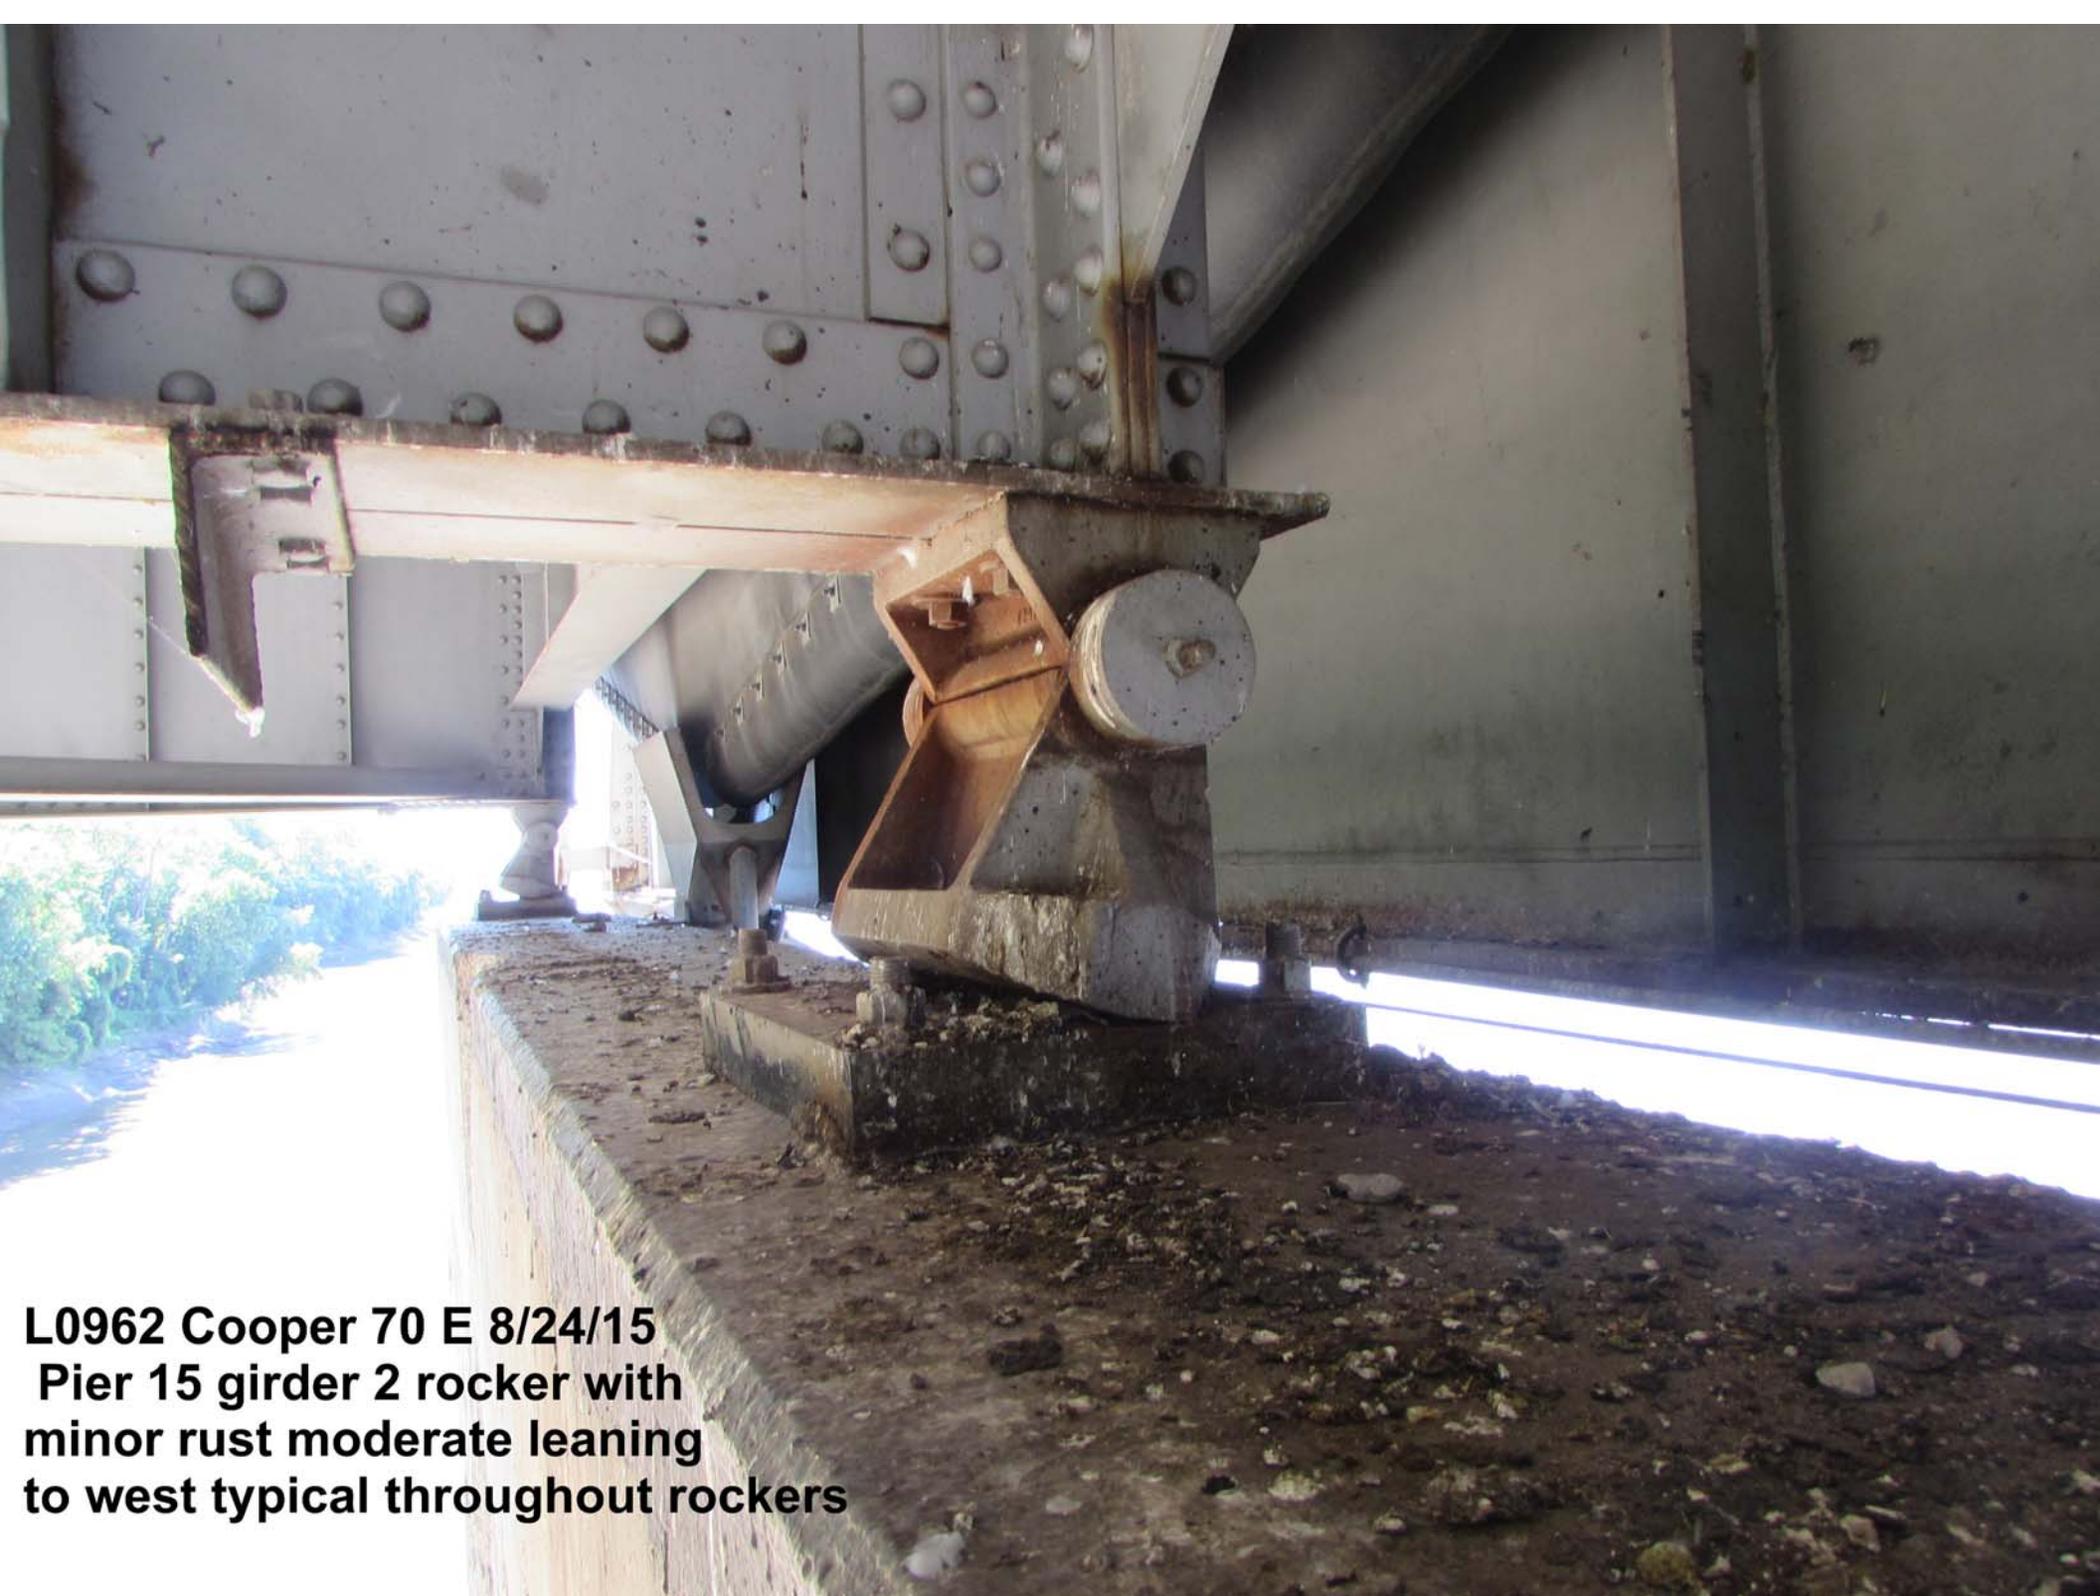
**L0962 Cooper 70 E 8/24/15
Pier 15 girder 2 rocker with
minor rust moderate leaning
to west typical throughout rockers**

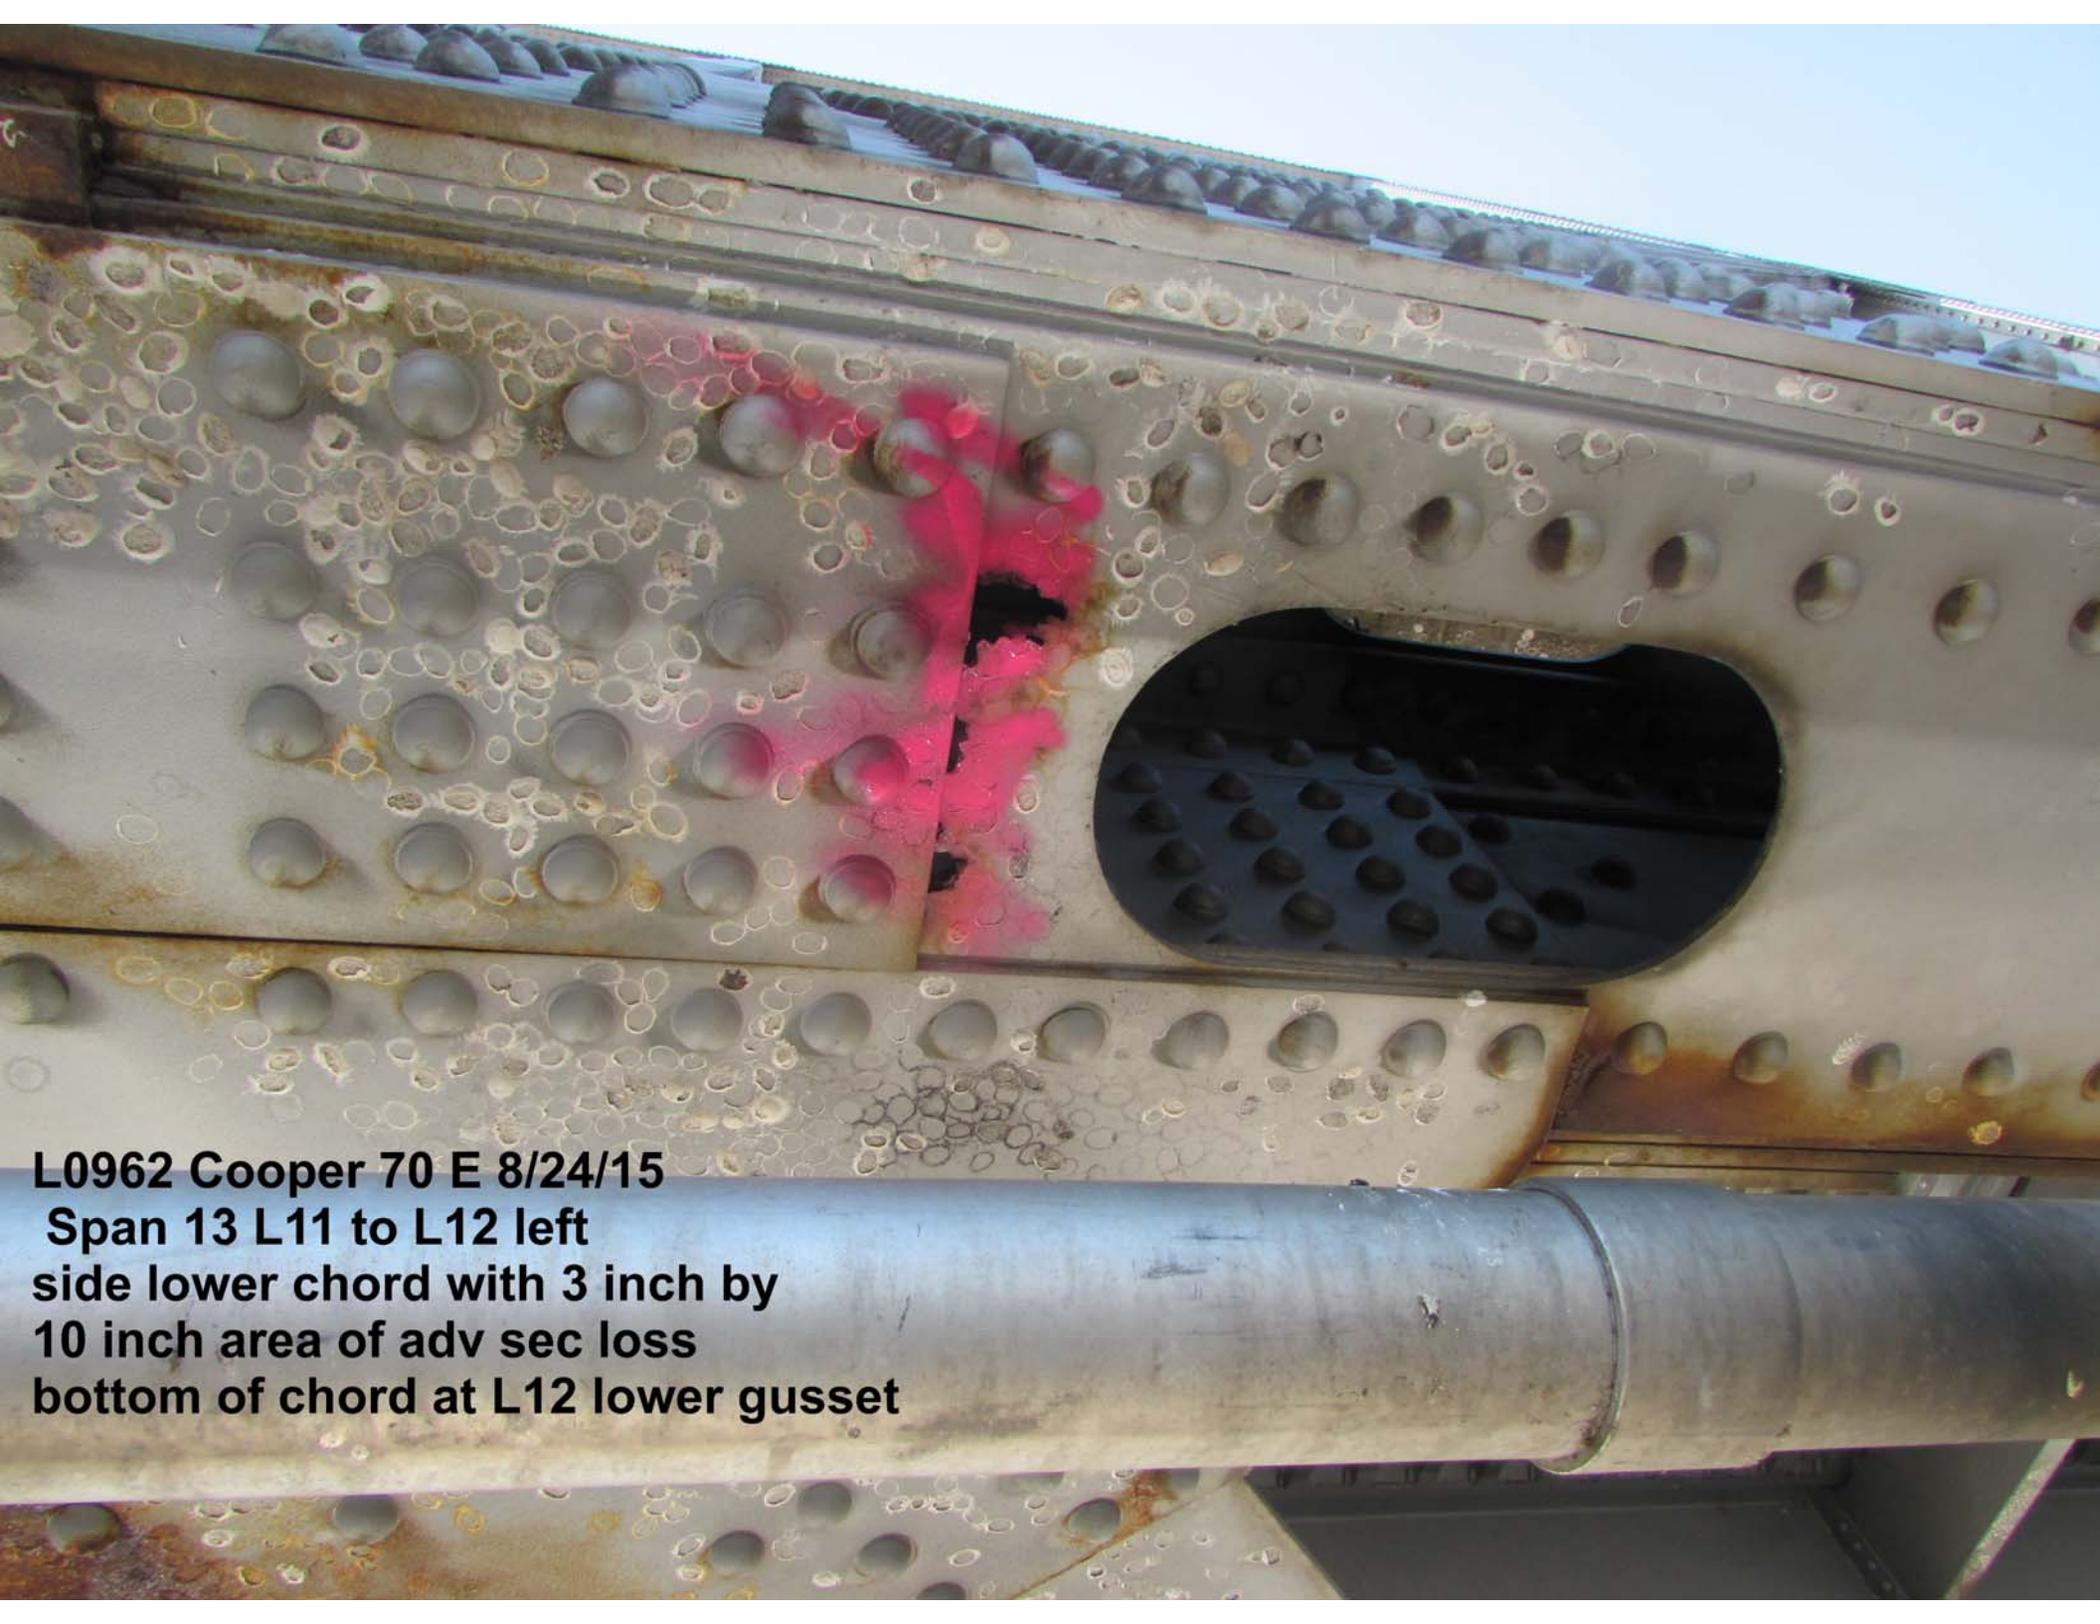
L0962 Cooper 70 E 8/24/15
Span 13 L11 to L12 left
side lower chord with 3 inch by
10 inch area of adv sec loss
bottom of chord at L12 lower gusset

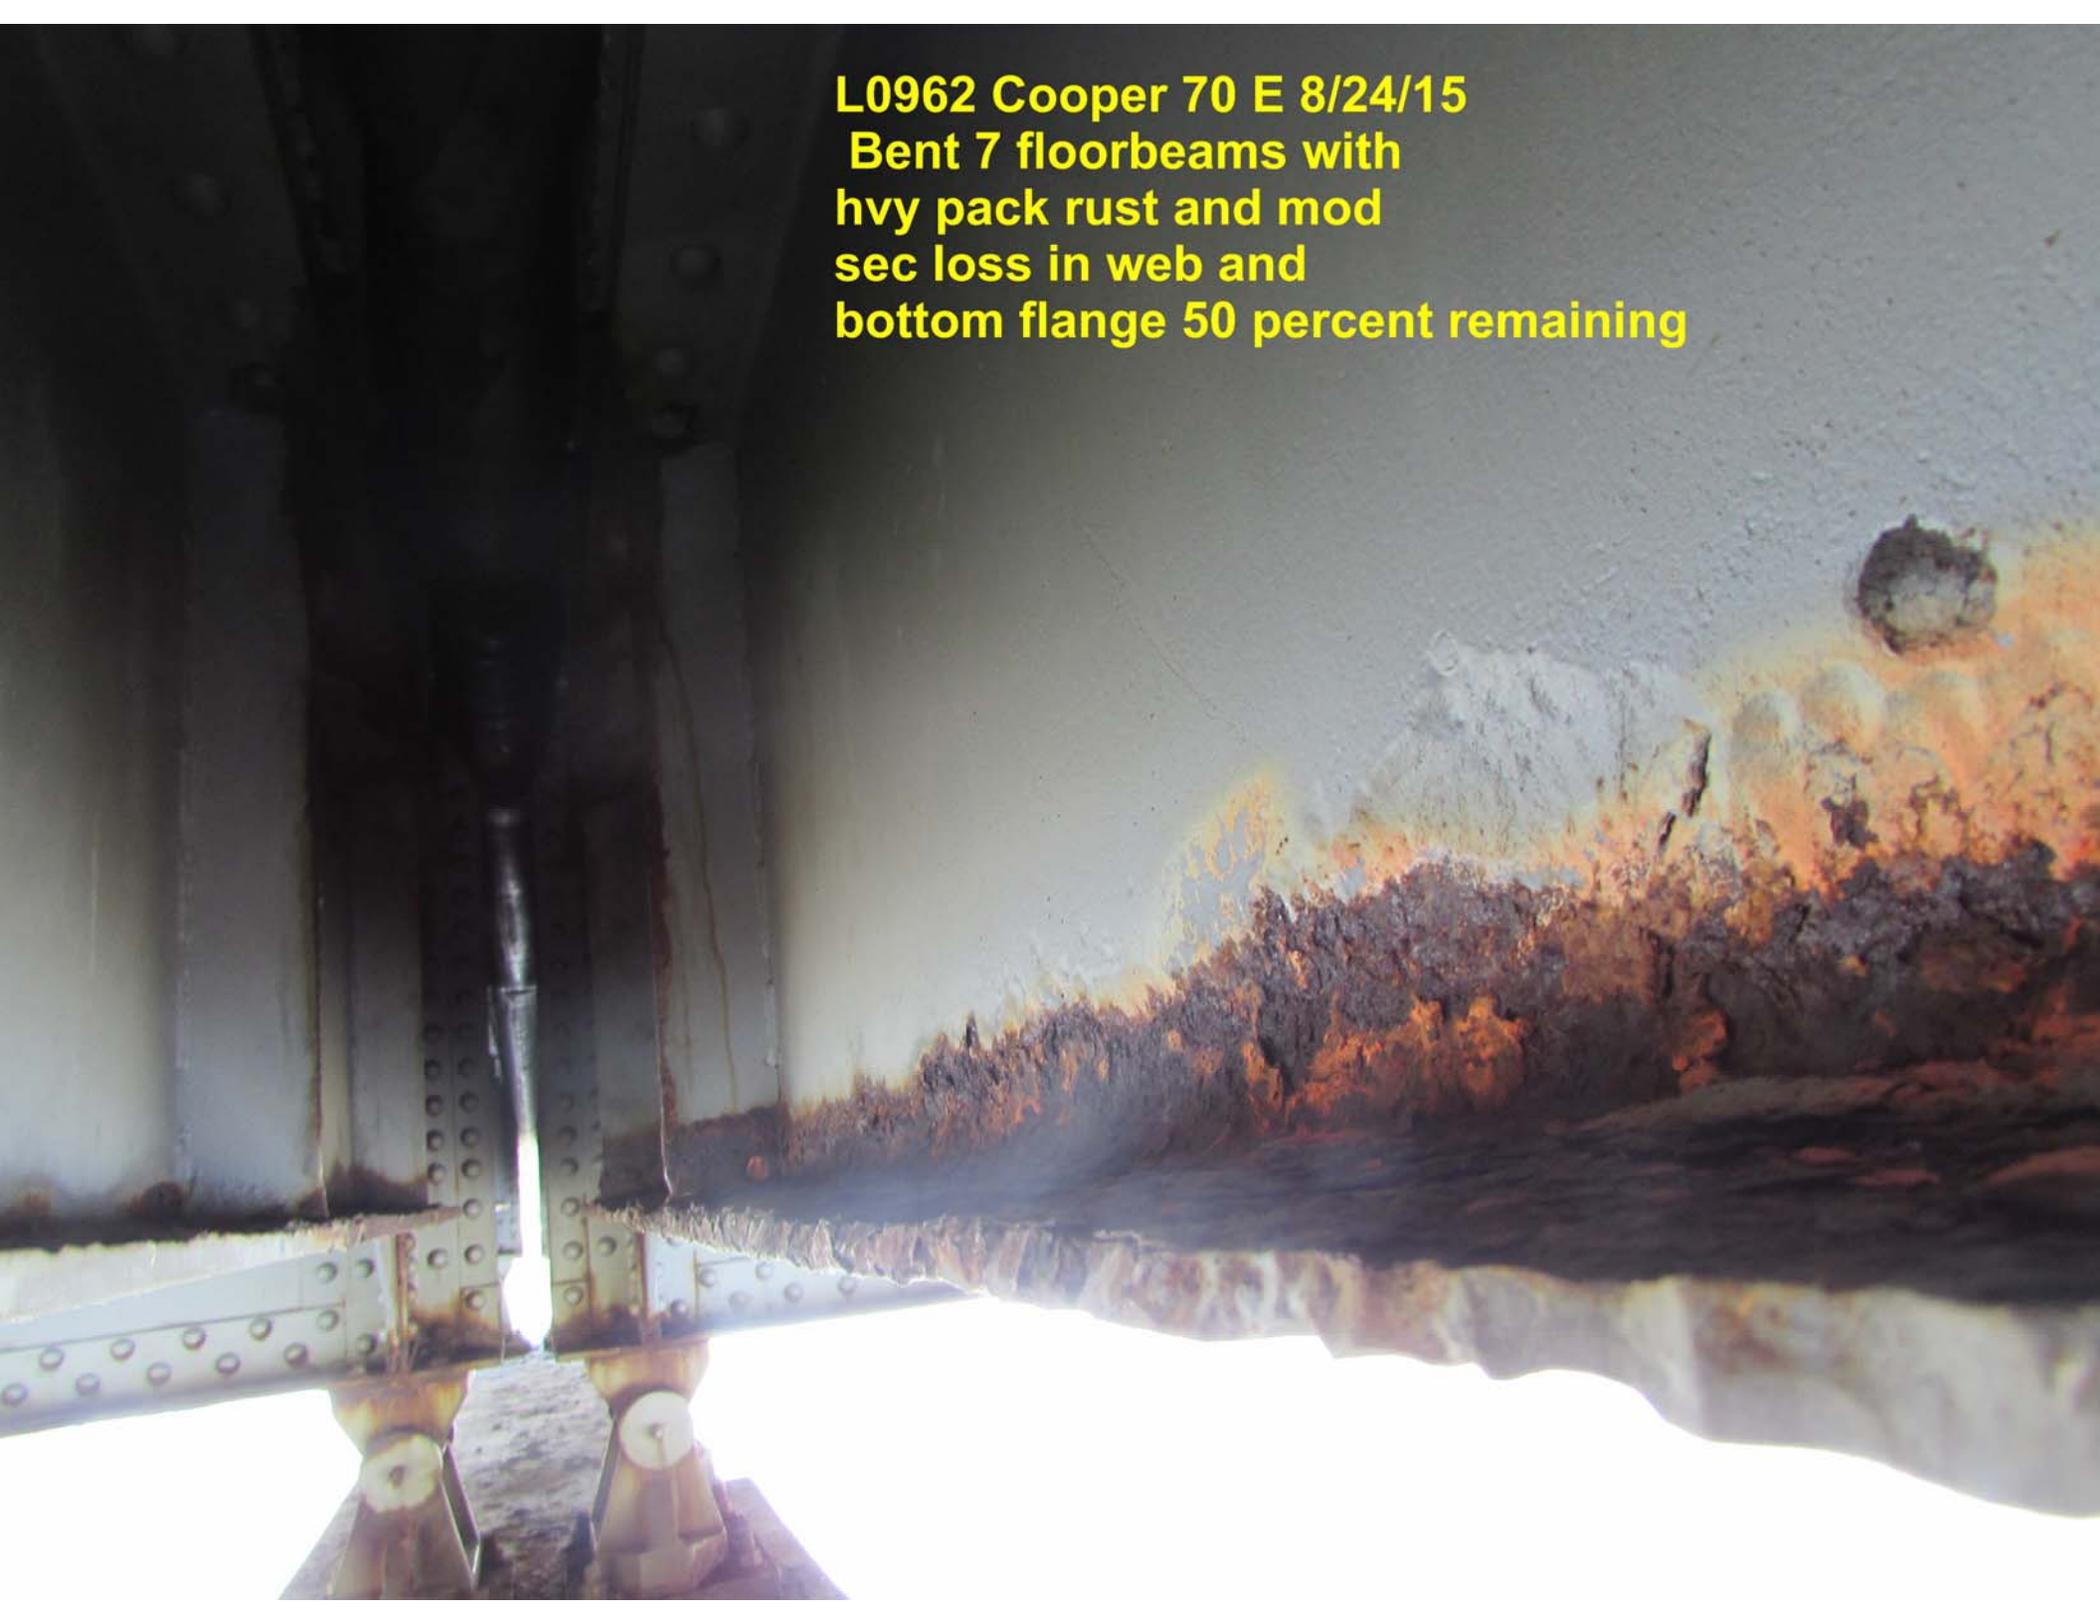
**L0962 Cooper 70 E 8/24/15
Bent 7 floorbeams with
hvy pack rust and mod
sec loss in web and
bottom flange 50 percent remaining**

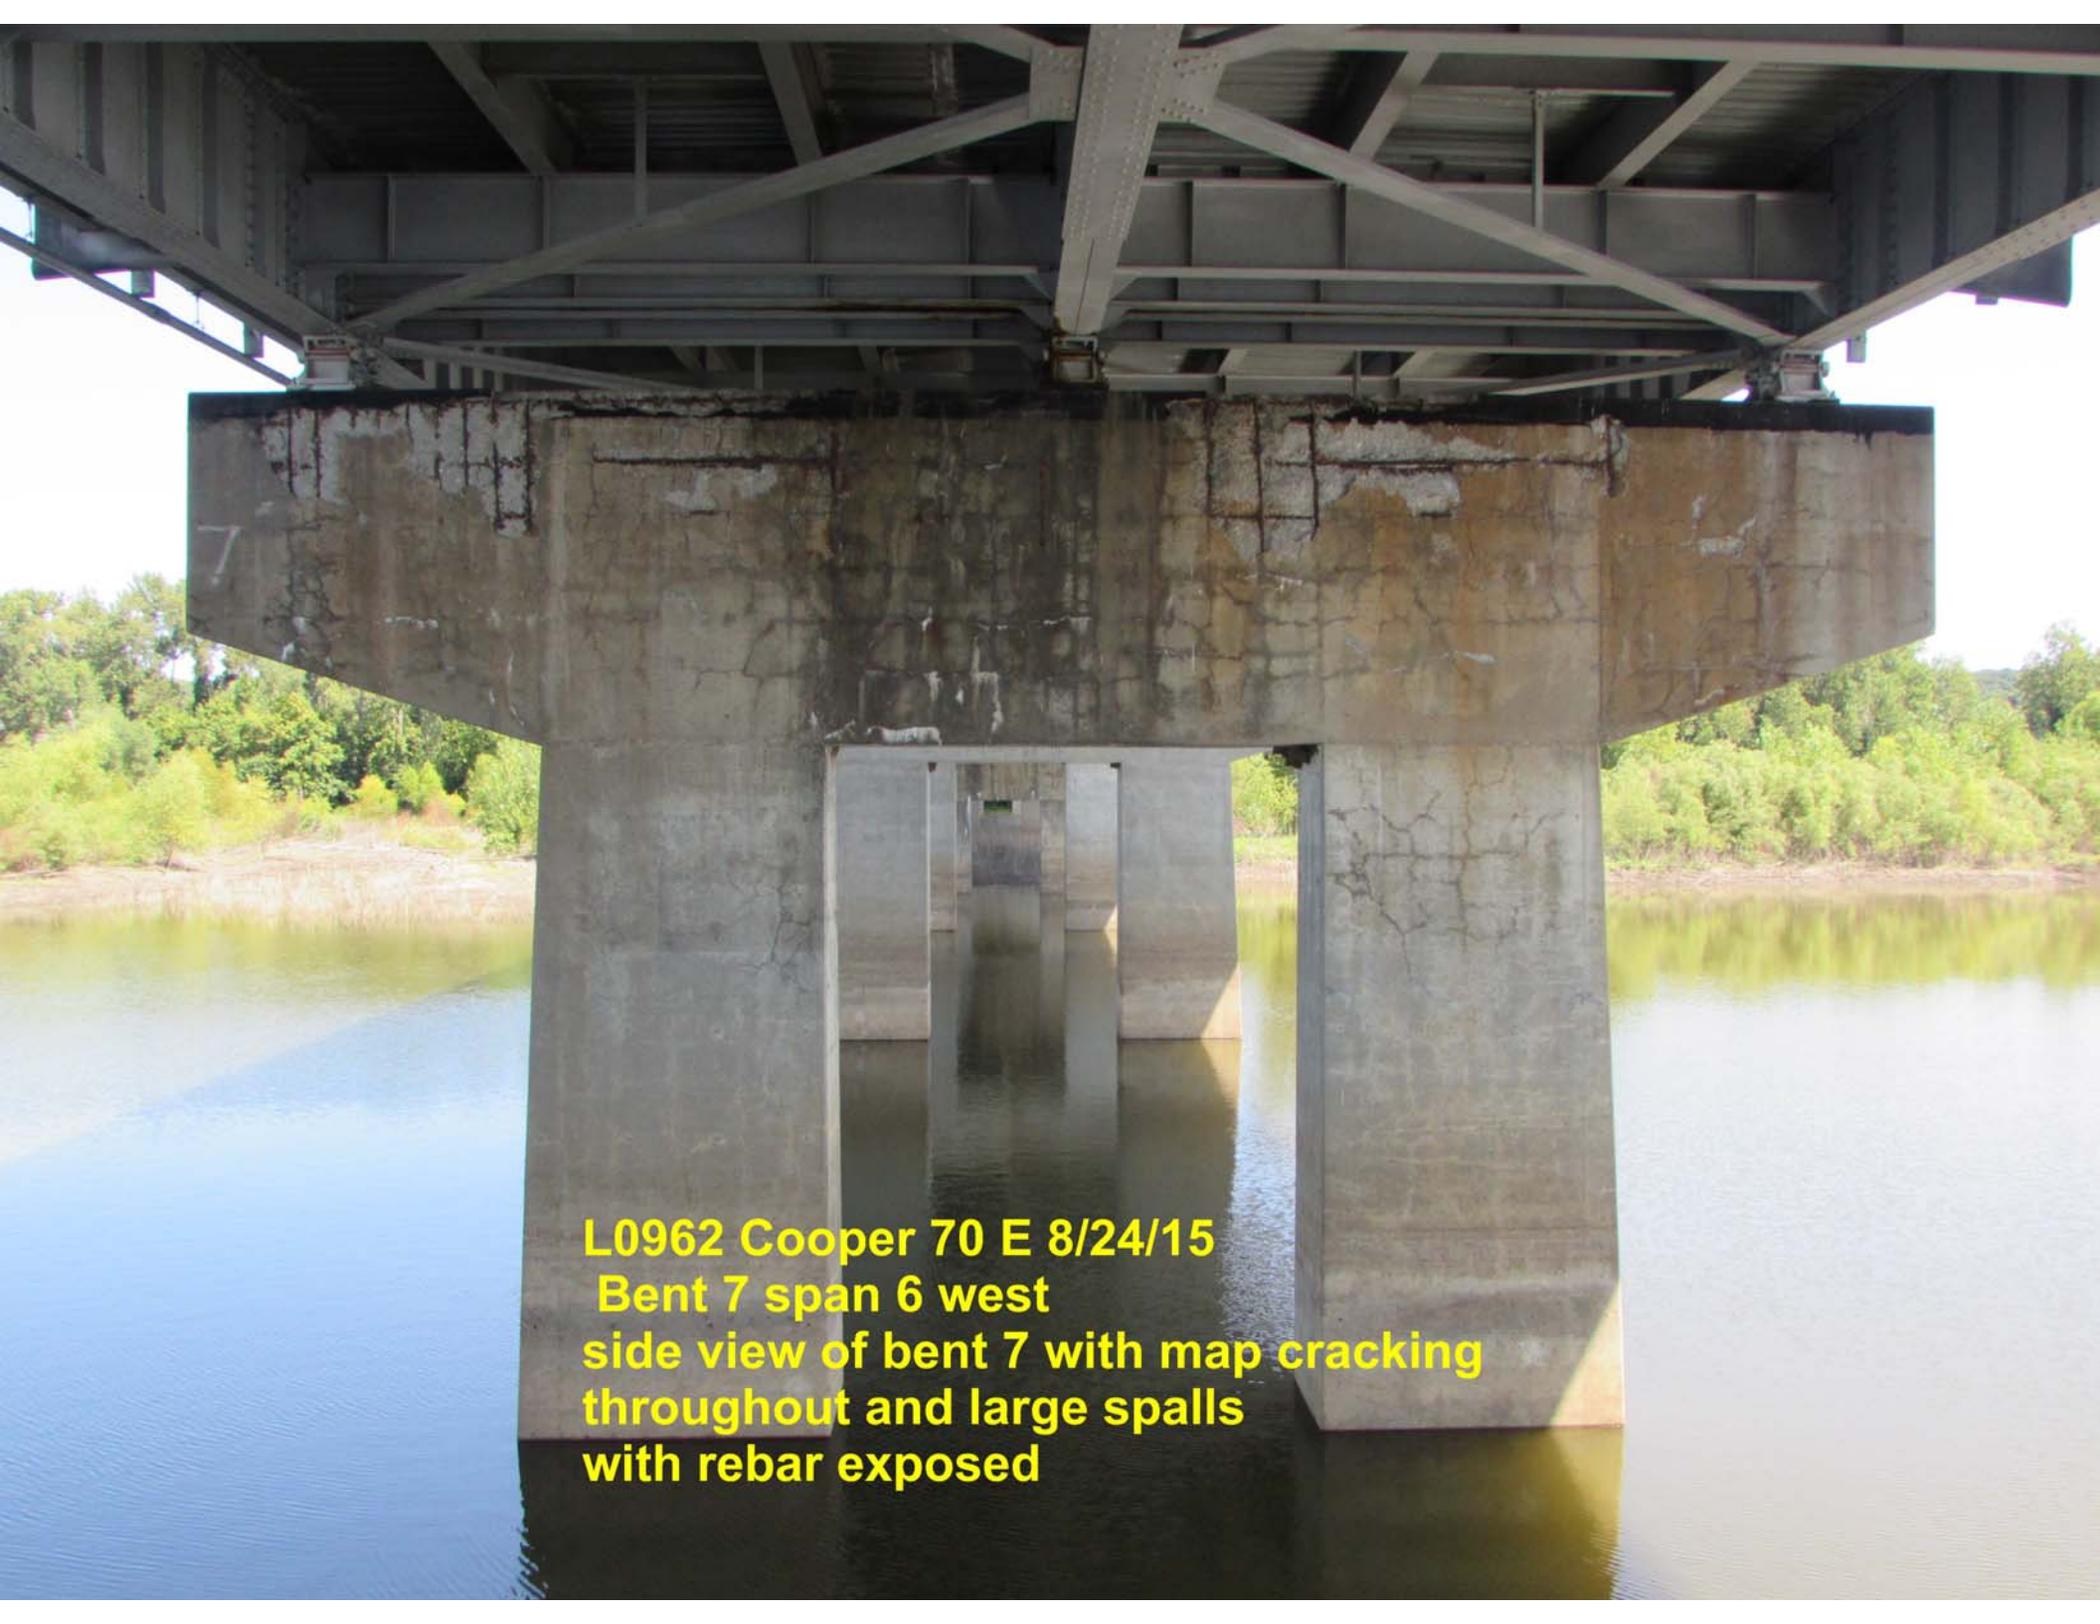
**L0962 Cooper 70 E 8/24/15
Bent 7 span 6 west
side view of bent 7 with map cracking
throughout and large spalls
with rebar exposed**

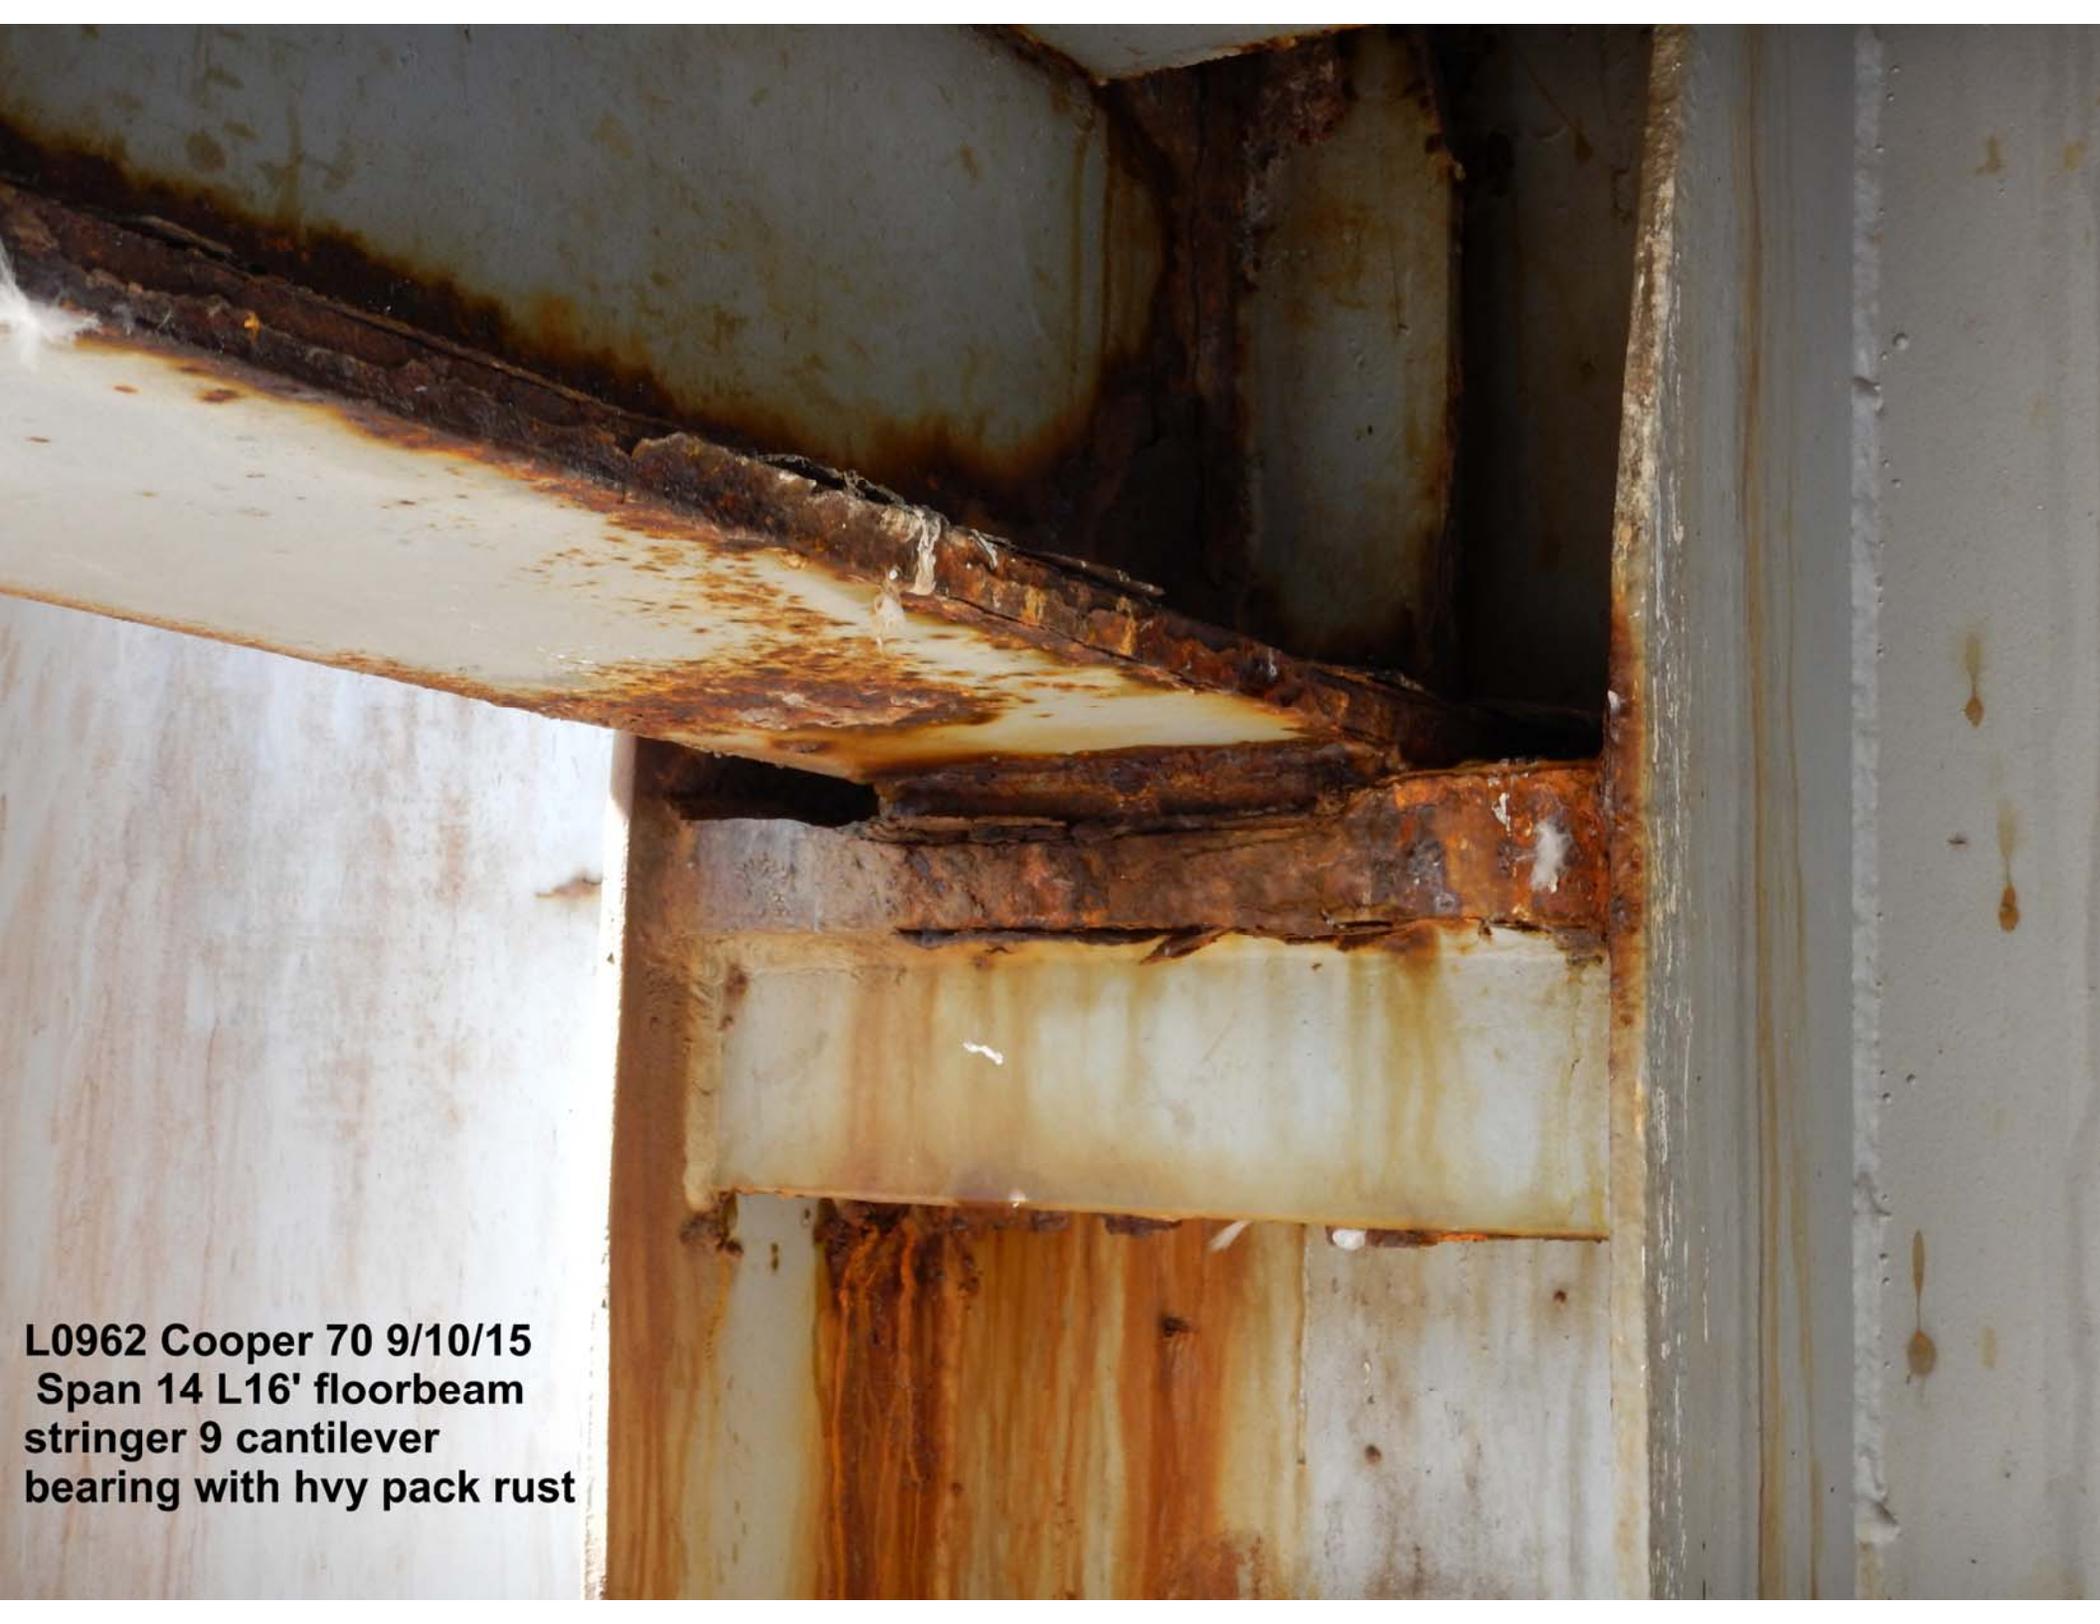
**L0962 Cooper 70 9/10/15
Span 14 L16' floorbeam
stringer 9 cantilever
bearing with hvy pack rust**

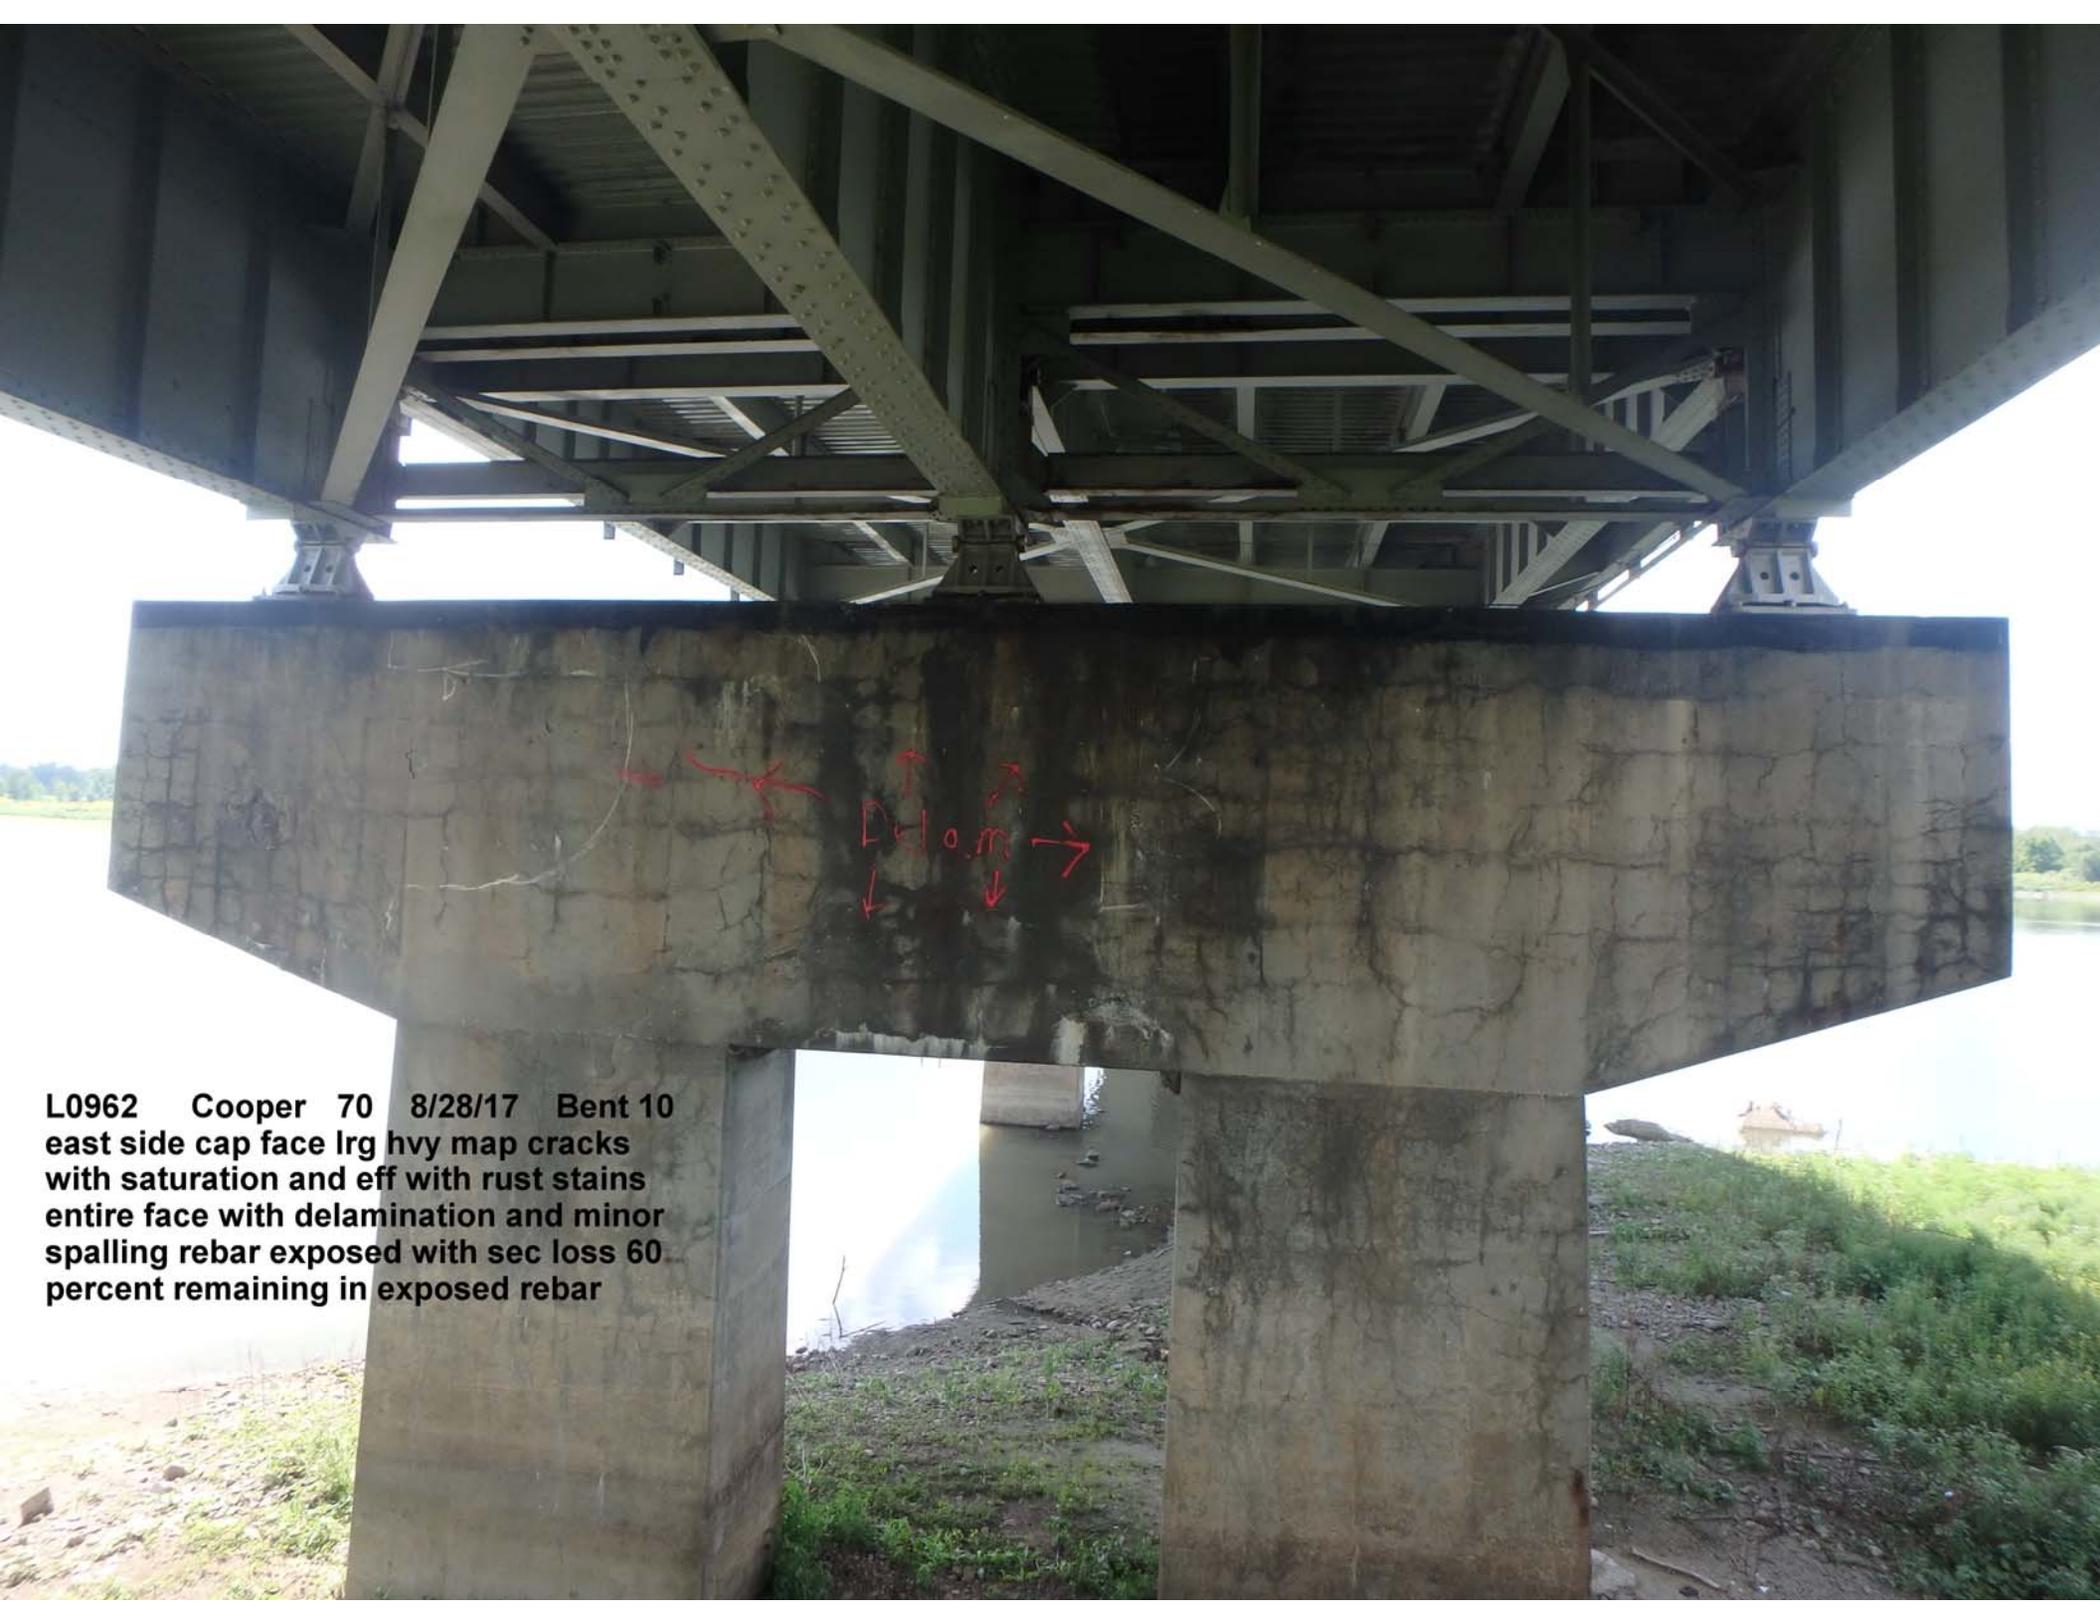
**L0962 Cooper 70 8/28/17 Bent 10
east side cap face lrg hvy map cracks
with saturation and eff with rust stains
entire face with delamination and minor
spalling rebar exposed with sec loss 60
percent remaining in exposed rebar**
