251 MISSOURI BRIDGES PROJECT

MoDOT Bridge Inspection Report

**Missouri Department of Transportation
Bridge Inventory and Inspection System
Structural Inventory & Appraisal Sheet**

COUNTY : COOPER	BRIDGE : L0962 2	REVIEW STATUS : REVIEW	NBI STATUS : T
RECORD TYPE : ROUTE CARRIED 'ON' STRUCT		RUN DATE : 11/28/2017	SUBMITTAL YEAR : 2017

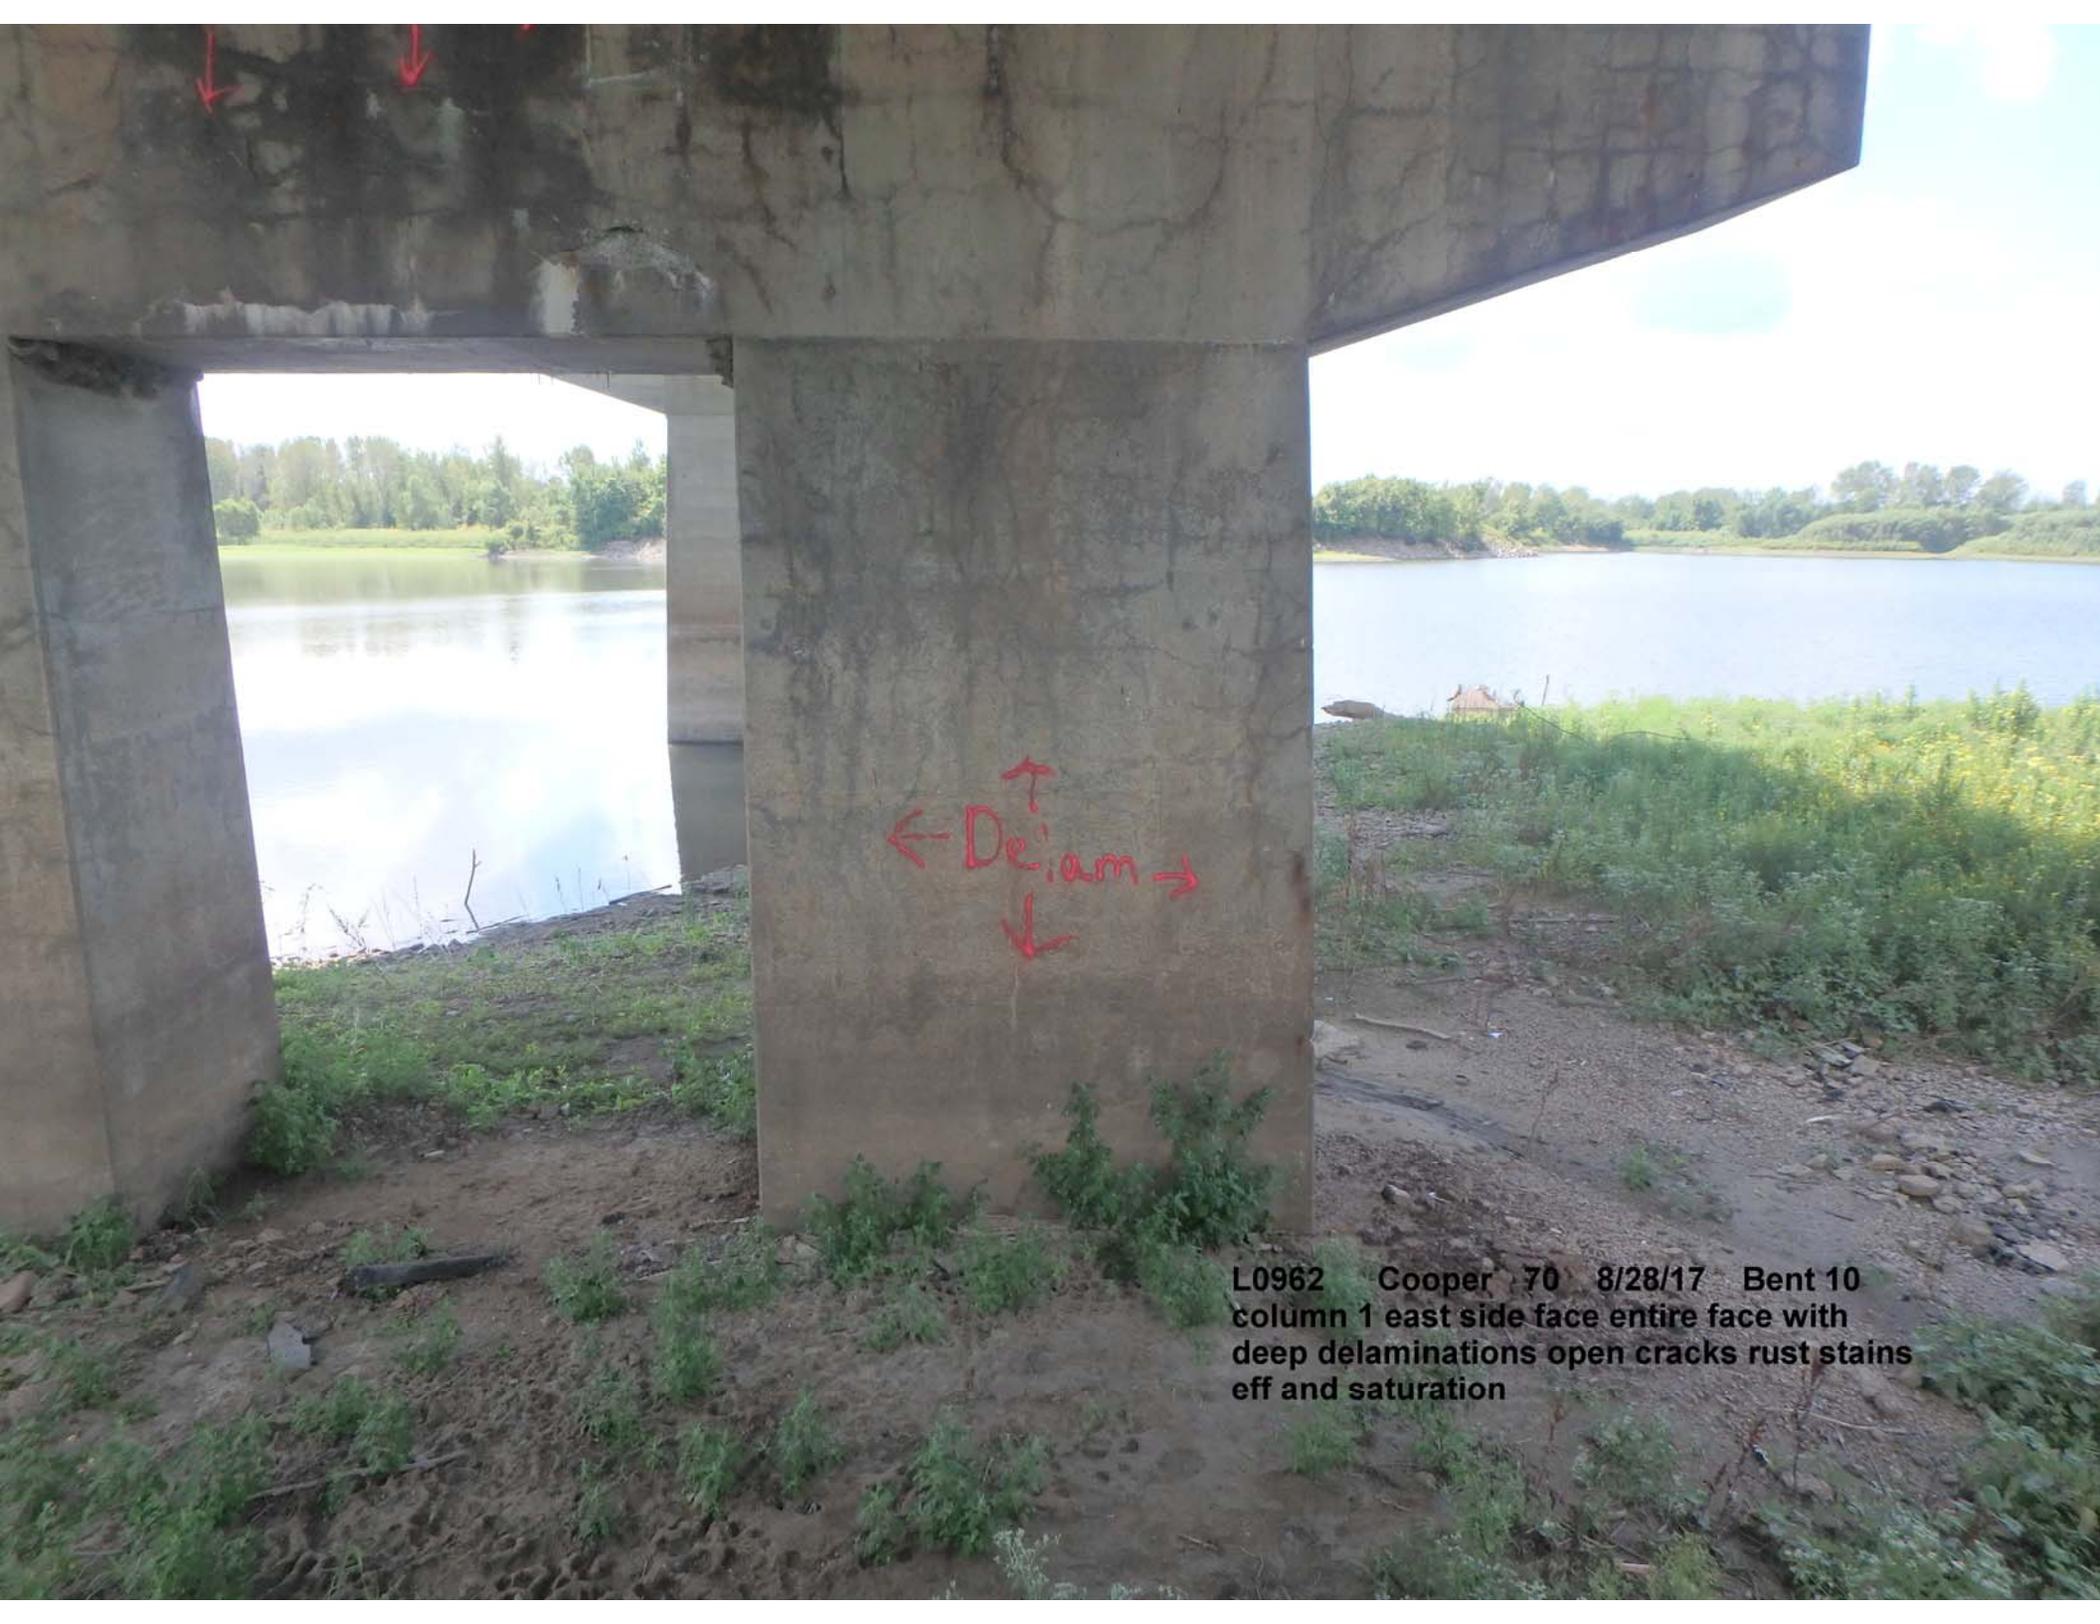
L0962 Cooper 70 8/28/17 Bent 10
column 1 east side face entire face with
deep delaminations open cracks rust stains
eff and saturation

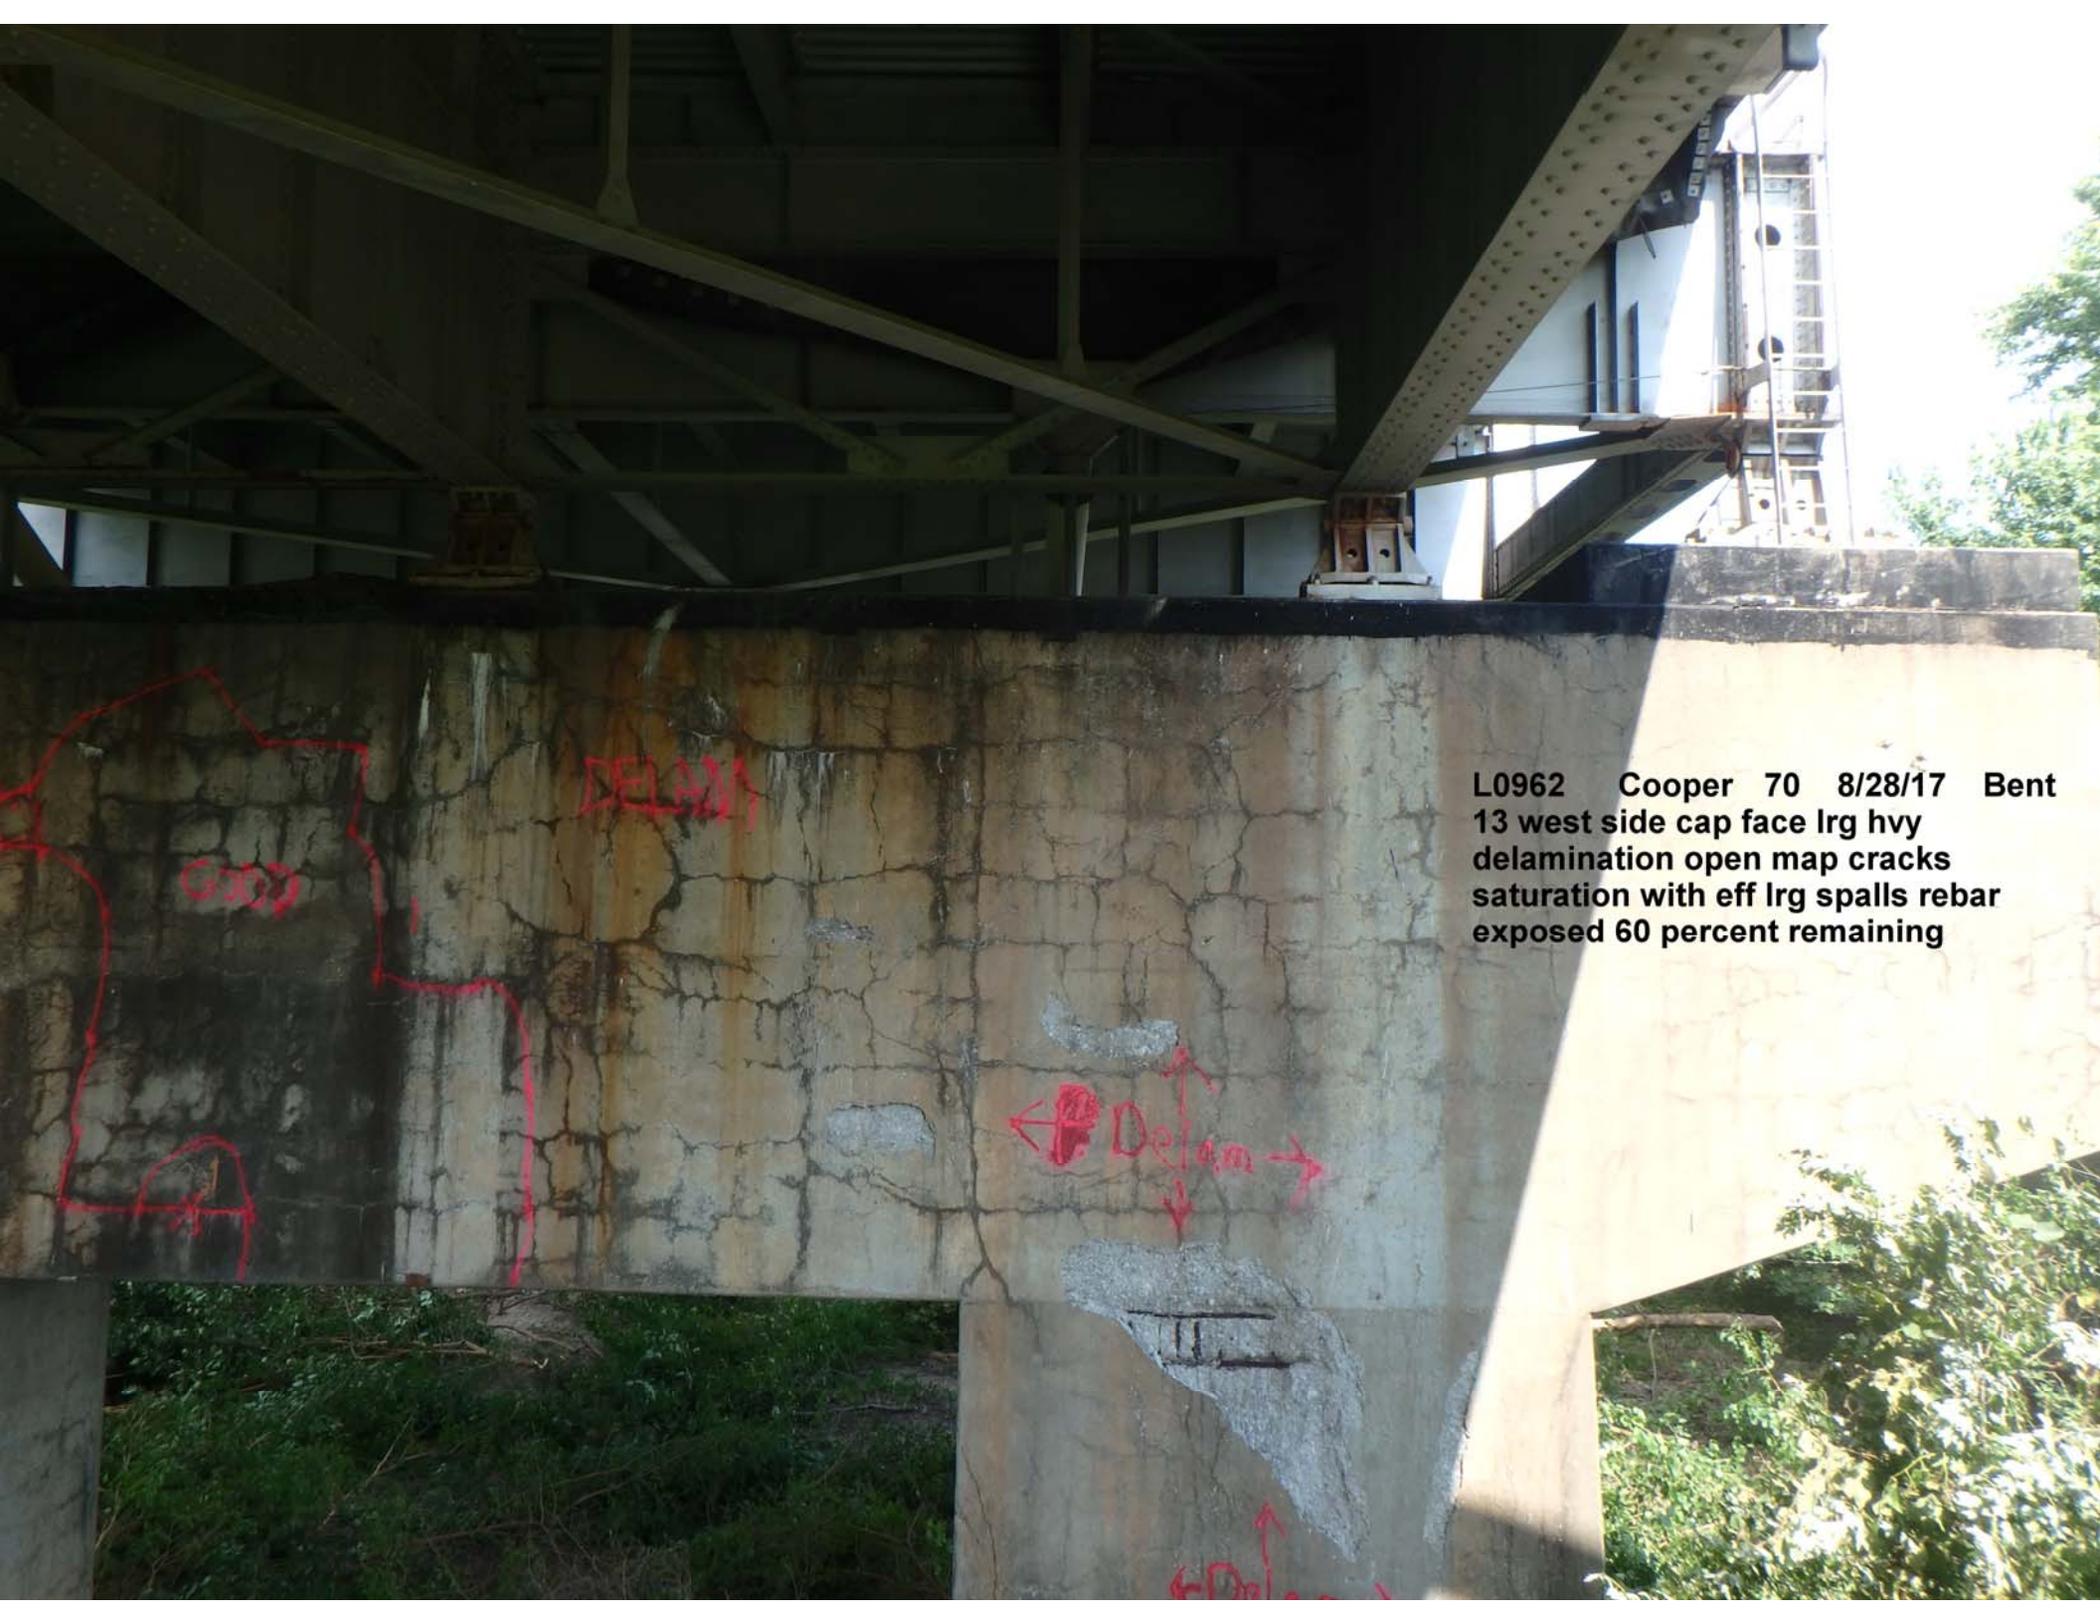
L0962 Cooper 70 8/28/17 Bent
13 west side cap face lrg hvy
delamination open map cracks
saturation with eff lrg spalls rebar
exposed 60 percent remaining

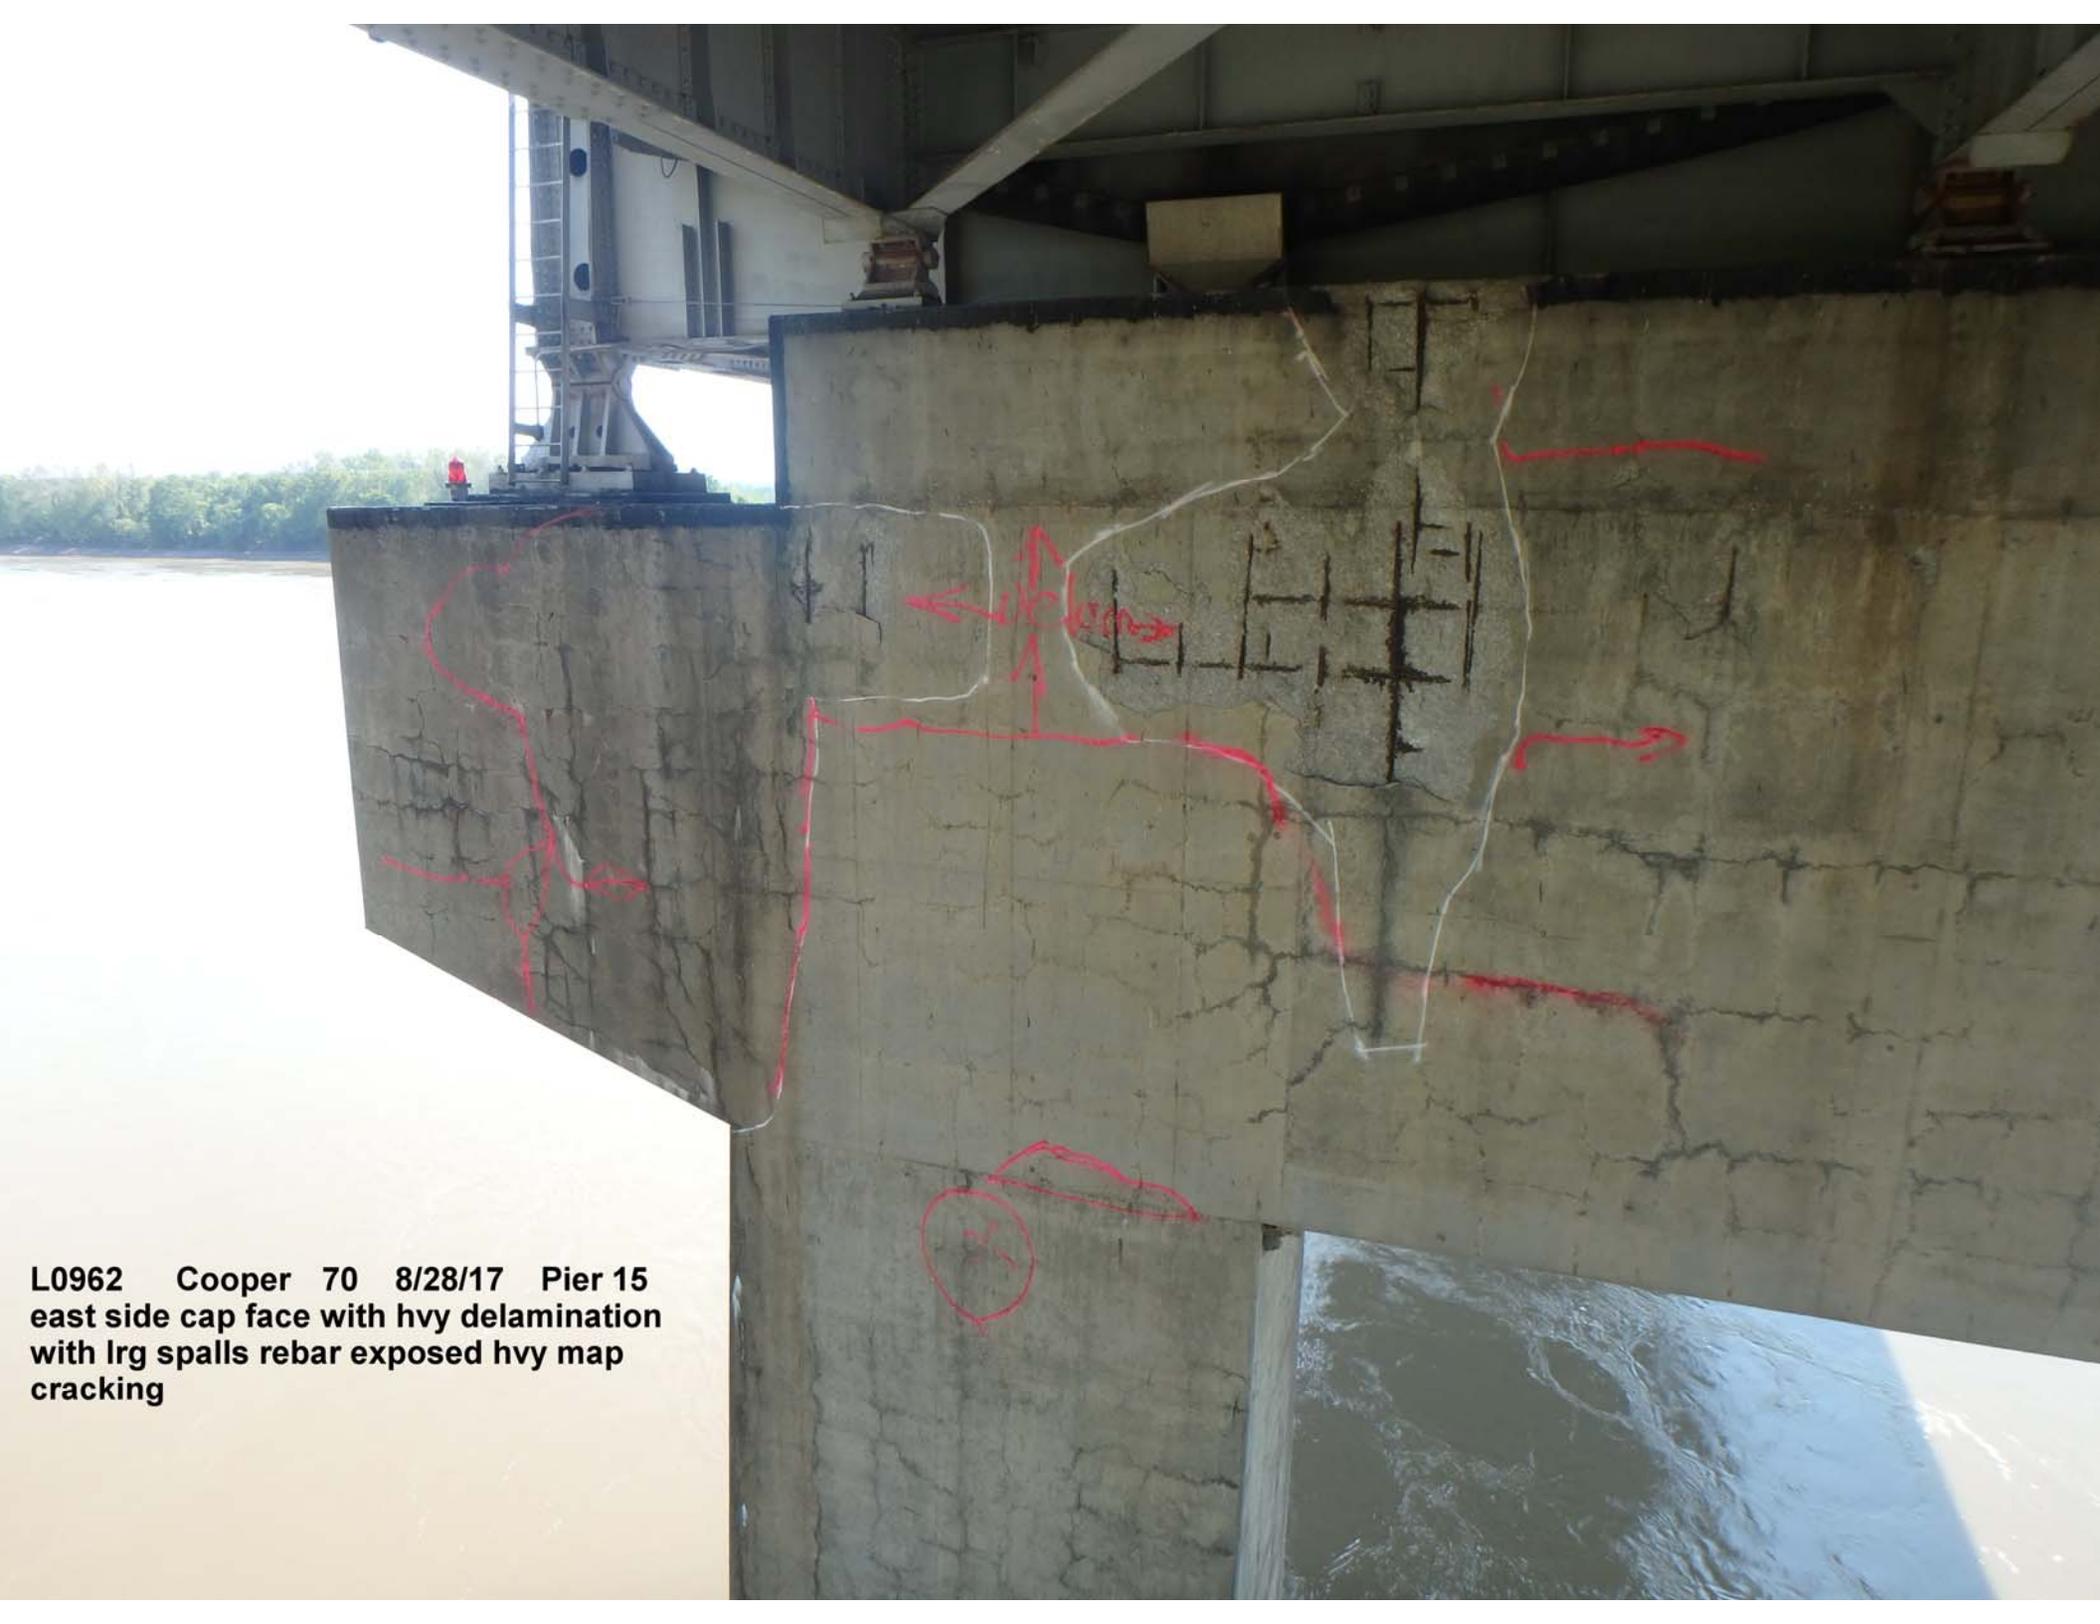
**L0962 Cooper 70 8/28/17 Pier 15
east side cap face with hvy delamination
with lrg spalls rebar exposed hvy map
cracking**

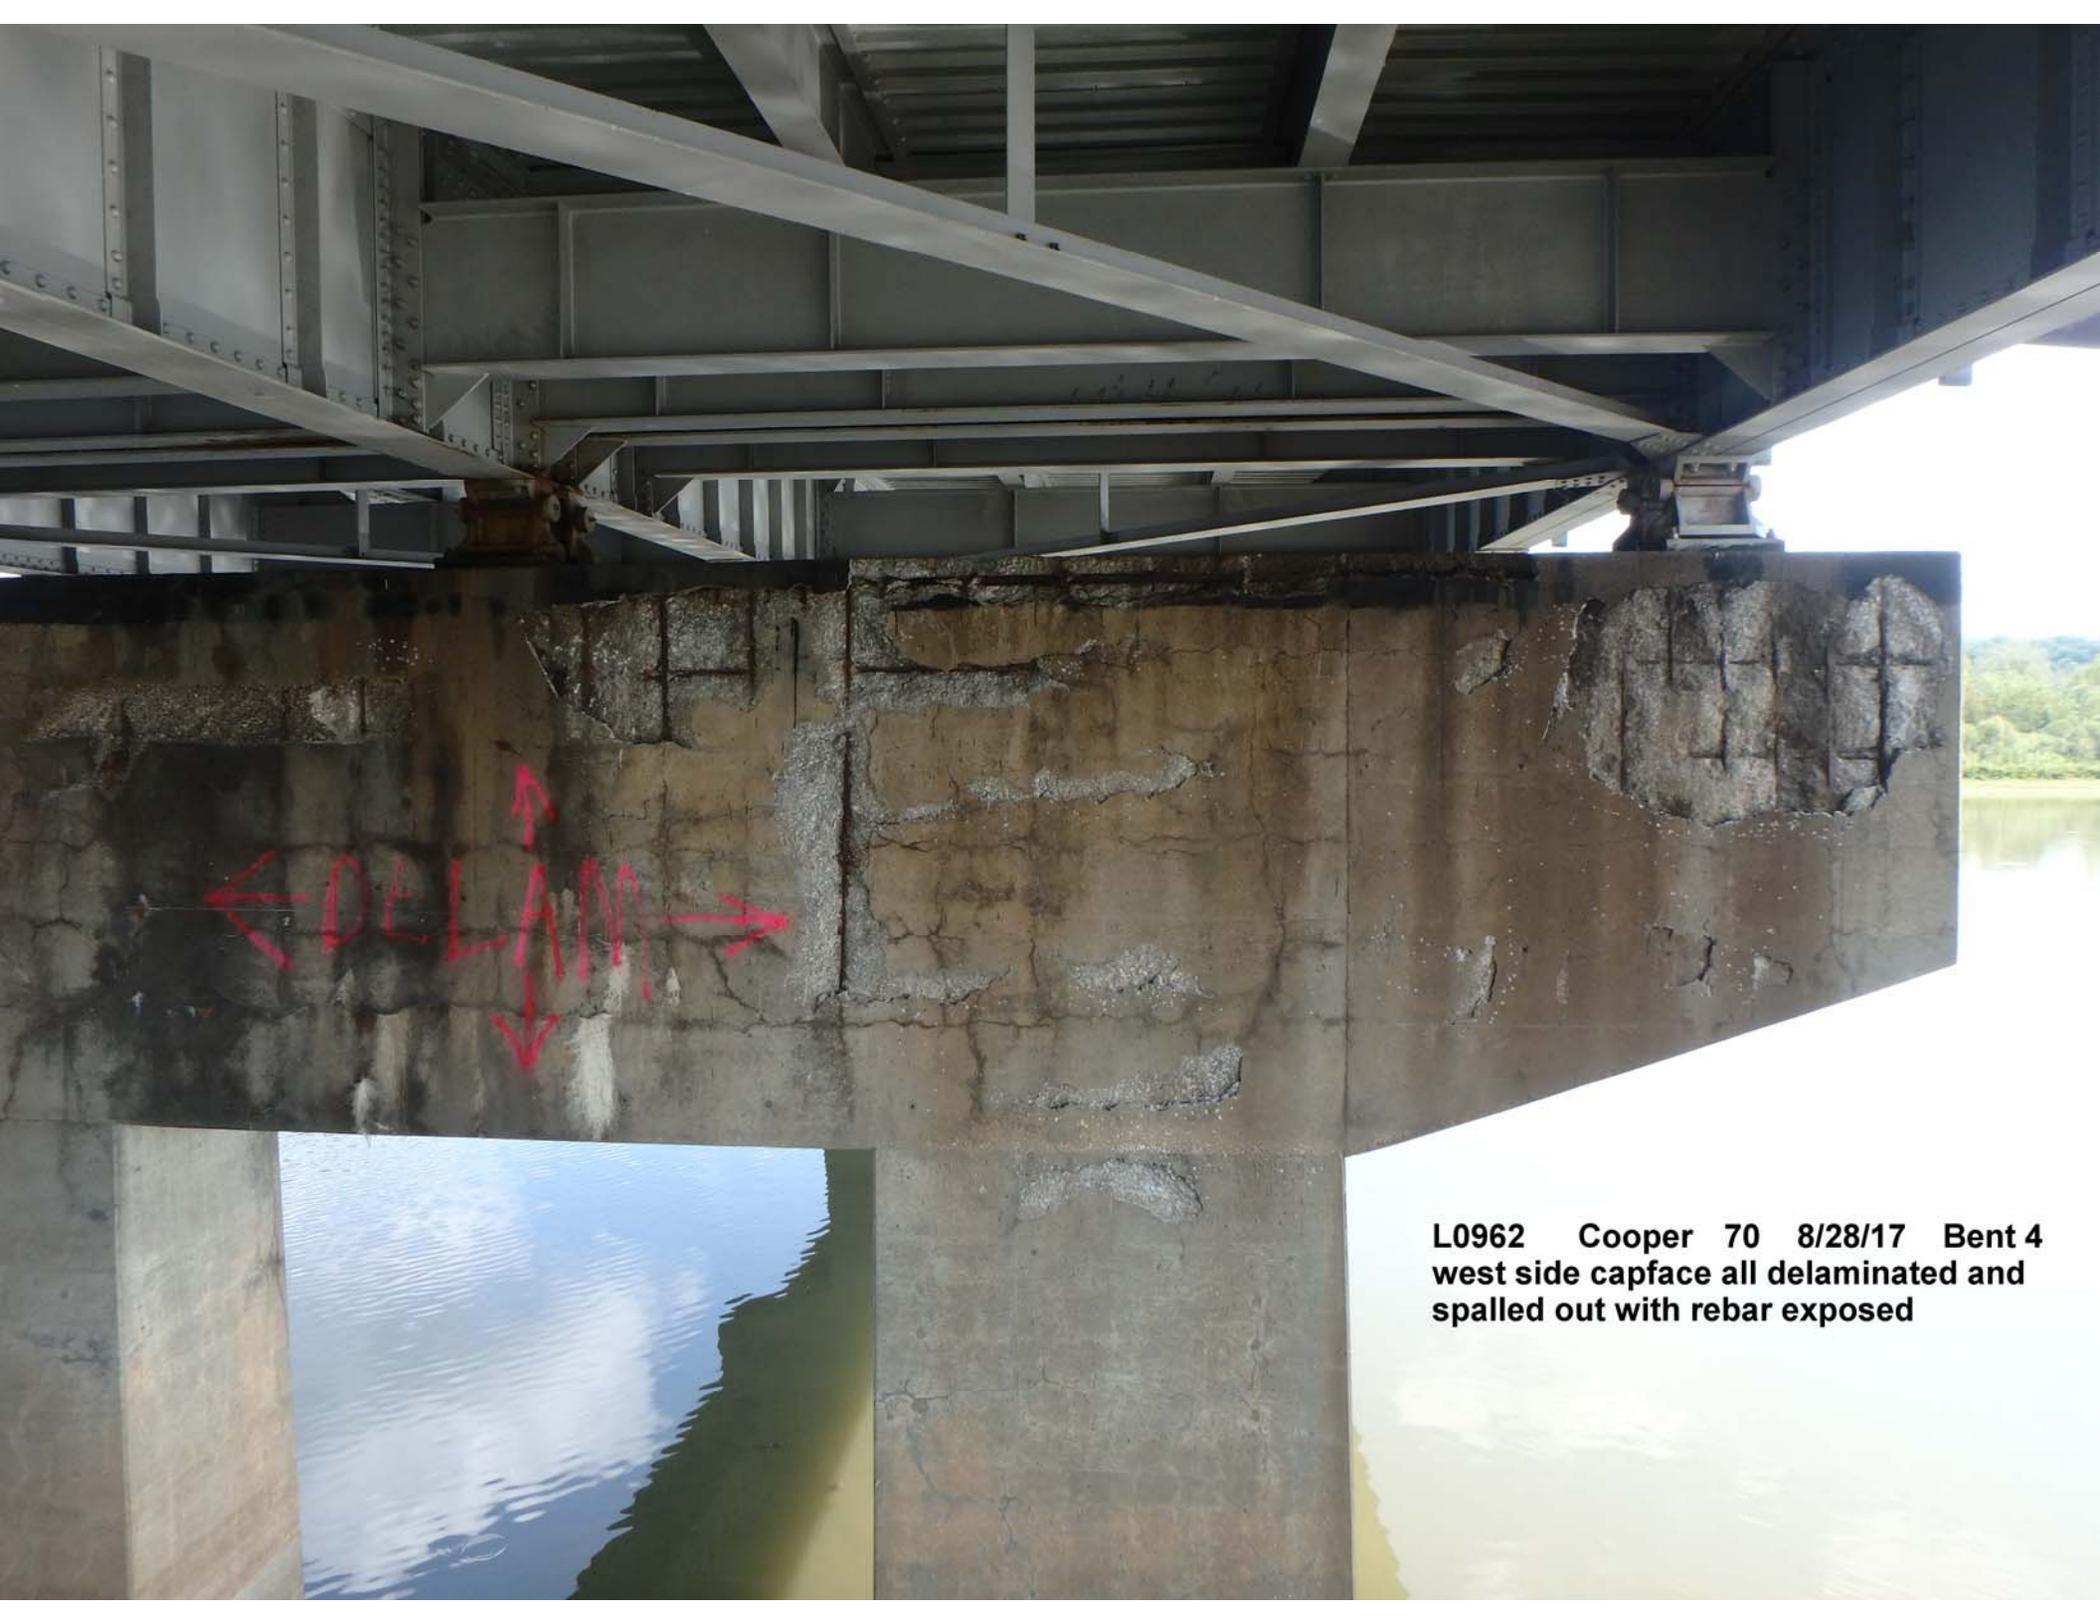
**L0962 Cooper 70 8/28/17 Bent 4
west side capface all delaminated and
spalled out with rebar exposed**

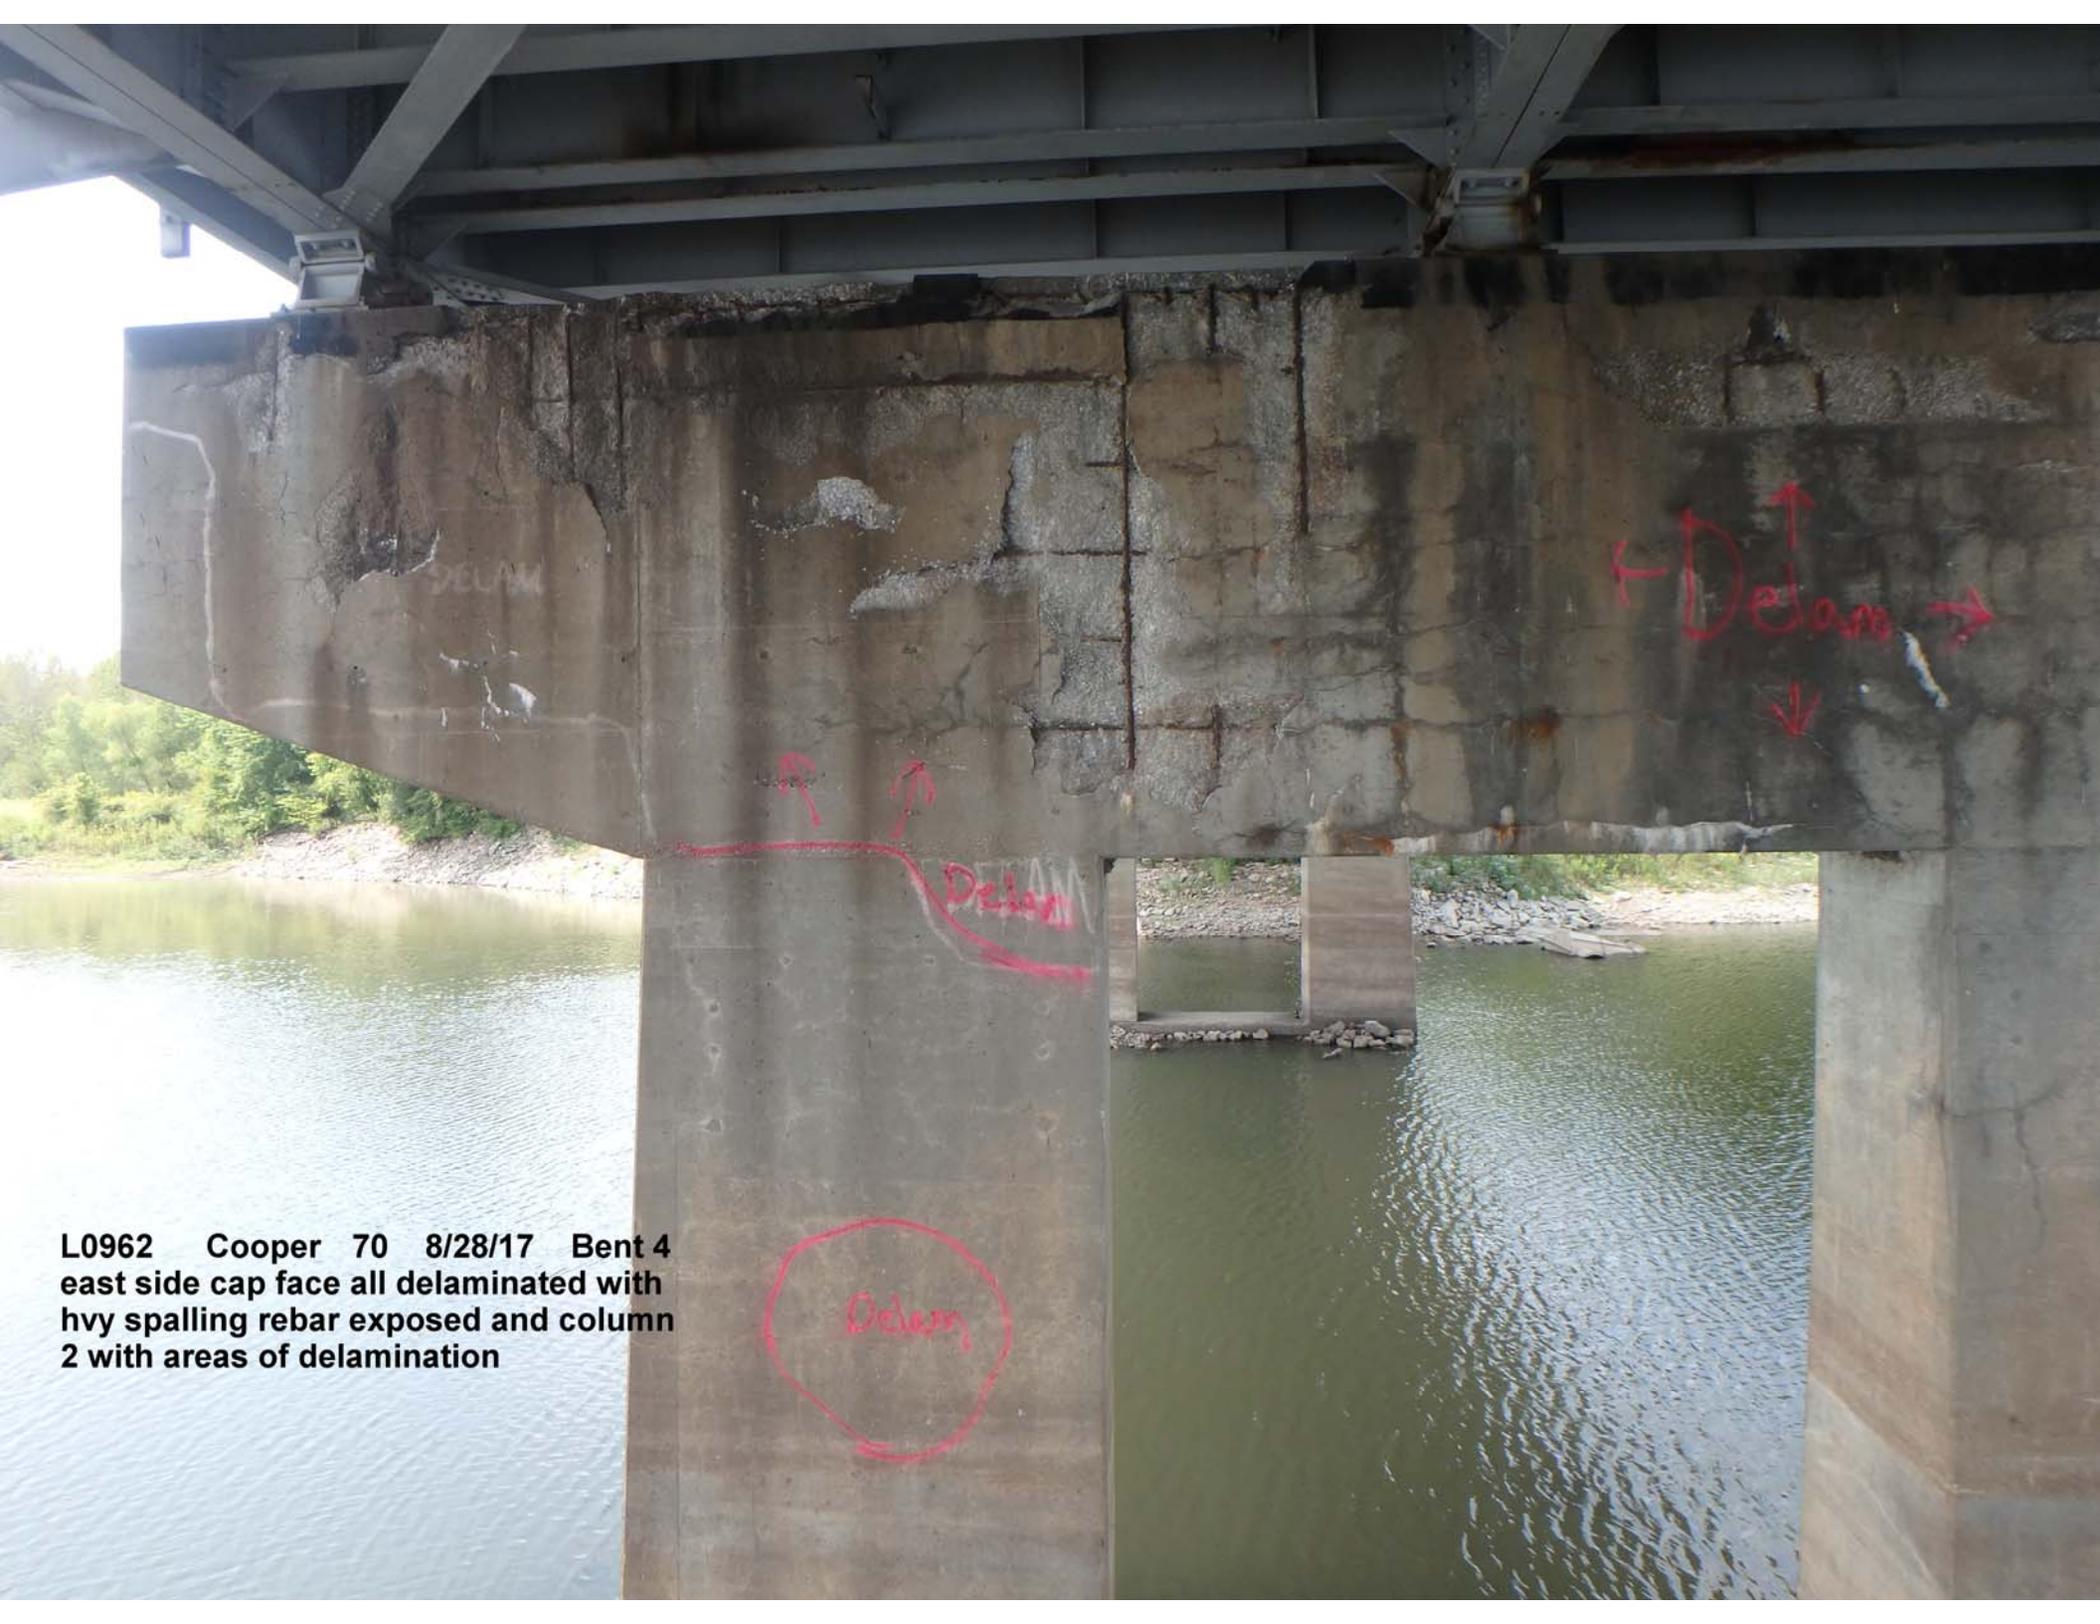
L0962 Cooper 70 8/28/17 Bent 4
east side cap face all delaminated with
hvy spalling rebar exposed and column
2 with areas of delamination

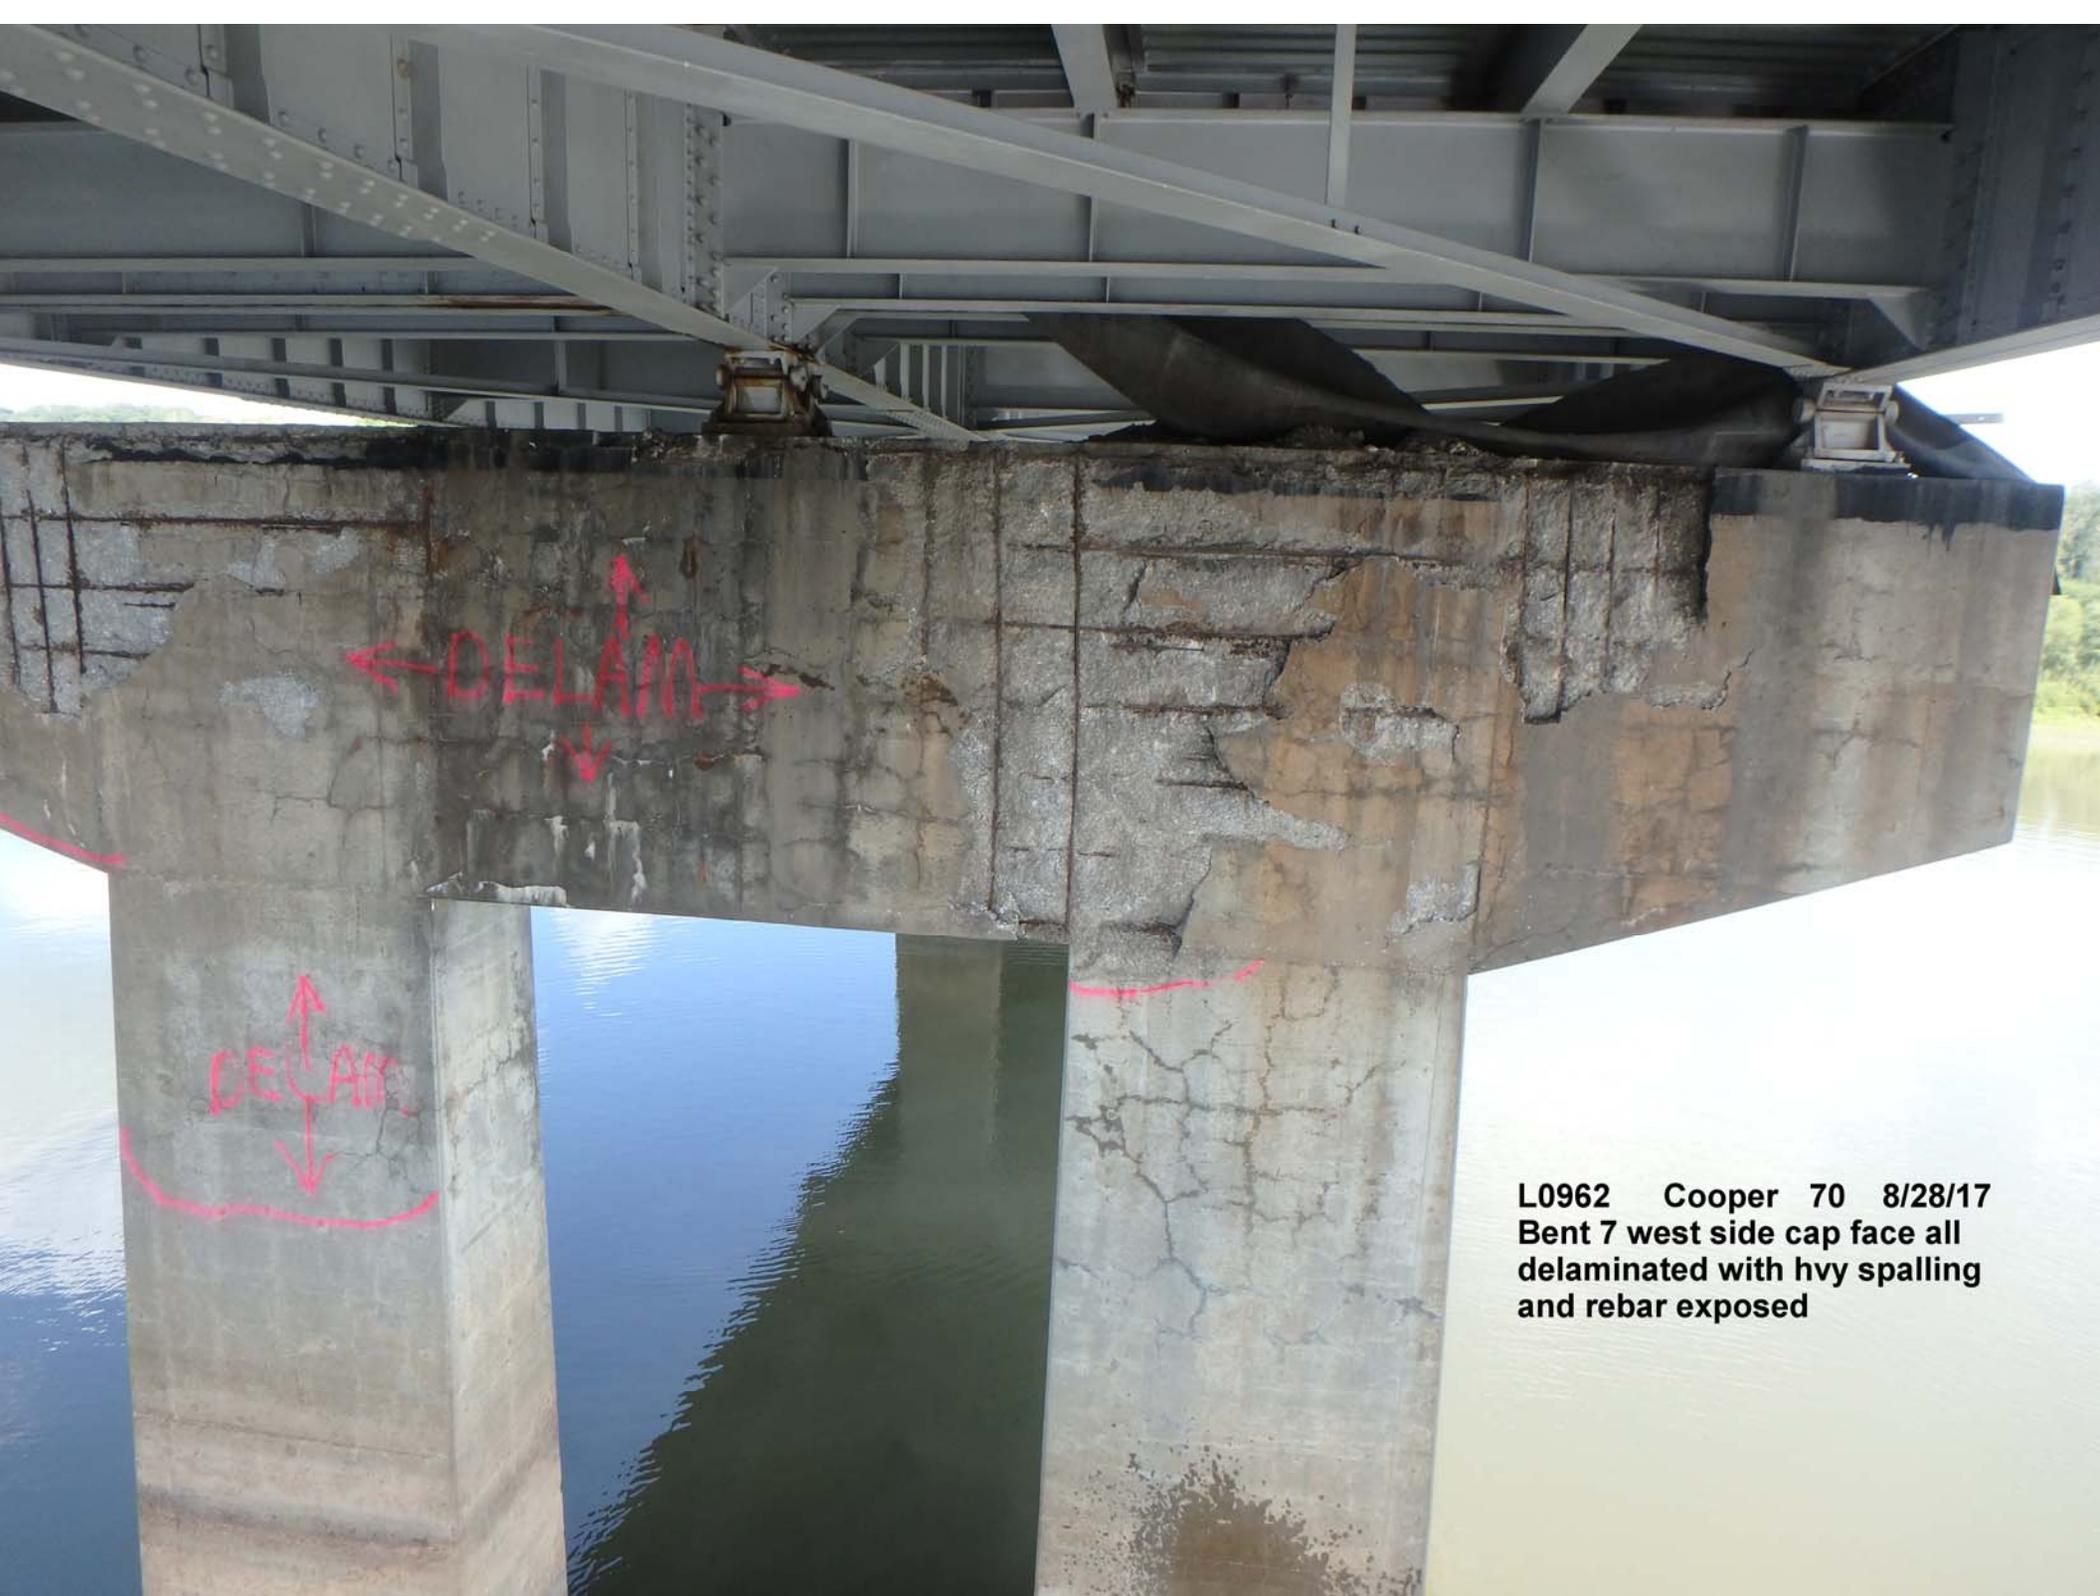
**L0962 Cooper 70 8/28/17
Bent 7 west side cap face all
delaminated with hvy spalling
and rebar exposed**
