251 MISSOURI BRIDGES PROJECT

MoDOT Bridge Inspection Report

**Missouri Department of Transportation
Bridge Inventory and Inspection System
Structural Inventory & Appraisal Sheet**

COUNTY : COOPER	BRIDGE : L0962 2	REVIEW STATUS : REVIEW	NBI STATUS : T
RECORD TYPE : ROUTE CARRIED 'ON' STRUCT		RUN DATE : 11/28/2017	SUBMITTAL YEAR : 2017

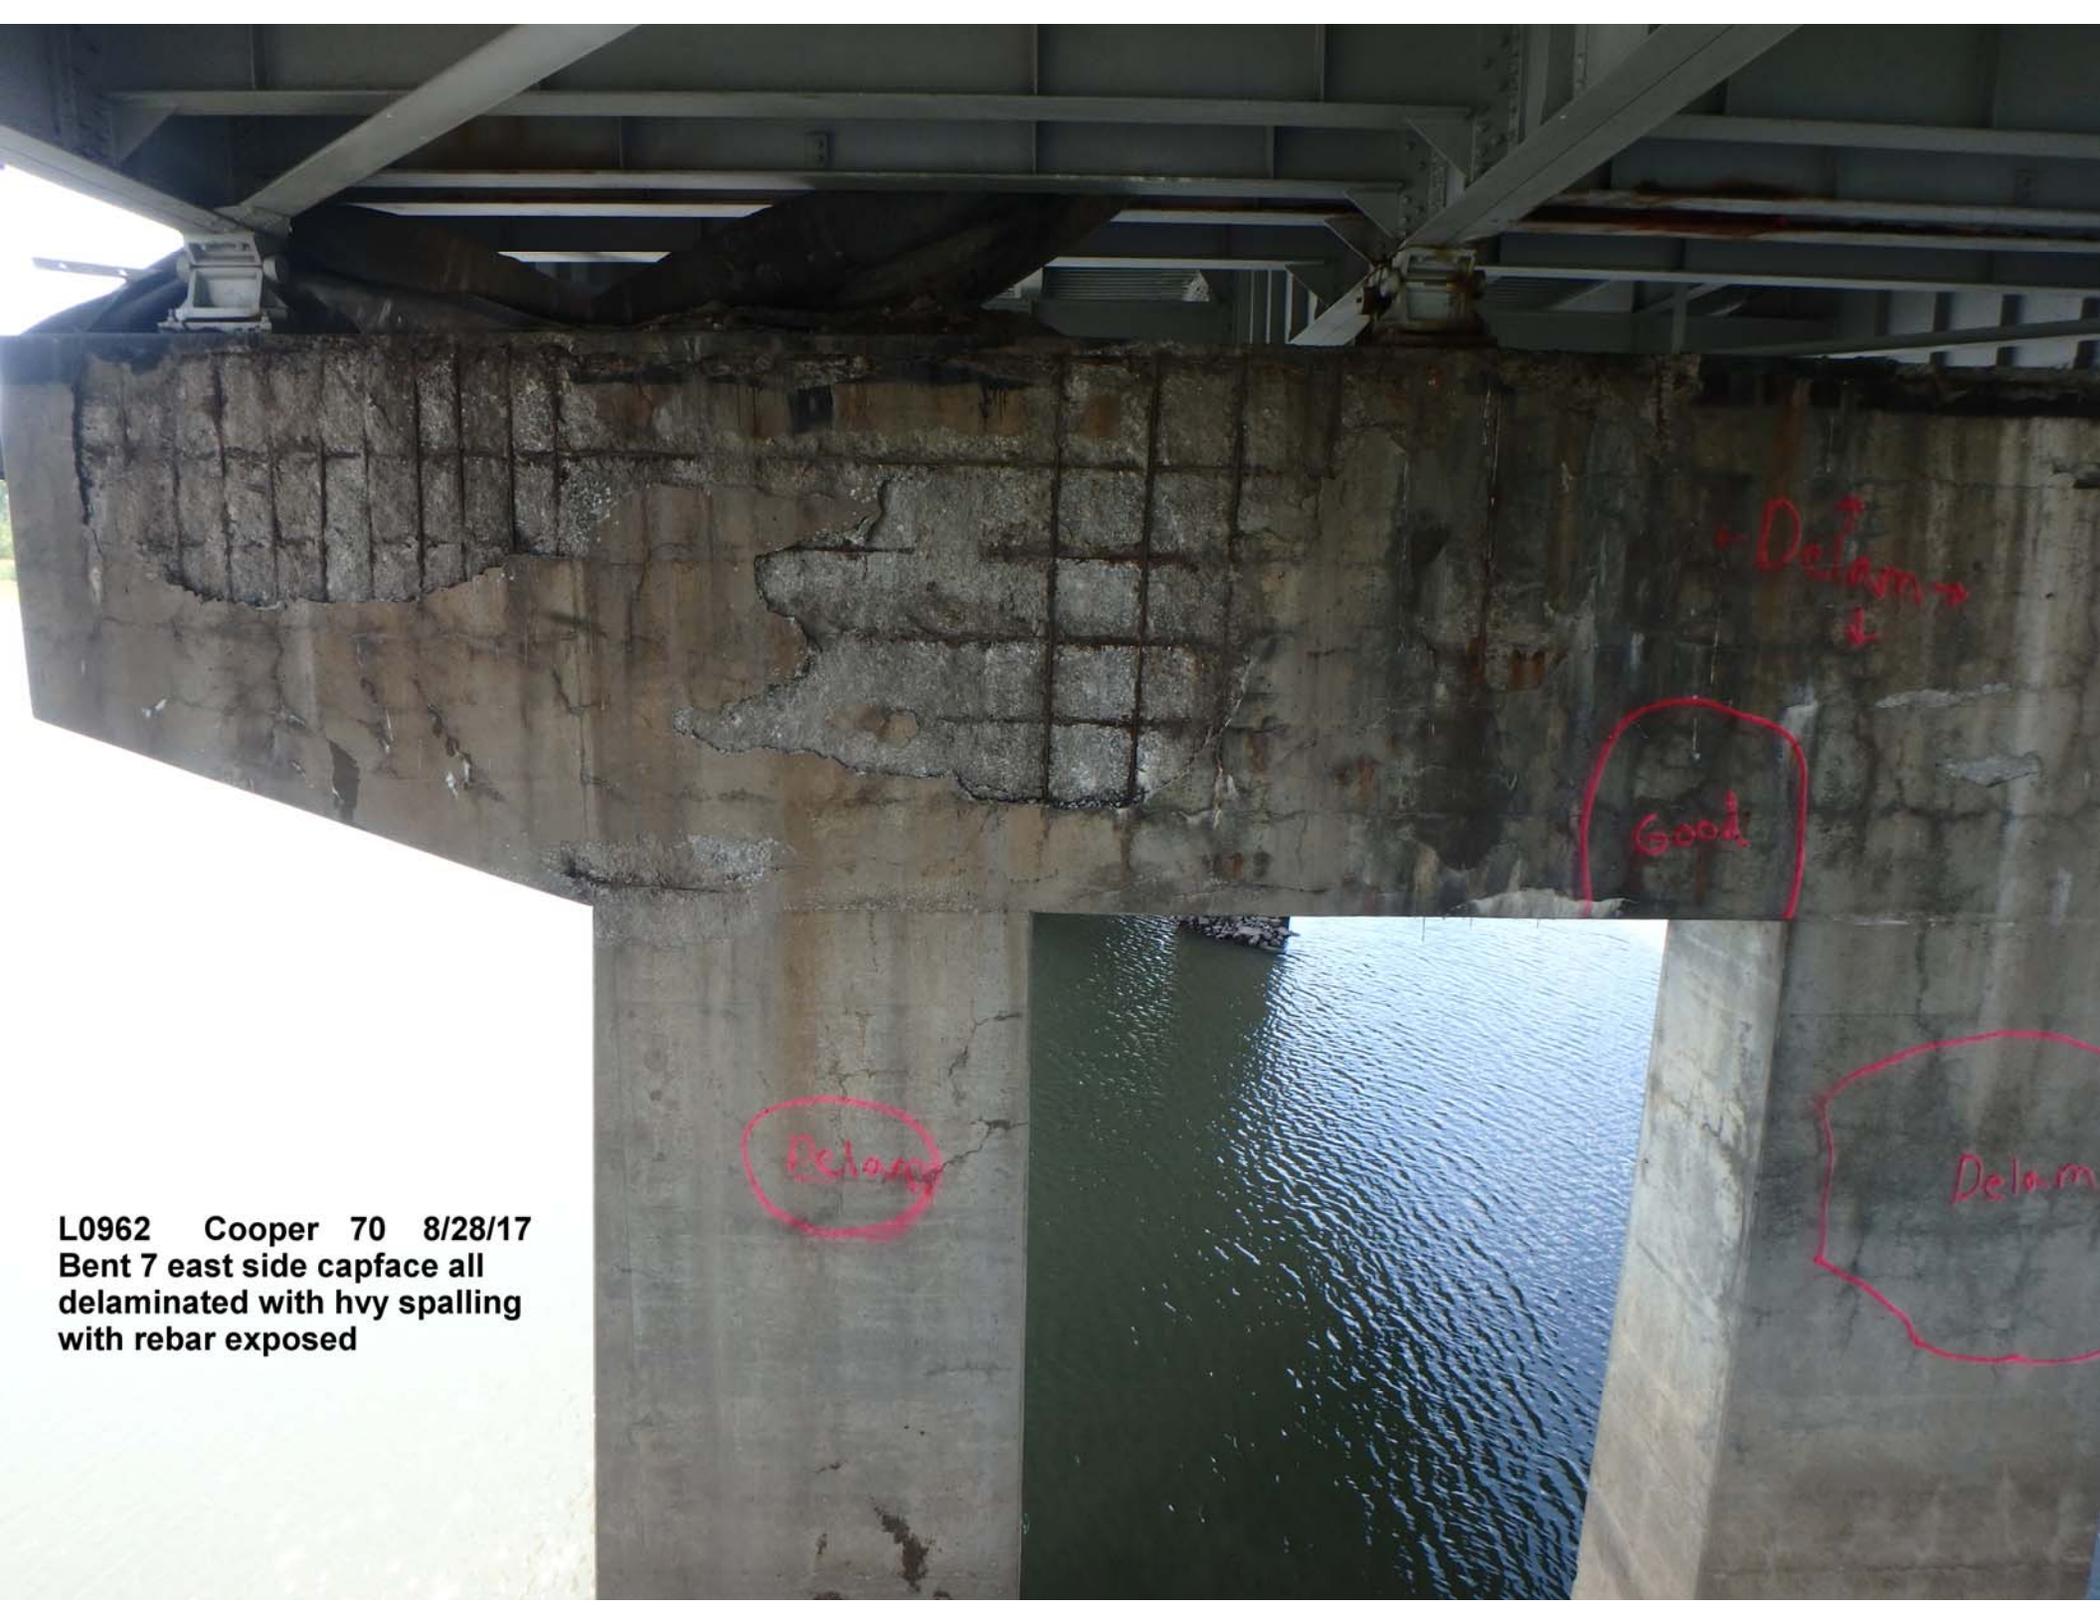
L0962 Cooper 70 8/28/17
Bent 7 east side capface all
delaminated with hvy spalling
with rebar exposed

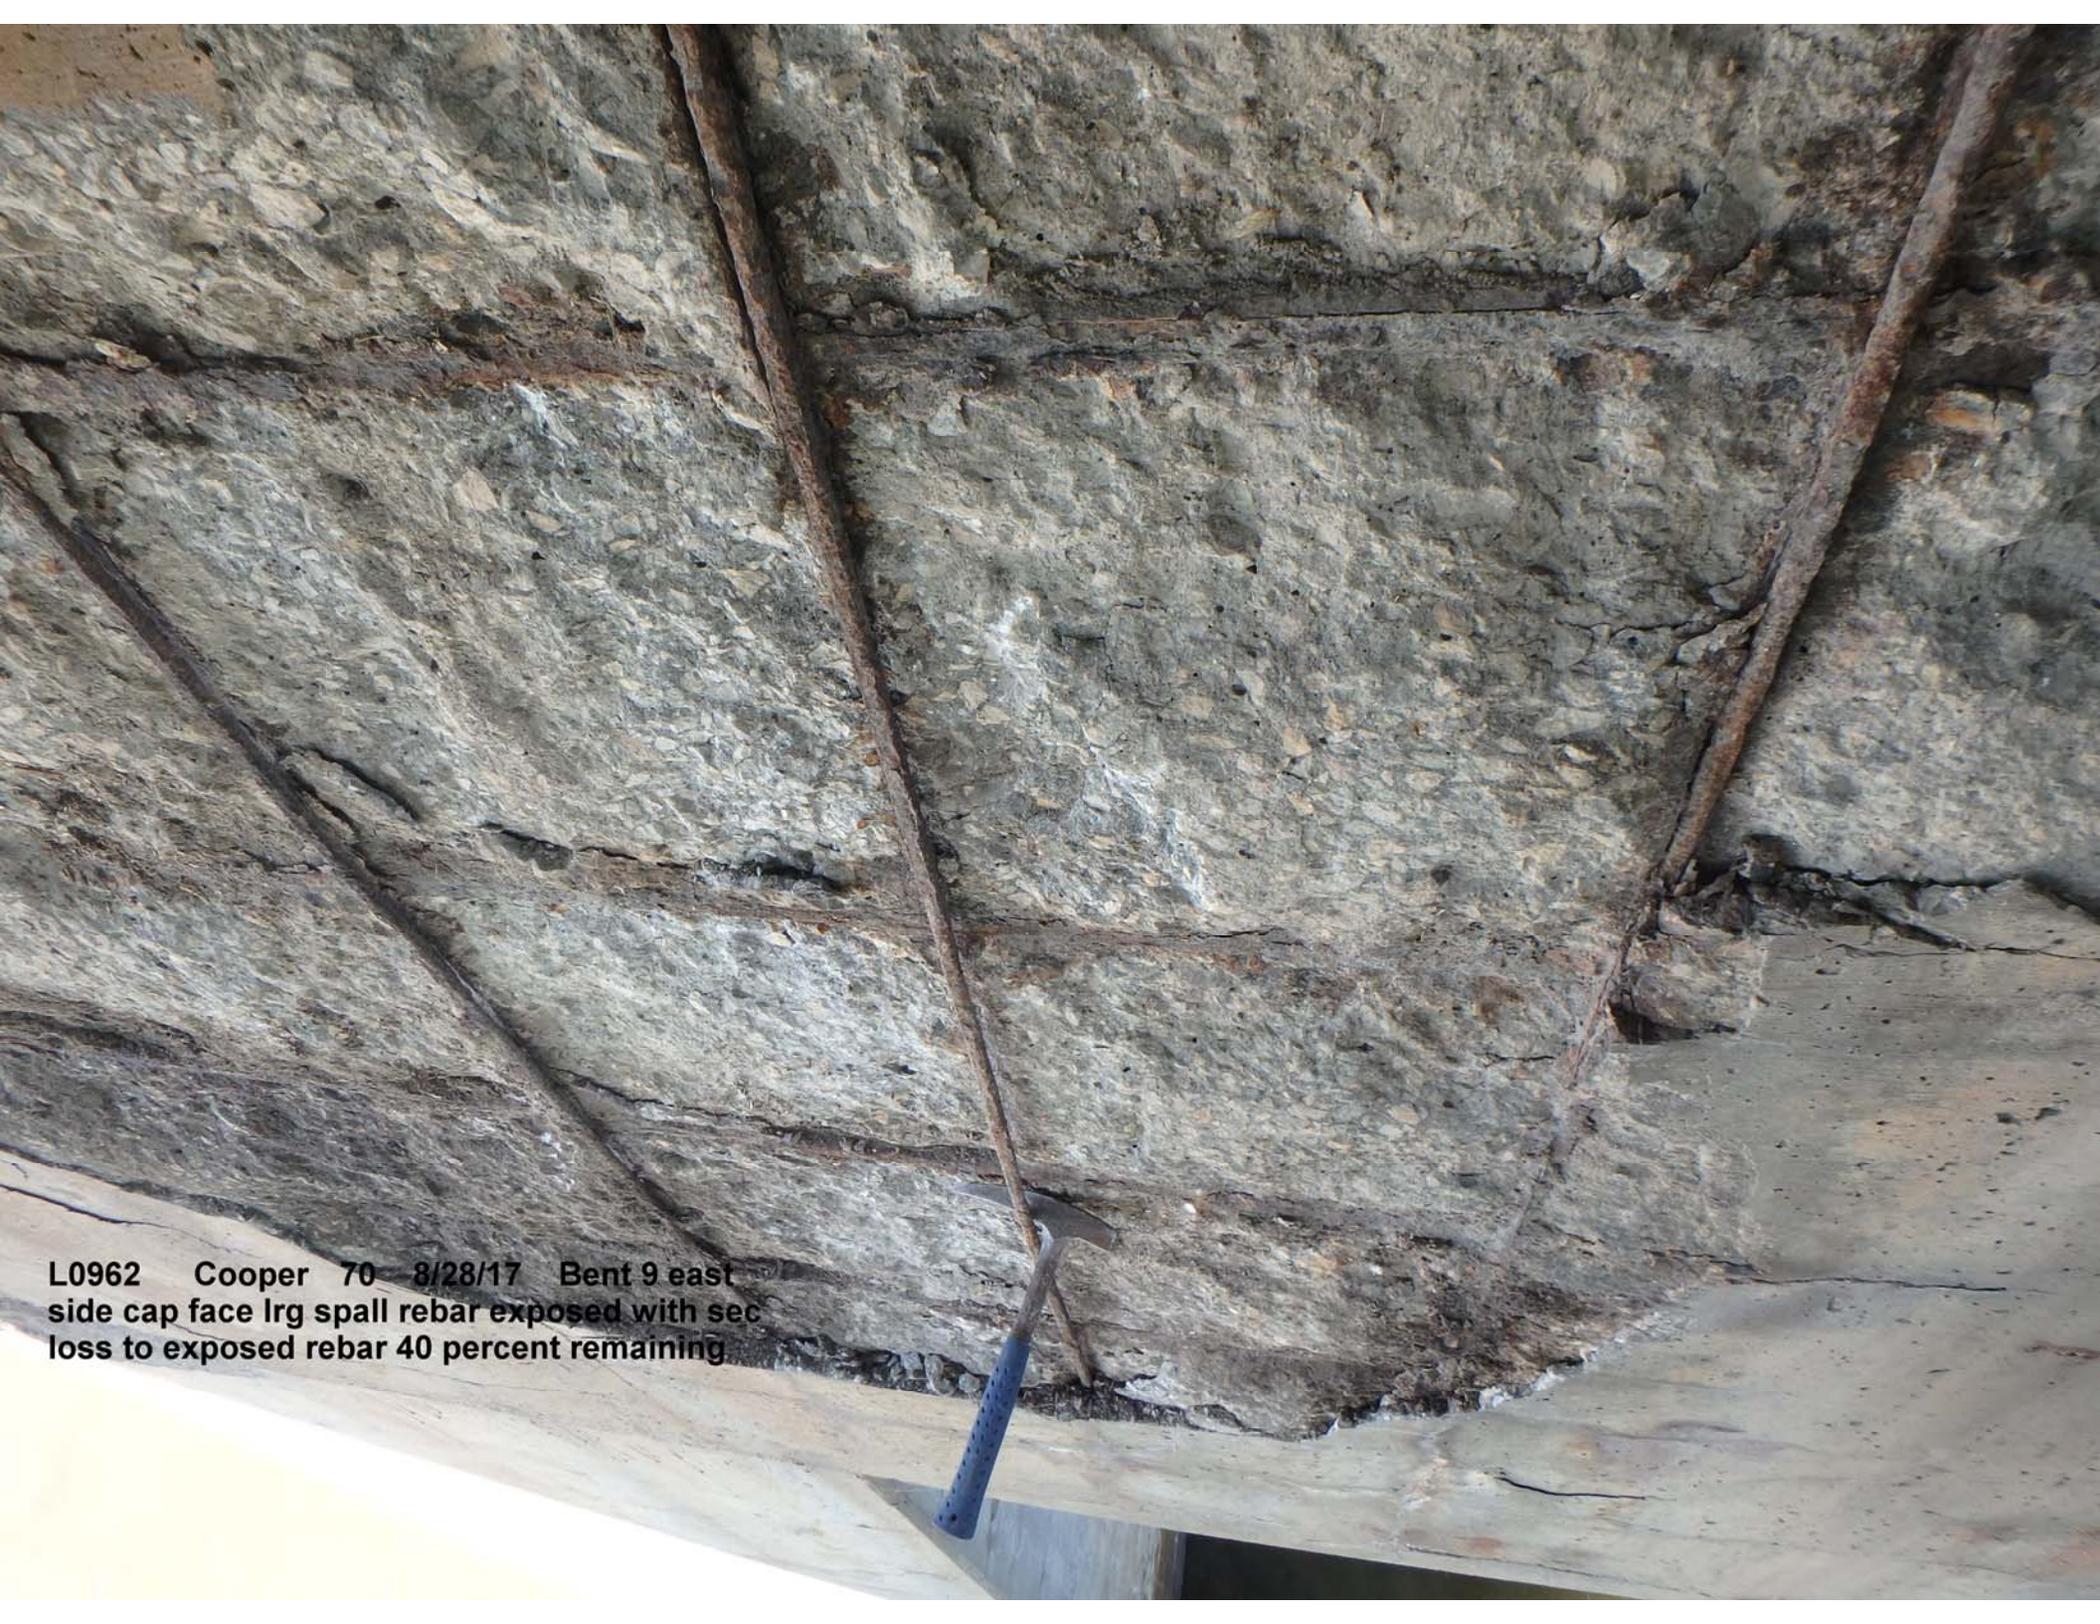
L0962 Cooper 70 8/28/17 Bent 9 east
side cap face lrg spall rebar exposed with sec
loss to exposed rebar 40 percent remaining

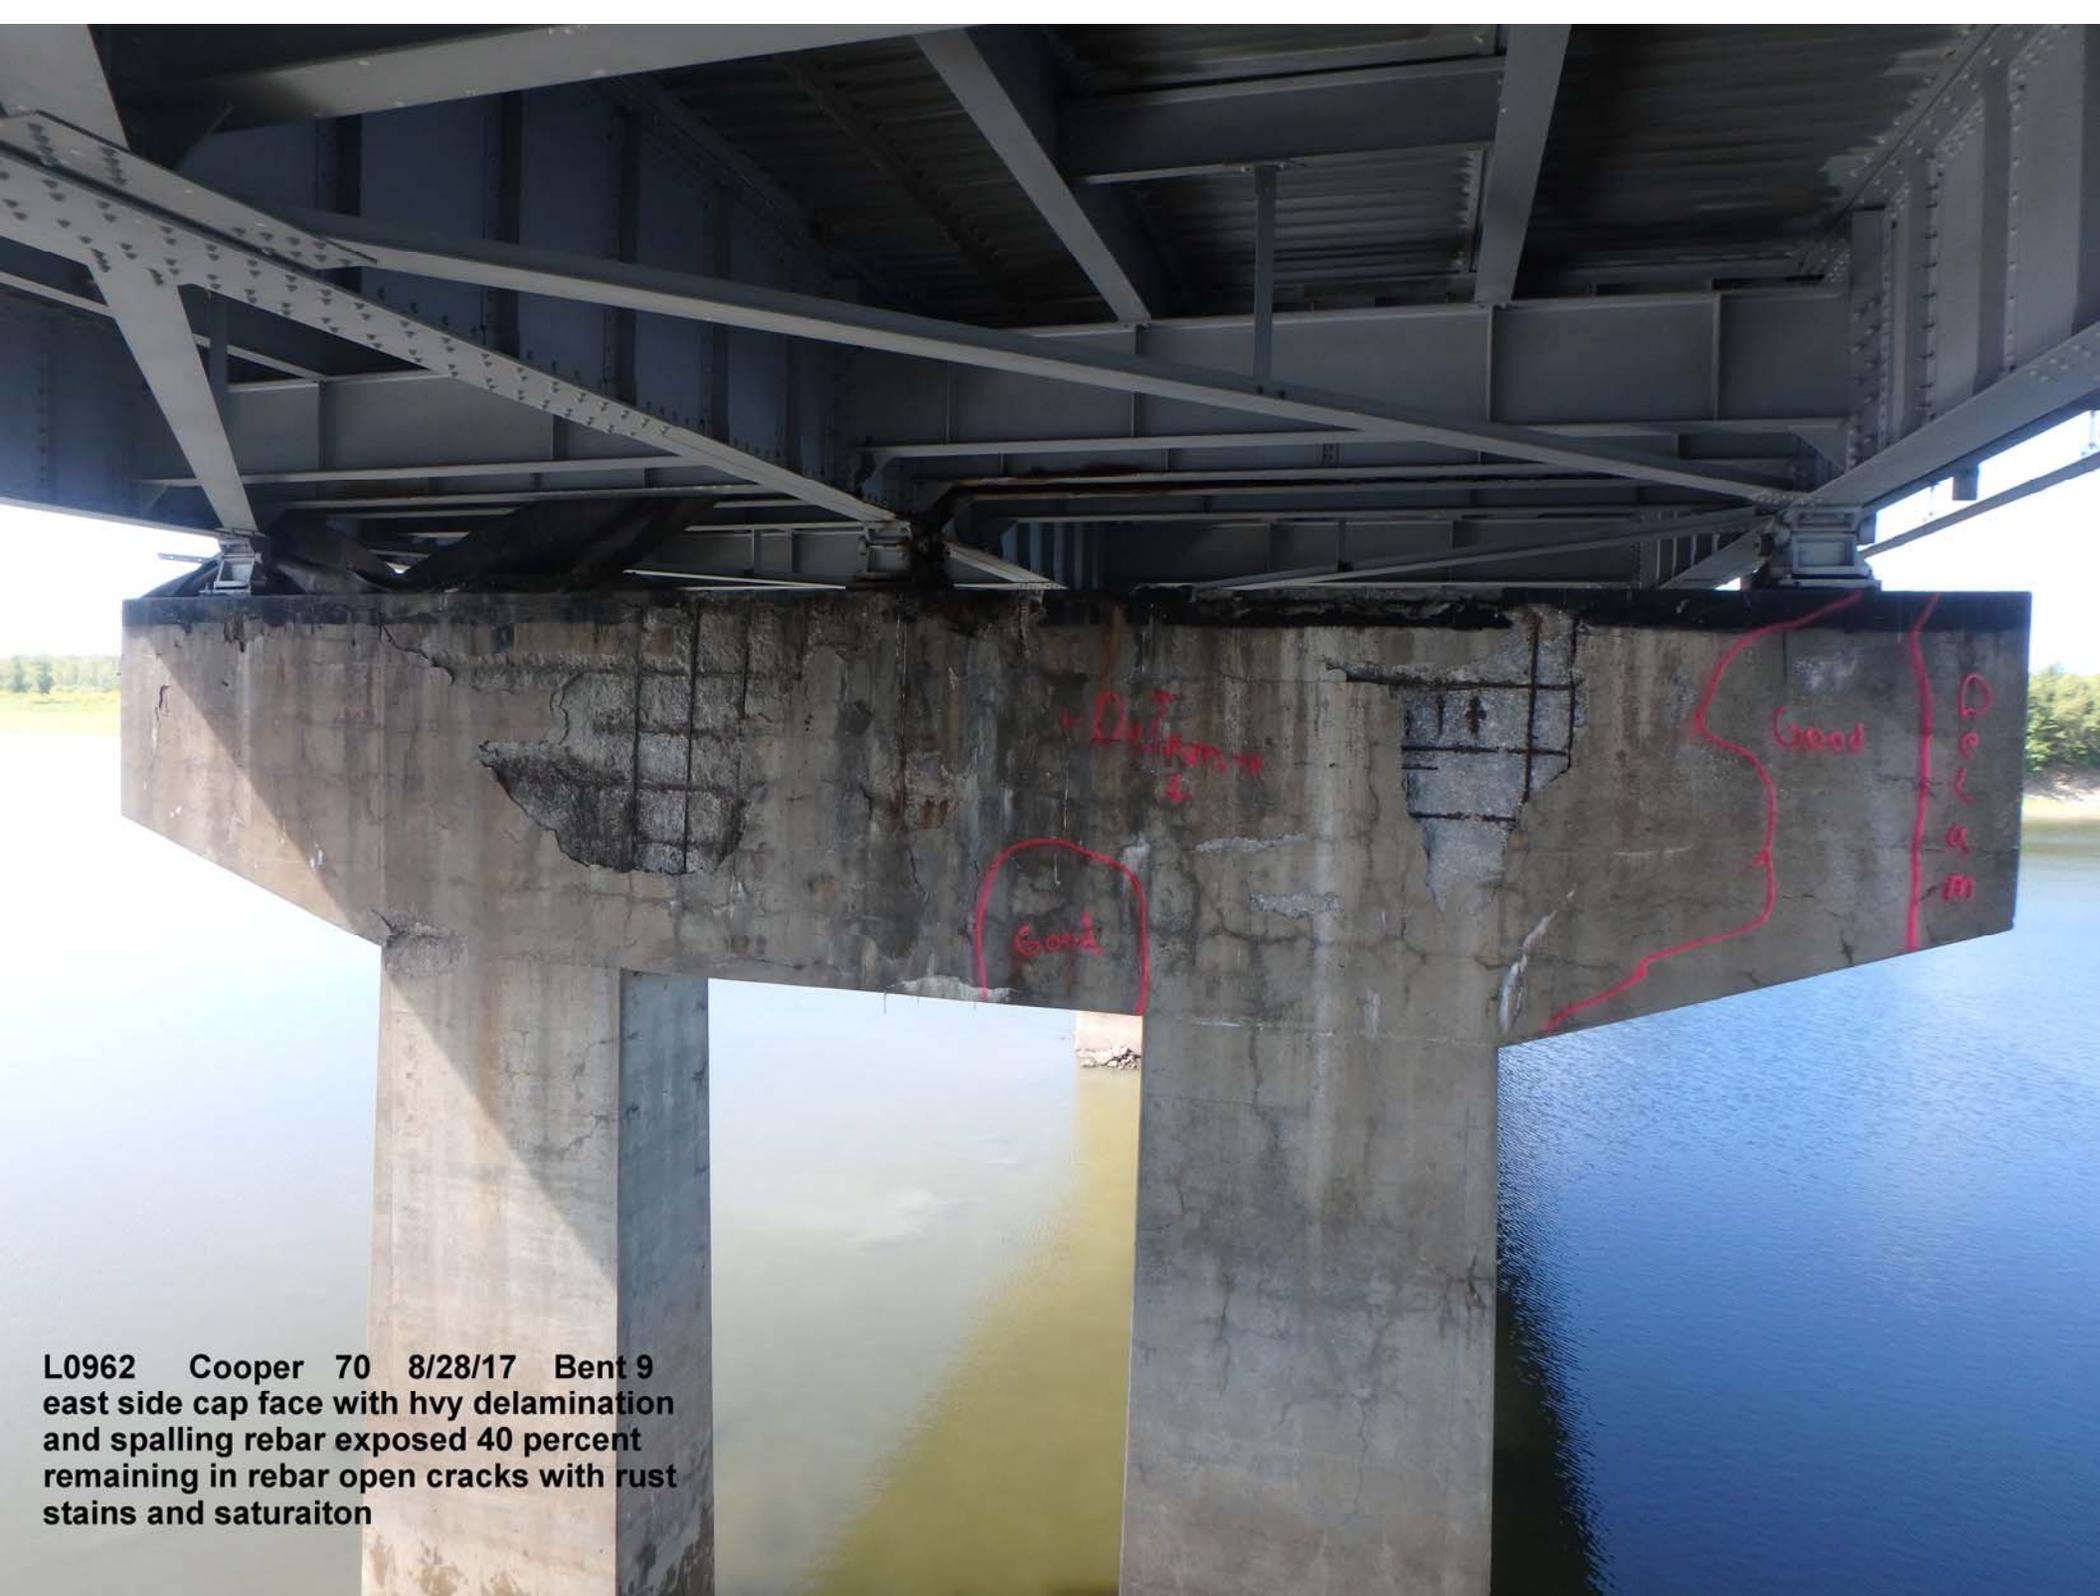
L0962 Cooper 70 8/28/17 Bent 9
east side cap face with hvy delamination
and spalling rebar exposed 40 percent
remaining in rebar open cracks with rust
stains and saturaiton

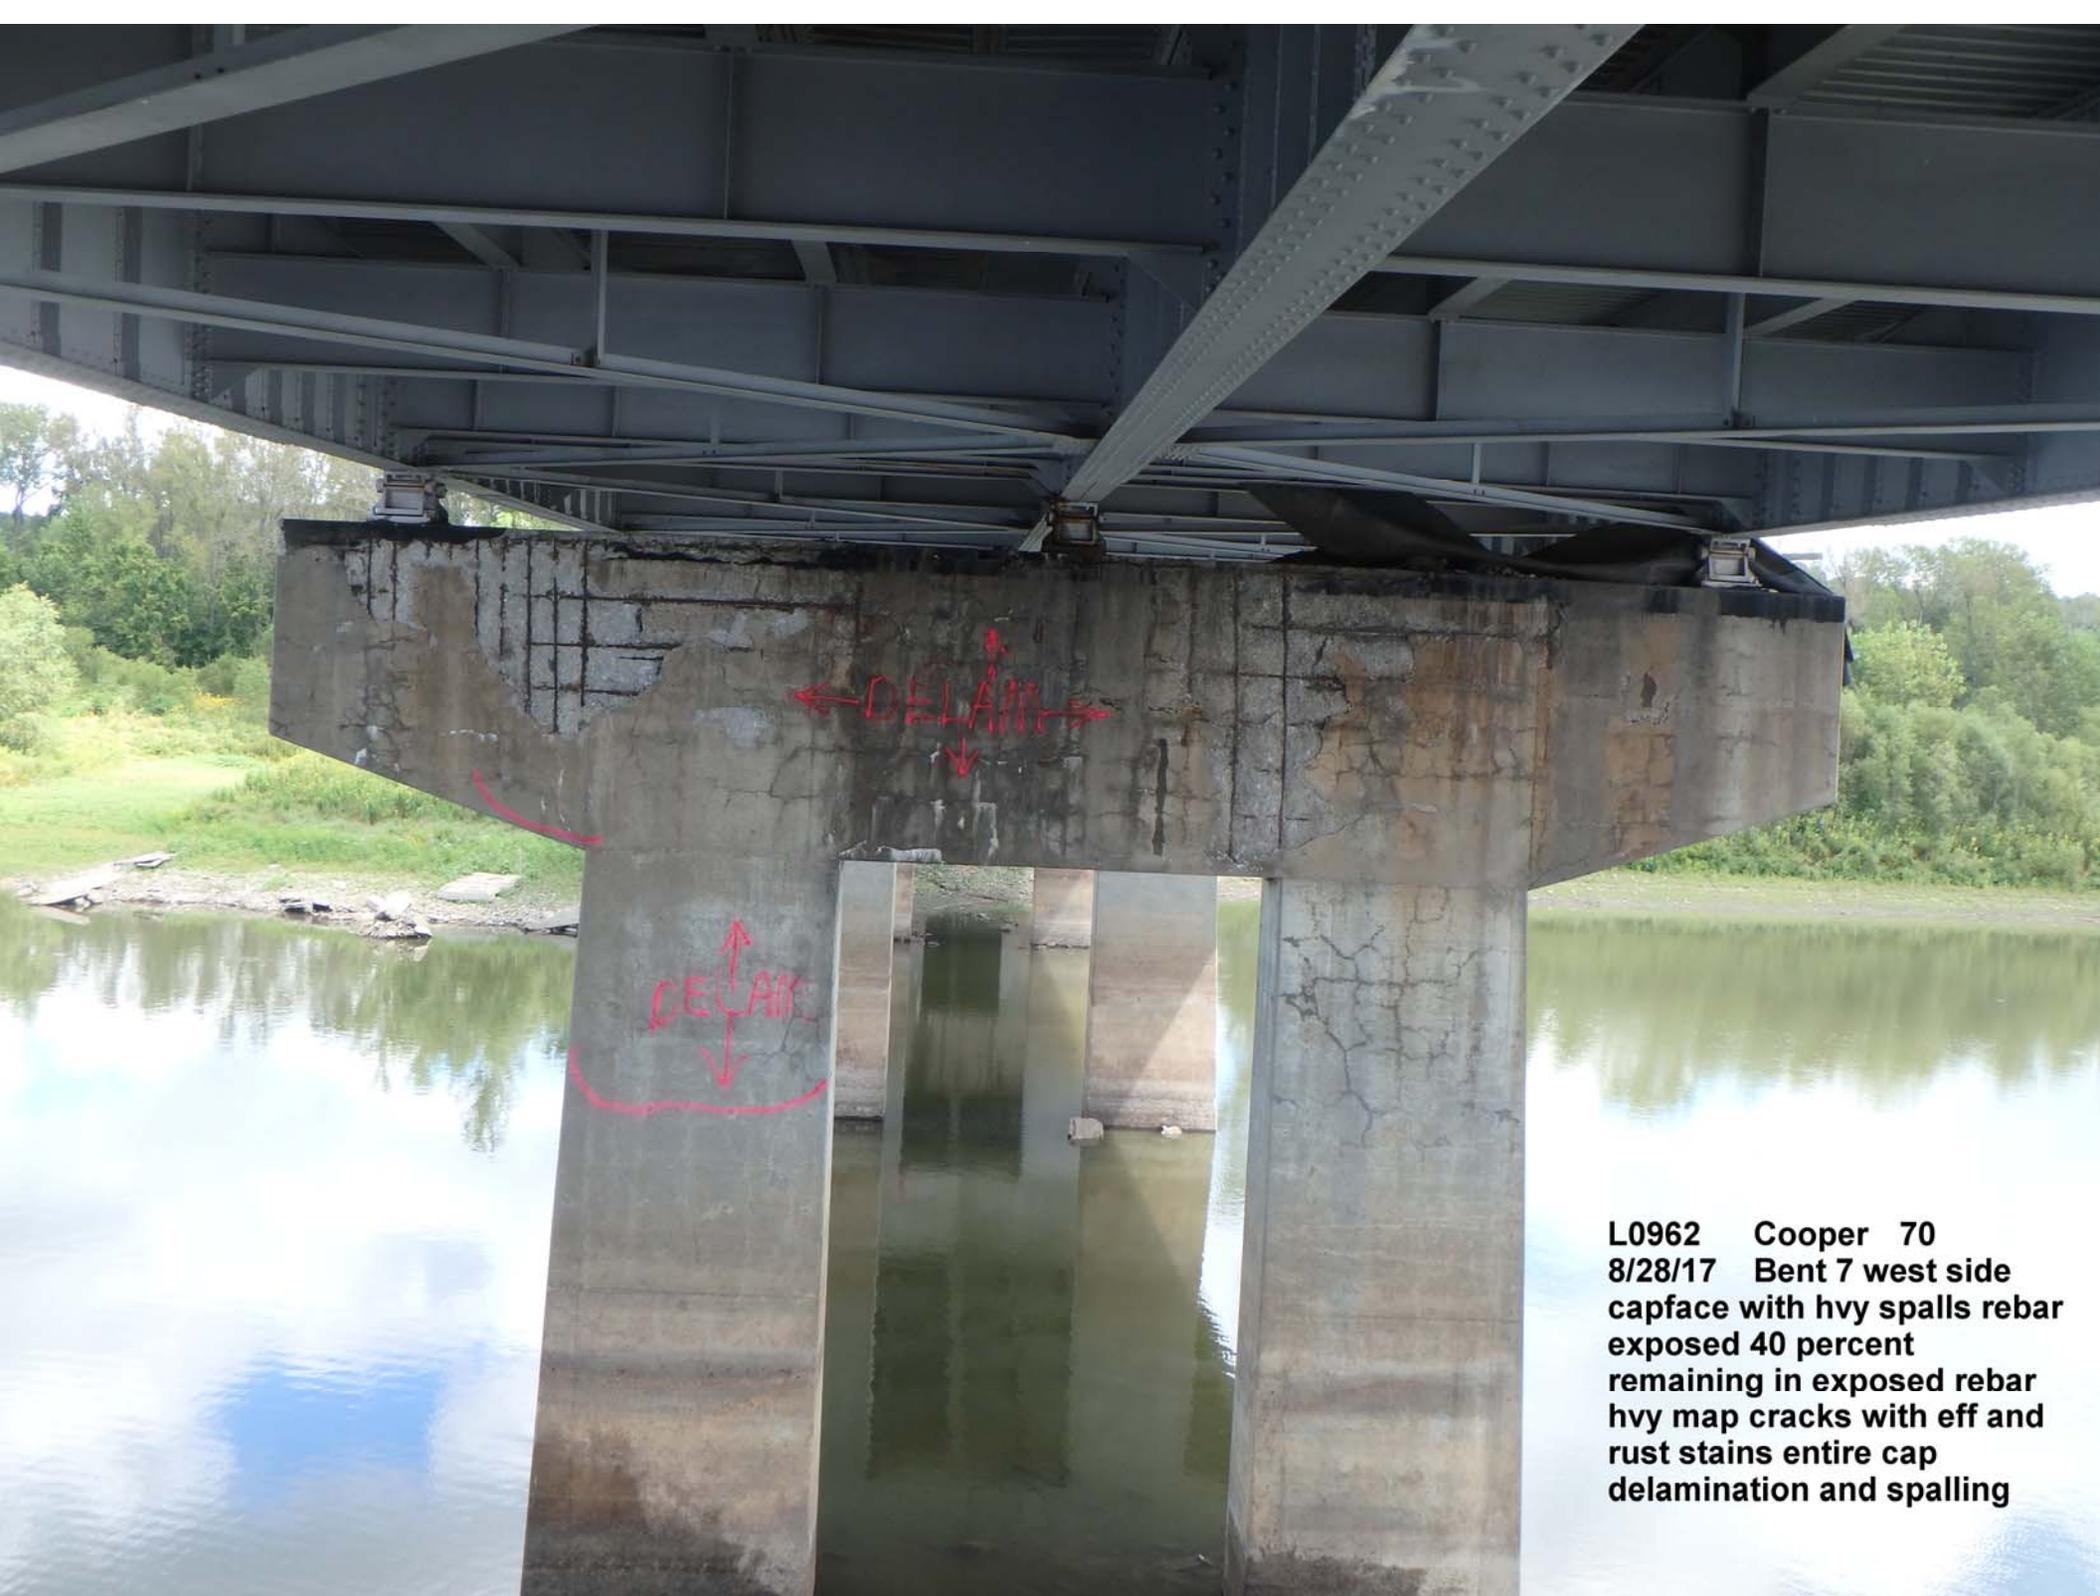
**L0962 Cooper 70
8/28/17 Bent 7 west side
capface with hvy spalls rebar
exposed 40 percent
remaining in exposed rebar
hvy map cracks with eff and
rust stains entire cap
delamination and spalling**

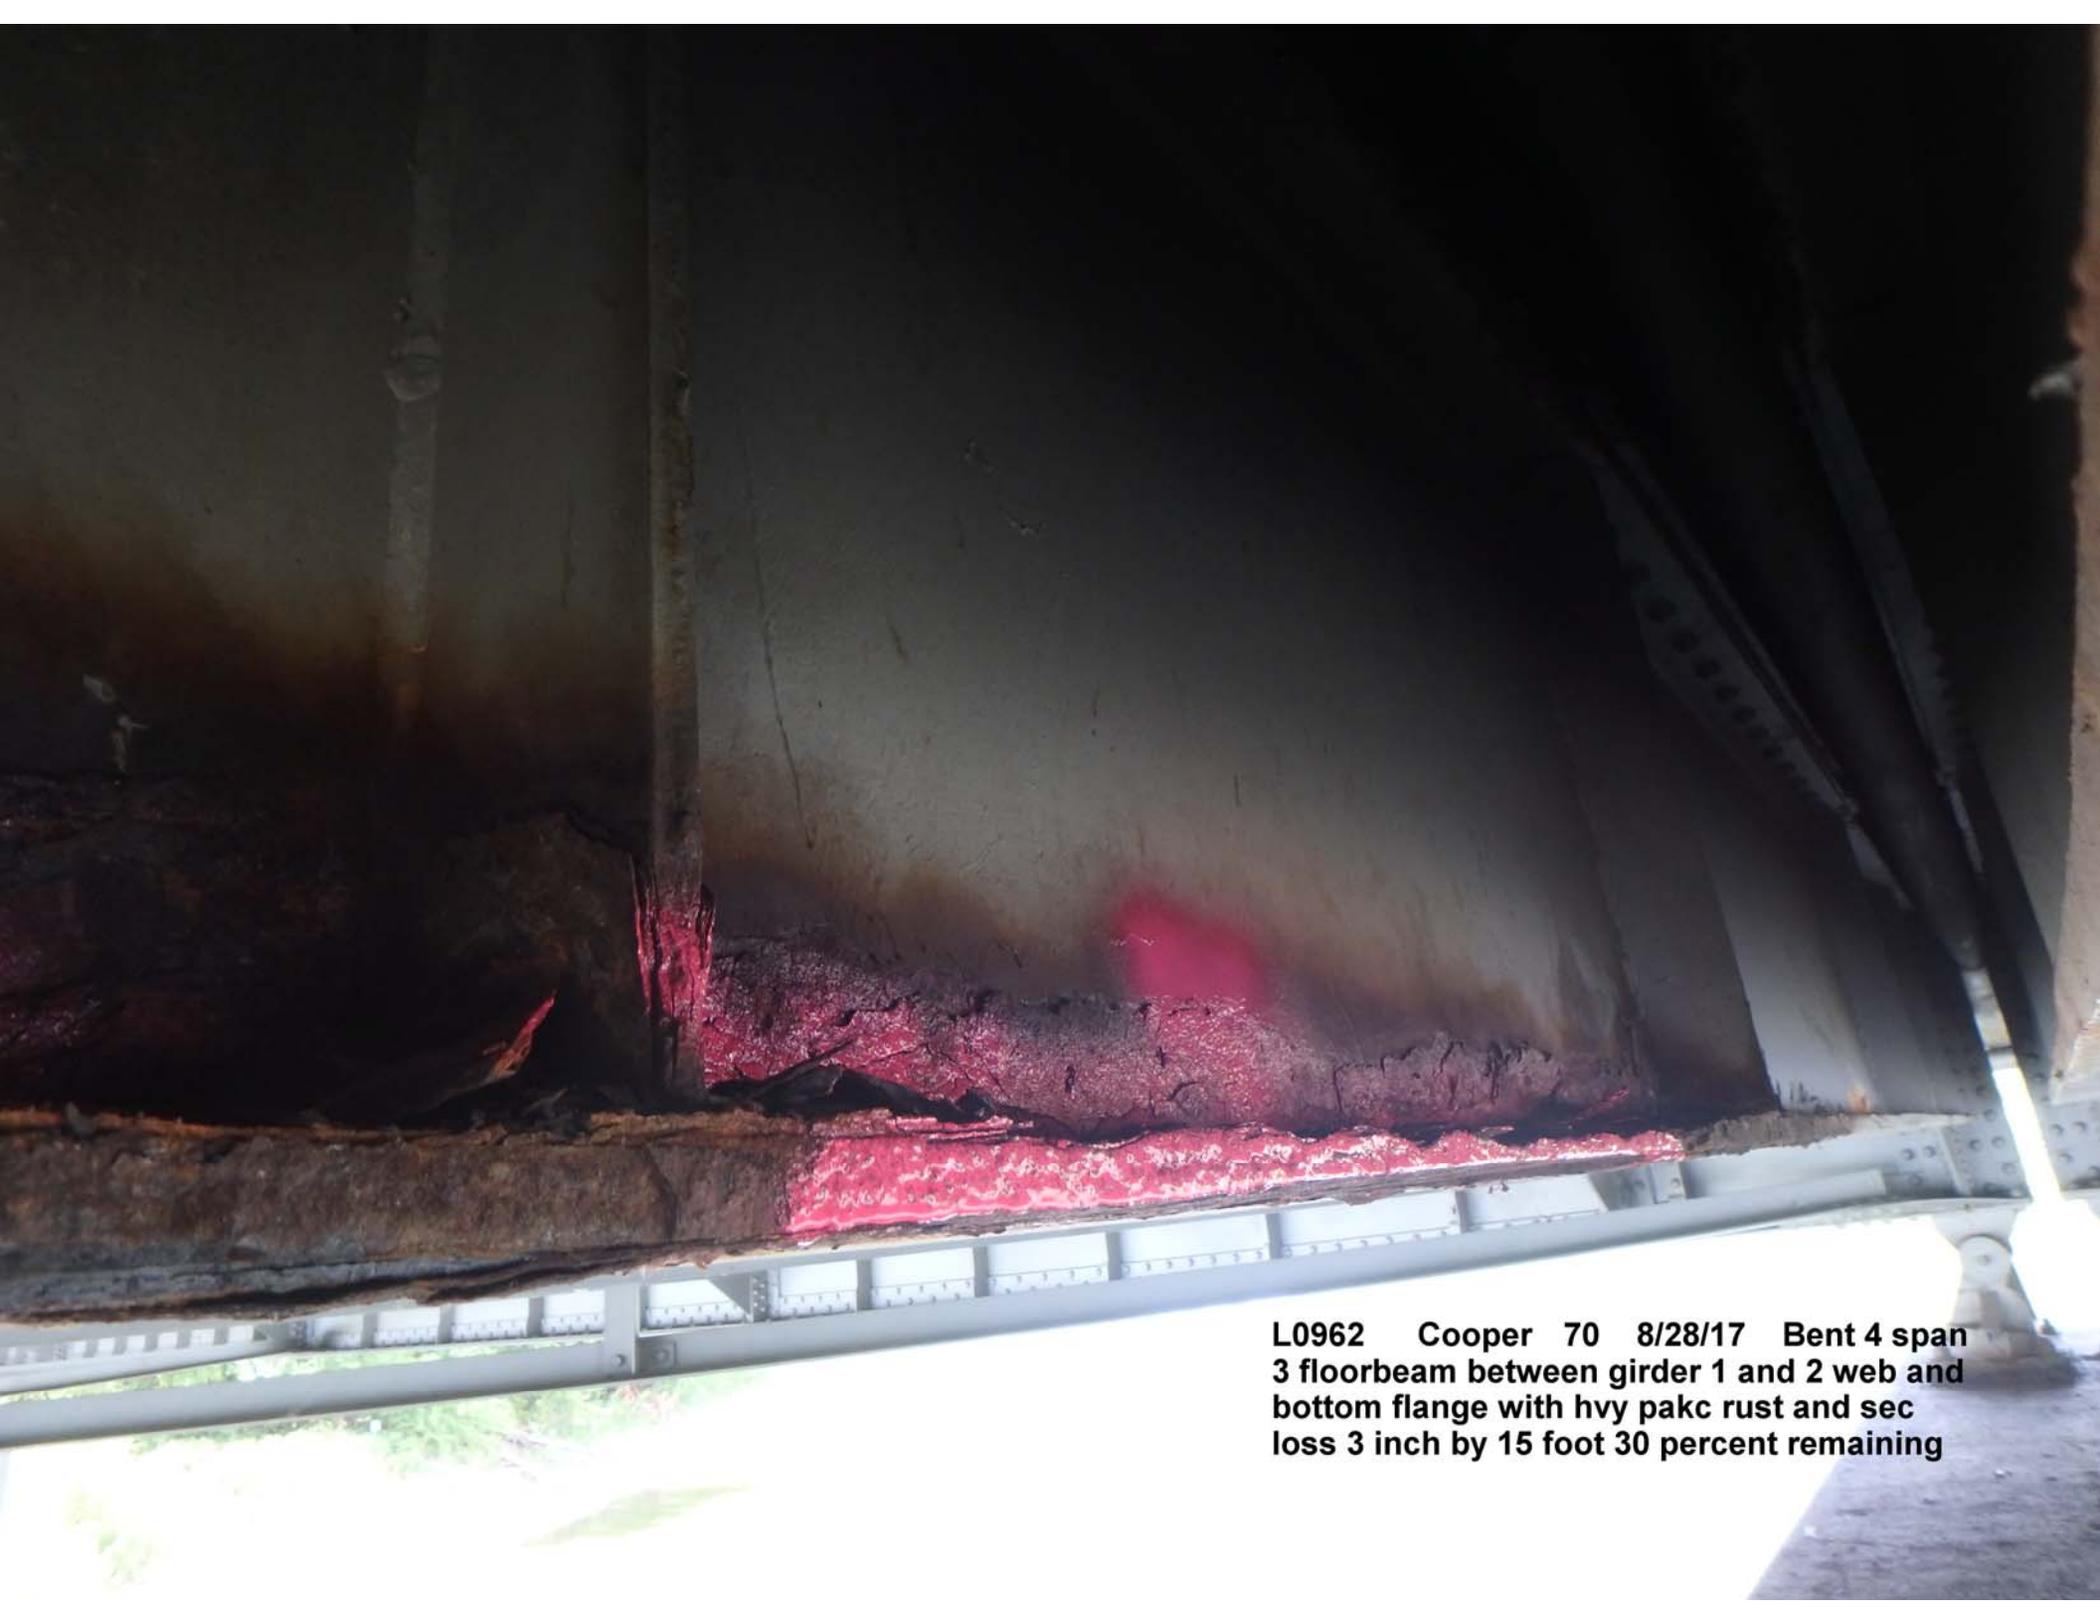
**L0962 Cooper 70 8/28/17 Bent 4 span
3 floorbeam between girder 1 and 2 web and
bottom flange with hvy pakc rust and sec
loss 3 inch by 15 foot 30 percent remaining**

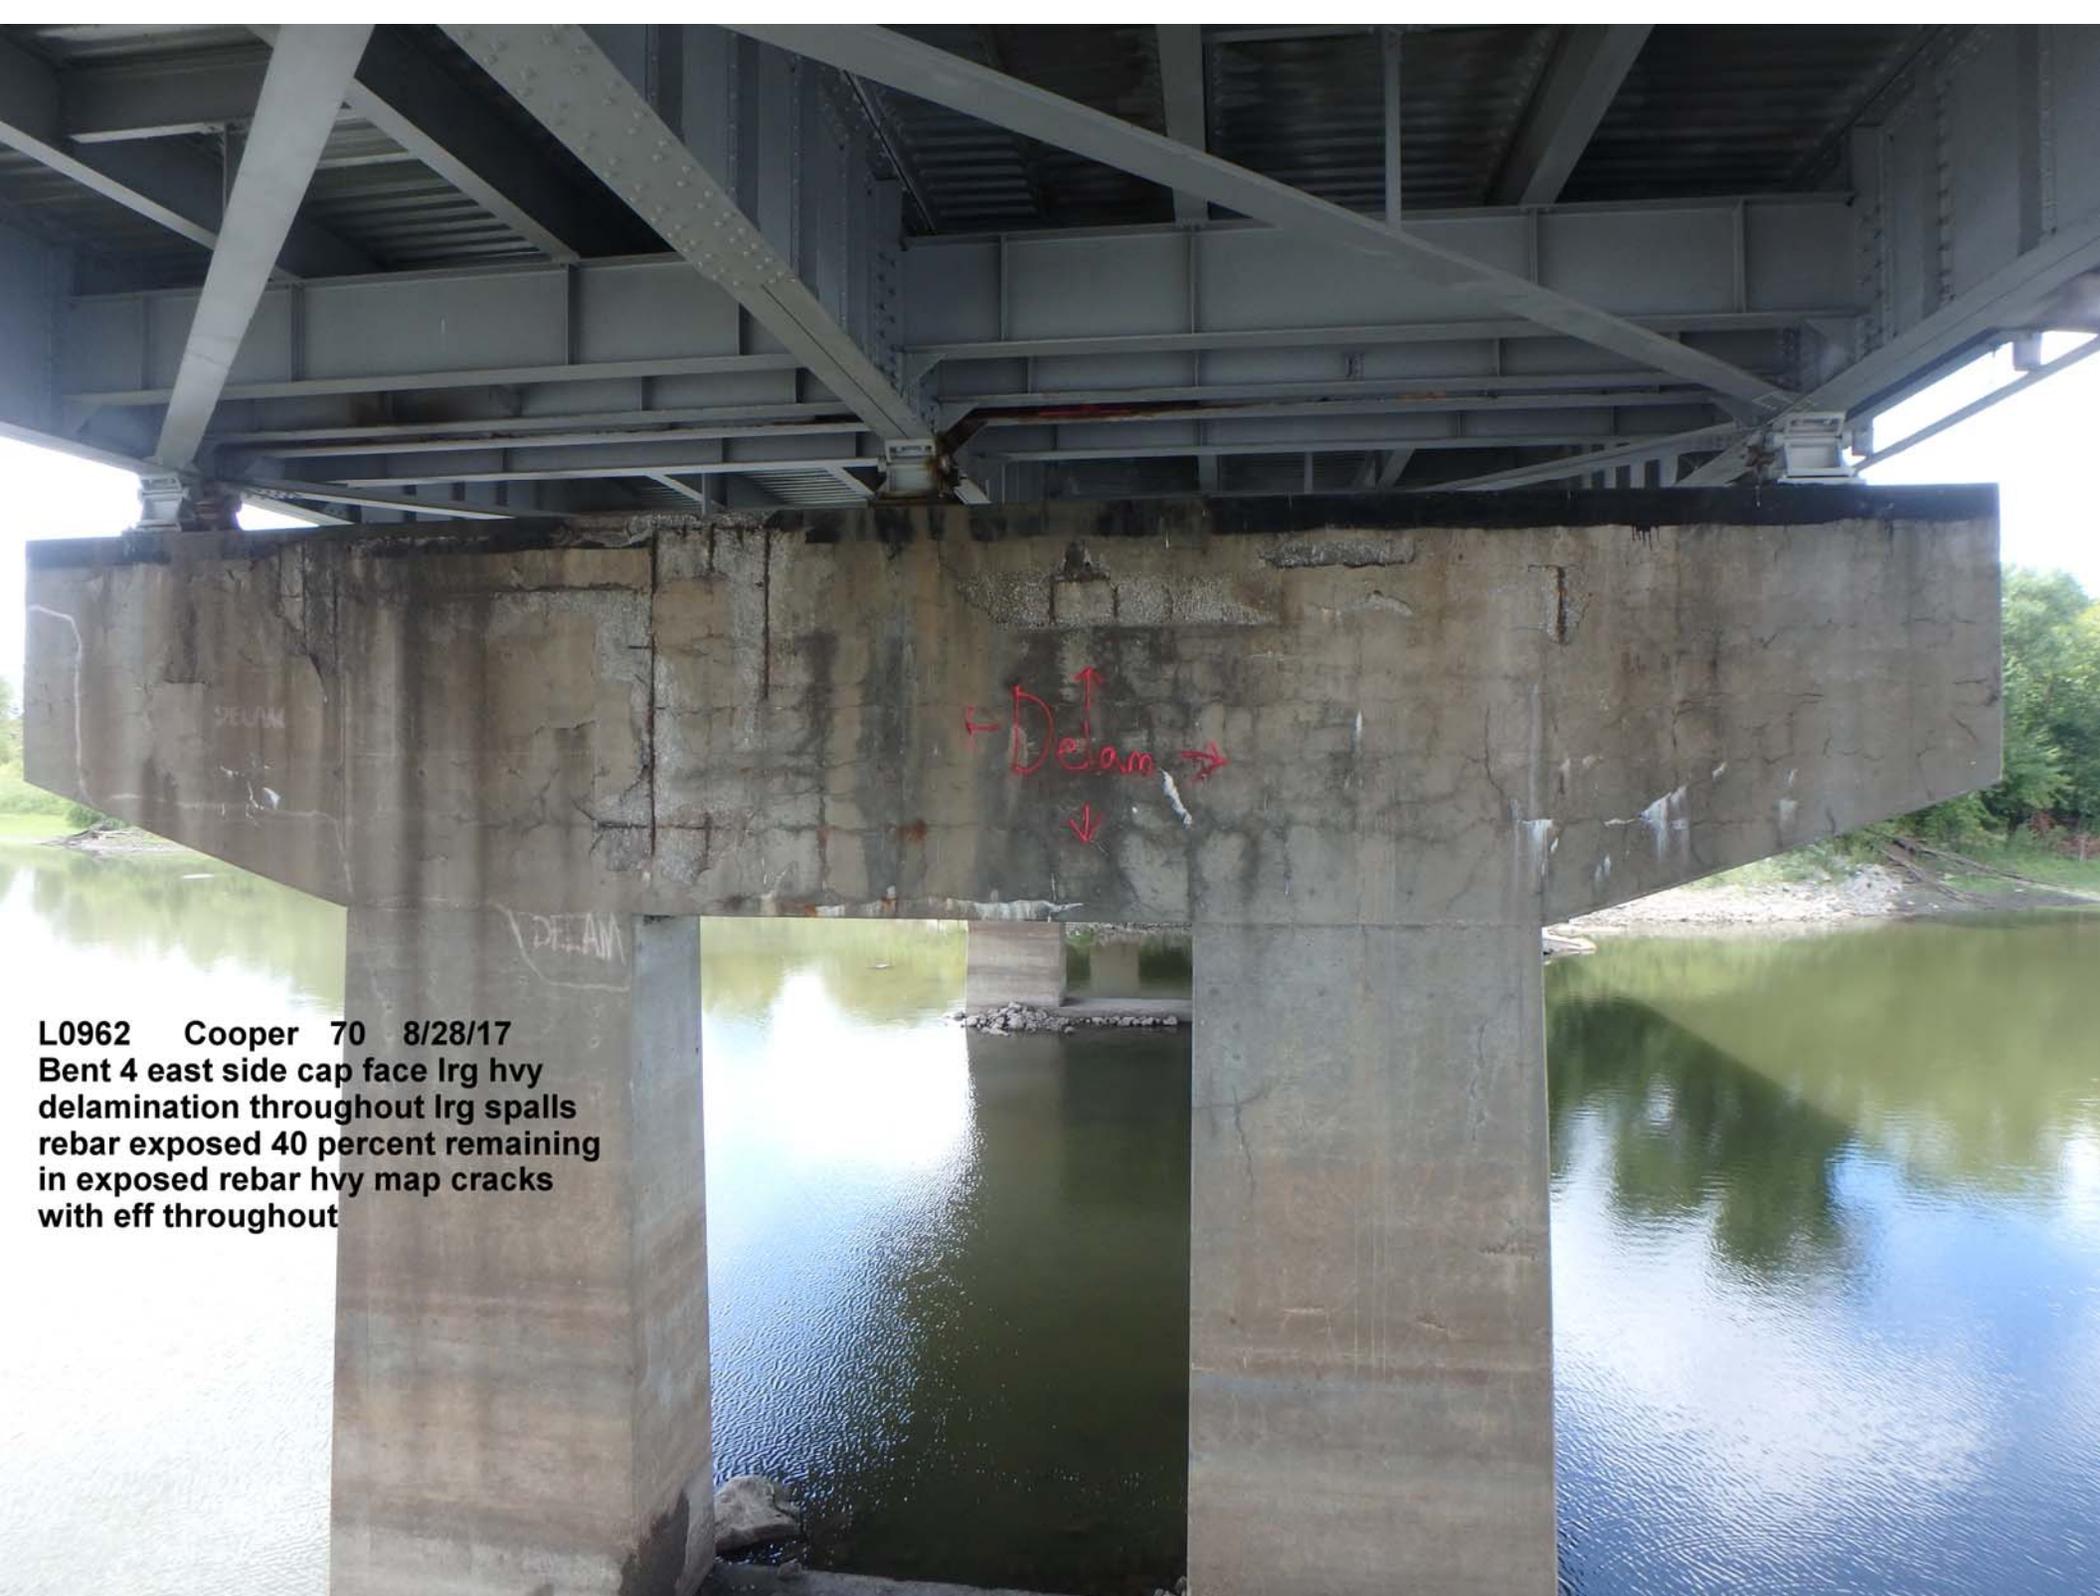
**L0962 Cooper 70 8/28/17
Bent 4 east side cap face lrg hvy
delamination throughout lrg spalls
rebar exposed 40 percent remaining
in exposed rebar hvy map cracks
with eff throughout**
