ADDENDUM NO. 1

Reconstruct Apron and Taxiway  
Trenton Municipal Airport  
Trenton, Missouri  
Bid Date: Friday, August 24, 2018 – 2:00 pm  
MoDOT# 18-011A-1  
OA Project No. 018-1755

# GEOTECHNICAL ENGINEERING REPORT

## TRENTON AIRPORT TRENTON, MISSOURI

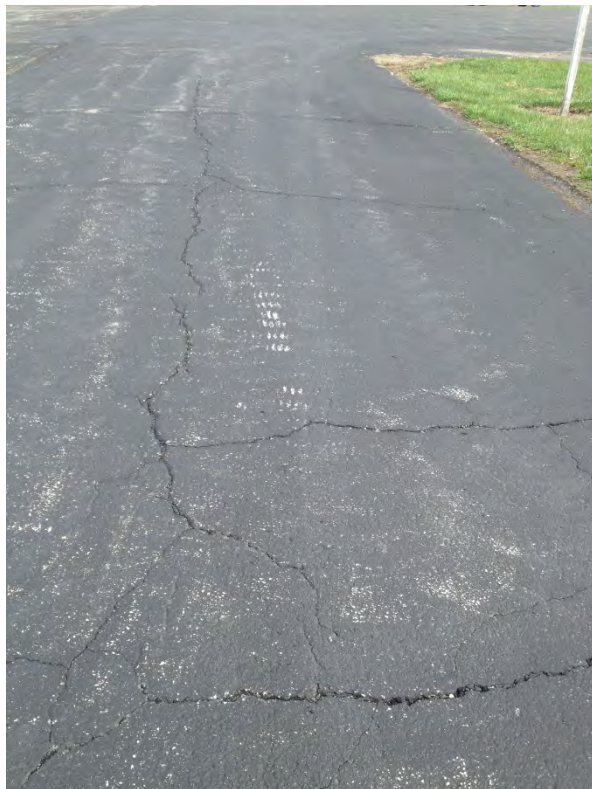
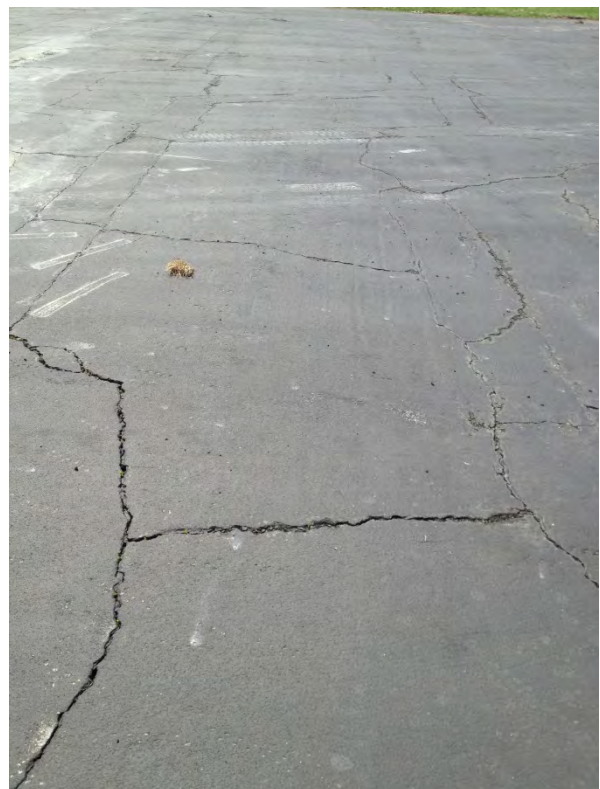
**Figures 2 and 3: Block Cracking**

Block cracking is typically caused by shrinkage of the asphaltic concrete and freeze-thaw cycling. This type of distress is indicative of the natural hardening of asphaltic concrete over time. We observed this type of distress across large areas throughout the apron. Figures 2 and 3 show typical sections displaying block cracking.

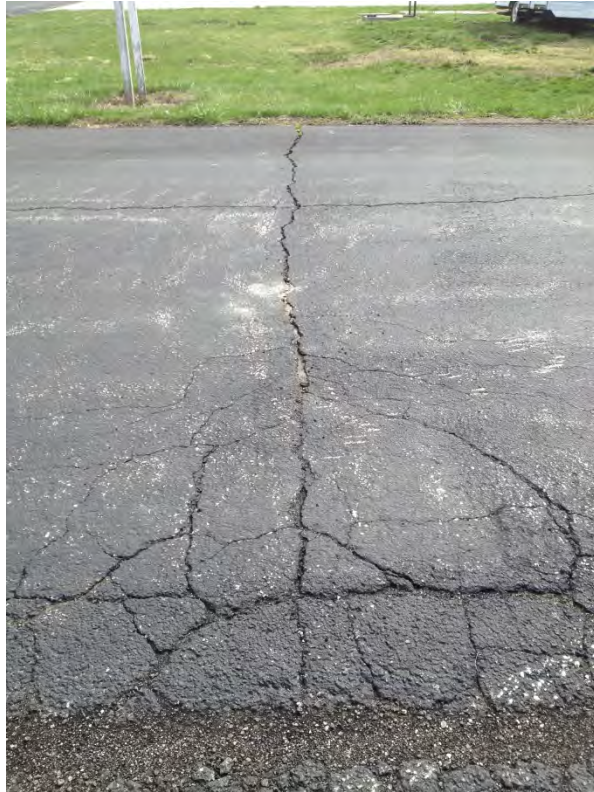
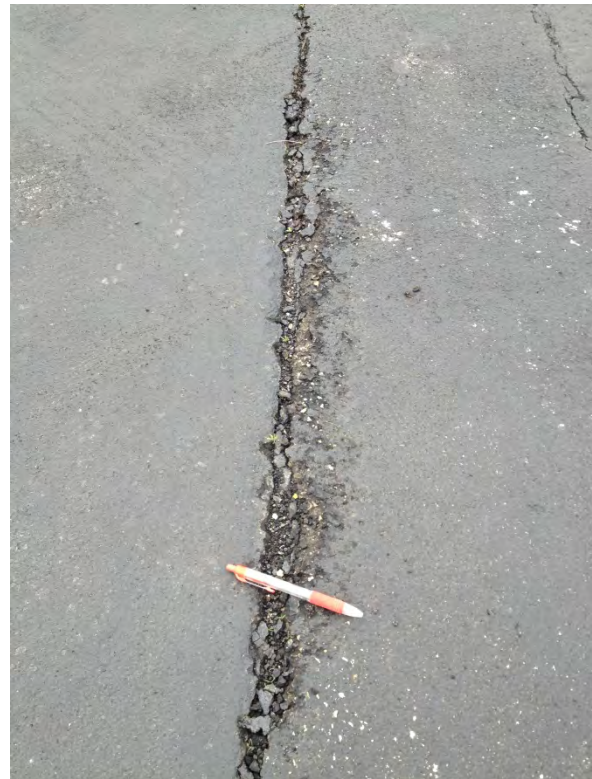
**Figures 4 and 5: Transverse Cracking w/ Related Deterioration**

Transverse cracking, as with block cracking, is typically caused by shrinkage of the pavement and freeze-thaw cycling. We observed this type of cracking throughout the asphaltic concrete on both the apron and taxiway. Some cracks show evidence of deterioration and breaking along the edges, examples are shown in Figure 4 and 5.

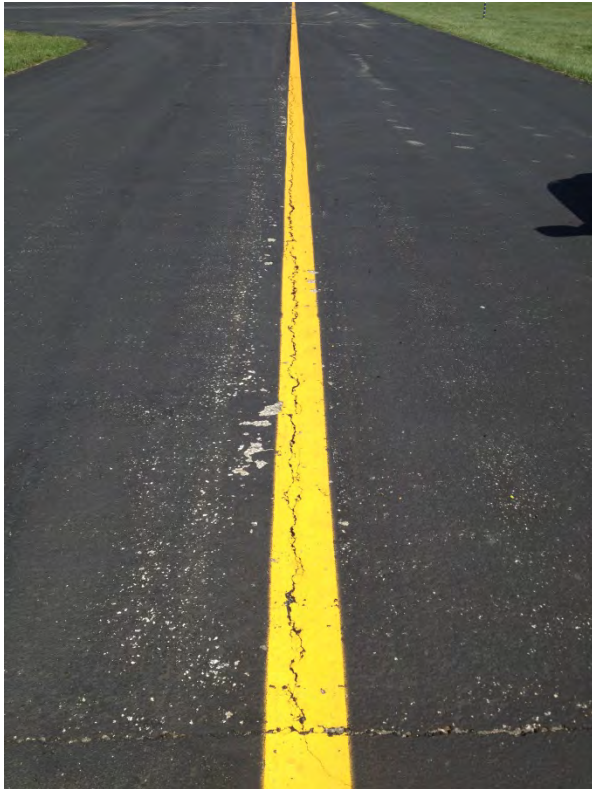
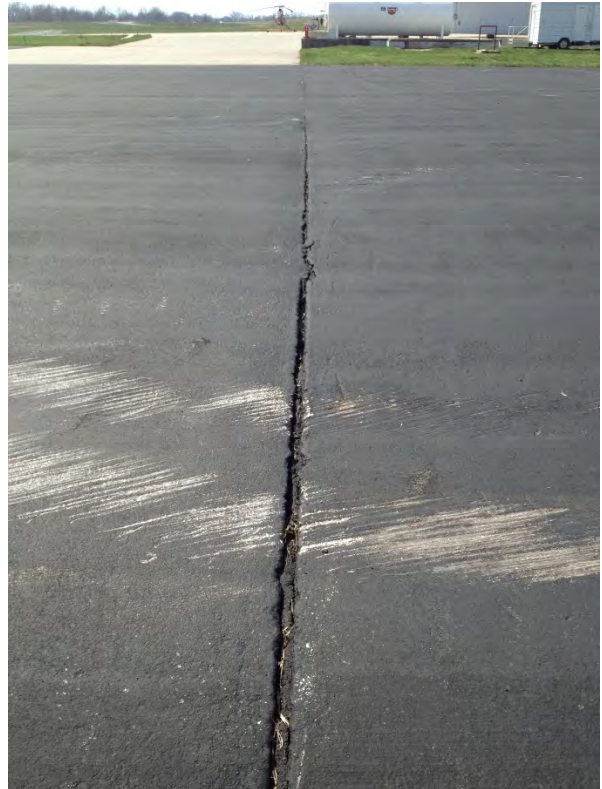
**Figures 6 and 7: Longitudinal Cracking**

We also observed longitudinal cracks that run parallel to the pavement's centerline and along joints. These are typically caused by a poorly constructed paving joint, shrinkage of the asphaltic concrete, freeze thaw cycling, or hardening of the asphaltic concrete. We observed longitudinal cracks along both the aprons and taxiways. Representative photos of the longitudinal cracking are shown in Figures 6 and 7.

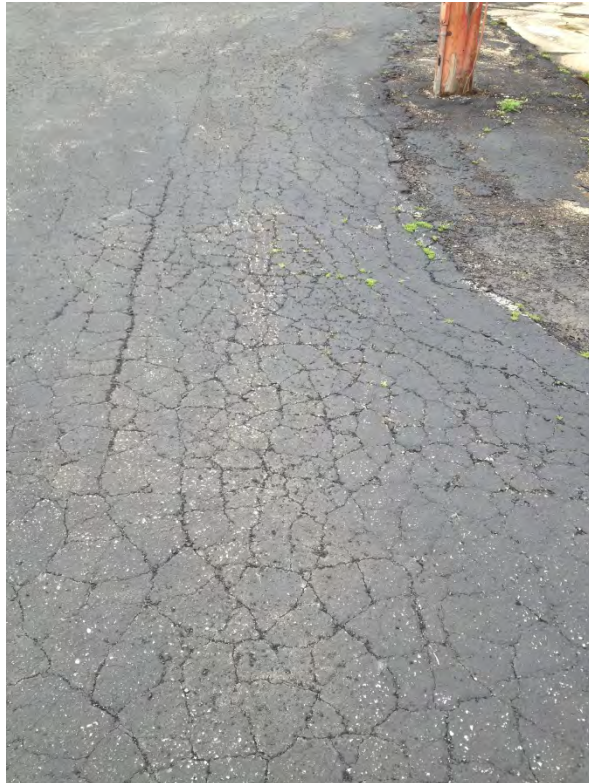
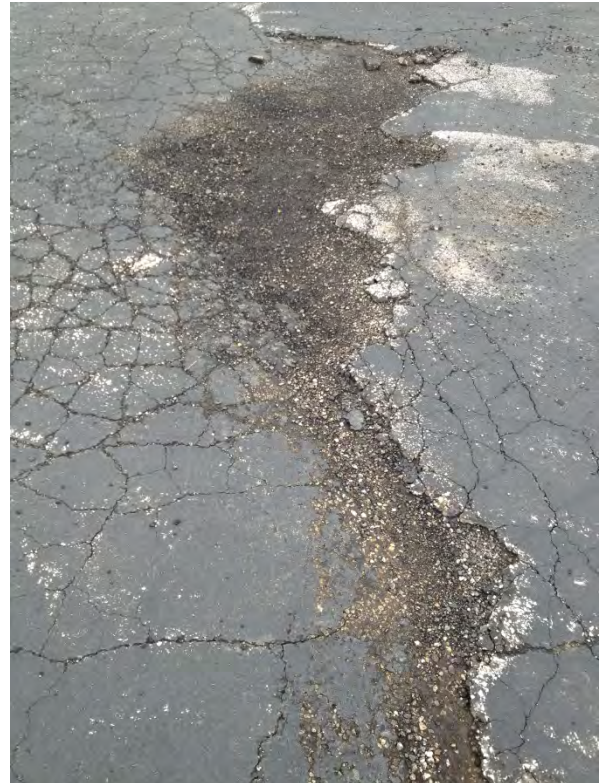
**Figures 8 and 9: Fatigue Cracking**

Fatigue (alligator) cracking occurs in areas with repeated traffic loading and is typically an indication of pavement subgrade deterioration. We observed alligator cracking in multiple areas throughout the apron, especially near the hangars to the northwest. Examples of the distress are shown in Figures 8 and 9.

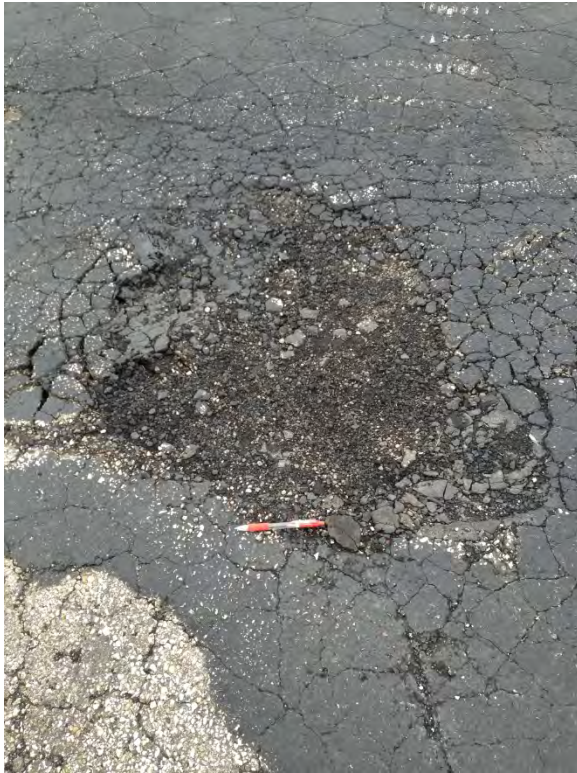
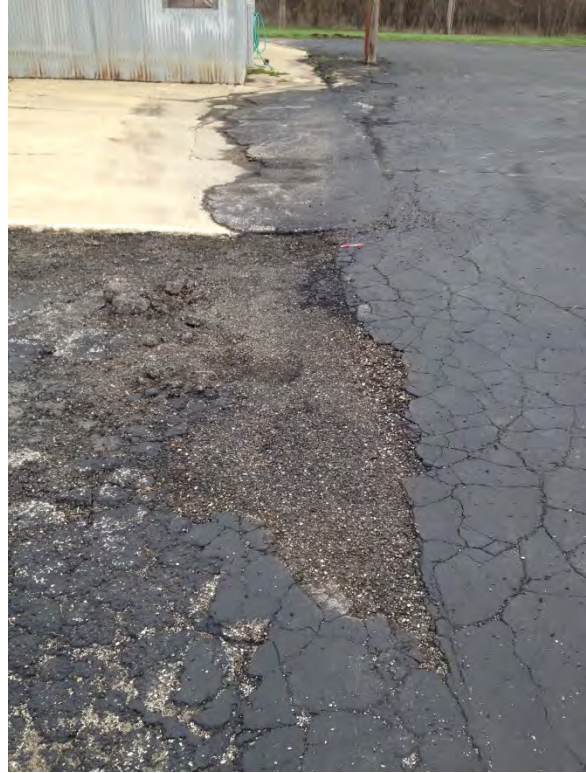
**Figures 10 and 11: Potholes**

Potholes were also noted in areas and are usually a result of severe fatigue cracking and subgrade deterioration. As fatigue cracking worsens, potholes begin forming. We observed potholes in the apron area with the majority of the deterioration in the northwest sections as shown in Figures 10 and 11.

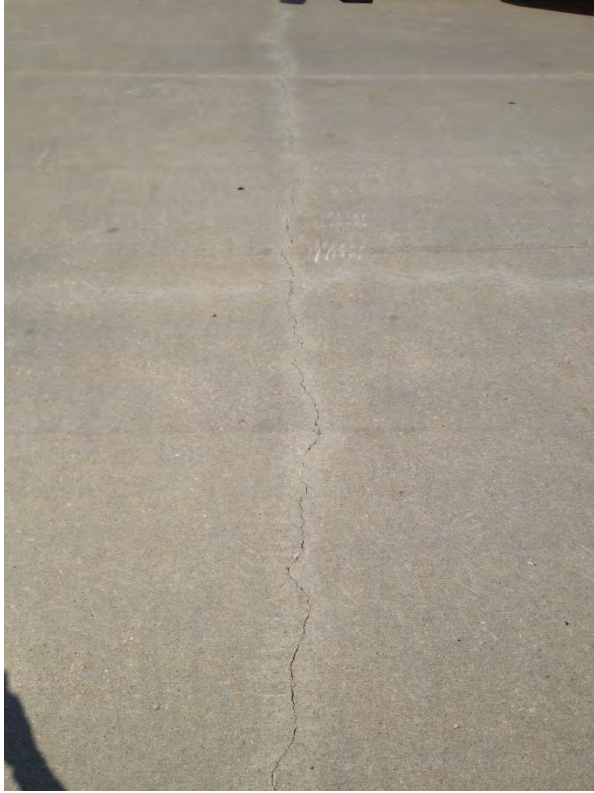
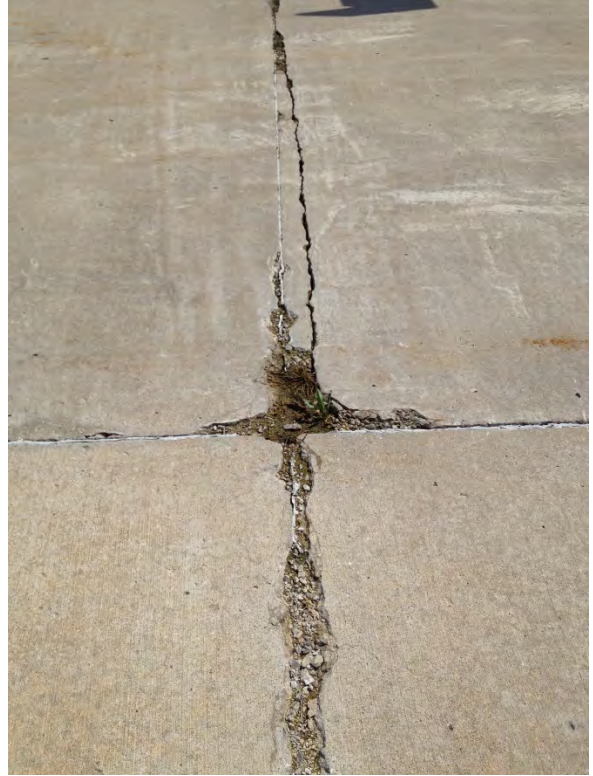
**Figures 12 and 13: Linear Cracking**

Portland cement concrete pavement were located around the terminal building. In the areas, we observed linear cracking and some spalling, as shown in Figures 12 and 13.

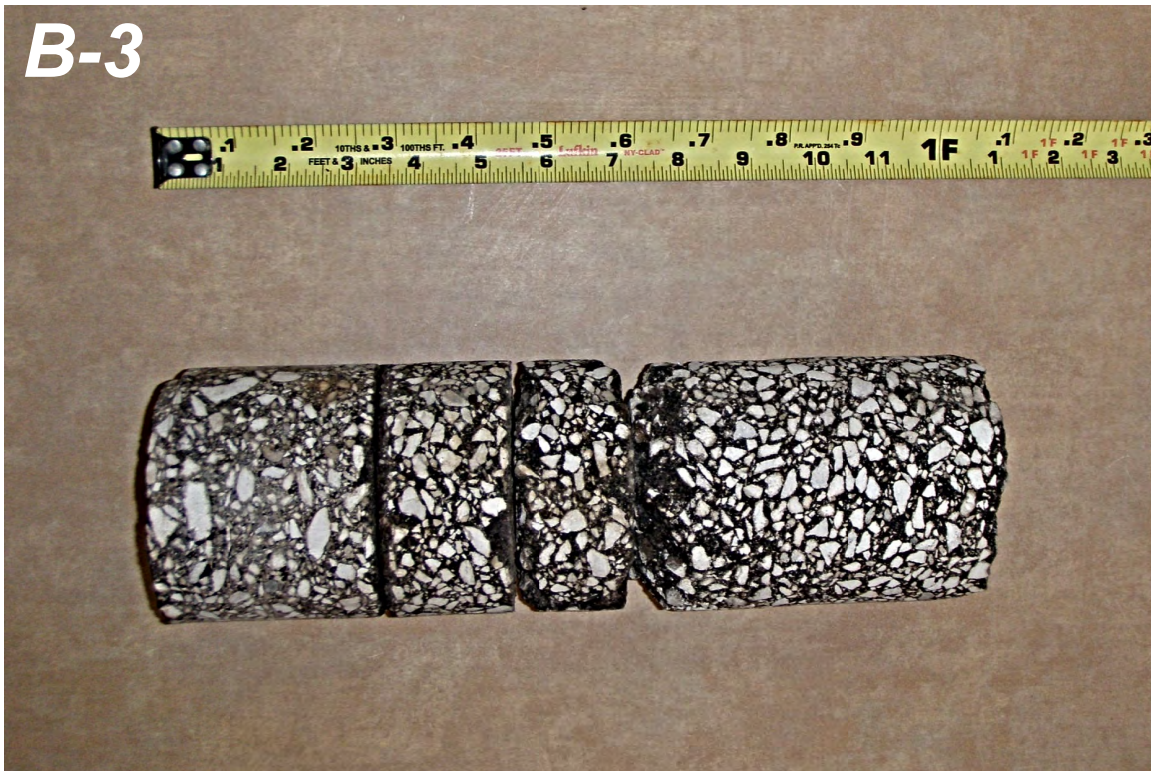
**B-3**

The asphaltic concrete varied in thickness from approximately 1.5 inches to 12 inches. The asphaltic concrete cores from borings B-3 and B-10 showed signs of deterioration beneath the surface of the pavement. Beneath the base of the pavement, poorly graded gravel was noted in borings B-2 through B-6 and B-10 and varied in depth from approximately 3 to 7 inches. Fill material was encountered beneath the gravel and continued to the base of the borings. Borings B-1, B-8, B-9 and B-11 encountered a developed zone at the surface. The developed zone was underlain by fill material which continued to the base of the borings. The fill consisted of lean to fat clay soils with varying amounts of silt, sand and gravel and was soft to very stiff.
