MEMORANDUM

SUBJECT: Major Bridge Inspection Reports
D 6 -- St. Louis County
L0623 and A2643 - Fenton
I – 44 over the Meramec River

**MAJOR BRIDGE INSPECTION REPORT
BRIDGE NO. L0623 (FENTON)
IS 44 WESTBOUND, ST. LOUIS COUNTY
OVER THE MERAMEC RIVER**

**MAJOR BRIDGE INSPECTION REPORT
BRIDGE NO. A2643 (FENTON)
IS 44 EASTBOUND, ST. LOUIS COUNTY
OVER THE MERAMEC RIVER**

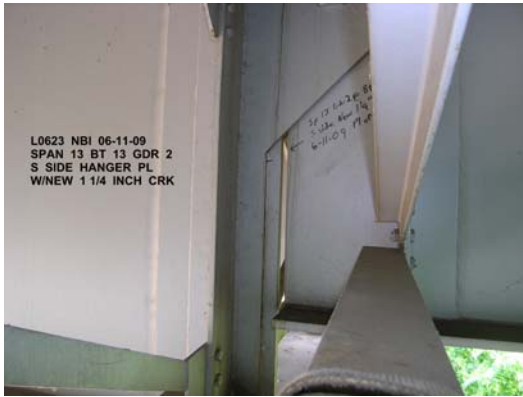
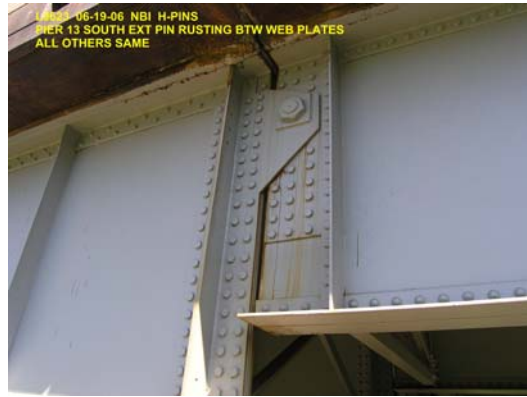
Superstructure Condition Rating (Item 59) = 5 (Fair), pack rust bulging hanger pin plates and crack at hanger pin plate

In February 2004, six locations of cracking were noted, in the web of the original girders. This cracking was observed where the diaphragms for the widened girders are bolted to the webs of the existing girders. Also at this 2004 inspection, a crack was observed in an older replaced diaphragm connection angle. These cracks were repaired in 2005. Hanger plates at bents 10 and 13 are bulging and rusting.

- ❖ Install missing load post sign (65t) at east approach
- ❖ Replace or re-build step cap at bent 3
- ❖ Clean & seal pin connector plate areas with “anti rust” gel
- ❖ Repair expansion joints, bents 6, 9, 14
- ❖ Seal holes in asphalt overlay at expansion joints (pave mend), bents 2, 3, 10, 13, 15
- ❖ Cut trees / brush
- ❖ Clean, paint, reset rockers at bents 6, 9, 13, 14
- ❖ Remove drift at bent 12

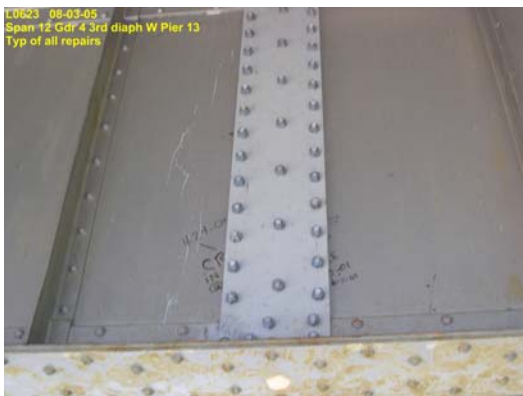
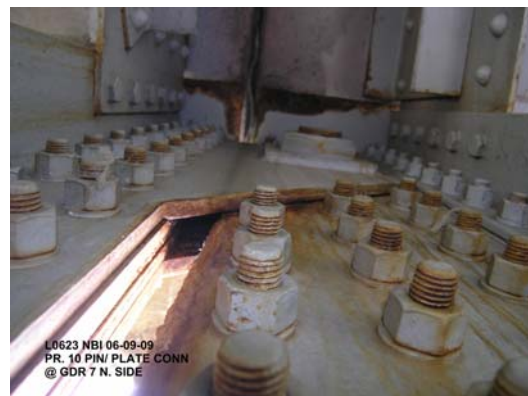
As of this inspection, we have the following three cracks documented:

- ❖ (New in 6-19-07) Diaph conn angle Sp 10, G4
- ❖ (New in 6-09-09) Diaph conn angle (9") Sp 12, G5
- ❖ (New in 6-11-09) Hanger plate (1-1/4") Bt 13, G2

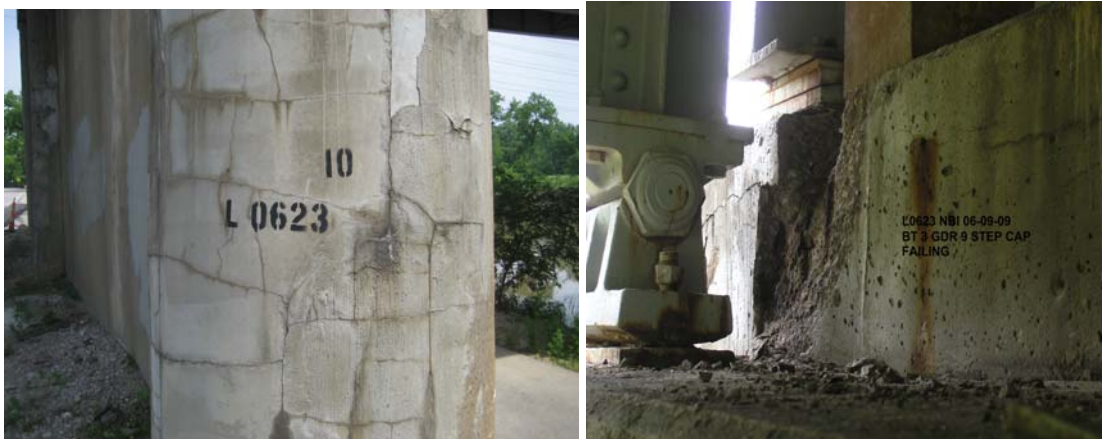
Substructure Condition Rating (Item 60) = 4 (Poor Condition), major disintegration of step cap at bent 3

The step cap bent 3 is in need of immediate repair. Blocking was installed under diaphragms during this inspection, as a precaution. Heavy cracking and leaching is common among most of the bents. Previous patchwork has map cracked and is delaminating. Extensive repairs of the substructure are needed in the near future. Rockers are tipped and need to be reset at bents 6, 9, 13 & 14.

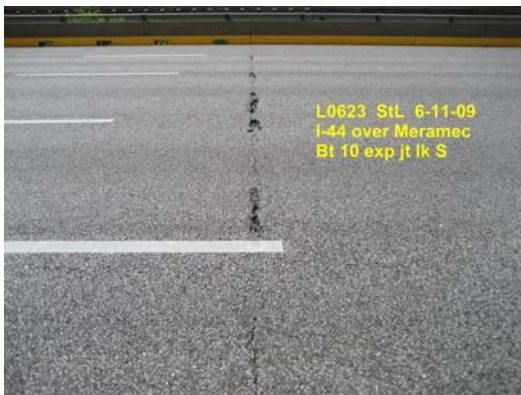
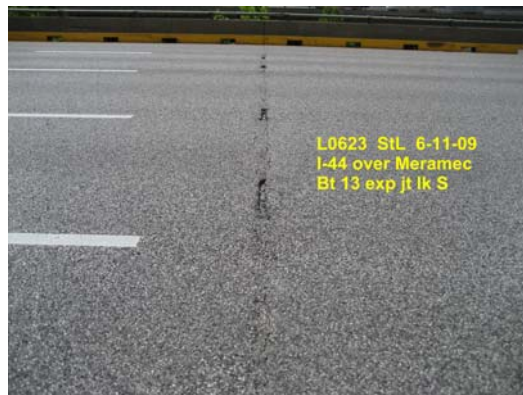
Expansion Devices: Poor

Location	Type	Condition	Comments
Bt 2	Closed	Poor	Failing, Leaking
Bt 3	Closed	Poor	Failing, Leaking
Bt 6	Closed	Poor	Failing Seal debonding
Bt 9	Closed	Poor	Failing Seal debonding
Bt 10	Closed	Poor	Failing Seal debonding, nose break
Bt 13	Closed	Poor	Failing
Bt 14	Closed	Poor	Seal debonding, nosing breaking out
Bt 15	Closed	Poor	Leaking

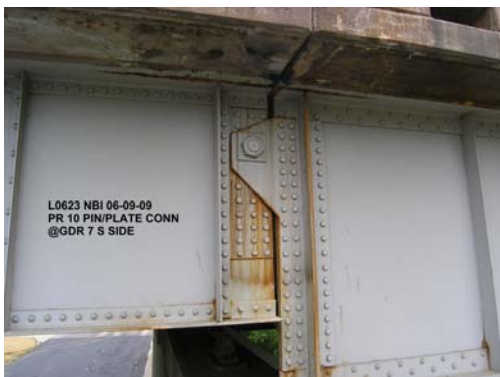
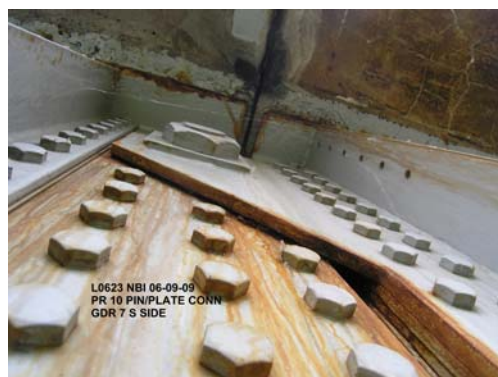
Paint Condition = Good, Rust Code 6, rusting at diaphragms and bearings at joints

Existing paint systems includes System S (Calcium Sulfonate over lead), Gray, painted in 2006, good condition. The girder ends under the expansion devices are System G (Inorganic Zinc), Gray, painted in 2006, good condition. There is general rust staining evident at hanger pin locations.

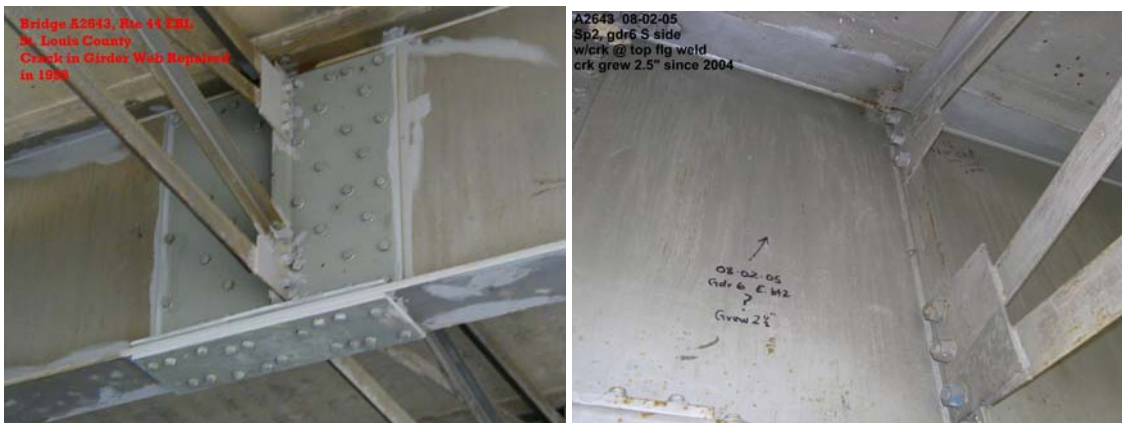
As of this inspection, we have the following three cracks were documented:

- ❖ (6-13-06) In weld of lat guss pl (4-1/2") Sp 9, G5
- ❖ (6-13-06) Top flange weld (2-1/2") Sp 2, G6
- ❖ Bott of Vert Stiff to web weld, s side (1") Sp 8, G5

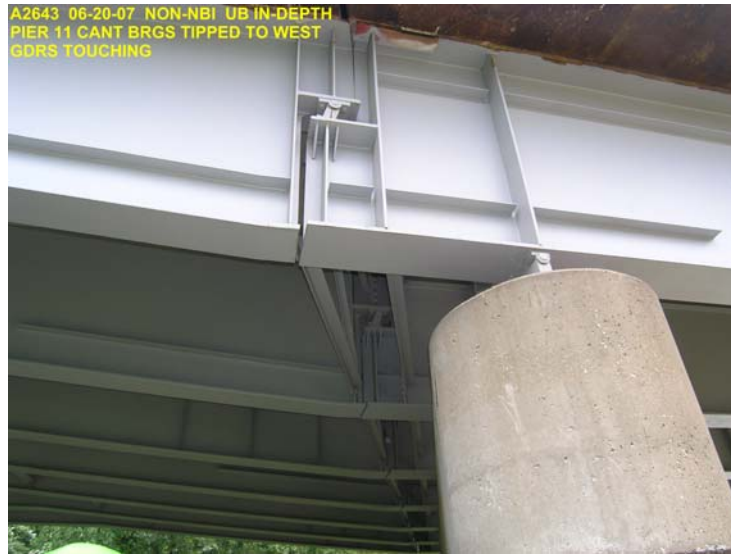
At pier 11, the entire webs of adjacent girders are touching in the top half, due to the cantilever rockers being maxed out.

- ❖ Install missing load post sign (60 Tons) at west approach
- ❖ Repair spall on cap at bt 4
- ❖ Repair expansion joint at bent 8
- ❖ Clean & flush drain outlets
- ❖ Cut trees / brush
- ❖ Reset rockers bents 4 & 11
- ❖ Deck repair span 8
- ❖ Trim girder ends bt 11

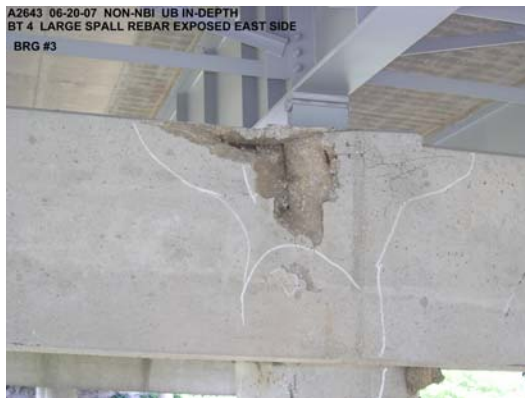
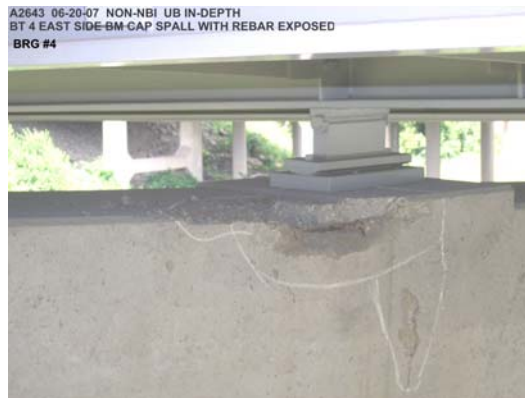
Substructure Condition Rating (Item 60) = 6 (Satisfactory Condition), spalling on Bt 4, not affecting bearing

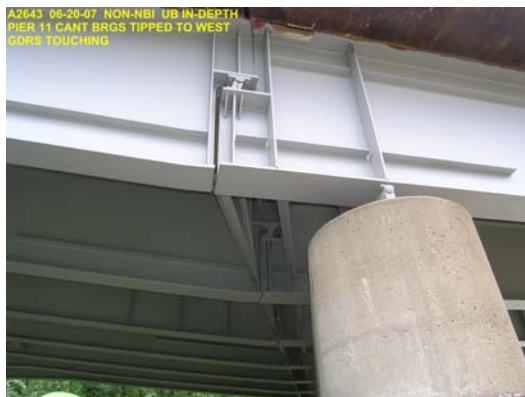
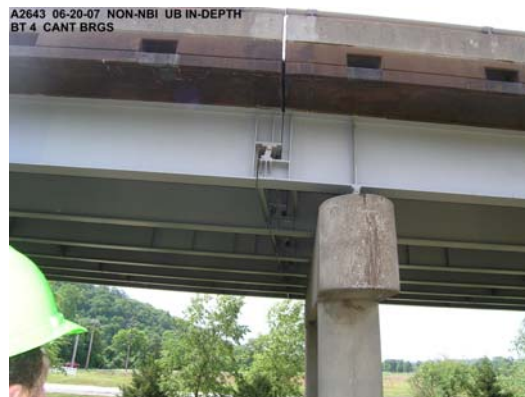
Cantilever rockers tipped and need reset at bents 4 & 11.

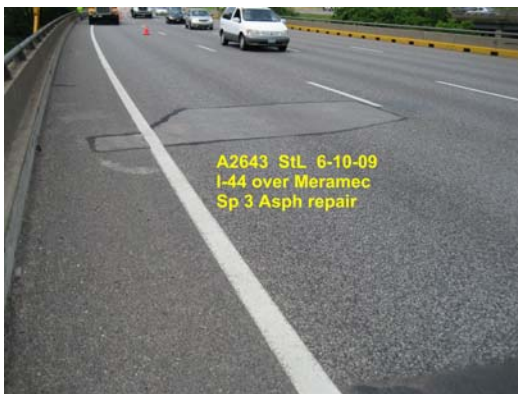
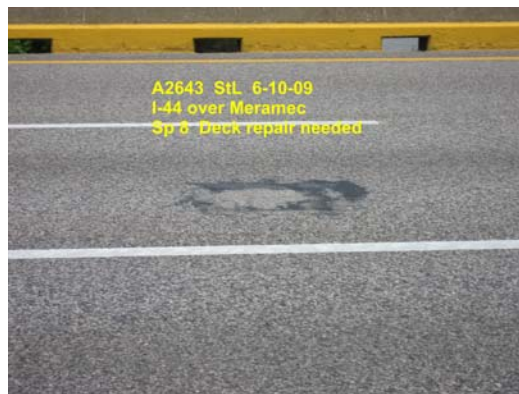
Wearing Surface Condition: Fair

In 1997 an epoxy polymer wearing surface was applied. Many epoxy areas had been repaired over the years. 1-1/2” asphalt overlay was laid a few years ago with SRI. There are a few patches in the surface and one area that needs repair.

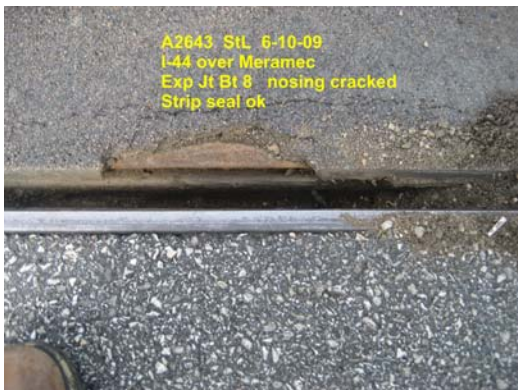
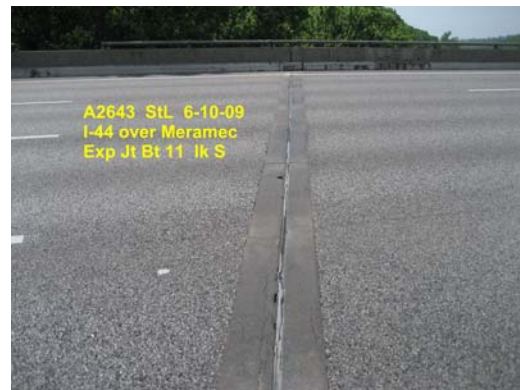
Expansion Devices: Poor Condition

Location	Type	Condition	Comments
Bt 4	Closed	Fair	Nosing Cracking-Dry
Bt 8	Closed	Poor	Failing, Leaking, Pounding
Bt 11	Closed	Fair	Nosing Cracking-Dry
