# **MAJOR BRIDGE INSPECTION REPORT**

## **BRIDGE L0623 (FENTON)**

### **I-44 WB, ST. LOUIS COUNTY**

### **OVER THE MERAMEC RIVER**

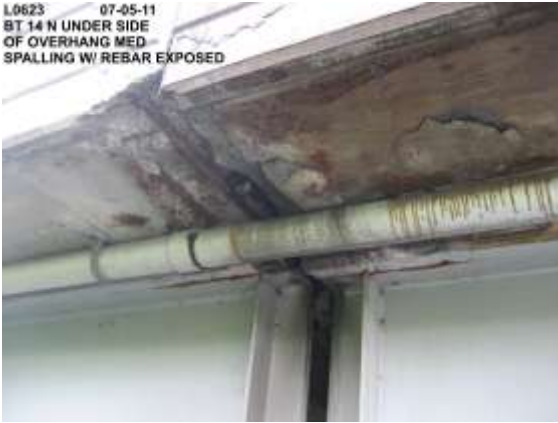
The deck consists of cast in place reinforced concrete. The asphalt overlay conceals the deck condition. Past projects include deck repair and a wearing surface in 1997, deck repair in 2004, and the current wearing surface was placed in 2006. Throughout the overhang areas, there is moderate random cracking with efflorescence and few patches.

L0623 07-05-11  
BT 14 N UNDER SIDE  
OF OVERHANG MED  
SPALLING W/ REBAR EXPOSED

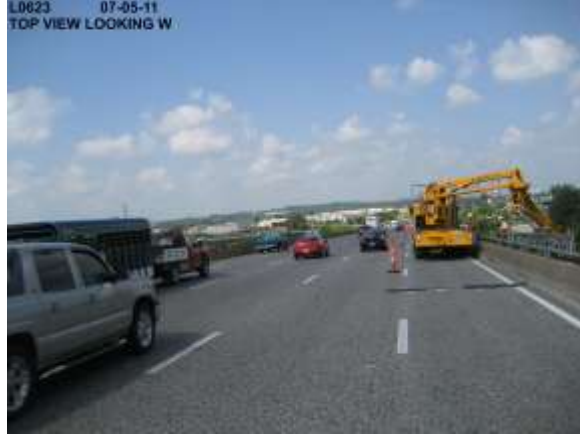
L0623 07-05-11  
TOP VIEW LOOKING W

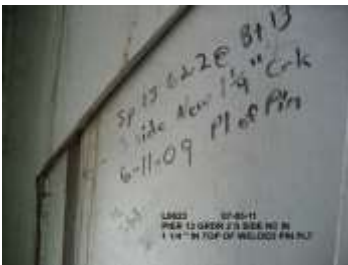
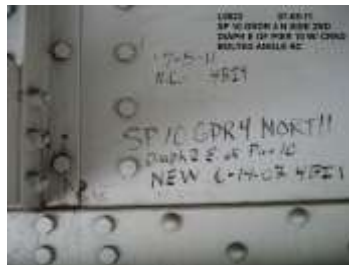
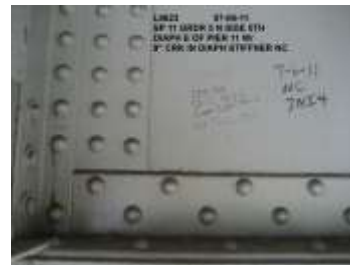
During the June 2009 inspection, three cracks were documented, no change has occurred:

- ❖ (New in 6-19-07) Diaph conn angle Sp 10, G4
- ❖ (New in 6-09-09) Diaph conn angle (9") Sp 11, G5
- ❖ (New in 6-11-09) Hanger plate (1-1/4") Bt 13, G2

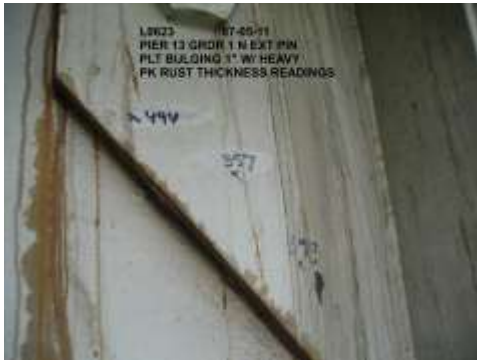
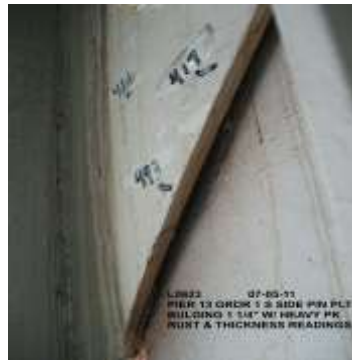
Hanger plates on all girders at bent 13 are bulging and rusting. Most of the plate bulging is less than 1", the maximum is 1 1/4". Plate thickness readings were taken, most readings

range from 0.460" to 0.609". The thinnest reading is 0.357", located at bent 13, girder 1, north exterior plate.

- ❖ Clean & seal pin connector plate areas with "anti rust" gel
- ❖ Repair expansion joints, bents 6 & 14
- ❖ Hot Pour/Seal missing asphalt overlay at expansion joints (pave mend), bents 2, 3, 10, 13 & 15
- ❖ Cut trees/brush, spray vines
- ❖ Clean, paint, reset rockers at bents 6 & 14
- ❖ Remove drift at bent 12

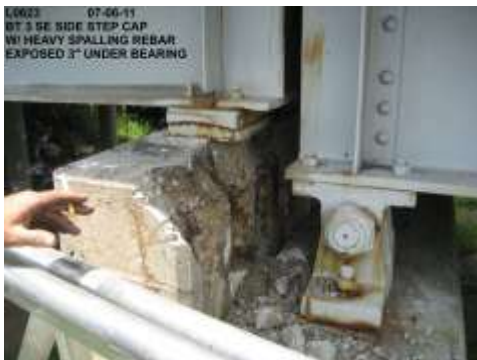
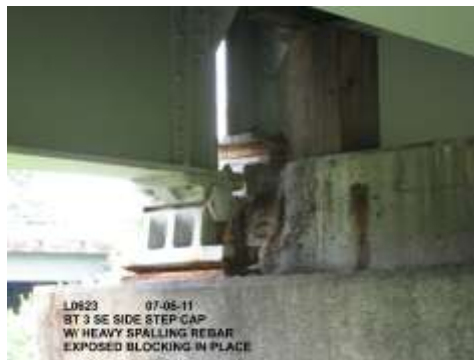
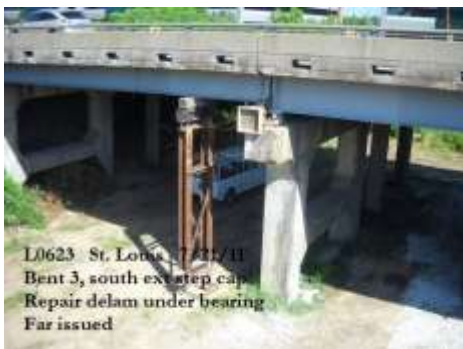
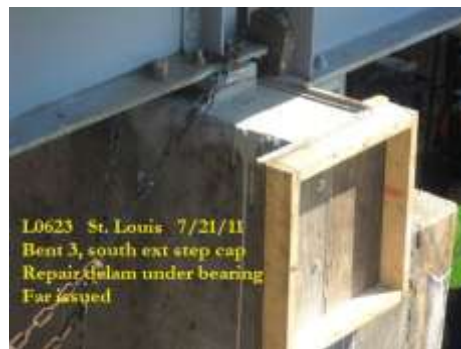
The condition ratings (items 58, 59 & 60) for the bridge are 6-5-5. In 2009, the substructure was lowered from a '5' to a '4', due to major disintegration at bent 3, precautionary blocking was installed at the bearing seat on the south end at girder 9. This was identified as a FAR with this inspection, it was repaired on 7/21/11 and the substructure rating was raised from '4' to '5'.

The substructure units are in fair condition overall, with the exception of bent 3. The south end of the step cap is deteriorating under the exterior girder and blocking was installed under diaphragms two years ago. This inspection deemed bent 3 to be a "Follow-up Action Required", in need of immediate repair. The regional crew completed repairs on July 21<sup>st</sup>, 2011.

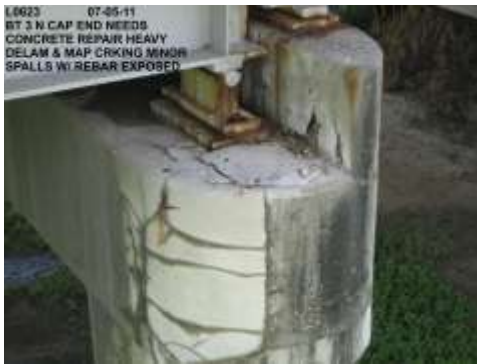
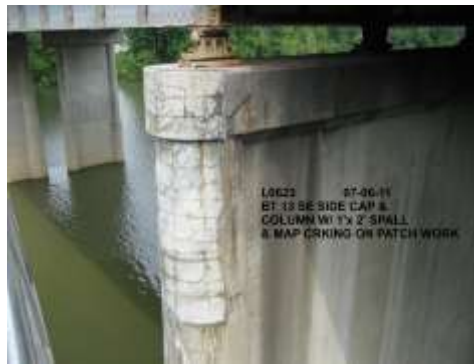
Heavy cracking and leaching is common among most of the bents. Previous concrete repairs are map cracked and are delaminating. Extensive repairs of the substructure are needed in the near future.

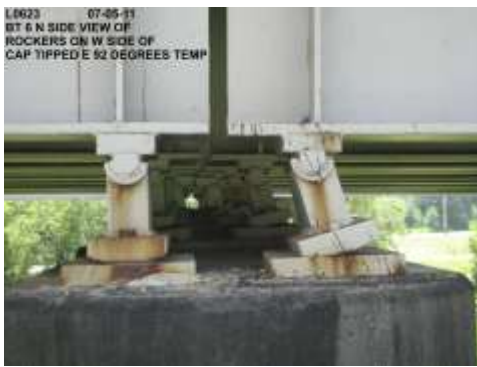
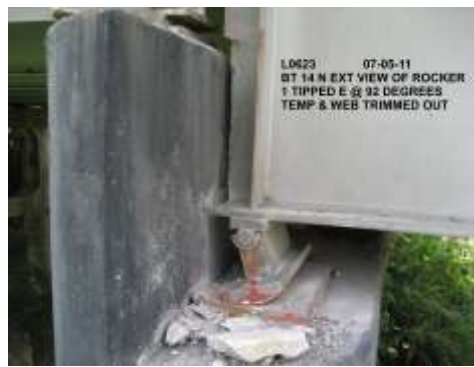
Rockers are tipped and need to be reset at bents 6 & 14.
