Mandatory Bridges

June 3, 2021

Laurel McKean, Project Director

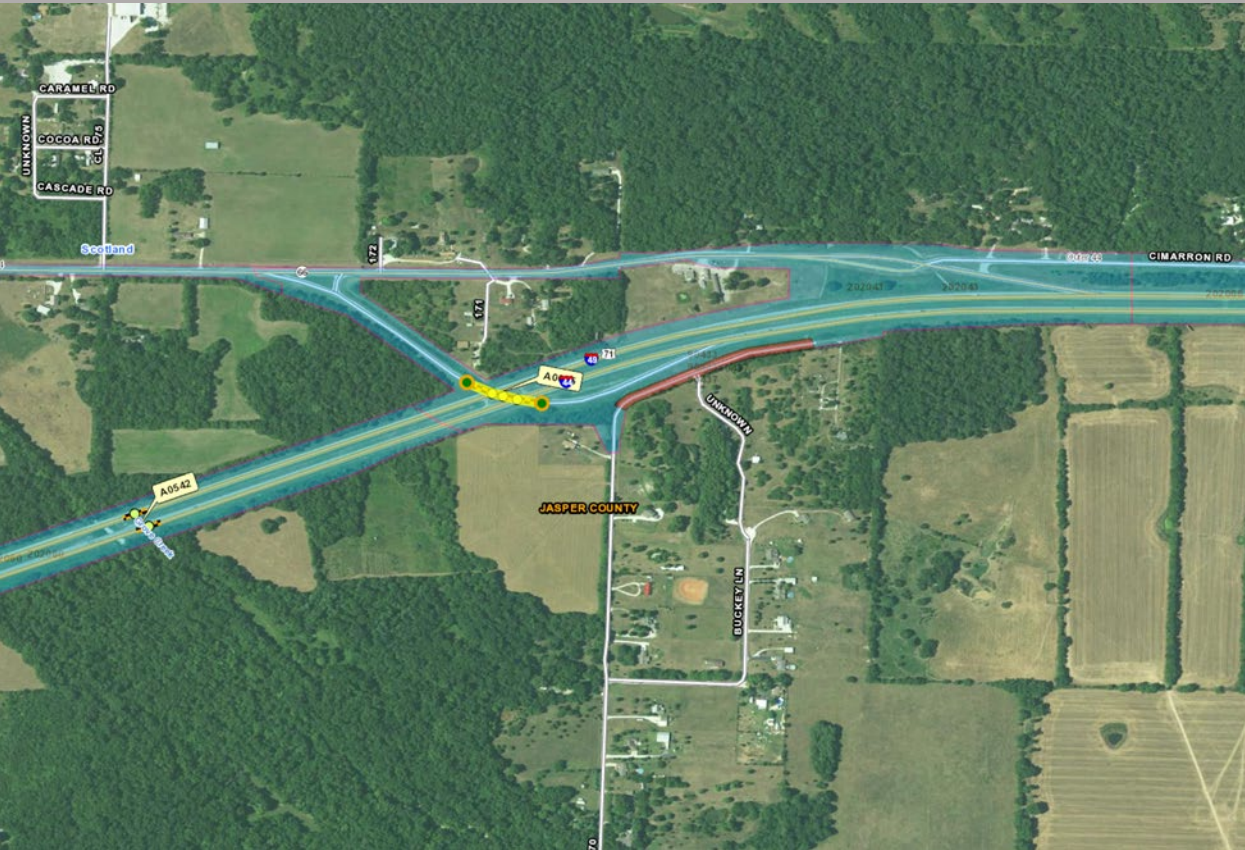
Bridge #A0625

- Known as Scotland Interchange
- East of Dueneweg
- TIS/AJR/CE2 in process to completely remove Exit
- Potential to remove from list if cannot gain consensus on elimination
- Option: Keep in and minimum treatment of replacement

Mandatory:	Y	AADT:	1509
Ratings:	3,3,5	Truck %:	13.5
Treatment:	Elimination	Existing Bridge Type:	Concrete Box Girder
Grade Change:	0"	44 Incident Bypass Route:	No
Crossing Type:	Interstate

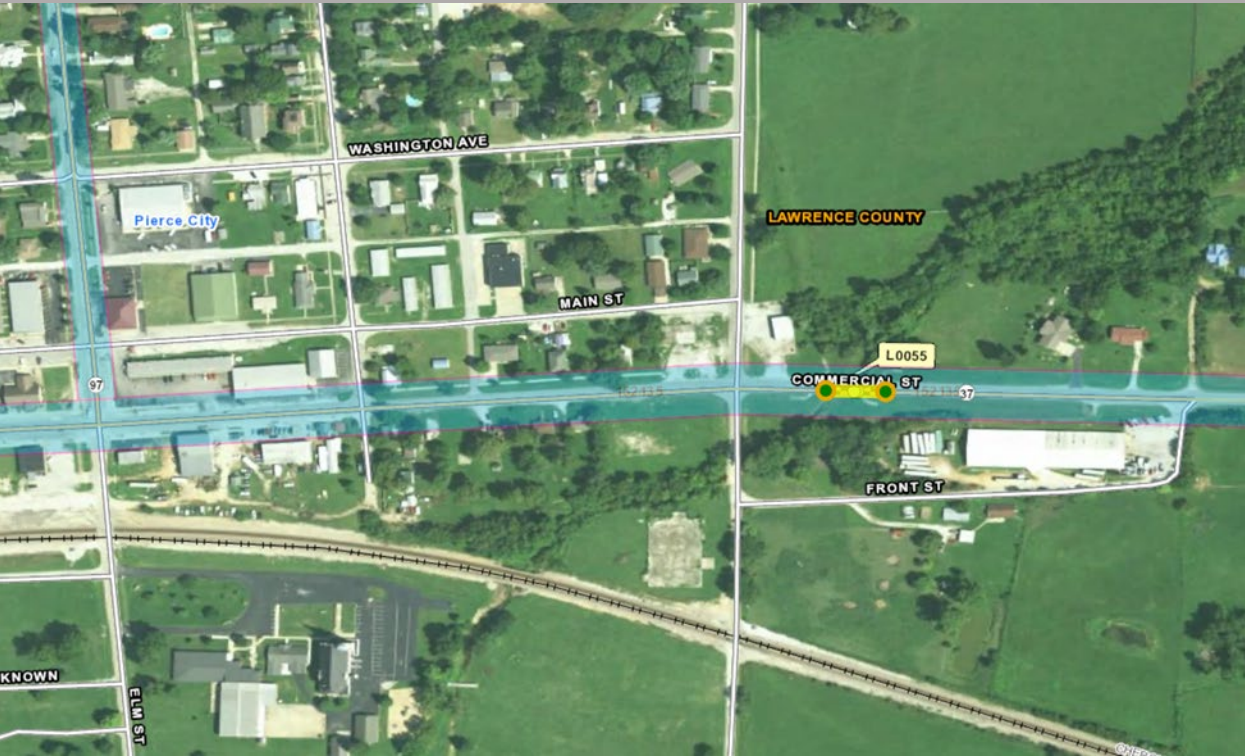
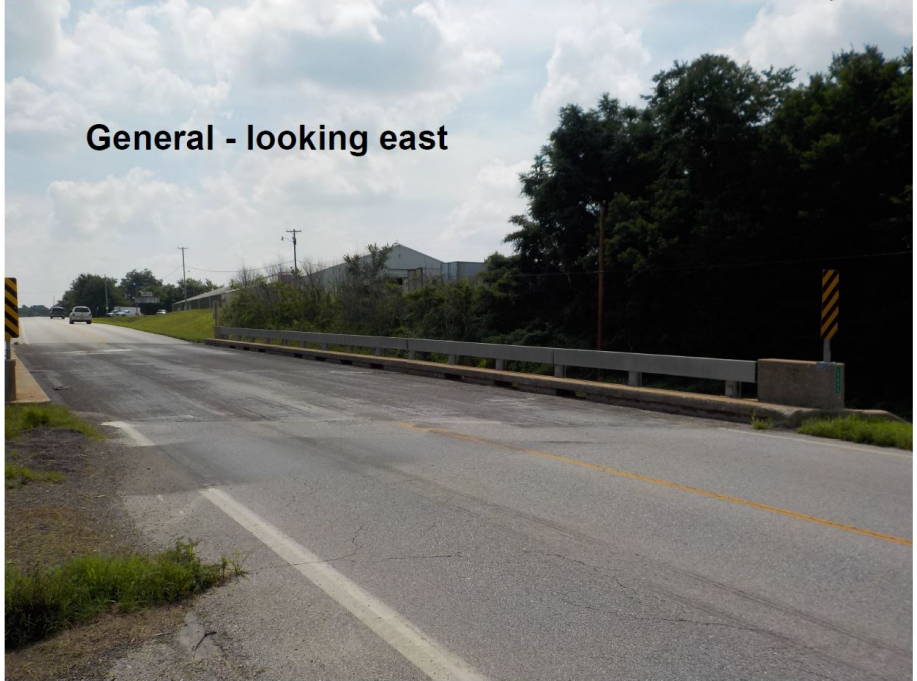
Bridge #L0055
MO37 over Dry Branch
Lawrence County

- East side of Pierce City
- Main route into Pierce City
- Water does not overtop the bridge
- No routine removal of drift
- Water will go over the road surface 150’ west of structure
- Fire Station west of location
- City park on south side of RR tracks
- No crashes
- Utilities in area

Mandatory:	Y	AADT:	3279
Ratings:	4,4,3	Truck %:	9.1
Treatment:	Replacement	Existing Bridge Type:	Wide Flange Girder
Potential Grade Change:	0.1’	I44 Designated Bypass Route:	Yes
Crossing Type:	Water

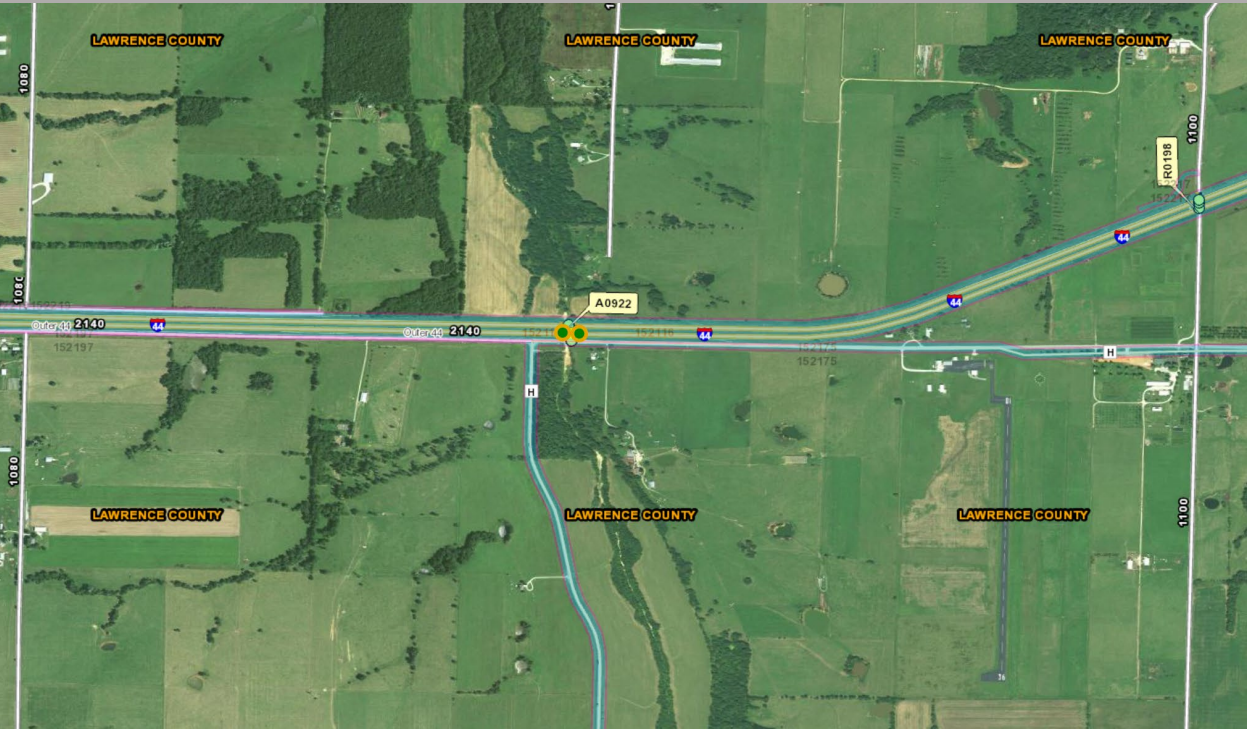
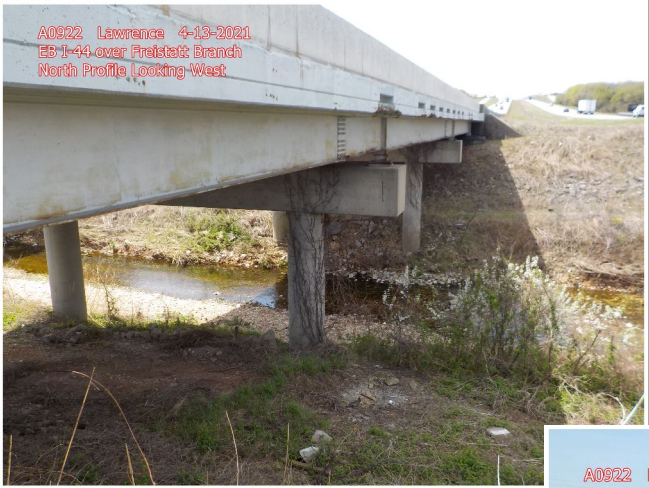
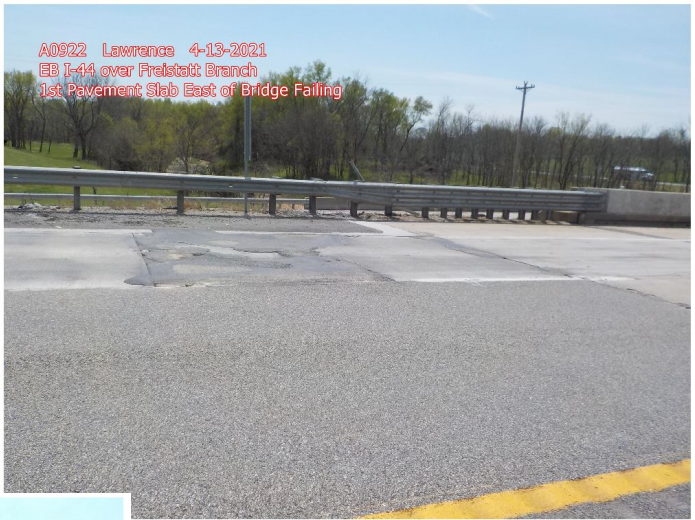
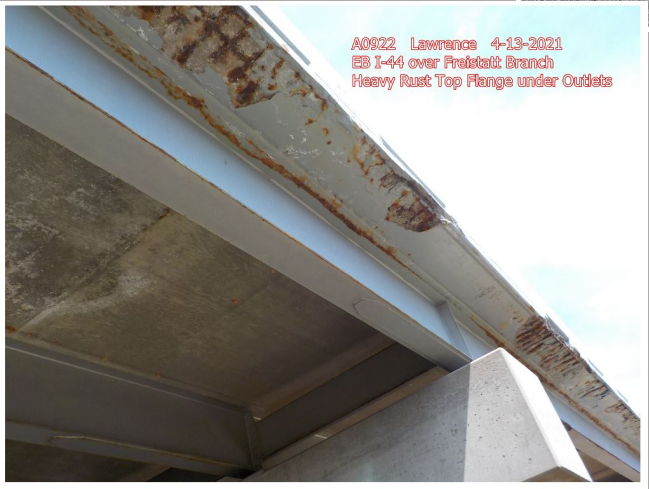
Bridge #A0922E
I-44 over Freistatt Branch
Lawrence County

- No knowledge of water over bridge
- Remove drift once every 5 years

- No crashes
- Kissee Farms go under the bridges to access property on N side of I-44

Mandatory:	Y	AADT:	14865
Ratings:	6,4,6	Truck %:	26.2
Min Treatment:	Rehab	Existing Bridge Type:	Wide Flange Girder
Potential Grade Change:	0"	I44 Incident Bypass Route:	Mainline
Crossing Type:	Water

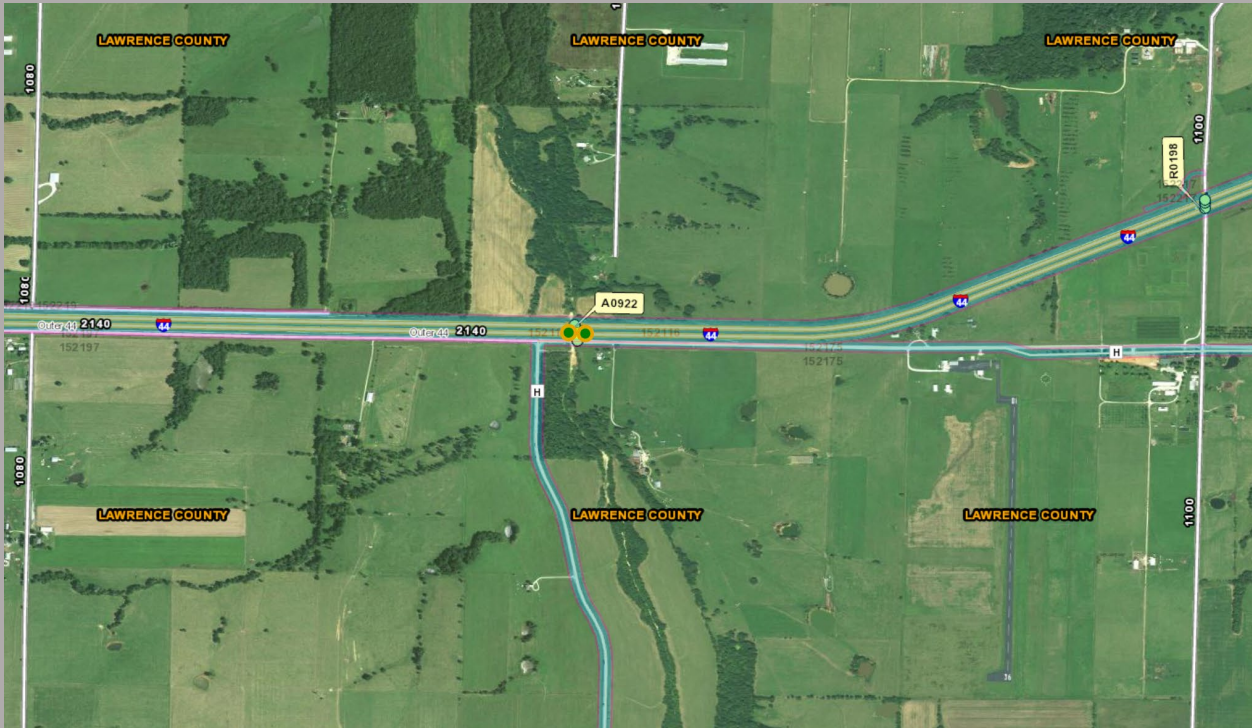
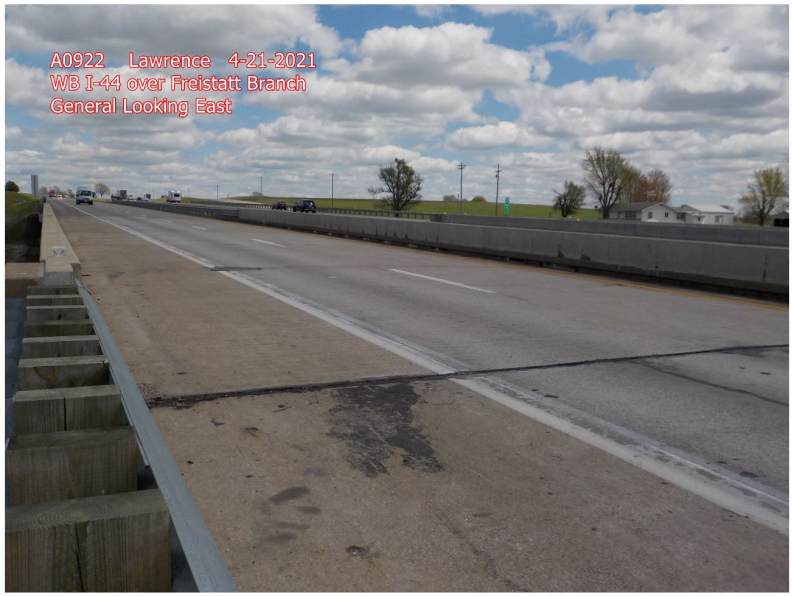
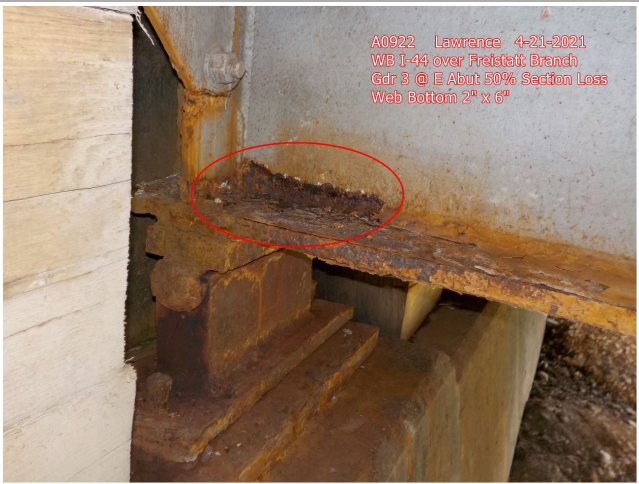
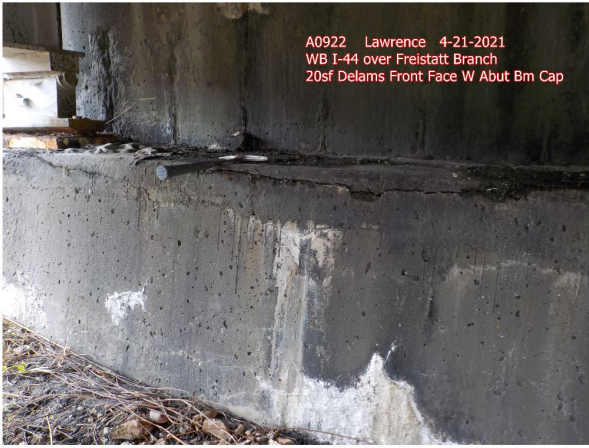
Bridge #A0922 W
I-44 over Freistatt Branch
Lawrence County

- No knowledge of water over bridge
- Remove drift once every 5 years

- No crashes
- Kisse Farm go under the bridges to access property on both sides of 44

Mandatory:	Y	AADT:	14773
Ratings:	6,4,6	Truck %:	26.2
Min Treatment:	Rehab	Bridge Type:	Wide Flange Girder
Potential Grade Change:	0"	I44 Incident Bypass Route:	Mainline
Crossing Type:	Water

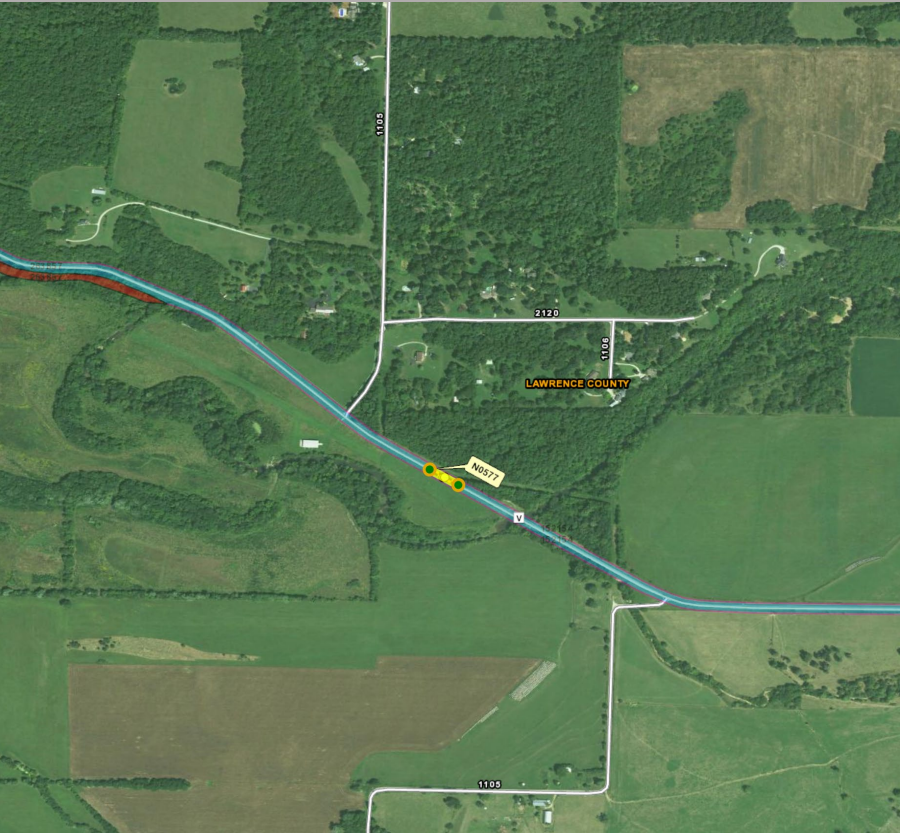
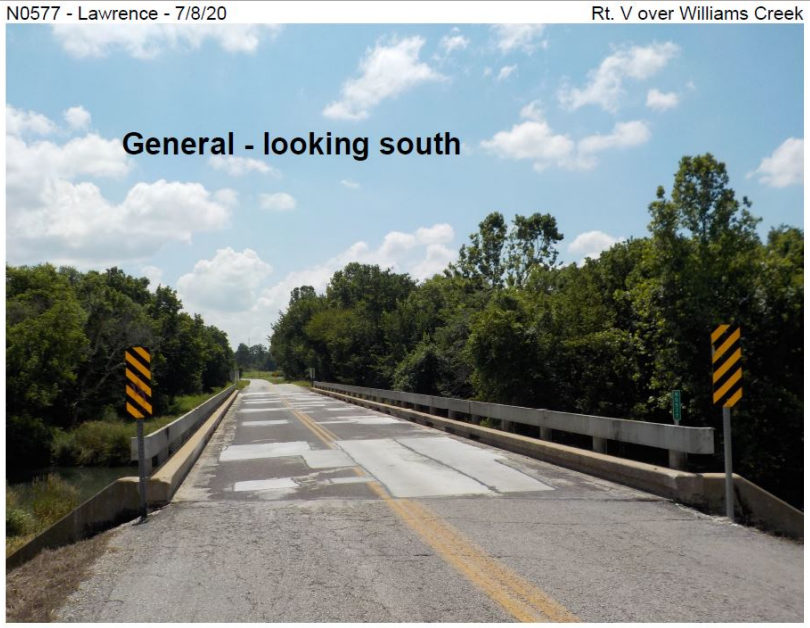
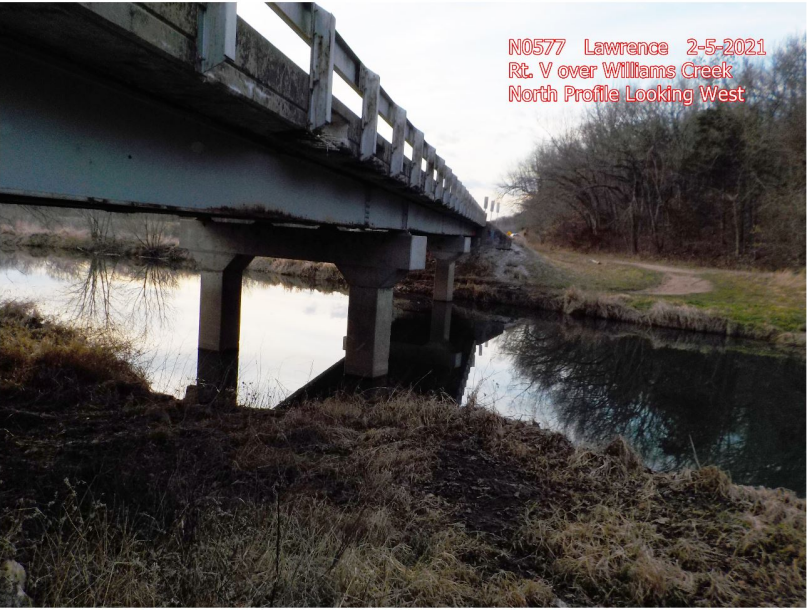
Bridge #N0577
Route V over Williams Creek
Lawrence County

- No routine occurrences of water overtopping bridge
- No major drift issues
- Used by farming equipment
- Tight work space
- ROW tight on south side N of creek
- No crashes

Mandatory:	Y	AADT:	723
Ratings:	3,6,6	Truck %:	6.8
Min Treatment:	Redeck	Existing Bridge Type:	Wide Flange Girder
Potential Grade Change:	0.04'	I44 Incident Bypass Route:	No
Crossing Type:	Water

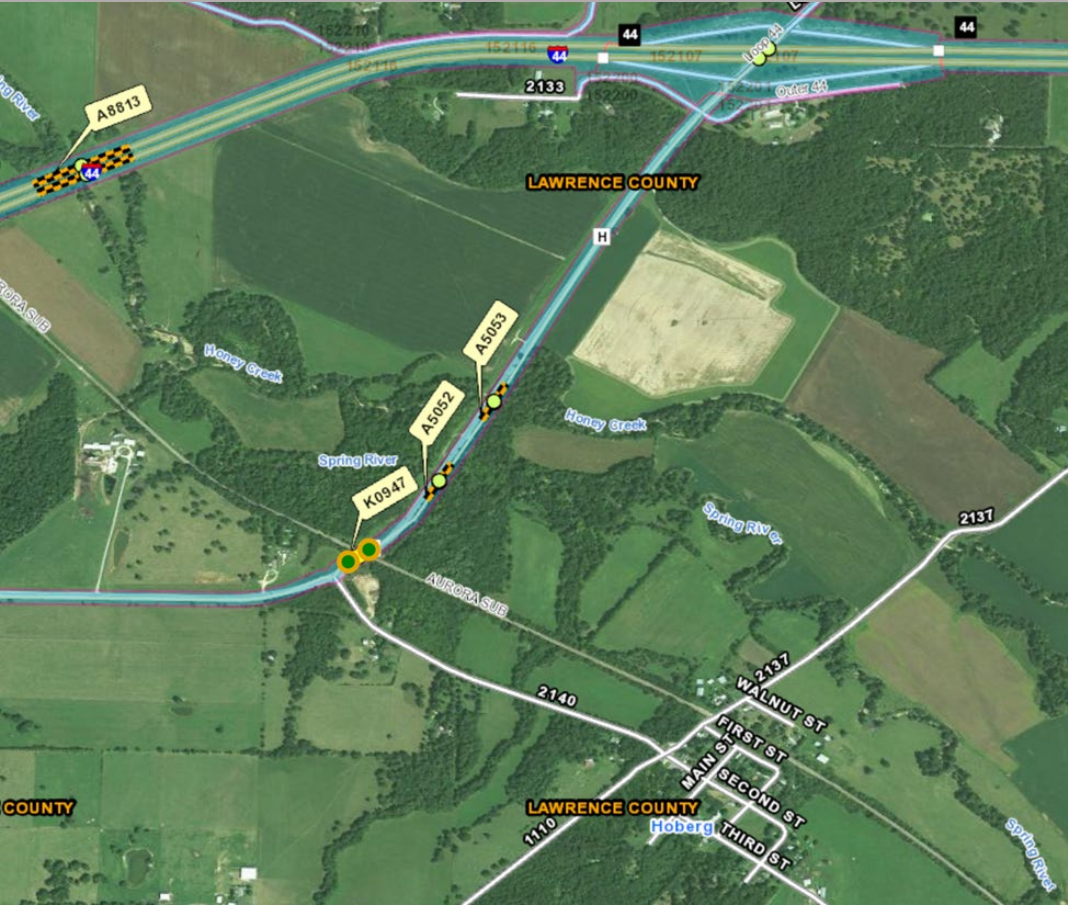
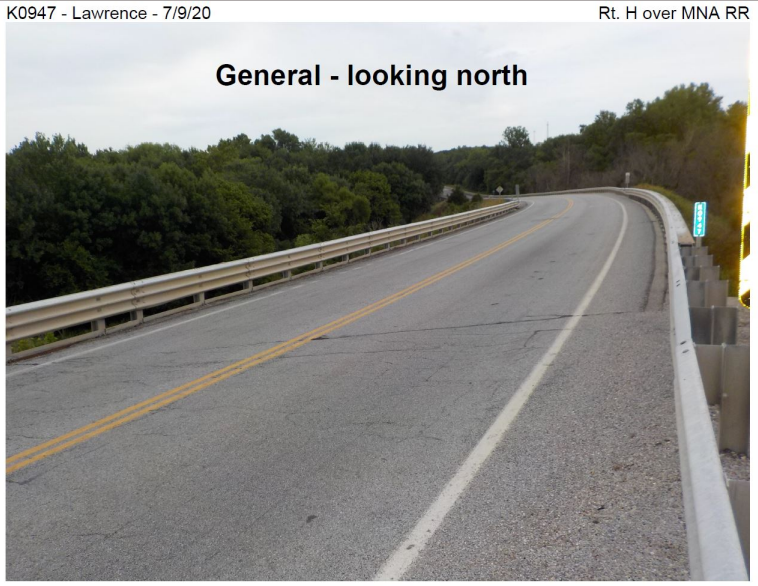
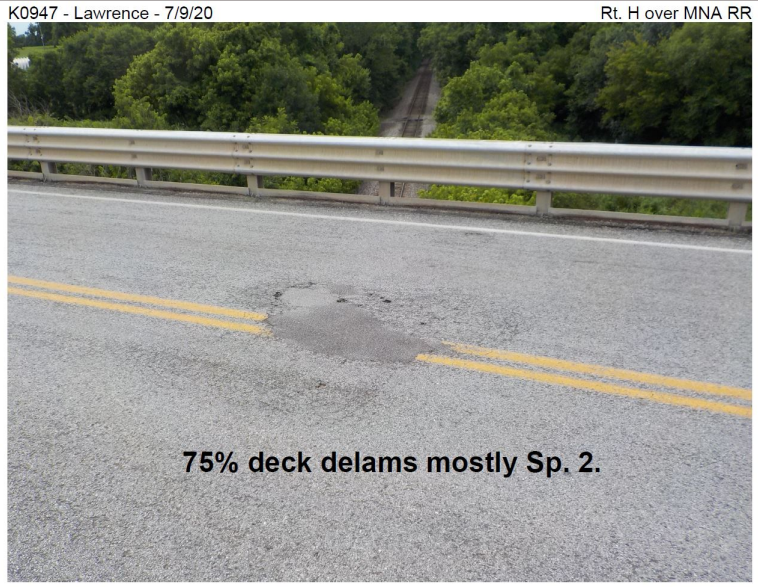
Bridge #K0947
Route H over MNA/UP RR
Lawrence County

- Conceptual plans have already been sent to UP RR
- Plan to provide at least 30% Preliminary plans
- Potential to remove from list of bridges
- MoDOT has a lot on south end which could be used for staging

Mandatory:	Y	AADT:	4359
Ratings:	3,3,5	Truck %:	12.9
Min Treatment:	Replacement	Existing Bridge Type:	Concrete Deck Girder
Potential Grade Change:	2.33'	I44 Incident Bypass Route:	
Crossing Type:	Railroad

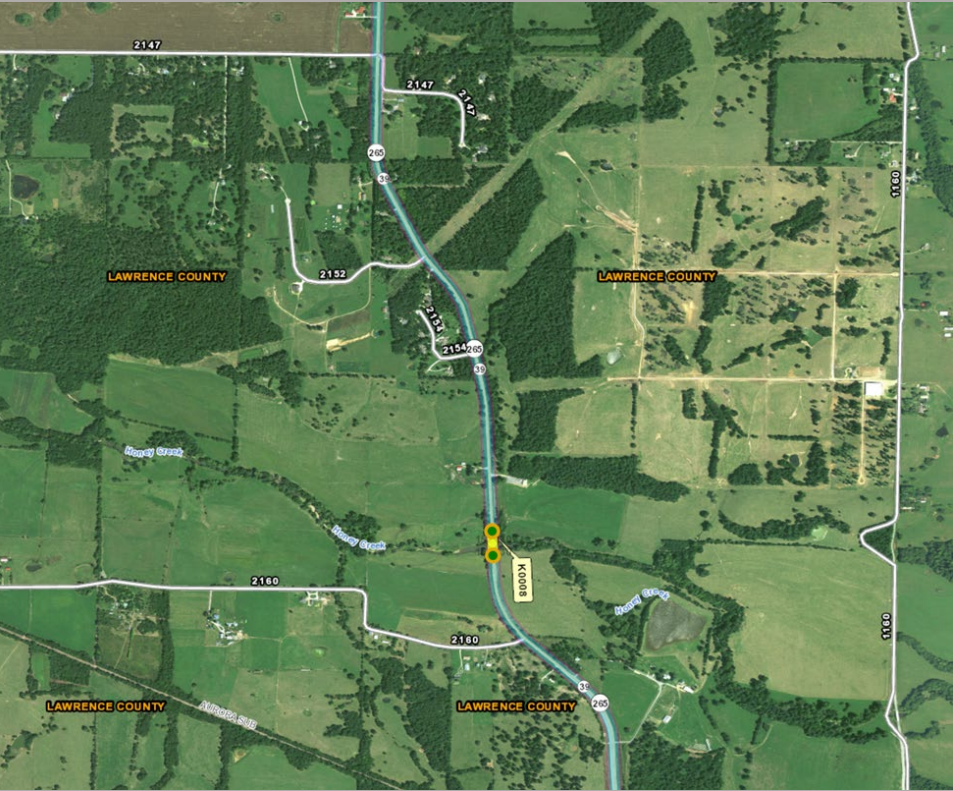
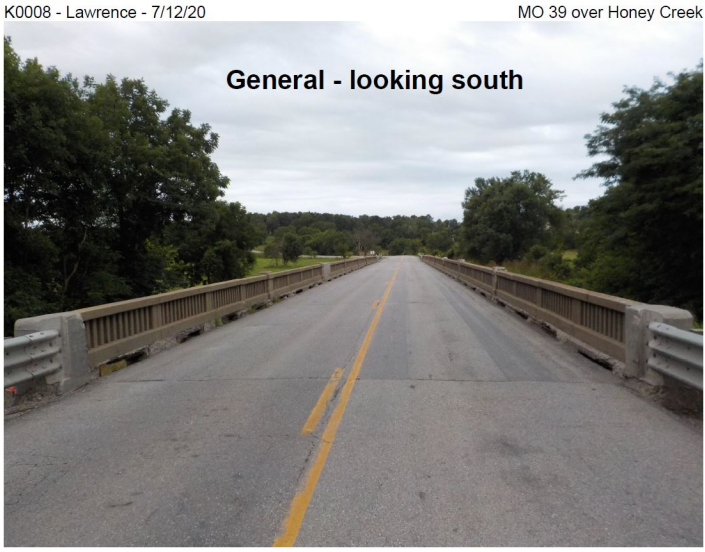
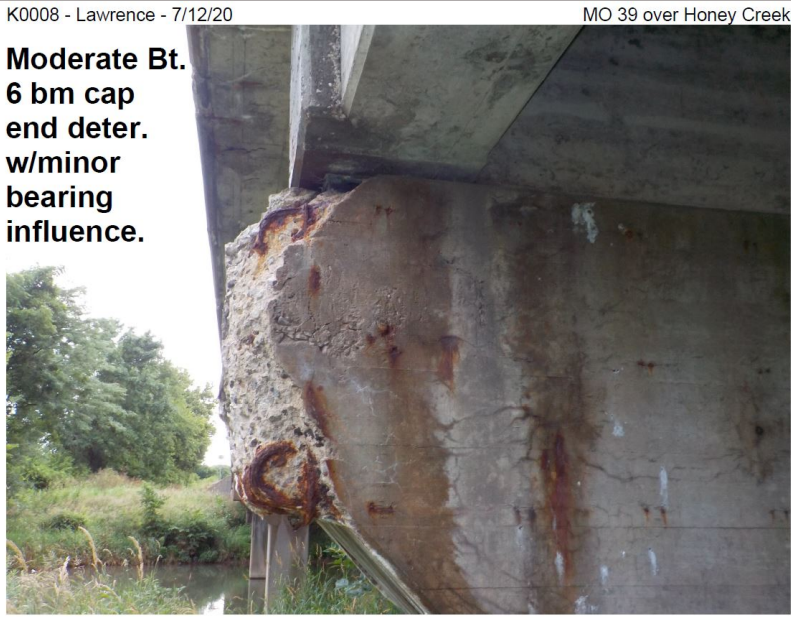
Bridge #K0008
MO39 over Honey Creek
Lawrence County

- MO39 connects Mt. Vernon to Aurora
- Water has gone over the road but not very deep
- Seldomly must remove drift
- Trash trucks, farming and fuel trucks utilize the route
- Narrow bridge and curve on south side

9 crashes in 6 years

- 7 crashes involved two vehicles striking mirrors or other part of vehicle with many involving one of the vehicles crossing the centerline

Mandatory:	Y	AADT:	4585
Ratings:	3,3,5	Truck %:	15.5
Min Treatment:	Replacement	Existing Bridge Type:	Concrete Deck Girder
Potential Grade Change:	3"	I44 Incident Bypass Route:	
Crossing Type:	Water

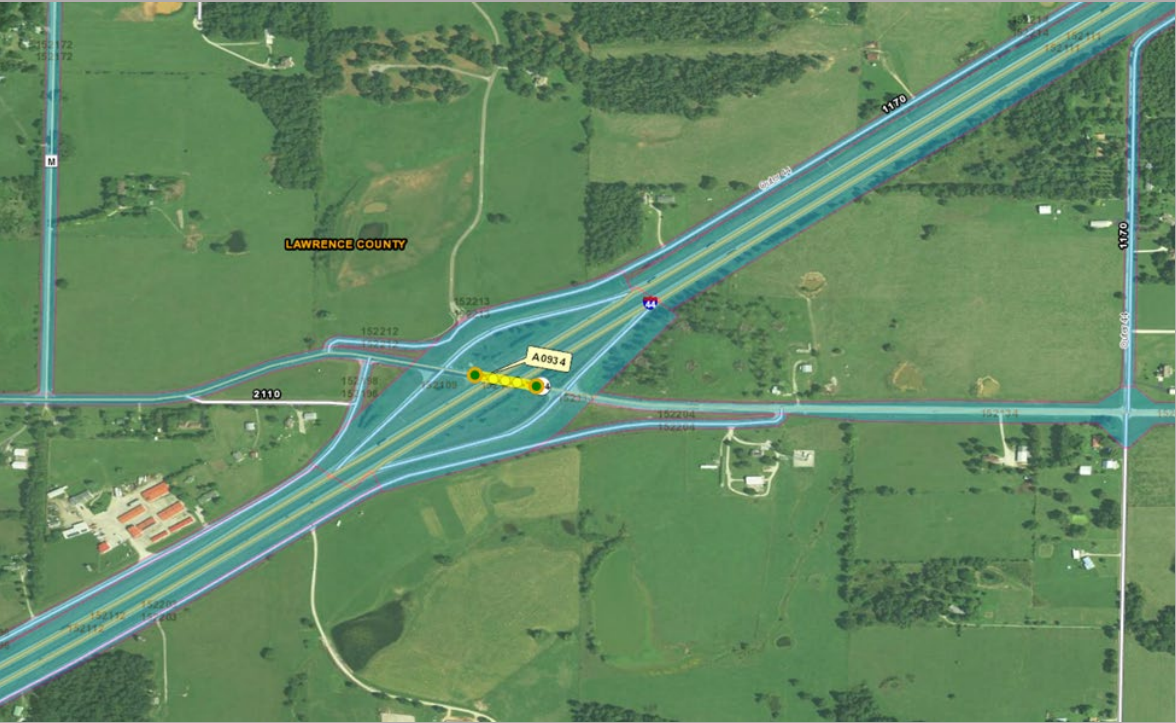
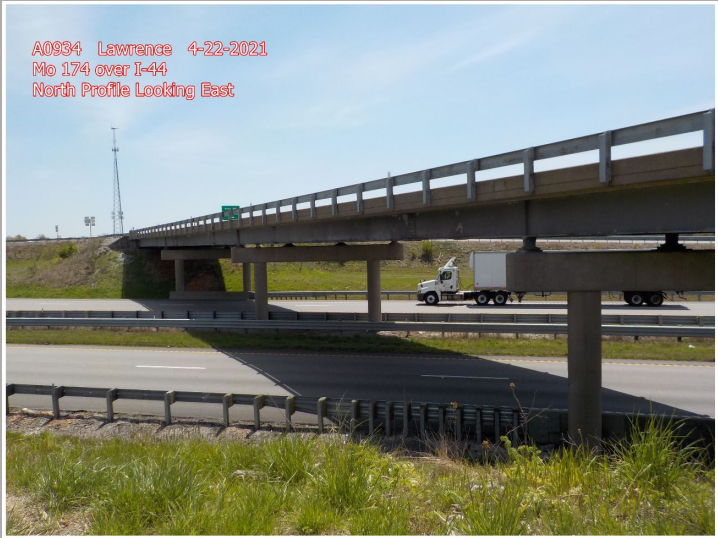
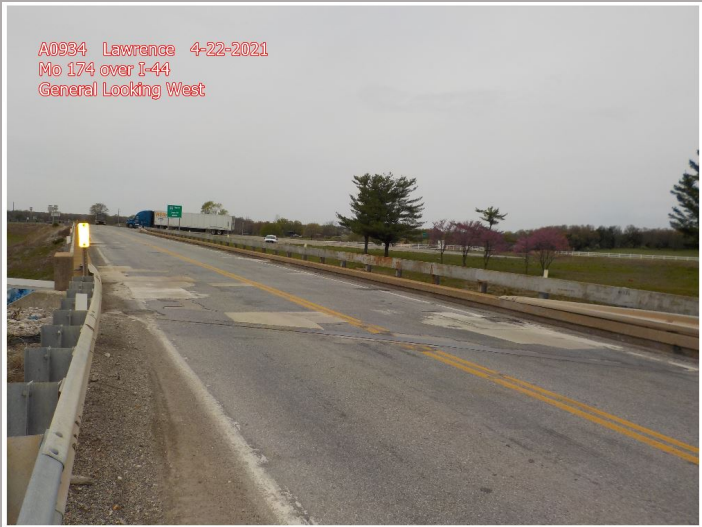
Bridge #A0934 MO174 over I-44 EB & WB Lawrence County

- One of 3 interchanges for Mt. Vernon
- Used by dump trucks, fuel trucks, tractor trailers and farming
- Must be mindful of sight distance
- Energy truck company down outer road
- Quarry out south of bridge
- Housing developments
- Standing water under bridge

- Crashes at ramps and W OR typical of intersection crash types

Mandatory:	Y	AADT:	2672
Ratings:	3,4,6	Truck %:	6.5
Min Treatment:	Redeck	Existing Bridge Type:	Wide Flange Girder
Potential Grade Change:	2’-10”	I44 Incident Bypass Route:	Yes
Crossing Type:	Interstate

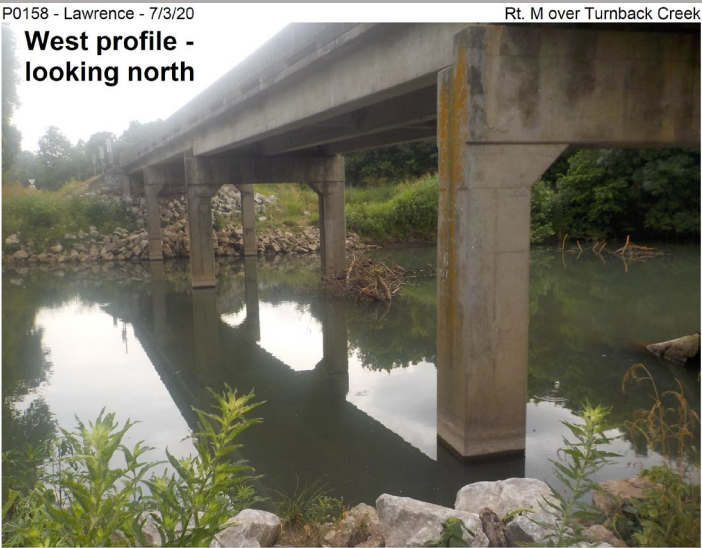
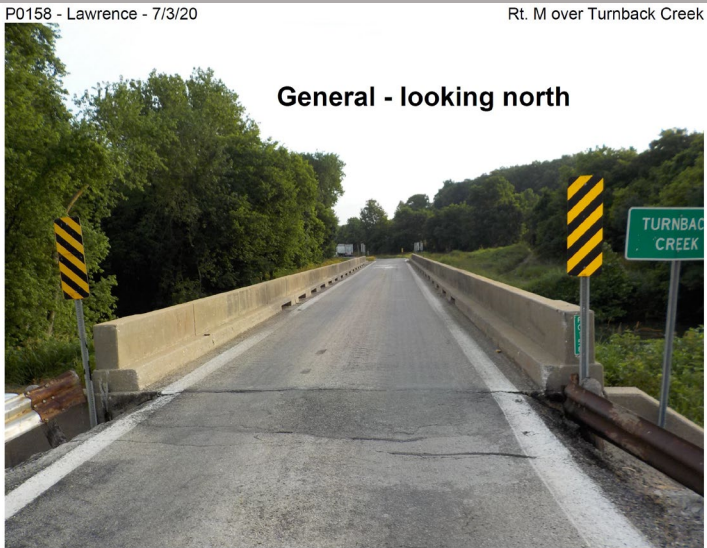
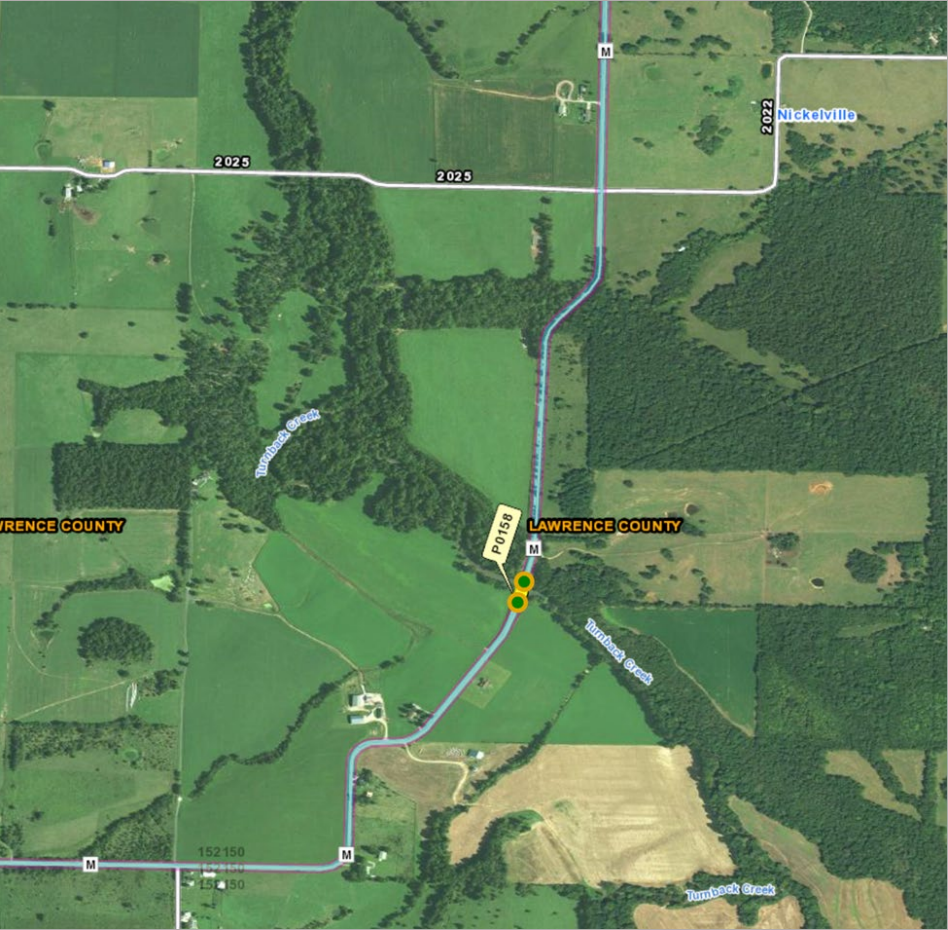
Bridge #P0158 Route M over Turnback Creek Lawrence County

Mandatory:	Y	AADT:	295
Ratings:	3,3,5	Truck %:	10.7
Min Treatment:	Replacement	Existing Bridge Type:	Concrete Deck Girder
Potential Grade Change:	0"	I44 Incident Bypass Route:	No
Crossing Type:	Water

- No knowledge of water overtopping bridge
- 4” deep water over roadway about 100 yards
- Remove drift about once every other year
- Farming
- Fishing and recreational use around and under bridge
- One lane bridge

- No crashes

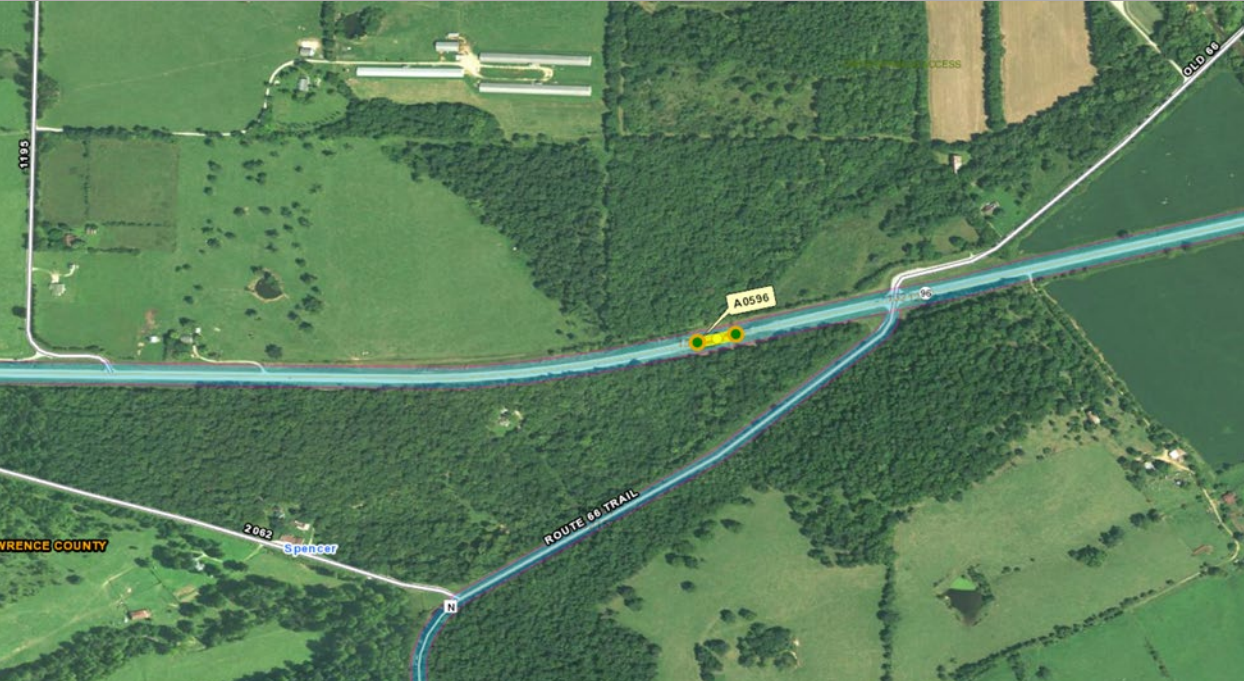
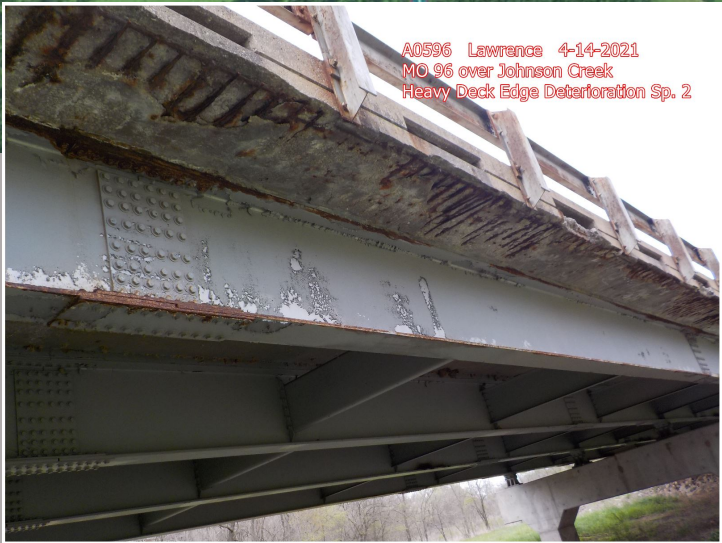
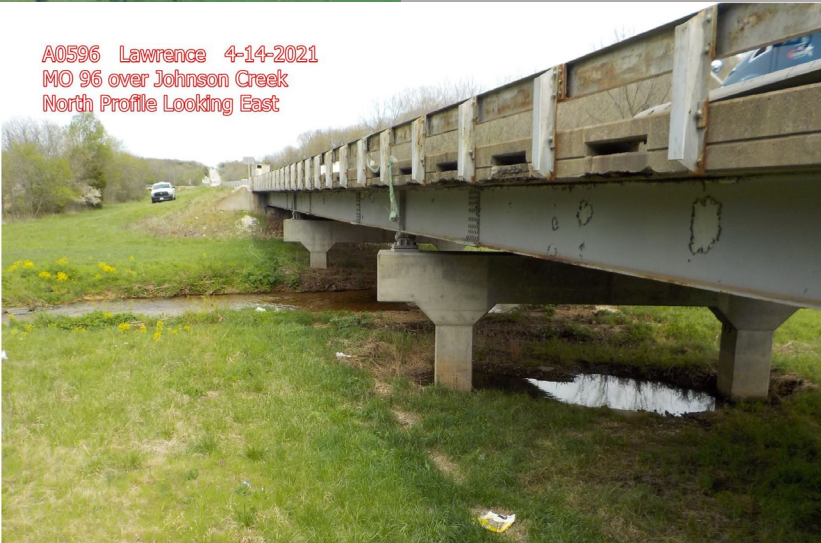
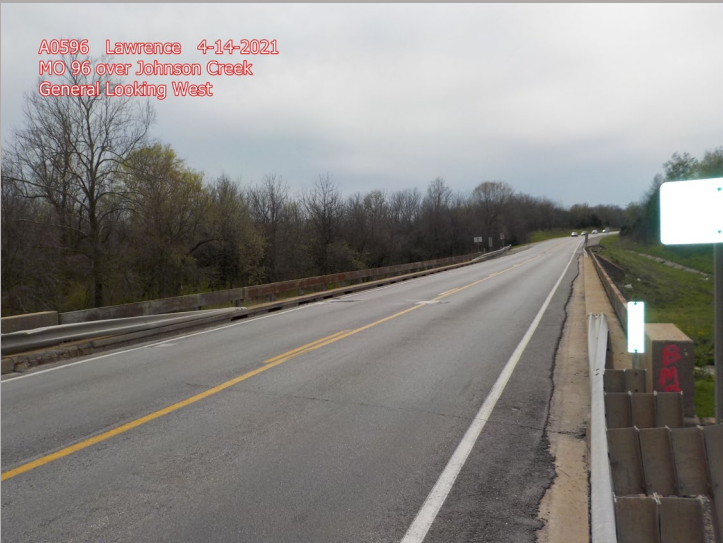
Bridge #A0596 MO96 over Johnson Creek Lawrence County

Mandatory:	Y	AADT:	4129
Ratings:	3,6,6	Truck %:	25.1
Min Treatment:	Redeck	Existing Bridge Type:	Wide Flange Girder
Potential Grade Change:	0"	I44 Incident Bypass Route:	Yes
Crossing Type:	Water

- No known issues of water overtopping bridge
- No issues with drift
- Fuel trucks, trash trucks, farming and grain truck usage
- No crashes
- Main incident bypass route for I-44
- Route for trash trucks to Lamar landfill because cannot use I-44

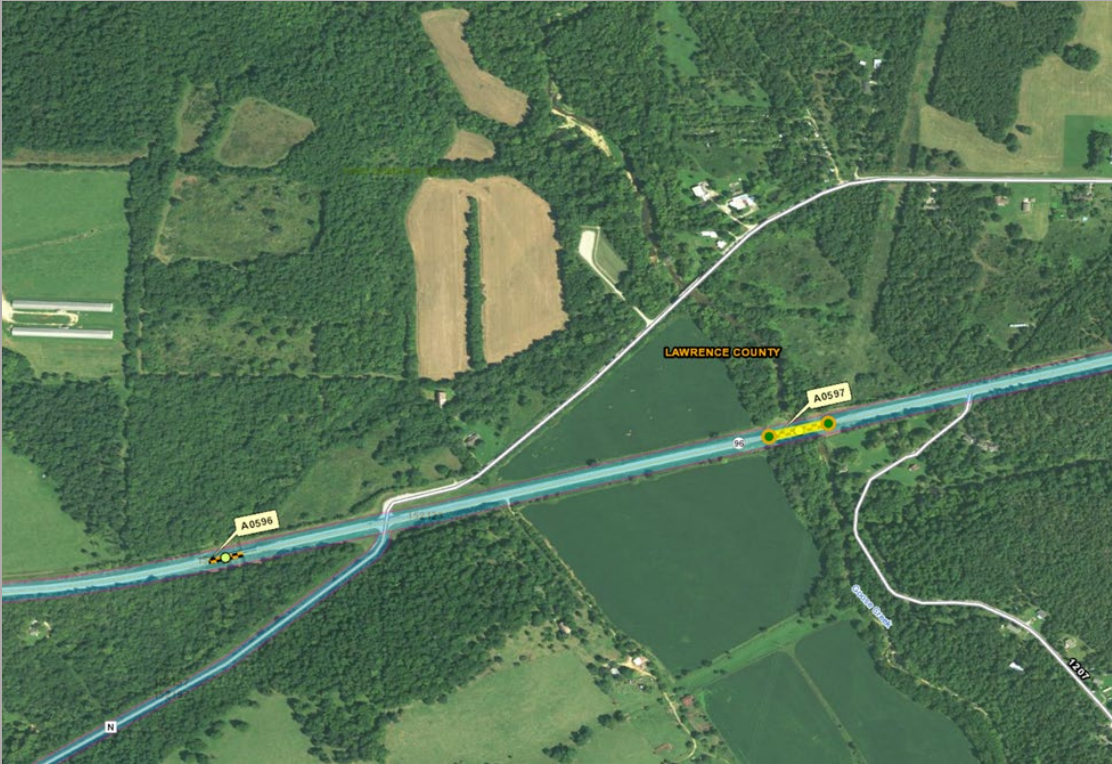
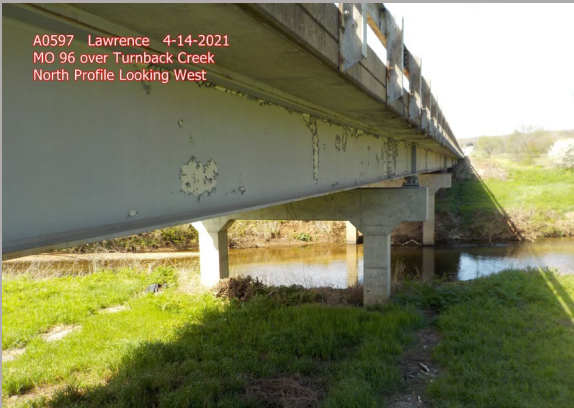
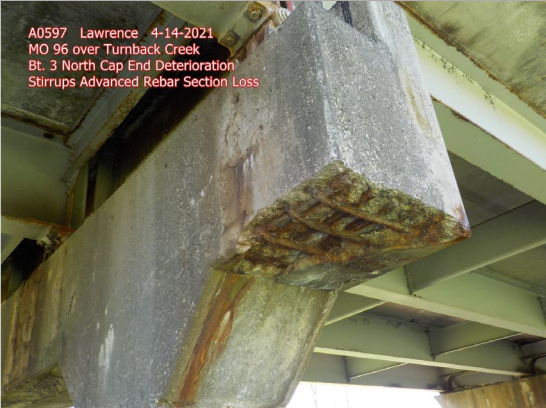
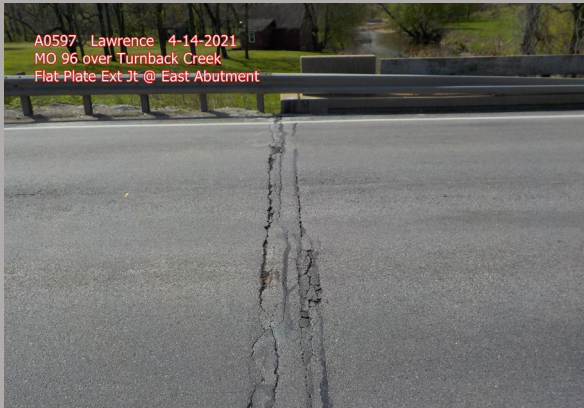
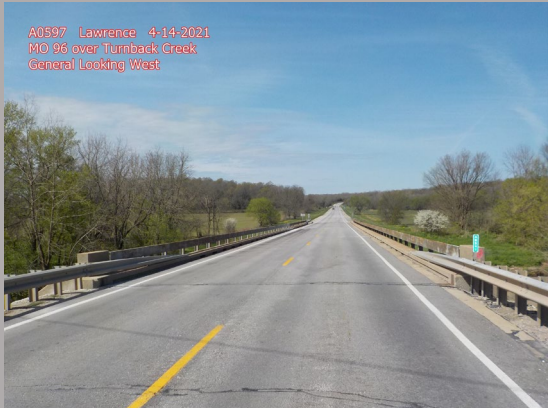
Bridge #A0597 MO96 over Turnback Creek Lawrence County

Mandatory:	Y	AADT:	6060
Ratings:	4,6,5	Truck %:	16.6
Min Treatment:	Redeck	Existing Bridge Type:	Simple WF & Cont. Non-Comp WF
Potential Grade Change:	0"	I44 Incident Bypass Route:	44 Designated
Crossing Type:	Water

- No known overtopping of bridge
- 500’ to west of bridge water does overtop the road but not deep
- Fuel trucks, trash trucks, farming and grain trucks
- Main incident bypass route for I-44
- Route for trash trucks to Lamar Landfill
- No crashes
- Conservation river public access to the north of the bridge
- Brittain Mill to the south of the bridge

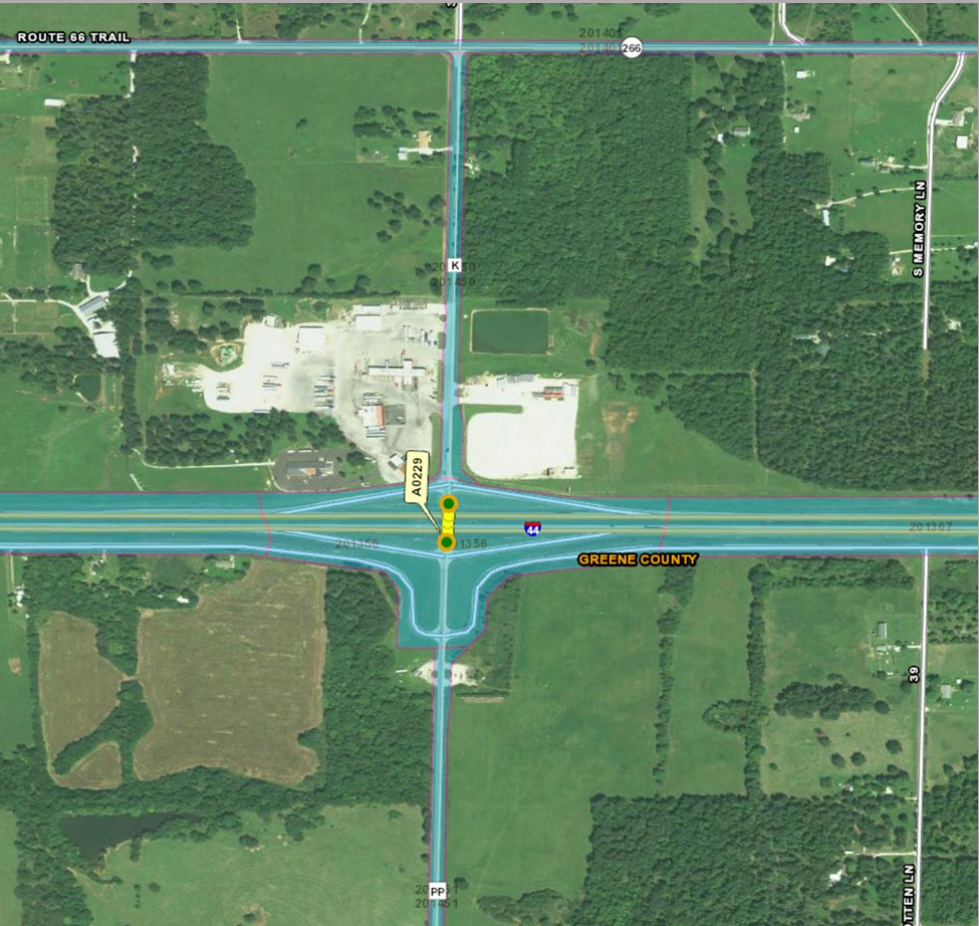
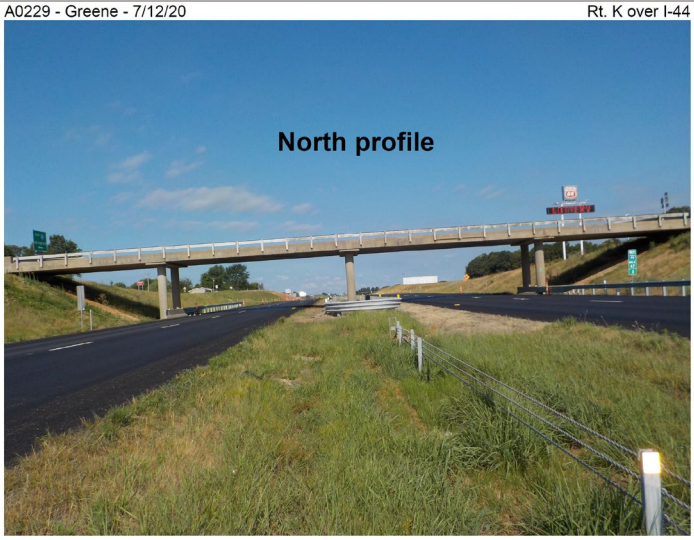
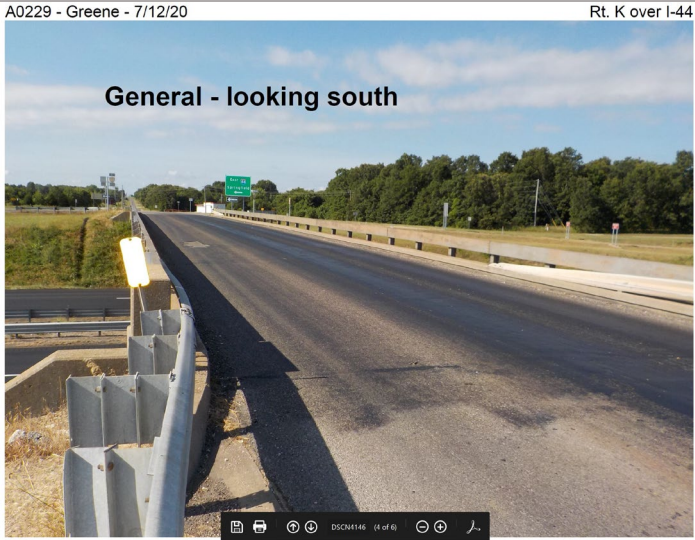
Bridge #A0229
Route K over I-44 EB&WB
Greene County

- Hood’s Truck Stop in the NW quadrant
- CDL training school in NE Quadrant
- WB67 design critical
- Potential concrete pavement only option
- Sight distance critical at ramp intersections
- Crash History: 2015- 2021
 - 7 crashes total
 - 3 angle type crashes EB Ramp intersection
 - 3 angle type crashes at WB Ramp intersection
 - 1 dump truck with raised bed striking the bridge underneath

Mandatory:	Y	AADT:	1832
Ratings:	5,5,6	Truck %:	8.2
Min Treatment:	Replacement	Existing Bridge Type:	Voided Concrete Slab
Potential Grade Change:	2’-9”+	I44 Incident Bypass Route:	Yes
Crossing Type:	Interstate
