Mandatory Bridges

June 3, 2021

Laurel McKean, Project Director

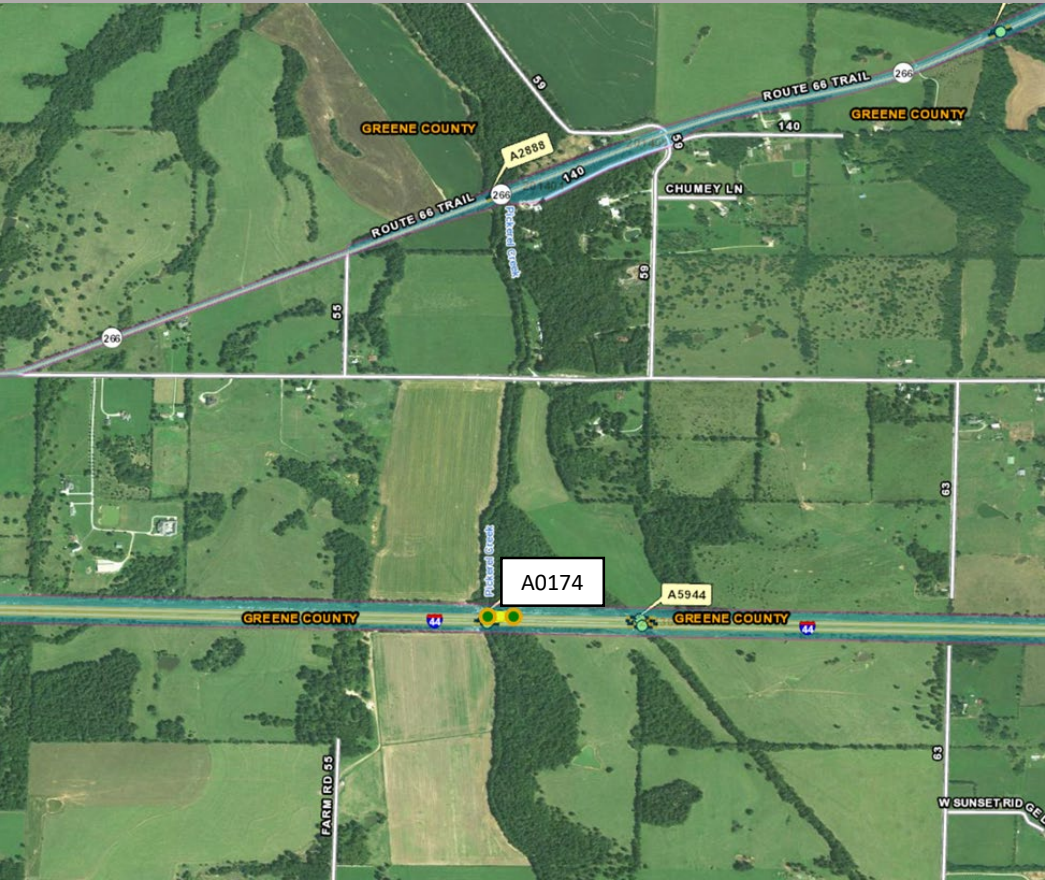
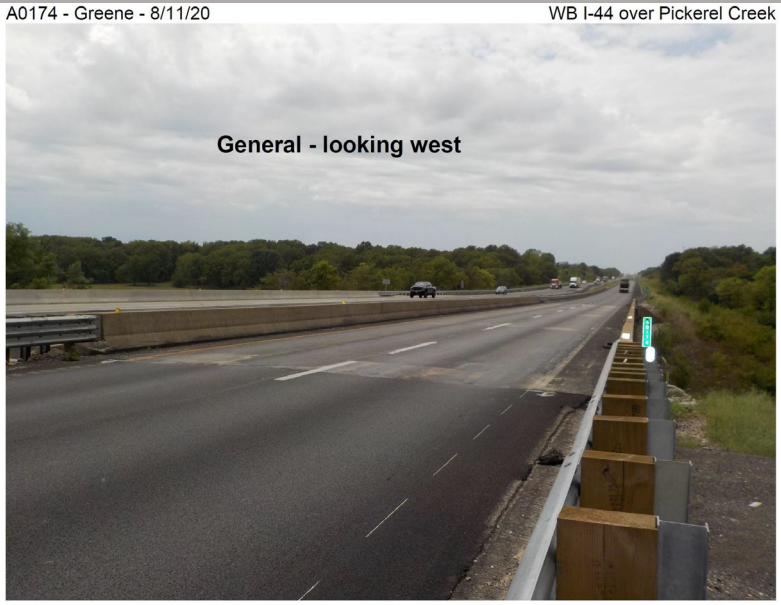
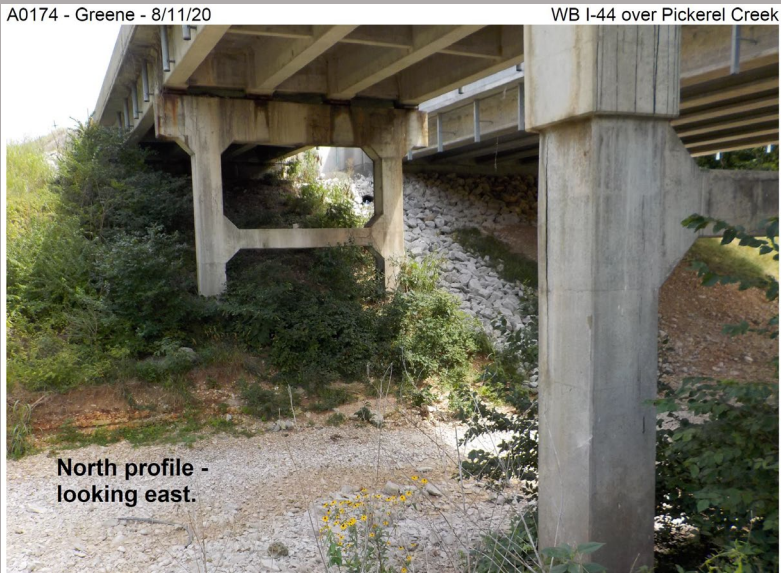
Bridge #A0174W
I-44 over Pickerel Creek
Greene County

- Water does not overtop bridge
- Remove drift maybe every 5 years
- Landowner on S side does go to N side under bridge
- No correctable crashes
- Hydraulics and profile must match new companion bridge
- Traffic control concern with bridge being in valley and another bridge east of location

Mandatory:	Y	AADT:	16620
Ratings:	4,4,6	Truck %:	26.2
Min Treatment:	Replacement	Existing Bridge Type:	Concrete Deck Girder
Potential Grade Change:	0"	I44 Incident Bypass Route:	Mainline
Crossing Type:	Water

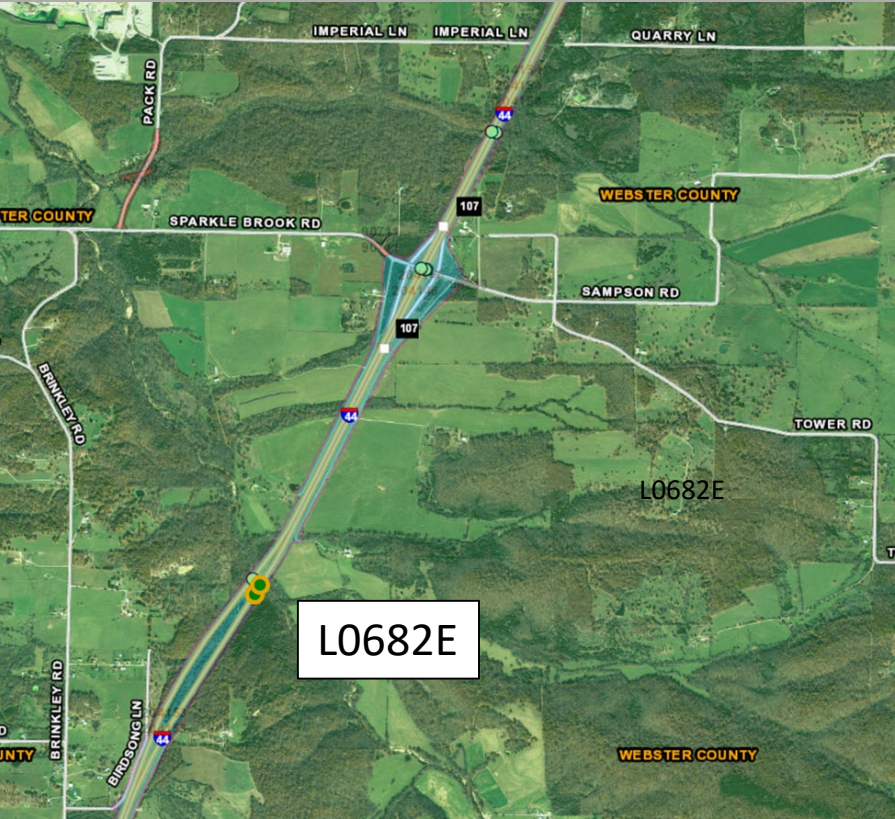
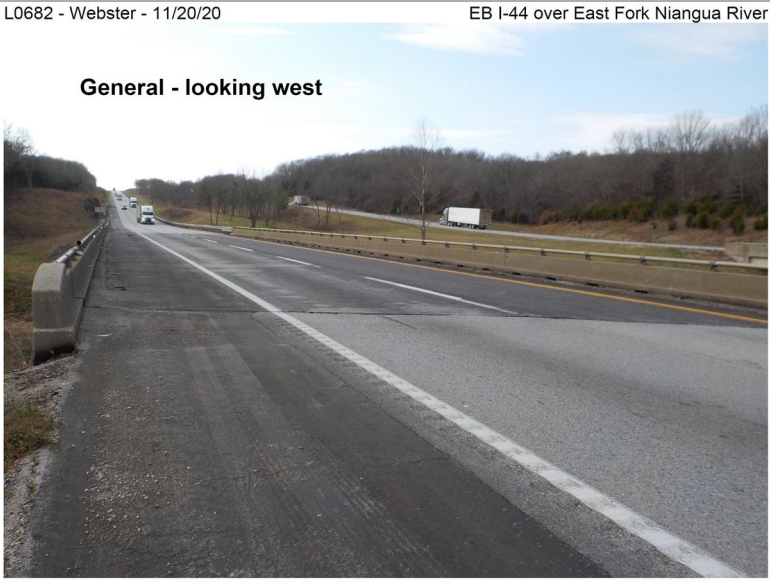
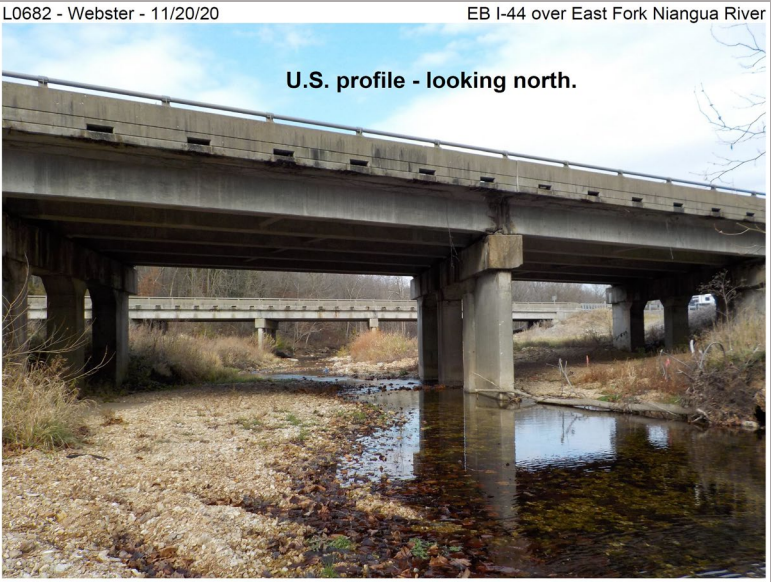
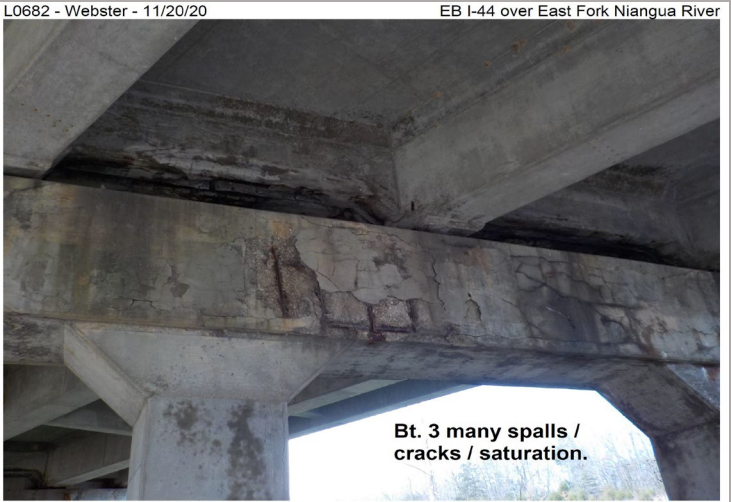
Bridge #L0682E
I-44 over East Fork Niangua River
Webster County

- No issues with water overtopping bridge
- Remove drift every 2 to 3 years
- No design exceptions for Freeboard will be accepted
- Design in conjunction with companion bridge L0379

Mandatory:	Y	AADT:	13840
Ratings:	6,3,4	Truck %:	29.3
Min Treatment:	Replacement	Existing Bridge Type:	Concrete Deck Girder (Widened)
Potential Grade Change:	0"	I44 Incident Bypass Route:	Mainline
Crossing Type:	Water

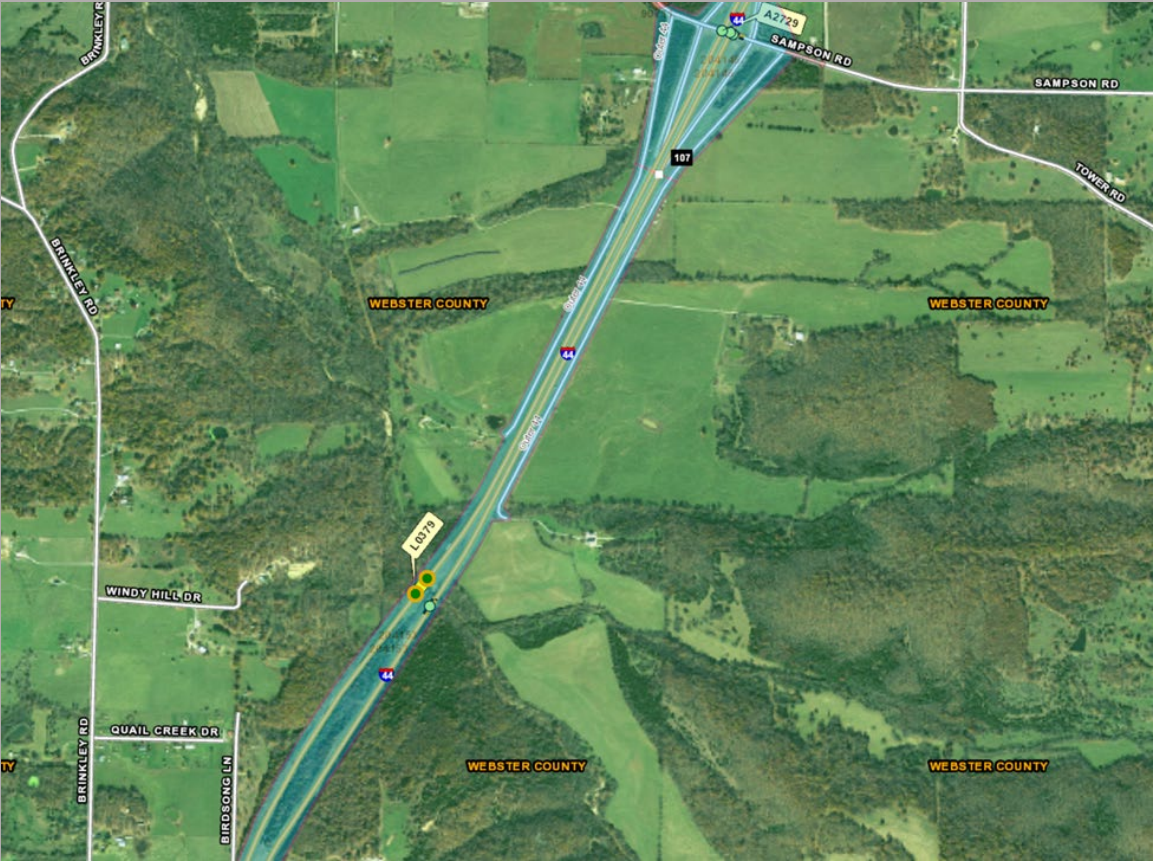
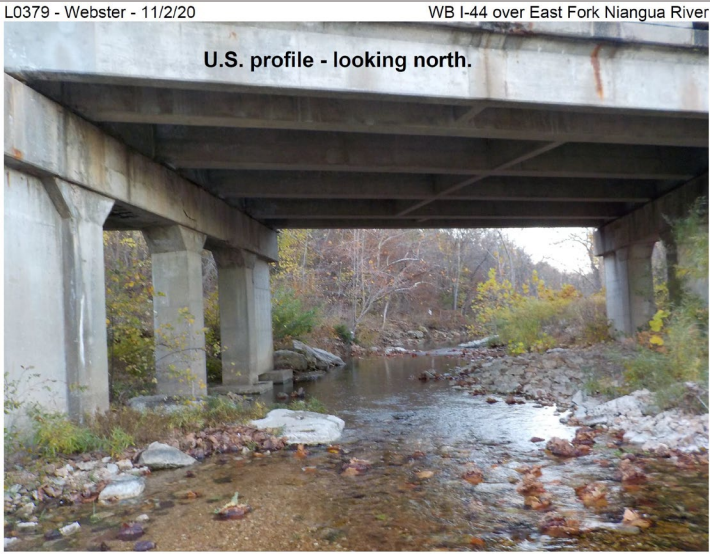
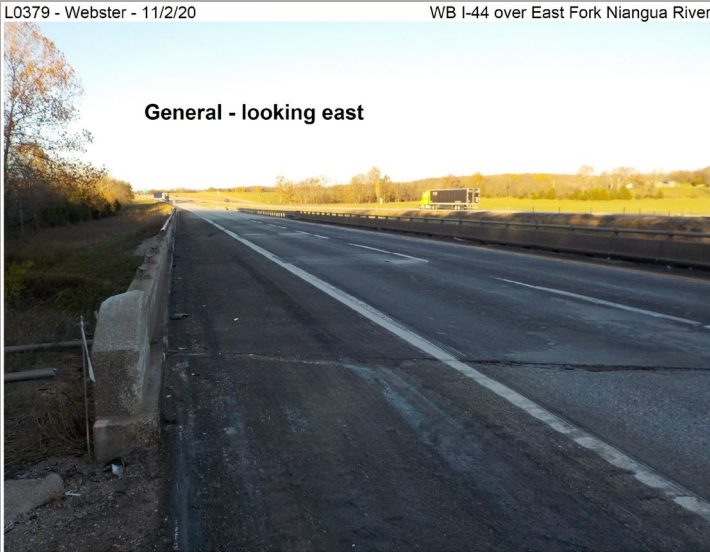
Bridge #L0379W I-44 over East Fork Niangua River Webster County

- No issues with water overtopping bridge
- Remove drift every 2 to 3 years
- No design exceptions for freeboard will be accepted
- Design in conjunction with companion bridge L0682

Crash History 2015- 2021

- 7 crashes East of and on bridge
- 3 went off left side of road, down the grassy median and into the Niangua
- 2 lost control downhill, hit end terminal, ended in grassy median
- 1 lost control avoiding deer
- 1 hit disabled car parked on shoulder

Mandatory:	Y	AADT:	14,594
Ratings:	5,4,4	Truck %:	28.7
Min Treatment:	Replacement	Existing Bridge Type:	Concrete Deck Girder (Widened)
Potential Grade Change:	0"	I44 Incident Bypass Route:	Mainline
Crossing Type:	Water

- Bridge has slight incline as you exit bridge end creating issues during winter events

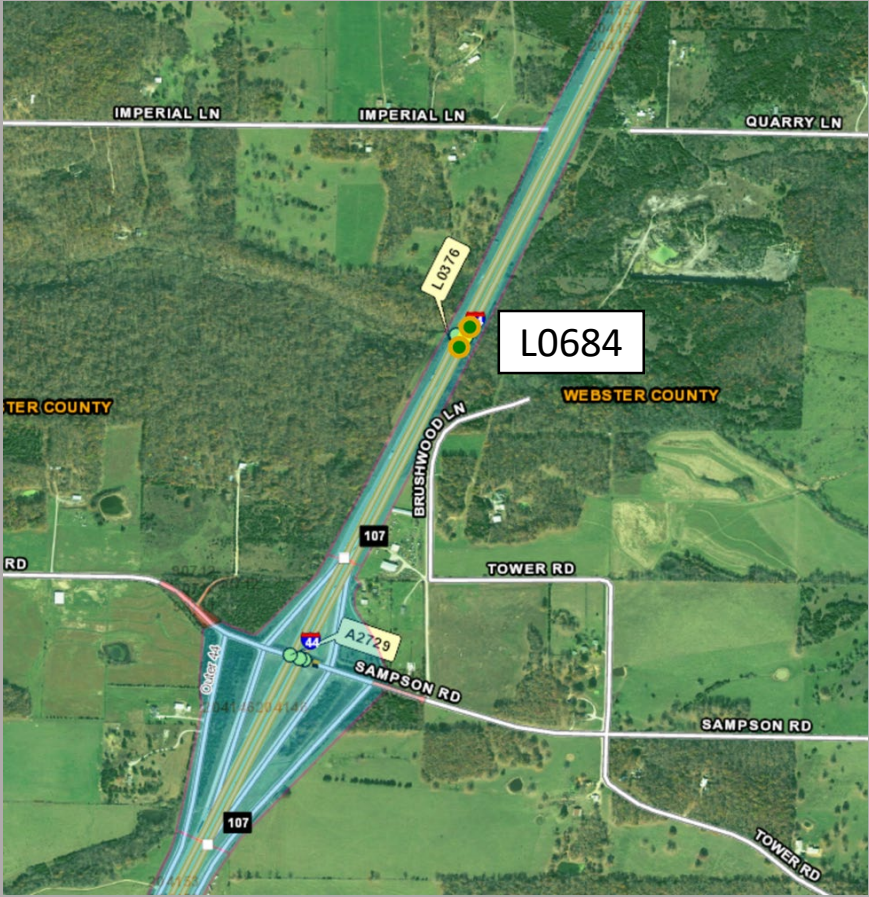
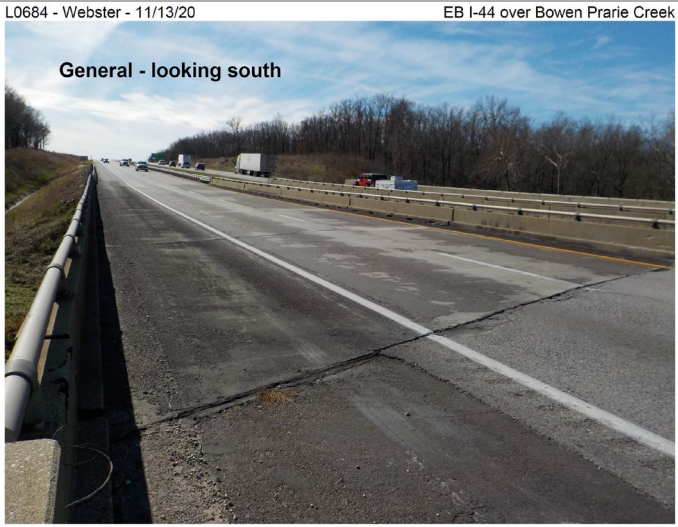
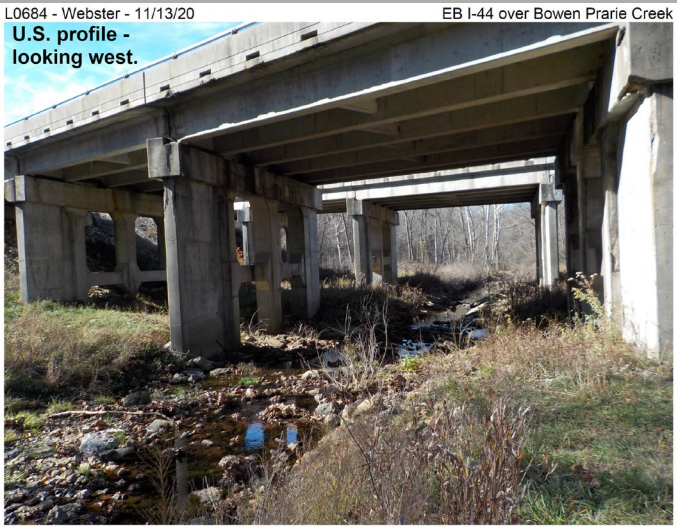
Bridge #L0684E I-44 over Sarah Branch Webster County

- Known as Sarah Branch and Bowen Prairie Creek
- No knowledge of water overtopping bridge
- Clean drift maybe every 5 years
- Design exceptions for freeboard will not be accepted
- Design in conjunction with companion bridge L0376

Mandatory:	Y	AADT:	14633
Ratings:	5,5,5	Truck %:	29.3
Min Treatment:	Replacement	Existing Bridge Type:	Concrete Deck Girder (Widened)
Potential Grade Change:	0"	I44 Incident Bypass Route:	Mainline
Crossing Type:	Water

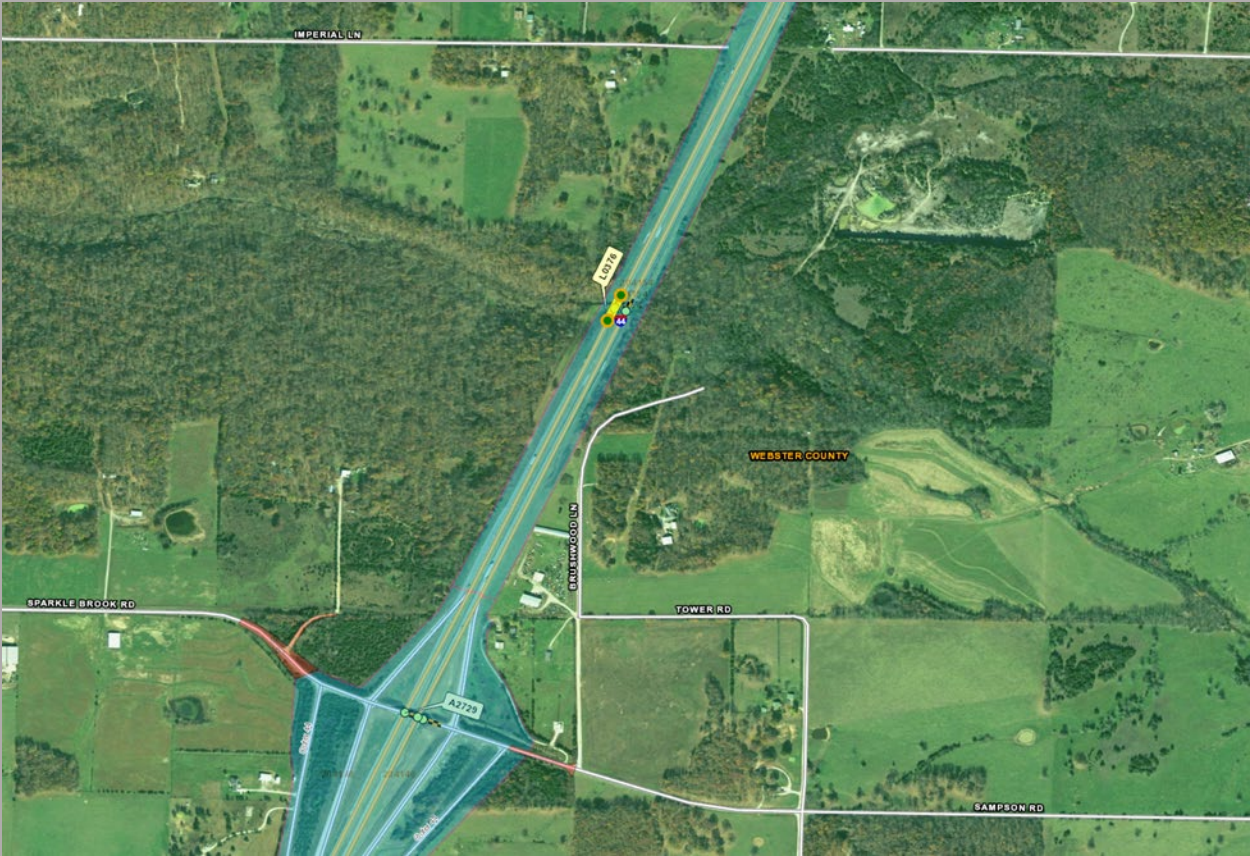
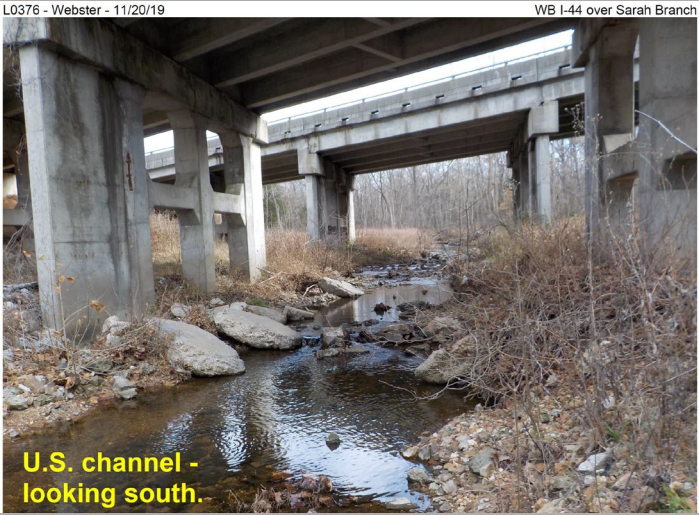
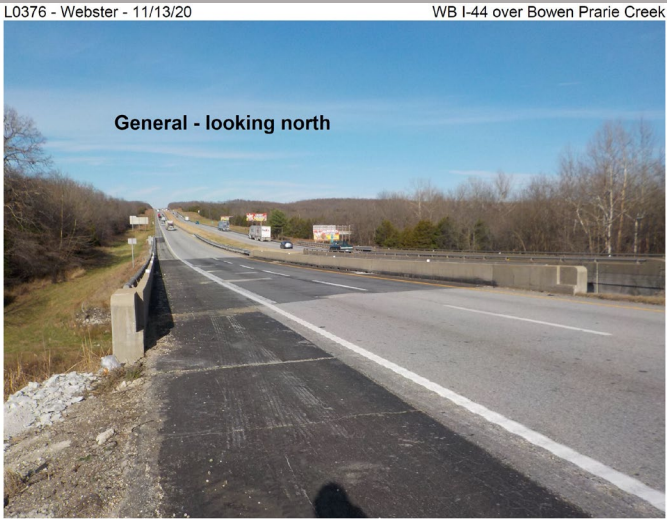
Bridge #L0376W
I-44 over Sarah Branch
Webster County

- Known as Sarah Branch and Bowen Prairie Creek
- No knowledge of water overtopping bridge
- Clean drift maybe every 5 years
- Design exception for freeboard will not be accepted
- Design in conjunction with companion bridge L0684

Mandatory:	Y	AADT:	14506
Ratings:	4,4,4	Truck %:	28.7
Min Treatment:	Replacement	Existing Bridge Type:	Concrete Deck Girder (Widened)
Potential Grade Change:	0"	I44 Incident Bypass Route:	Mainline
Crossing Type:	Water
