Secondary Bridges

June 8, 2021

Laurel McKean, Project Director

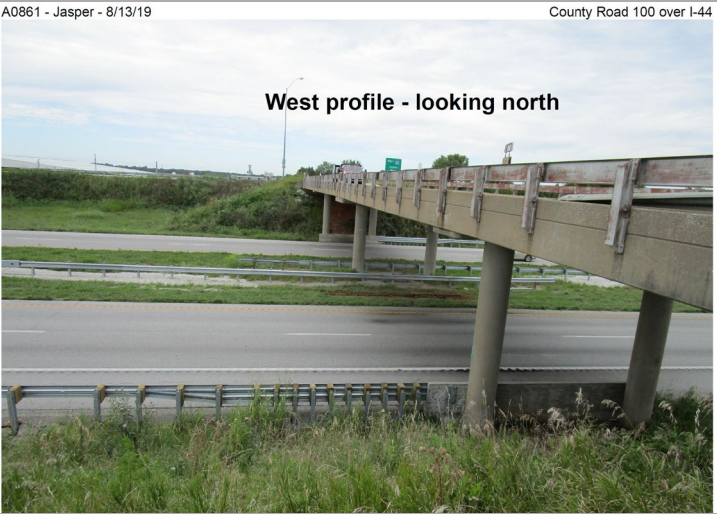
Bridge #A0861 CRD100 over I-44 EB&WB Jasper County

- Joplin Regional Stockyards in NW quadrant
- Heaviest day for Stockyard is Saturdays
- RV businesses on each side of 44
- Steel company has yards on both sides of 44
- WB67 design critical
- Guardrail damaged on every corner
- Better striping at end of the ramps
- Concern with how to tie OR and entrances
- Sight distance at end of ramps crucial
- Already a bit of a sight distance issue at WB ramps seeing NB vehicles

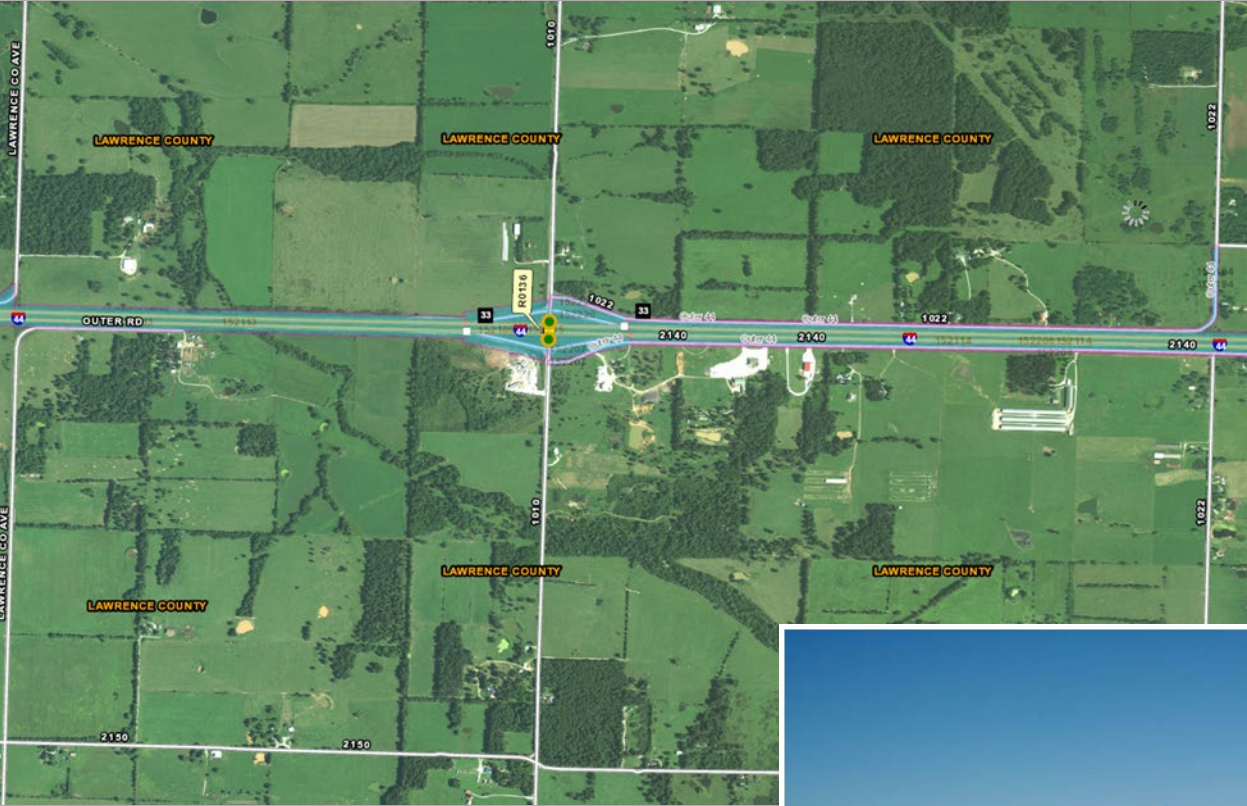
Bridge #R0136
CRD1010 over I-44 EB&WB
Lawrence County

- Mainly farming around the area
- WB 67 design critical
- Potential truck stop being built in SW corner
- Down the OR is a truck was and a trailer sales business
- Sight distance concern when raise bridge
- Ditches are wet
- Guardrail damage all around

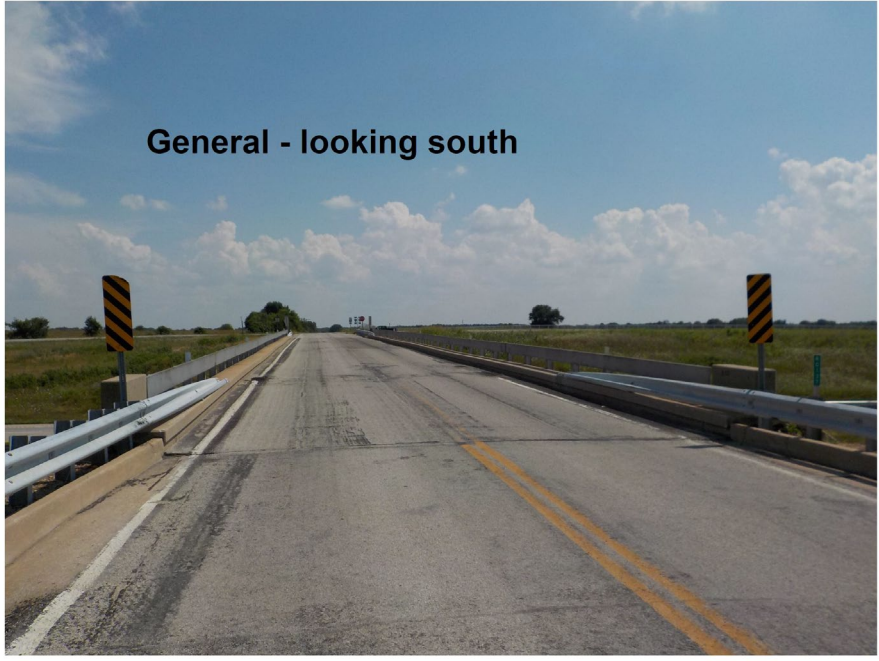
R0137 - Lawrence - 7/6/20

- Mainly farming in the area
- Profile of road before and after bridge is not consistent
- Ditches along I44 full of water
- No crashes
- Visibility of Stop sign with raised bridge profile

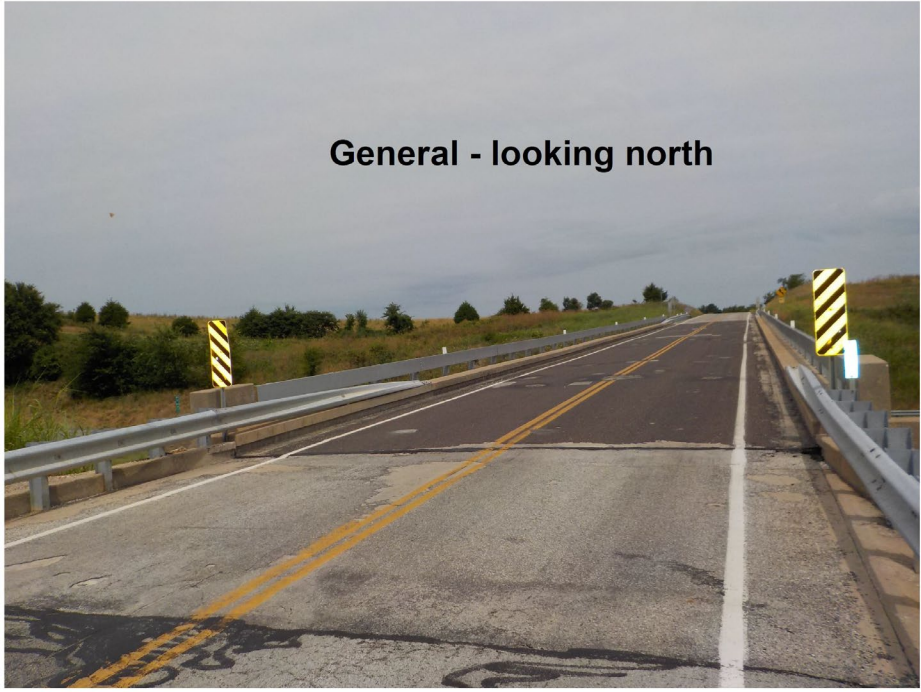
R0144 - Lawrence - 7/10/20

- Farming is the main use
- Subdivision in the NE side which has asked for full interchange multiple times
- Concern with OR tie-ins due to raise in profile of bridge

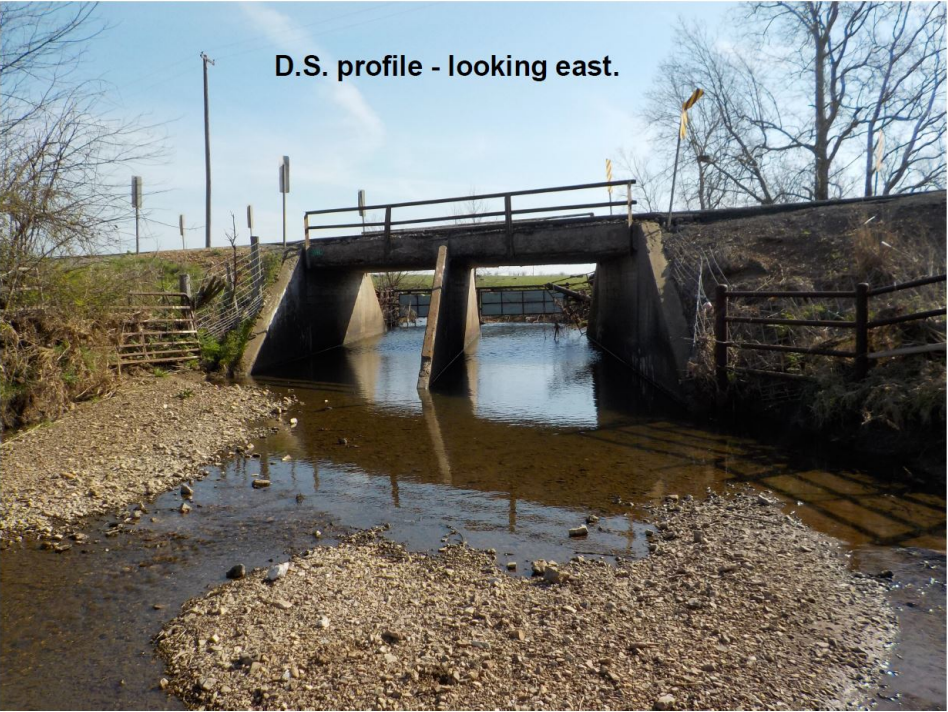
S0482 - Lawrence - 4/6/21

- No reported issues of water overtopping
- No reported issues of removing debris often
- Used by farming industry, grain trucks and trash trucks going to the landfill in Lamar, MO
- Used to cross cattle
- No crashes

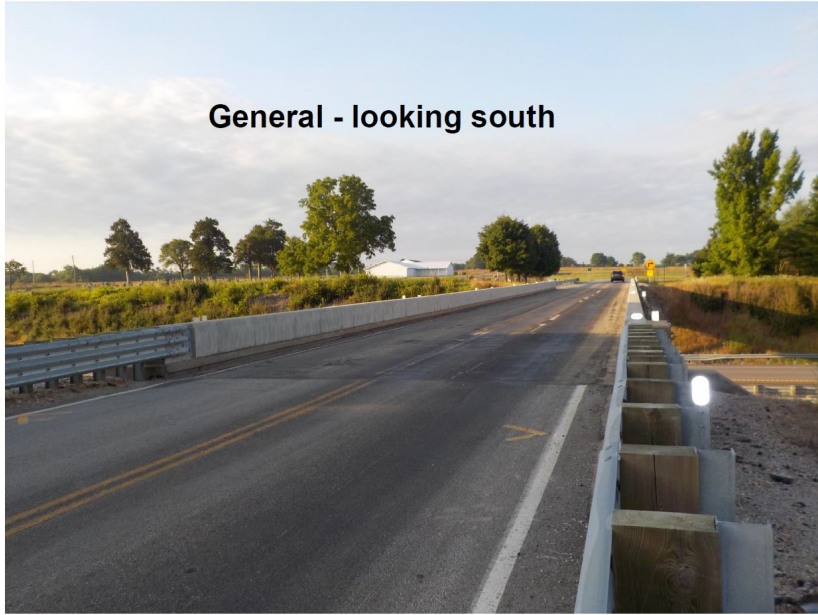
A0600 - Lawrence - 7/10/20

- Weight restricted Pony Truss bridge on MO266 in Halltown is being replaced – potential detour impact
- Crash information provided on next slide
- WB67 consideration in design
- Cemetery in SE quadrant
- Gas station and large engine repair in SW quadrant
- Used by fuel trucks, semis and farming
- Will provide past AJR to shortlisted teams

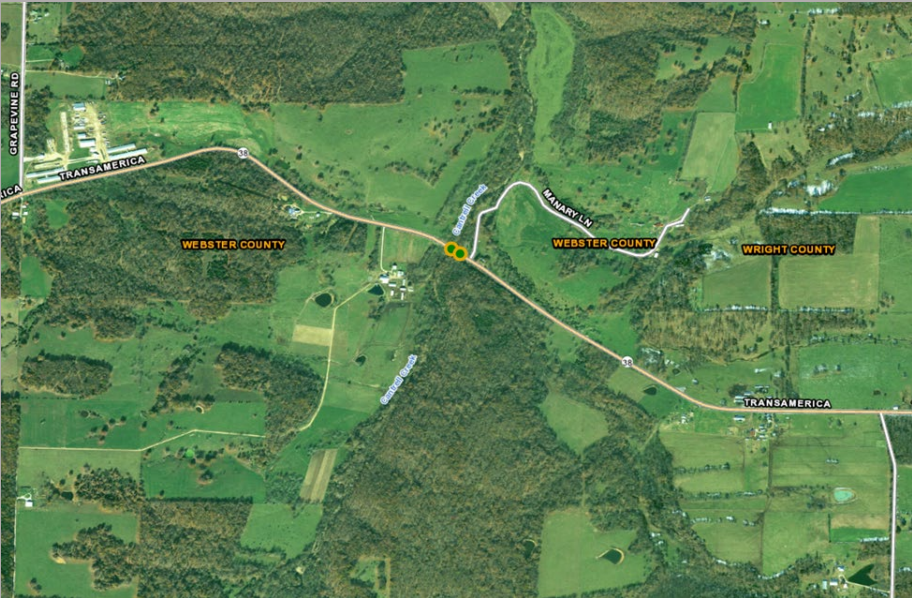
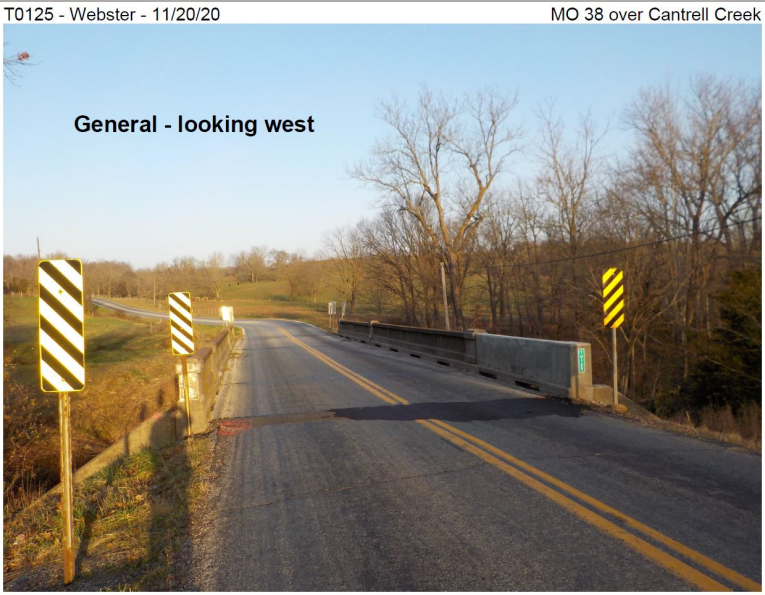
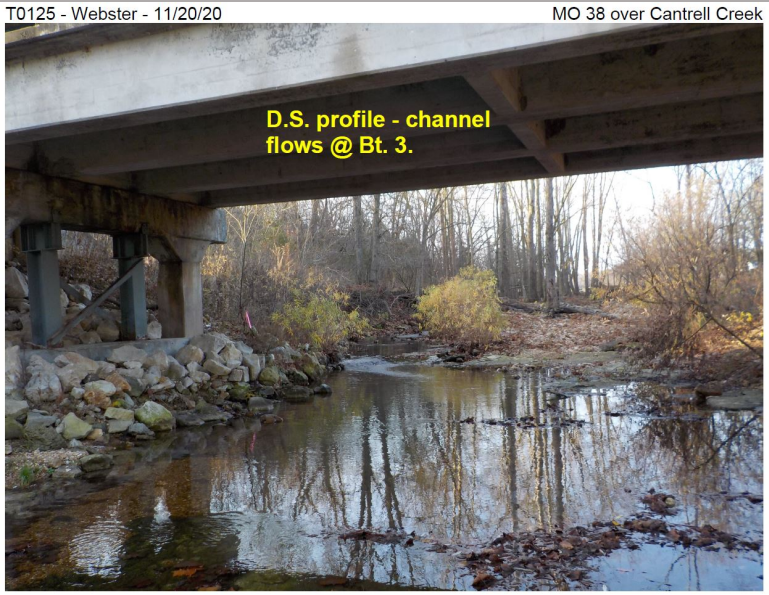
Bridge #T0125 MO38 over Cantrell Creek Webster County

- No known issue of water overtopping
- No known issue of frequent debris removal
- Previous erosion issues on the east end bridge abutment, crews have performed slurry treatment in voids.
- Narrow bridge
- Overhead utilities on N side
- Shallow bedrock
- 2 crashes (2015-2021): 1 rear end when vehicle stopped to allow a large vehicle cross, 1 out of control when trailer started sliding and truck ended up on and hanging over the railing
