MEMORANDUM
Missouri Department of Transportation

SUBJECT: District St. Louis - Design
Route 231, St. Louis County
Route 231 Rehabilitation
Job No. 6S3275 (HR Green Project No. 171052)
Conceptual Study Report

SUBJECT: Condition Survey
Job No.: J6S3275
Route: 231, St. Louis County

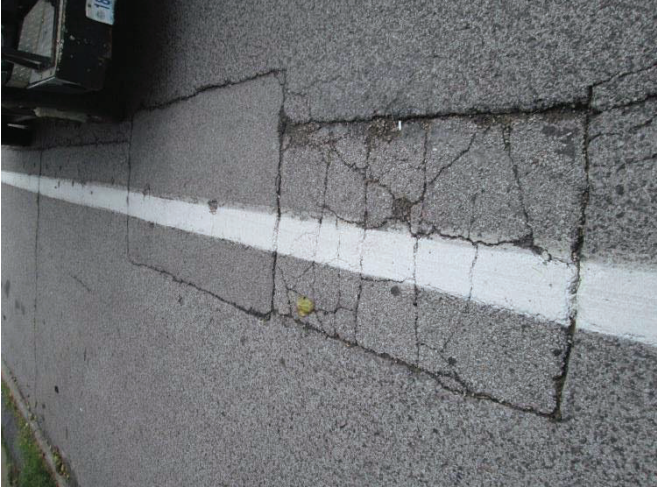
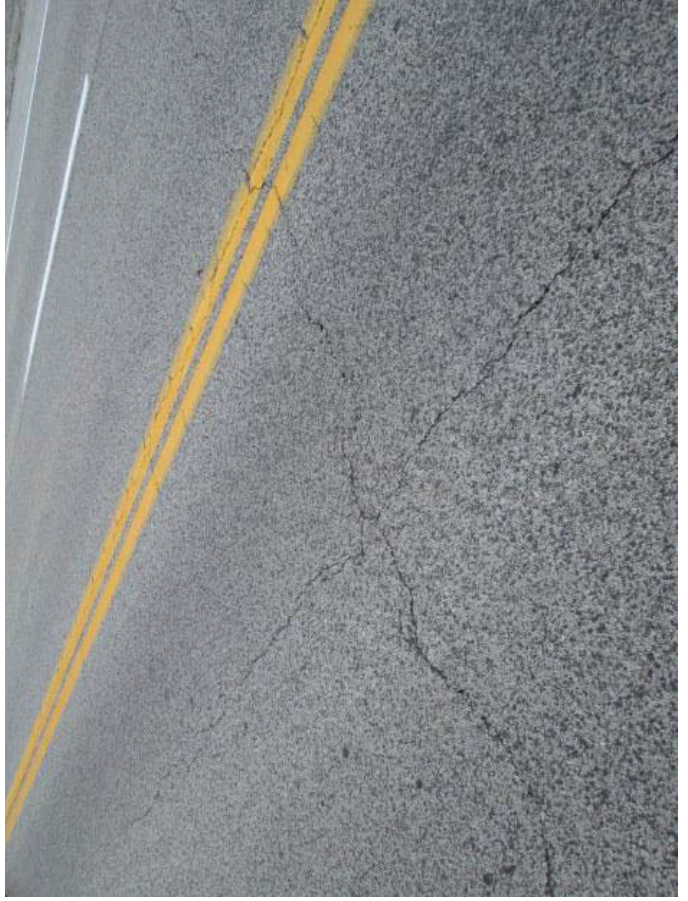
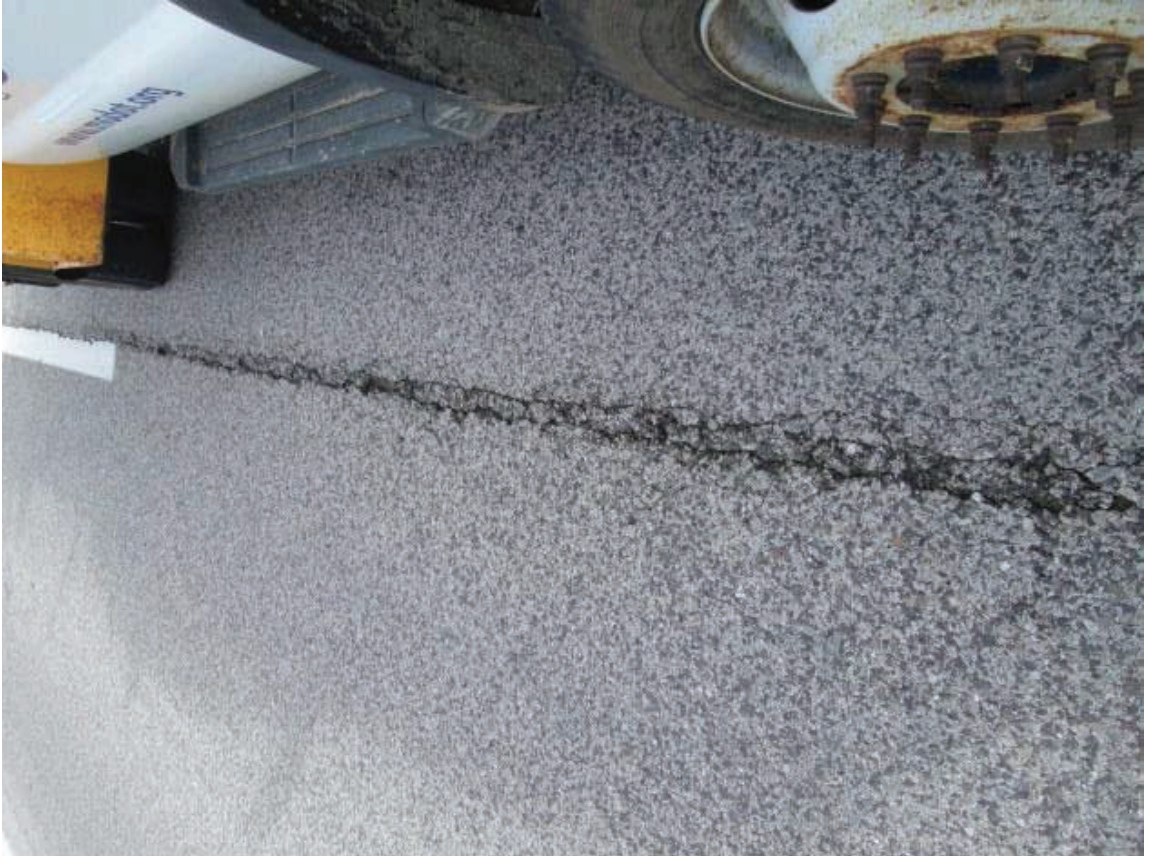
Typical Distress

Overall, the most predominant sign of distress is surface cracking mirroring the underlying concrete joints or repairs. The longitudinal construction joints are also raveled at times.

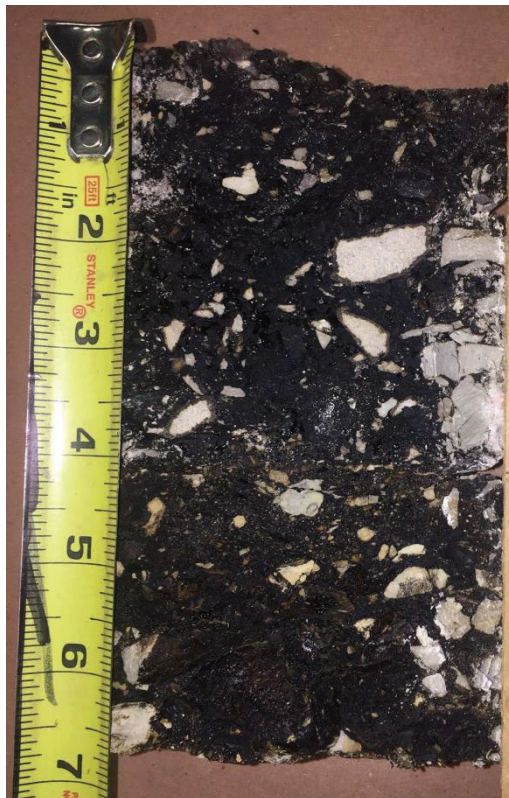
Top 3 ¾-inch of asphalt structure very stable material with good bond to underlying lifts.

Underlying layers have some stripping and are soft weaker materials that pre-date SuperPave.

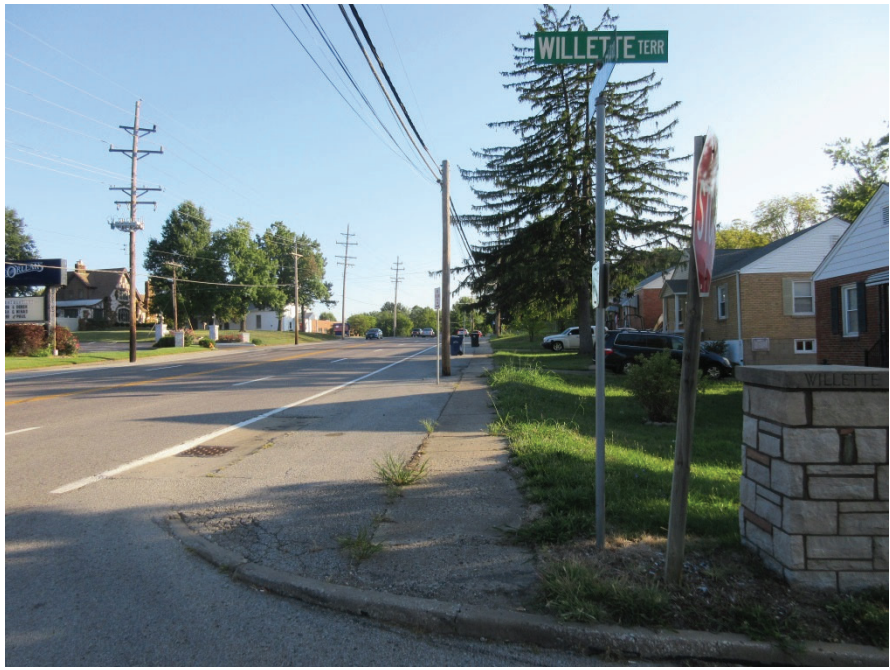
Figure 1: Franru Lane to Sigsbee Avenue (looking North at Willette Terrace)

Existing power poles are located along both sides of Route 231 with the majority of these poles located within the shoulders. See **Figures 1 and 2** in the Existing Roadway and Sidewalk Conditions Appendix for photographs of this section of Route 231. There are also several Metro bus stops along this corridor that are non-compliant as well, mostly because they rely on existing sidewalks for their stops and the sidewalks are non-compliant. The existing signalized intersection at Jeffersonian Drive/Jefferson Barracks Road does not contain any pedestrian accommodations and will be upgraded as a part of this project. The intersection at Telegraph Rd. / Kingston Ave. is excluded from this study as new curb ramps and signal improvements are being included with another programmed project currently in the design phase (J6S3220 by WSP).

The proposed conceptual design for this section includes both pavement rehabilitation and pedestrian facility reconstruction. The proposed work includes removal of the existing sidewalk throughout this segment with the exception of the short segment in front of Walgreens (southeast corner of Route 231 and Jefferson Barracks Rd.) Sidewalks will be replaced with 5-foot wide sidewalks adjacent to the parking lanes or where treelawns are present, and 6-foot wide sidewalks where adjacent to backs of curb. Where adjacent to parking (between Franru Lane and Jeffersonian Drive / Jefferson Barracks Road), the additional foot needed to widen the sidewalk footprint will be taken from either the parking lane or lawn area behind the existing sidewalk. North of that intersection, the additional foot needed for the sidewalk widening will be taken from adjacent parking lots and may require property acquisition.

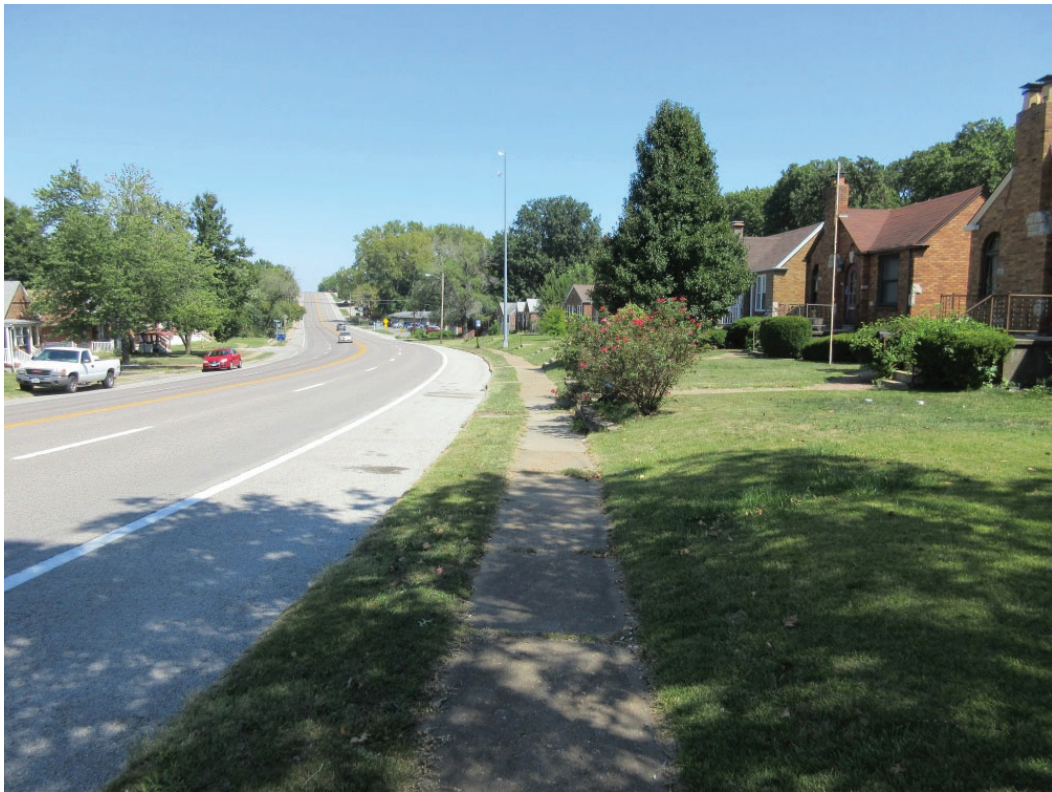
Figure 3: Sigsbee Avenue to Southwark Lane (looking North at Terrel Drive)

The sidewalk on the east side of Route 231 terminates between Tacoma Drive and Southwark Drive. See **Figures 3 and 4** in the Existing Roadway and Sidewalk Conditions Appendix for photographs of this section.

The proposed conceptual design for this section includes both pavement rehabilitation and pedestrian facility reconstruction. The proposed work includes removal of the existing sidewalk throughout this segment. Sidewalks will be replaced with 6-foot wide sidewalks adjacent to the backs of curb because the existing treelawn is narrow in the present condition. In the area between Telegraph Rd. / Kingston Dr. and Southwark Ln., the sidewalk will be shifted to the curb line resulting in the appearance of additional grass / yard to each resident. This will require the replacement of some curb along the route, which for the purposes of estimating was calculated as 50% of the length of sidewalk being replaced. In the area on the east side of Route 231 between Tacoma and S. Broadway, where no sidewalk is present, the proposed infrastructure will include the construction of a new curb within the existing shoulder line and the addition of a new 6-foot wide sidewalk immediately behind it. This would result in a wider footprint and almost every parcel along the eastern side of Route 231 in this section will require at a minimum temporary construction easement. Additionally, a permanent sidewalk and utility easement would also be needed since this sidewalk will be outside the right-of-way. However, because of the existing slope of the road and the nearby culvert, drainage improvements required as a part of this curbing are expected to be minor. And finally, between Clyde and Ripa, are numerous retaining walls and steep back slopes adjacent to the residential houses. In this area, temporary construction easements or right-of-way may be required to construct the required sidewalk width for this section. All intersections along this section will require the complete replacement of curb ramps and installation of truncated domes.

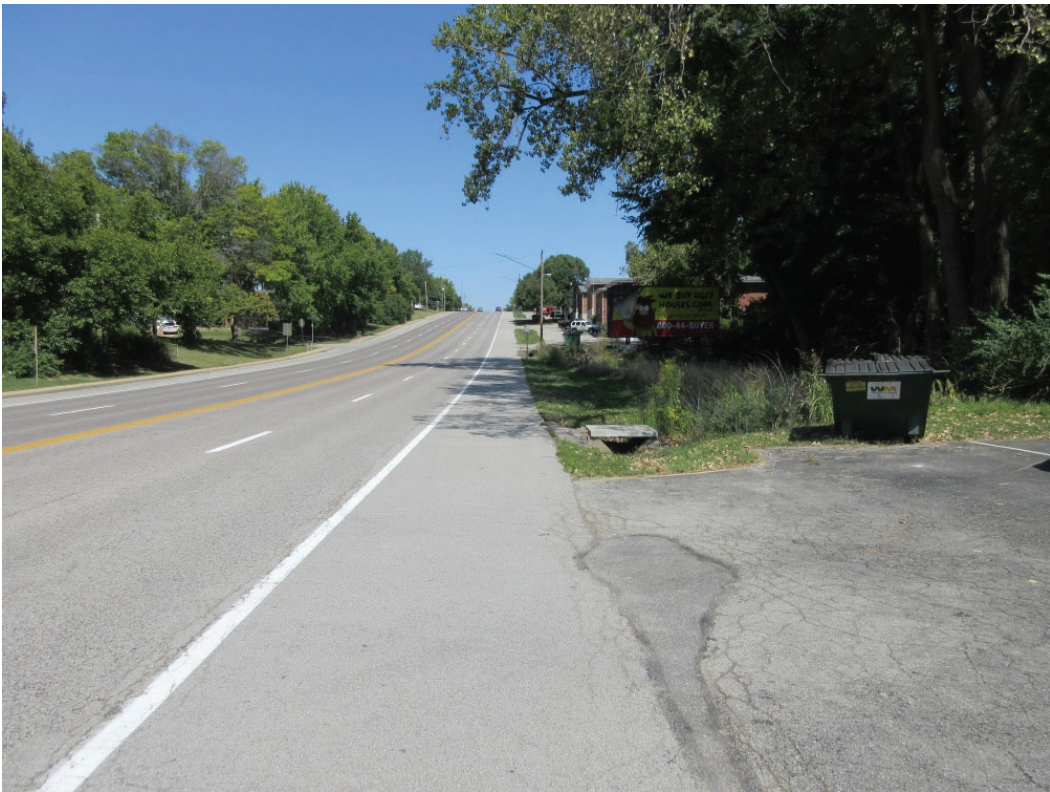
Figure 5: Southwark Lane to Ripa Avenue (looking North at Southwark Lane)

Between Southwark Lane and Ripa Avenue, there are four 11' travel lanes with parking of the roadway and combination concrete curb and gutter for the southbound lanes. There is an existing sidewalk located along the western side of Route 231 throughout this section. It varies from sidewalk on the back of curb to a treelawn section, and varies in width. All is within existing right of way, but the conditions adjacent to it and outside of right of way get more difficult as one progresses north. On the east side of the roadway, parking lots, box culvert outlets, and apartment complexes line the route and the only existing pedestrian infrastructure present is a series of 3-foot wide paths within the apartment complexes that is outside public right of way. Similar to the previous sections of Route 231, these sidewalks have deficient cross slopes and widths, countless trip

hazards, and very few curb ramps and truncated domes. See **Figures 5 and 6** in the Existing Roadway and Sidewalk Conditions Appendix for photographs of this section. Furthermore, there are several Metro bus stops along this corridor that are non-compliant and numerous power poles located within the existing sidewalk as well. The existing signalized intersection at Ripa Avenue is excluded from this study as new curb ramps and signal improvements are being included with another programmed project currently in the design phase (J6S3220 by WSP).

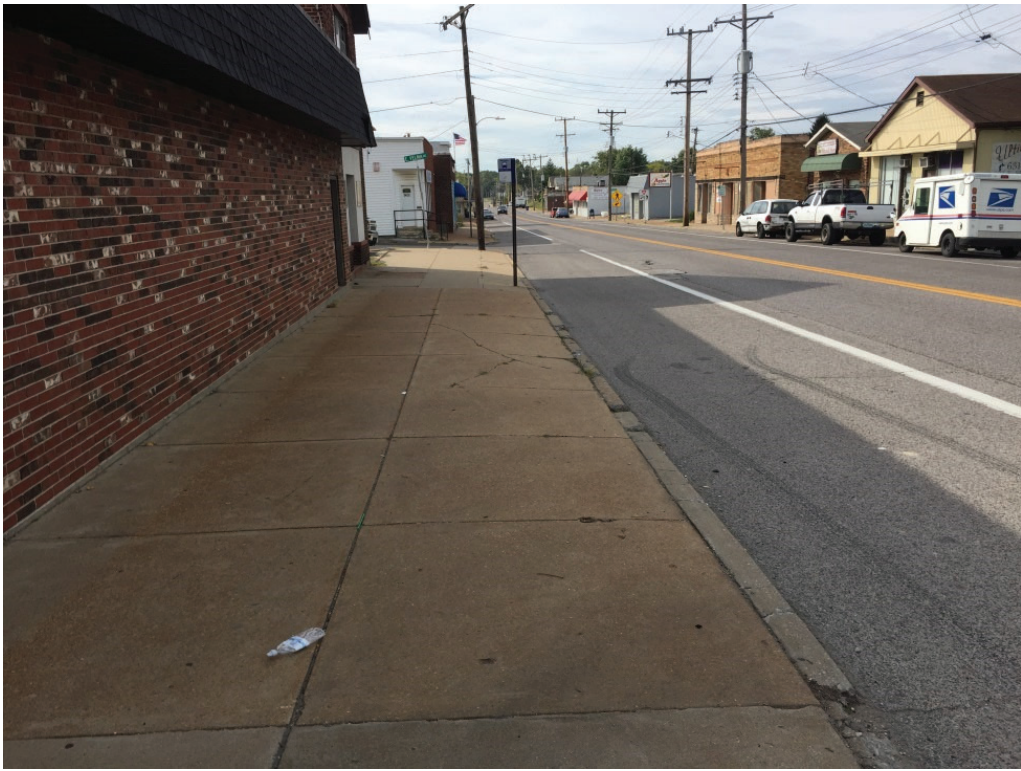
Figure 7: Ripa Avenue to Hoffmeister Avenue (looking South at Velma Avenue)

The existing section between Ripa Avenue and Hoffmeister Avenue consists of 2-11' travel lanes with parking along both sides of the roadway and curb and gutter at the outside roadway limits. This portion of Route 231 is the stereotypical downtown suburban street of the 1940's and 50's consisting of residential and supporting commercial uses intermixed. The segment has existing sidewalks along both sides of the road, adjacent to the curb and gutter, with only a few locations where existing sidewalk is not present. The sidewalk has deficient cross slopes and widths, countless trip hazards, and very few curb ramps and truncated domes. See **Figures 7 and 8** in the Existing Roadway and Sidewalk Conditions Appendix for photographs of the existing sidewalk conditions.

Existing power poles are present along this section of Route 231, with the majority located either between the sidewalk and edge of pavement, within the existing sidewalk, or in some instances such as at Etta Ave., within the curb ramp. There are several Metro bus stops along this corridor that are non-compliant as well. Additionally, numerous residential and commercial buildings are located immediately adjacent to the back of sidewalks. As such, ADA compliance is hampered because of existing slopes, steps, building foundations, etc. and will require creative solutions during the design development process. Furthermore, several intersections in this stretch have inlets either within roundings at the intersections, or immediately adjacent to the roundings. At Loretta for instance, the inlets are actually within the curb ramps, bringing the ramps out of compliance.

The proposed conceptual design for this section includes both pavement rehabilitation and pedestrian facility reconstruction. The proposed work includes removal of the existing sidewalk throughout this segment. Sidewalks will be replaced with 6-foot wide sidewalks adjacent to the backs of to match the existing suburban downtown section. This will require the replacement of some curb along the route, which for the purposes of estimating was calculated as 50% of the length of sidewalk being replaced. Furthermore, in areas where adjacent buildings flank the sidewalk, the sidewalk will be replaced from back of curb to face of building in order to provide ample room to correct cross slopes and remove obstructions within the pedestrian access route.

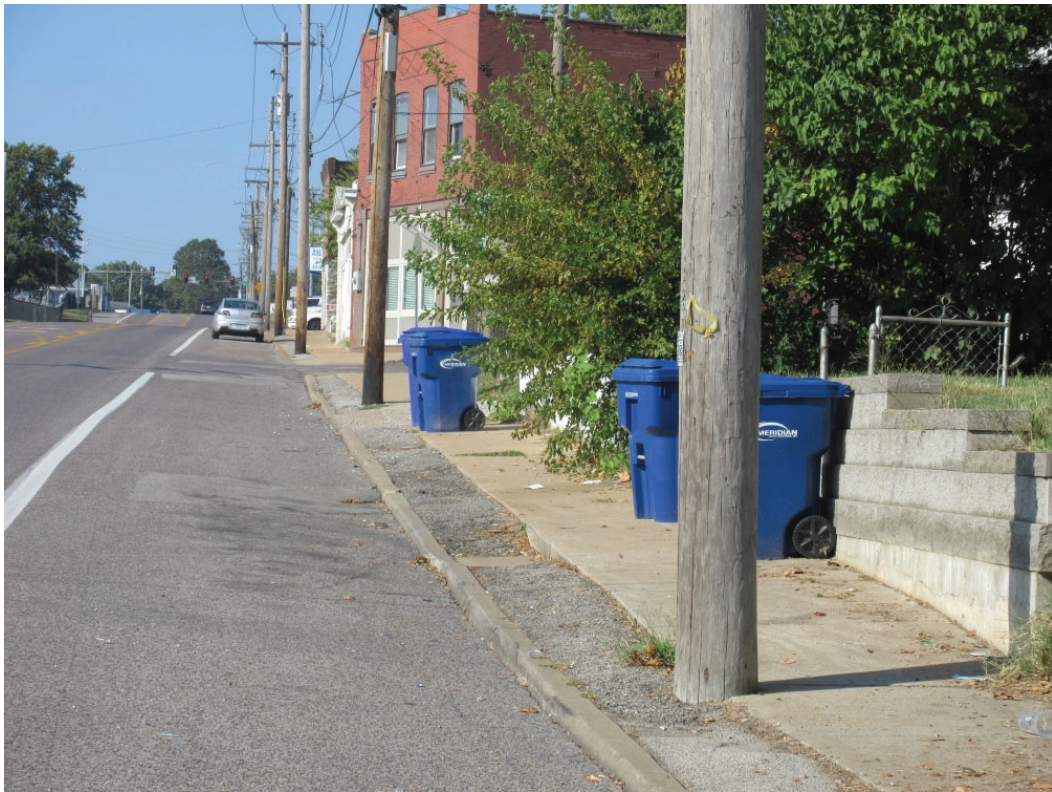
Figure 9: Hoffmeister Avenue to River City Casino Boulevard (looking South at Horn Avenue)

Existing power poles are present along both sides of the segment, with the majority located either between the sidewalk and edge of pavement or within the existing sidewalk on the western side of the roadway. In addition to these obstructions, there are several retaining walls of varying materials, ages, and conditions – all adjacent to the back of the existing sidewalk. Creative solutions will be required along the west side of the alignment in order to achieve a compliant pedestrian accessible route for the entire segment.

The proposed conceptual design for this section includes both pavement rehabilitation and pedestrian facility reconstruction. The proposed work includes removal of the existing sidewalk on the western side throughout this segment. Sidewalks will be replaced with 6-foot wide sidewalks adjacent to the backs of curb because the existing treelawn is narrow in the present condition, and existing walls and buildings are adjacent to the back of the existing walk. This will result in several power poles being located within the confines of the new sidewalk, but final design should include wider walk in these areas to provide the necessary pedestrian access route. Furthermore, these improvements will require the replacement of some curb along the route, which for the purposes of estimating was calculated as 50% of the length of sidewalk being replaced. In areas where adjacent buildings flank the sidewalk, the sidewalk will be replaced from back of curb to face of building in order to provide ample room to correct cross slopes and remove obstructions within the pedestrian access route.

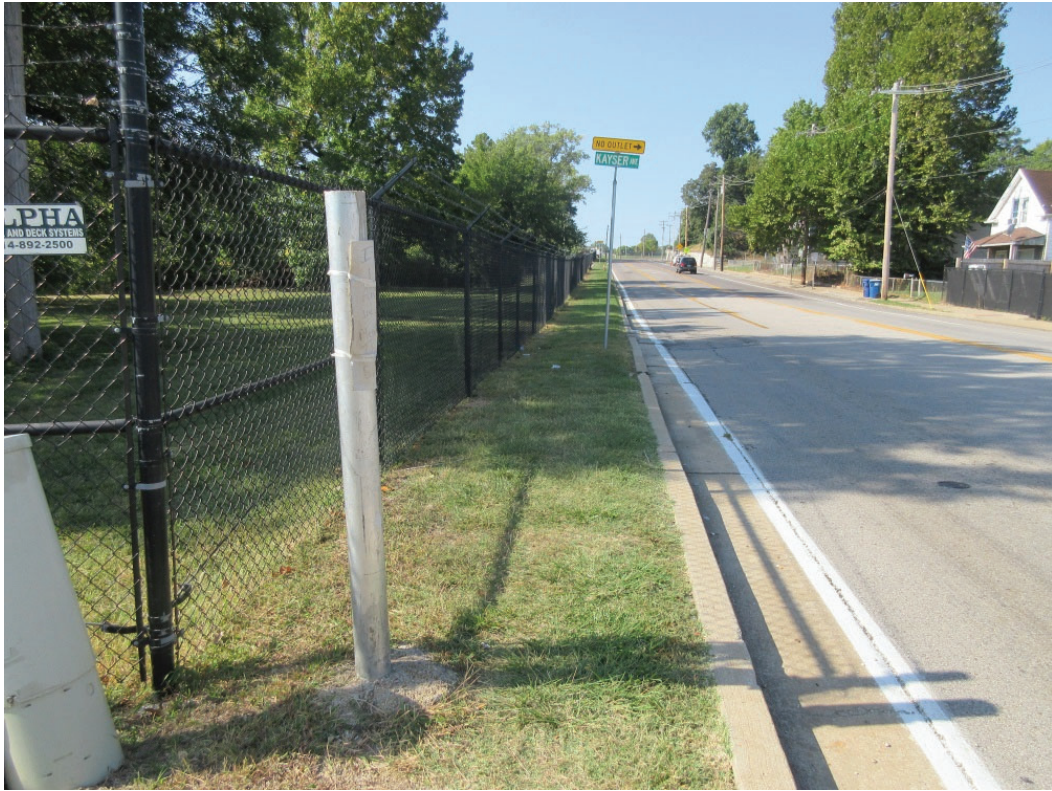
Figure 10: Hoffmeister Avenue to River City Casino Boulevard (looking South at River City Casino Blvd)

At the intersection of River City Casino Blvd., a complete replacement of curb ramps, installation of truncated domes, and reconstruction of some pedestrian push buttons are assumed as they were constructed prior to the ADA requirements currently in effect.

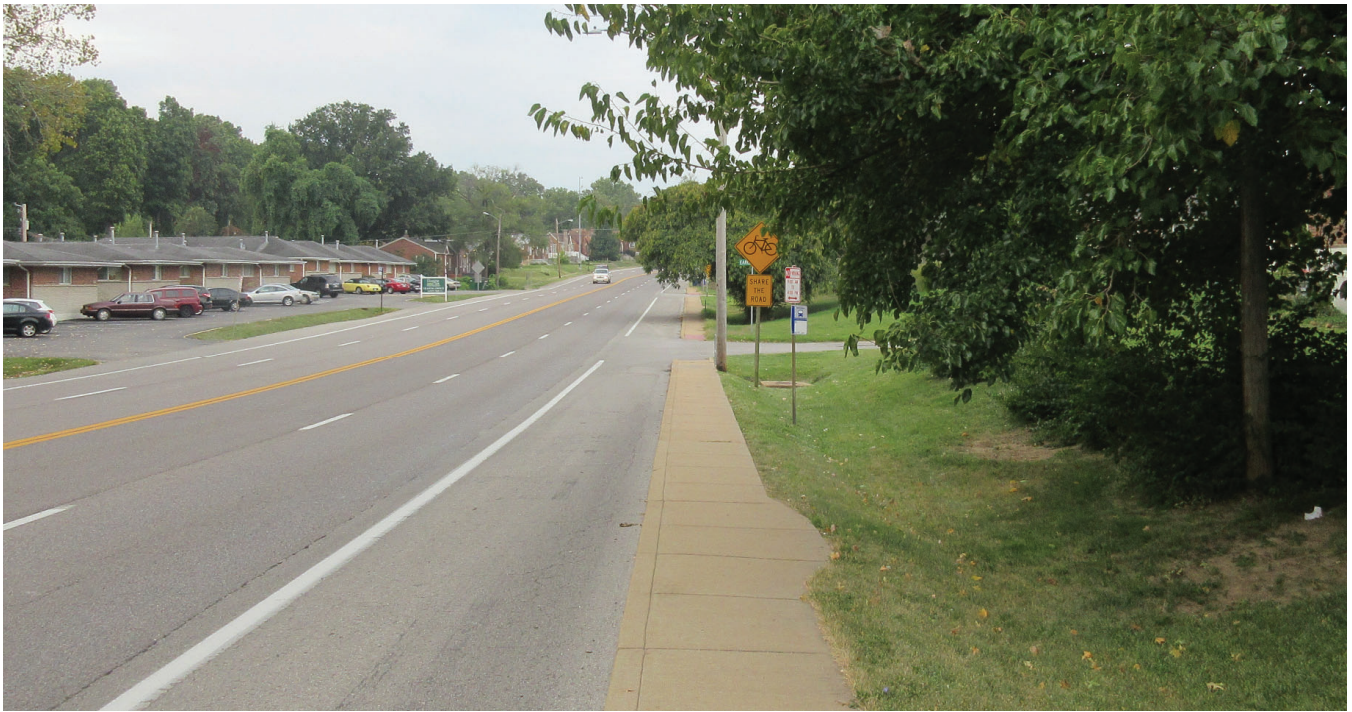
Figure 11: Metro Bus Stop Landing Pad (looking South at Southampton Drive)

There are thirty-one (31) existing bus stops within the limits of this study and in general, most are not compliant or accessible due to poor condition or lack of connecting pedestrian facilities. Most of the bus stop locations are existing sidewalk adjacent to the roadway which neither meets cross slope minimum requirements or width/length preferences. In other locations, there are bus landing pads (which still do not meet slope requirements) that have no compliant infrastructure leading to or from them, leaving the bus users nowhere to go after boarding/un-boarding. An example of this type of scenario can be found in **Figure 11** of the Existing Roadway and Sidewalk Conditions Appendix.

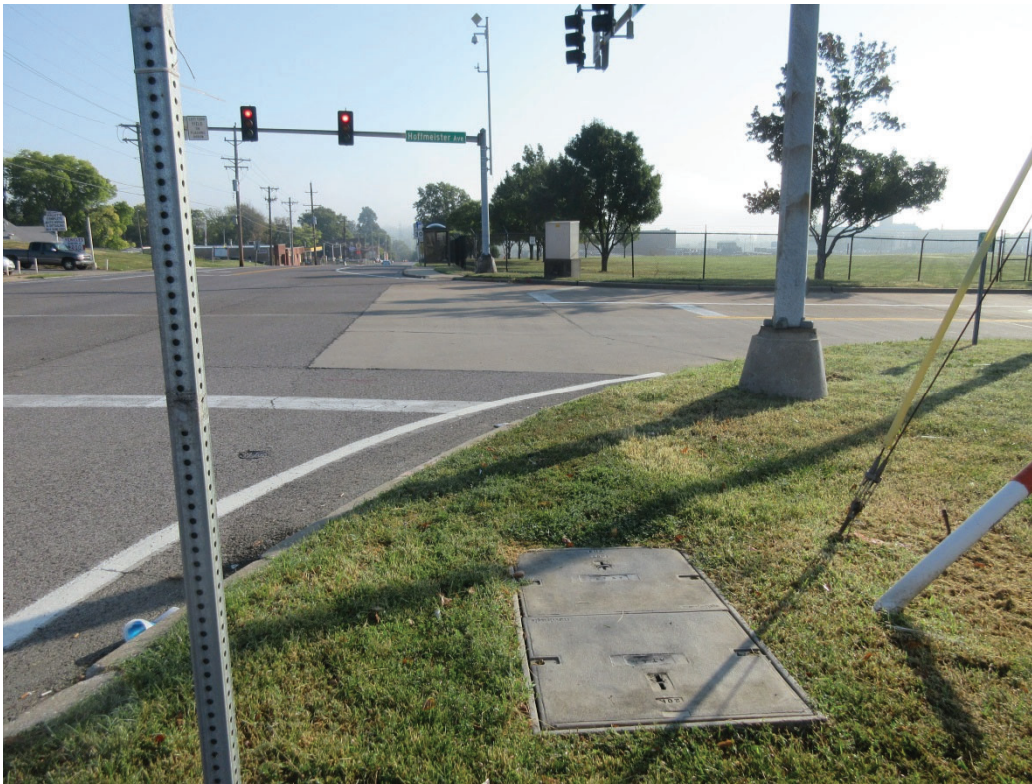
Figure 14: Route 231 at Hoffmeister Avenue (Northbound)

The intersection of Hoffmeister Avenue and Route 231 is signalized, but contains no pedestrian accommodations. It is assumed that improvements will entail complete removal and replacement of sidewalk and ramps at all 4 corners of the intersection. Furthermore, because of the existing configuration of the signal posts, it is assumed that additional posts will be required for pedestrian push buttons in order to provide compliant crossings at each landing. This appears to be possible by reusing the existing controller, which has the capacity to handle the additional load switches. Right of way and temporary easement will be required in order to make these improvements as shown on the conceptual stripmap and accounted for in the estimate.

To bring the corridor into full compliance with current ADA standards, traffic signal modifications will be necessary throughout. There are four existing signalized intersections within the project corridor, which are Jeffersonian Drive, Telegraph Rd. / Kingston Dr., Ripa Avenue, and Hoffmeister Avenue. The existing traffic signals at the project terminus – River City Casino Boulevard – was not included in this project as ADA improvements were completed when the roadway was constructed as the casino was built (2009-2010). However, it should be noted that many of the standards and requirements for ADA compliance have changed since then, and during the pedestrian audit of the corridor, noticeable discrepancies were identified at this signal. Furthermore, after the concept study for the corridor was scoped, it was determined that two of the intersections – Telegraph Rd. / Kingston Dr. and Ripa Avenue, would be excluded from the conceptual design estimate because they were going to be escalated and taken to final design in 2017/2018 as part of a separate contract. Therefore, the conceptual design study will only focus on the intersections of Jeffersonian Avenue and Hoffmeister Avenue.

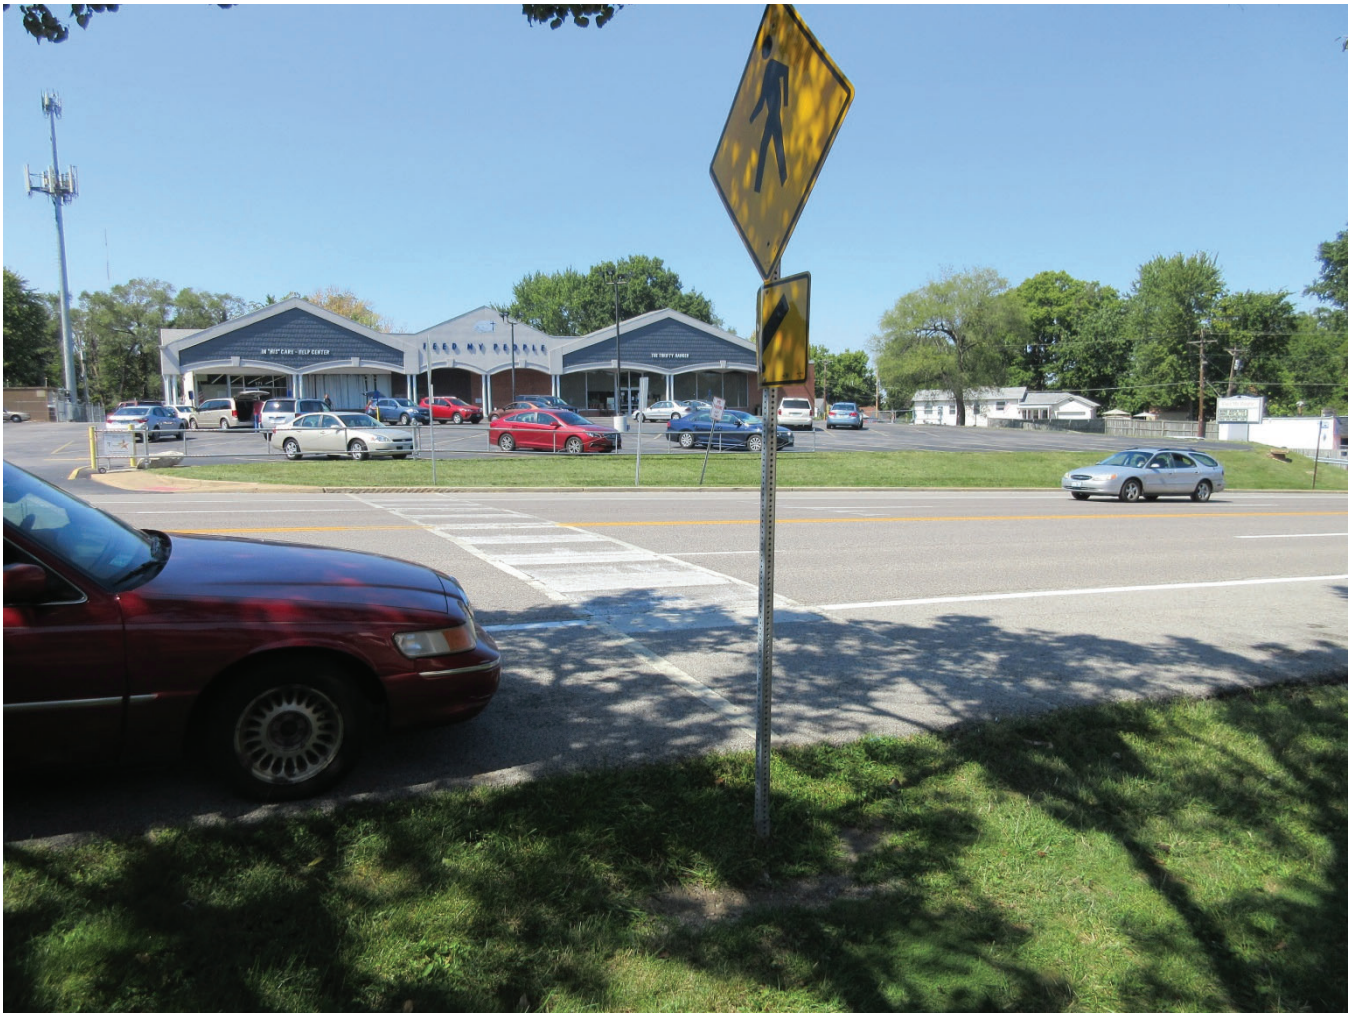
Figure 16: Mid-block Crossing at Feed My People (South of Clyde Avenue)

An existing mid-block crossing is striped and signed (continental-type markings) between the apartment complex and the Feed My People store at 171 Kingston, just south of Clyde Avenue. This crossing is quite wide and requires users to cross four travel lanes of pavement plus two wide outside shoulders. Observations throughout the pedestrian audit showed some usage at the marked crossing, but not consistent usage as other crossings were observed in the same area outside of the marked crossing.

The proposed project includes the upgrade of an existing mid-block crossing immediately south of Clyde Avenue in front of Feed My People. See **Figure 16** in the Existing Signal Conditions Appendix for a photograph of this existing mid-block crossing. In addition, a new mid-block crossing is proposed at the existing bus stop near Route 231 and Weiss Avenue. Advanced flashing beacons for both directions of vehicular traffic along Route 231 as well as additional signage and striping based on the current guidelines and latest version of the MUTCD are recommended to provide for advance warning of the mid-block crossing. To further increase safety, the installation of an actuated pedestrian crossing, such as a High Intensity Activated Crosswalk Beacon (or HAWK system) should be evaluated in final design if further warning is desired for pedestrians using the crosswalk.
