RECEIVED**BRIDGE REPORT**

COUNTY St. Francois PROJ. NO. S-1291(2) STA. NO. 57+93.65 BRIDGE NO. _____ DESIGN NO. Y-935*ON ROAD FROM Pilot Knob TO Mineral City : 4.3 MILES N. E. OF Pilot KnobBRIDGE OVER Brewers Creek SEC. 15 TWP. 34 N. RG. 4 E.REPORTED BY O. A. Wetzel DATE 4-2-52

BRIDGE INSPECTION REPORT

COUNTY St Francis ROUTE NUMBER V BRIDGE NUMBER Y935
 DATE OF INSPECTION 4-15-54 INSPECTION MADE BY JAW
 TYPE OF SUPERSTR. 3-10' conc slabs TYPE OF SUBSTR. conc bents & abut

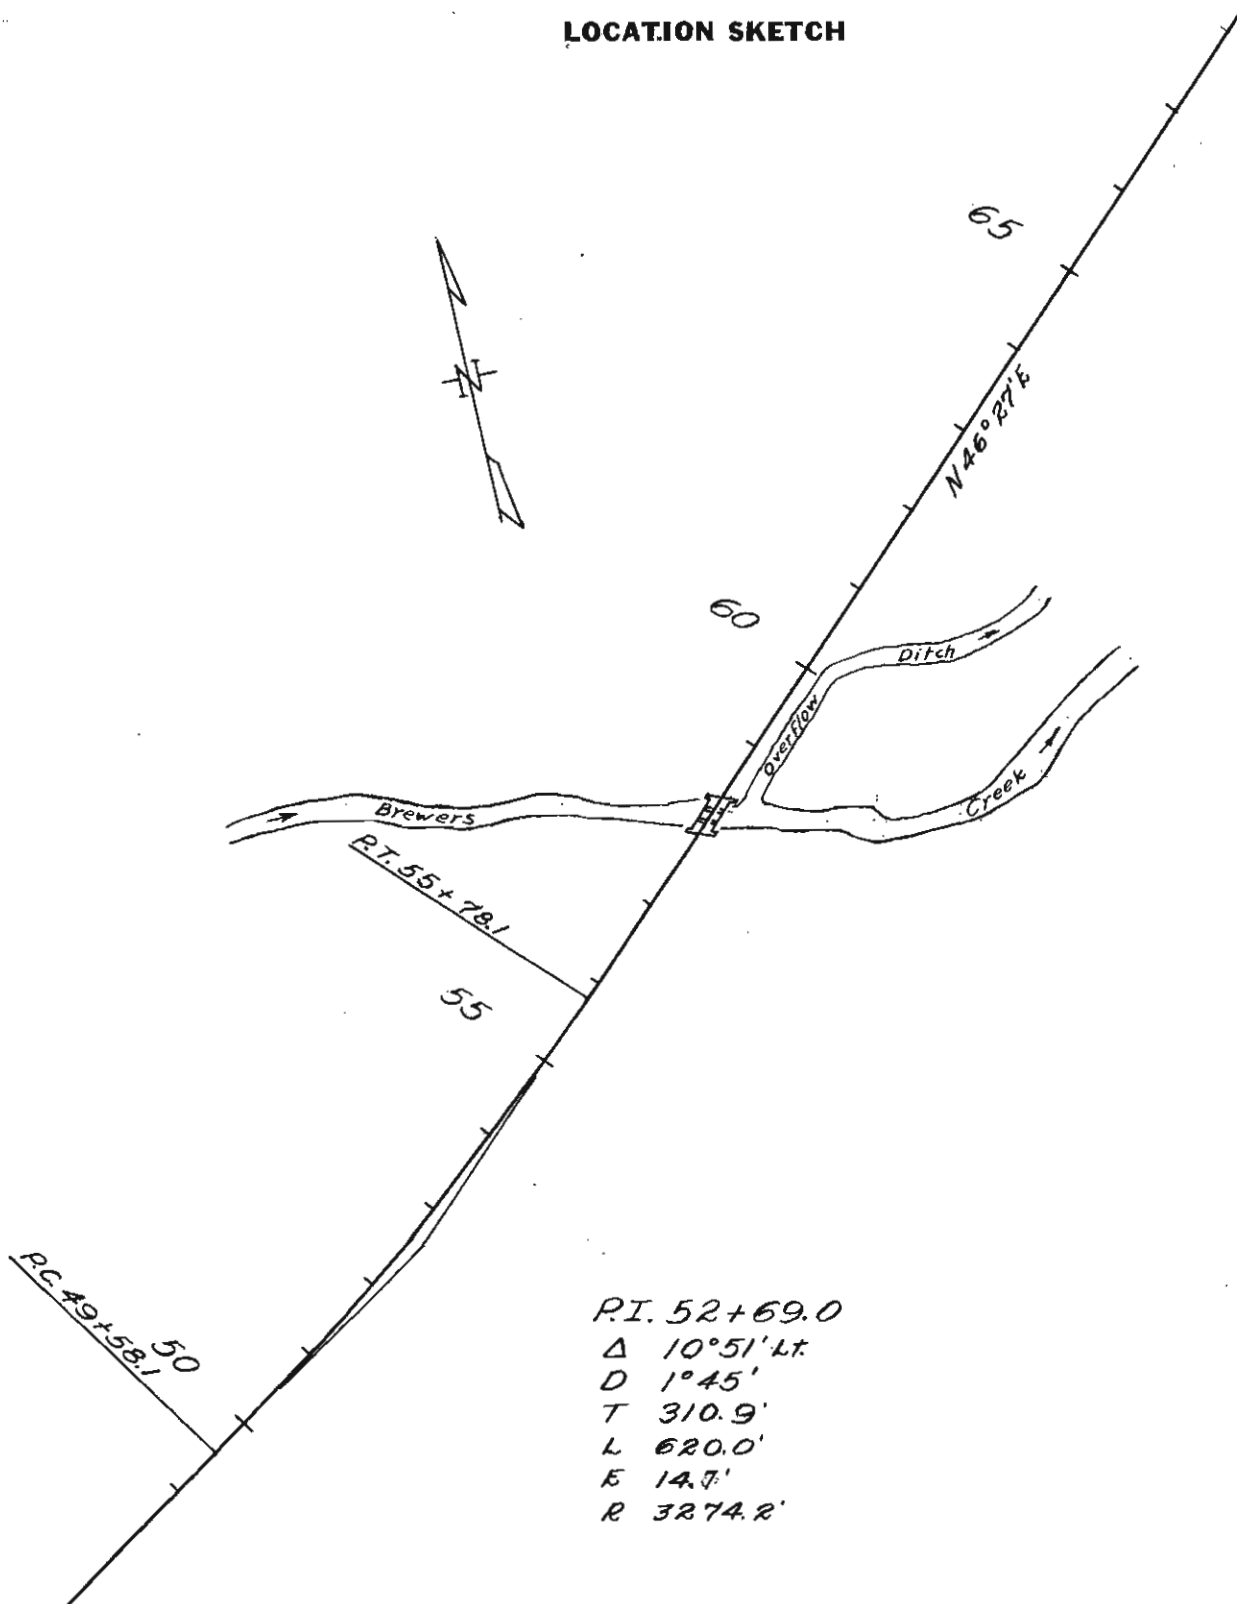
LOCATION SKETCH

GENERAL REMARKS: Heavy scouring at upstream end of Bent No. 2
Downstream channel obstructed with heavy brush in channel
Upstream channel obstructed with heavy brush along banks.

*use in place**Concrete the undermined section
upstream end of the south bent 400.00**note**Have the road plans provide for
upstream and downstream channel
cleanout*28 TOTAL ESTIMATED COST OF
REPAIRS RECOMMENDED
