Re: BEAP Project 22TTAP-04
Bridge No. 2220012

We are pleased to submit our recommendations under the Bridge Engineering Assistance Program (BEAP) for the above referenced structure. The City has requested recommendations for potential repairs of Bridge 2220012 in order to reopen this currently closed bridge. In addition, recommendation for a full structure replacement option is discussed in this report.

BRIDGE NO. 2220012
 PARKVILLE, MISSOURI

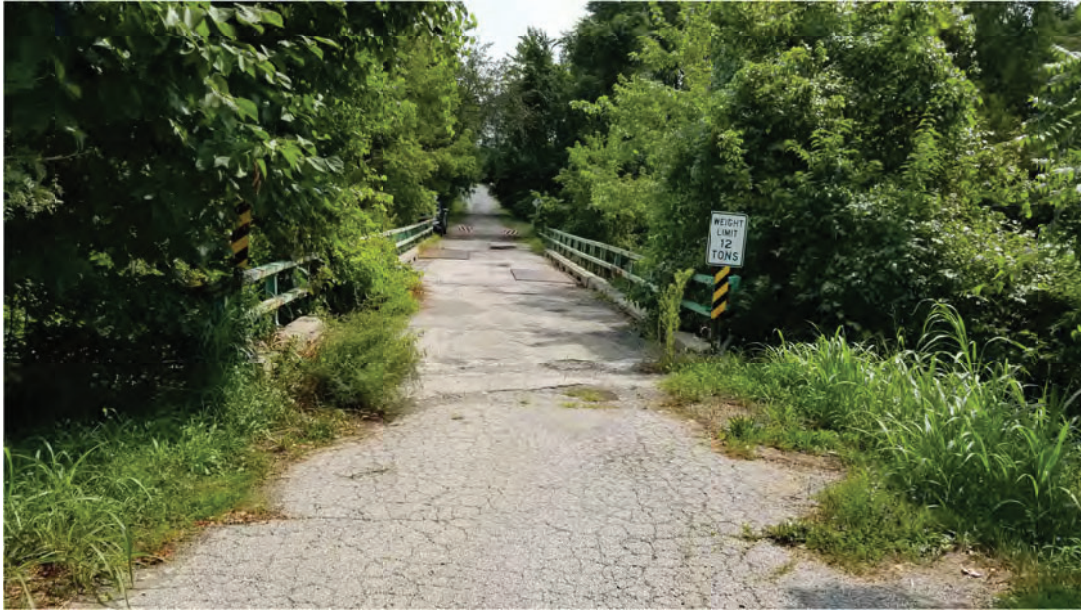
PHOTO 1 - NORTH APPROACH

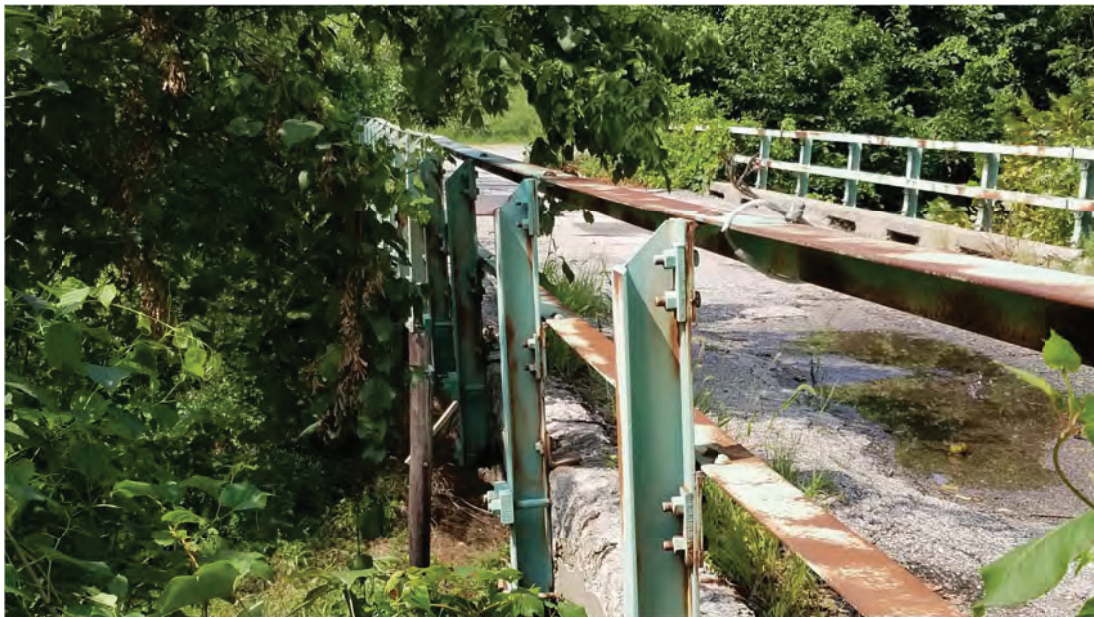
PHOTO 2 - EAST FASCIA

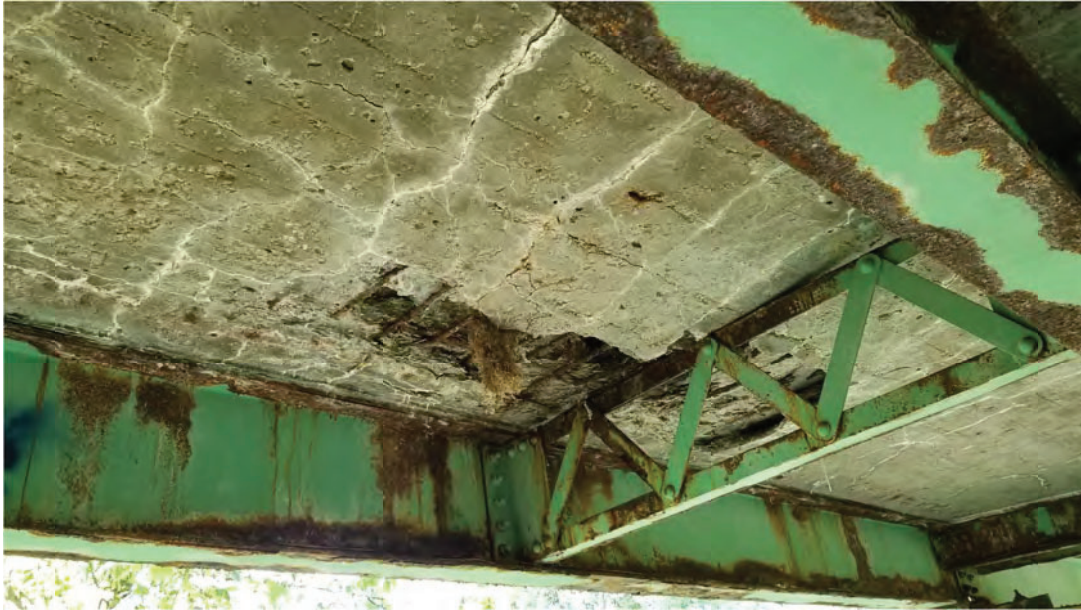
The concrete deck and asphalt pavement wearing surface are in poor/failed condition as observed from above and below the deck. The asphalt pavement is missing, cracked, and has failing patches in many locations. The concrete deck has failed in several locations. There are two plates that cover two failed locations. However, the deck over the north pier is spalled with holes and exposed rebar and not plated. The overhangs on both sides are severely spalled with exposed and deteriorated rebar. The concrete deck in the east bay in the north span is severely cracked and deflected as observed from below. This area is also not plated. (See Photos 3 thru 8 - Exhibits 3,4, and 5, attached) The steel stringers and bearings are in fair to poor condition with heavy rust, corrosion, and loss of section particularly at the substructure units and where steel diaphragms frame into the beams. (See Photo 9 and Photo 10 - Exhibit 6, attached)

PHOTO 3 - LOCAL DECK FAILURE (SOUTH SPAN, WEST BAY)

The entire concrete deck and bridge rail will require removal and replacement. For safety, the bridge rail should be replaced with a crash-tested bridge rail.

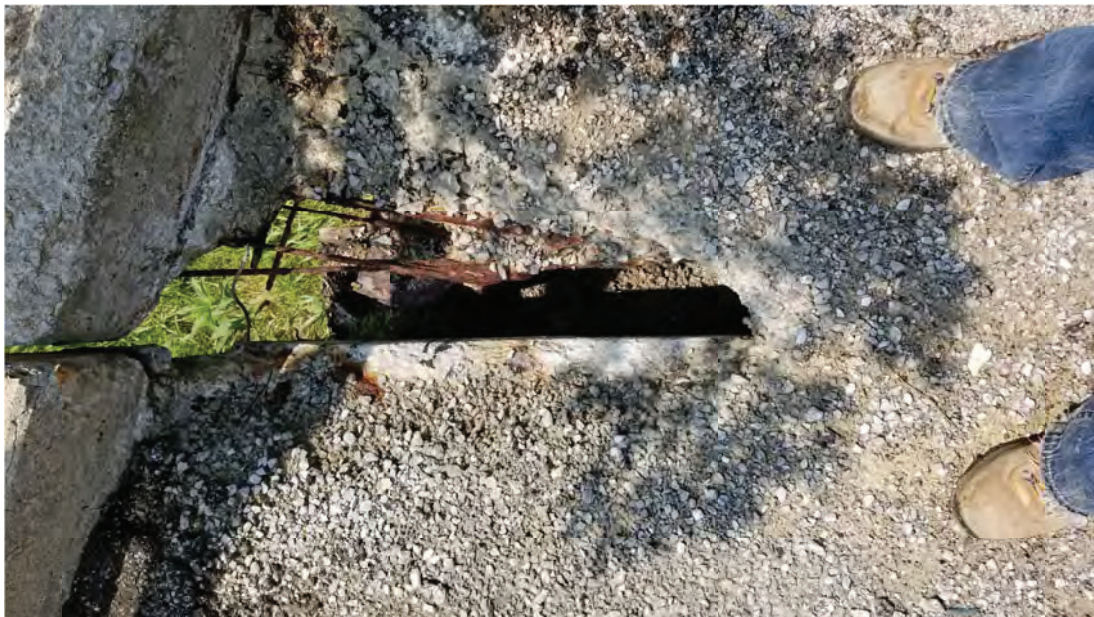
PHOTO 4 - DECK SPALL (OVER NORTH PIER)

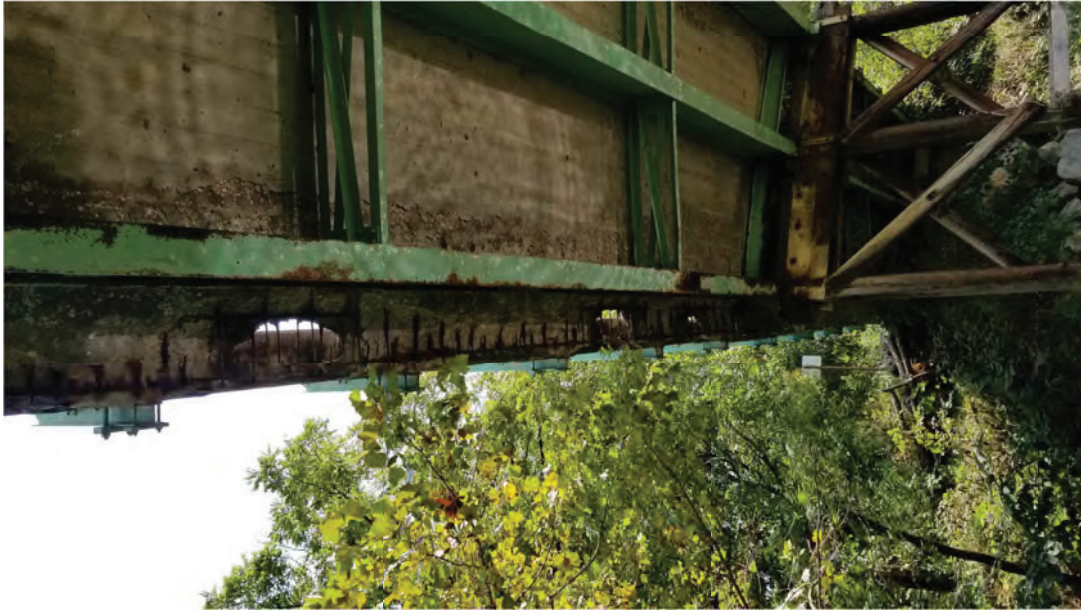
PHOTO 5 - DECK DETERIORATION (EAST OVERHANG, MIDDLE SPAN)

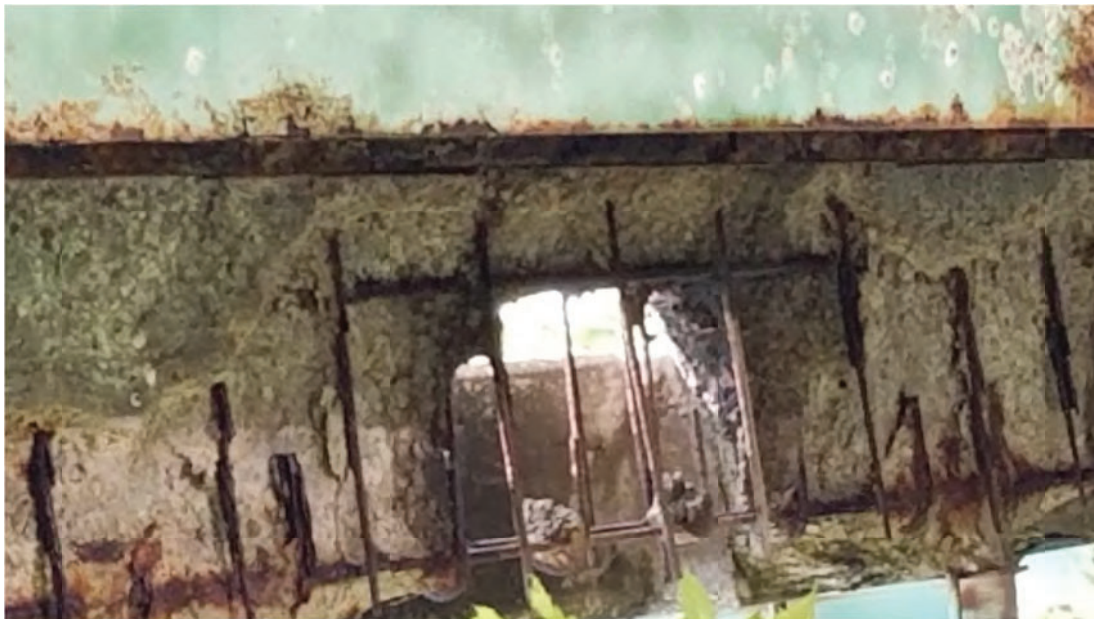
PHOTO 6 - DECK DETERIORATION (EAST OVERHANG, MIDDLE SPAN)

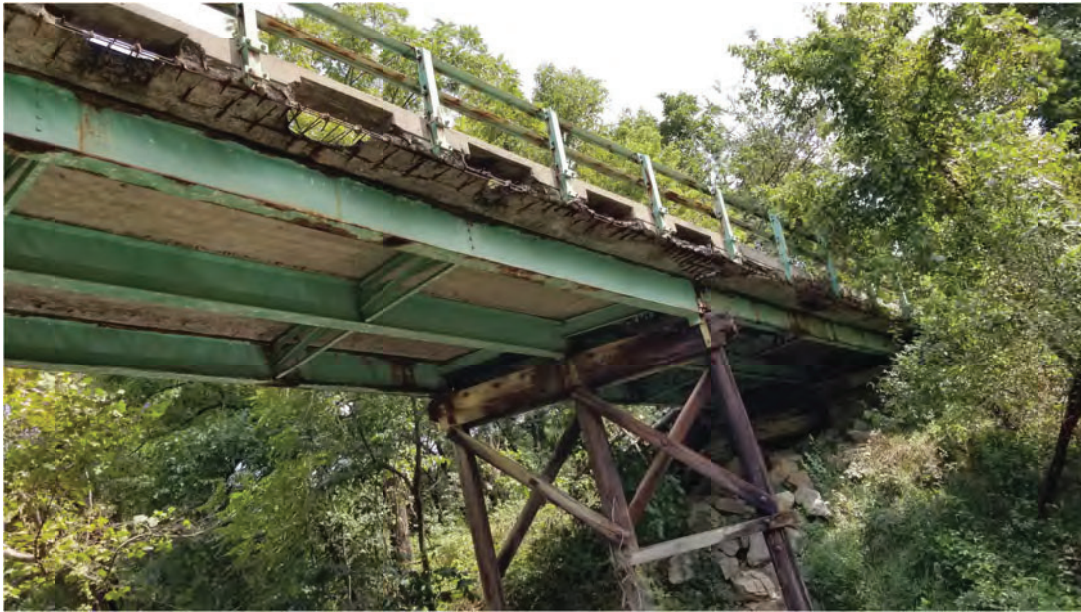
PHOTO 7 - DECK DETERIORATION (WEST FASCIA, MIDDLE SPAN)

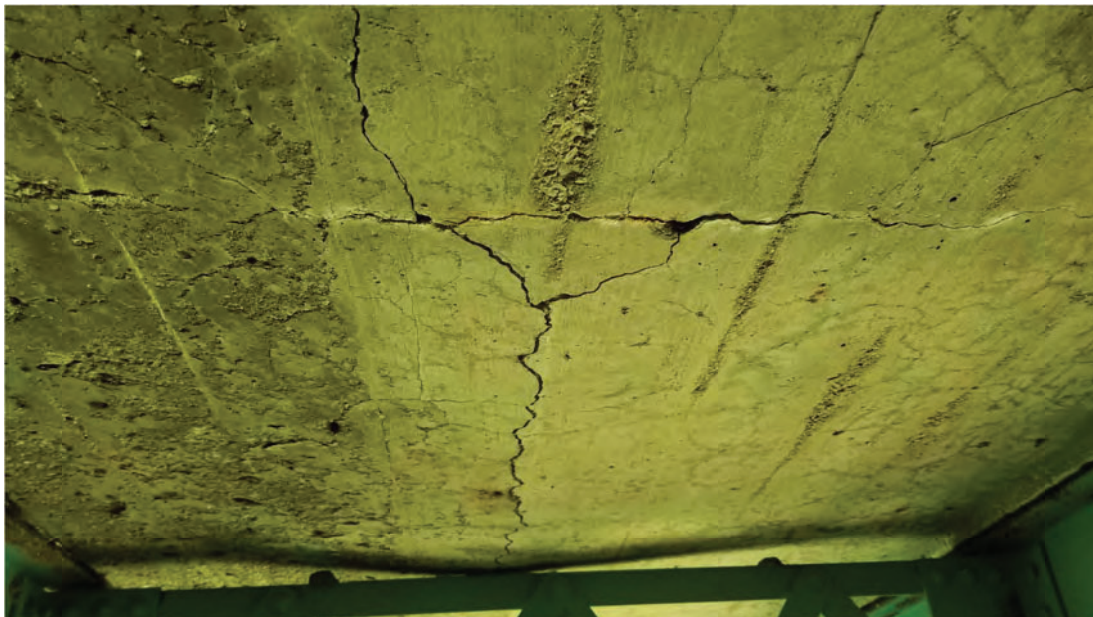
PHOTO 8 - DECK FAILURE (EAST BAY, NORTH SPAN)

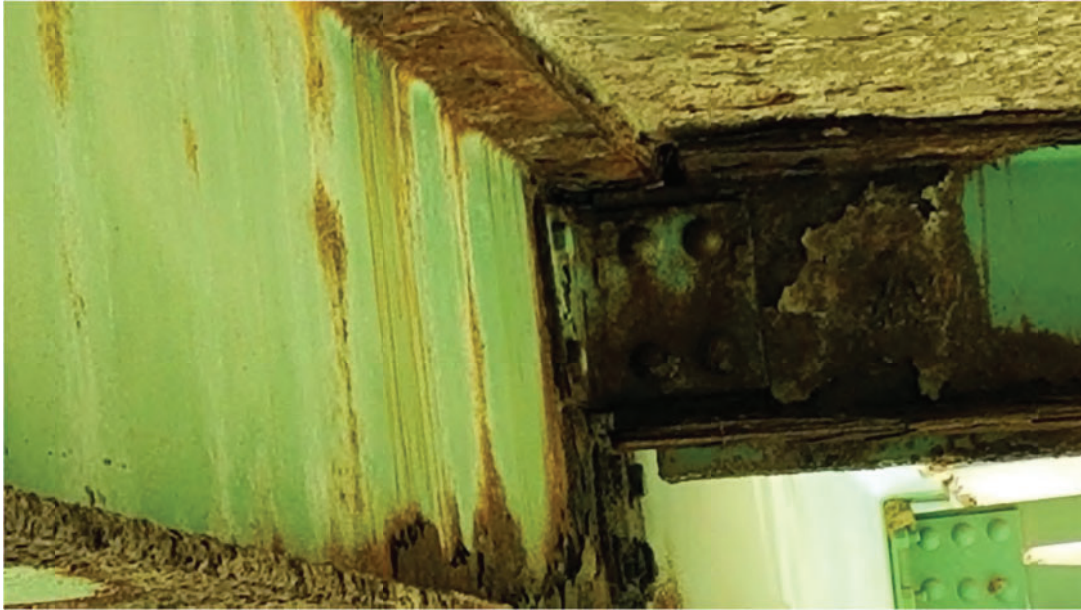
PHOTO 9 - STRUCTURAL STEEL, RUST & CORROSION
(MIDDLE STRINGER, SOUTH END - NORTH SPAN)

The steel stringers should have all the rust removed and the steel members cleaned for inspection. It is likely that several stringers will require repair to restore the cross-sectional area and thus the steel properties of the stringers. This can be accomplished by welding steel plates to the web and flanges of the deteriorated beams. The bearings for the stringers should be cleaned, inspected, and replaced if required. All structural steel will be painted after cleaning and repair.

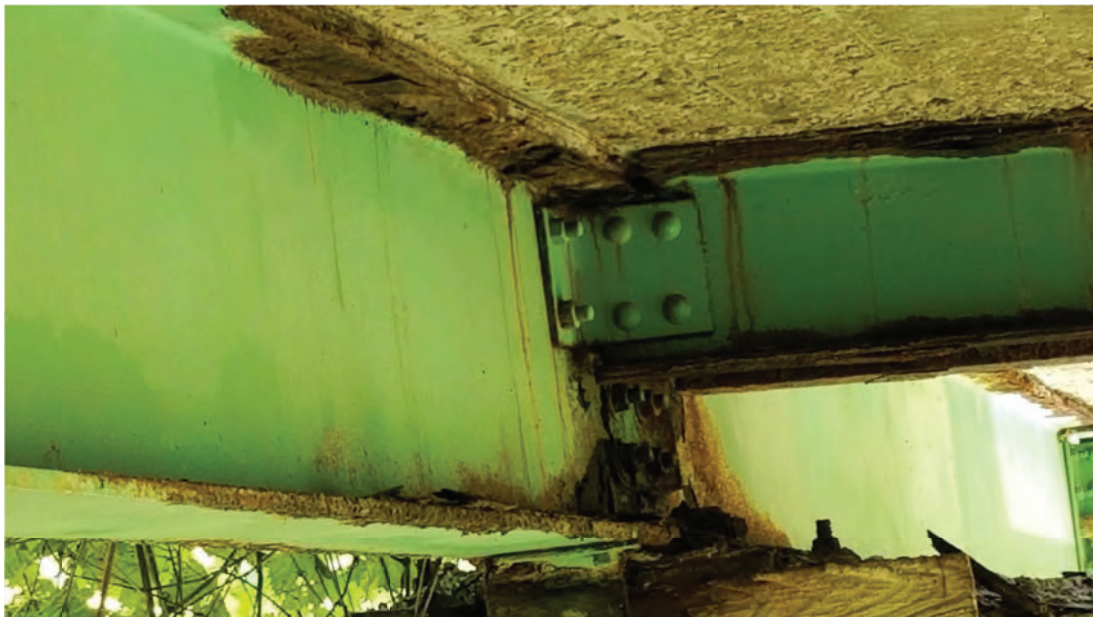
PHOTO 10 - RUST, CORROSION
(EAST STRINGER, SOUTH END - NORTH SPAN)

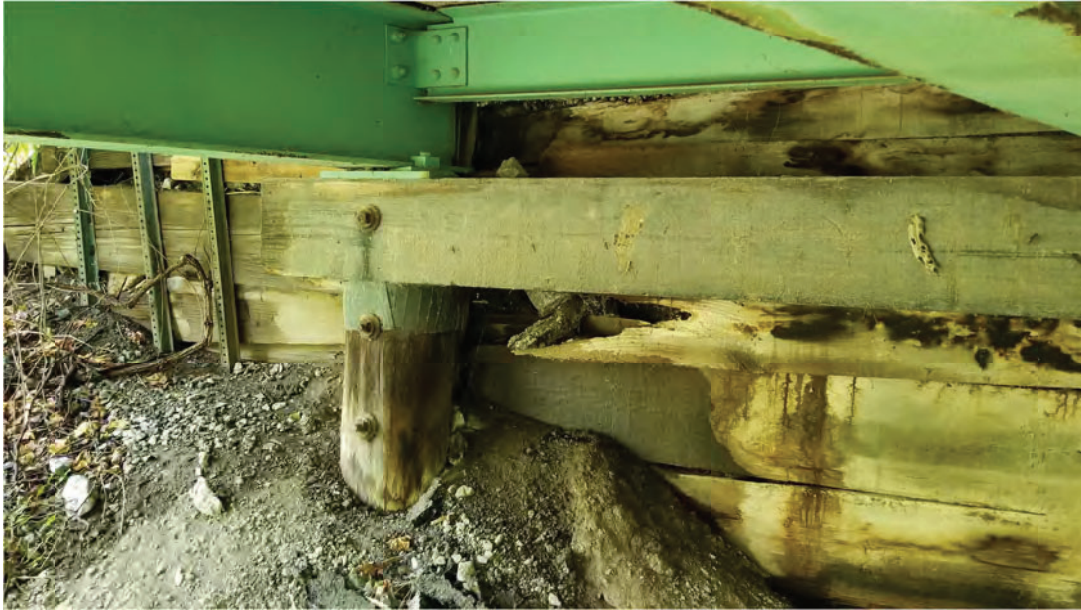
The timber abutments are in fair condition. The piles and cap have moderate splitting. The abutment backwalls and wingwalls have local rot and gaps with some loss of backfill material. The timber piers are

PHOTO 11 - ROTTED AND WEATHERED TIMBER BACKWALL
(NORTH ABUTMENT)

Bridge Repair: In order to restore the bridge to a functional condition and safely carry the previously posted limit of 12 tons, it is recommended that the entire bridge be removed and the steel stringers be rehabilitated for reuse. The piers are unstable or will become unstable due to the bow in the timber piles and lack of lateral support from the missing bracing. These piers should be replaced with steel pile trestle bents with additional steel channel sections for lateral stability. The abutment piles may be in fair condition but should be replaced with steel piles to assure that the piles have adequate bearing capacity. The repaired structure should not be dependent on the existing piles that have unknown deterioration and questionable capacity below the groundline. Wingwalls and backing should be replaced in the abutments also.

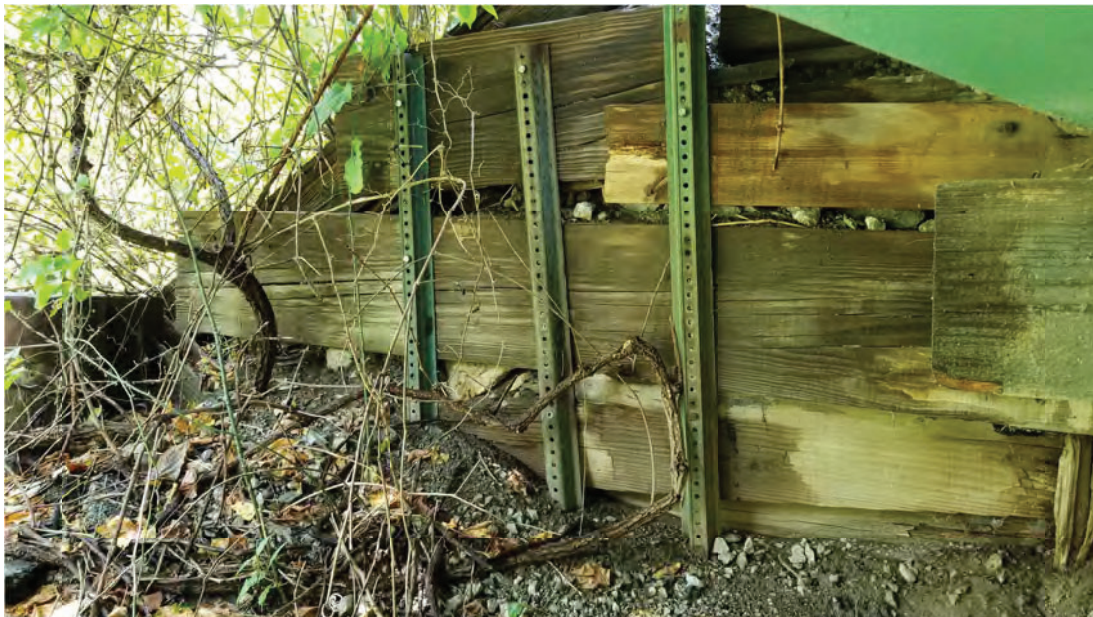
PHOTO 12 - WEATHERED AND MISSING TIMBER BACKING
(NORTHWEST WINGWALL)

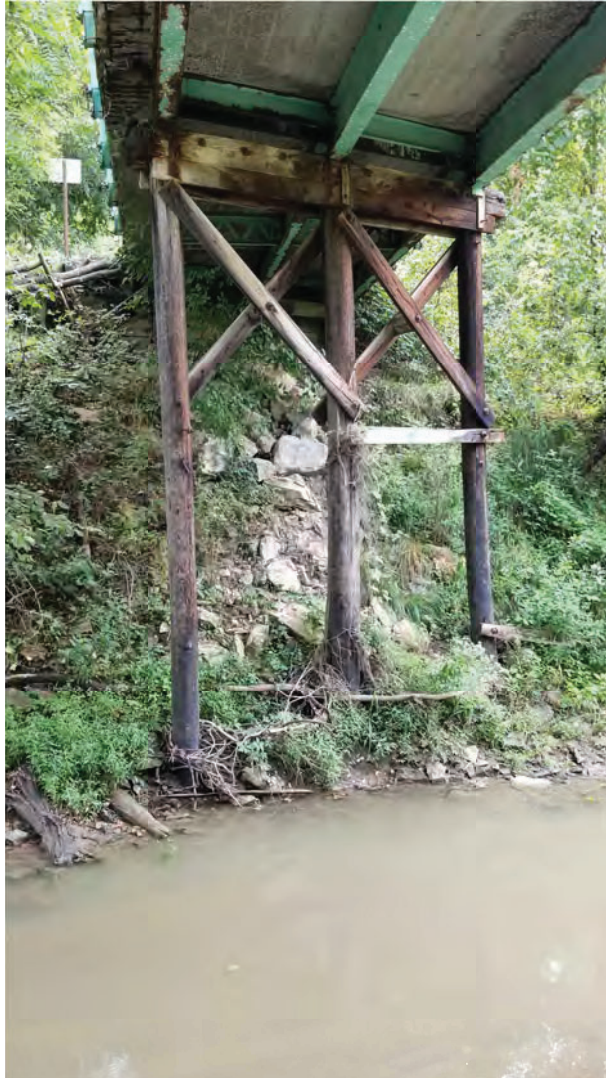
in fair to poor condition. There is moderate splitting in all piles. The piles are bowed, particularly in the south pier. The lateral bracing is partially missing in the south pier. (See Photos 11, 12, and 13 - Exhibits 7 and 8, attached.)

PHOTO 13 - BOWED, SPLIT PILES
MISSING BRACING
(SOUTH PIER)
