# STRUCTURAL REHABILITATION CHECKLIST

| <b>Bridge No.:</b> | <b>A2588</b> | <b>Job No.:</b> | <b>JCD0240</b> |
| <b>Route:</b> | <b>H</b> | <b>Over:</b> | <b>Dry Fork Creek</b> |
| <b>County:</b> | <b>Dent</b> | <b>Date of Field Check:</b> | <b>11/10/2025</b> |

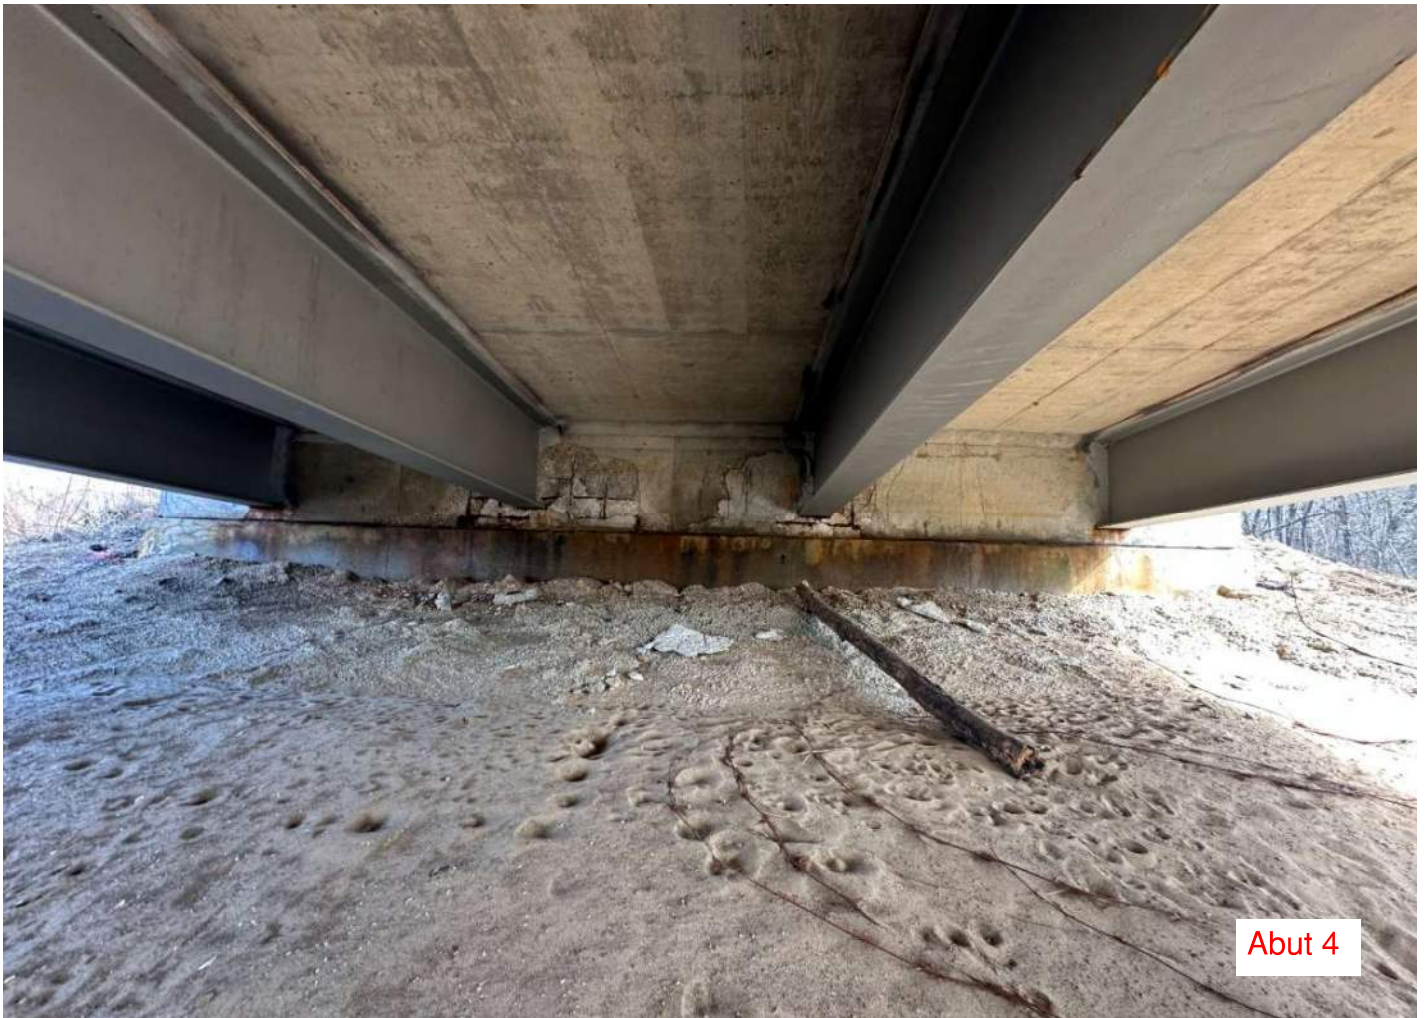
Abut 4

| ASSOCIATED SUBSTRUCTURE COMPONENTS | | | |
|---|--|---|---|
| Condition Comment: MINOR-DETERIORAT-ENDS__01/28/21, MEYERM3 --(BMSCONV, 01/09/2026) | | | |

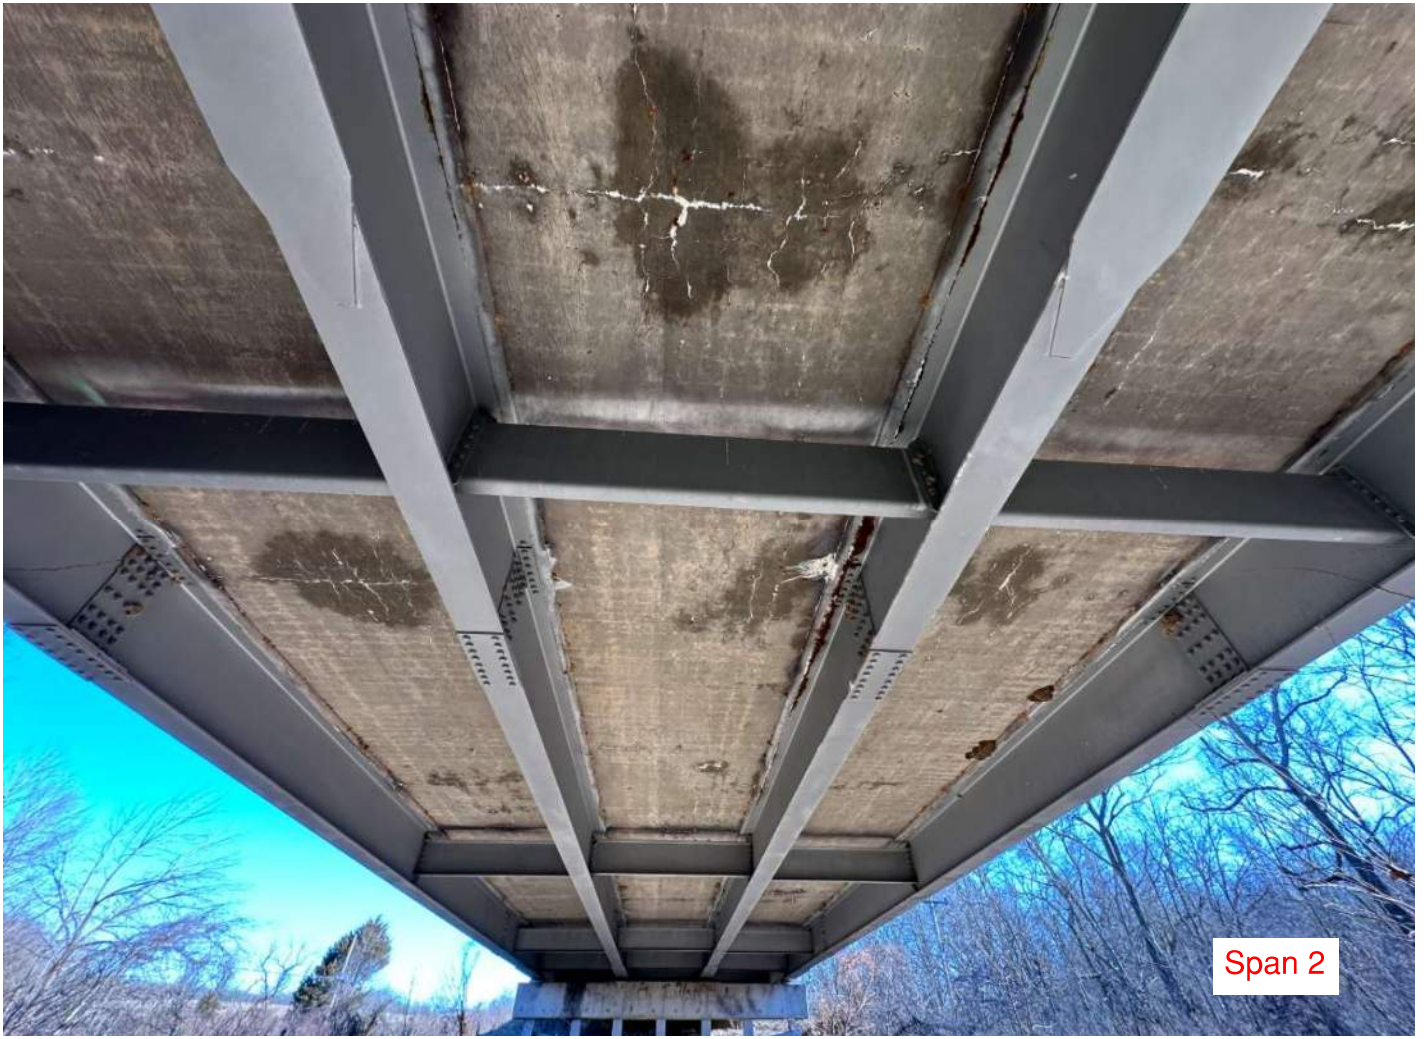
Span 2

| Condition Comments: MINOR-RUSTING-TOPFLANGE__04/06/15, OTTINM --(BMSCONV, 01/09/2026) | | | | | | | | | | | |
