Missouri Department of Transportation

STRUCTURAL REHABILITATION CHECKLIST

Bridge No.: **A6500**

Route: **I-70**

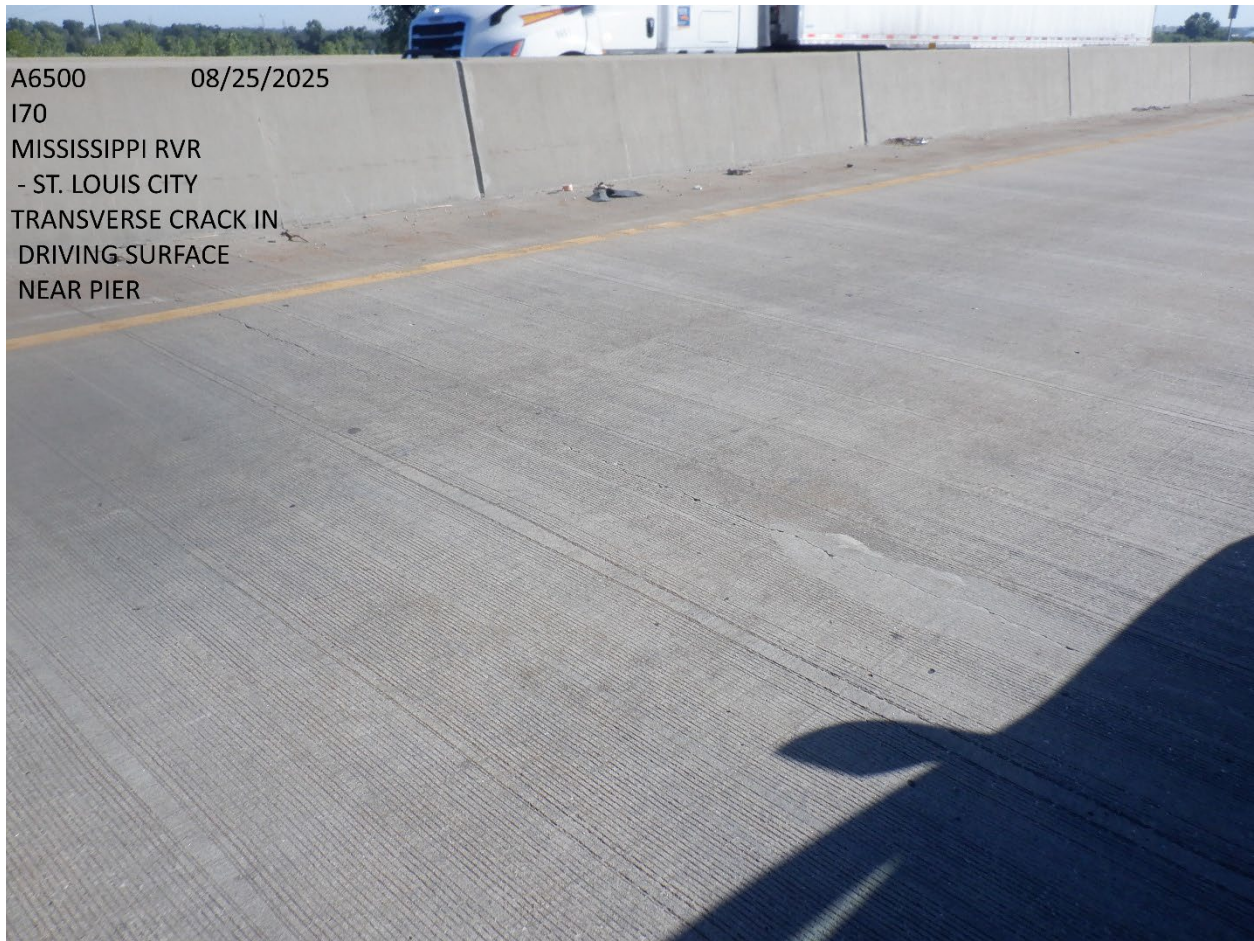
A6500 08/25/2025
I70
MISSISSIPPI RVR
- ST. LOUIS CITY
TRANSVERSE CRACK IN
DRIVING SURFACE
NEAR PIER

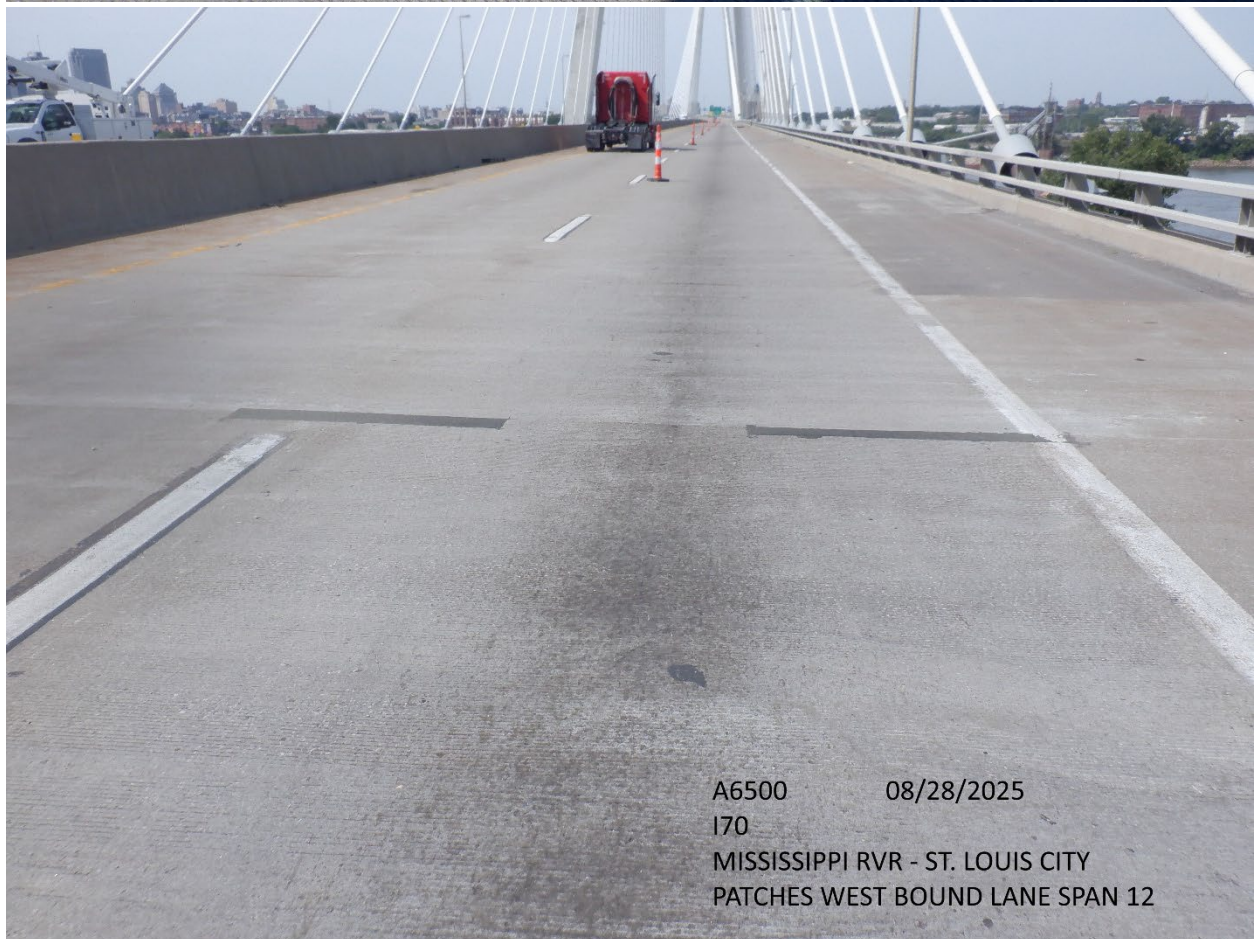
A6500 08/28/2025
I70
MISSISSIPPI RVR - ST. LOUIS CITY
PATCHES WEST BOUND LANE SPAN 12

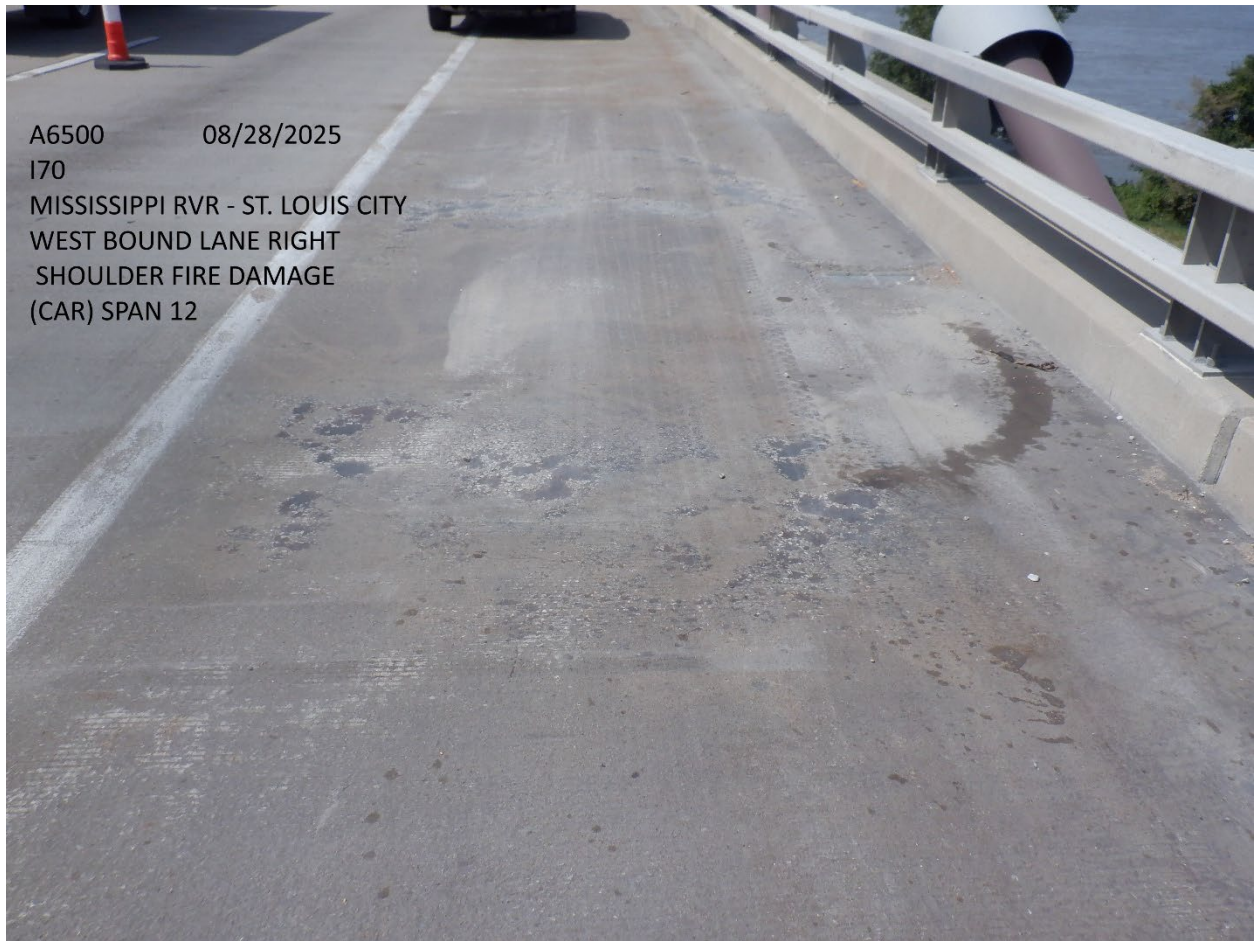
A6500 08/28/2025
I70
MISSISSIPPI RVR - ST. LOUIS CITY
WEST BOUND LANE RIGHT
SHOULDER FIRE DAMAGE
(CAR) SPAN 12

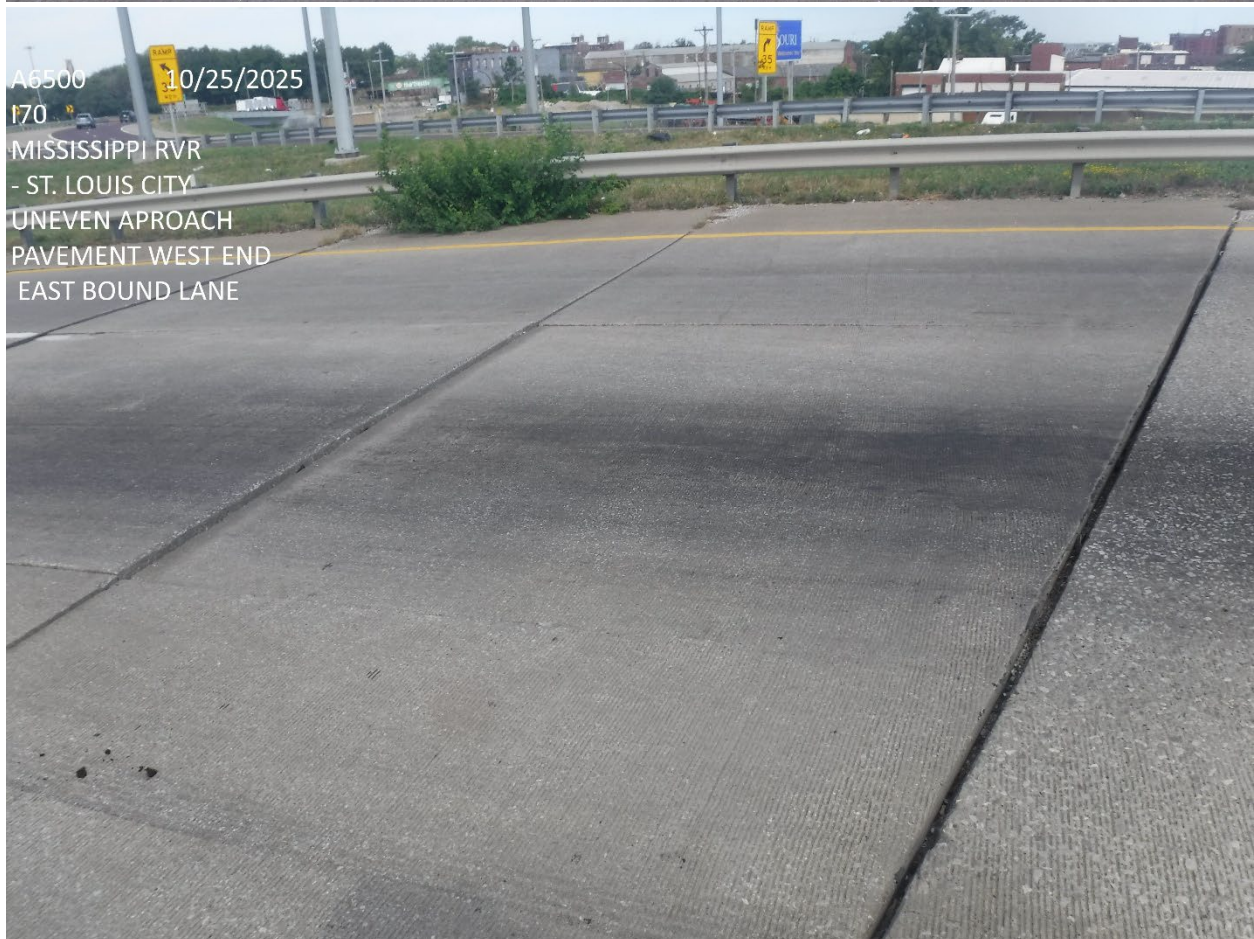
A6500 10/25/2025
I70
MISSISSIPPI RVR
- ST. LOUIS CITY
UNEVEN APPROACH
PAVEMENT WEST END
EAST BOUND LANE

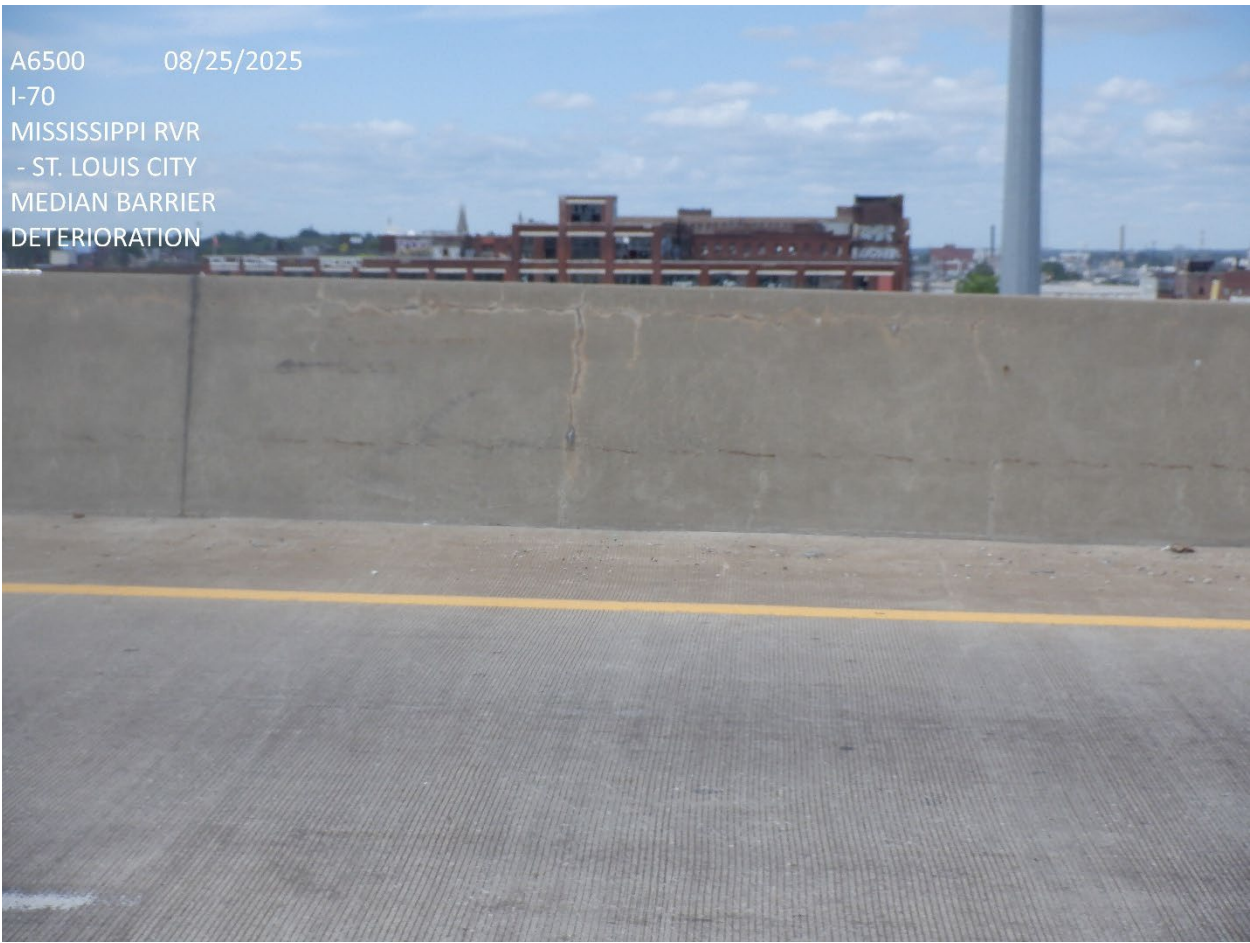
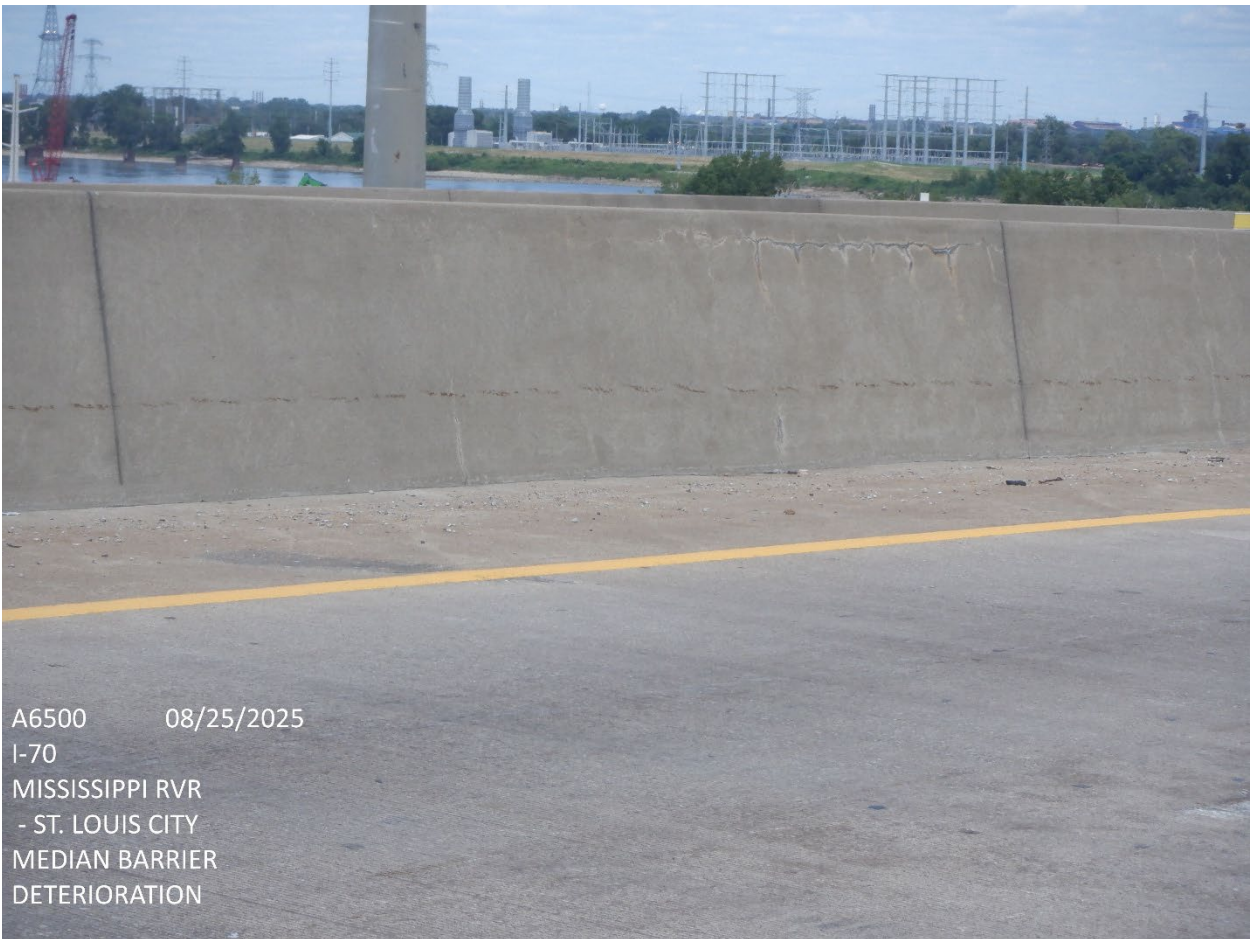
A6500 08/25/2025
I-70
MISSISSIPPI RVR
- ST. LOUIS CITY
MEDIAN BARRIER
DETERIORATION

* Curb repair **20** lin. ft.

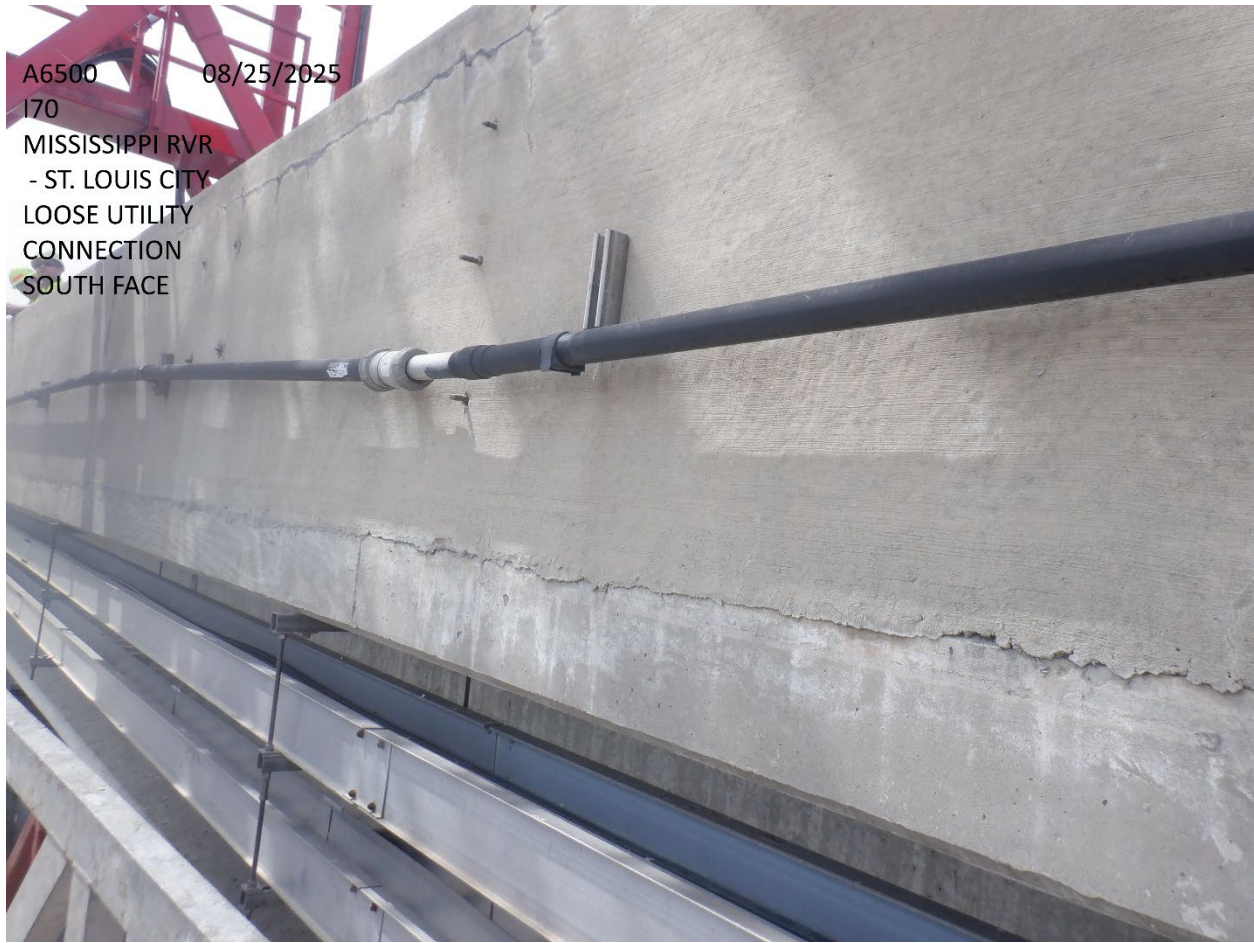
A6500 08/25/2025
I70
MISSISSIPPI RVR
- ST. LOUIS CITY
LOOSE UTILITY
CONNECTION
SOUTH FACE

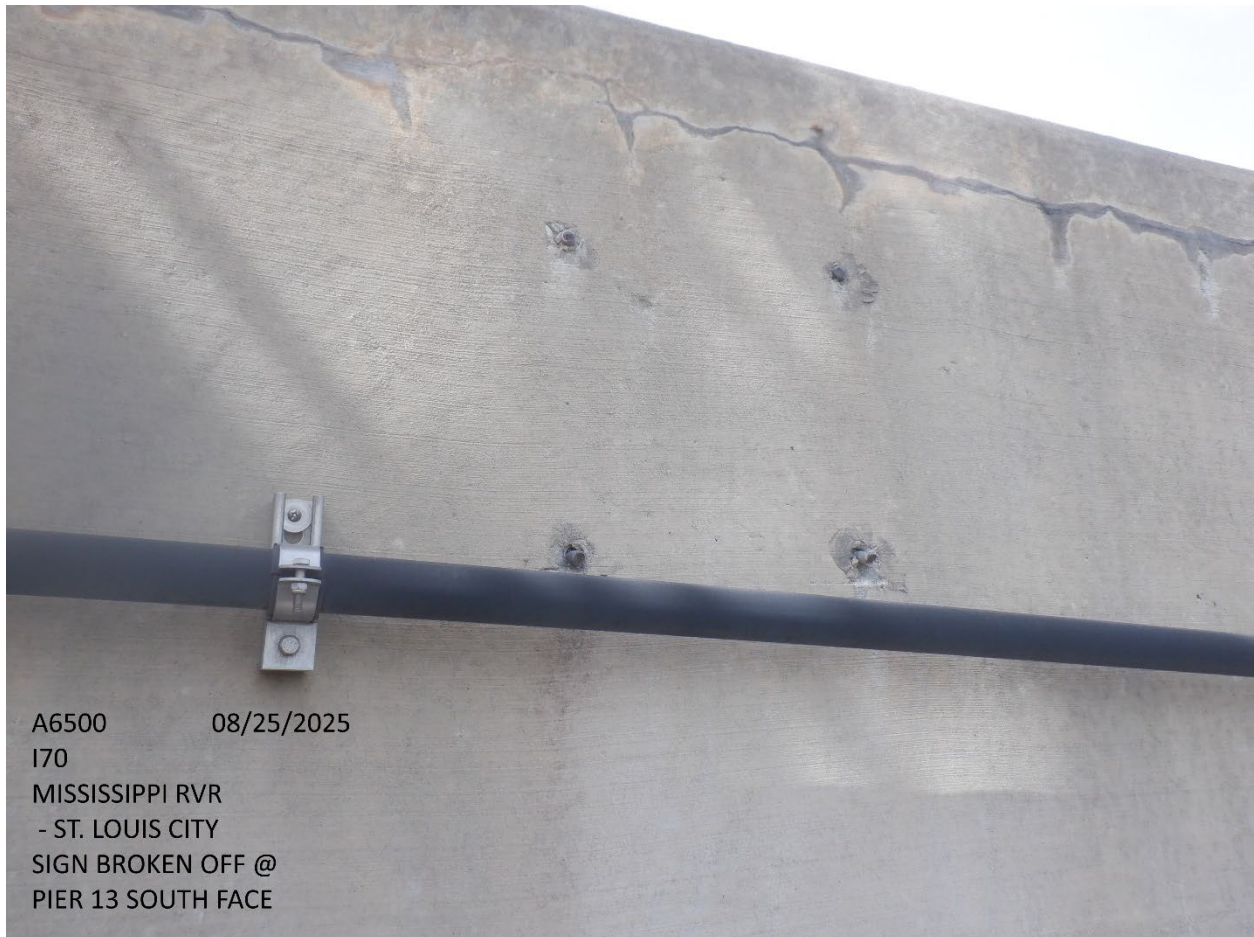
A6500 08/25/2025
I70
MISSISSIPPI RVR
- ST. LOUIS CITY
SIGN BROKEN OFF @
PIER 13 SOUTH FACE

* Describe proposed work to be done to signs. **Replace all roadside signs due to reflectivity**

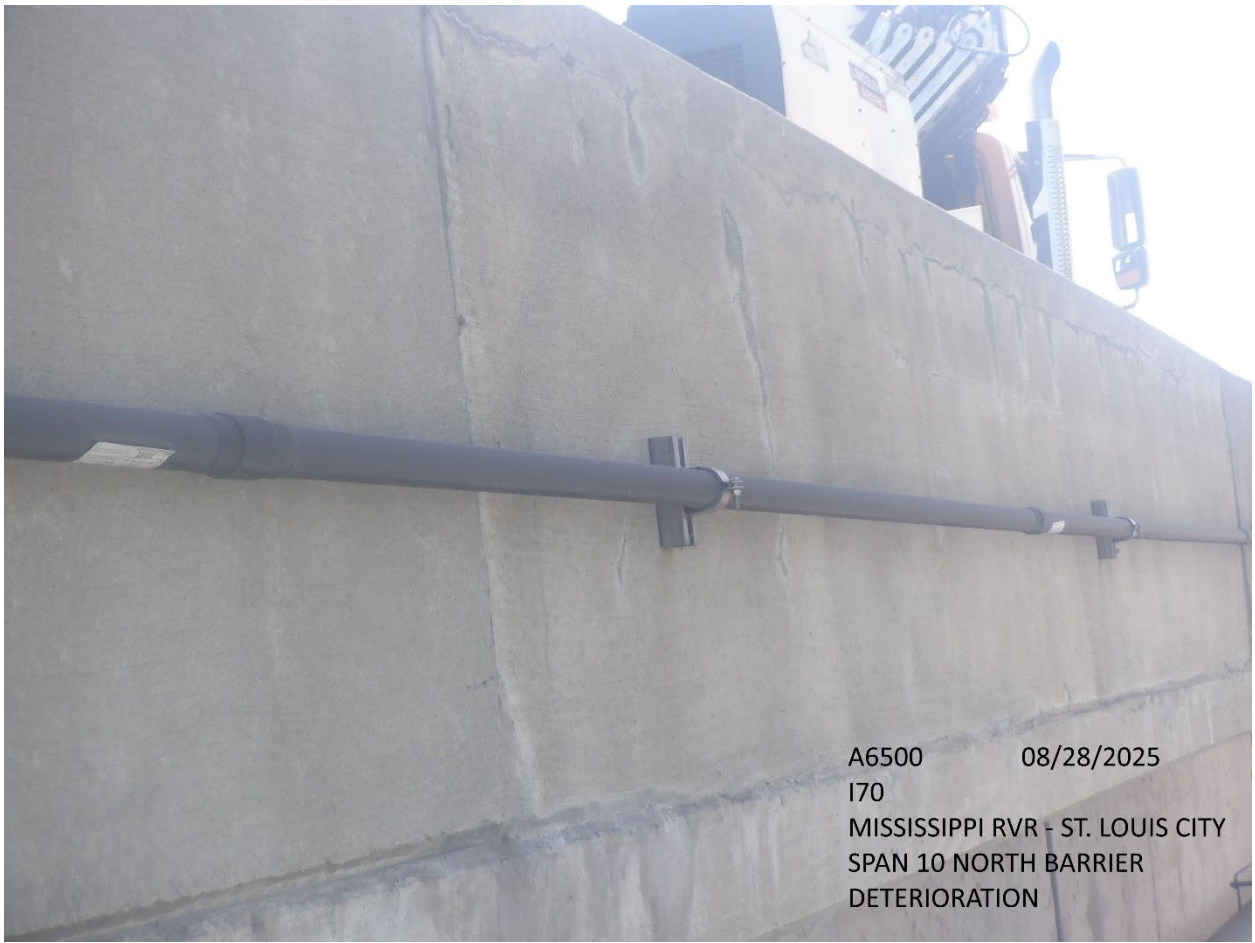
A6500 08/28/2025
I70
MISSISSIPPI RVR - ST. LOUIS CITY
SPAN 10 NORTH BARRIER
DETERIORATION

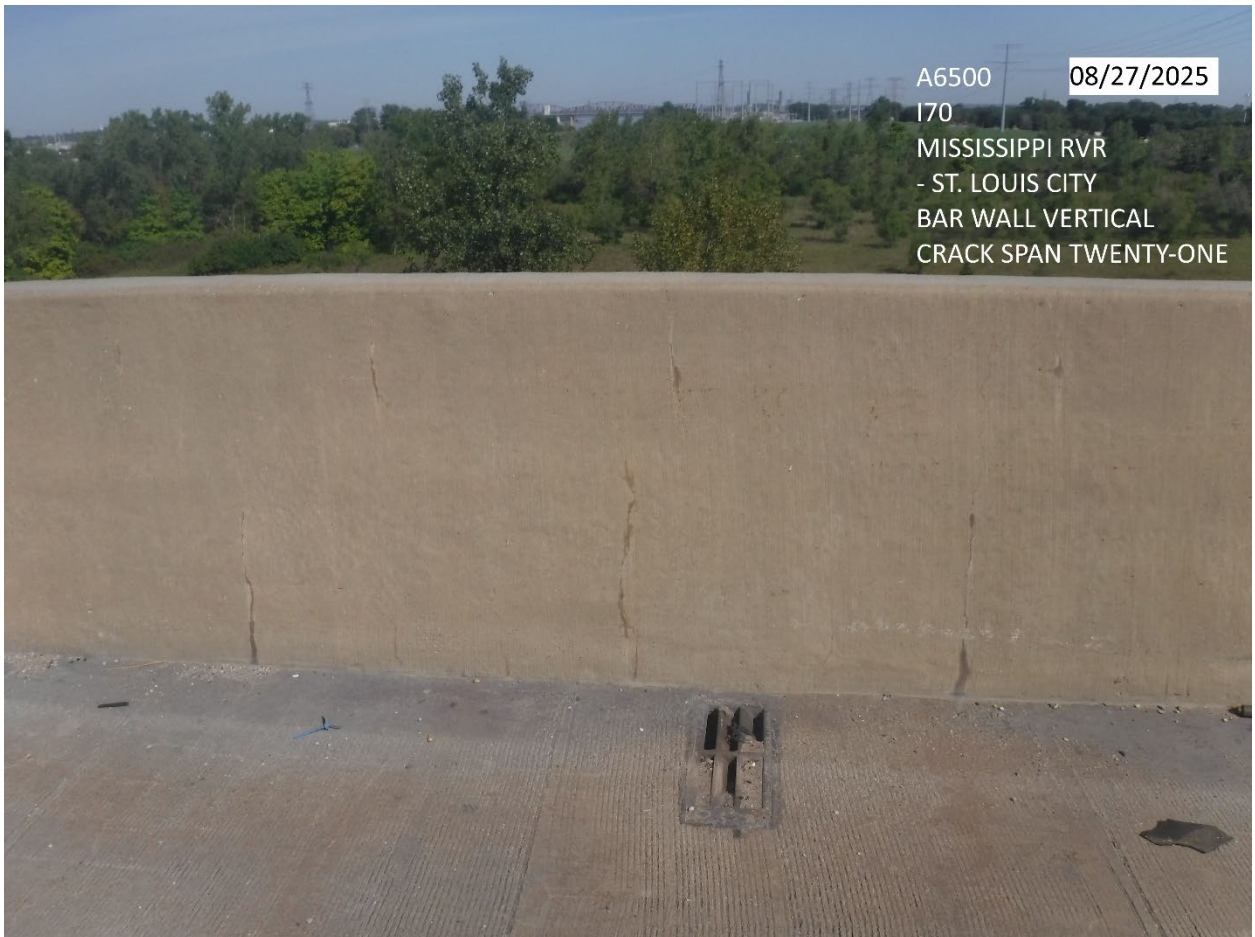
A6500 08/27/2025
I70
MISSISSIPPI RVR
- ST. LOUIS CITY
BAR WALL VERTICAL
CRACK SPAN TWENTY-ONE

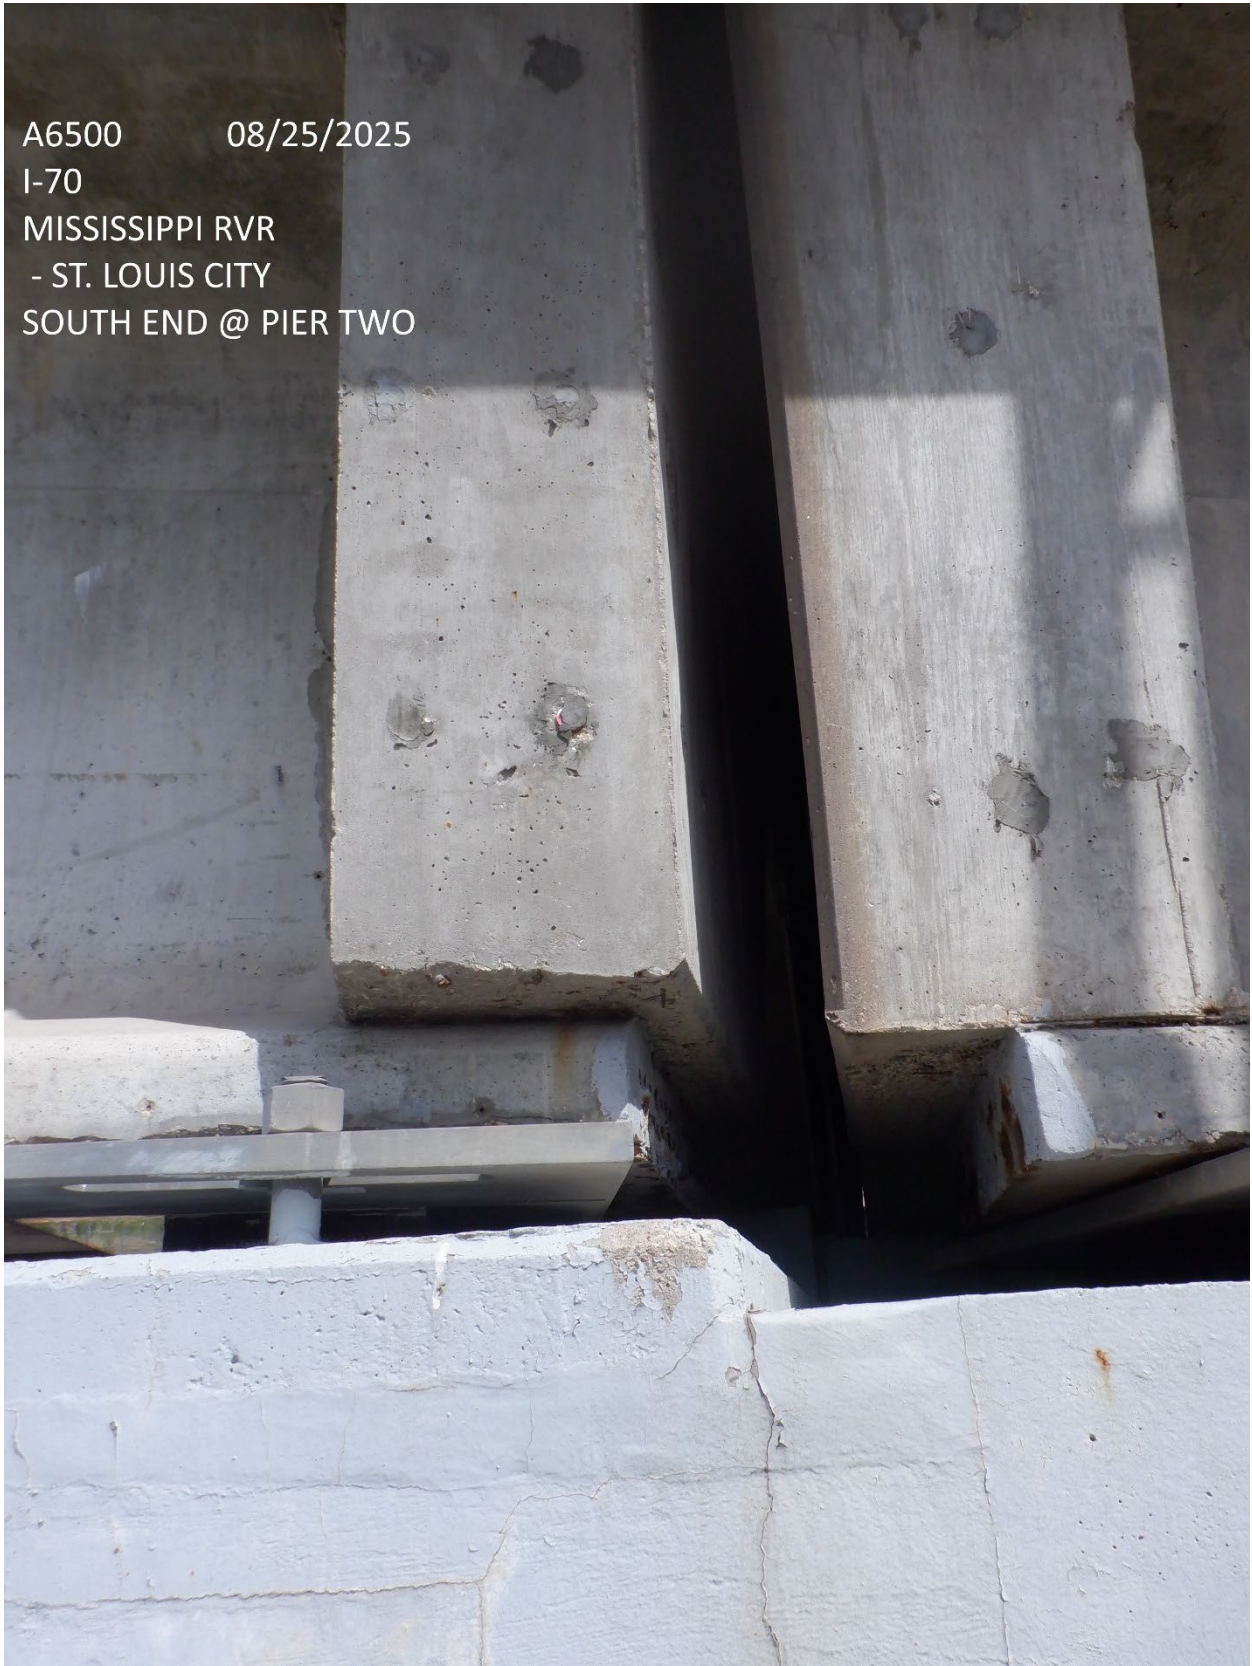
A6500 08/25/2025
I-70
MISSISSIPPI RVR
- ST. LOUIS CITY
SOUTH END @ PIER
TWO RUSTY CABLE ENDS

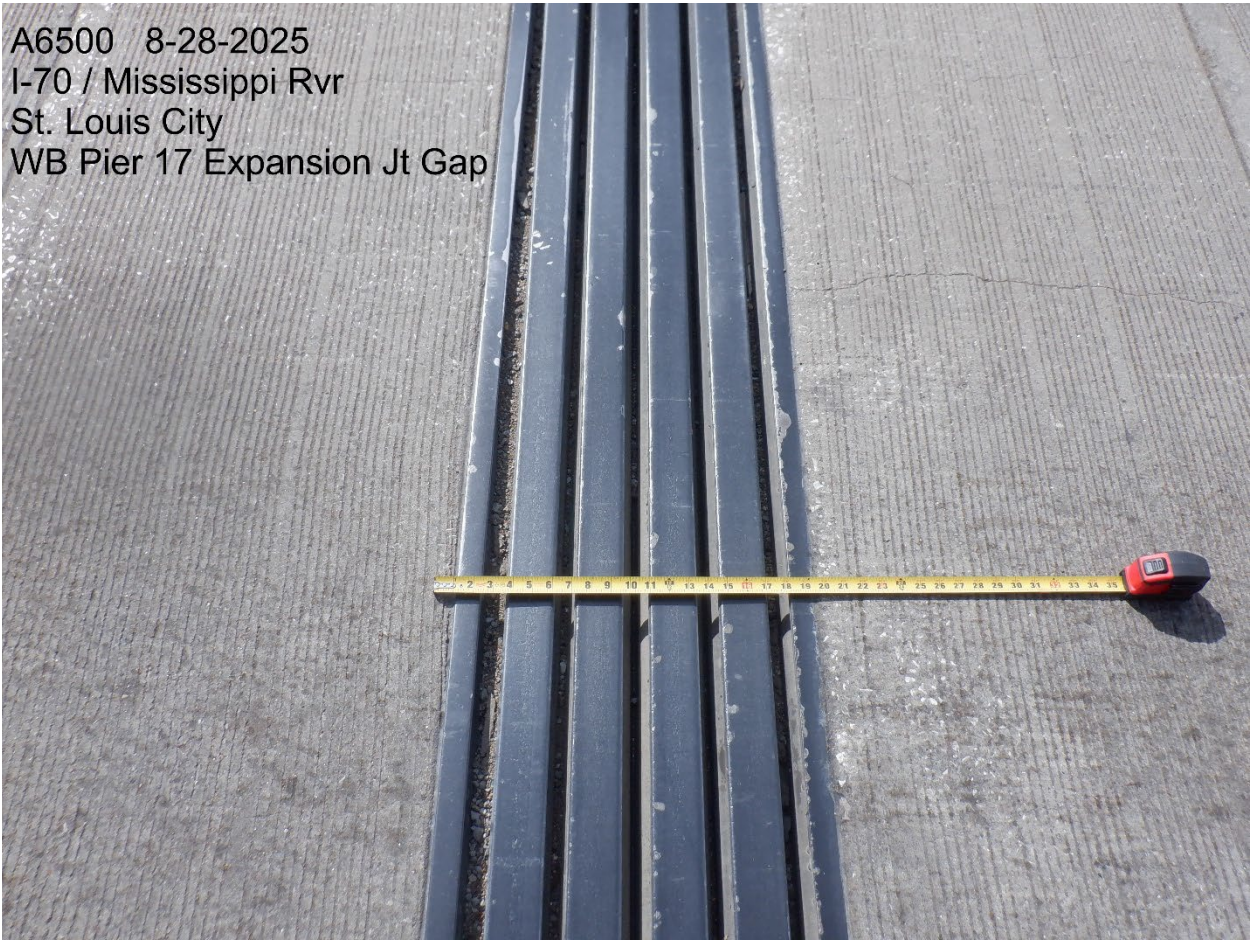
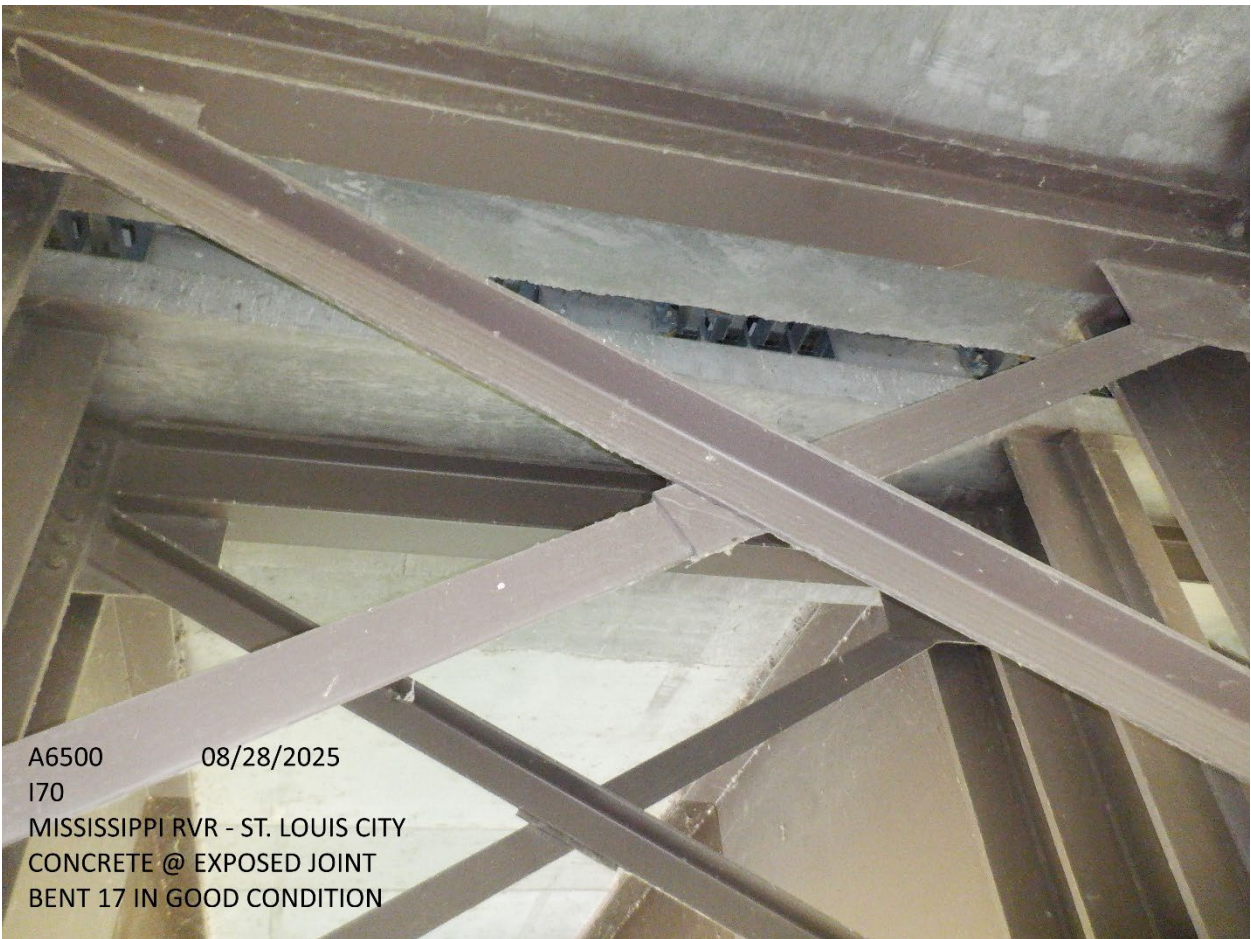
A6500 08/28/2025
I70
MISSISSIPPI RVR - ST. LOUIS CITY
CONCRETE @ EXPOSED JOINT
BENT 17 IN GOOD CONDITION

Pier 17 - replace elastomeric joint with finger joint. Blast and recoat under joints per specifications.

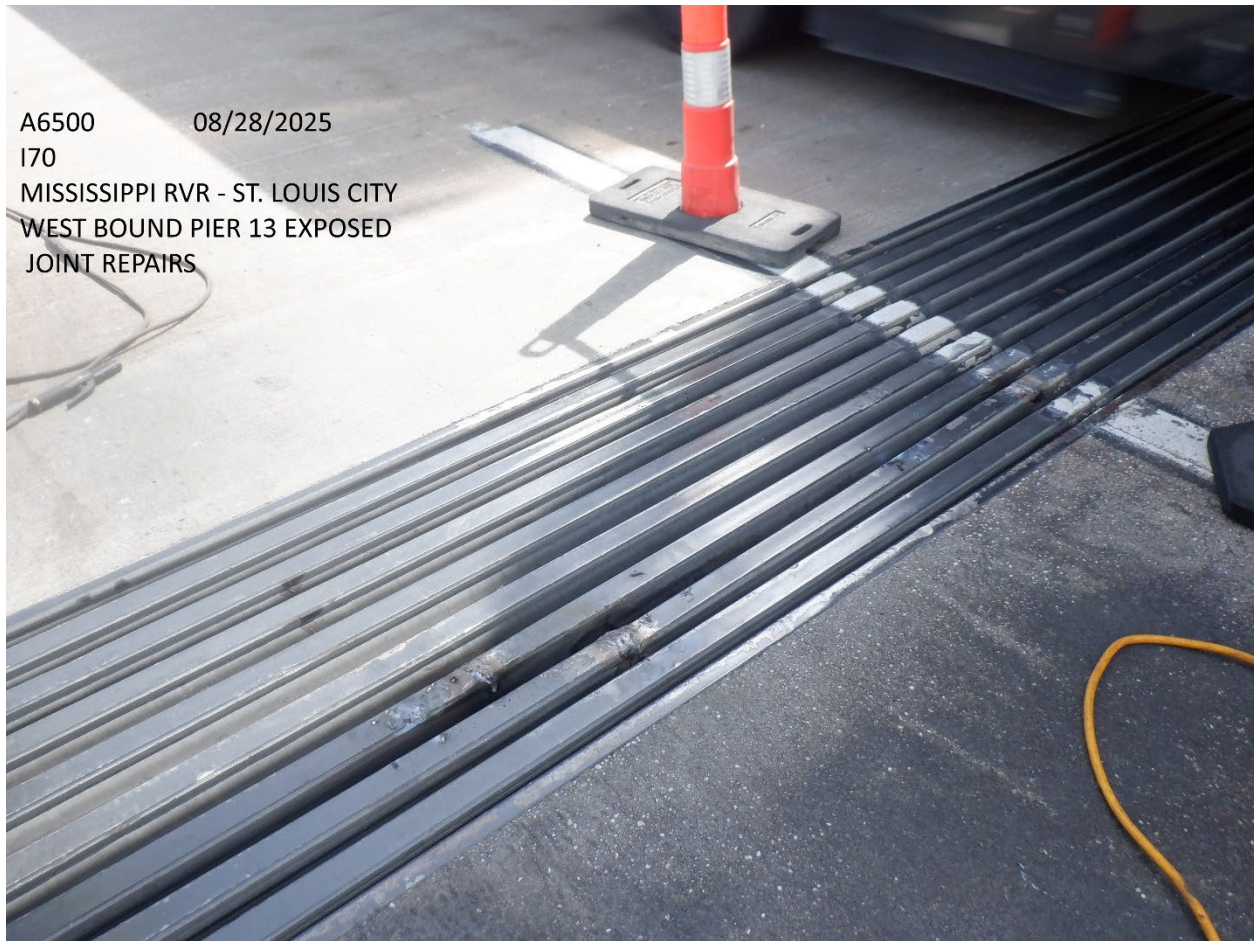
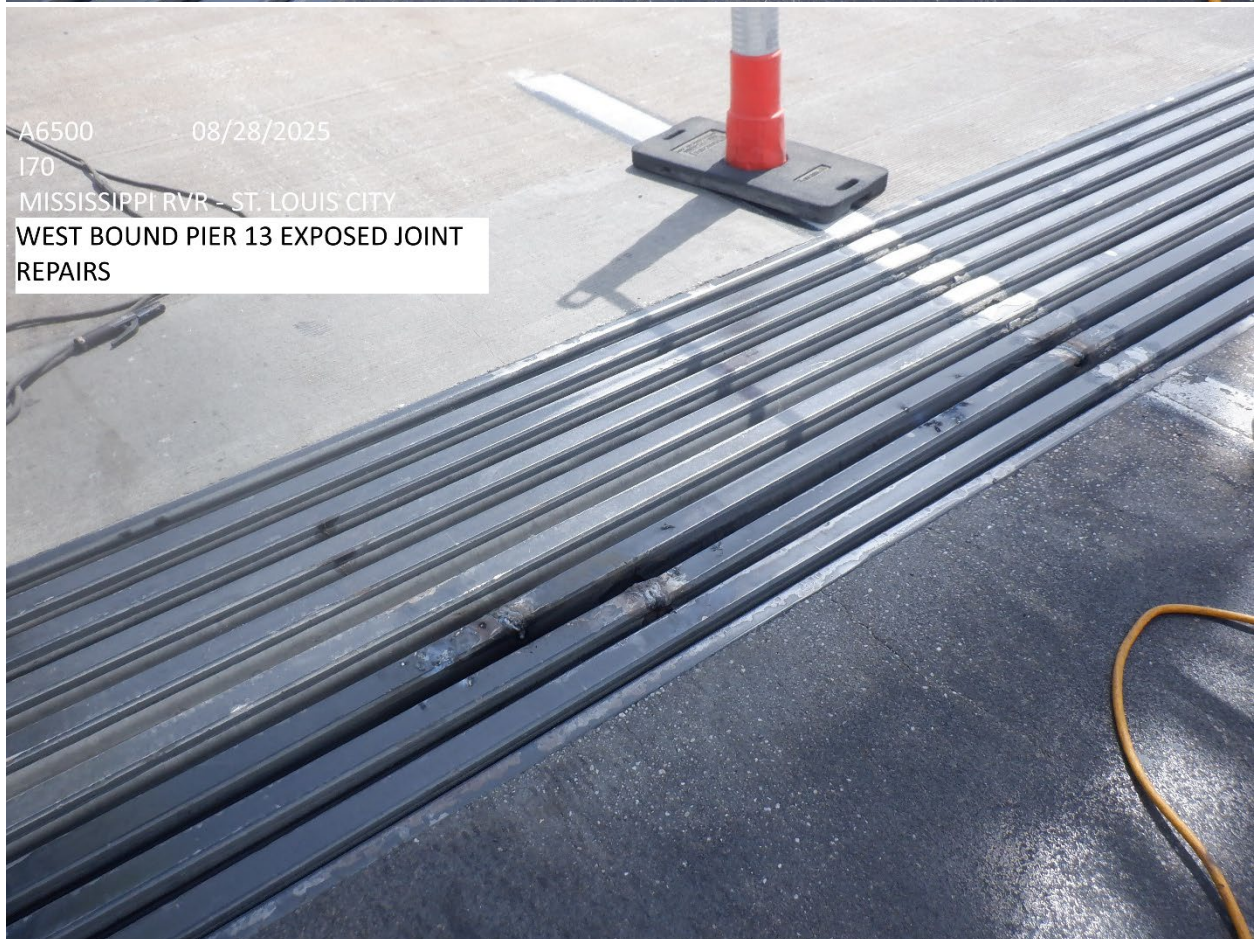
A6500 08/28/2025
170
MISSISSIPPI RVR - ST. LOUIS CITY
WEST BOUND PIER 13 EXPOSED
JOINT REPAIRS

* Notes: Replace flat plate with Waboflex joint. Pier 10 and 13 replace elastomeric with finger joint (similar to A1850).

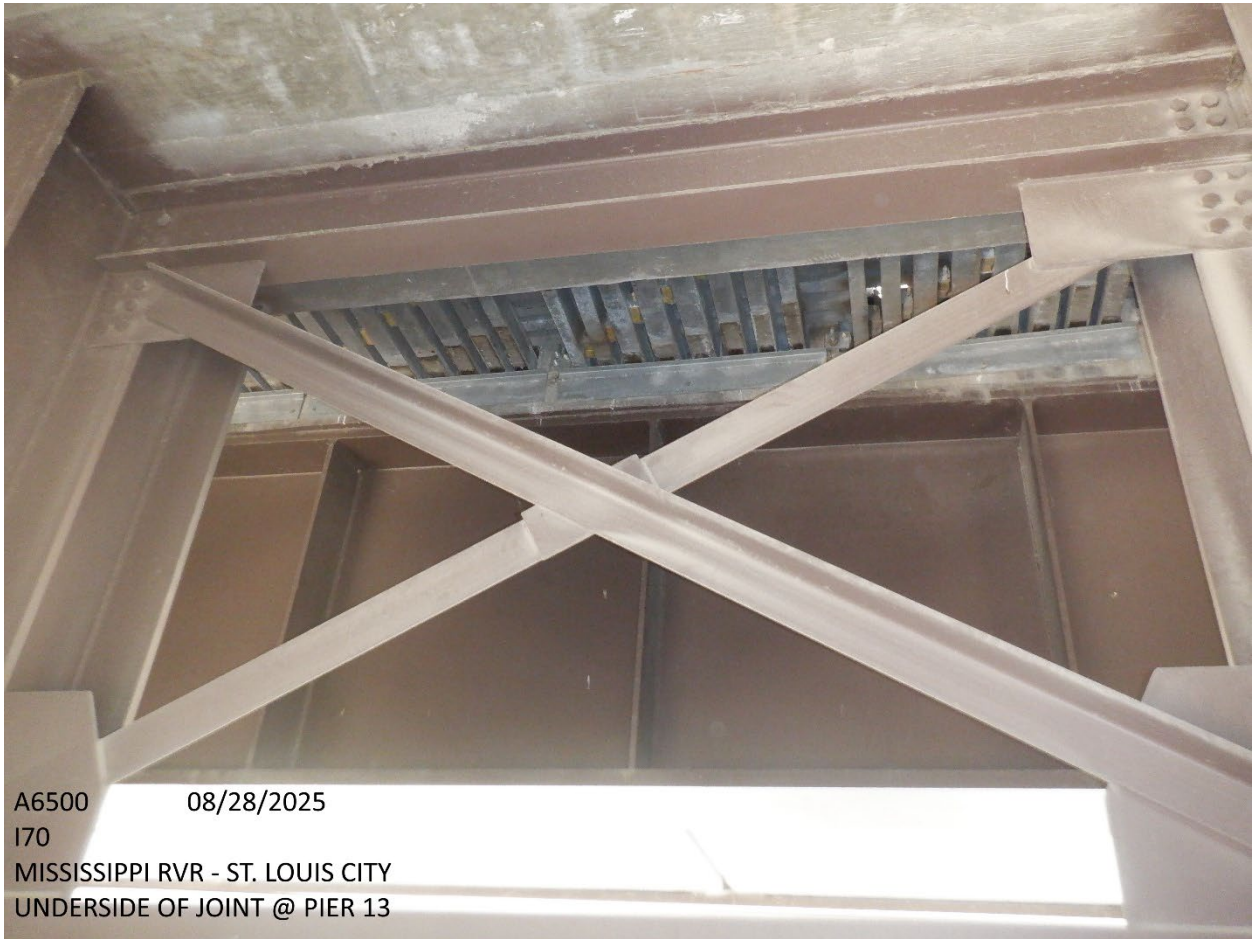
A6500 08/28/2025
I70
MISSISSIPPI RVR - ST. LOUIS CITY
UNDERSIDE OF JOINT @ PIER 13

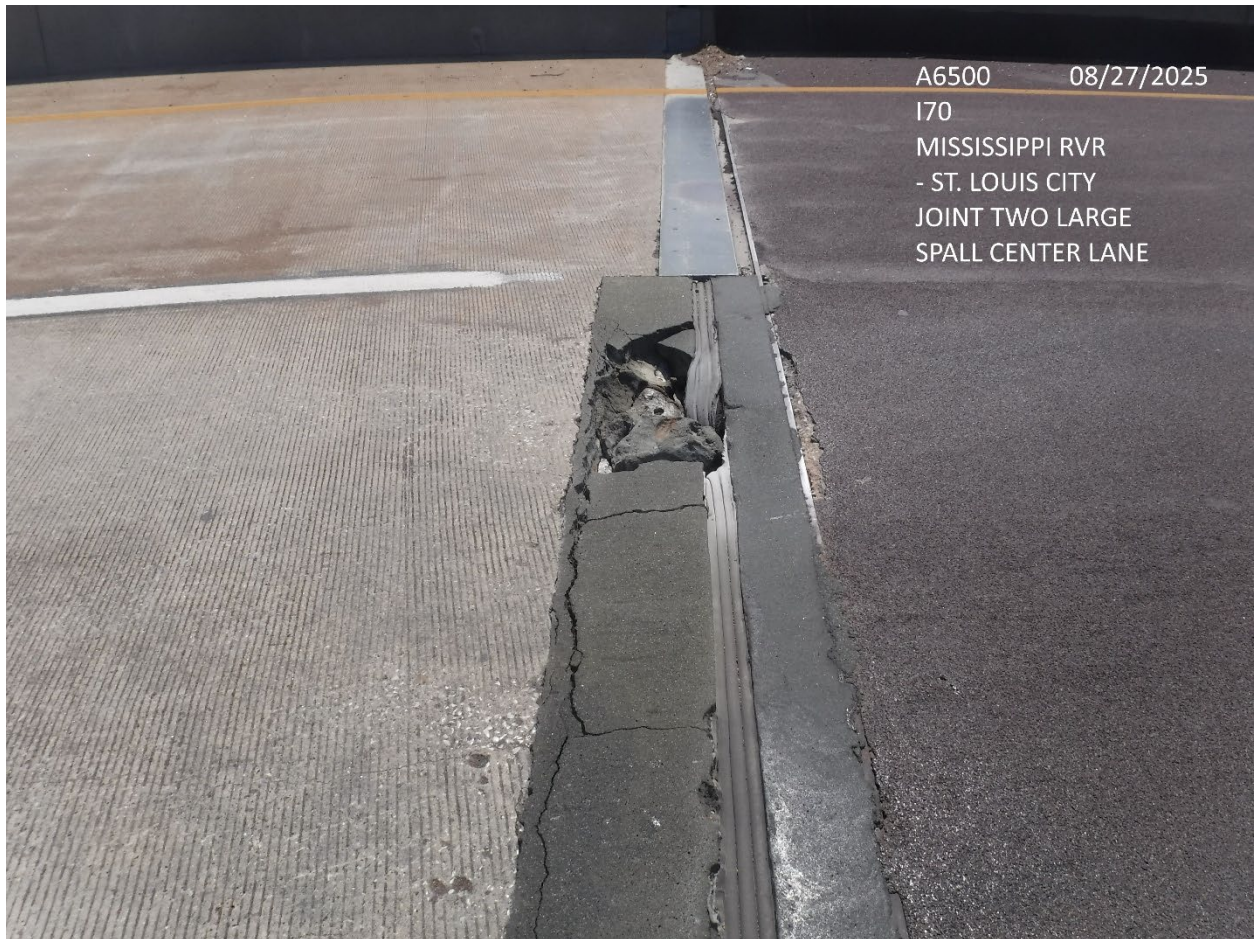
A6500 08/27/2025
I70
MISSISSIPPI RVR
- ST. LOUIS CITY
JOINT TWO LARGE
SPALL CENTER LANE
