Missouri Department of Transportation

STRUCTURAL REHABILITATION CHECKLIST

Bridge No.: **A6500**

Route: **I-70**

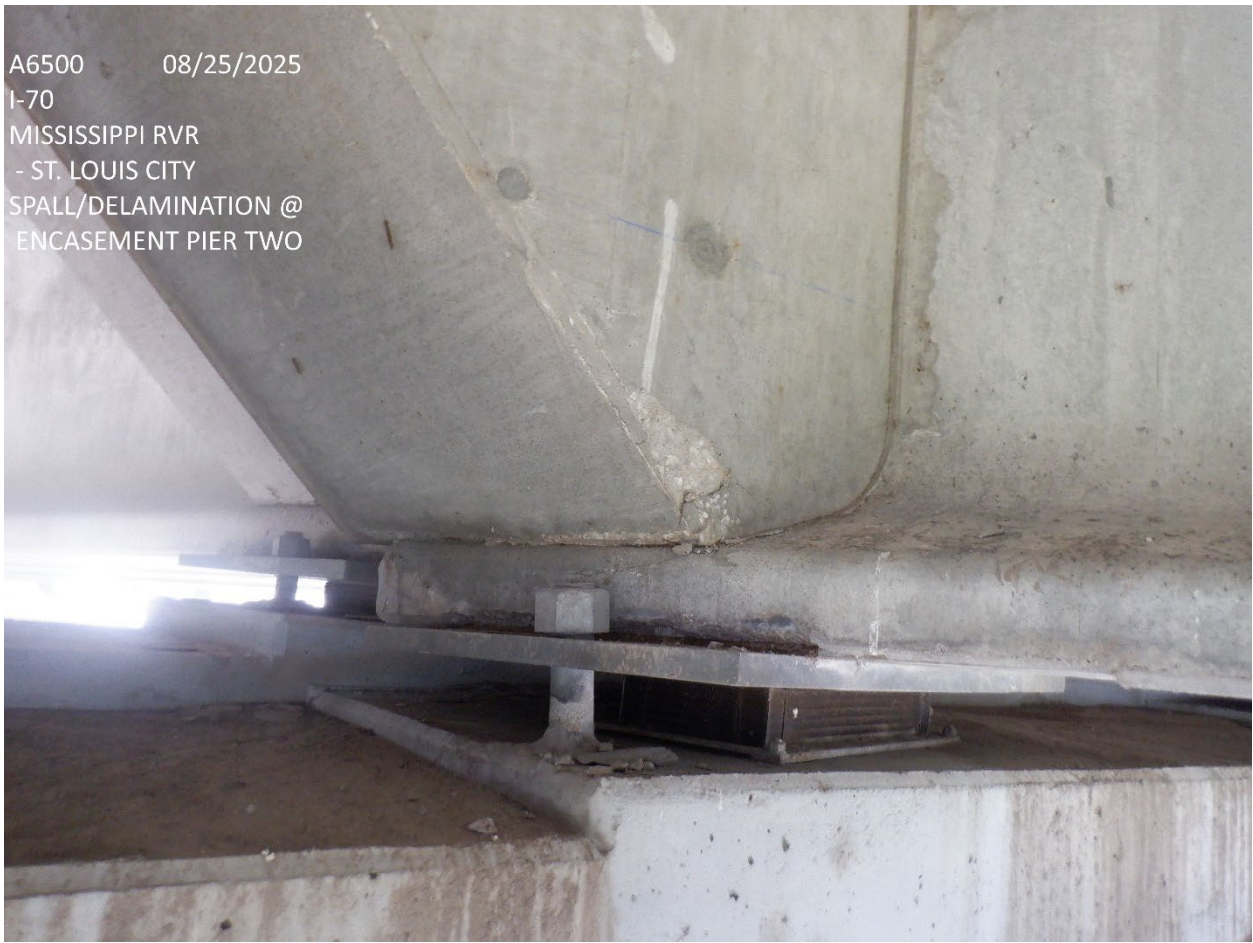
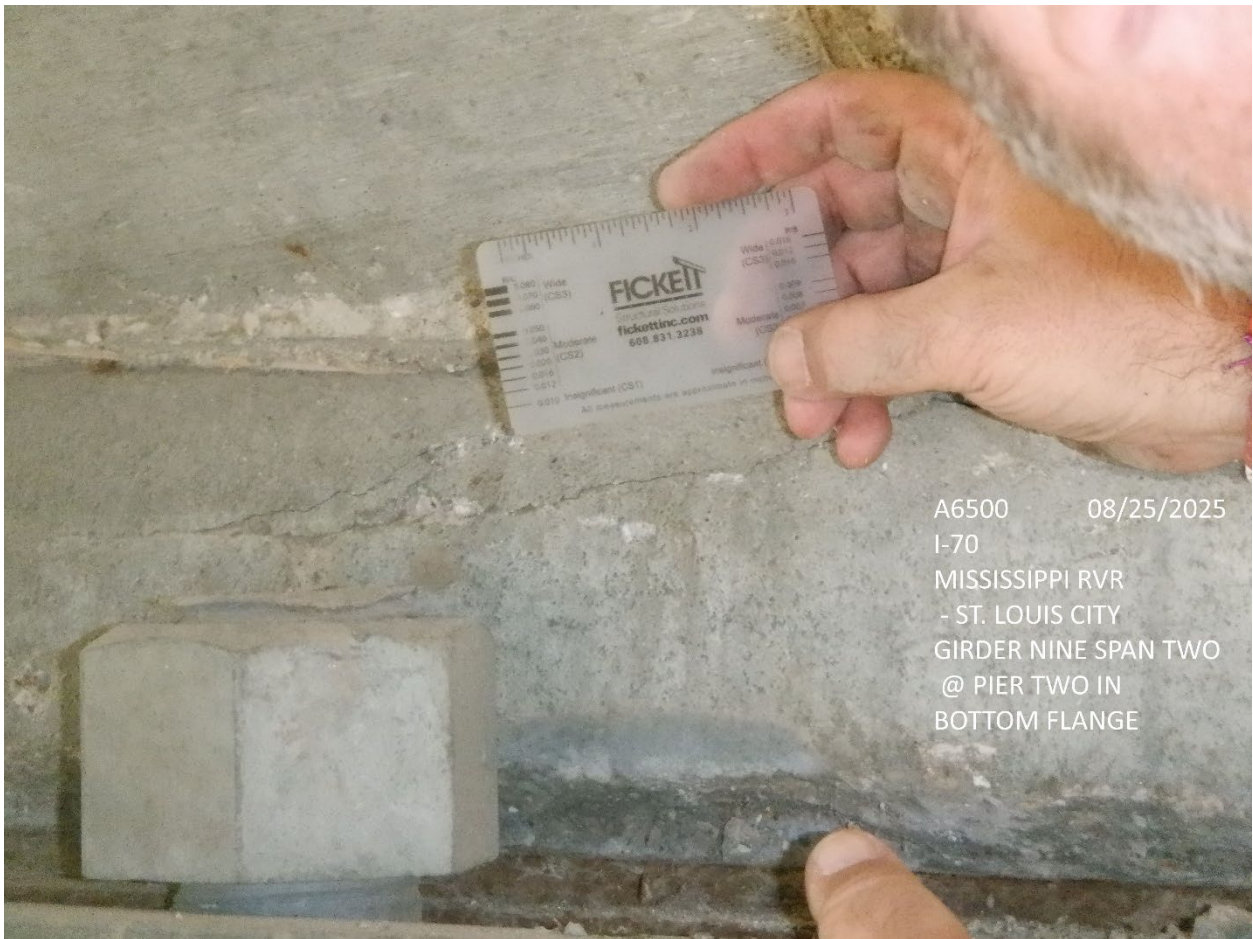
A6500 08/25/2025
I-70
MISSISSIPPI RVR
- ST. LOUIS CITY
GIRDER NINE SPAN TWO
@ PIER TWO IN
BOTTOM FLANGE

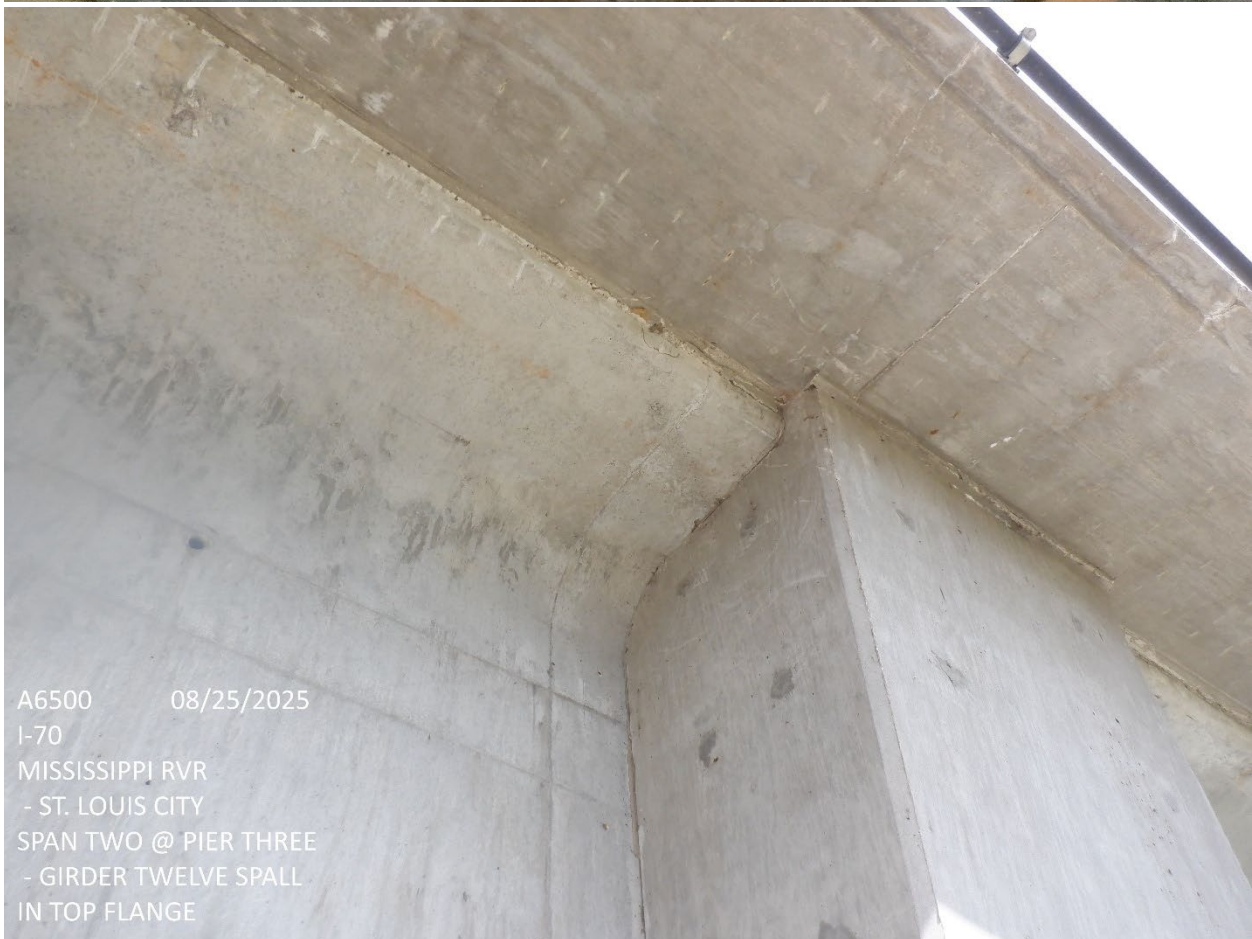
A6500 08/25/2025
I-70
MISSISSIPPI RVR
- ST. LOUIS CITY
SPAN TWO @ PIER THREE
- GIRDER TWELVE SPALL
IN TOP FLANGE

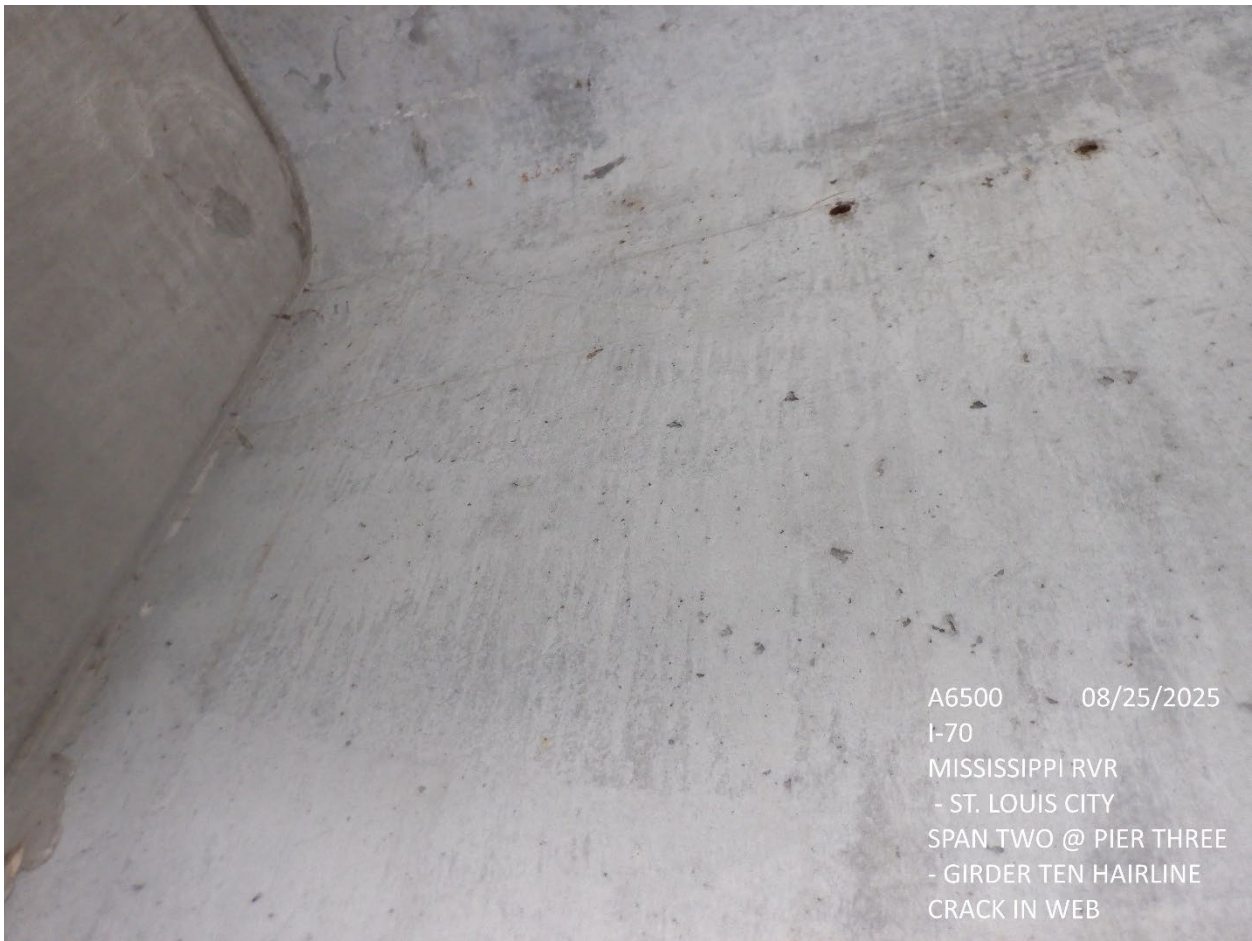
A6500 08/25/2025
I-70
MISSISSIPPI RVR
- ST. LOUIS CITY
SPAN TWO @ PIER THREE
- GIRDER TEN HAIRLINE
CRACK IN WEB

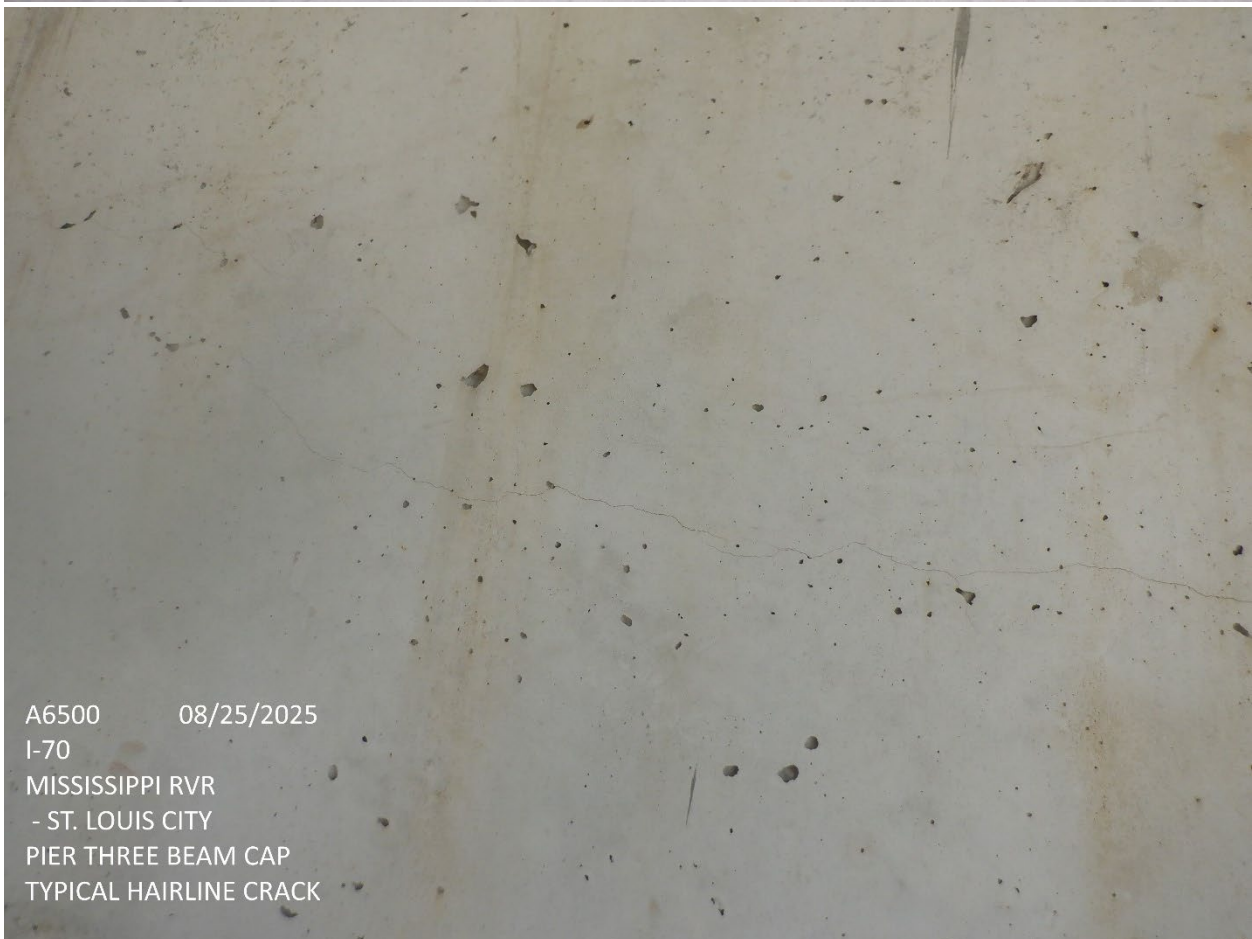
A6500 08/25/2025
I-70
MISSISSIPPI RVR
- ST. LOUIS CITY
PIER THREE BEAM CAP
TYPICAL HAIRLINE CRACK

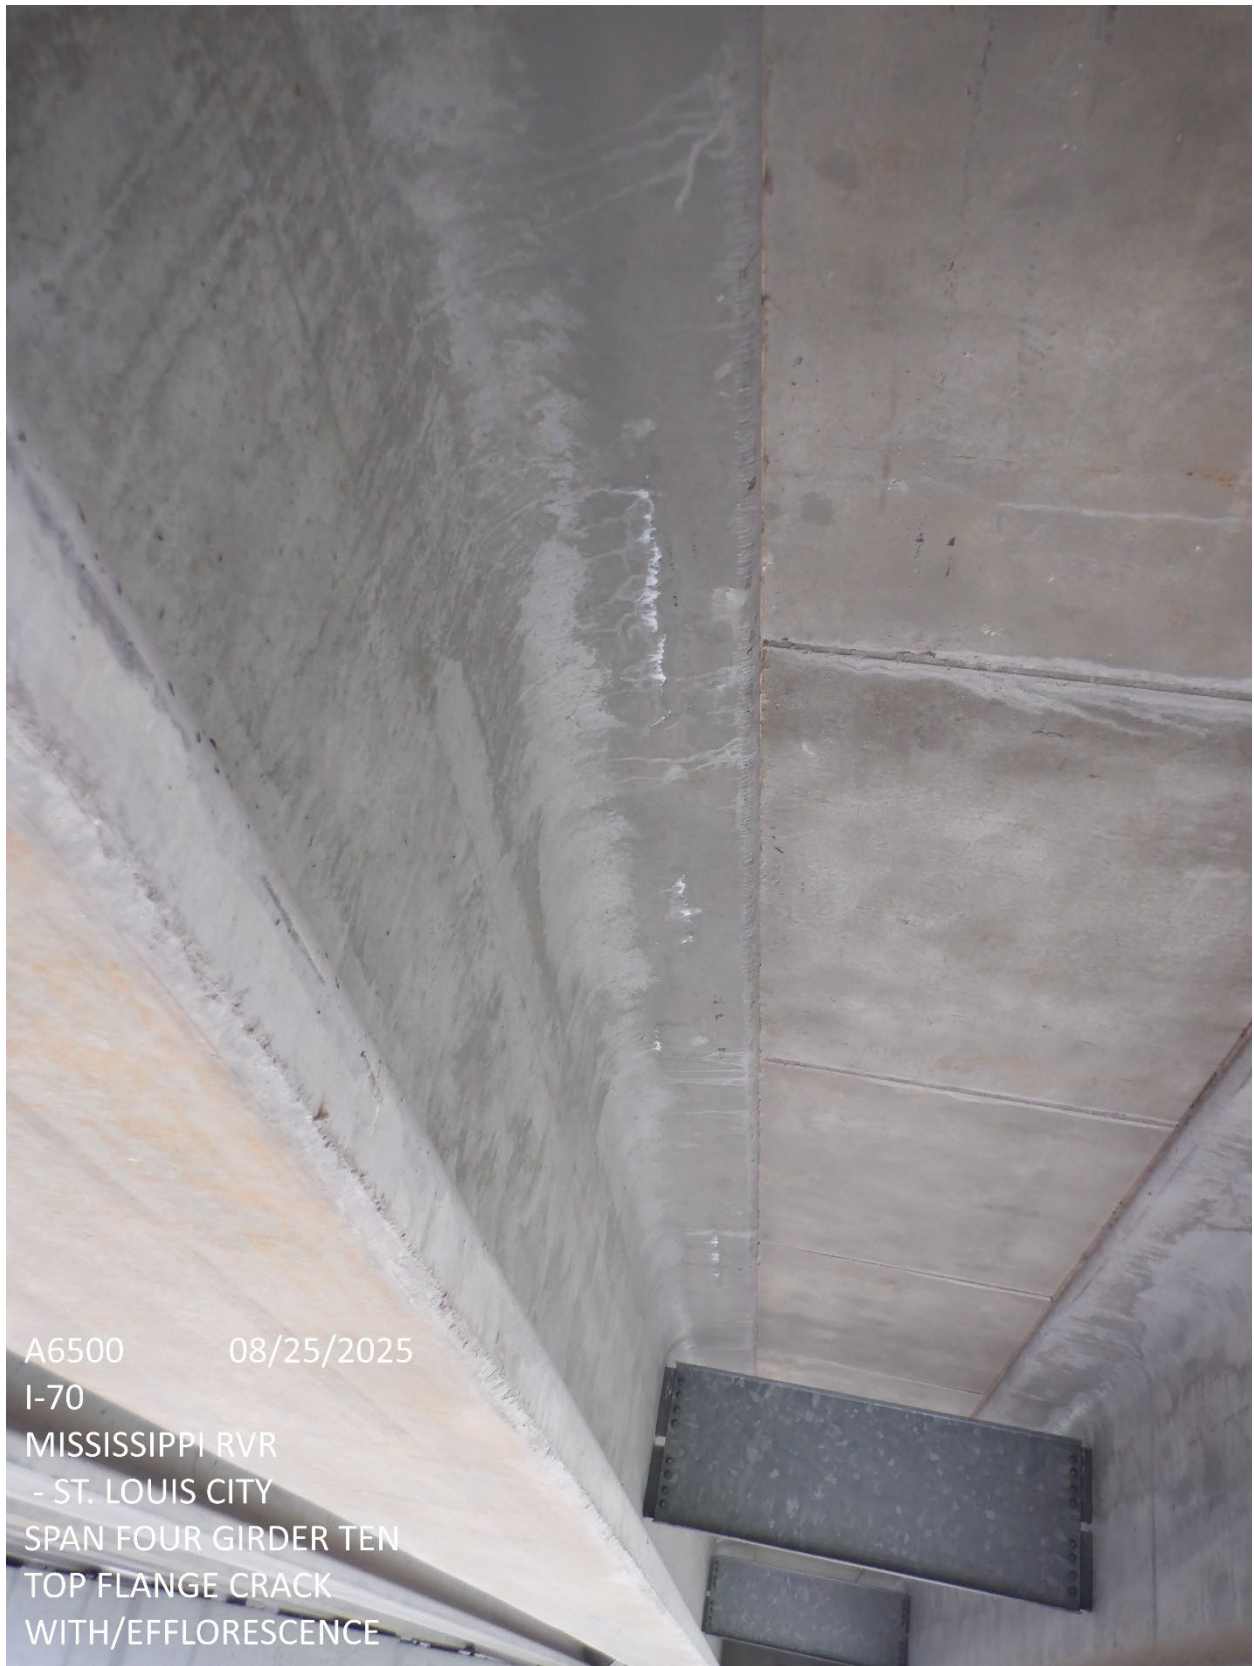
A6500 08/25/2025
I-70
MISSISSIPPI RVR
- ST. LOUIS CITY
SPAN FOUR GIRDER TEN
TOP FLANGE CRACK
WITH/EFFLORESCENCE

Chip and seal girder ends. Span 4 girder 10: epoxy inject 10'
Span 4 girder 11: epoxy inject 2' crack. 200SF concrete repair at
girder encasement delaminations

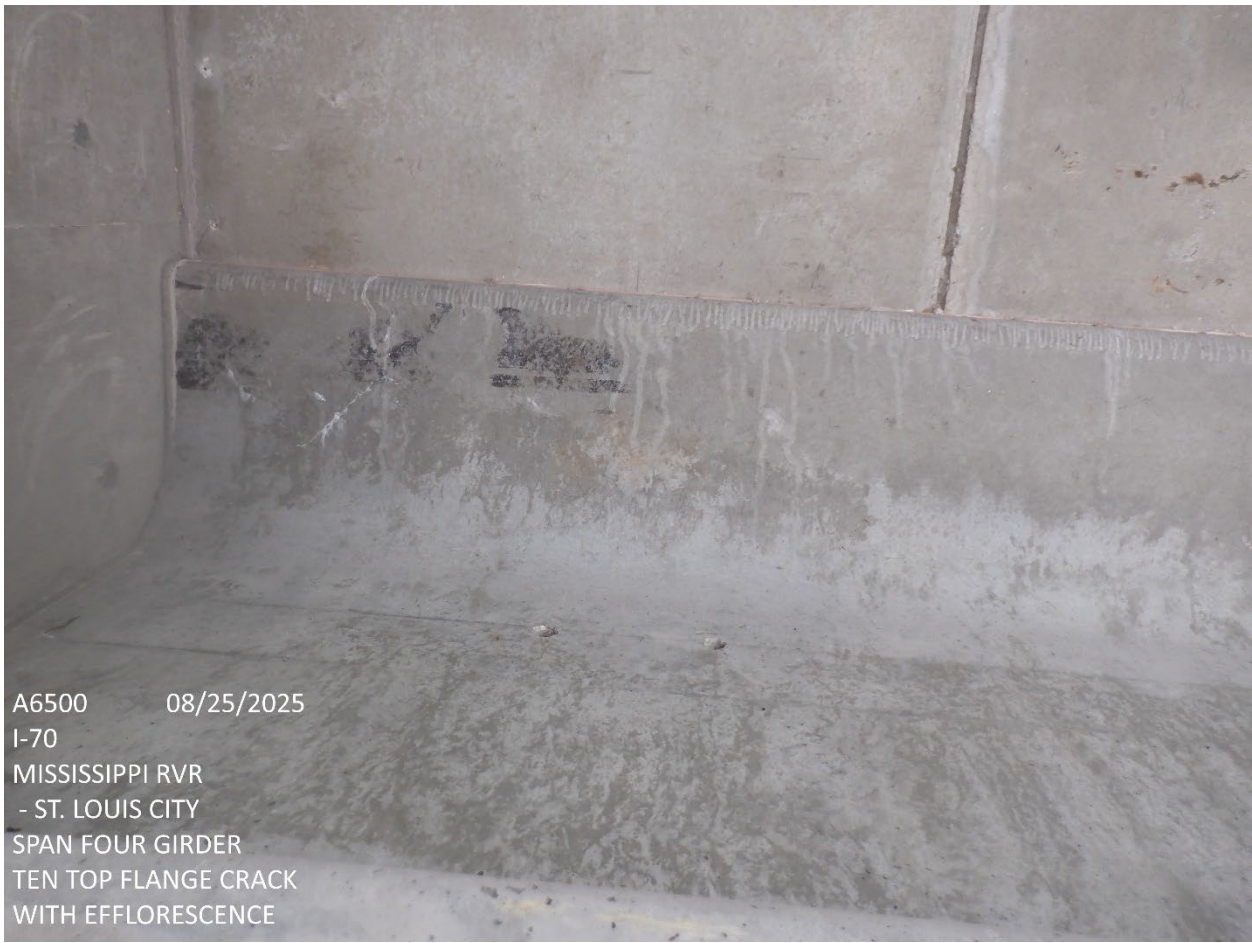
A6500 08/25/2025
I-70
MISSISSIPPI RVR
- ST. LOUIS CITY
SPAN FOUR GIRDER
TEN TOP FLANGE CRACK
WITH EFFLORESCENCE

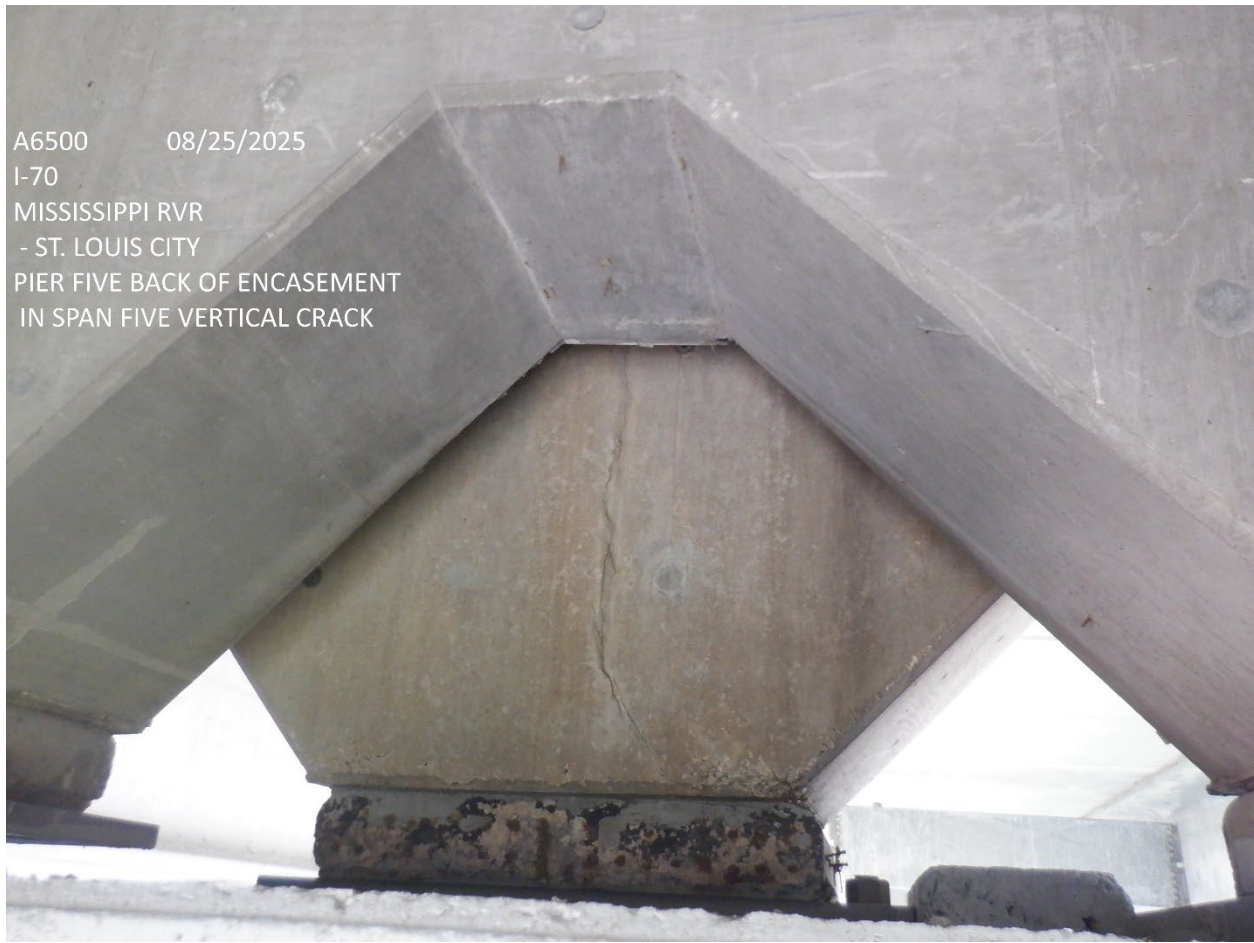
A6500 08/25/2025
I-70
MISSISSIPPI RVR
- ST. LOUIS CITY
PIER FIVE BACK OF ENCASEMENT
IN SPAN FIVE VERTICAL CRACK

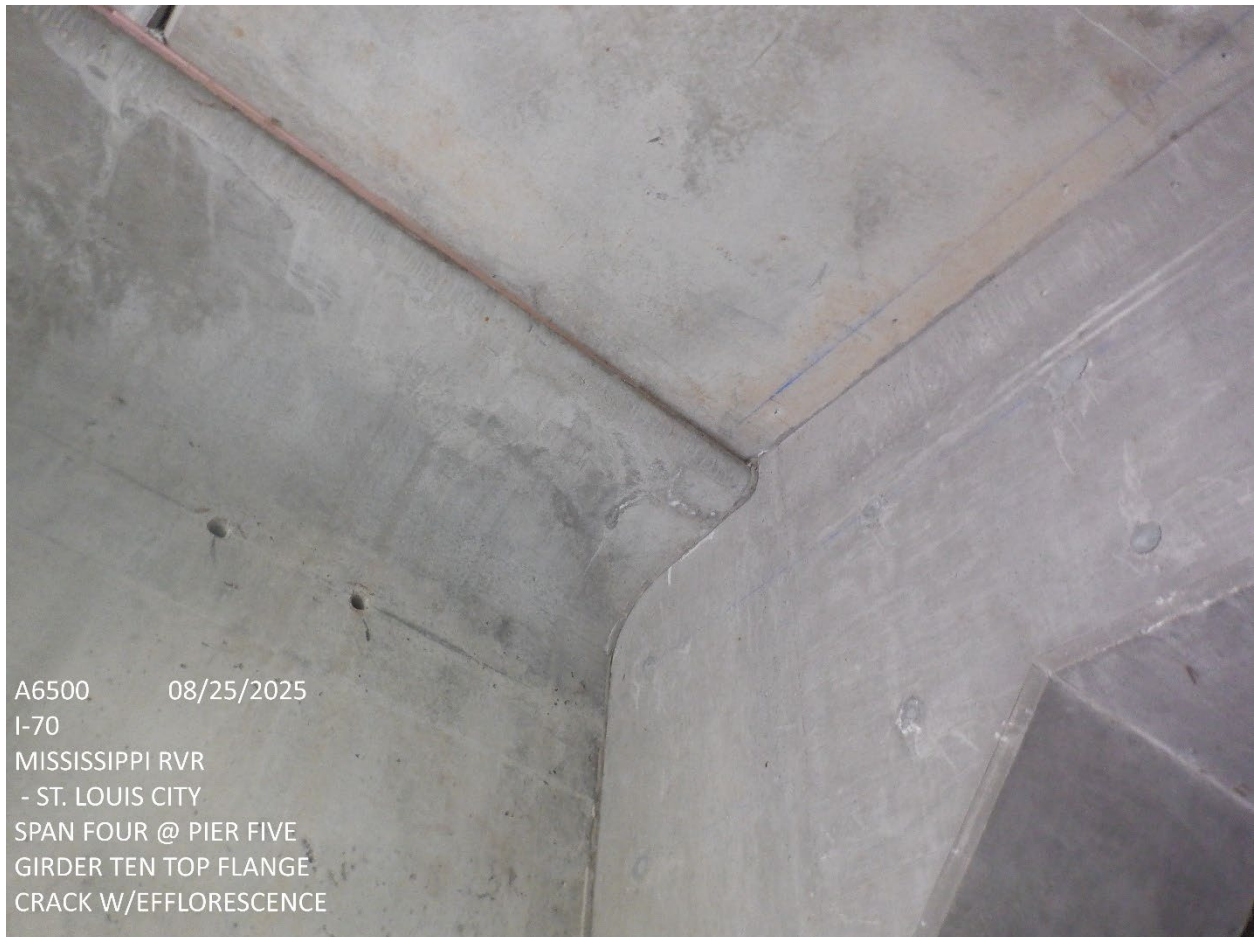
A6500 08/25/2025
I-70
MISSISSIPPI RVR
- ST. LOUIS CITY
SPAN FOUR @ PIER FIVE
GIRDER TEN TOP FLANGE
CRACK W/EFFLORESCENCE

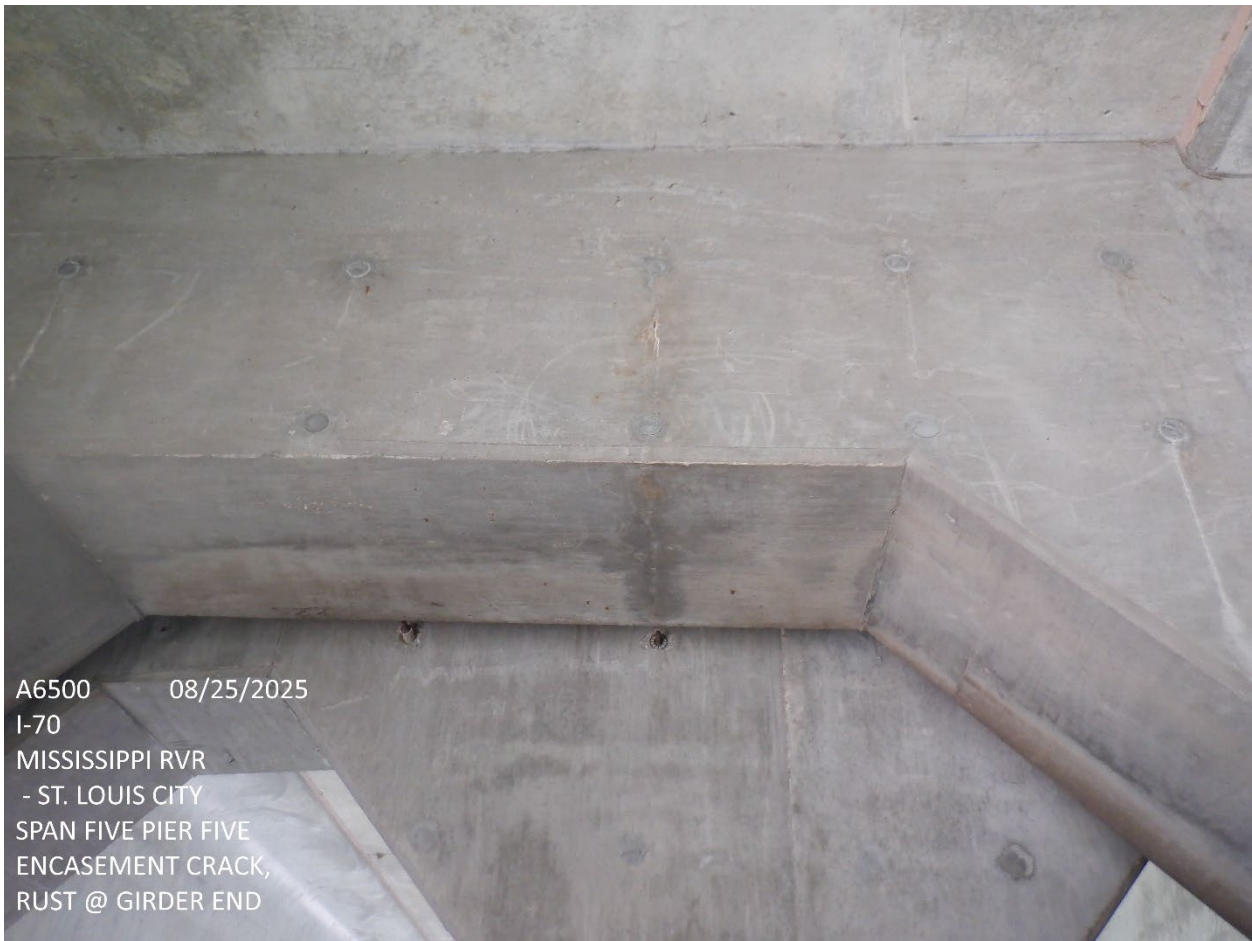
A6500 08/25/2025
I-70
MISSISSIPPI RVR
- ST. LOUIS CITY
SPAN FIVE PIER FIVE
ENCASEMENT CRACK,
RUST @ GIRDER END

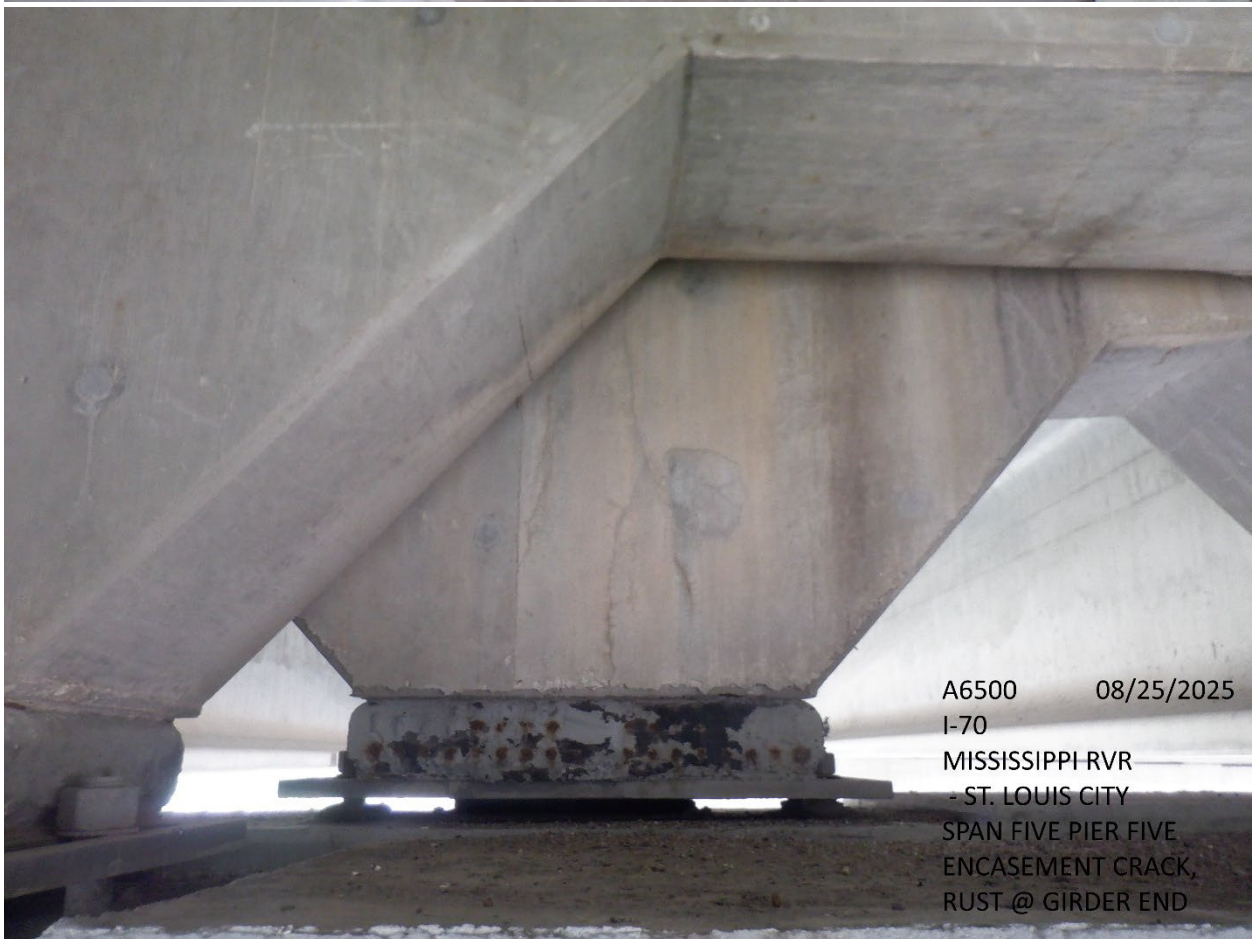
A6500 08/25/2025
I-70
MISSISSIPPI RVR
- ST. LOUIS CITY
SPAN FIVE PIER FIVE
ENCASEMENT CRACK,
RUST @ GIRDER END

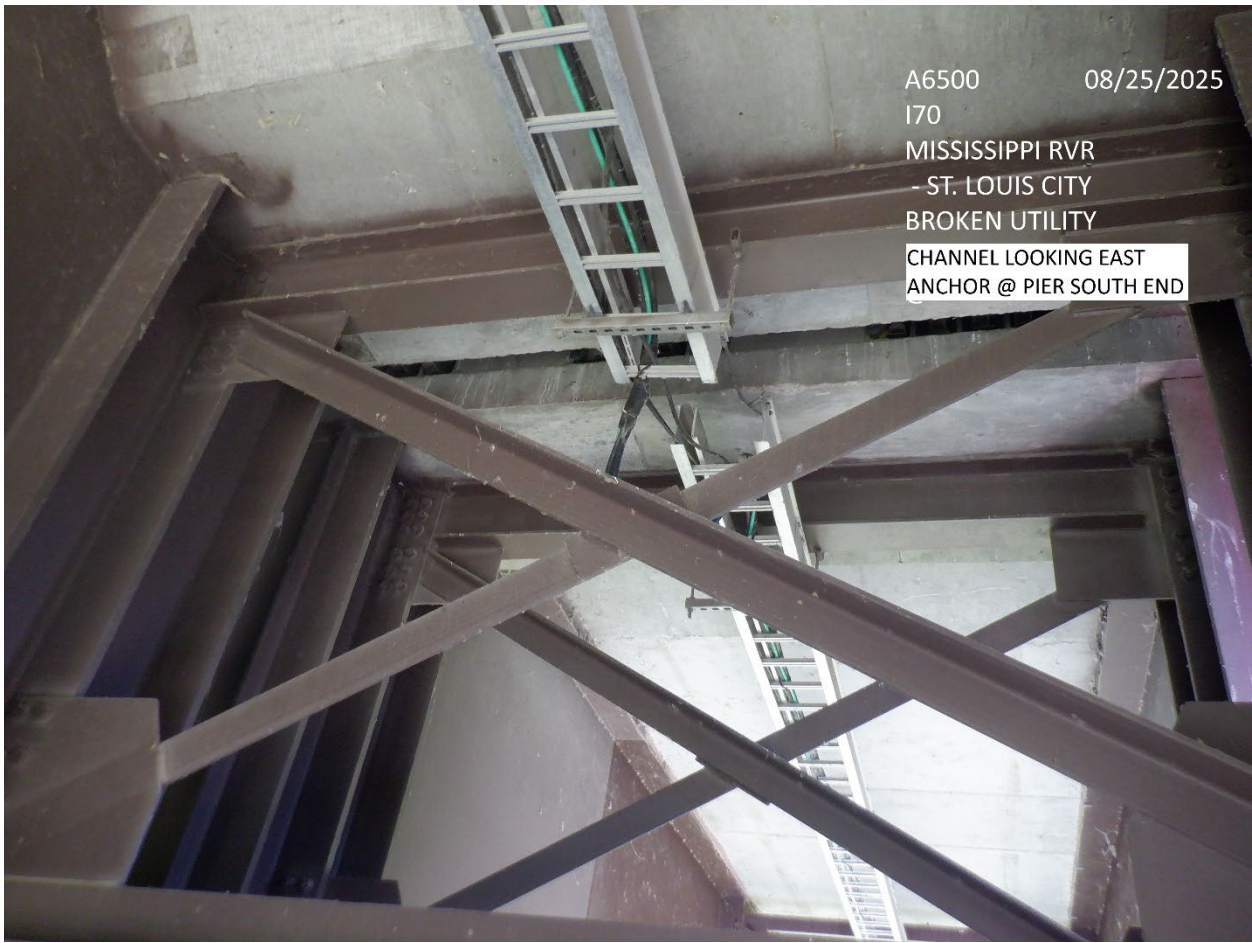
A6500 08/25/2025
I70
MISSISSIPPI RVR
- ST. LOUIS CITY
BROKEN UTILITY
CHANNEL LOOKING EAST
ANCHOR @ PIER SOUTH END

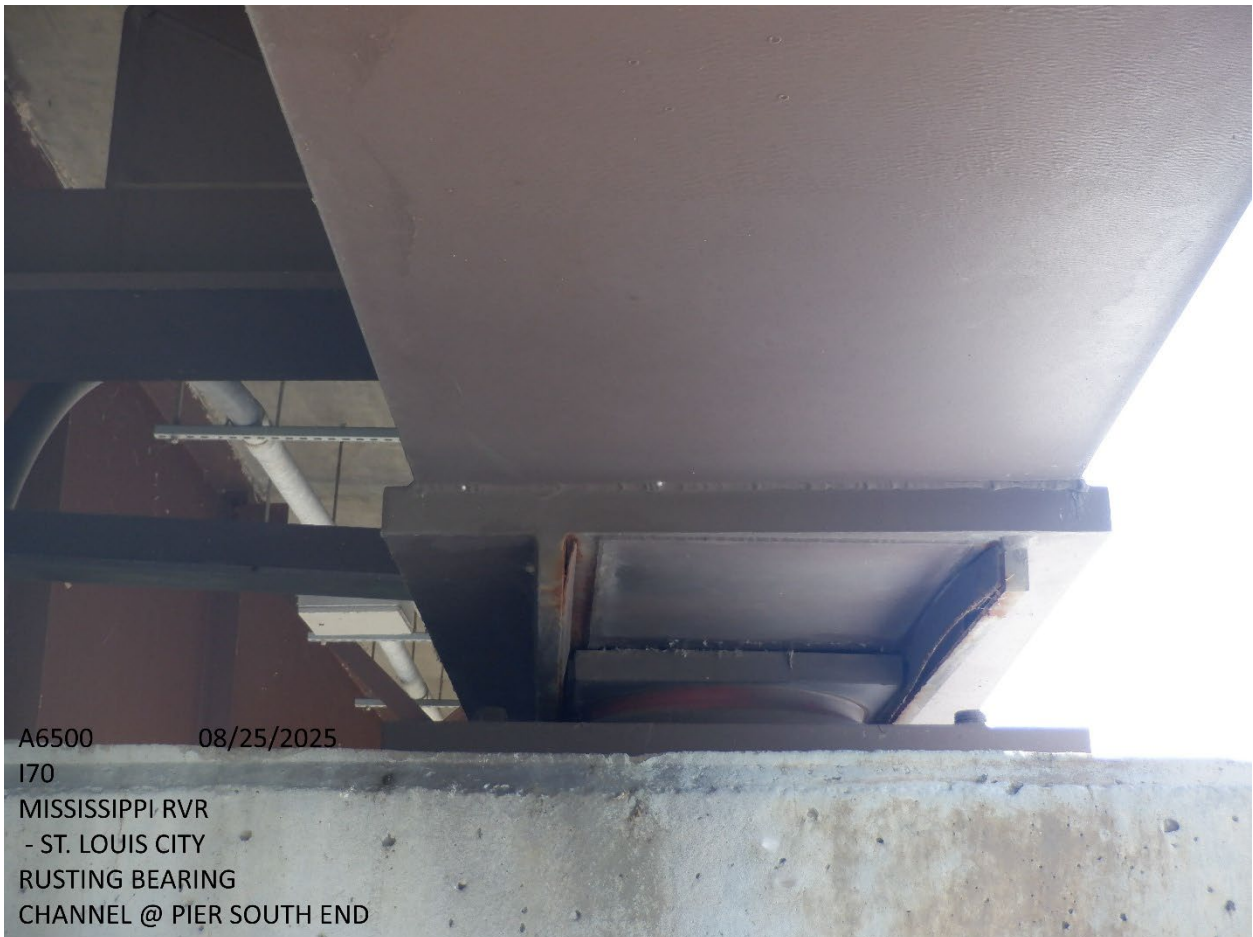
A6500 08/25/2025
I70
MISSISSIPPI RVR
- ST. LOUIS CITY
RUSTING BEARING
CHANNEL @ PIER SOUTH END

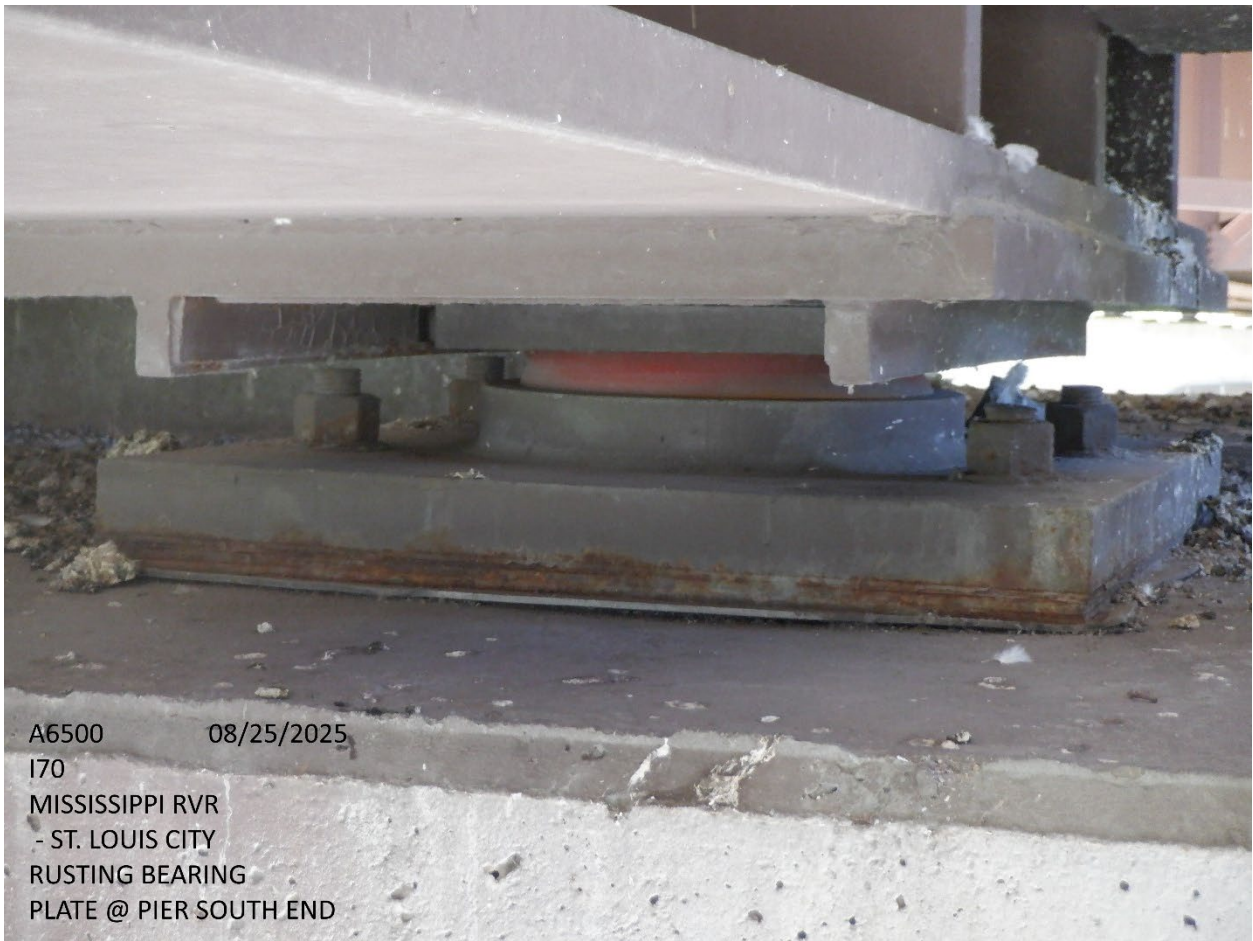
A6500 08/25/2025
I70
MISSISSIPPI RVR
- ST. LOUIS CITY
RUSTING BEARING
PLATE @ PIER SOUTH END

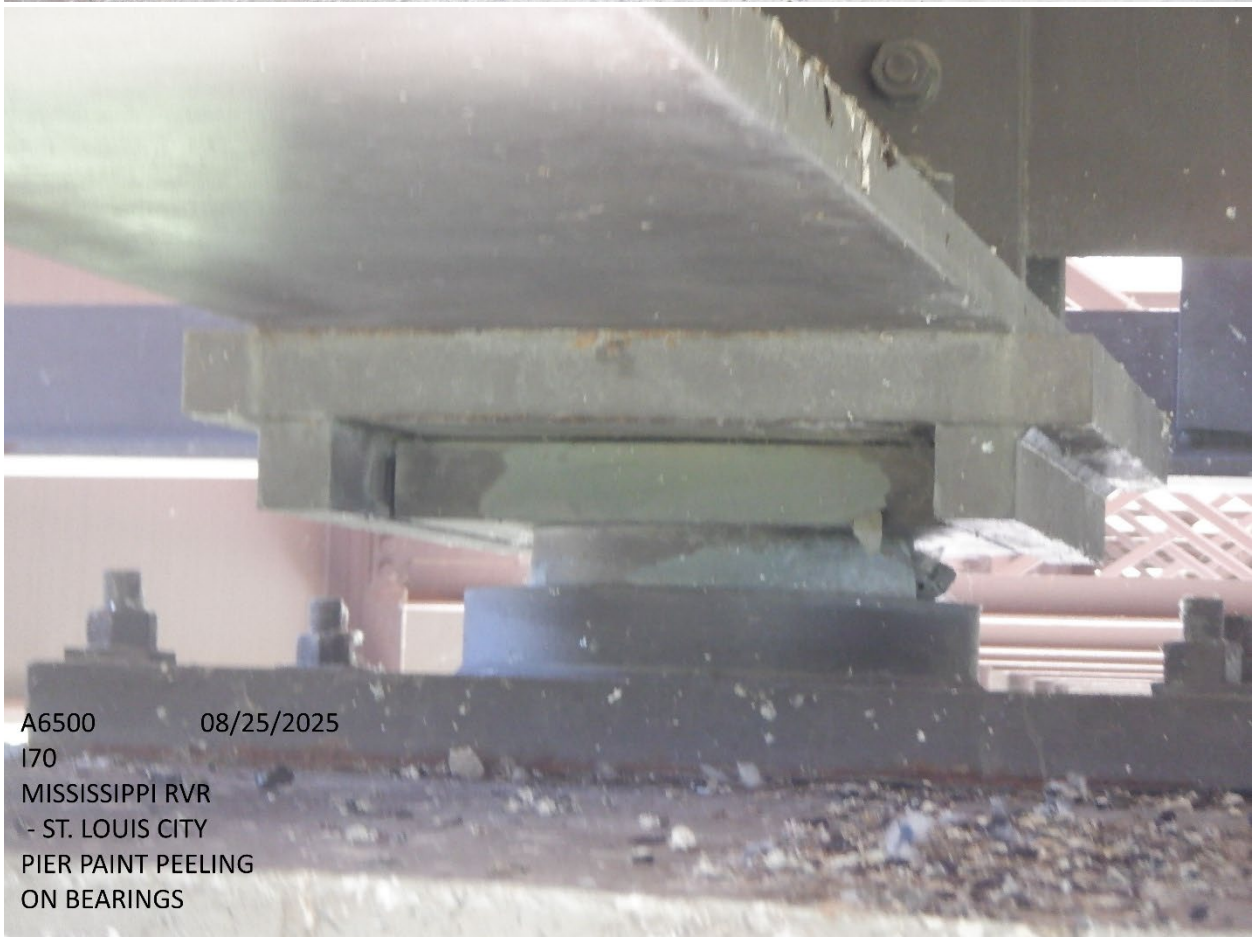
A6500 08/25/2025
I70
MISSISSIPPI RVR
- ST. LOUIS CITY
PIER PAINT PEELING
ON BEARINGS

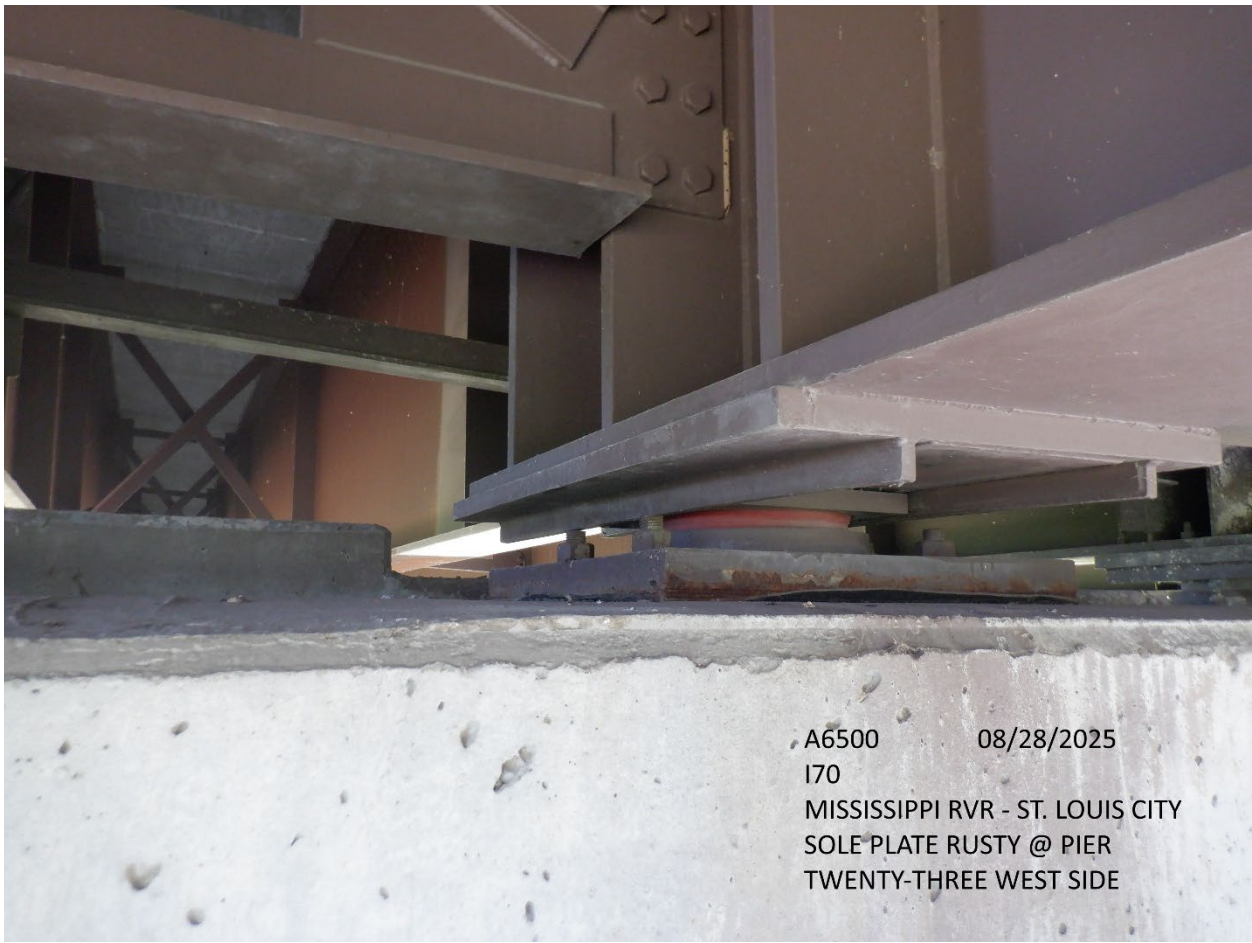
A6500 08/28/2025
I70
MISSISSIPPI RVR - ST. LOUIS CITY
SOLE PLATE RUSTY @ PIER
TWENTY-THREE WEST SIDE

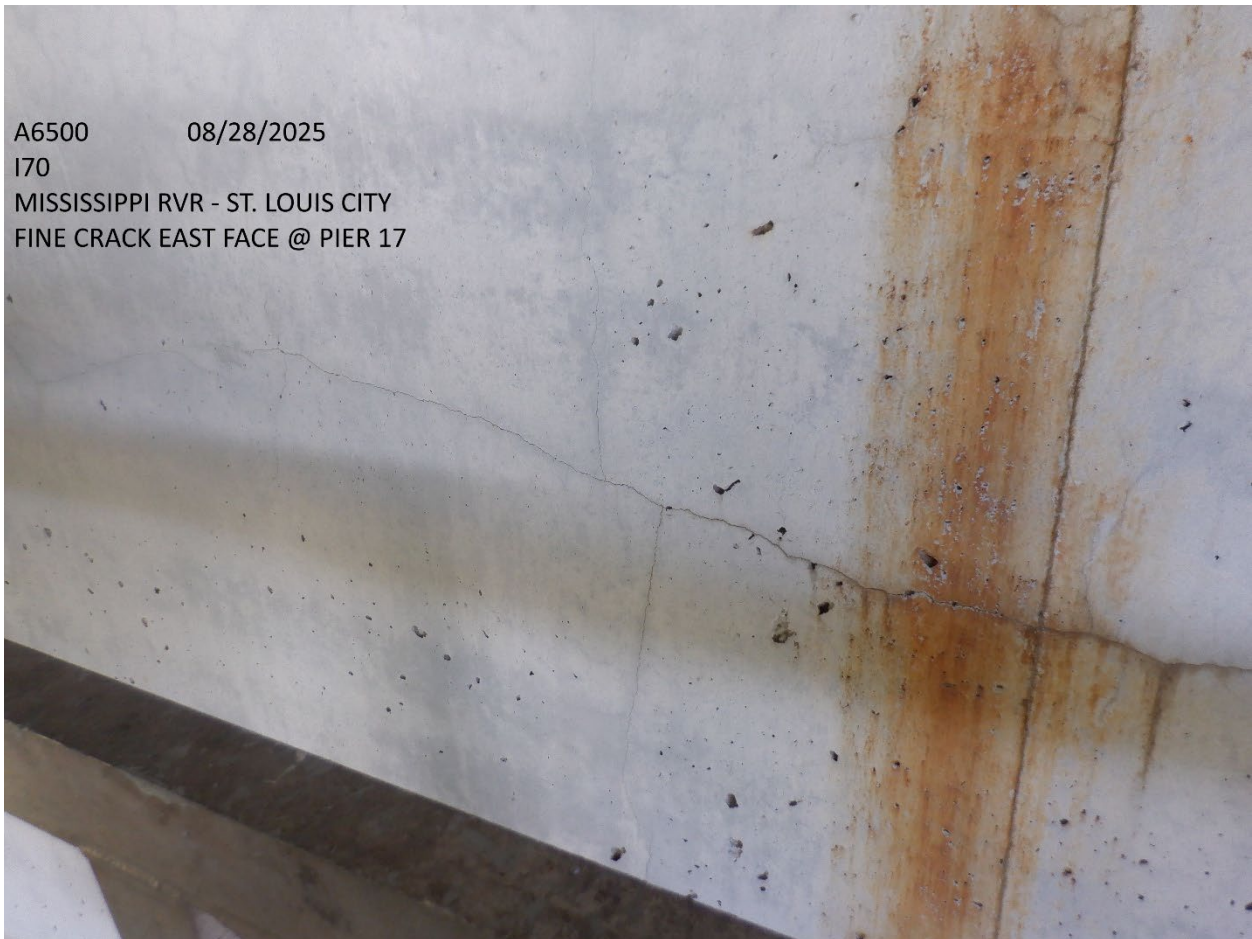
A6500 08/28/2025
I70
MISSISSIPPI RVR - ST. LOUIS CITY
FINE CRACK EAST FACE @ PIER 17

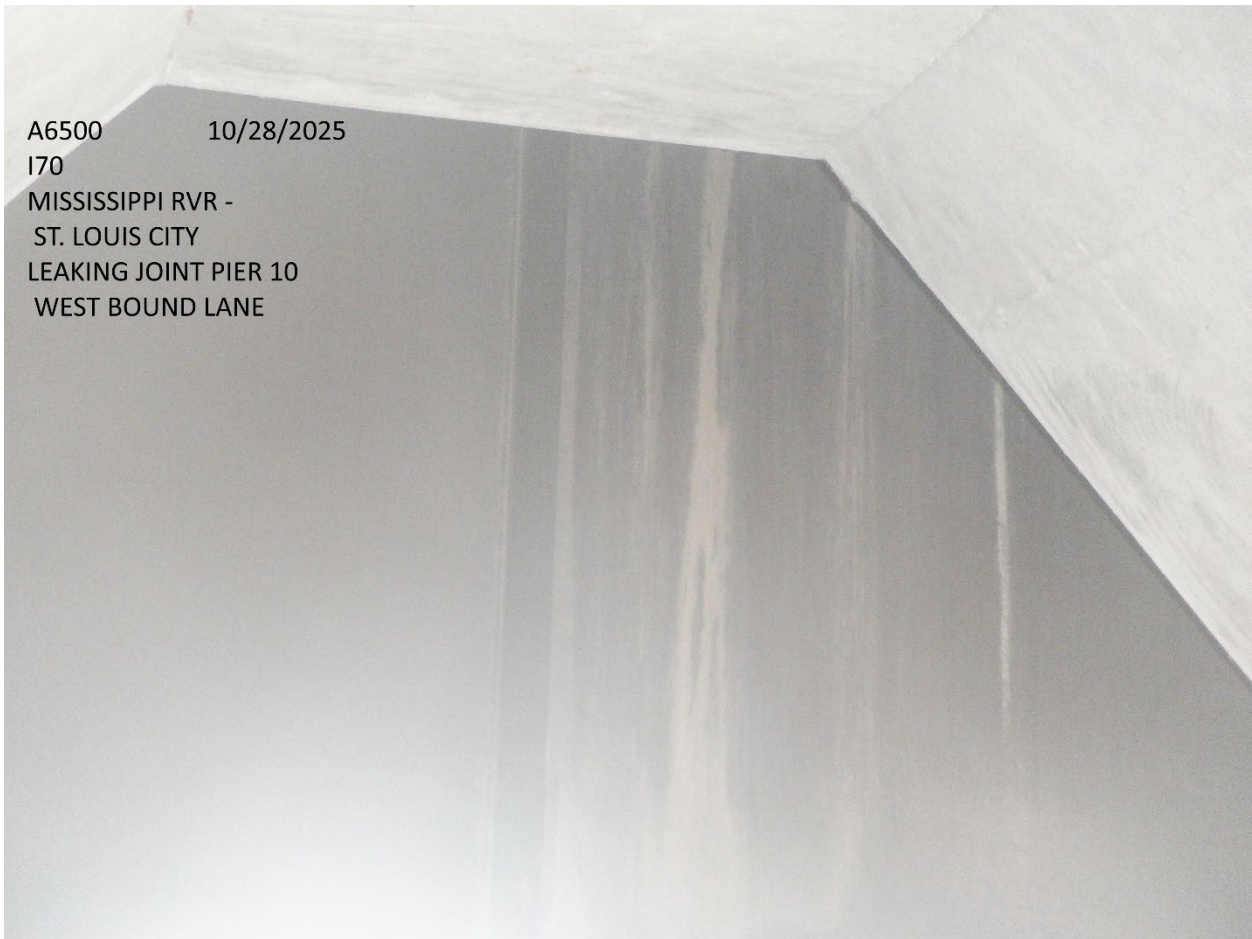
A6500 10/28/2025
I70
MISSISSIPPI RVR -
ST. LOUIS CITY
LEAKING JOINT PIER 10
WEST BOUND LANE
