Missouri Department of Transportation

STRUCTURAL REHABILITATION CHECKLIST

Bridge No.: **A6500**

Route: **I-70**

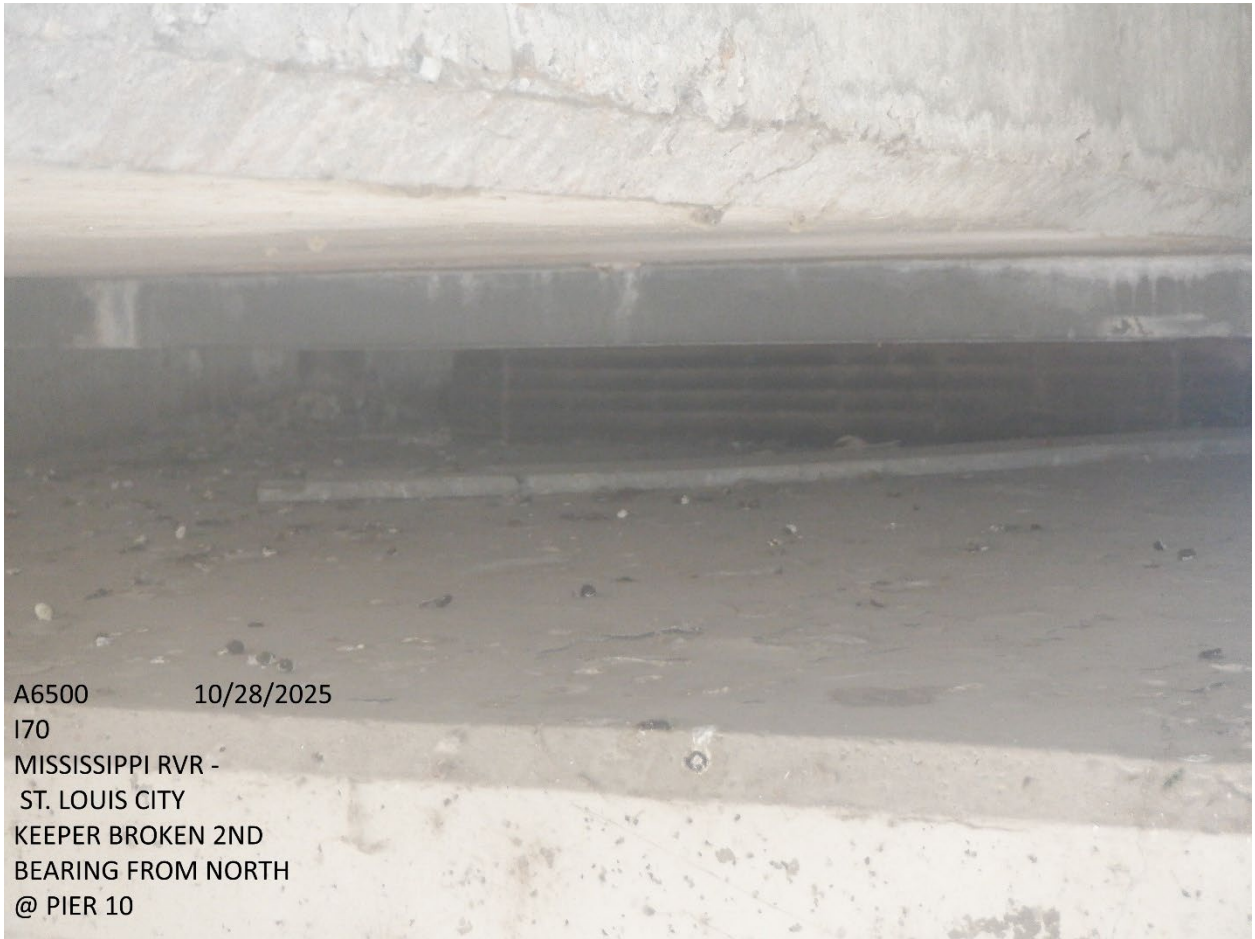
A6500 10/28/2025
I70
MISSISSIPPI RVR -
ST. LOUIS CITY
KEEPER BROKEN 2ND
BEARING FROM NORTH
@ PIER 10

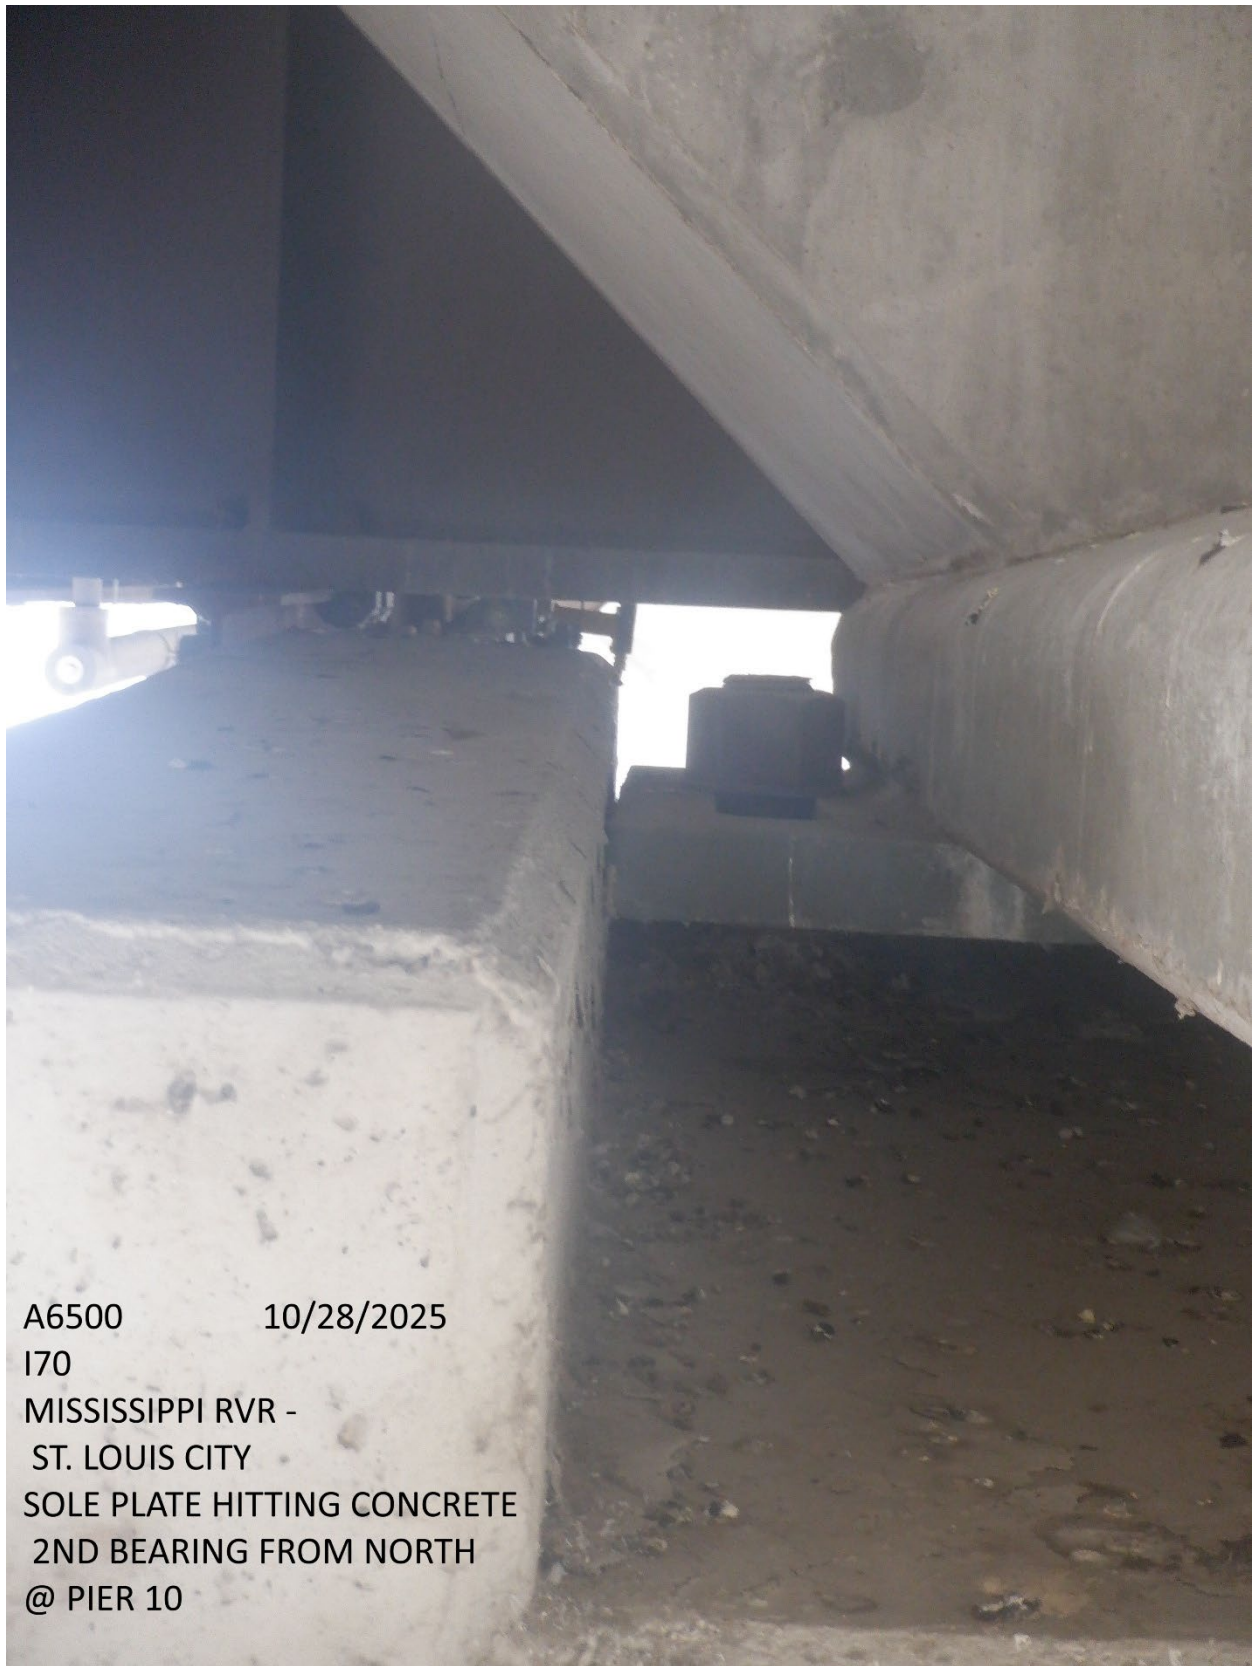
A6500 10/28/2025
I70
MISSISSIPPI RVR -
ST. LOUIS CITY
SOLE PLATE HITTING CONCRETE
2ND BEARING FROM NORTH
@ PIER 10

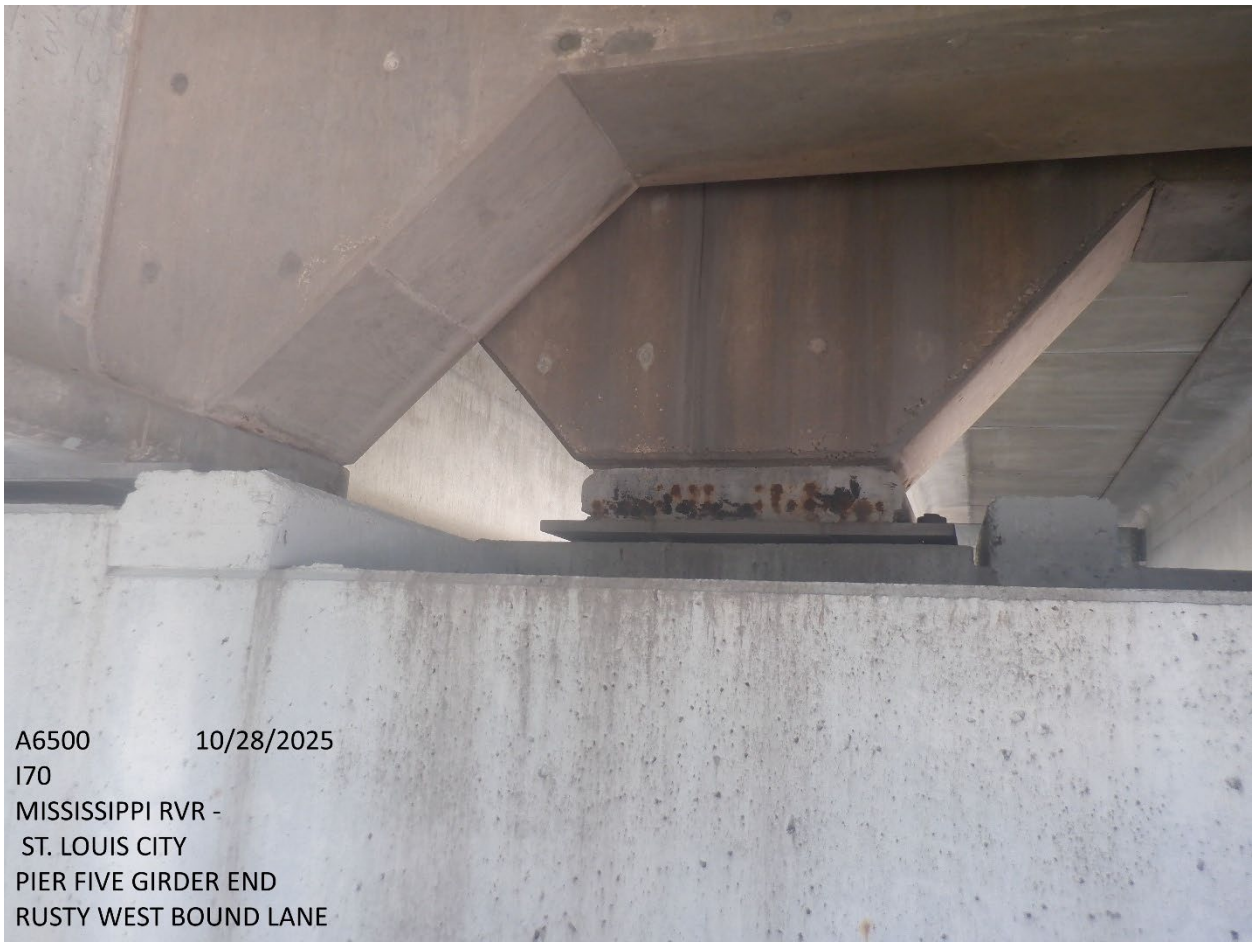
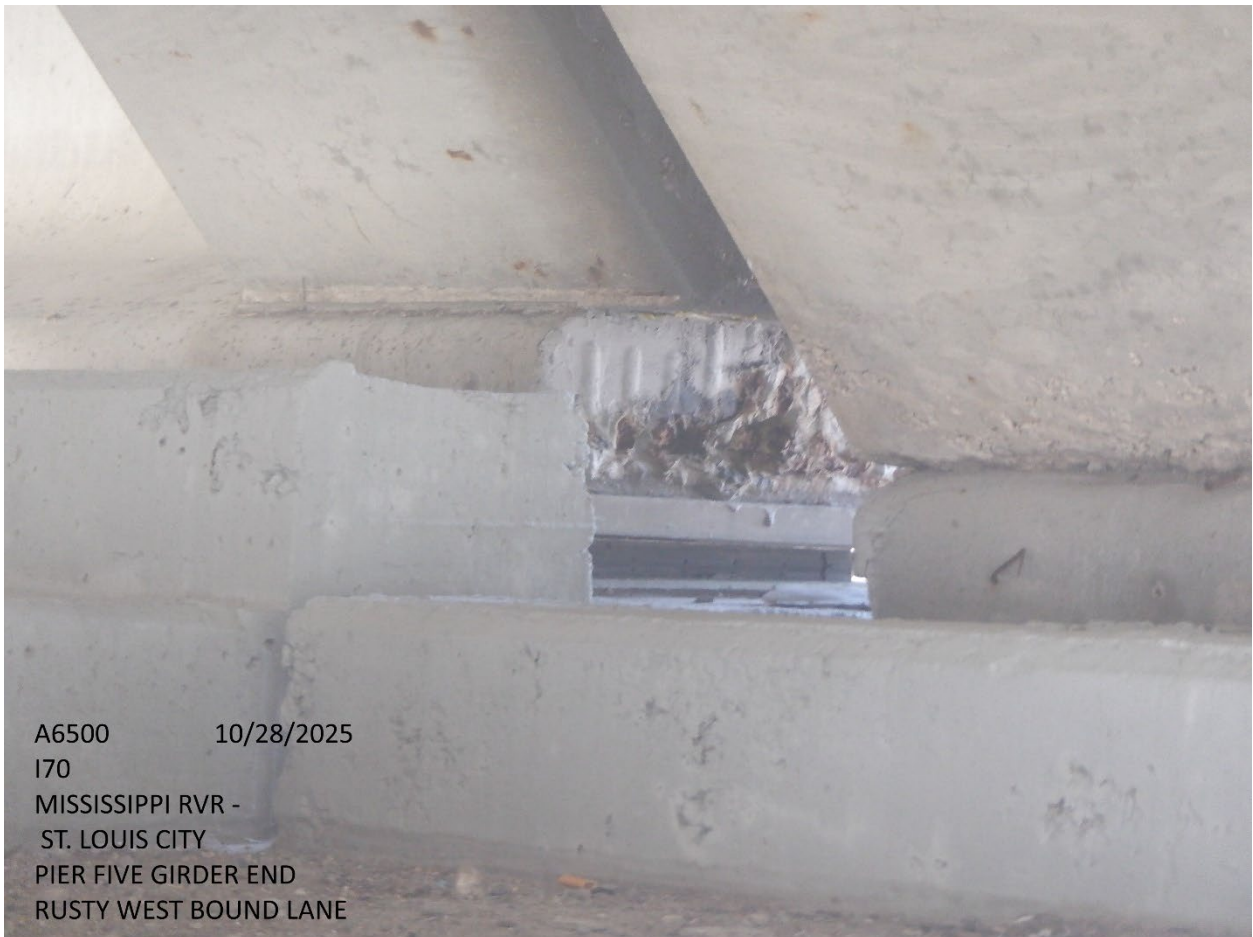
A6500 10/28/2025
I70
MISSISSIPPI RVR -
ST. LOUIS CITY
PIER FIVE GIRDER END
RUSTY WEST BOUND LANE

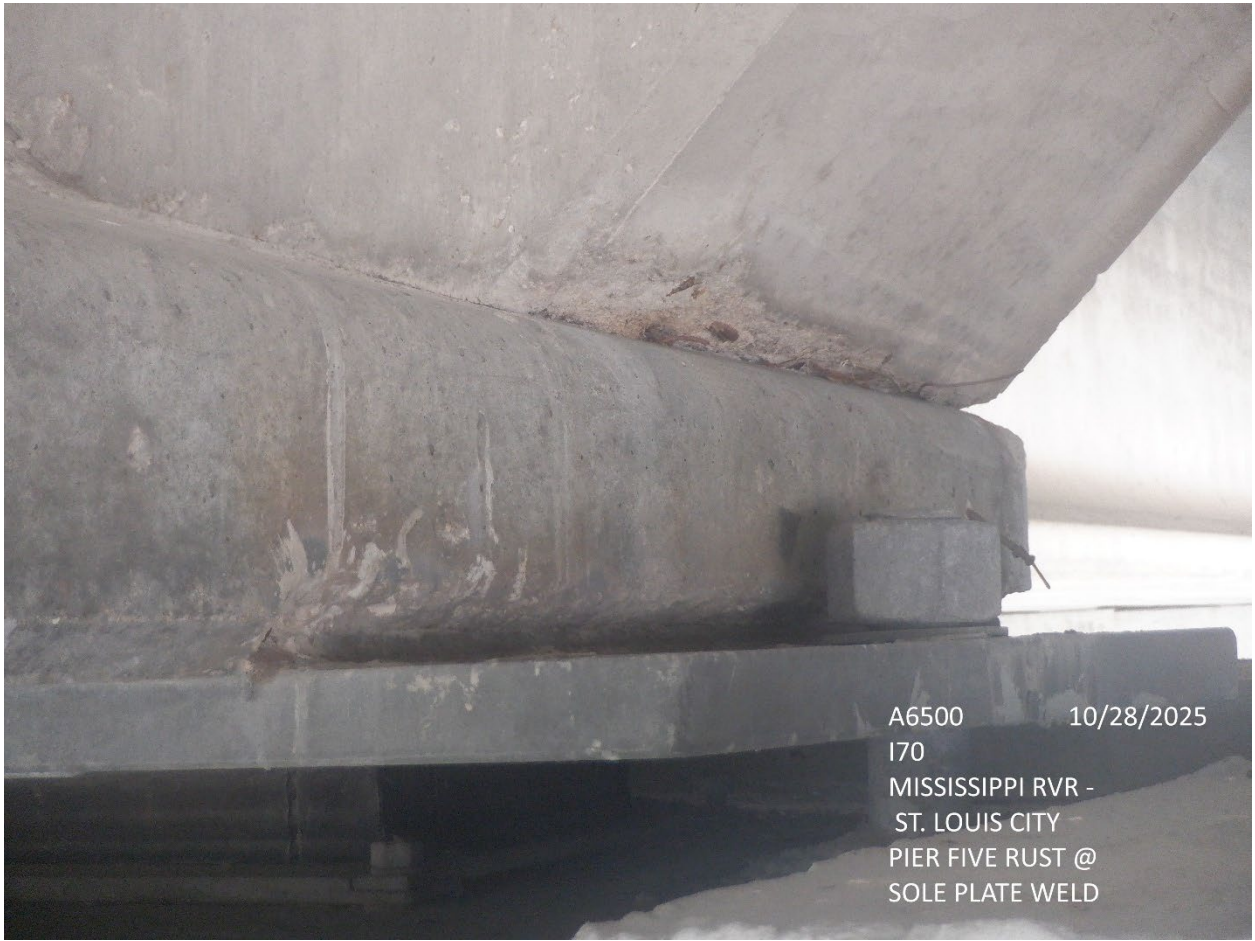
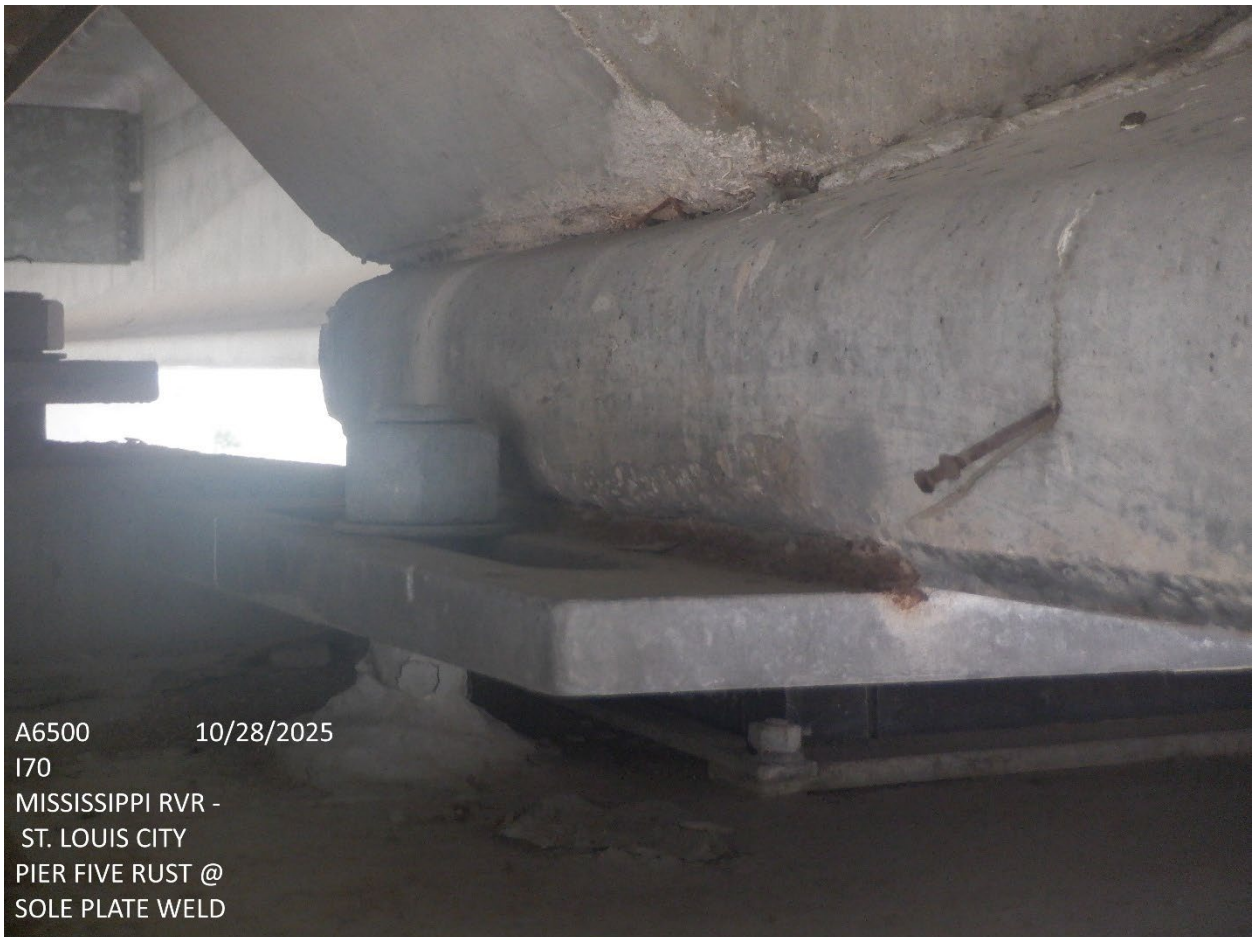
A6500 10/28/2025
I70
MISSISSIPPI RVR -
ST. LOUIS CITY
PIER FIVE RUST @
SOLE PLATE WELD

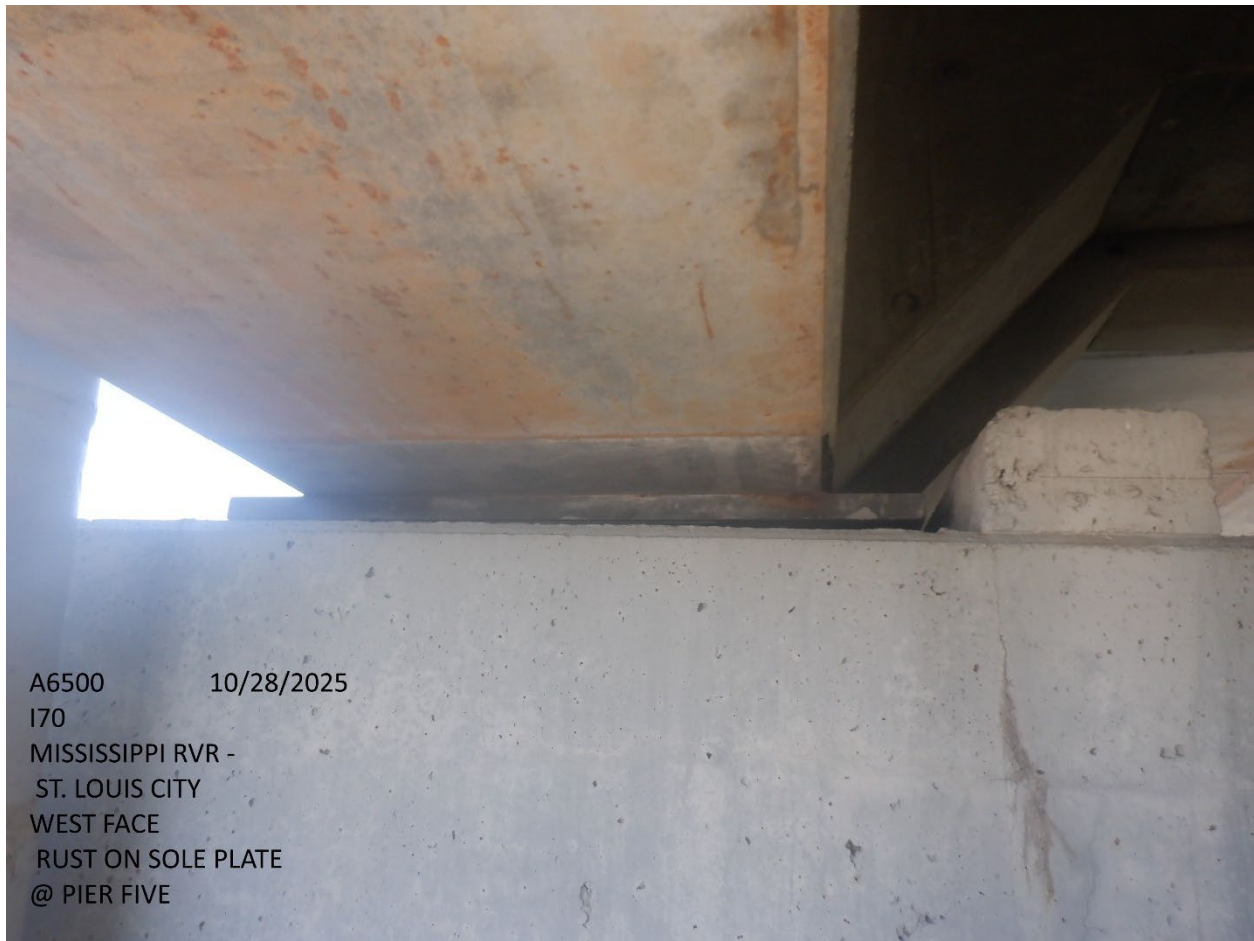
A6500 10/28/2025
I70
MISSISSIPPI RVR -
ST. LOUIS CITY
WEST FACE
RUST ON SOLE PLATE
@ PIER FIVE

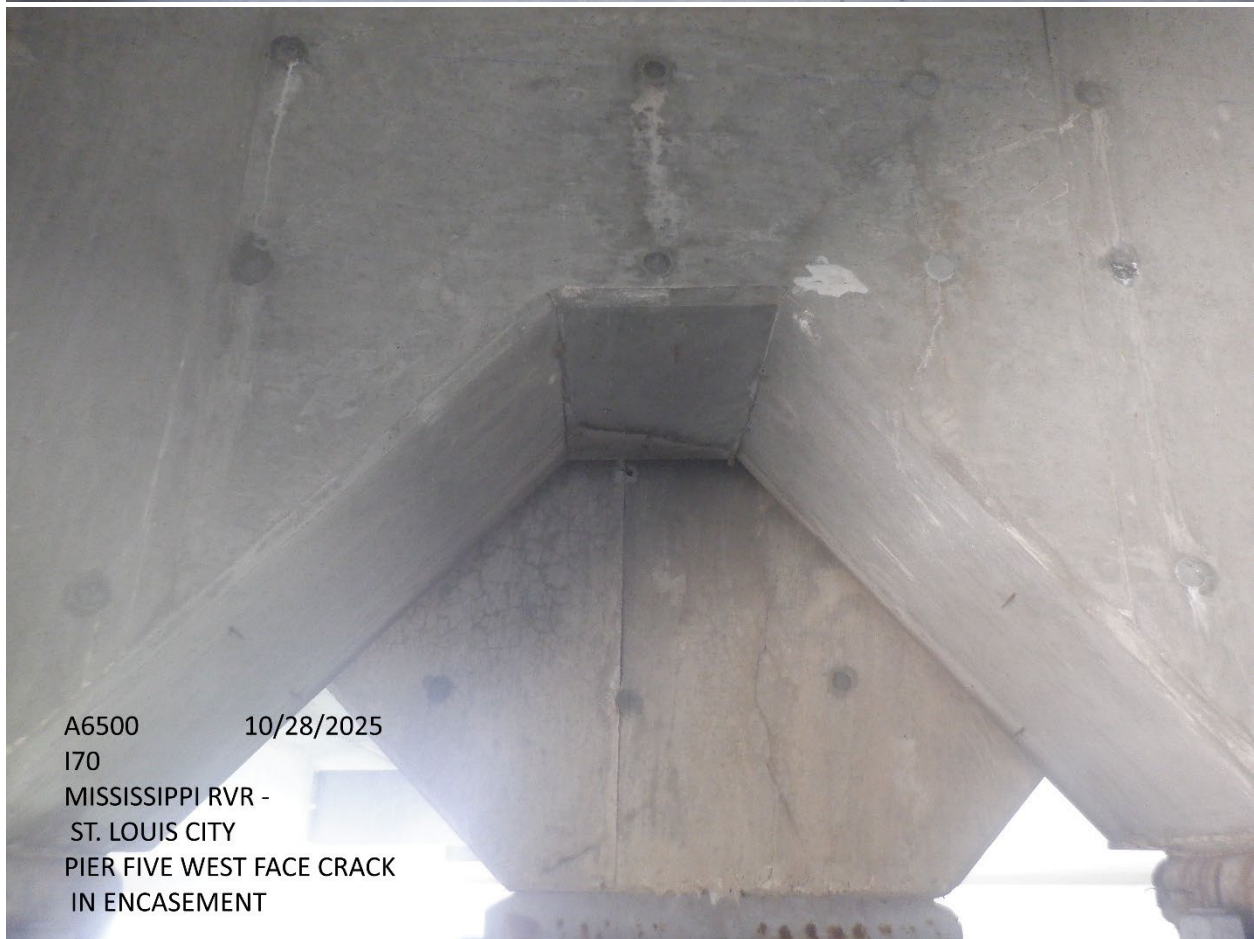
A6500 10/28/2025
I70
MISSISSIPPI RVR -
ST. LOUIS CITY
PIER FIVE WEST FACE CRACK
IN ENCASMENT

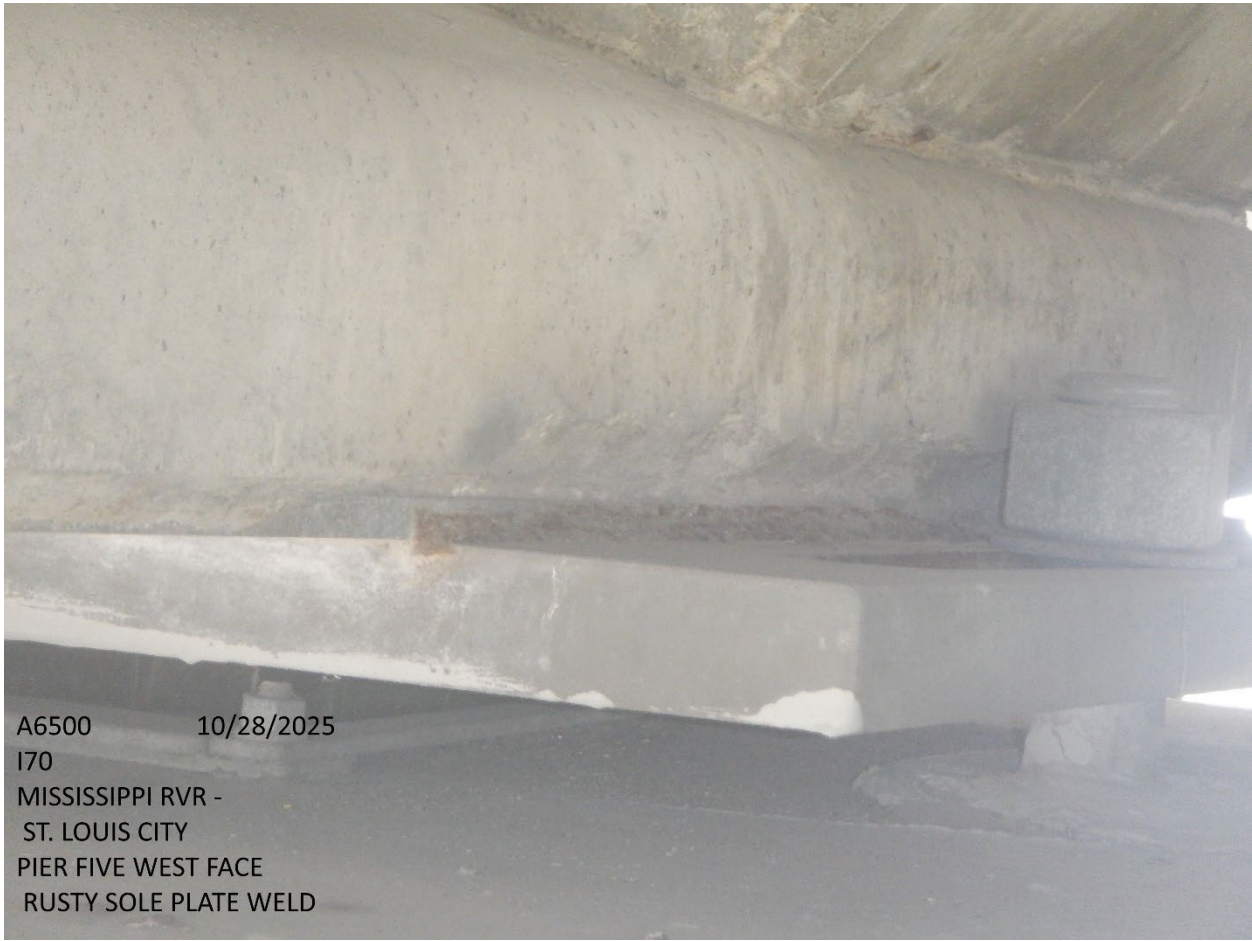
A6500 10/28/2025
I70
MISSISSIPPI RVR -
ST. LOUIS CITY
PIER FIVE WEST FACE
RUSTY SOLE PLATE WELD

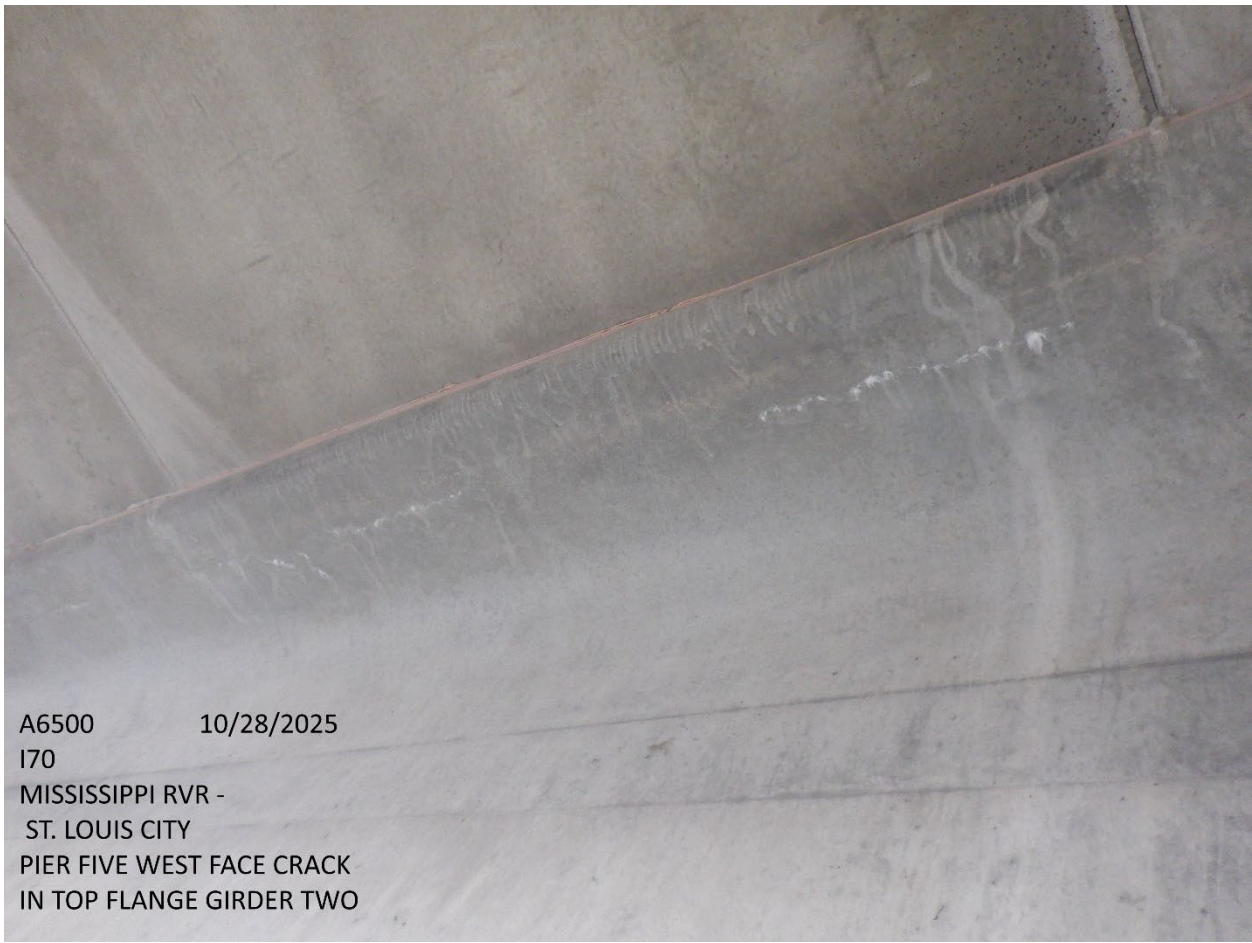
A6500 10/28/2025
170
MISSISSIPPI RVR -
ST. LOUIS CITY
PIER FIVE WEST FACE CRACK
IN TOP FLANGE GIRDER TWO

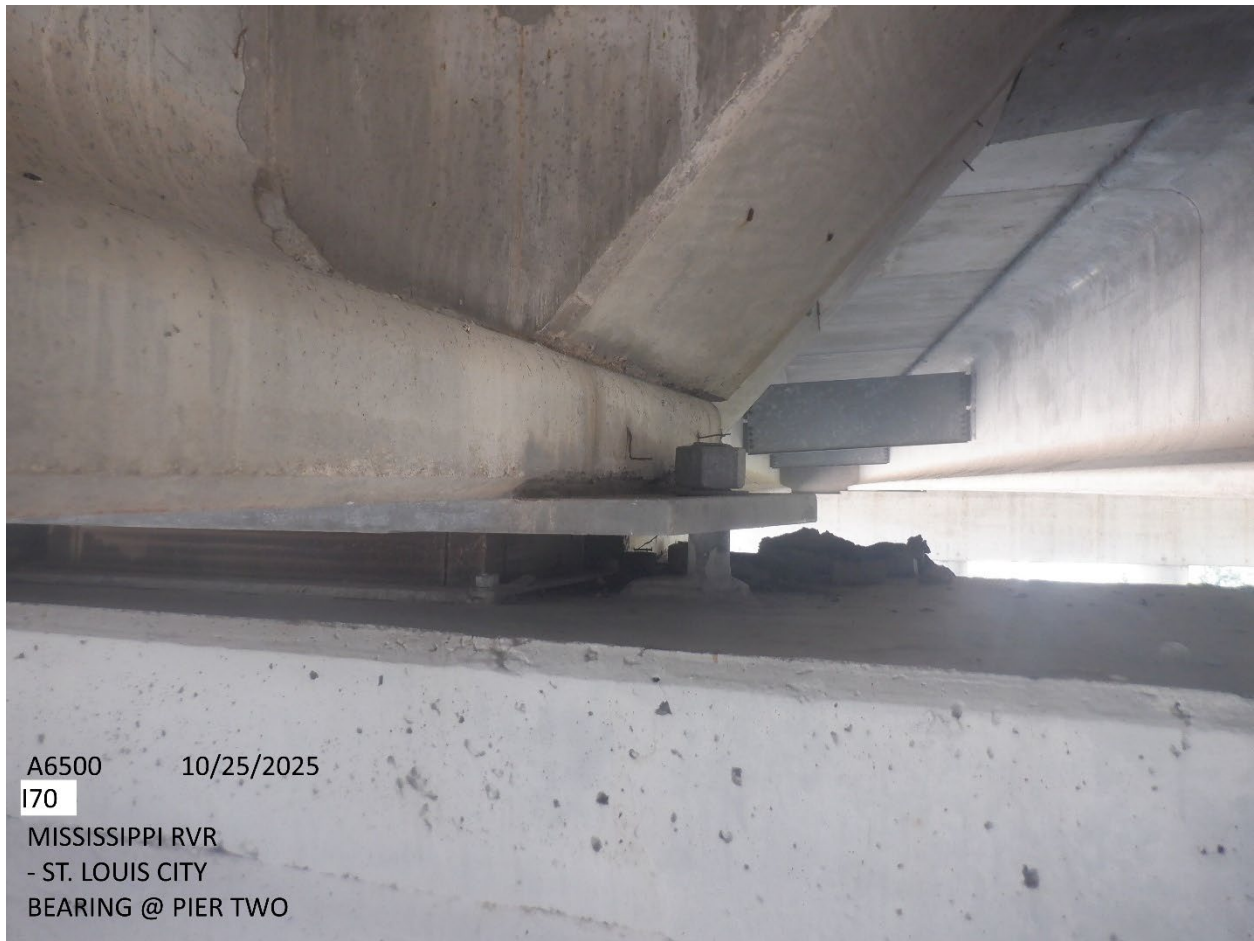
A6500 10/25/2025
I70
MISSISSIPPI RVR
- ST. LOUIS CITY
BEARING @ PIER TWO

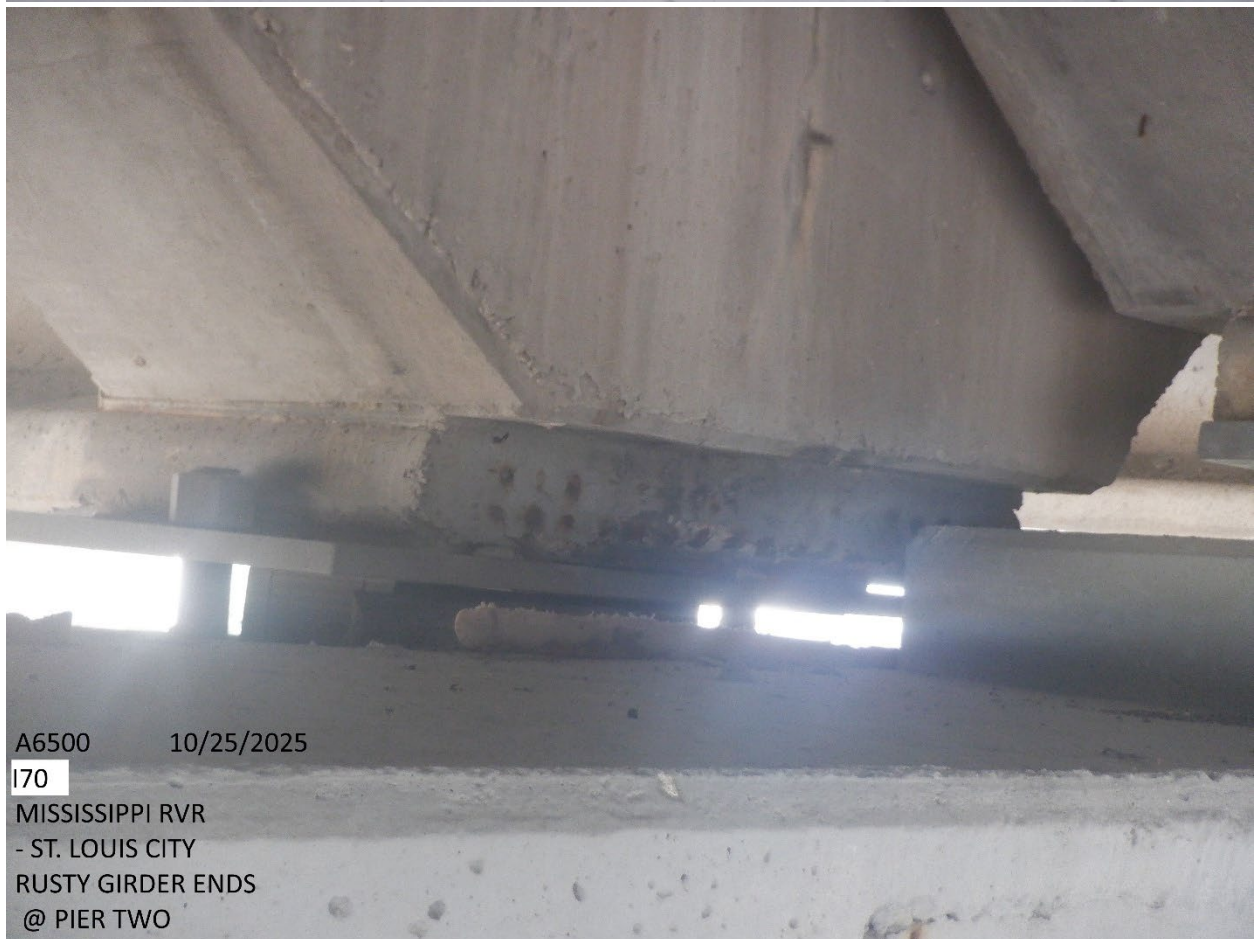
A6500 10/25/2025
I70
MISSISSIPPI RVR
- ST. LOUIS CITY
RUSTY GIRDER ENDS
@ PIER TWO

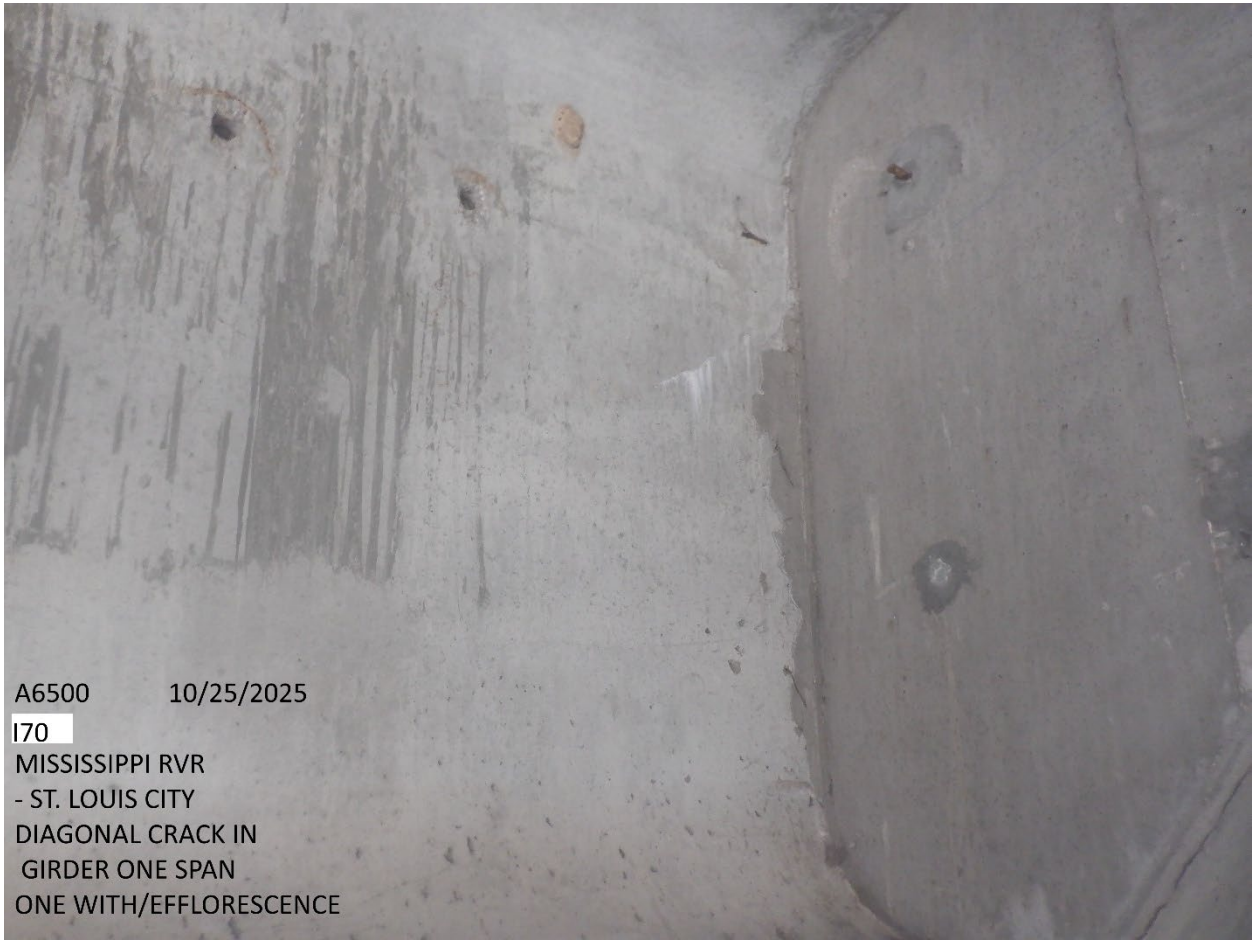
A6500 10/25/2025
I70
MISSISSIPPI RVR
- ST. LOUIS CITY
DIAGONAL CRACK IN
GIRDER ONE SPAN
ONE WITH/EFFLORESCENCE

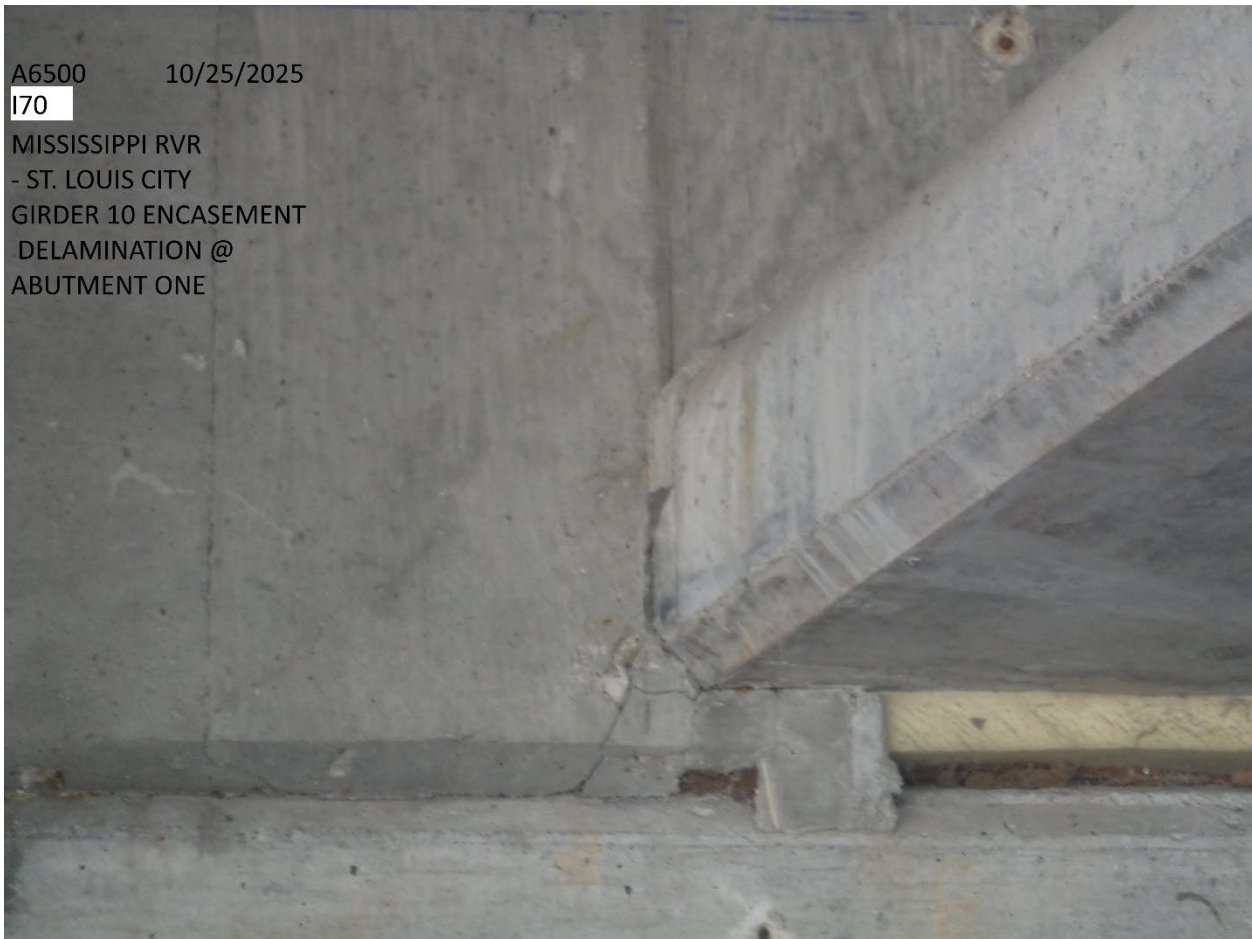
A6500 10/25/2025
I70
MISSISSIPPI RVR
- ST. LOUIS CITY
GIRDER 10 ENCASEMENT
DELAMINATION @
ABUTMENT ONE

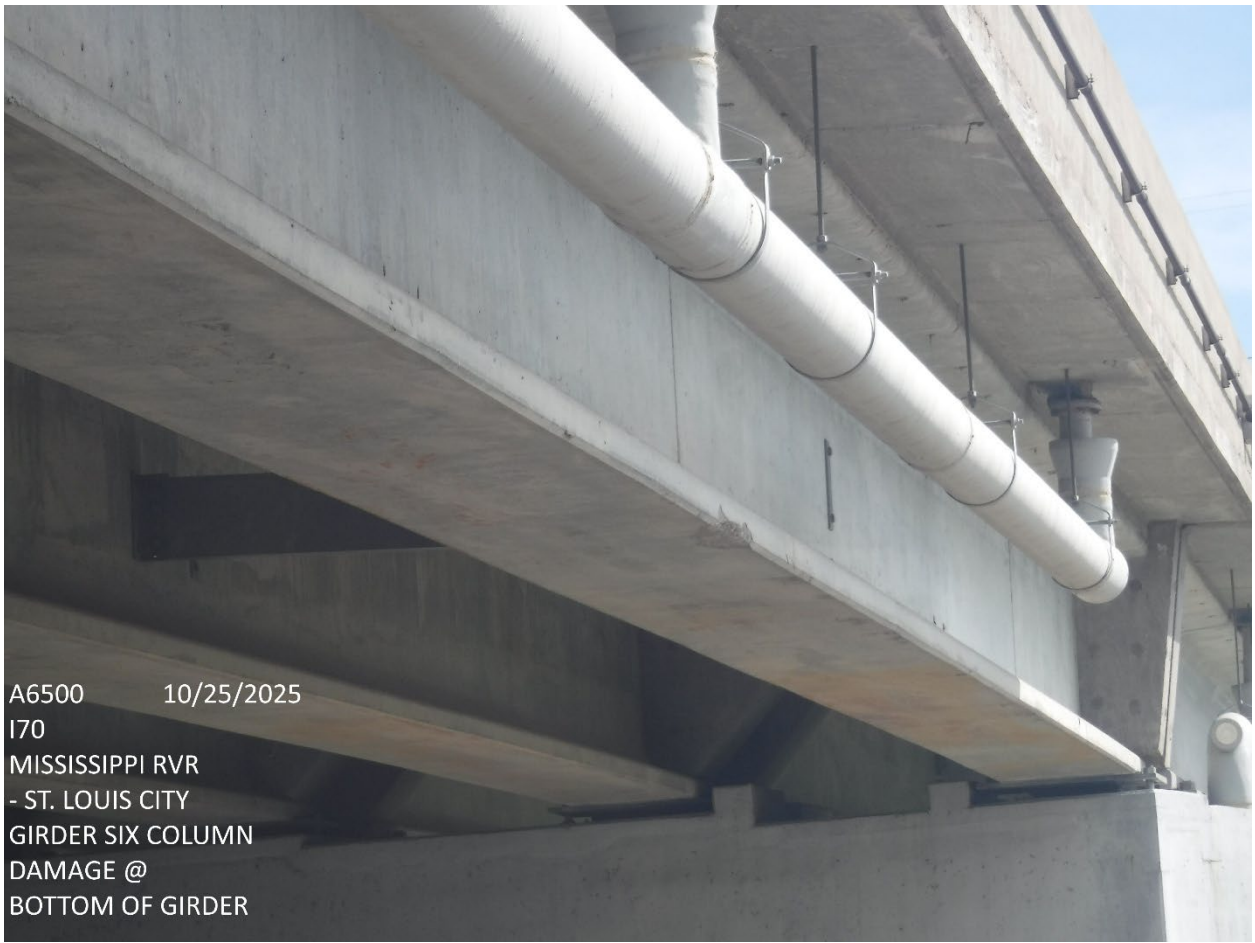
A6500 10/25/2025
I70
MISSISSIPPI RVR
- ST. LOUIS CITY
GIRDER SIX COLUMN
DAMAGE @
BOTTOM OF GIRDER

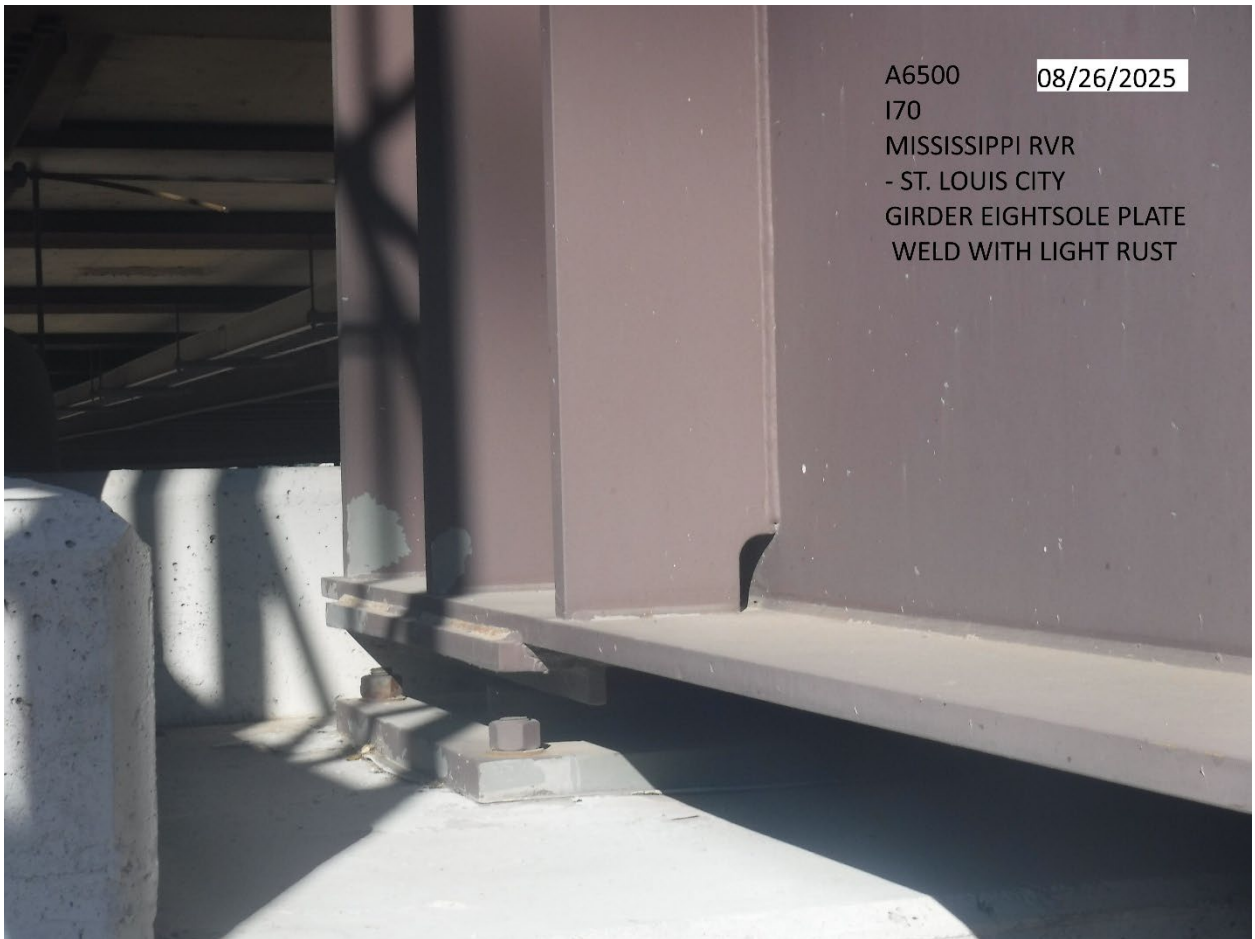
A6500 08/26/2025
I70
MISSISSIPPI RVR
- ST. LOUIS CITY
GIRDER EIGHTSOLE PLATE
WELD WITH LIGHT RUST

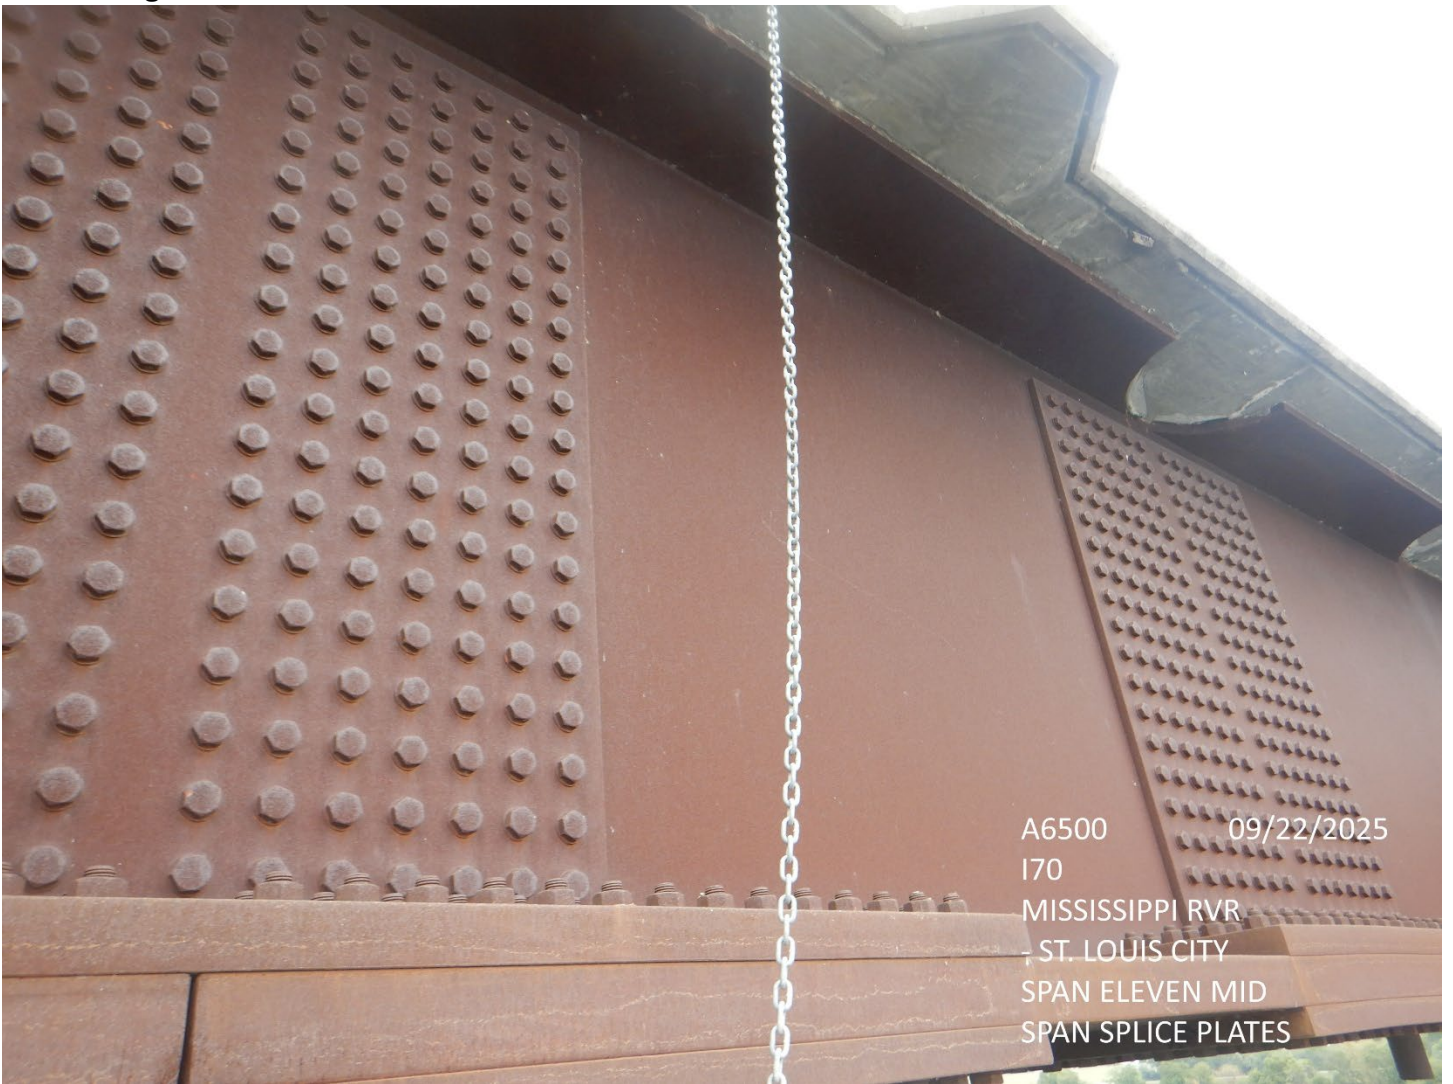
A6500 09/22/2025
I70
MISSISSIPPI RVR
- ST. LOUIS CITY
SPAN ELEVEN MID
SPAN SPLICE PLATES

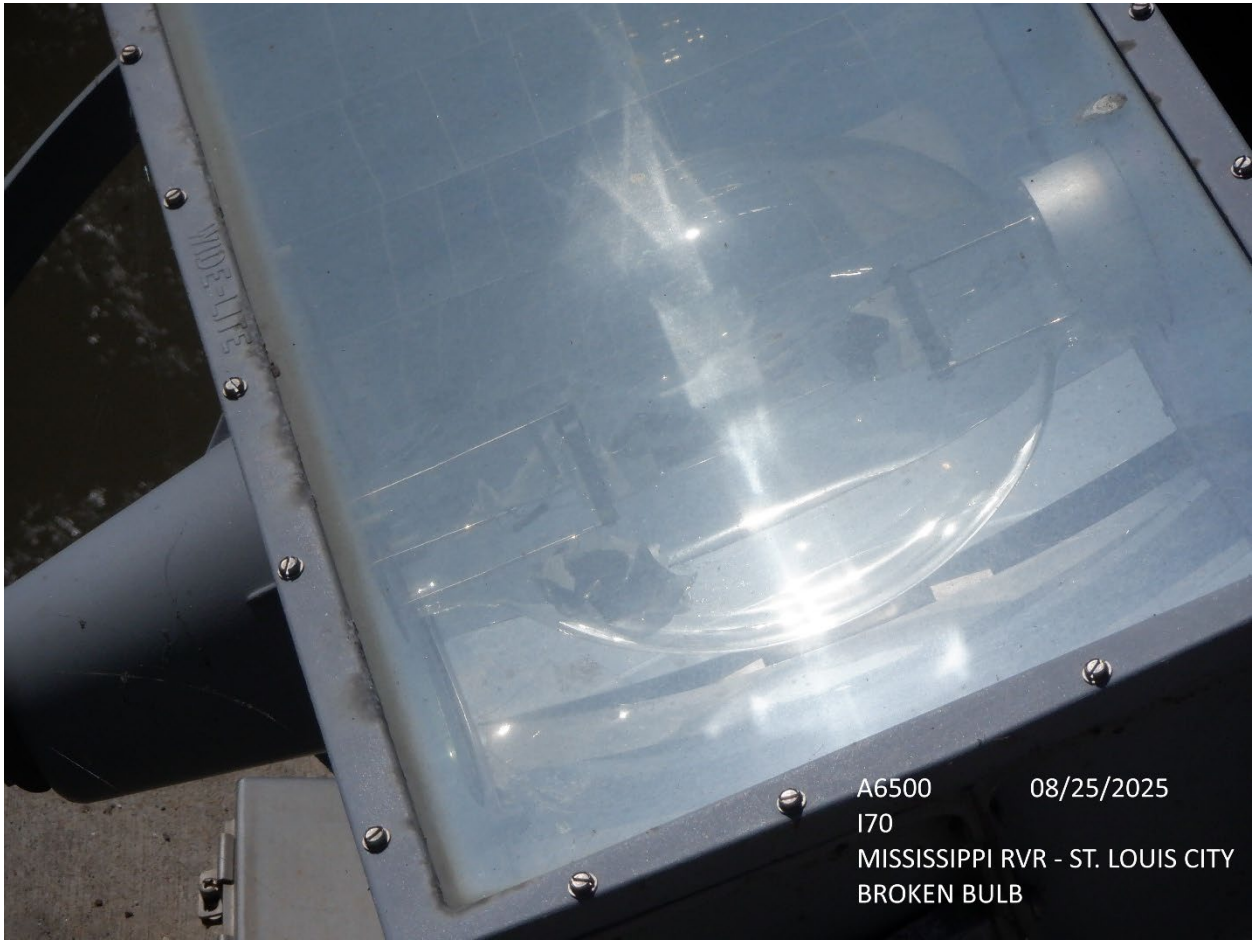
A6500 08/25/2025
I70
MISSISSIPPI RVR - ST. LOUIS CITY
BROKEN BULB

* Describe proposed work to be done to lighting. **Replace SE tower control box contents. New navigation lighting fixtures. Replace Aviaion Control Board on IL side (needs red, has white). Make weep holes in shields. Change fixtures to flood light LED - verify vibration rating for bridge. 480V system, 1000 watt bulbs for asthetic lights. Replace navigation placards.**
