Missouri Department of Transportation

STRUCTURAL REHABILITATION CHECKLIST

Bridge No.: **A6500**

Route: **I-70**

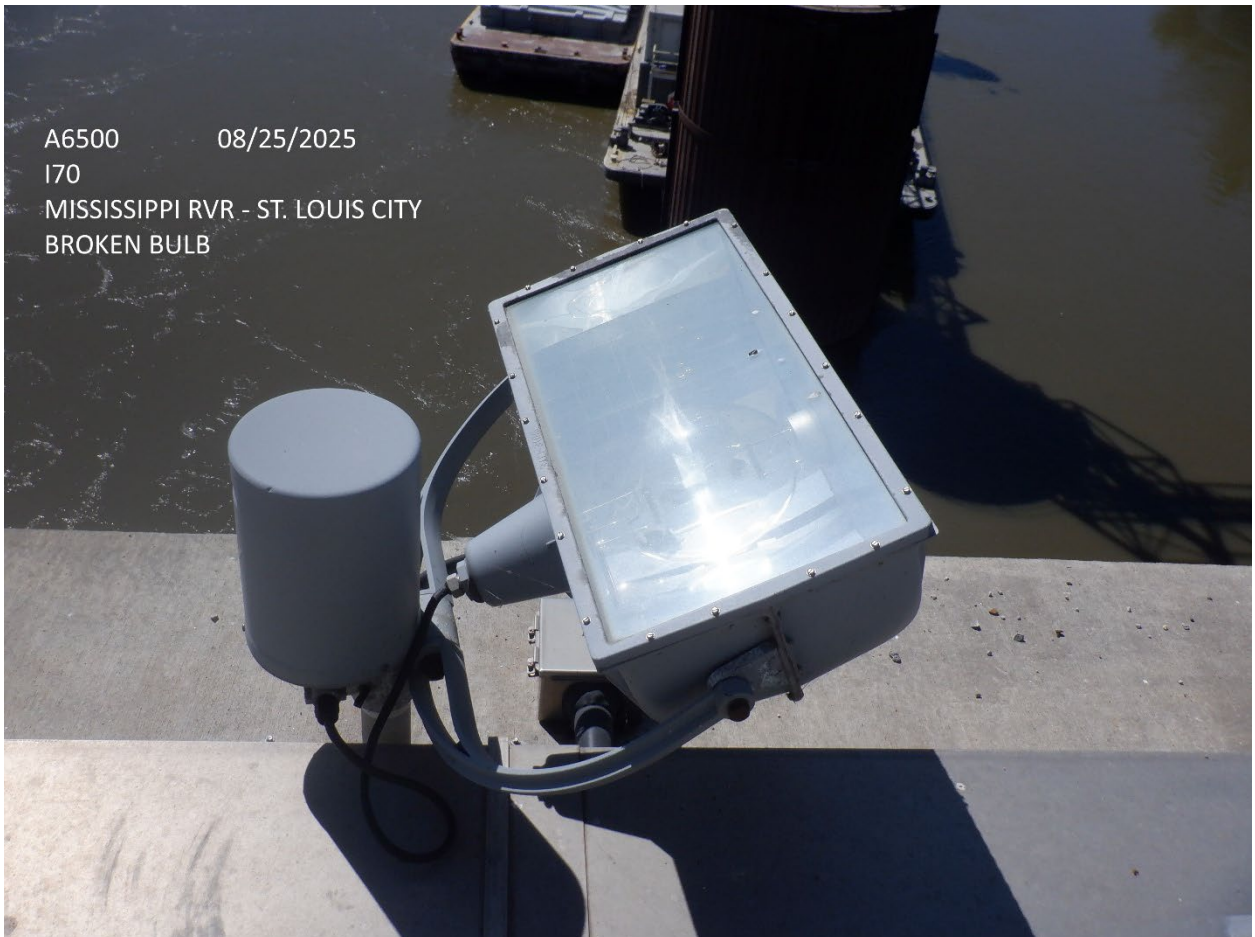
A6500 08/25/2025
I70
MISSISSIPPI RVR - ST. LOUIS CITY
BROKEN BULB

* Describe proposed work to be done to lighting. **Replace SE tower control box contents. New navigation lighting fixtures. Replace Aviaion Control Board on IL side (needs red, has white). Make weep holes in shields. Change fixtures to flood light LED - verify vibration rating for bridge. 480V system, 1000 watt bulbs for asthetic lights. Replace navigation placards.**

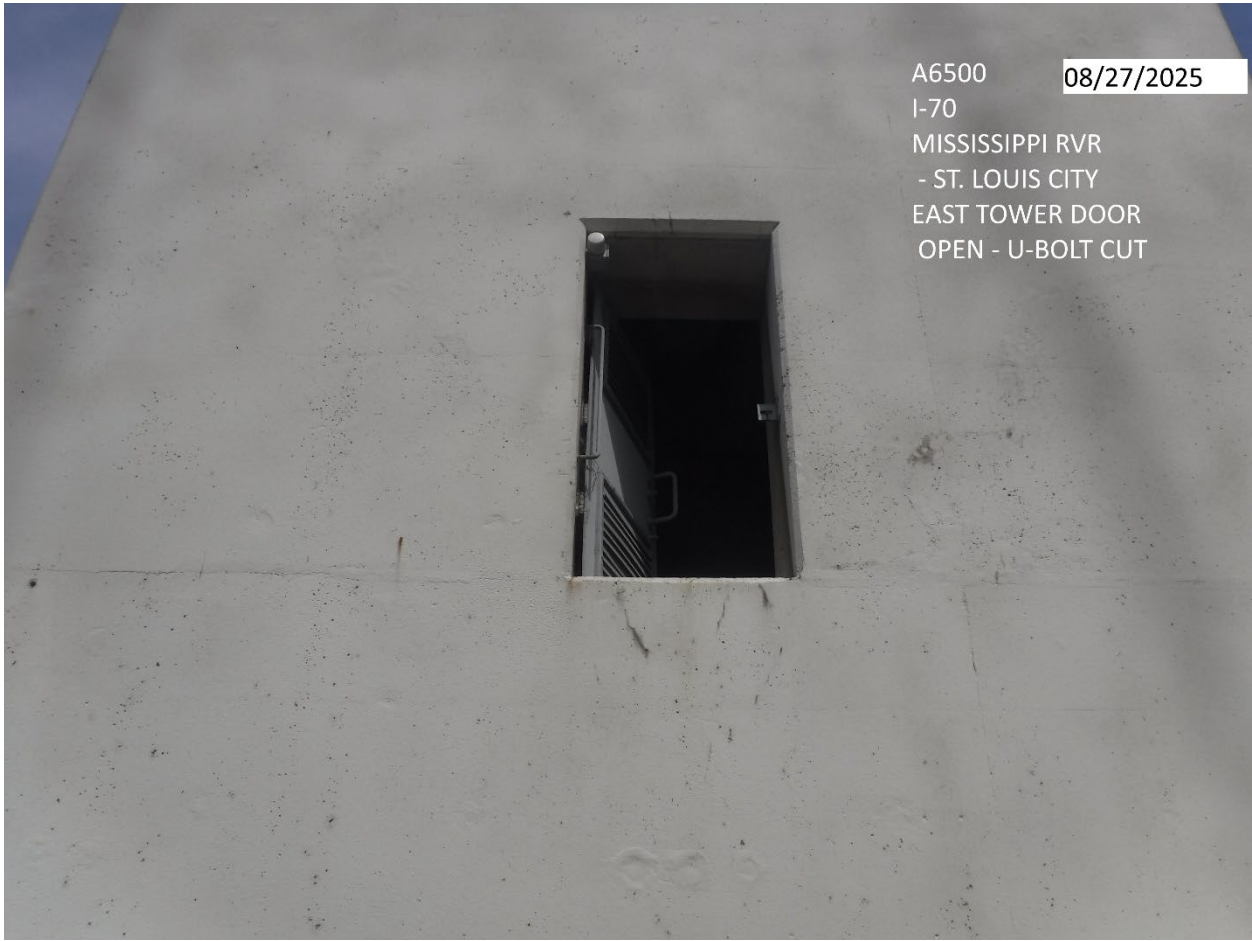
A6500
I-70
MISSISSIPPI RVR
- ST. LOUIS CITY
EAST TOWER DOOR
OPEN - U-BOLT CUT

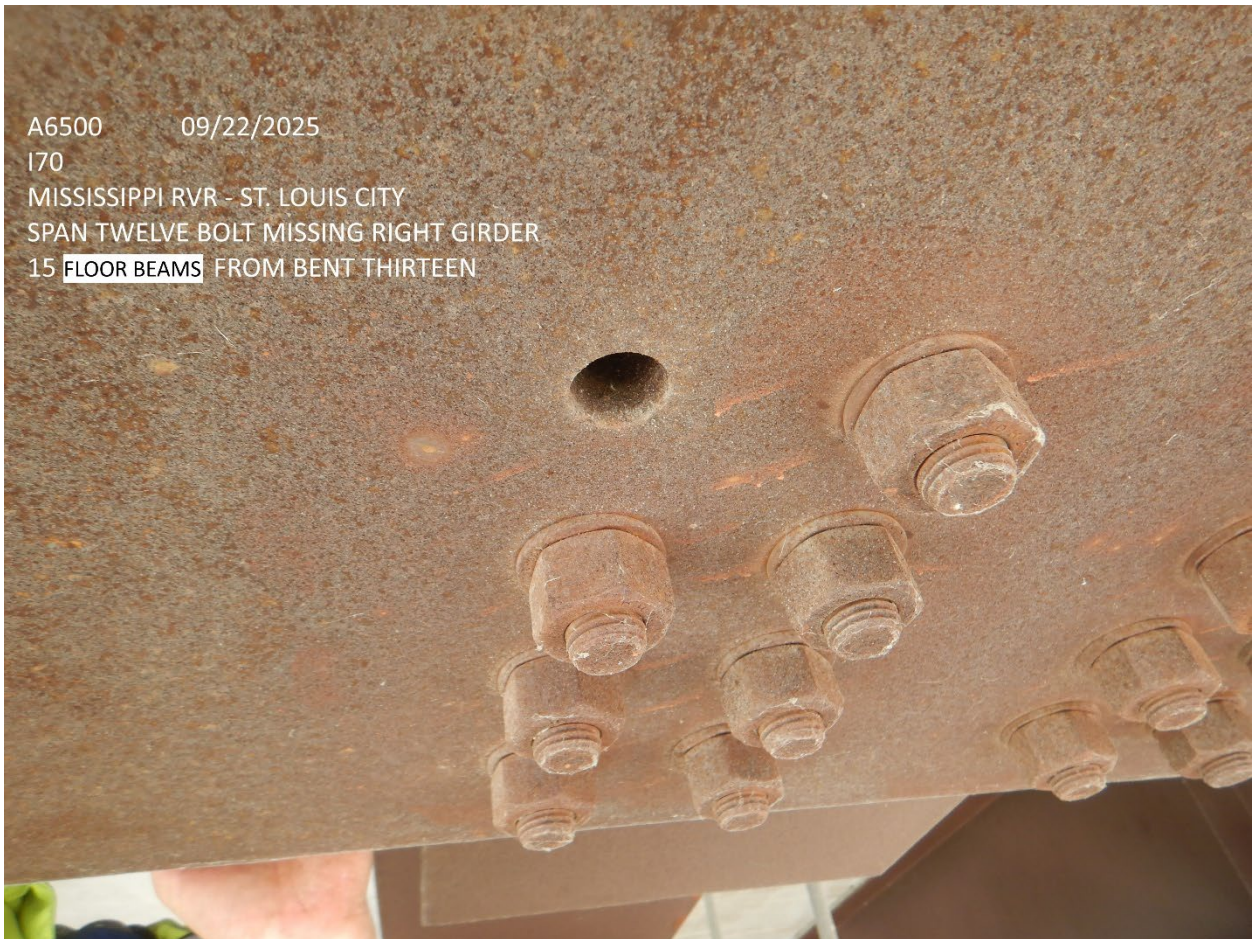
A6500 09/22/2025
I70
MISSISSIPPI RVR - ST. LOUIS CITY
SPAN TWELVE BOLT MISSING RIGHT GIRDER
15 FLOOR BEAMS FROM BENT THIRTEEN
