# MISSOURI SCOUR ASSESSMENT FIELD FORM

Date: 2/14/94  
 Inspector: JAY BESTGEN, GARY BAKKE

District # 5  
 Bridge # W-559 BOONE

**SUBJECT:** Materials  
Asbestos Inspection & Heavy Metal Paint Survey  
Route 163  
Bridge W-0559  
Boone County

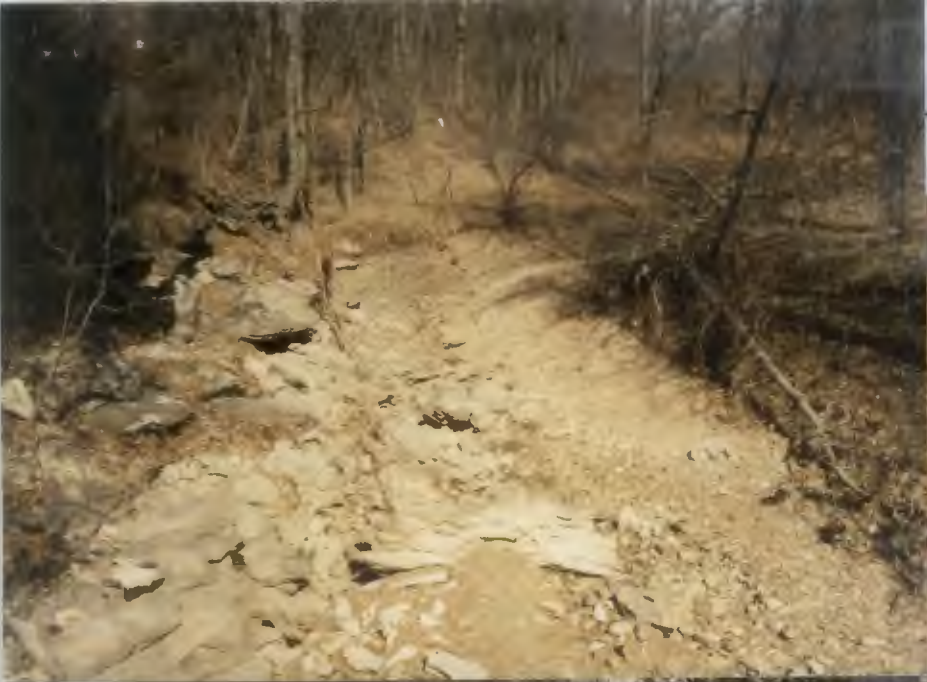
## Picture from Bridge Looking US

Roll #: 16 Frame #: 1 Standing: BRIDGE DECK  
 Looking At: UPSTREAM

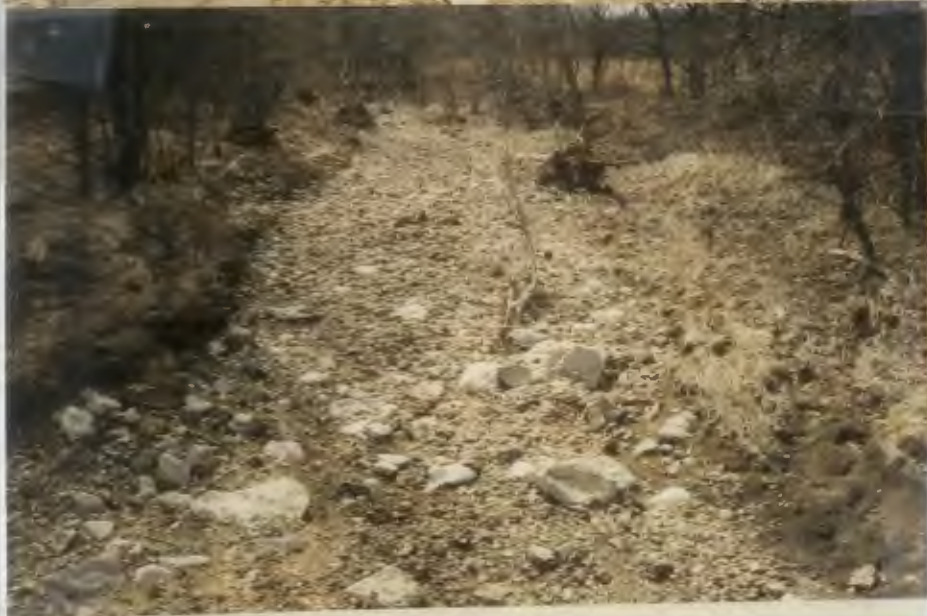
## Picture from Bridge Looking DS

Roll #: 16 Frame #: 2 Standing: BRIDGE DECK  
 Looking At: DOWNSTREAM

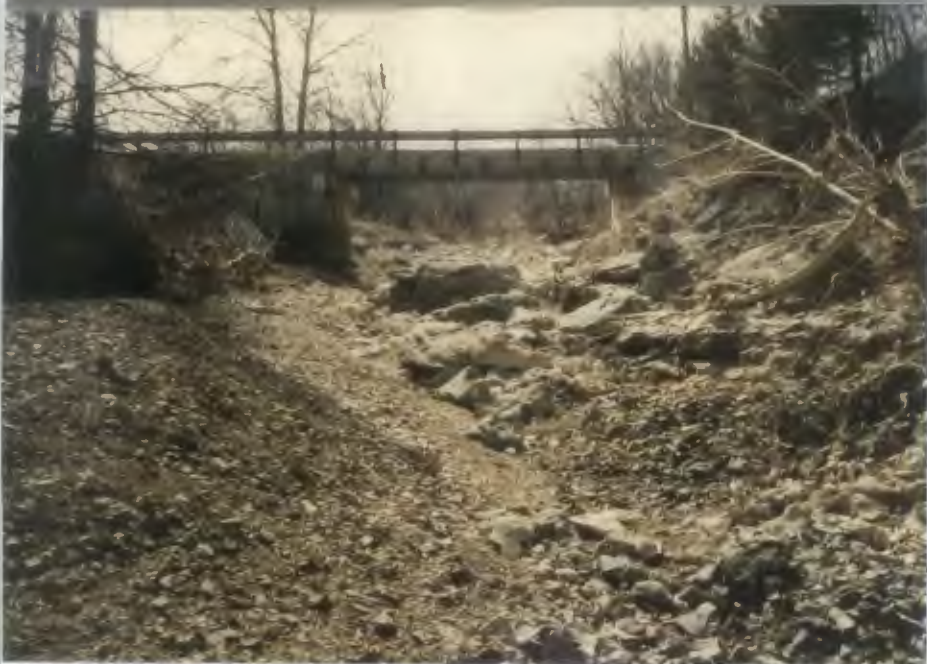
## Picture from US Looking DS

Roll #: 16 Frame #: 3 Standing: Middle Upstream  
 Looking At: BRIDGE

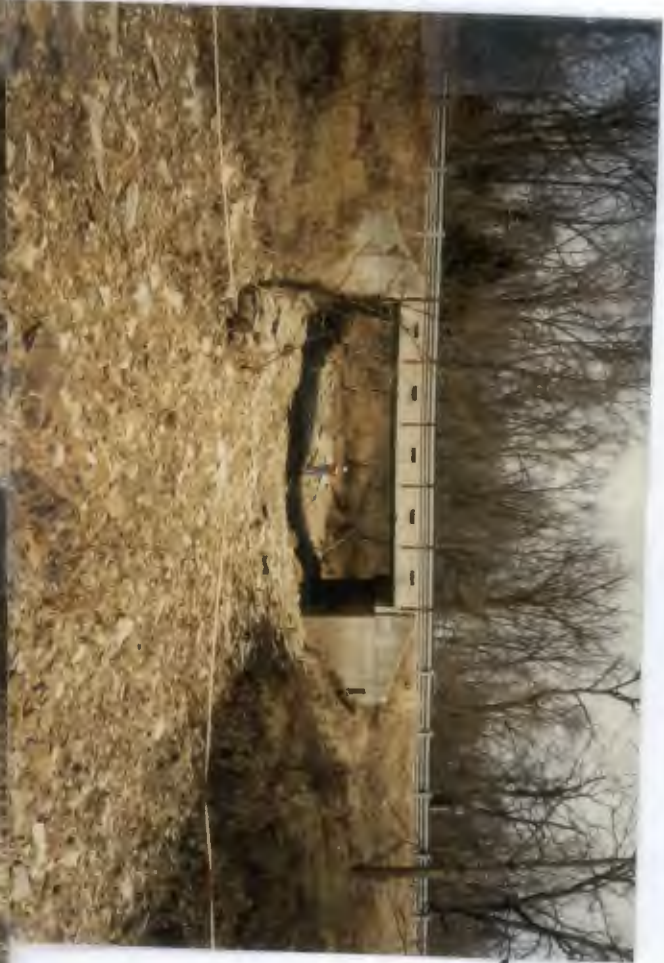
Picture from DS Looking US

Roll #: 16 Frame #: 4 Standing: Middle downstream

Looking At: BRIDGE
