Missouri Department of Transportation
State Bridge Inspection Report

COUNTY: COOPER DISTRICT: CD CLASS: STATBR FED-ID: 6689 BRIDGE: L0962

ROUTE: IS70E # SPANS: 17
FEATURE: MISSOURI RIVER, KATY TR LANES ON: 4
STATUS: A-OPEN LANES UNDER: 0
LOG MILE: 114.303 COMPASS DIRECTION: WEST to EAST
DETOUR: 4.00 MILES DIRECTION OF TRAFFIC: 2-WAY TRAF
NHS: YES FUNCTIONAL CLASS: RL-INTERSTATE
BUILT: 1960 NBI OWNER: MODOT
REHAB: 1993 NBI MAINTAINED: MODOT
LOCATION: S 18 T 48 R 14 W MAINTENANCE DISTRICT: CD
LATITUDE: 38 57 30.63 (DMS) MAINTENANCE COUNTY: COOPER
LONGITUDE: 92 32 49.03 (DMS) SUB AREA: 7D06

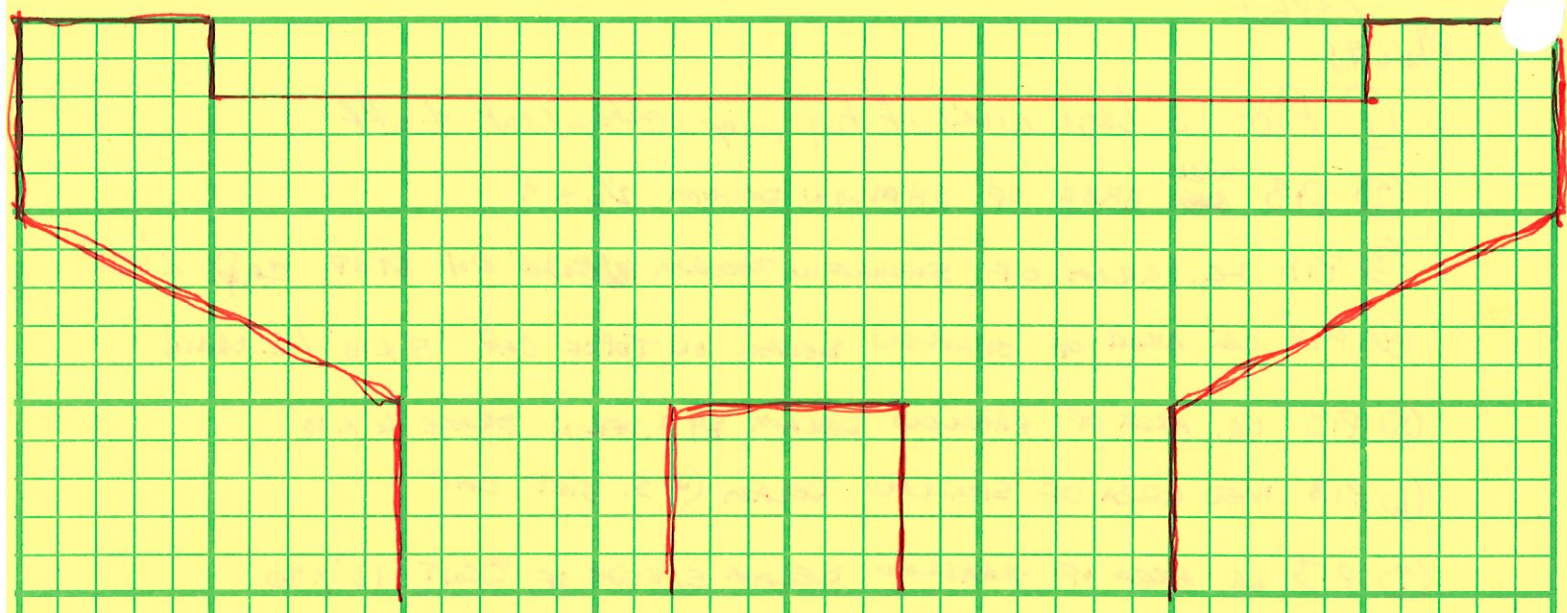
- ① Pier 13 Large areas of hwy map cracks w/sat & eff
- ② P13 ~~med.~~ ^{med.} AREA OF SHALLOW DELAM 2'x4'
- ③ P13 LG. AREA OF SHALLOW DELAM ~~16'x30'~~ ON STEP CAP 2'x10'

- ⑦ P13 LG. AREA OF SHALLOW DELAM E. SIDE OF BENT 16'x30'
- ⑧ P13 N. SIDE CAP EDGE LG. AREA OF MAP CRKS. w/SAT. & EFF
- ⑨ P13 W. SIDE 1'x3' SPALL REBAR EXPOSED w/DELAM MIN. S.L. IN REBAR
90% REMAINING

- ⑬ pier 13 col. 2 ~~west~~ face west side w/ server delam
hwy map crking & Large area of deep ~~spalling~~ spalling w/
rebar exp.
- ⑭ pier 13 east side cap face w/ hwy delam hwy map
crking w/ eff & sat.

- ⑮ pier 13 east side col. 2 face all delamed server w/
hwy map crking & sat.
