L0962 I 70 Cooper Co.  
Joint at L8, span 13  
Eastbound lane failing  
9-24-13

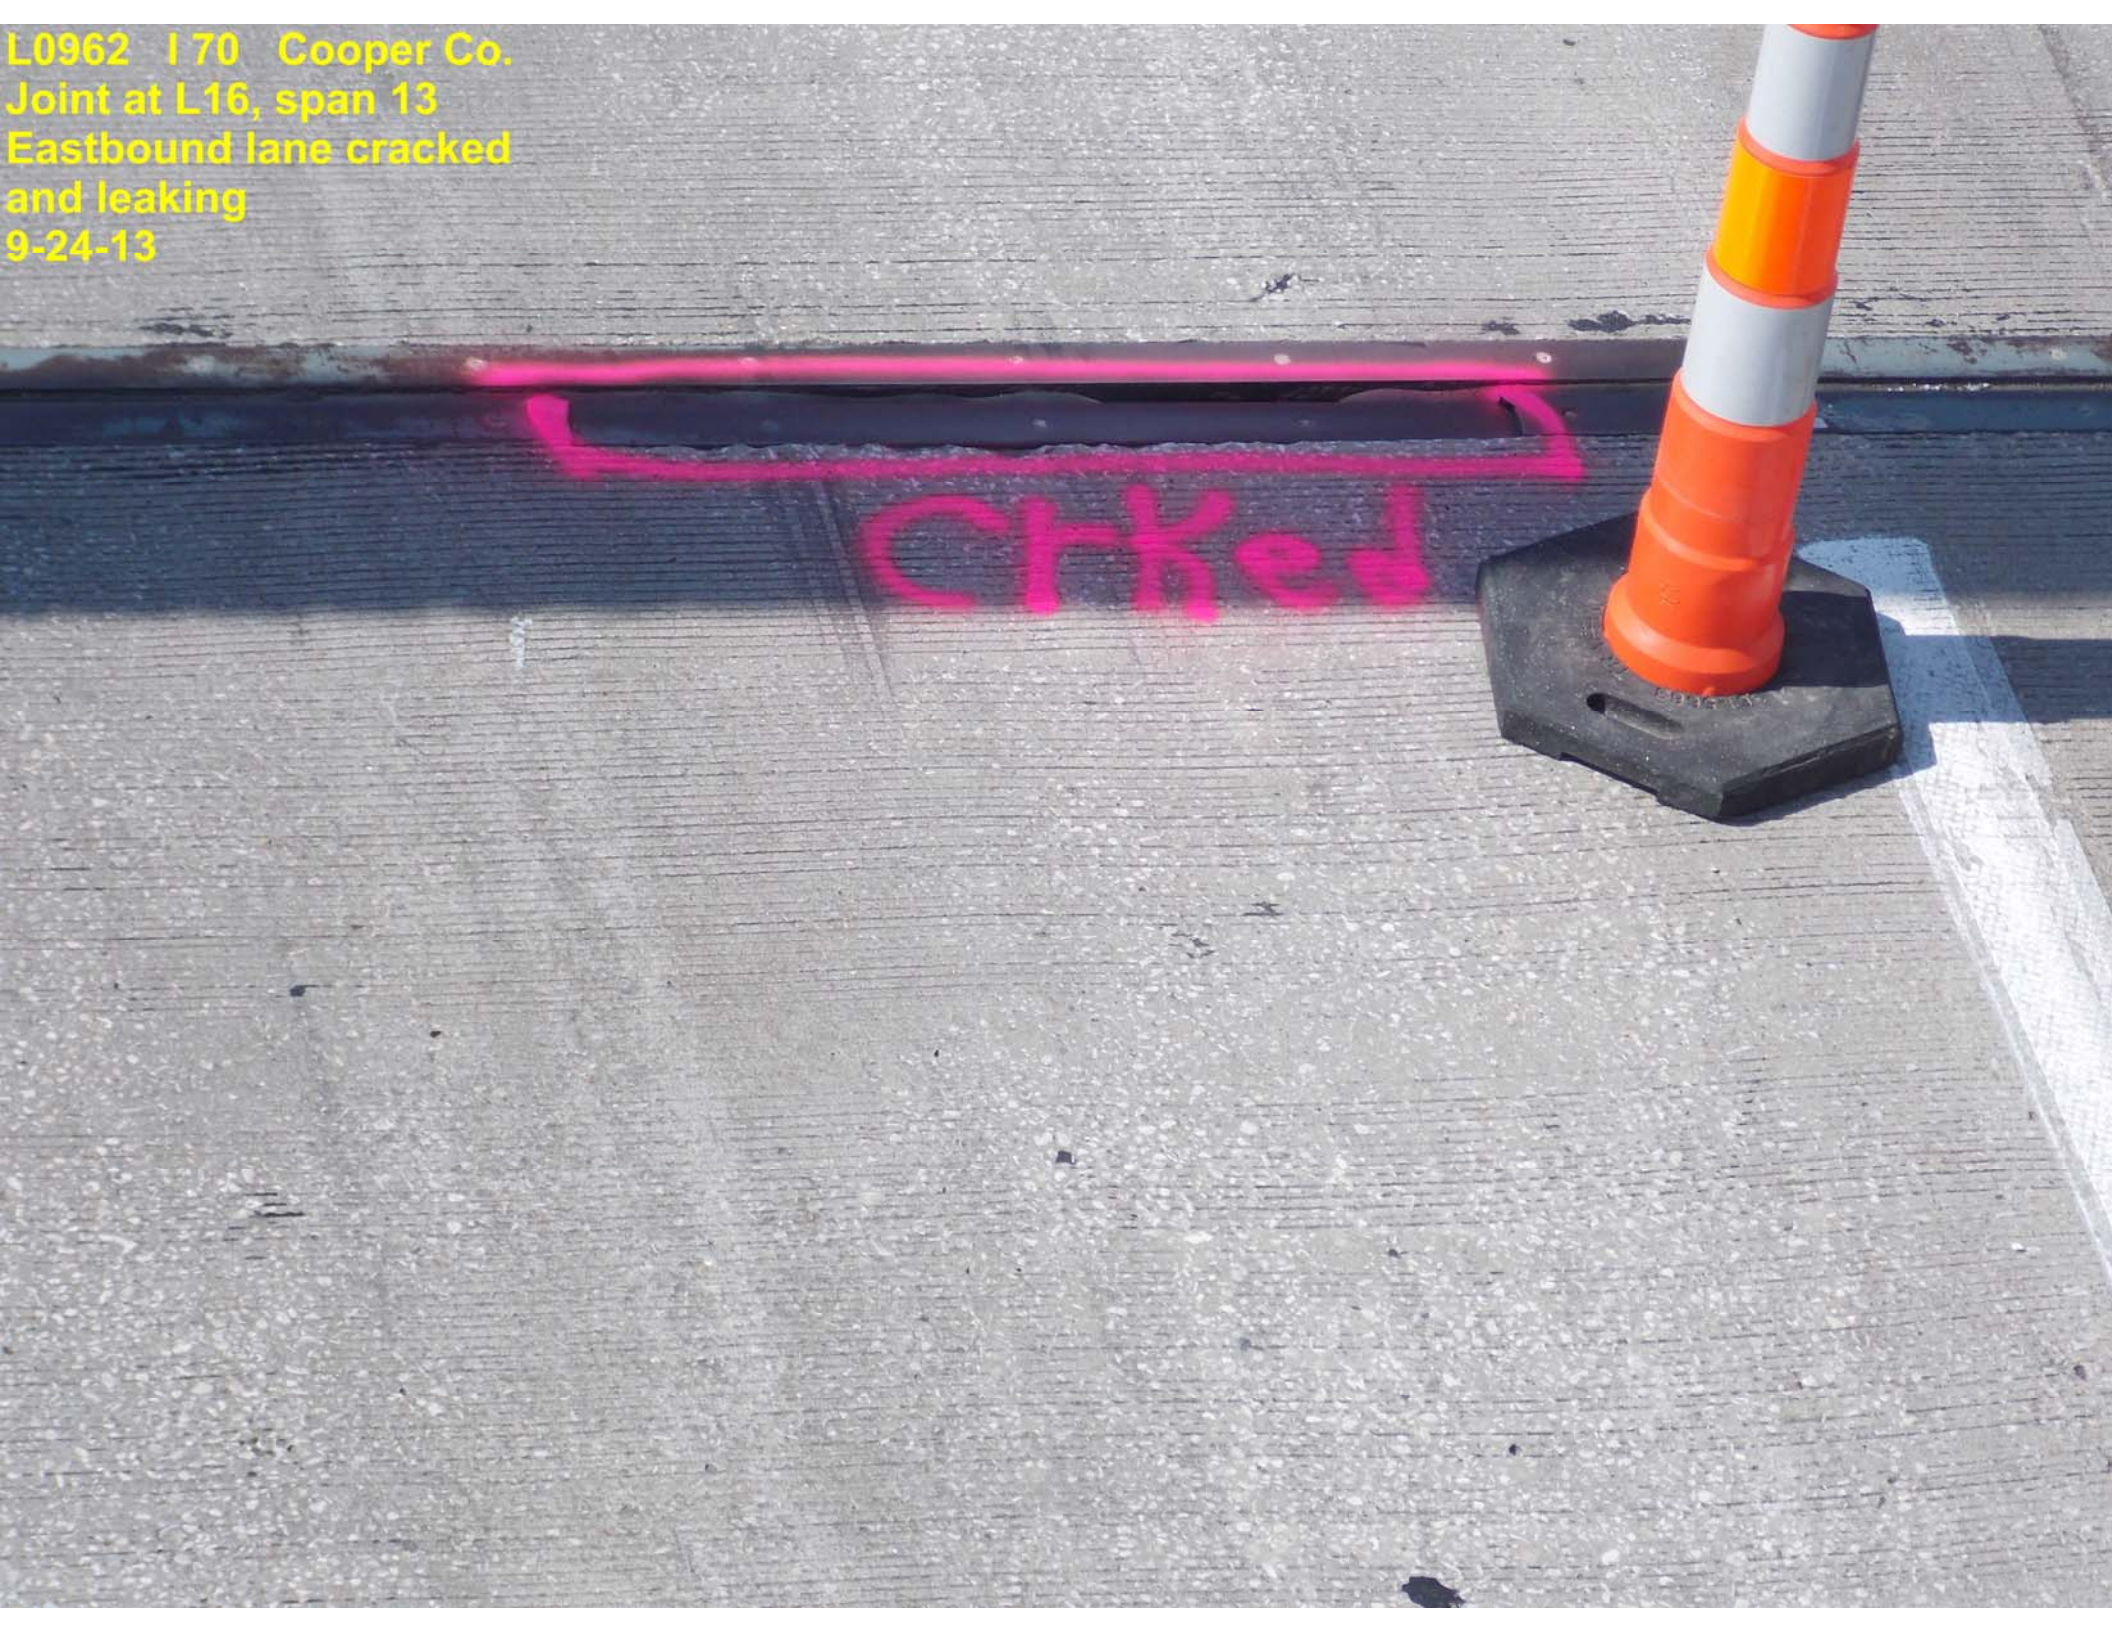
L0962 I 70 Cooper Co.  
Joint at L16, span 13  
Eastbound lane cracked  
and leaking  
9-24-13

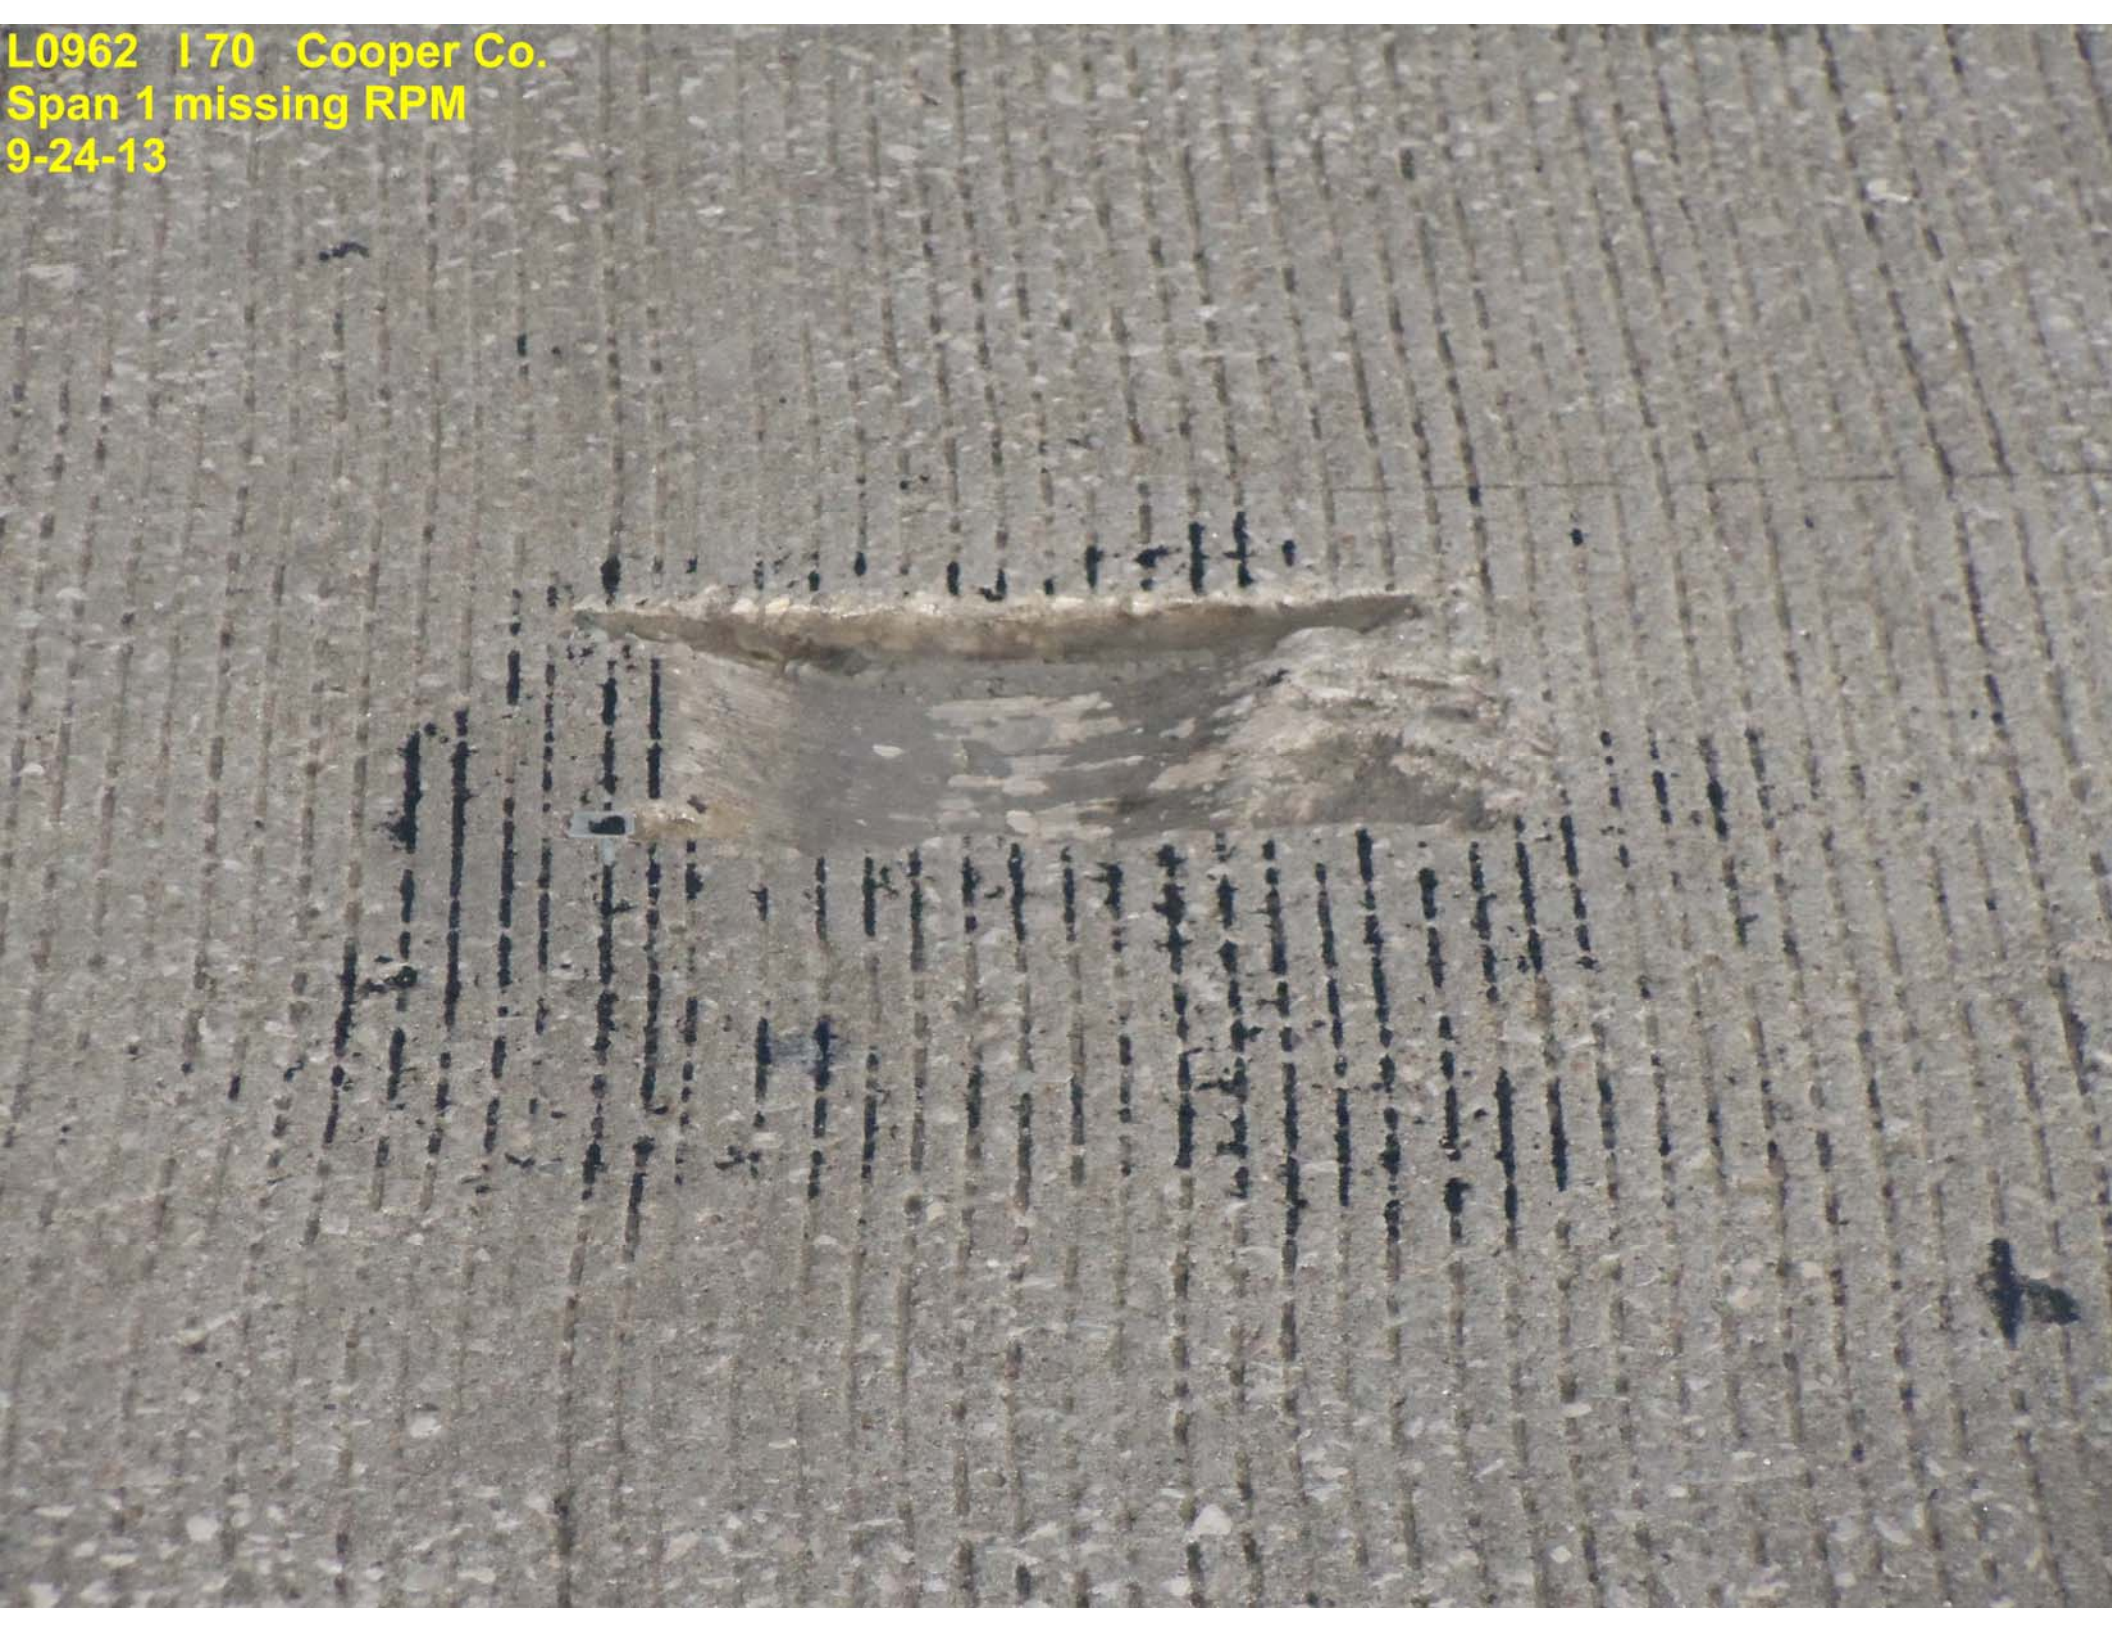
L0962 I 70 Cooper Co.  
Span 1 missing RPM  
9-24-13

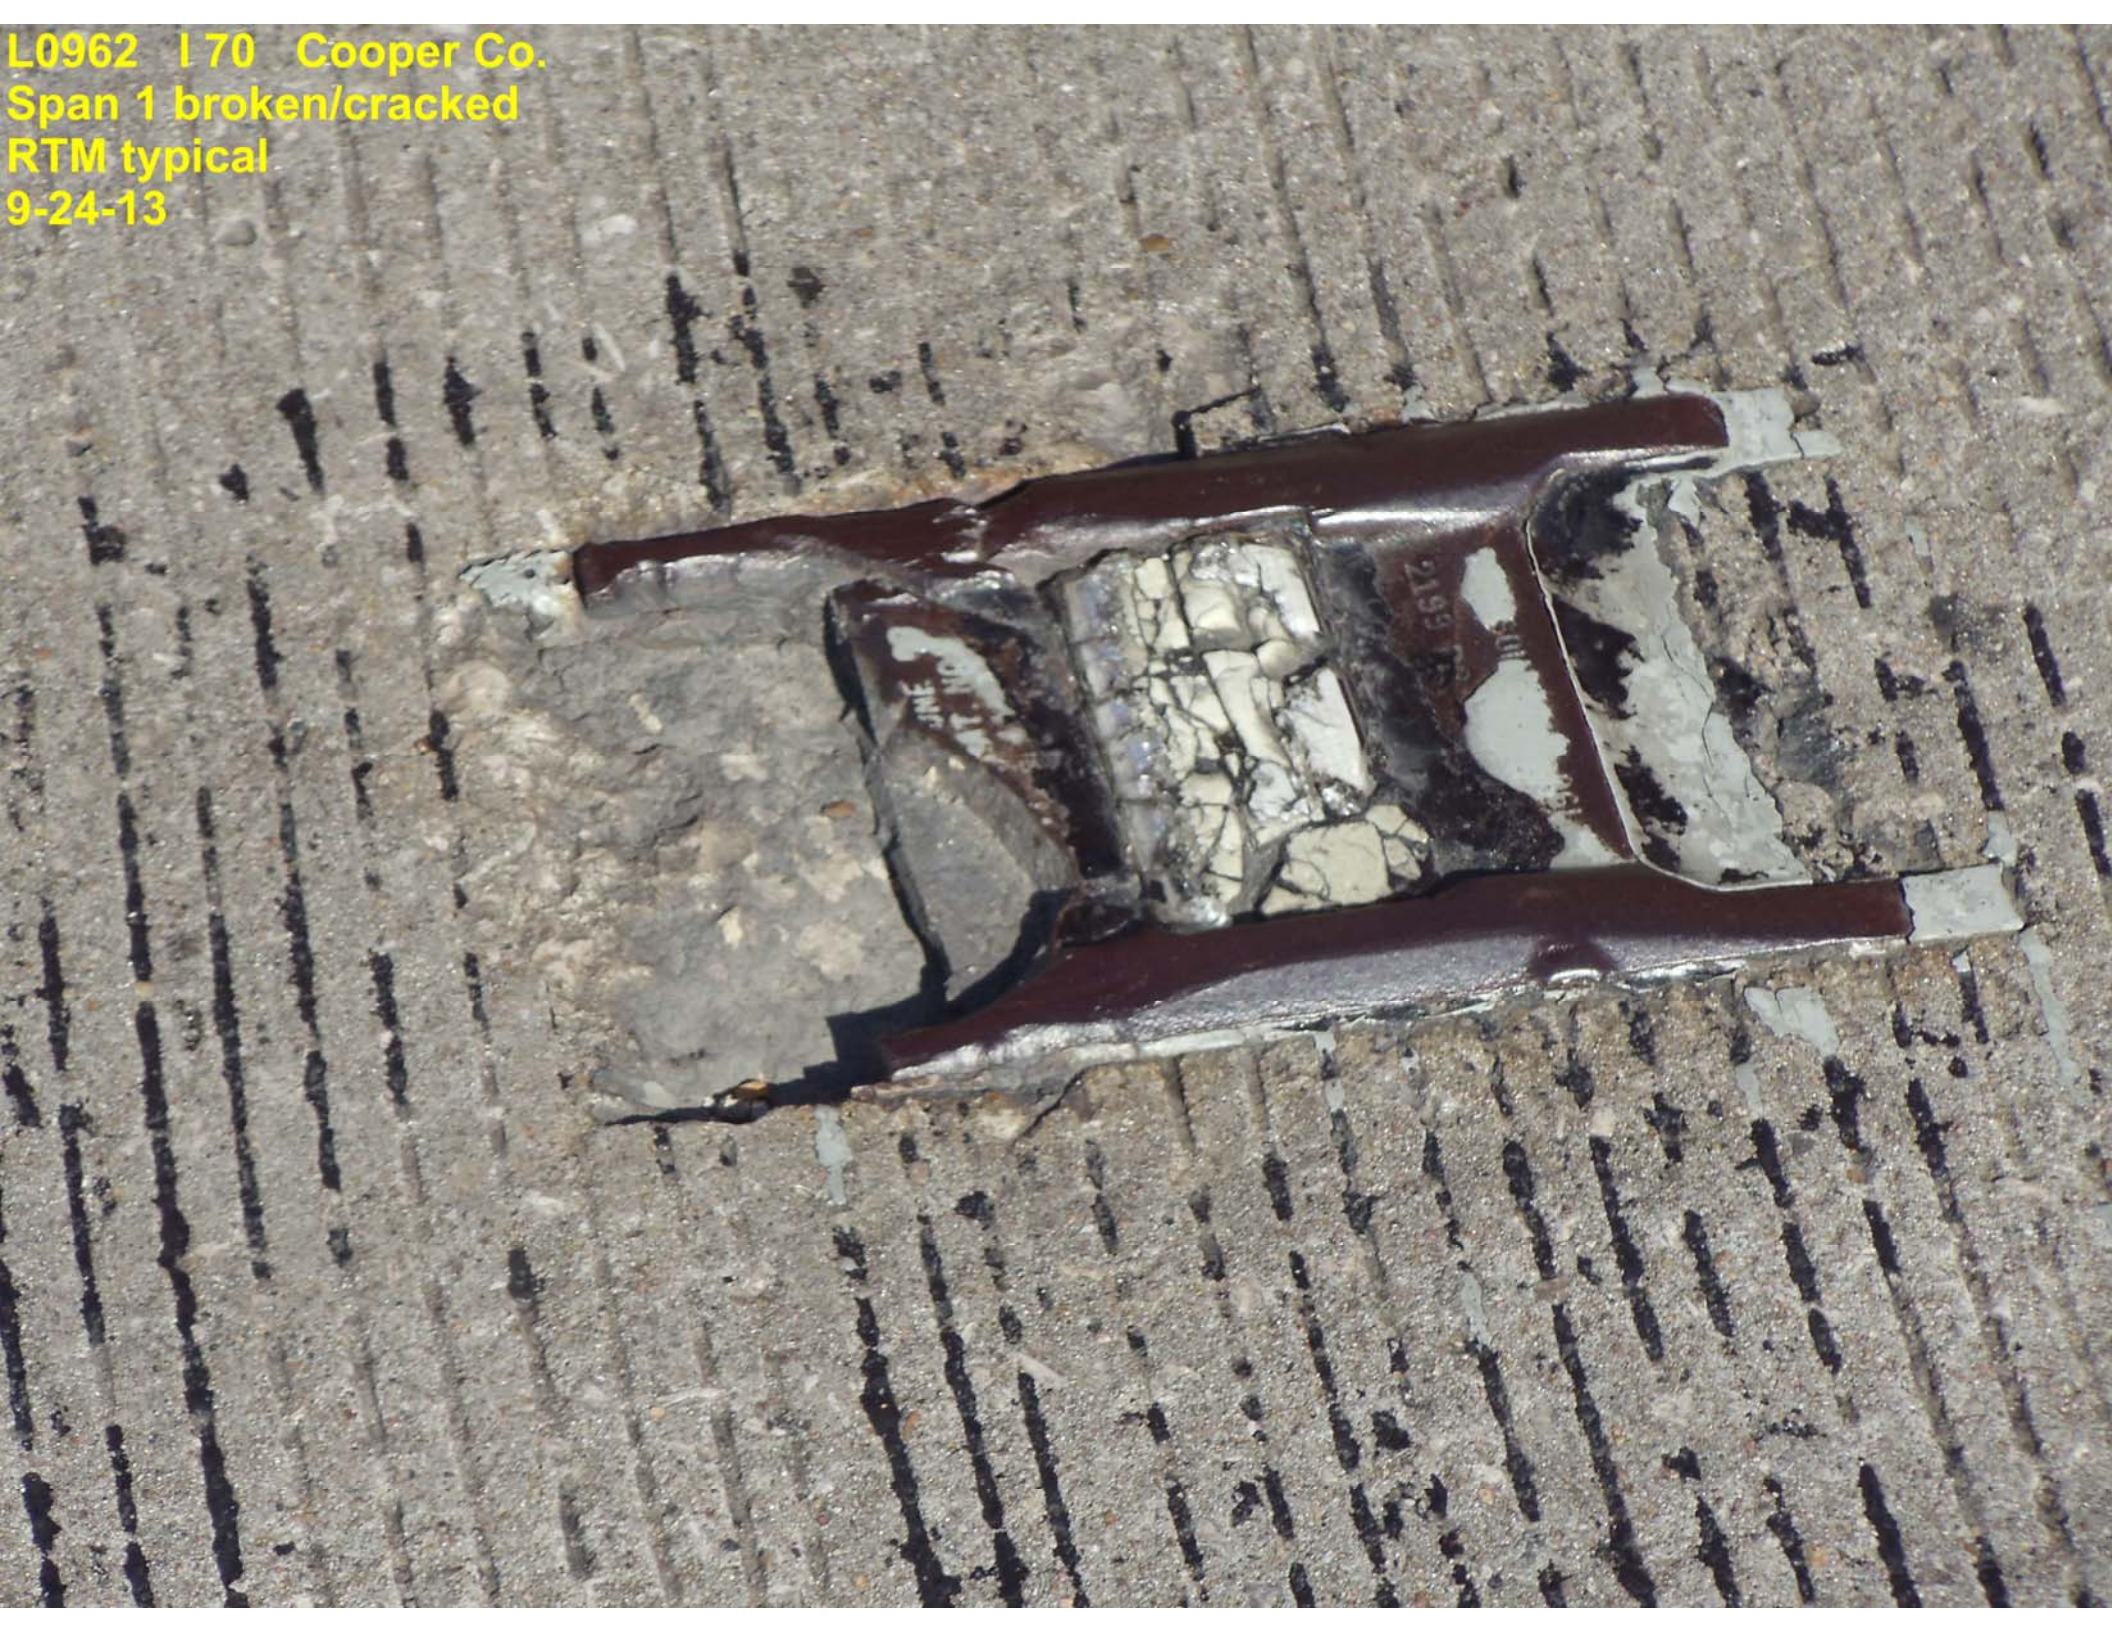
L0962 I 70 Cooper Co.  
Span 1 broken/cracked  
RTM typical  
9-24-13

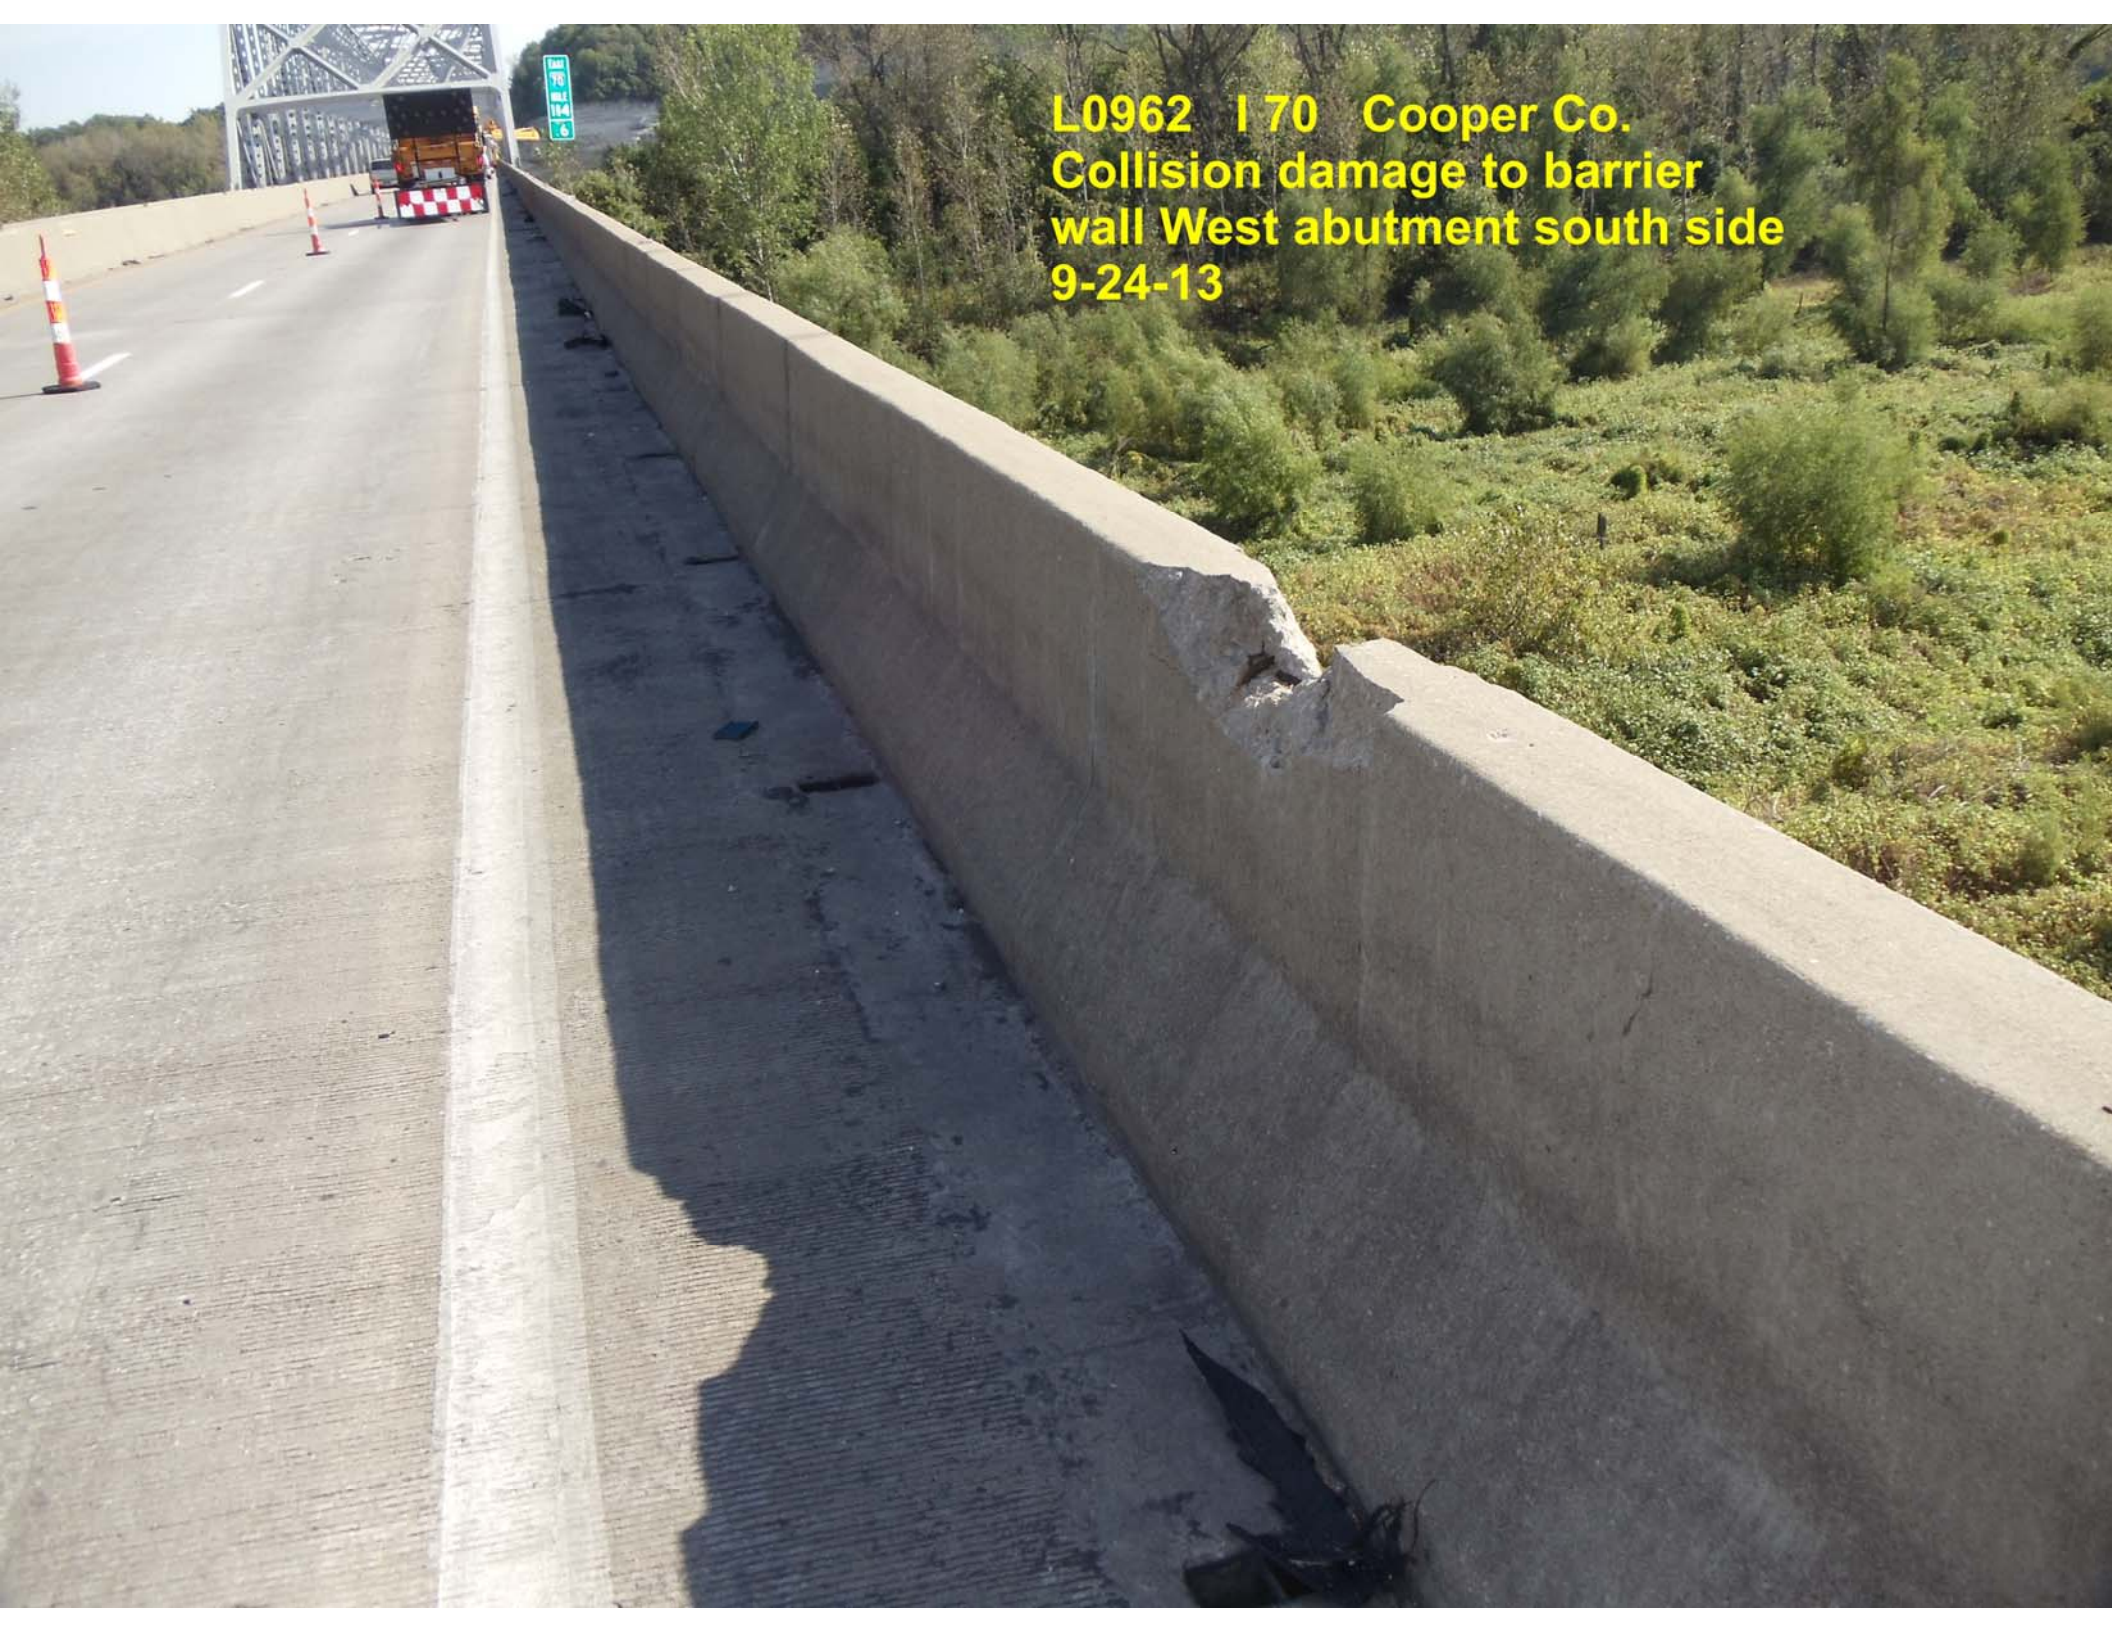
**L0962 I 70 Cooper Co.  
Collision damage to barrier  
wall West abutment south side  
9-24-13**

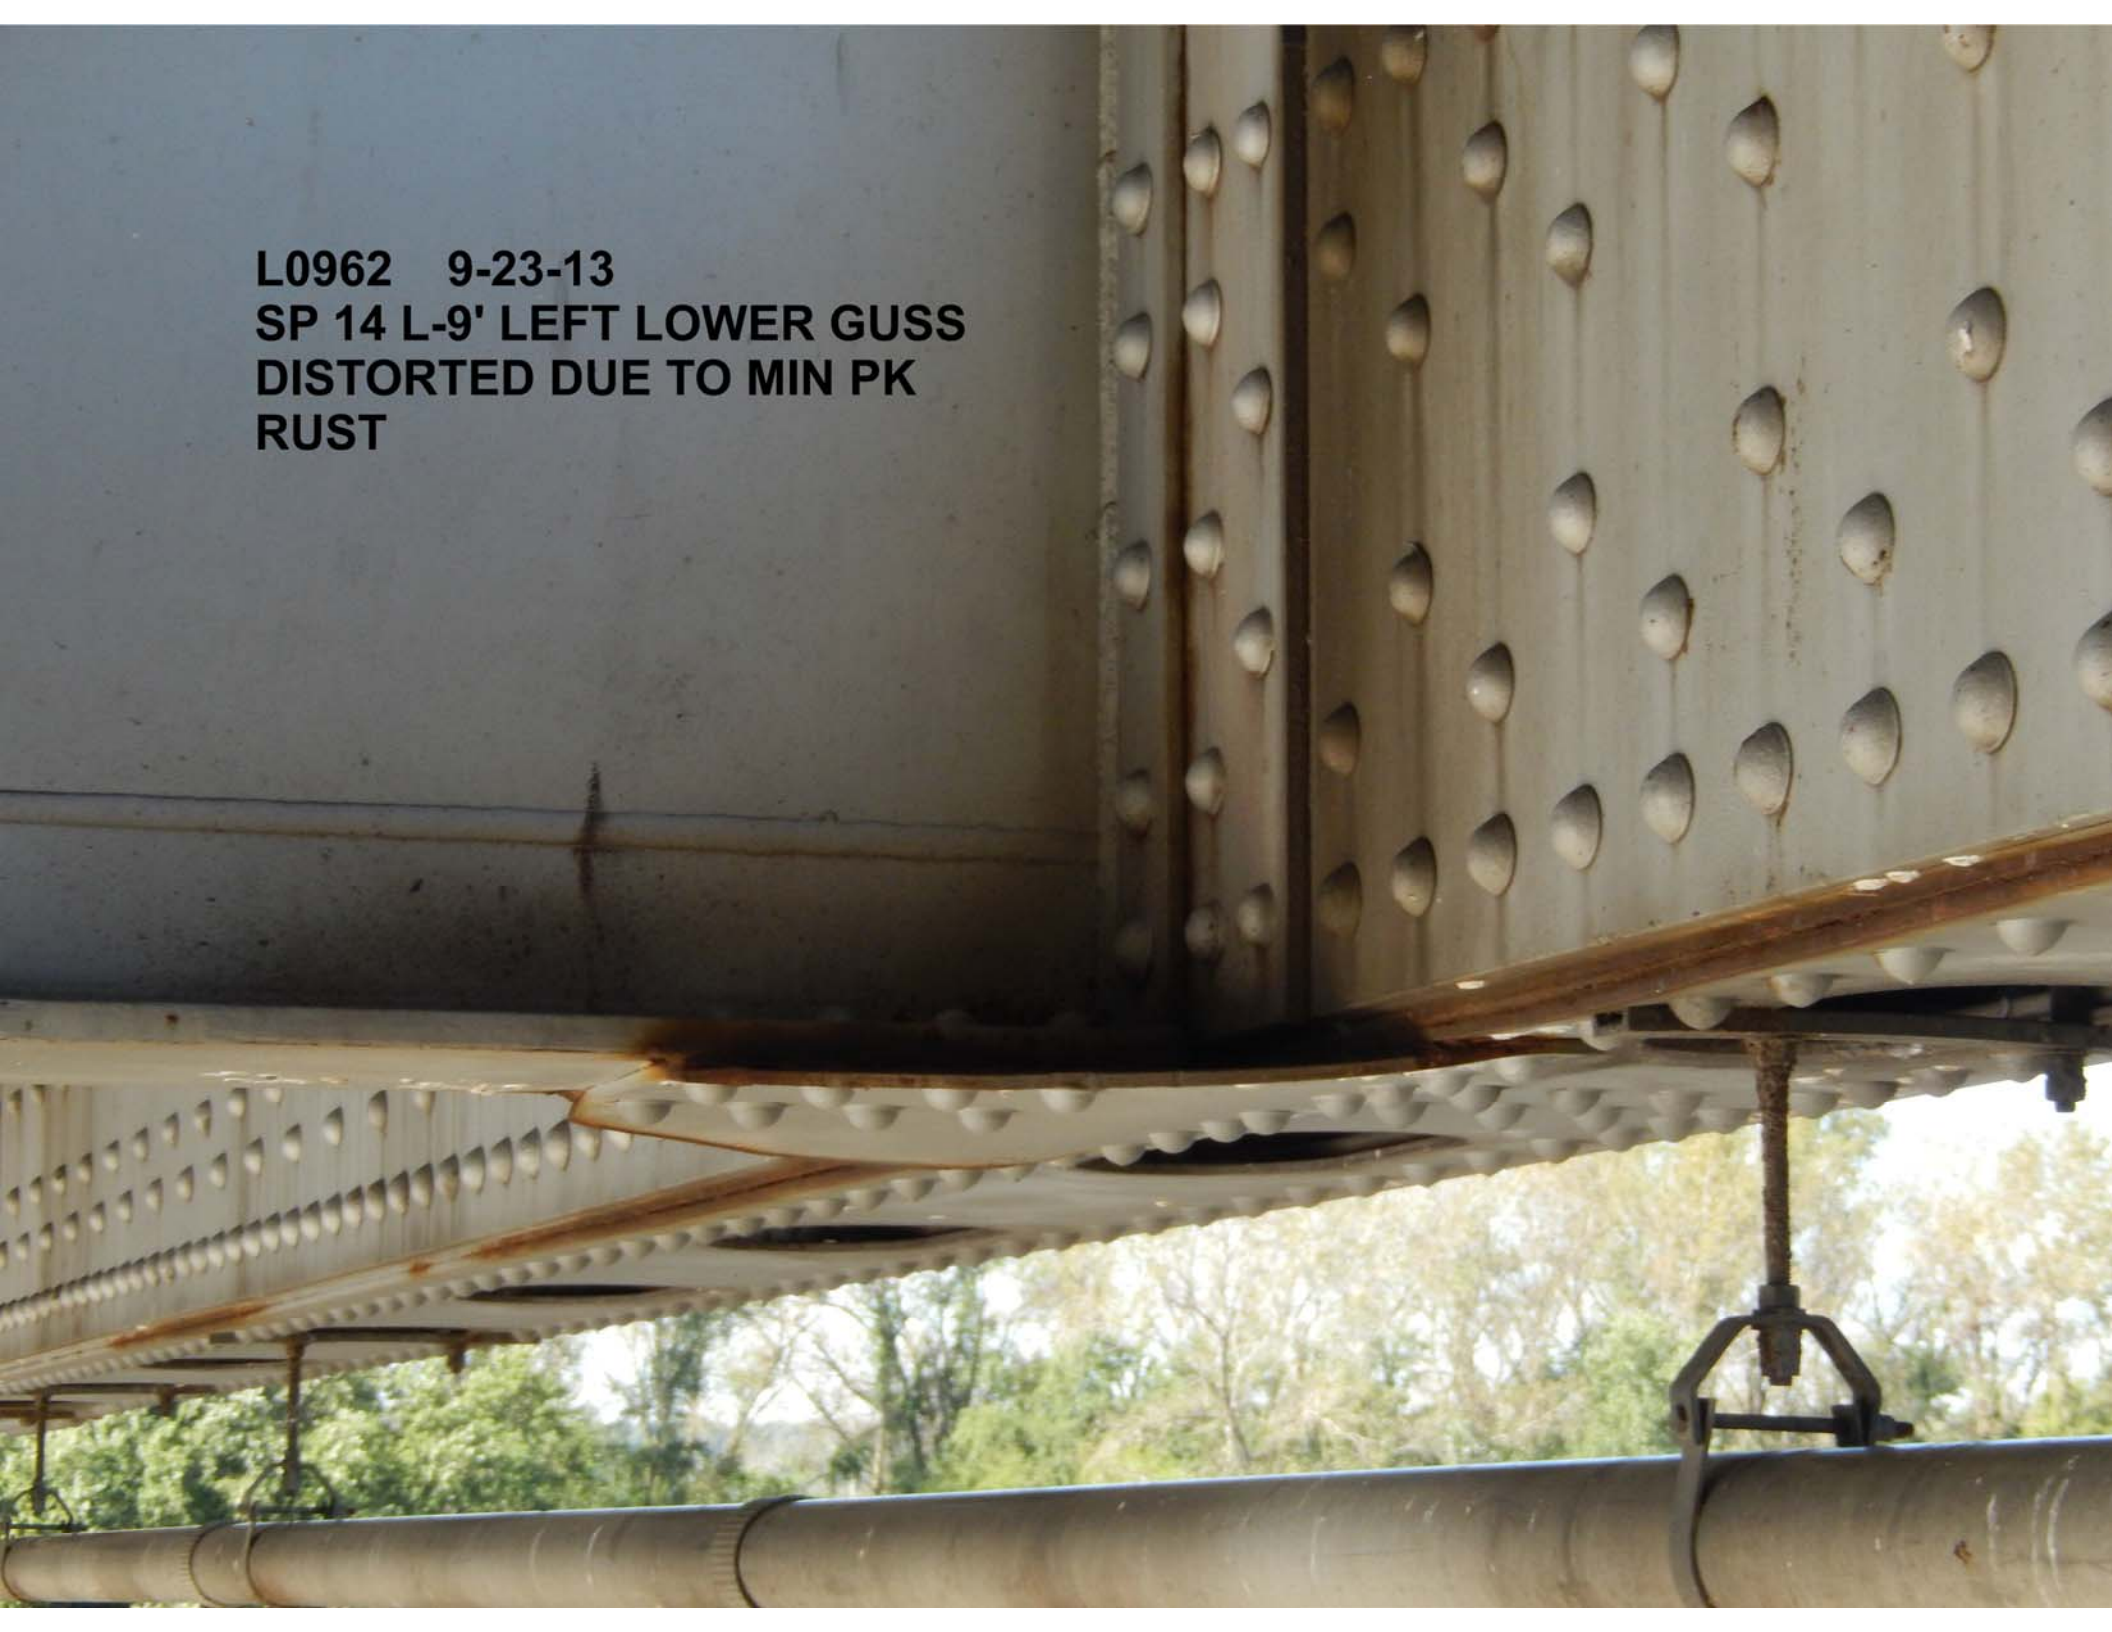
L0962 9-23-13  
SP 14 L-9' LEFT LOWER GUSS  
DISTORTED DUE TO MIN PK  
RUST

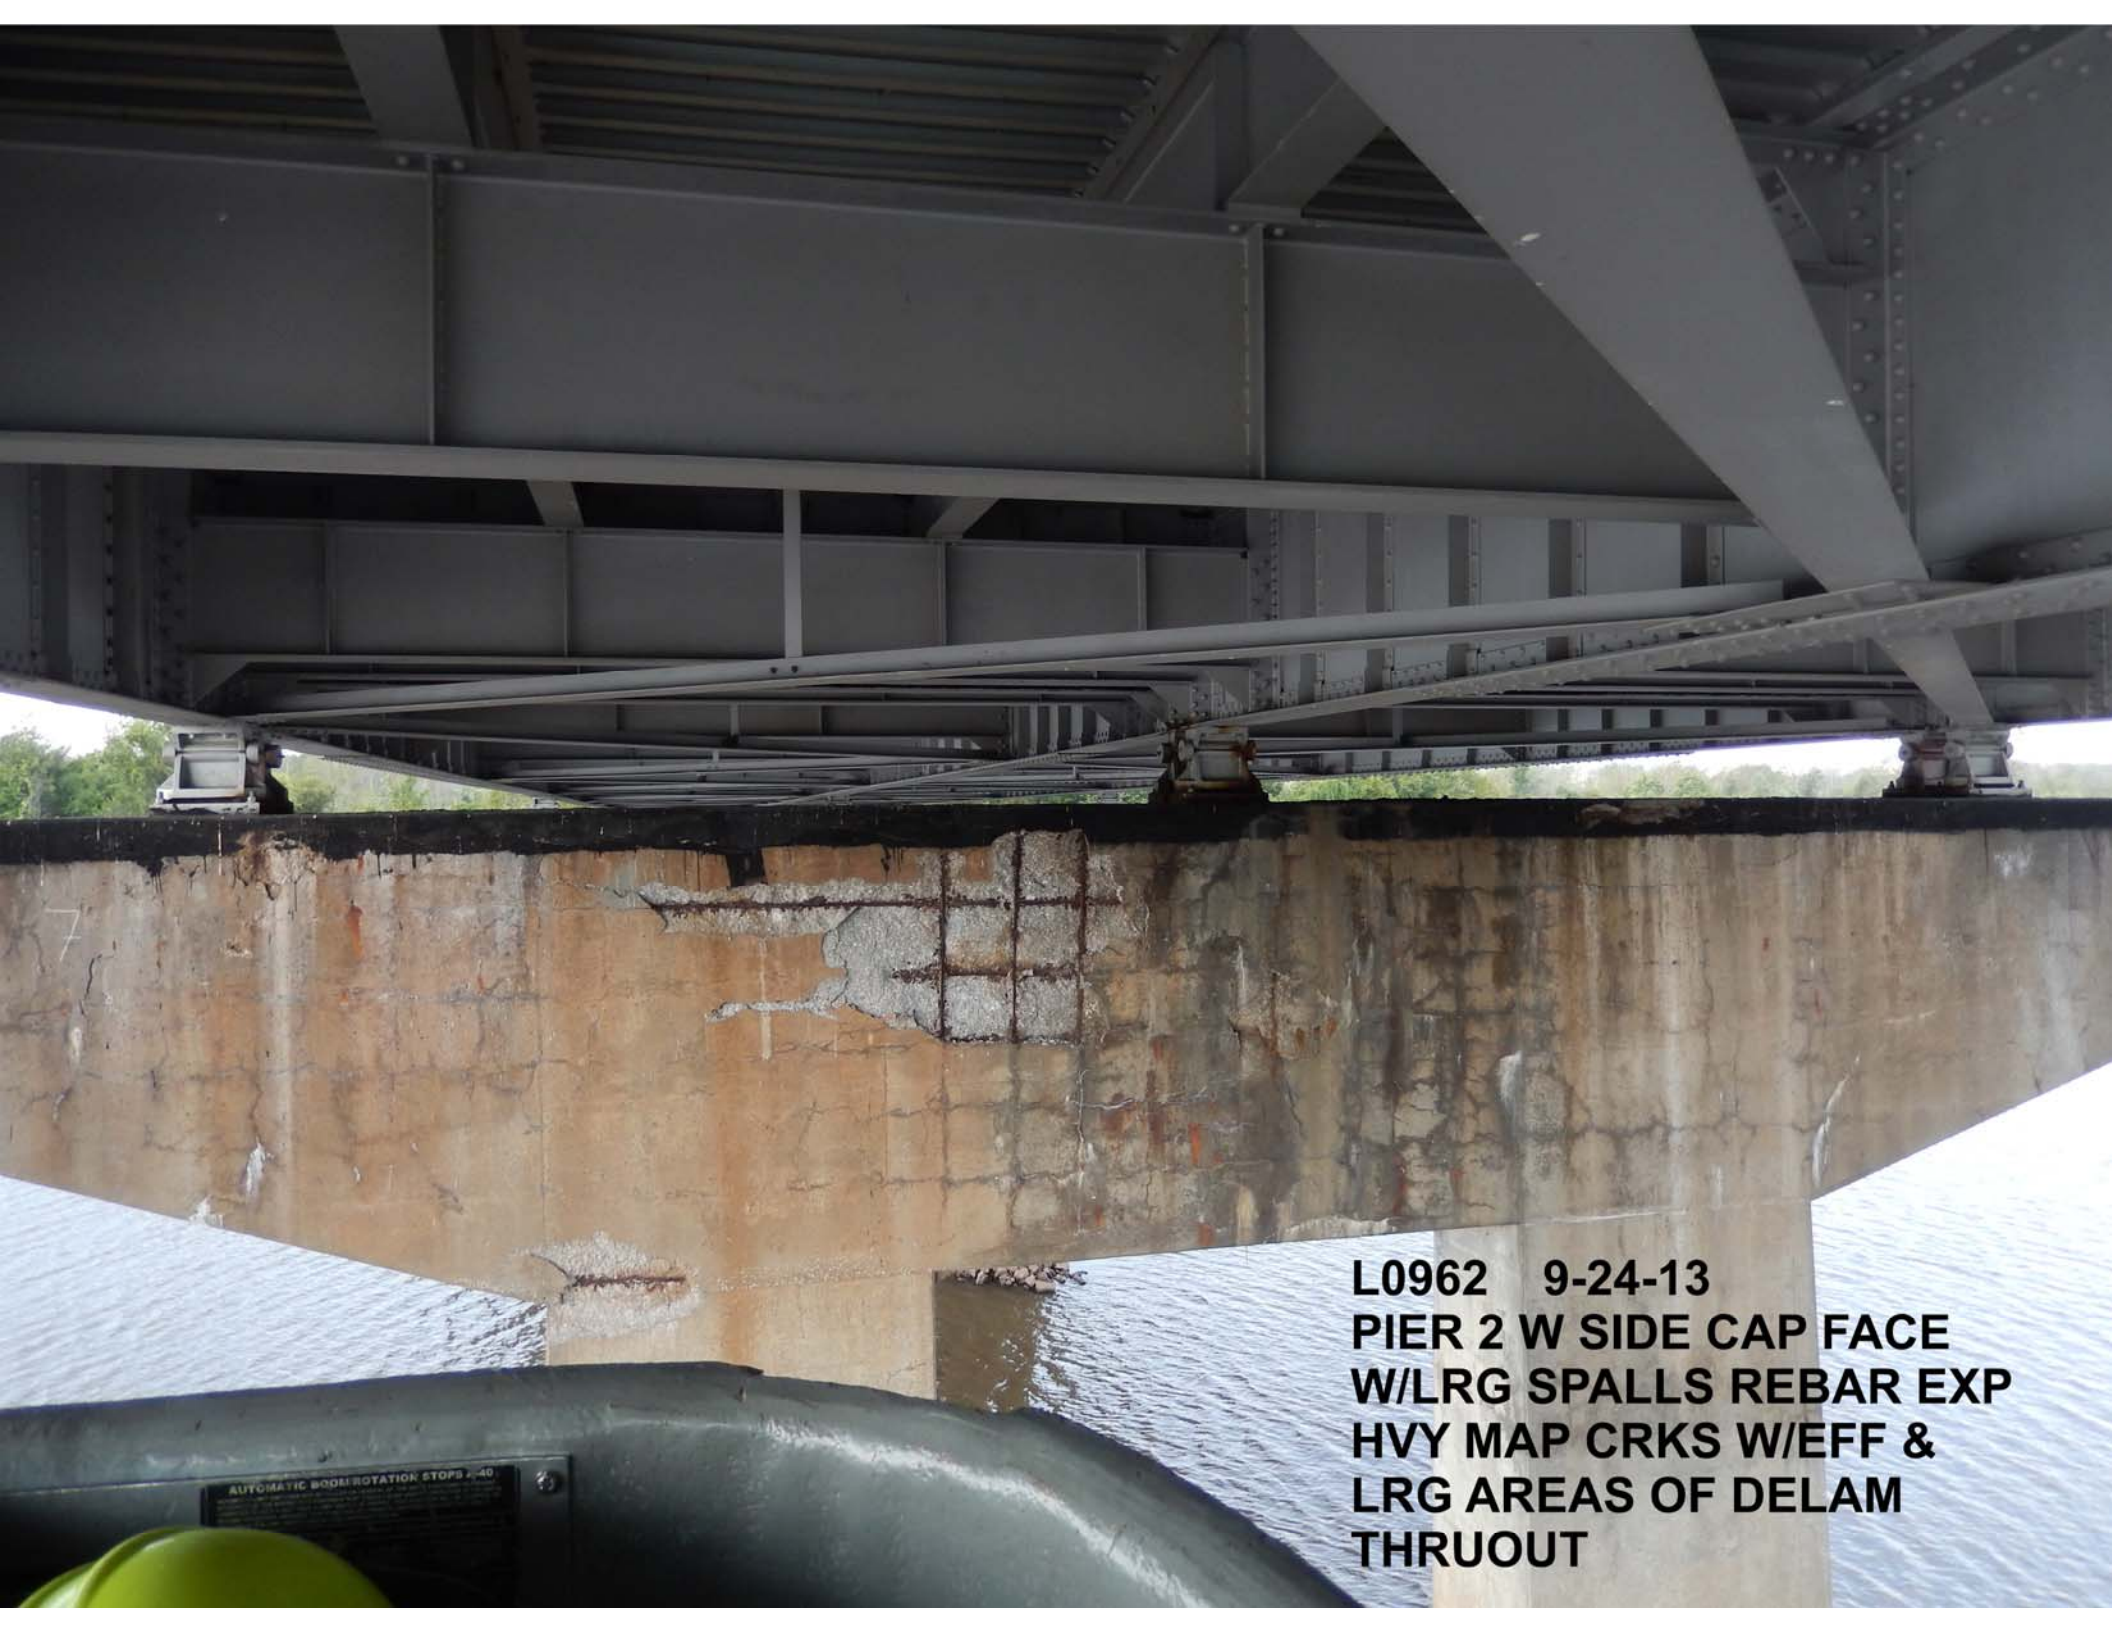
**L0962 9-24-13**  
**PIER 2 W SIDE CAP FACE**  
**W/LRG SPALLS REBAR EXP**  
**HVY MAP CRKS W/EFF**  
**& LRG AREAS OF DELAM**  
**THRUOUT**
