L0962 I 70 Cooper Co.  
Joint at L8, span 13  
Eastbound lane failing  
9-24-13

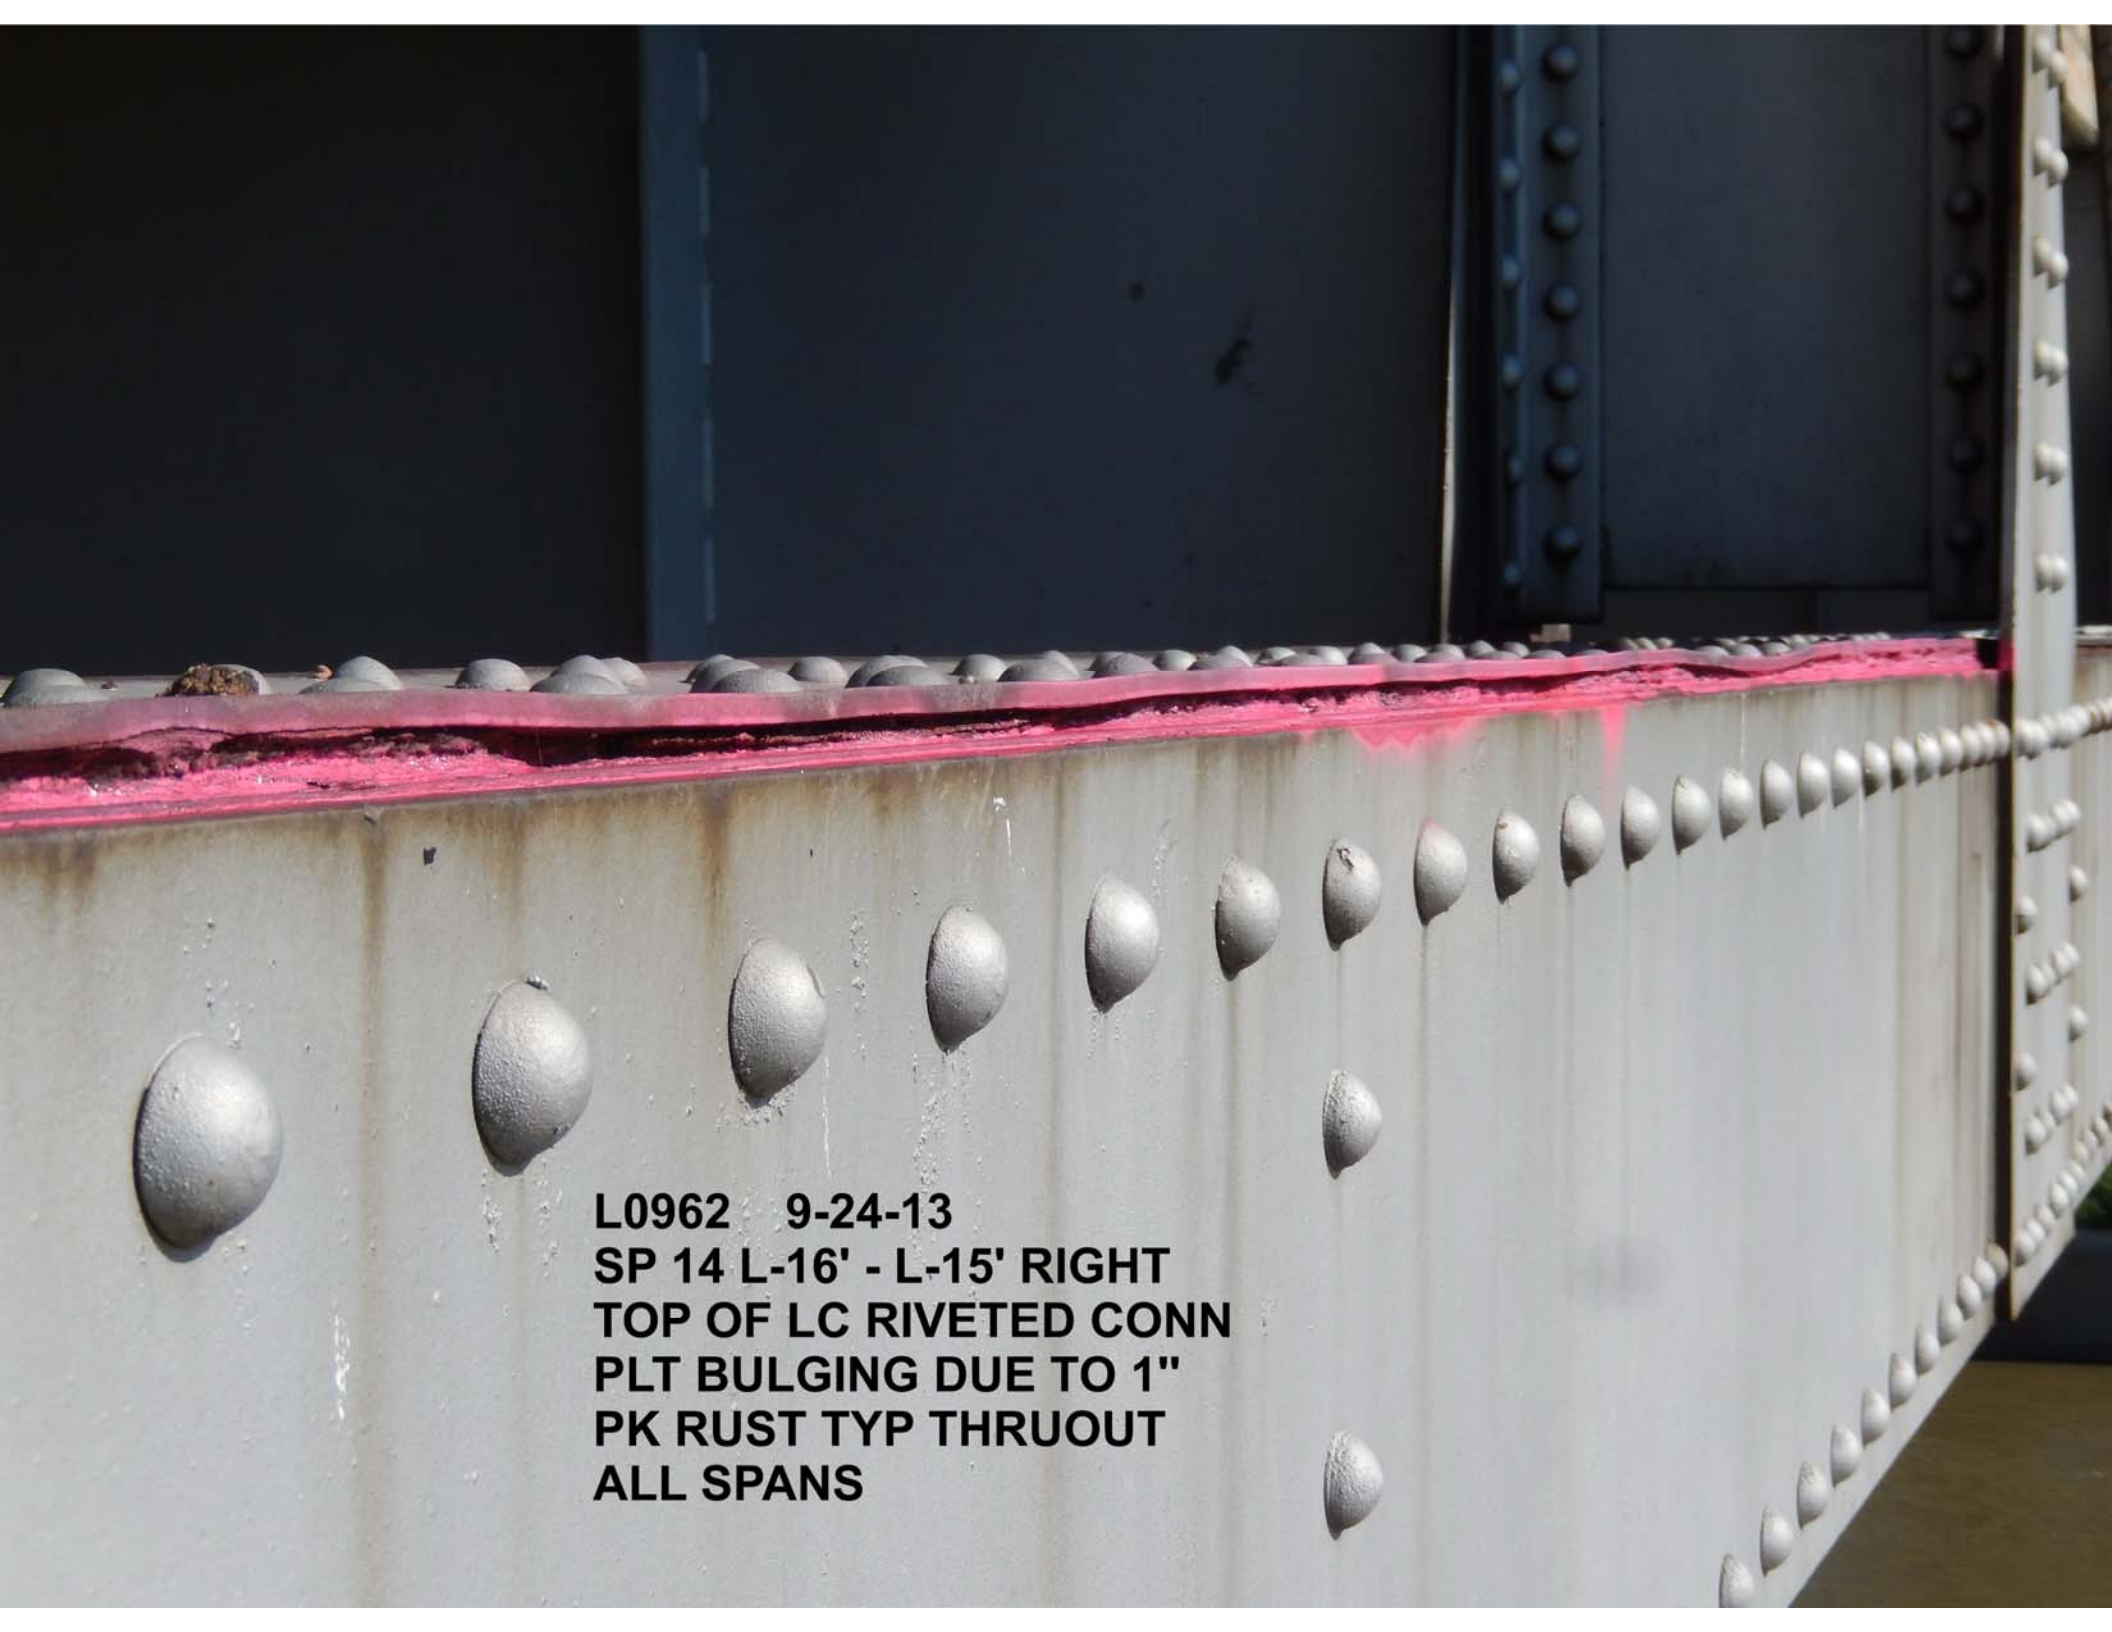
**L0962 9-24-13  
SP 14 L-16' - L-15' RIGHT  
TOP OF LC RIVETED CONN  
PLT BULGING DUE TO 1"  
PK RUST TYP THRUOUT  
ALL SPANS**

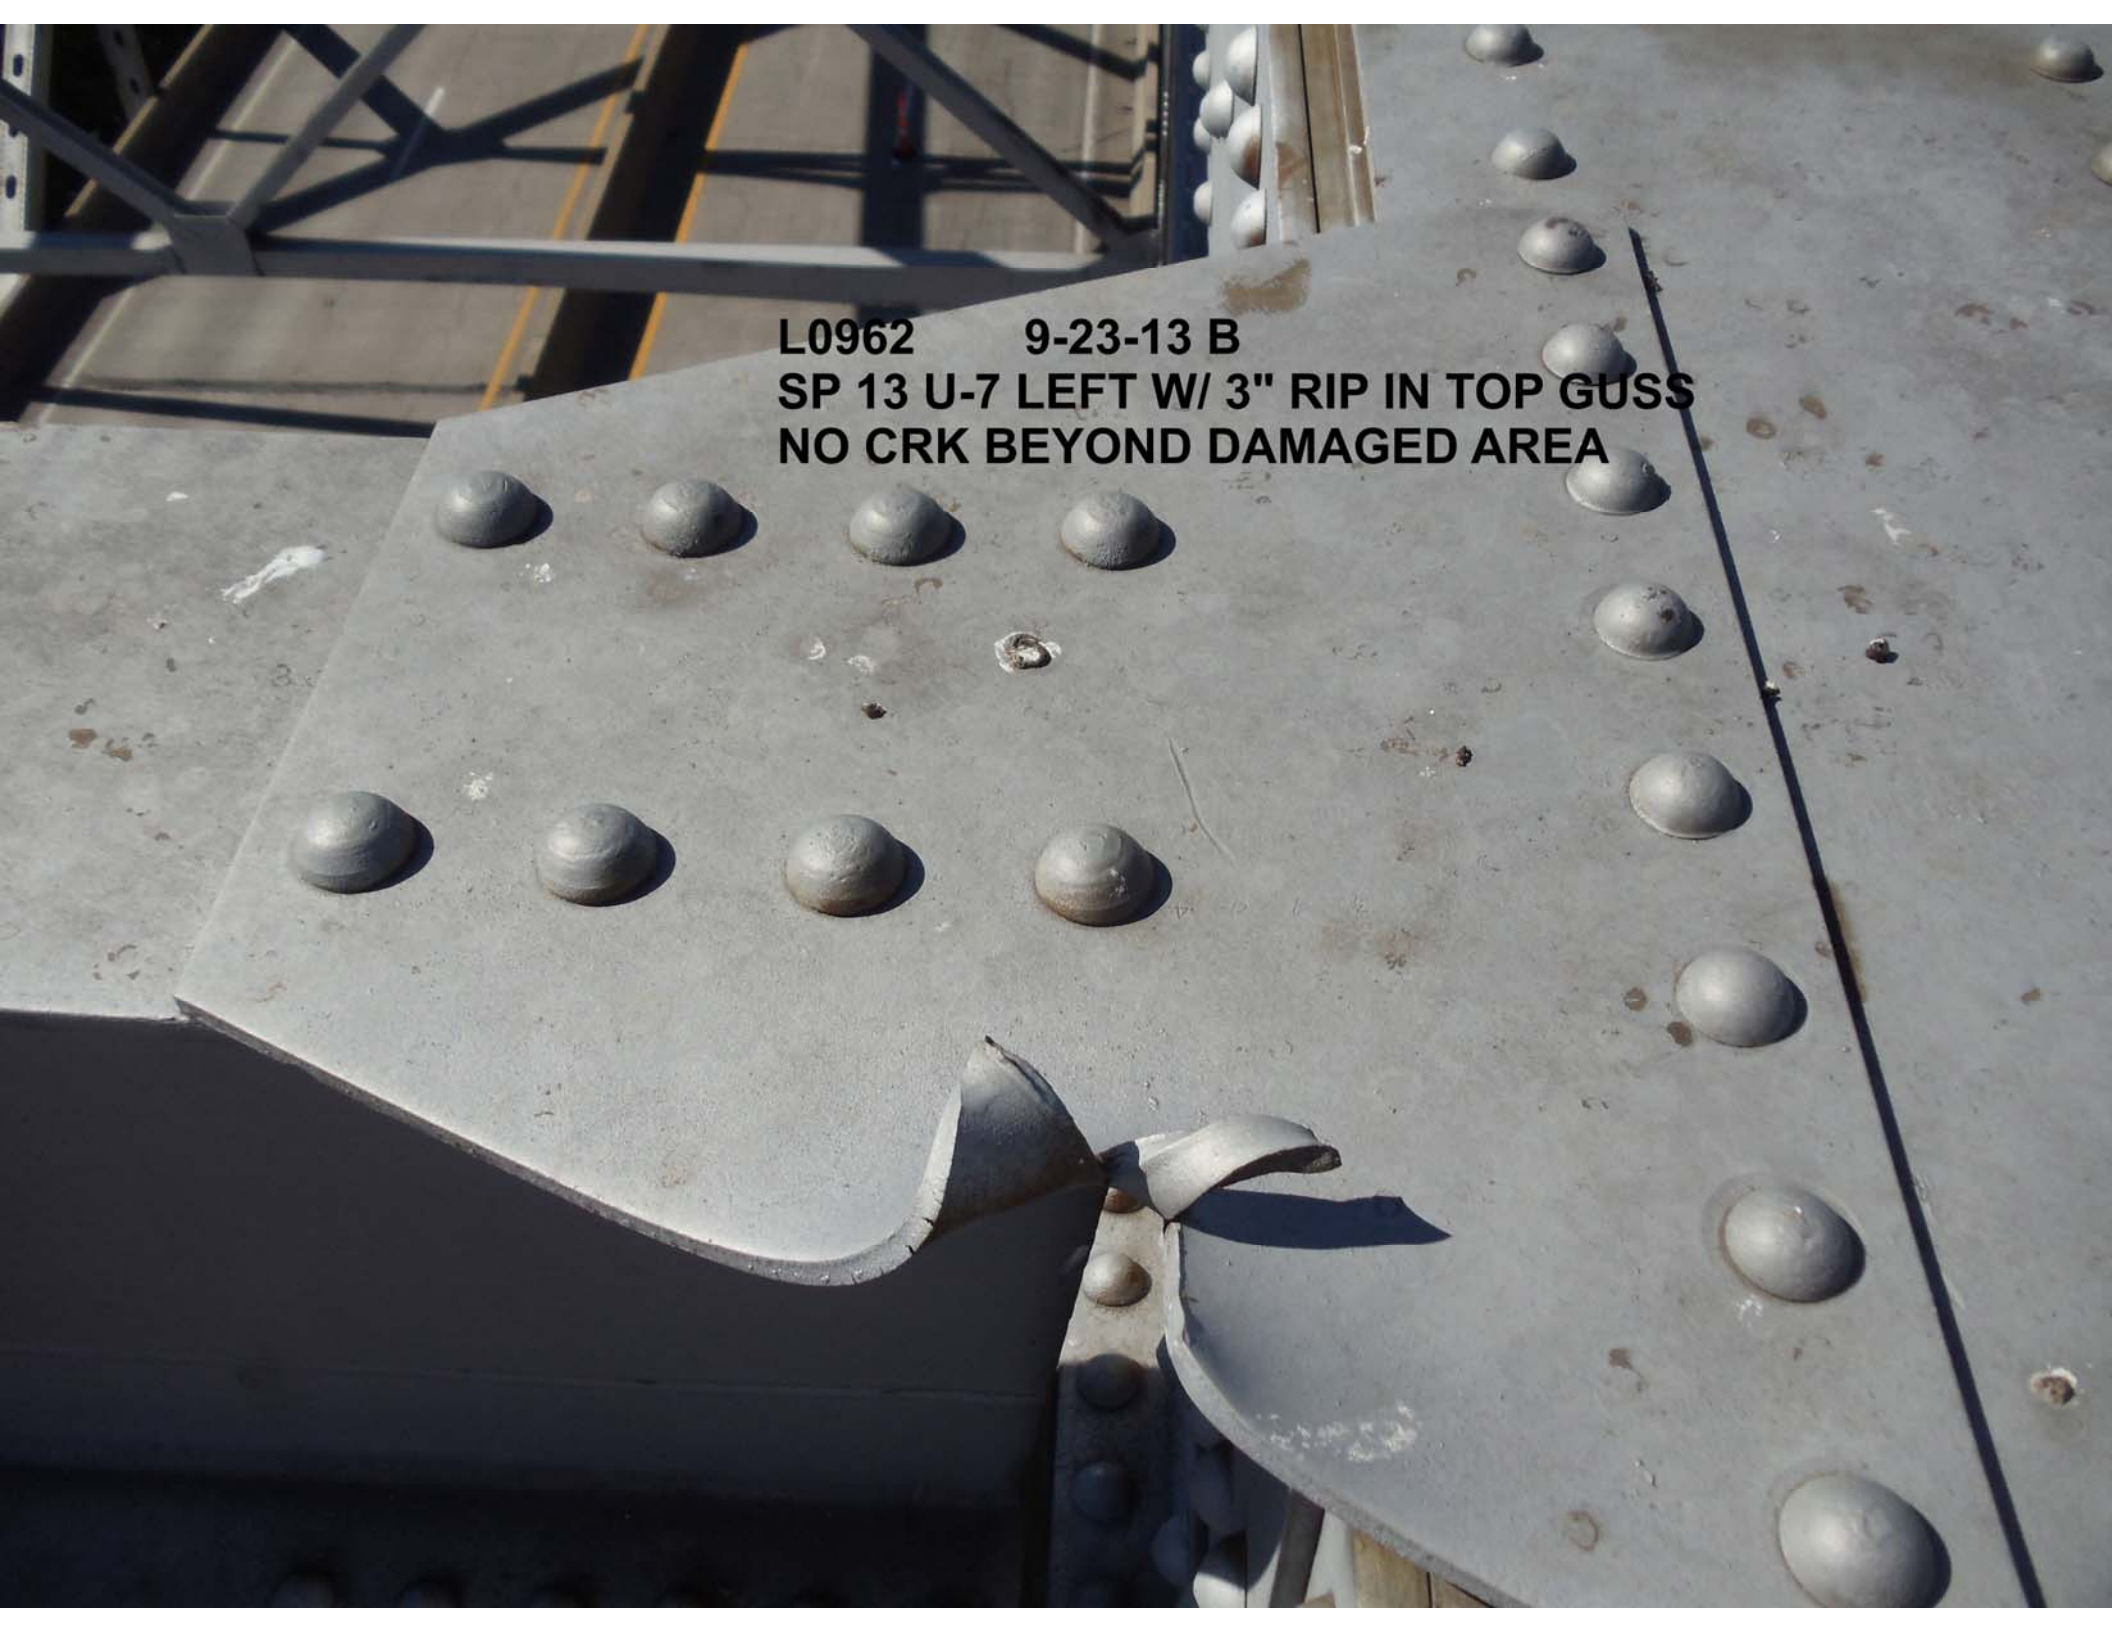
**L0962      9-23-13 B**  
**SP 13 U-7 LEFT W/ 3" RIP IN TOP GUSS**  
**NO CRK BEYOND DAMAGED AREA**

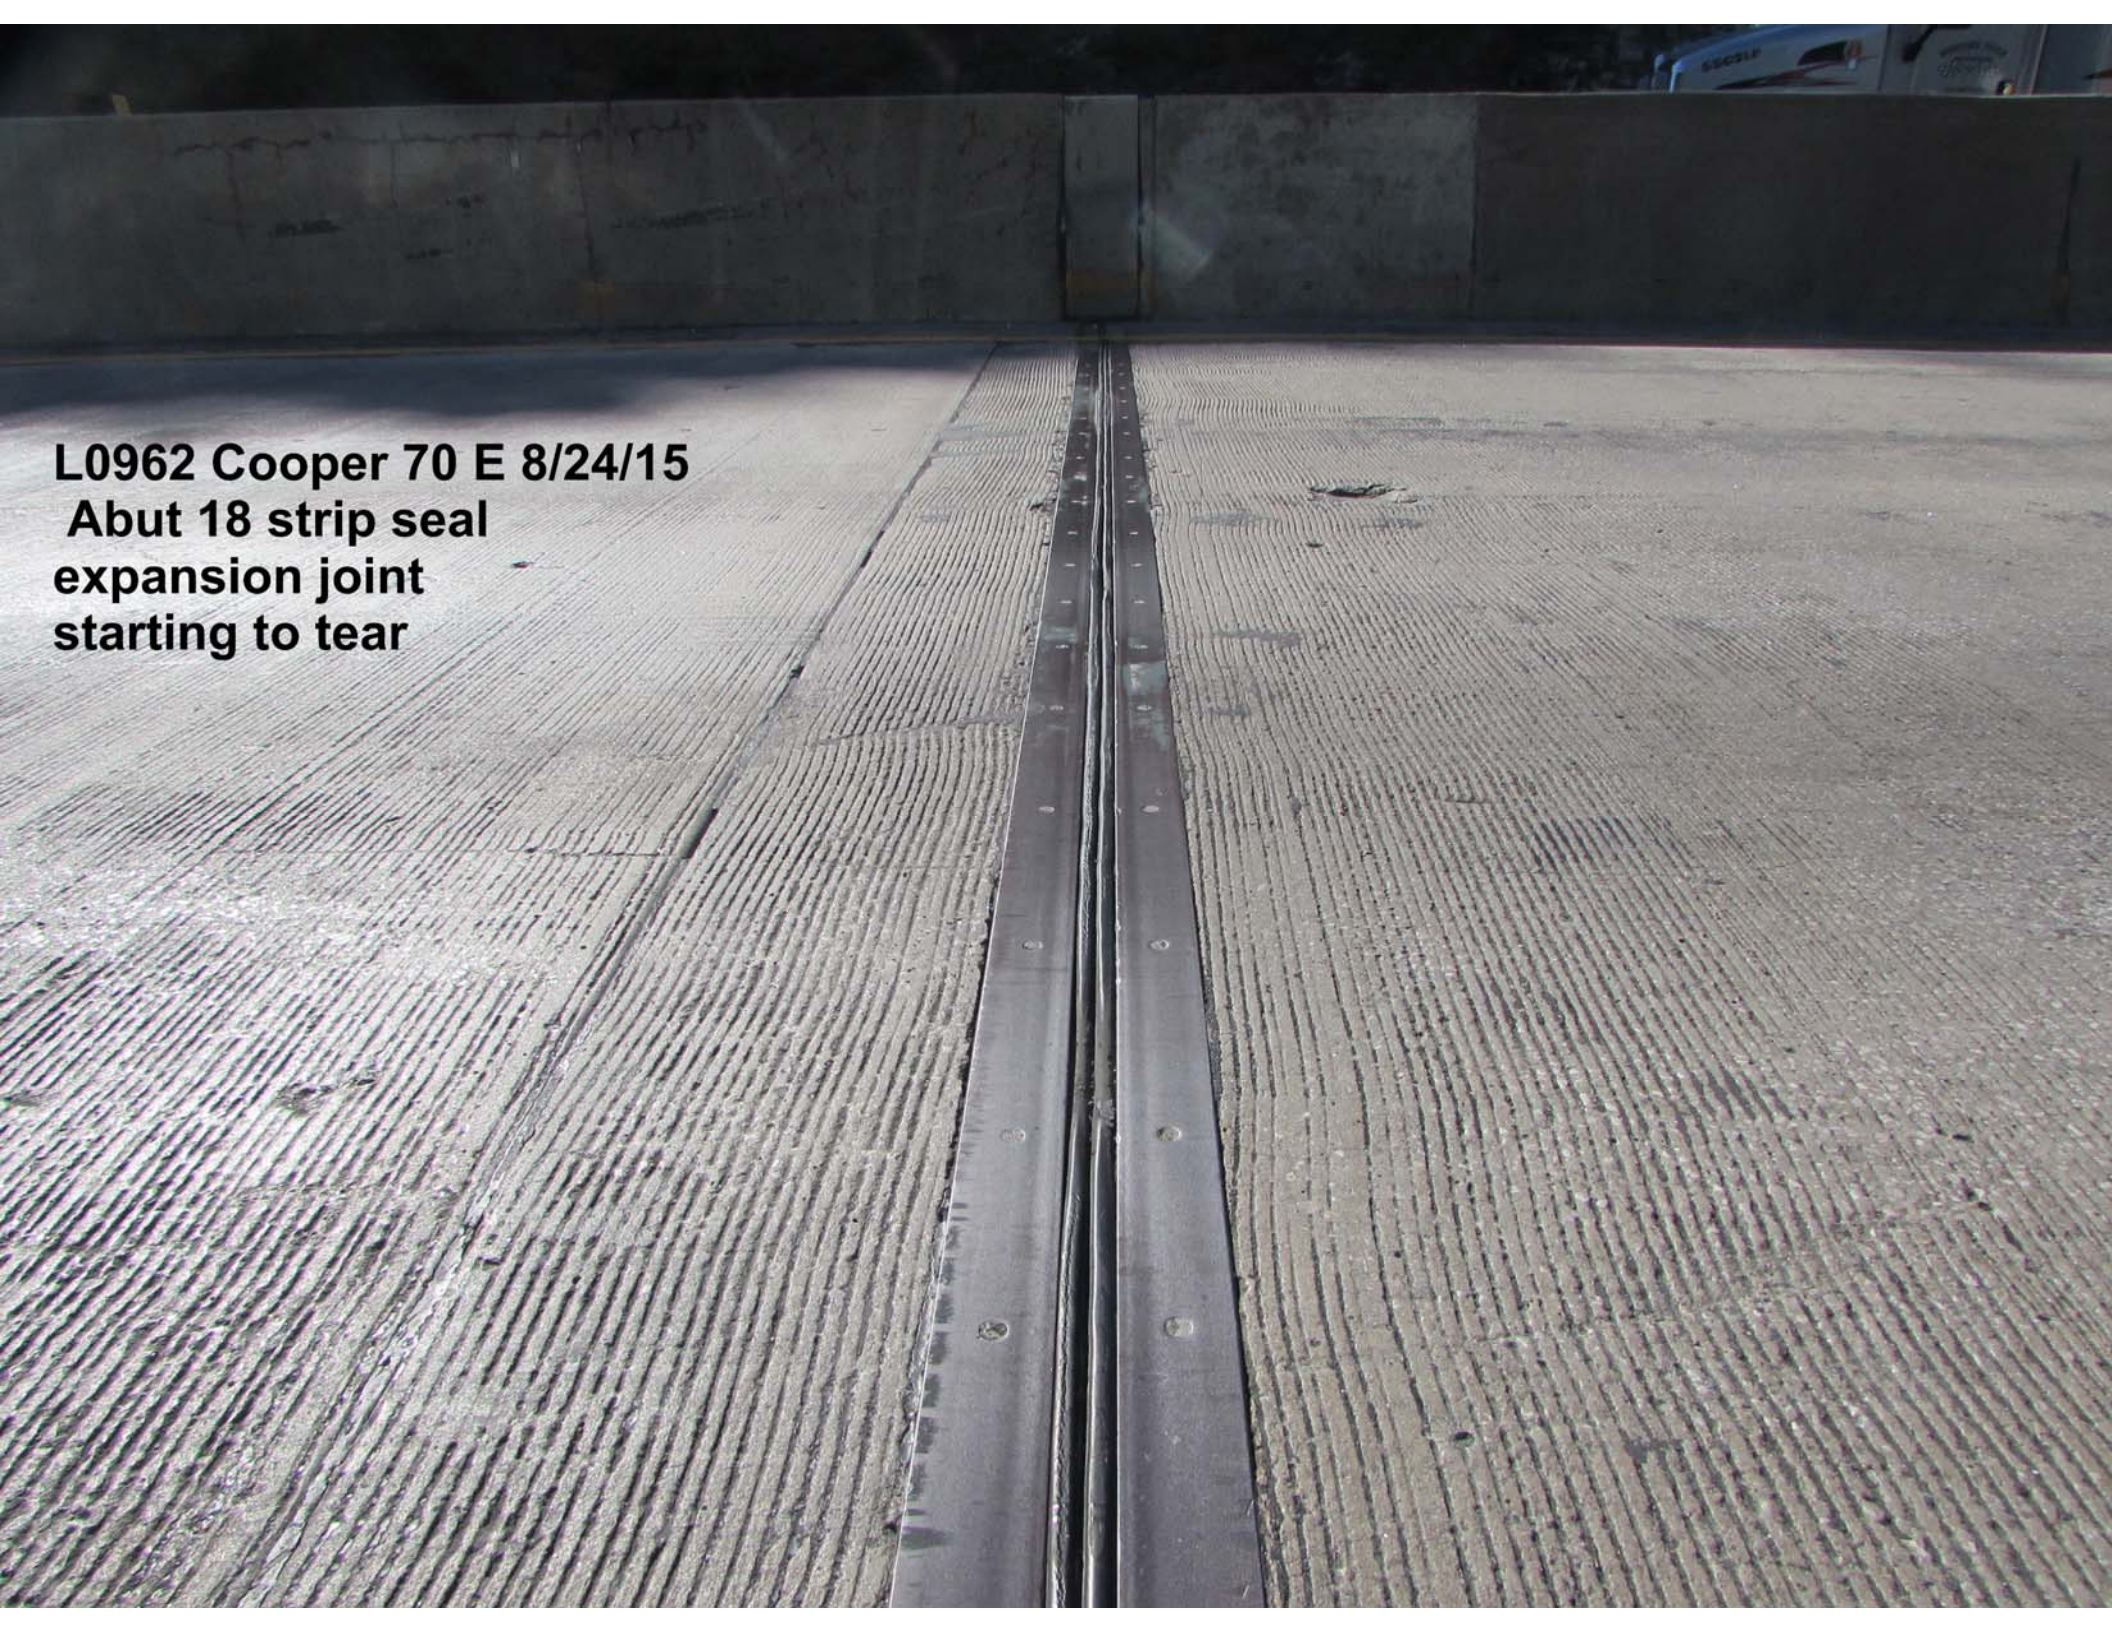
**L0962 Cooper 70 E 8/24/15**  
**Abut 18 strip seal**  
**expansion joint**  
**starting to tear**

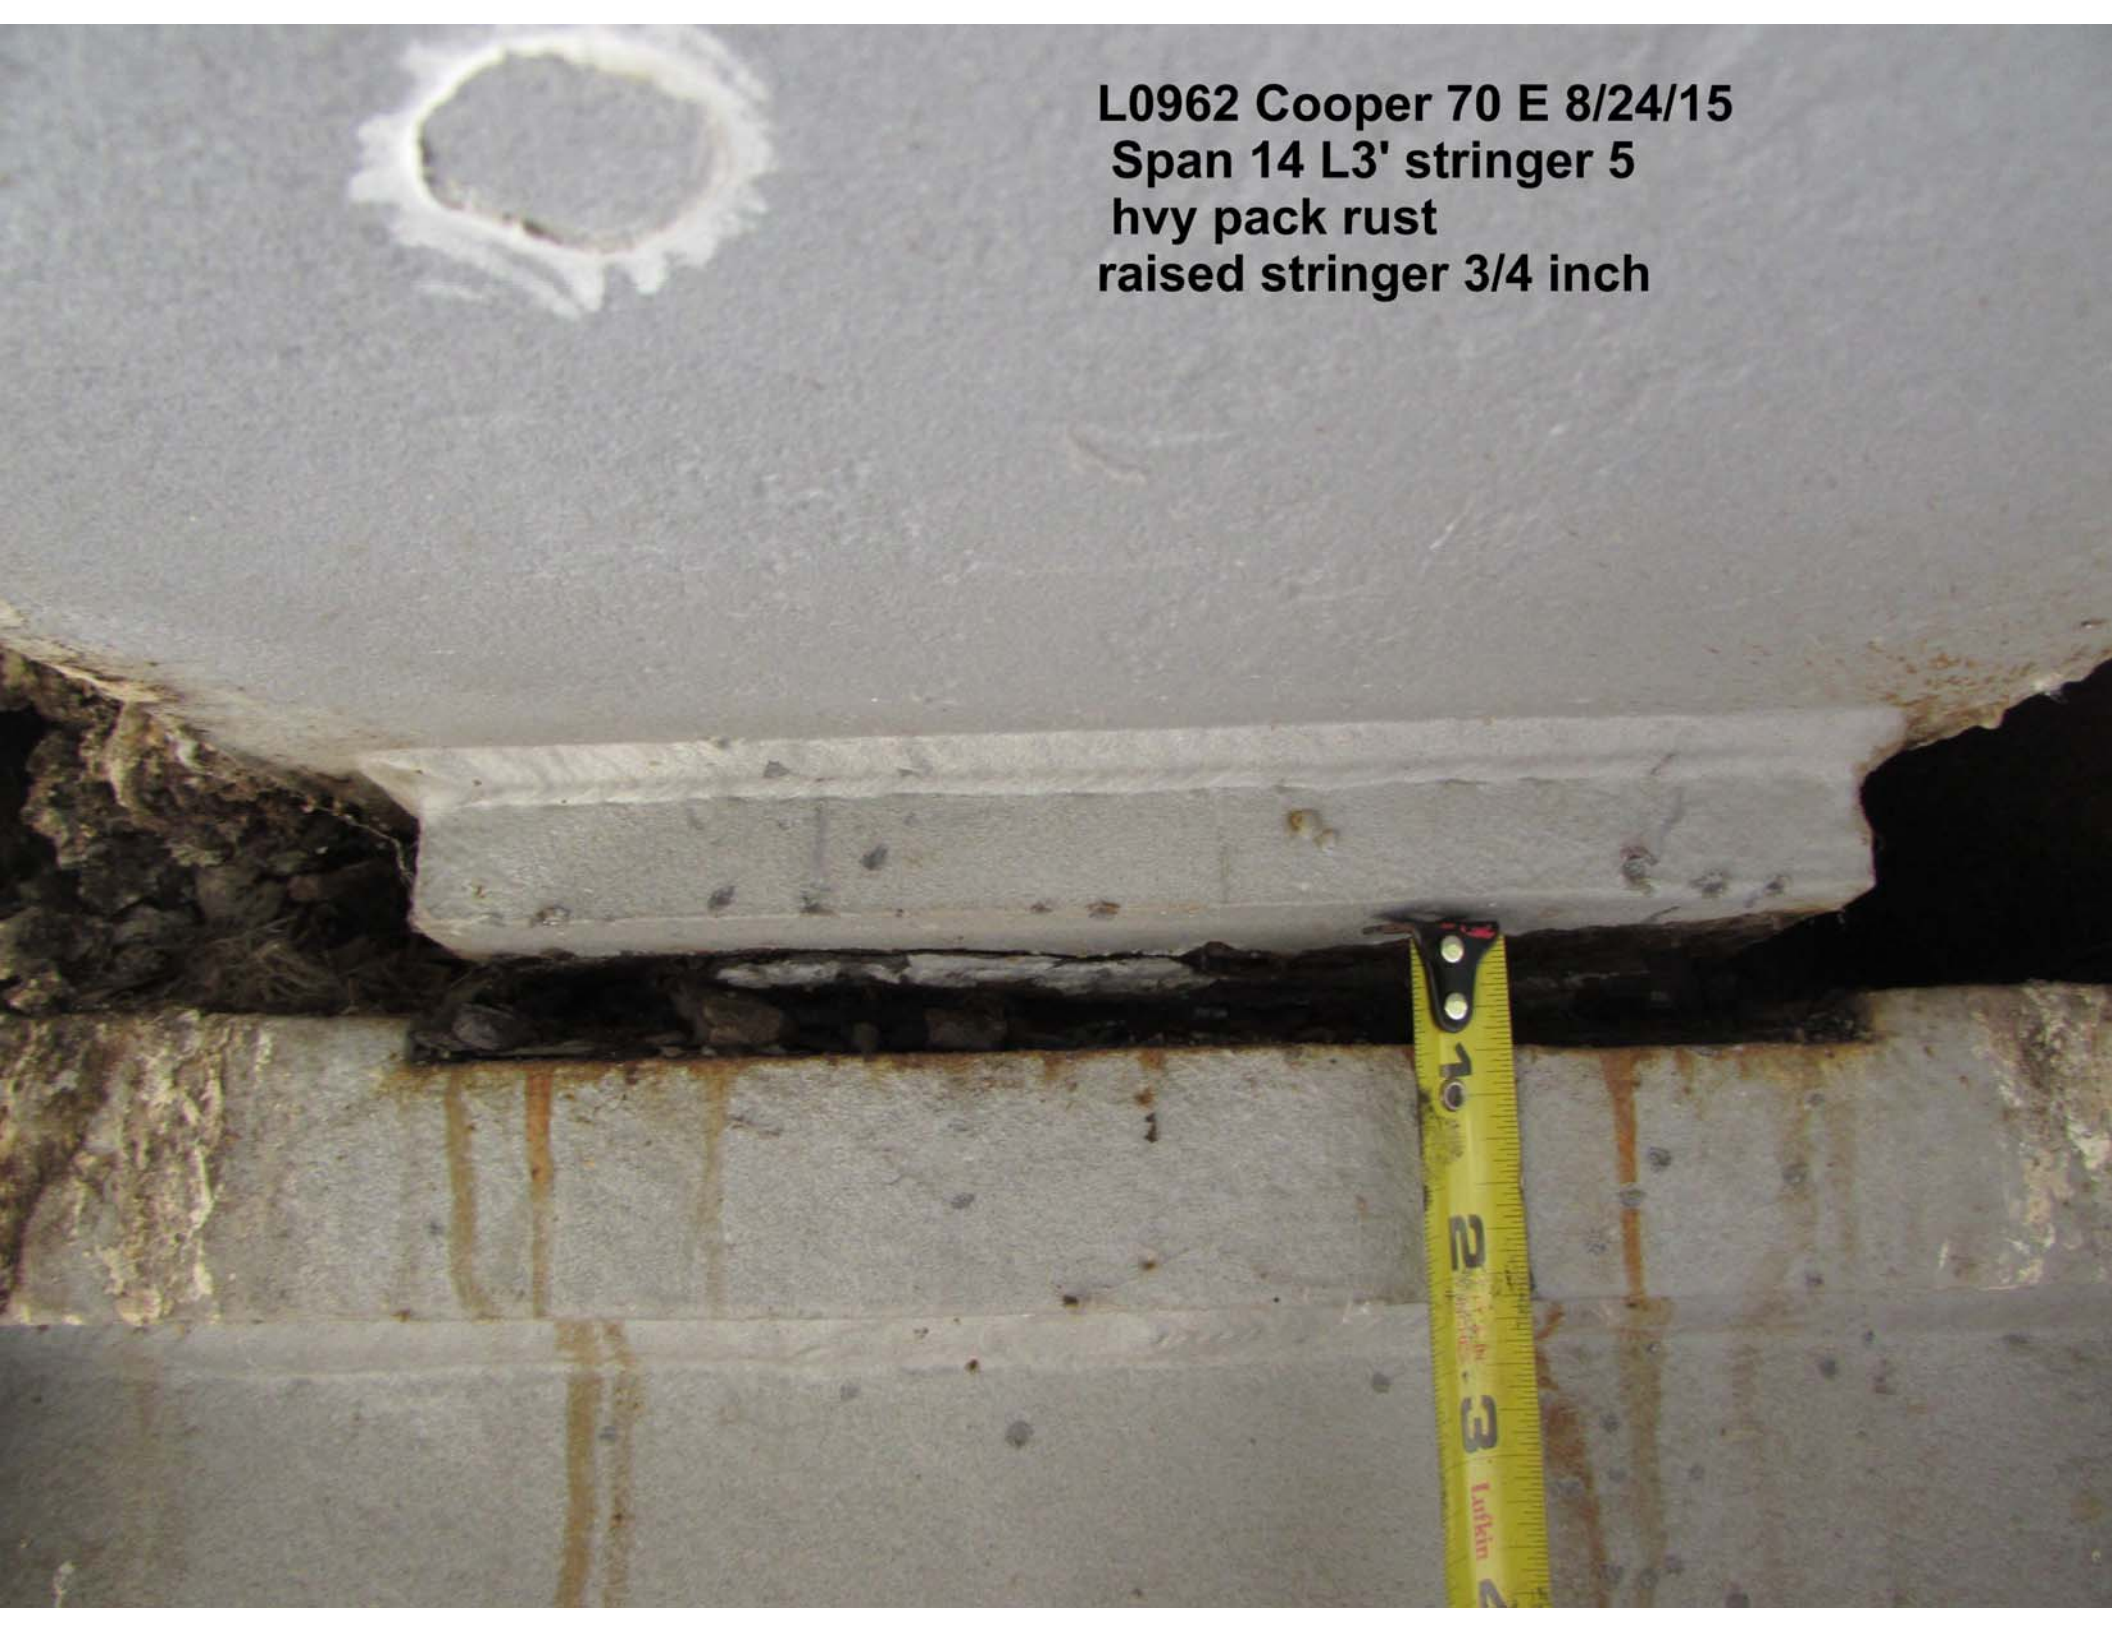
**L0962 Cooper 70 E 8/24/15**  
**Span 14 L3' stringer 5**  
**hvy pack rust**  
**raised stringer 3/4 inch**

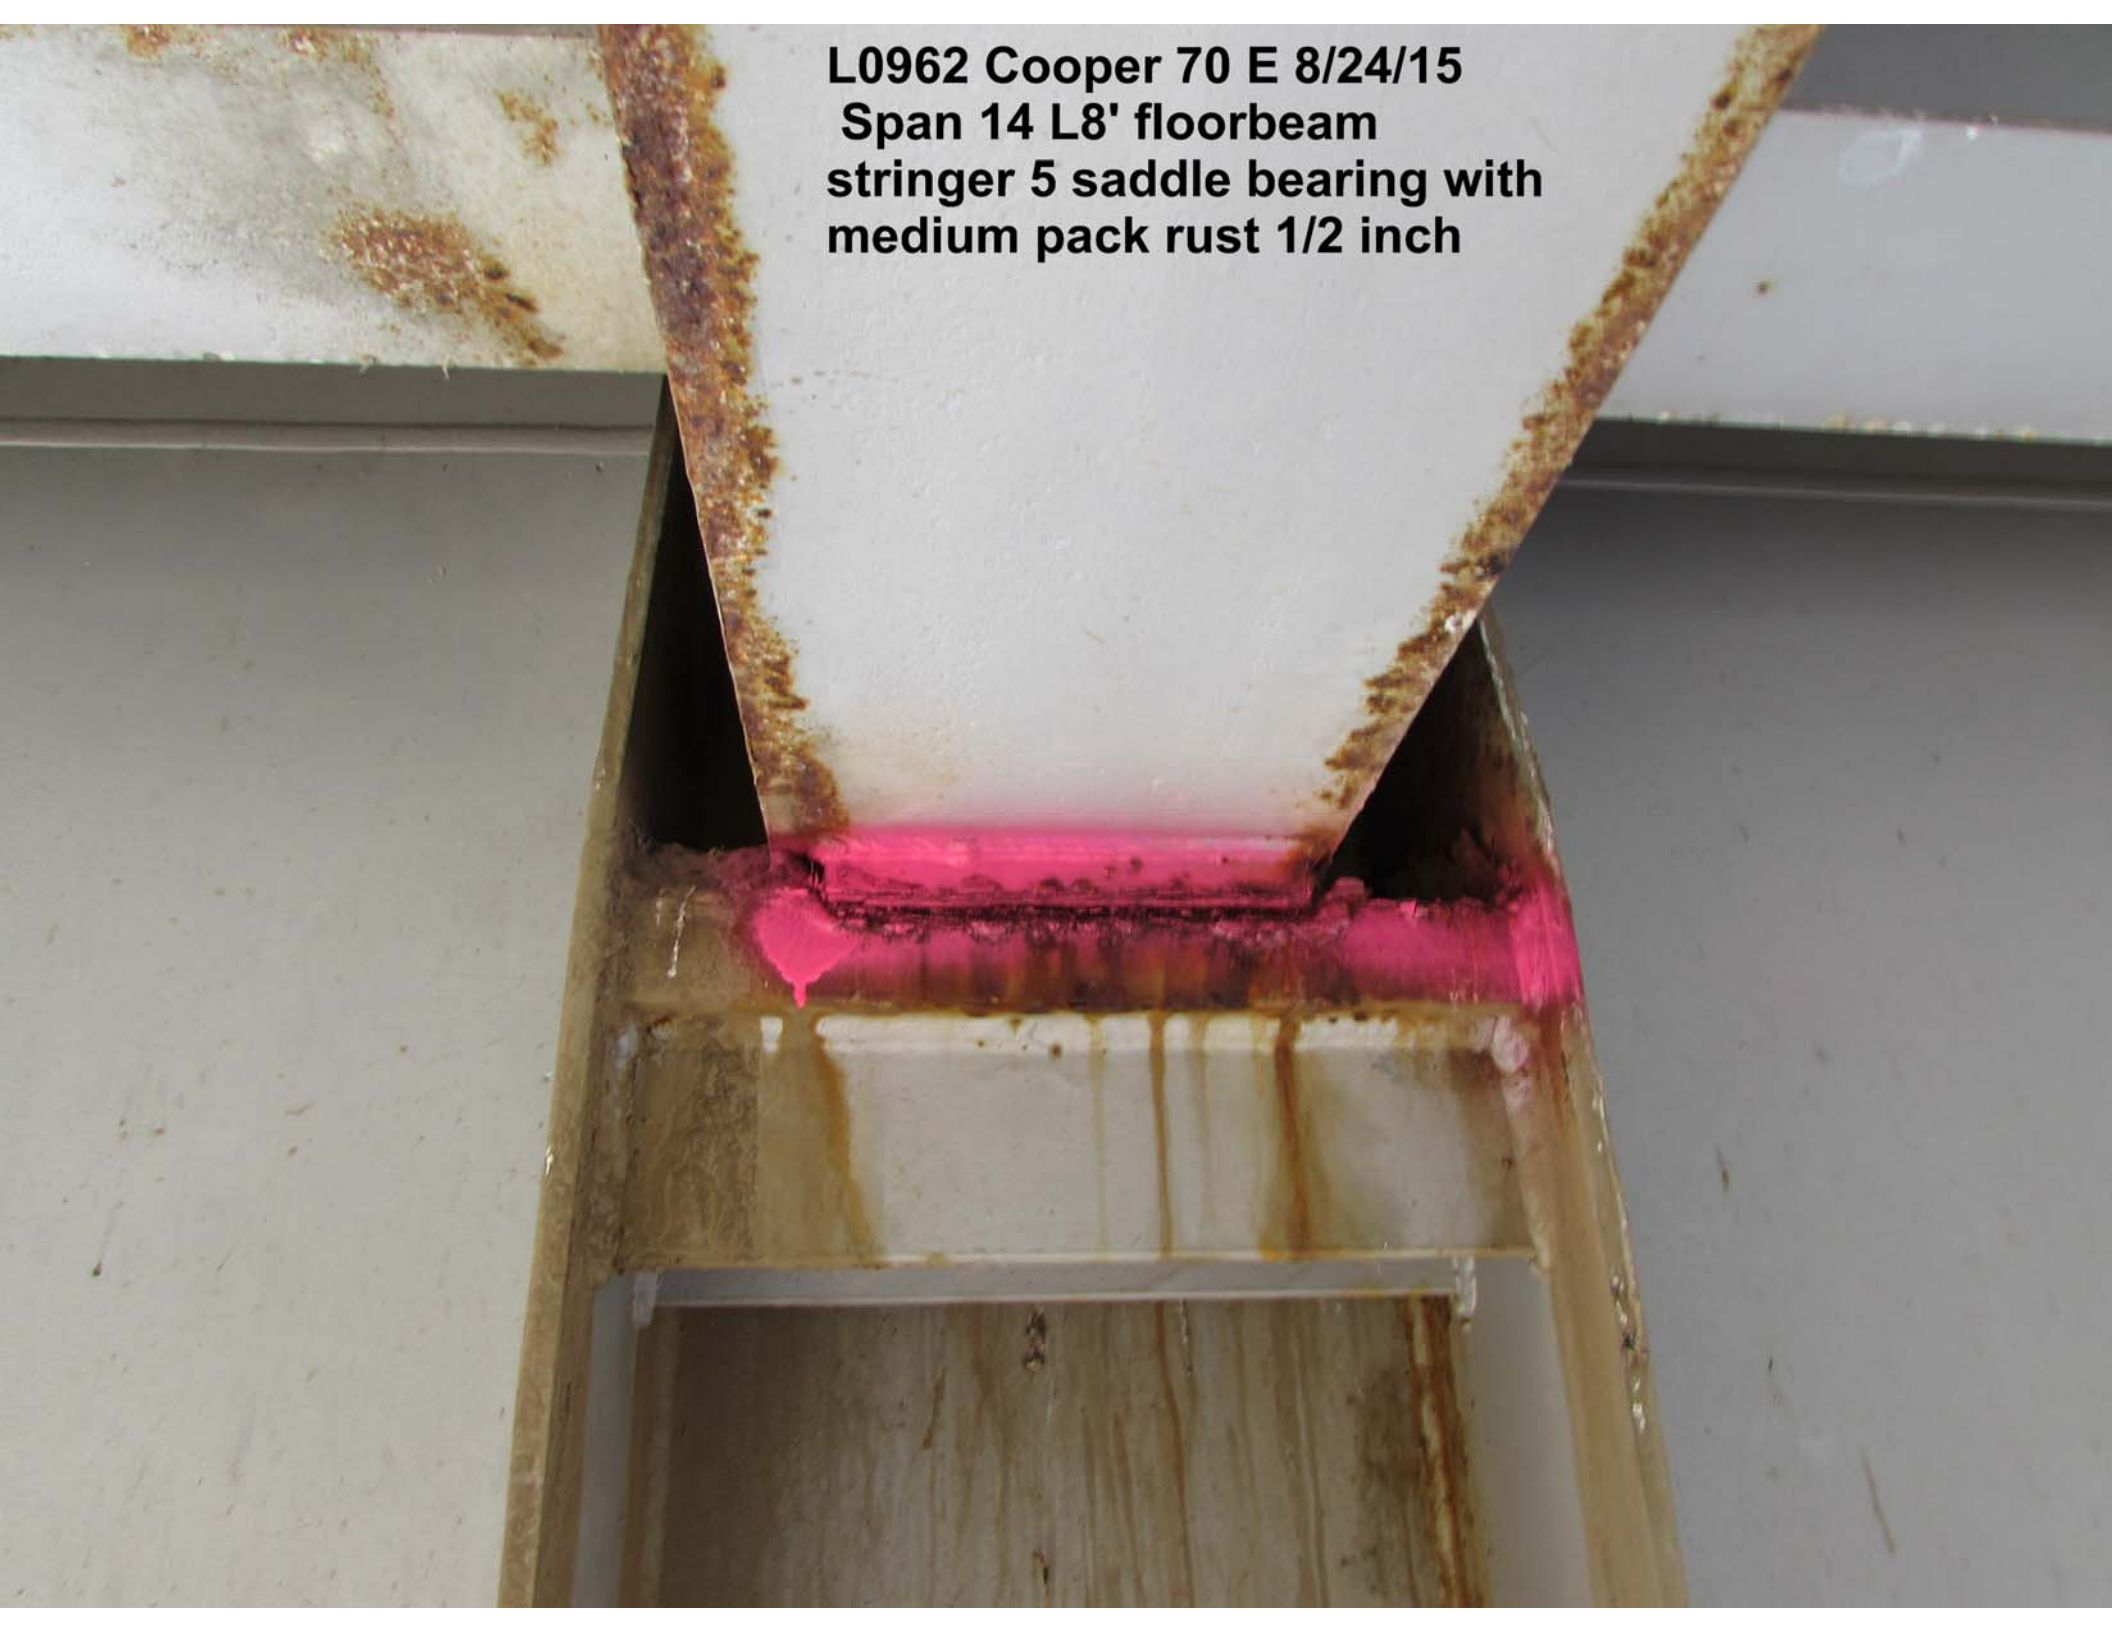
**L0962 Cooper 70 E 8/24/15**  
**Span 14 L8' floorbeam**  
**stringer 5 saddle bearing with**  
**medium pack rust 1/2 inch**

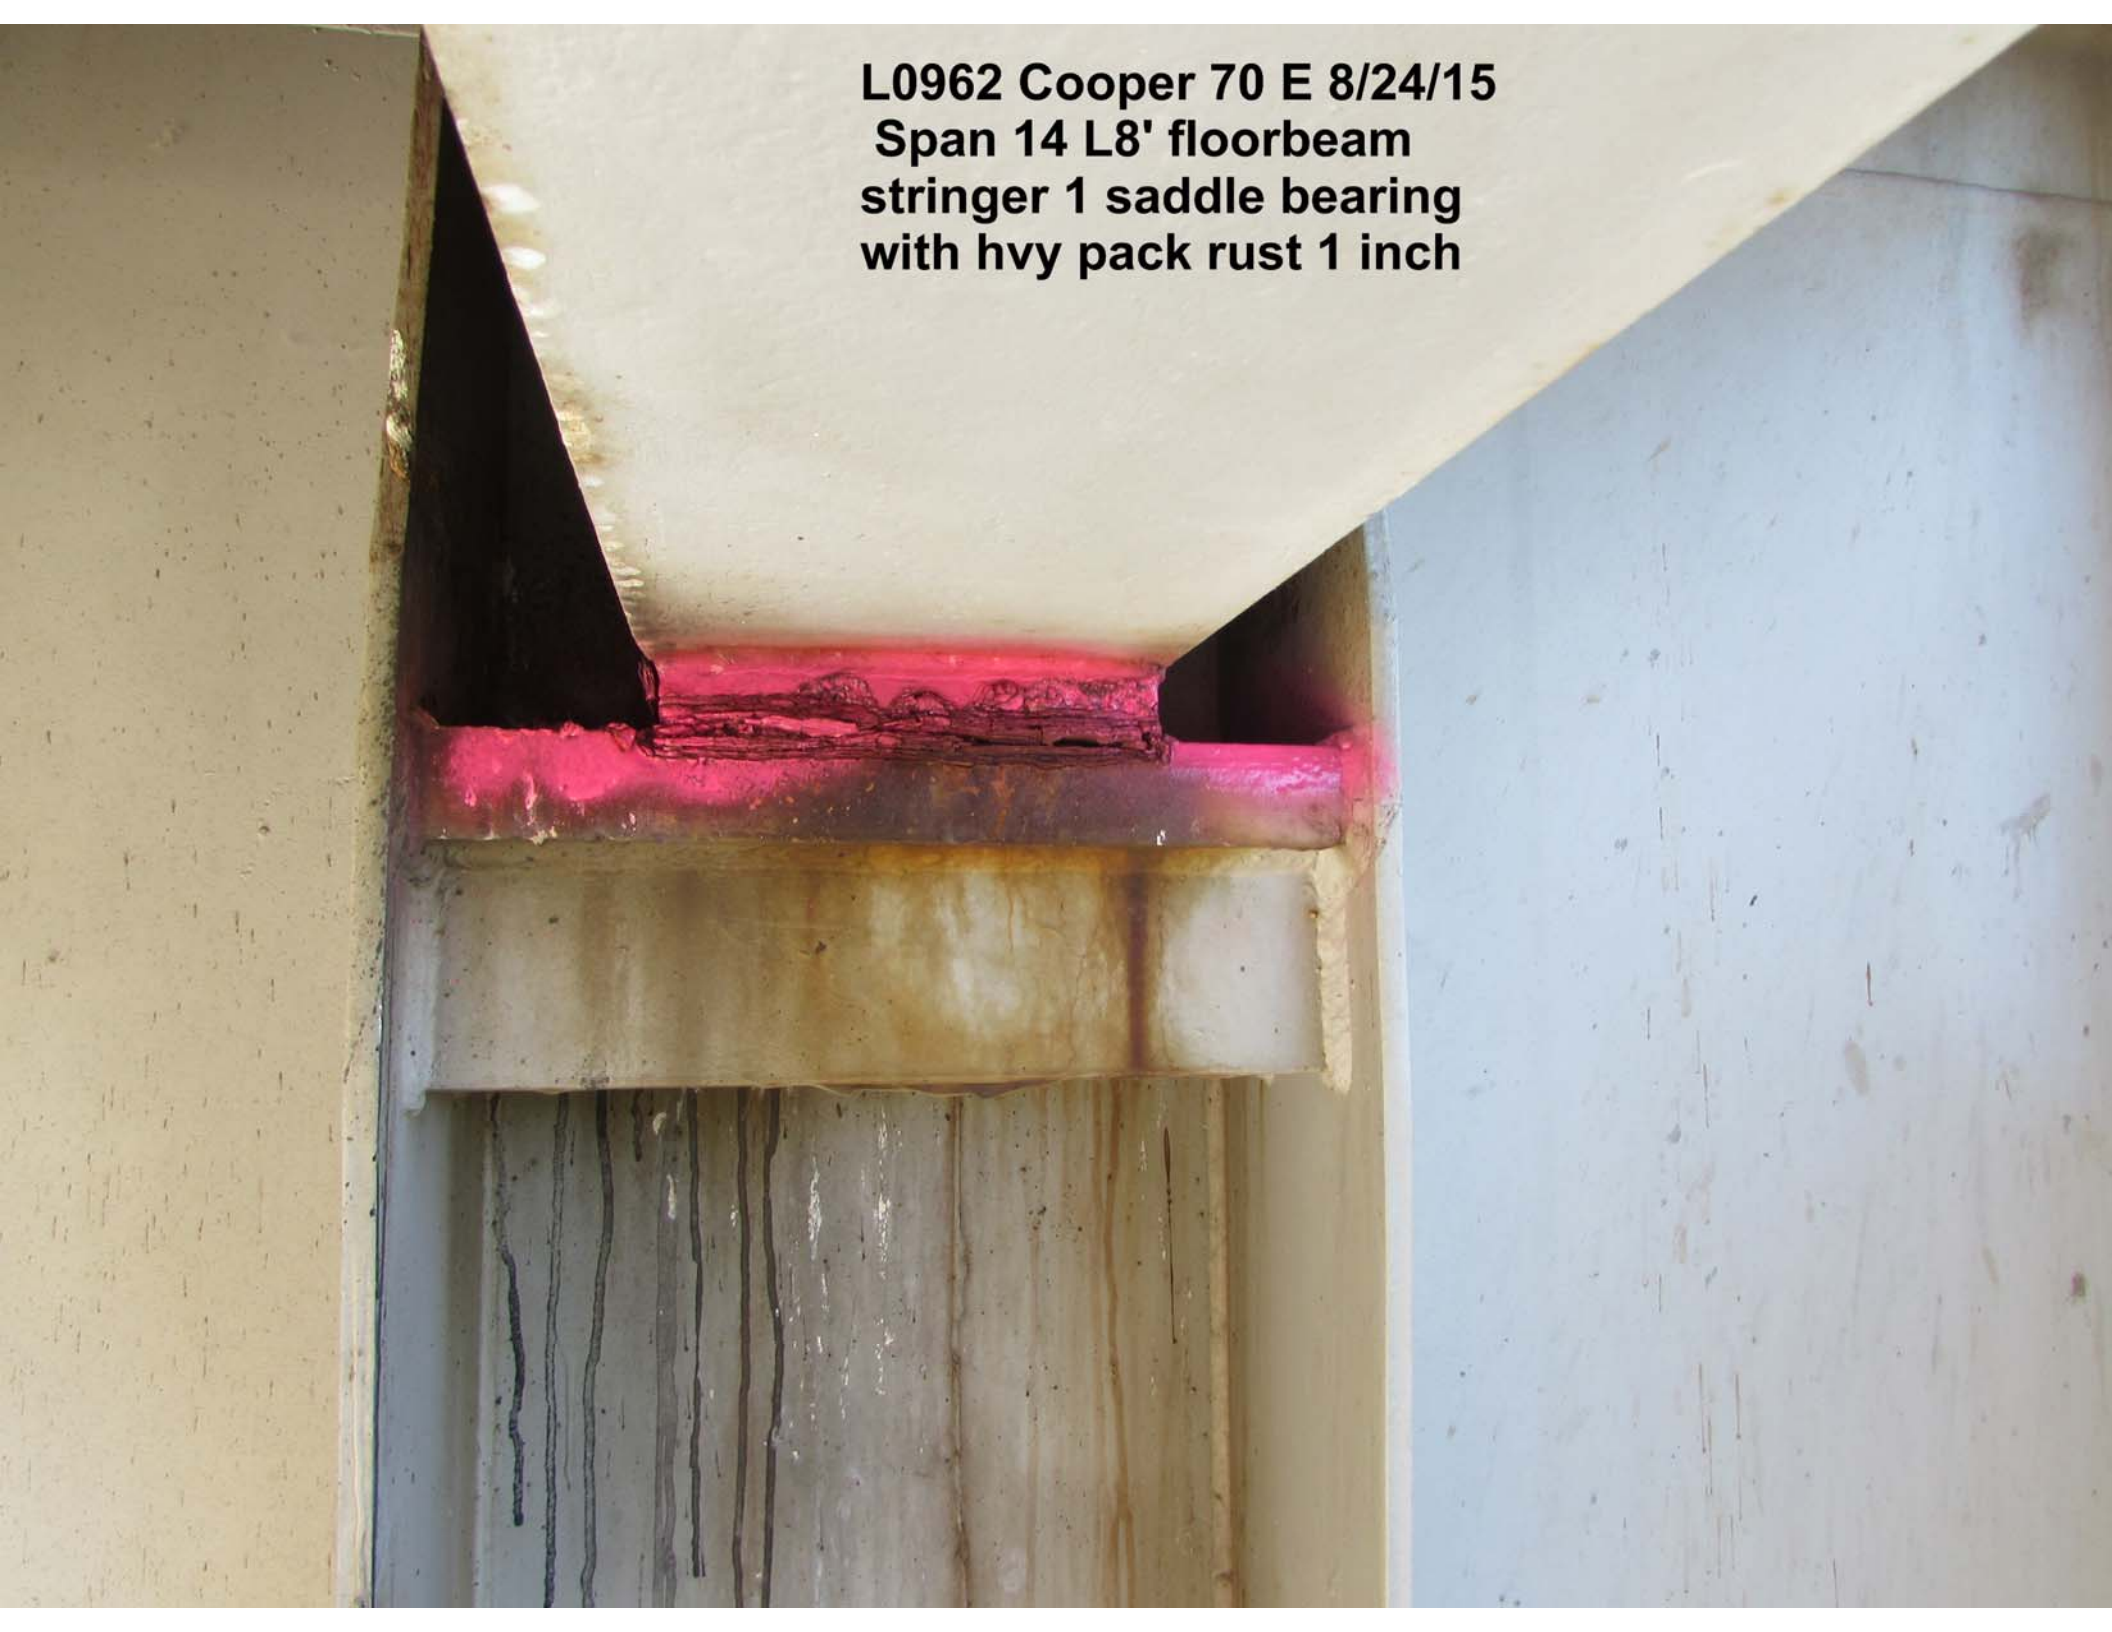
**L0962 Cooper 70 E 8/24/15**  
**Span 14 L8' floorbeam**  
**stringer 1 saddle bearing**  
**with hvy pack rust 1 inch**
