L0962 I 70 Cooper Co.  
Joint at L8, span 13  
Eastbound lane failing  
9-24-13

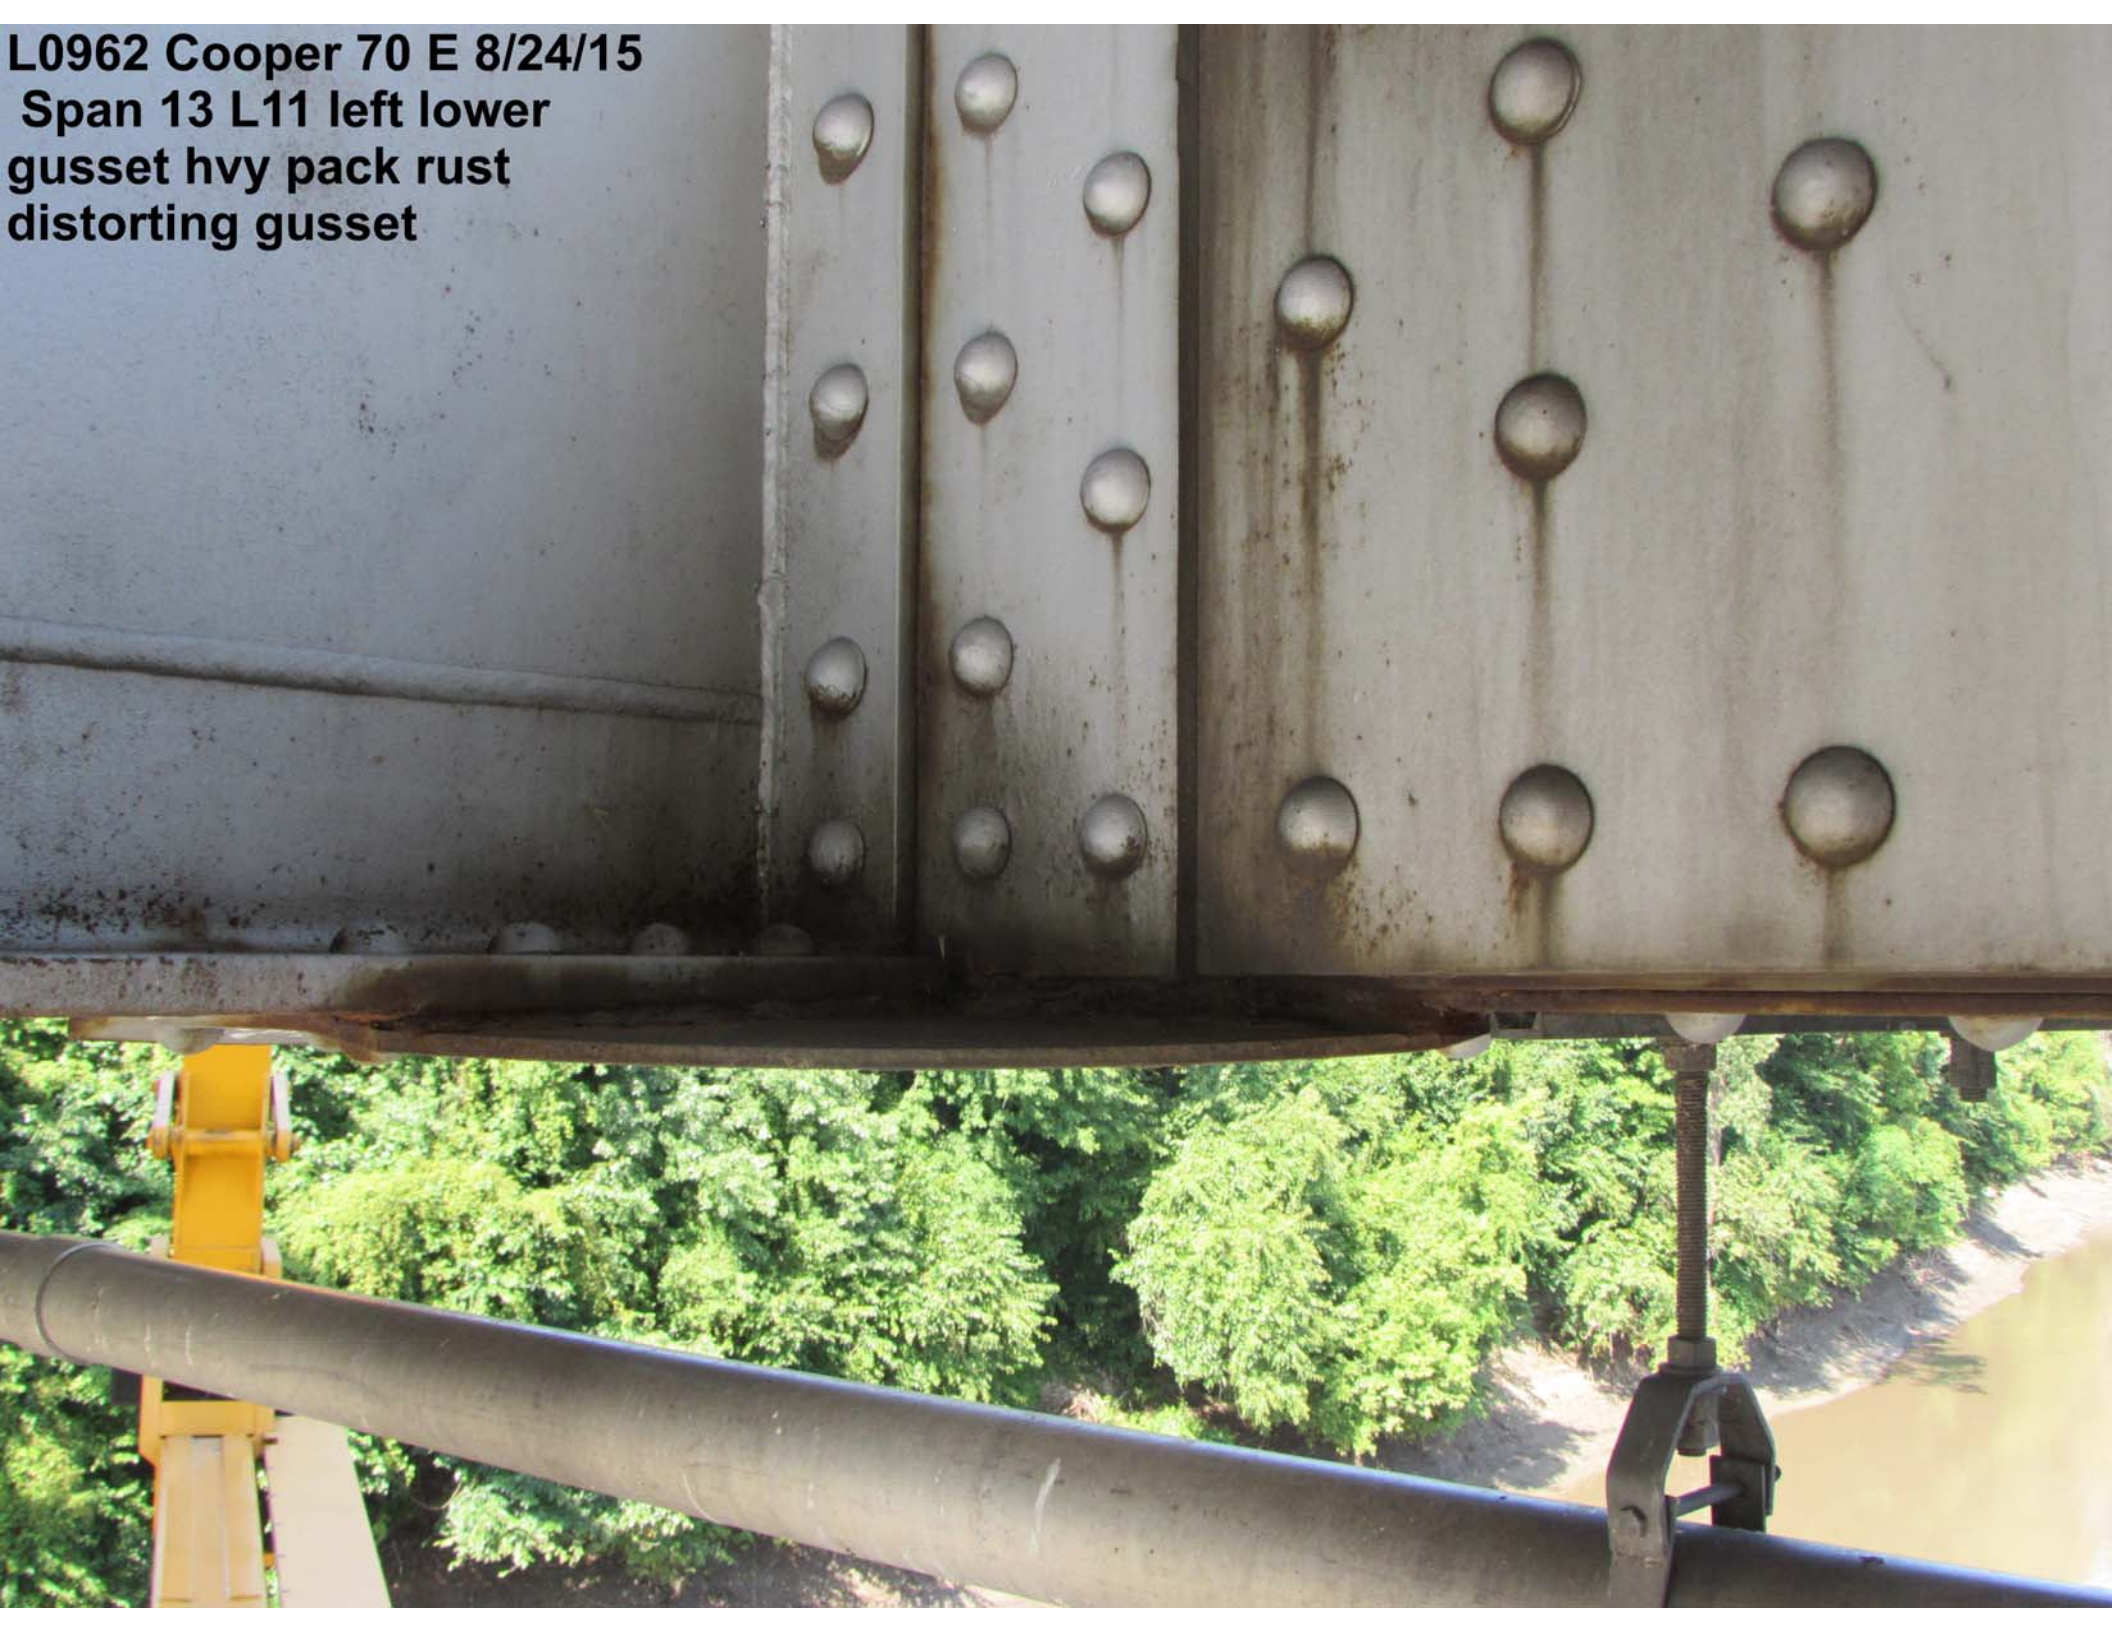
**L0962 Cooper 70 E 8/24/15**  
**Span 13 L11 left lower**  
**gusset hvy pack rust**  
**distorting gusset**

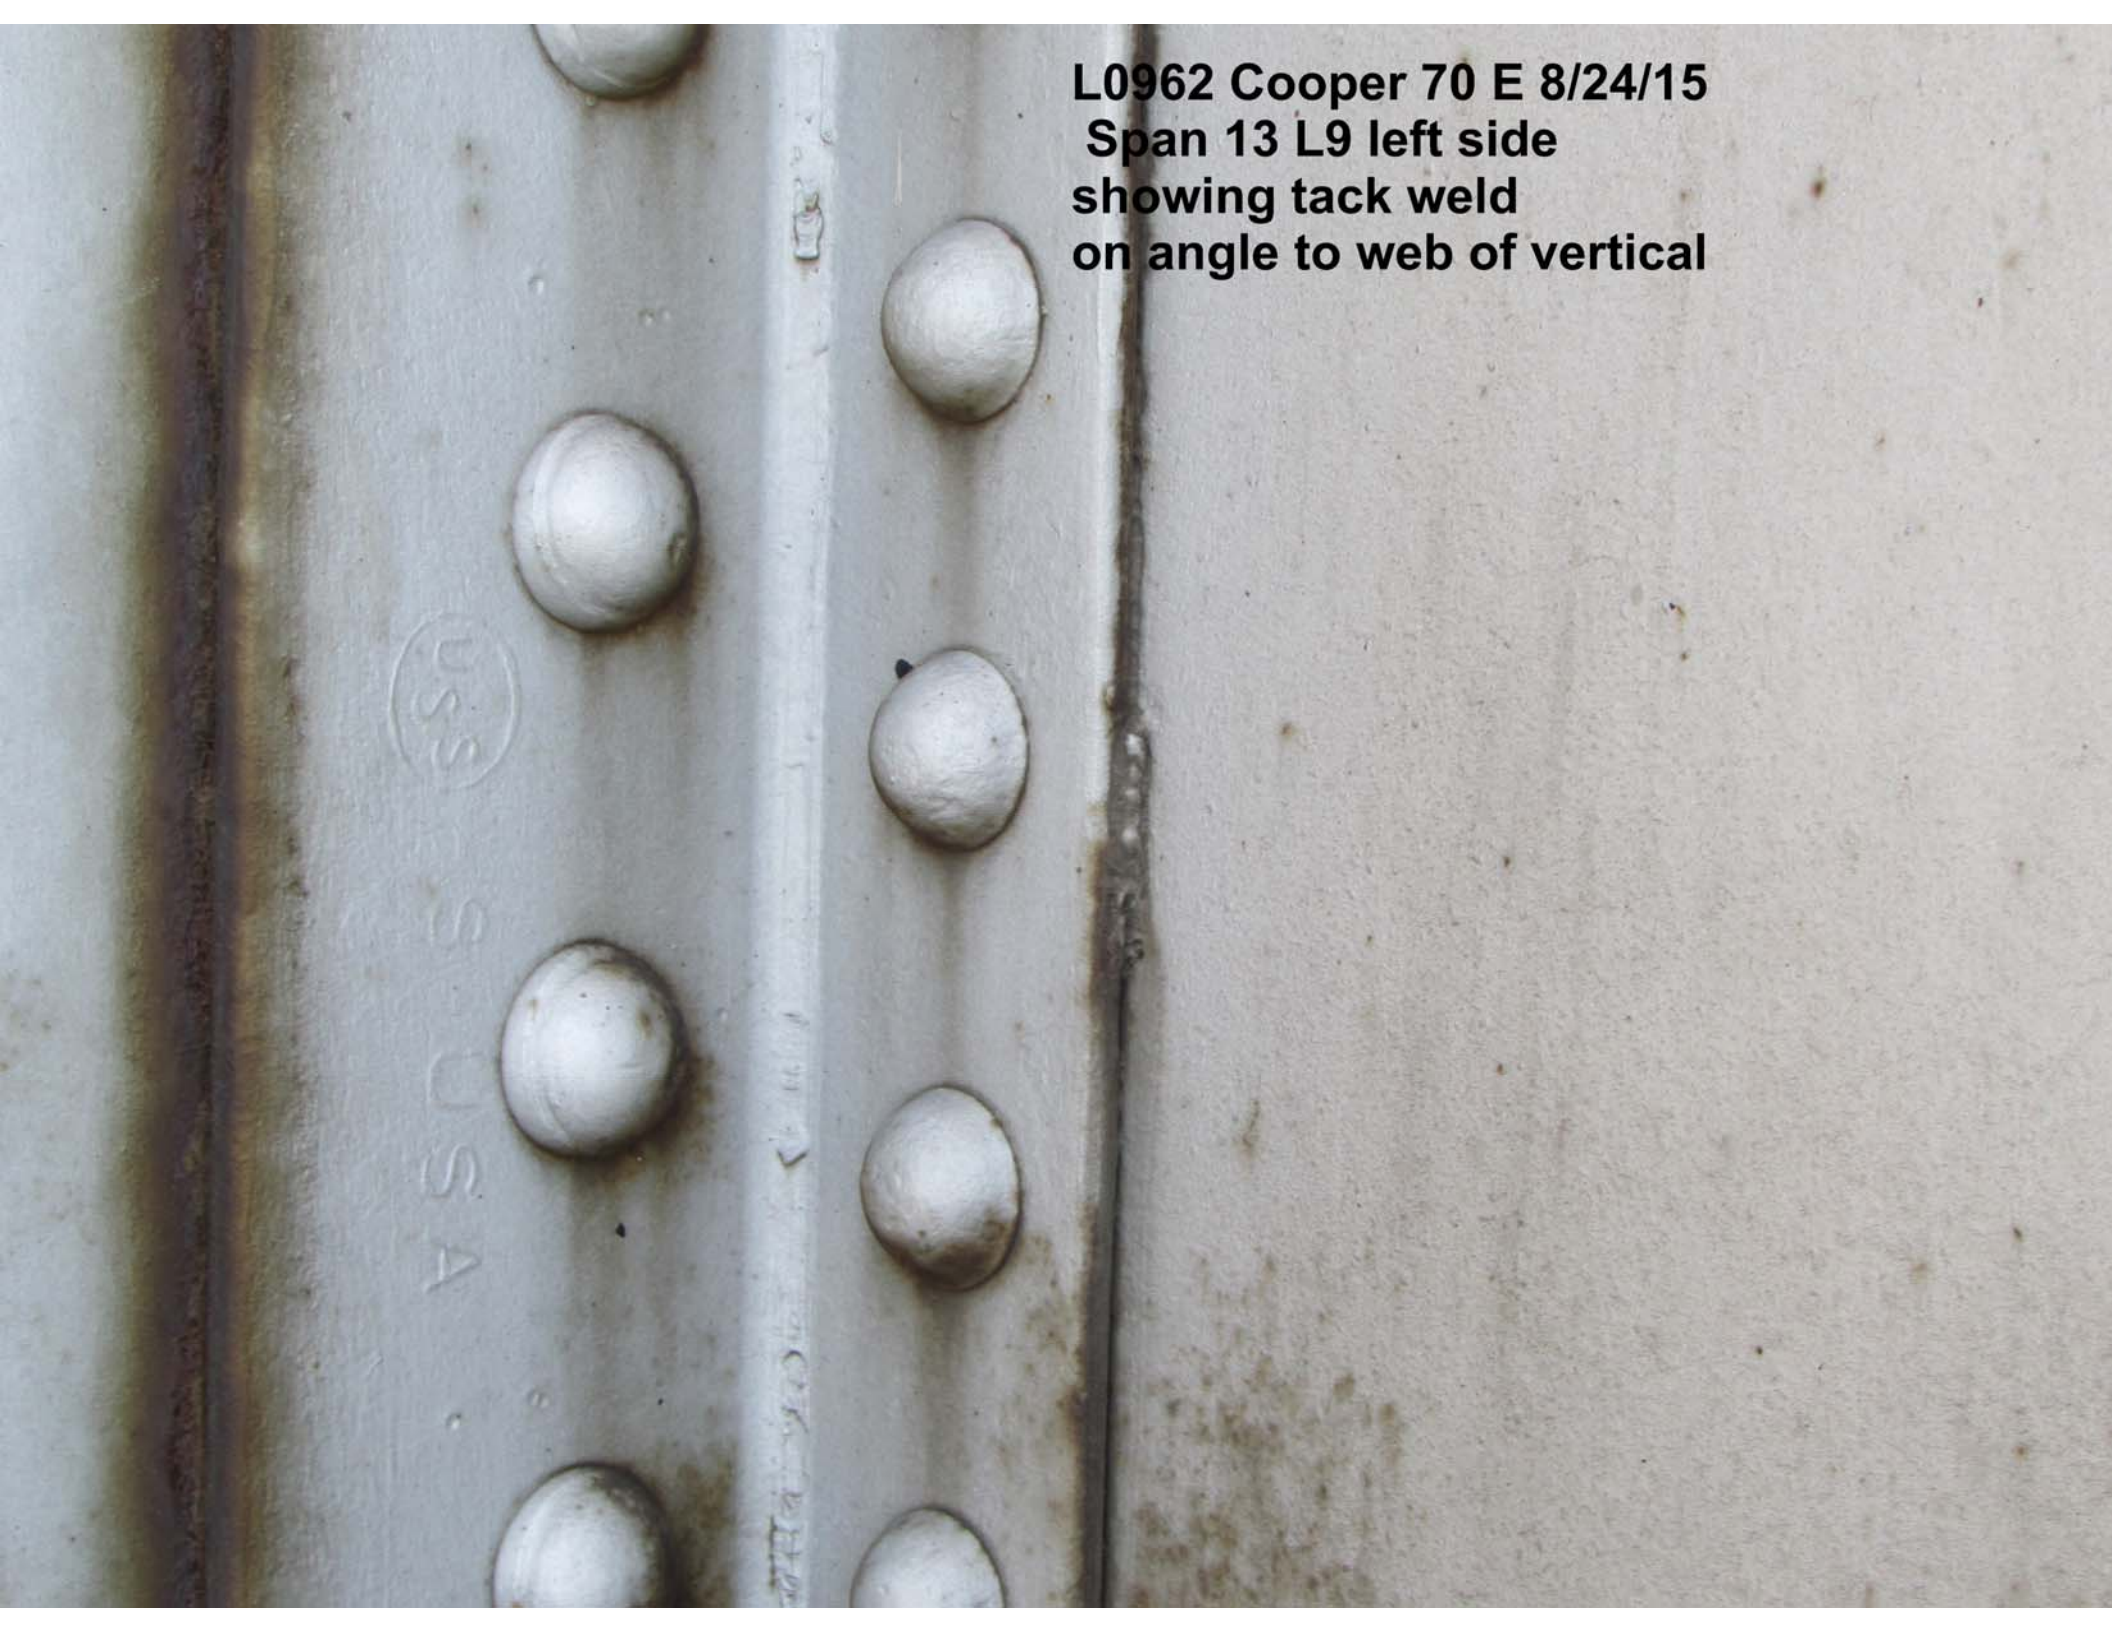
**L0962 Cooper 70 E 8/24/15  
Span 13 L9 left side  
showing tack weld  
on angle to web of vertical**

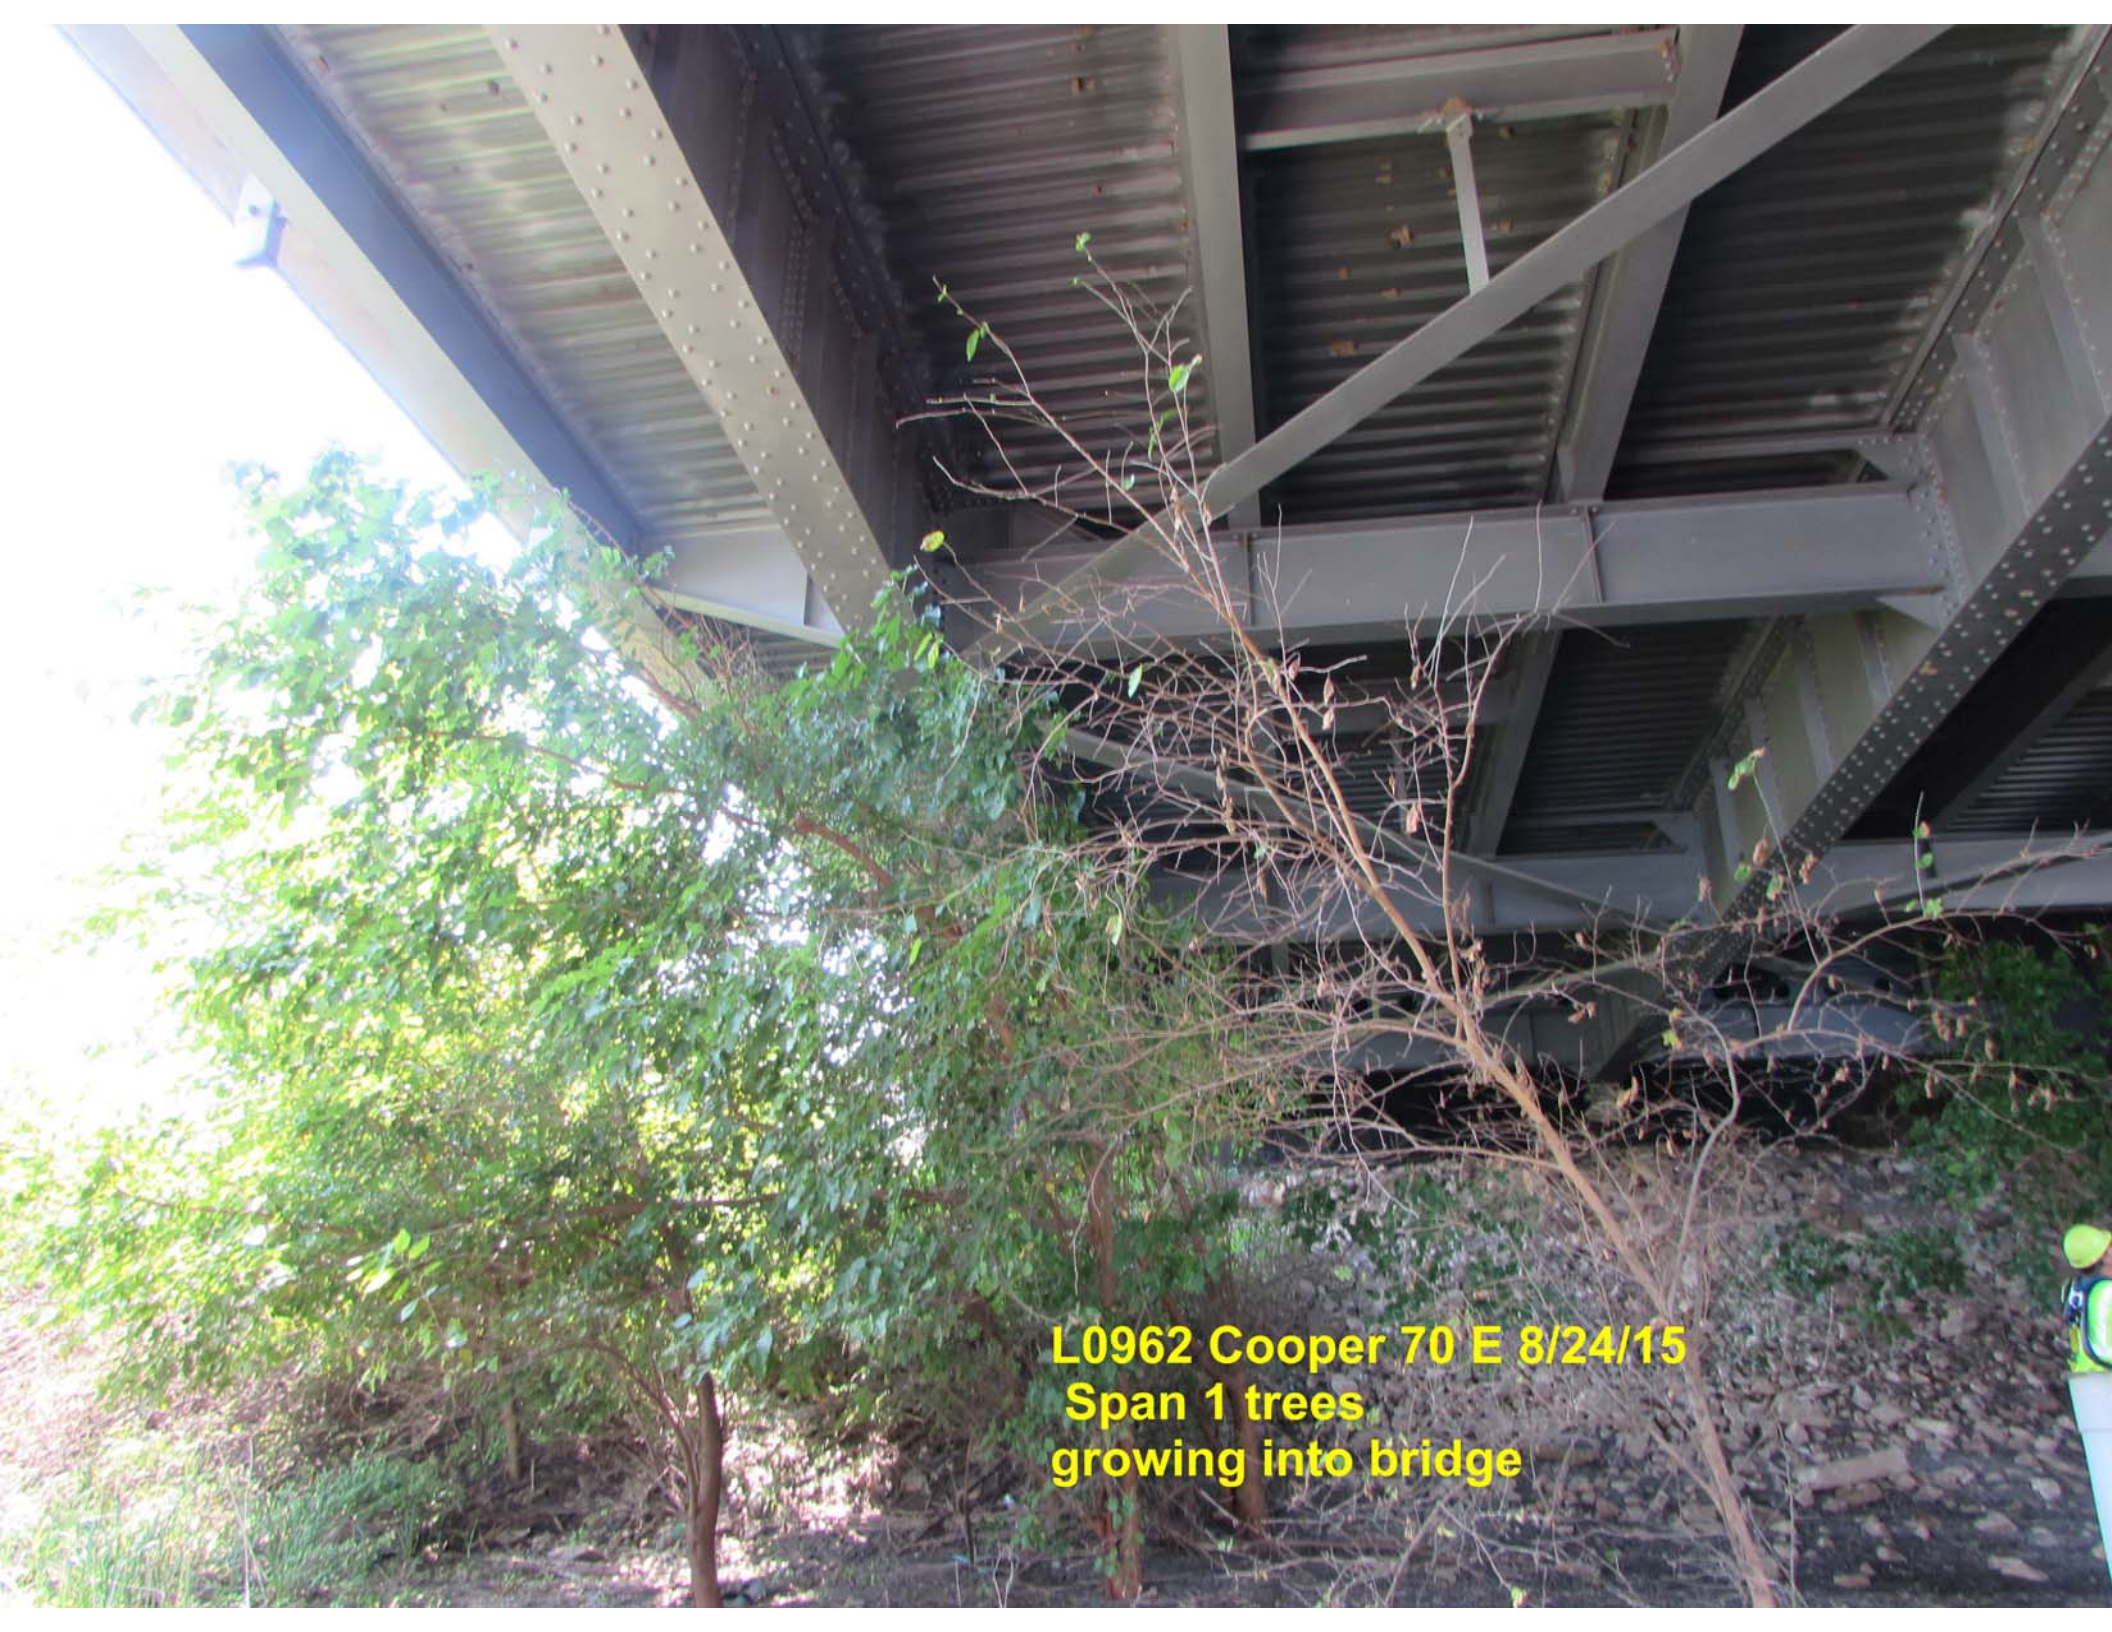
**L0962 Cooper 70 E 8/24/15**  
**Abut 1 rocker with**  
**hvy pack rust and**  
**H crack along abut**

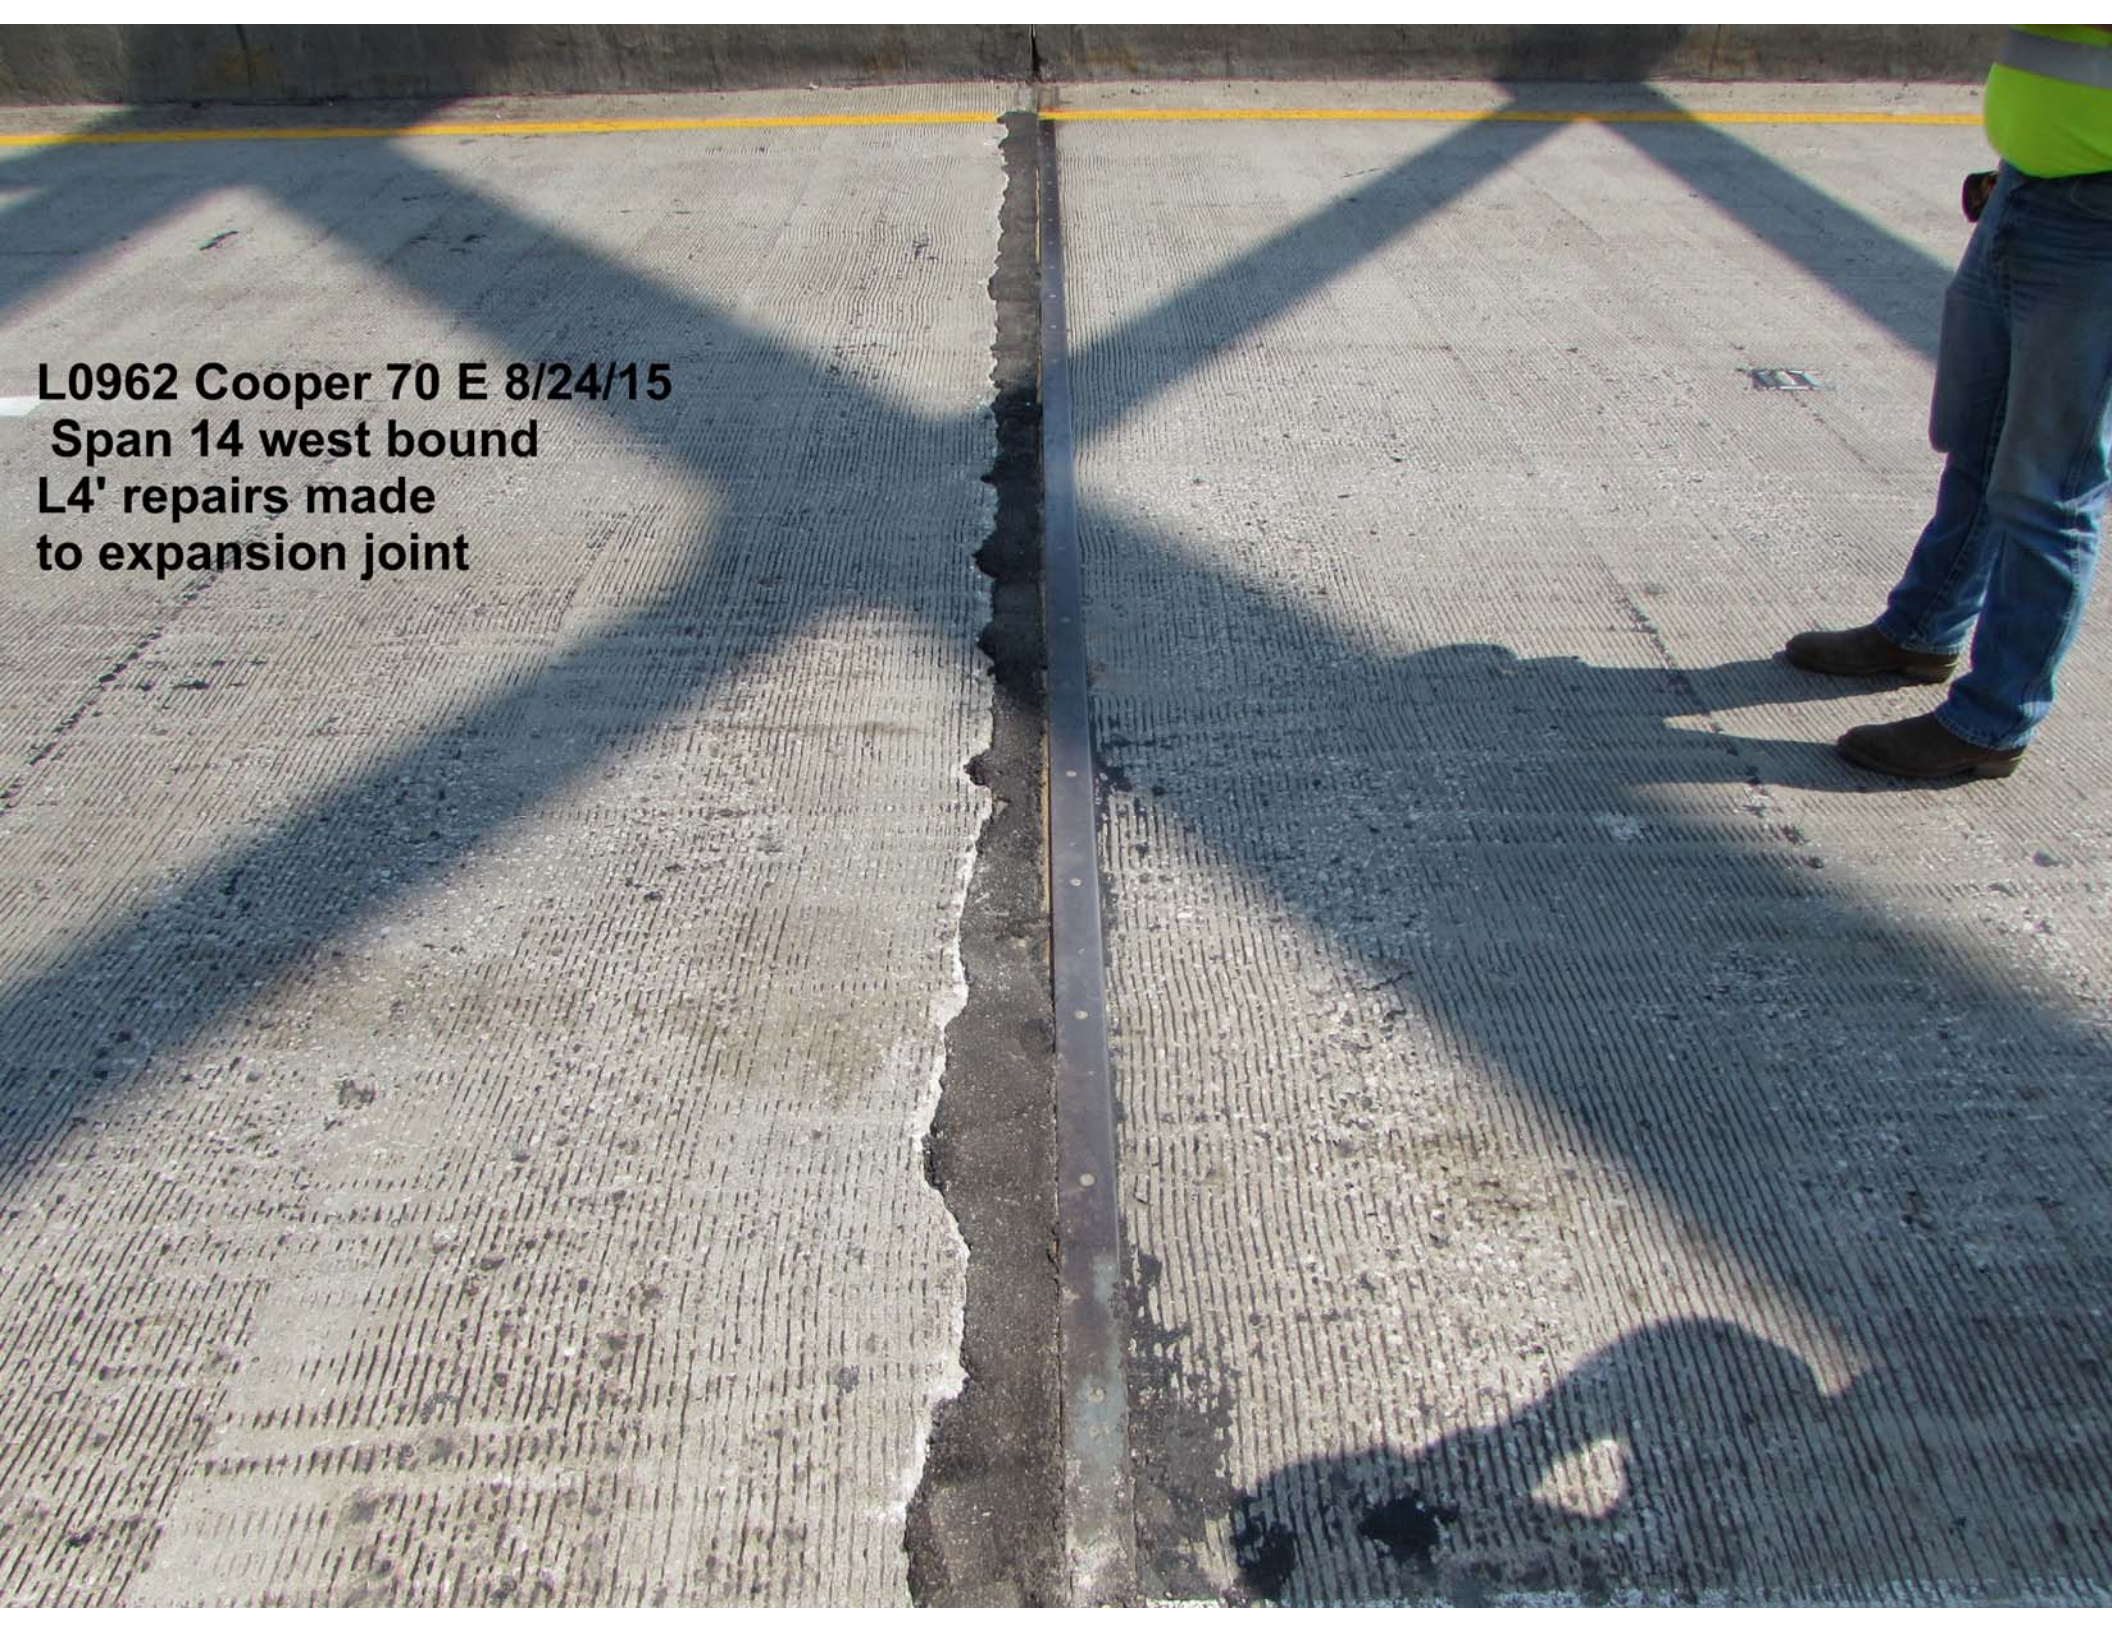
L0962 Cooper 70 E 8/24/15  
Span 14 west bound  
L8' expansion joint 3 foot  
of seal debonding

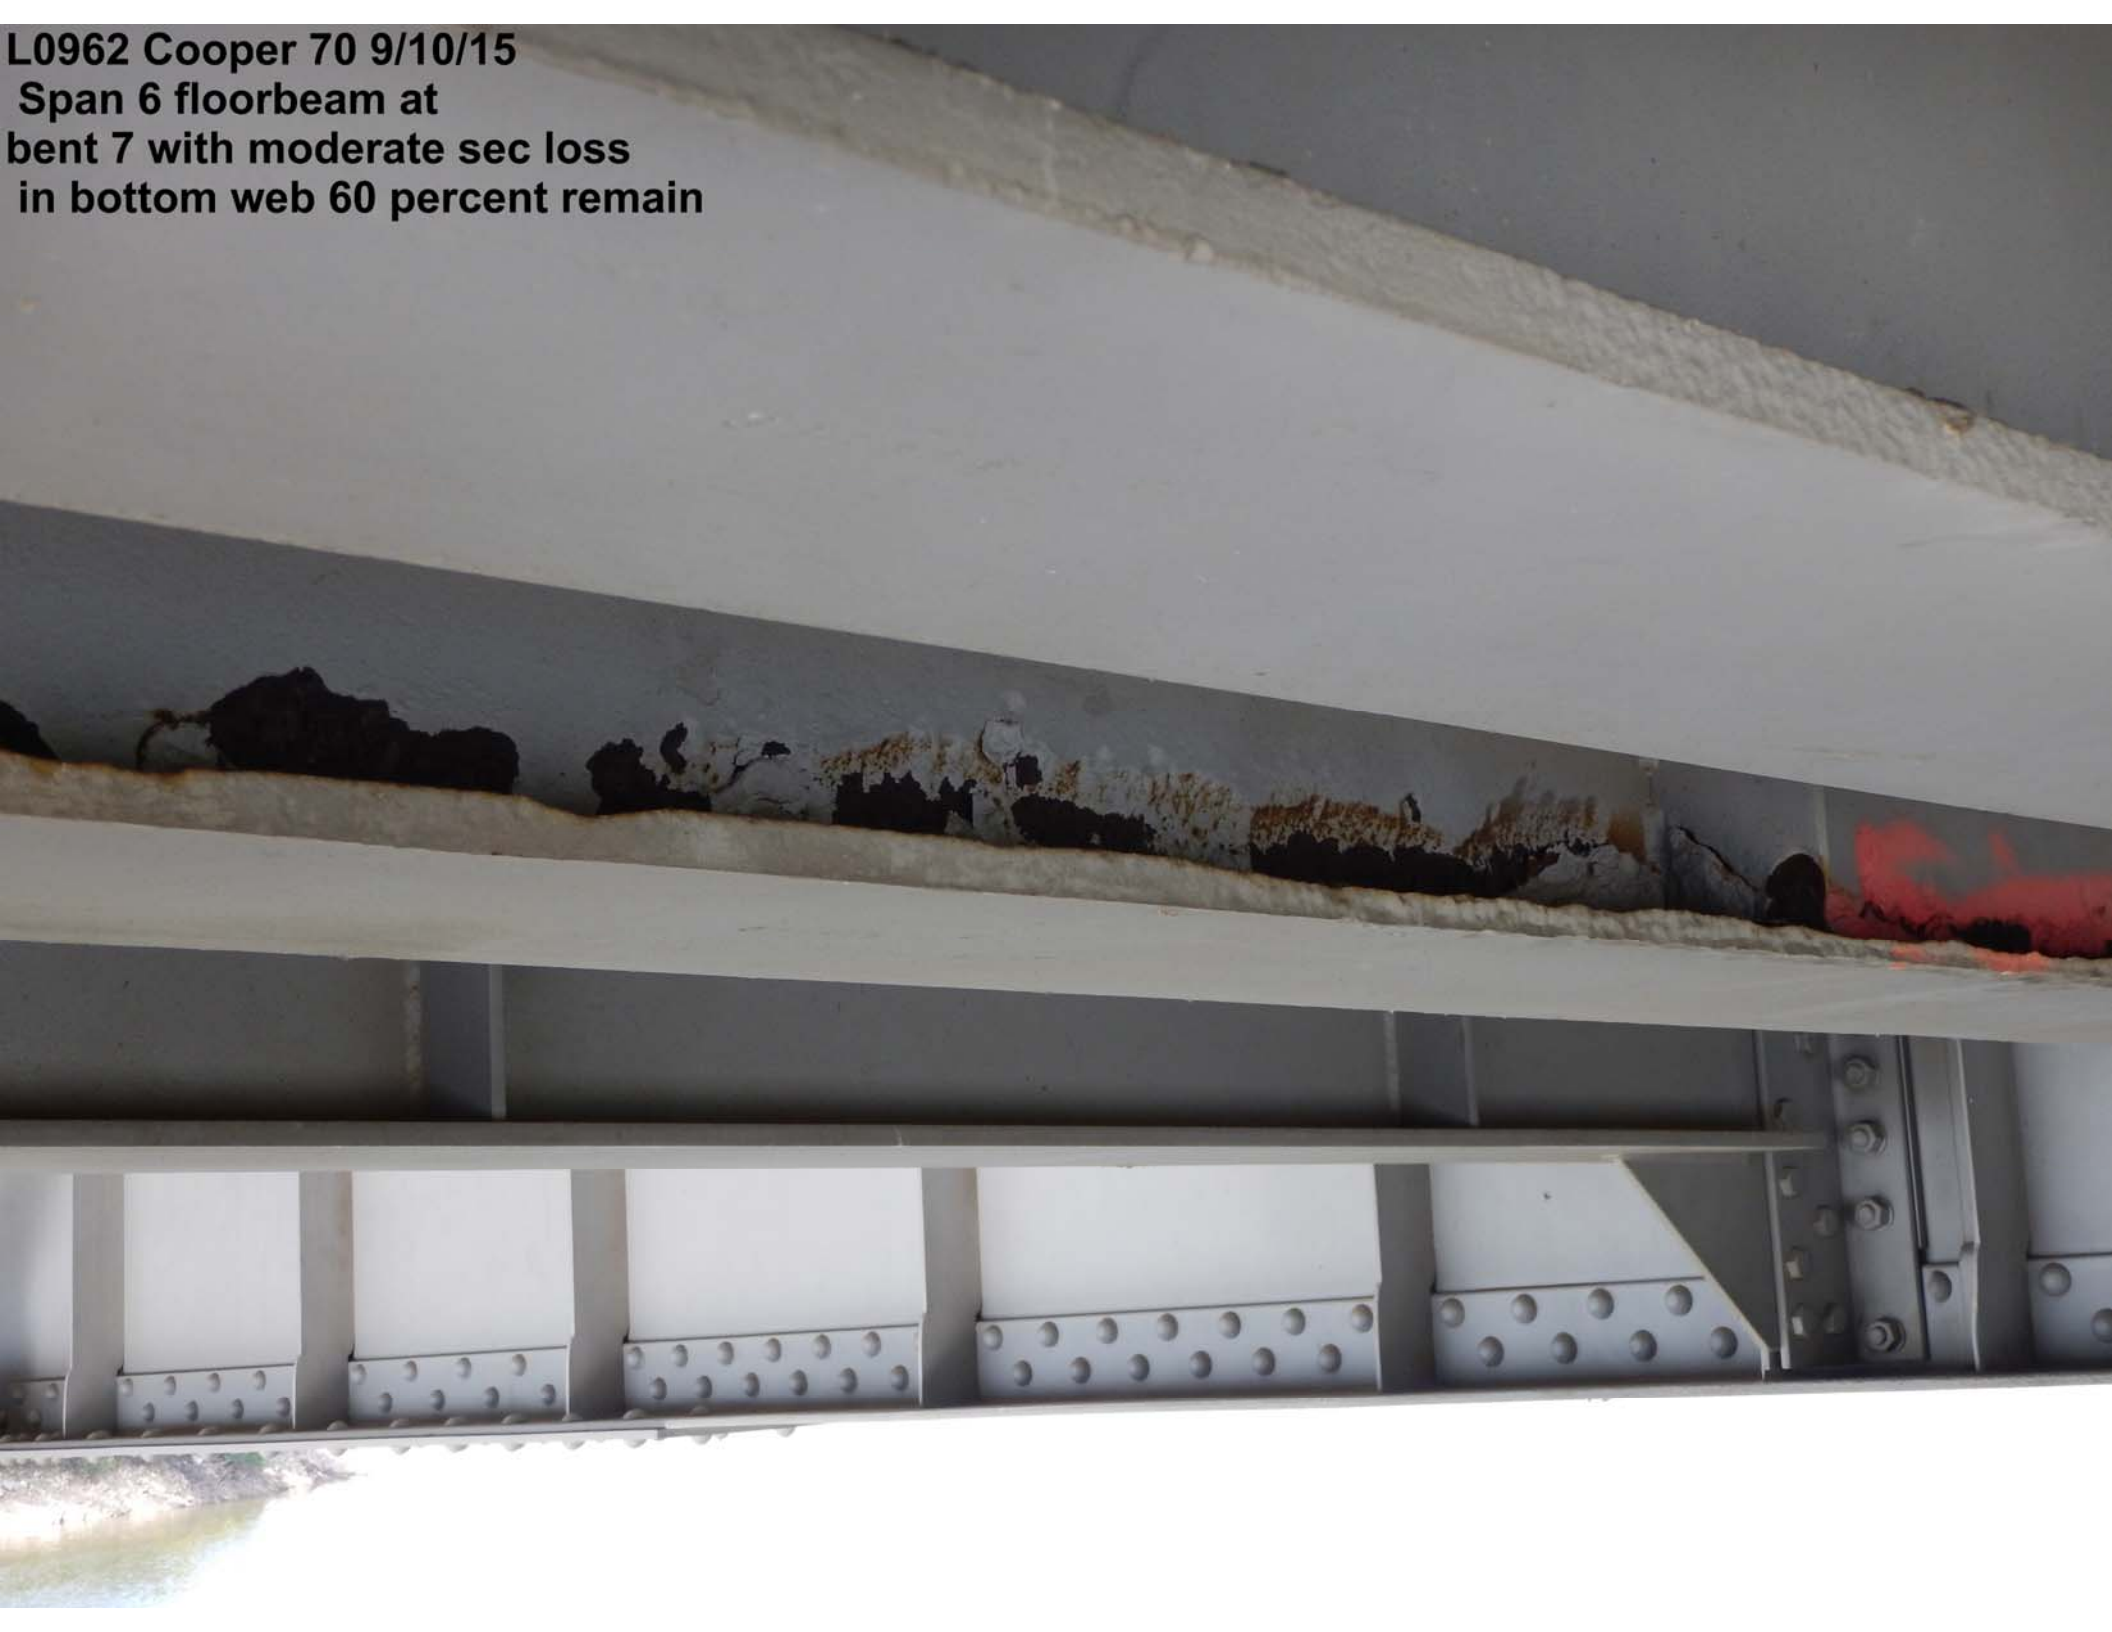
L0962 Cooper 70 9/10/15  
Span 6 floorbeam at  
bent 7 with moderate sec loss  
in bottom web 60 percent remain

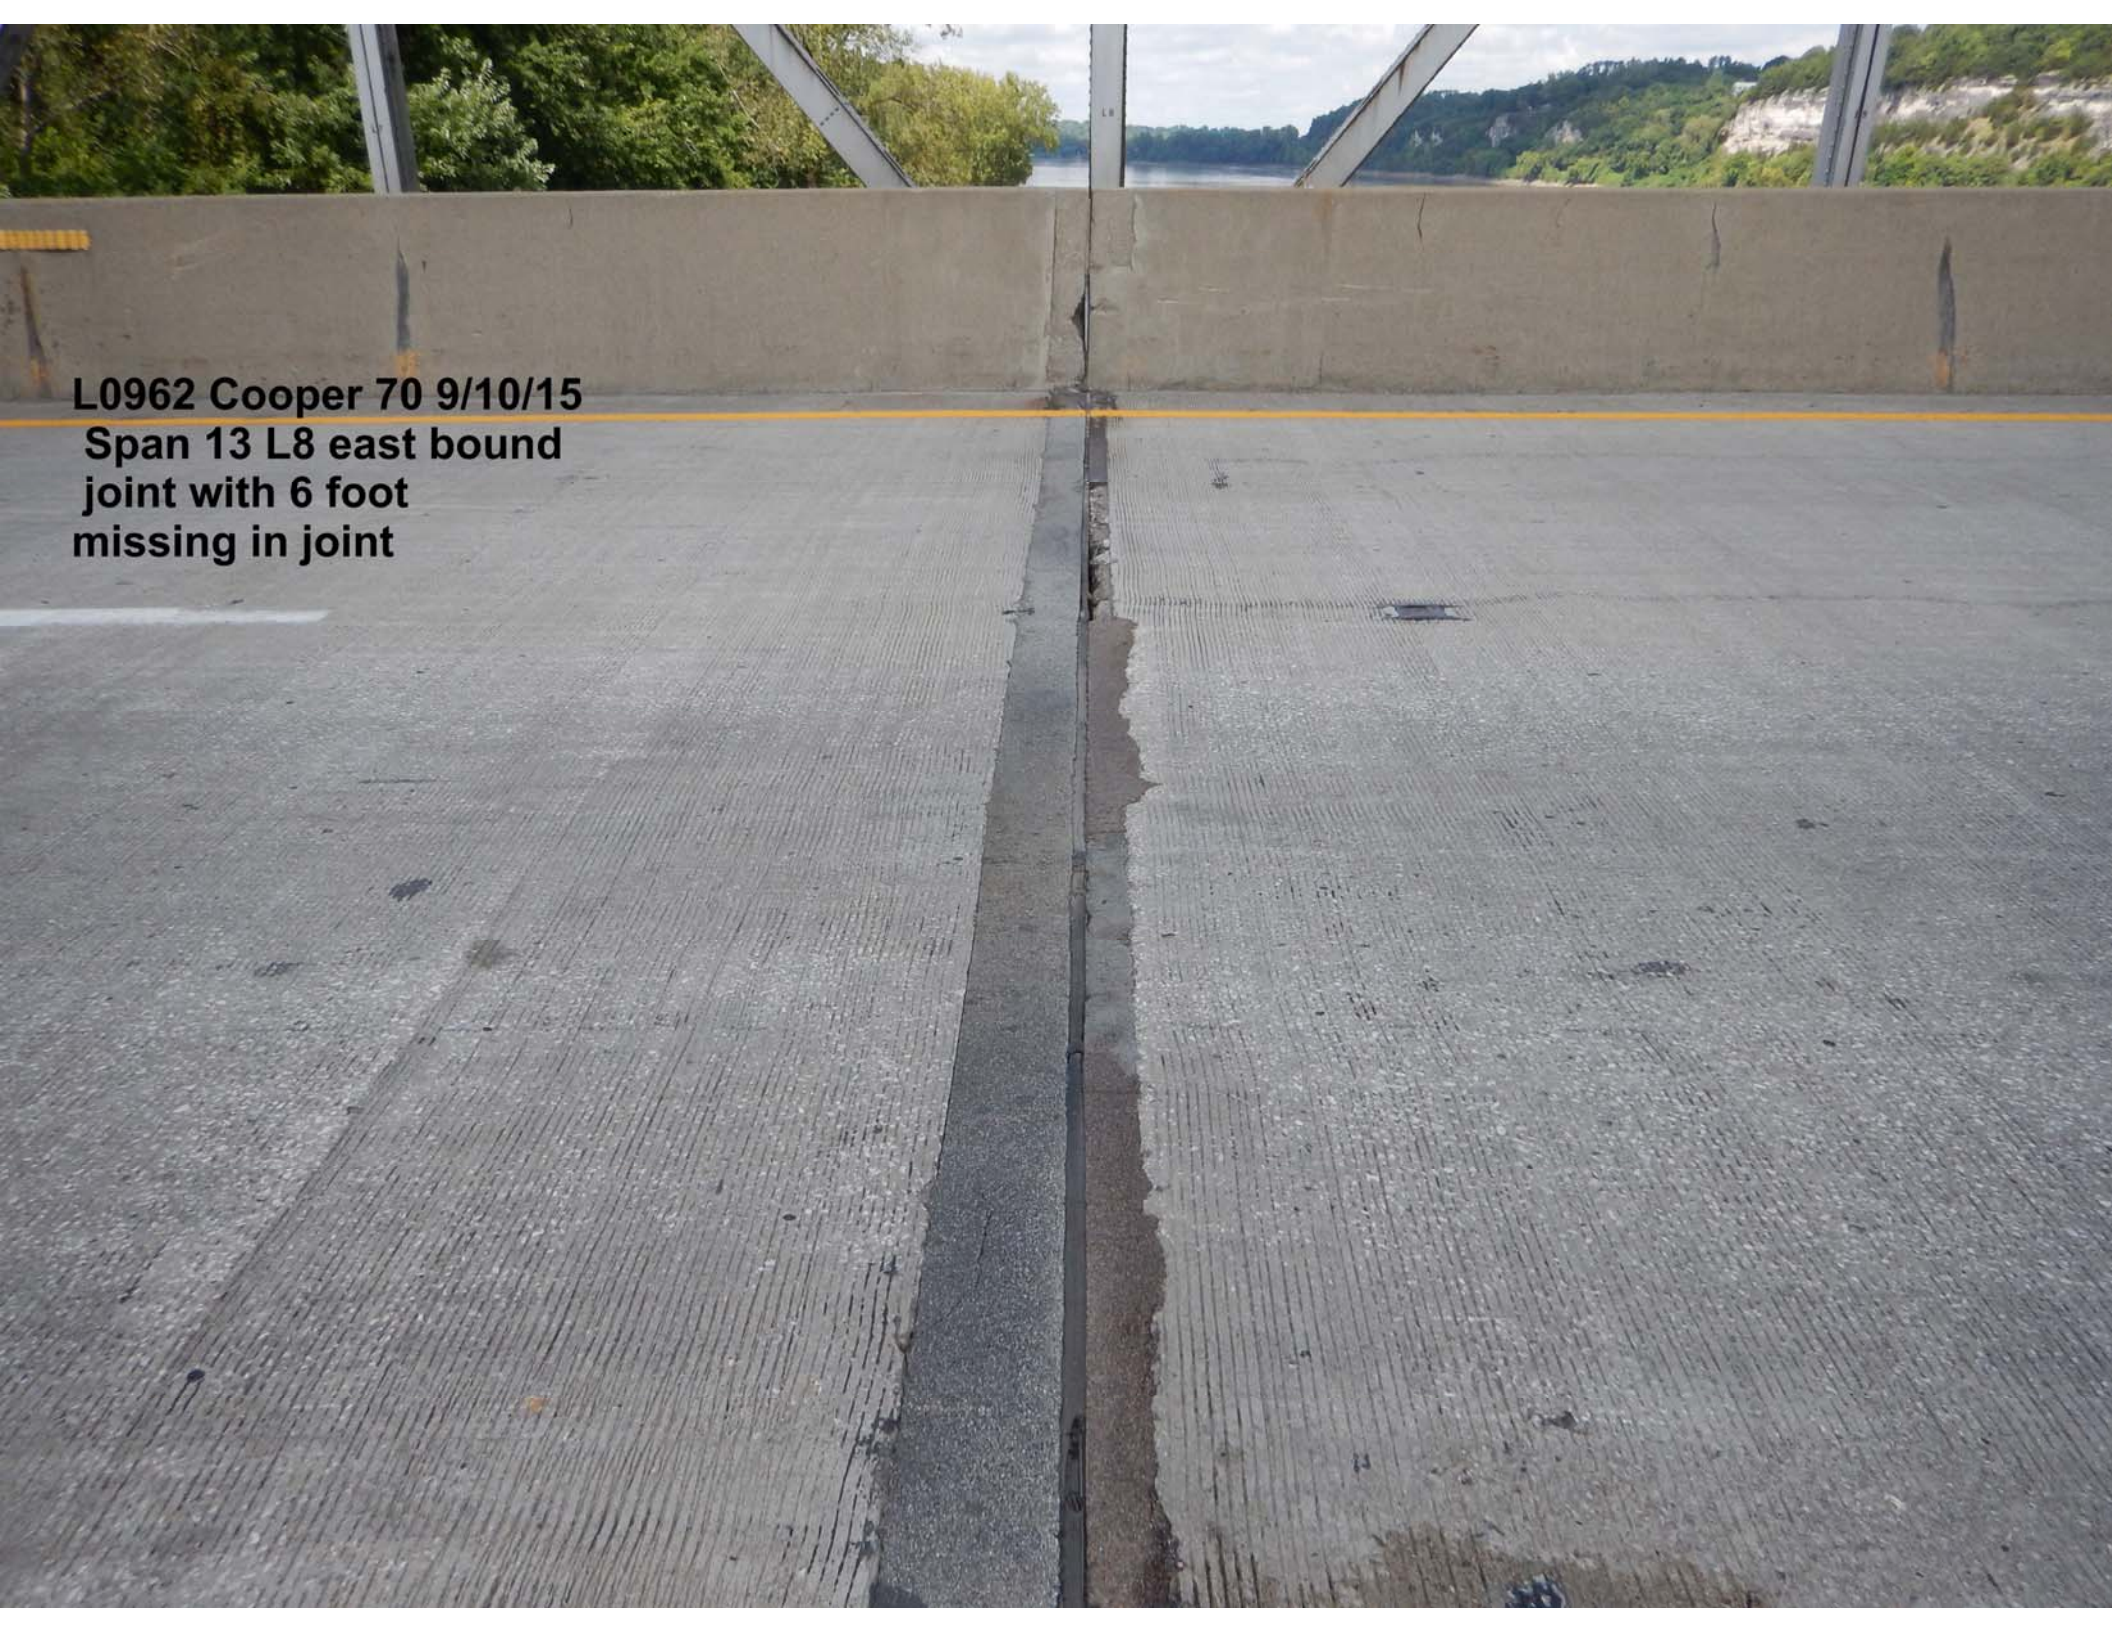
**L0962 Cooper 70 9/10/15**  
**Span 13 L8 east bound**  
**joint with 6 foot**  
**missing in joint**
