L0962 I 70 Cooper Co.  
Joint at L8, span 13  
Eastbound lane failing  
9-24-13

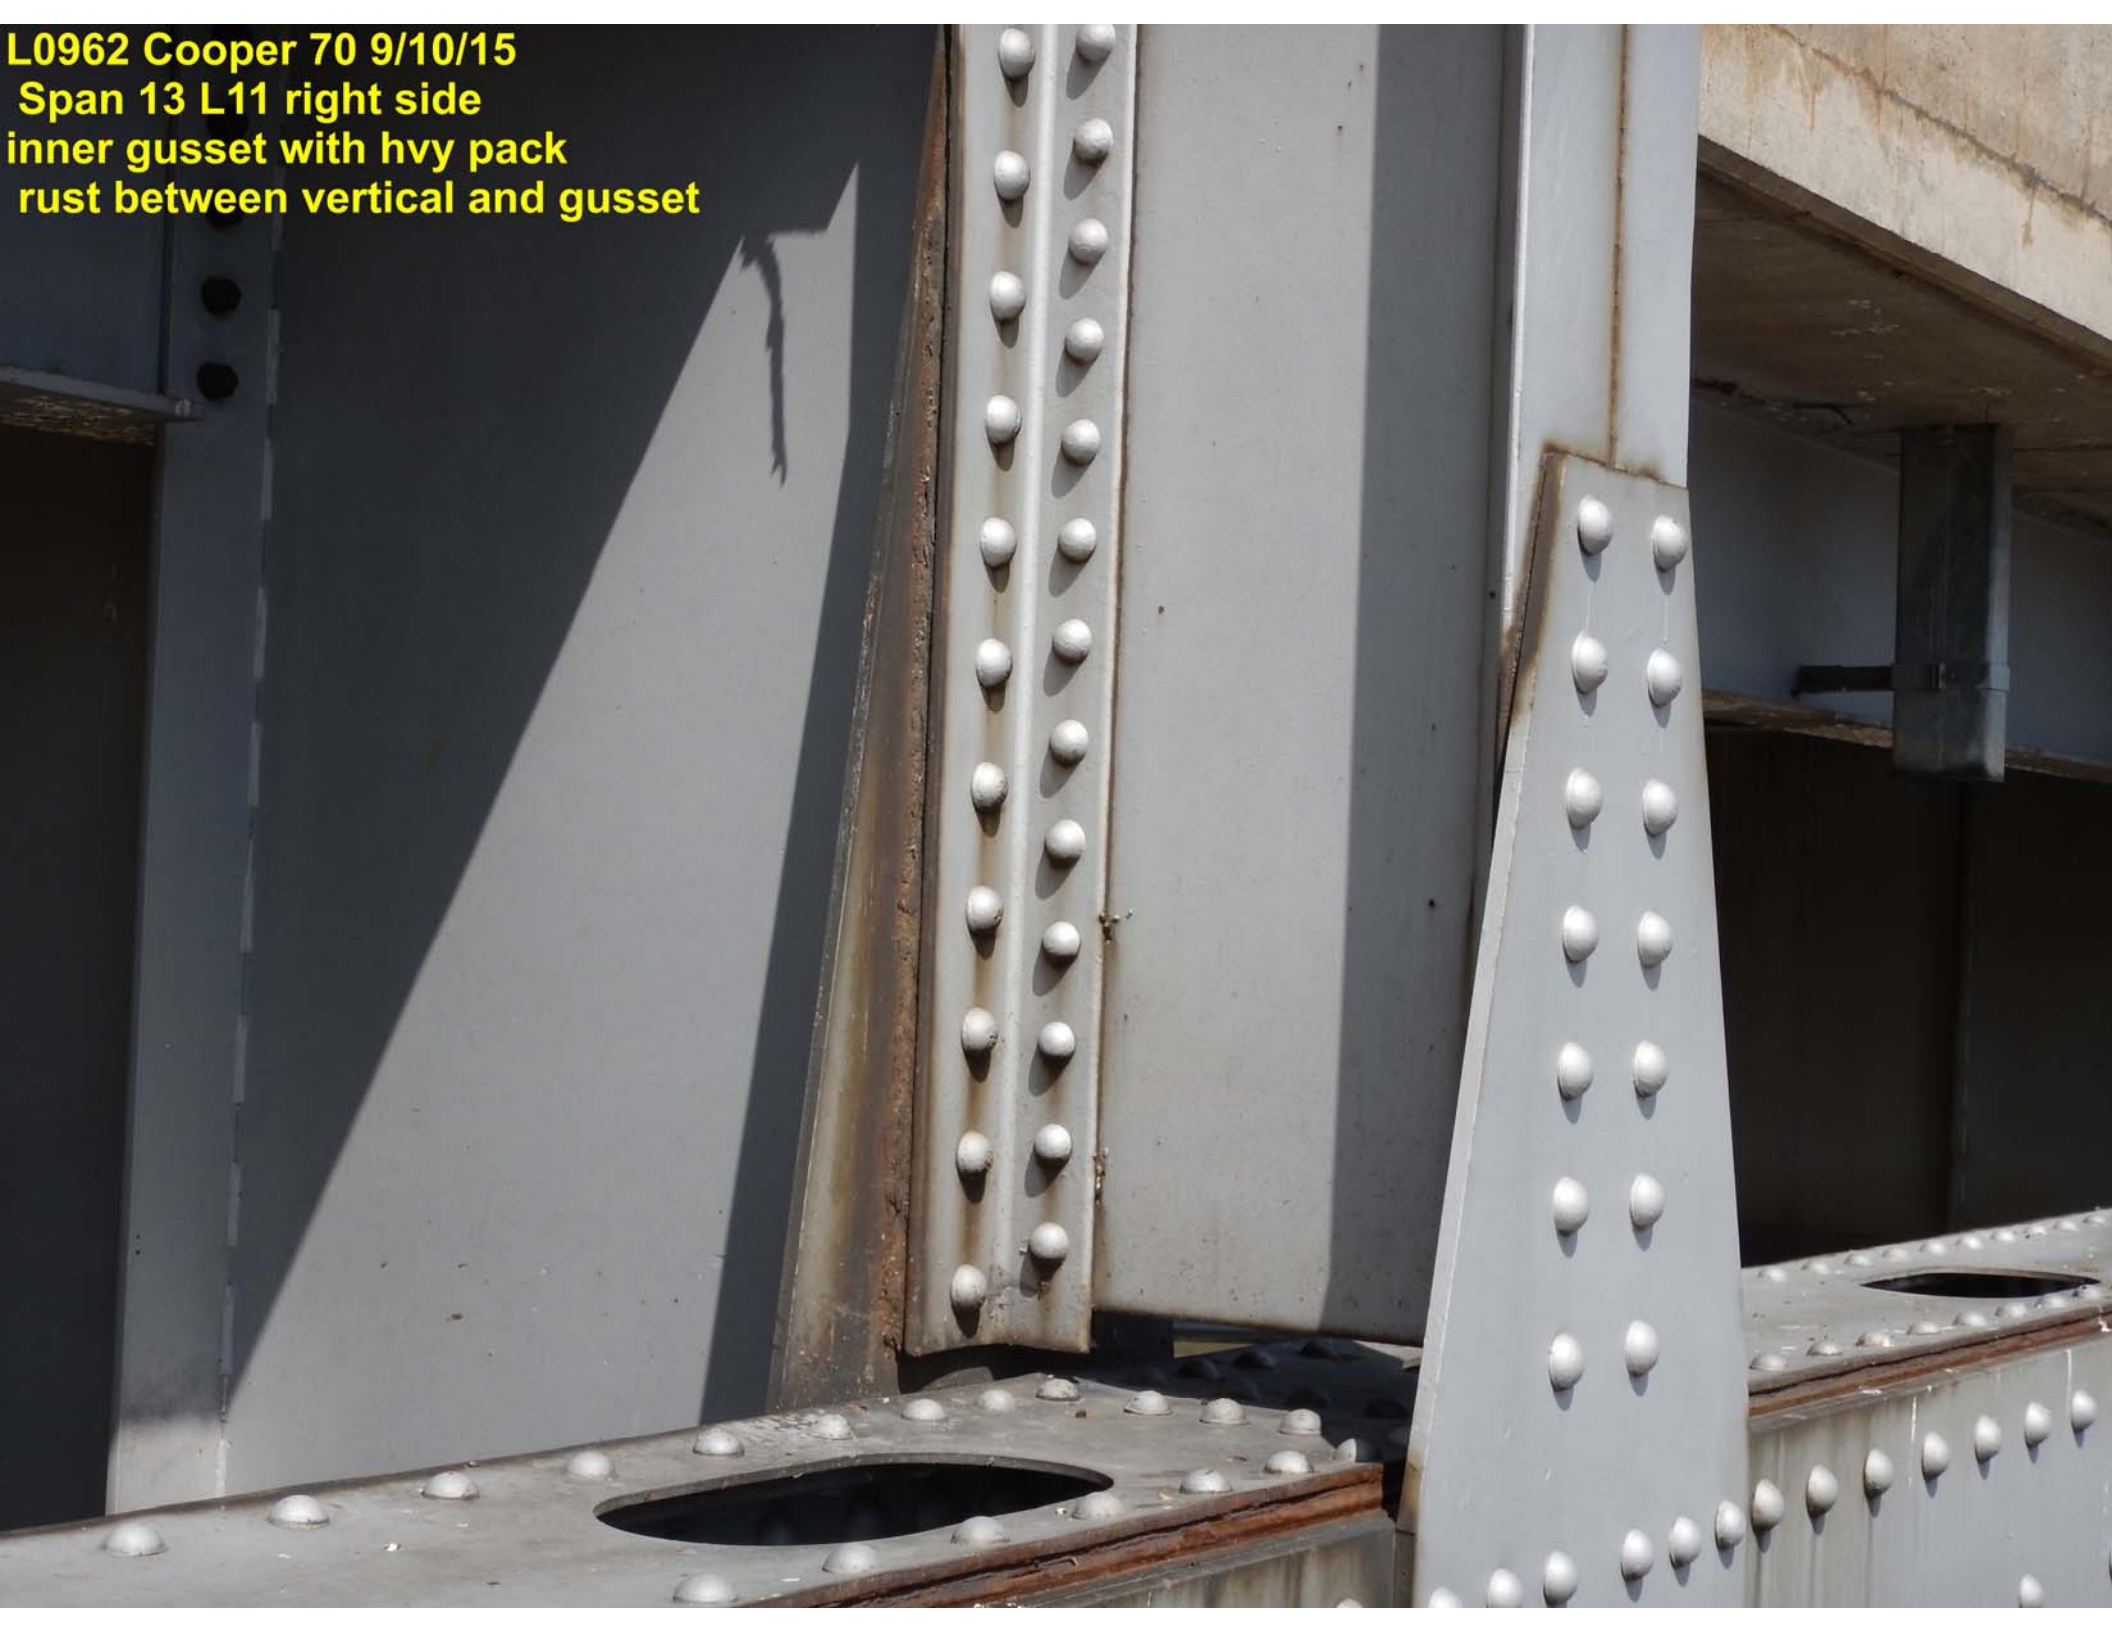
**L0962 Cooper 70 9/10/15**  
**Span 13 L11 right side**  
**inner gusset with hvy pack**  
**rust between vertical and gusset**
