L0962 Cooper 70 8/28/17
P13 east side lrg area of map
cracks with saturation and eff

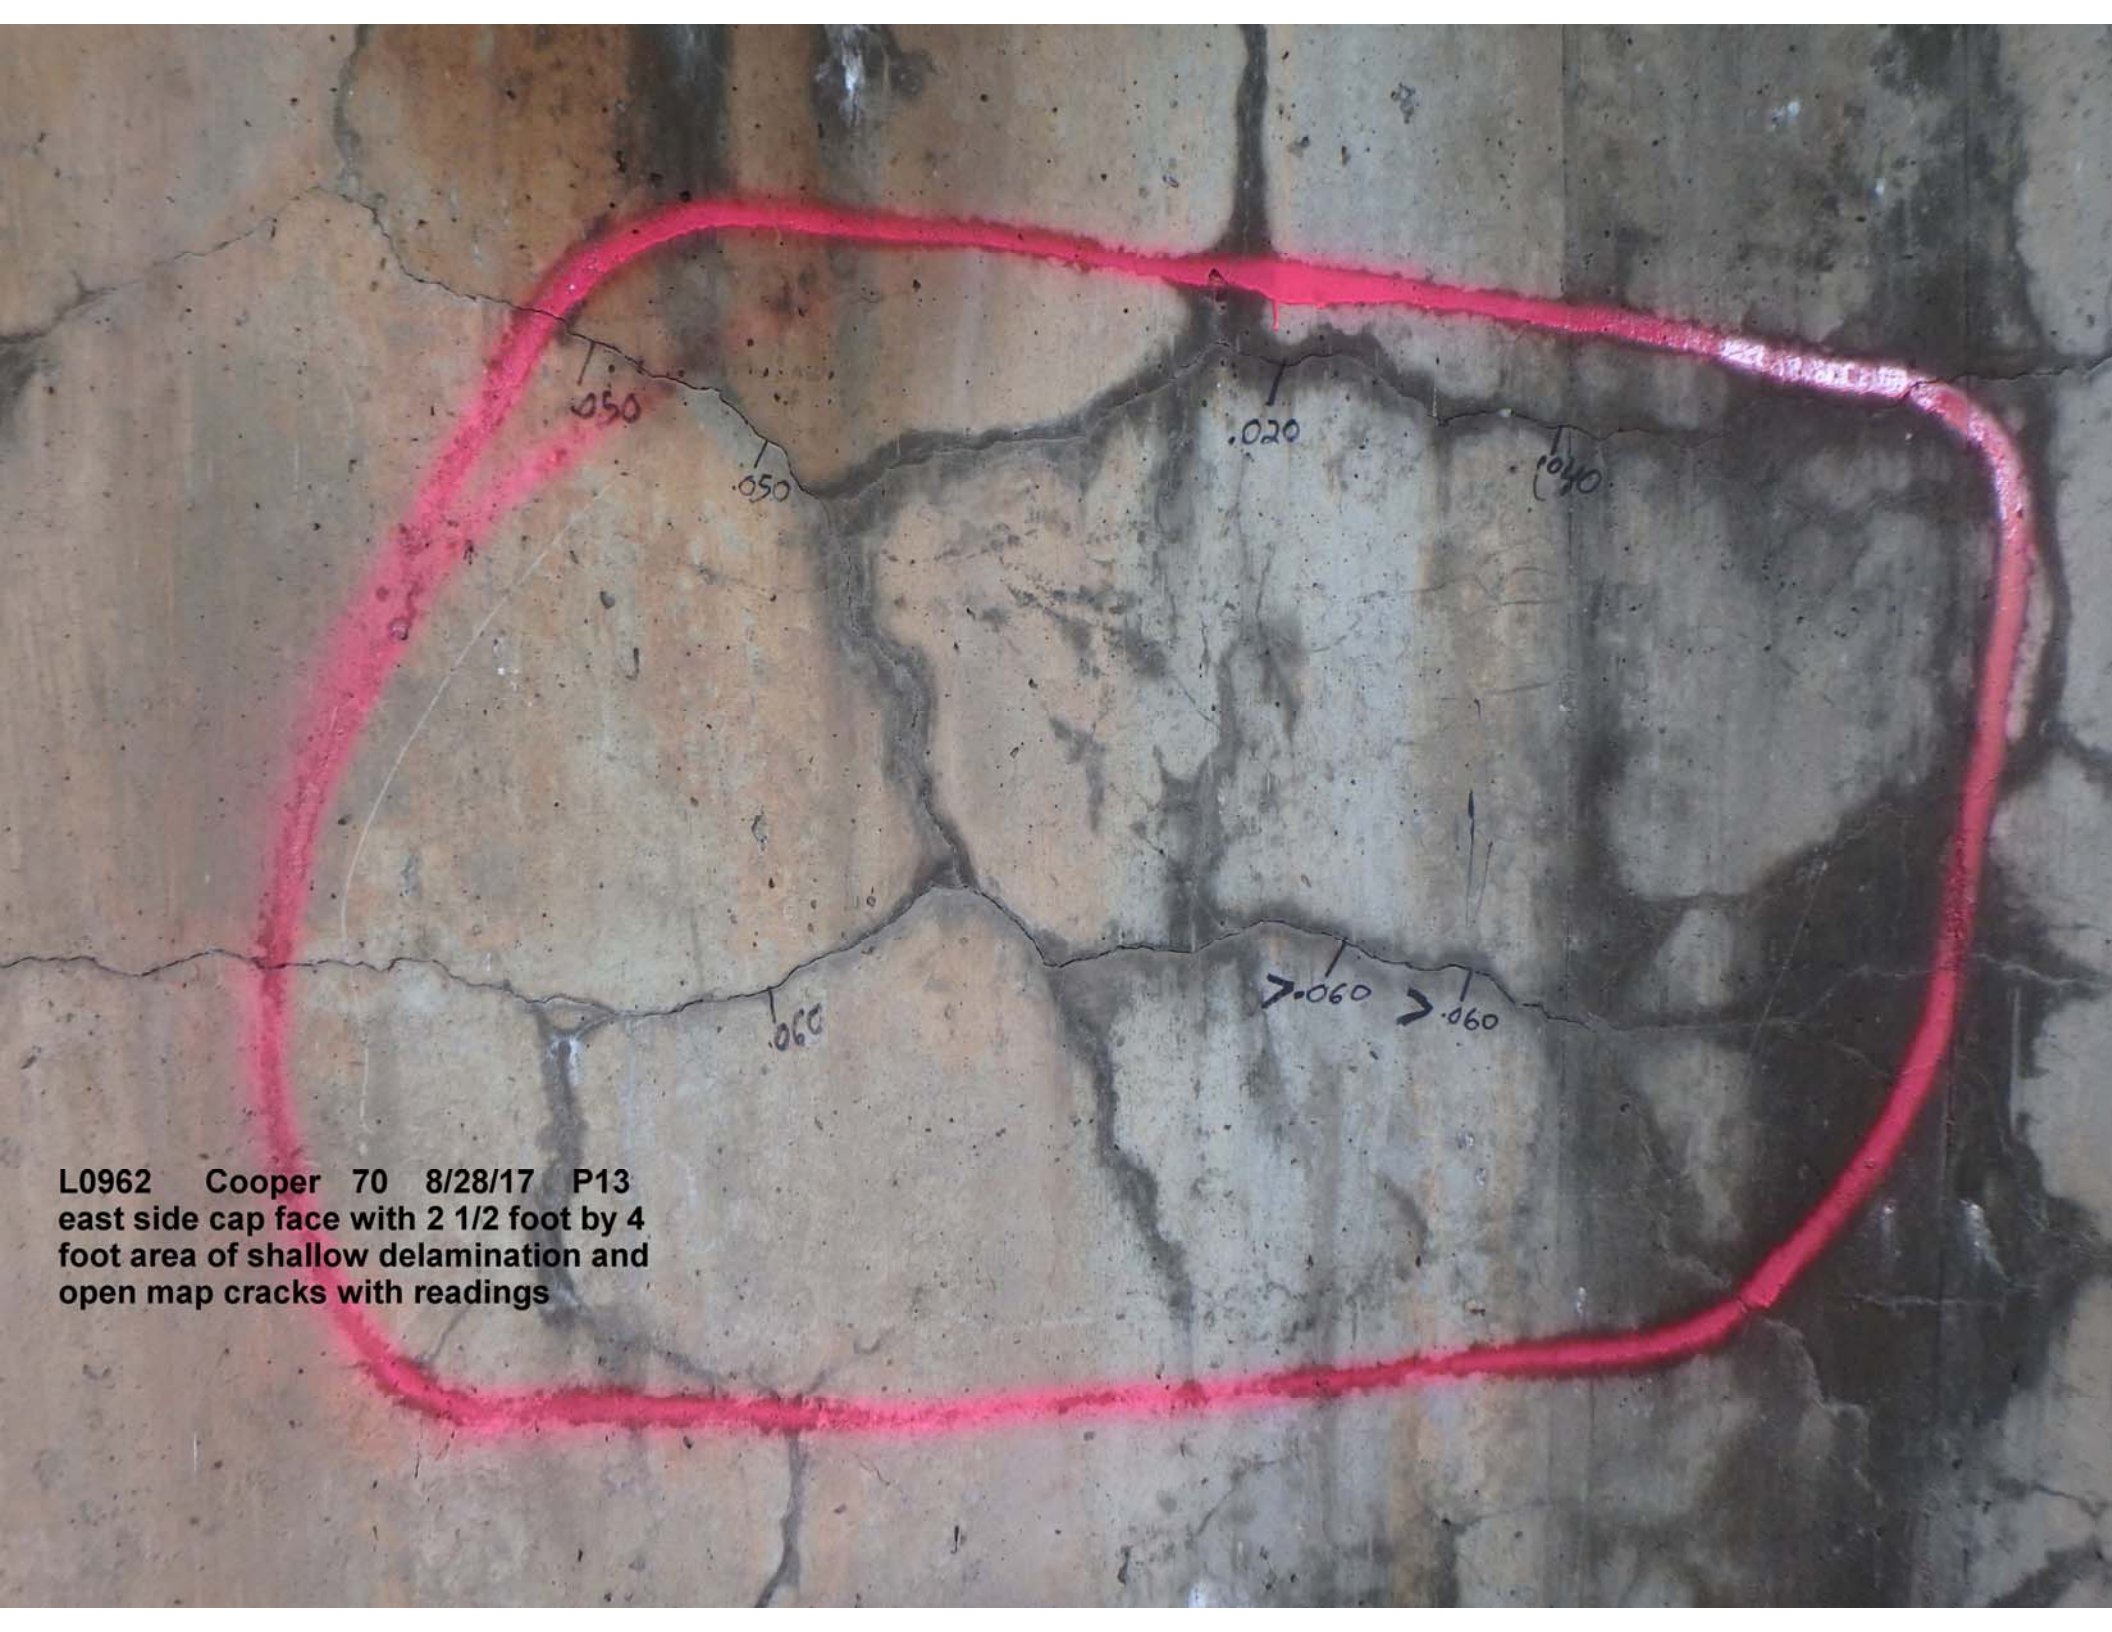
L0962 Cooper 70 8/28/17 P13
east side cap face with 2 1/2 foot by 4
foot area of shallow delamination and
open map cracks with readings

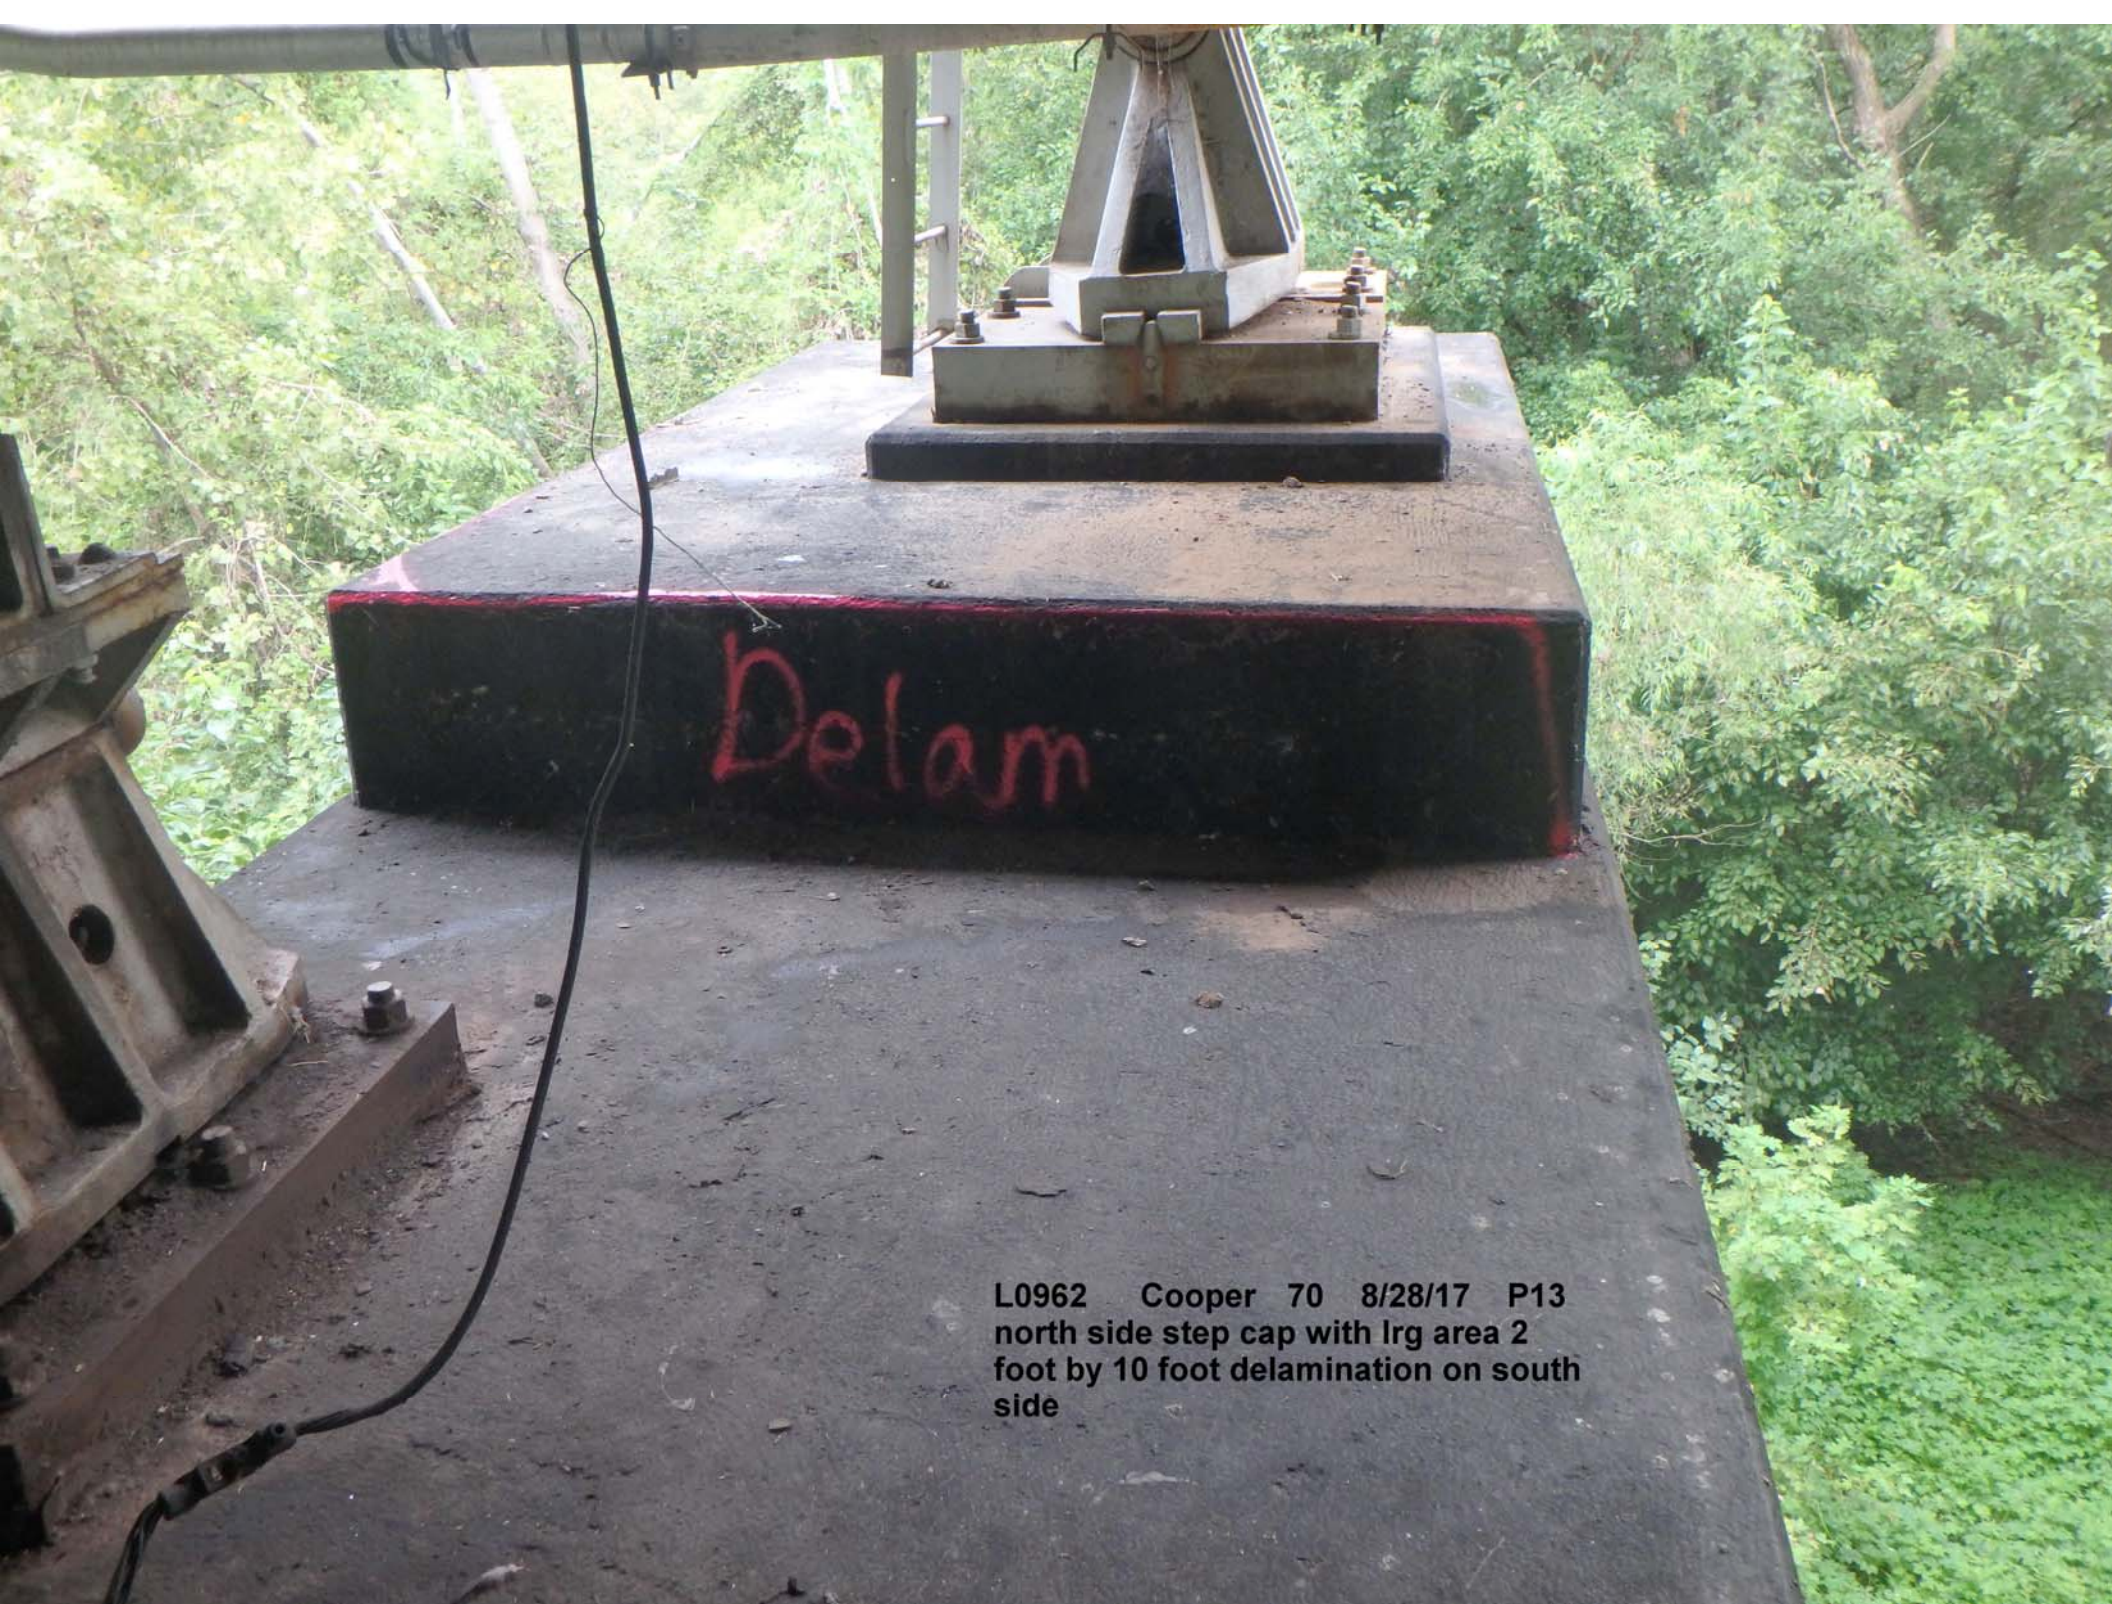
L0962 Cooper 70 8/28/17 P13
north side step cap with lrg area 2
foot by 10 foot delamination on south
side

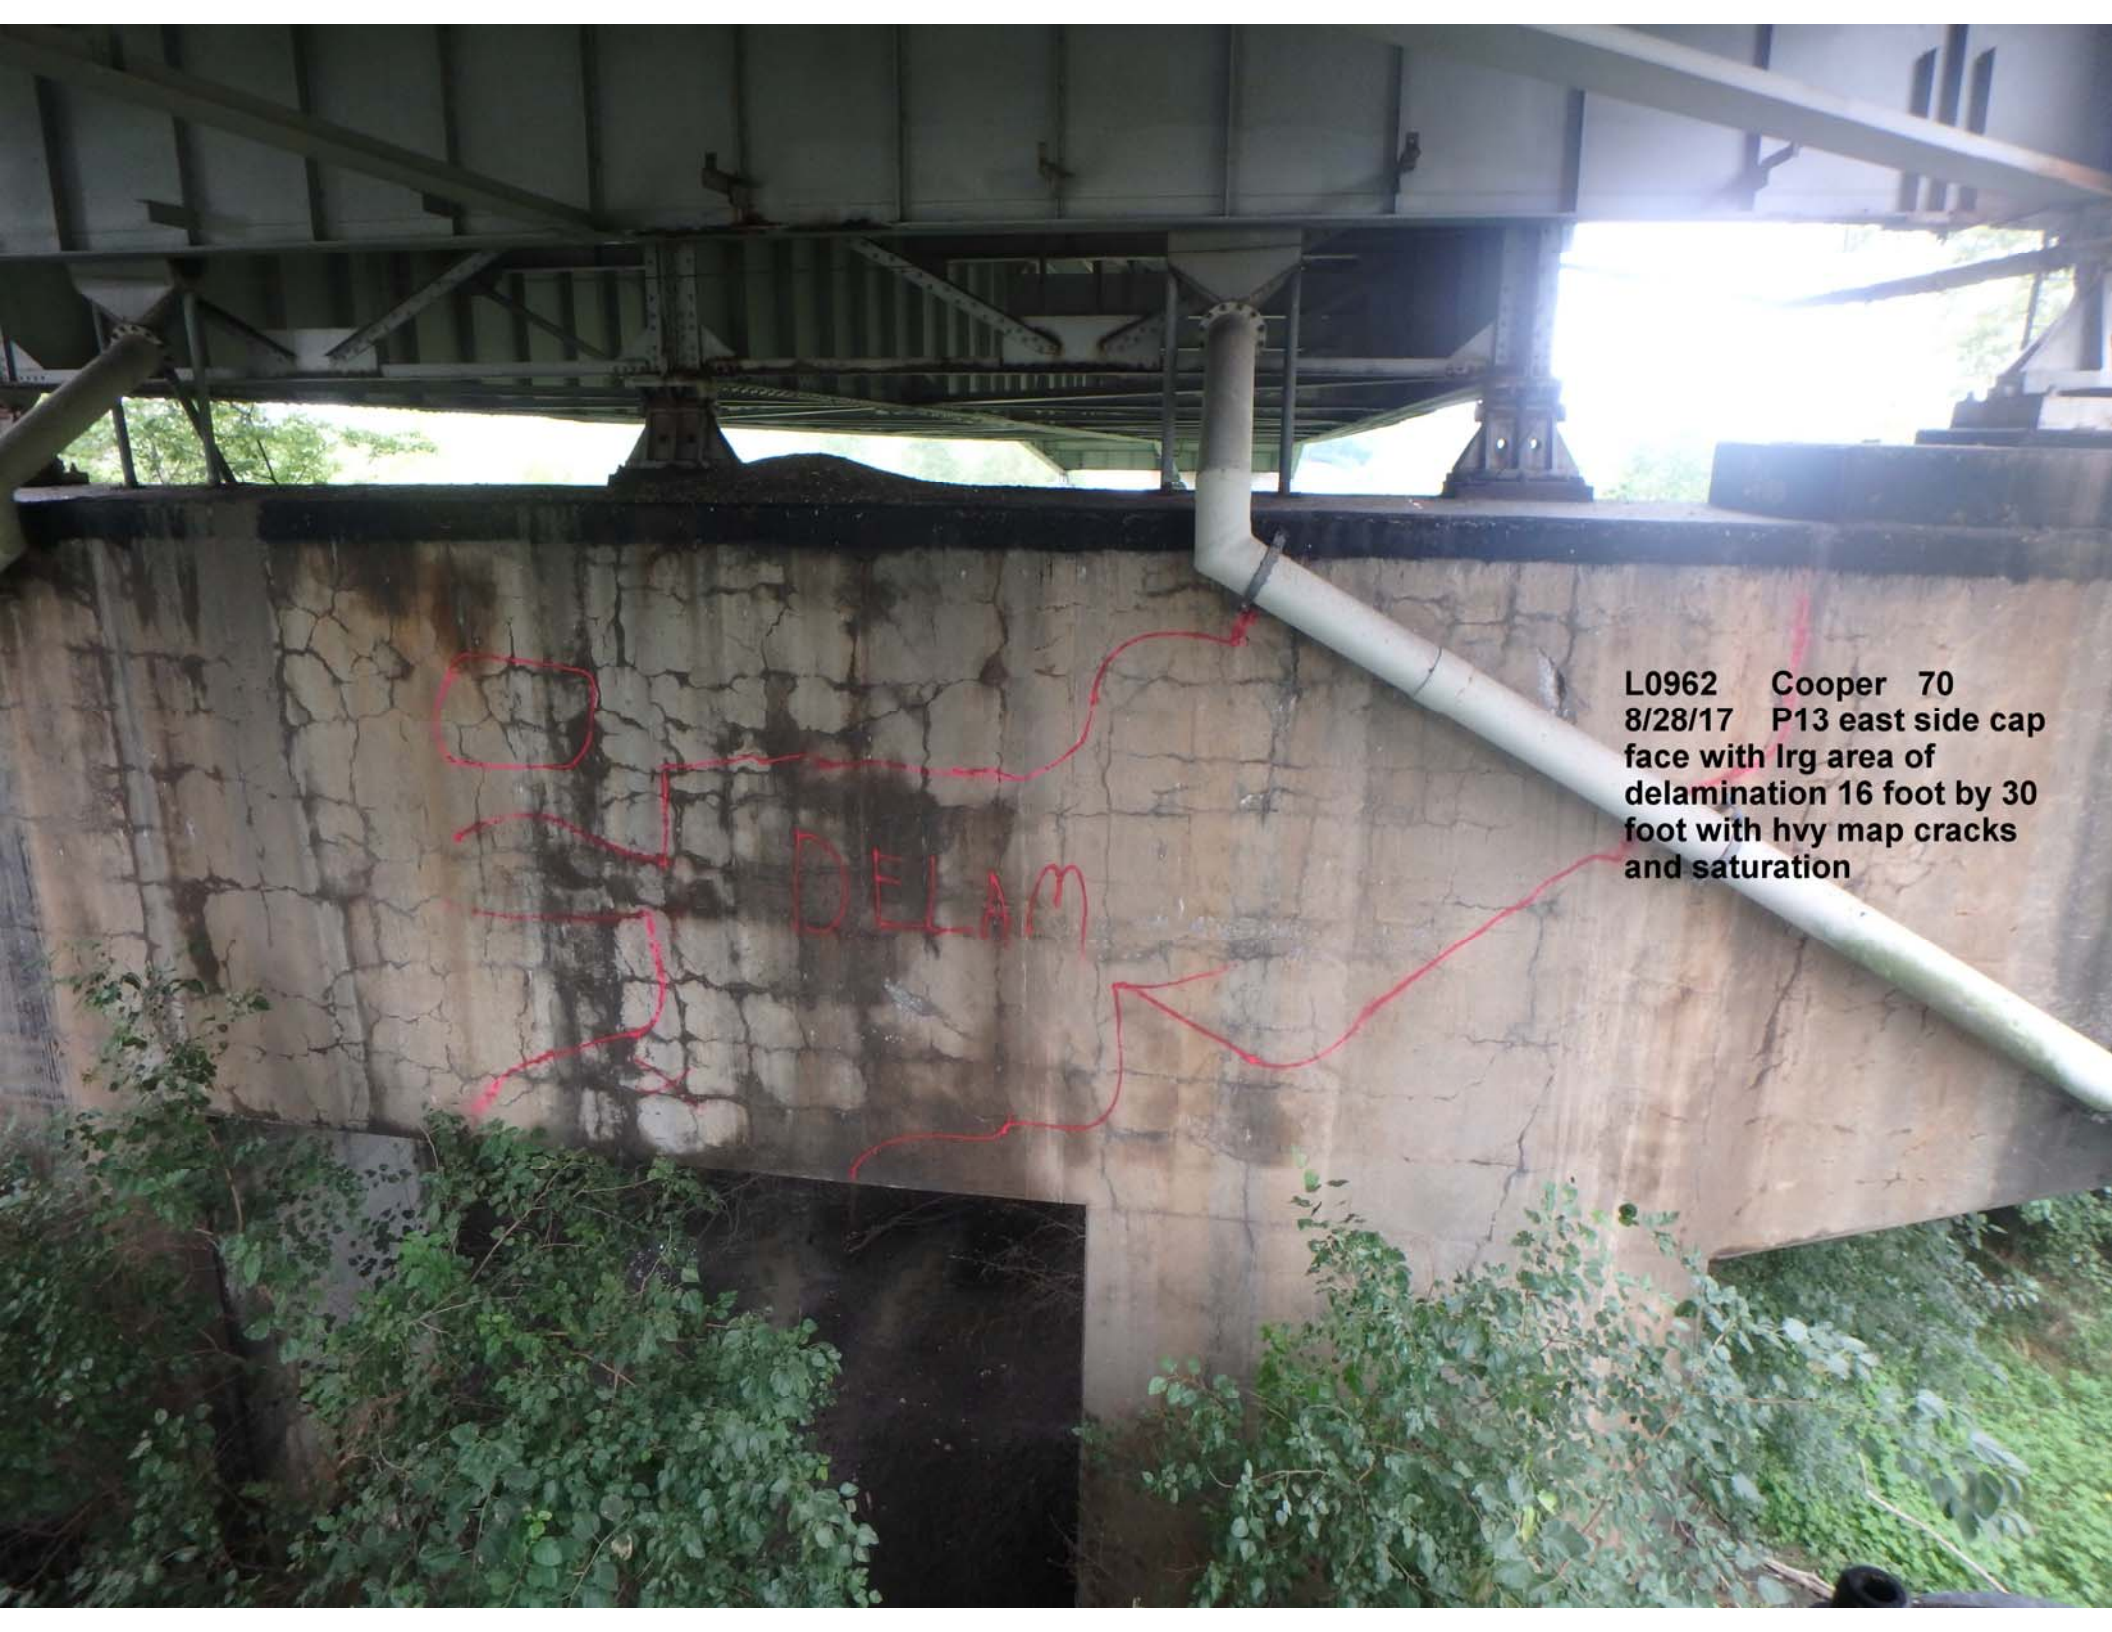
L0962 Cooper 70
8/28/17 P13 east side cap
face with lrg area of
delamination 16 foot by 30
foot with hvy map cracks
and saturation

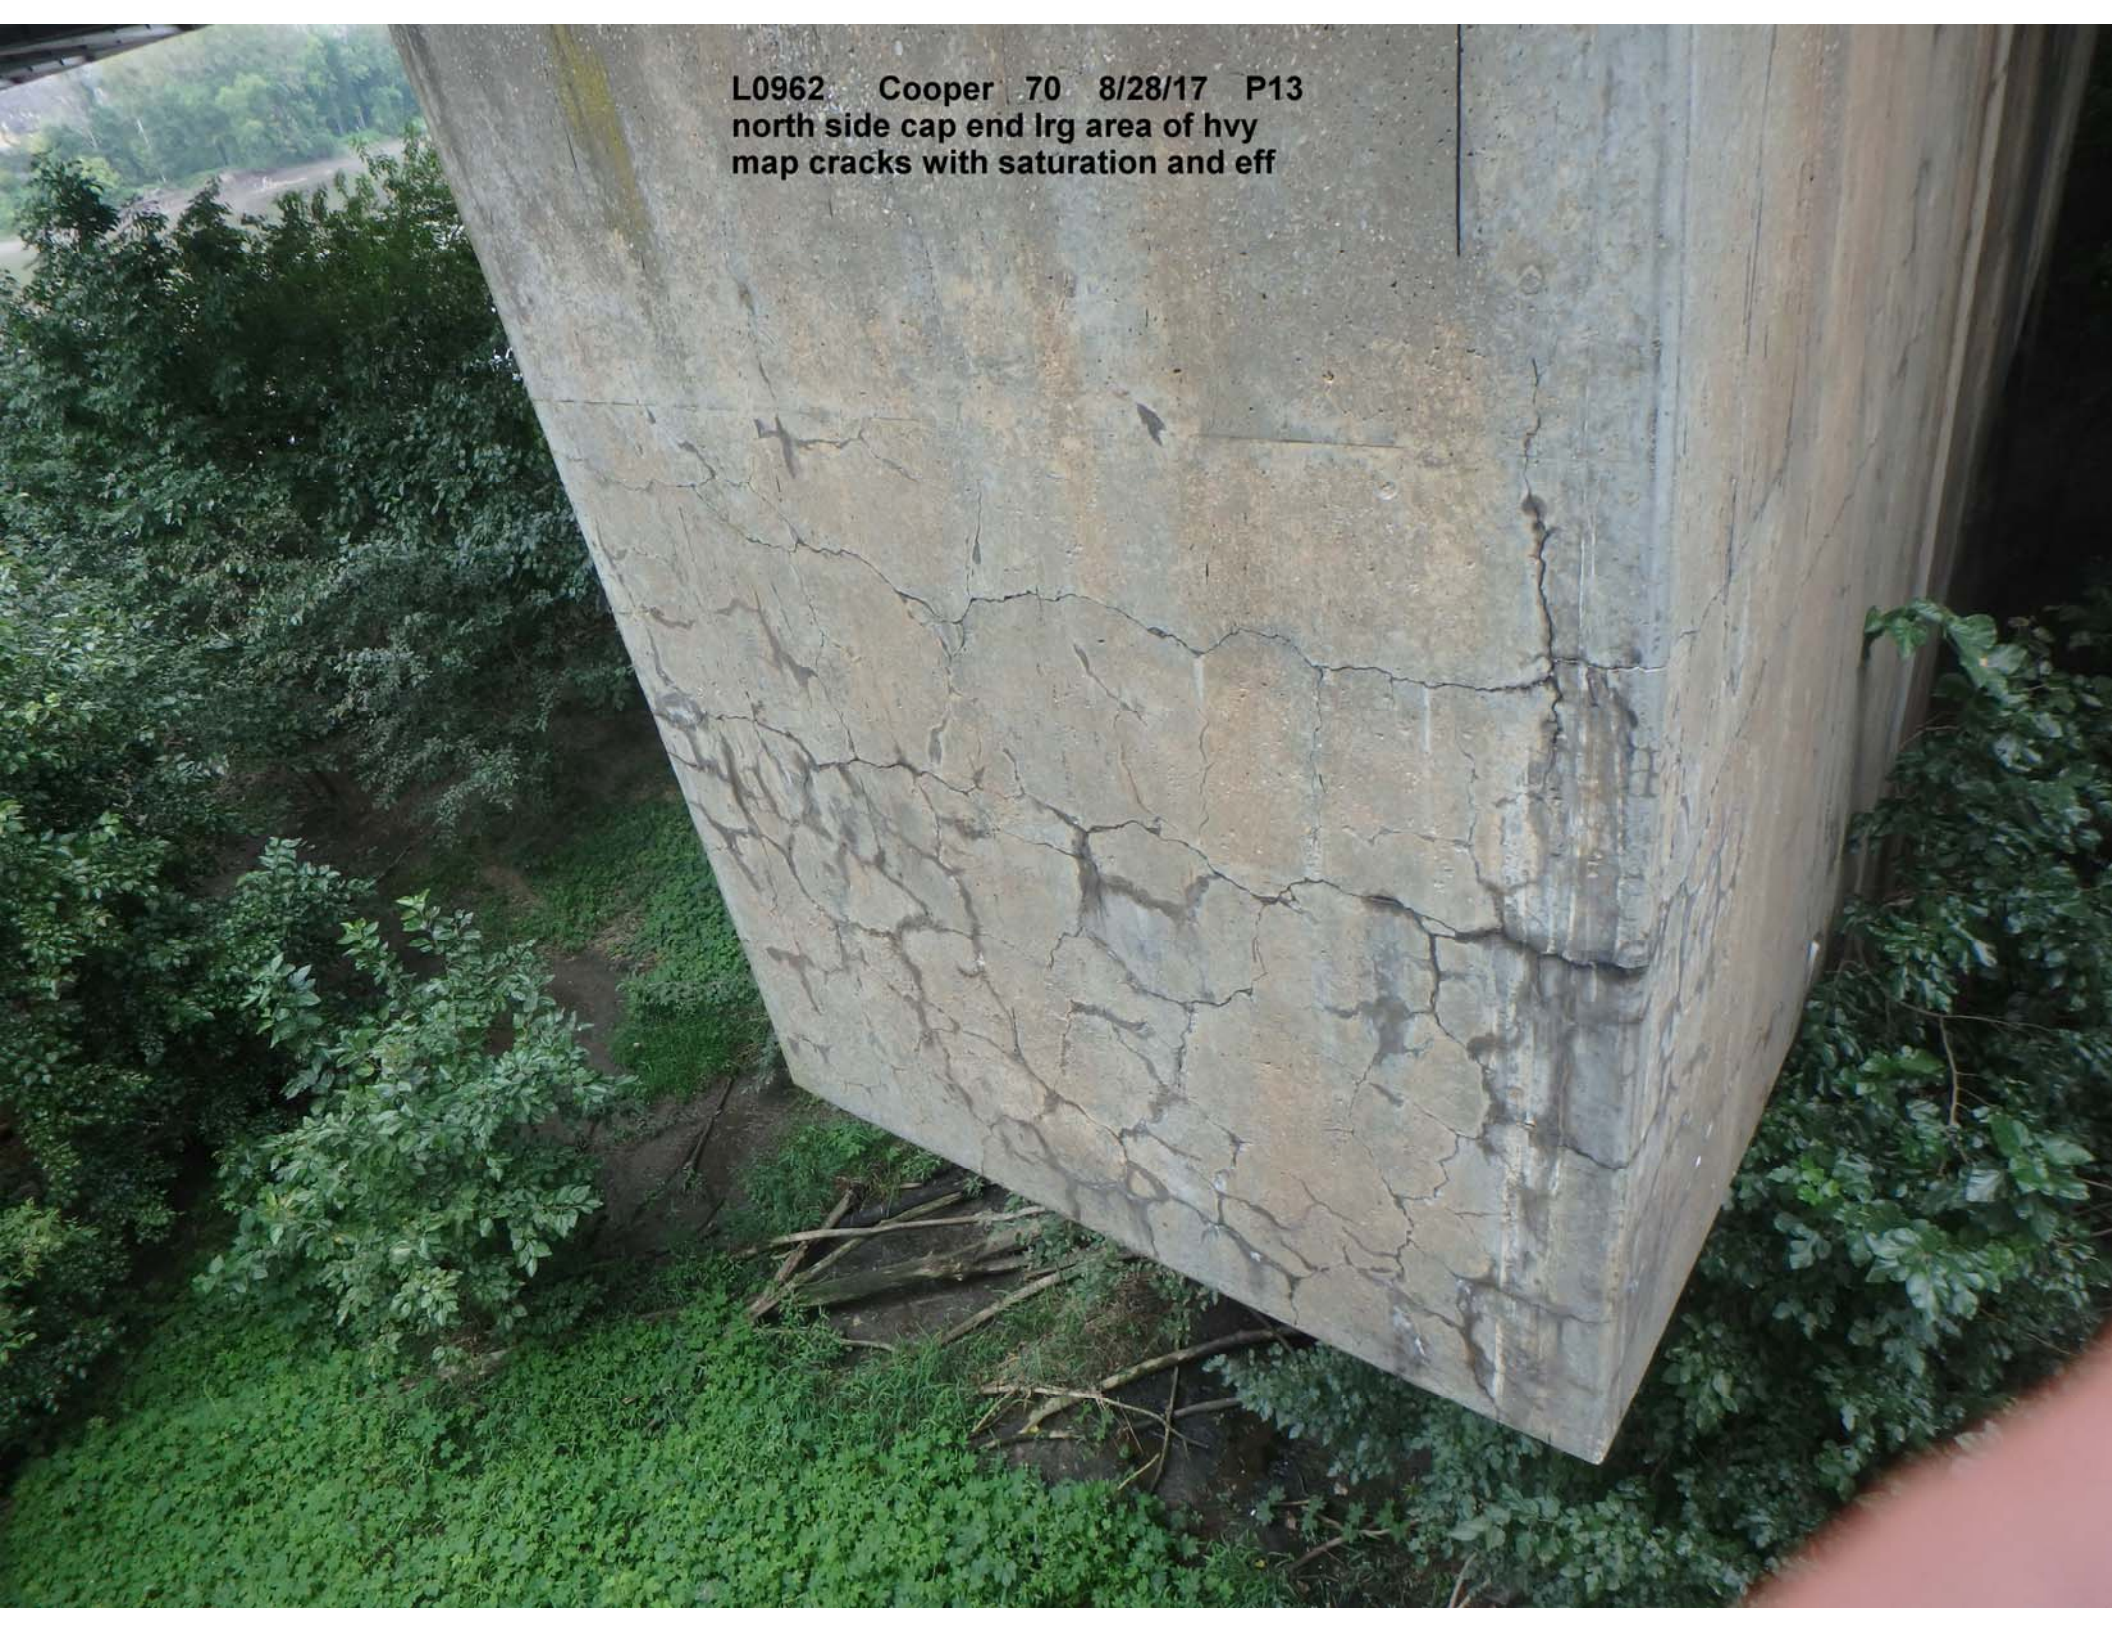
L0962 Cooper 70 8/28/17 P13
north side step cap west face with 2
foot by 5 foot area of delamination 1
foot by 3 foot spall with rebar
exposed minor sec loss in rebar 90
percent remaining

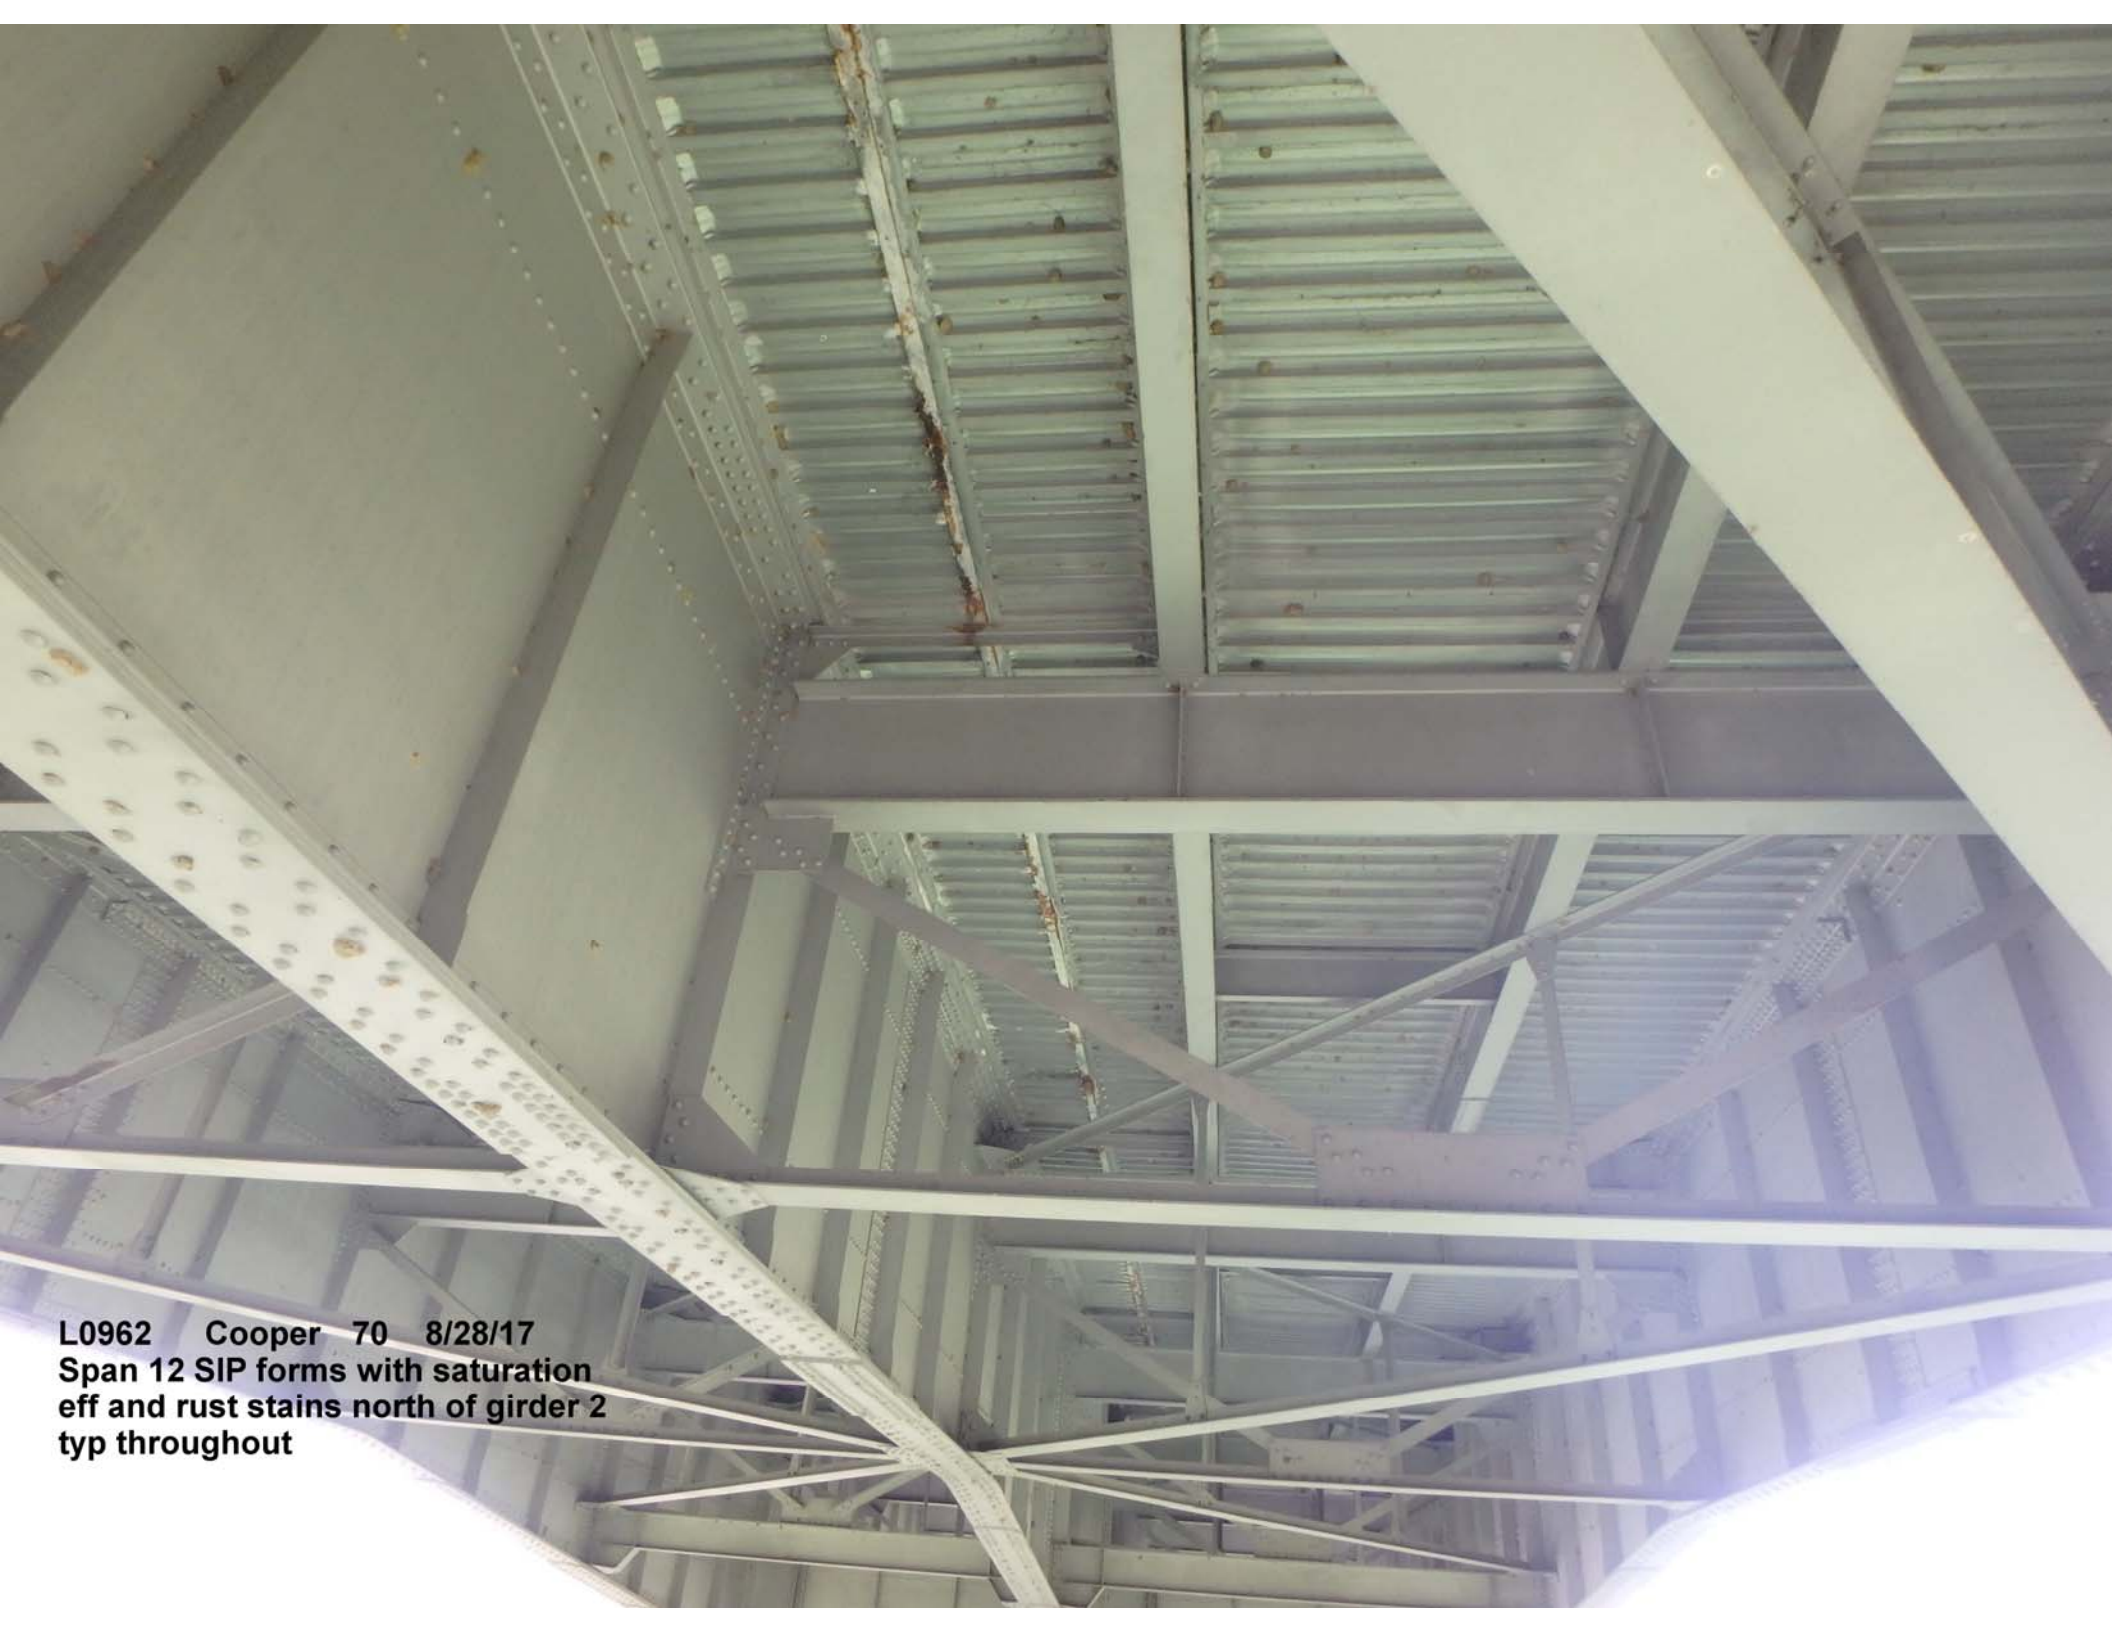
L0962 Cooper 70 8/28/17
Span 12 SIP forms with saturation
eff and rust stains north of girder 2
typ throughout

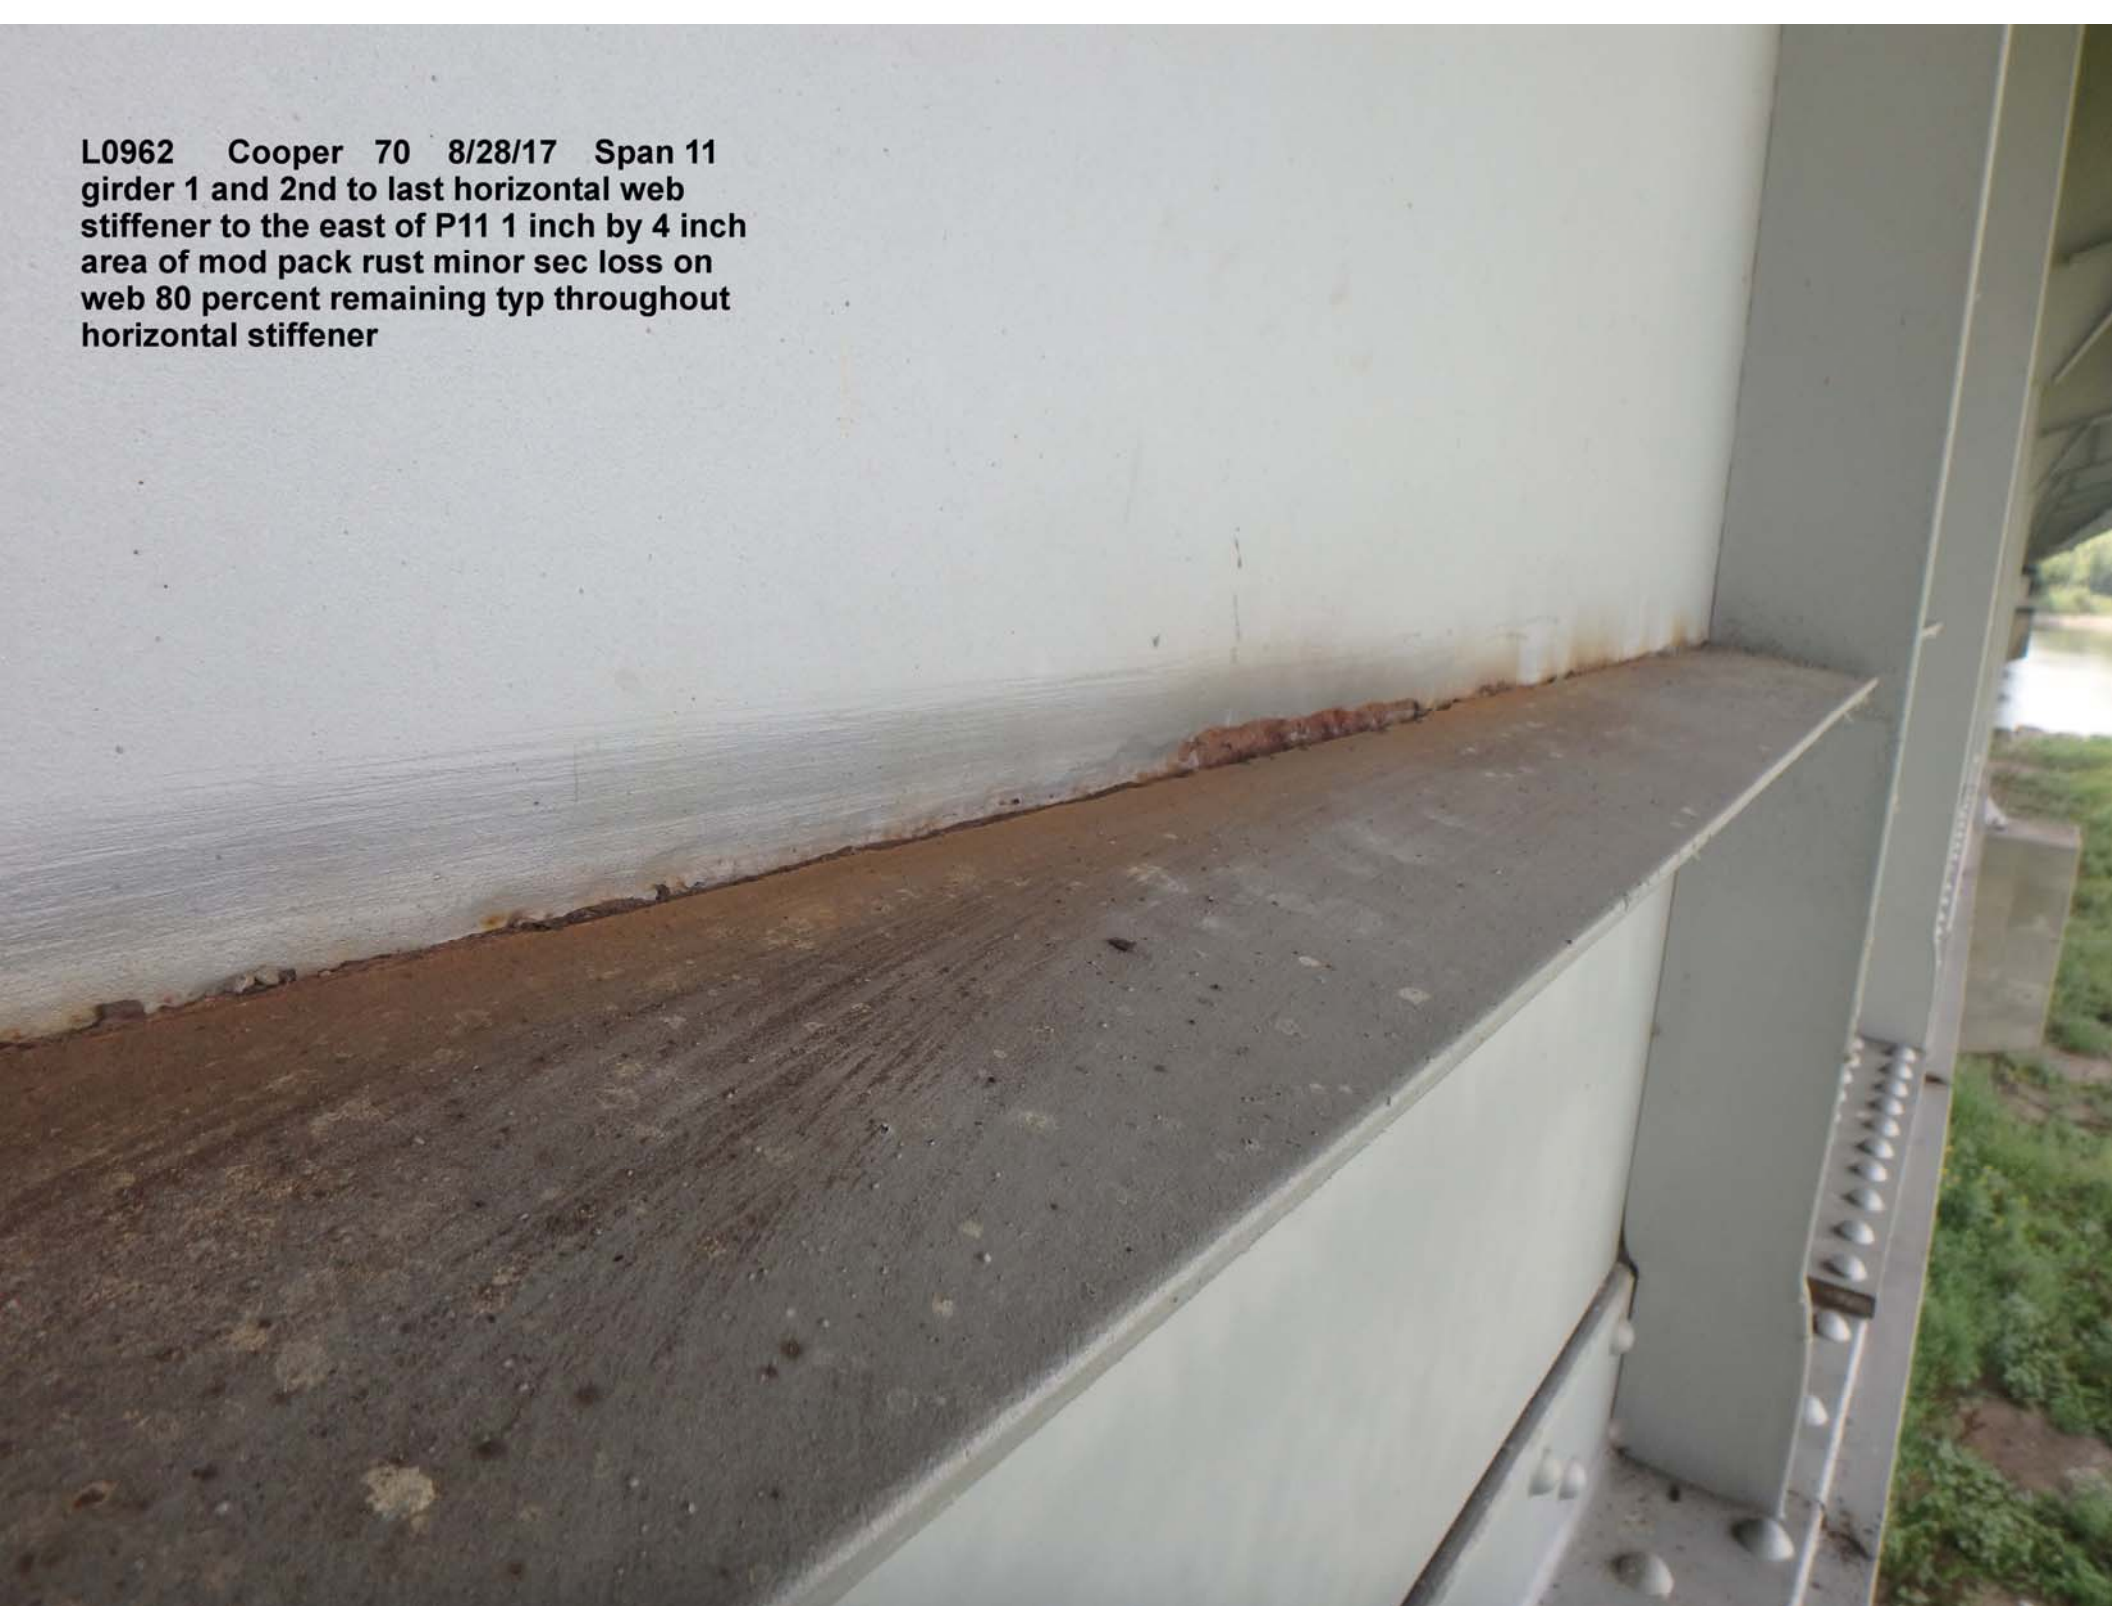
L0962 Cooper 70 8/28/17 Span 11
girder 1 and 2nd to last horizontal web
stiffener to the east of P11 1 inch by 4 inch
area of mod pack rust minor sec loss on
web 80 percent remaining typ throughout
horizontal stiffener
