L0962 Cooper 70 8/28/17
P13 east side lrg area of map
cracks with saturation and eff

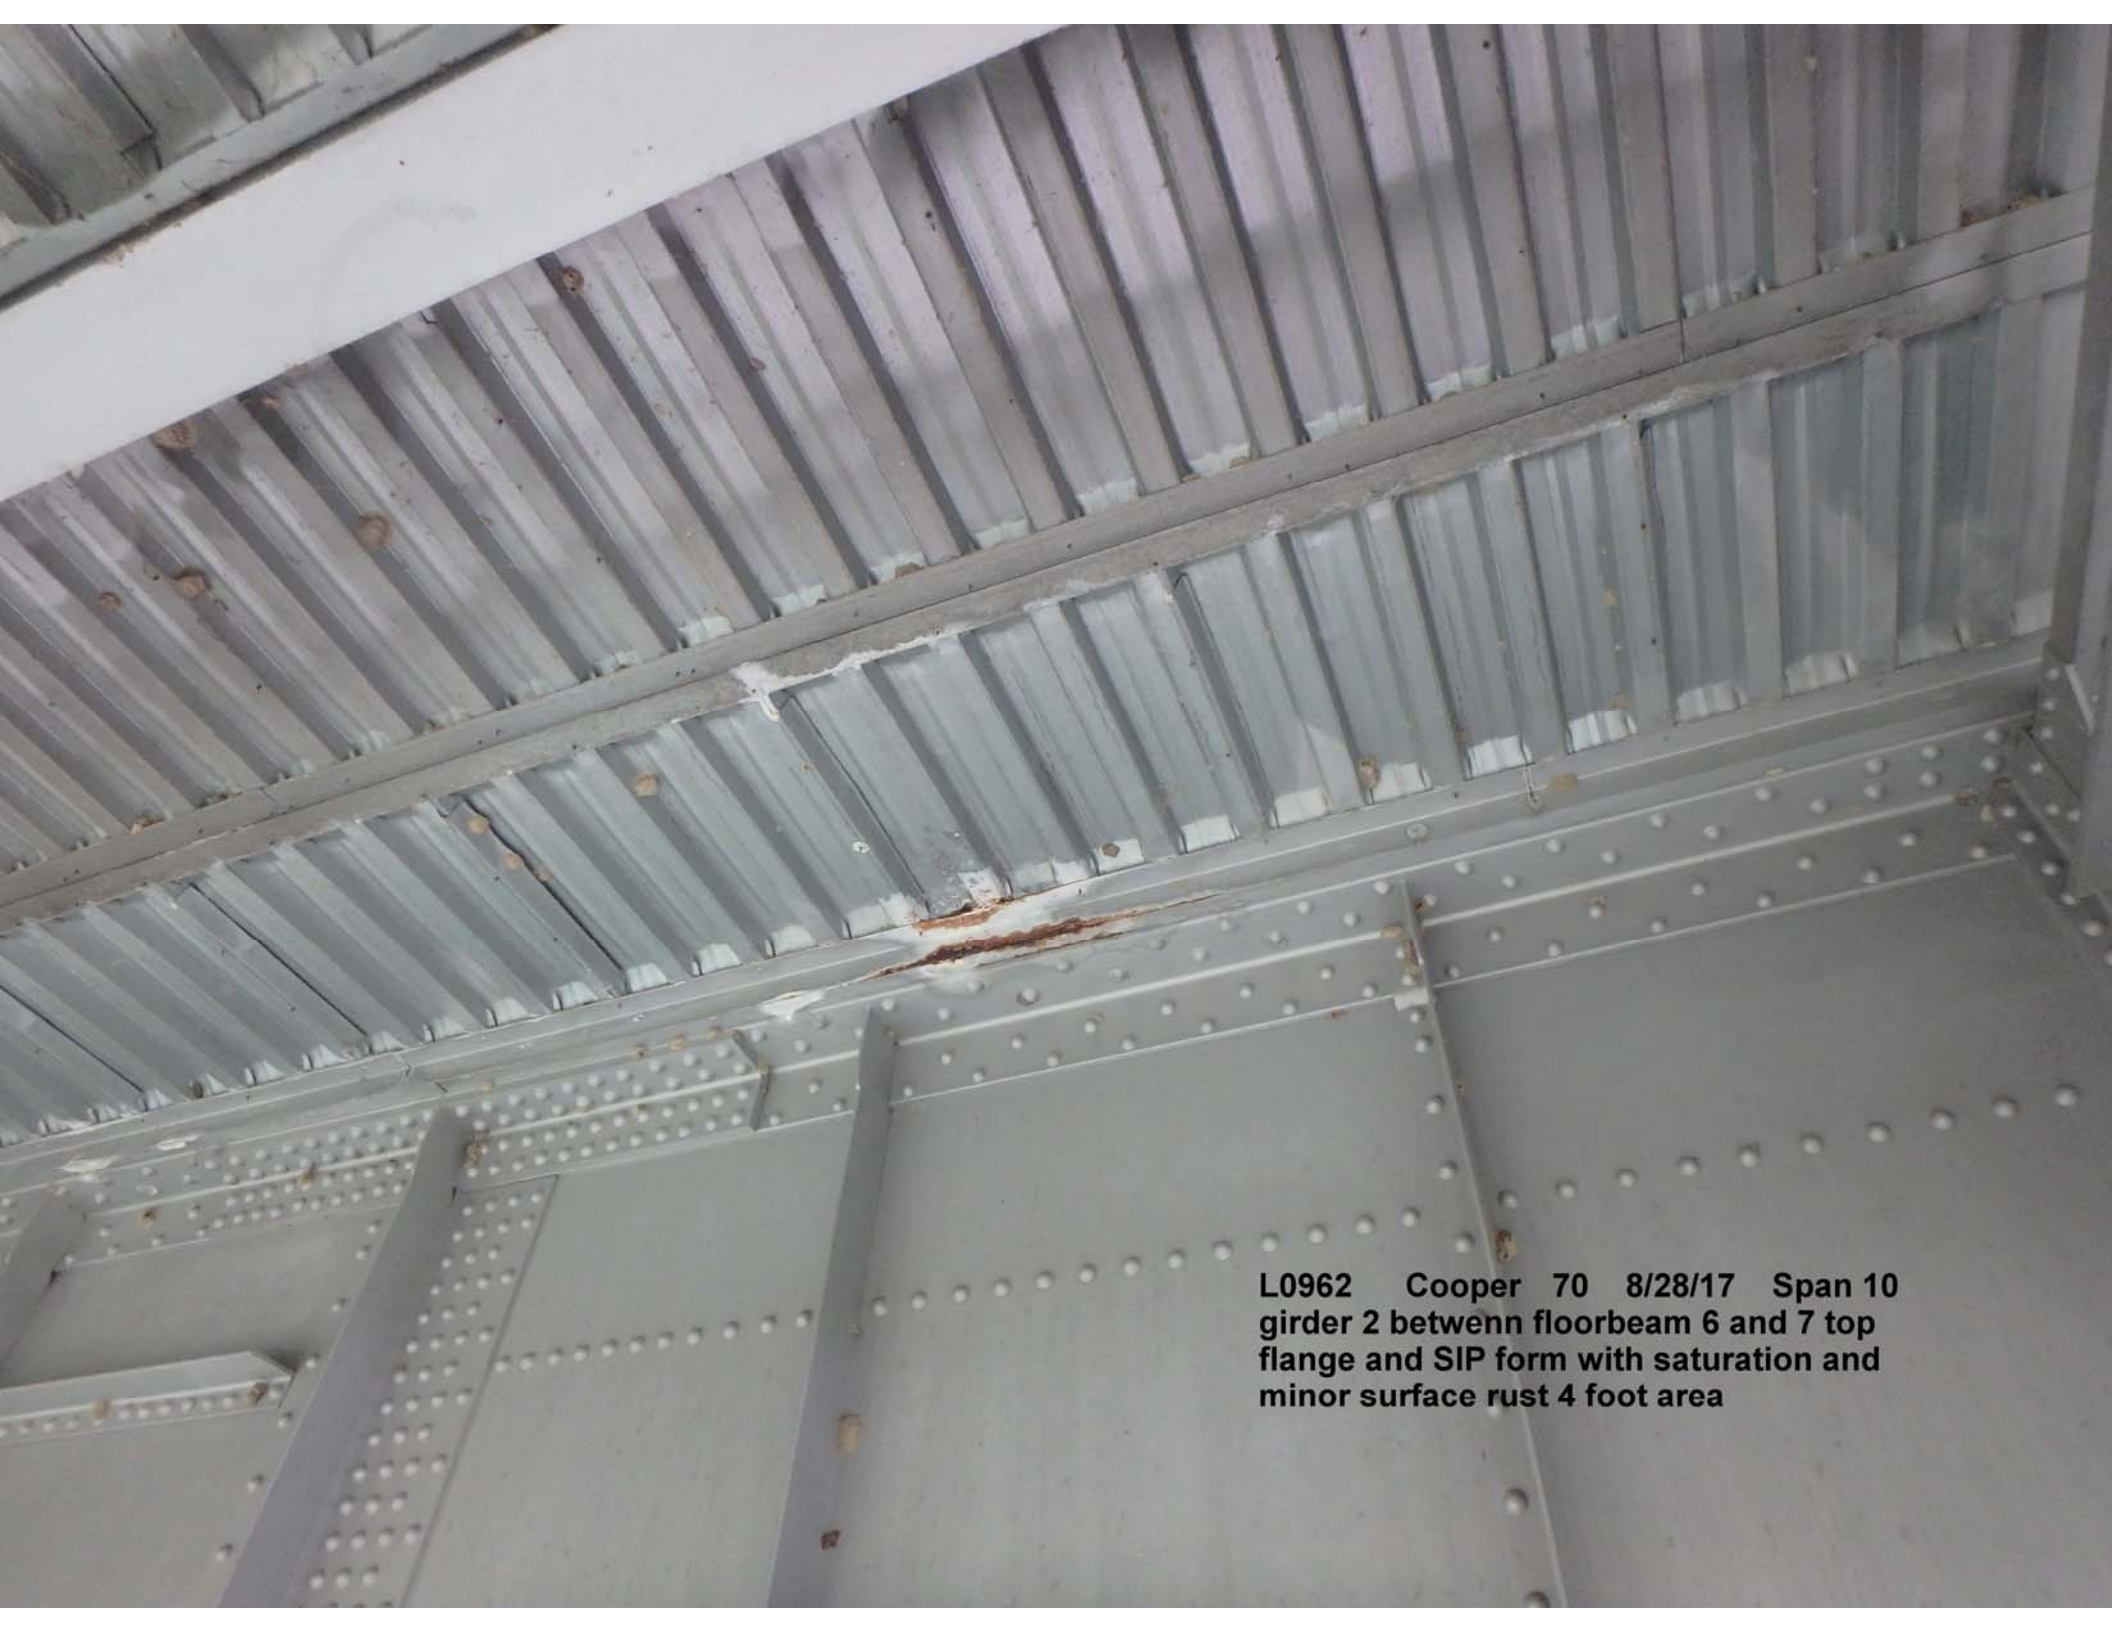
**L0962 Cooper 70 8/28/17 Span 10
girder 2 between floorbeam 6 and 7 top
flange and SIP form with saturation and
minor surface rust 4 foot area**

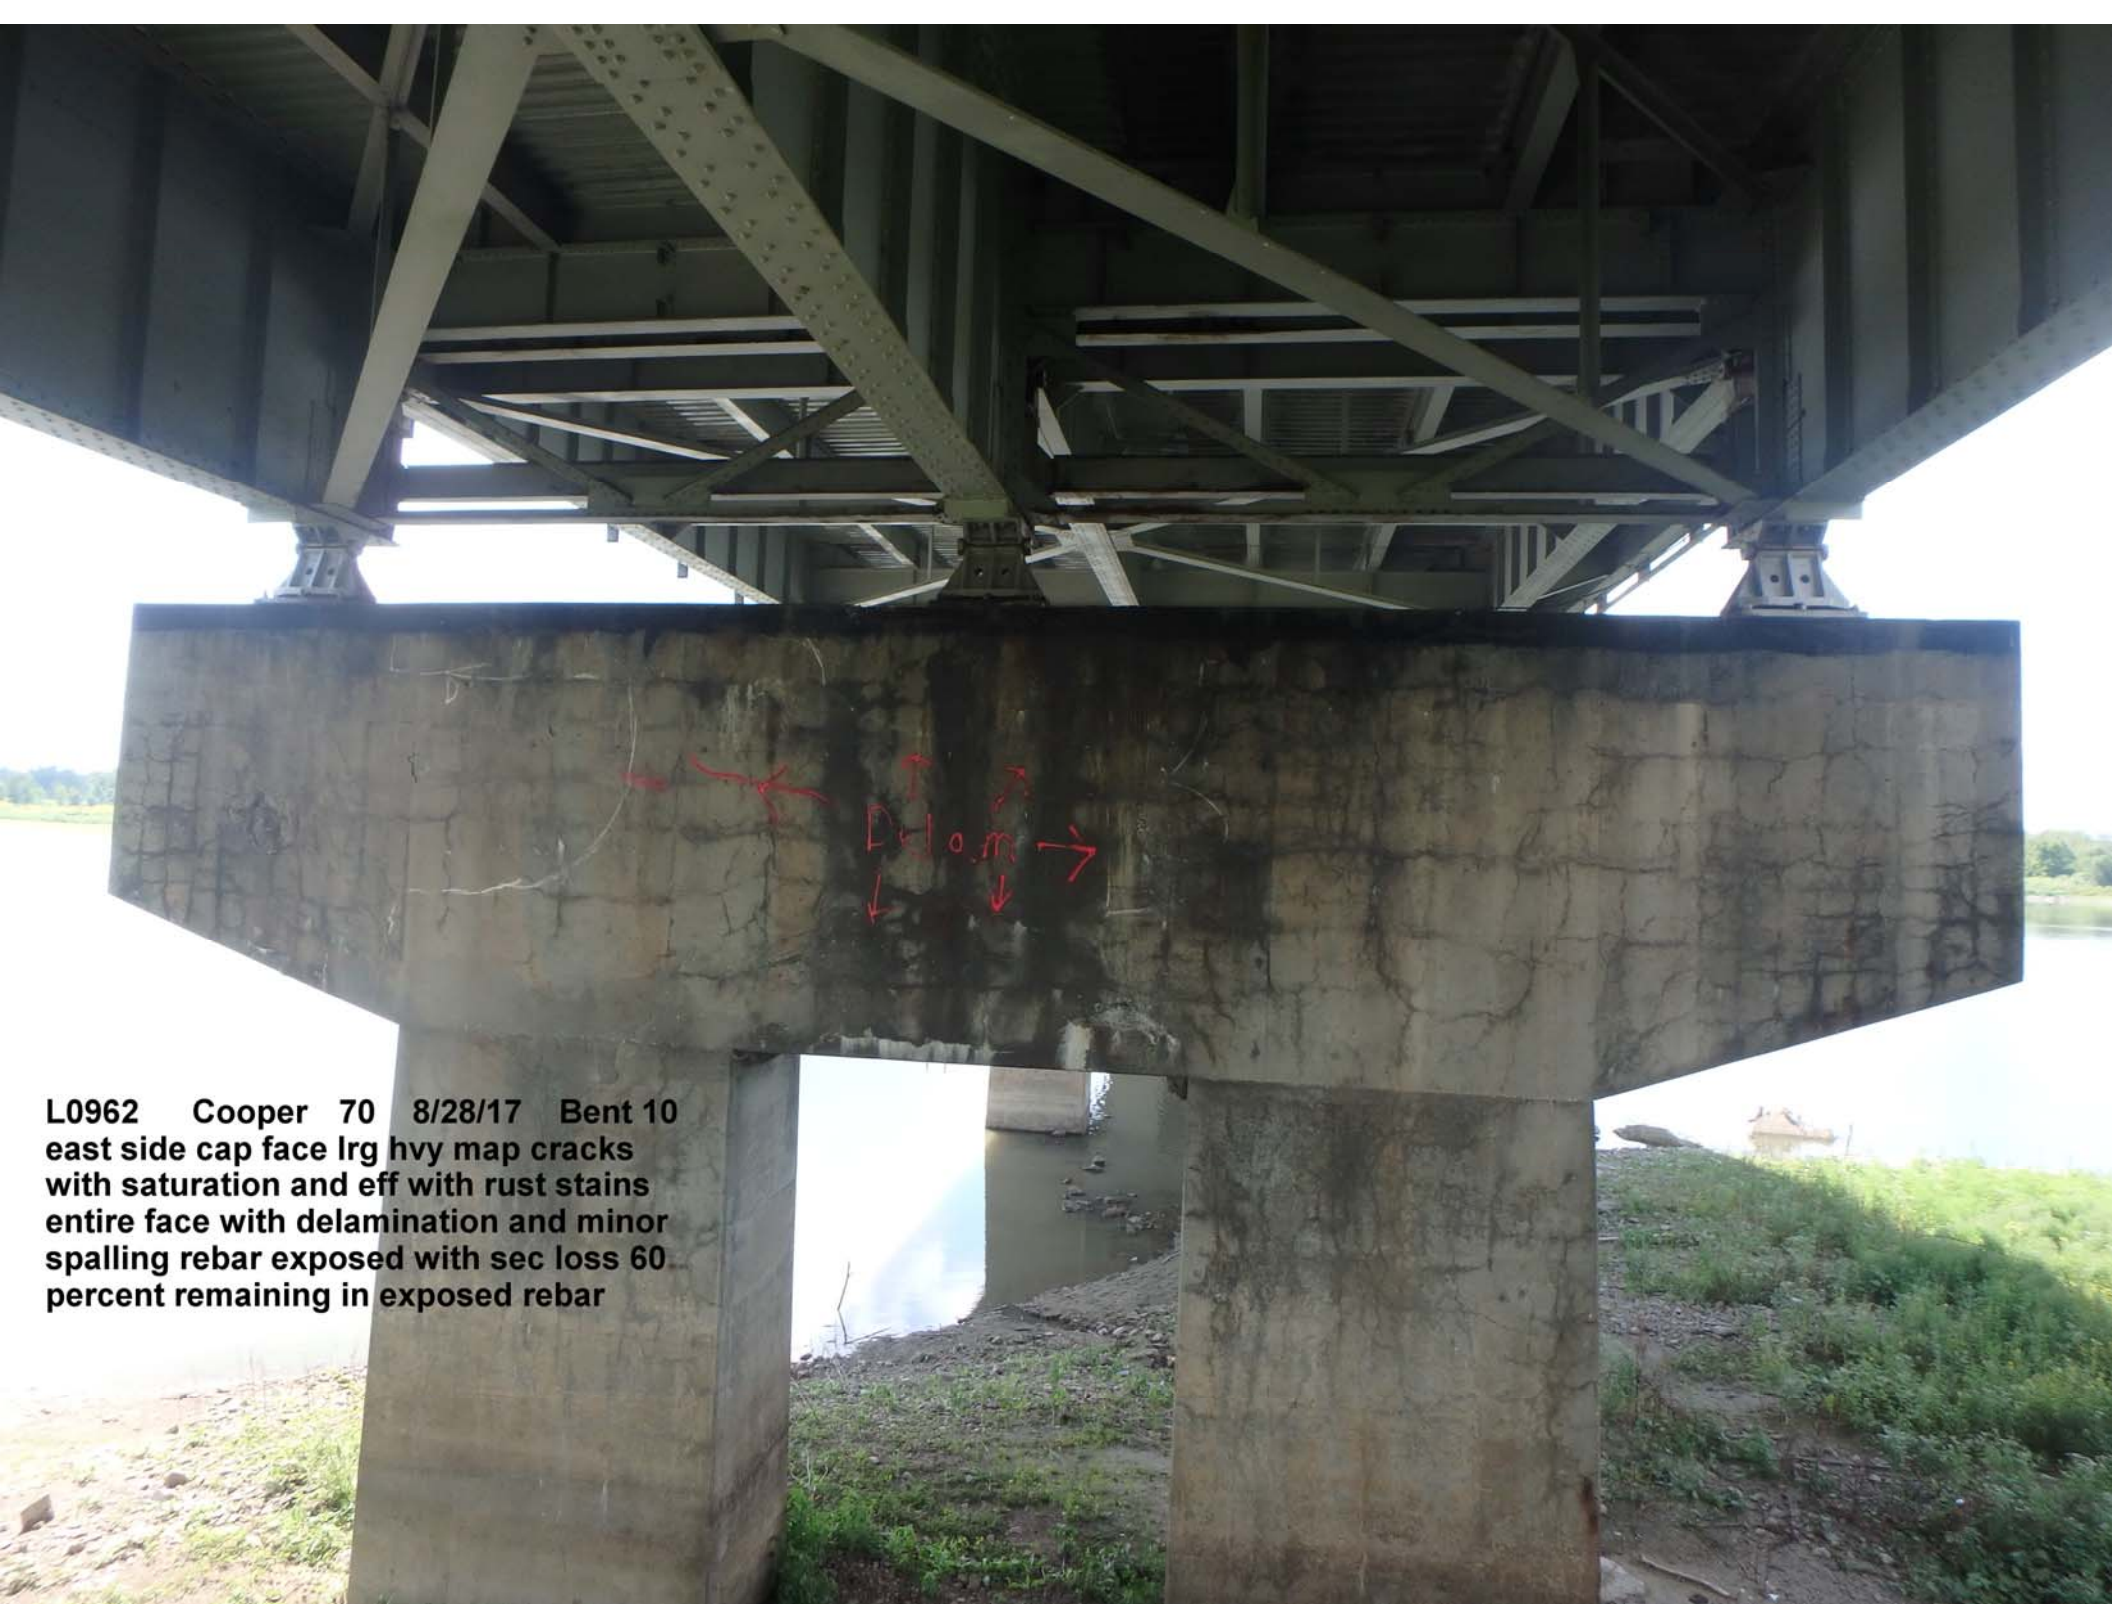
**L0962 Cooper 70 8/28/17 Bent 10
east side cap face lrg hvy map cracks
with saturation and eff with rust stains
entire face with delamination and minor
spalling rebar exposed with sec loss 60
percent remaining in exposed rebar**

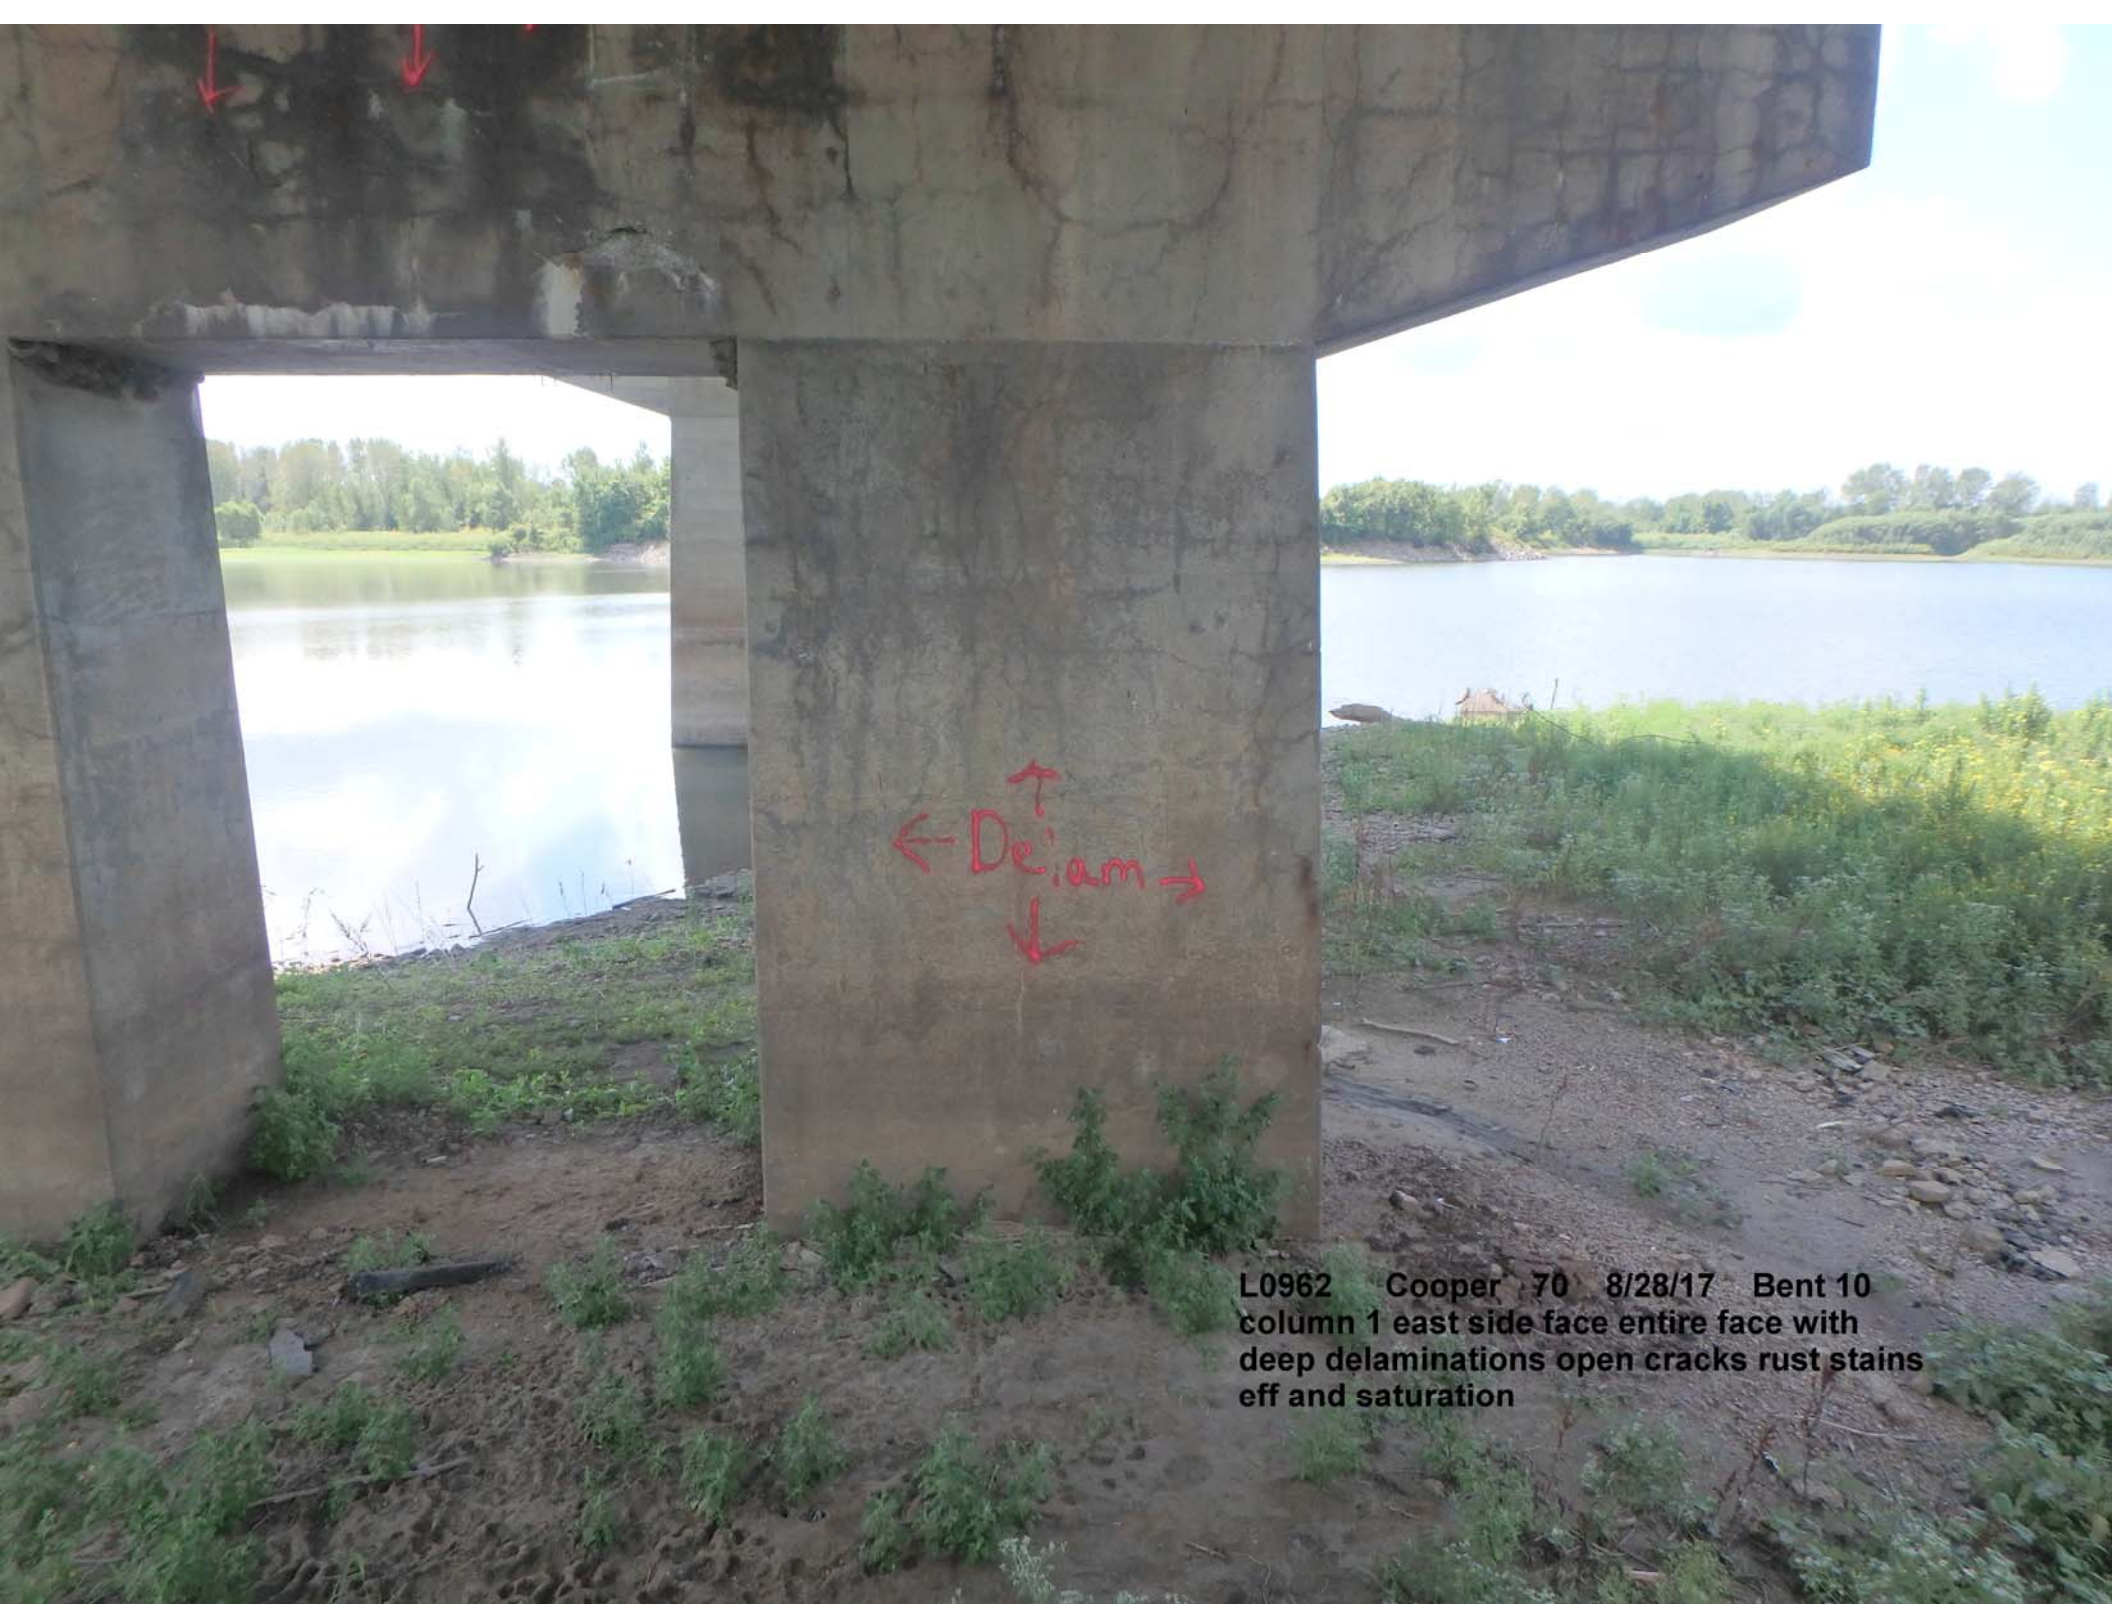
L0962 Cooper 70 8/28/17 Bent 10
column 1 east side face entire face with
deep delaminations open cracks rust stains
eff and saturation

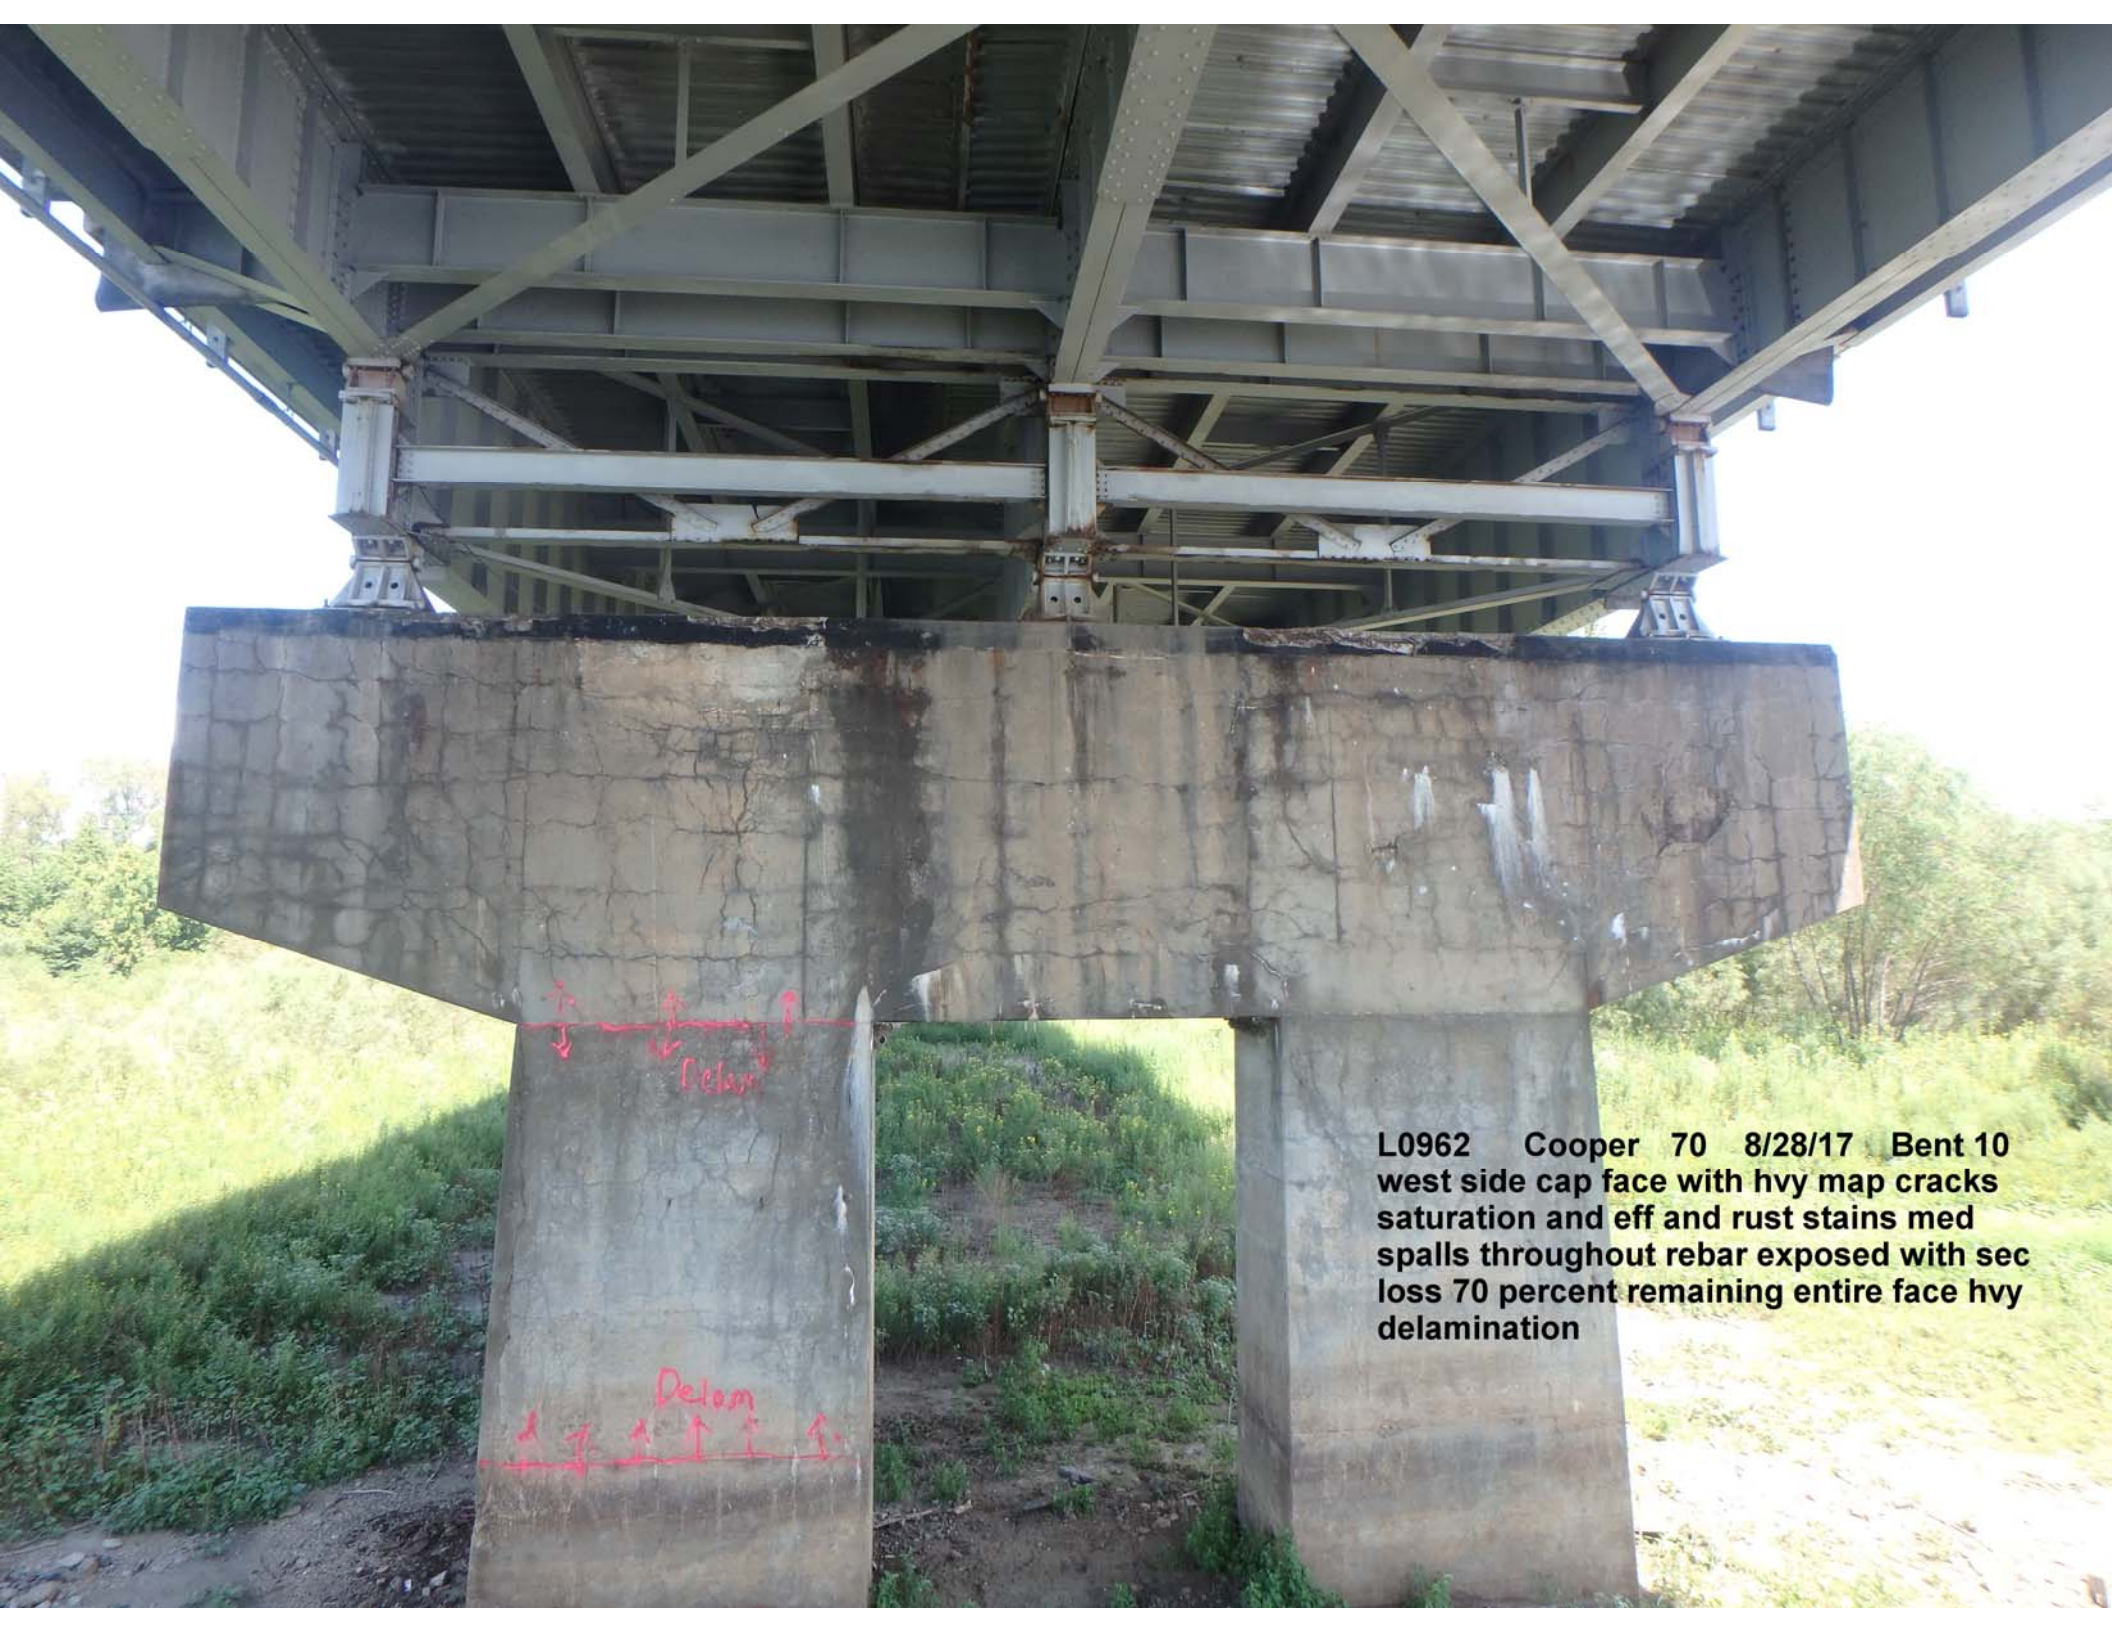
L0962 Cooper 70 8/28/17 Bent 10
west side cap face with hvy map cracks
saturation and eff and rust stains med
spalls throughout rebar exposed with sec
loss 70 percent remaining entire face hvy
delamination

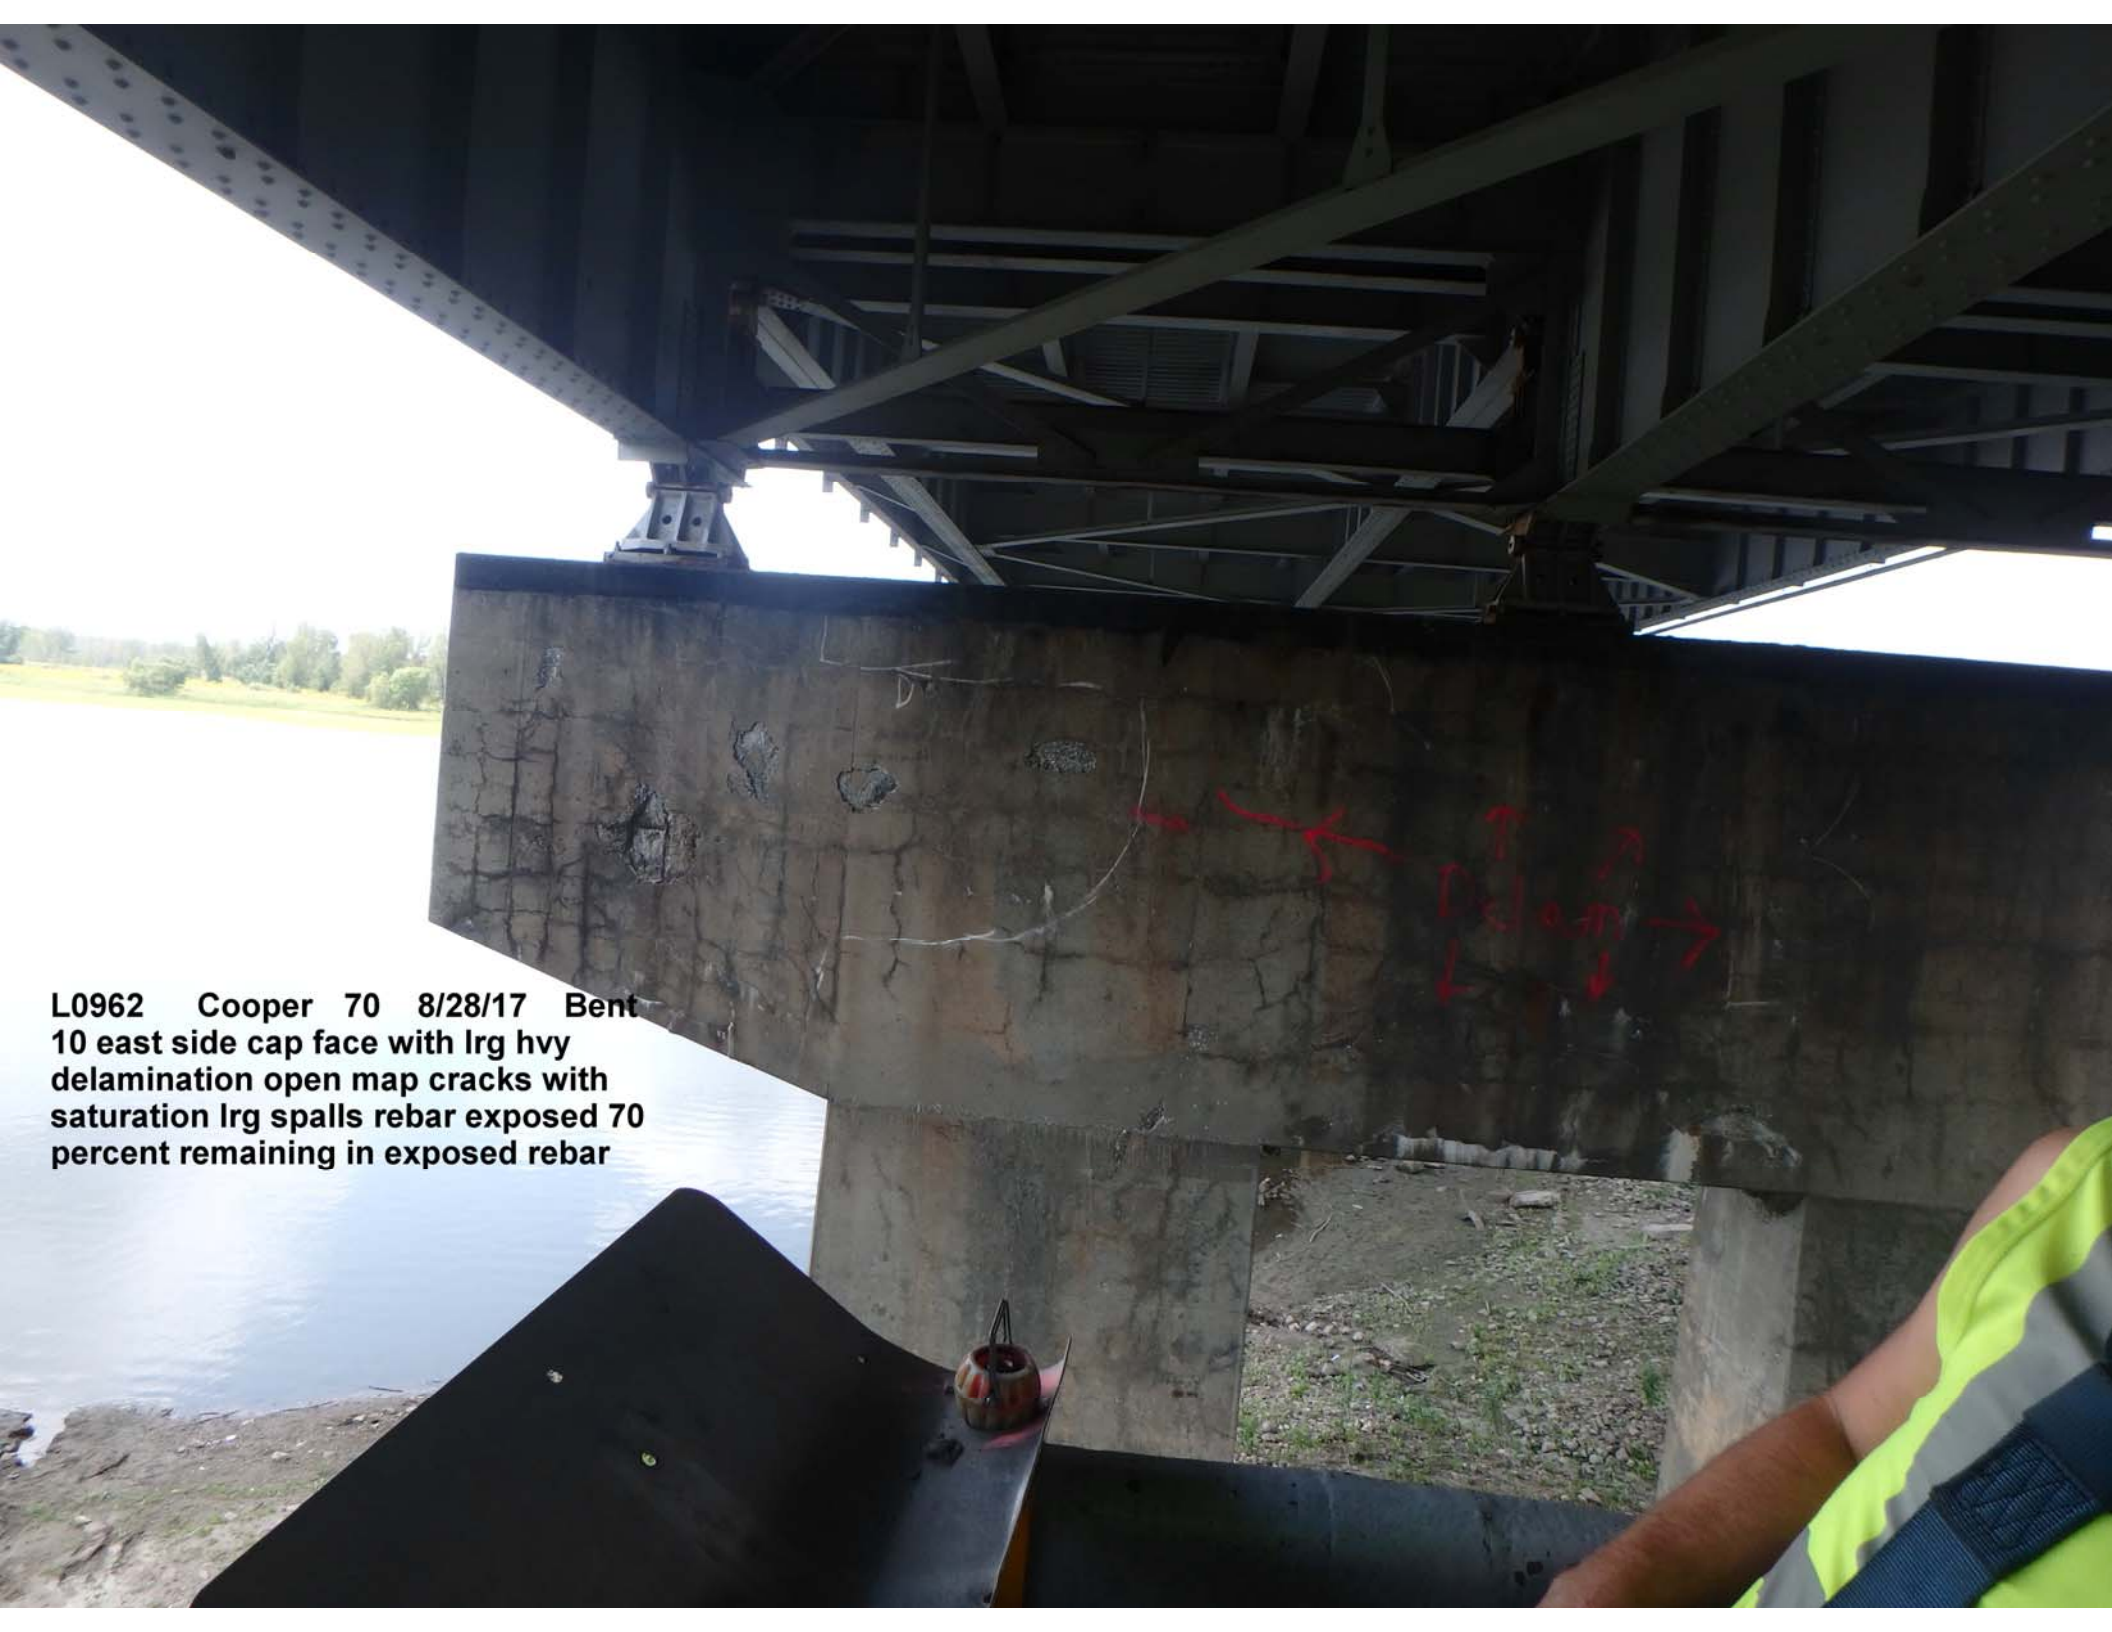
L0962 Cooper 70 8/28/17 Bent
10 east side cap face with lrg hvy
delamination open map cracks with
saturation lrg spalls rebar exposed 70
percent remaining in exposed rebar

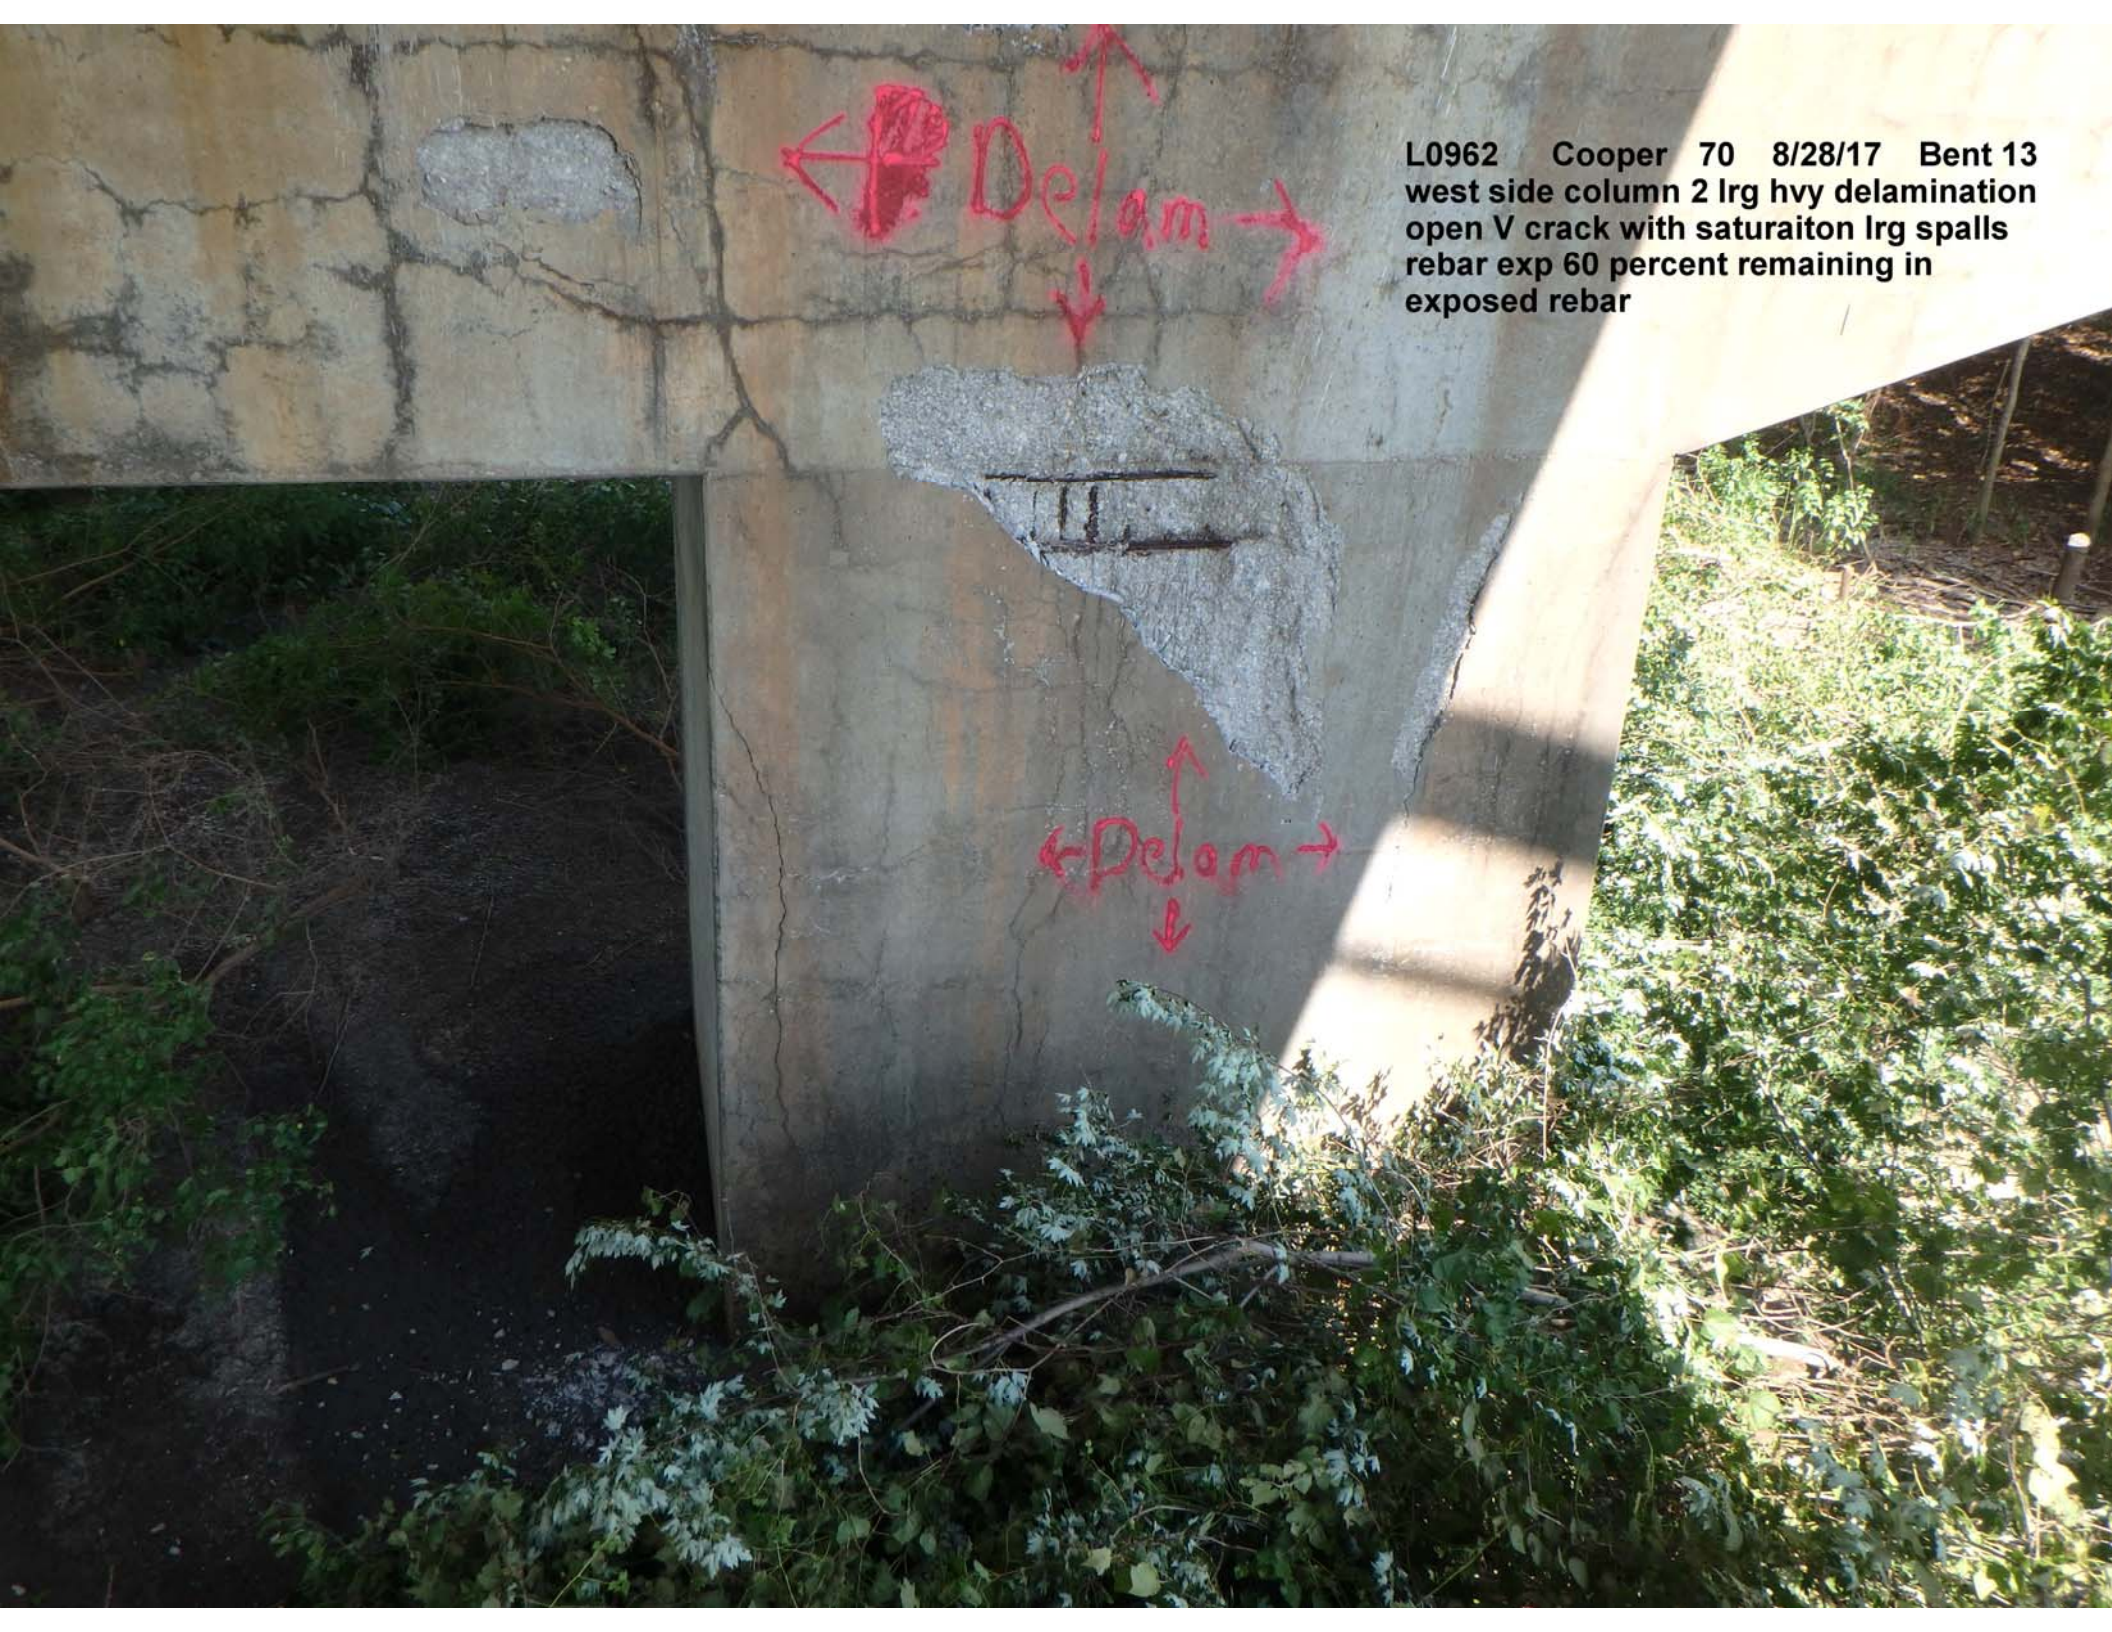
L0962 Cooper 70
8/28/17 Bent 13 cap face
east side lrg hvy map cracks
with saturation and eff lrg hvy
delaminations minor spalling
