L0962 Cooper 70 8/28/17
P13 east side lrg area of map
cracks with saturation and eff

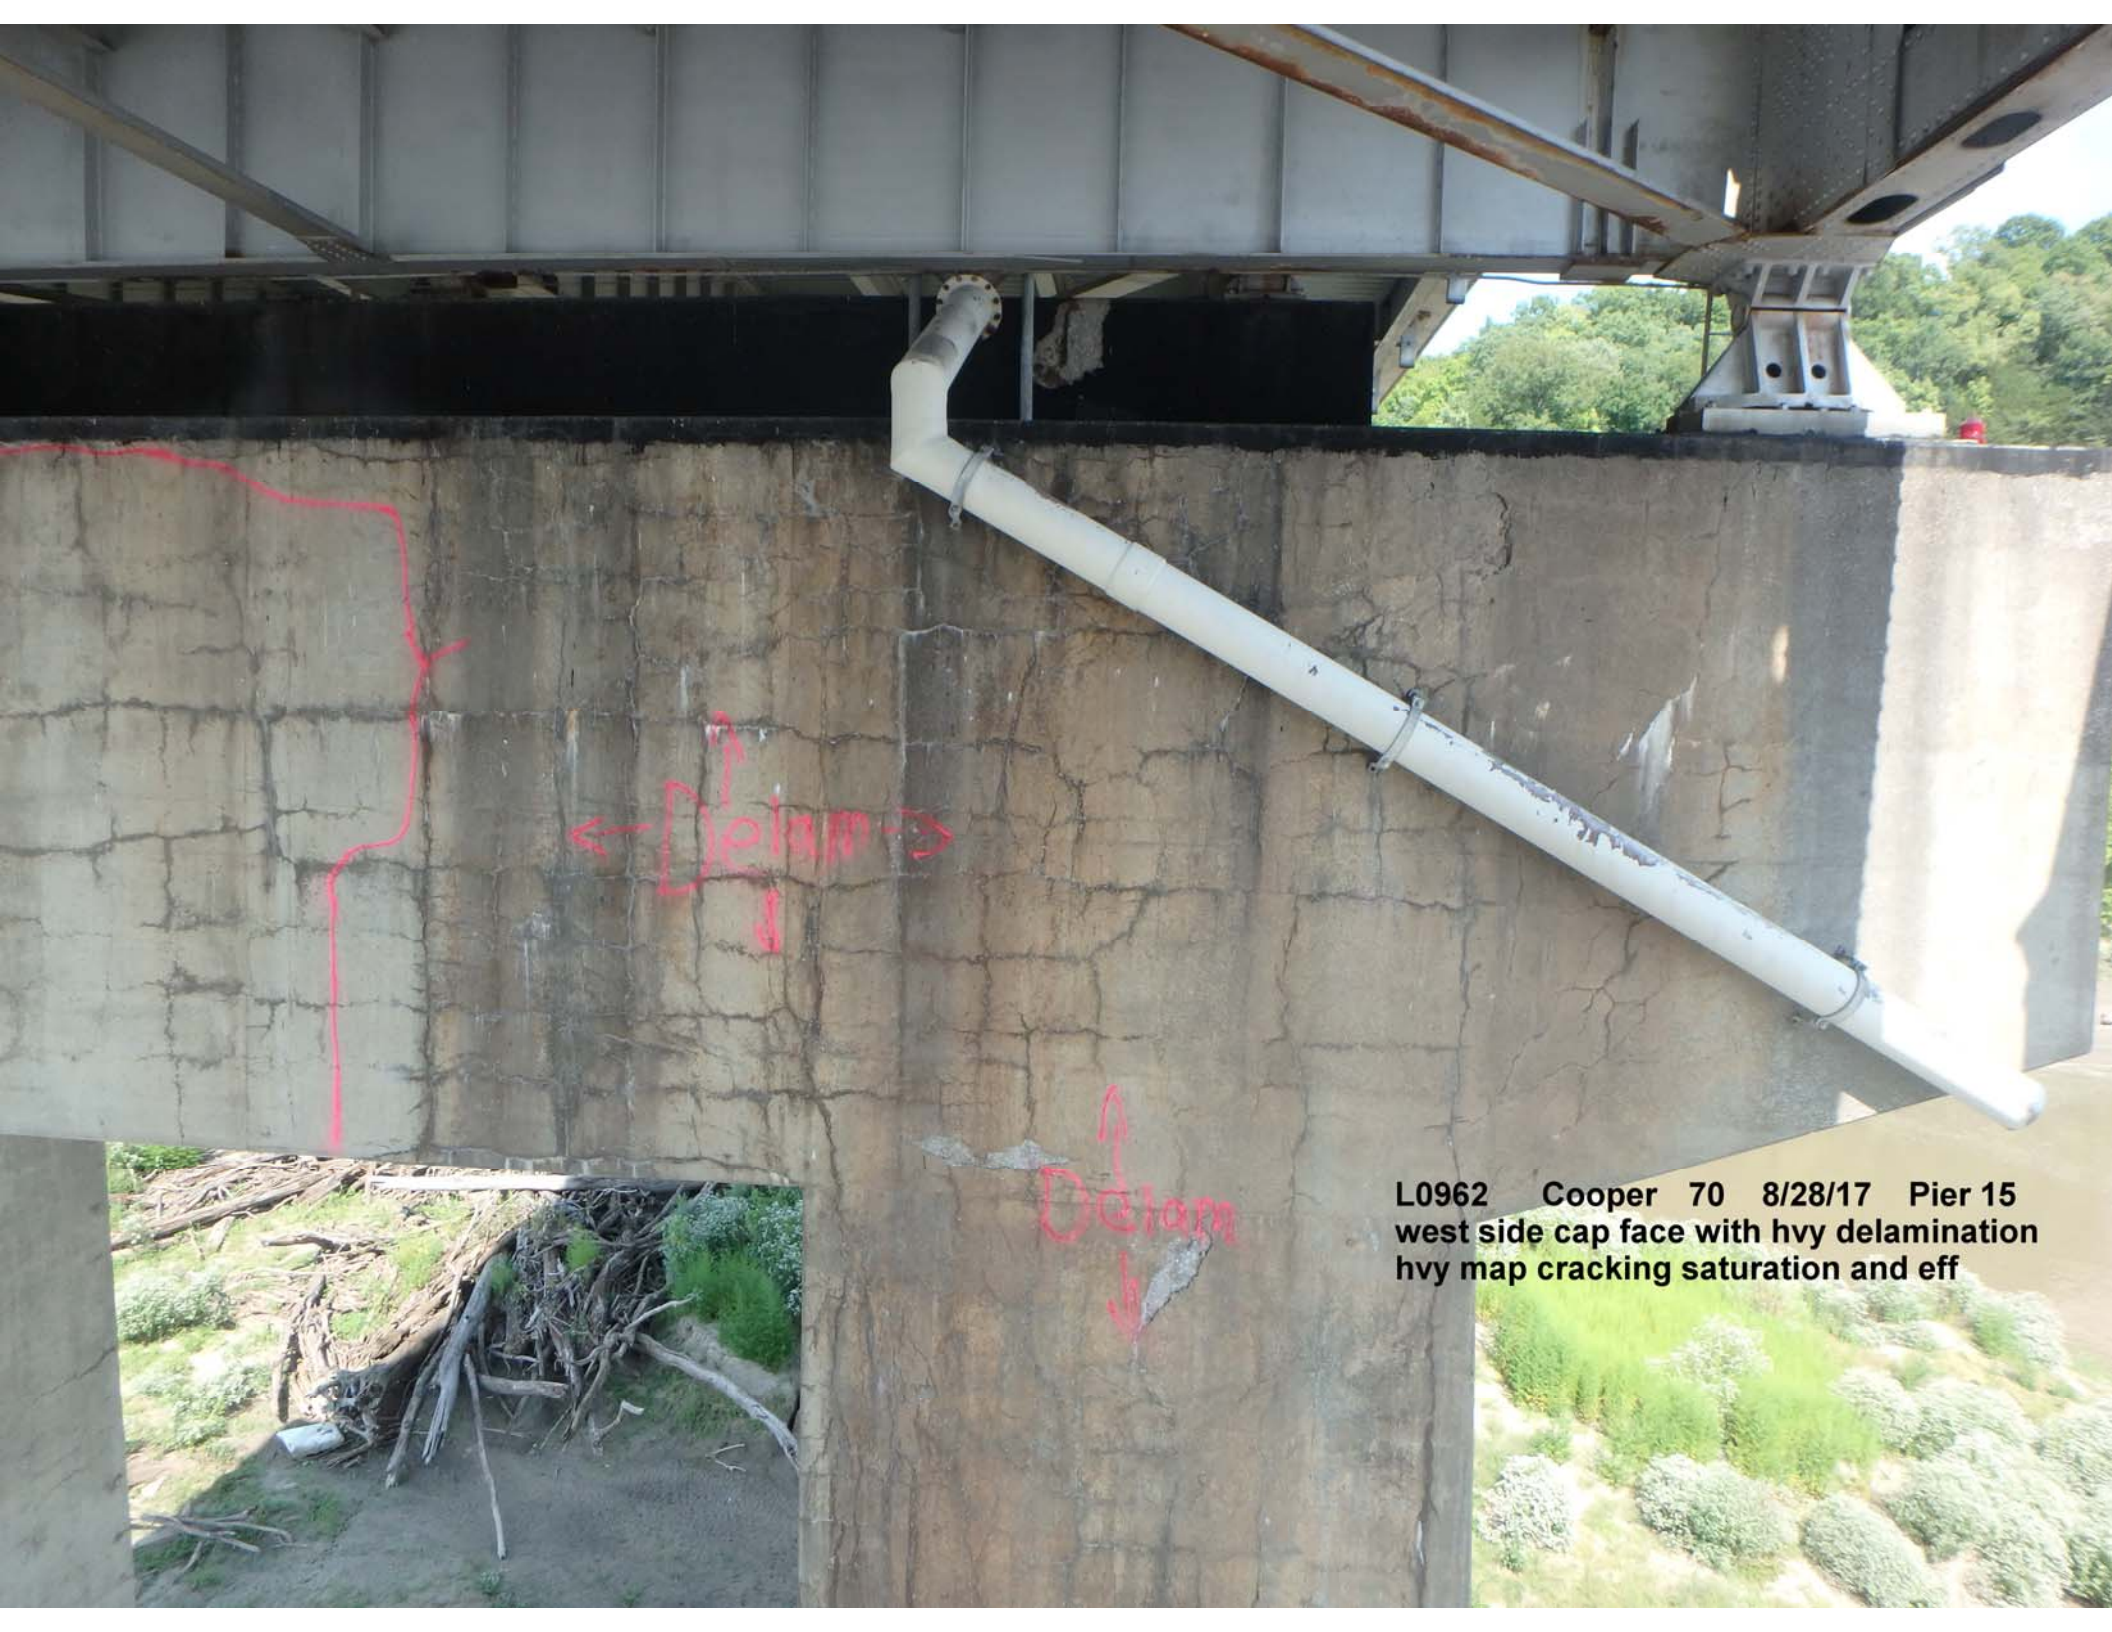
L0962 Cooper 70 8/28/17 Pier 15
west side cap face with hvy delamination
hvy map cracking saturation and eff

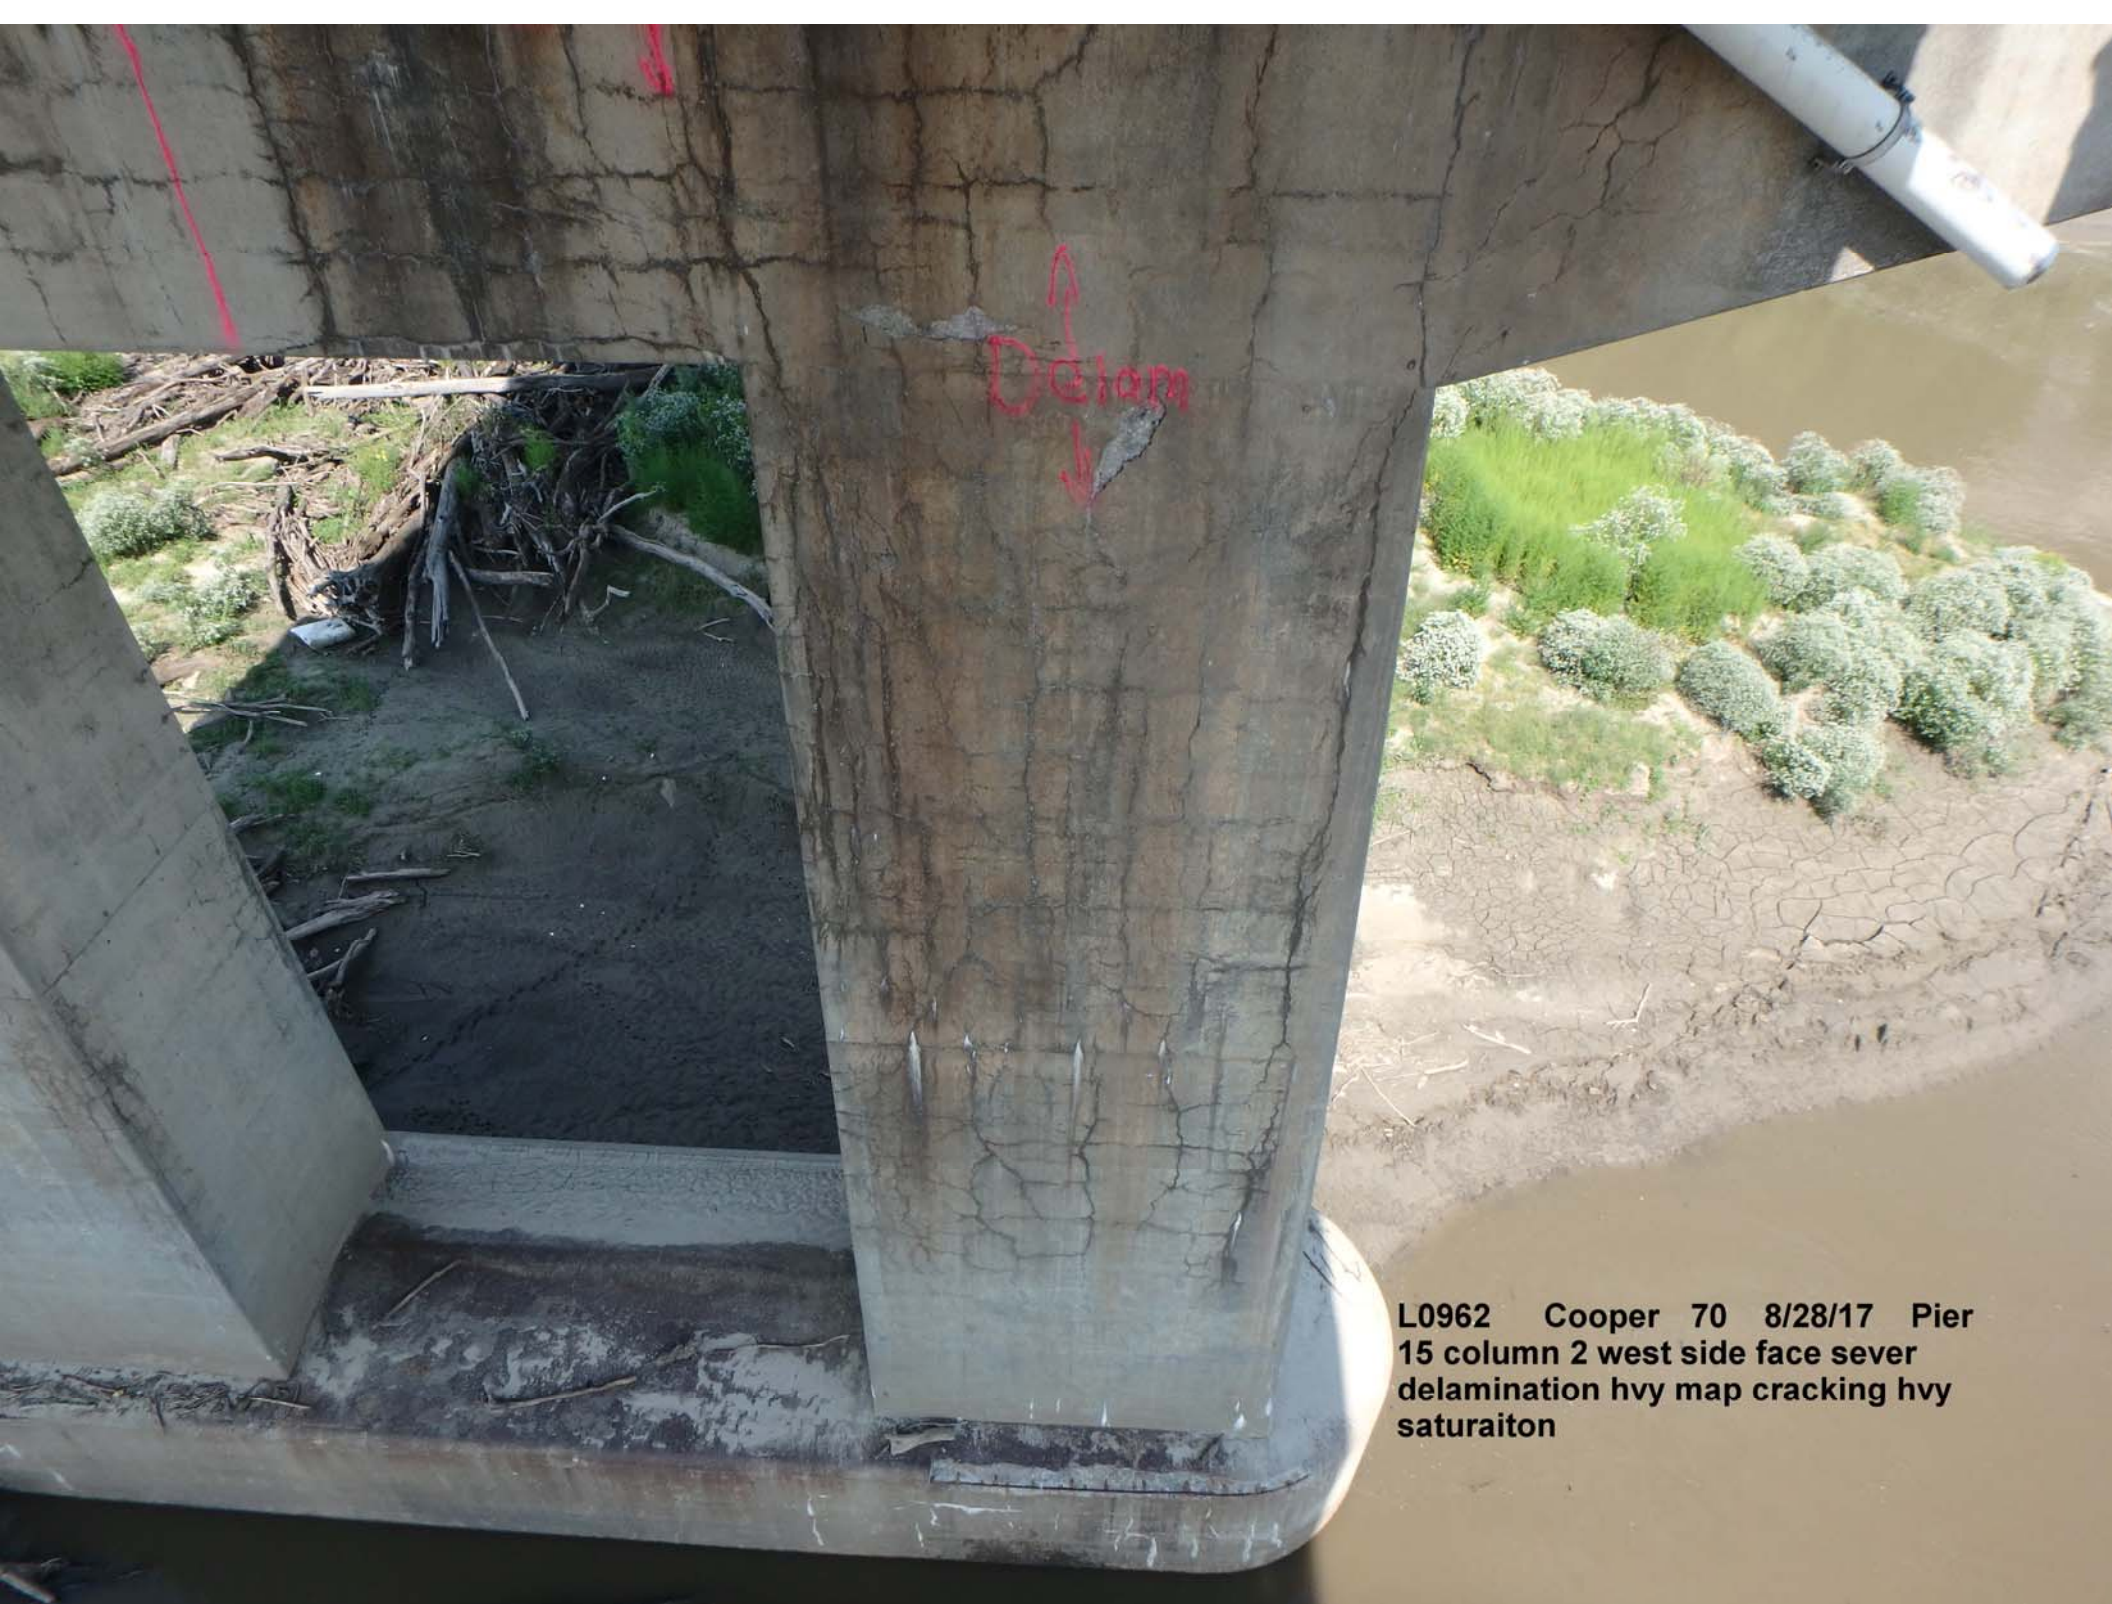
L0962 Cooper 70 8/28/17 Pier
15 column 2 west side face sever
delamination hvly map cracking hvly
saturation

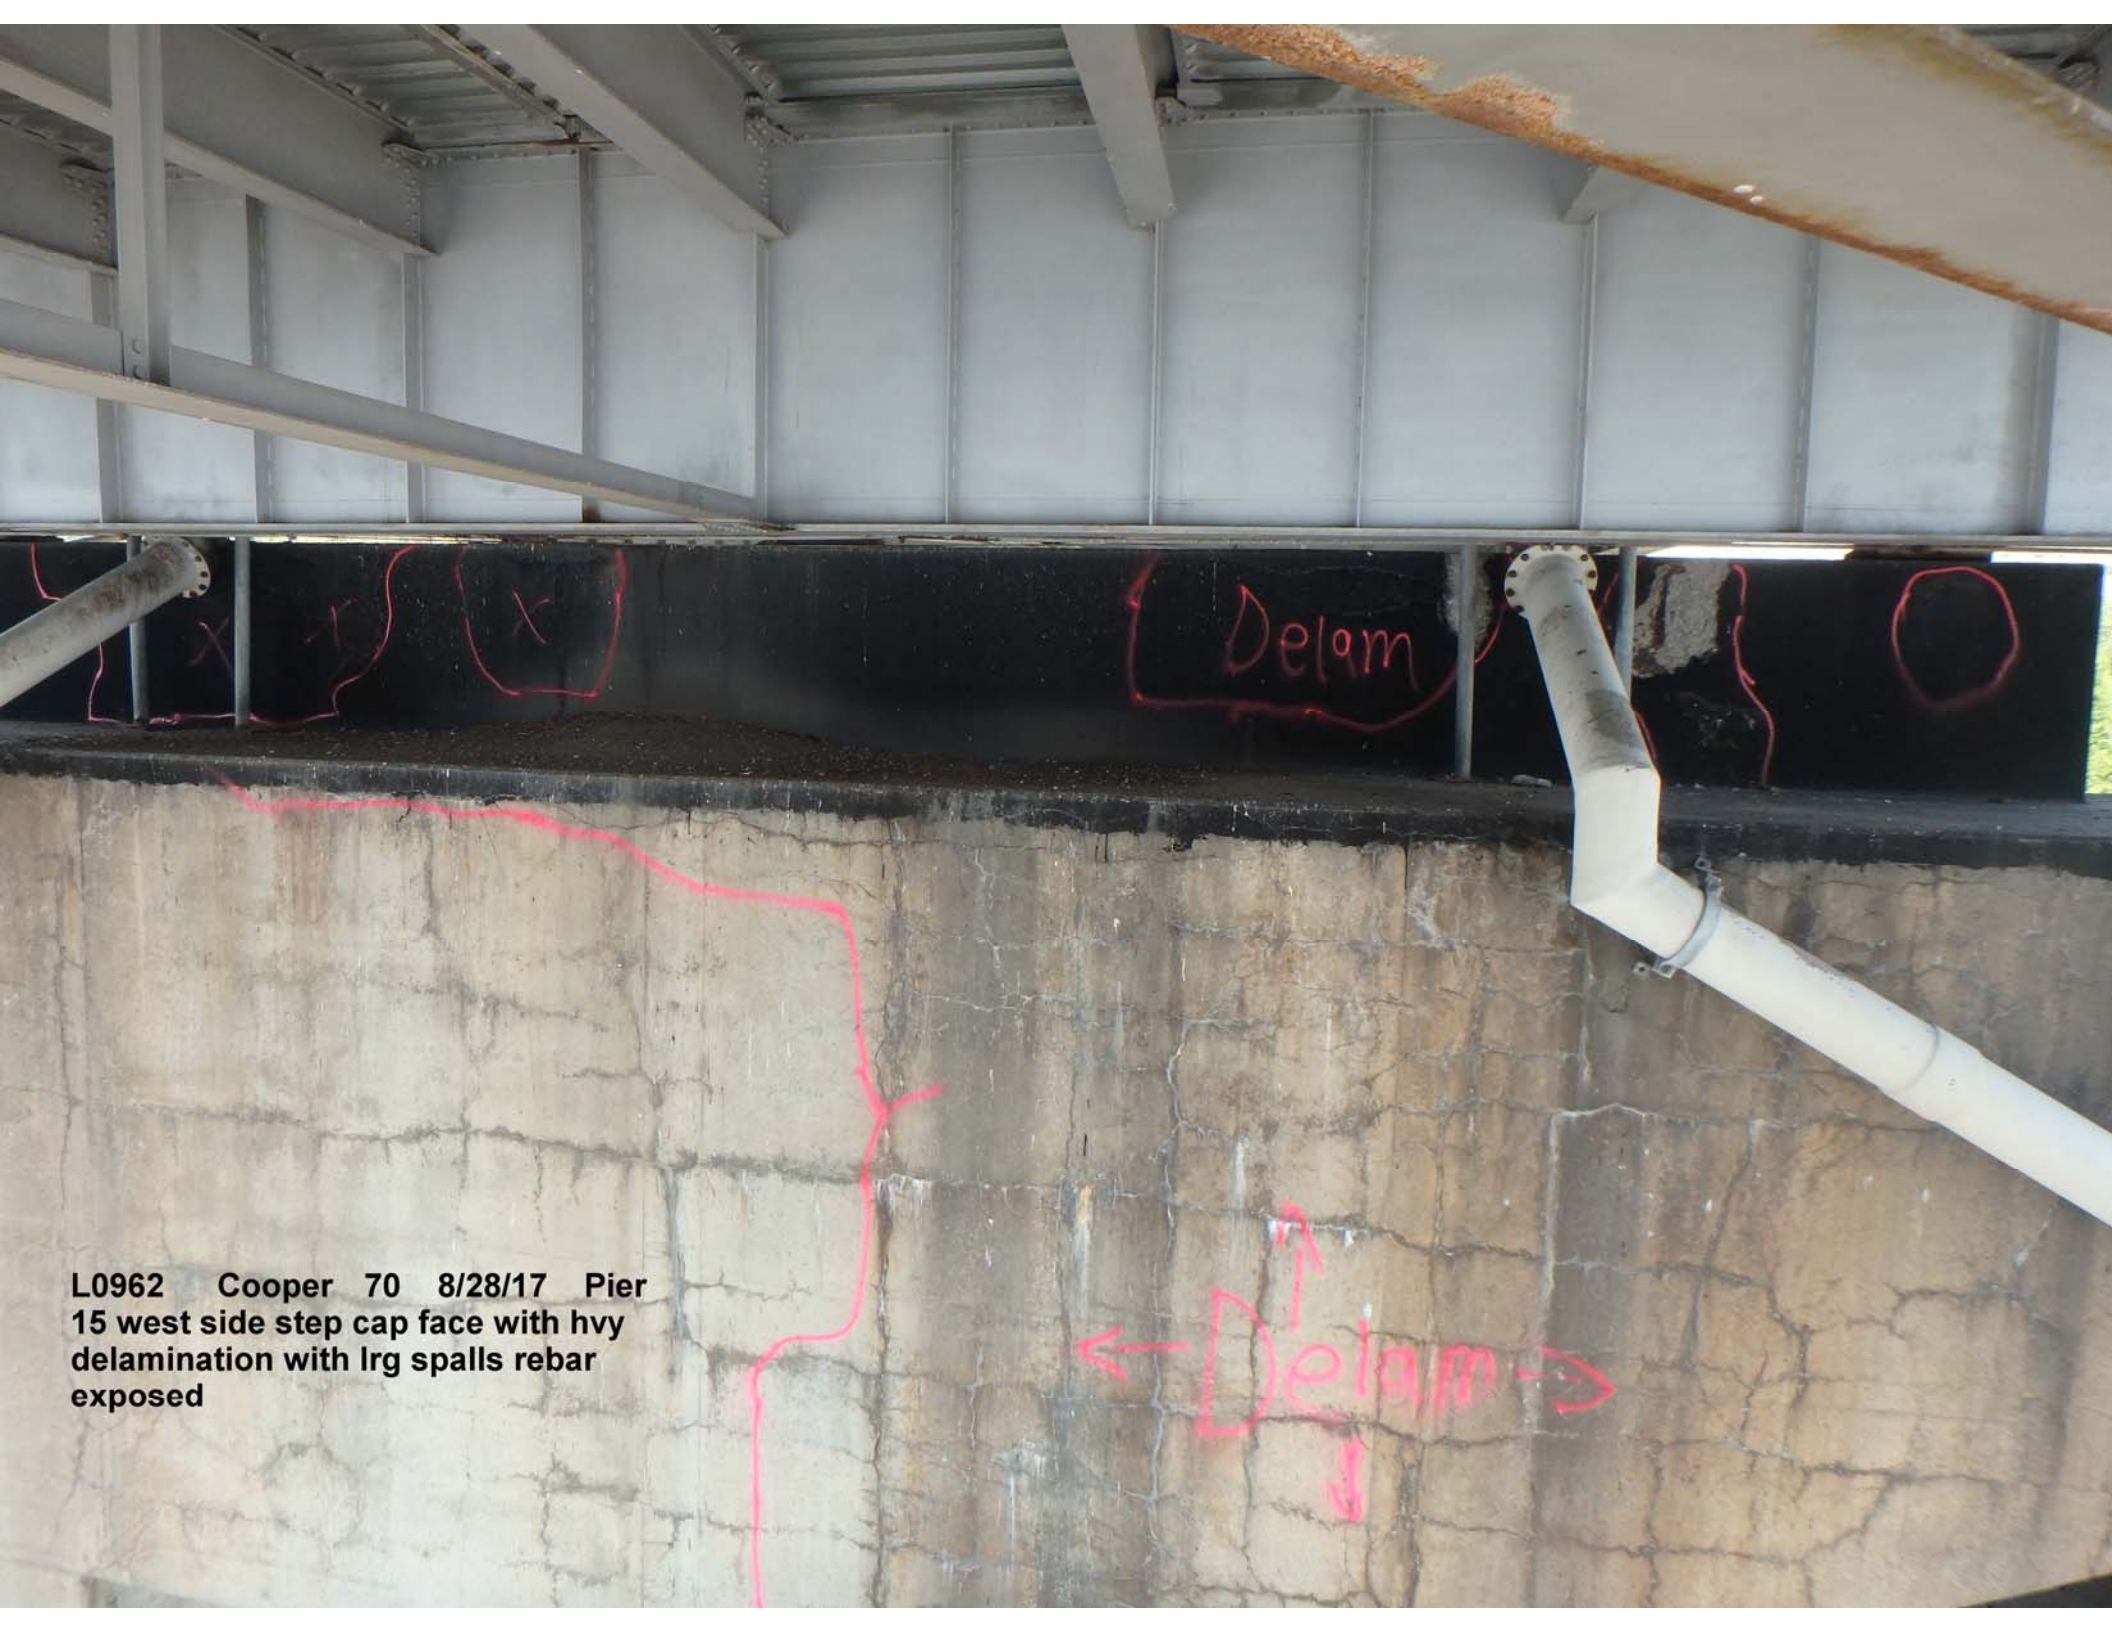
L0962 Cooper 70 8/28/17 Pier
15 west side step cap face with hvy
delamination with lrg spalls rebar
exposed

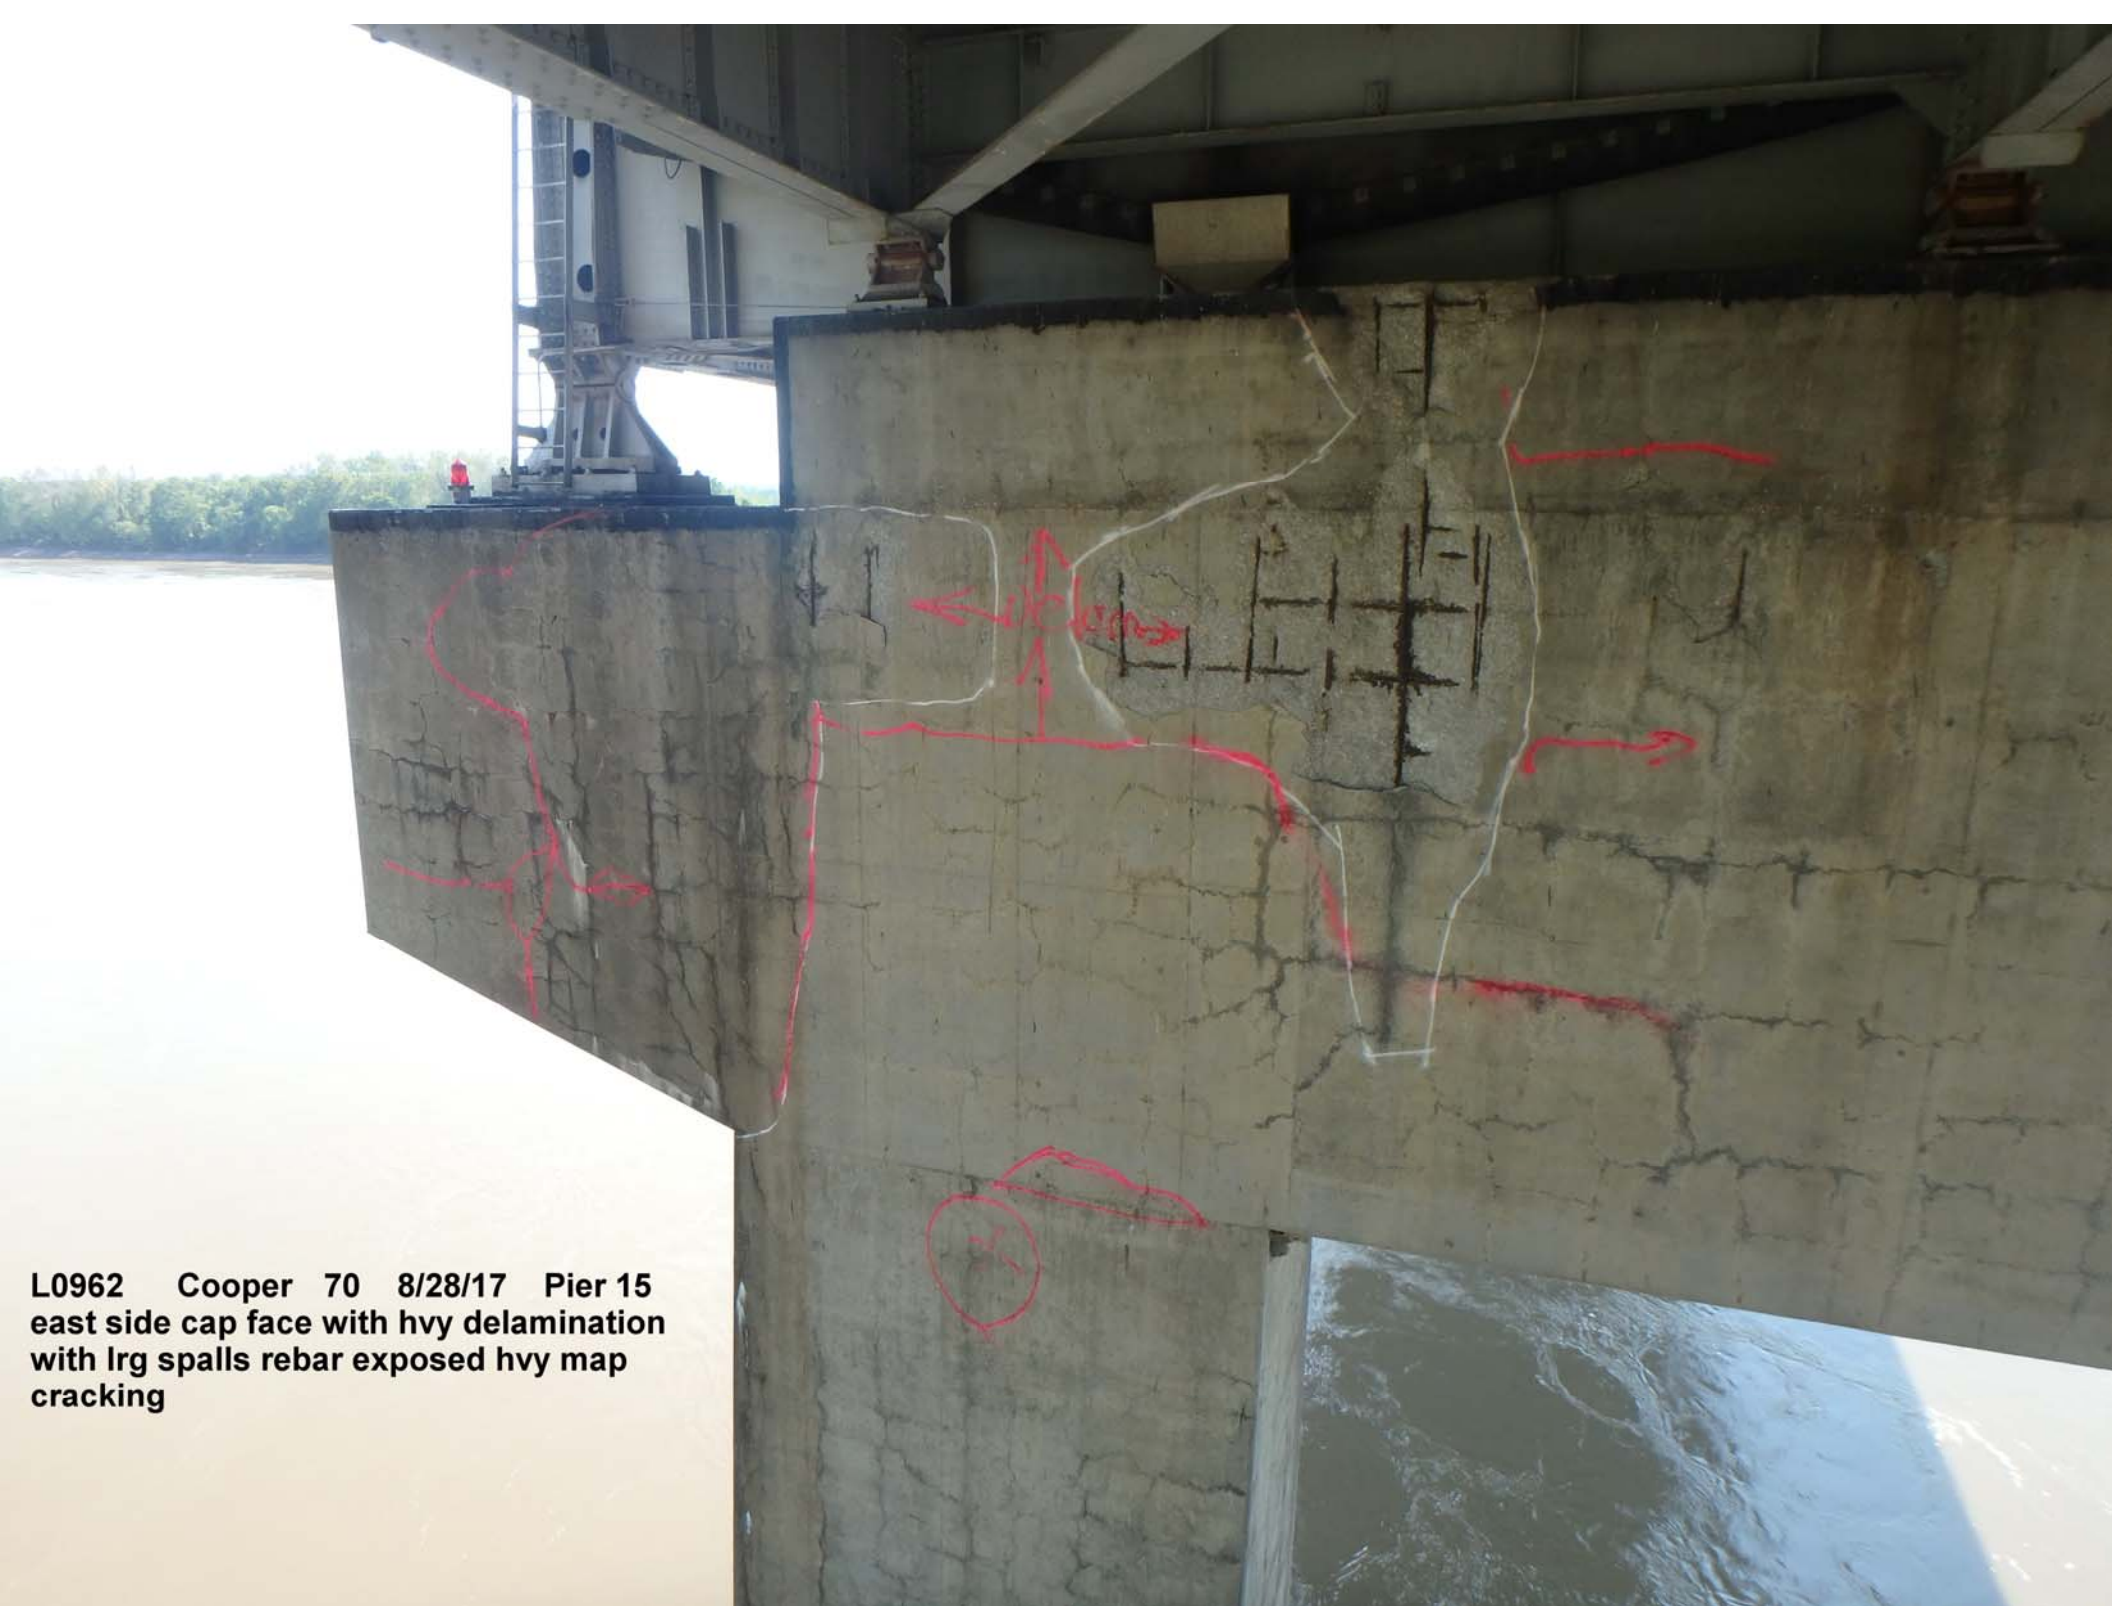
**L0962 Cooper 70 8/28/17 Pier 15
east side cap face with hvy delamination
with lrg spalls rebar exposed hvy map
cracking**

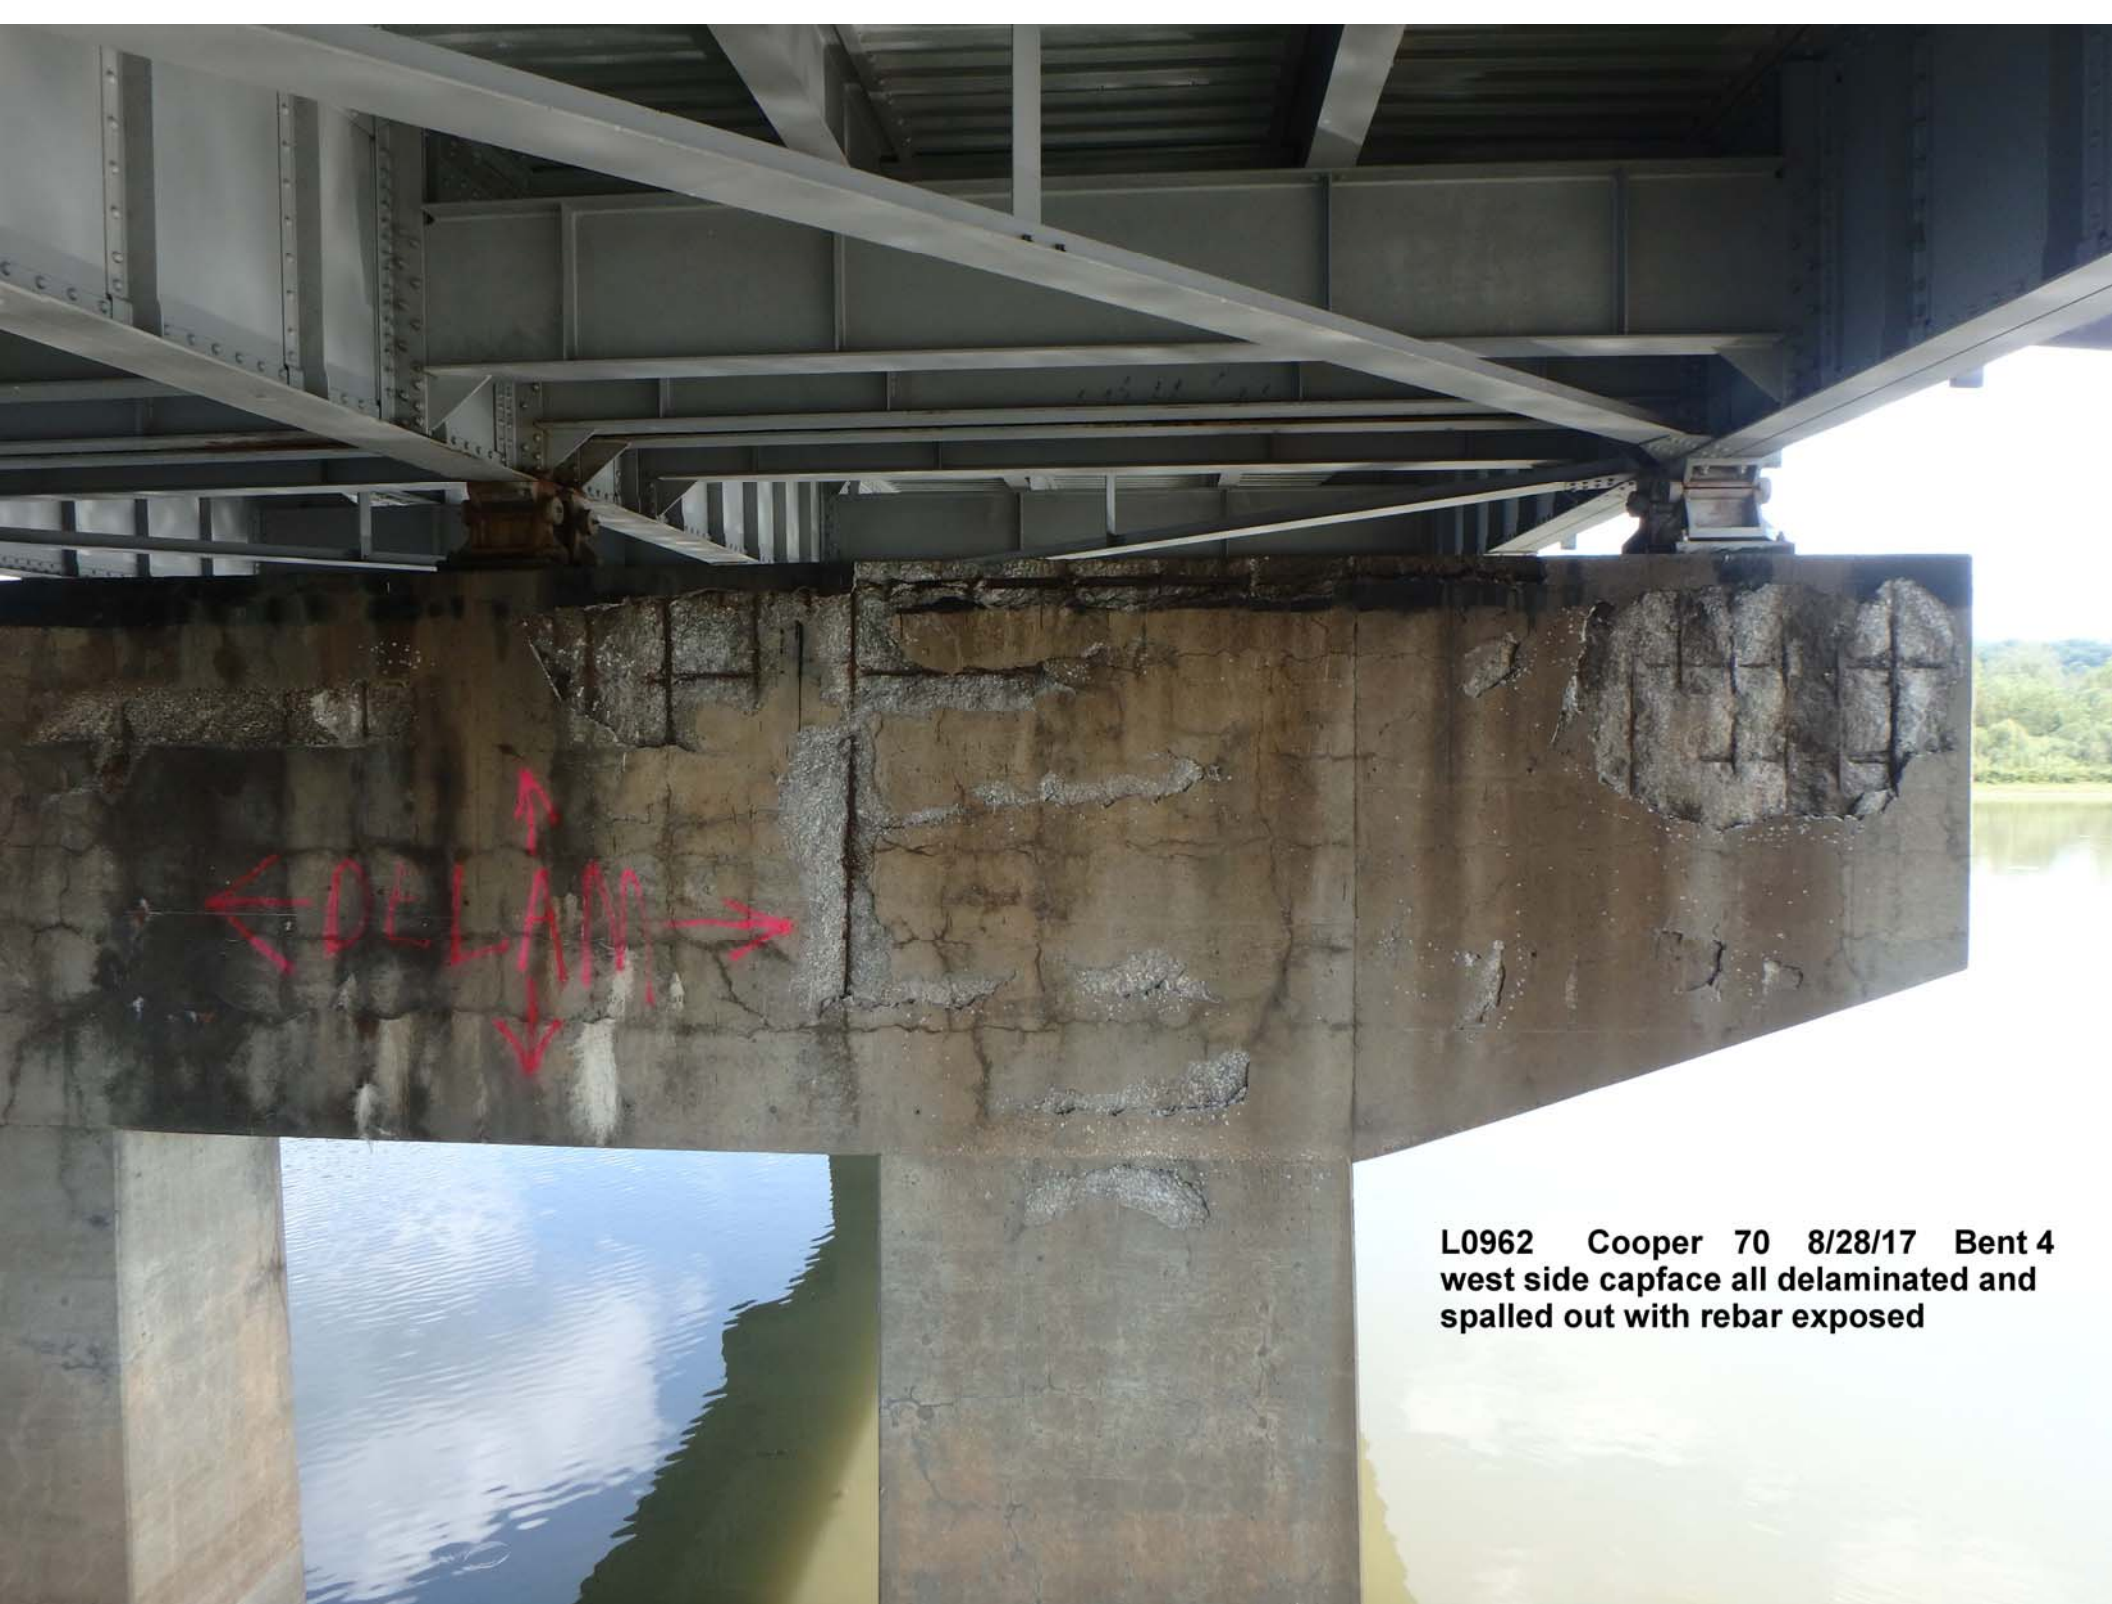
**L0962 Cooper 70 8/28/17 Bent 4
west side capface all delaminated and
spalled out with rebar exposed**

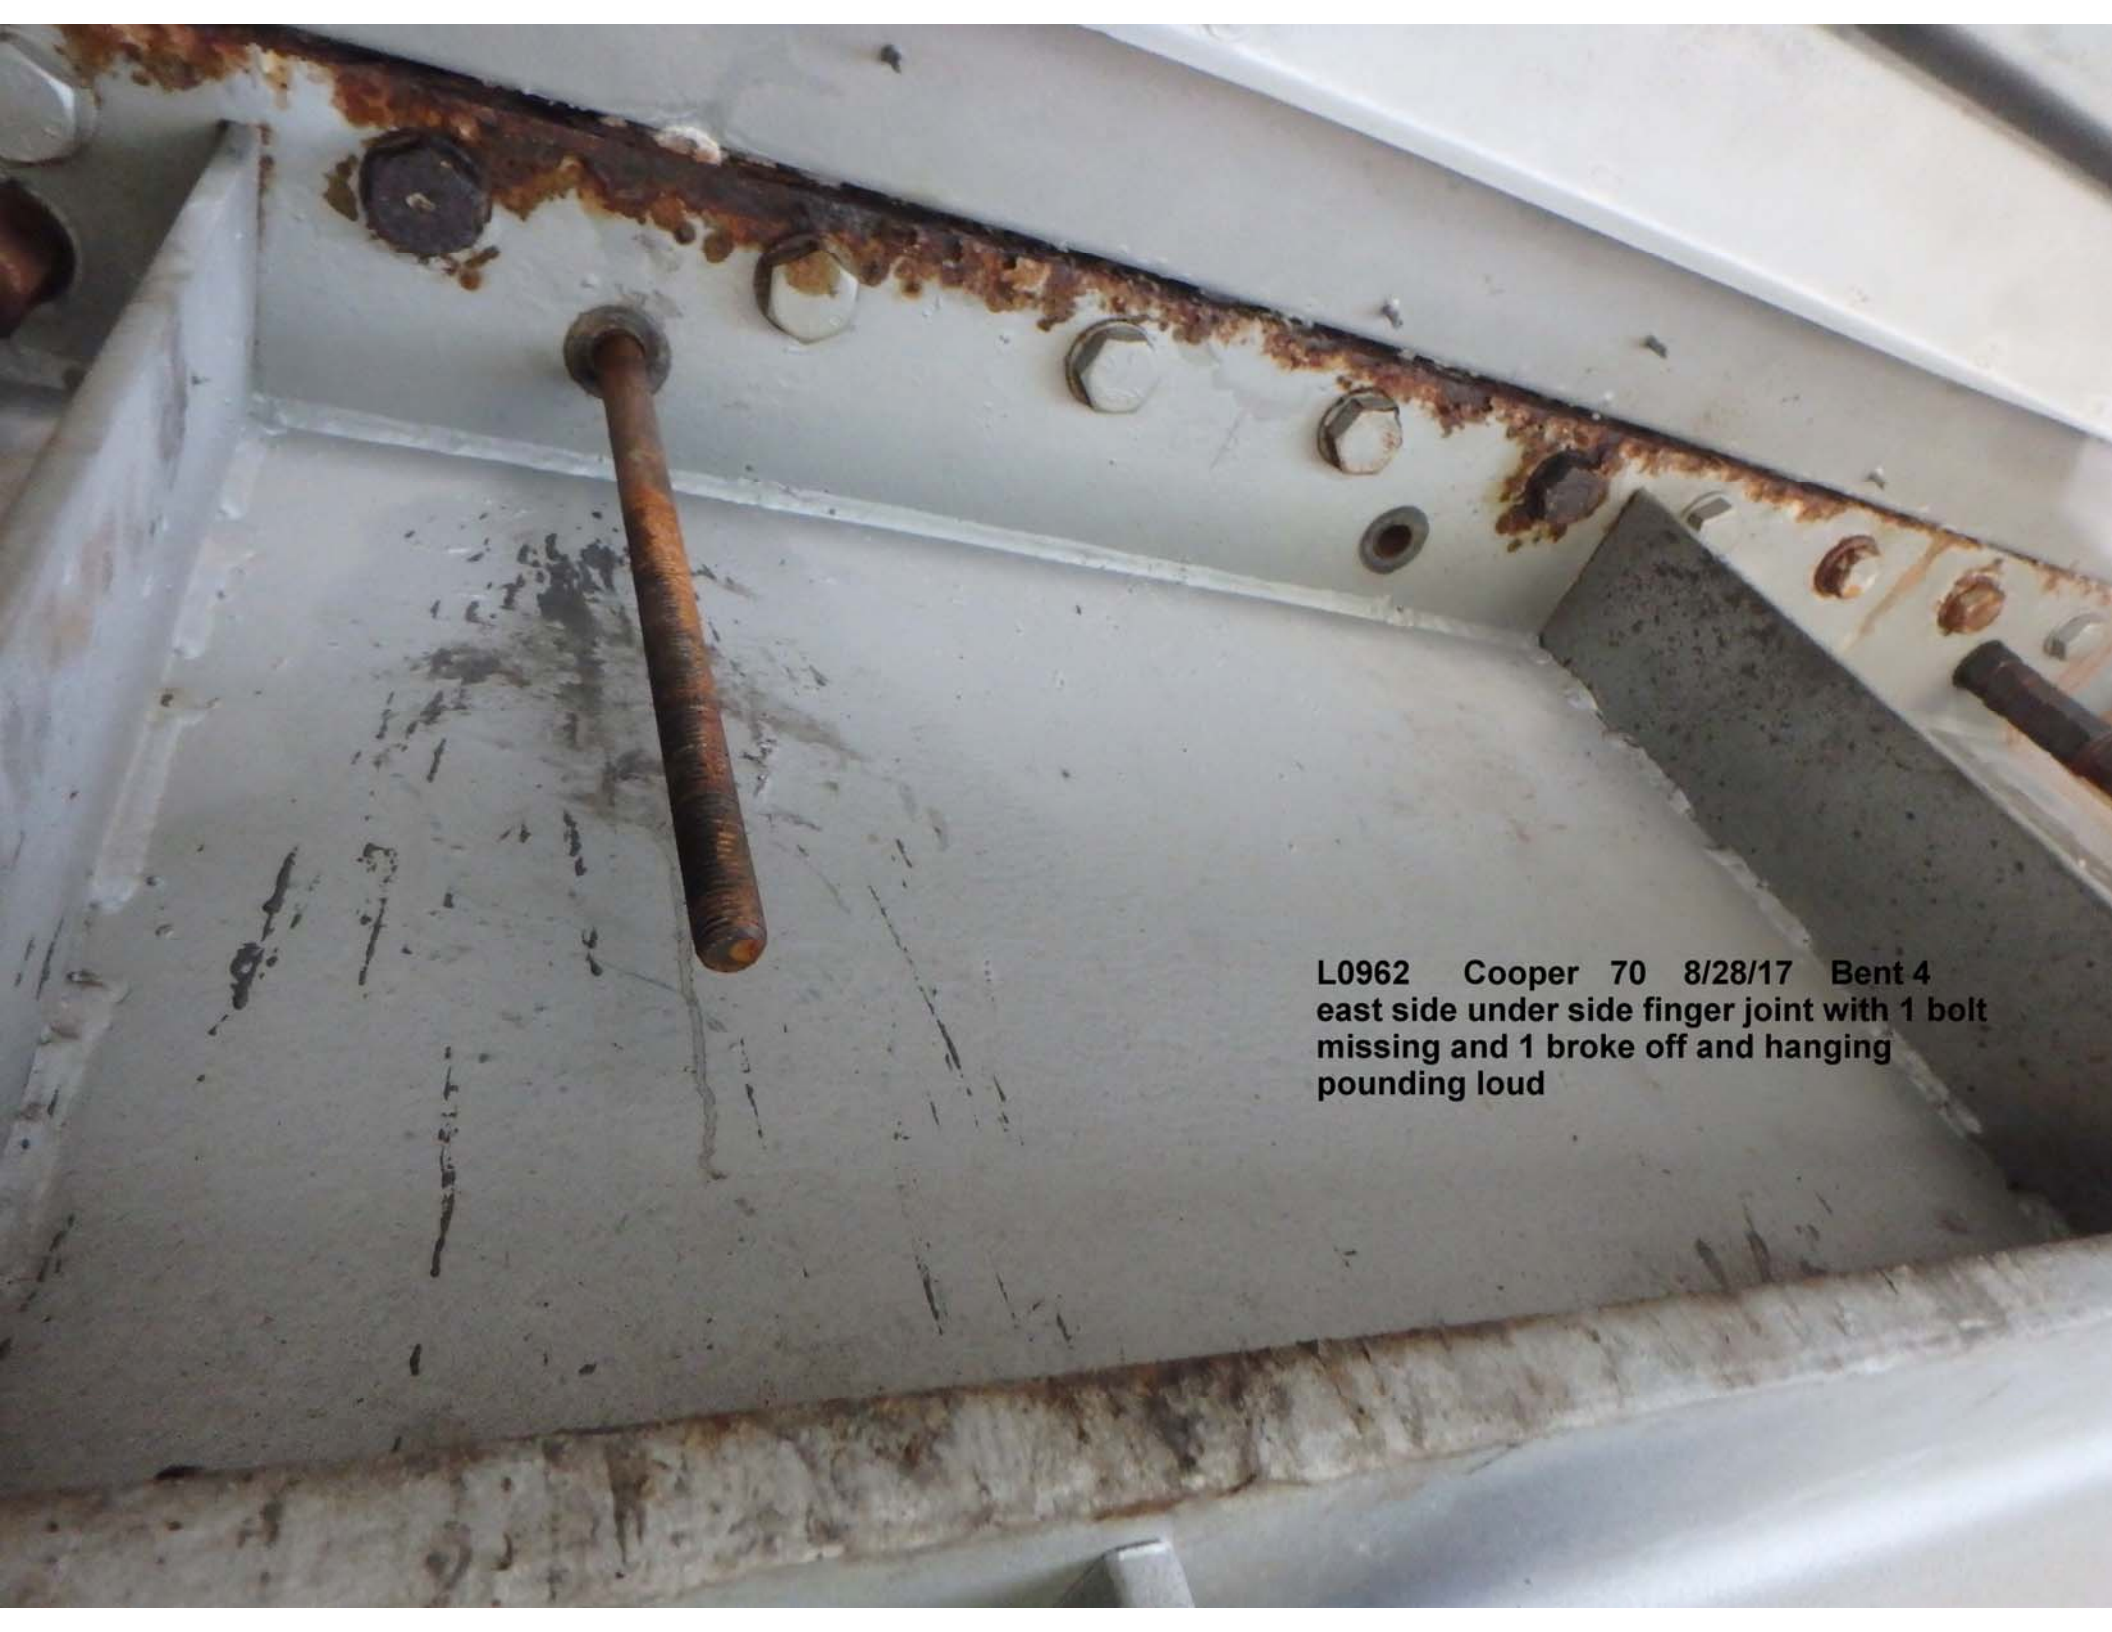
L0962 Cooper 70 8/28/17 Bent 4
east side under side finger joint with 1 bolt
missing and 1 broke off and hanging
pounding loud
