L0962 Cooper 70 8/28/17
P13 east side lrg area of map
cracks with saturation and eff

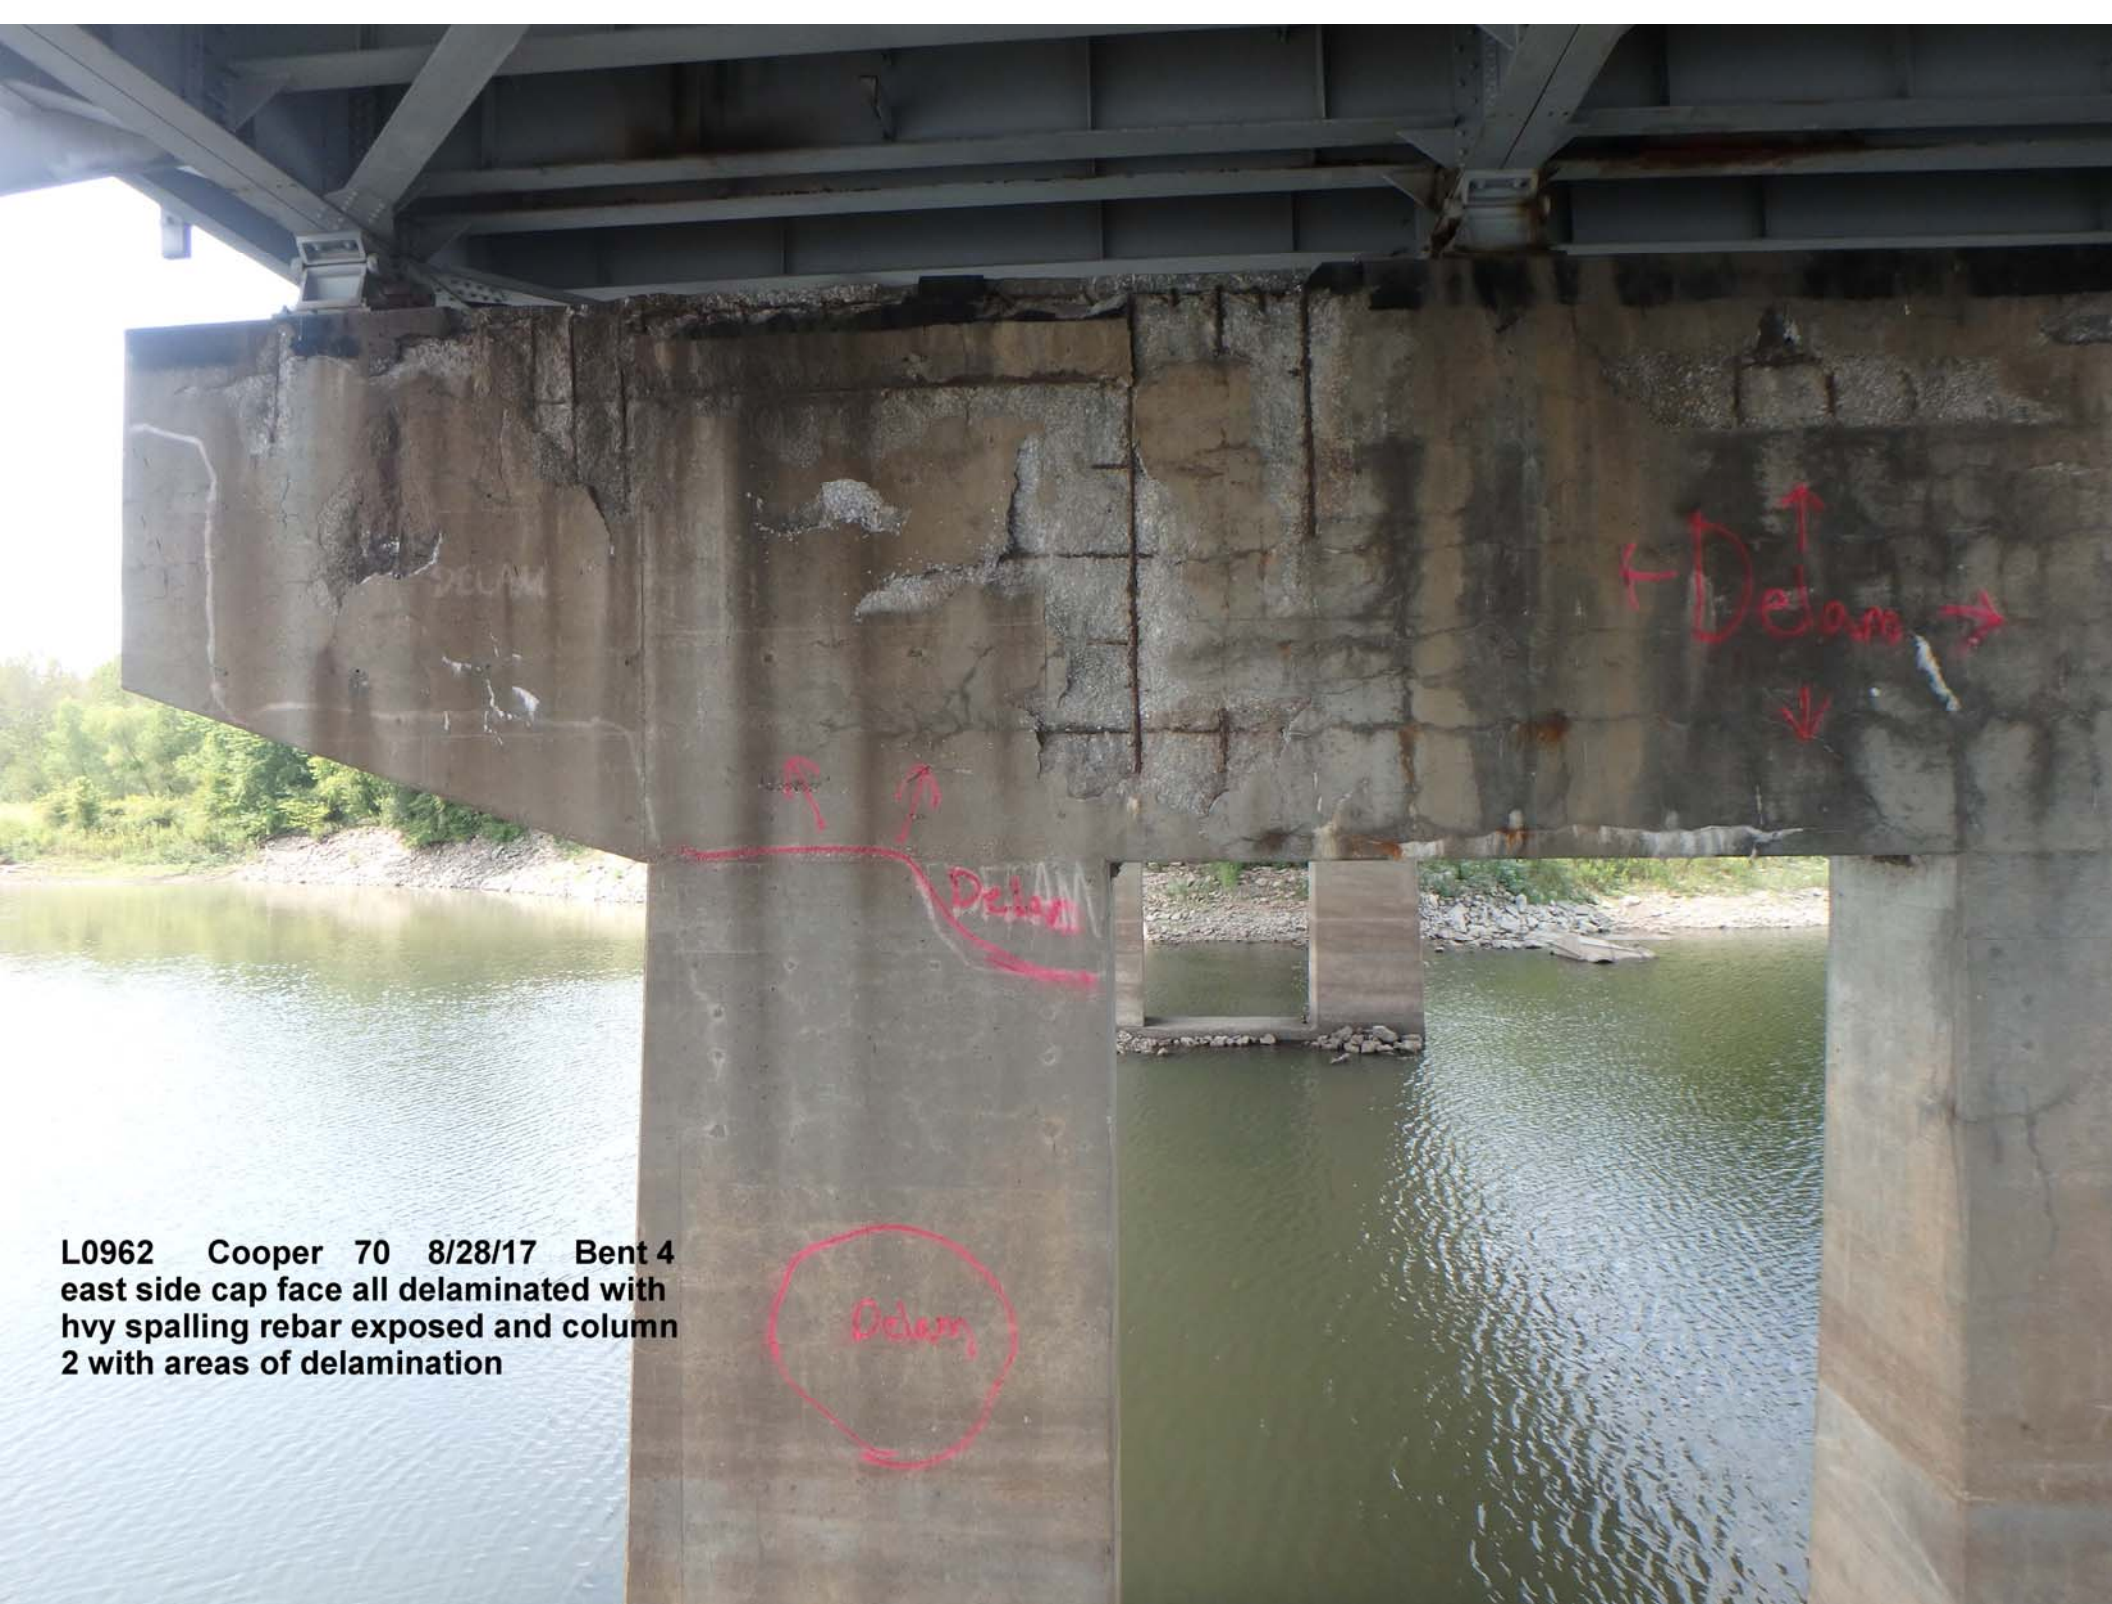
L0962 Cooper 70 8/28/17 Bent 4
east side cap face all delaminated with
hvy spalling rebar exposed and column
2 with areas of delamination

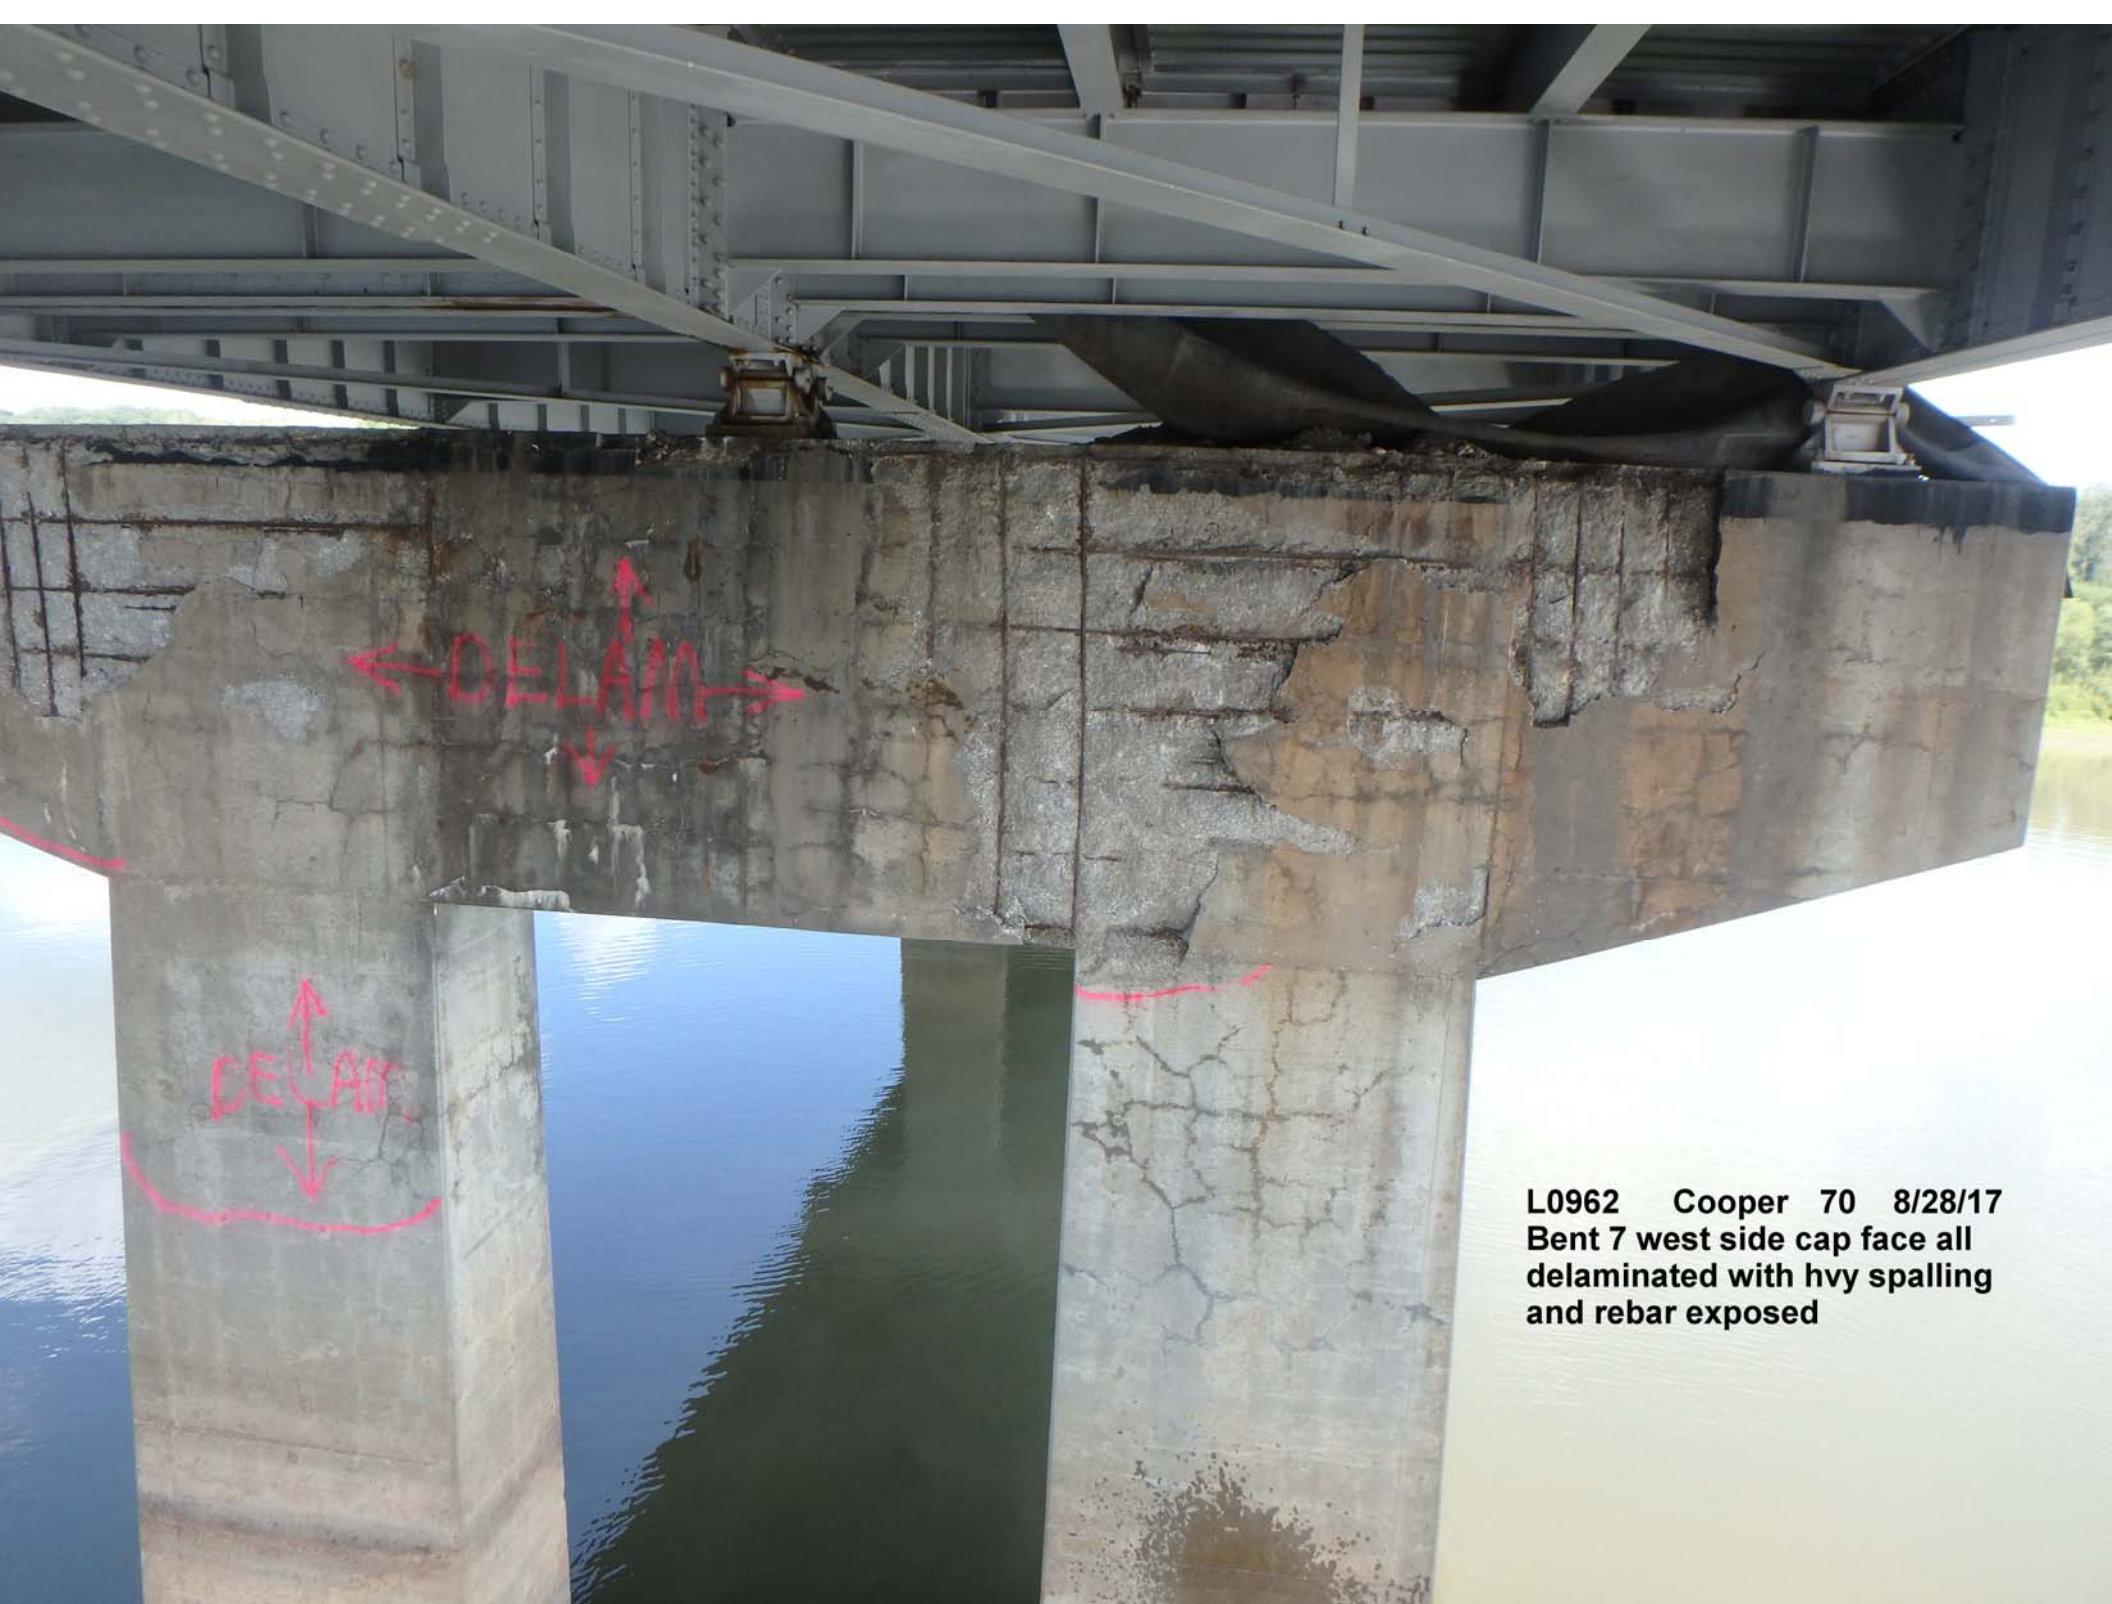
L0962 Cooper 70 8/28/17
Bent 7 west side cap face all
delaminated with hvy spalling
and rebar exposed

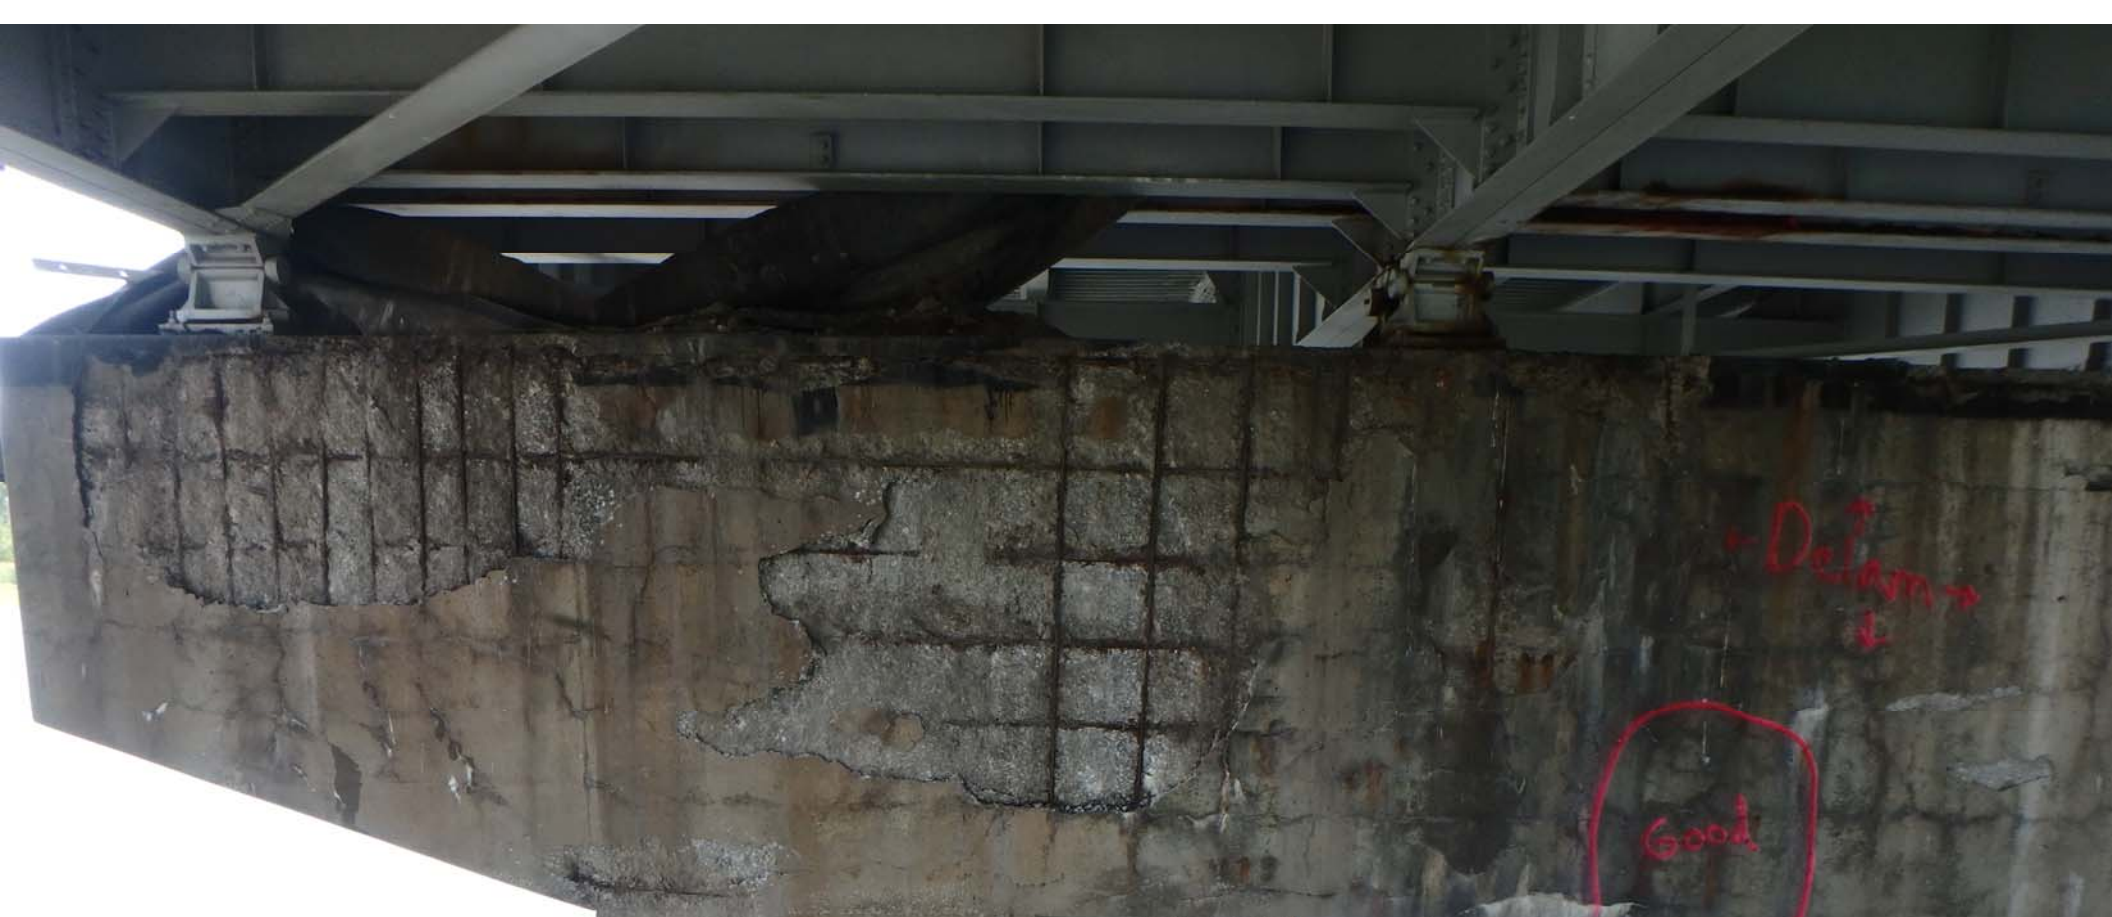
L0962 Cooper 70 8/28/17
Bent 7 east side capface all
delaminated with hvy spalling
with rebar exposed

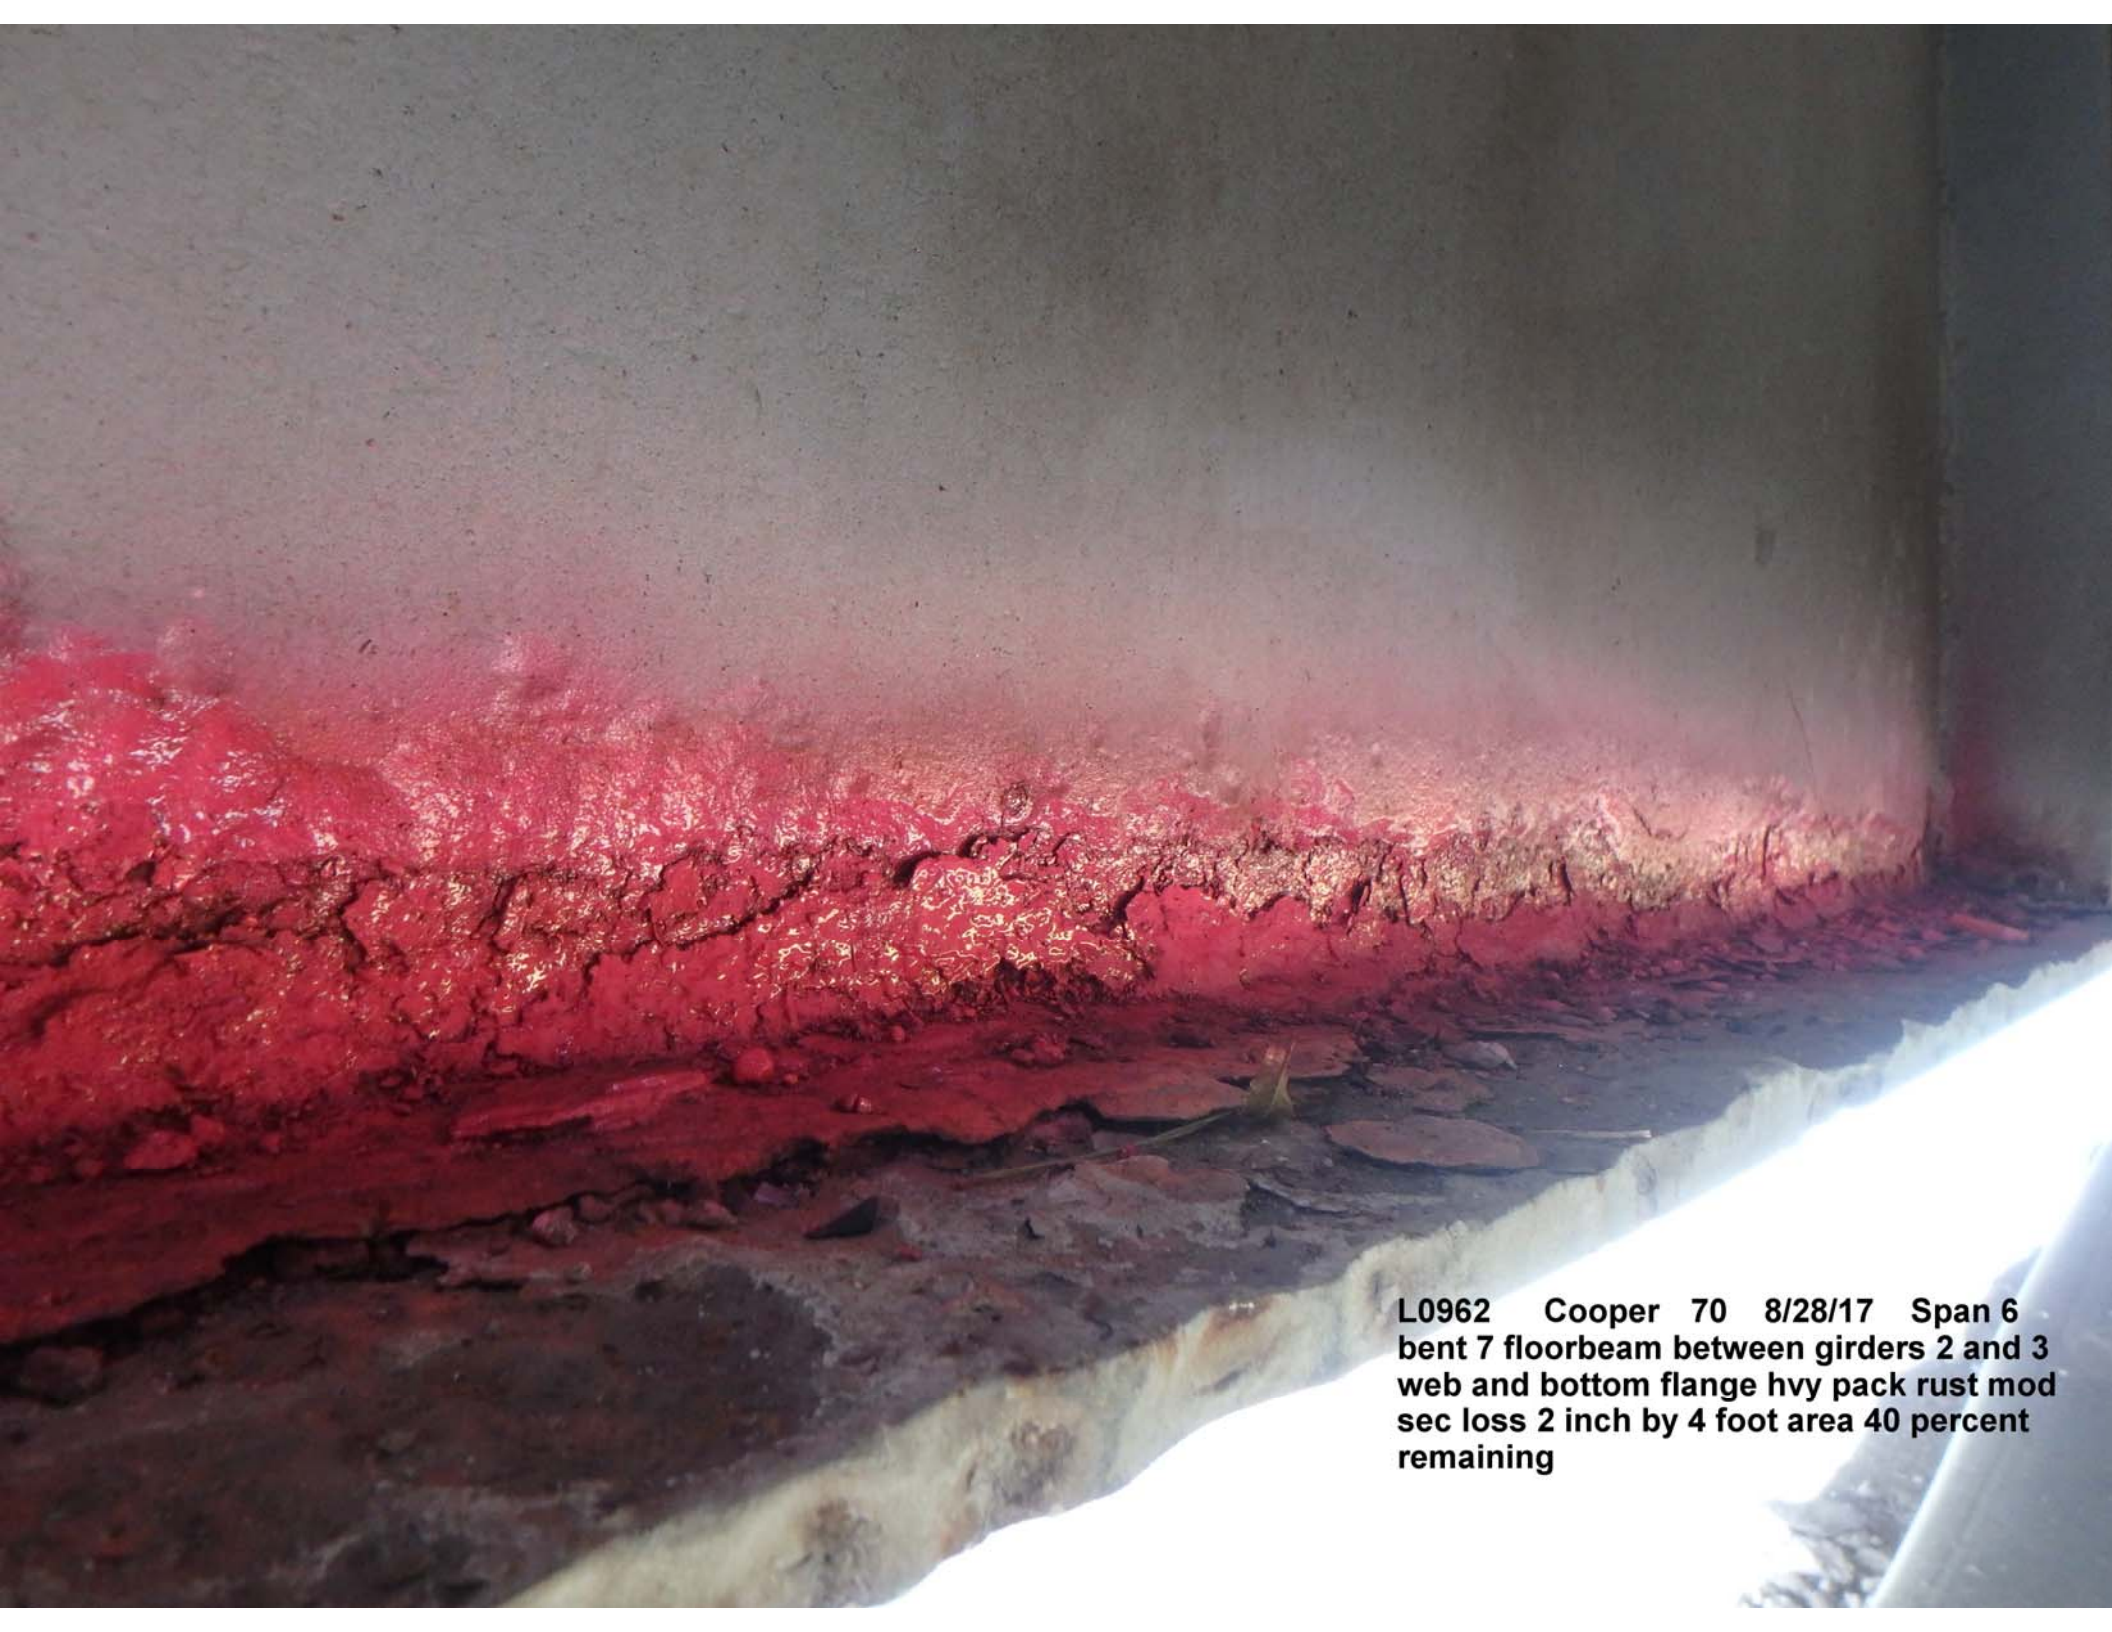
L0962 Cooper 70 8/28/17 Span 6
bent 7 floorbeam between girders 2 and 3
web and bottom flange hvy pack rust mod
sec loss 2 inch by 4 foot area 40 percent
remaining

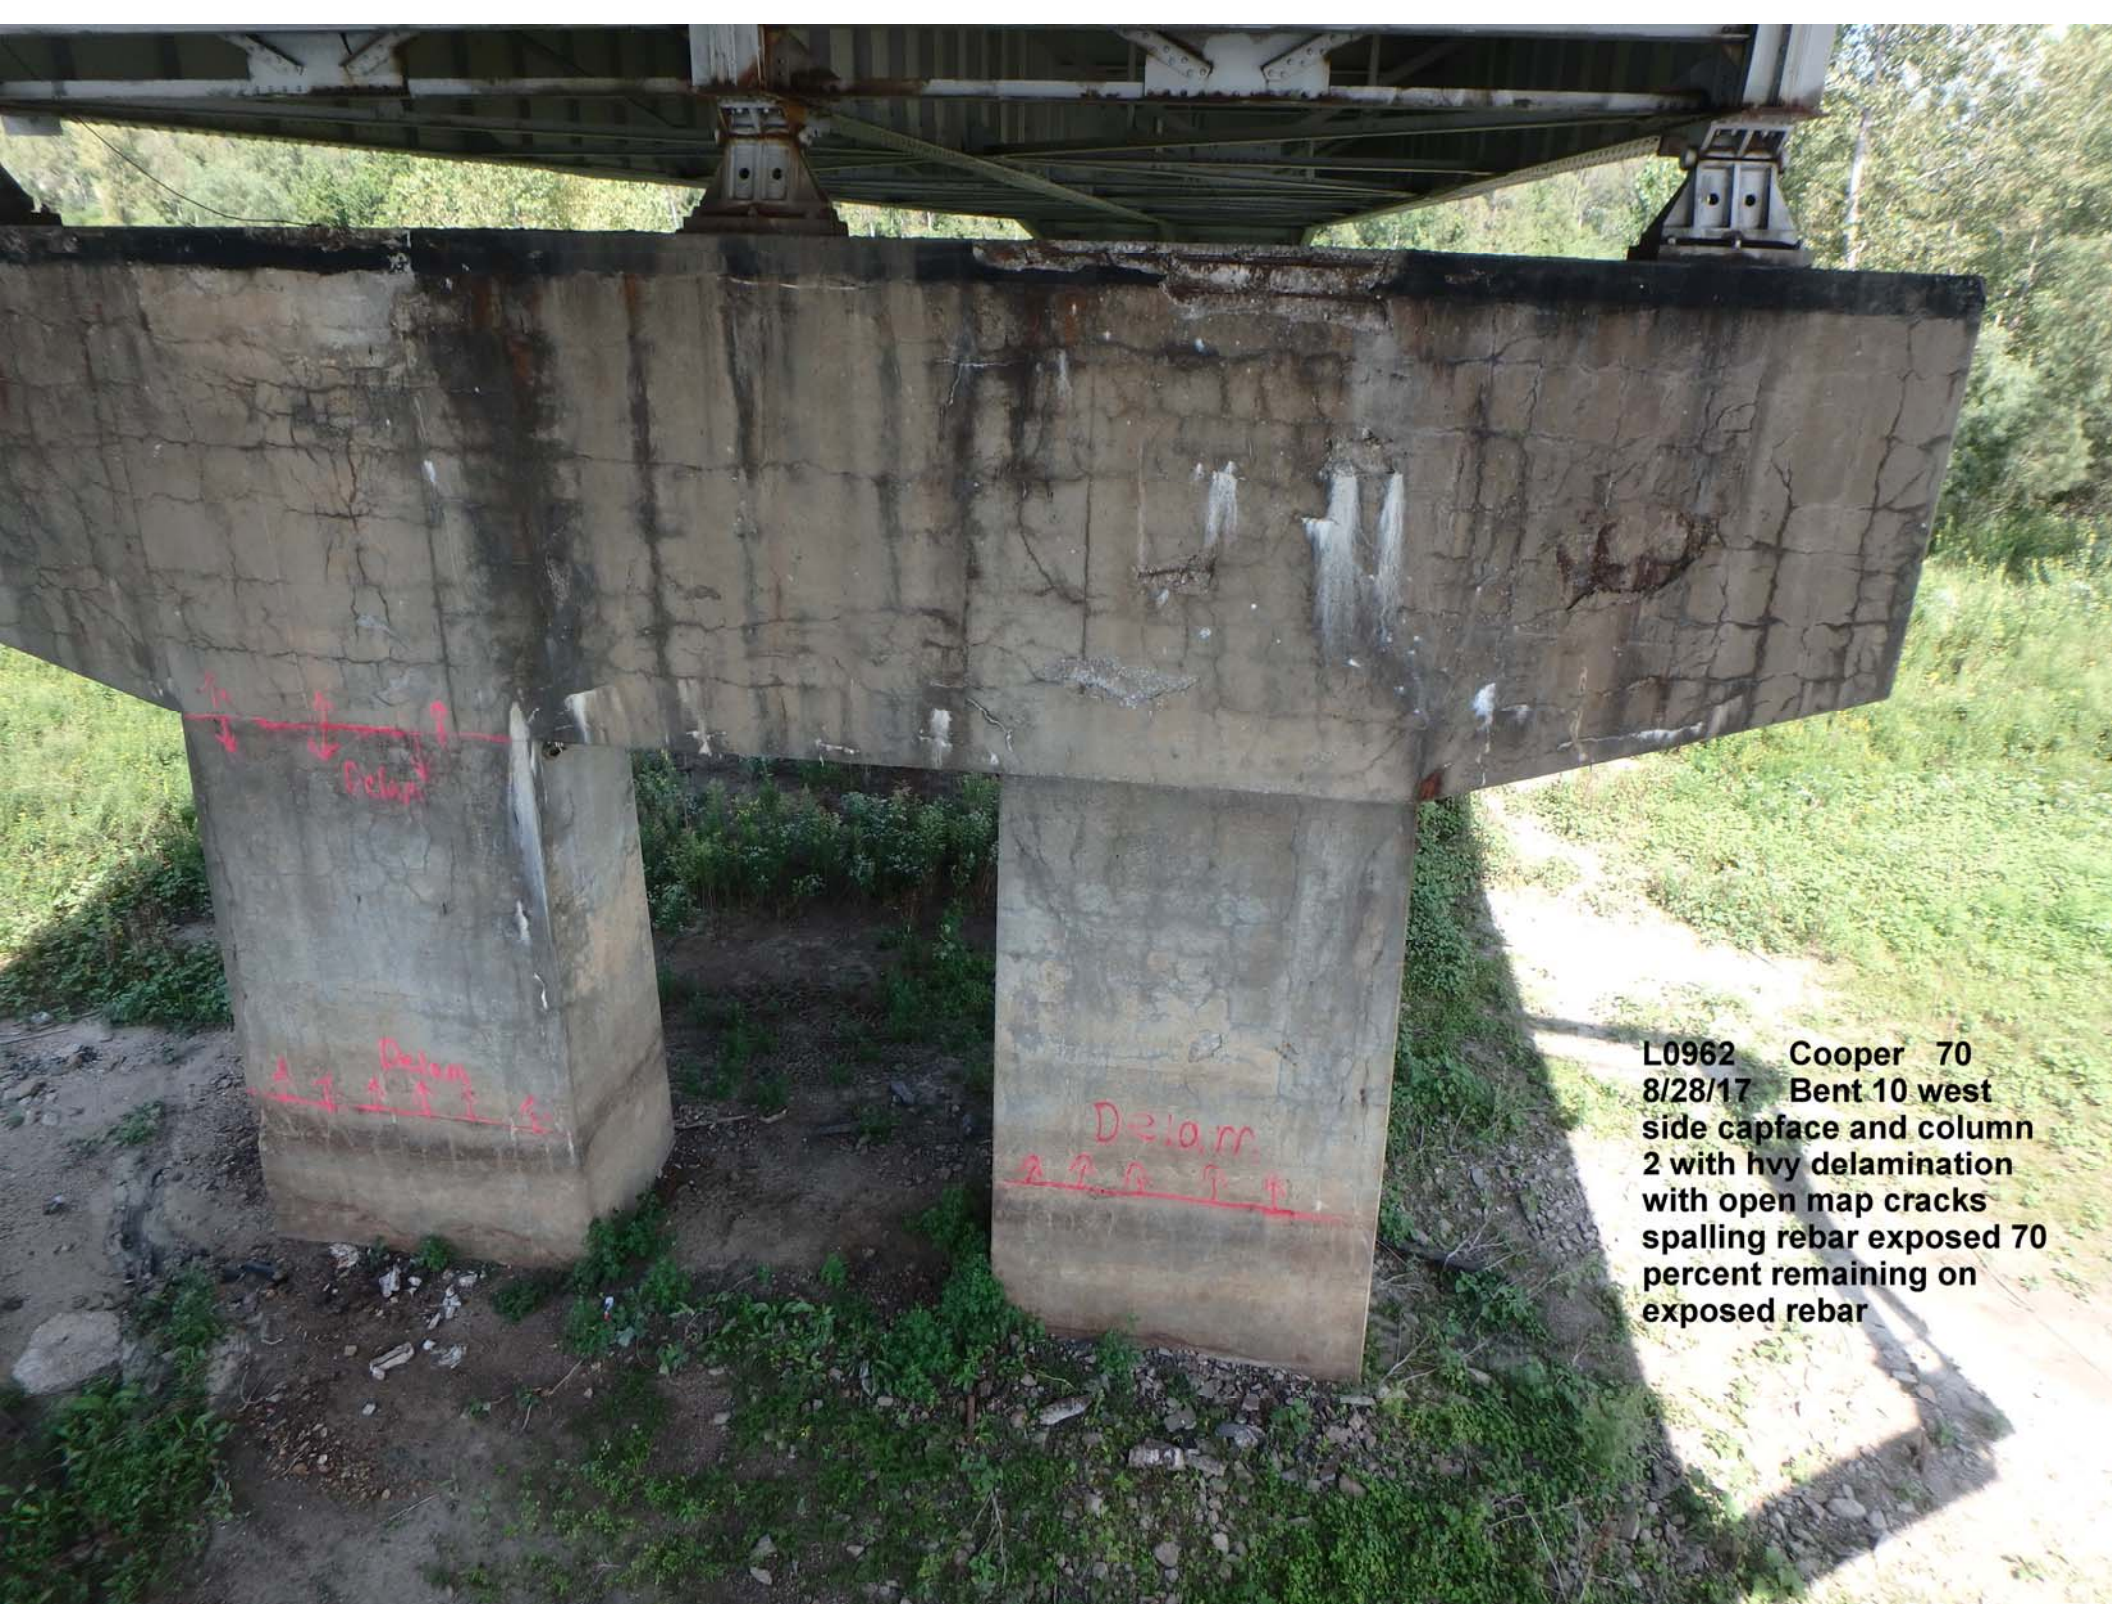
L0962 Cooper 70
8/28/17 Bent 10 west
side capface and column
2 with hvy delamination
with open map cracks
spalling rebar exposed 70
percent remaining on
exposed rebar

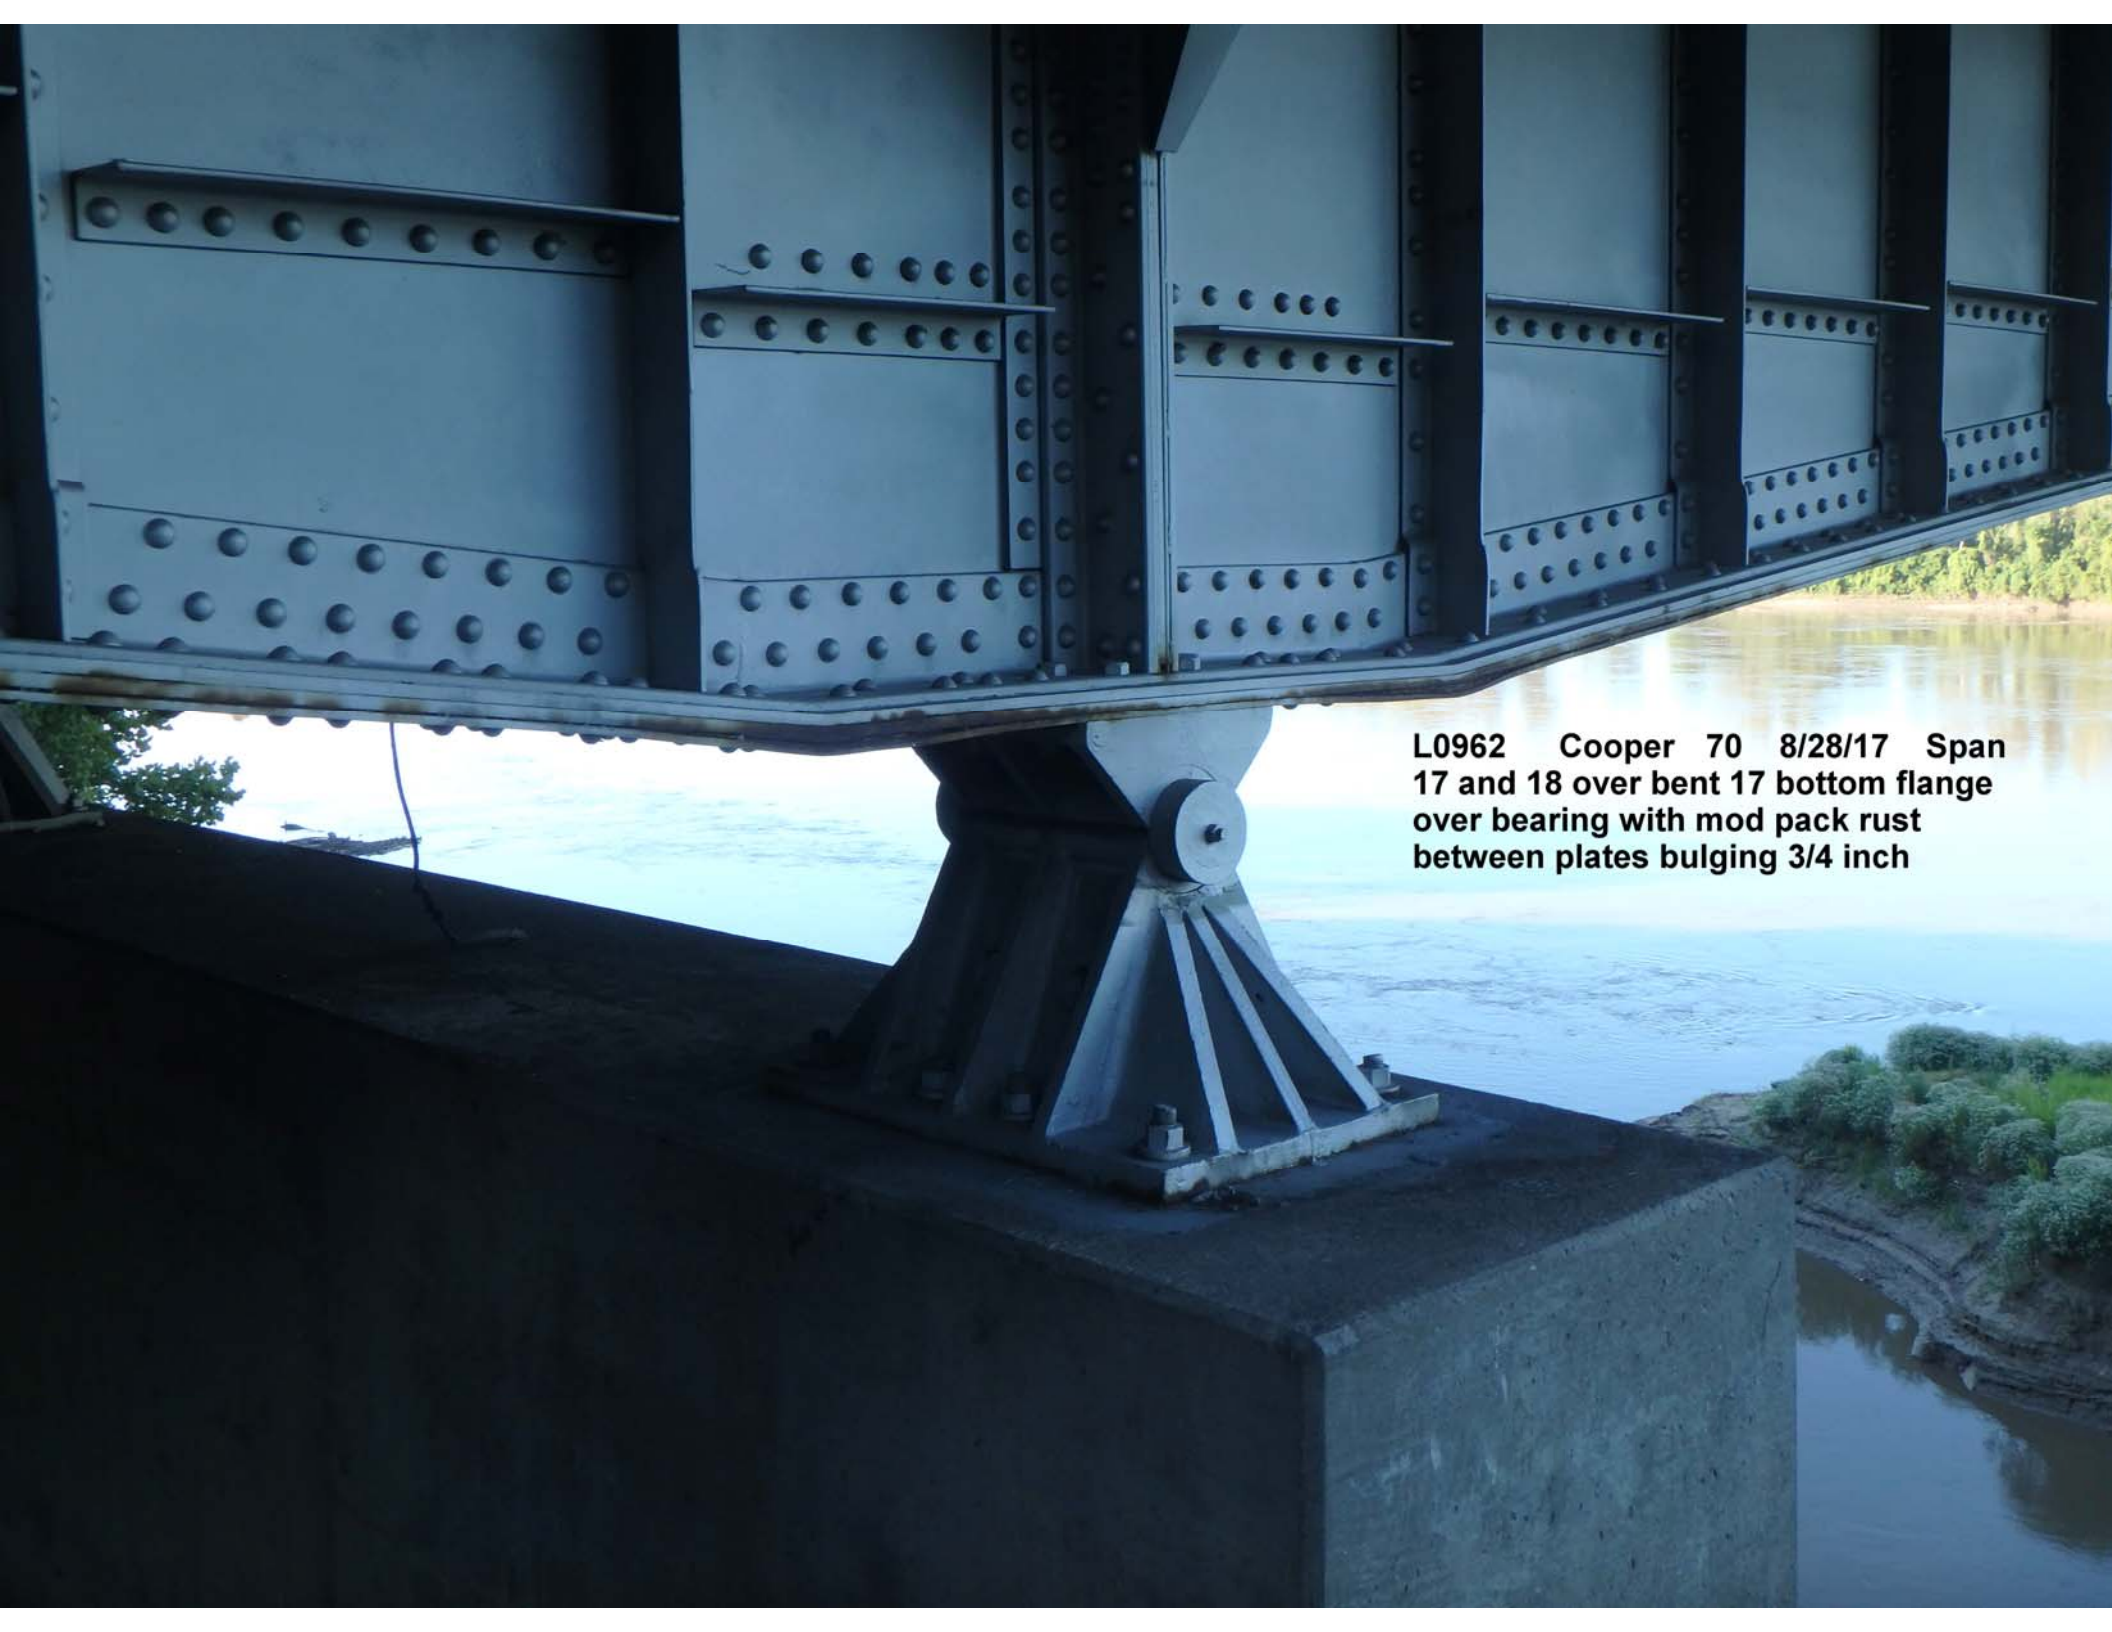
L0962 Cooper 70 8/28/17 Span
17 and 18 over bent 17 bottom flange
over bearing with mod pack rust
between plates bulging 3/4 inch

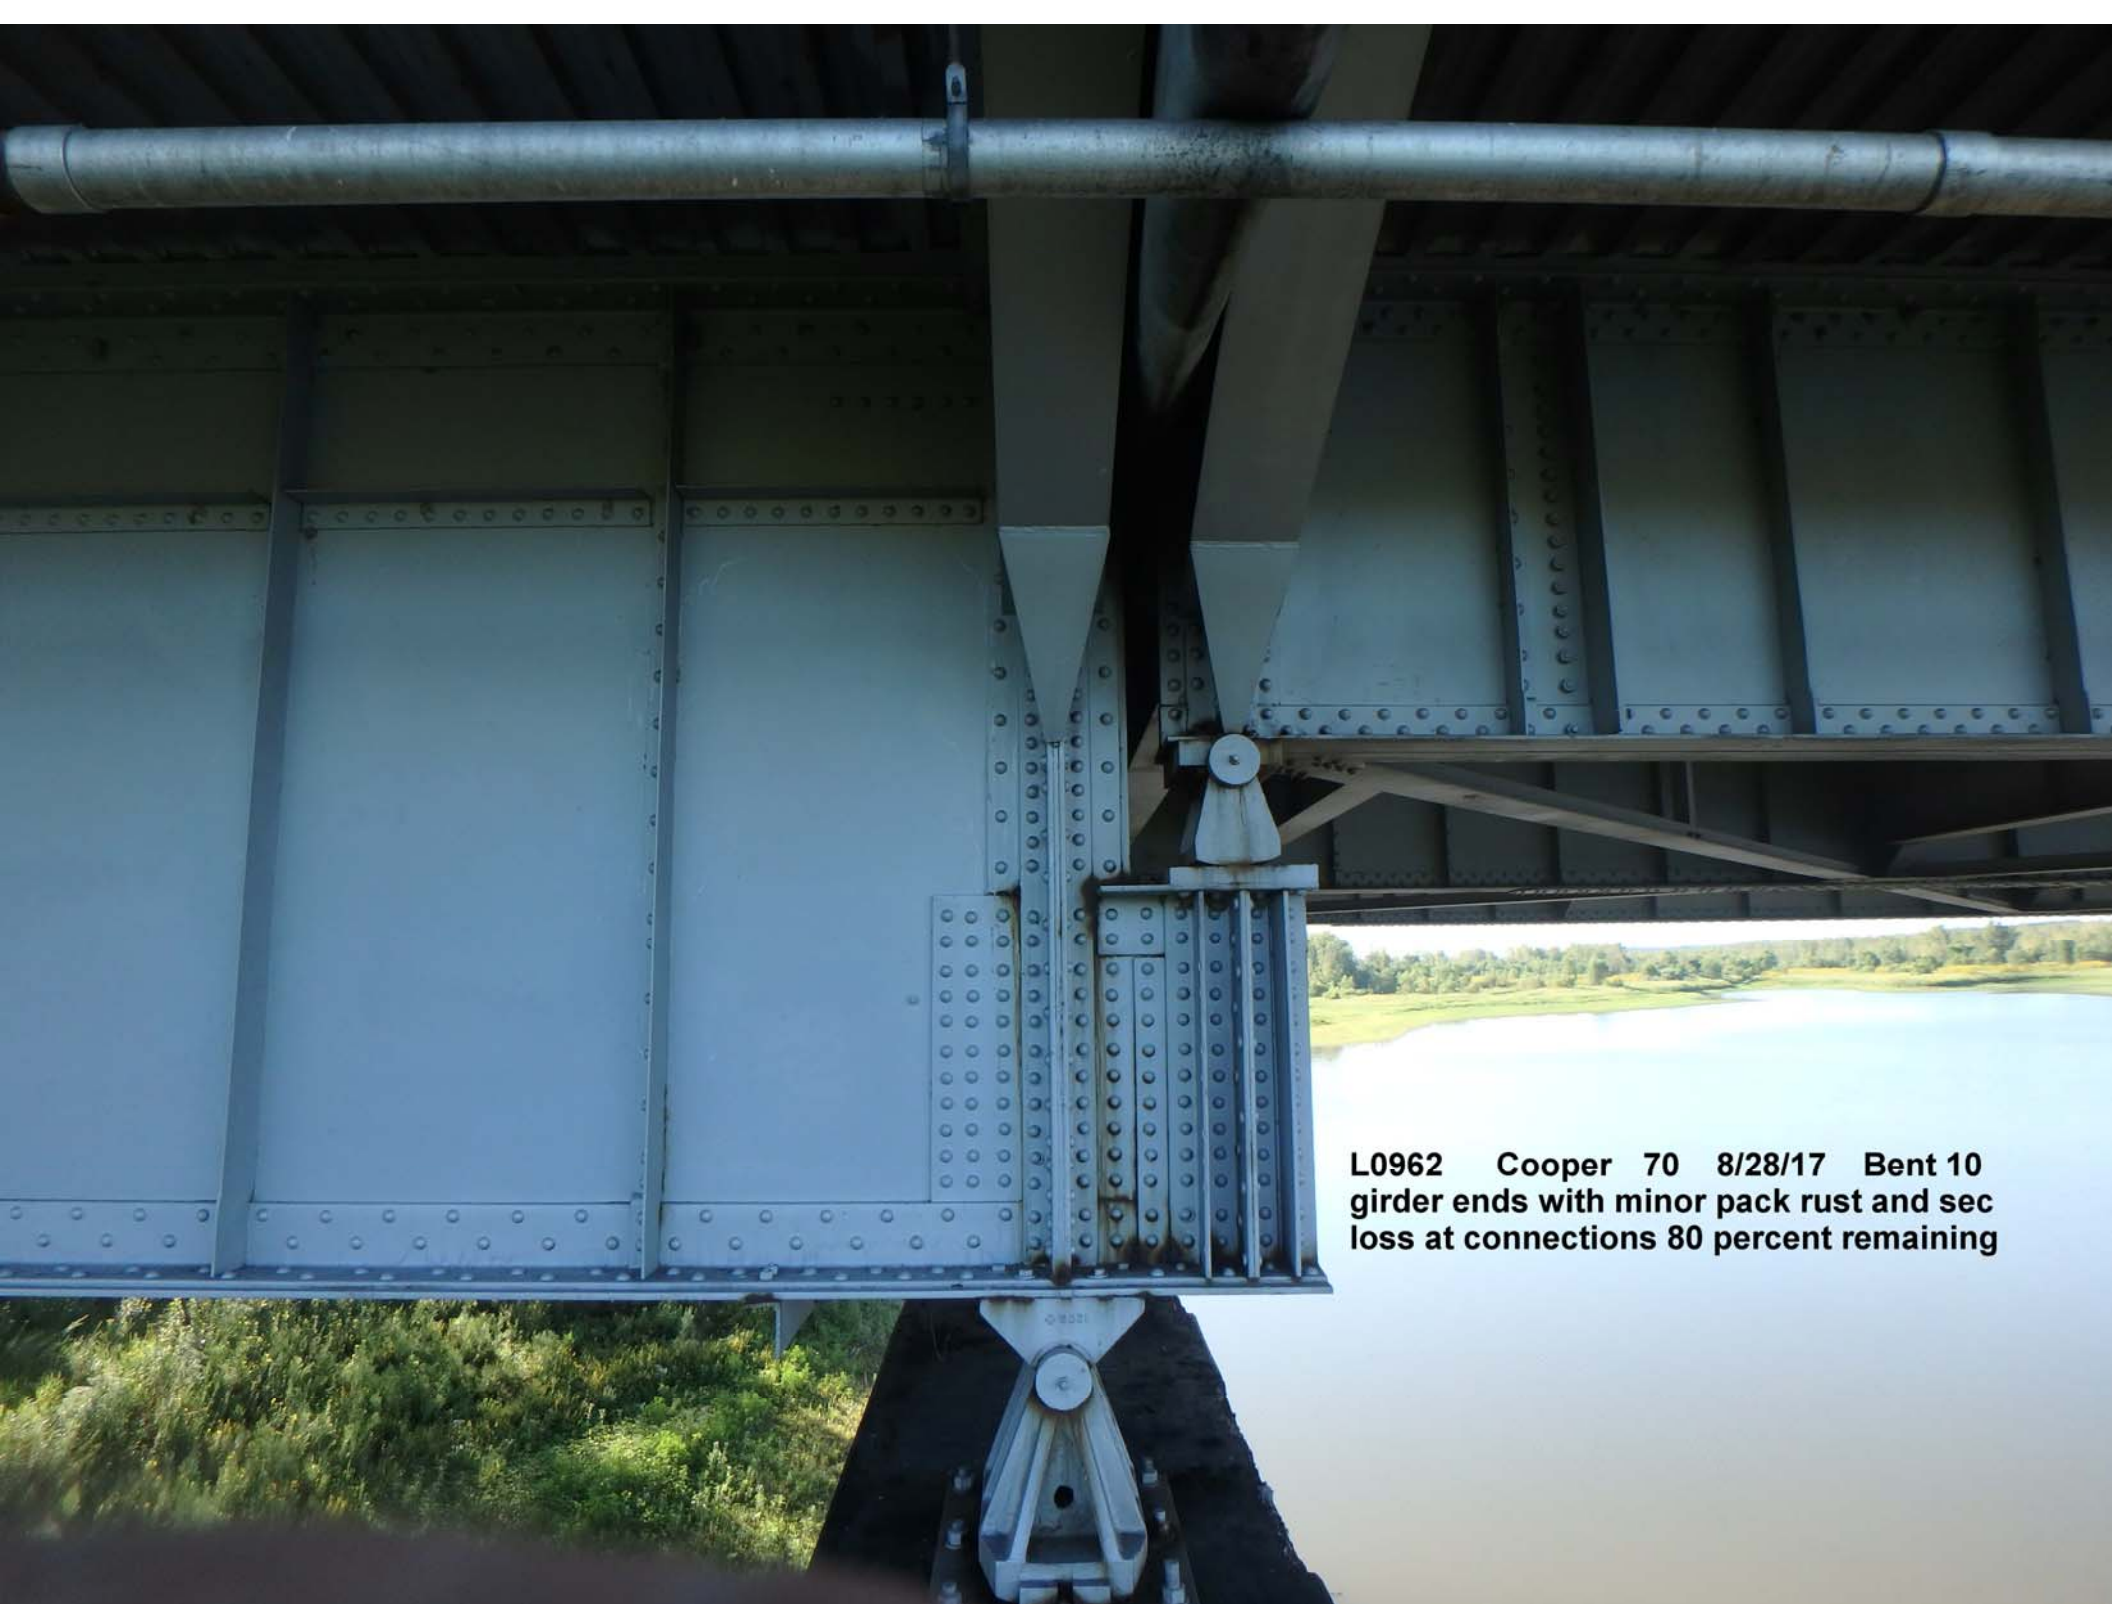
**L0962 Cooper 70 8/28/17 Bent 10
girder ends with minor pack rust and sec
loss at connections 80 percent remaining**
