L0962 Cooper 70 8/28/17
P13 east side lrg area of map
cracks with saturation and eff

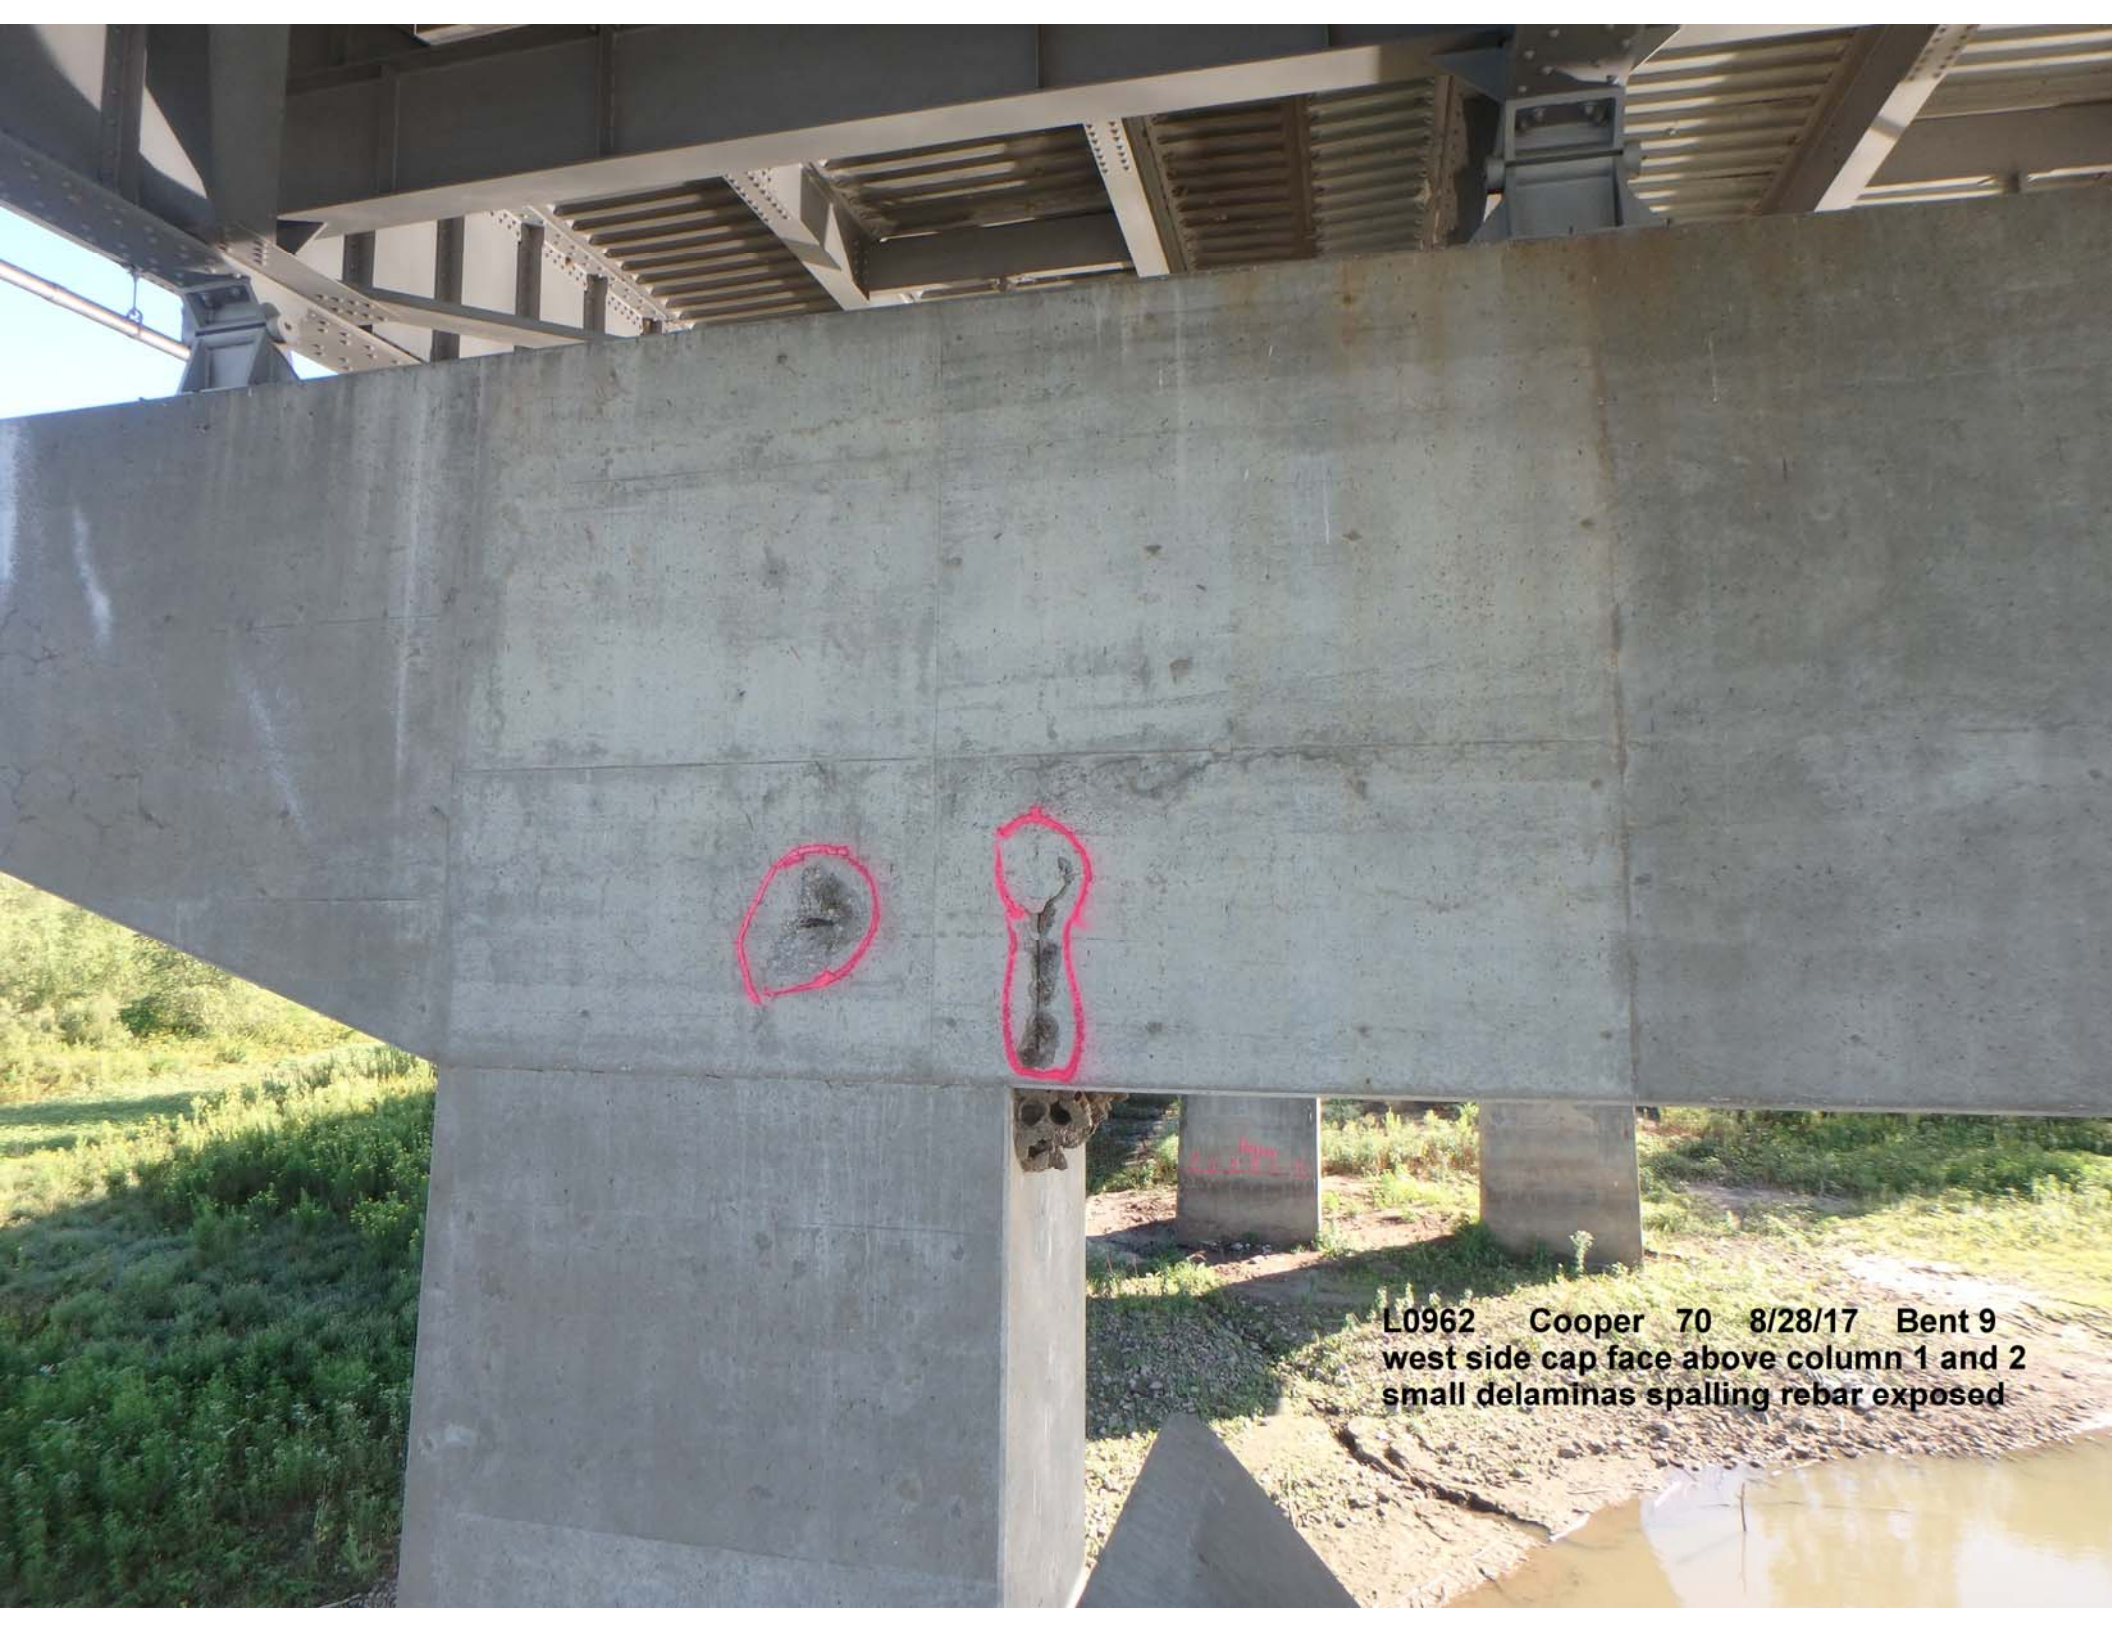
L0962 Cooper 70 8/28/17 Bent 9
west side cap face above column 1 and 2
small delaminas spalling rebar exposed

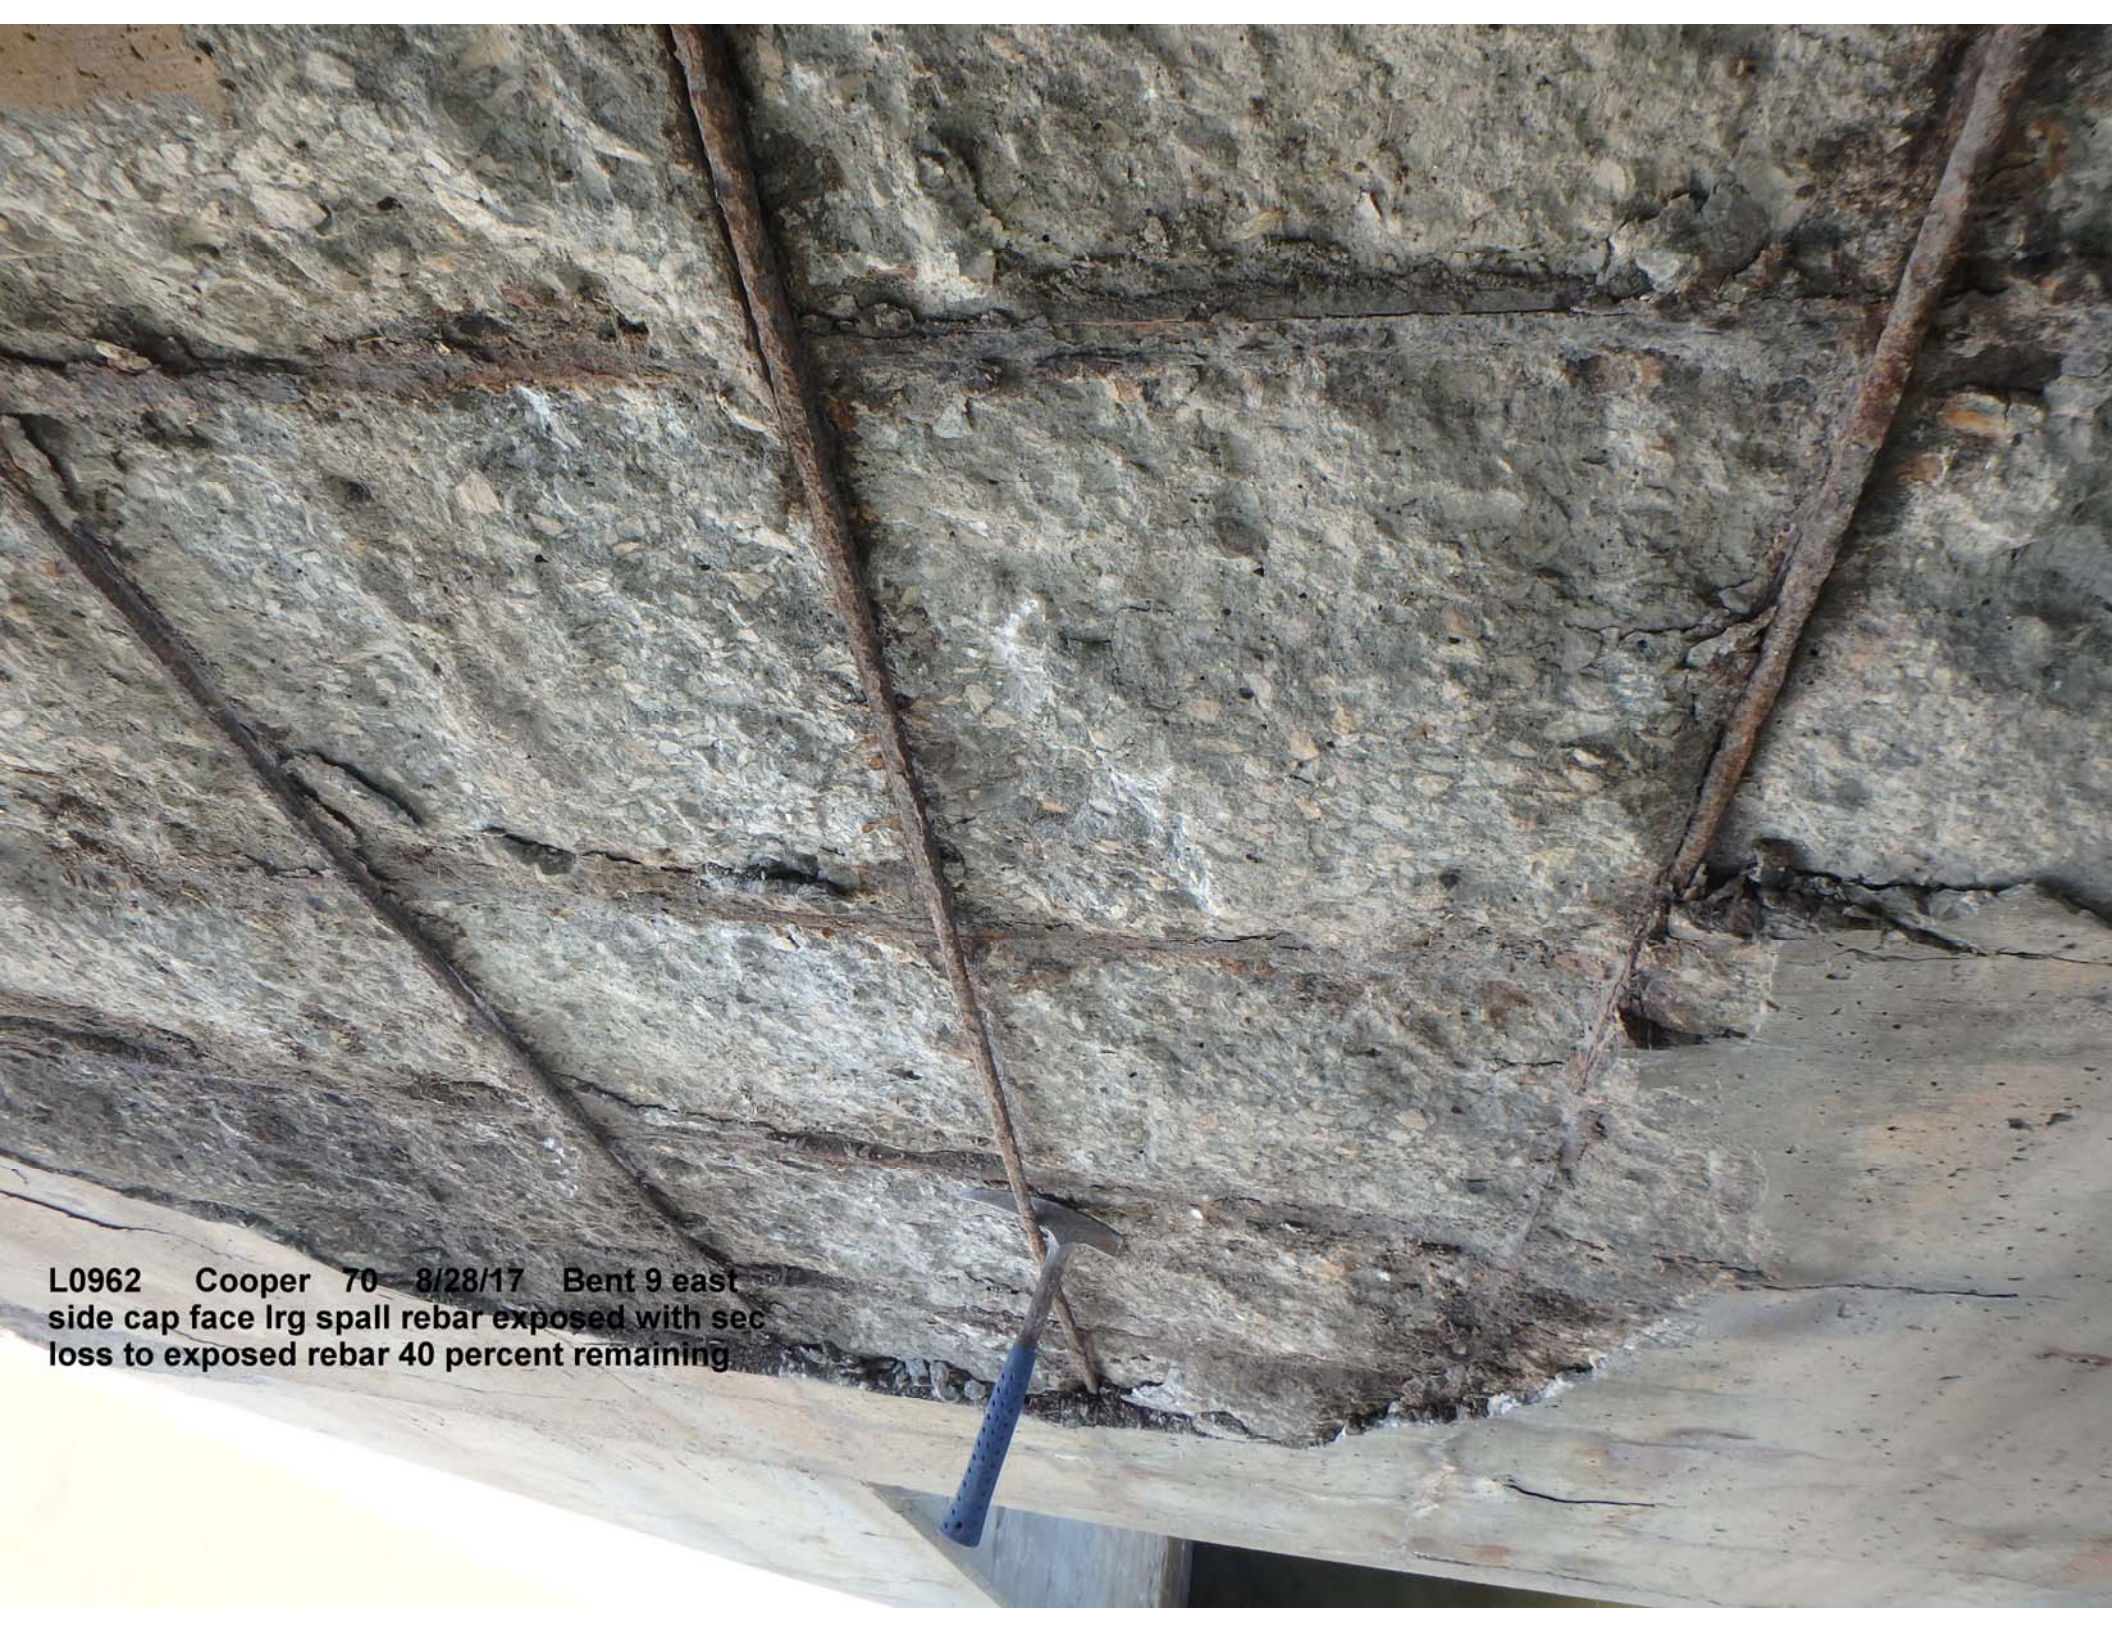
L0962 Cooper 70 8/28/17 Bent 9 east
side cap face lrg spall rebar exposed with sec
loss to exposed rebar 40 percent remaining

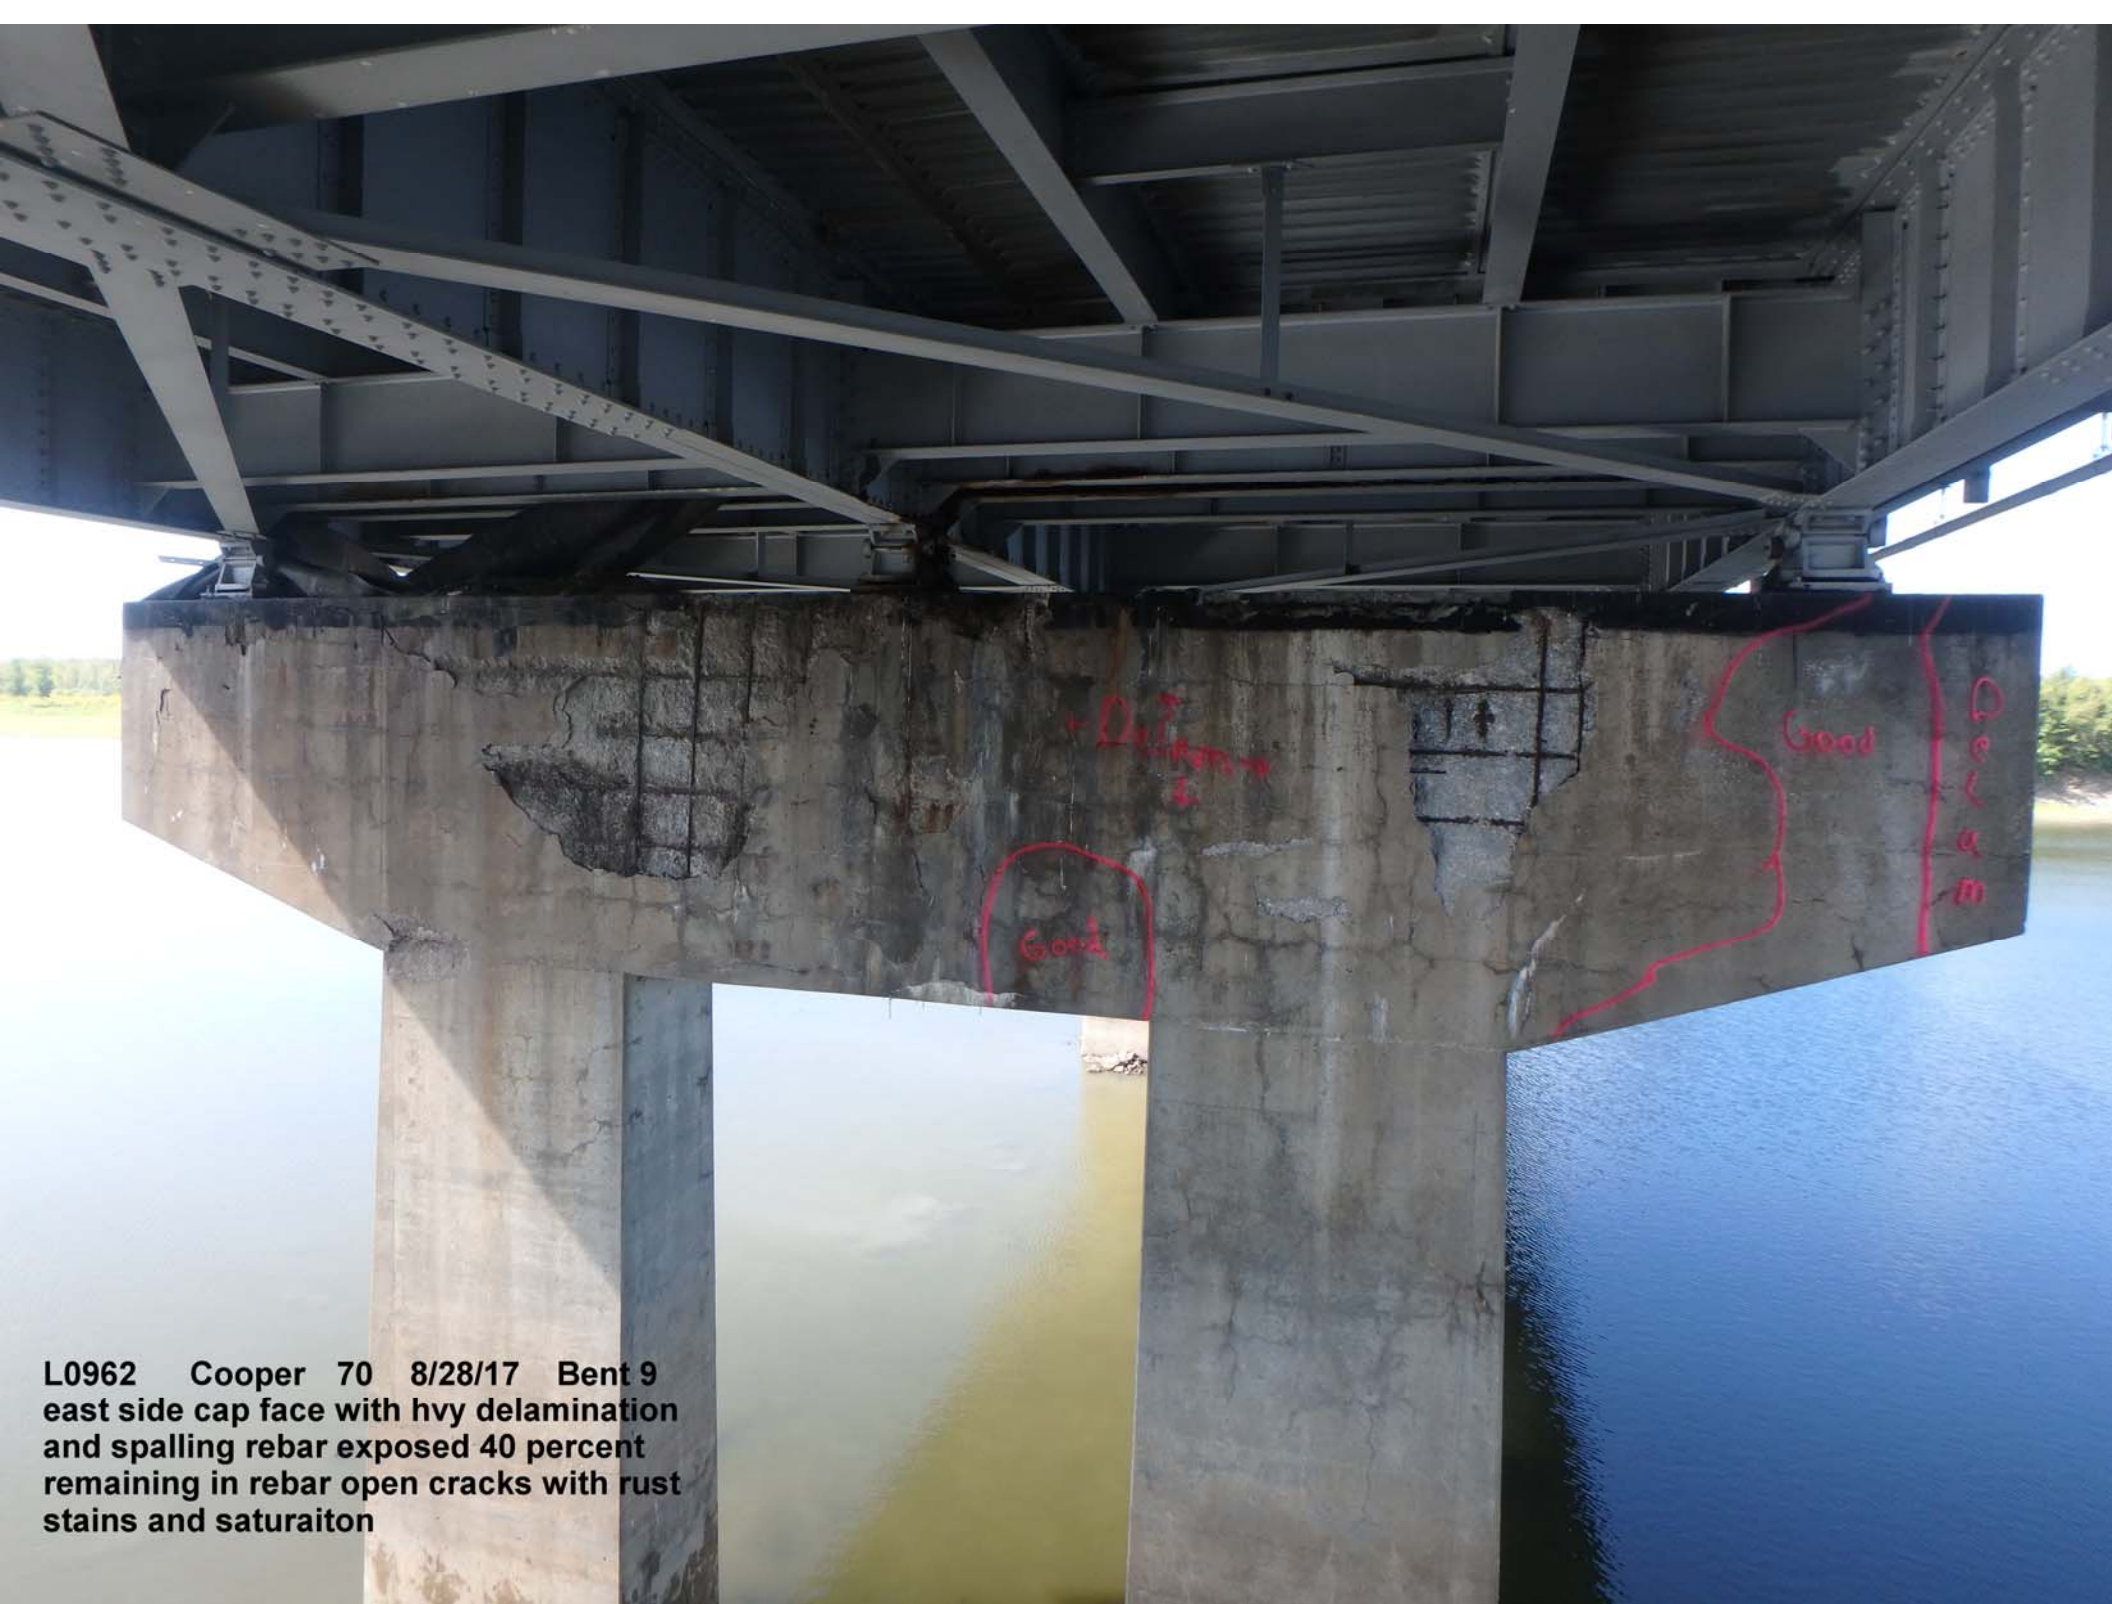
L0962 Cooper 70 8/28/17 Bent 9
east side cap face with hvy delamination
and spalling rebar exposed 40 percent
remaining in rebar open cracks with rust
stains and saturaiton

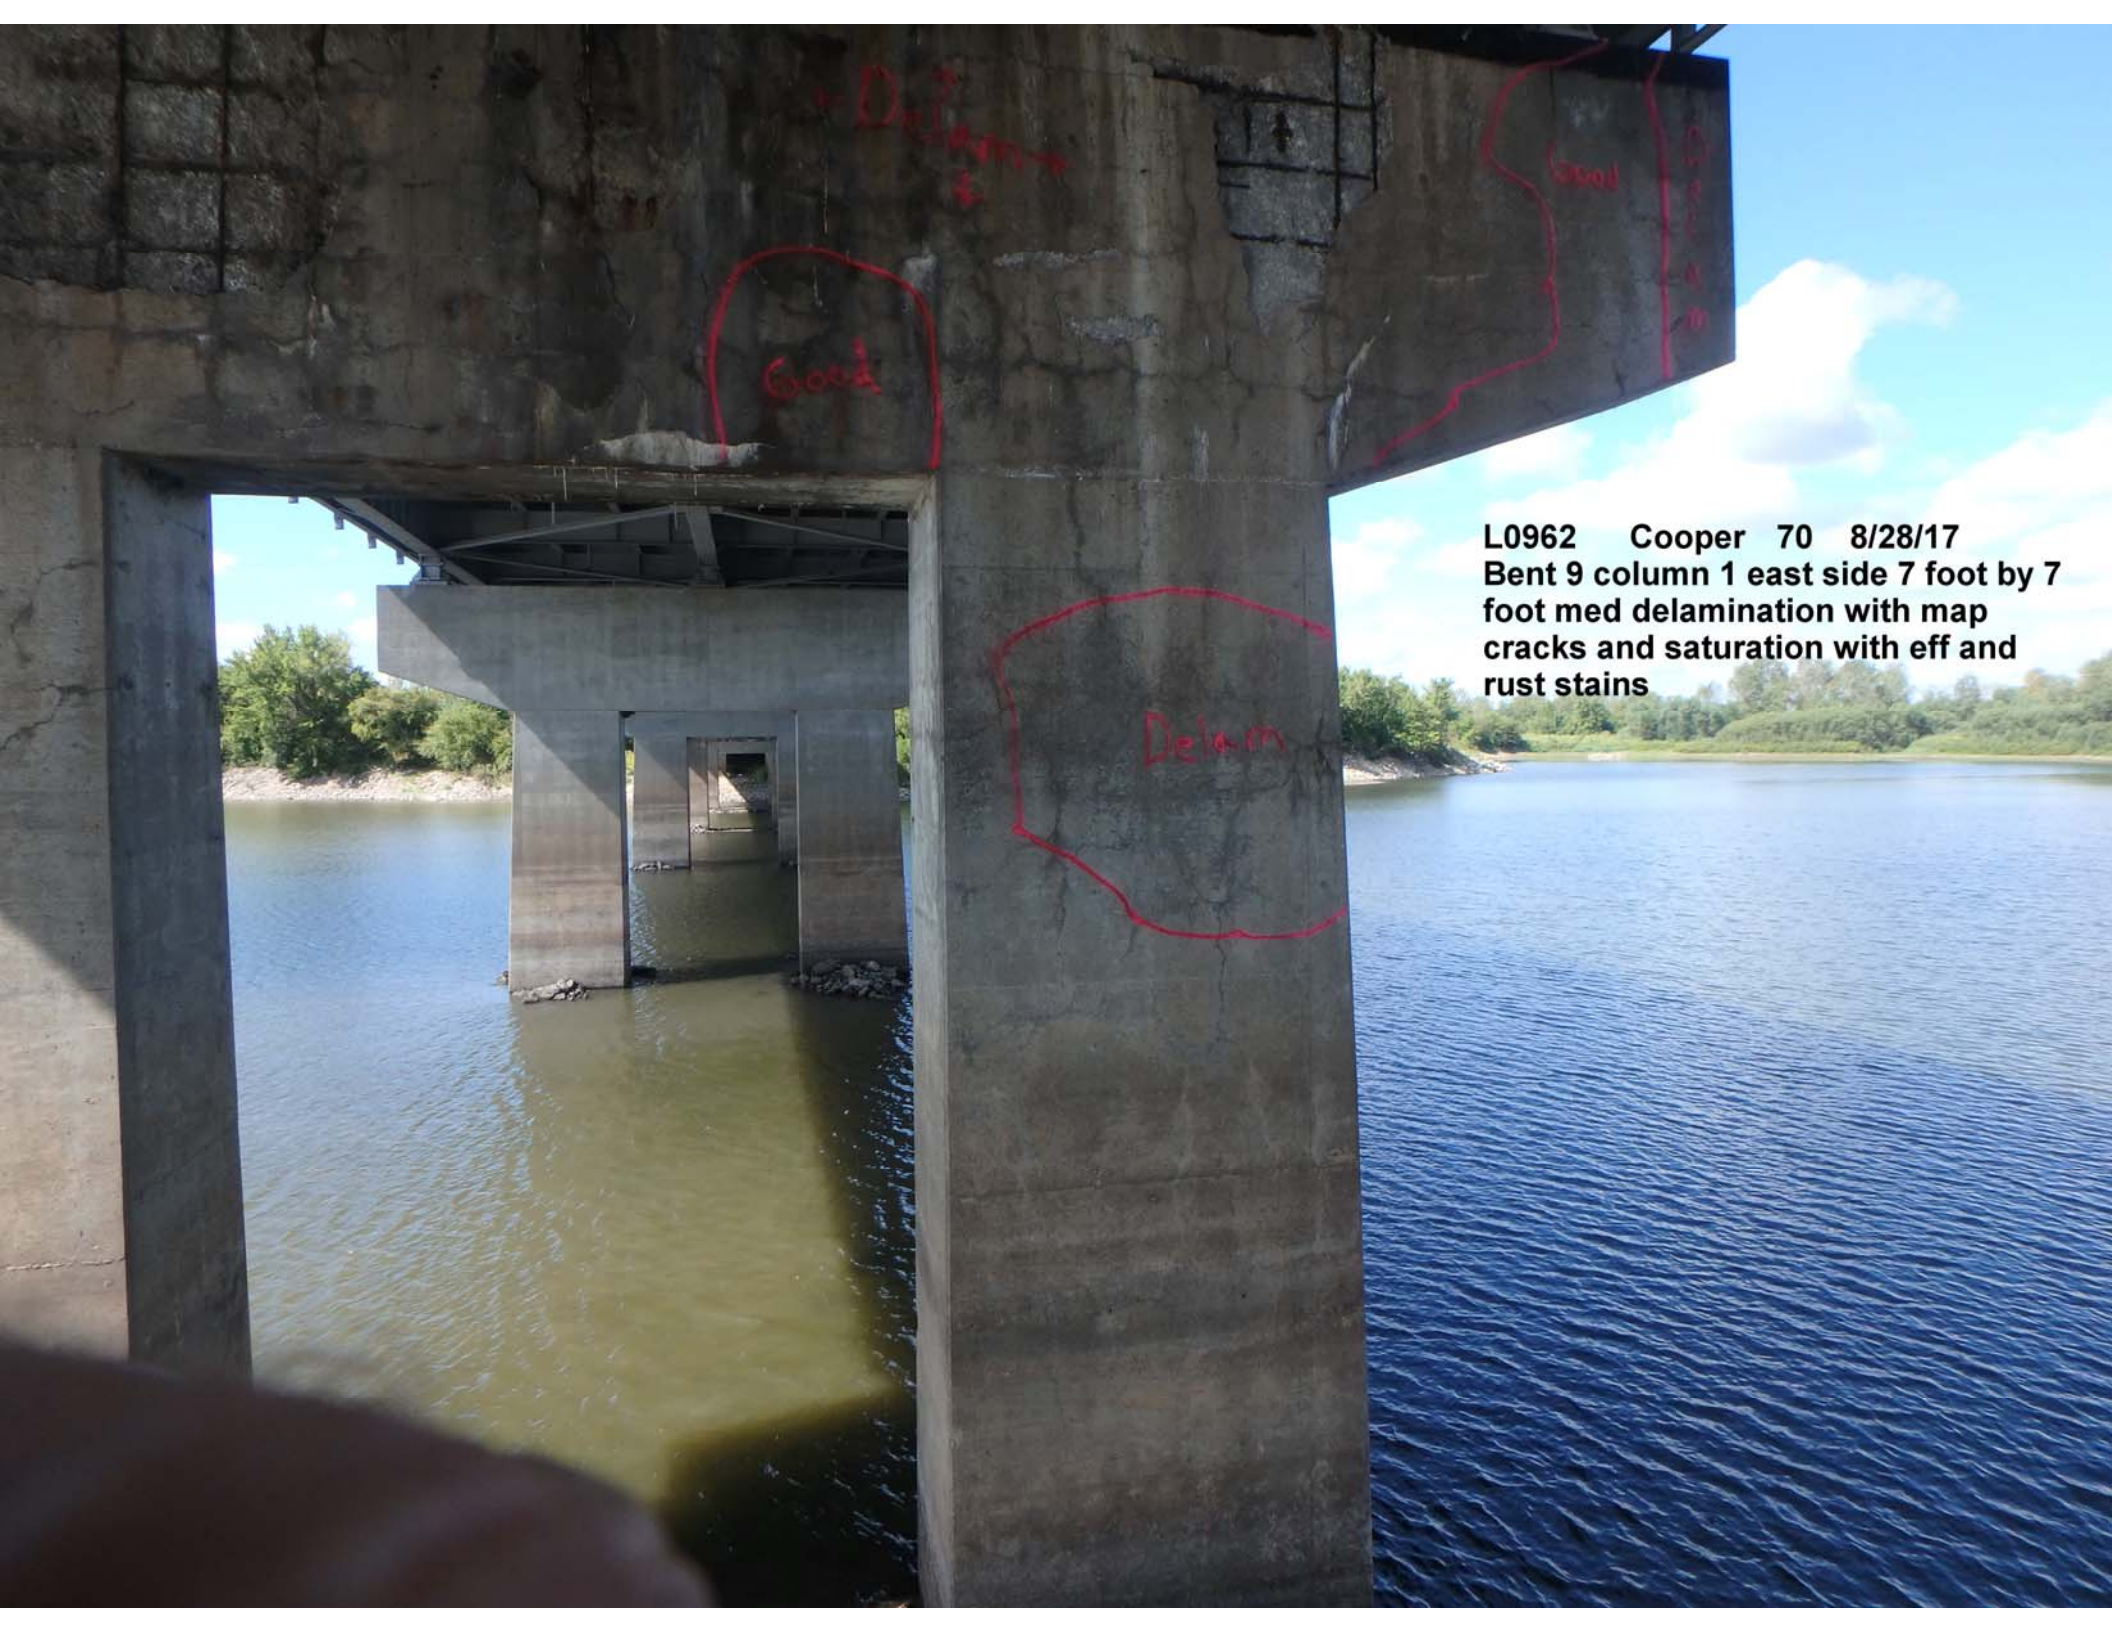
L0962 Cooper 70 8/28/17
Bent 9 column 1 east side 7 foot by 7
foot med delamination with map
cracks and saturation with eff and
rust stains

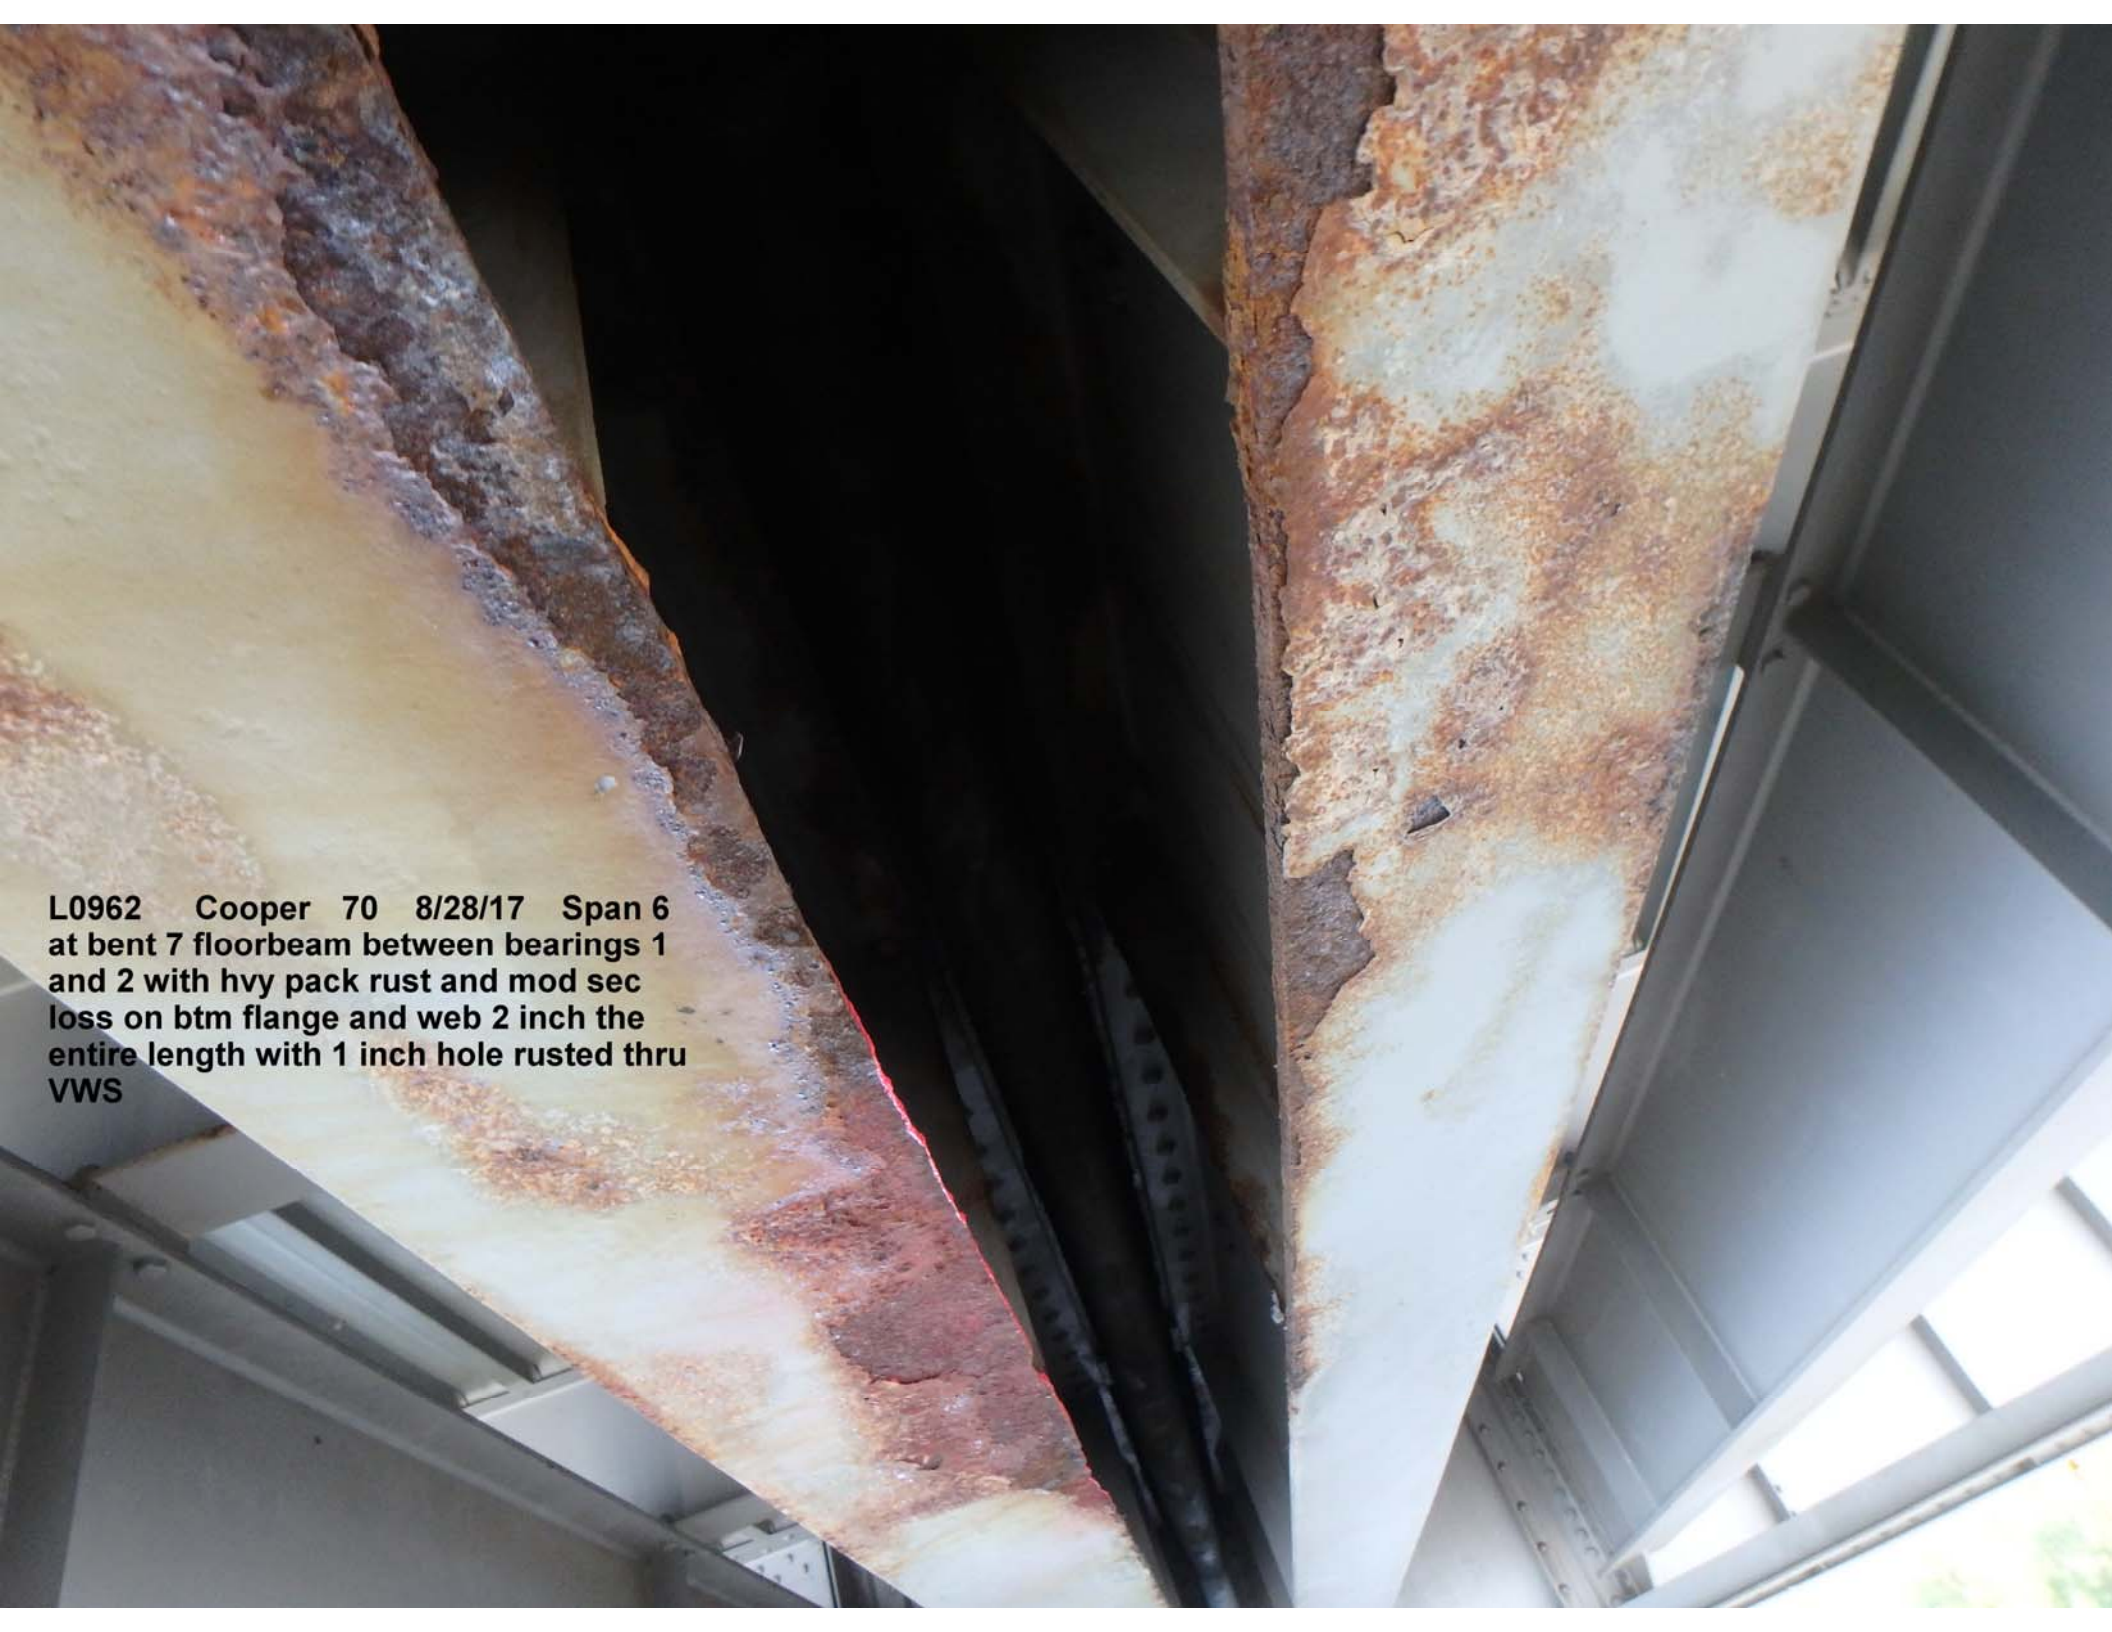
L0962 Cooper 70 8/28/17 Span 6
at bent 7 floorbeam between bearings 1
and 2 with hvy pack rust and mod sec
loss on btm flange and web 2 inch the
entire length with 1 inch hole rusted thru
VWS

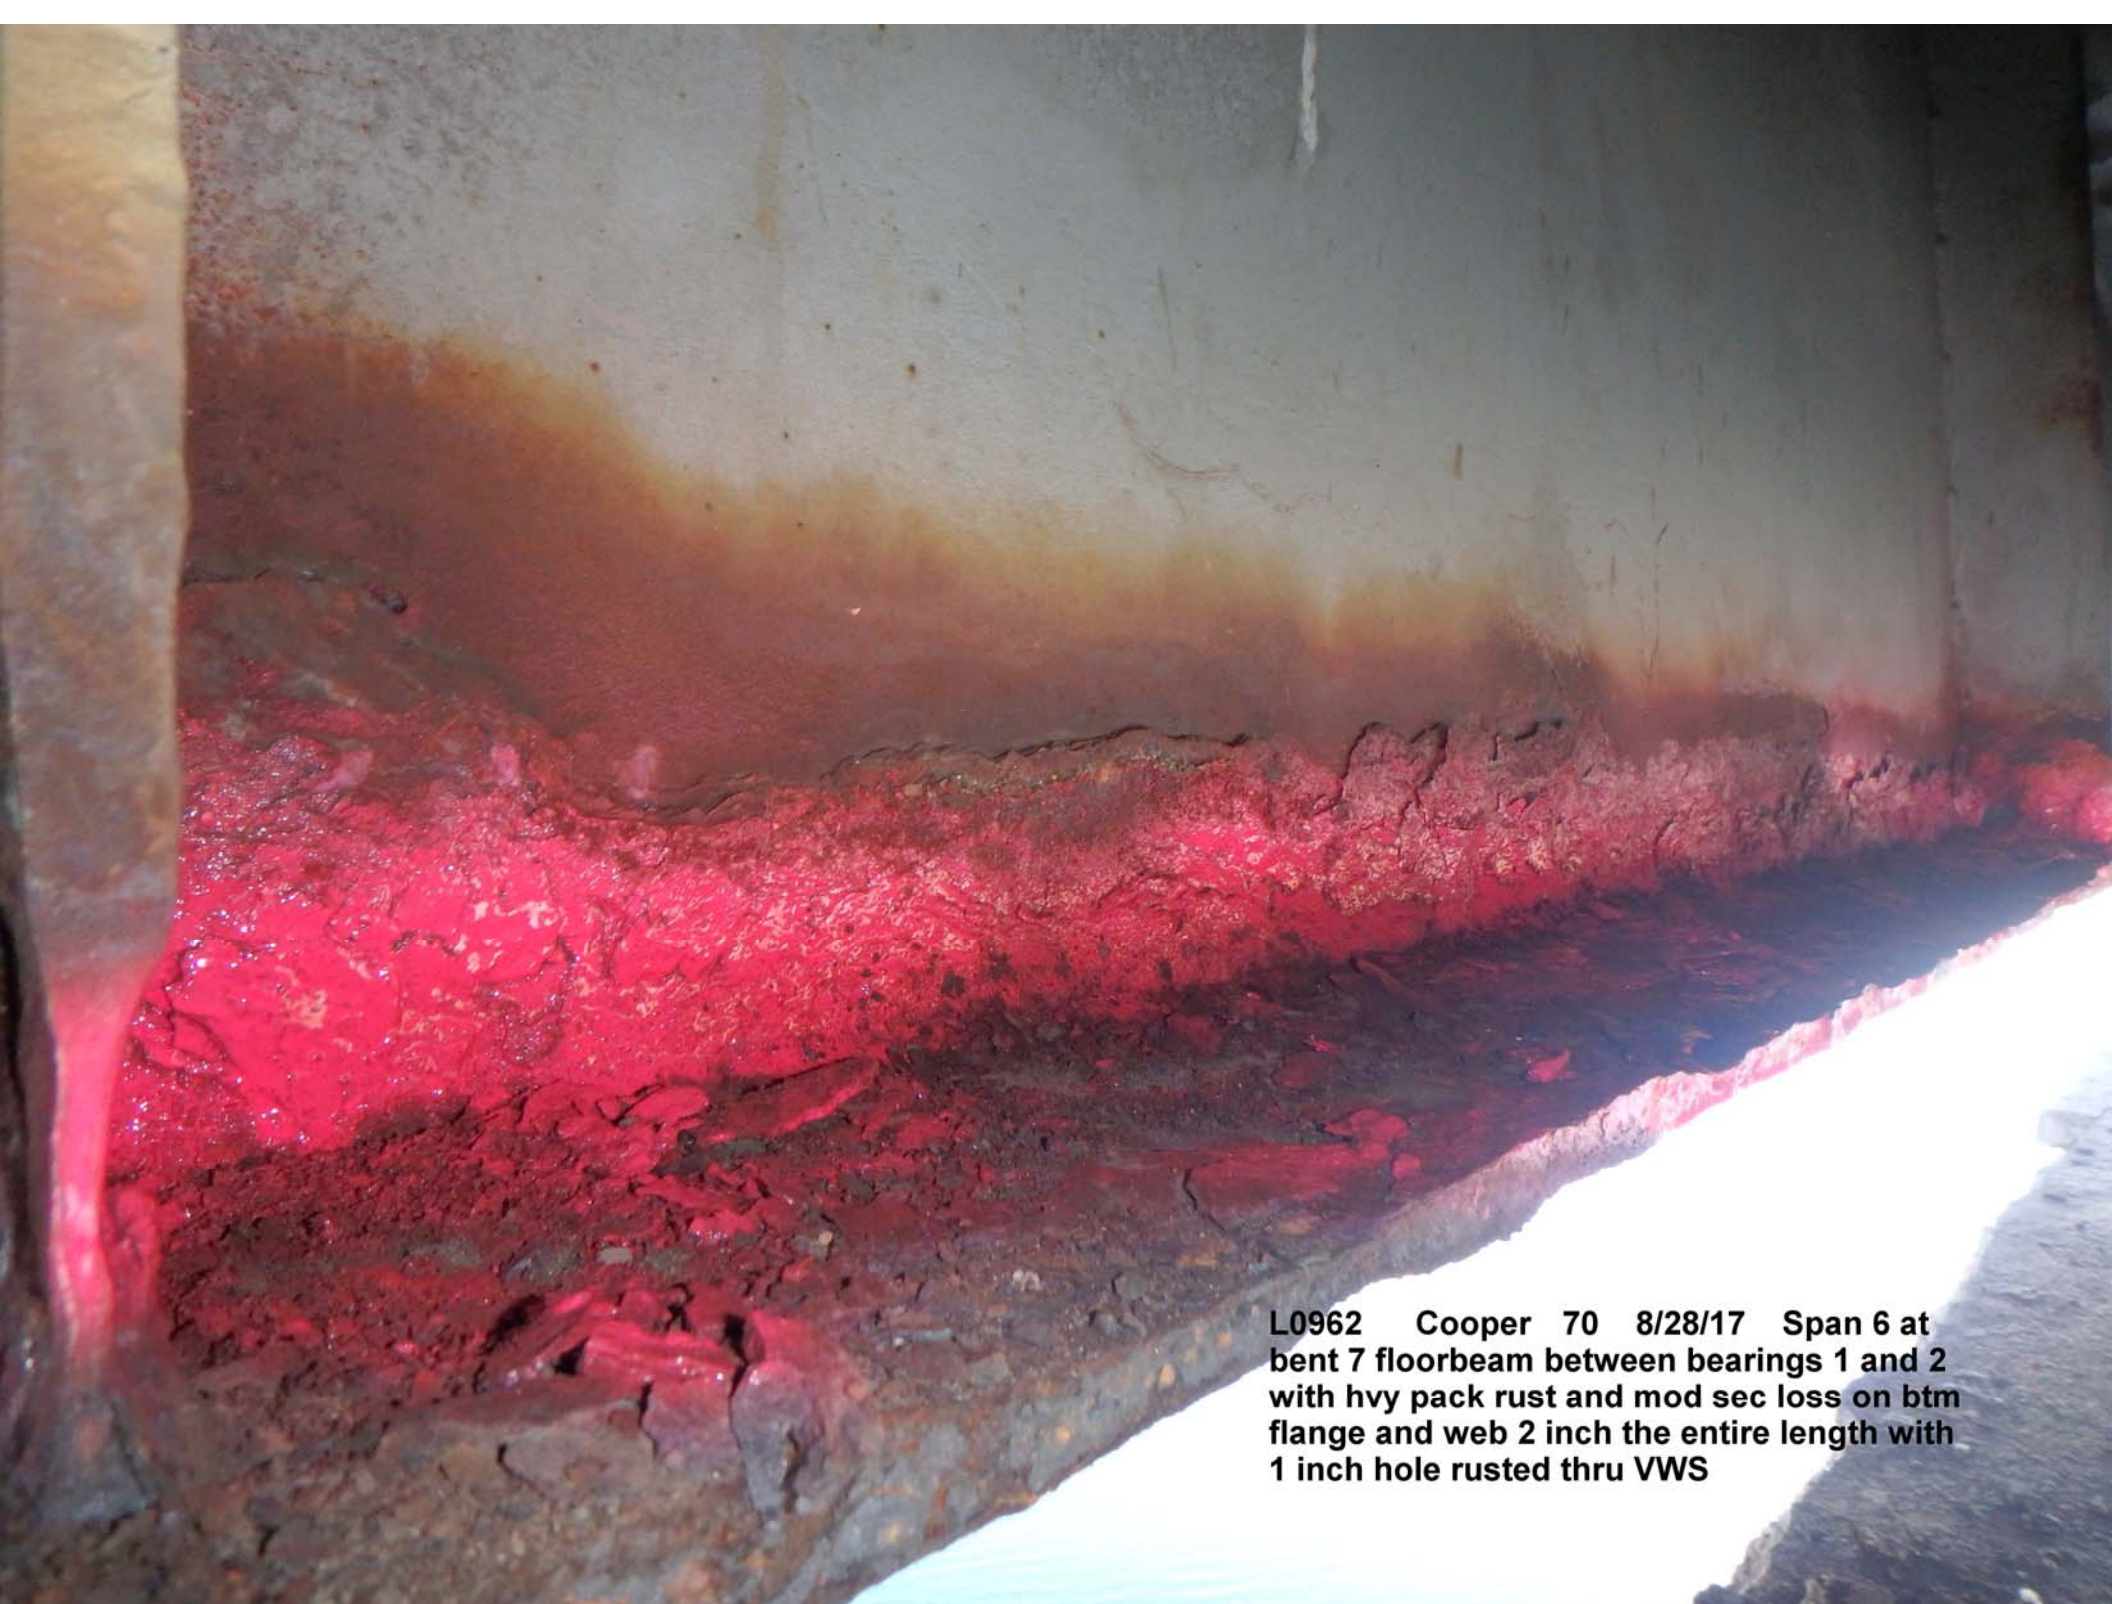
L0962 Cooper 70 8/28/17 Span 6 at bent 7 floorbeam between bearings 1 and 2 with hvy pack rust and mod sec loss on btm flange and web 2 inch the entire length with 1 inch hole rusted thru VWS
