L0962 Cooper 70 8/28/17
P13 east side lrg area of map
cracks with saturation and eff

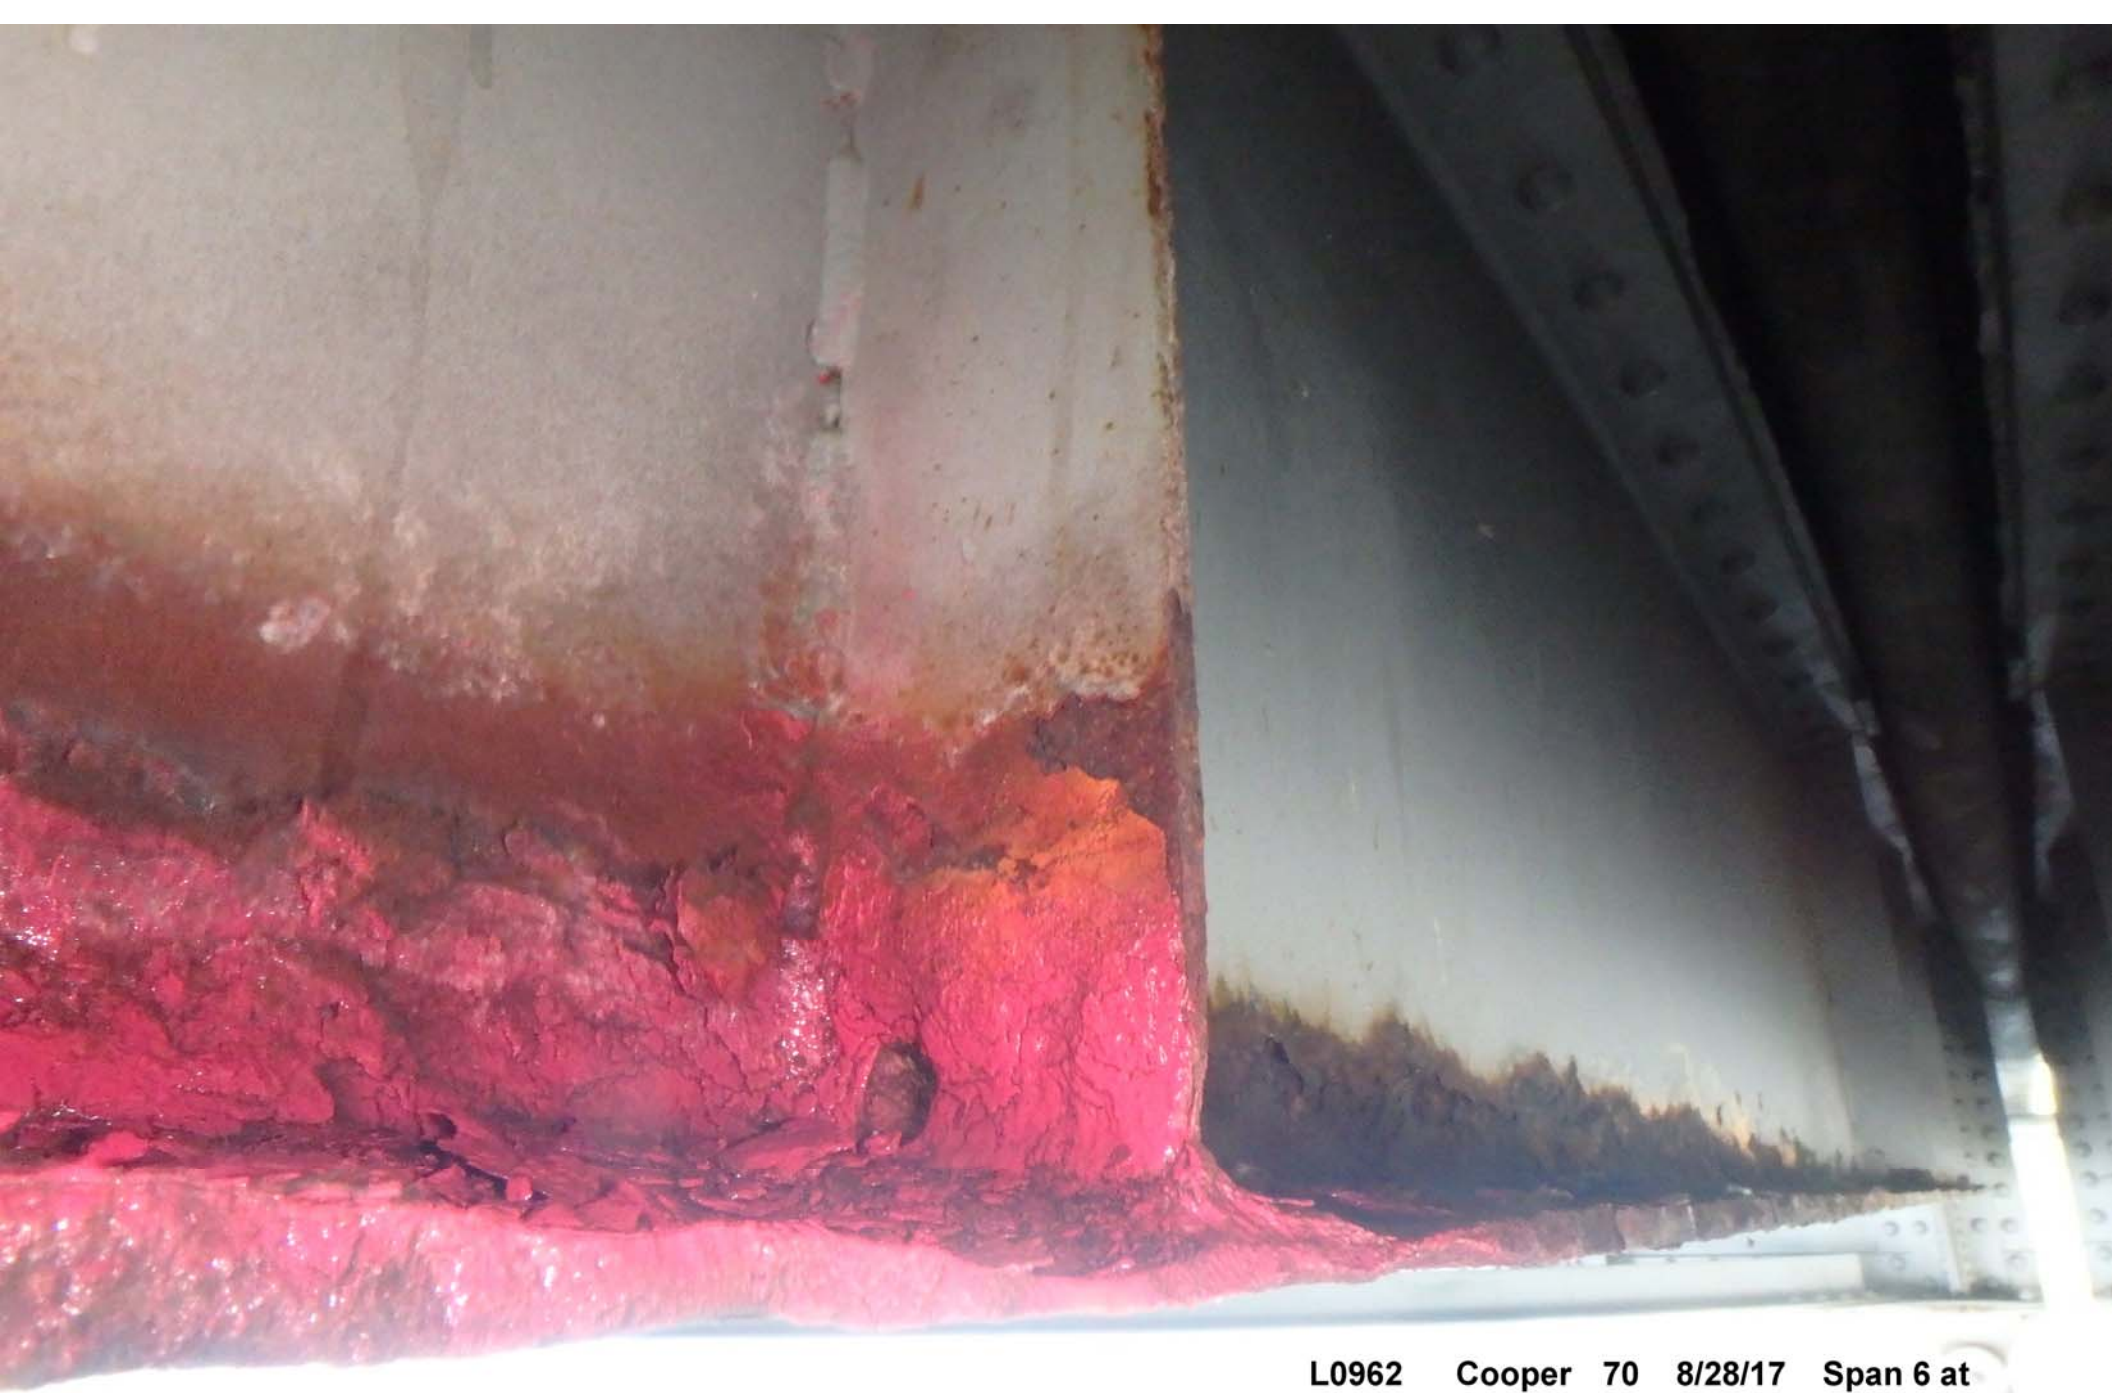
L0962 Cooper 70 8/28/17 Span 6 at bent 7 floorbeam between bearings 1 and 2 with hvy pack rust and mod sec loss on btm flange and web 2 inch the entire length with 1 inch hole rusted thru VWS

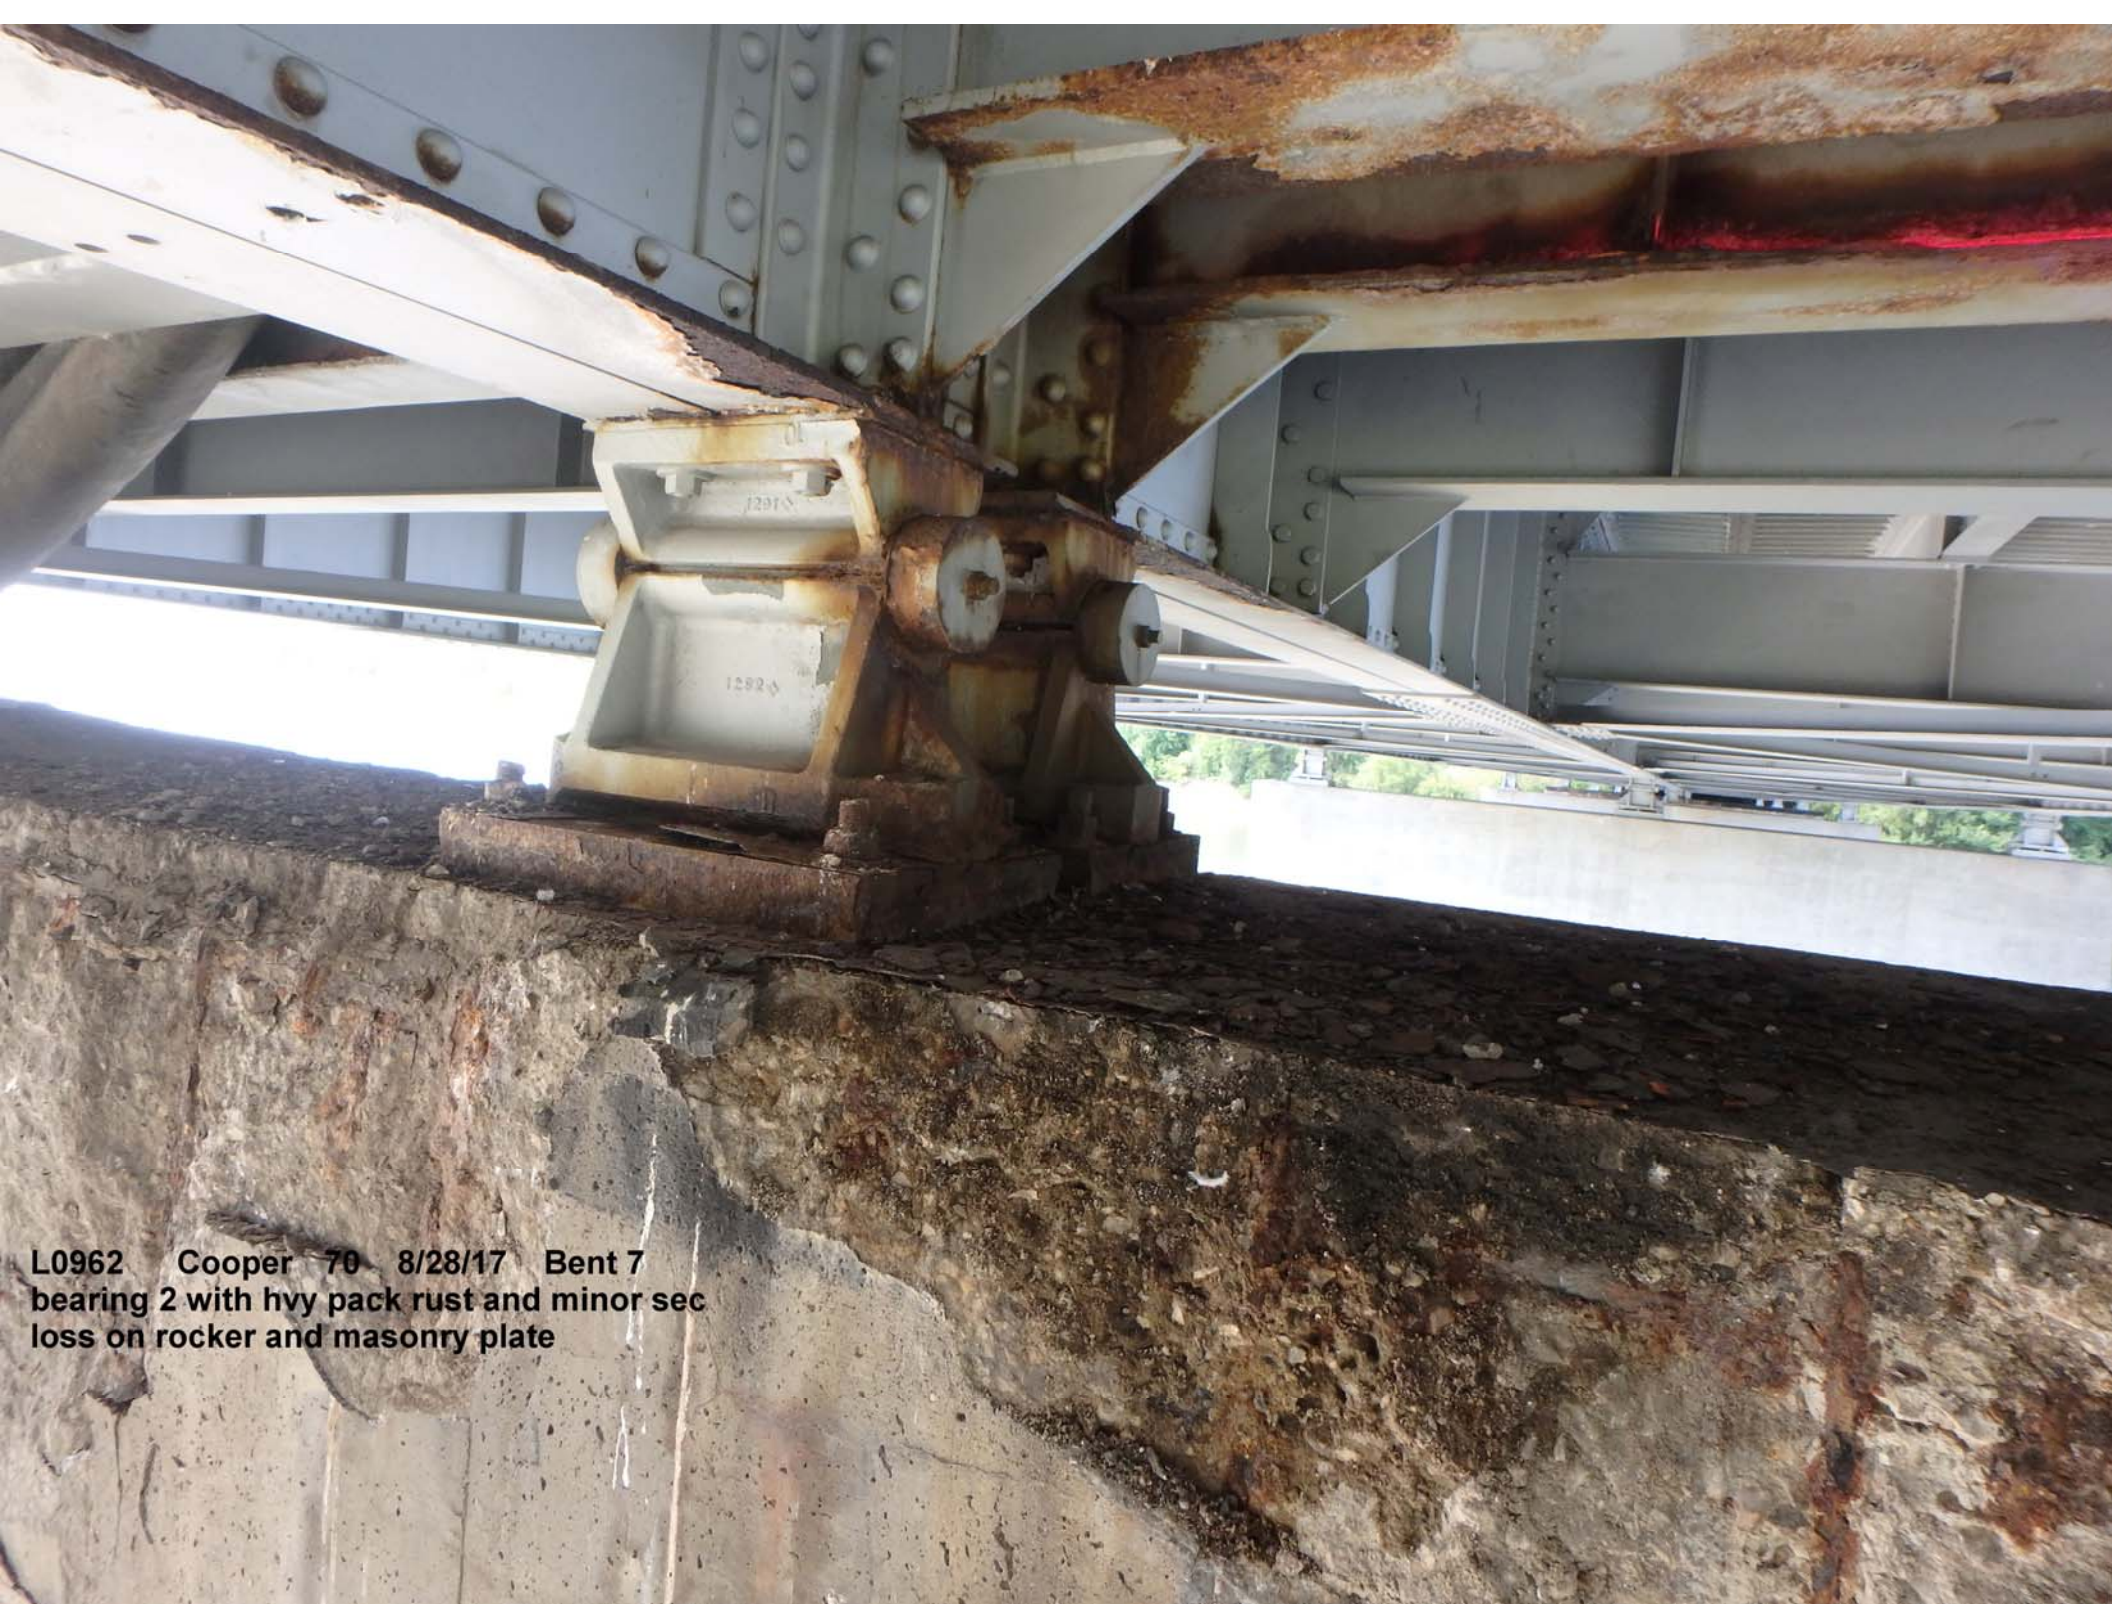
L0962 Cooper 70 8/28/17 Bent 7
bearing 2 with hvy pack rust and minor sec
loss on rocker and masonry plate

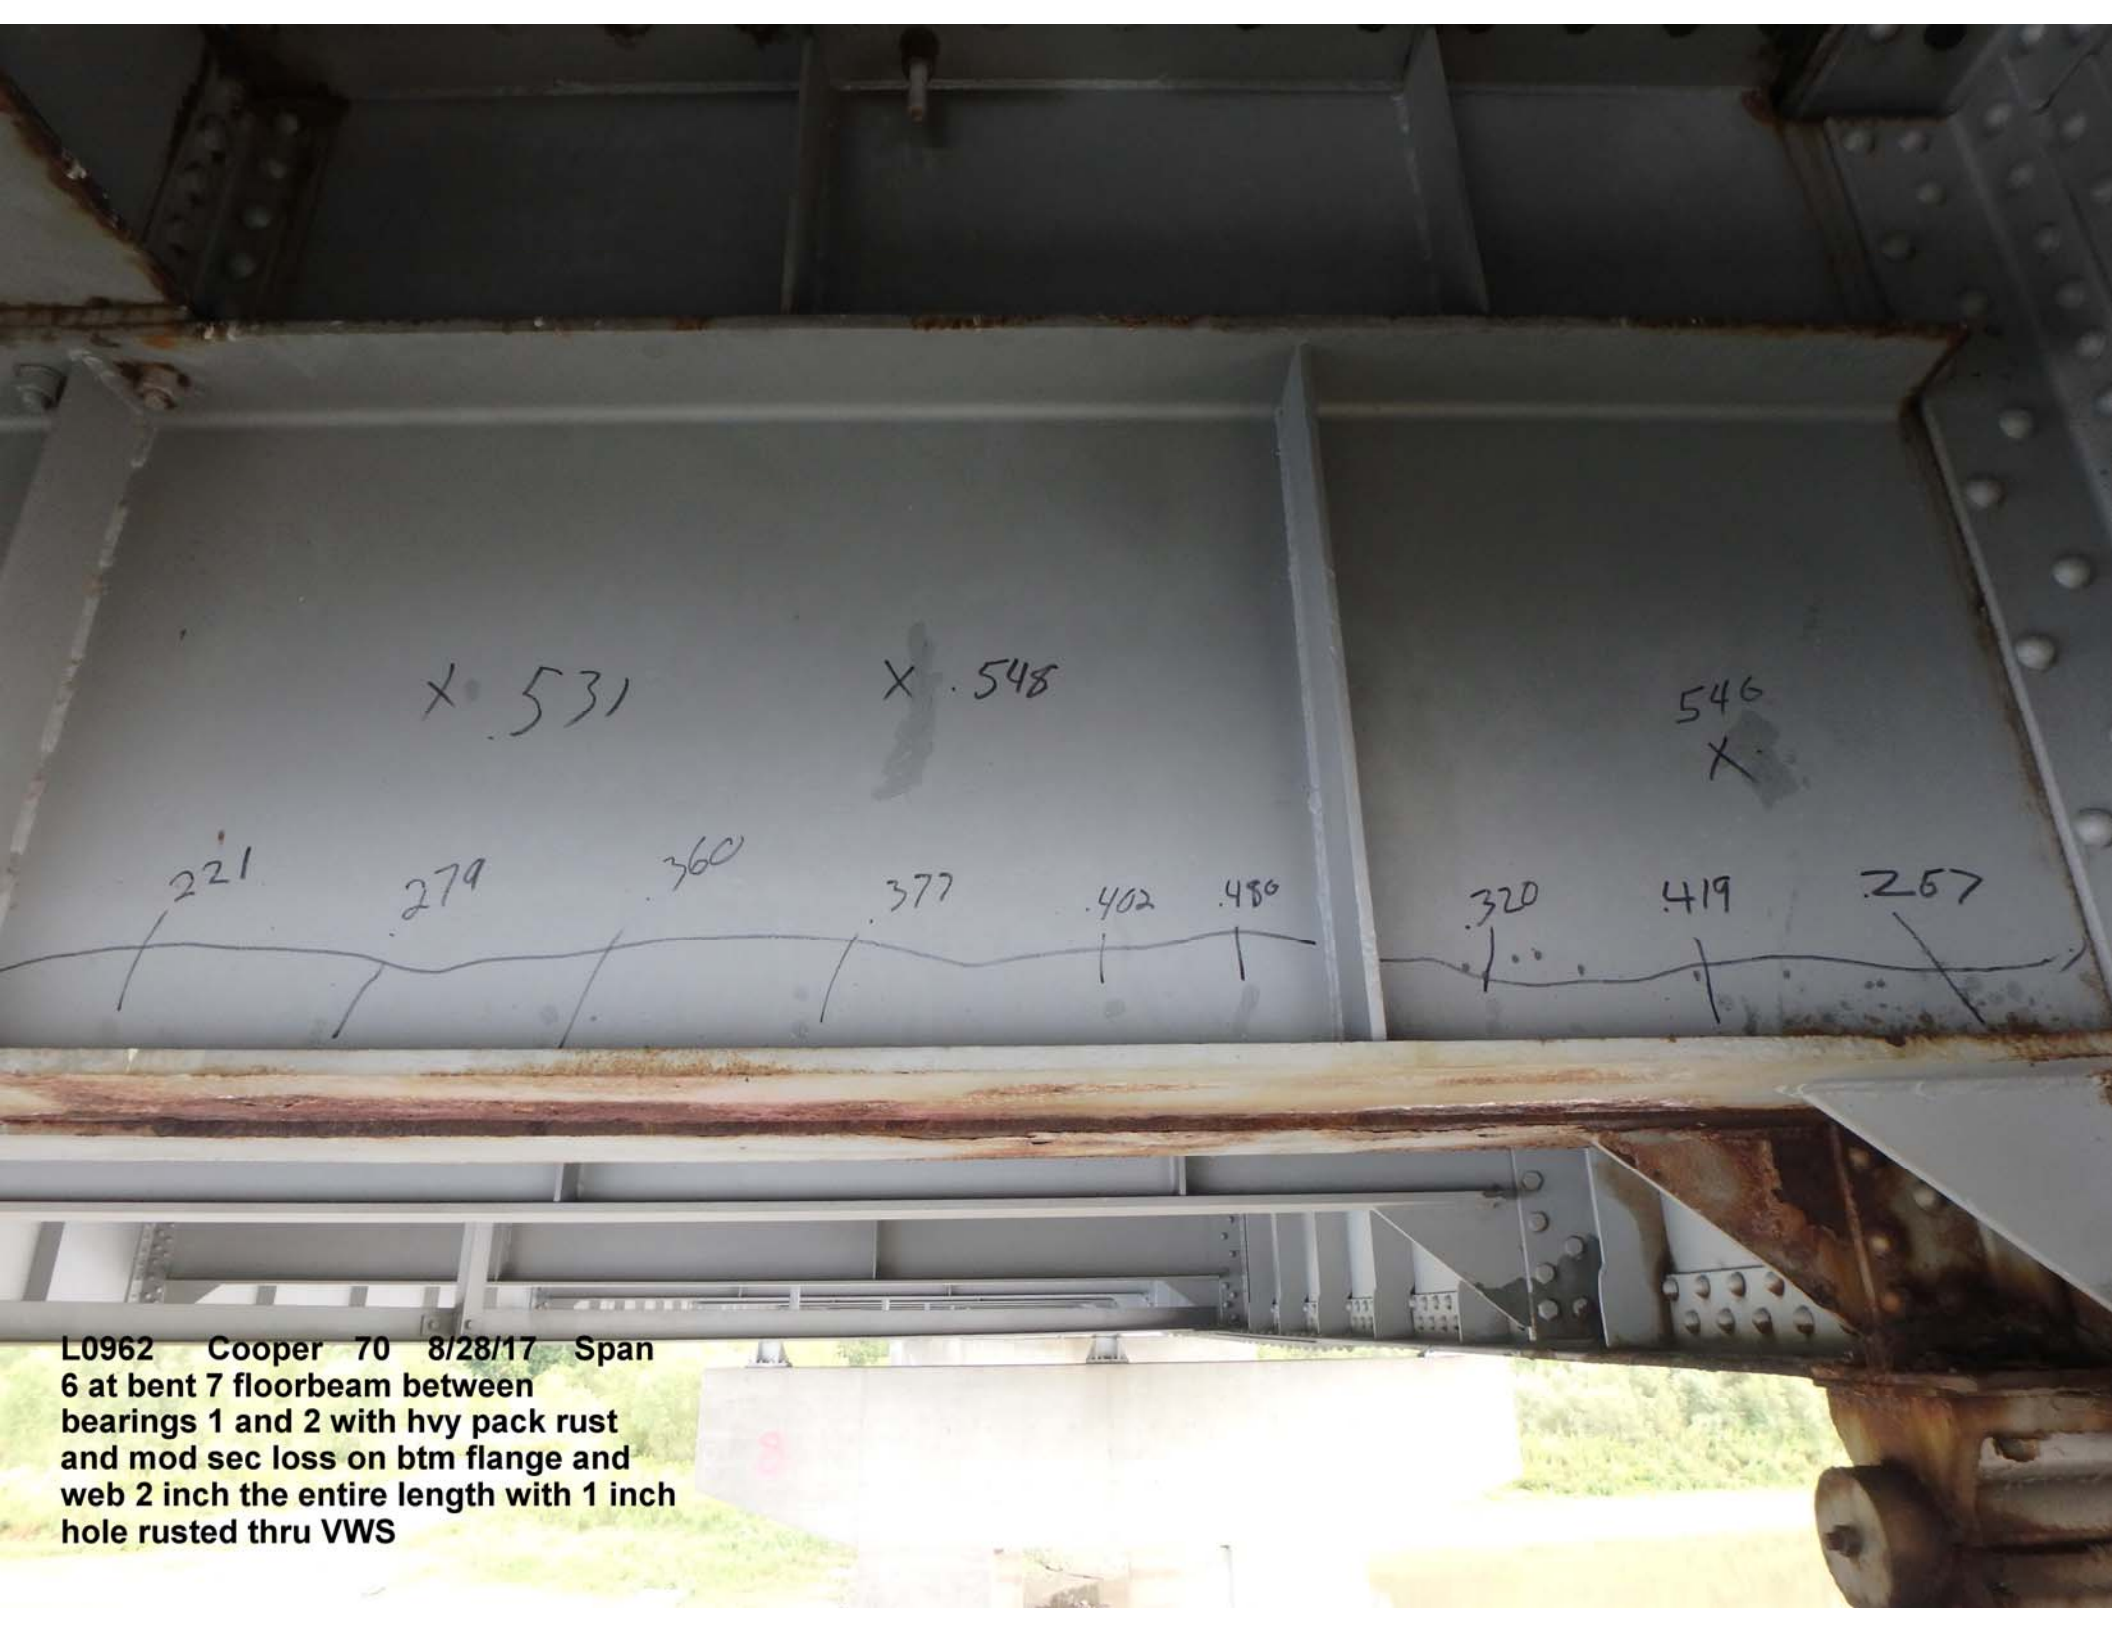
L0962 Cooper 70 8/28/17 Span
6 at bent 7 floorbeam between
bearings 1 and 2 with hvy pack rust
and mod sec loss on btm flange and
web 2 inch the entire length with 1 inch
hole rusted thru VWS

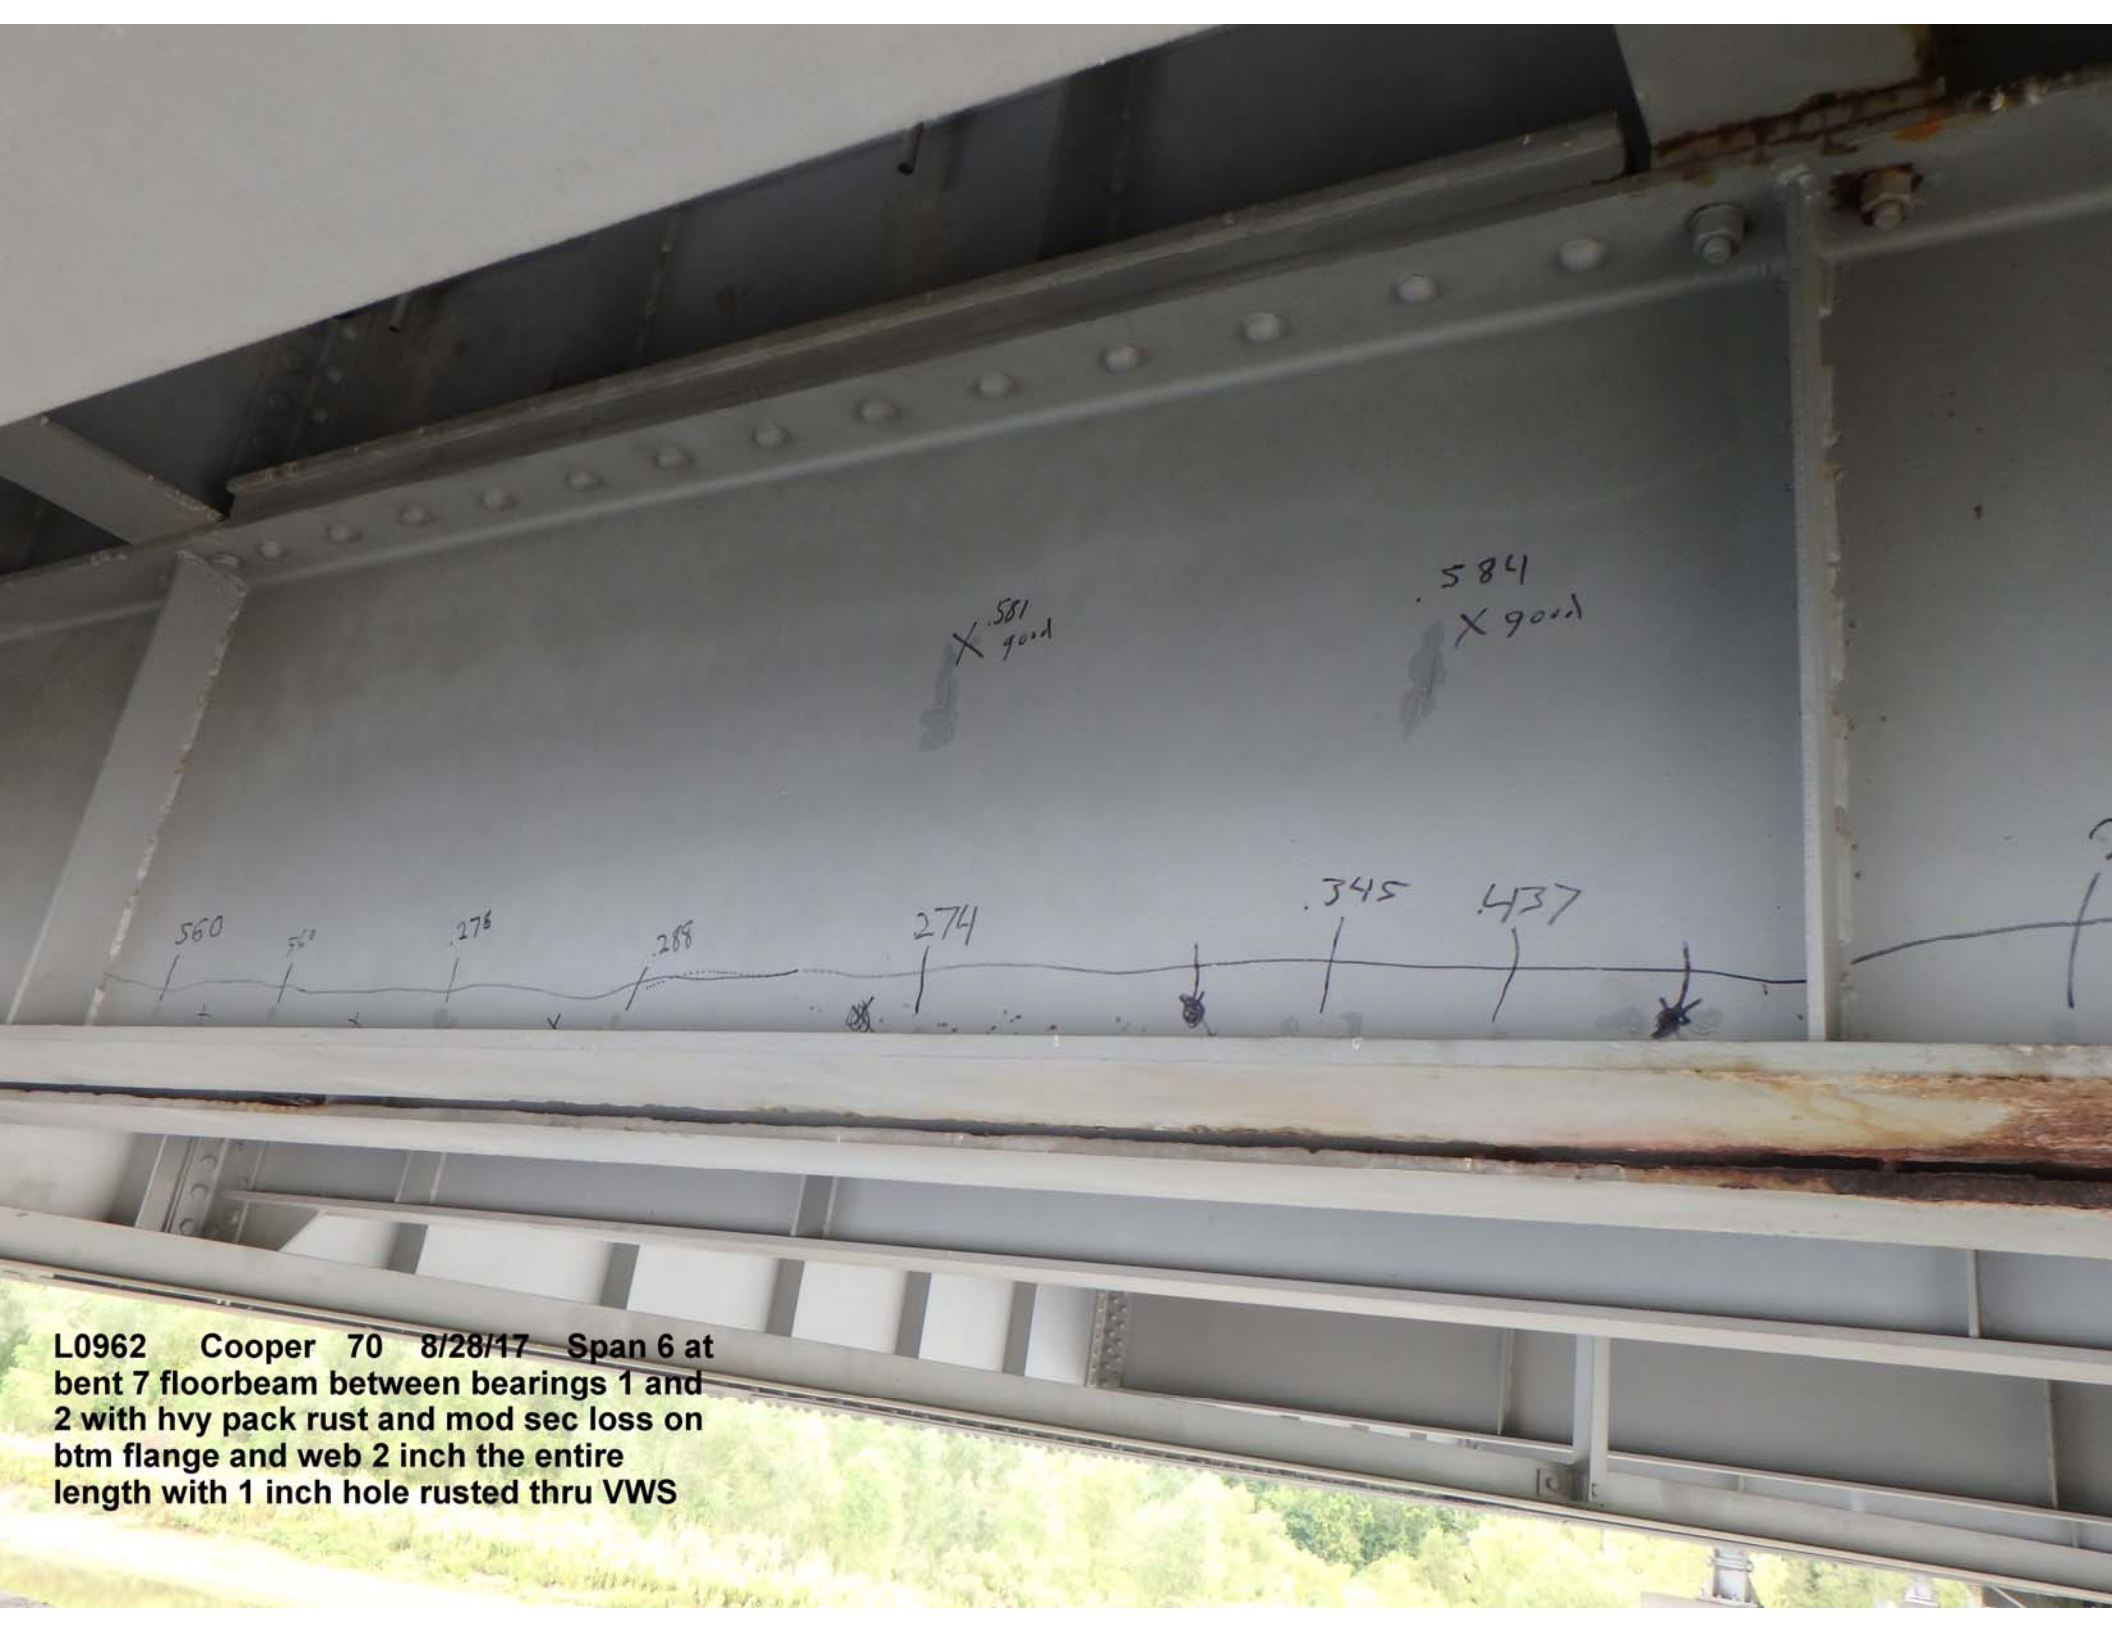
L0962 Cooper 70 8/28/17 Span 6 at bent 7 floorbeam between bearings 1 and 2 with hvy pack rust and mod sec loss on btm flange and web 2 inch the entire length with 1 inch hole rusted thru VWS

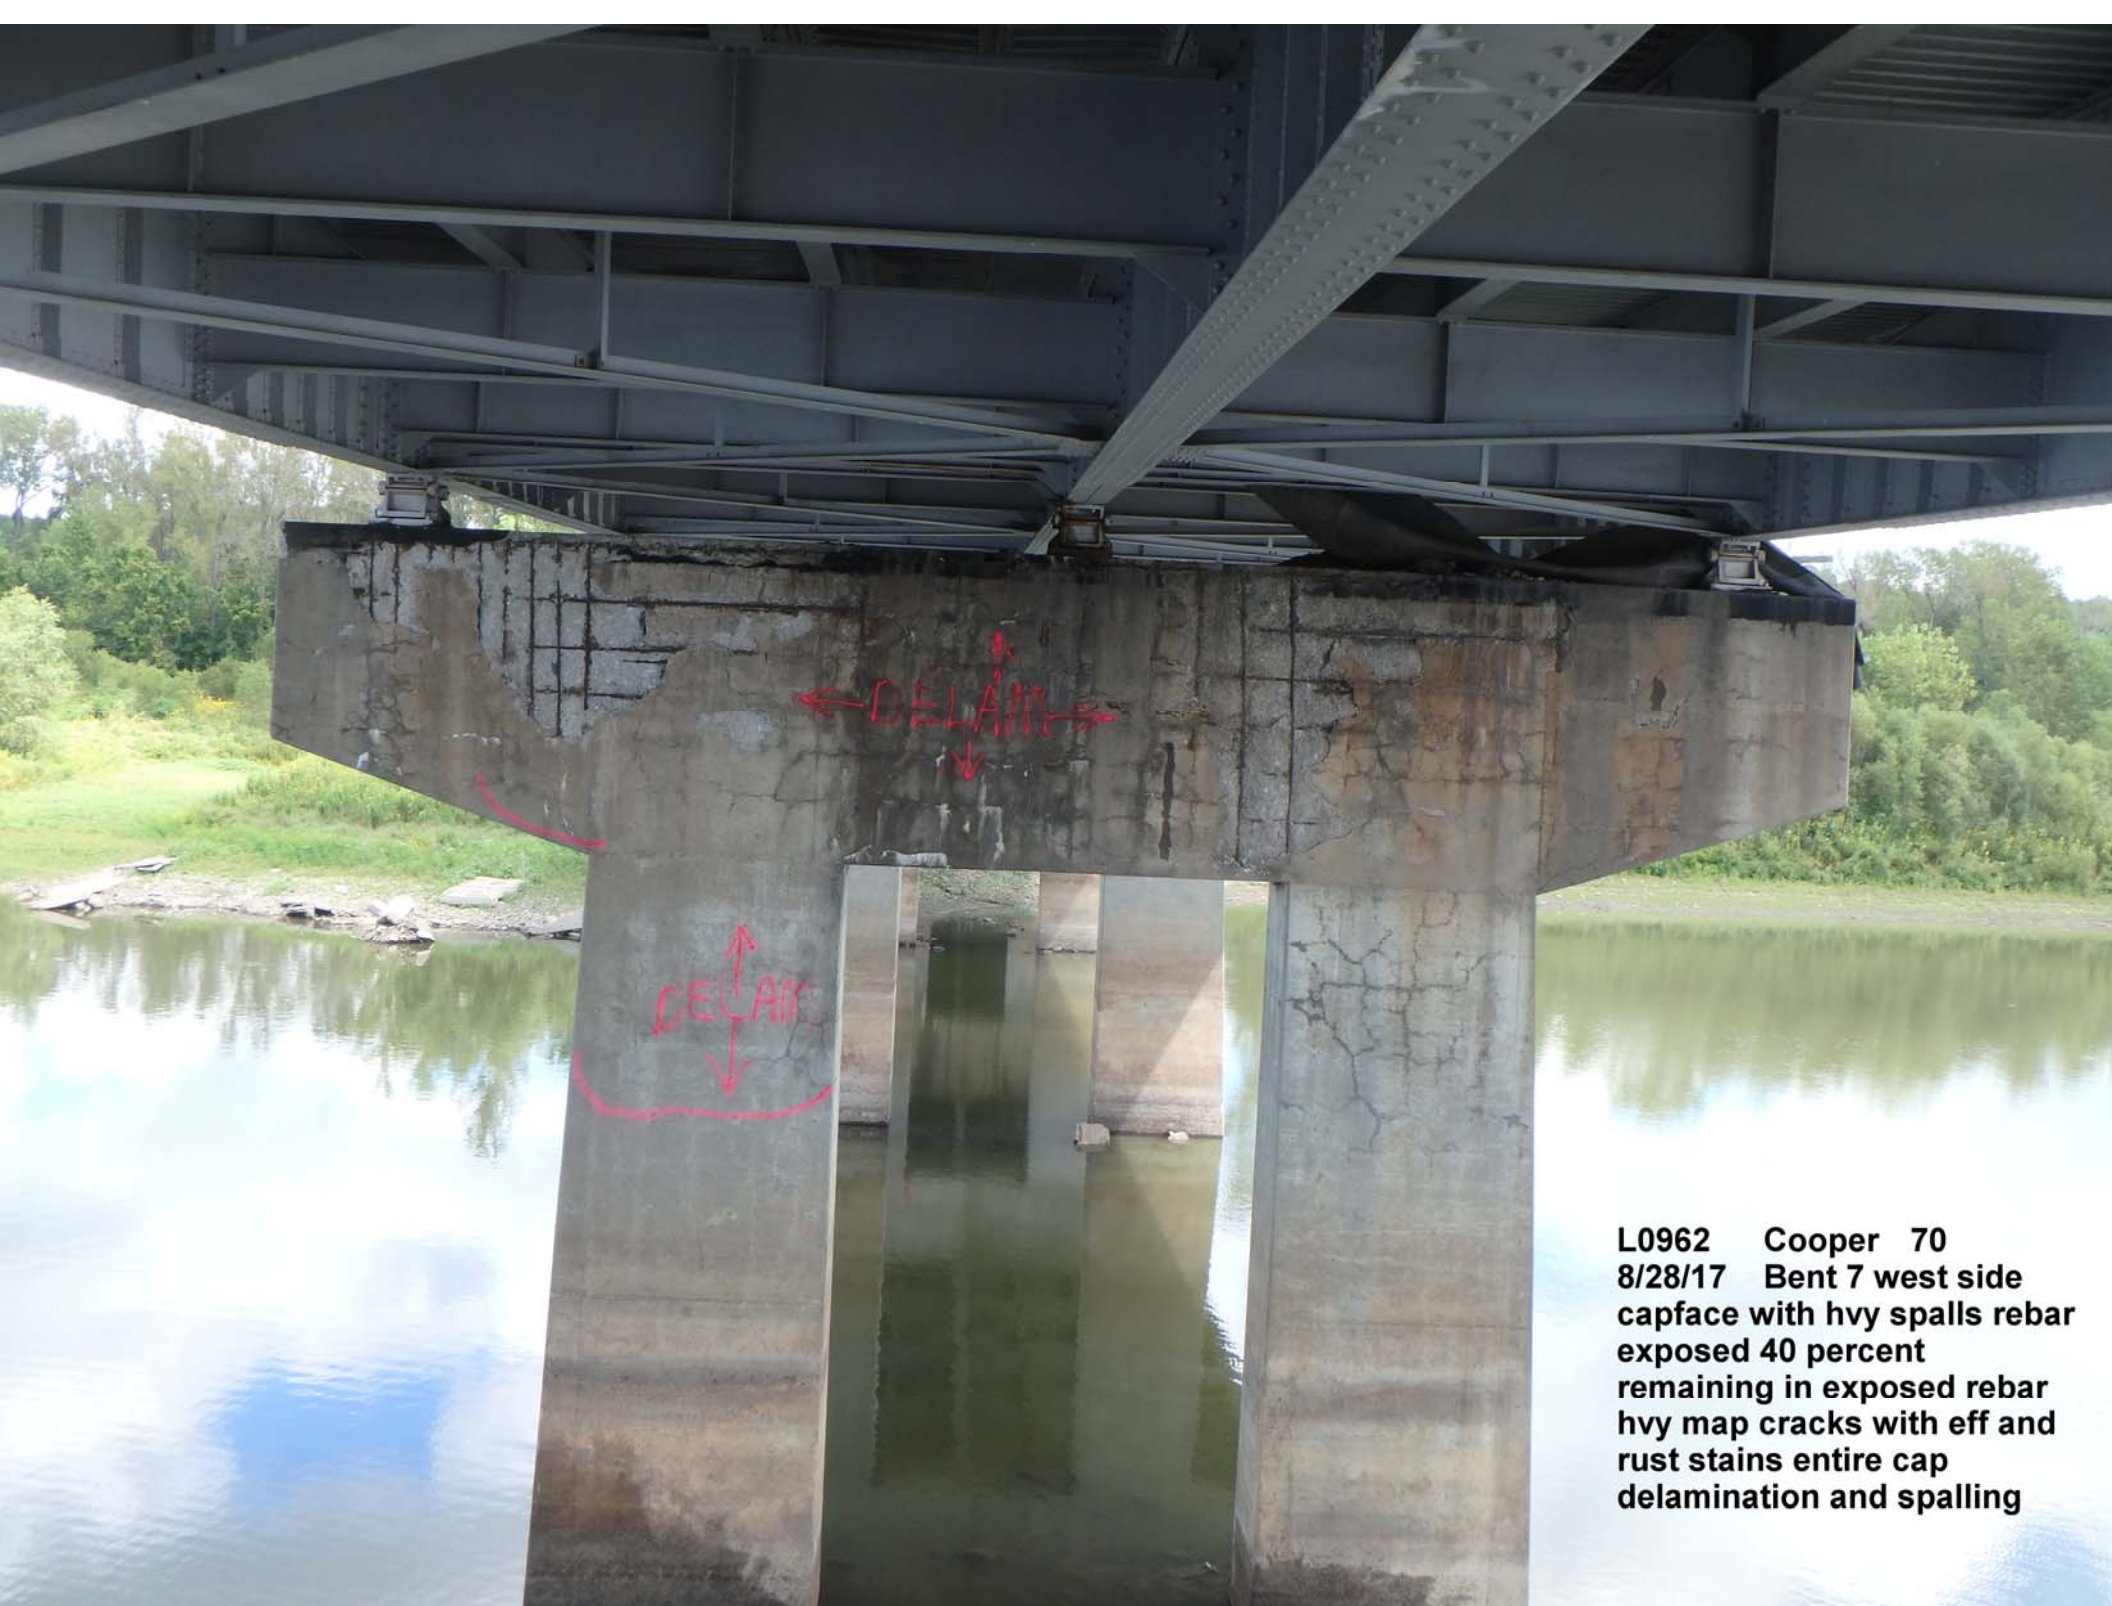
**L0962 Cooper 70
8/28/17 Bent 7 west side
capface with hvy spalls rebar
exposed 40 percent
remaining in exposed rebar
hvy map cracks with eff and
rust stains entire cap
delamination and spalling**

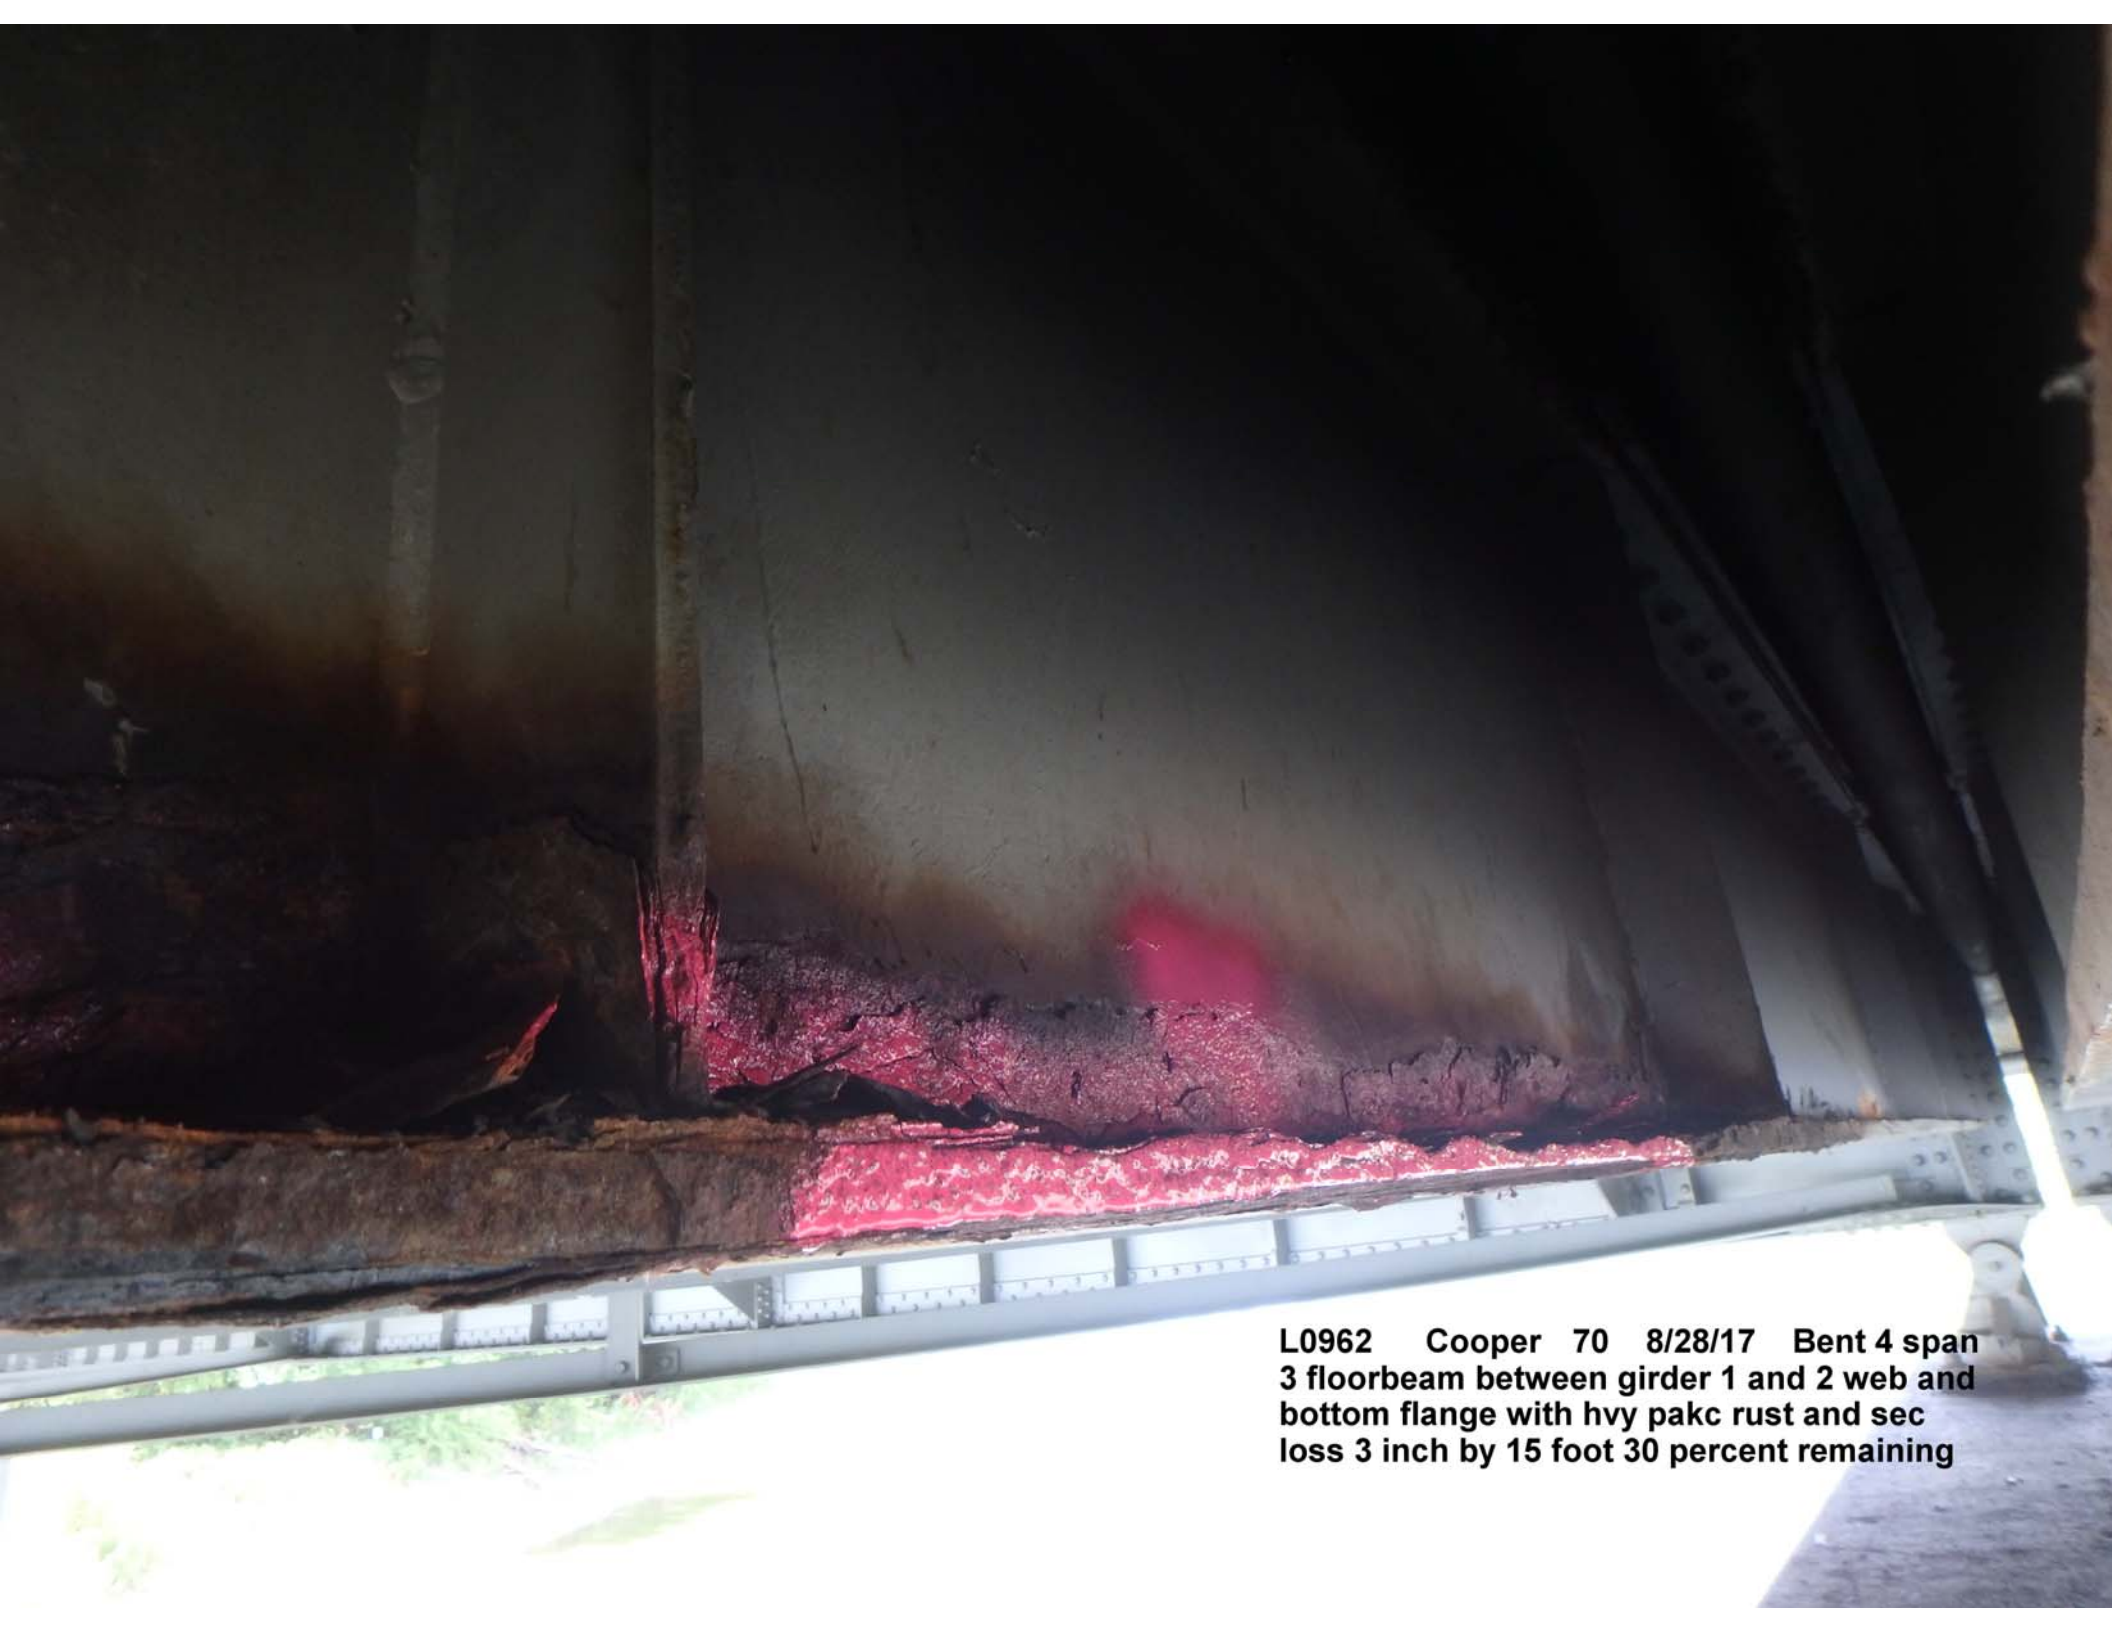
L0962 Cooper 70 8/28/17 Bent 4 span
3 floorbeam between girder 1 and 2 web and
bottom flange with hvy pakc rust and sec
loss 3 inch by 15 foot 30 percent remaining
