L0962 Cooper 70 8/28/17
P13 east side lrg area of map
cracks with saturation and eff

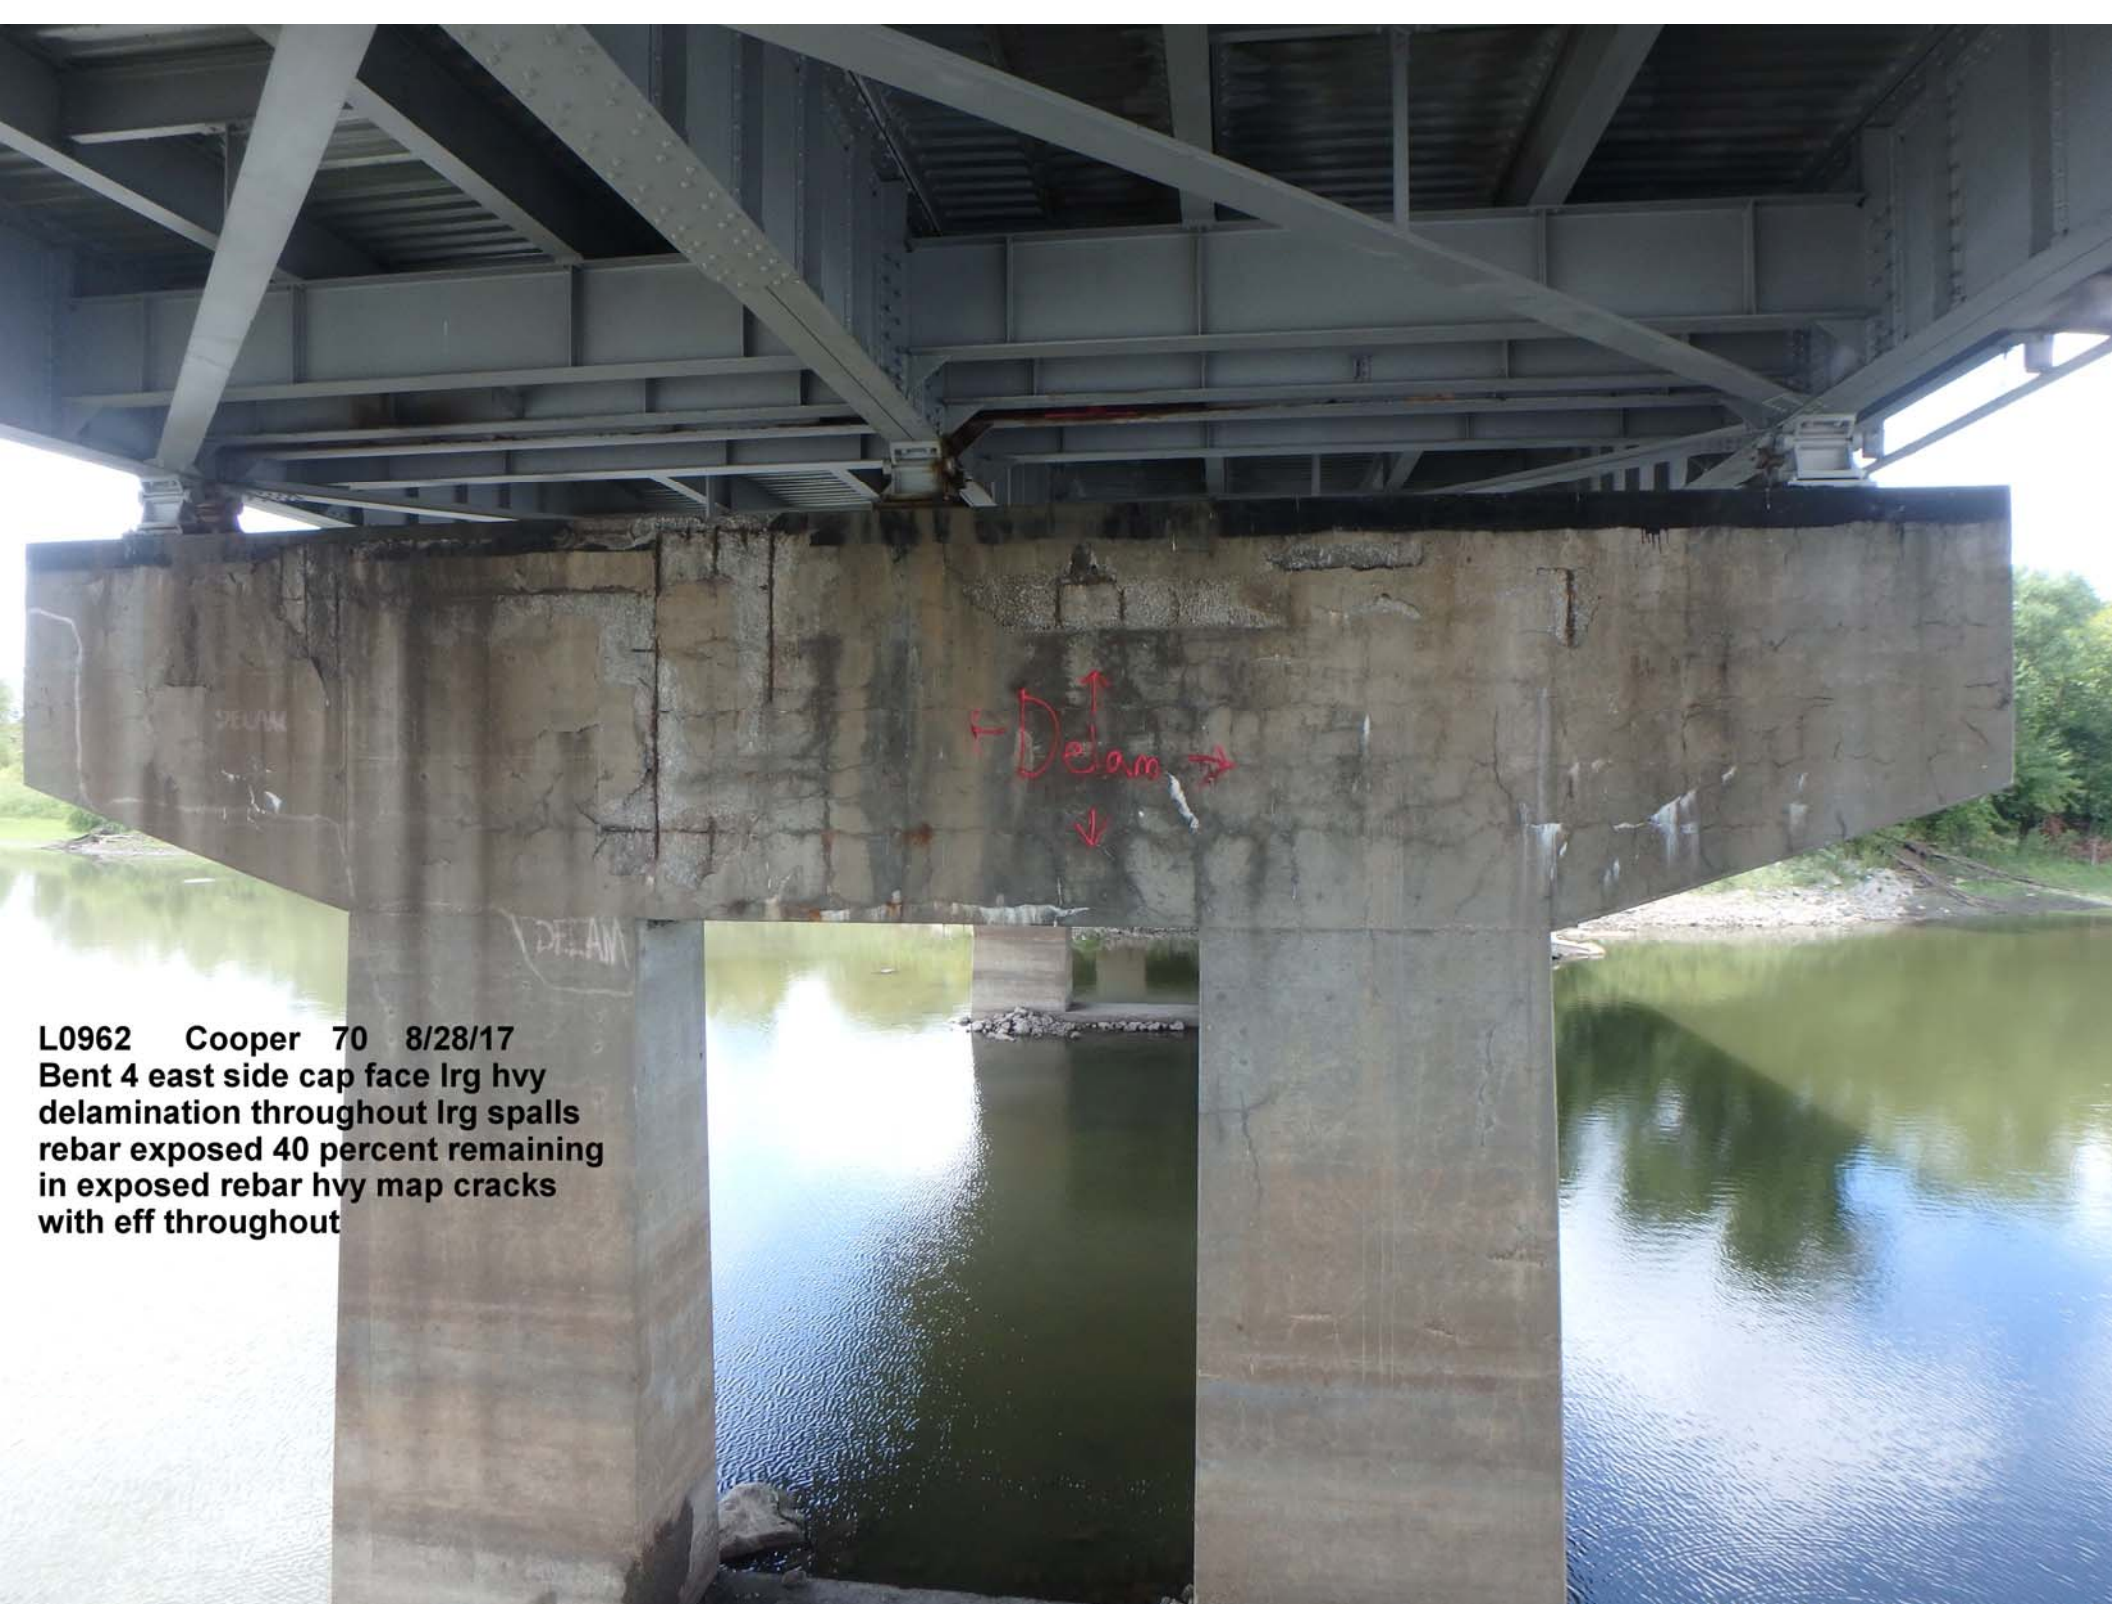
L0962 Cooper 70 8/28/17
Bent 4 east side cap face lrg hvy
delamination throughout lrg spalls
rebar exposed 40 percent remaining
in exposed rebar hvy map cracks
with eff throughout

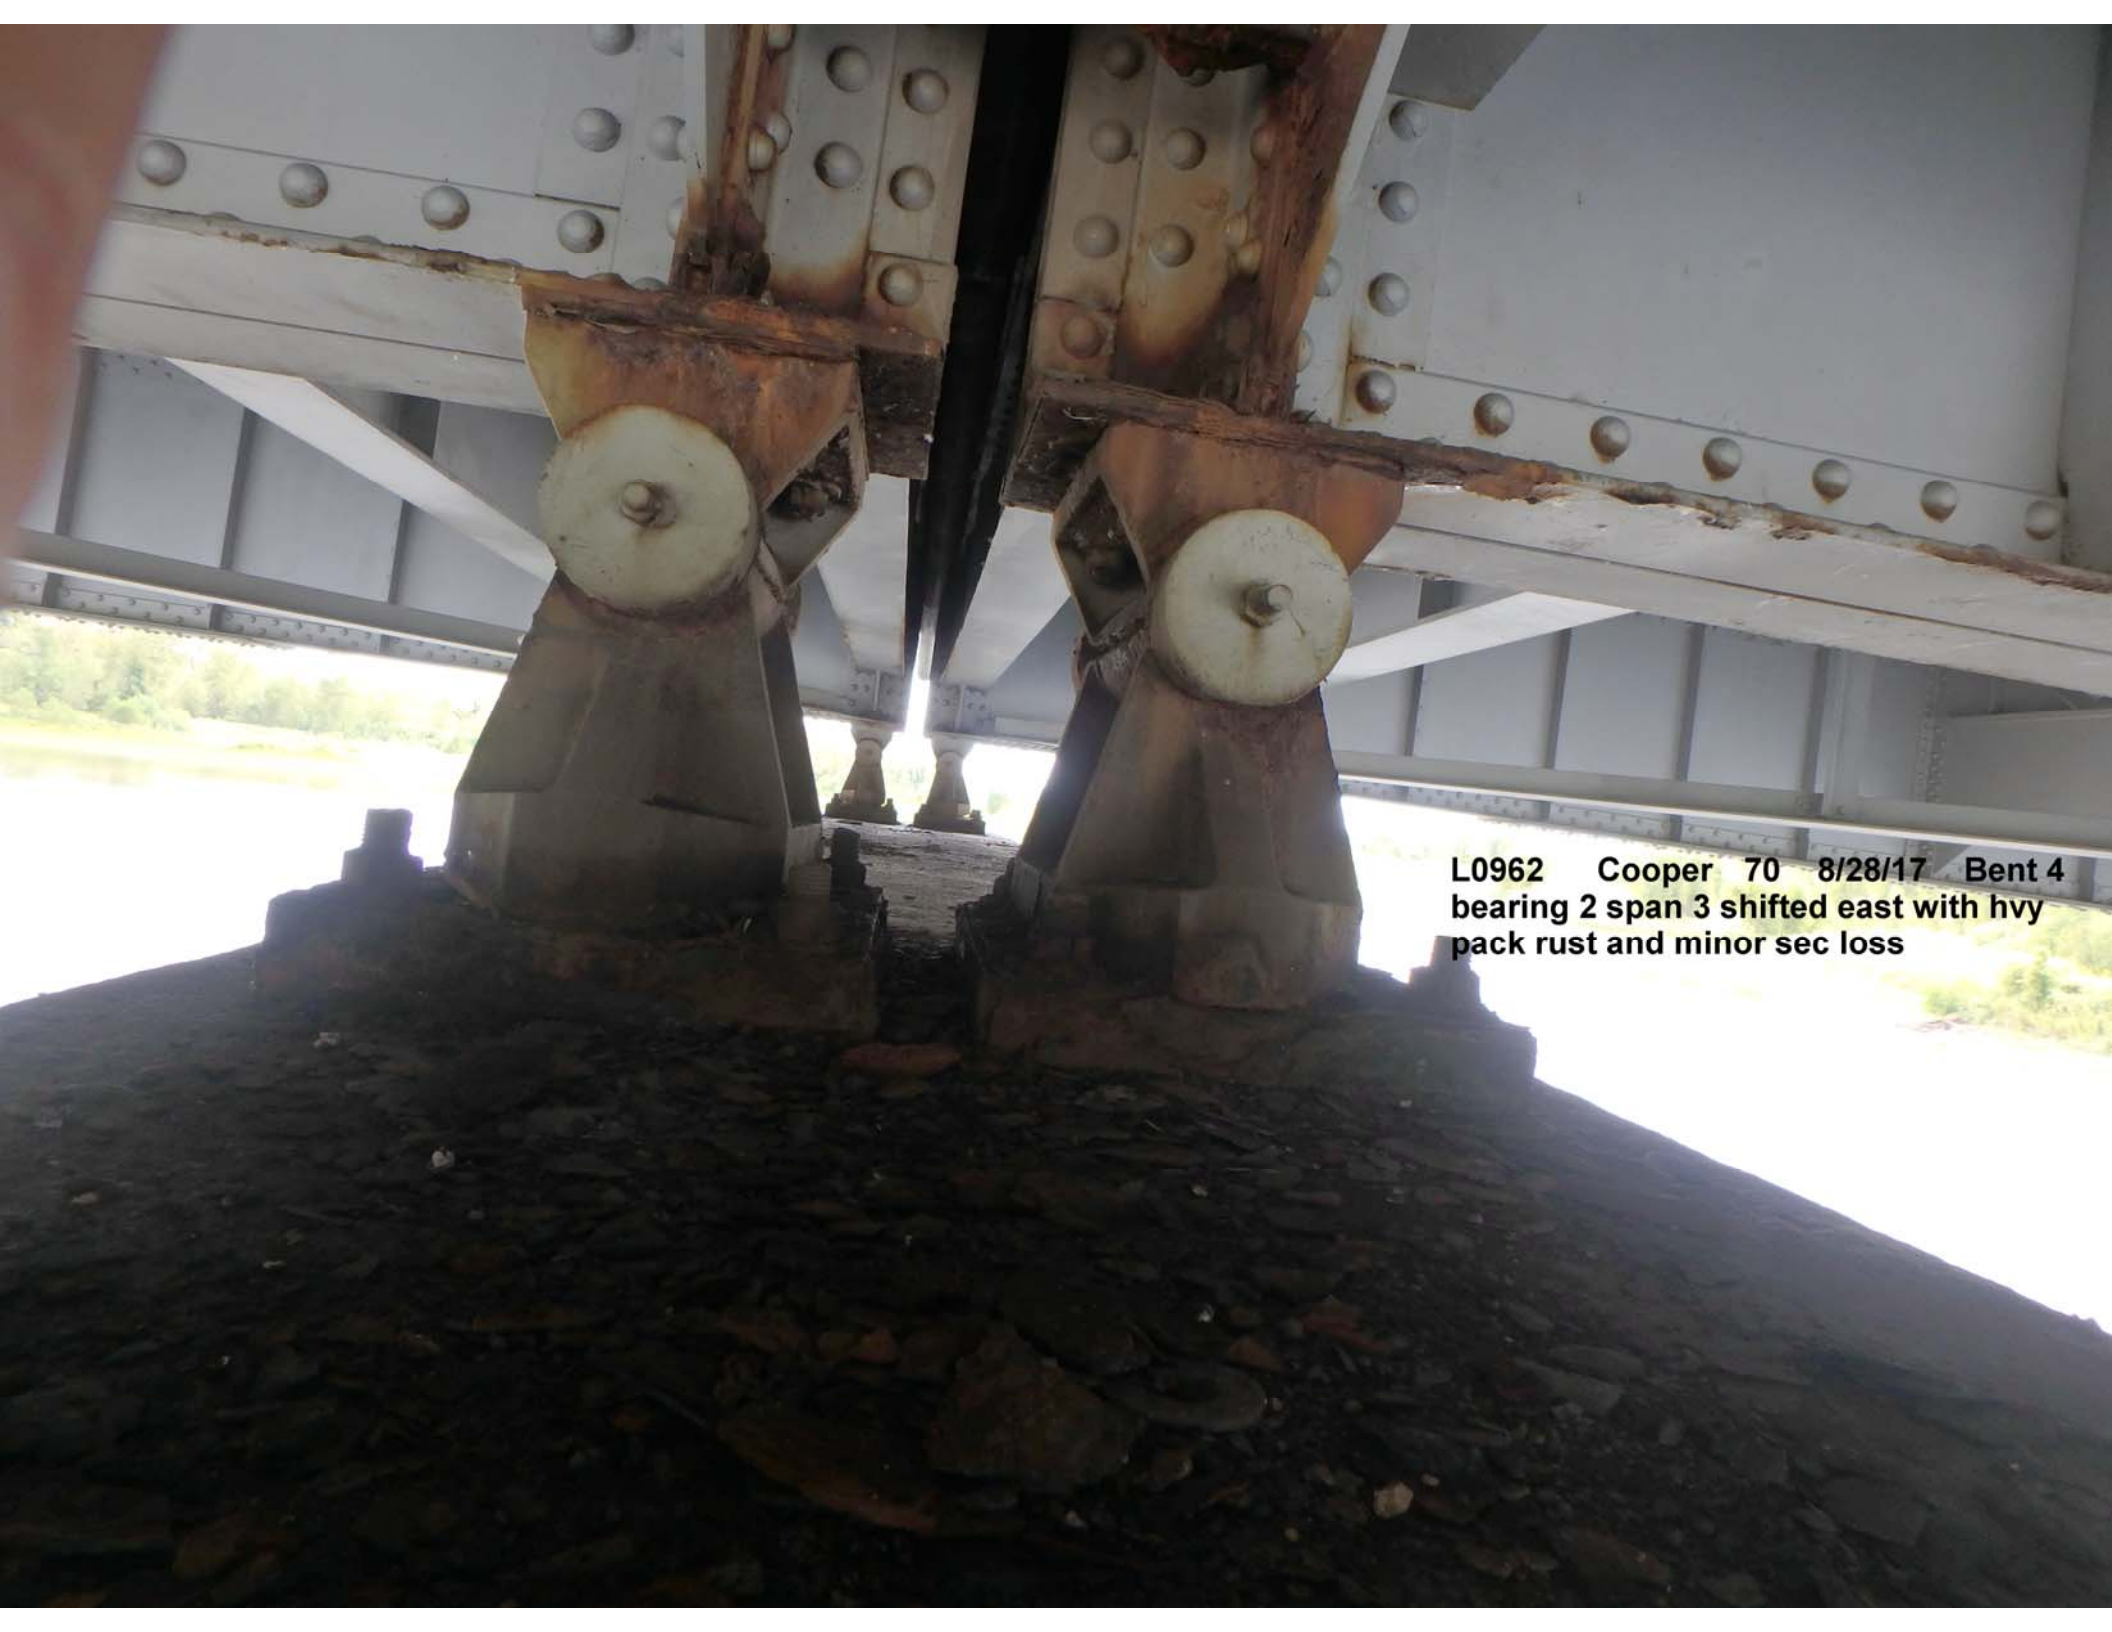
L0962 Cooper 70 8/28/17 Bent 4
bearing 2 span 3 shifted east with hvy
pack rust and minor sec loss

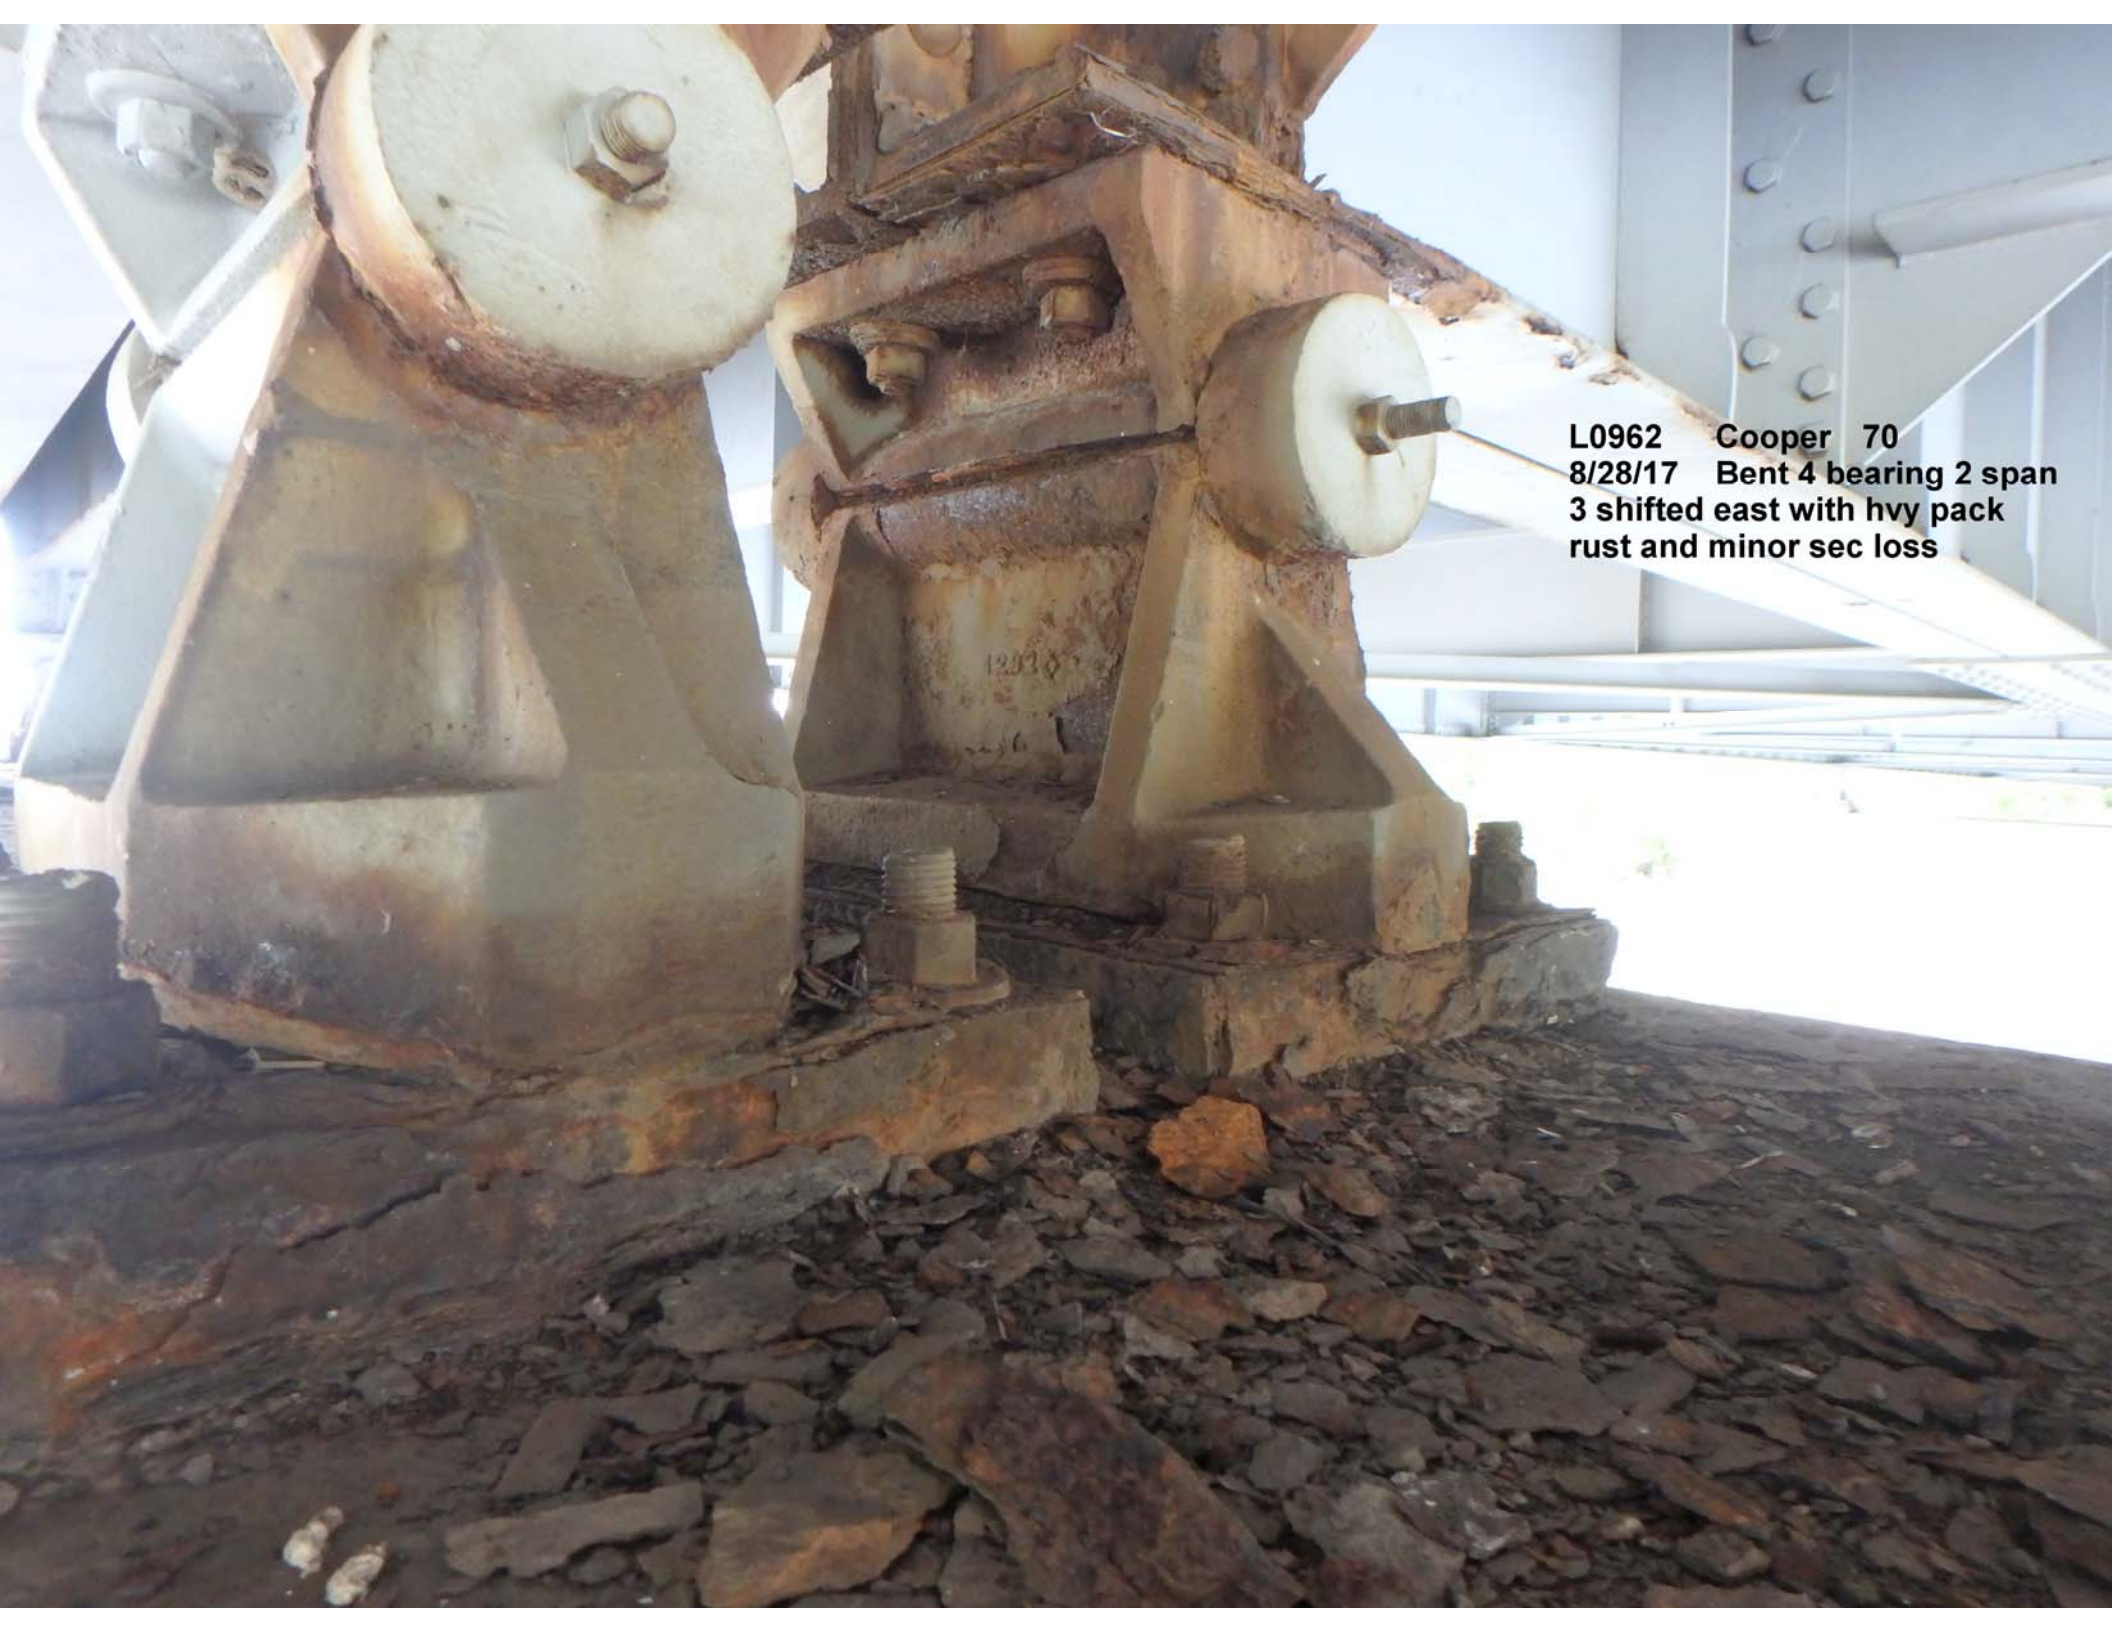
L0962 Cooper 70
8/28/17 Bent 4 bearing 2 span
3 shifted east with hvy pack
rust and minor sec loss

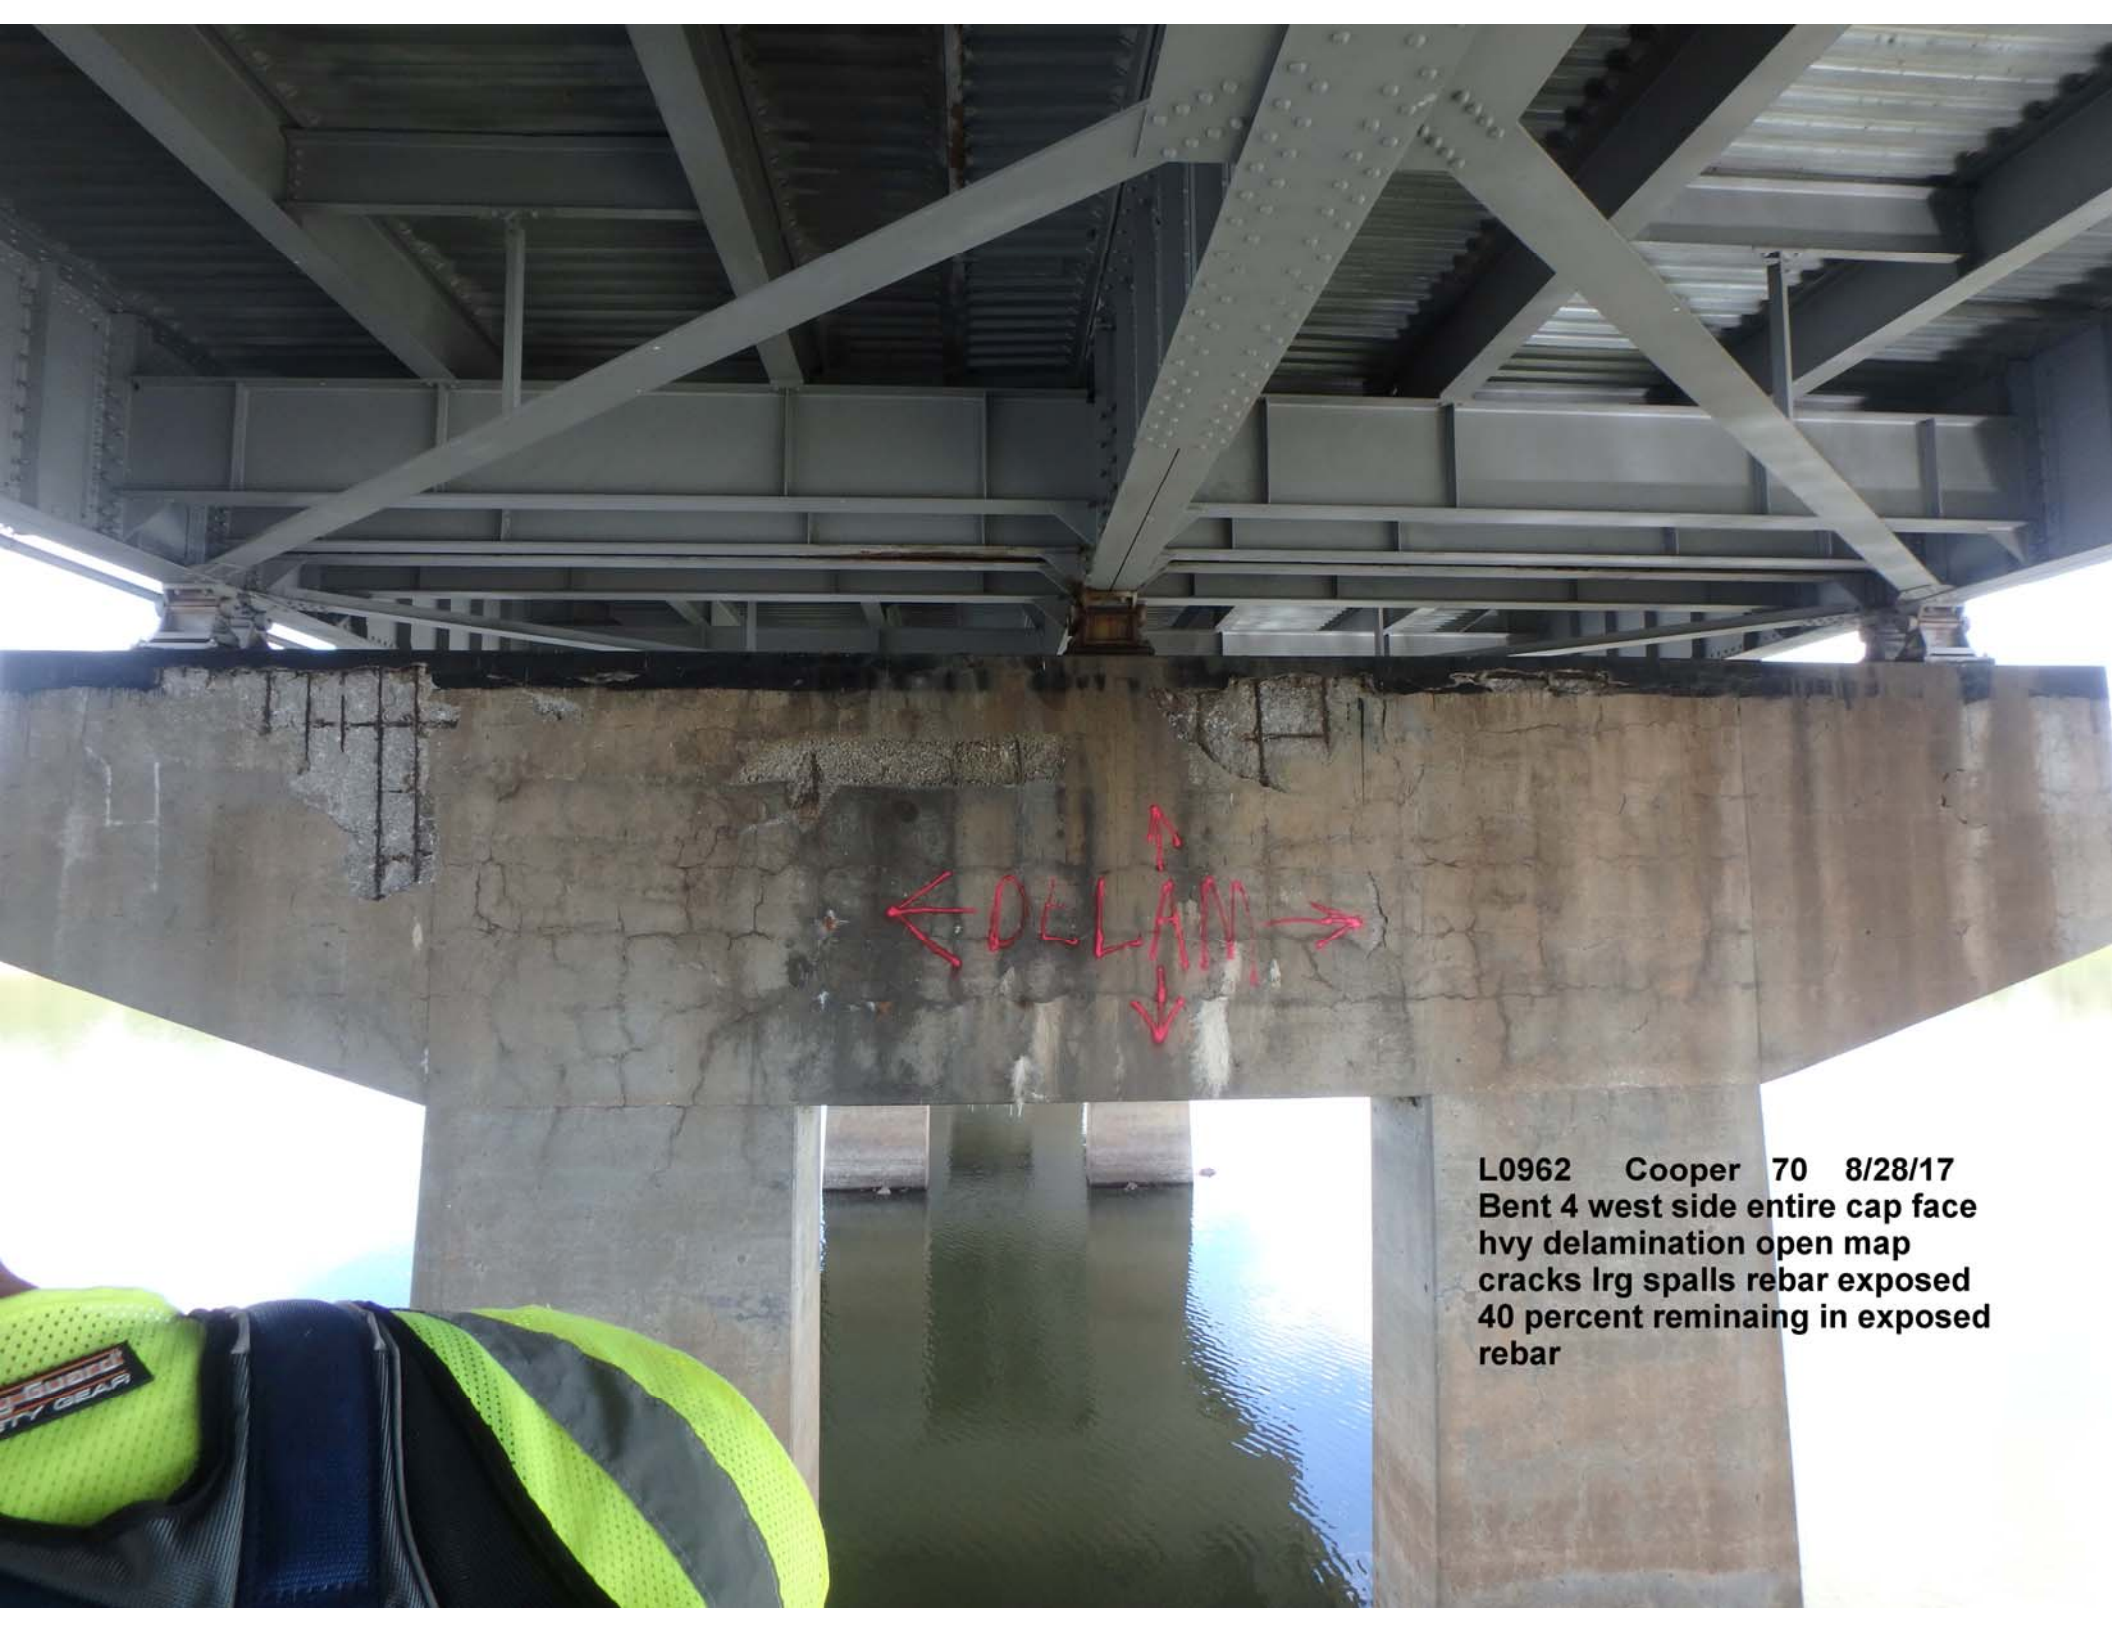
L0962 Cooper 70 8/28/17
Bent 4 west side entire cap face
hvy delamination open map
cracks lrg spalls rebar exposed
40 percent reminaing in exposed
rebar

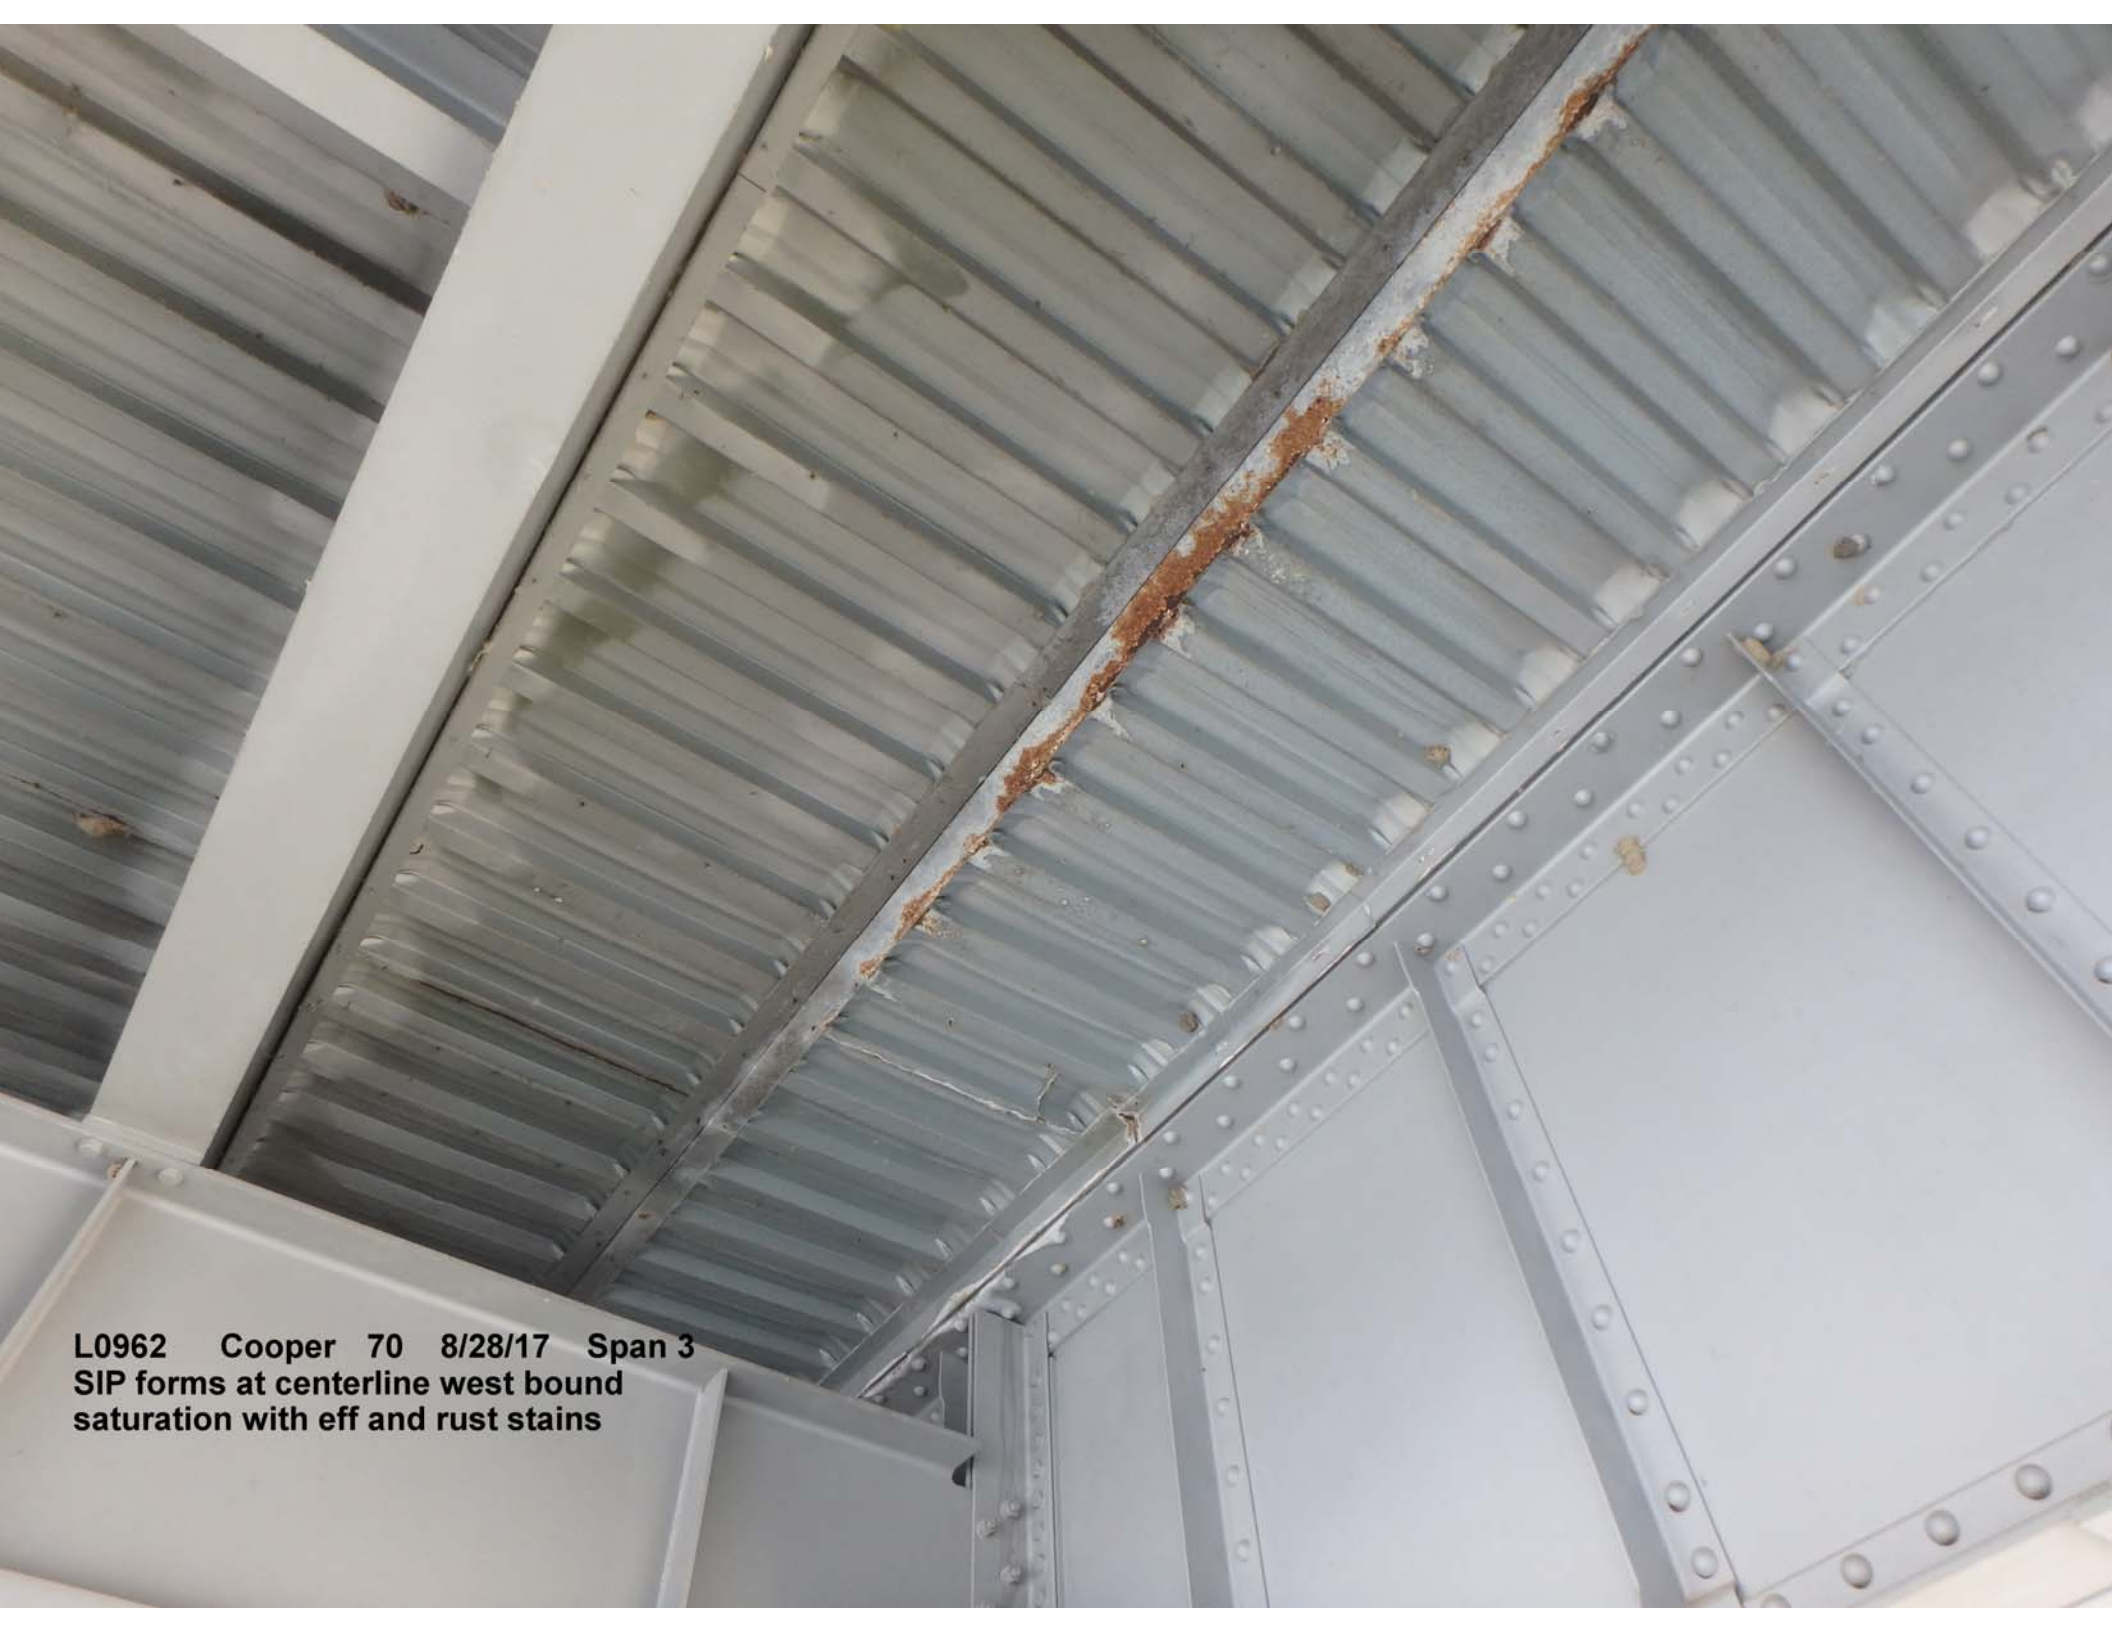
L0962 Cooper 70 8/28/17 Span 3
SIP forms at centerline west bound
saturation with eff and rust stains

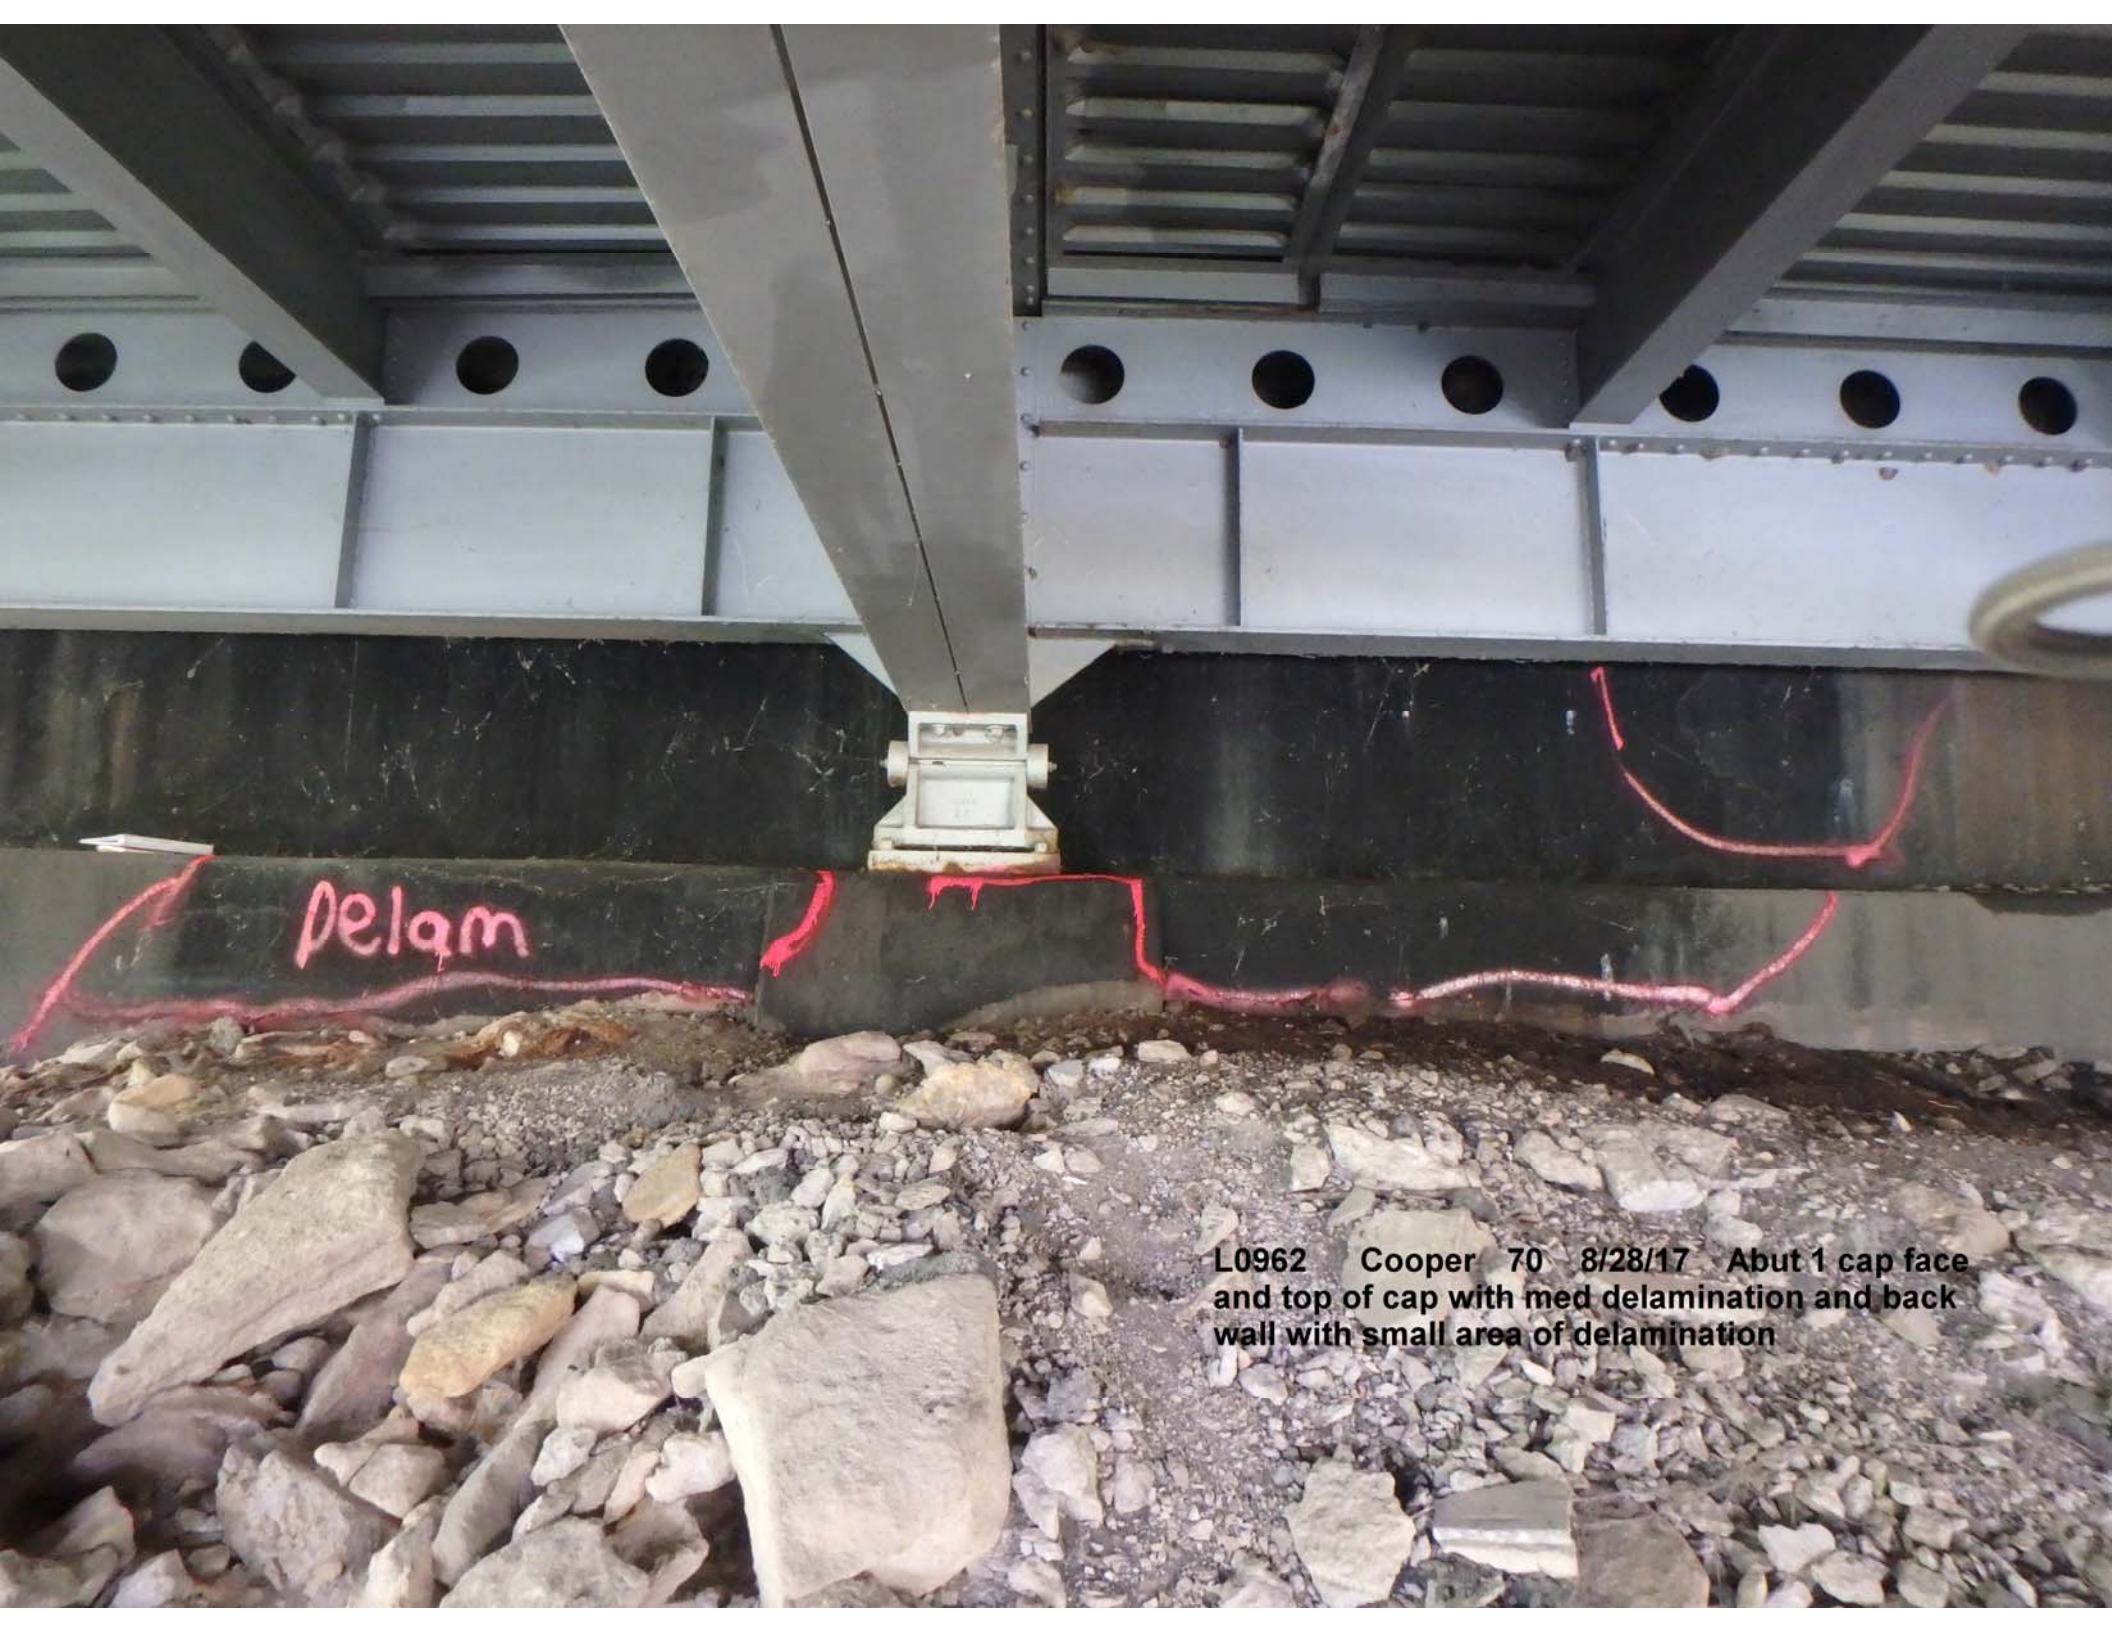
L0962 Cooper 70 8/28/17 Abut 1 cap face and top of cap with med delamination and back wall with small area of delamination
