L0962 Cooper 70 8/28/17
P13 east side lrg area of map
cracks with saturation and eff

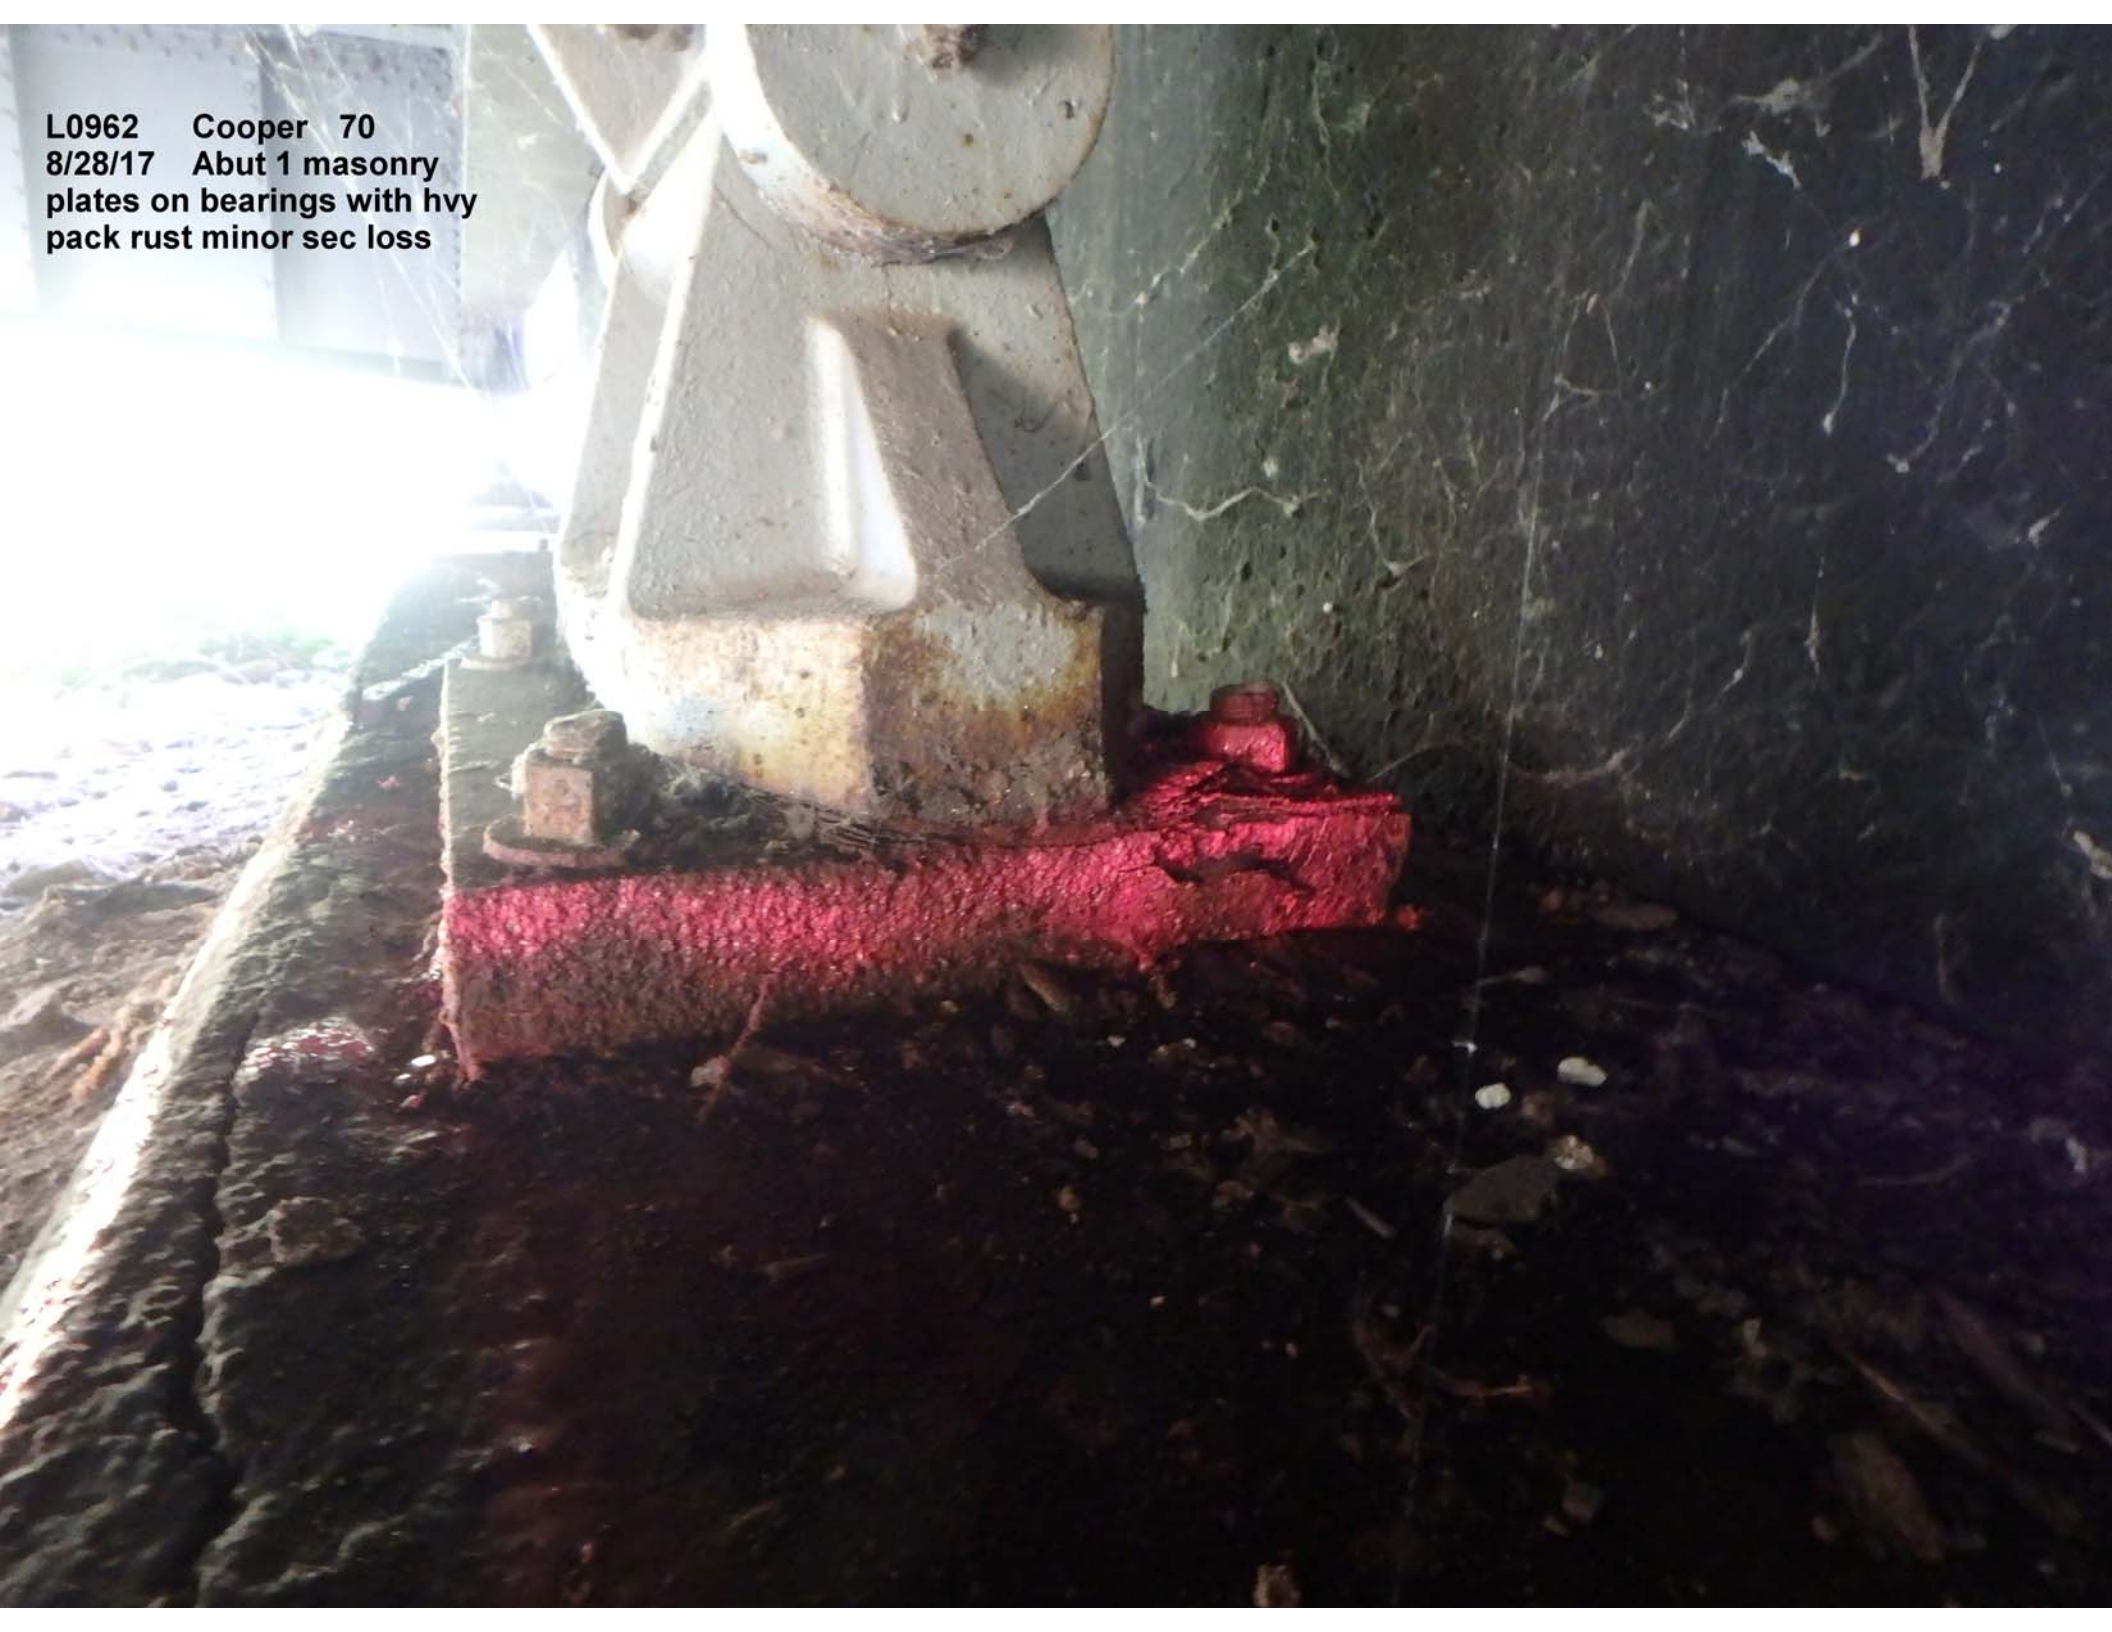
L0962 Cooper 70
8/28/17 Abut 1 masonry
plates on bearings with hvy
pack rust minor sec loss
