L0962 Cooper Co.
08/28/2017
Looking West

L0962 I-70 Cooper
Pier 15 Open Expansion Joint WBL
8-28-17

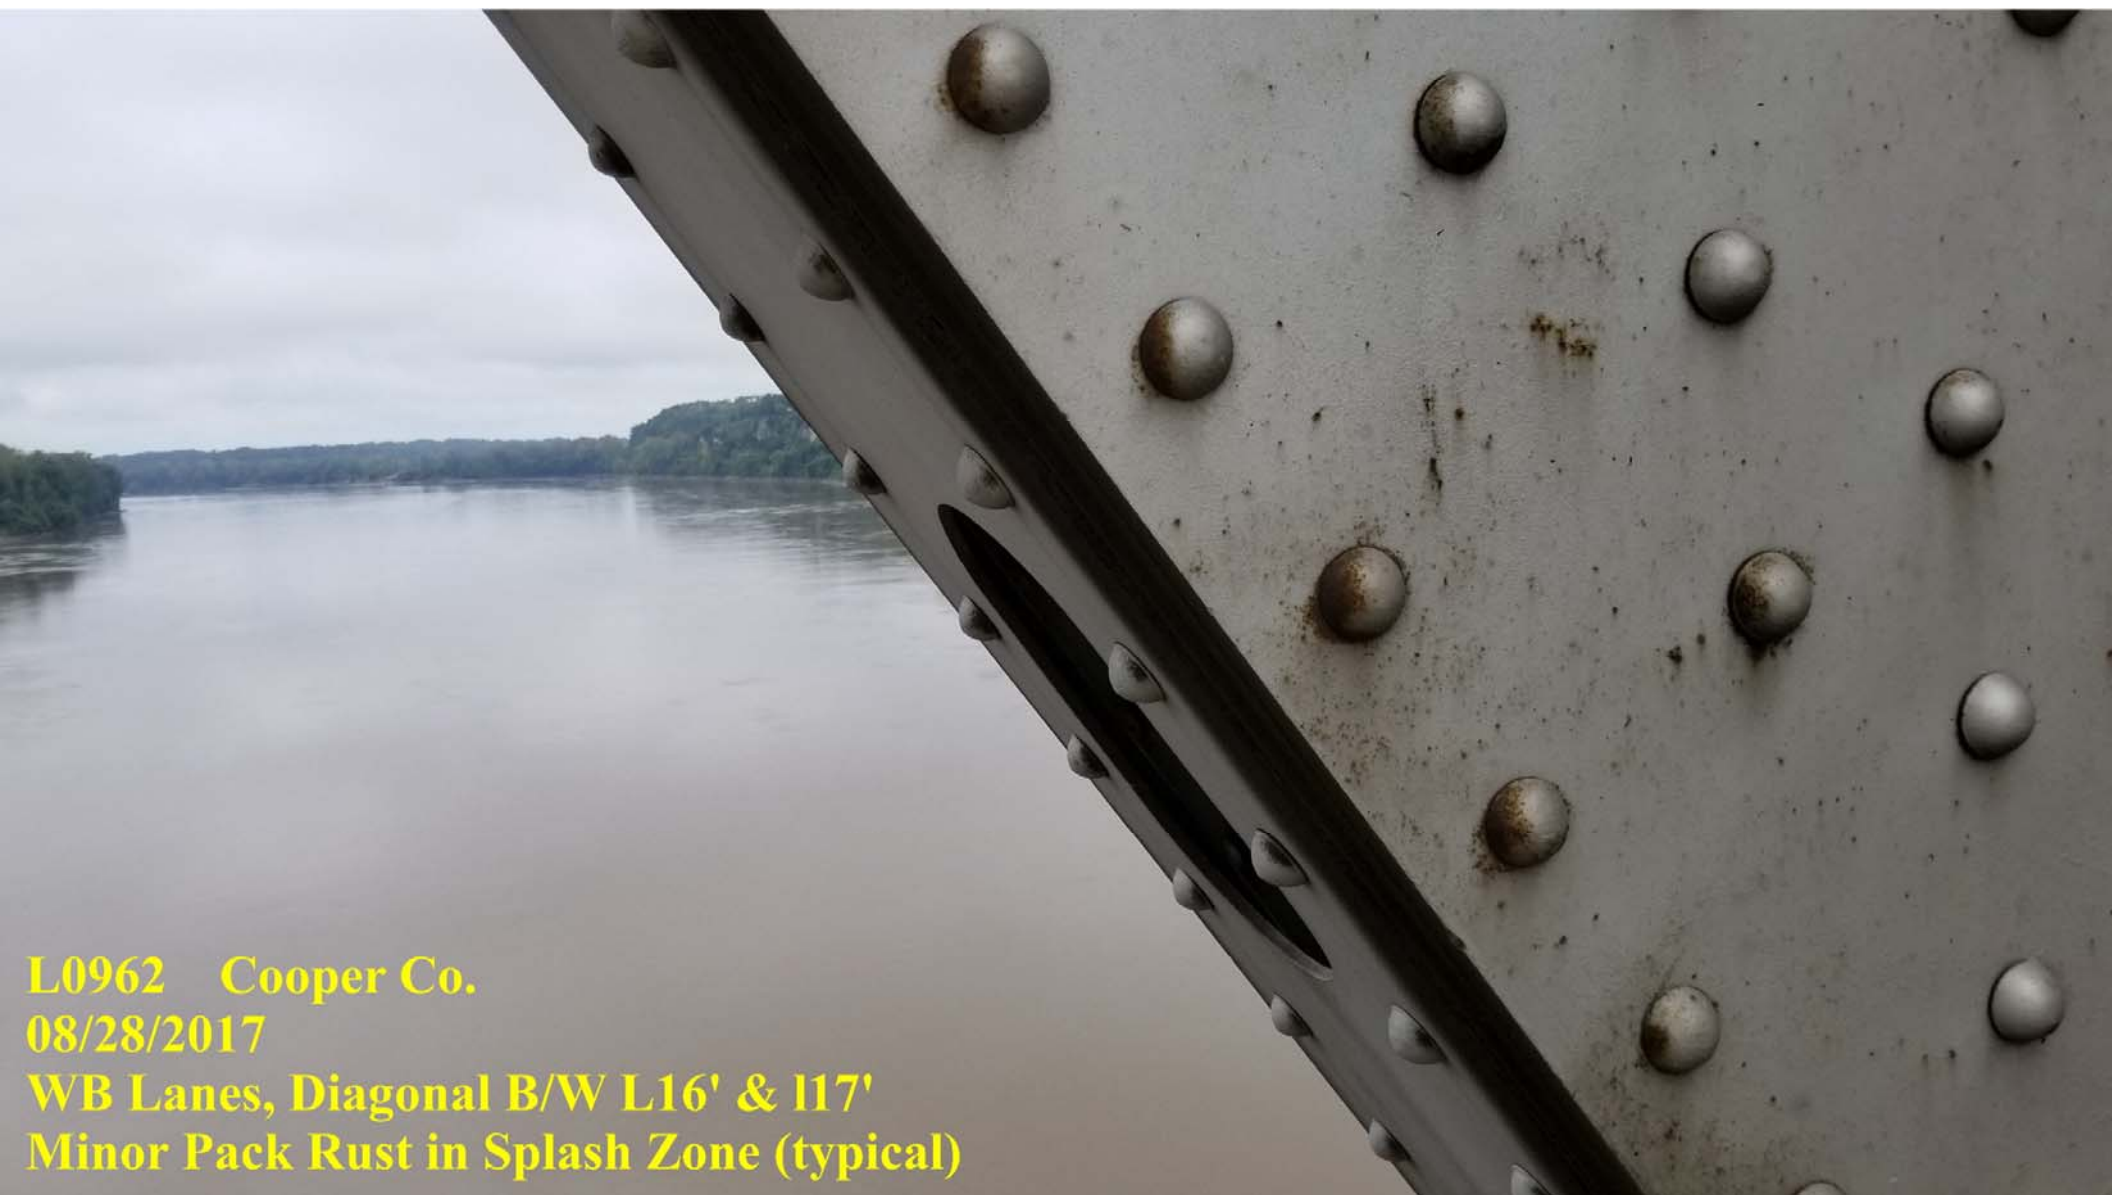
L0962 Cooper Co.
08/28/2017
WB Lanes, Diagonal B/W L16' & 117'
Minor Pack Rust in Splash Zone (typical)

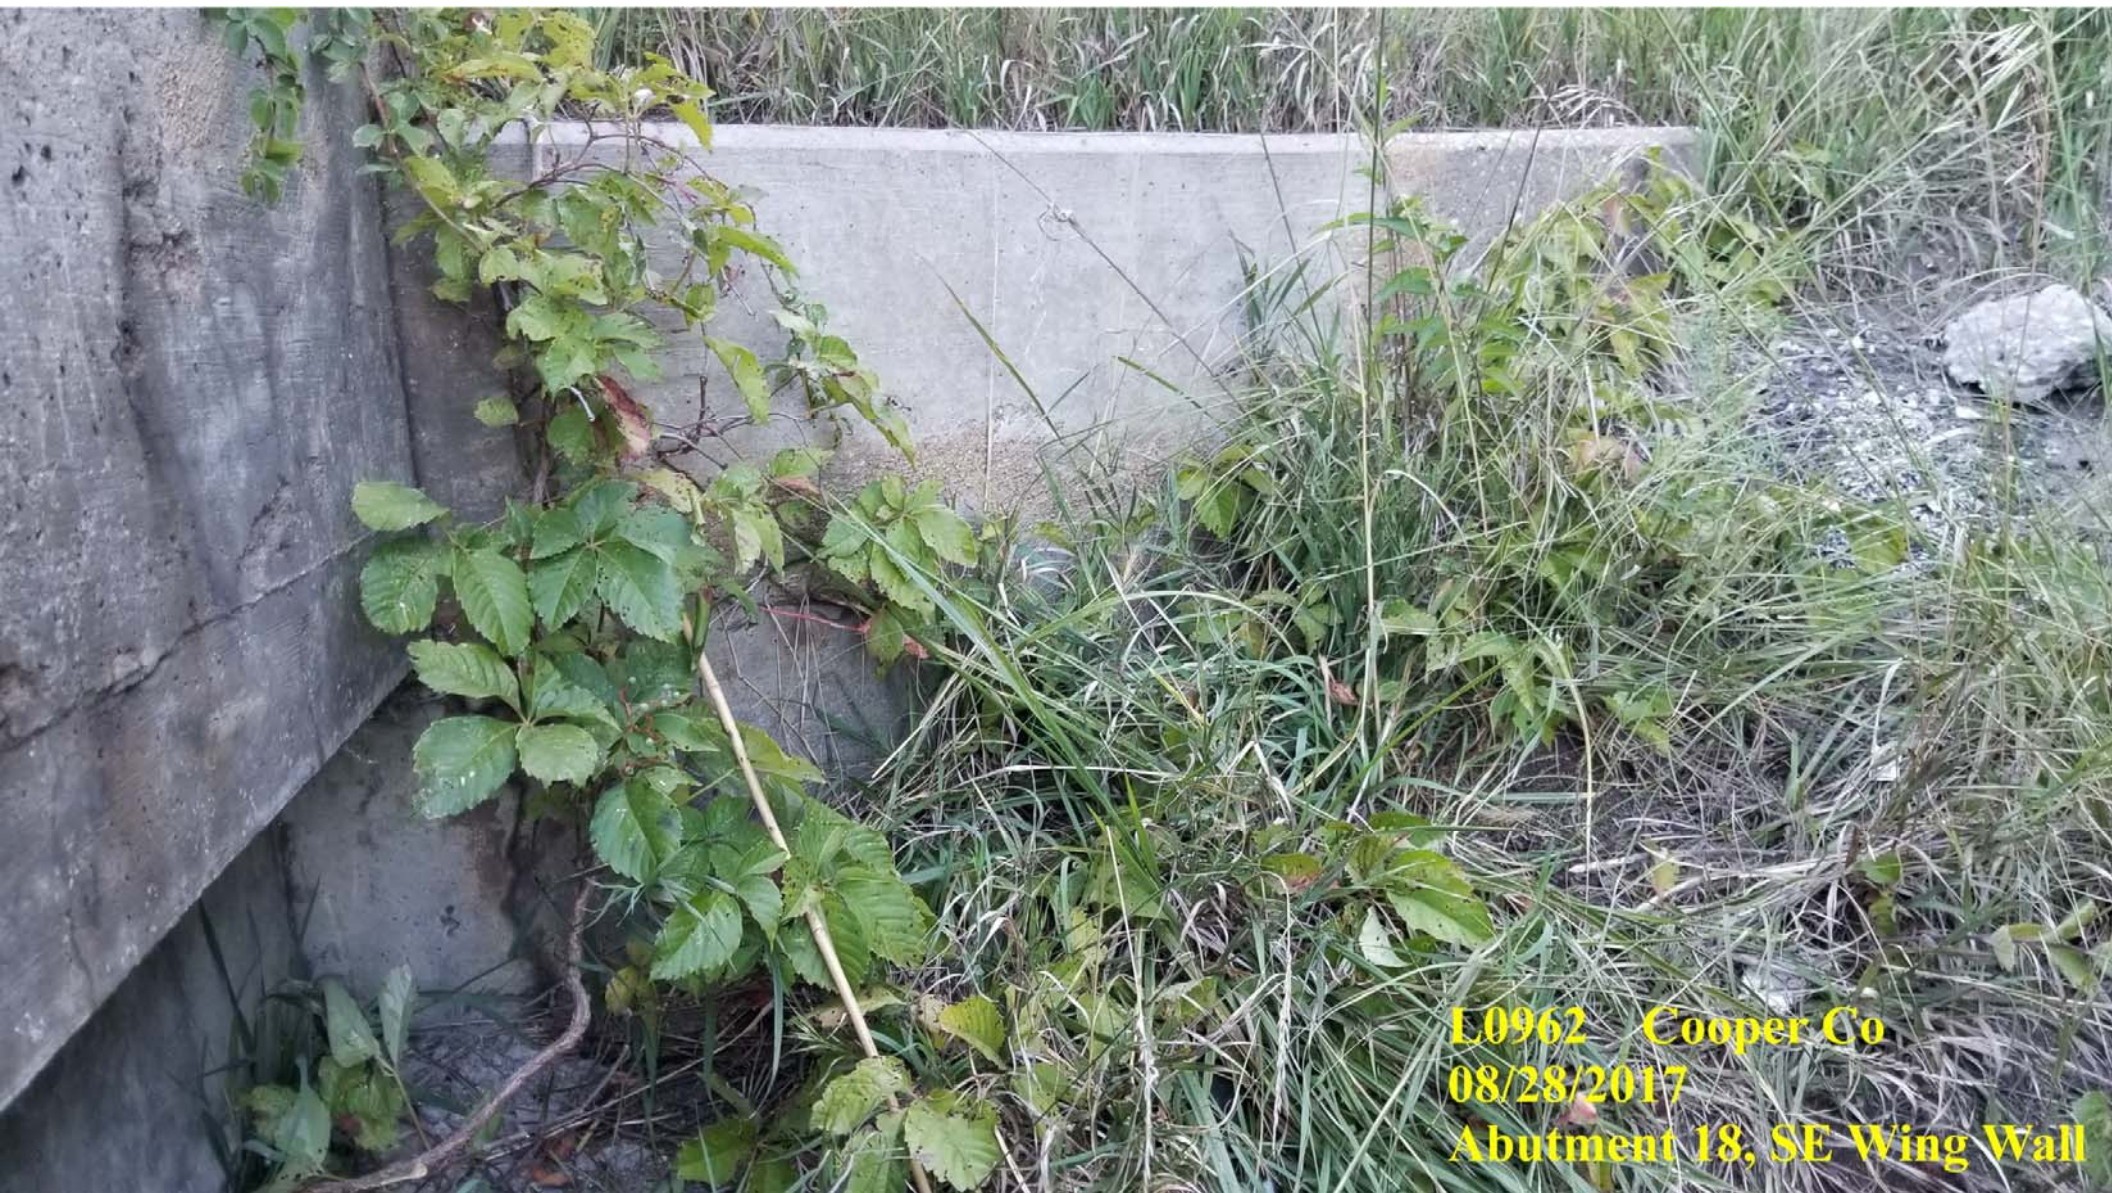
L0962 Cooper Co
08/28/2017
Abutment 18, Bearing 3
Nut Missing on Front Bolt

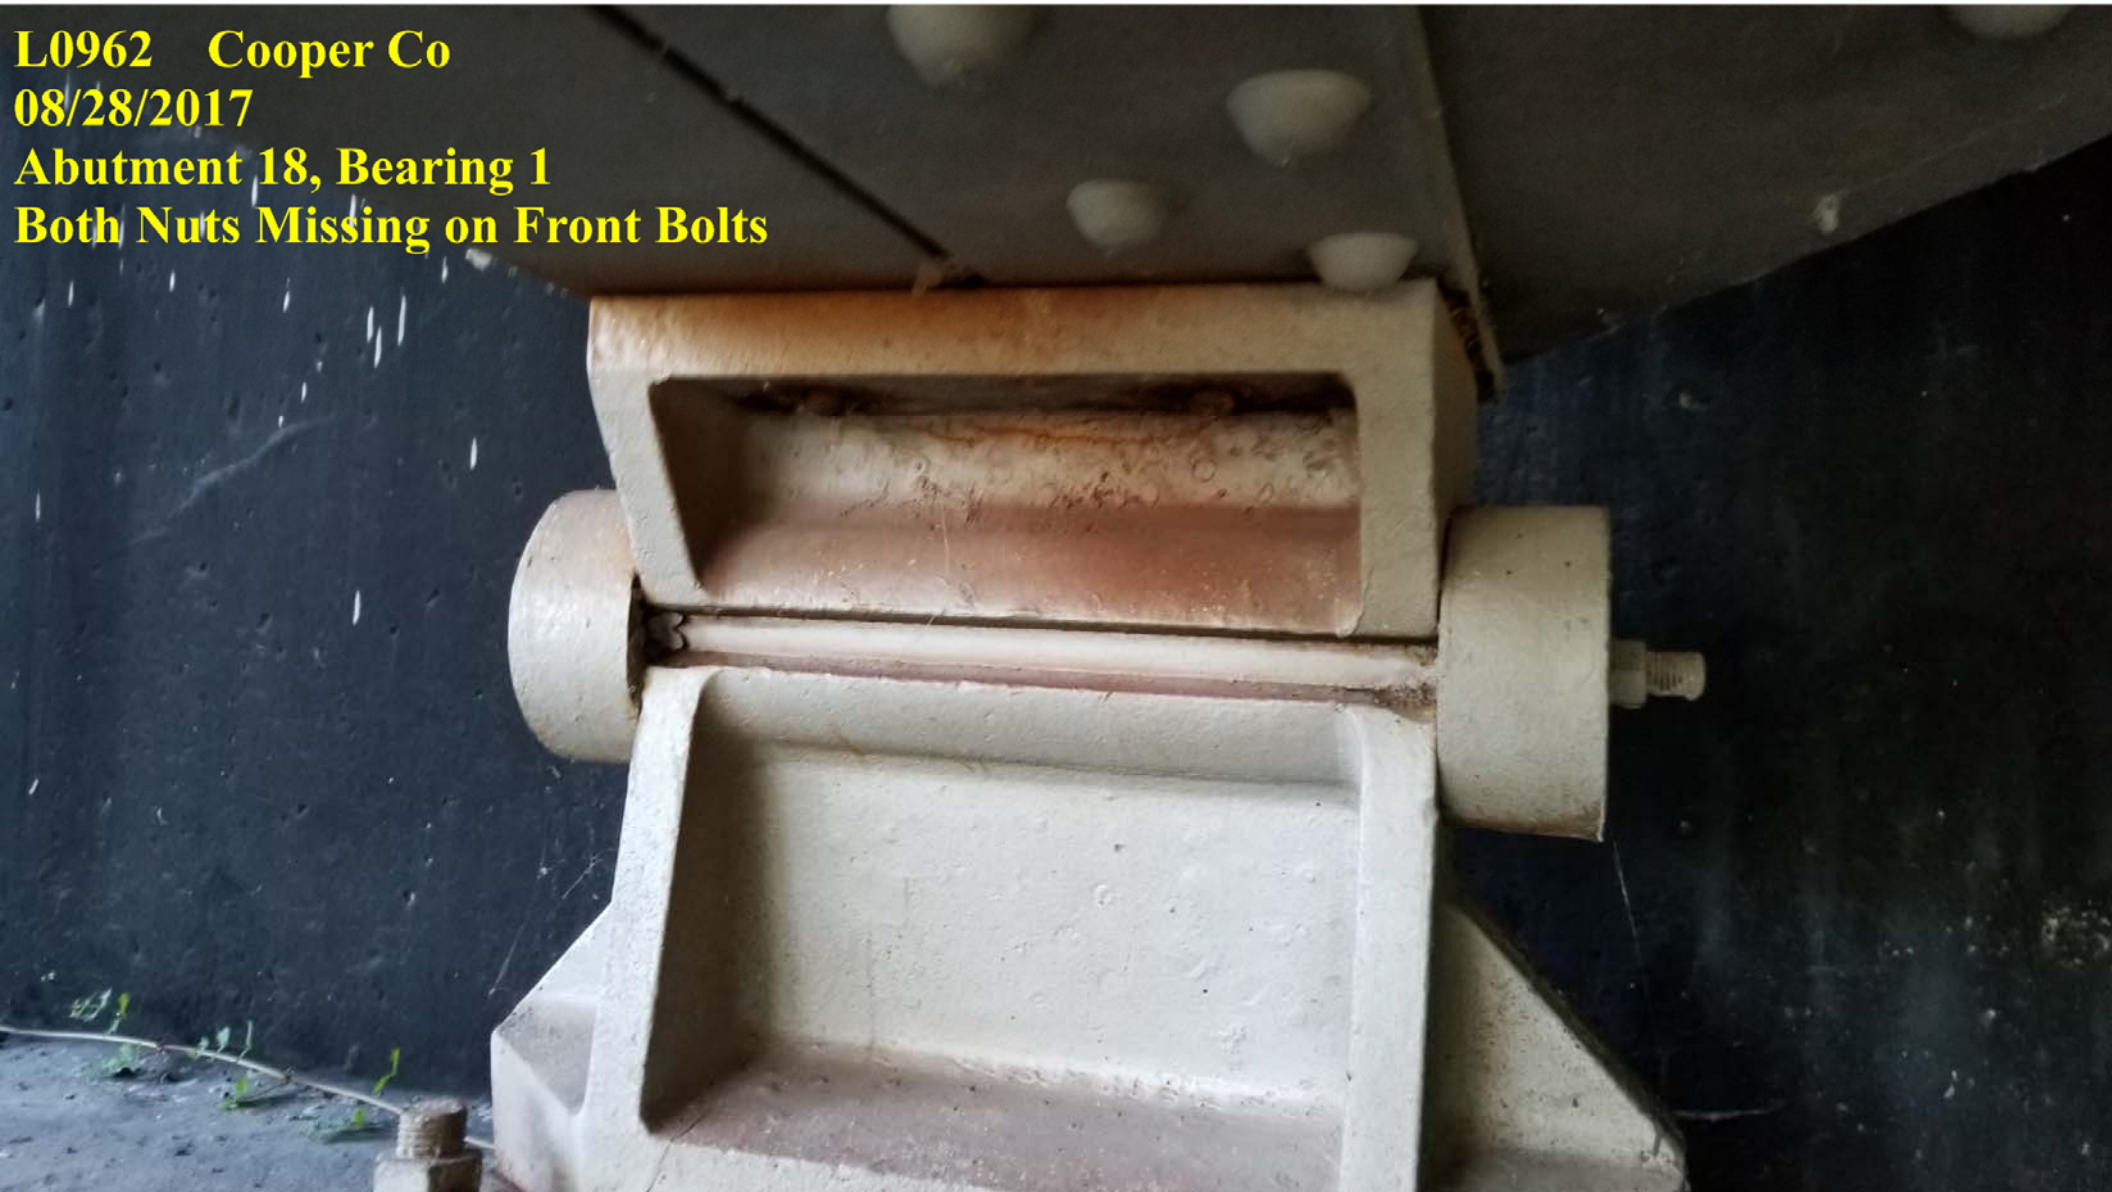
L0962 Cooper Co

08/28/2017

Abutment 18, Bearing 1

Both Nuts Missing on Front Bolts

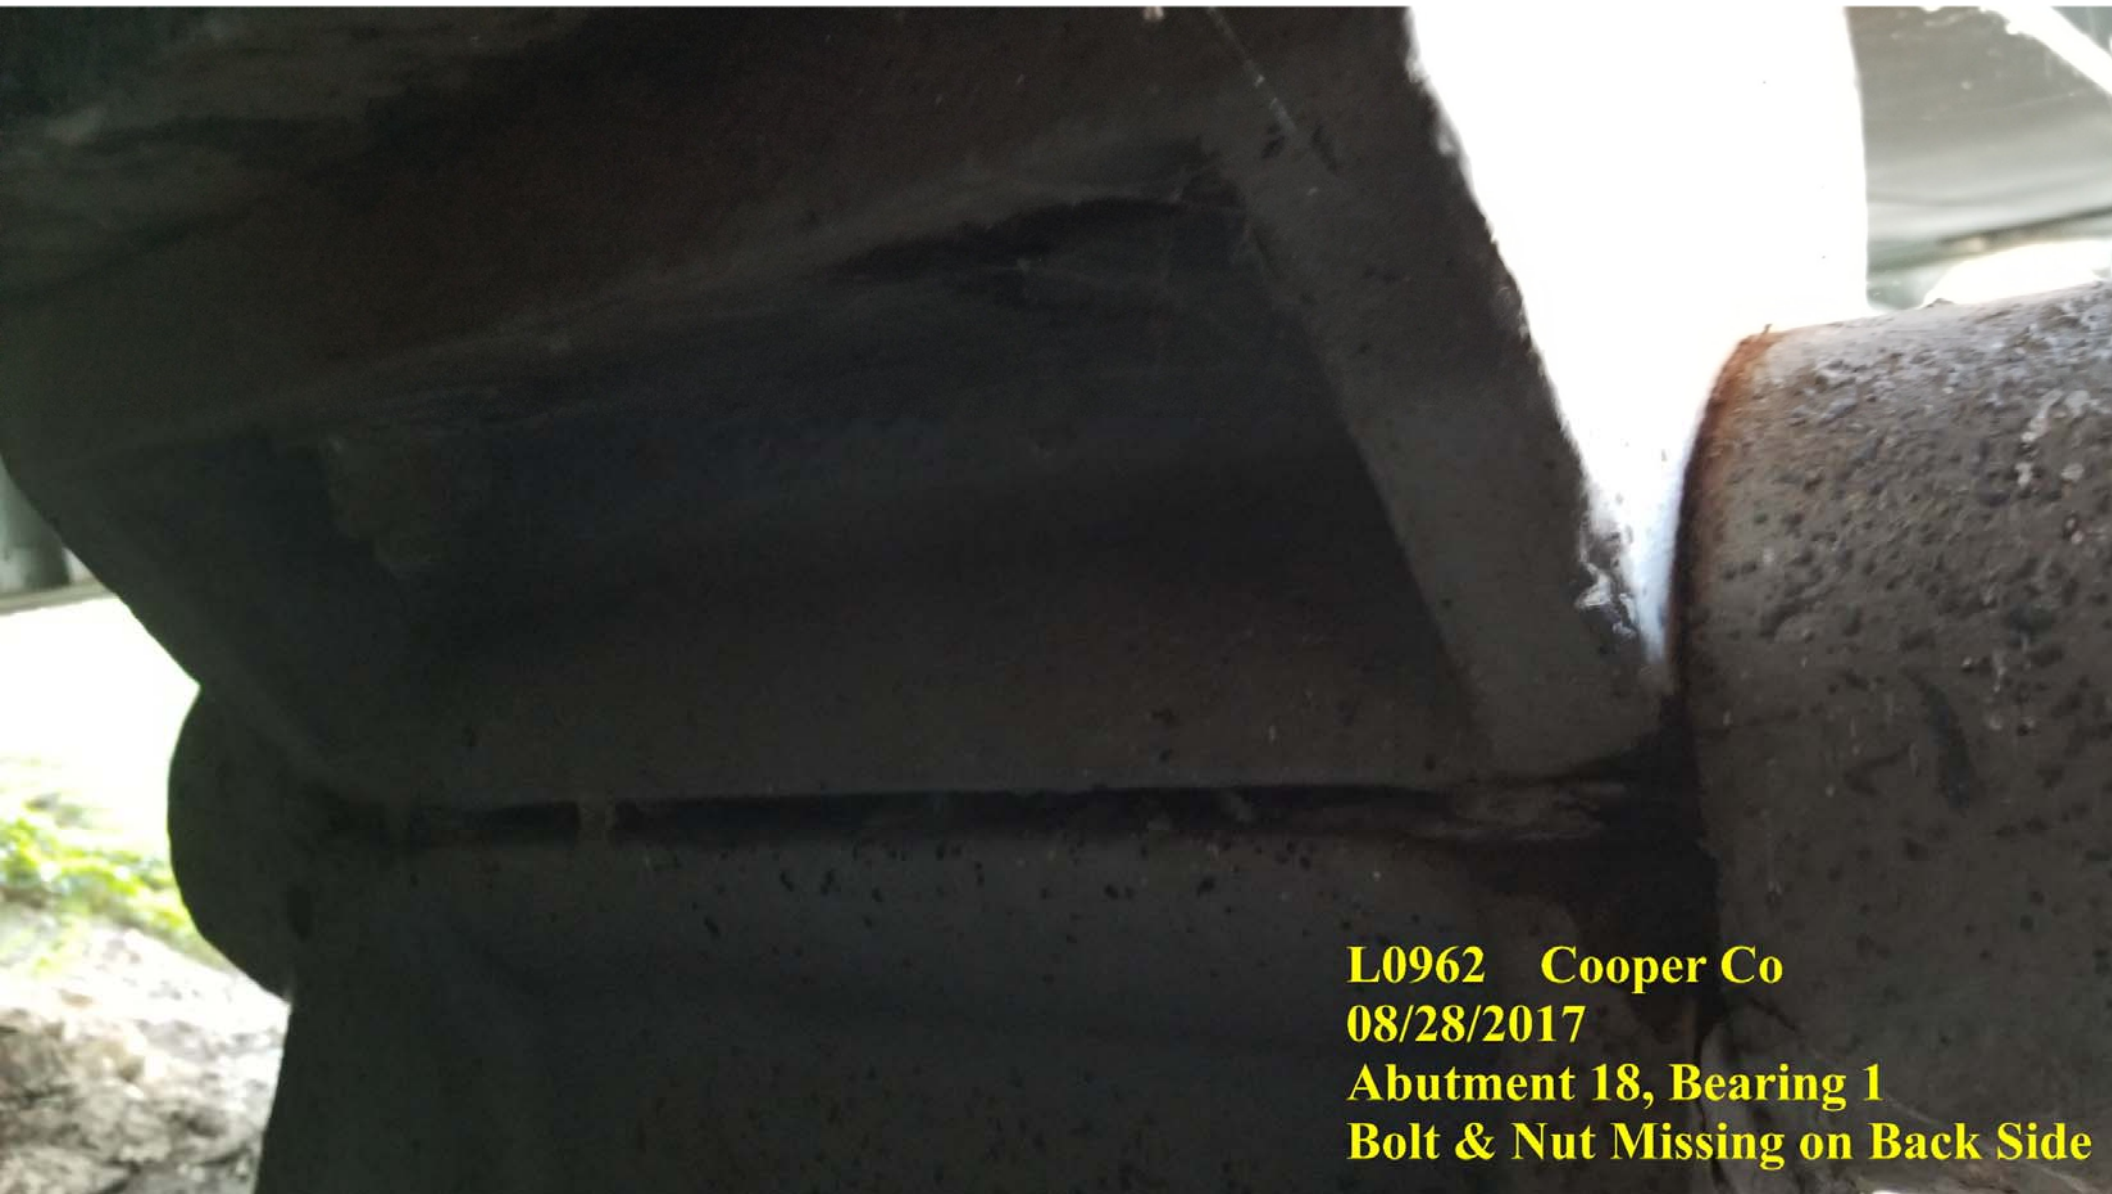
L0962 Cooper Co
08/28/2017
Abutment 18, Bearing 1
Bolt & Nut Missing on Back Side

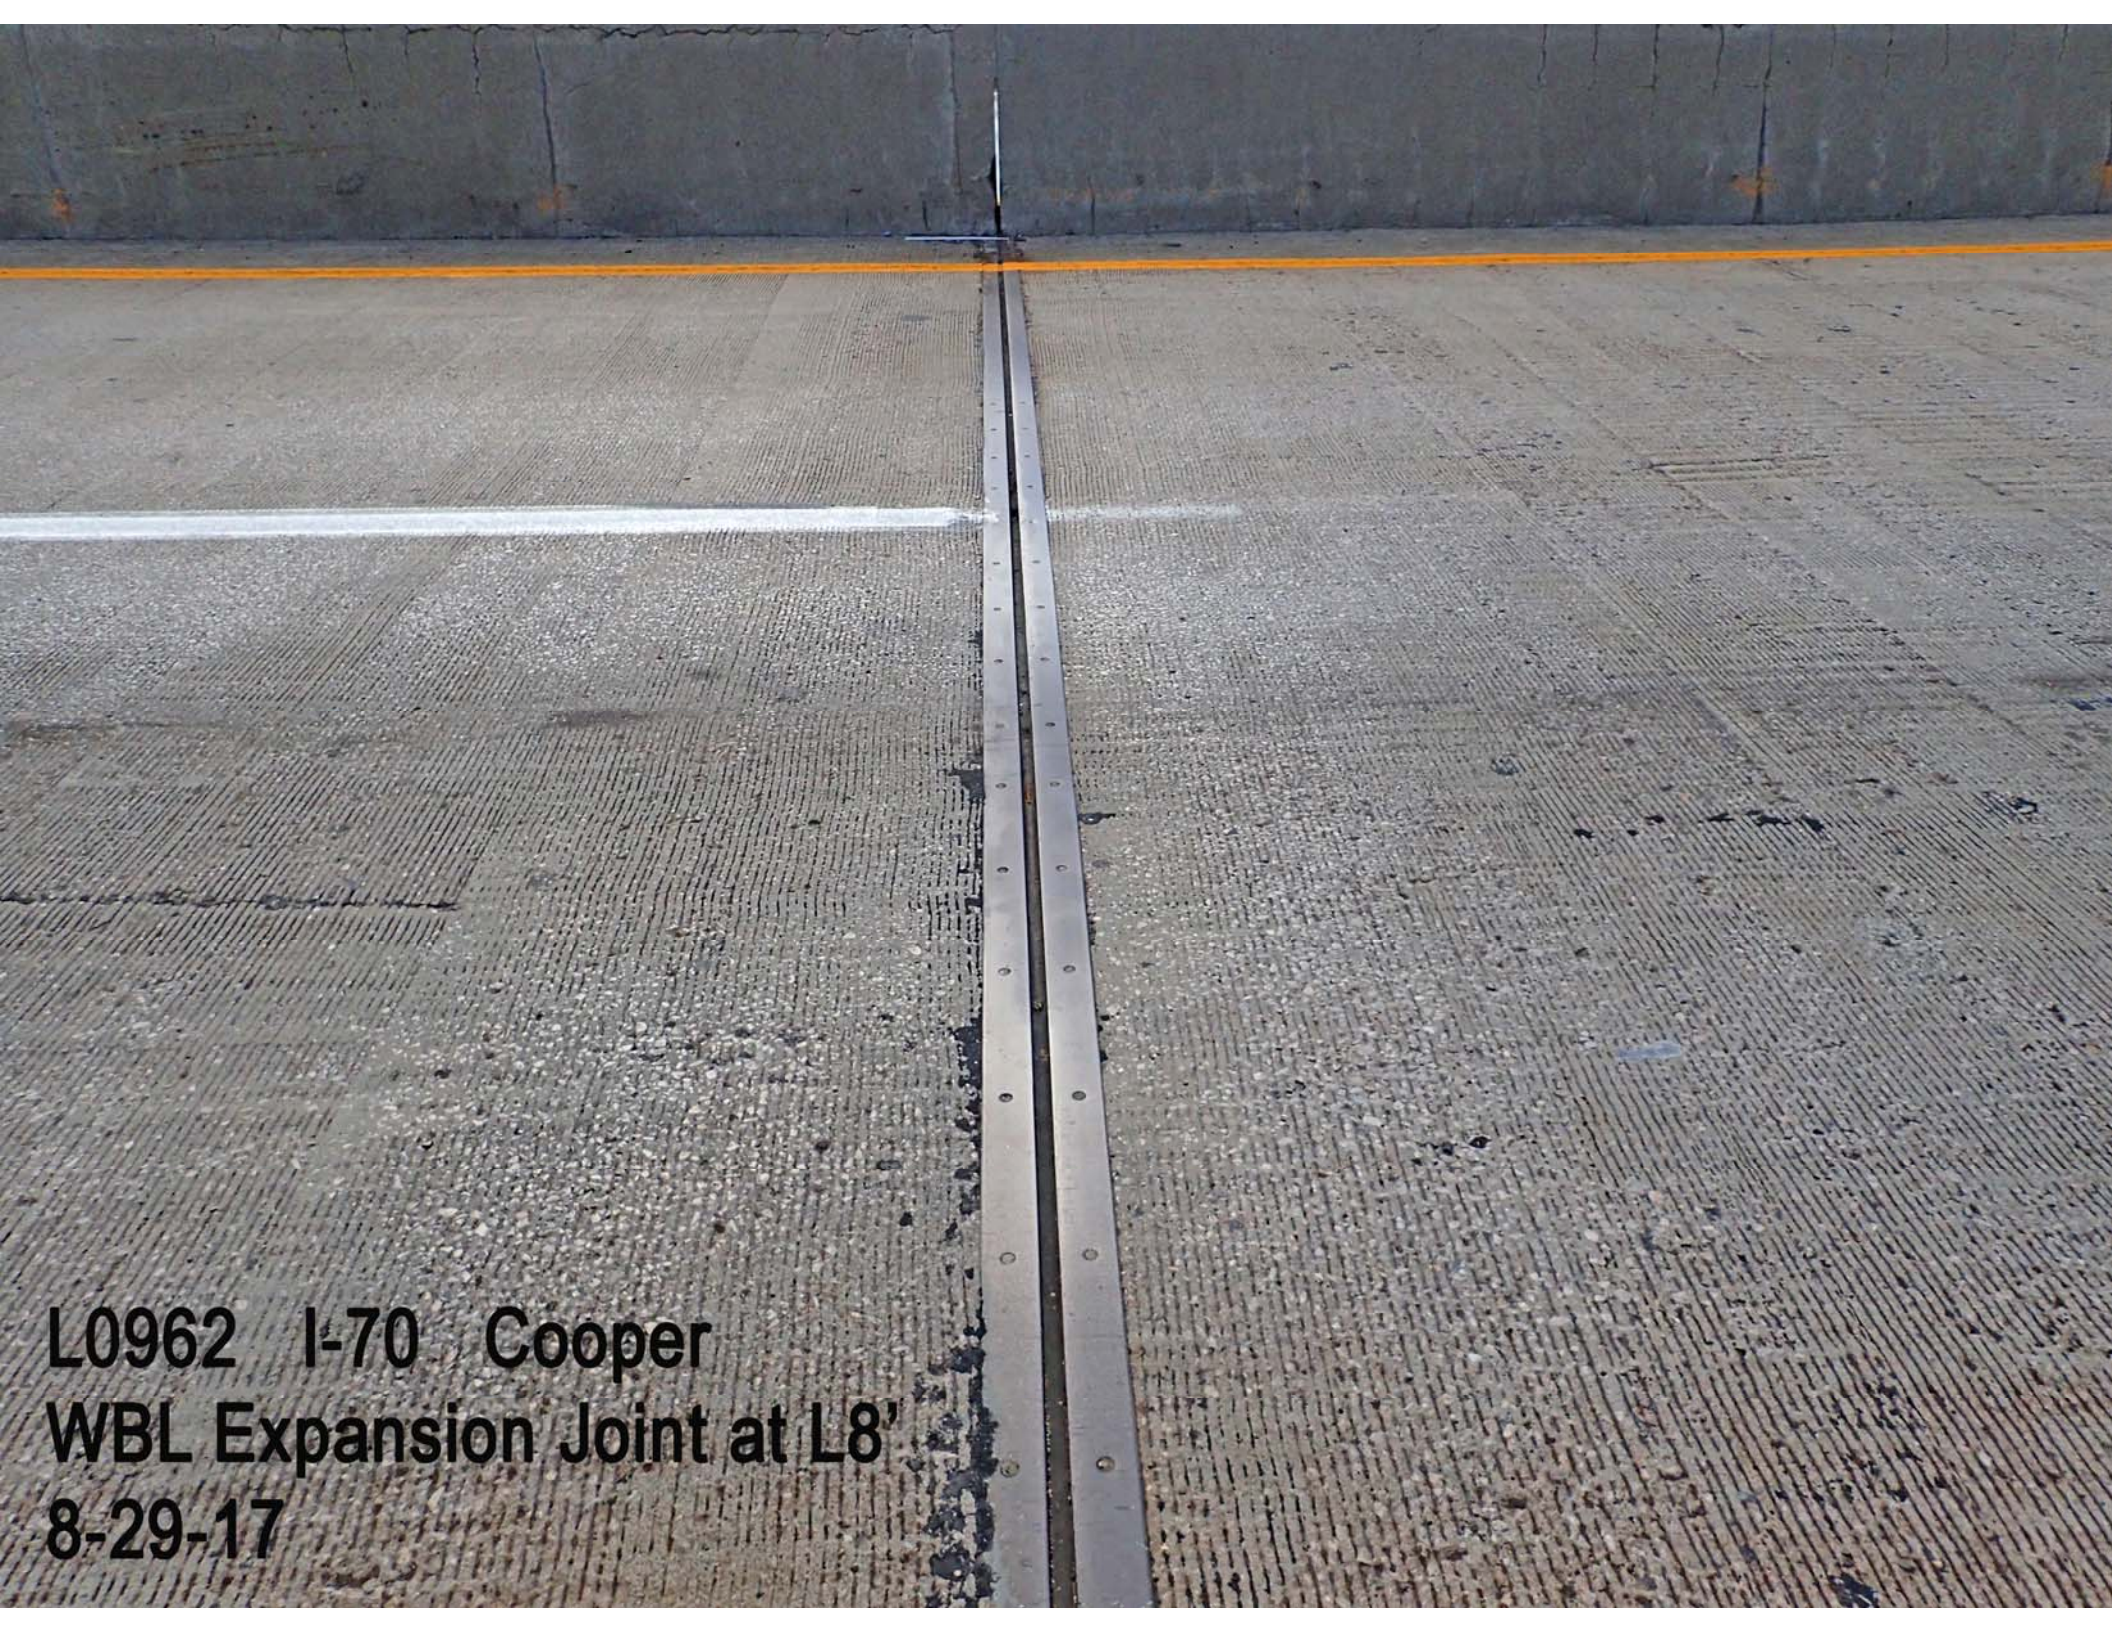
L0962 I-70 Cooper
South Side Floorbeam L8'L8'
Rust Pumping (typ)
8-29-17

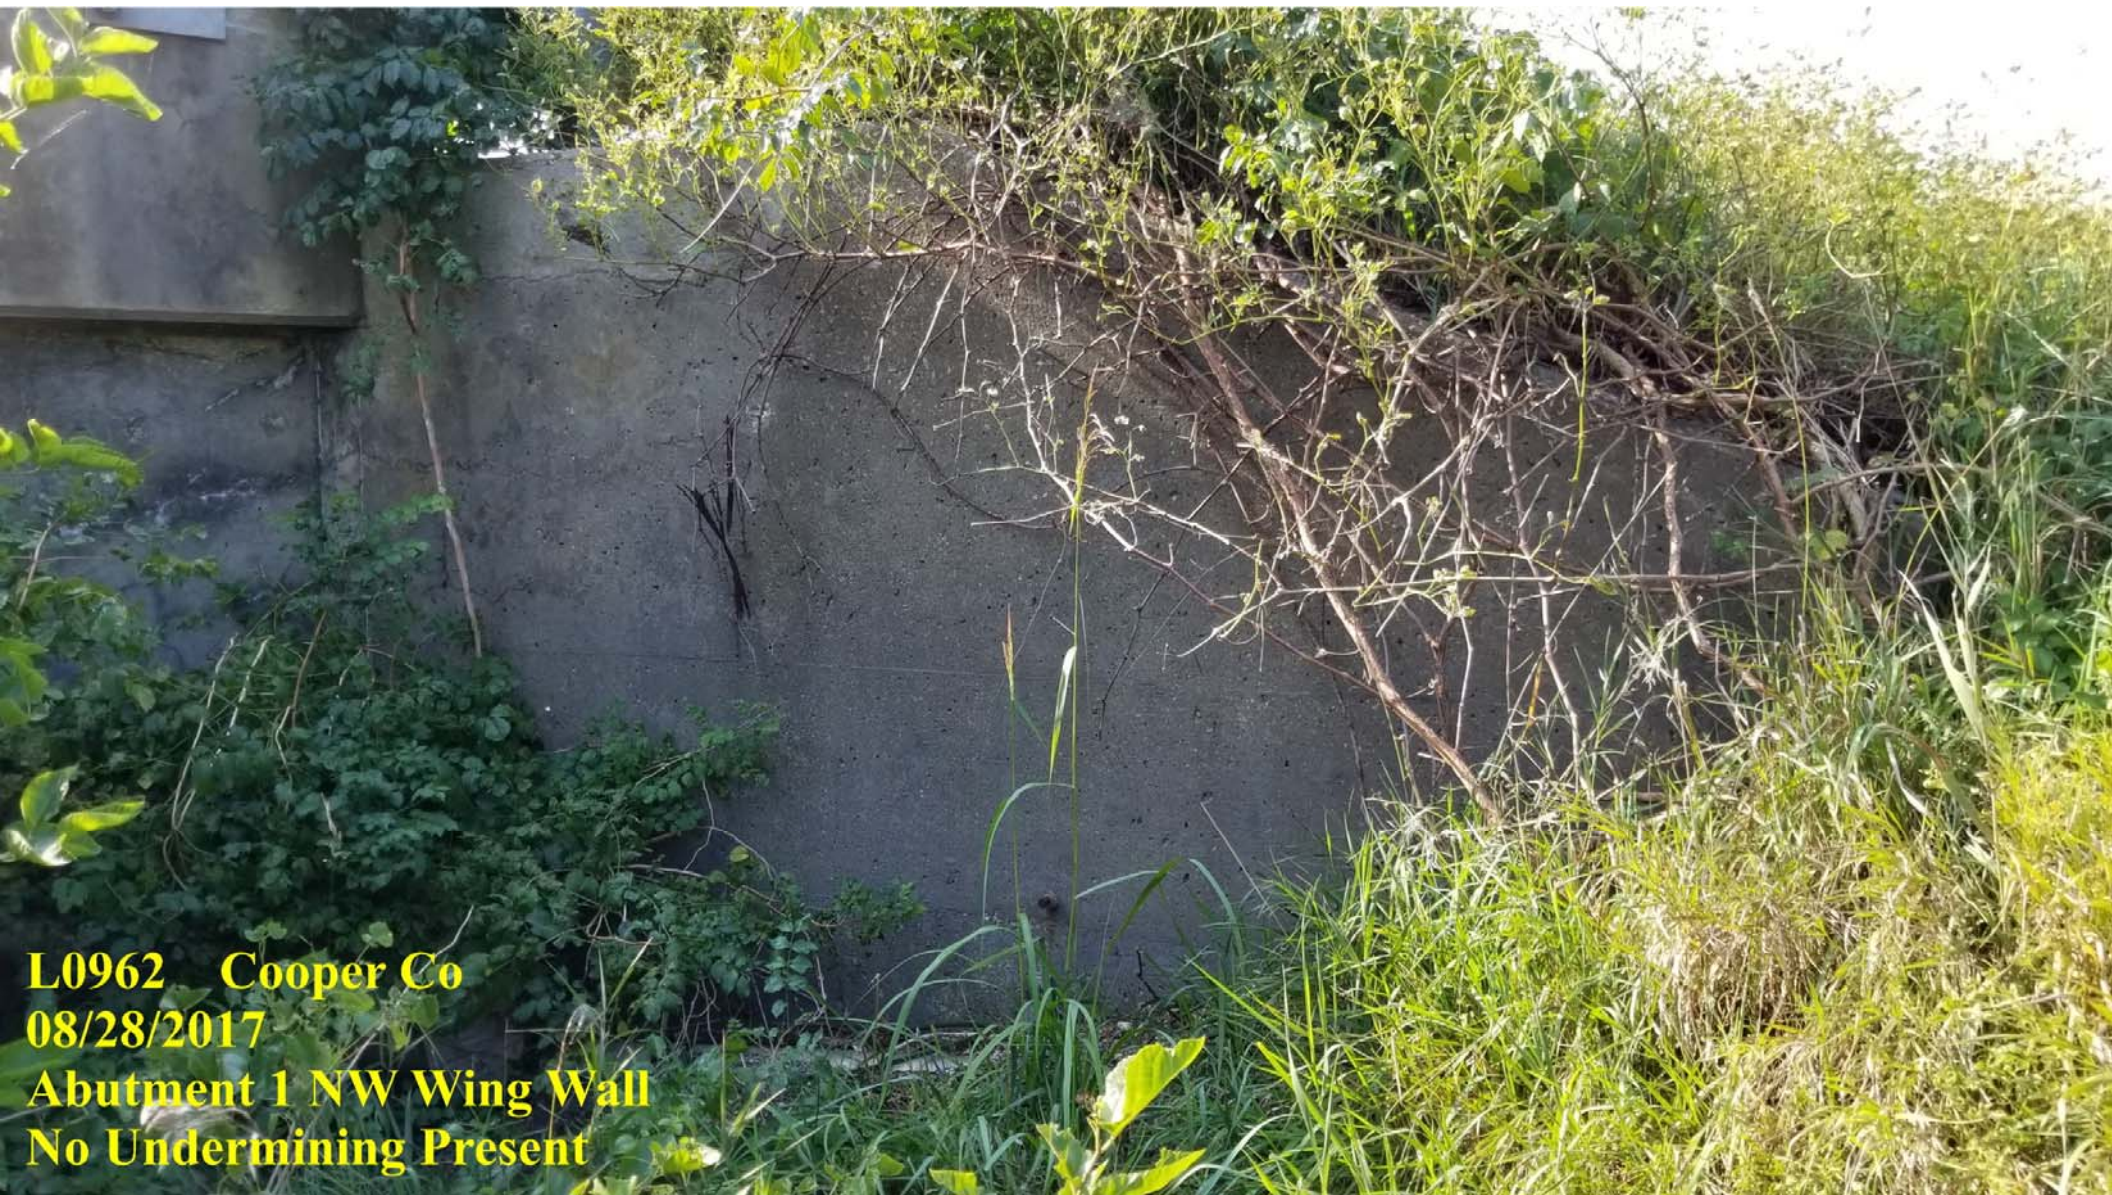
L0962 Cooper Co
08/28/2017
Abutment 1, Bearing 1,
rocker Keeper, Back Side
1 Nut Missing

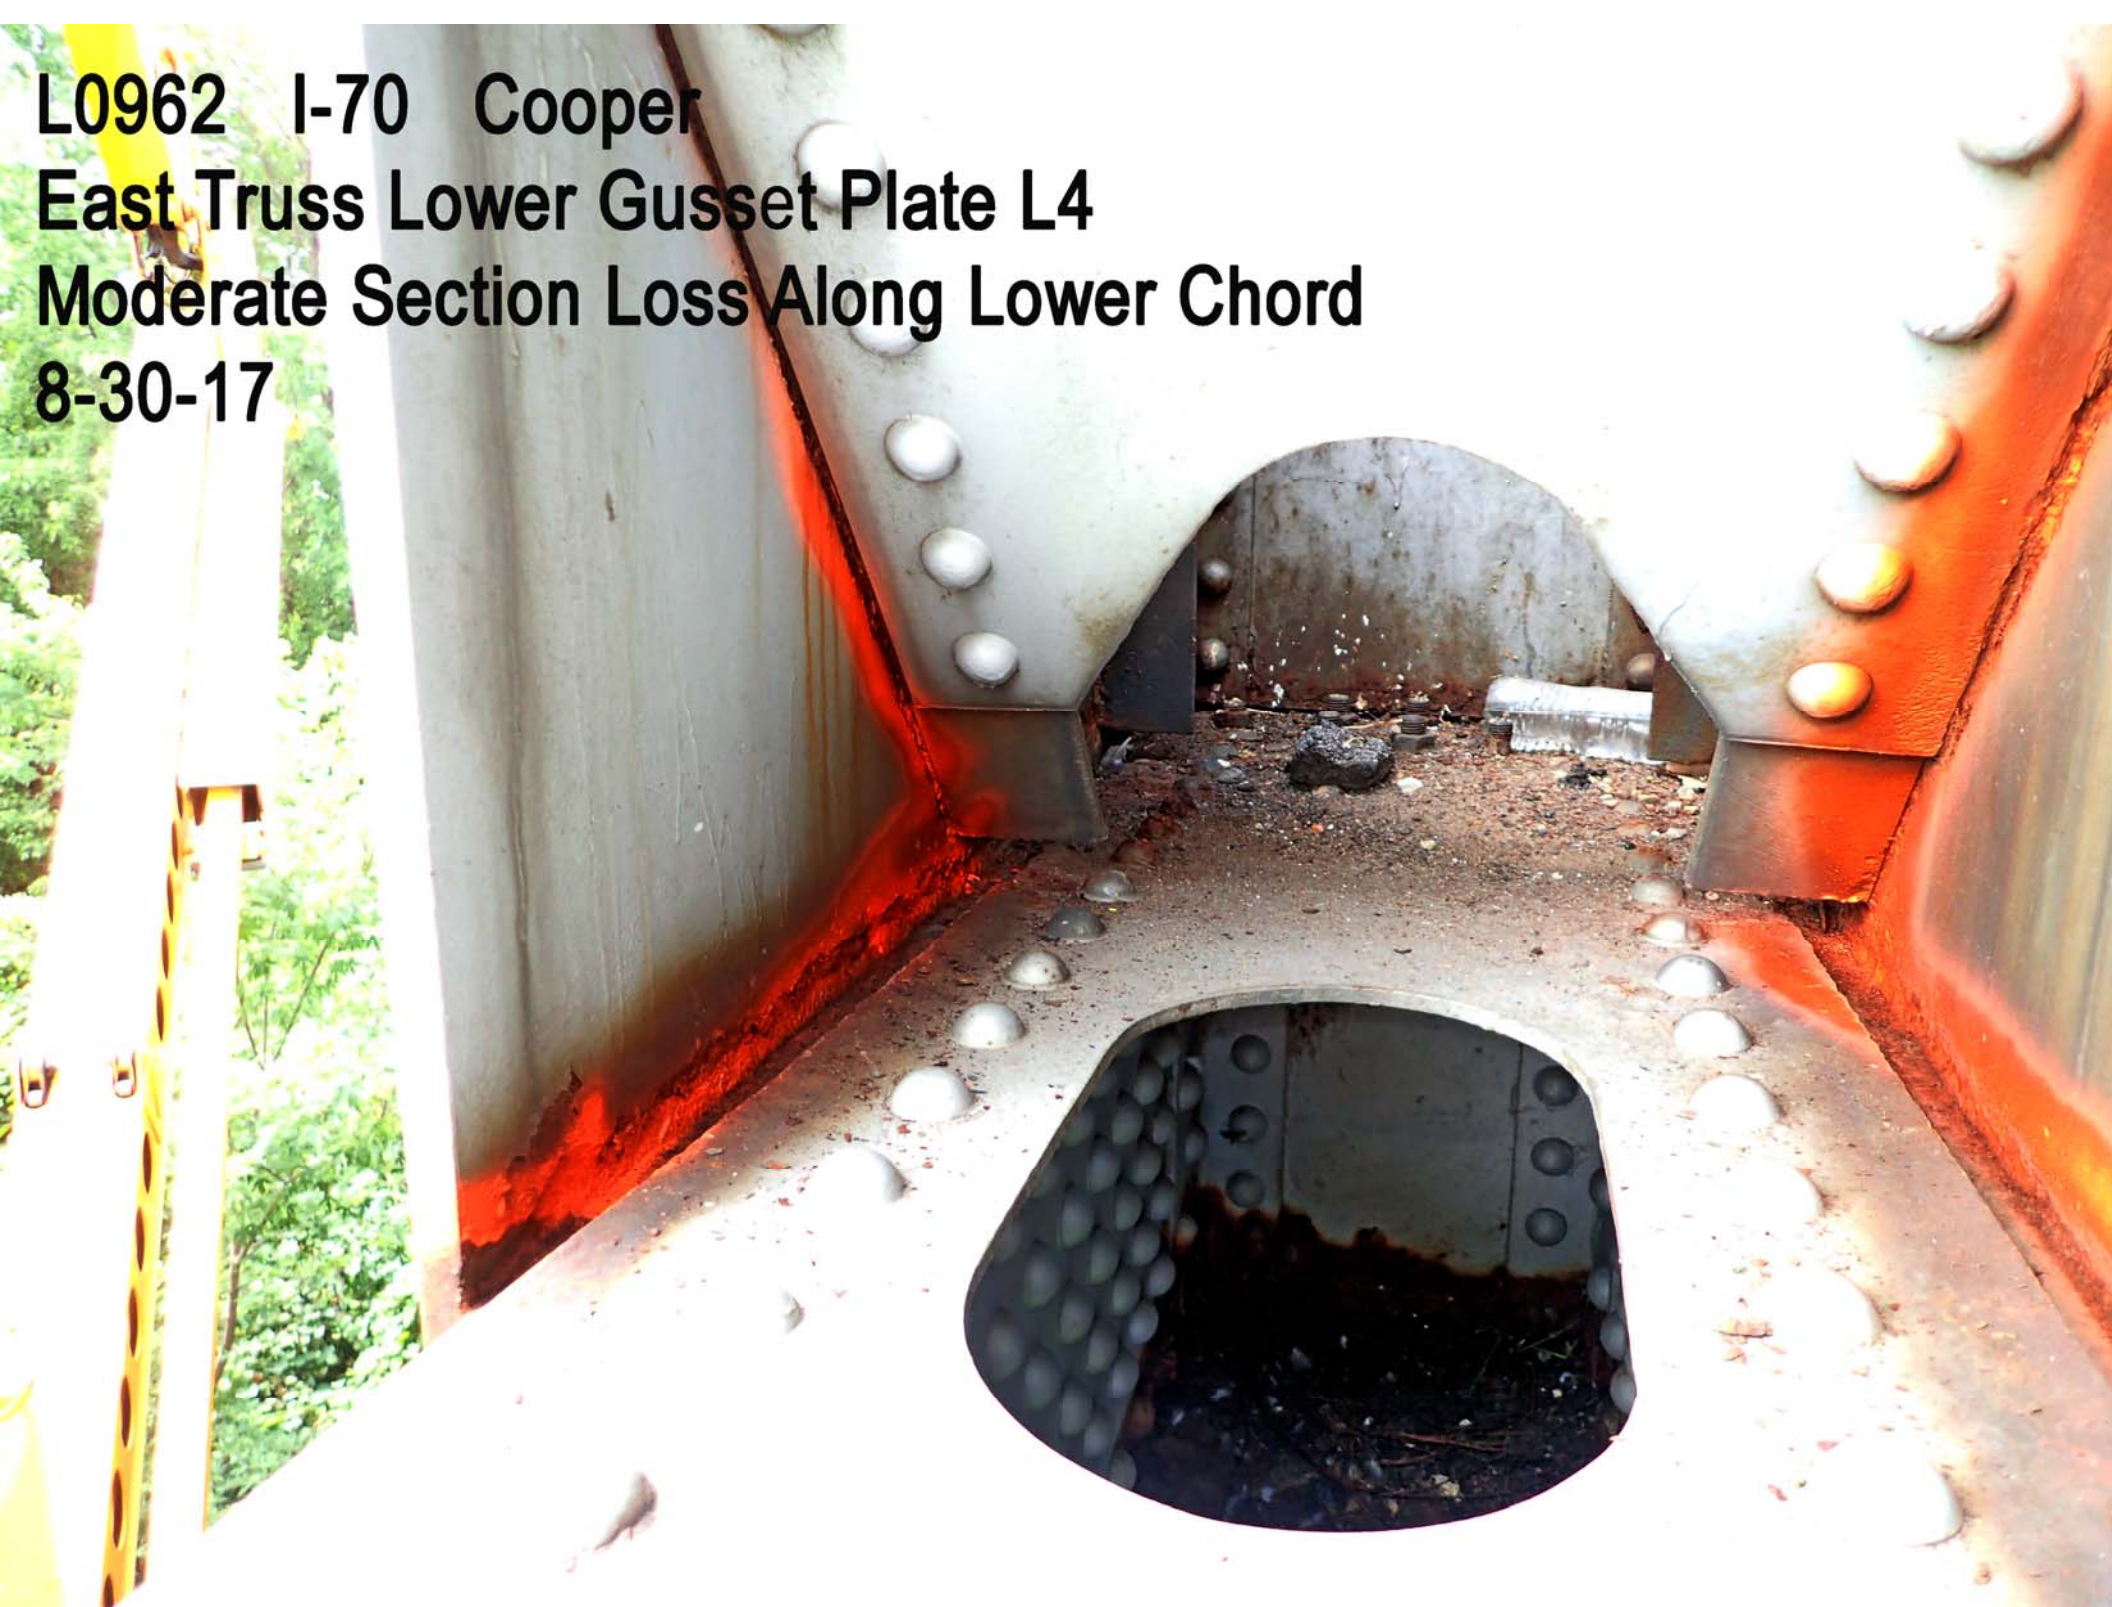
L0962 I-70 Cooper
East Truss Lower Gusset Plate L4
Moderate Section Loss Along Lower Chord
8-30-17

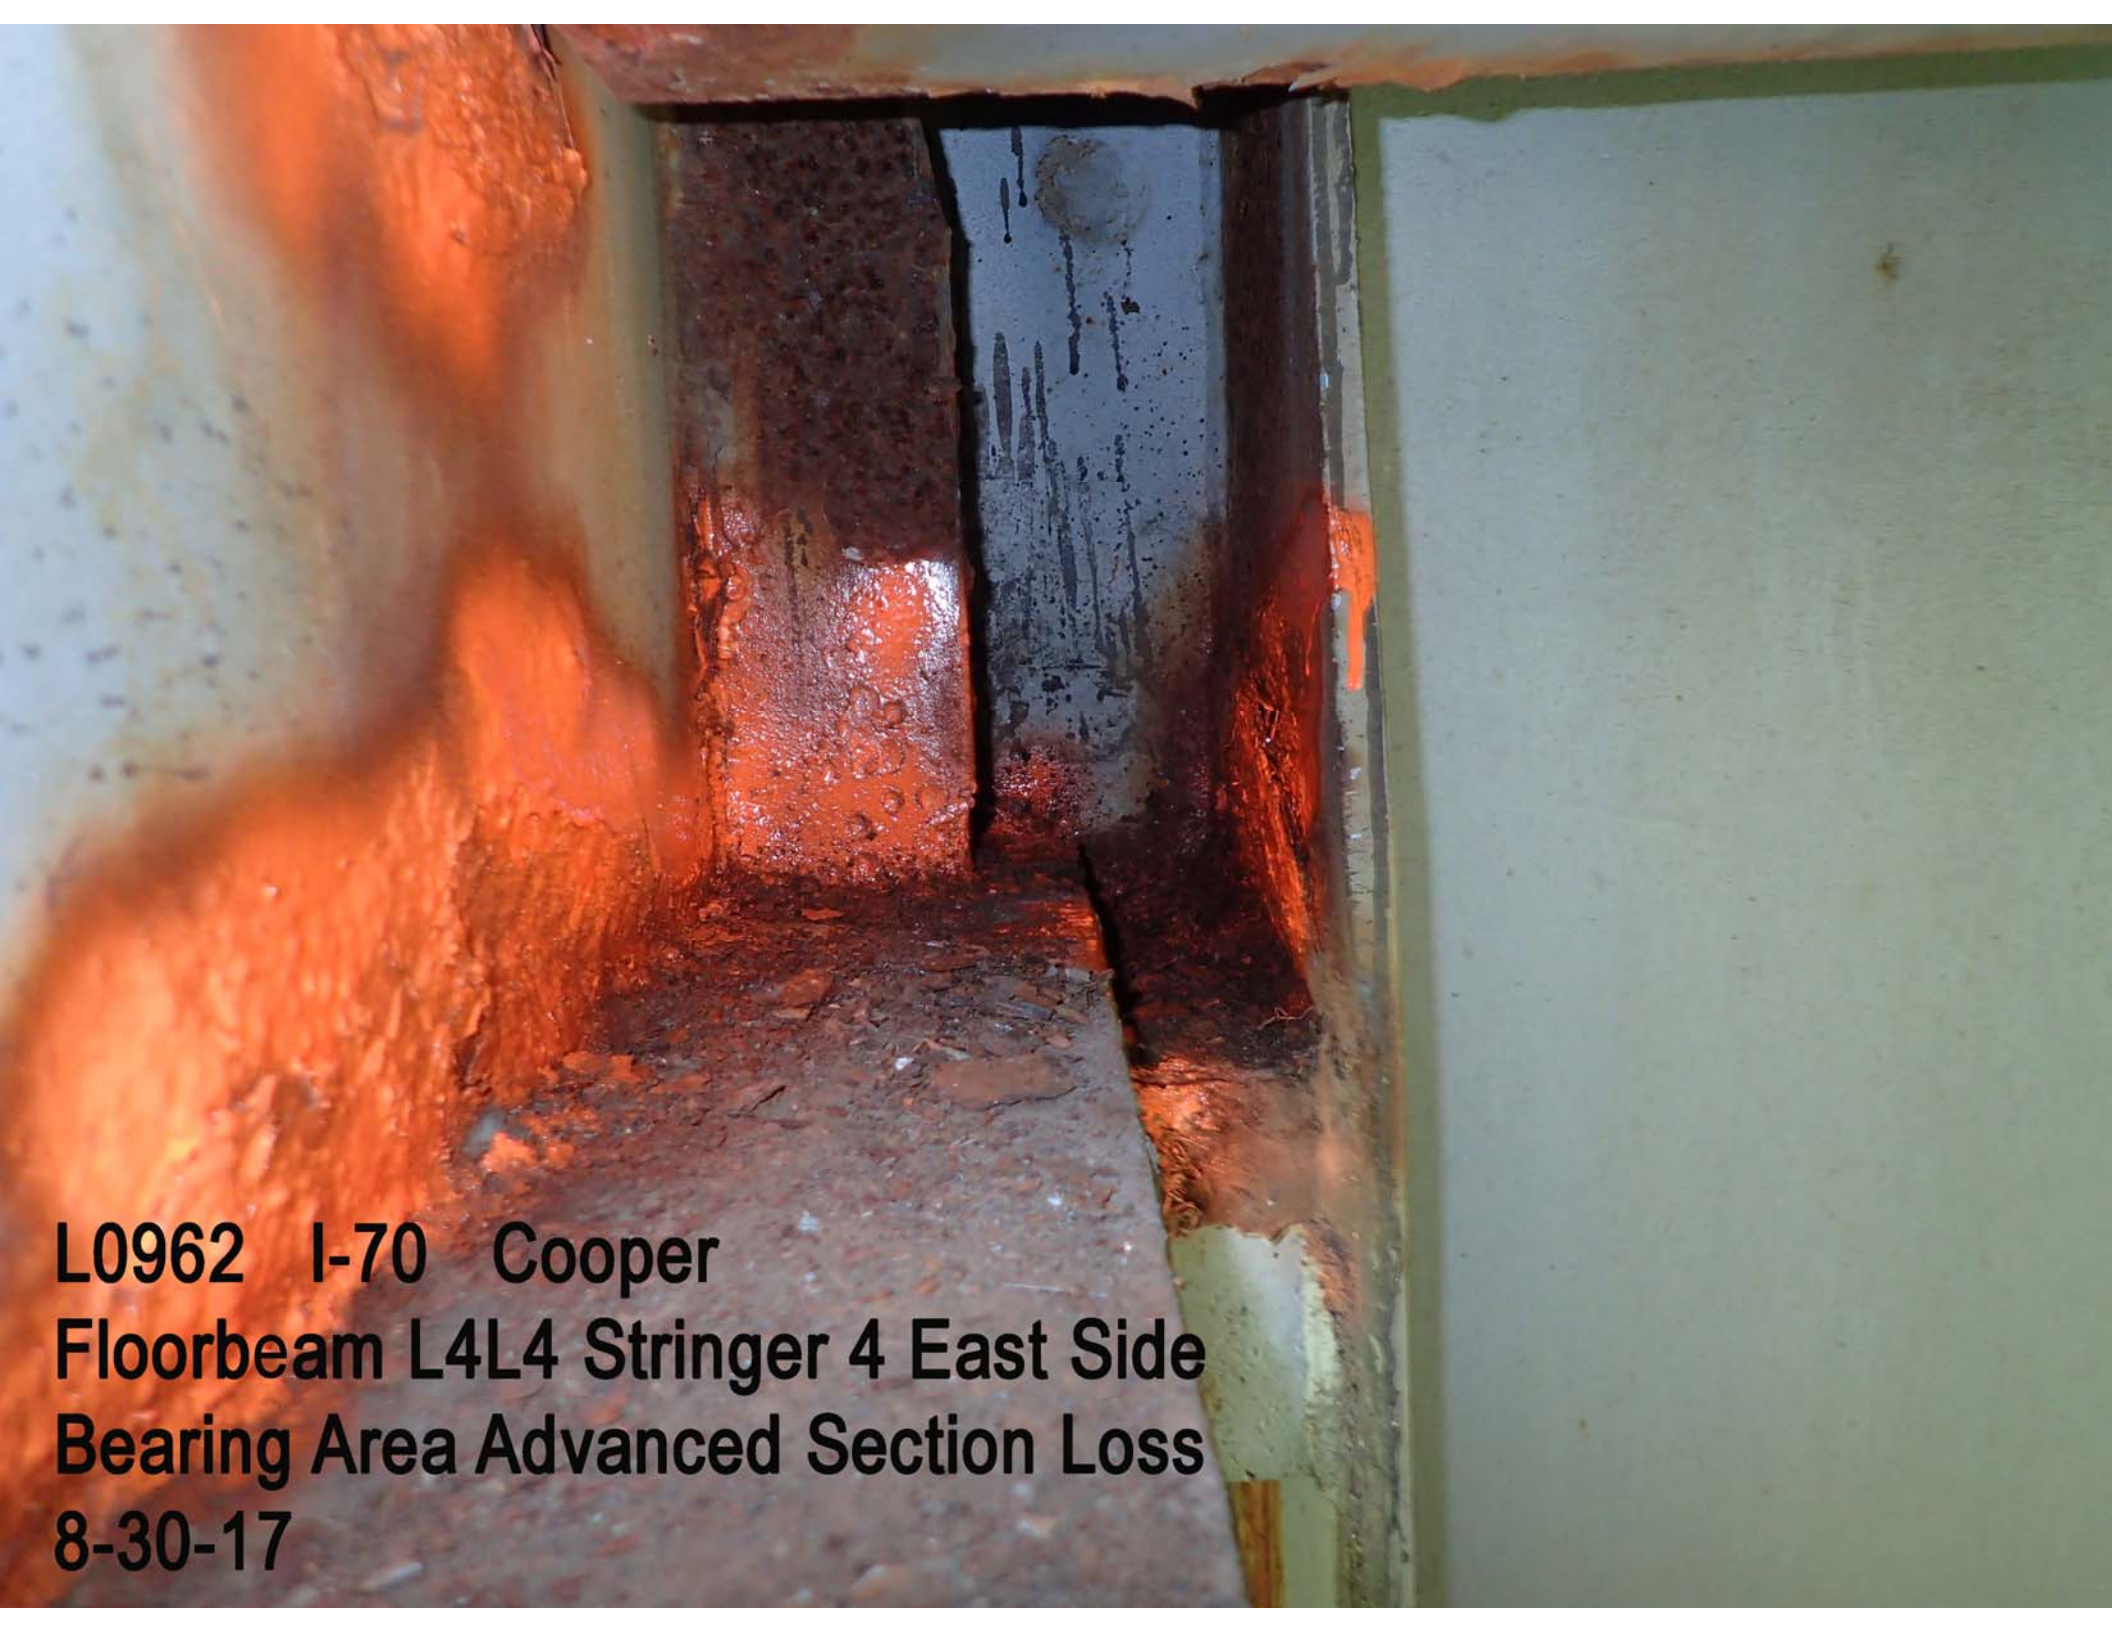
**L0962 I-70 Cooper
Floorbeam L4L4 Stringer 4 East Side
Bearing Area Advanced Section Loss
8-30-17**
