L0962 Cooper Co.
08/28/2017
Looking West

L0962 I-70 Cooper
Pier 15 Open Expansion Joint WBL
8-28-17

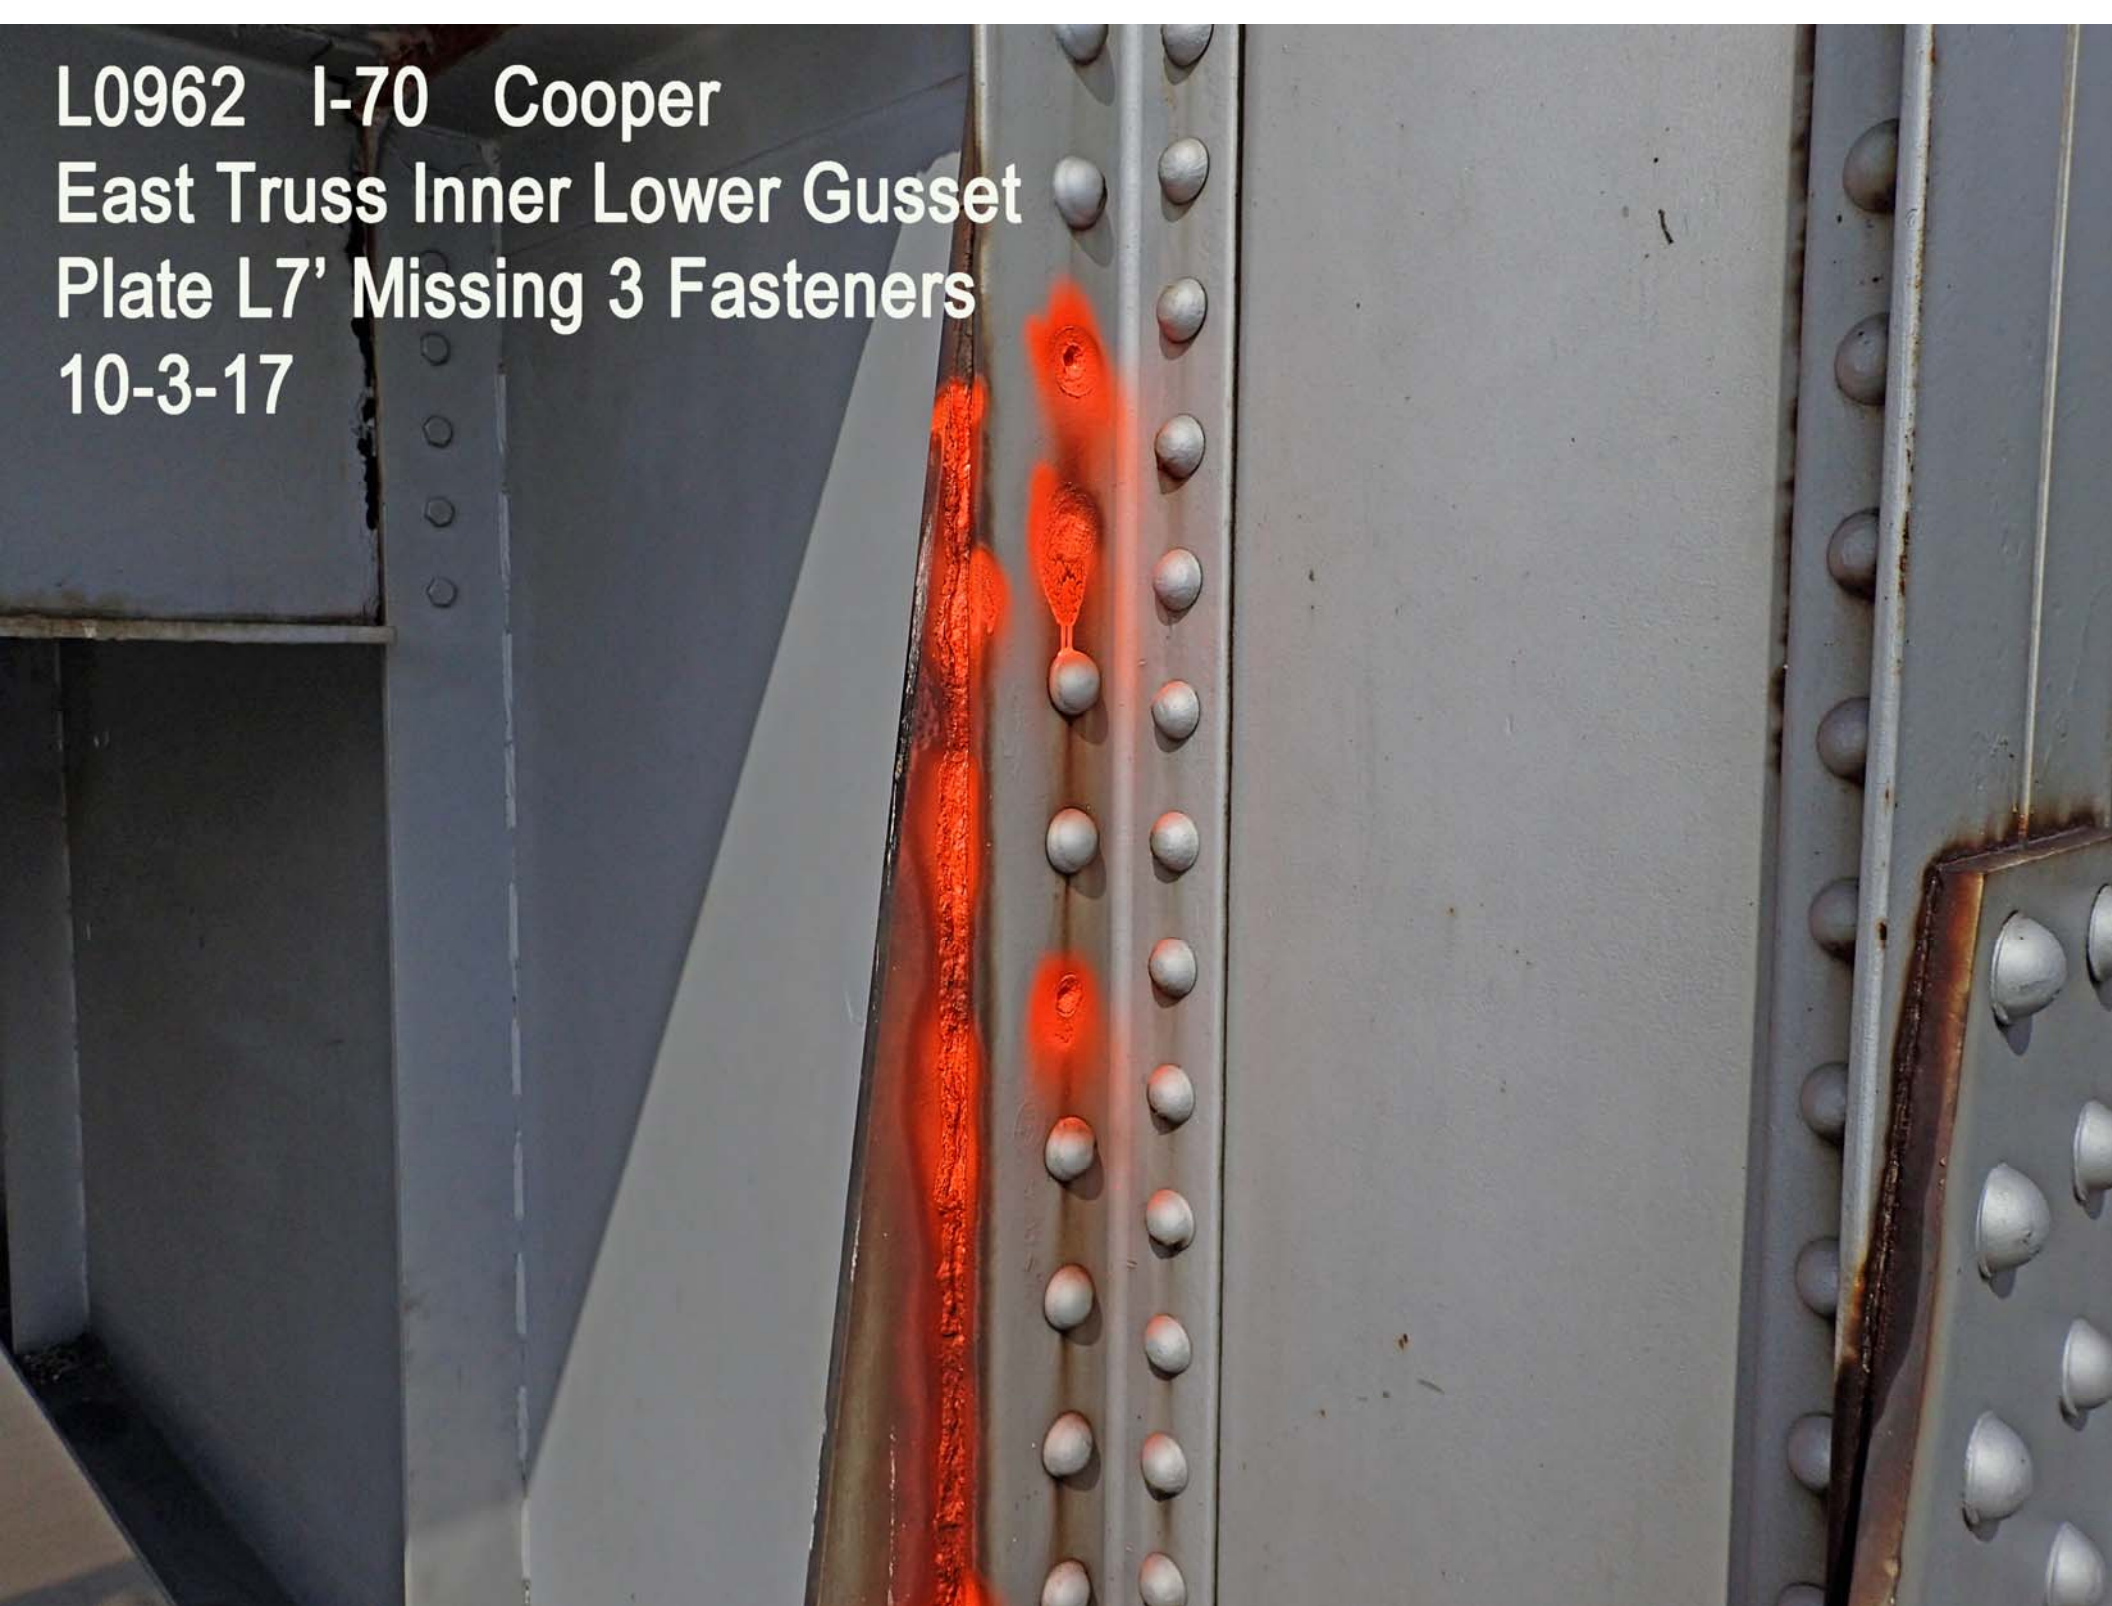
L0962 I-70 Cooper
East Truss Inner Lower Gusset
Plate L7' Missing 3 Fasteners
10-3-17

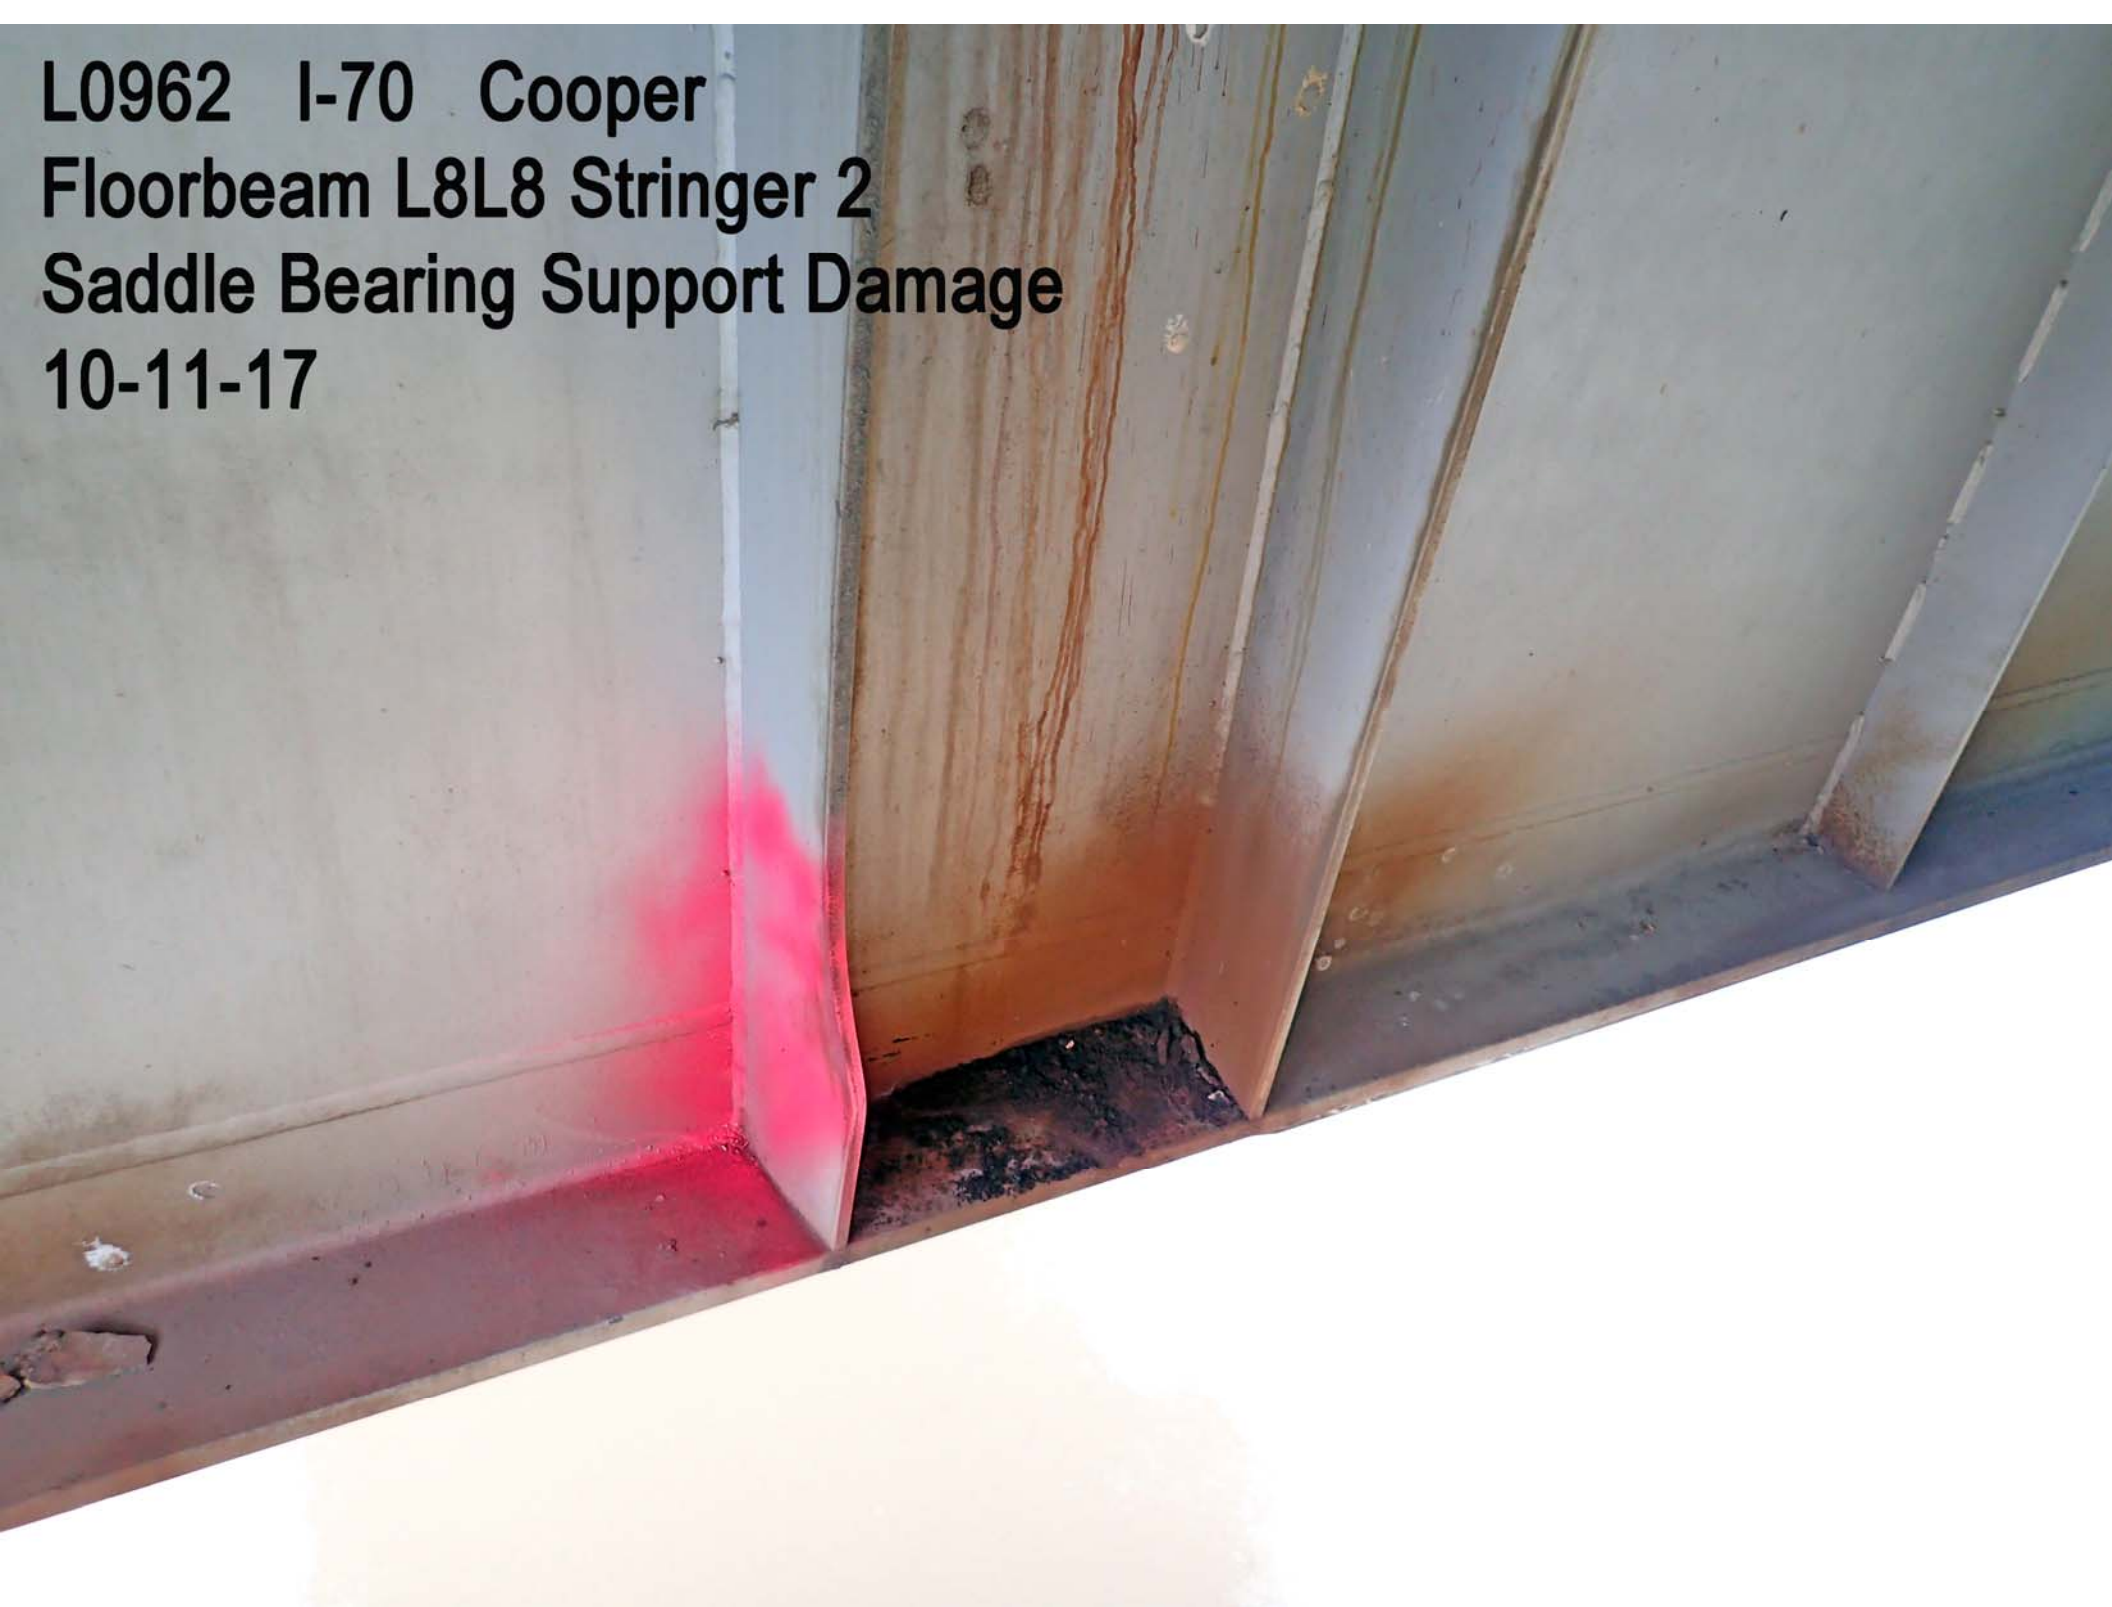
**L0962 I-70 Cooper
Floorbeam L8L8 Stringer 2
Saddle Bearing Support Damage
10-11-17**

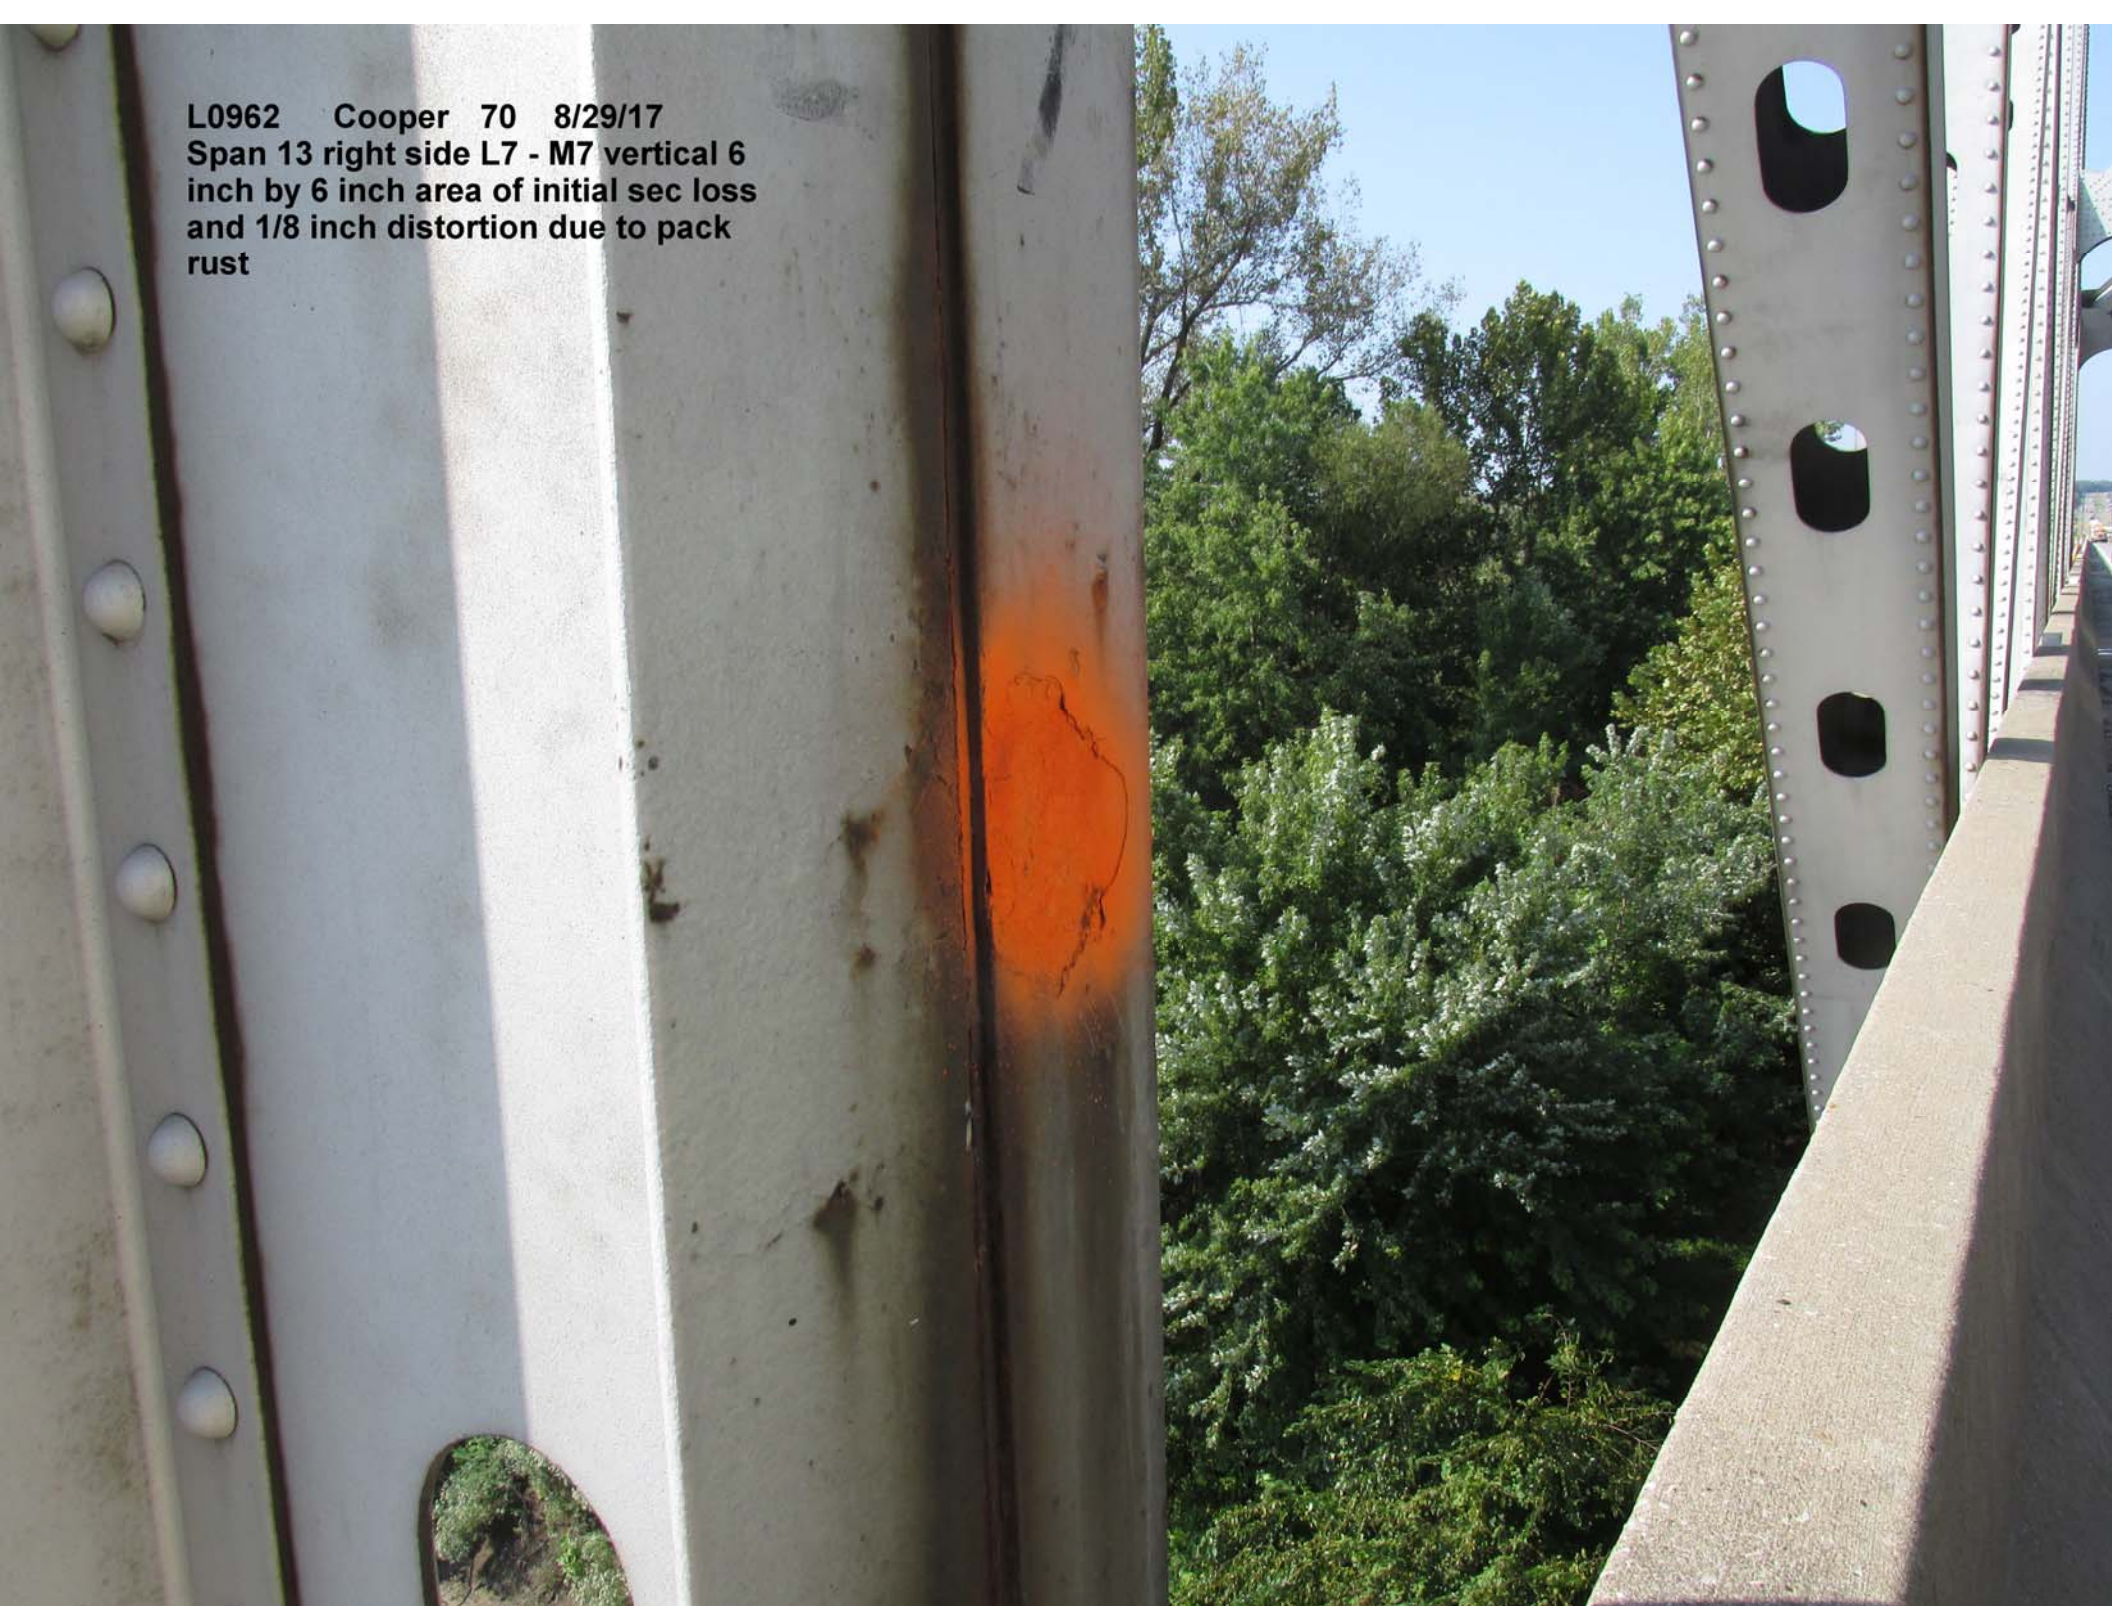
L0962 Cooper 70 8/29/17
Span 13 right side L7 - M7 vertical 6
inch by 6 inch area of initial sec loss
and 1/8 inch distortion due to pack
rust
