STRUCTURAL REHABILITATION CHECKLIST

Bridge No.: **A3176**

Route: **IS 170**

Over: **RT D**

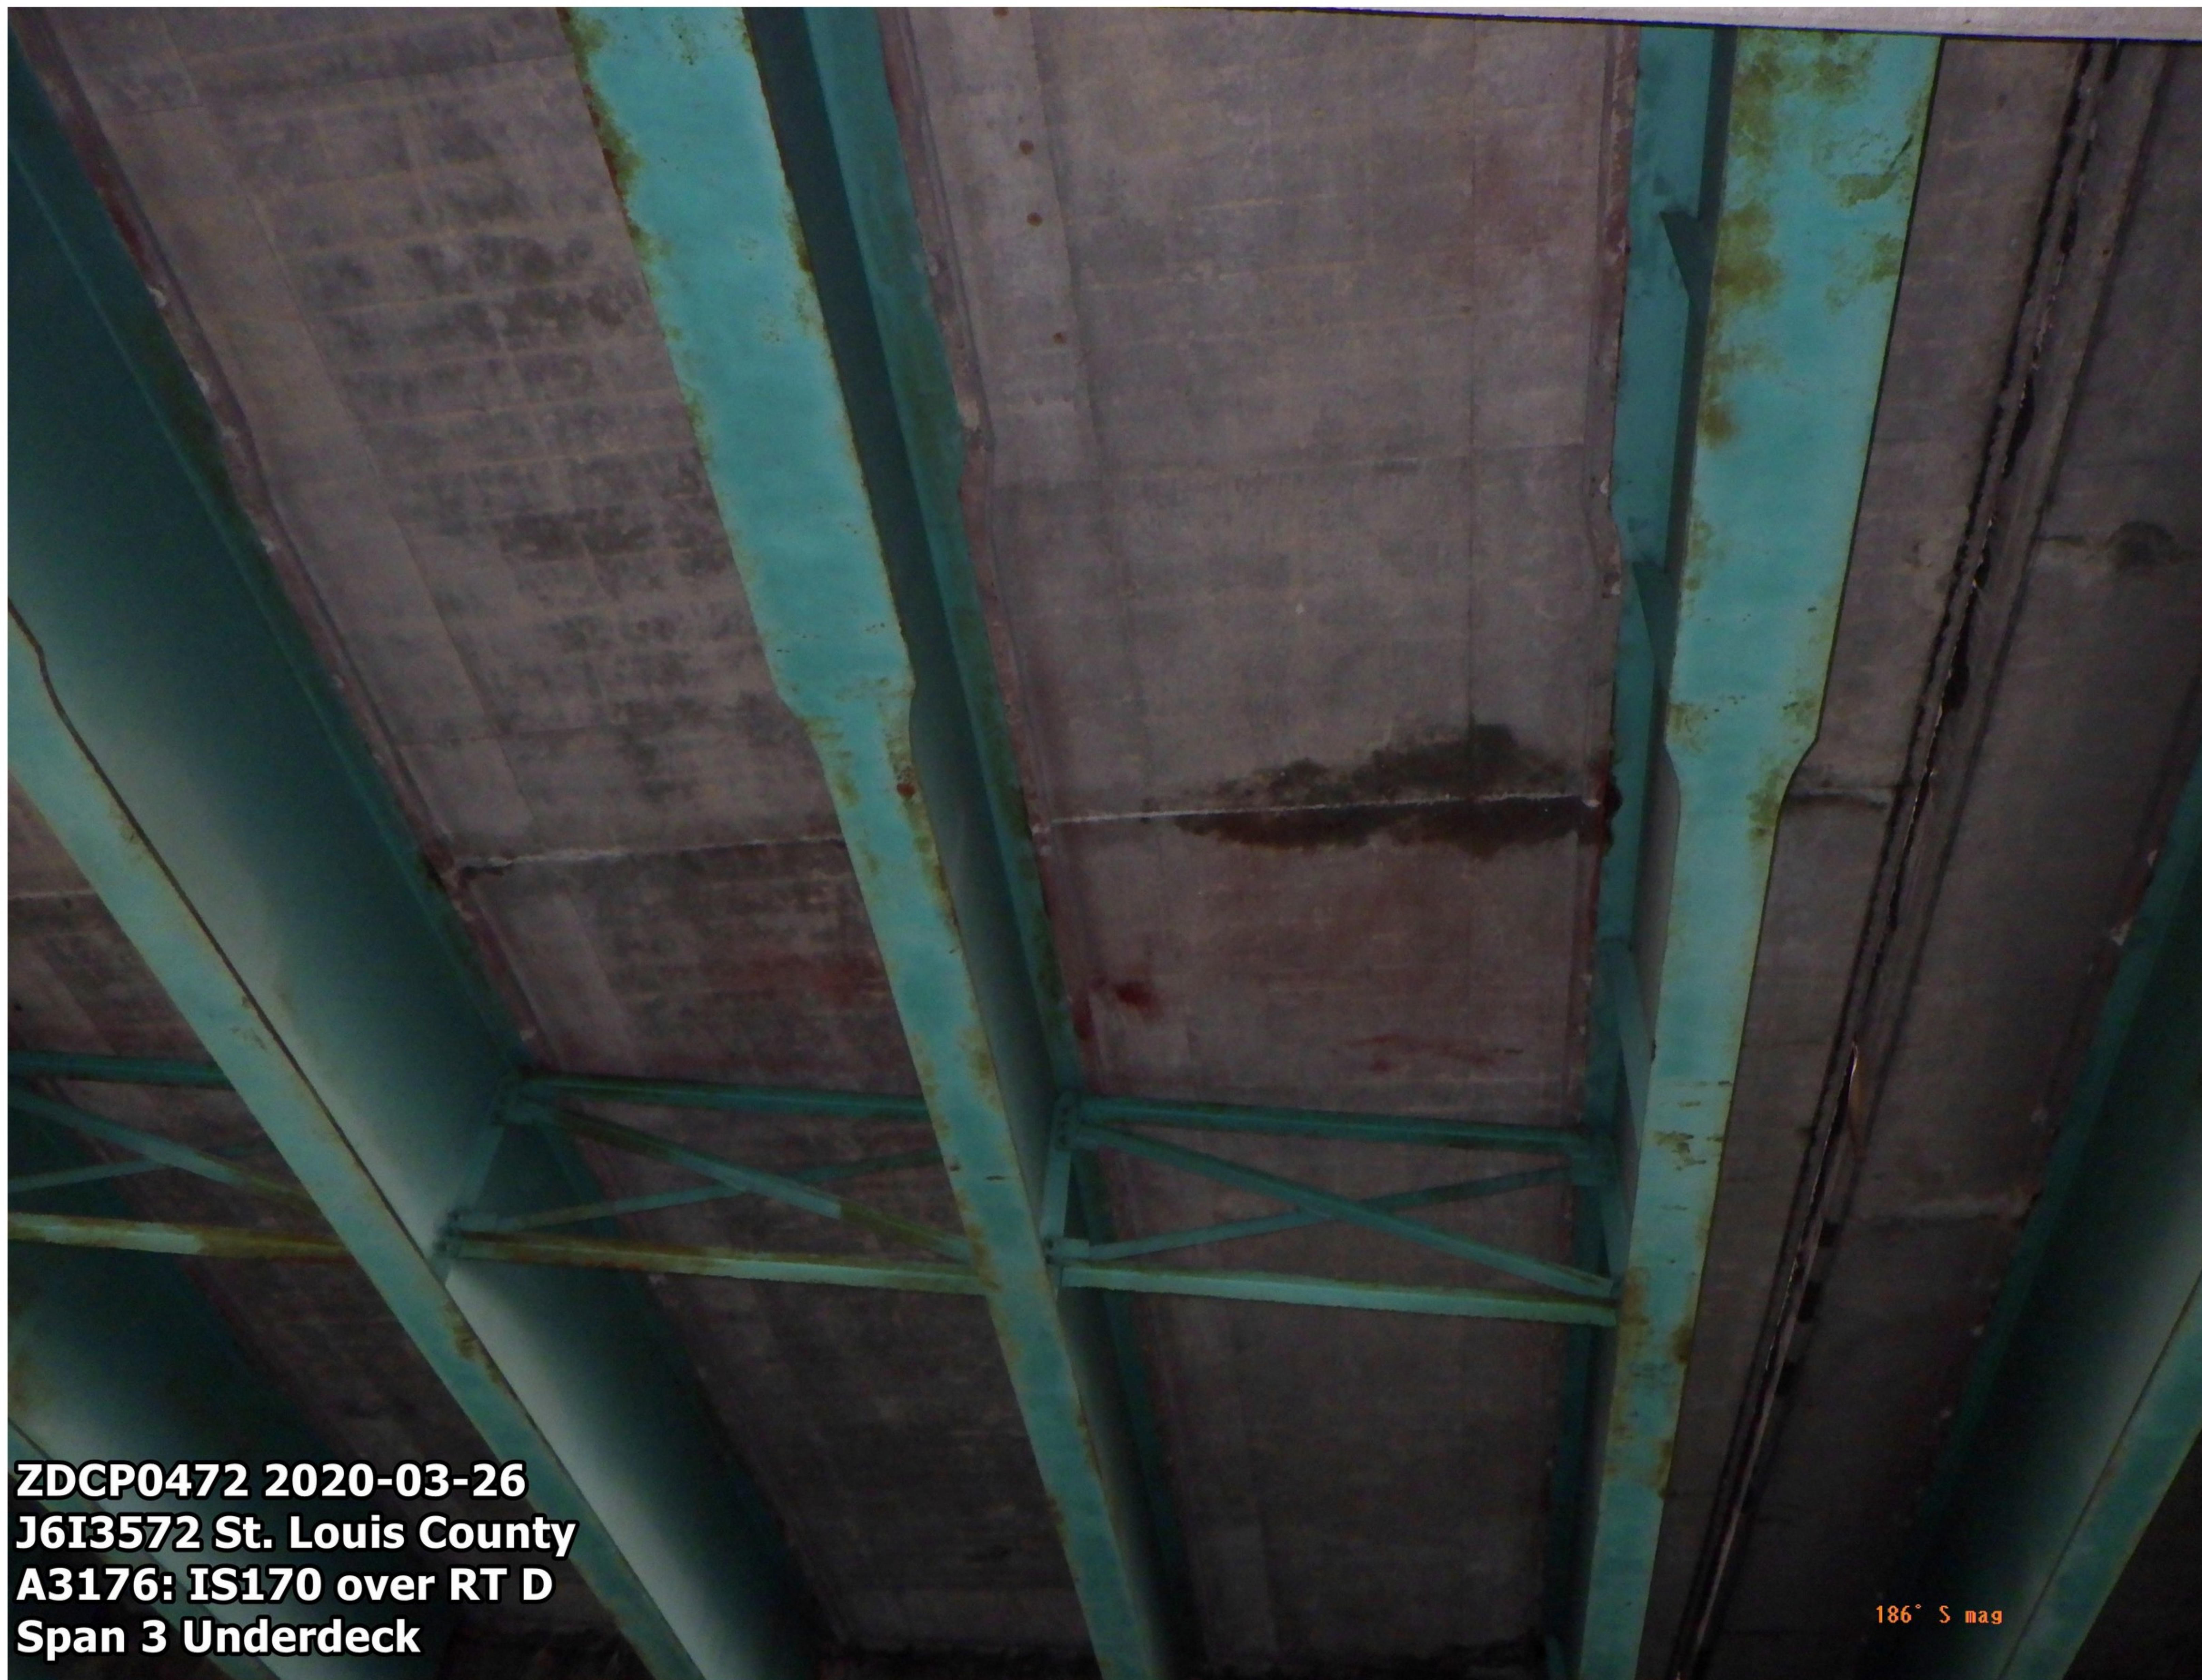
ZDCP0472 2020-03-26
J6I3572 St. Louis County
A3176: IS170 over RT D
Span 3 Underdeck

* Notes: **Consider eliminating median gap if re-deck option selected. Consider consultant GPR/IR for refined deck repair quantities**

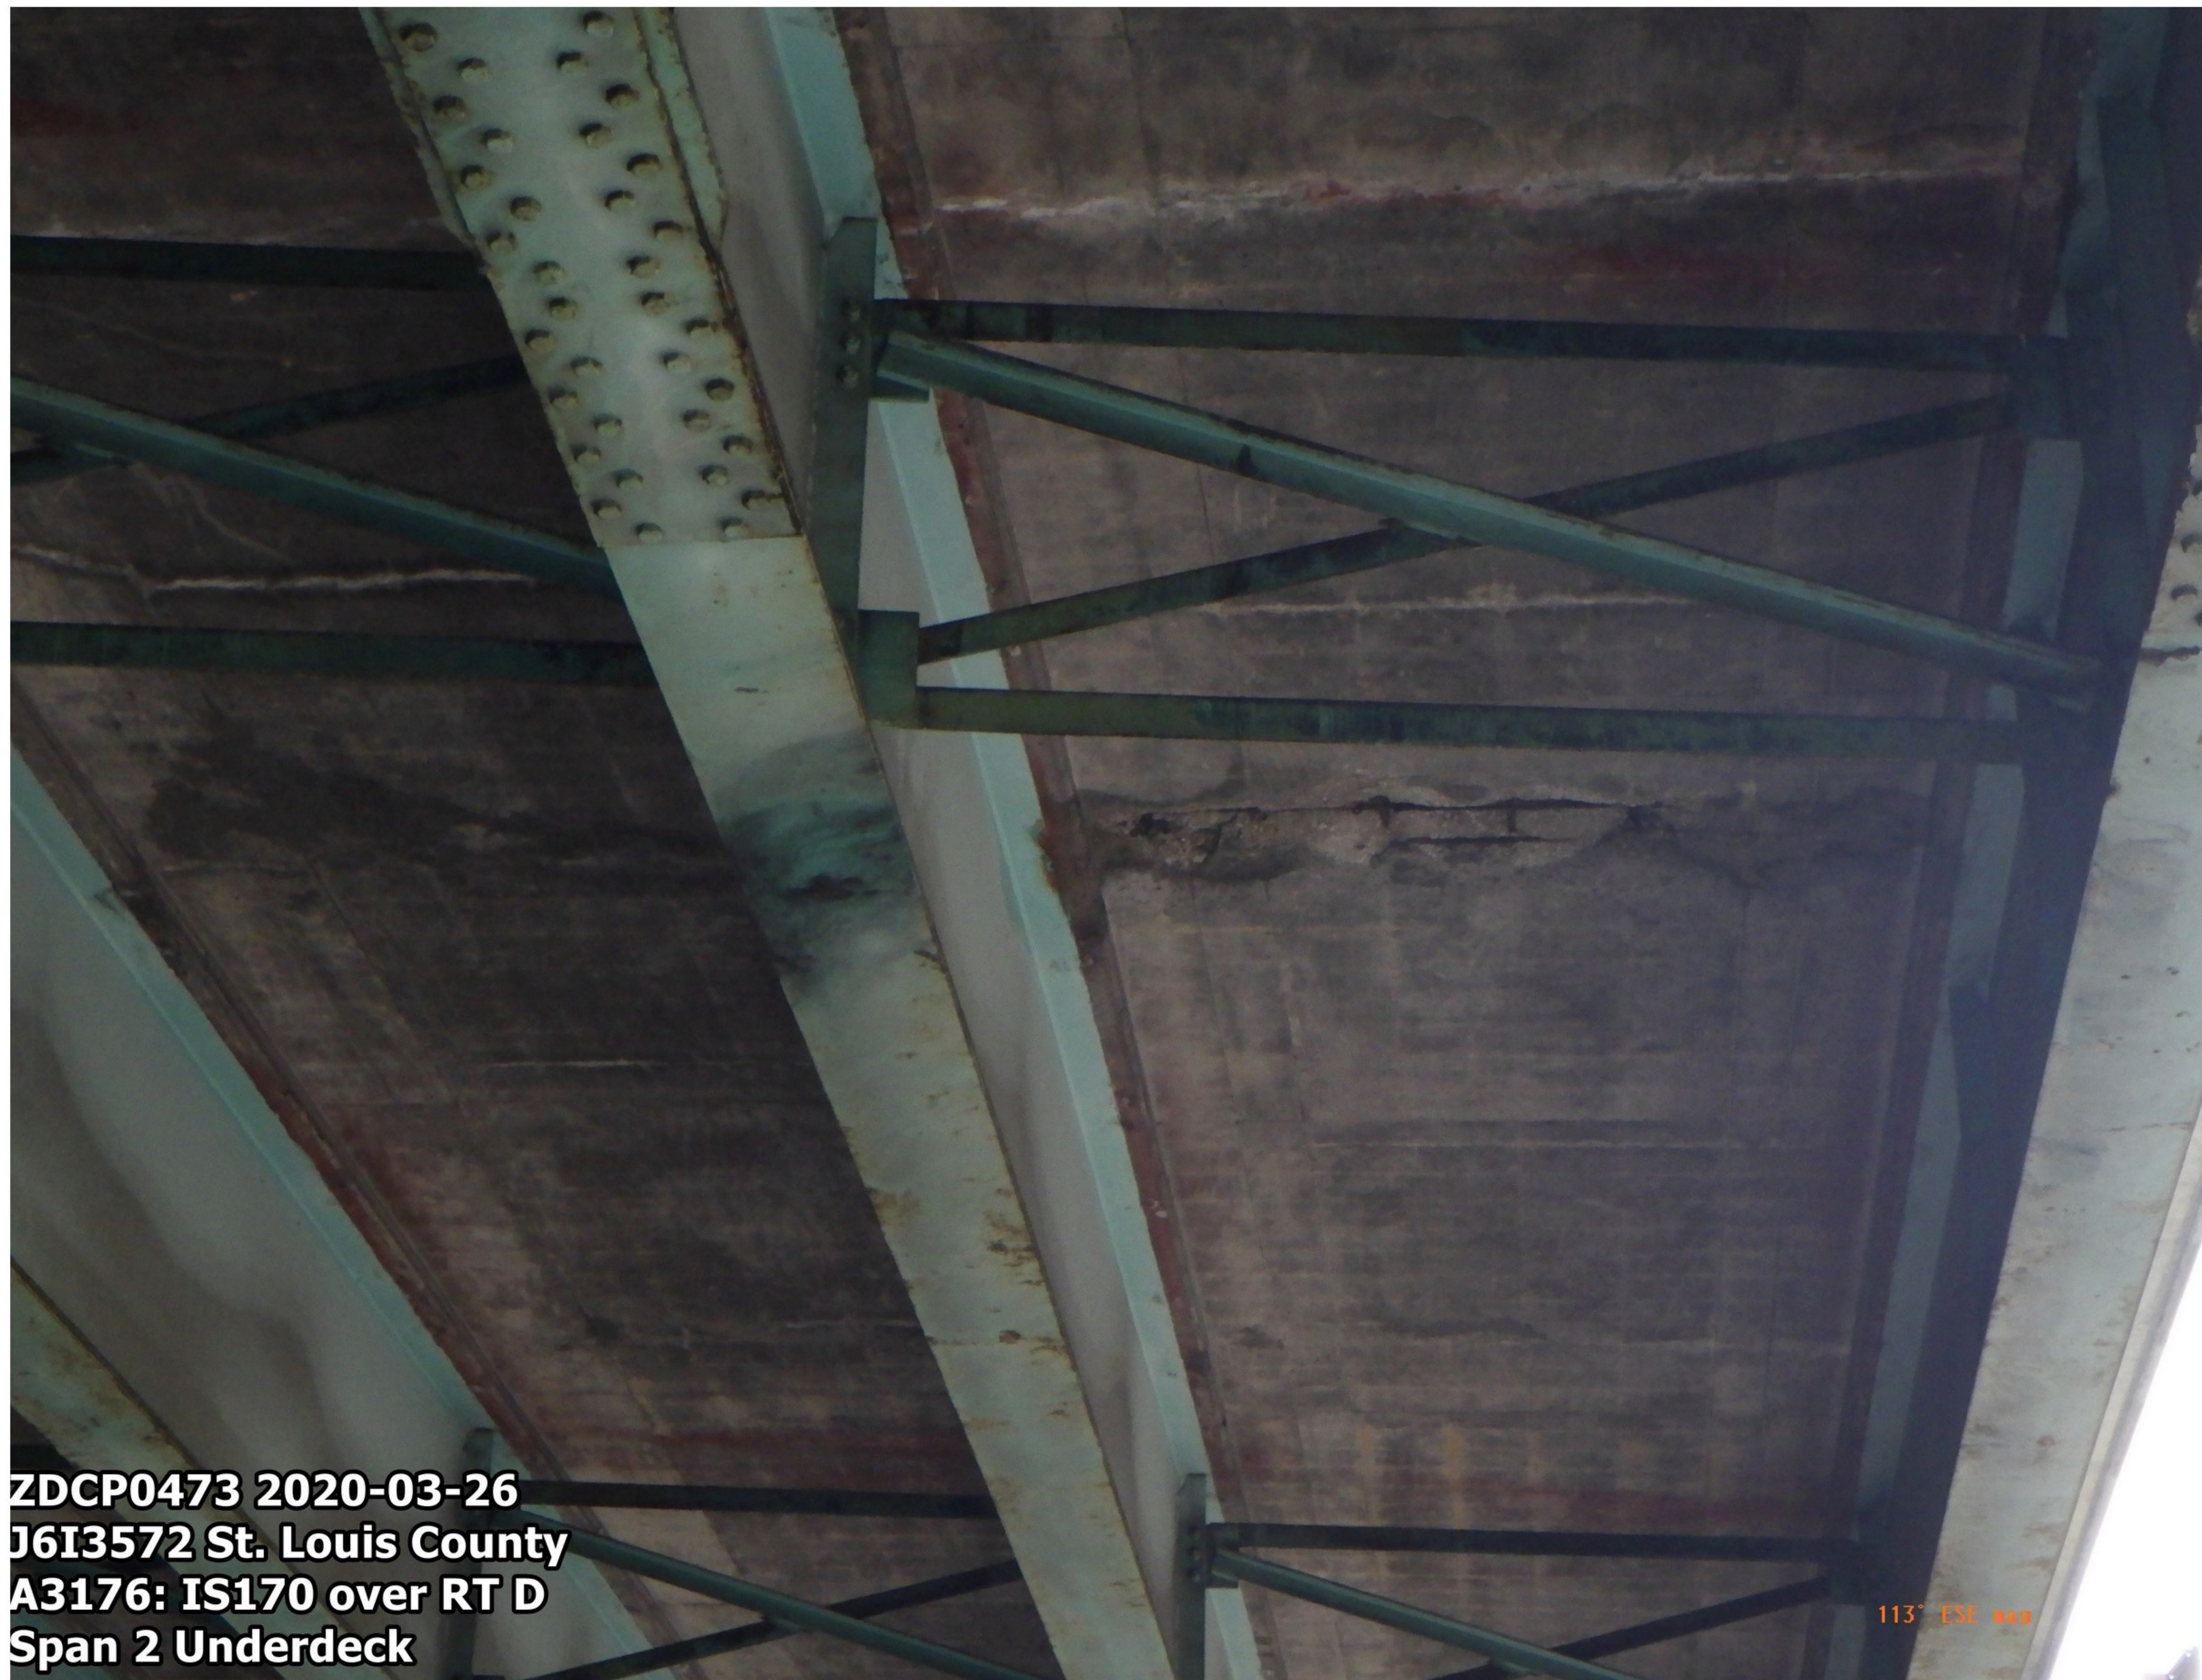
ZDCP0473 2020-03-26
J6I3572 St. Louis County
A3176: IS170 over RT D
Span 2 Underdeck

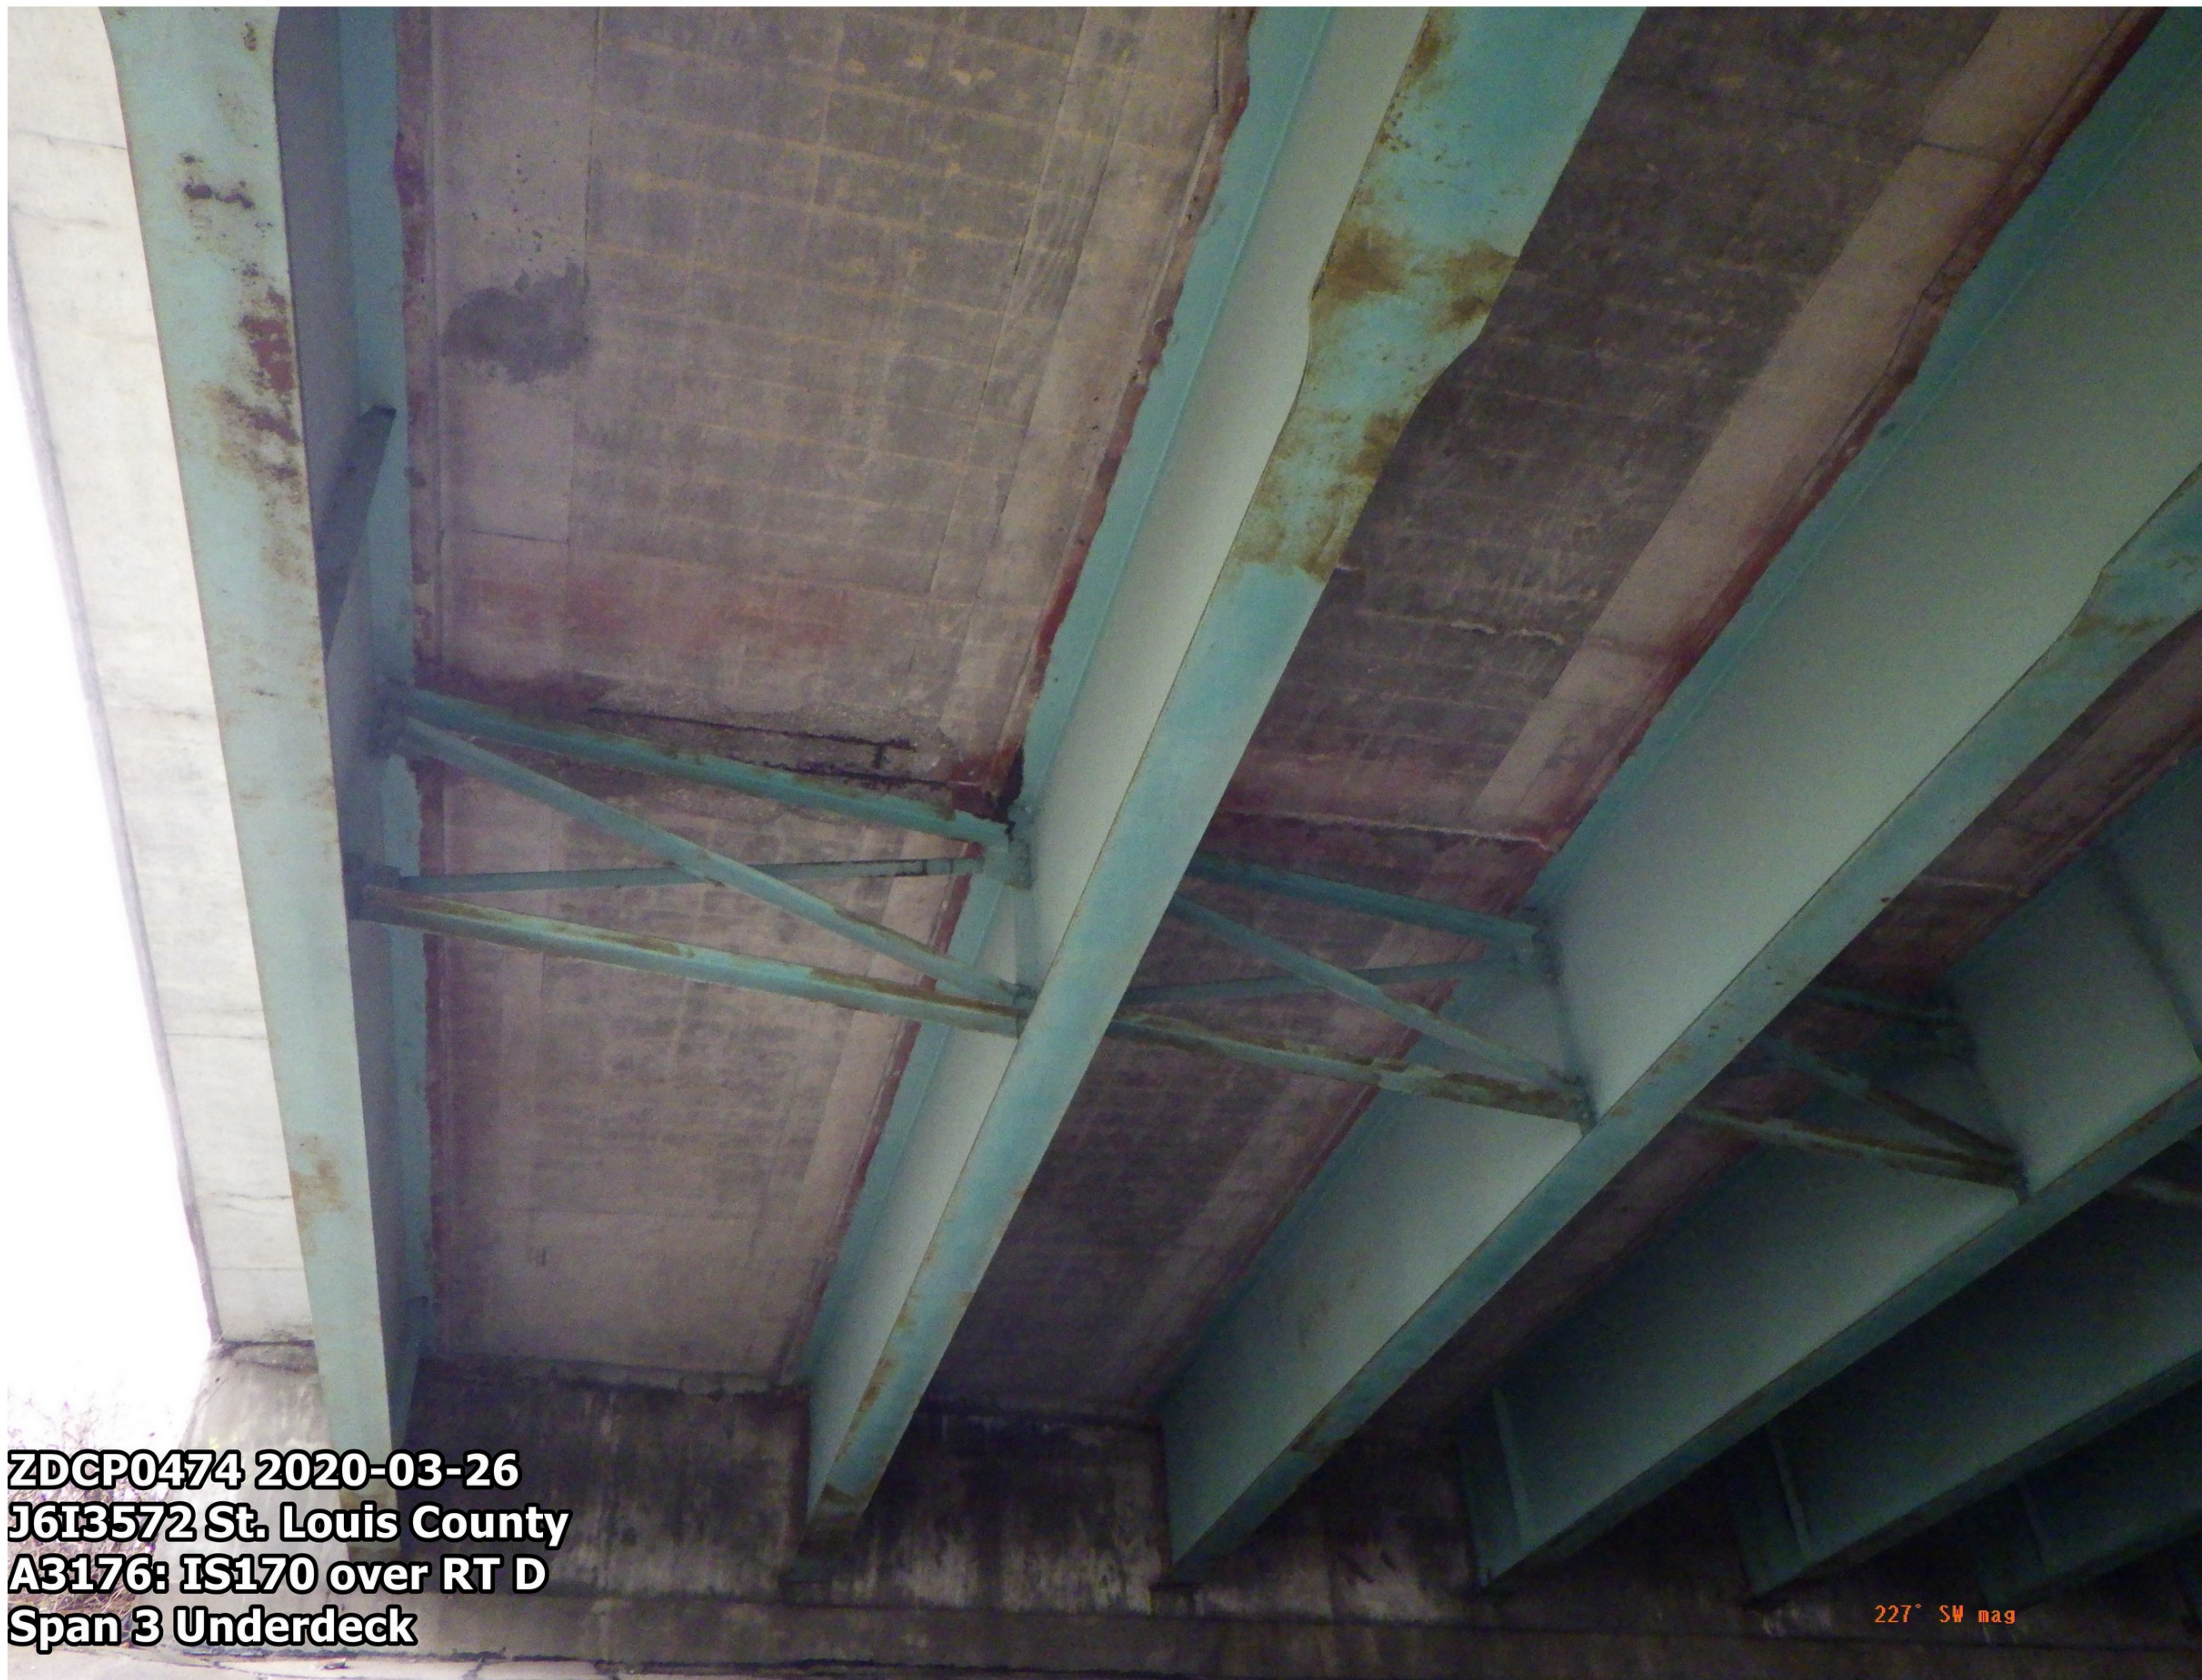
ZDCP0474 2020-03-26
J6I3572 St. Louis County
A3176: IS170 over RT D
Span 3 Underdeck

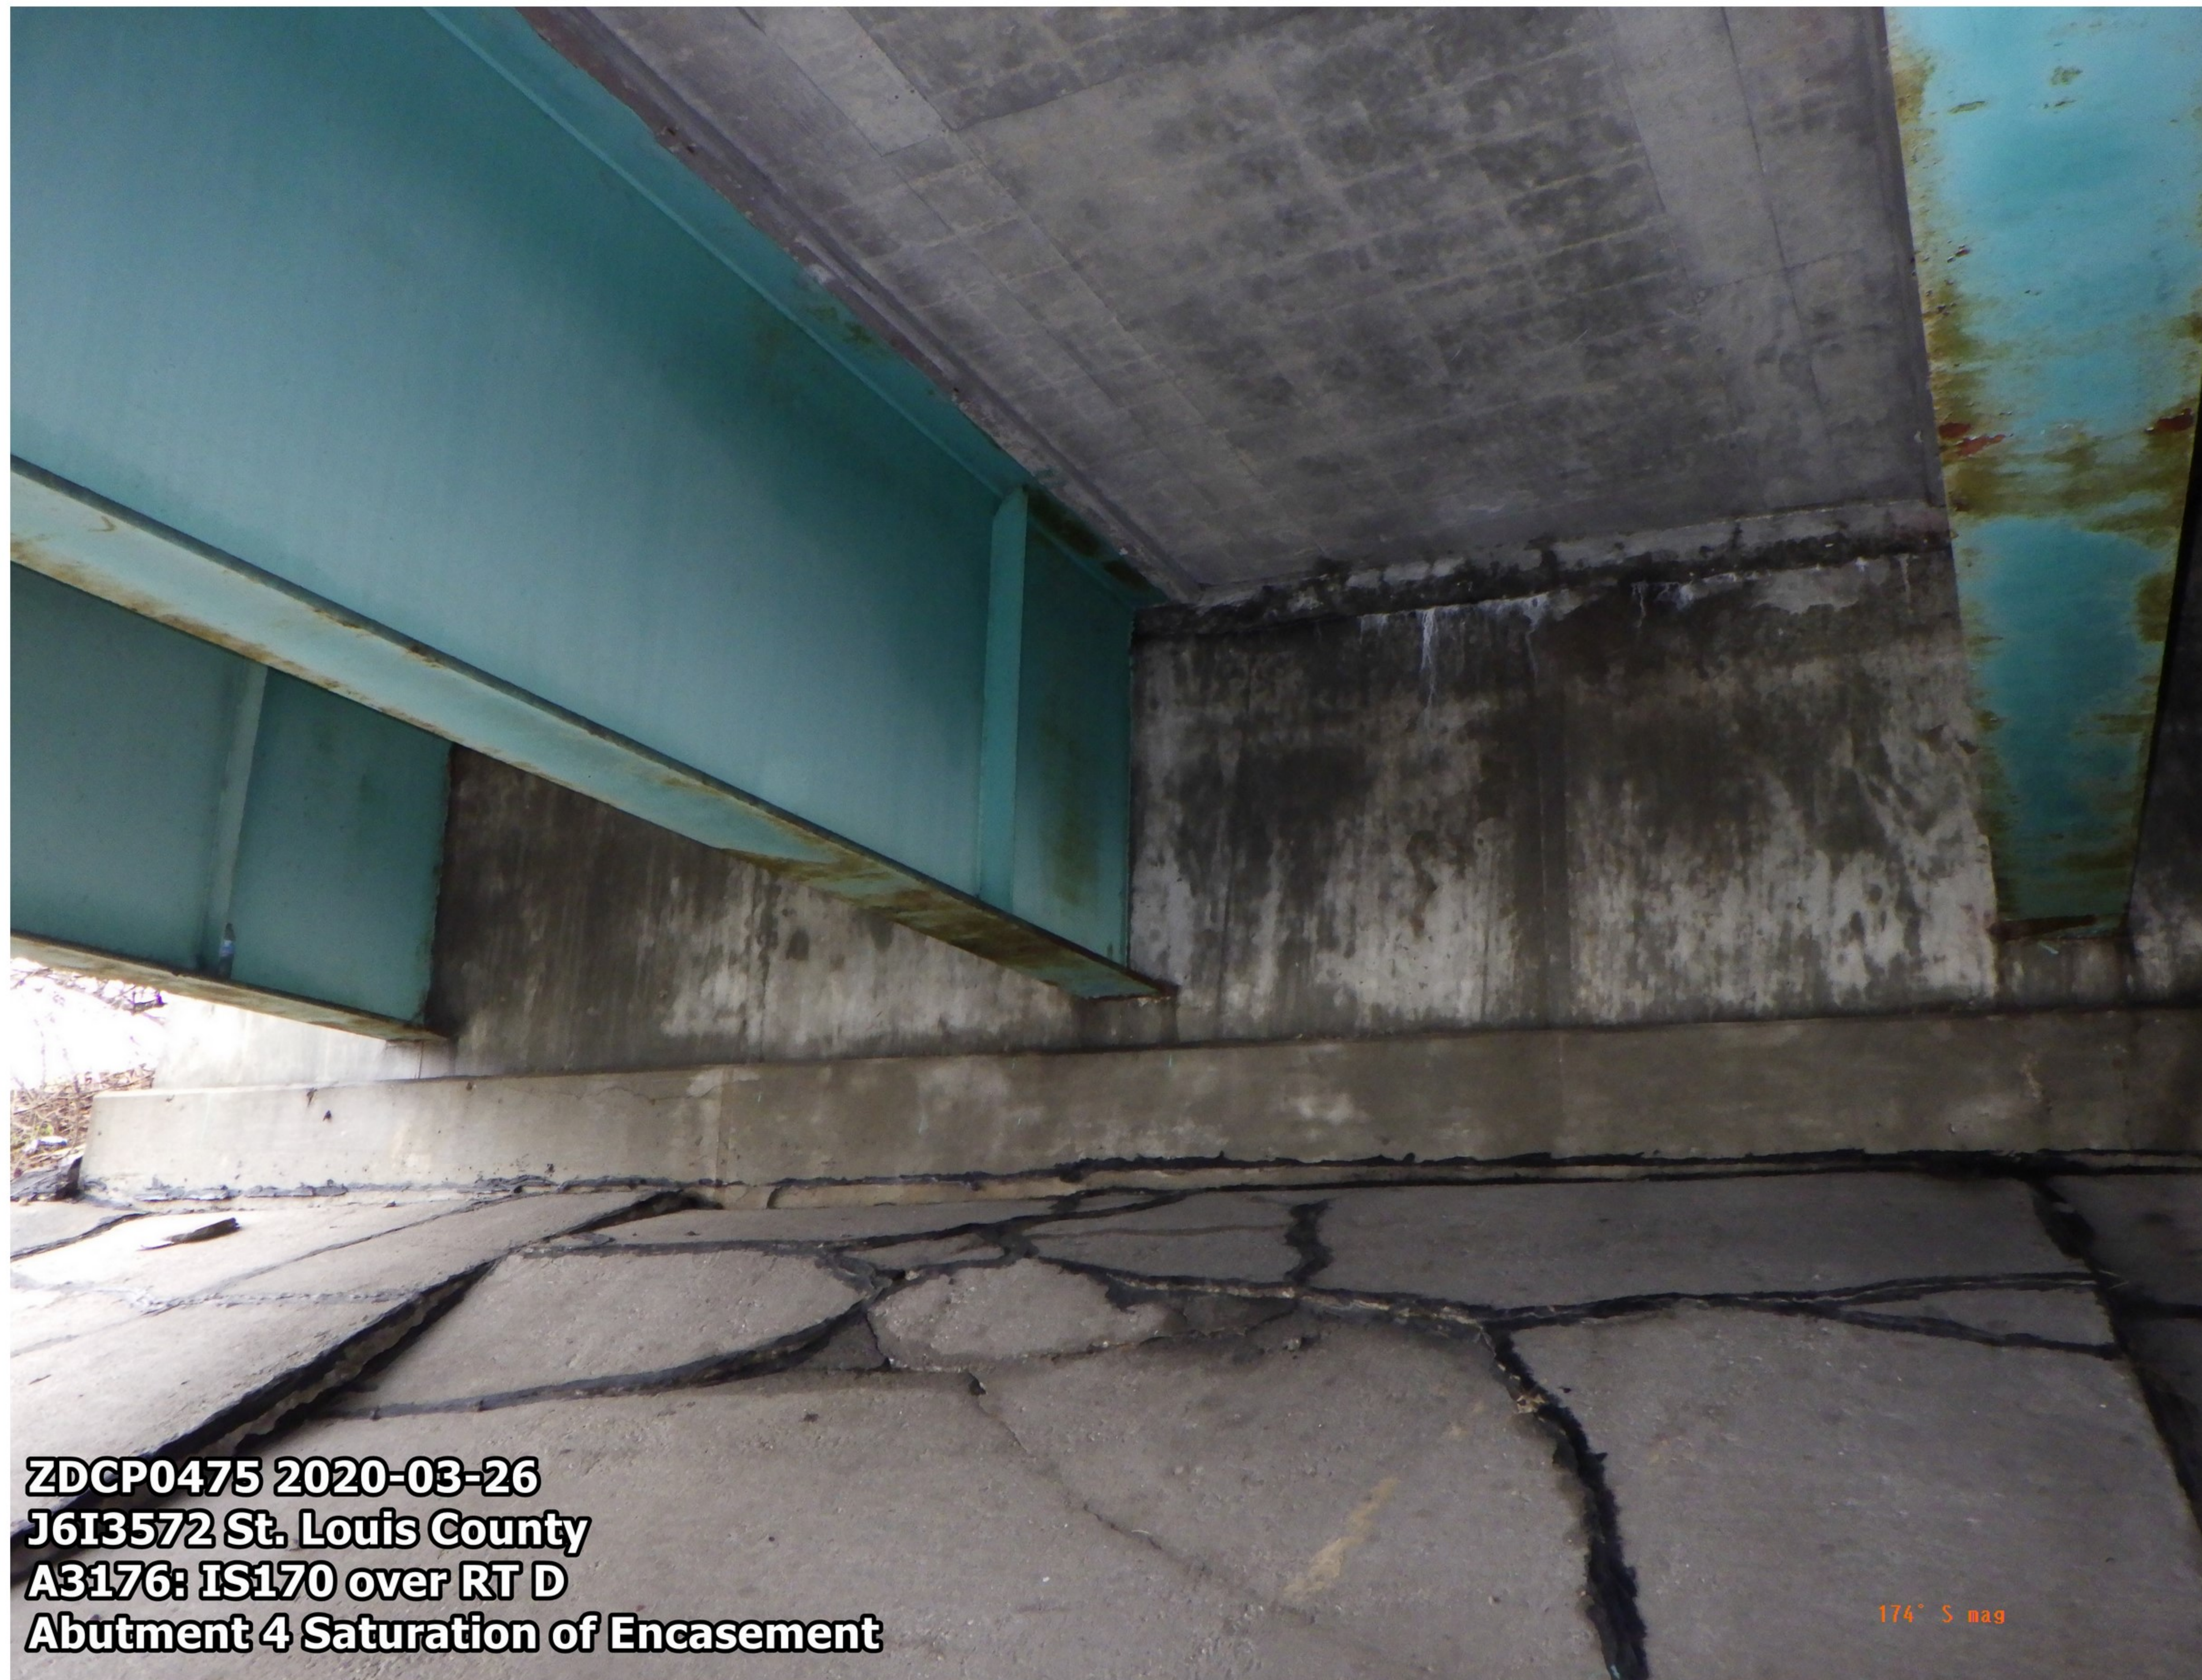
ZDCP0475 2020-03-26
J6I3572 St. Louis County
A3176: IS170 over RT D
Abutment 4 Saturation of Encasement

* Does the structure need graffiti protection? ☒ No ☐ Bottom 8' of Concrete ☐ End Bents ☐ Other _____* Notes: If Replacing Approaches, place Vertical Drain at Fill Face of Abutment, Seal Caps at end and Under Median (if opting for Dense Overlay), 9 LF each intermediate bent. REQUIRE Shotcrete for unformed repairs

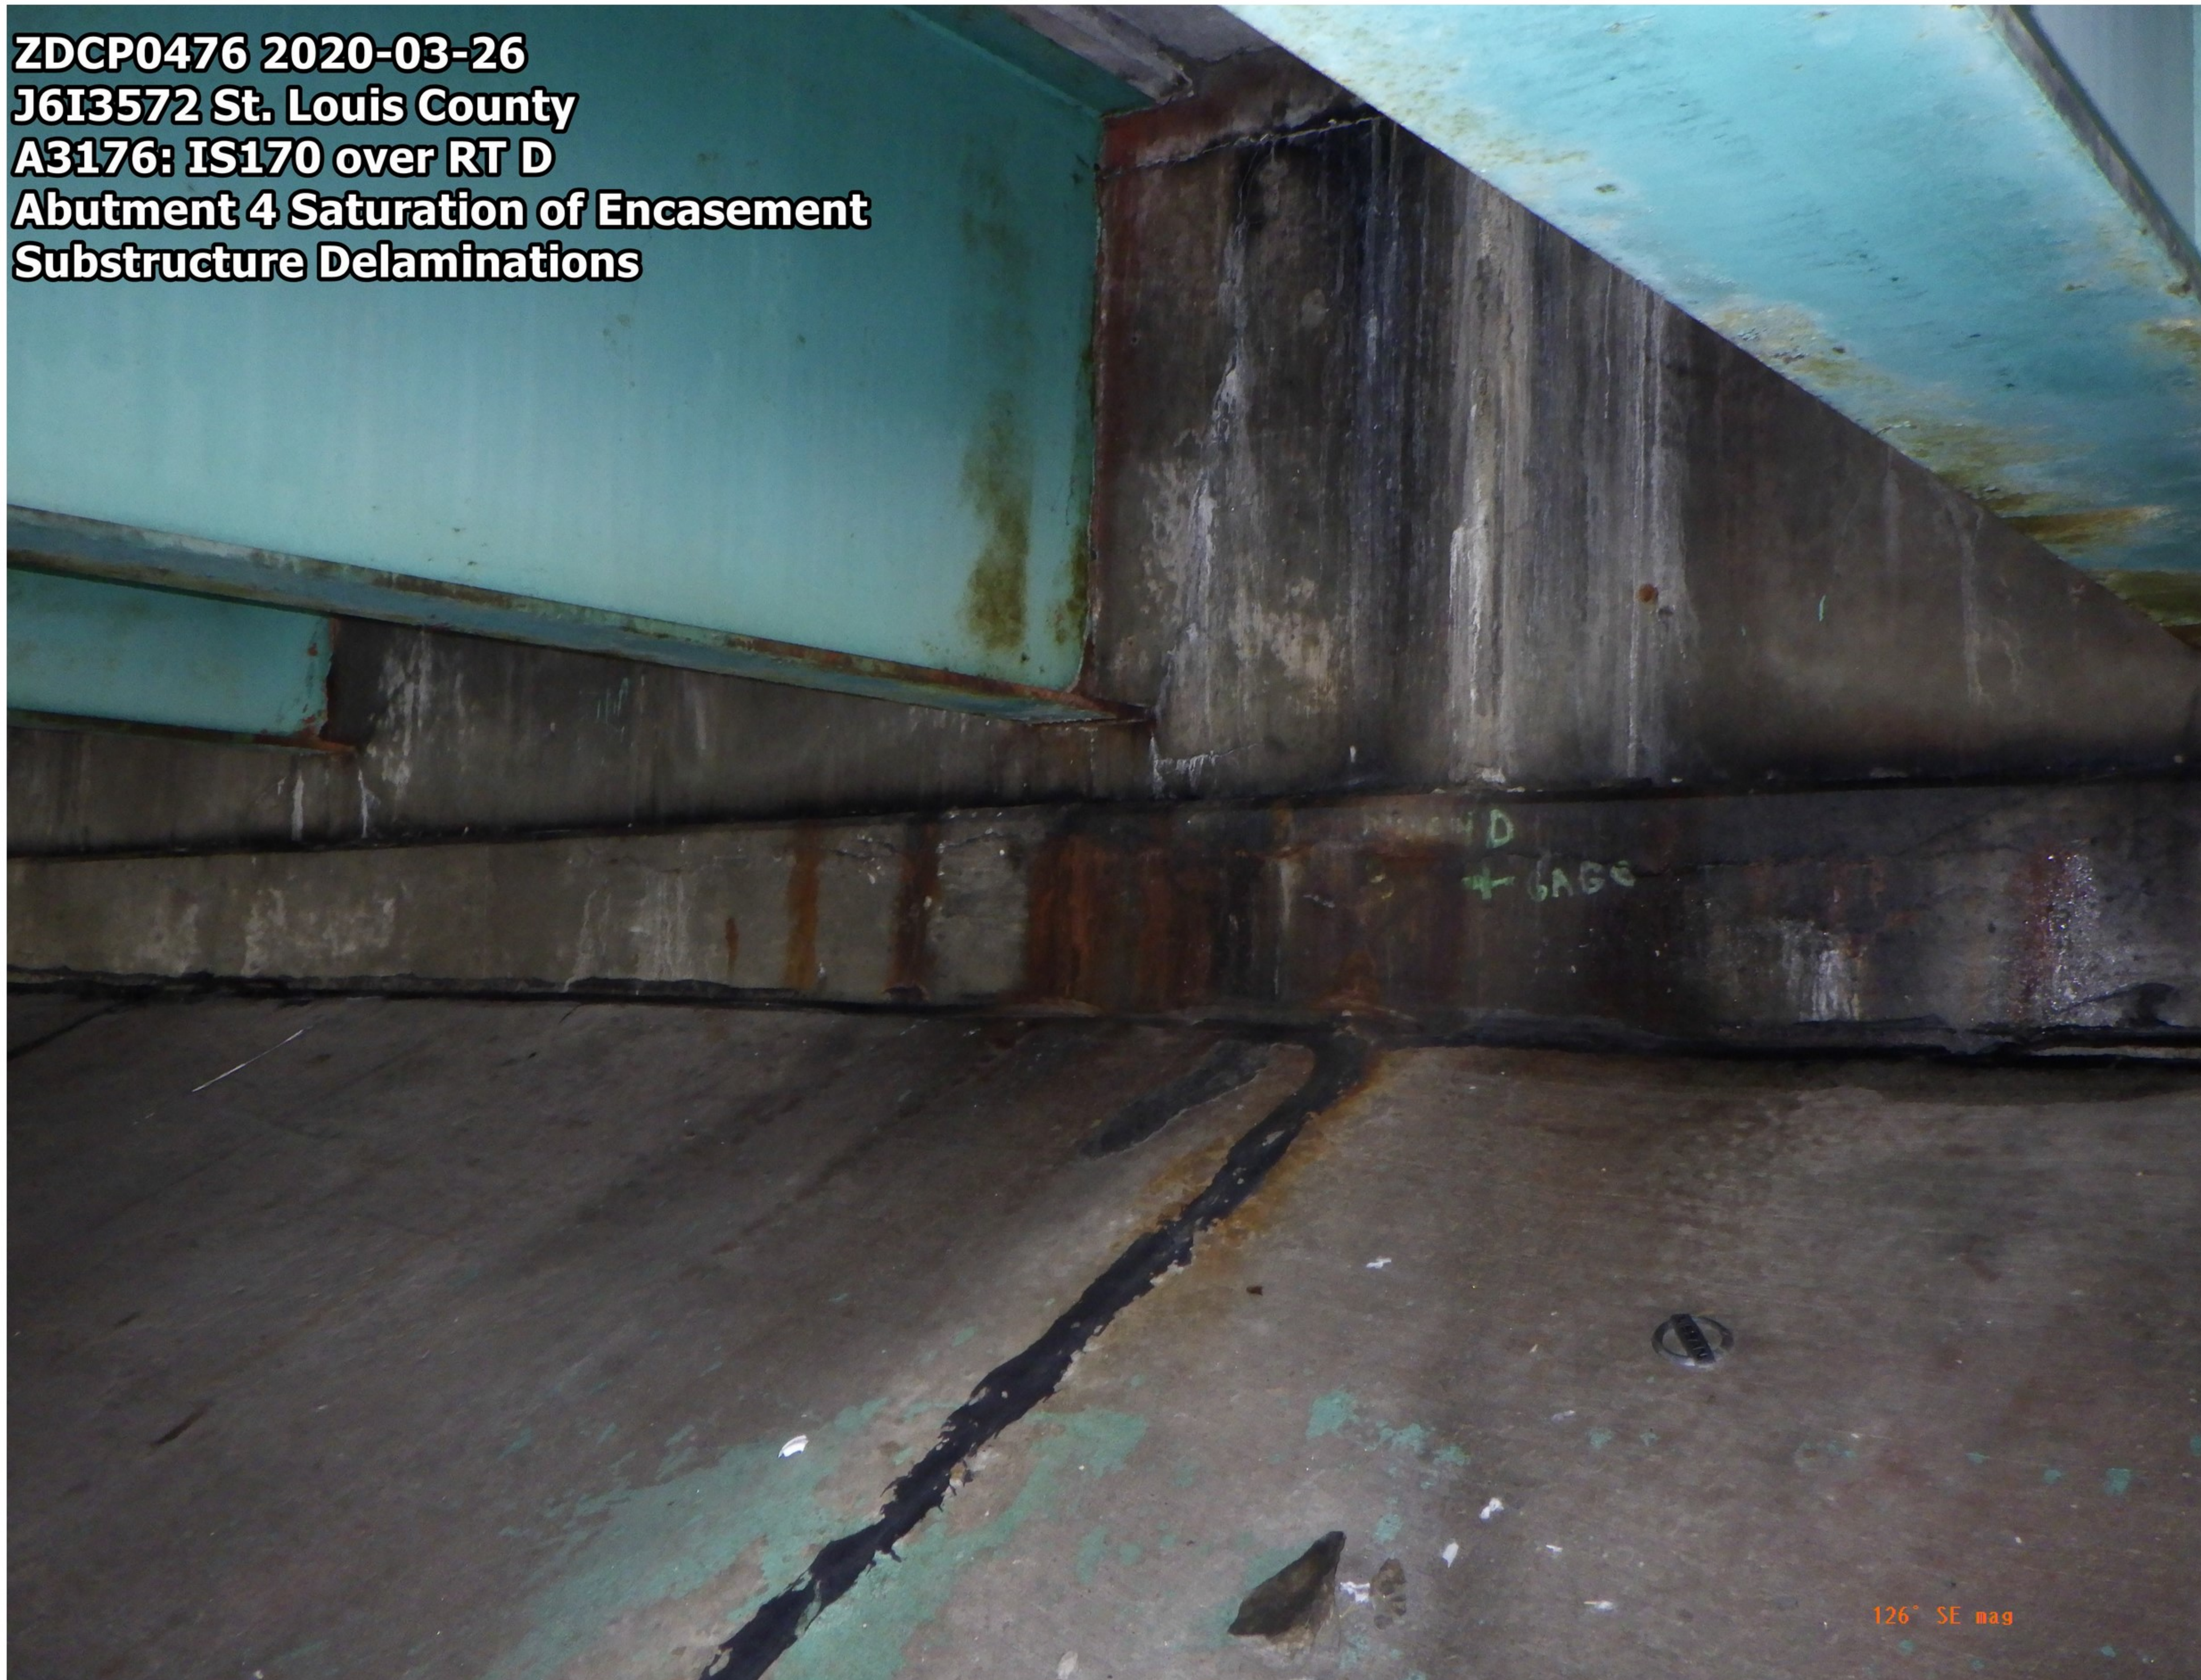
ZDCP0477 2020-03-26
J6I3572 St. Louis County
A3176: IS170 over RT D
Southbound South Approach

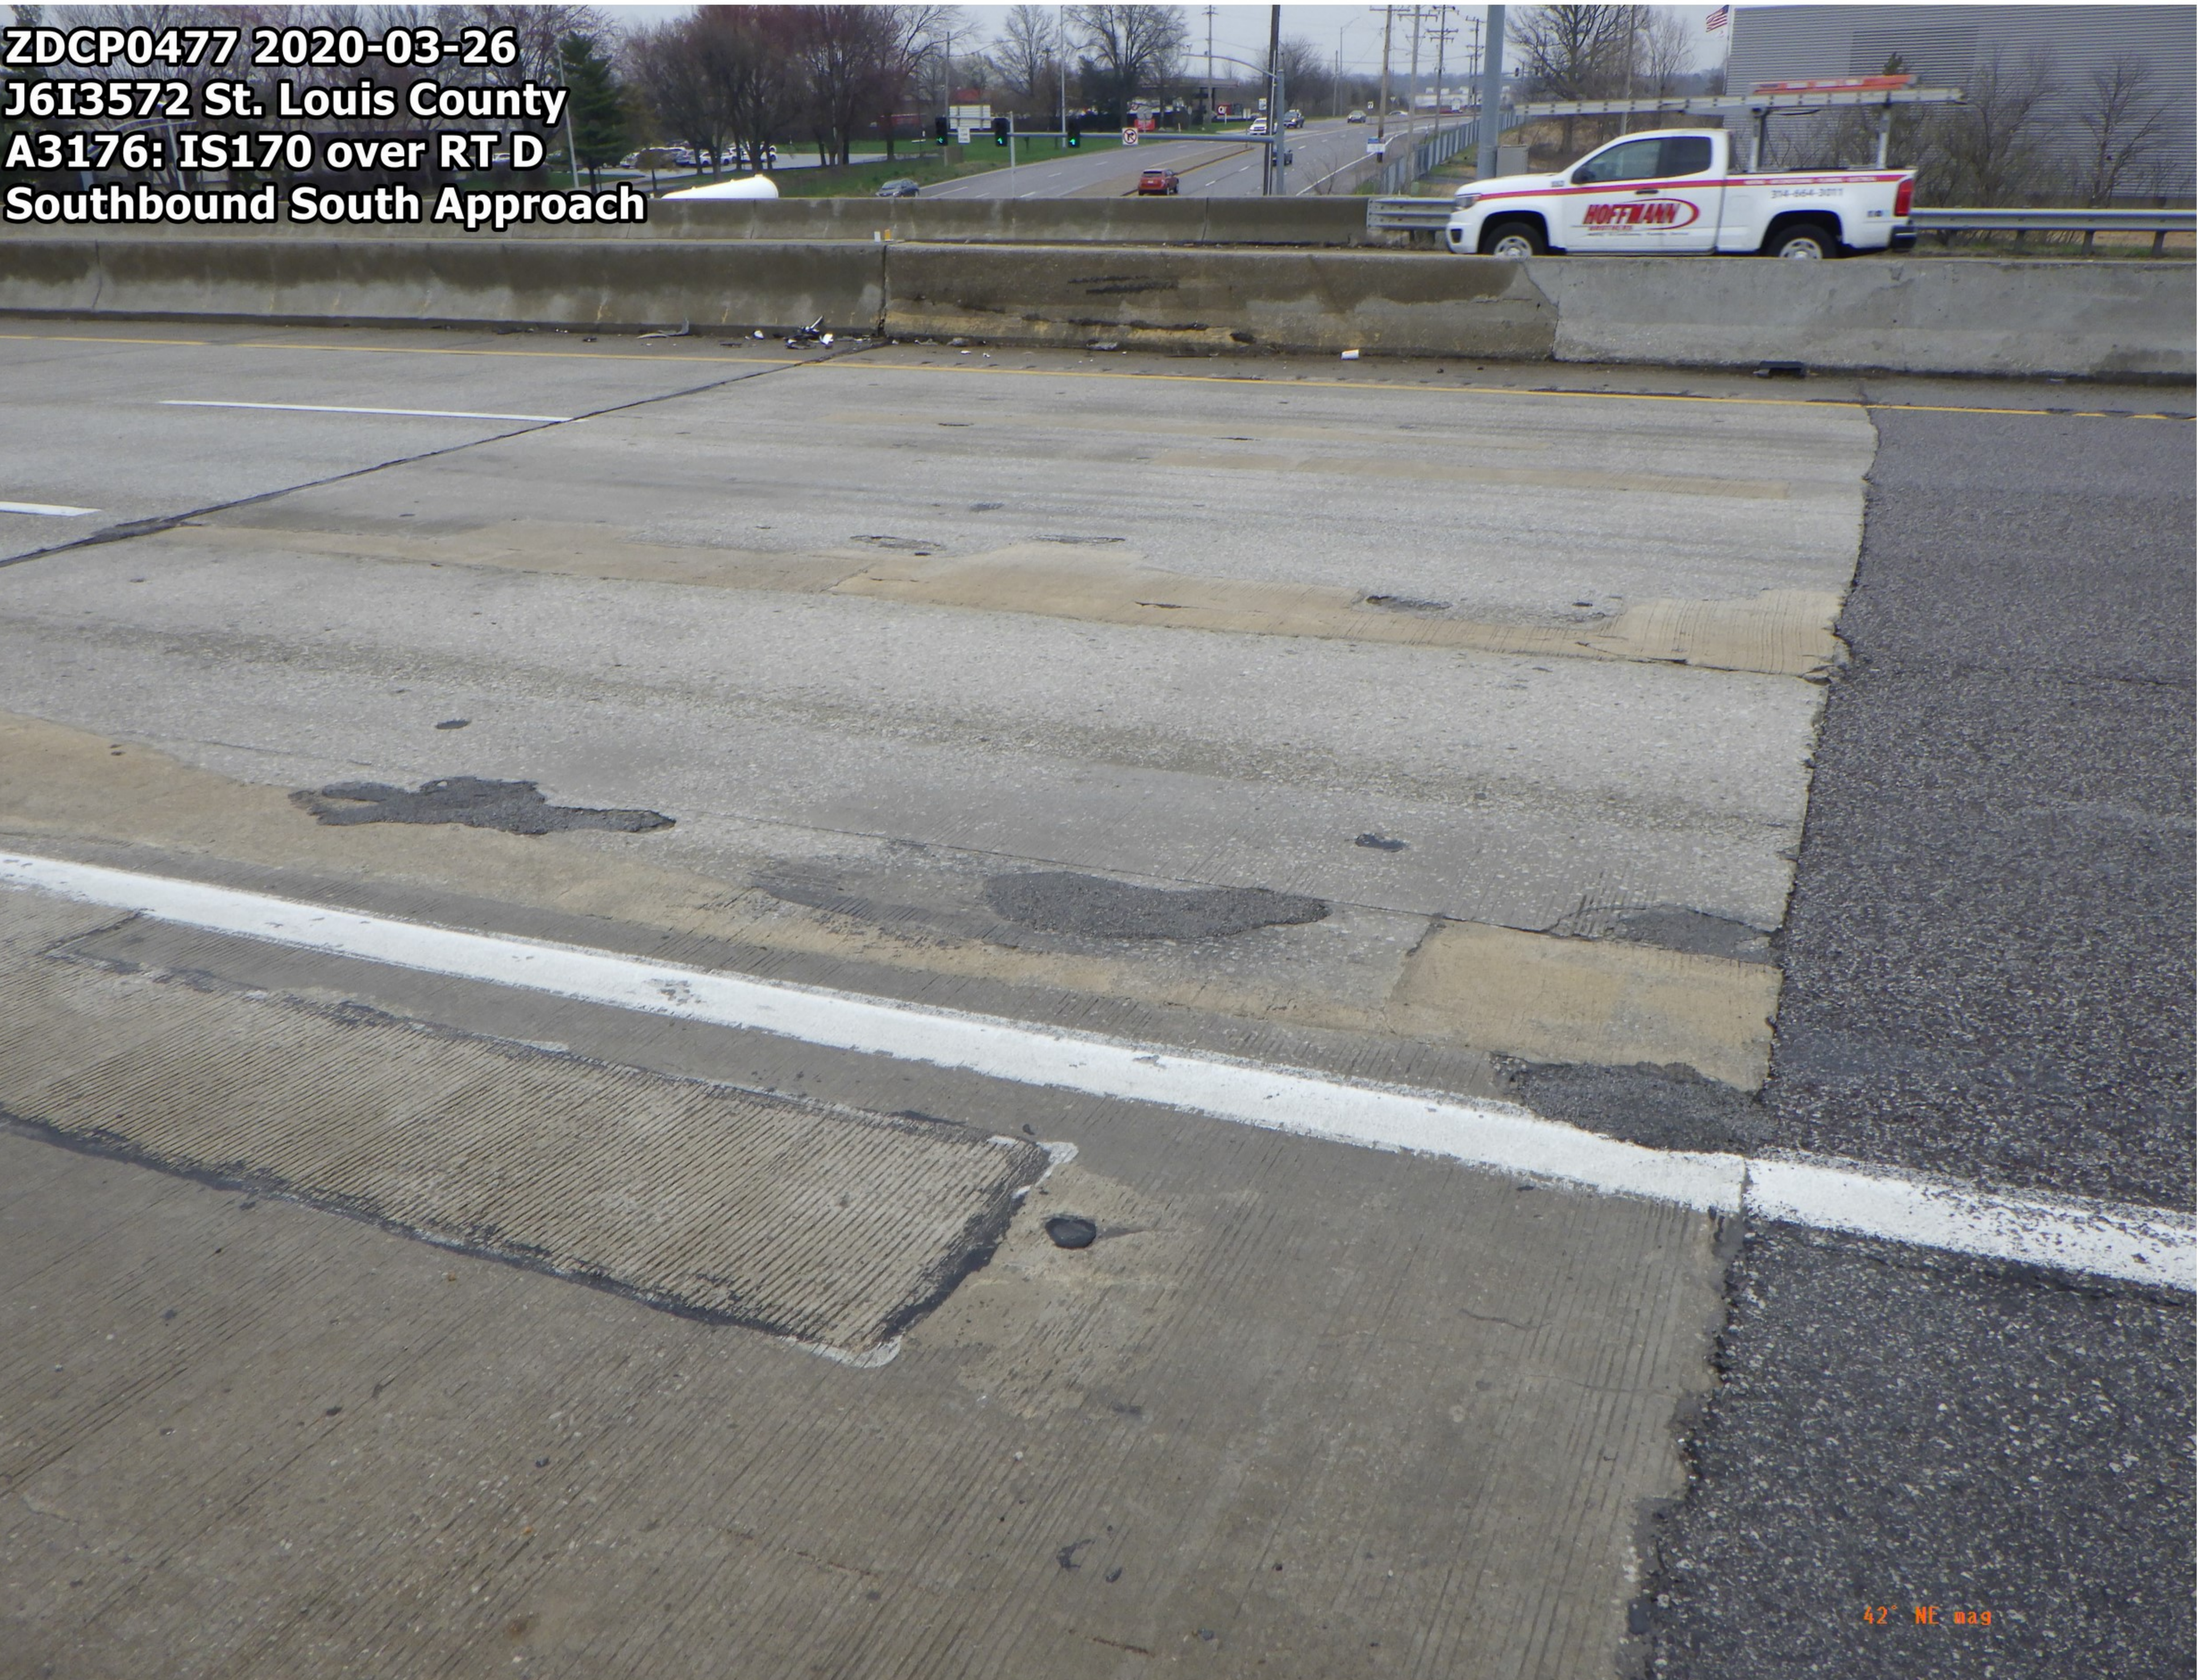
ZDCP0479 2020-03-26
J6I3572 St. Louis County
A3176: IS170 over RT D
Typical Deck Surface

* Notes: **Evaluate Between Hydrodemolition with Latex Modified Concrete Overlay, or Full Deck Replacement**
