STRUCTURAL REHABILITATION CHECKLIST

Bridge No.: **A3176**

Route: **IS 170**

Over: **RT D**

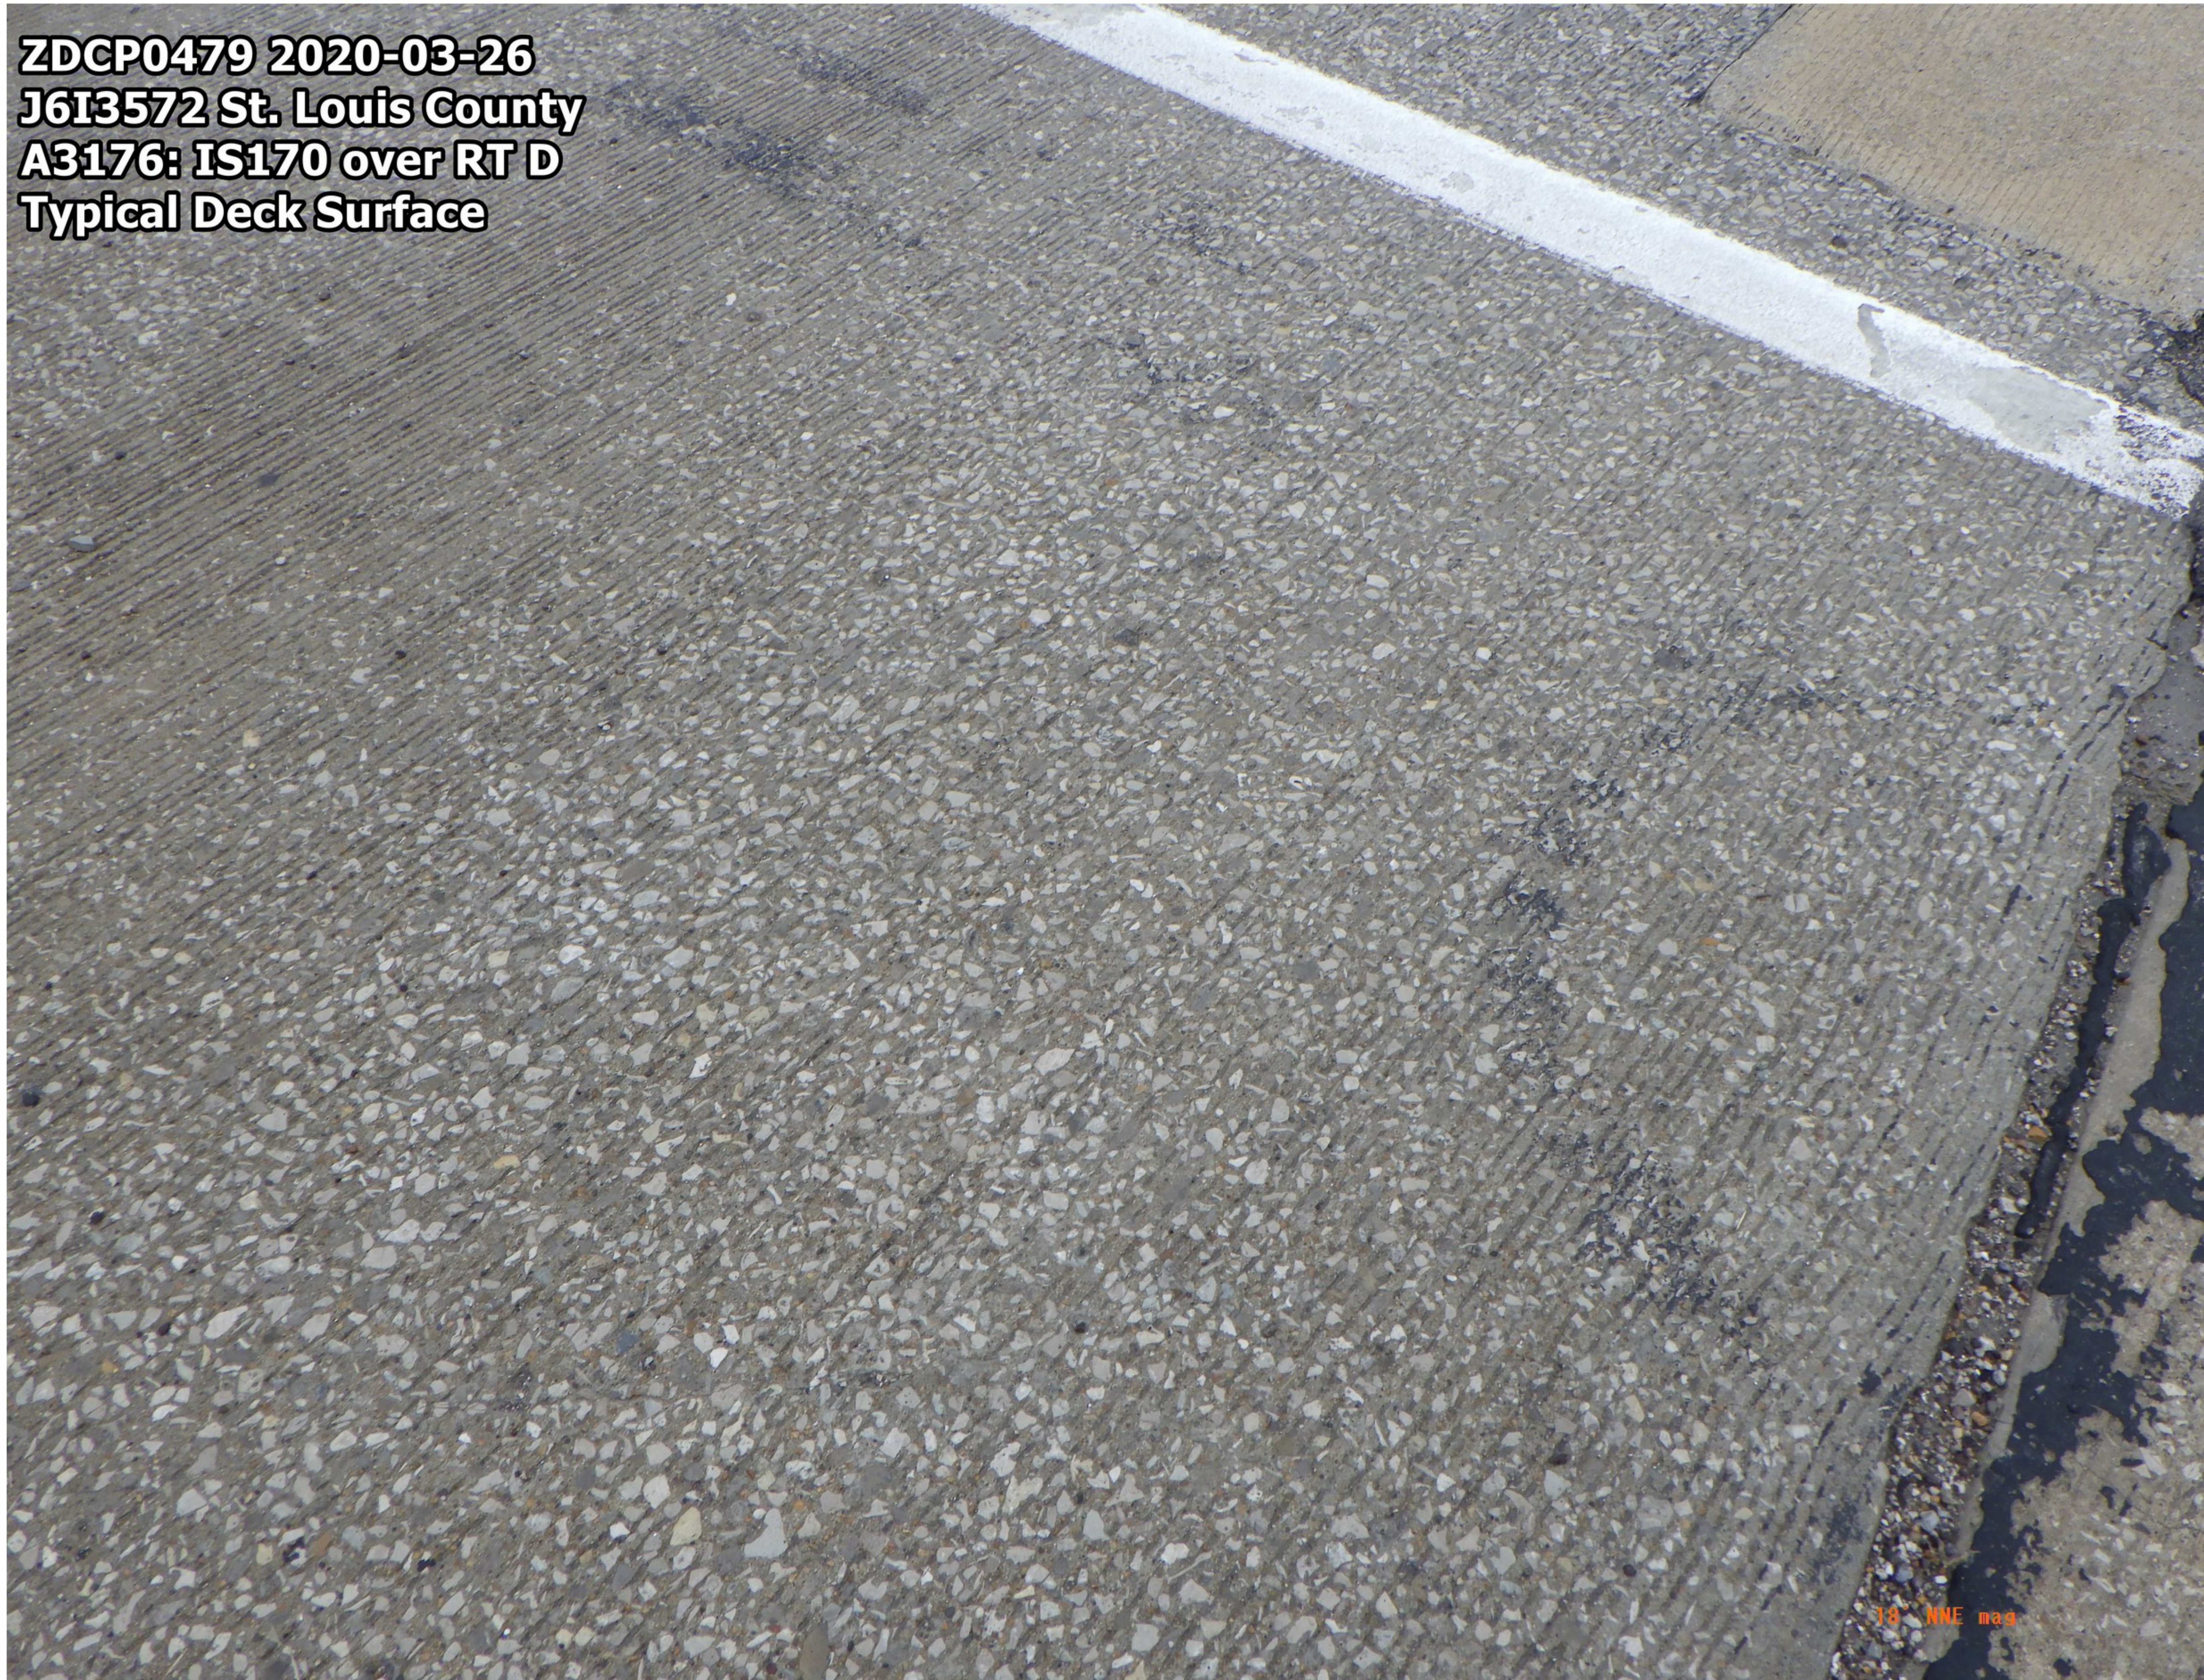
ZDCP0480 2020-03-26
J6I3572 St. Louis County
A3176: IS170 over RT D
Southbound General Looking North

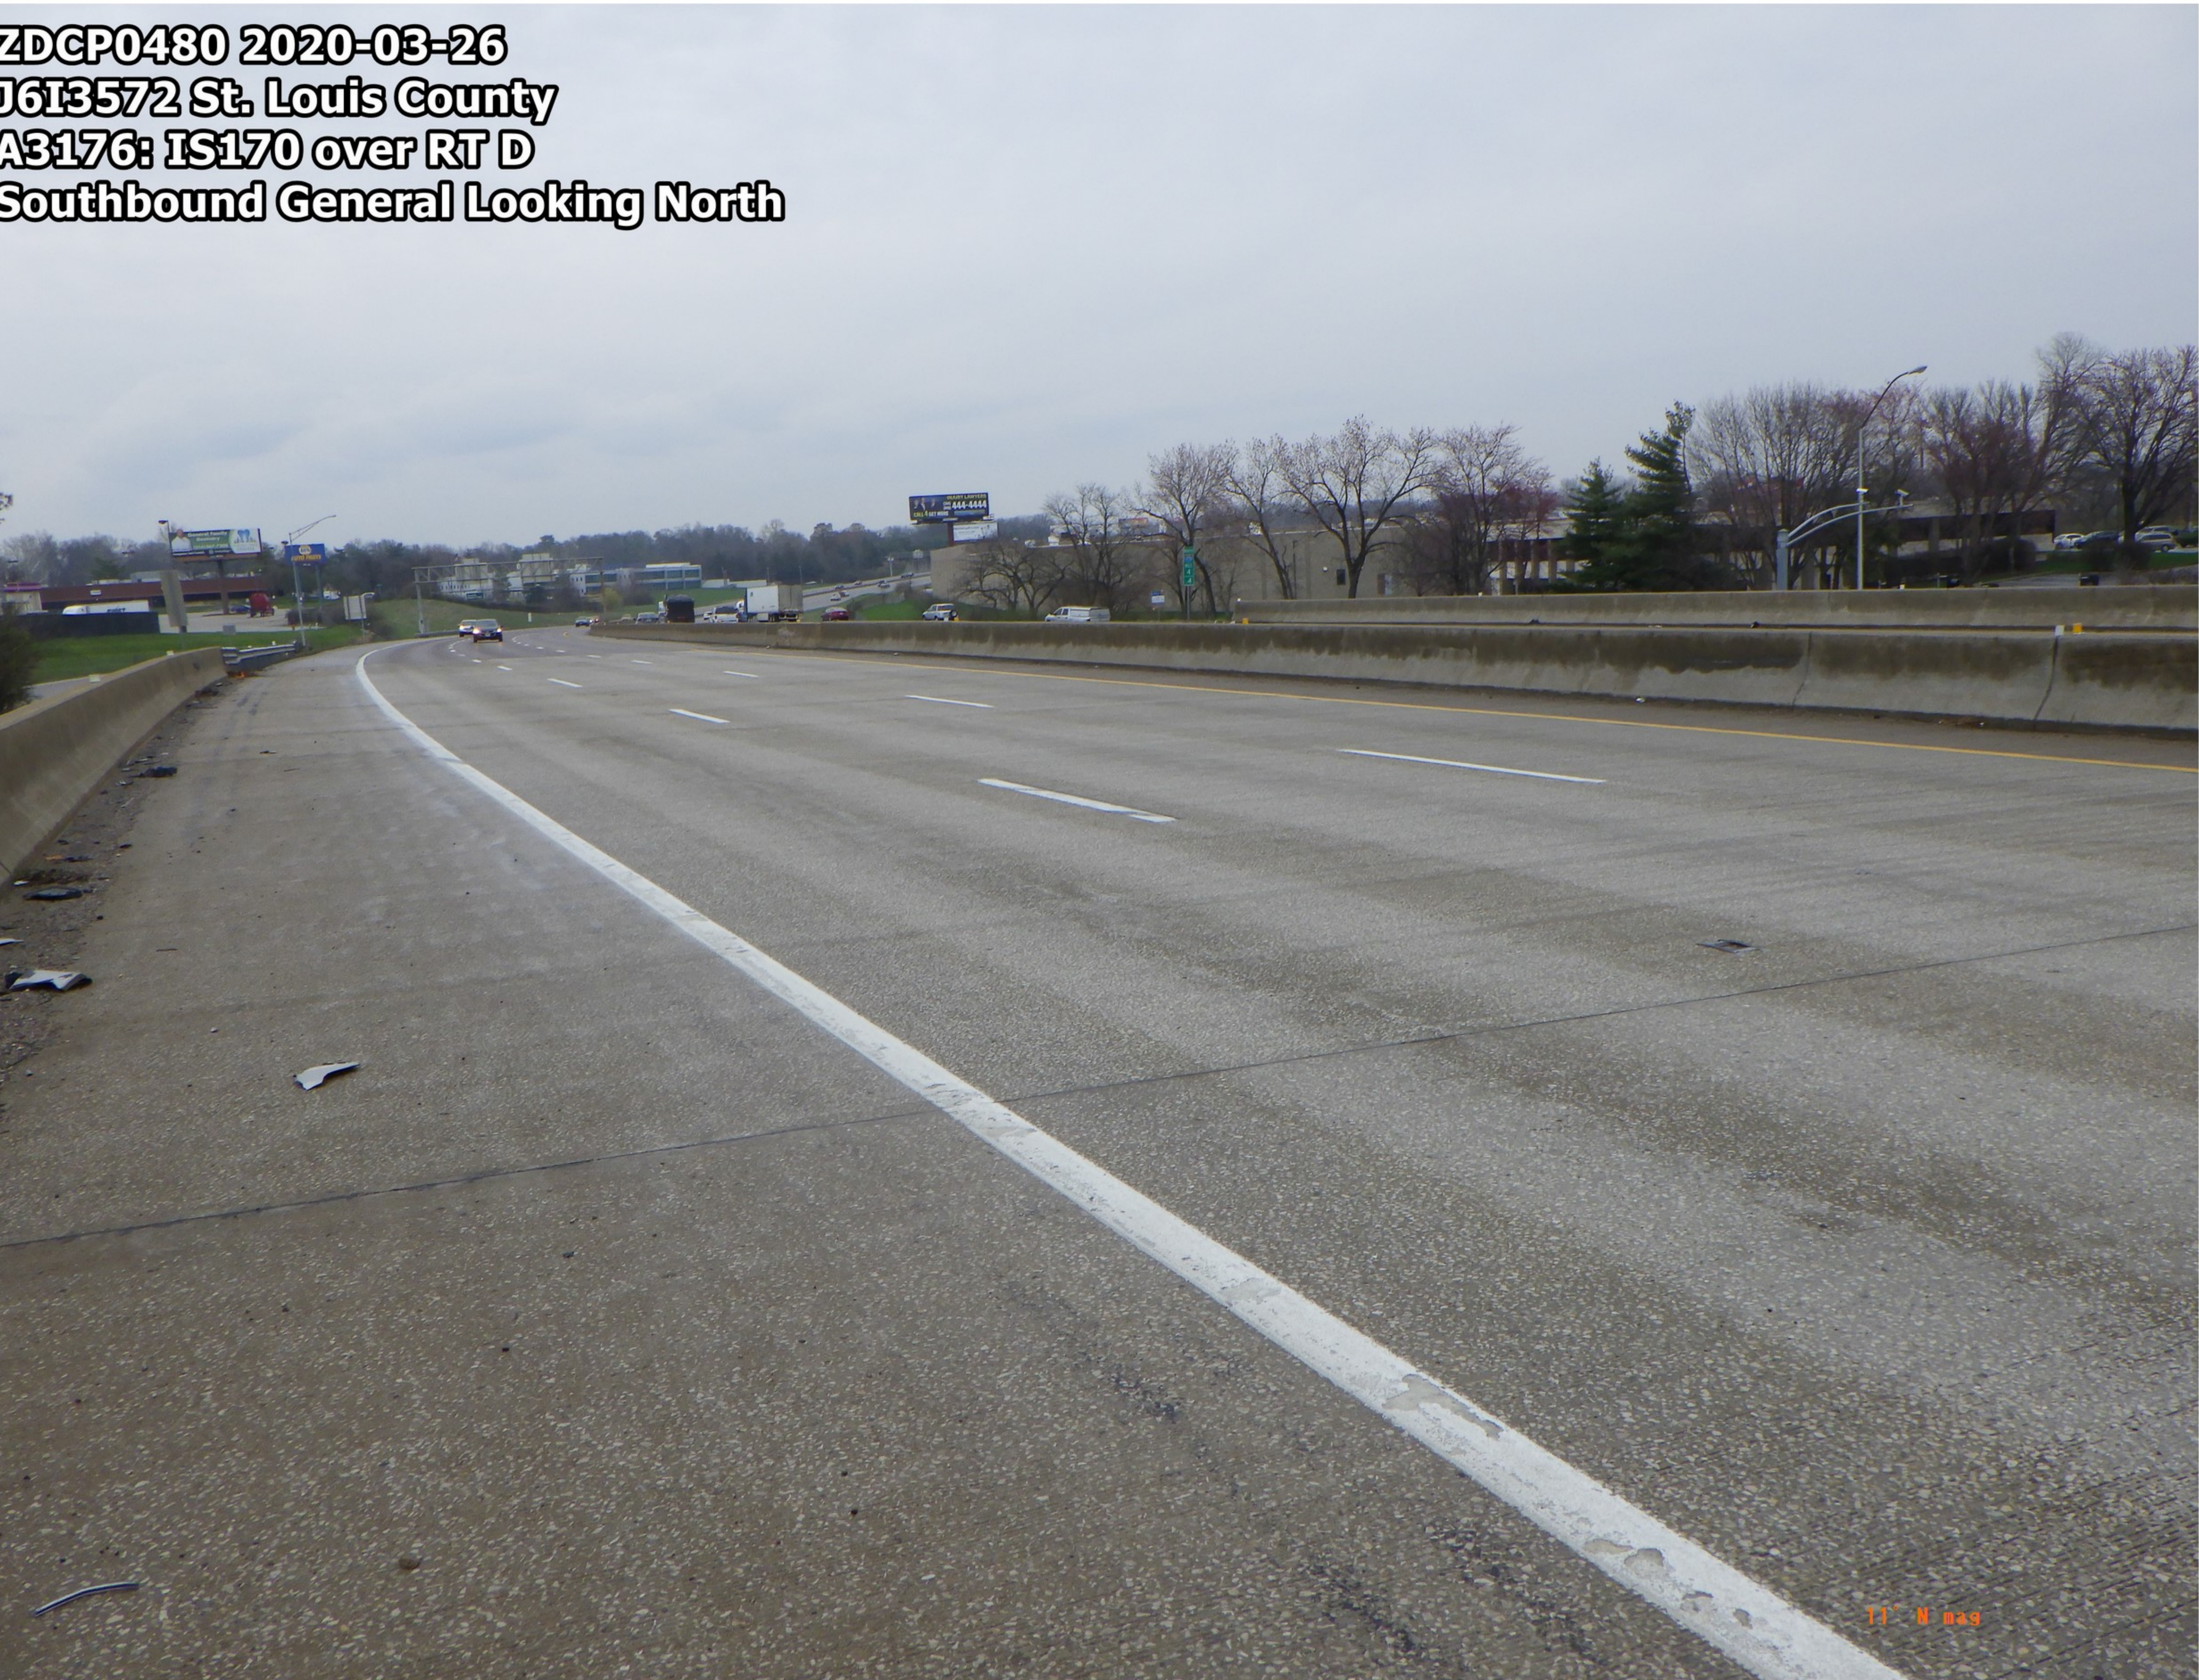
* Notes: SB Median @ S Appr - 20x2; North Appr - 10x3; NB Median @ N Appr - 10x3

ZDCP0481 2020-03-26
J6I3572 St. Louis County
A3176: IS170 over RT D
South Median Barrier Deterioration

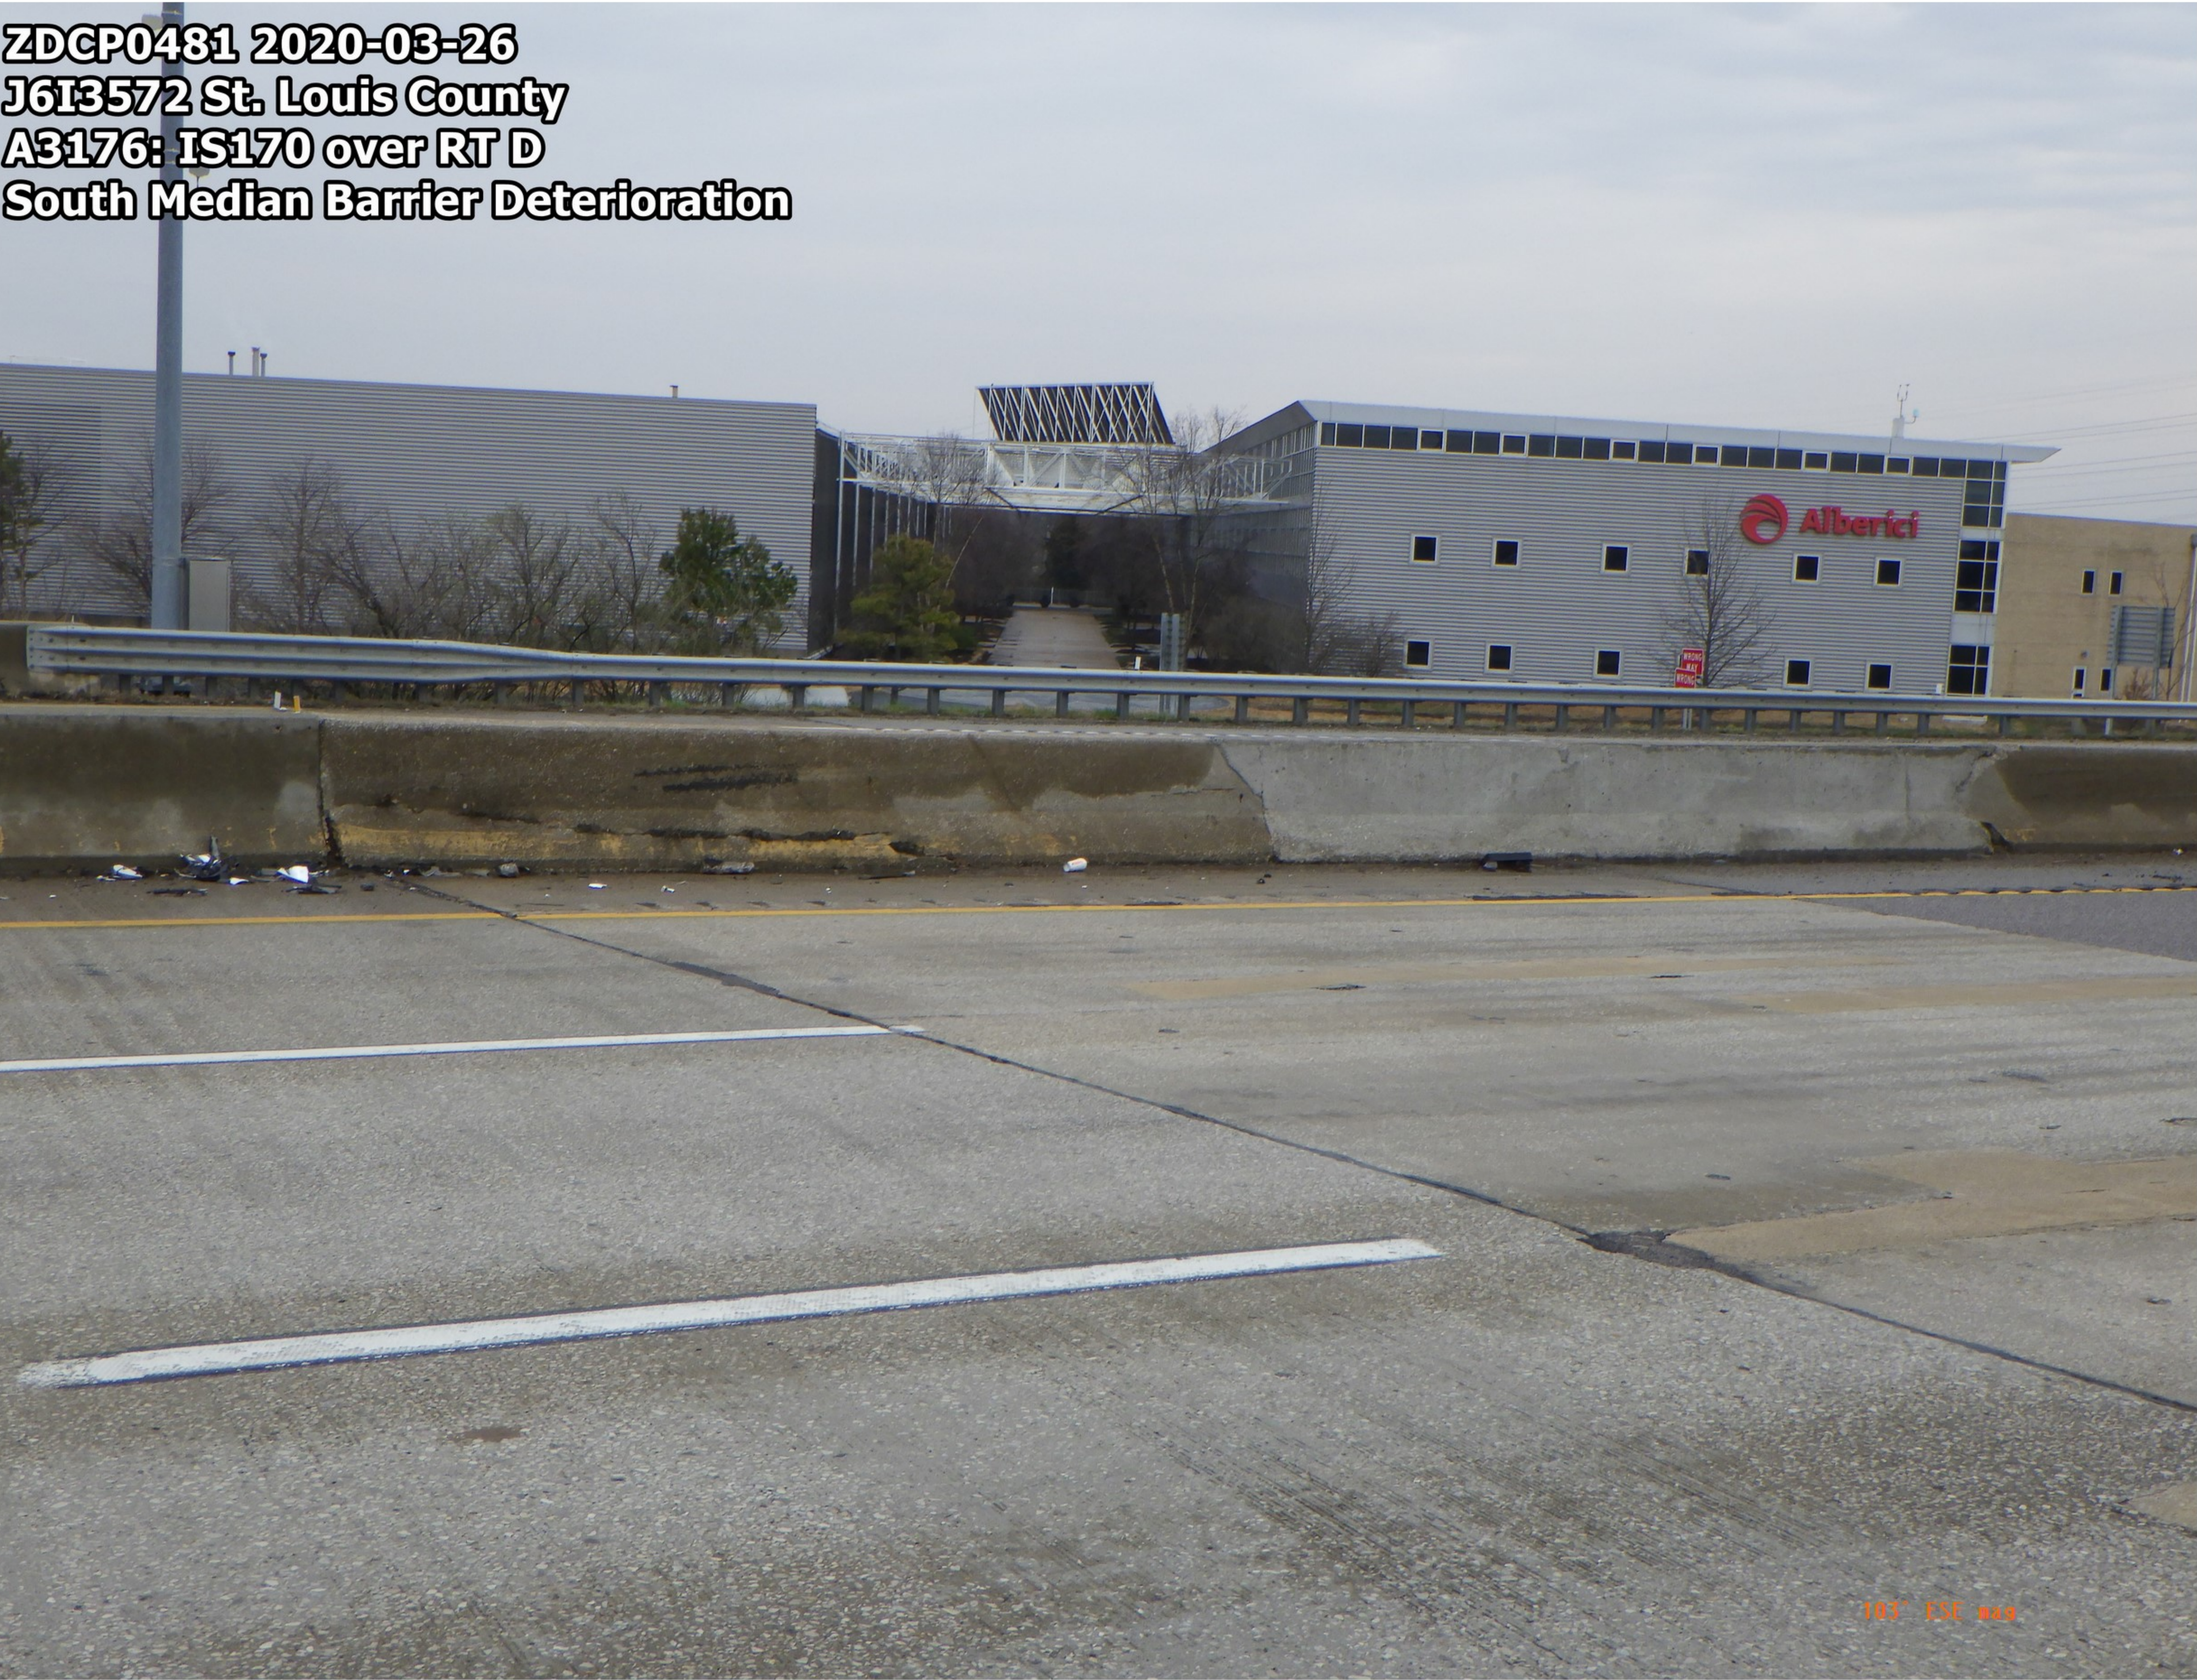
ZDCP0482 2020-03-26
J6I3572 St. Louis County
A3176: IS170 over RT D
SRPM's in Deck

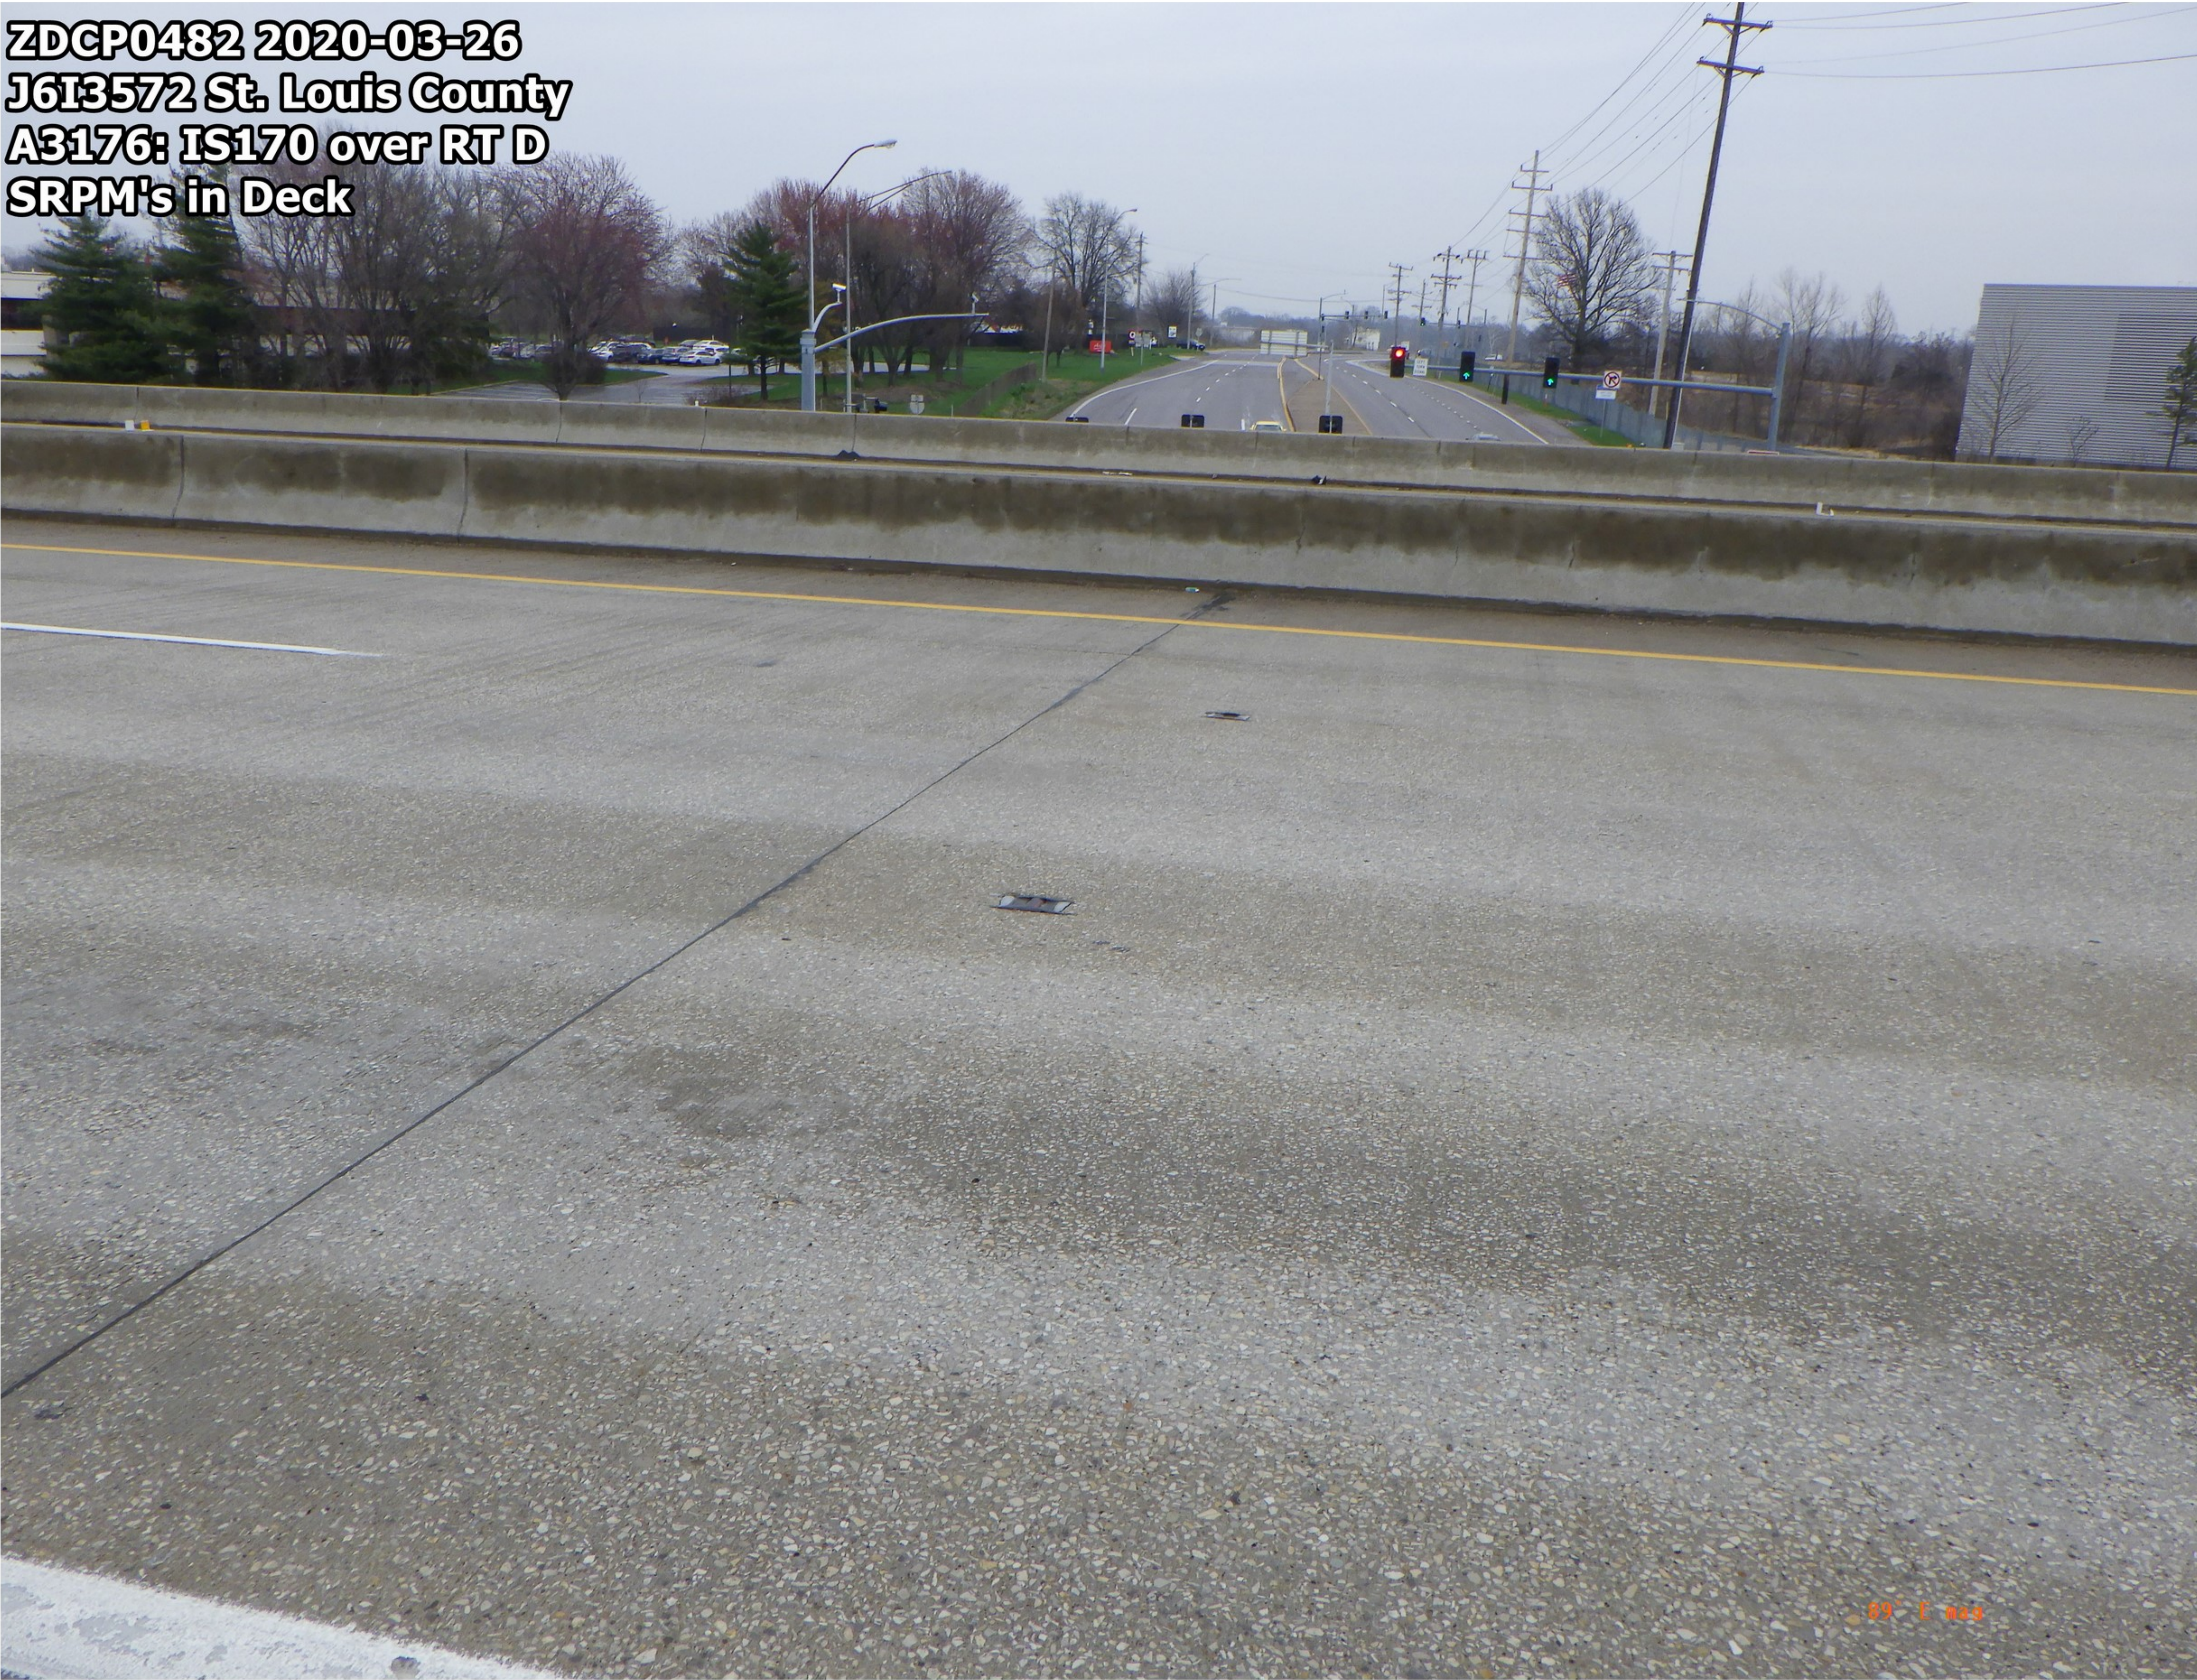
ZDCP0484 2020-03-26
J6I3572 St. Louis County
A3176: IS170 over RT D
Sothbound North Approach Condition

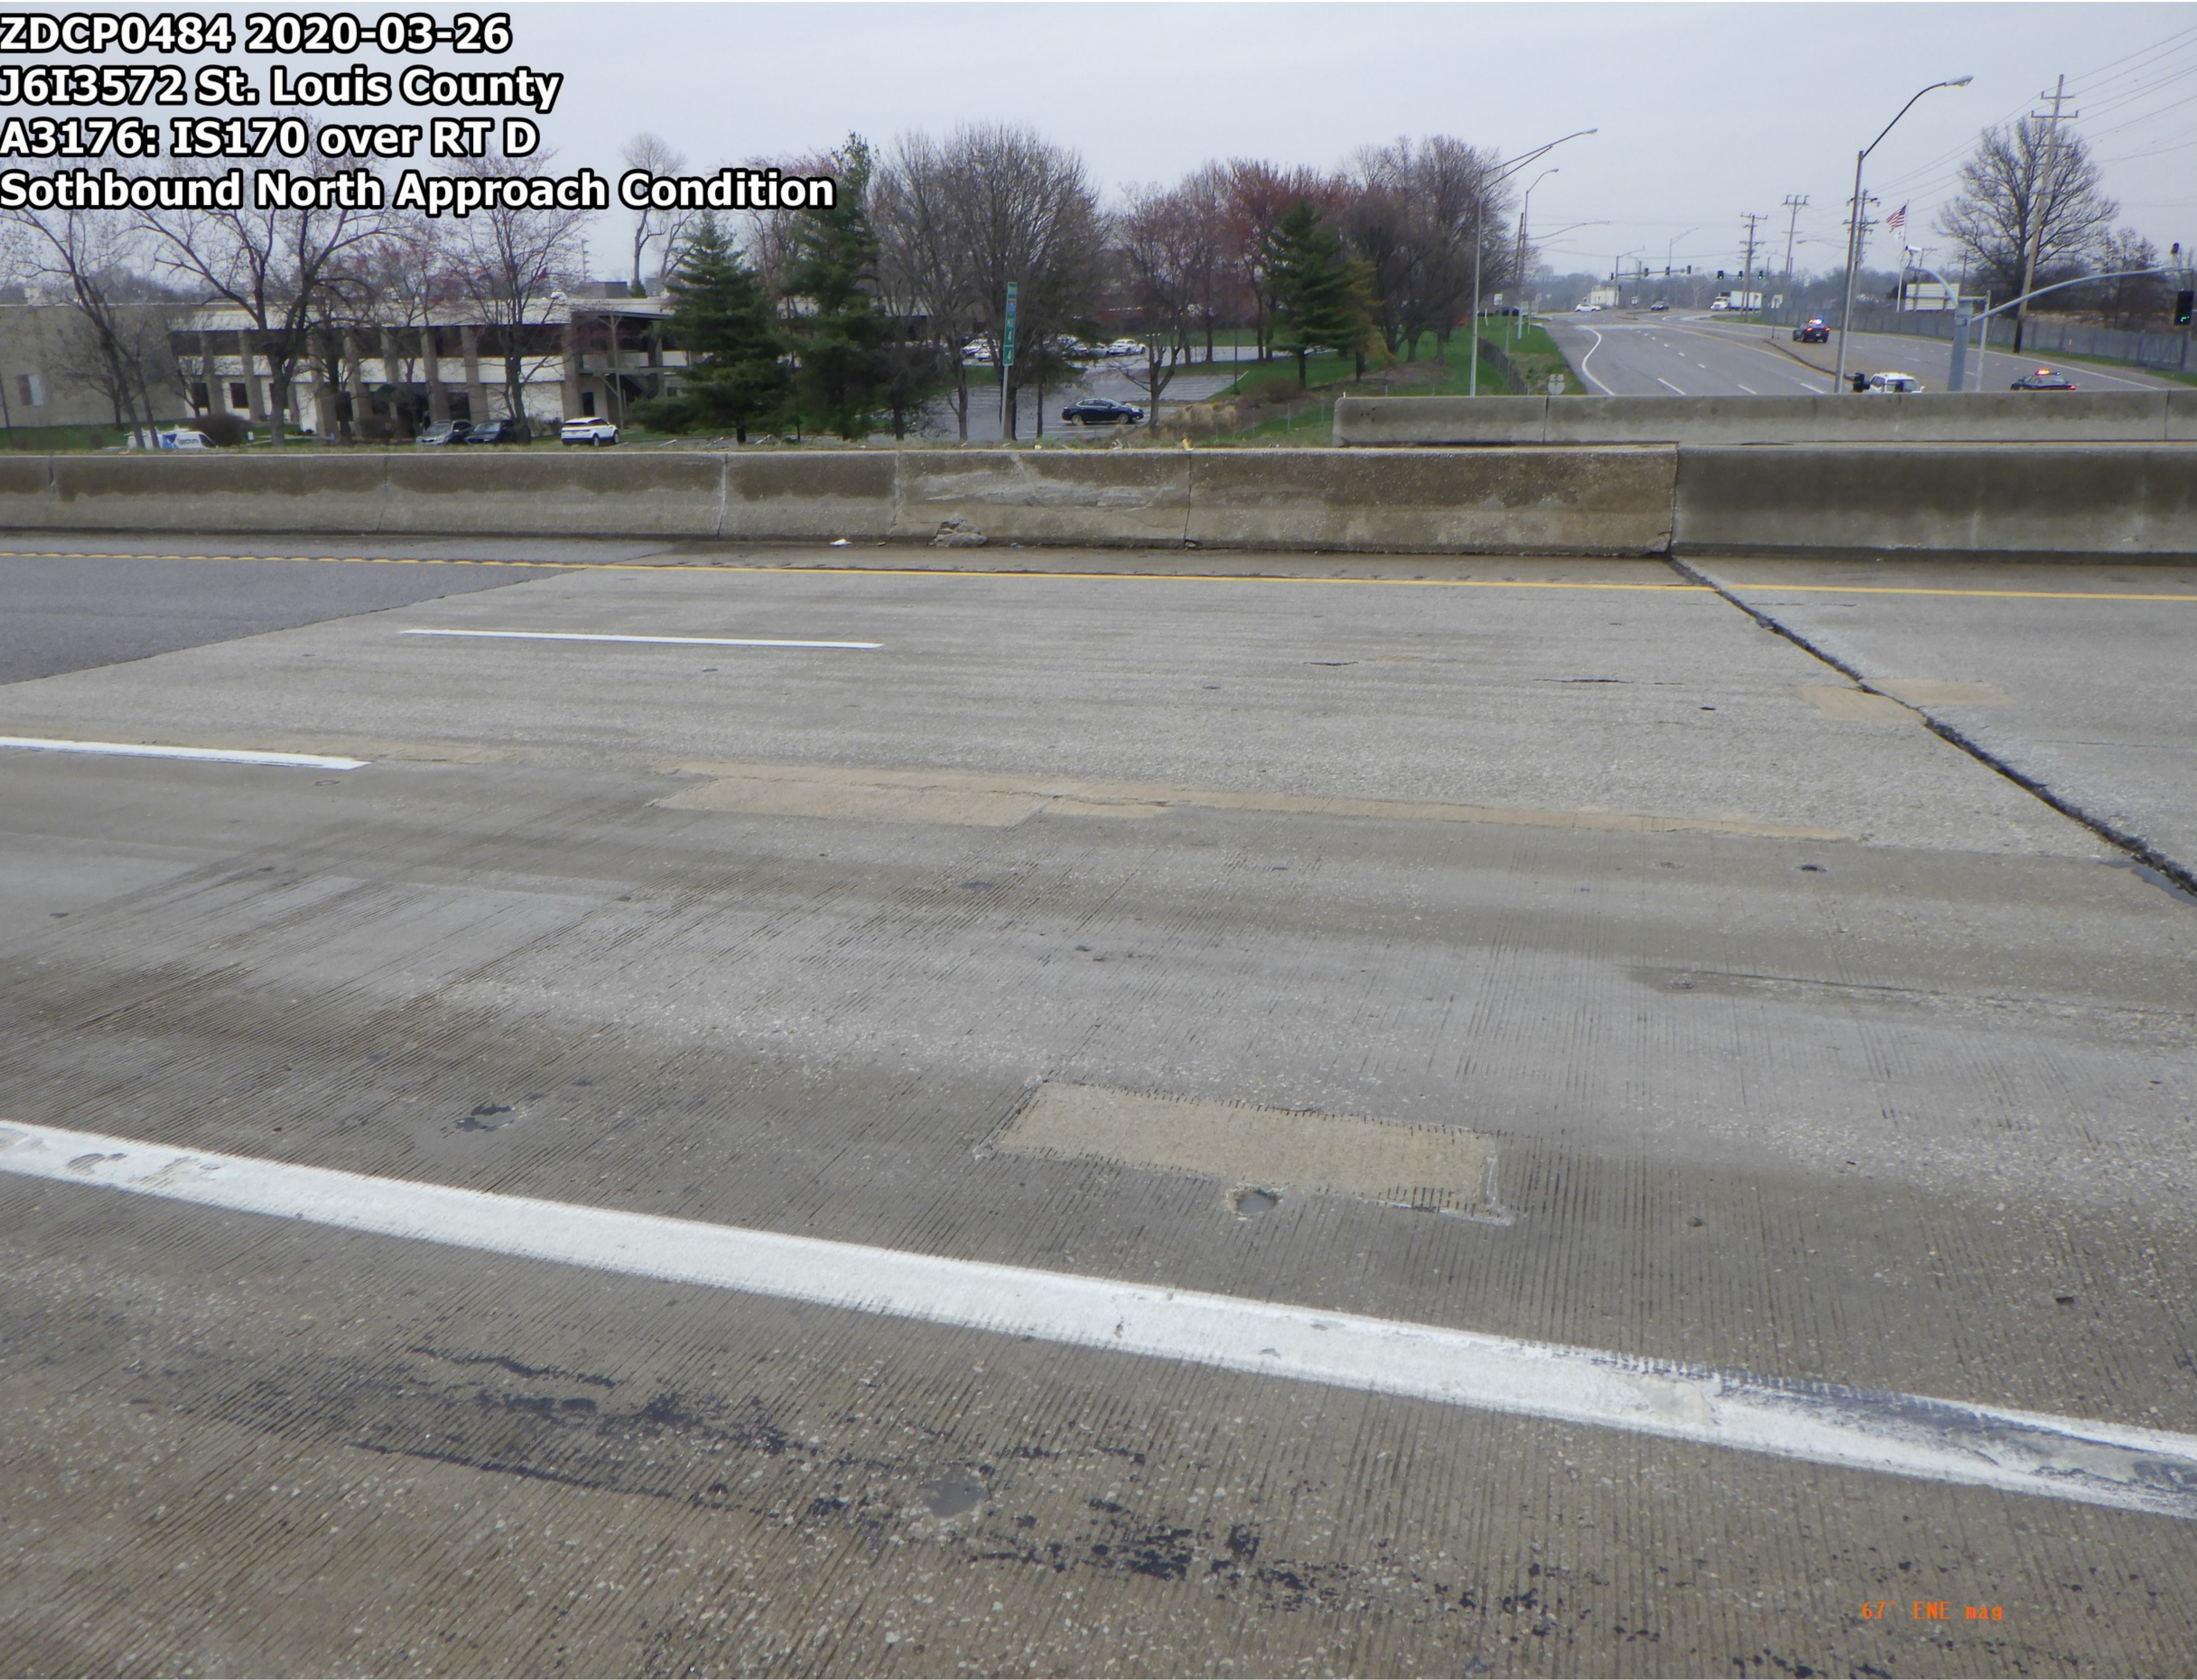
ZDCP0485 2020-03-26
J6I3572 St. Louis County
A3176: IS170 over RT D
Update Rail to MASH Standards

Update approach rail at NW and SE to MASH Standards

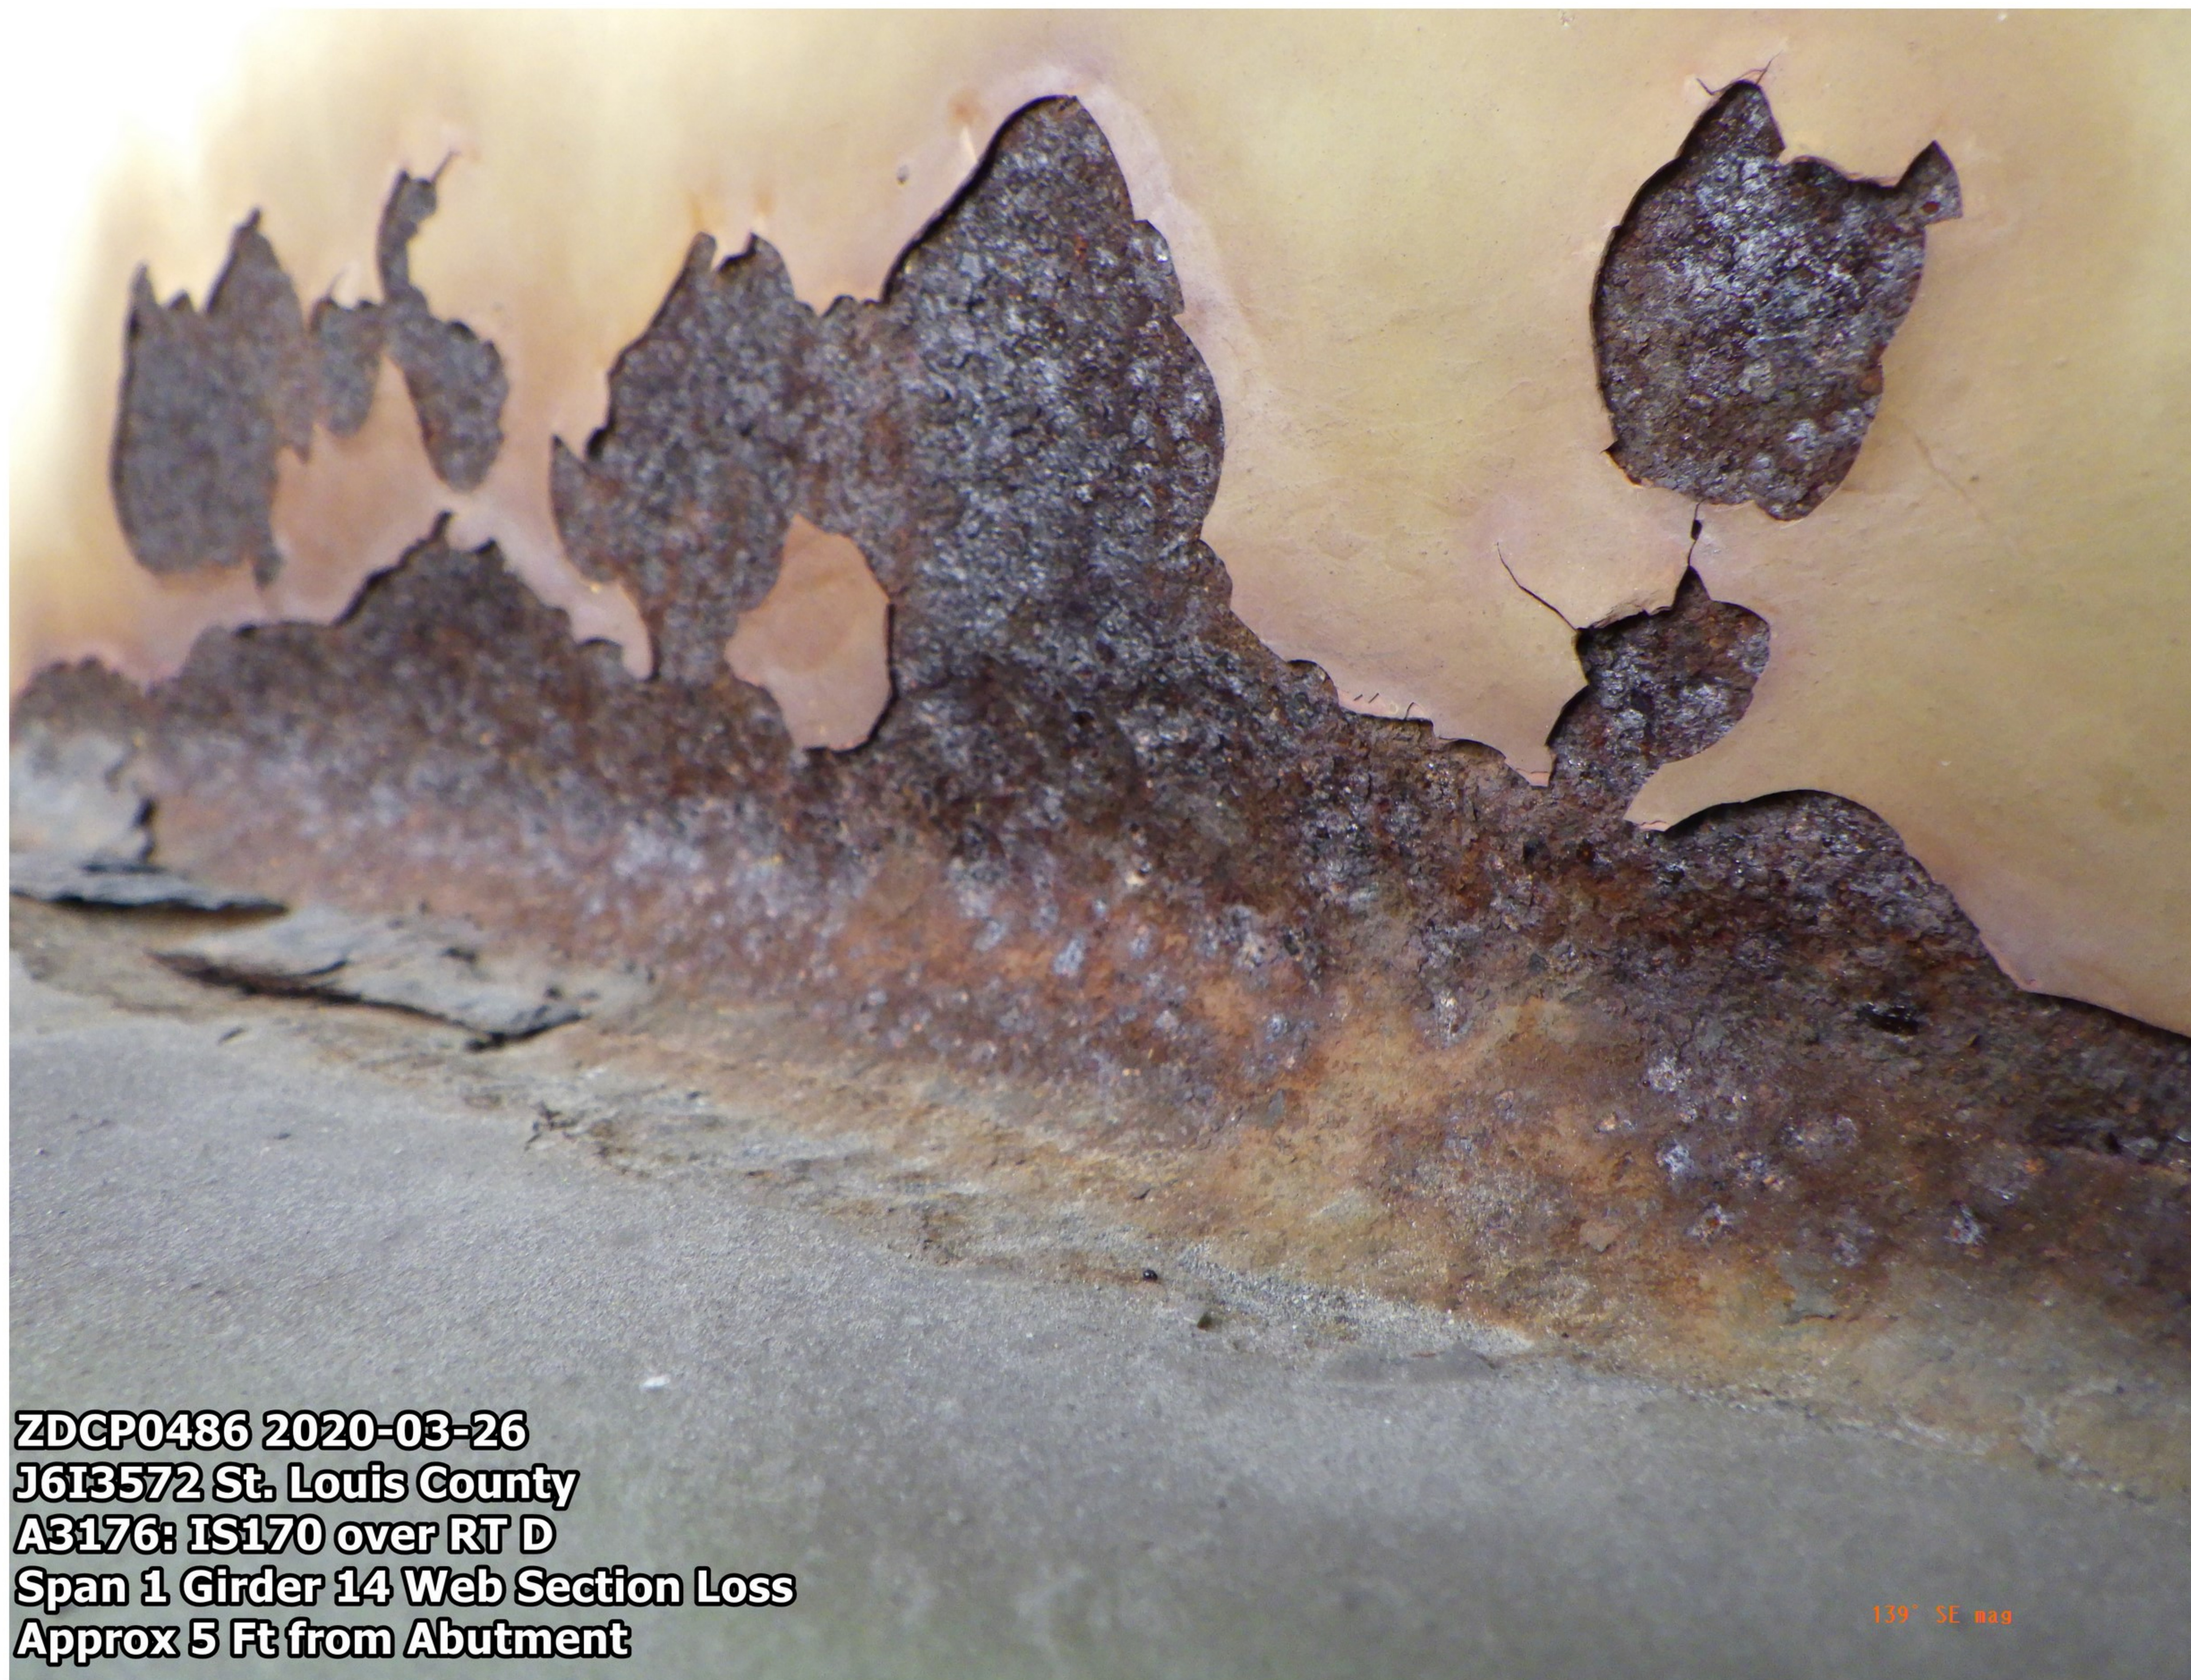
<u>14</u>	<input checked="" type="checkbox"/>	Section Loss	<u>10</u> %	<input type="checkbox"/>	Cracks	_____ in.	<u>Near Abut 1, Lower Web. Minor</u>
_____	<input type="checkbox"/>	Section Loss	_____ %	<input type="checkbox"/>	Cracks	_____ in.	_____
_____	<input type="checkbox"/>	Section Loss	_____ %	<input type="checkbox"/>	Cracks	_____ in.	_____
_____	<input type="checkbox"/>	Section Loss	_____ %	<input type="checkbox"/>	Cracks	_____ in.	_____

ZDCP0486 2020-03-26
J6I3572 St. Louis County
A3176: IS170 over RT D
Span 1 Girder 14 Web Section Loss
Approx 5 Ft from Abutment
