STRUCTURAL REHABILITATION CHECKLIST

Bridge No.: **A3176**

Route: **IS 170**

Over: **RT D**

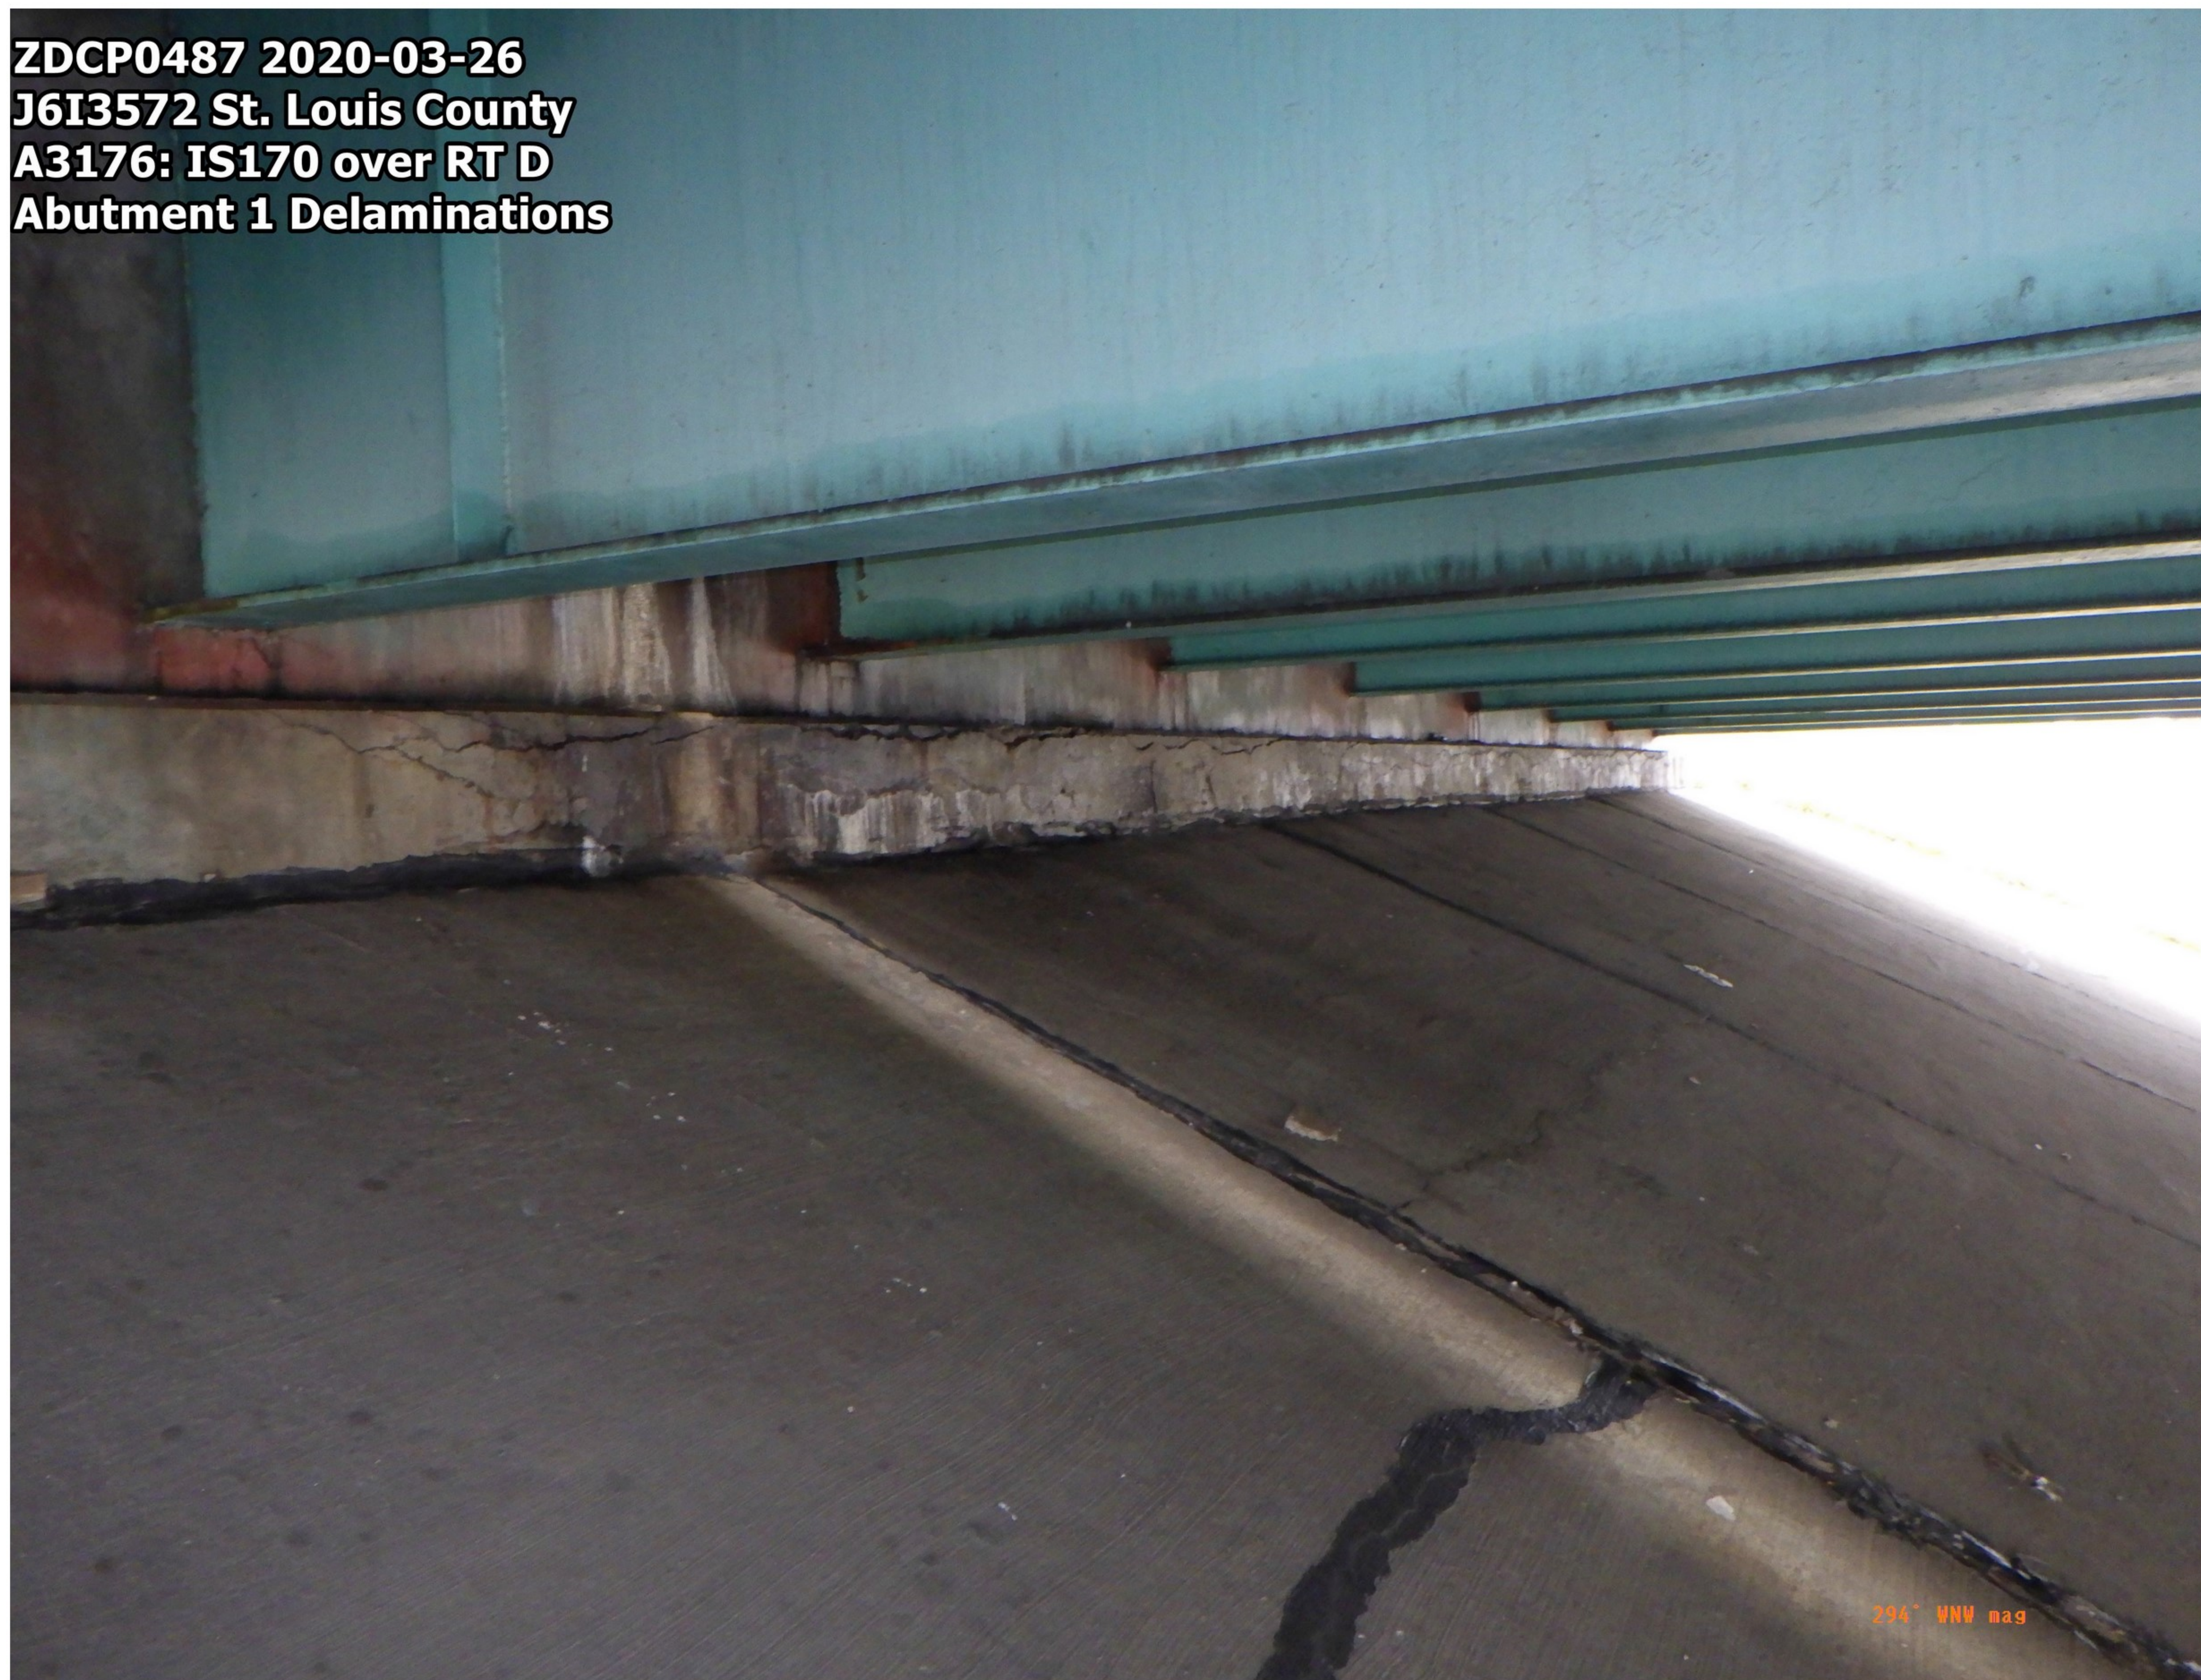
ZDCP0487 2020-03-26
J6I3572 St. Louis County
A3176: IS170 over RT D
Abutment 1 Delaminations

* Does the structure need graffiti protection? ☒ No ☐ Bottom 8' of Concrete ☐ End Bents ☐ Other _____* Notes: If Replacing Approaches, place Vertical Drain at Fill Face of Abutment, Seal Caps at end and Under Median (if opting for Dense Overlay), 9 LF each intermediate bent. REQUIRE Shotcrete for unformed repairs

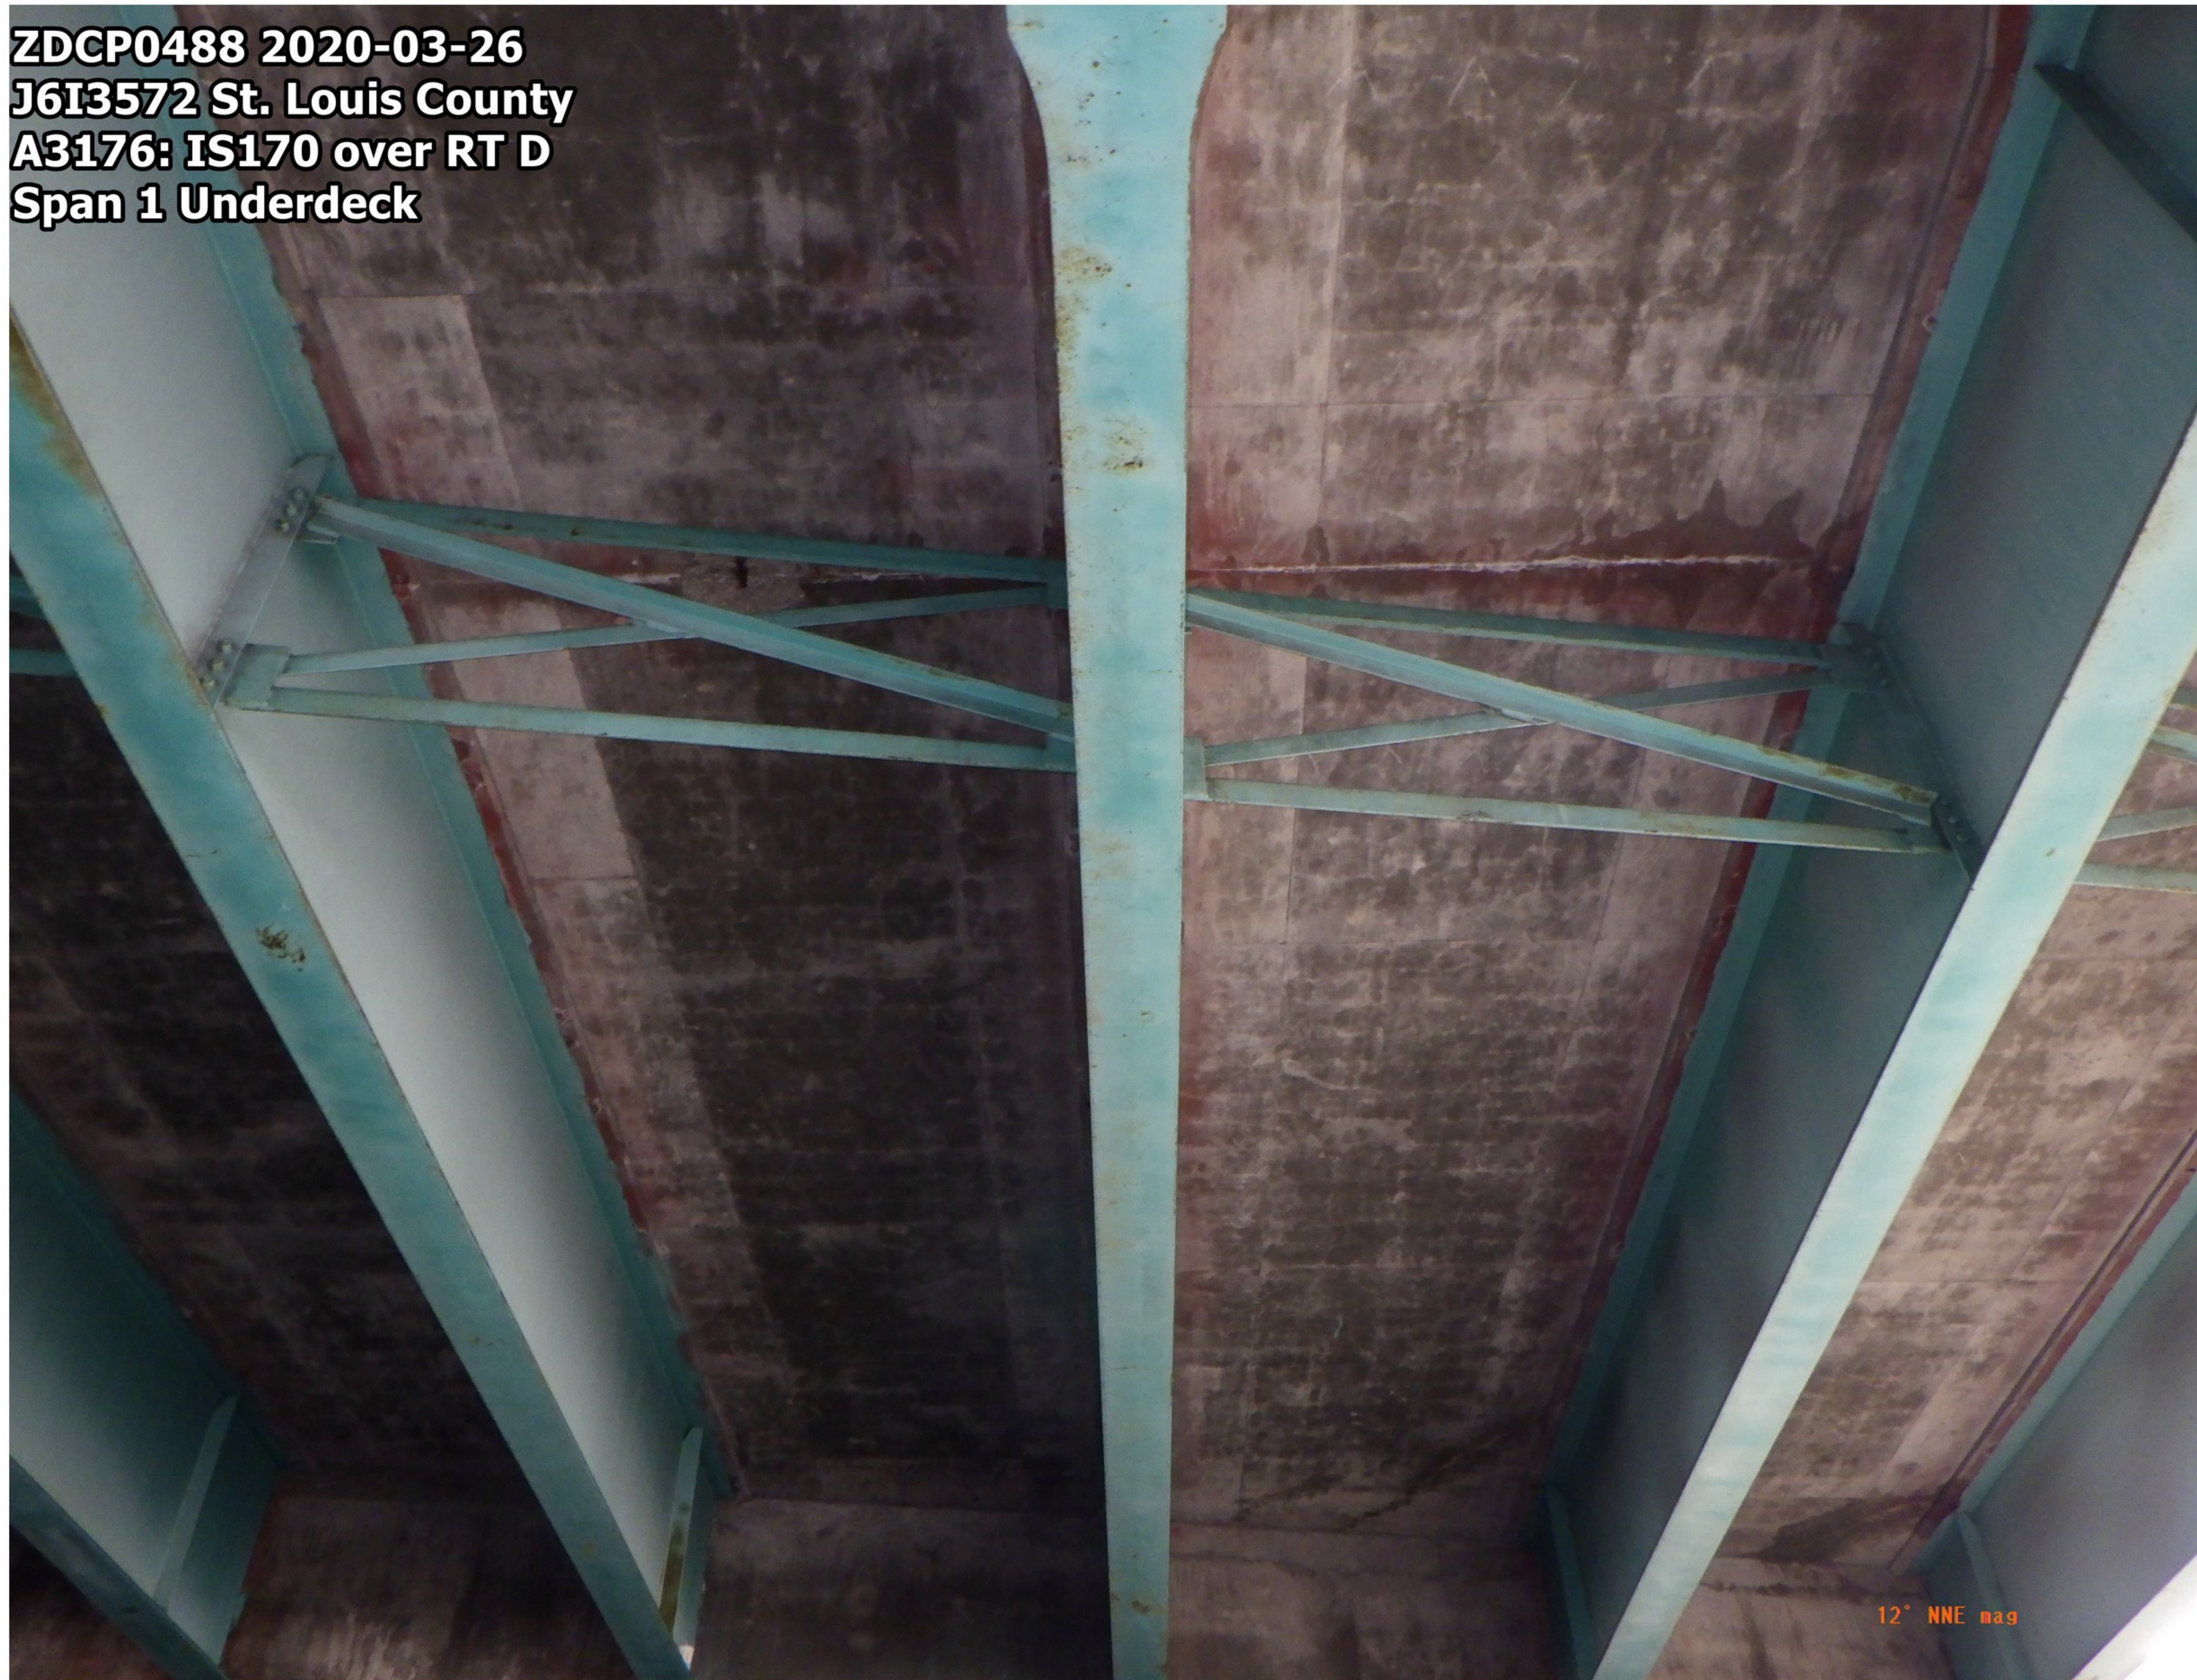
ZDCP0488 2020-03-26
J6I3572 St. Louis County
A3176: IS170 over RT D
Span 1 Underdeck

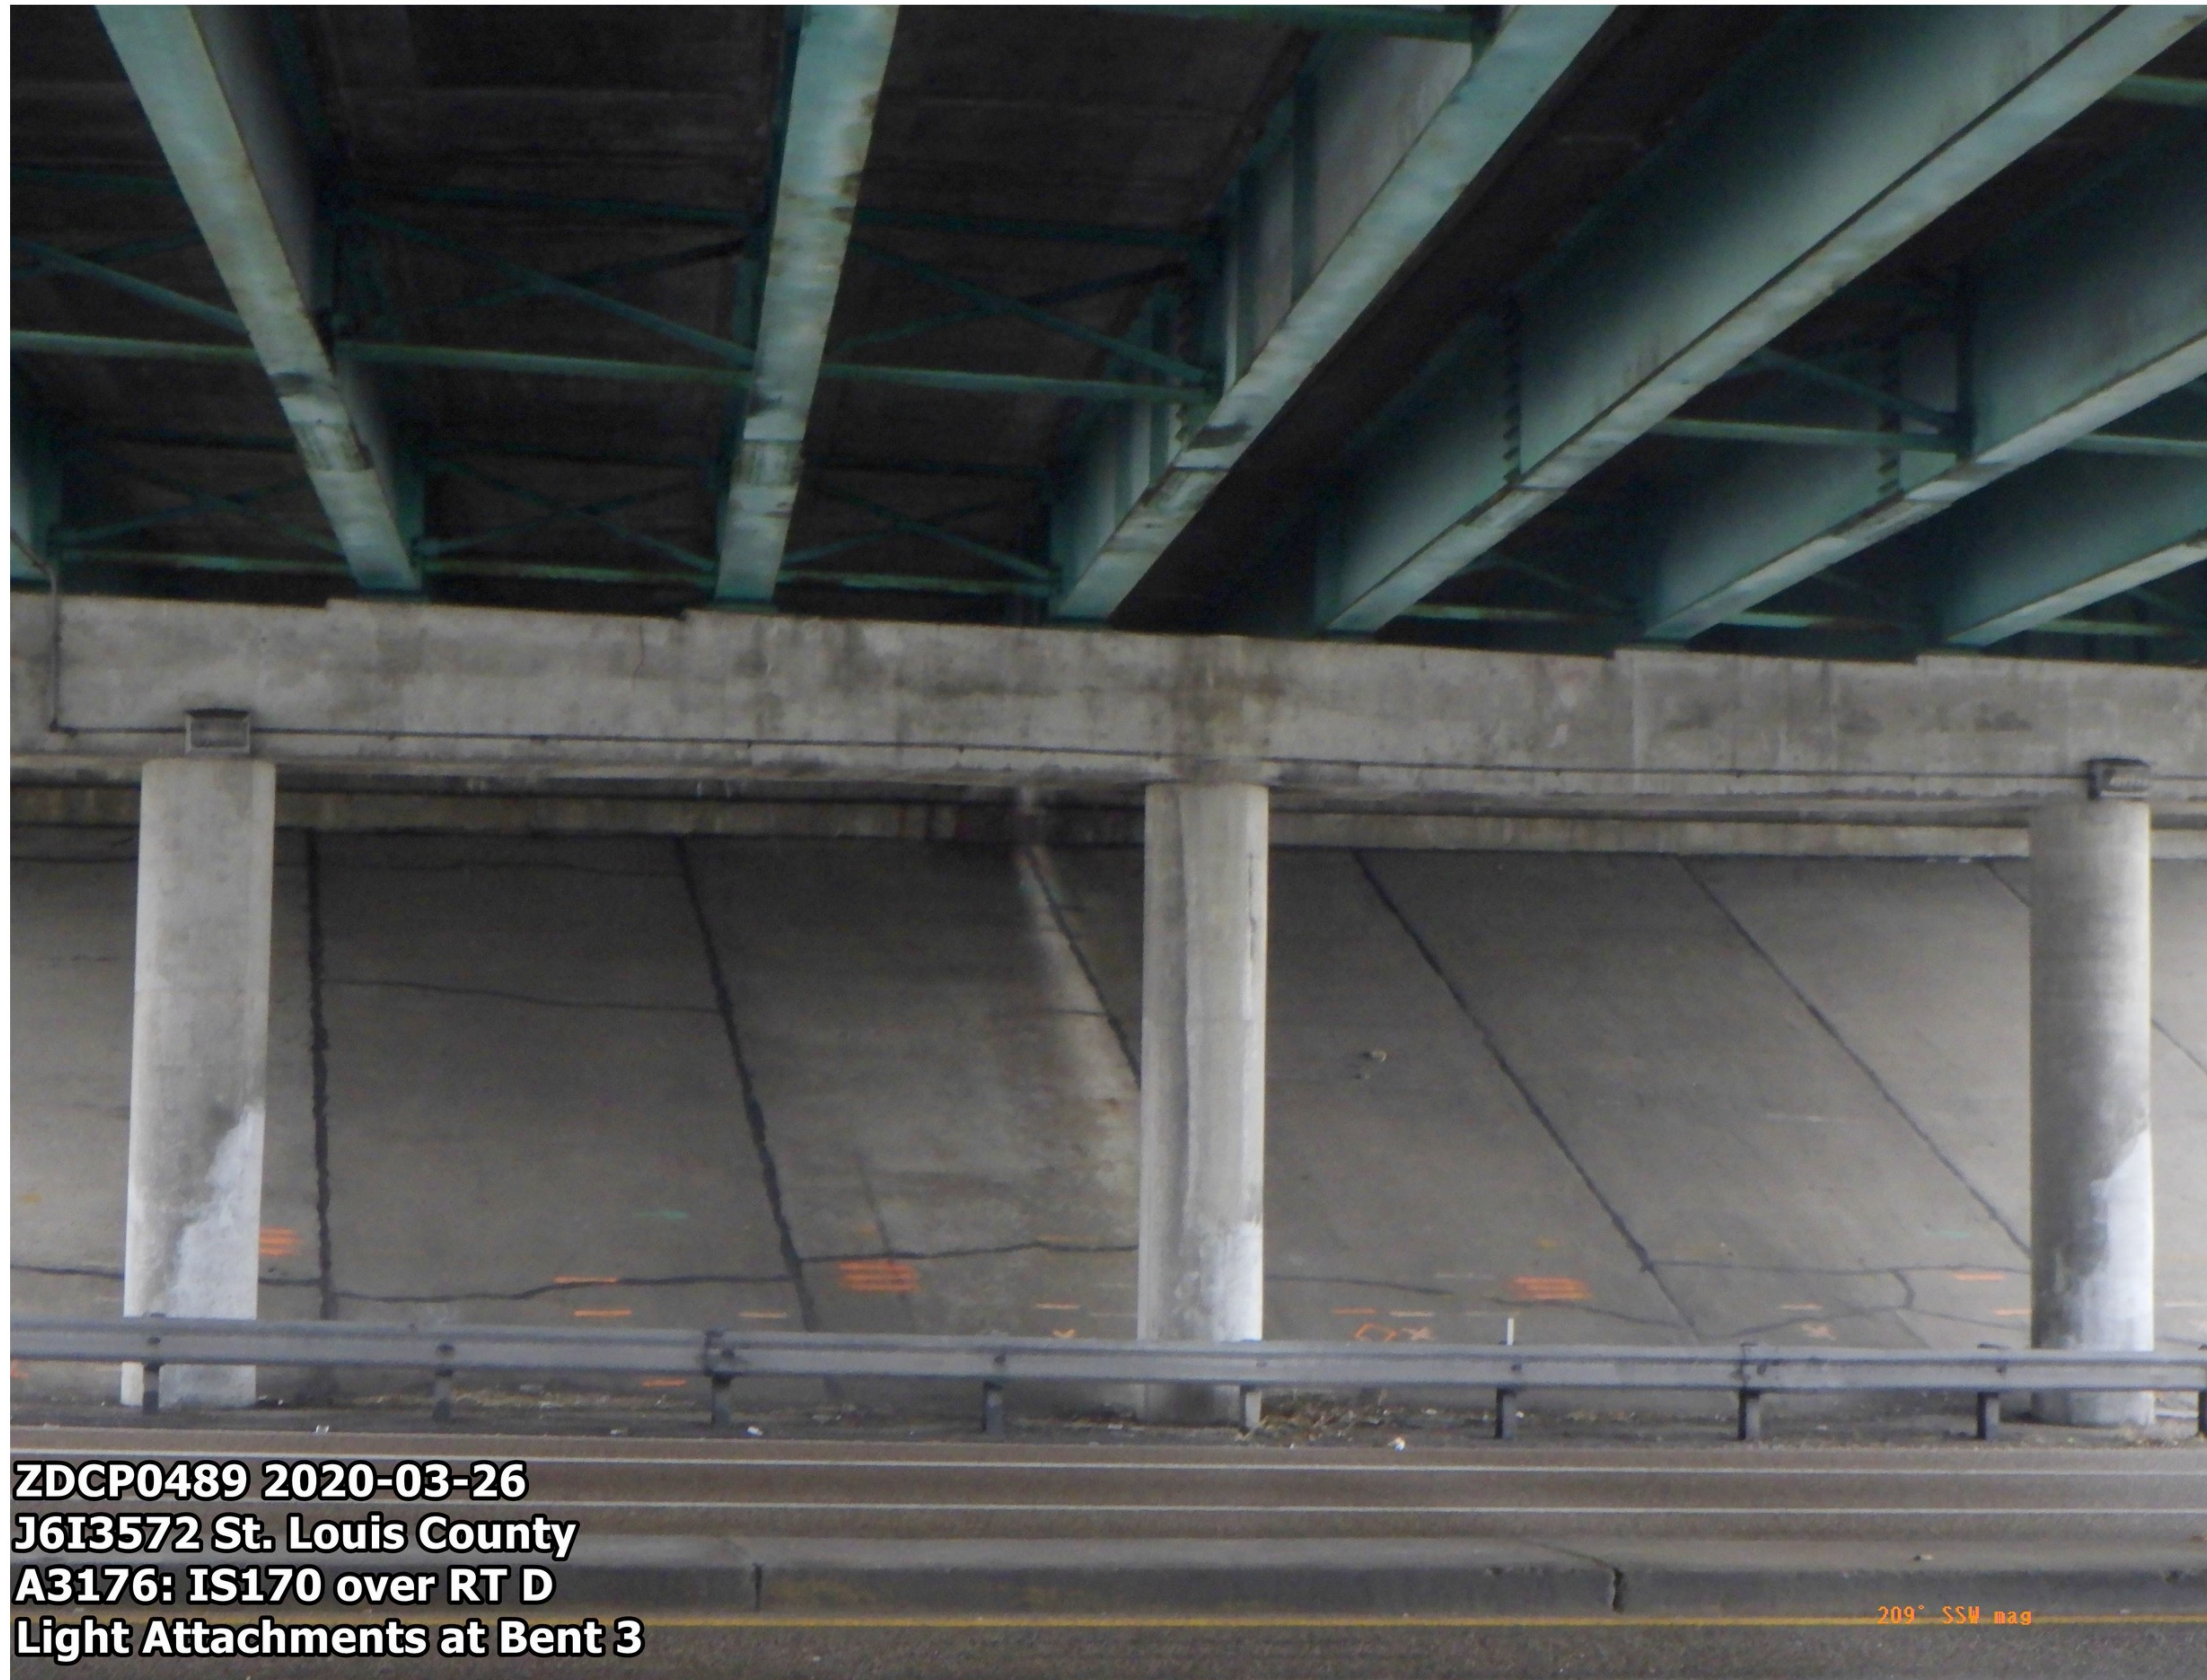
ZDCP0489 2020-03-26
J6I3572 St. Louis County
A3176: IS170 over RT D
Light Attachments at Bent 3

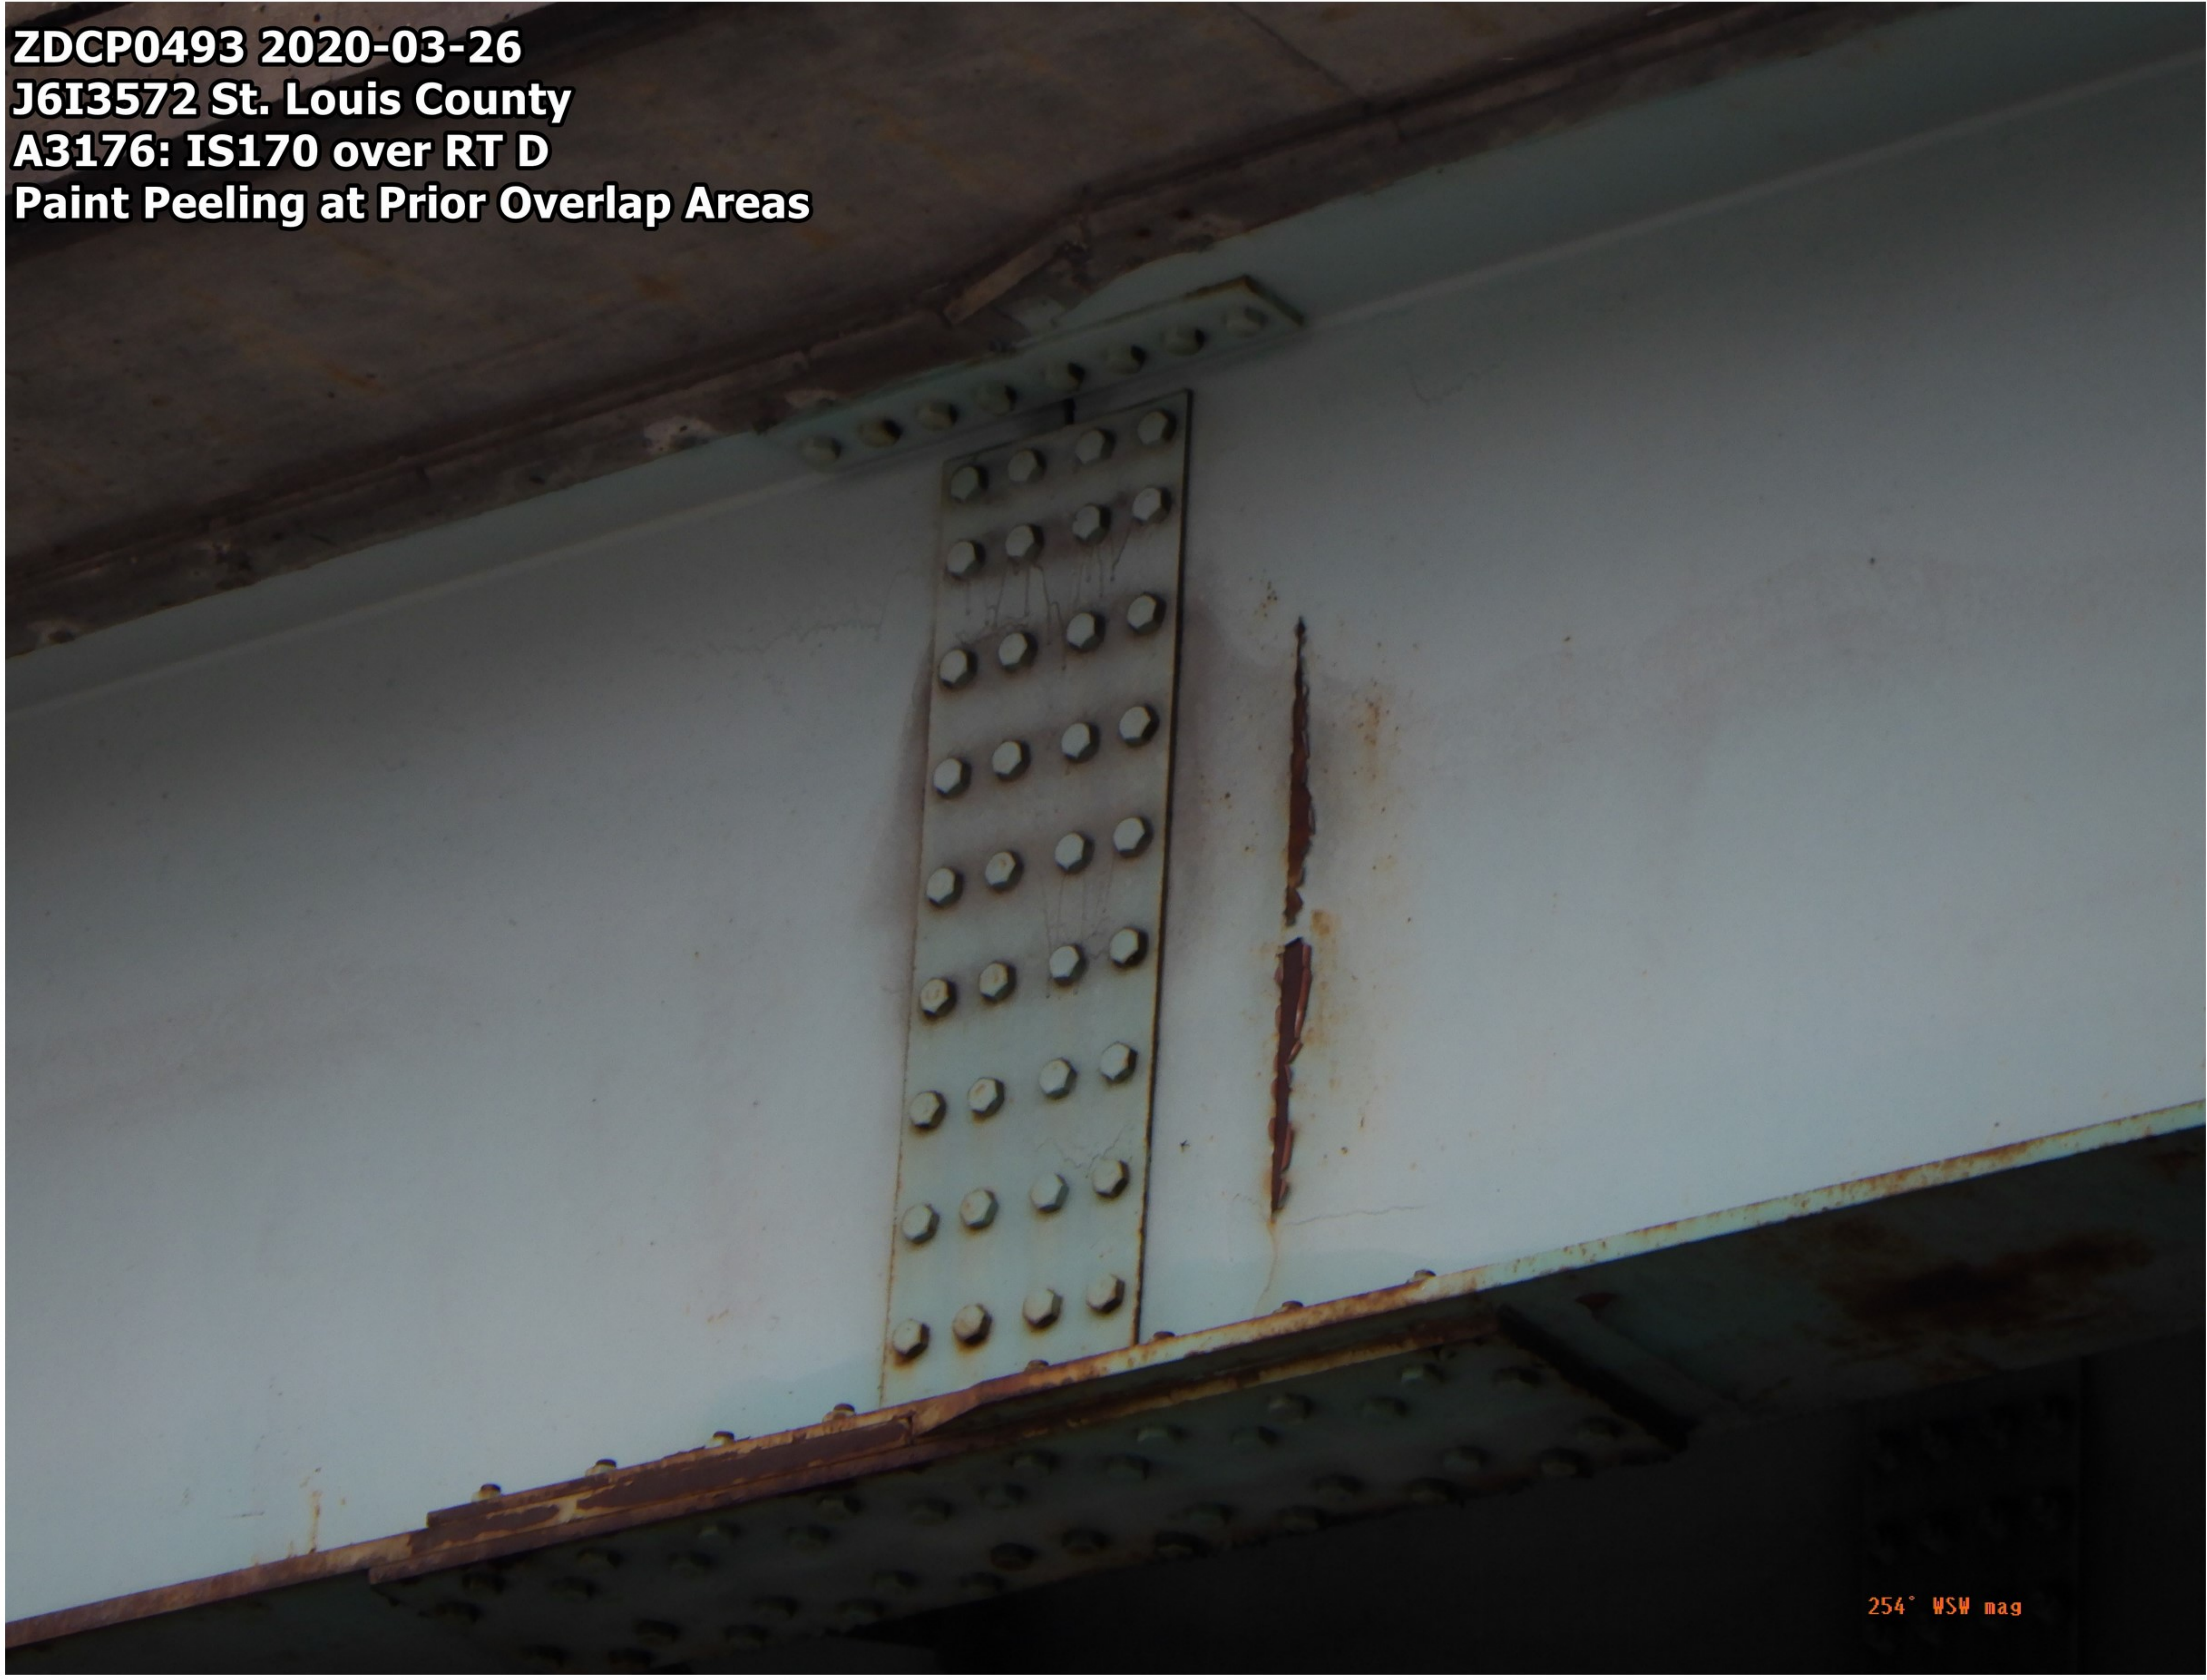
ZDCP0494 2020-03-26
J6I3572 St. Louis County
A3176: IS170 over RT D
Flush Basin at NE Quadrant

* Recommendations: Clean out Basin at NW Quadrant

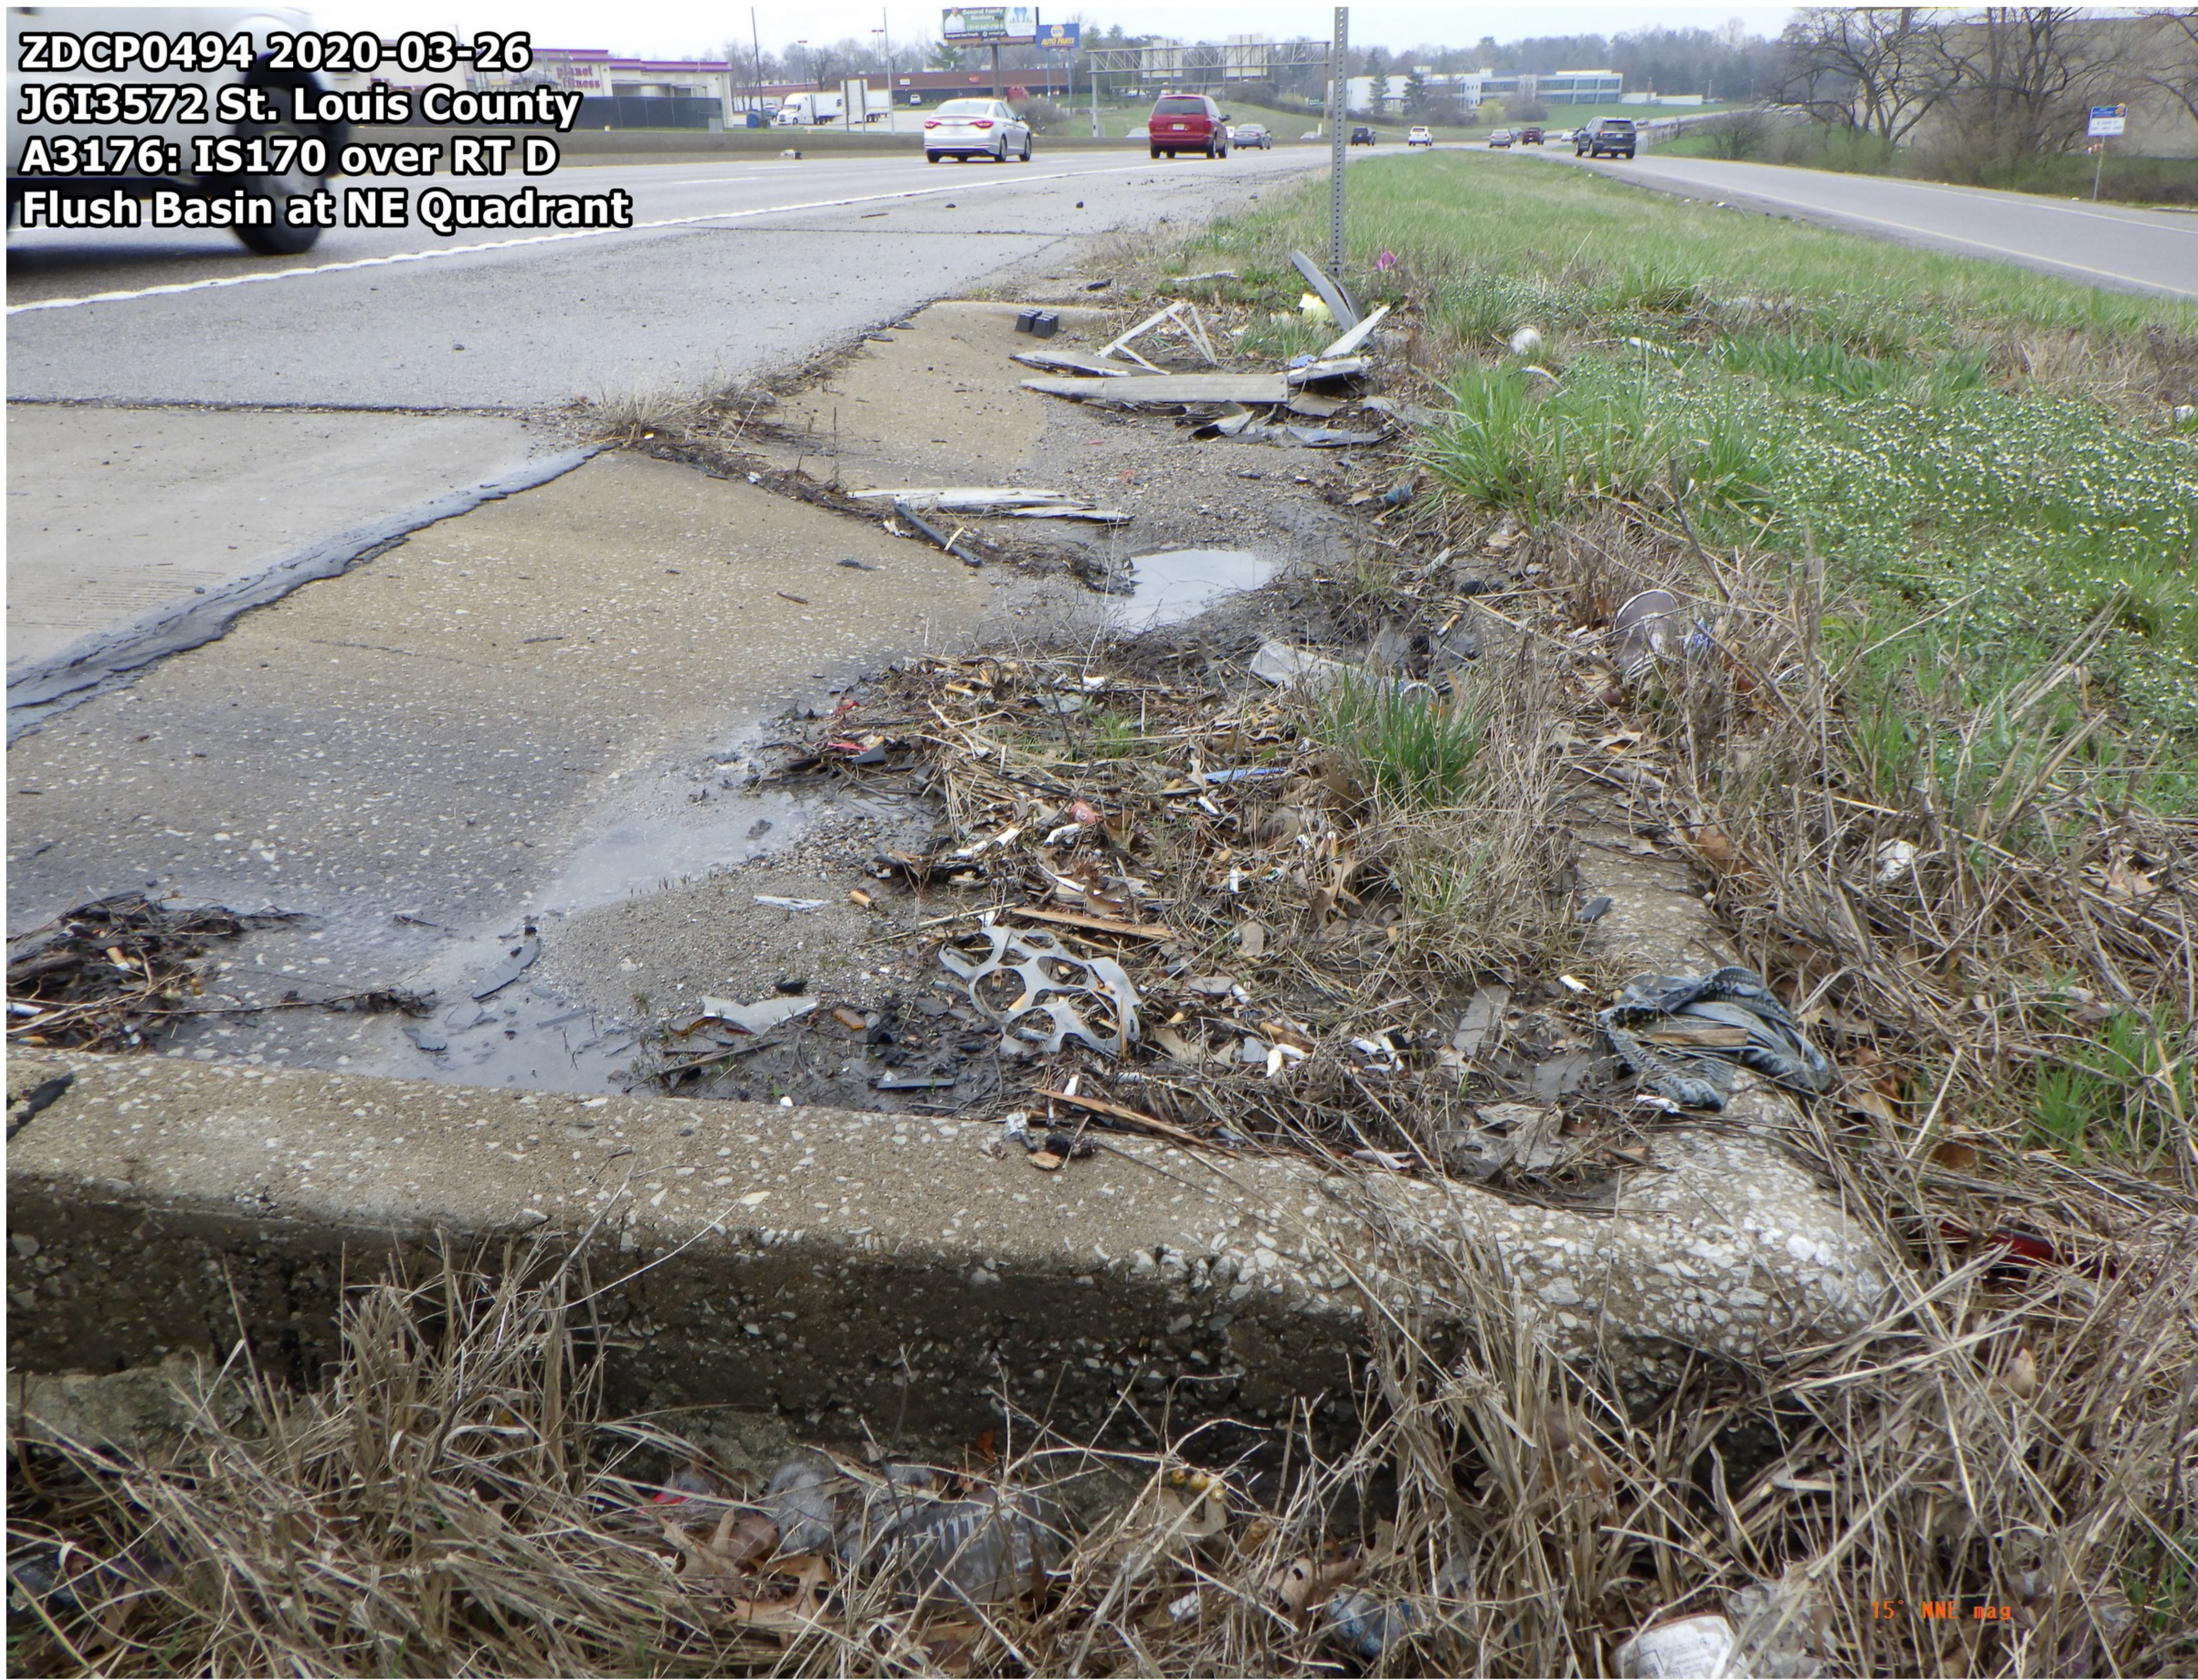
- * Is there a bridge approach slab in place? ☒ Yes ☐ No * Type: ☒ Concrete ☒ Asphalt ☐ Other _____
- * Is there a rdwy. approach pavement in place? ☒ Yes ☐ No * Type: ☒ Concrete ☐ Asphalt ☐ Other _____
- * Is the approach slab sinking at the end bent? ☐ N/A ☐ Yes ☒ No _____
- * Are repairs needed to the bridge approach slab driving surface? ☒ Yes ☐ No _____
(Typically a roadway item but will be reported to district on the Bridge Memorandum.)
- * Full Replacement of Approach Slab? ☐ Yes ☐ No **Optional - dependent on hydro or redeck determination.**
- * Notes: **Asphalt Overlay at NE**

ZDCP0497 2020-03-26
J6I3572 St. Louis County
A3176: IS170 over RT D
Northeast Approach Slab

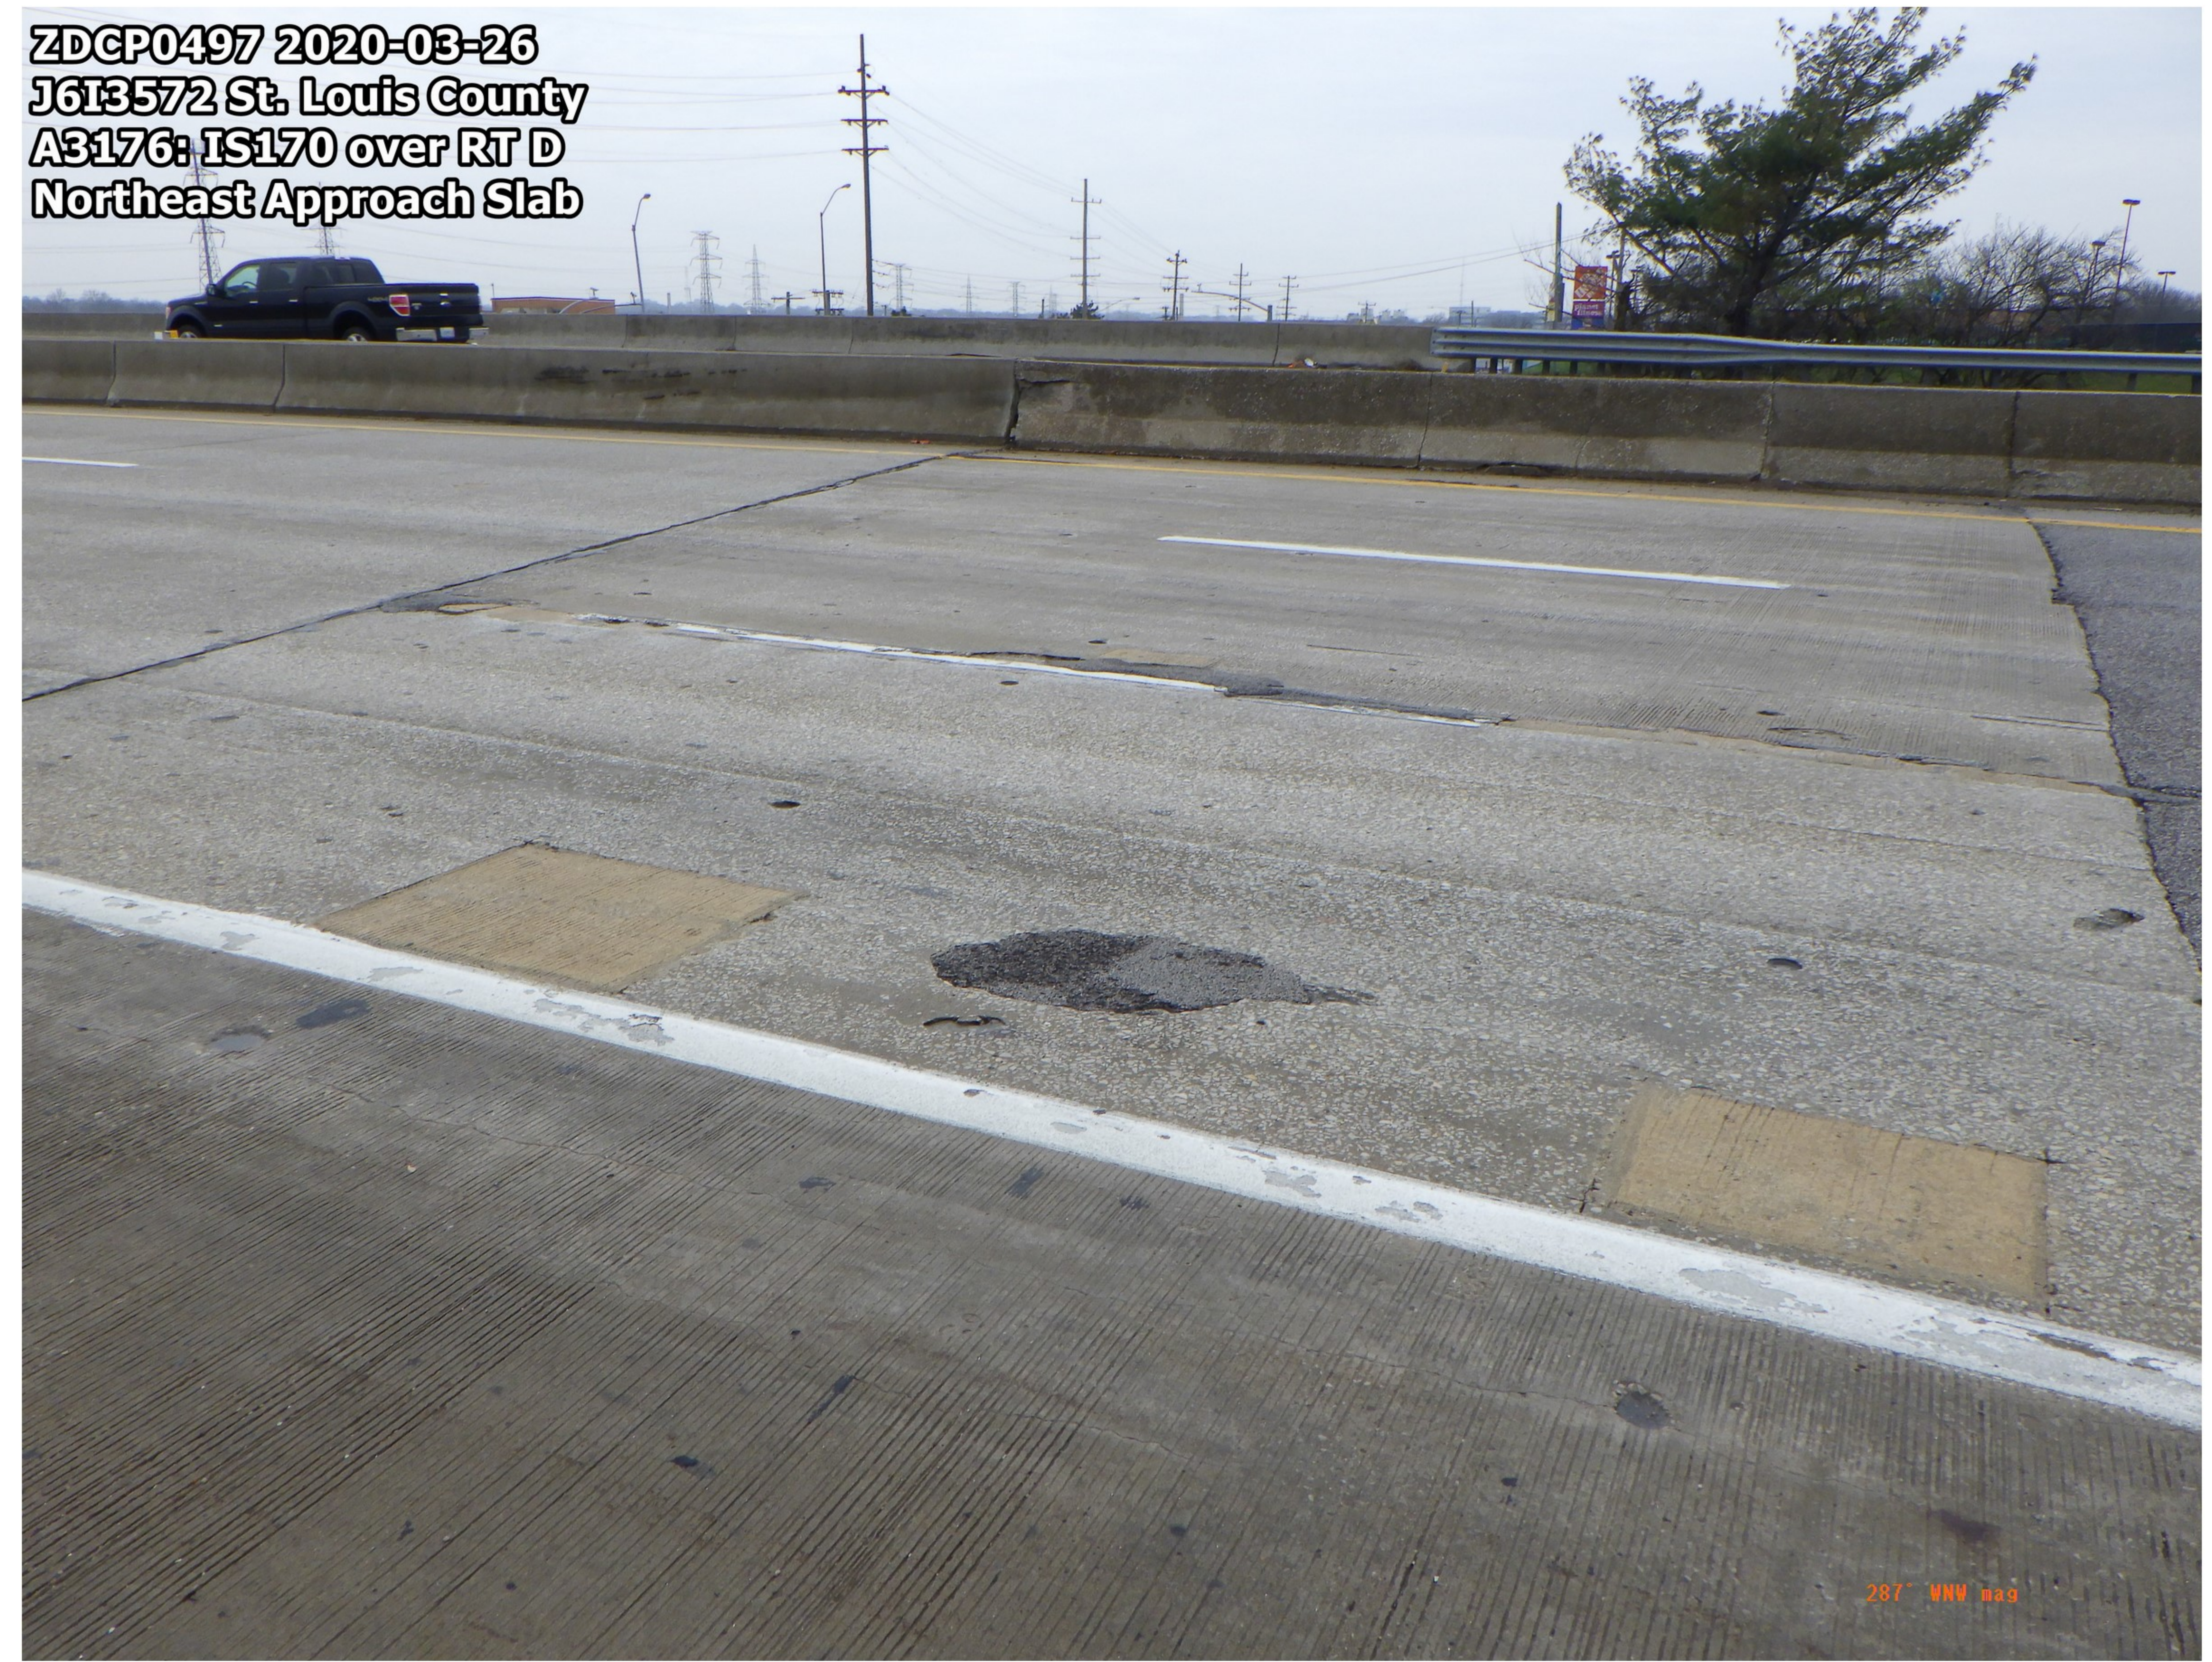
ZDCP0498 2020-03-26
J6I3572 St. Louis County
A3176: IS170 over RT D
North Bound General Looking South
