STRUCTURAL REHABILITATION CHECKLIST

Bridge No.: **A3176**

Route: **IS 170**

Over: **RT D**

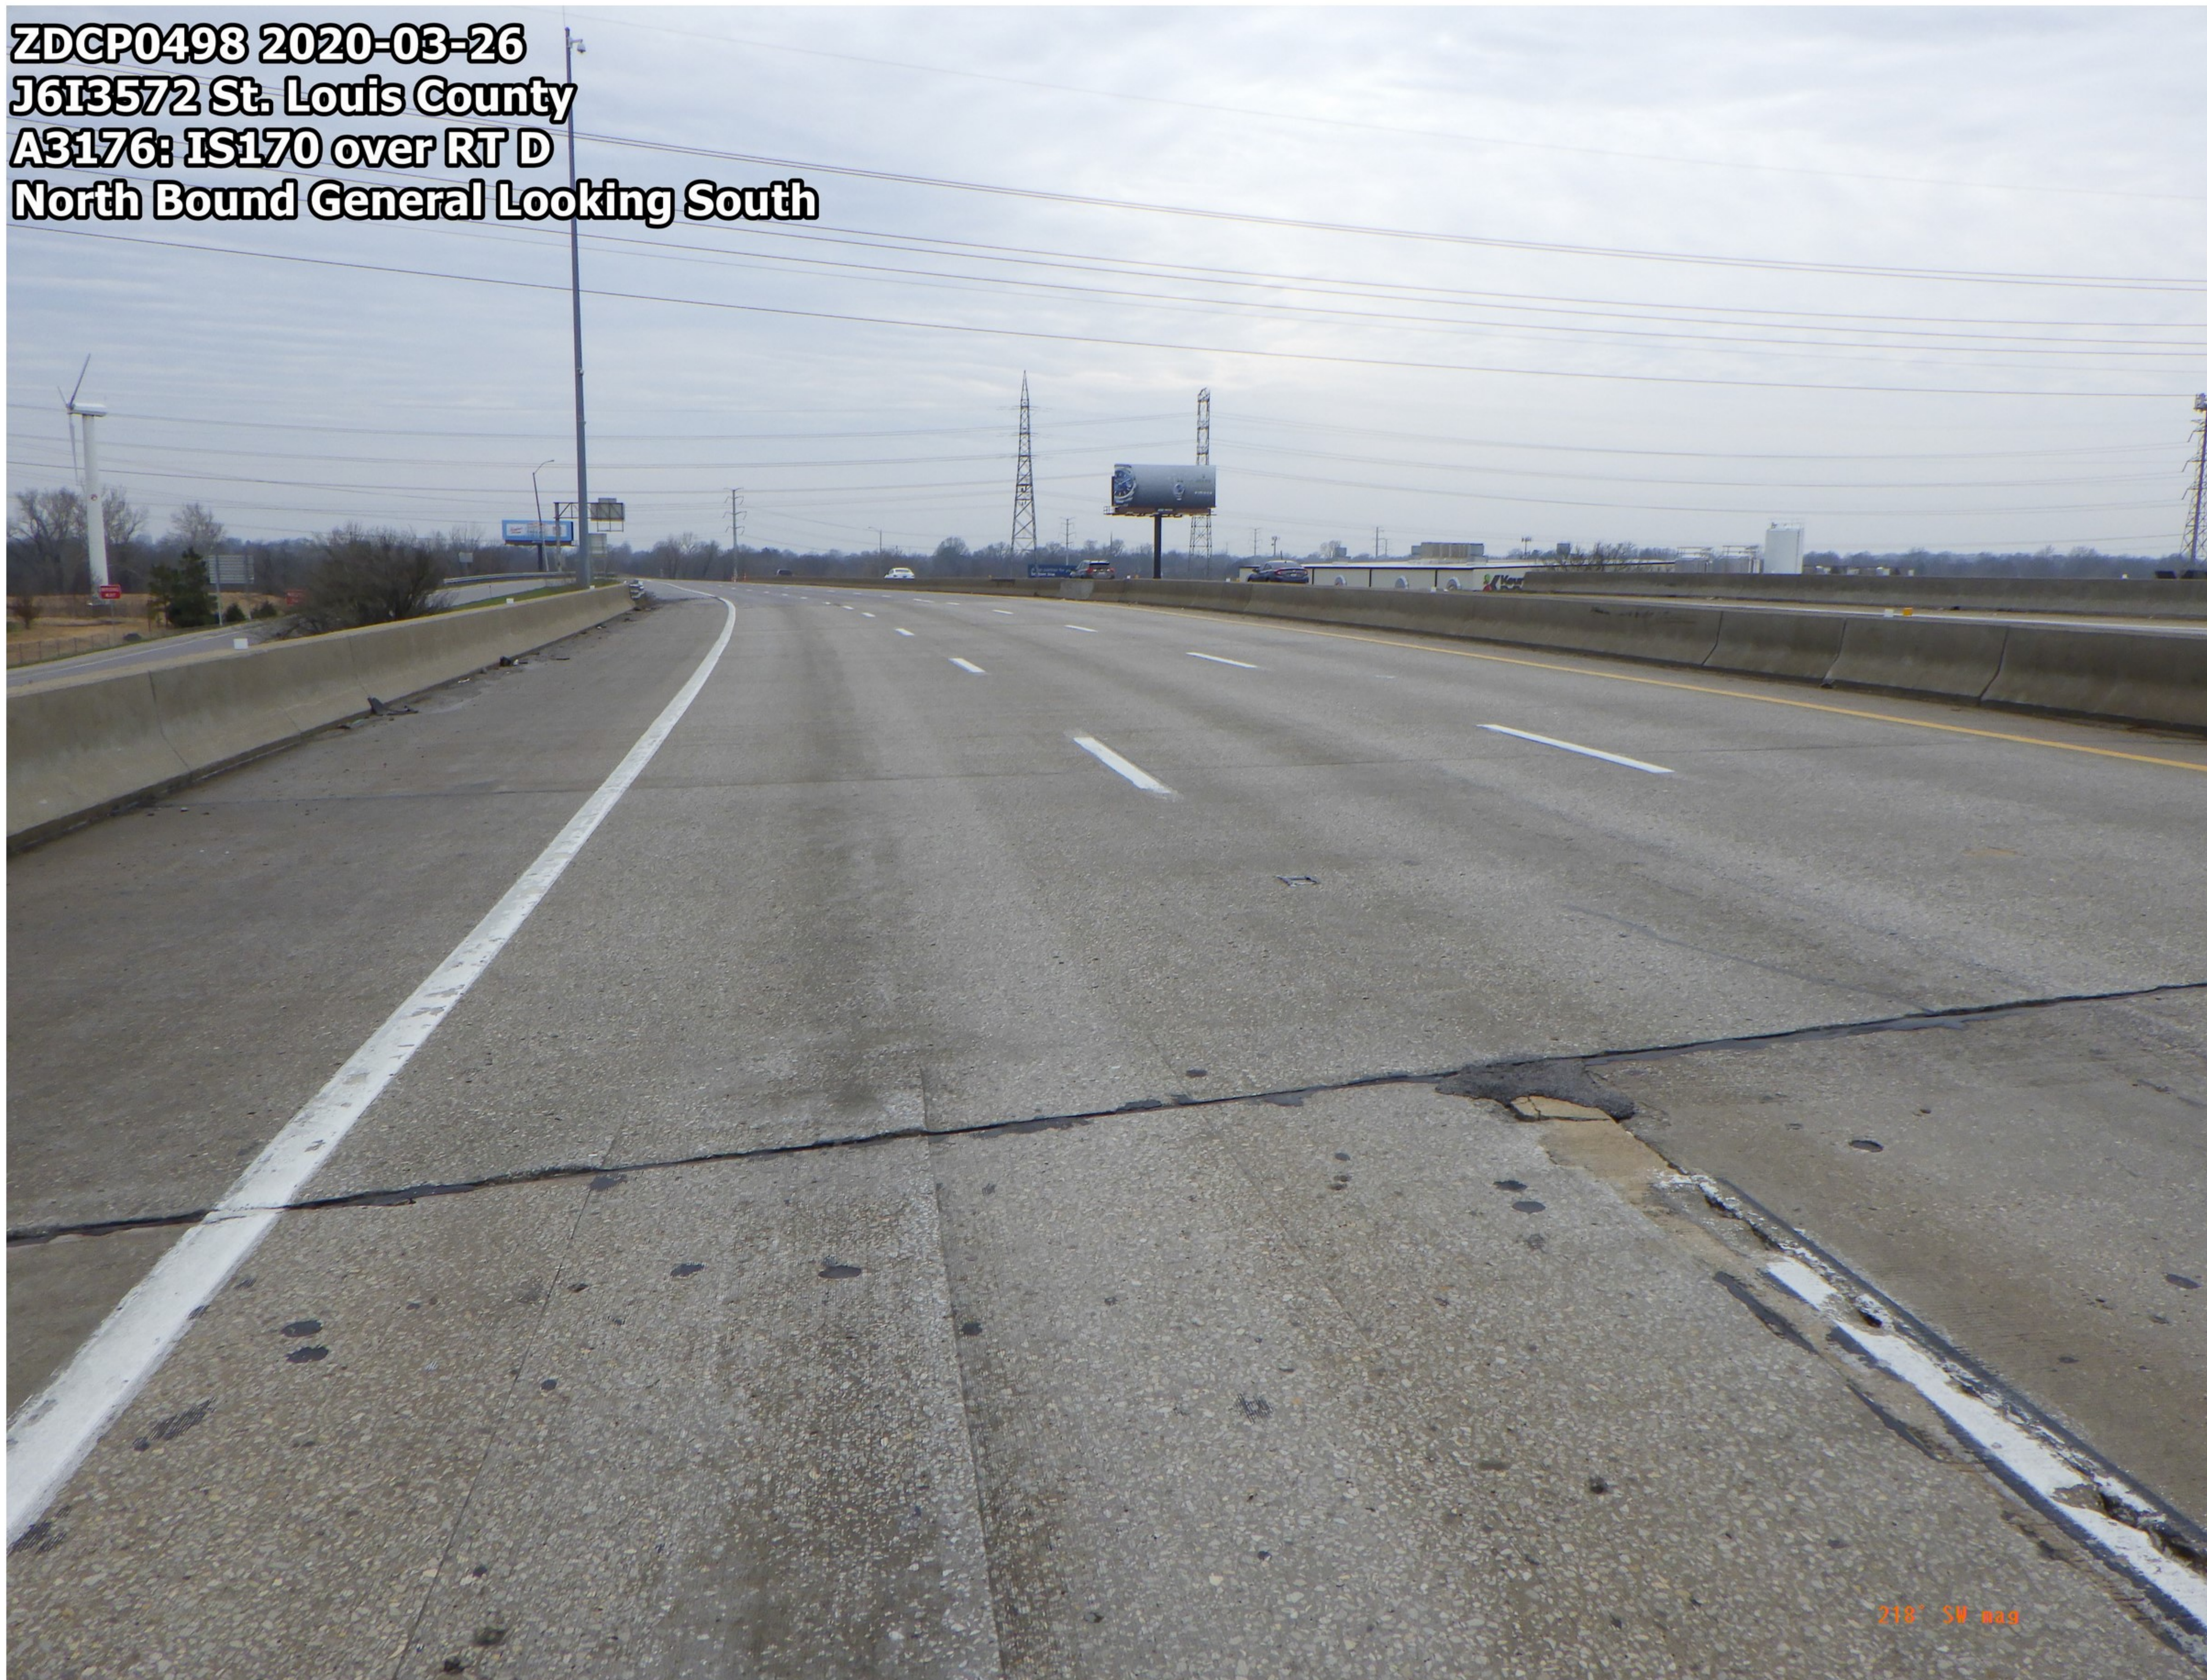
ZDCP0501 2020-03-26
J6I3572 St. Louis County
A3176: IS170 over RT D
Expansion Damage at North Median Appr Barrier

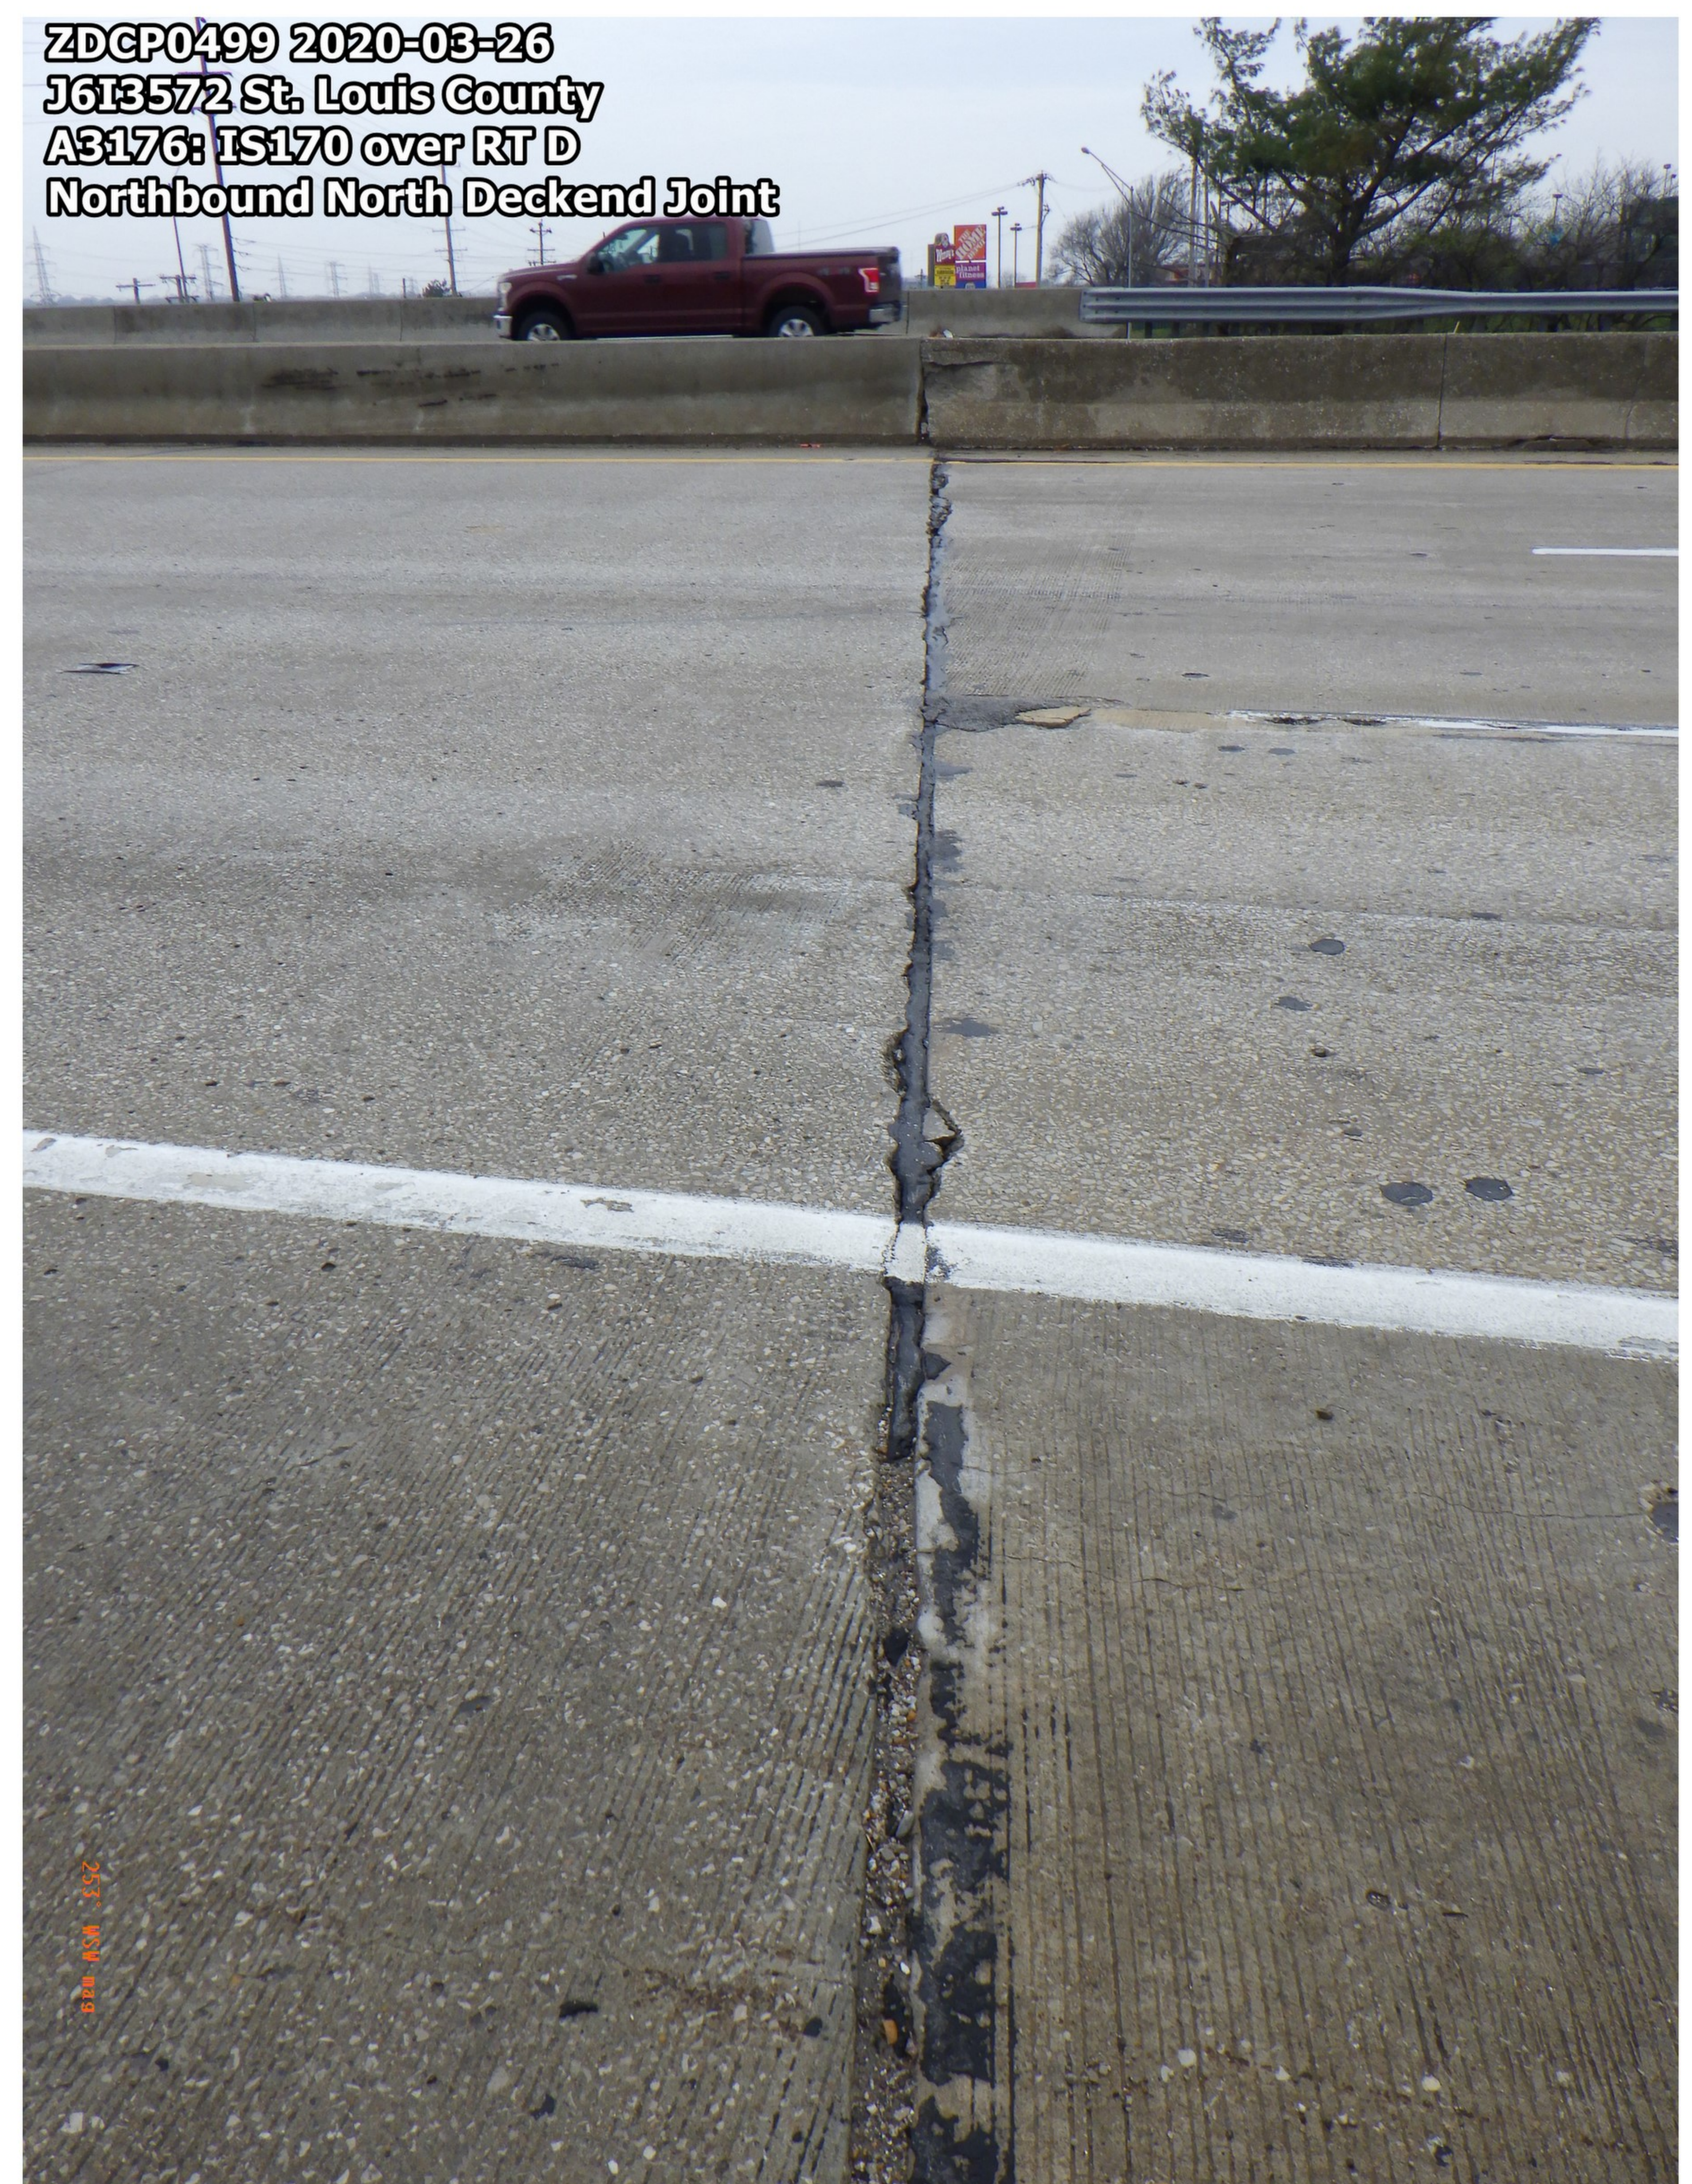
ZDCP0500 2020-03-26
J6I3572 St. Louis County
A3176: IS170 over RT D
Typical Deck Construcion Joint

Bent	Type	Recommendations			Gap Left	Gap Right	Temperature & Other Info
1	Filled Joint	<input type="checkbox"/>	<input type="checkbox"/>	<input checked="" type="checkbox"/>	"	"	Place Silicone Seal after Latex Mod Overlay
4	Filled Joint	<input type="checkbox"/>	<input type="checkbox"/>	<input checked="" type="checkbox"/>	"	"	Place Silicone Seal after Latex Mod Overlay
		<input type="checkbox"/>	<input type="checkbox"/>	<input type="checkbox"/>	"	"	
		<input type="checkbox"/>	<input type="checkbox"/>	<input type="checkbox"/>	"	"	
		<input type="checkbox"/>	<input type="checkbox"/>	<input type="checkbox"/>	"	"	
		<input type="checkbox"/>	<input type="checkbox"/>	<input type="checkbox"/>	"	"	
		<input type="checkbox"/>	<input type="checkbox"/>	<input type="checkbox"/>	"	"

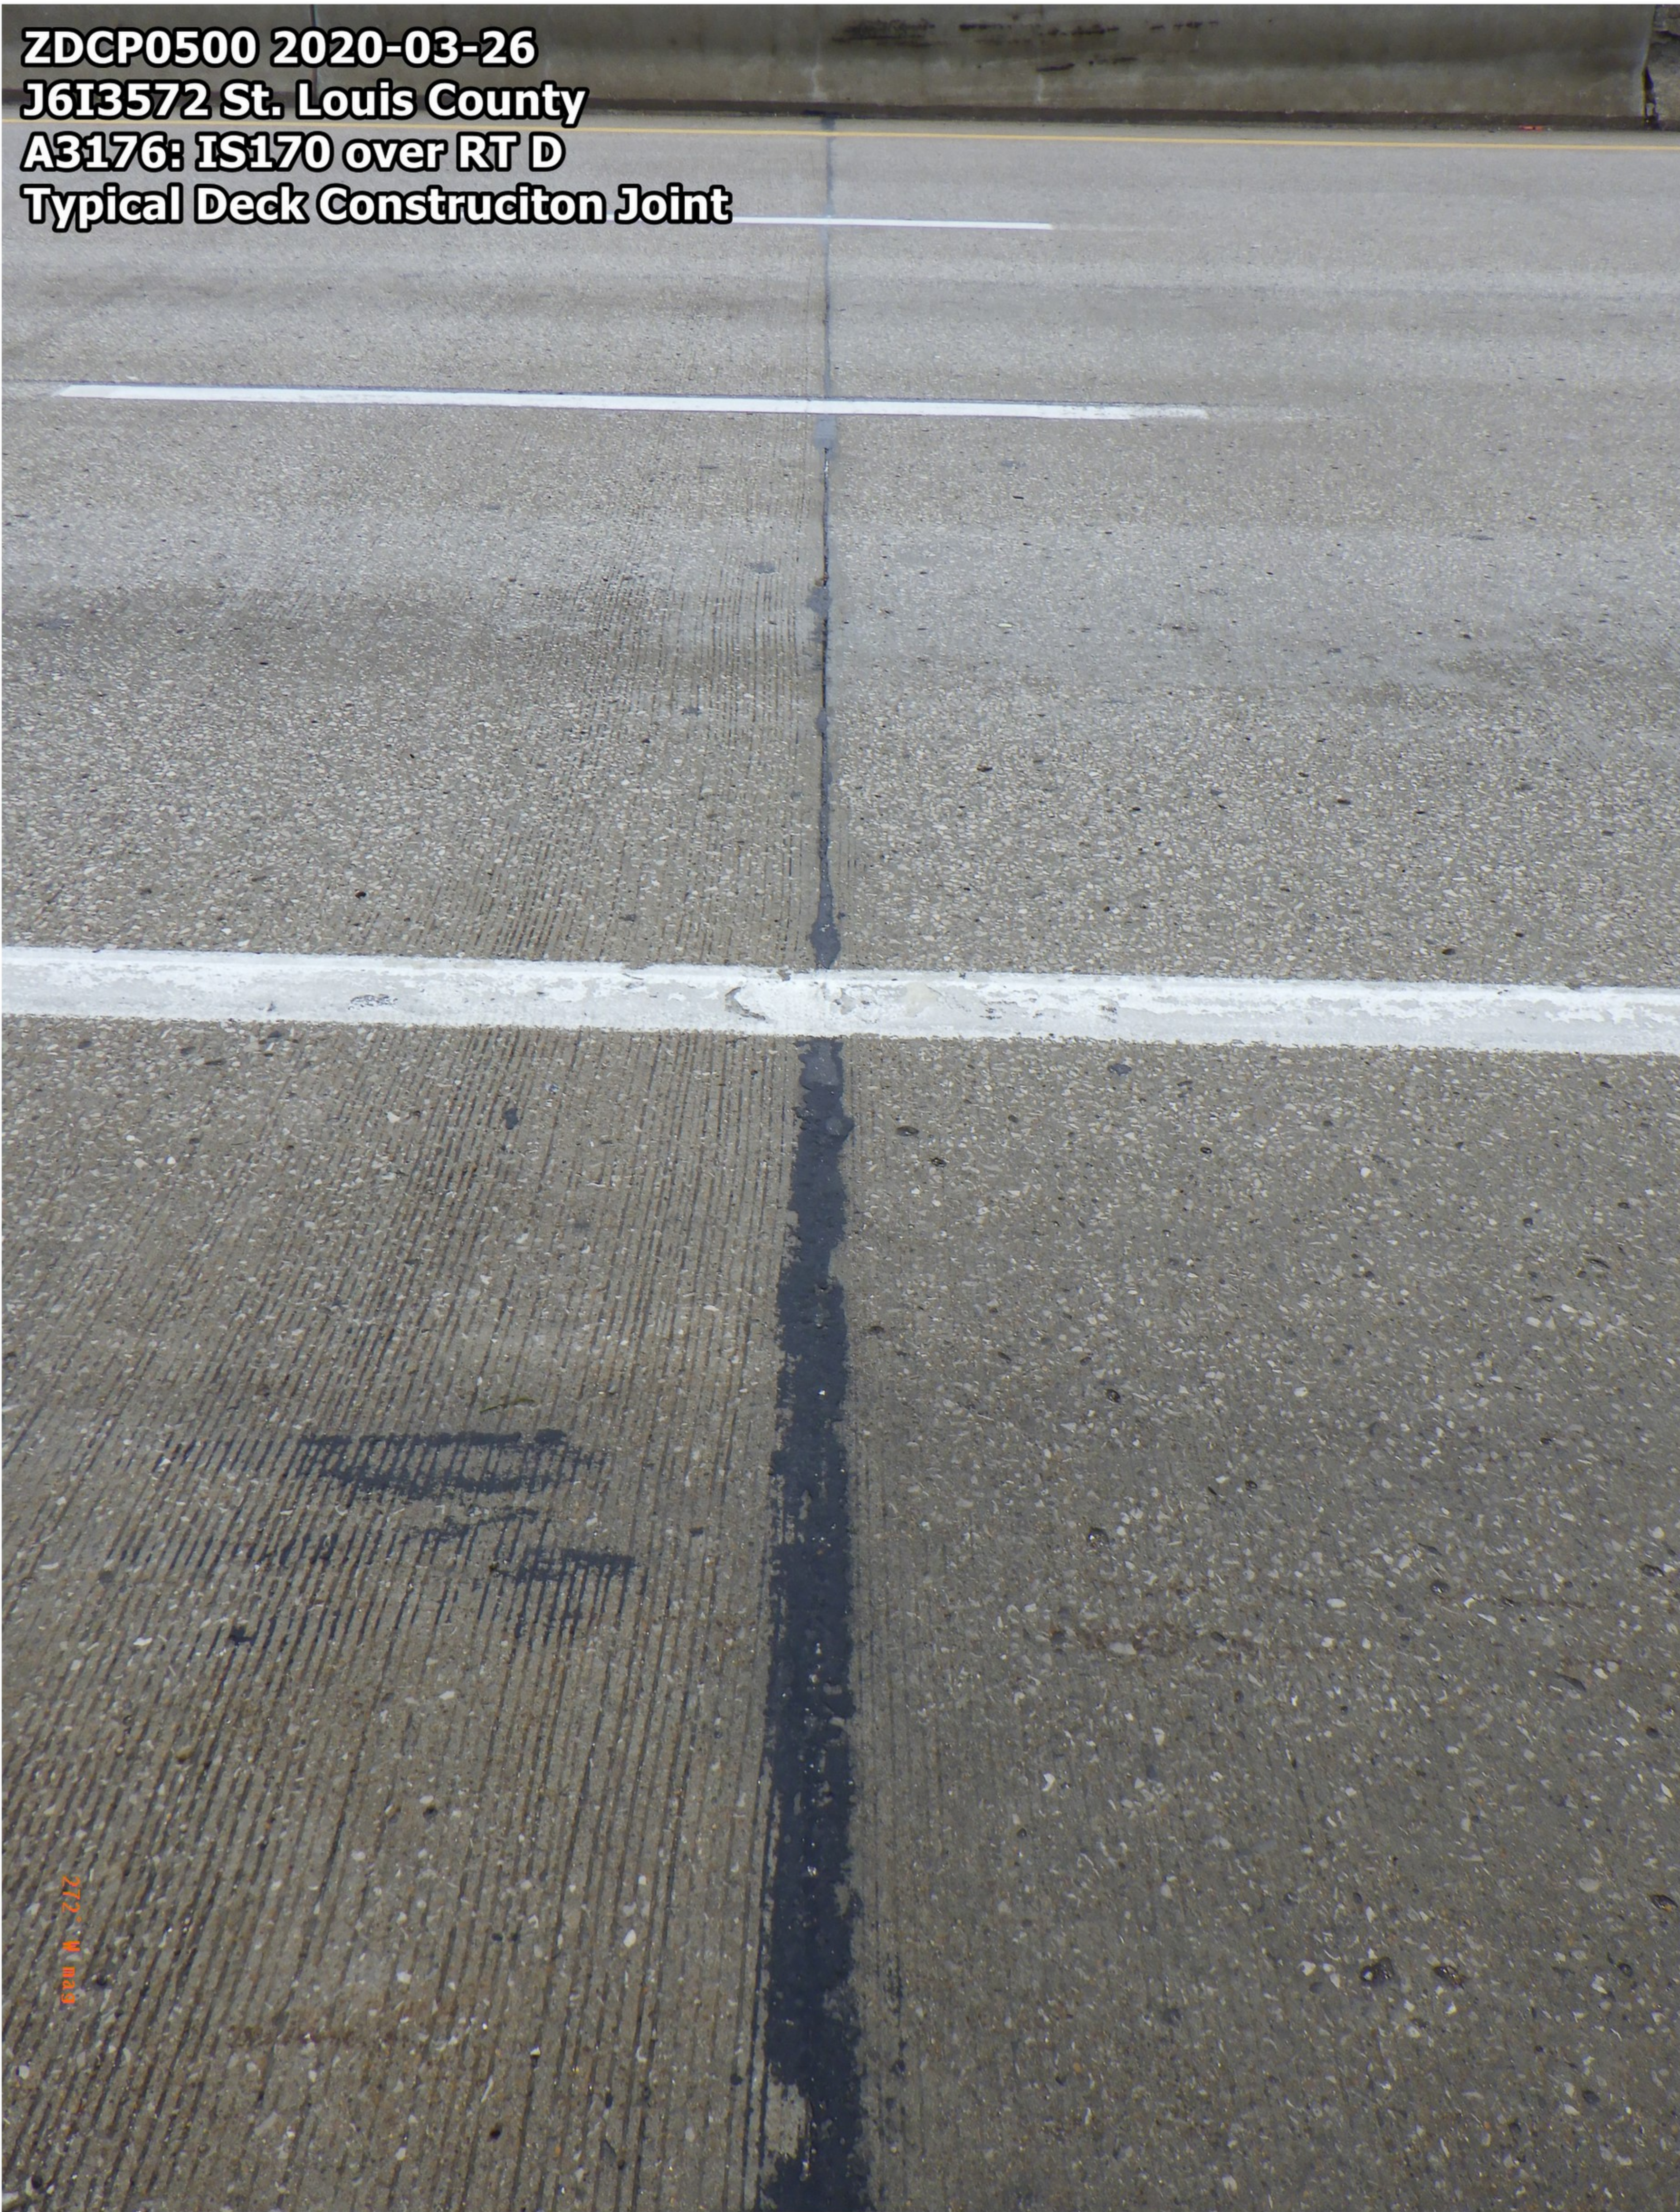
ZDCP0503 2020-03-26
J6I3572 St. Louis County
A3176: IS170 over RT D
Norhtbound South Deckend

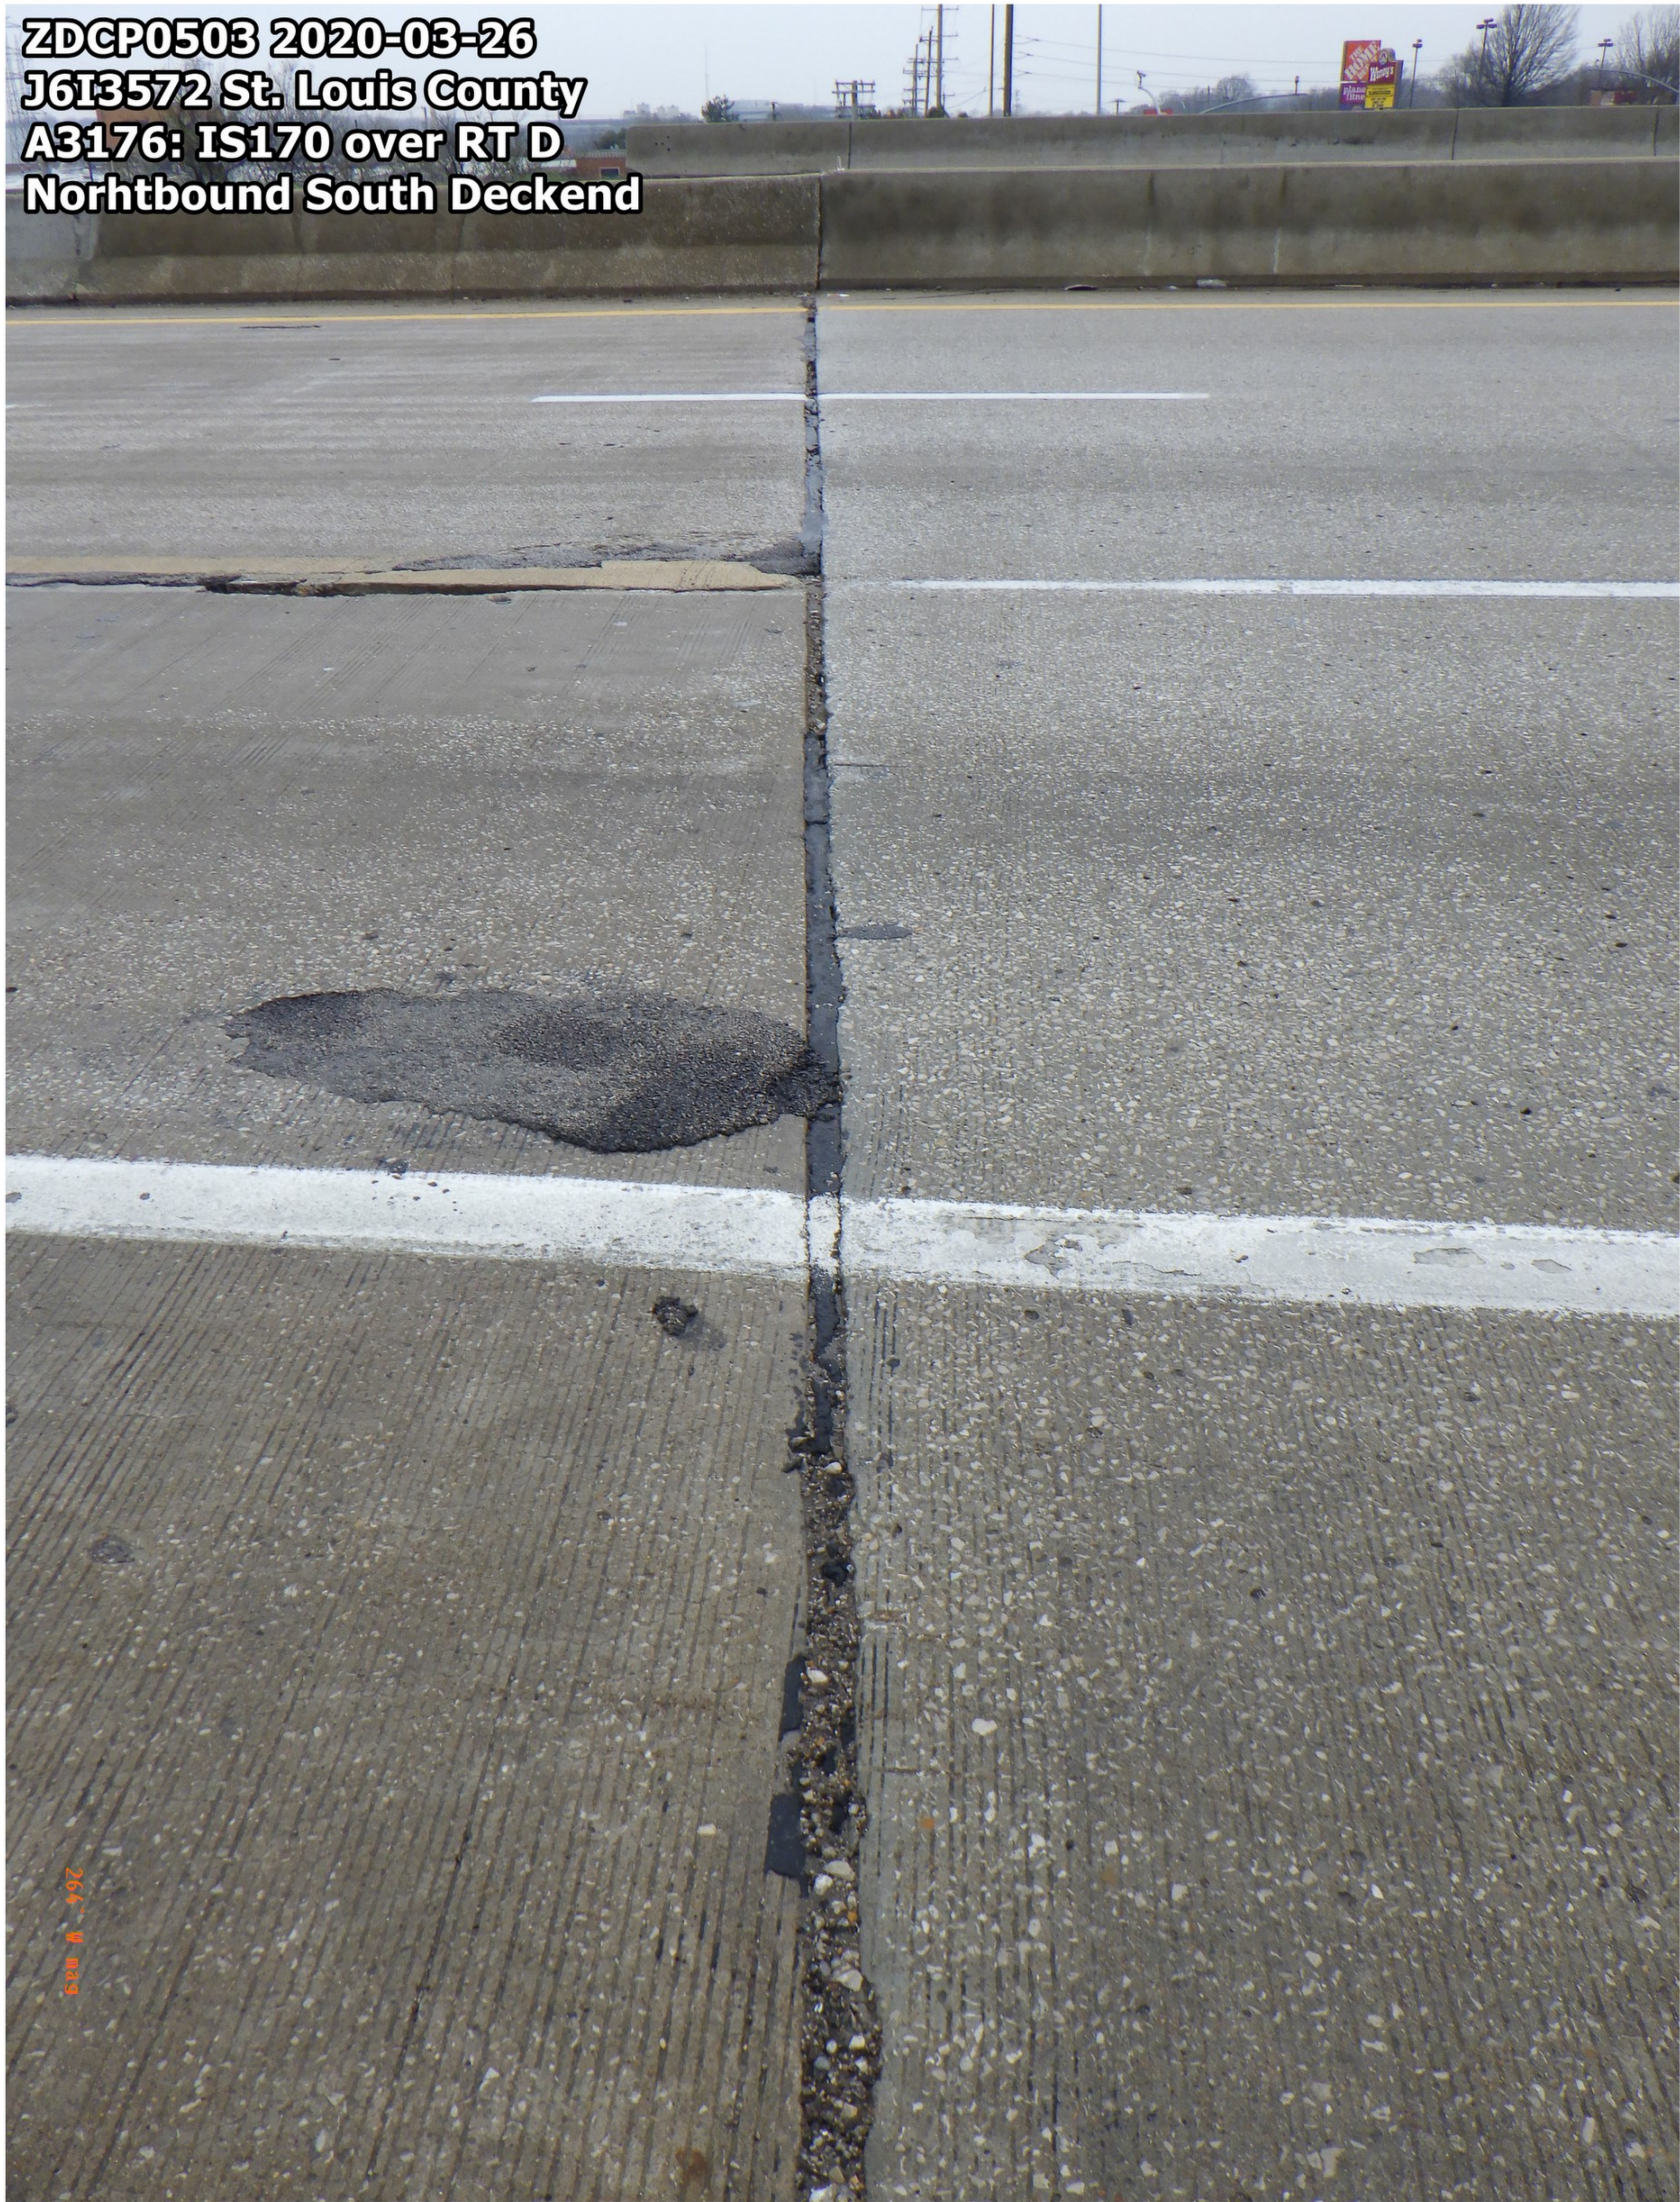
ZDCP0504 2020-03-26
J6I3572 St. Louis County
A3176: IS170 over RT D
Norhtbound South Approach/Roadway Joint

* Notes: **If replacing Approach Slabs, tie to deck to minimize joint at abutment fill face.**

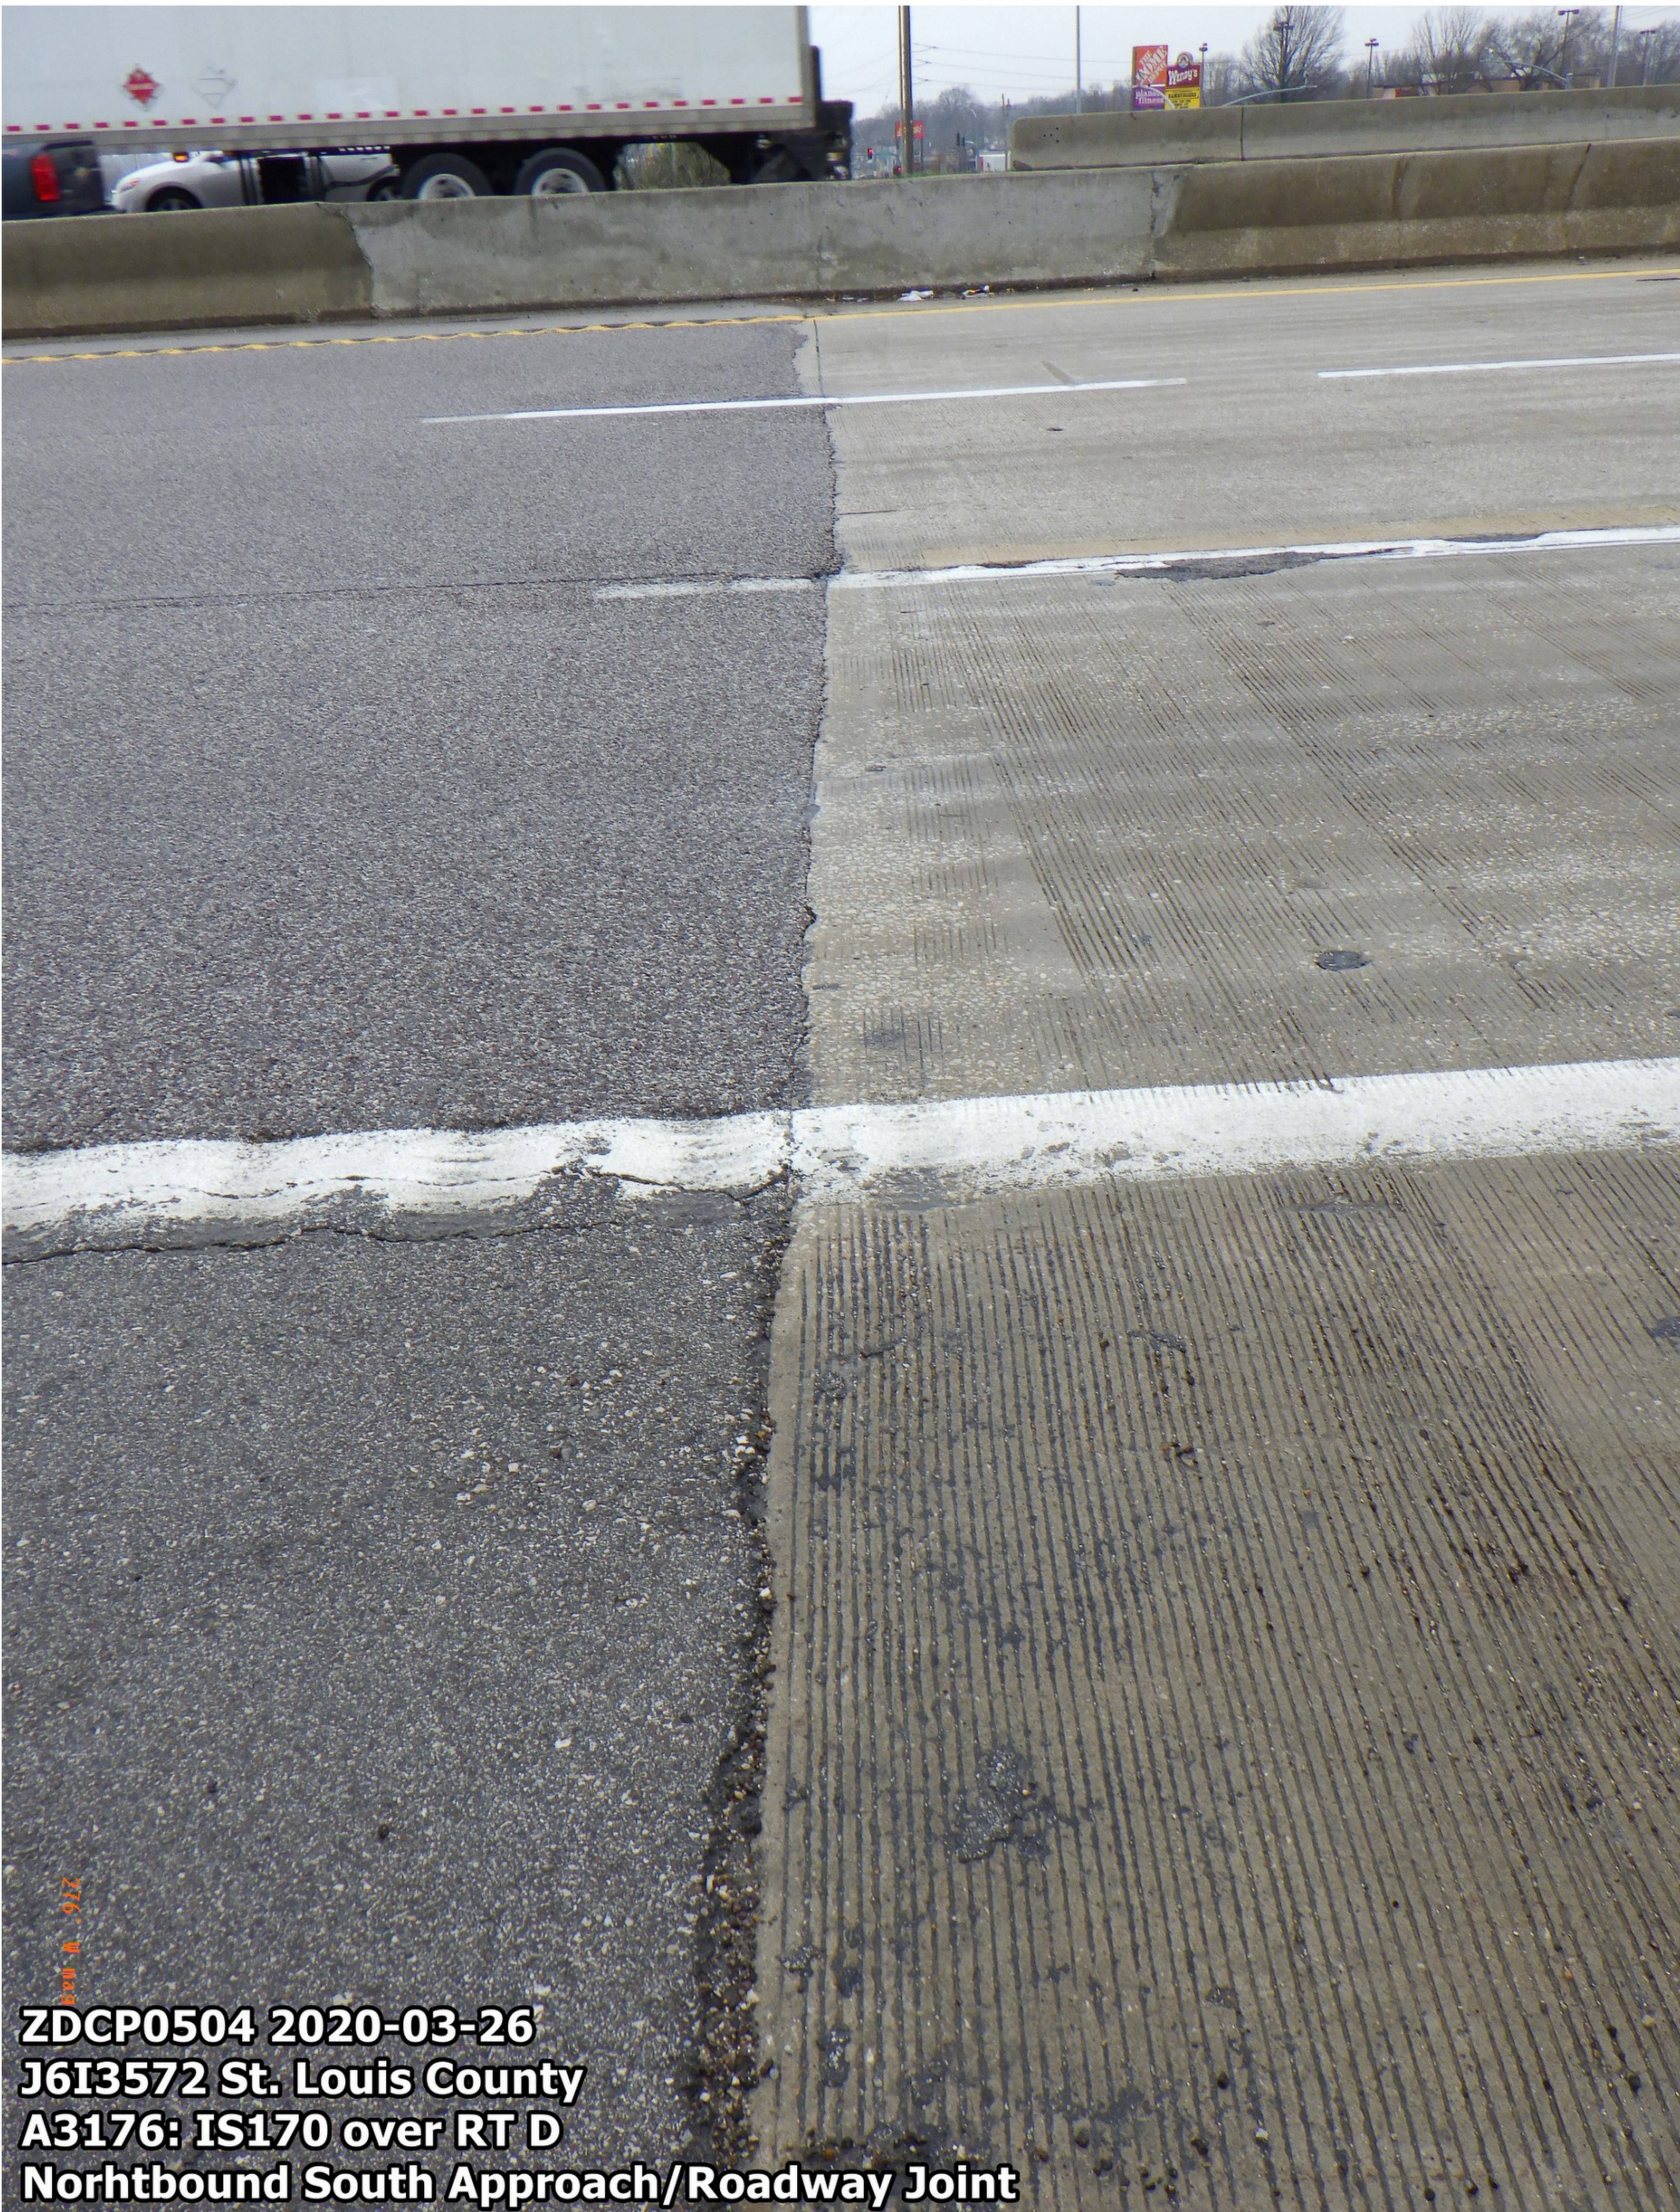
ZDCP0505 2020-03-26
J6I3572 St. Louis County
A3176: IS170 over RT D
West Overhang
