Missouri Department of Transportation

STRUCTURAL REHABILITATION CHECKLIST

Bridge No.: A2809 **Job No.:** J613572

Route: IS 170 **Over:** UP RR

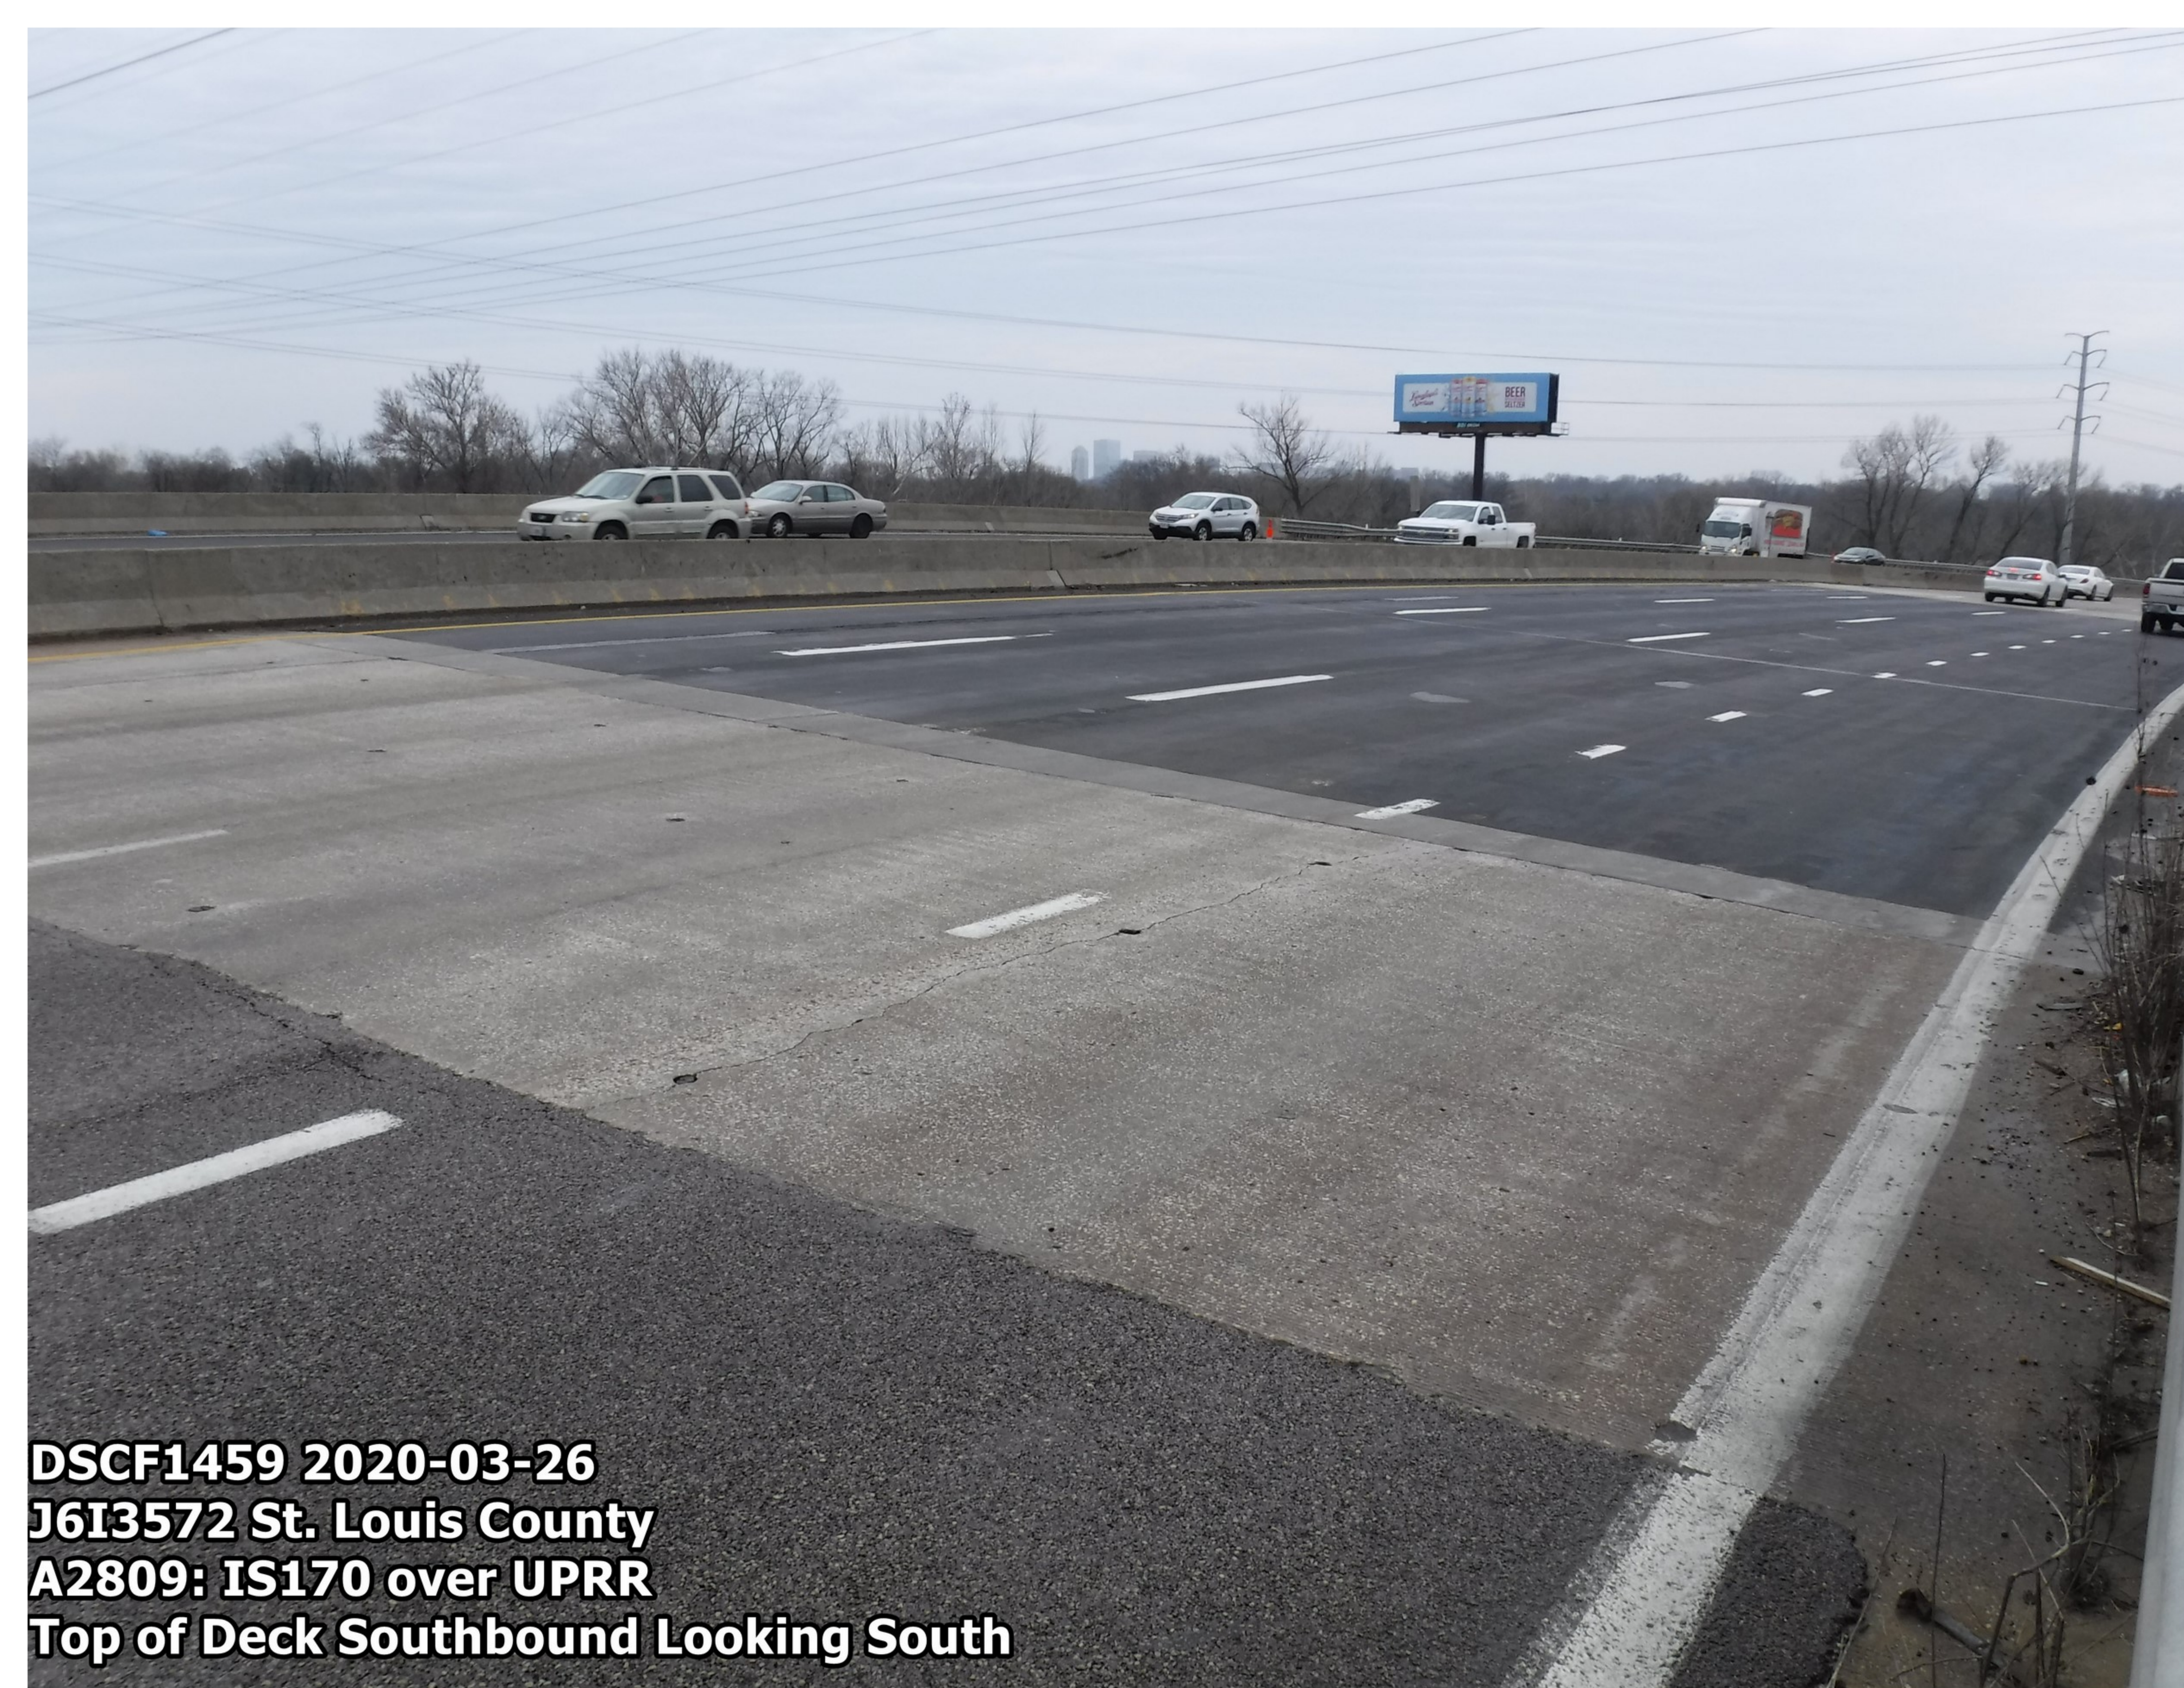
- * Type of existing overlay: ☐ None ☐ Asphalt ☐ Low Slump ☐ Silica Fume ☐ Latex ☒ Epoxy ☐ Other: _____
- * Existing overlay thickness: 3/8 " * Year overlay was applied: 2005 ☐ Unknown
- * % of overlay repaired or patched: _____ % * Replace overlay: ☒ Yes ☐ No
- * Notes: Place Latex Modified Concrete Overlay

DSCF1459 2020-03-26
J6I3572 St. Louis County
A2809: IS170 over UPRR
Top of Deck Southbound Looking South

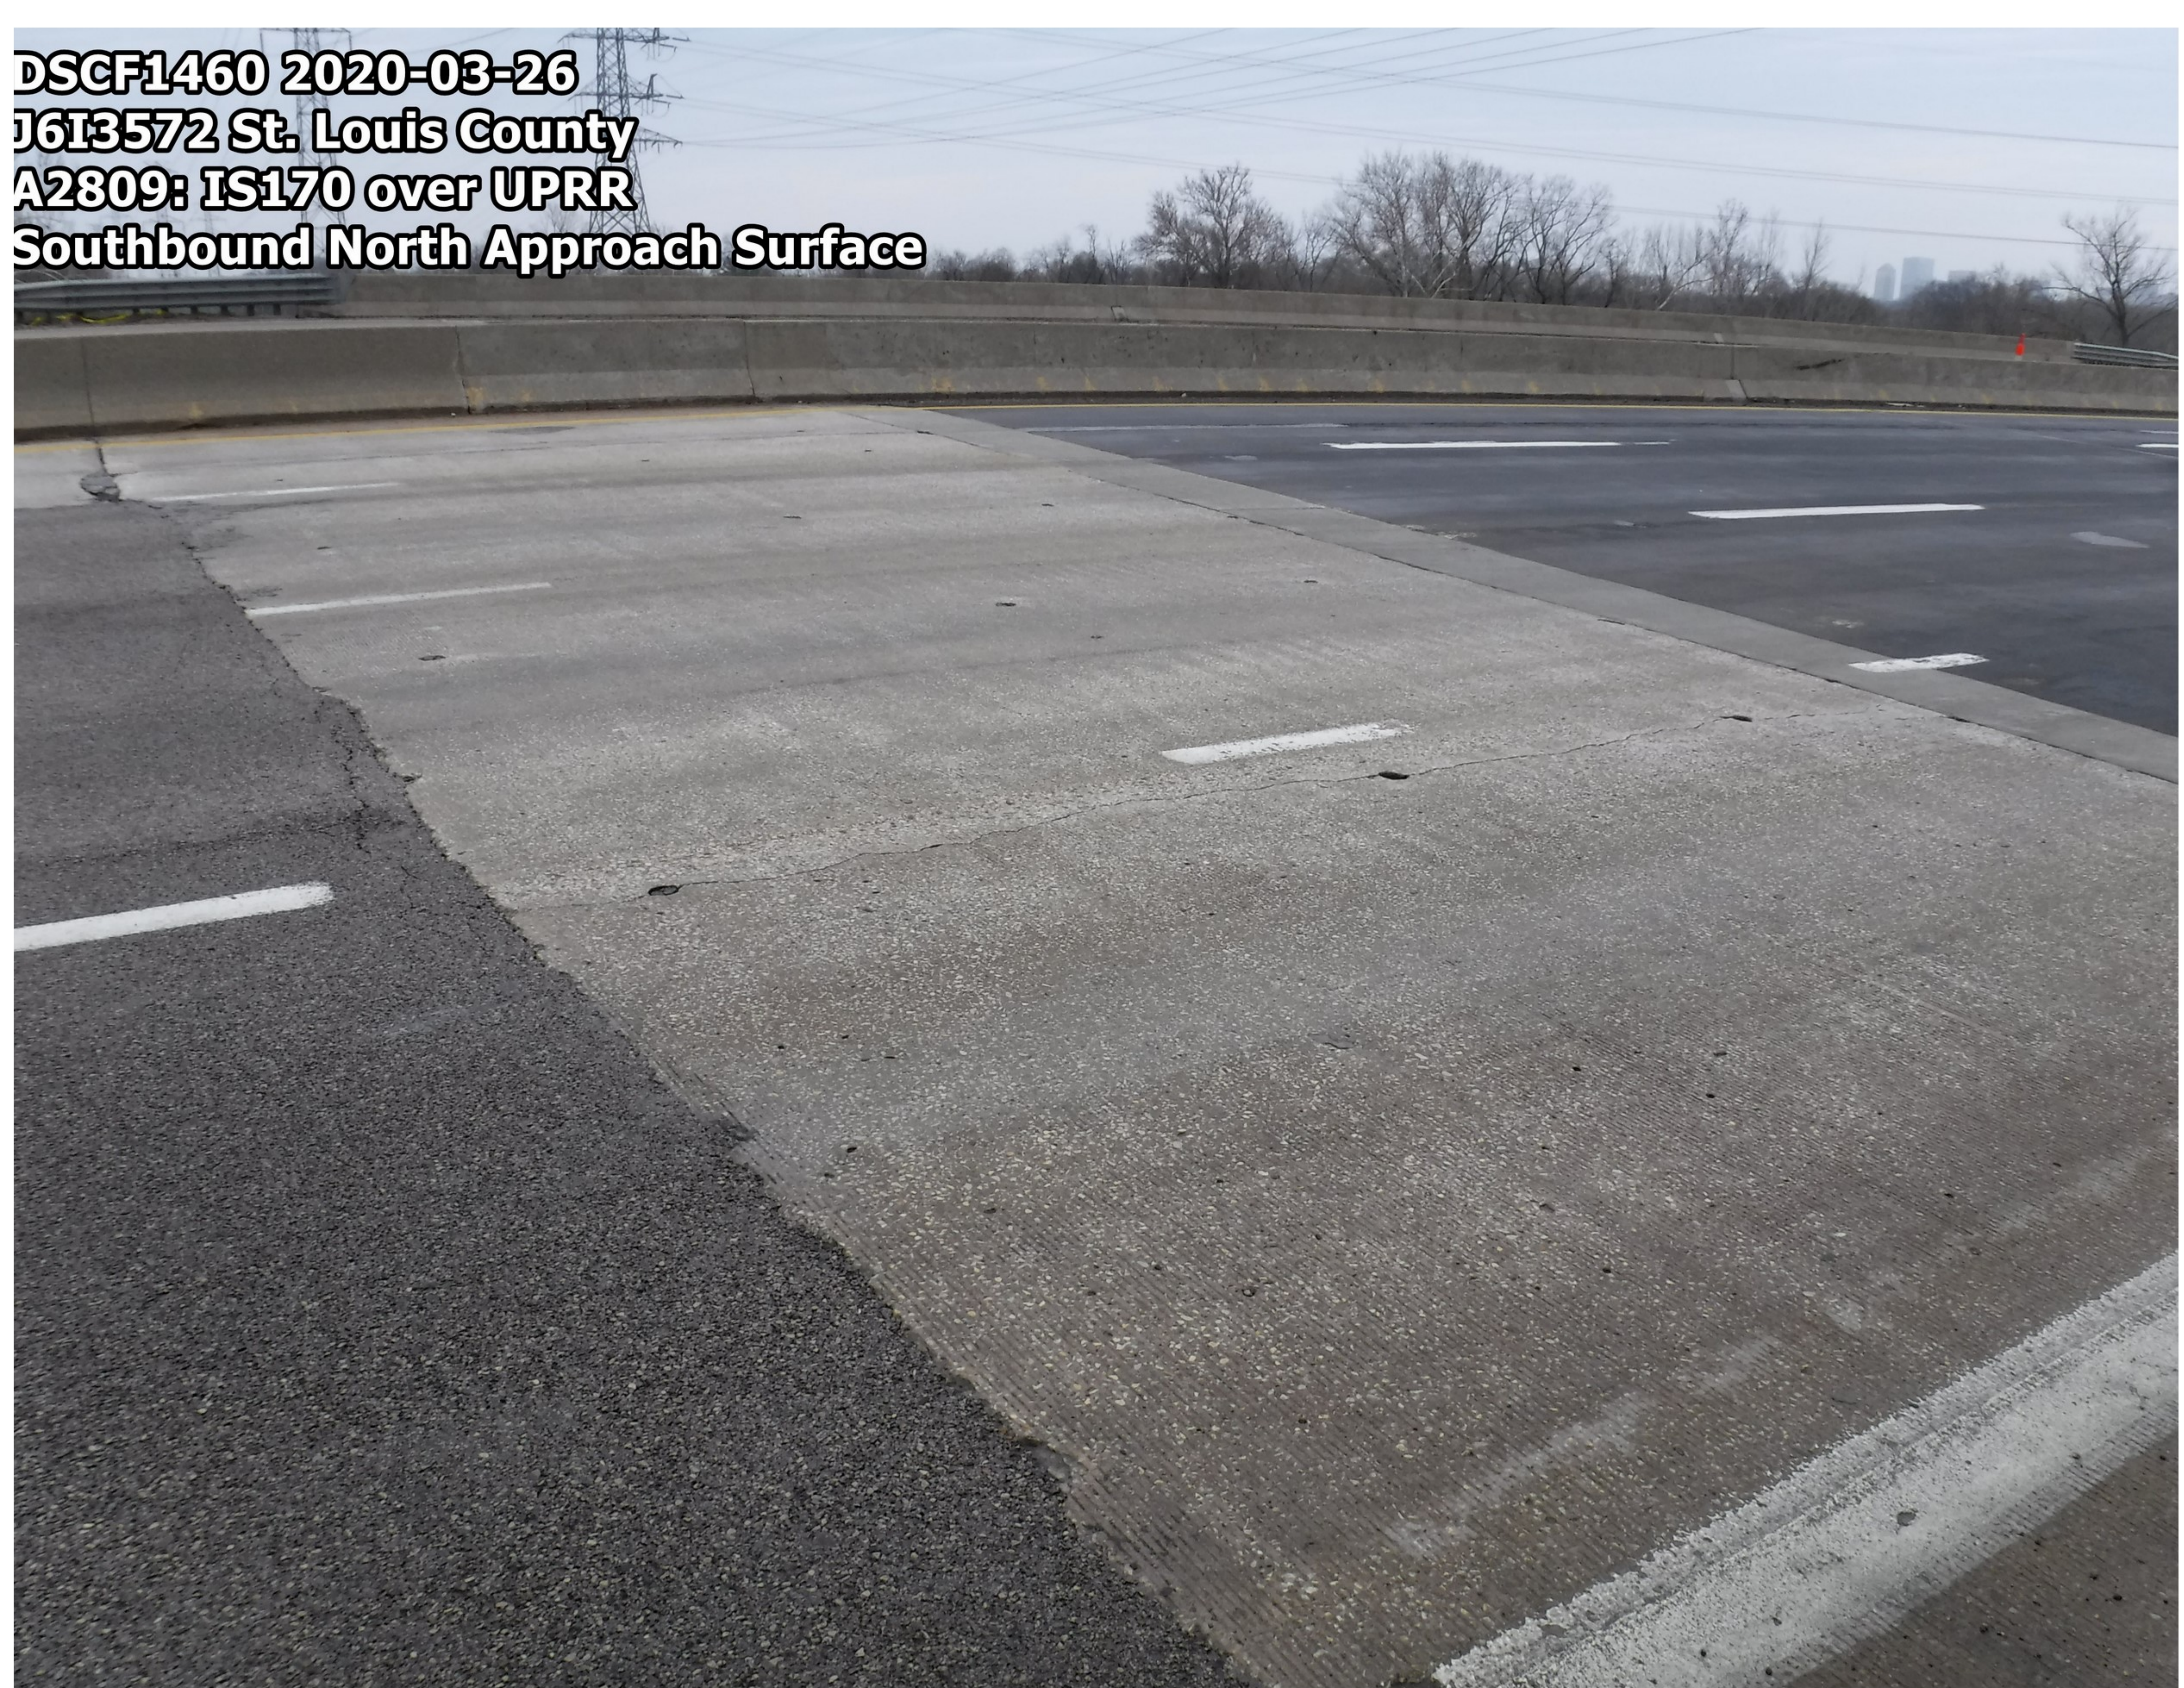
- * Is there a bridge approach slab in place? ☒ Yes ☐ No * Type: ☒ Concrete ☒ Asphalt ☐ Other _____
- * Is there a rdwy. approach pavement in place? ☒ Yes ☐ No * Type: ☒ Concrete ☐ Asphalt ☐ Other _____
- * Is the approach slab sinking at the end bent? ☐ N/A ☐ Yes ☒ No _____
- * Are repairs needed to the bridge approach slab driving surface? ☒ Yes ☐ No **105 SF at N Appr, 600 SF at S Appr.**
(Typically a roadway item but will be reported to district on the Bridge Memorandum.)
- * Full Replacement of Approach Slab? ☐ Yes ☒ No _____
- * Notes: **Include Approaches in Hydrodem/Overlay. Repairs can be accomplished monolithically.**

Approach at NE is covered with Asphalt, 1986 roadway plans show concrete bridge approach slab at all quads

DSCF1460 2020-03-26
J6I3572 St. Louis County
A2809: IS170 over UPRR
Southbound North Approach Surface

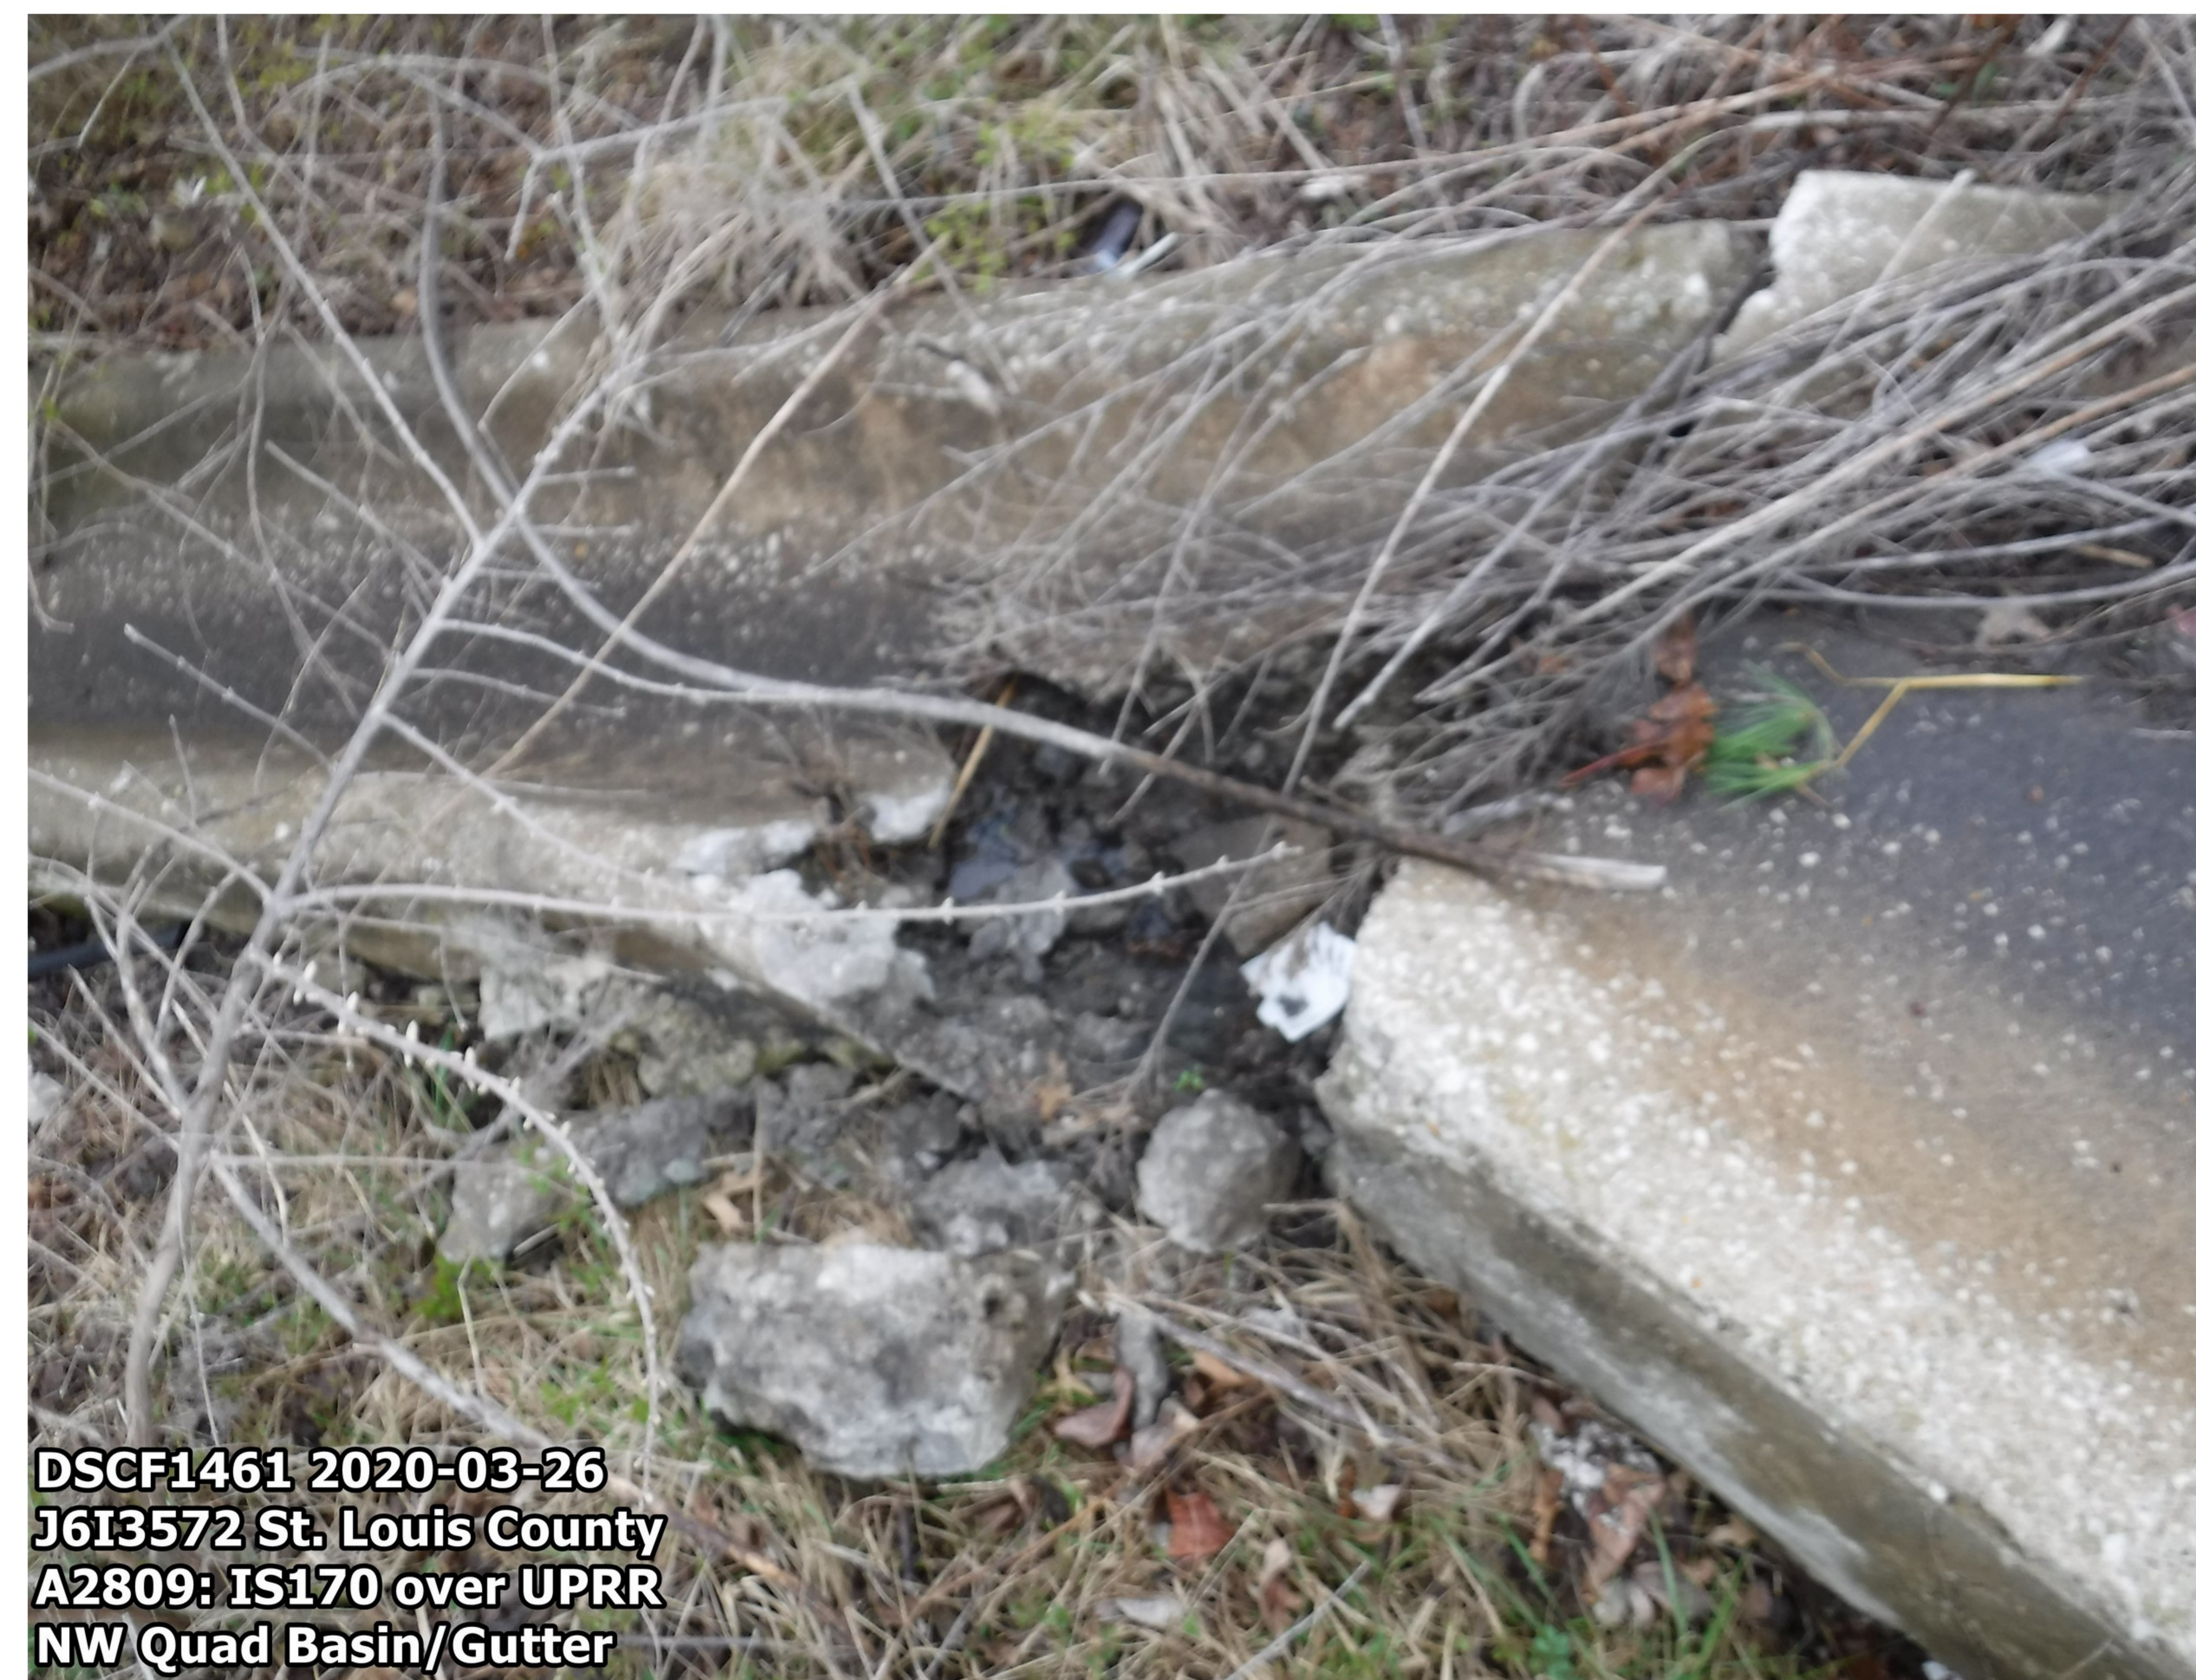
DSCF1461 2020-03-26
J6I3572 St. Louis County
A2809: IS170 over UPRR
NW Quad Basin/Gutter

* Recommendations: Repair Basin at NW Quadrant Broken and Settled

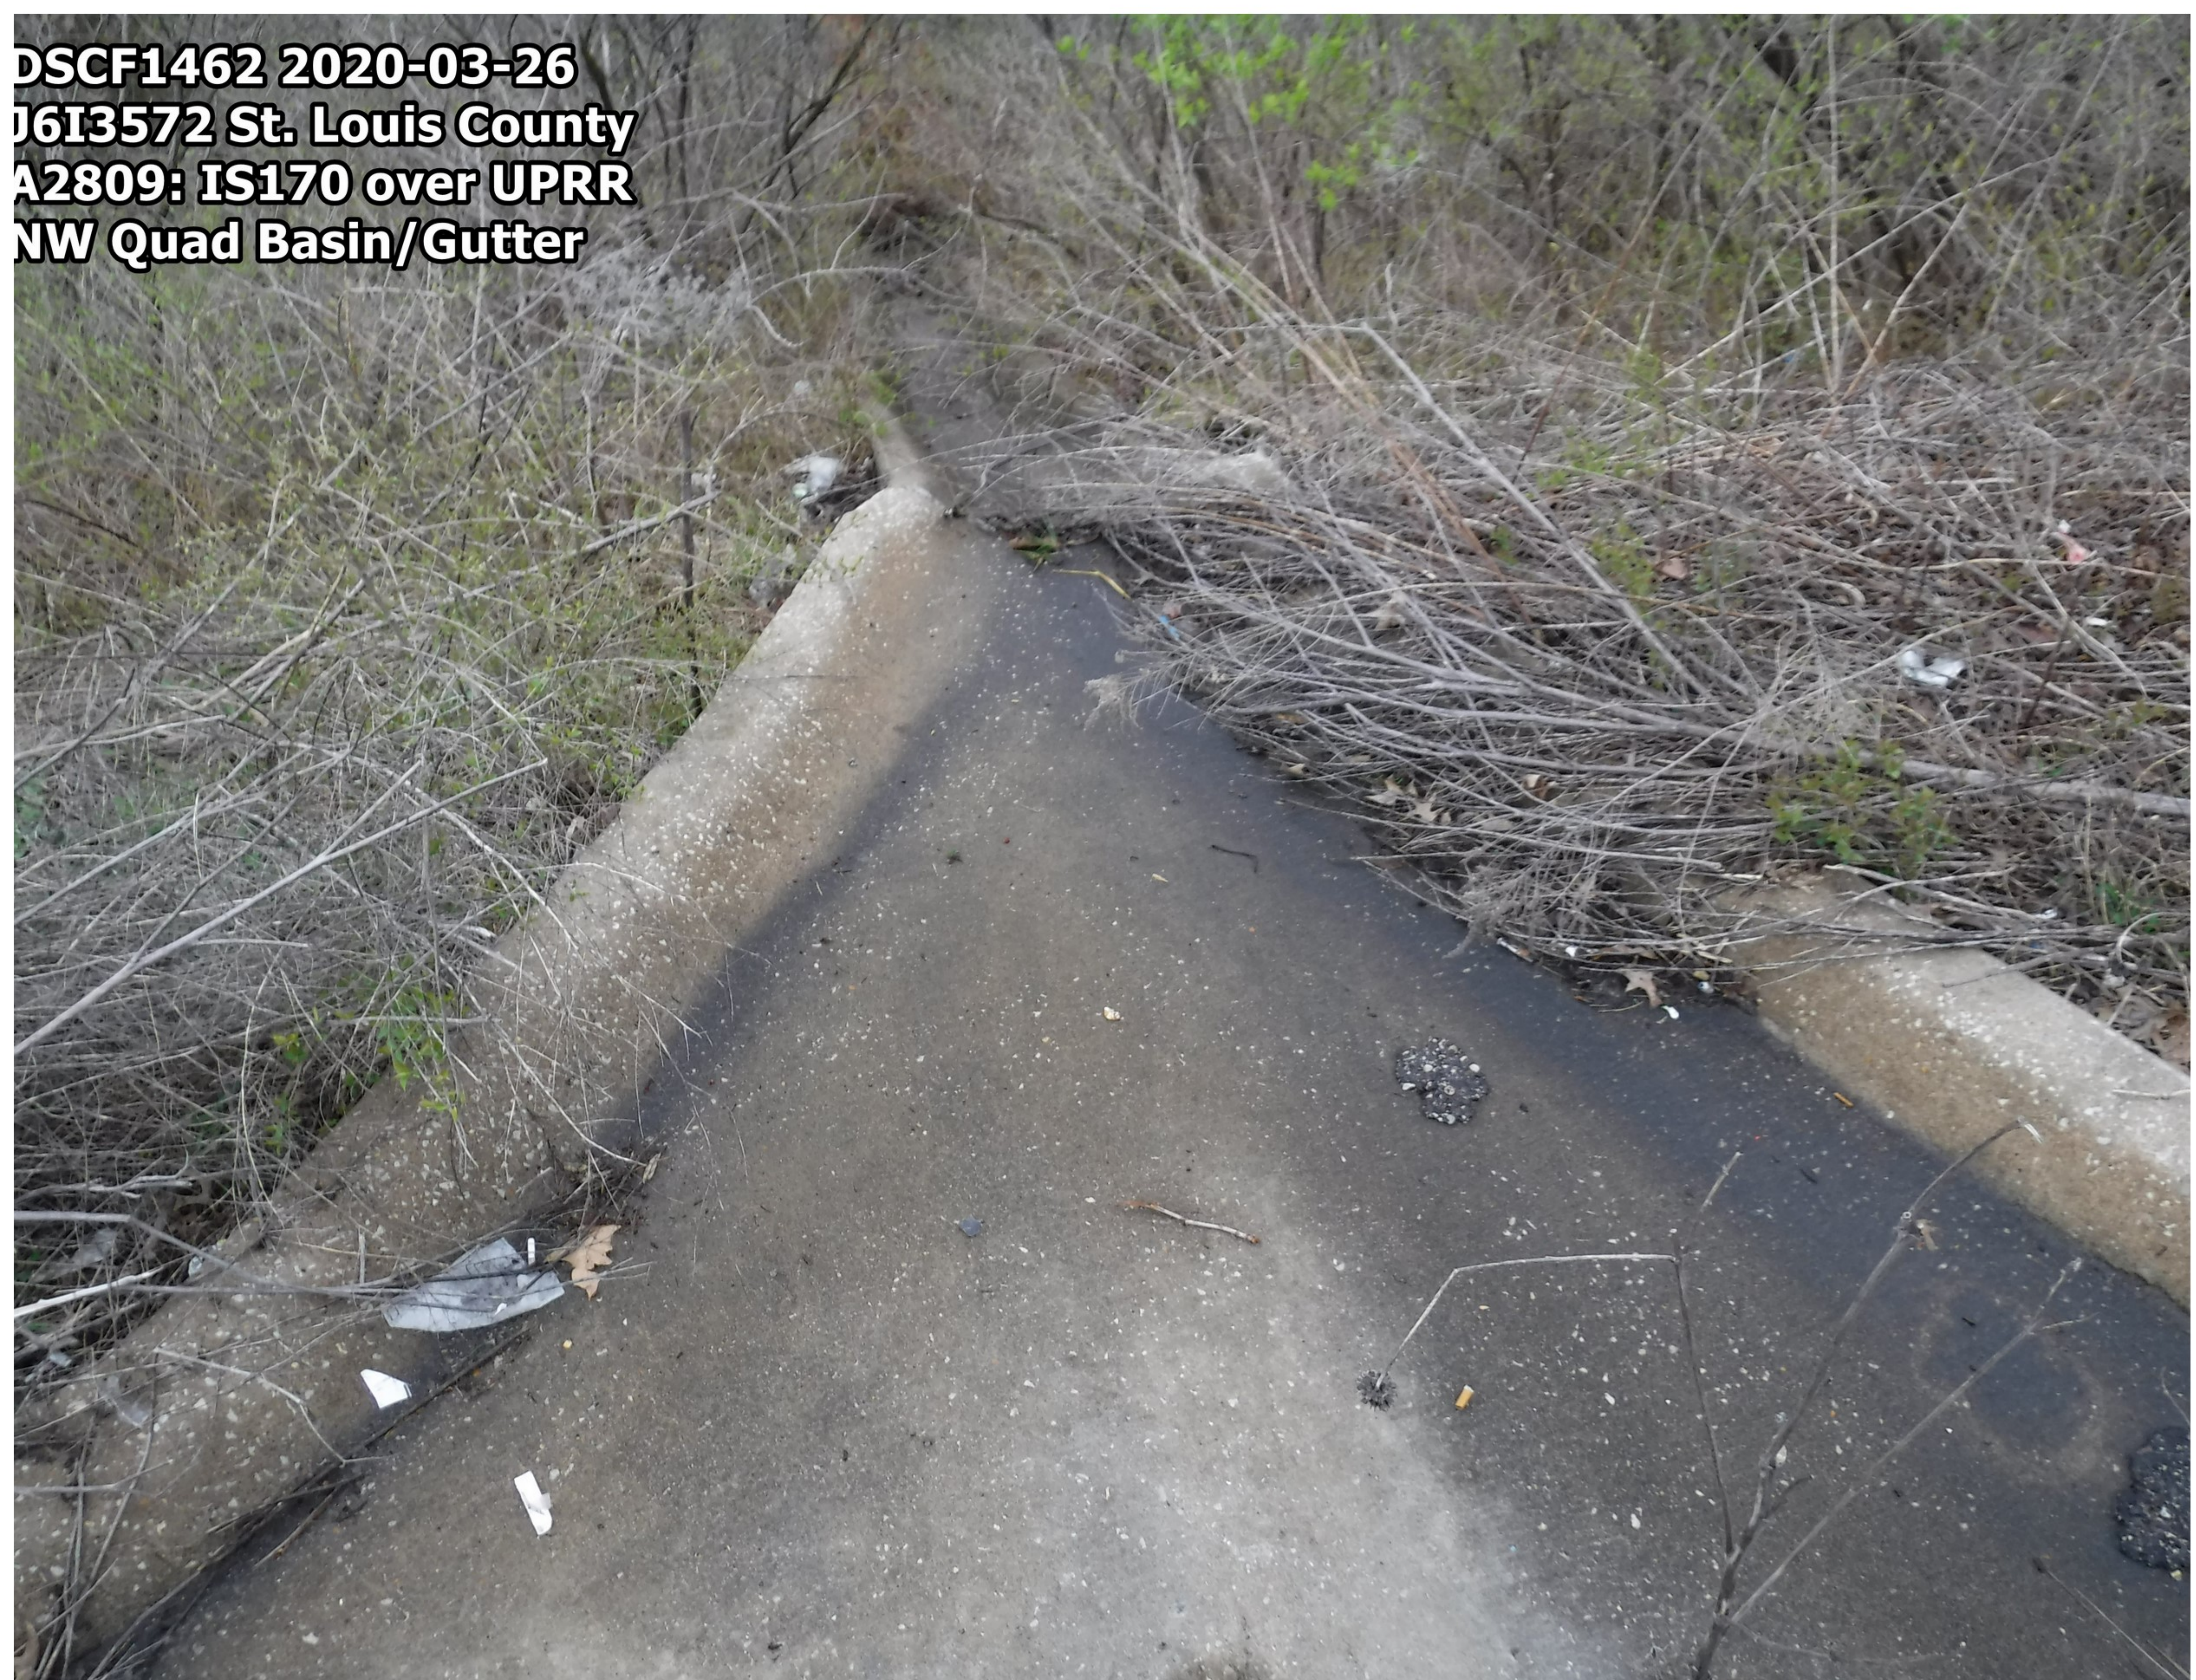
DSCF1462 2020-03-26
J6I3572 St. Louis County
A2809: IS170 over UPRR
NW Quad Basin/Gutter

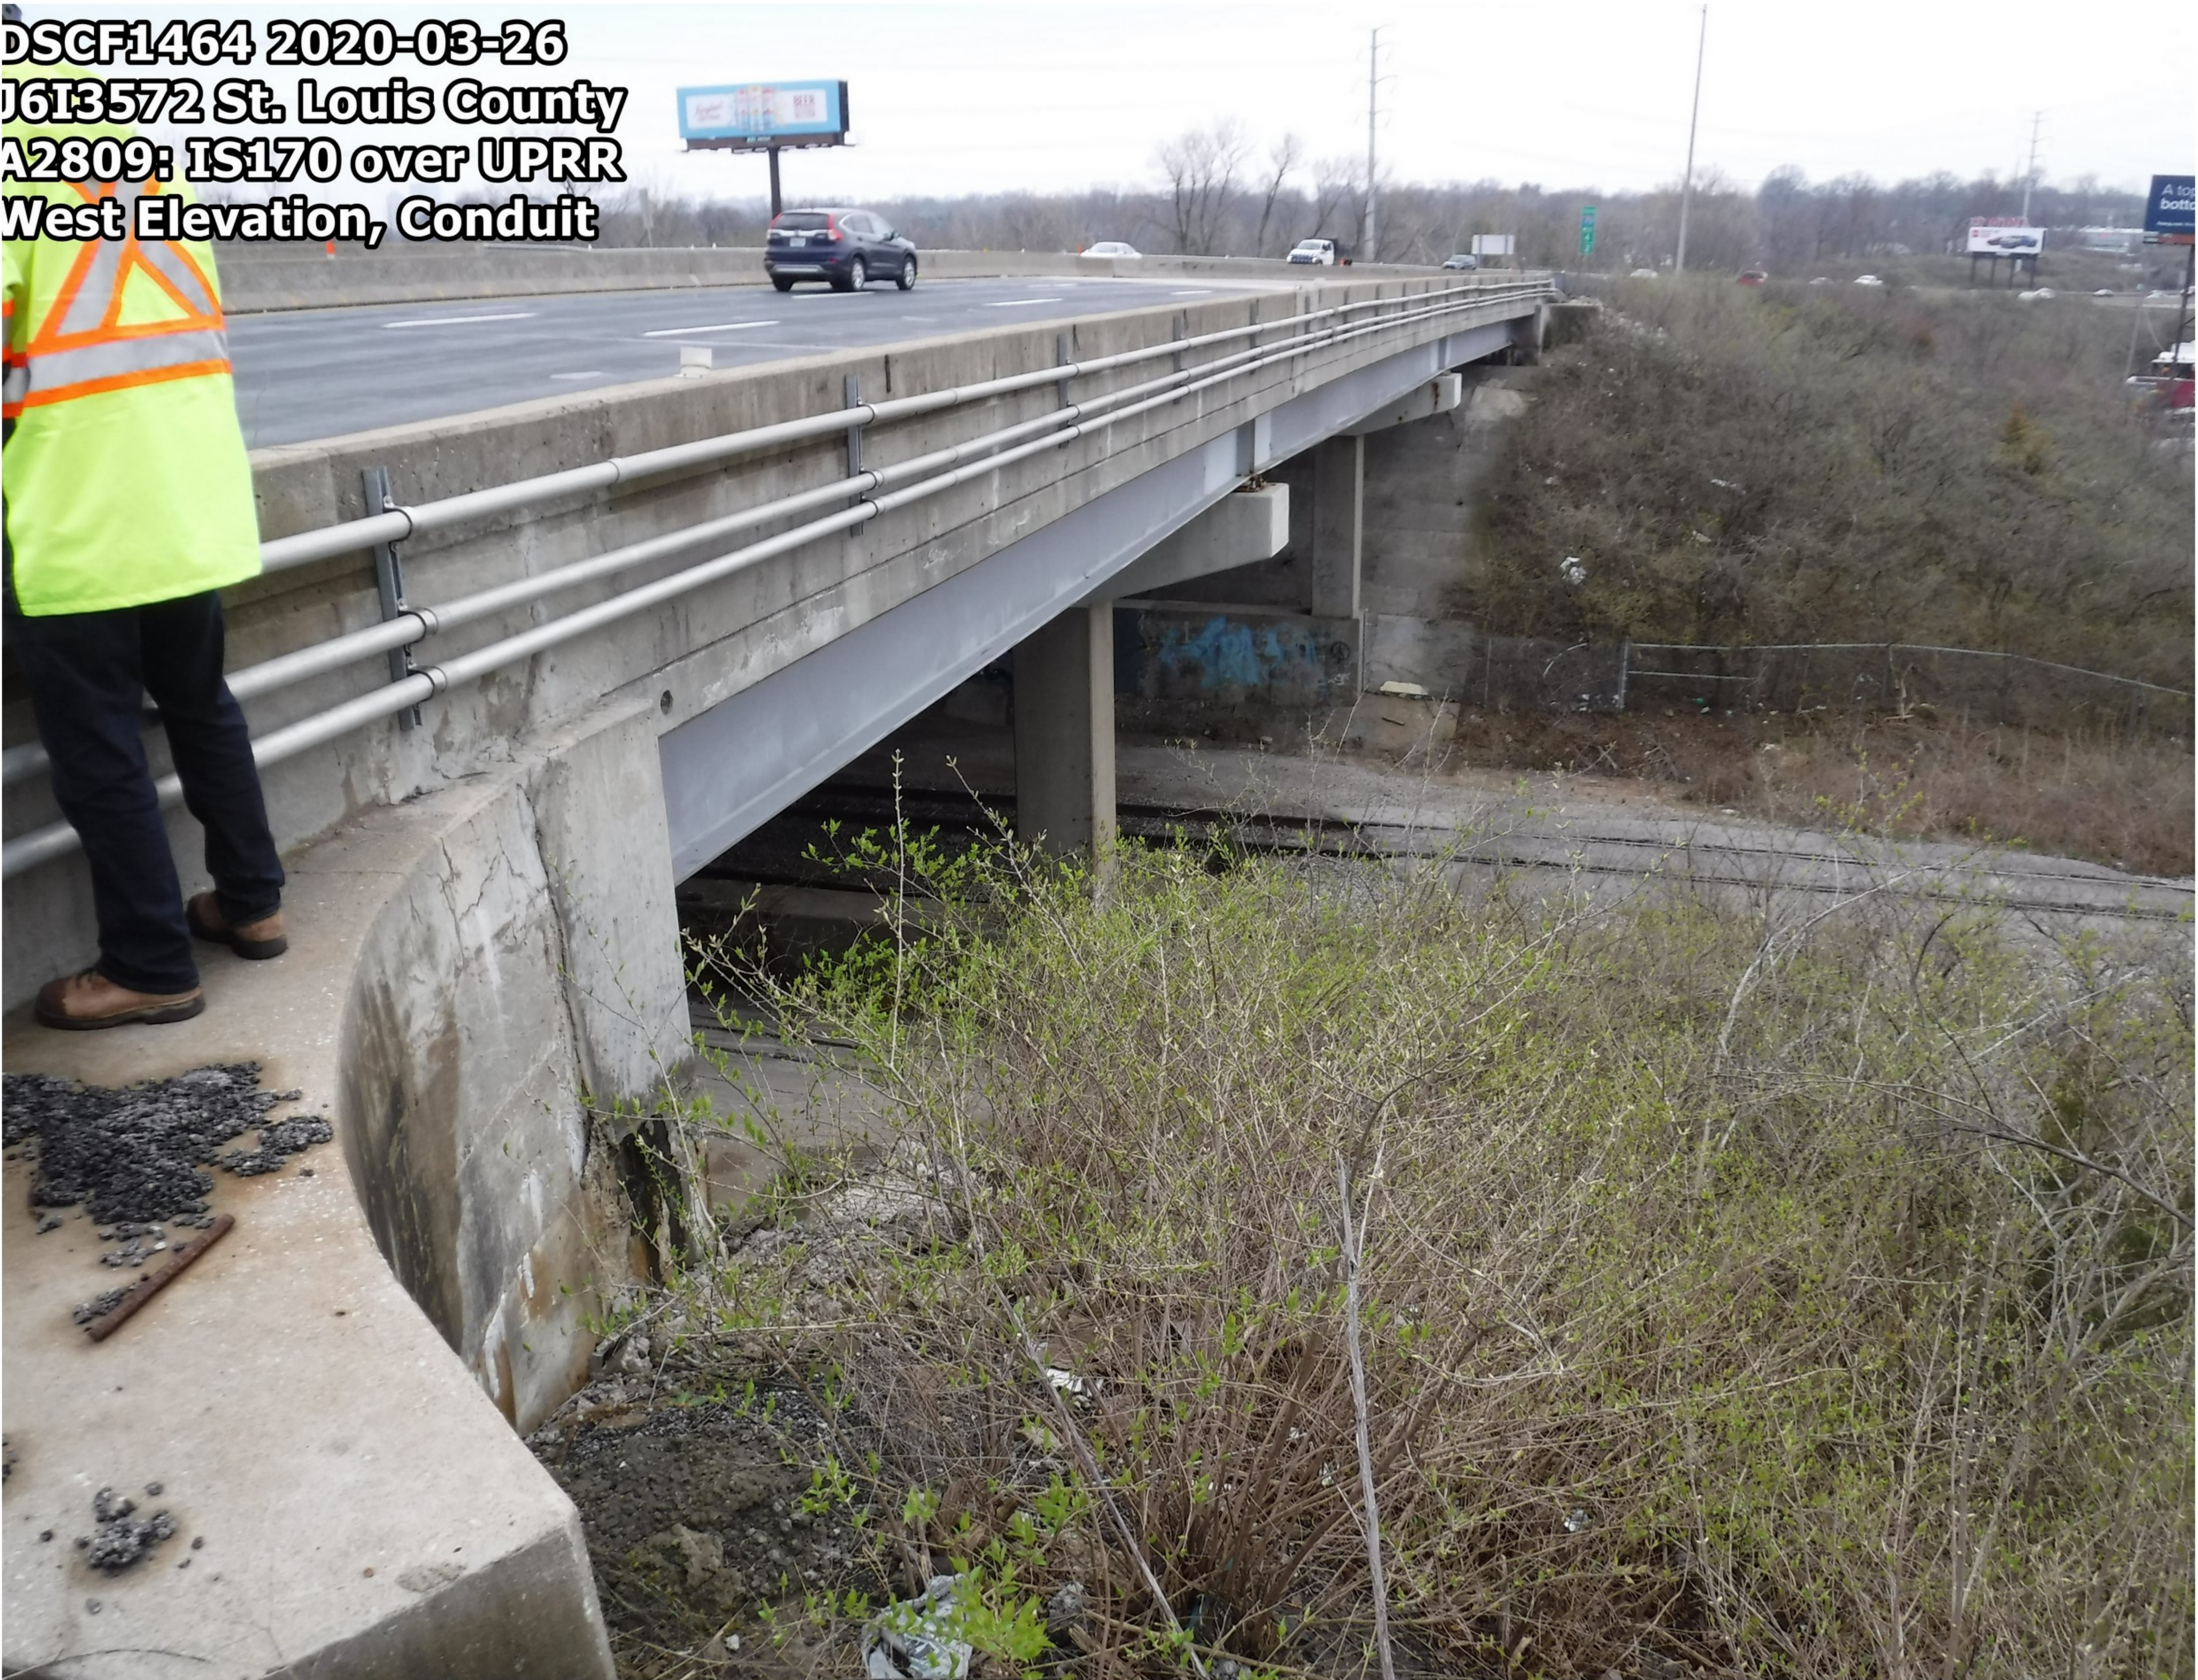
DSCF1465 2020-03-26
J6I3572 St. Louis County
A2809: IS170 over UPRR
Top of Deck, Southbound Looking South

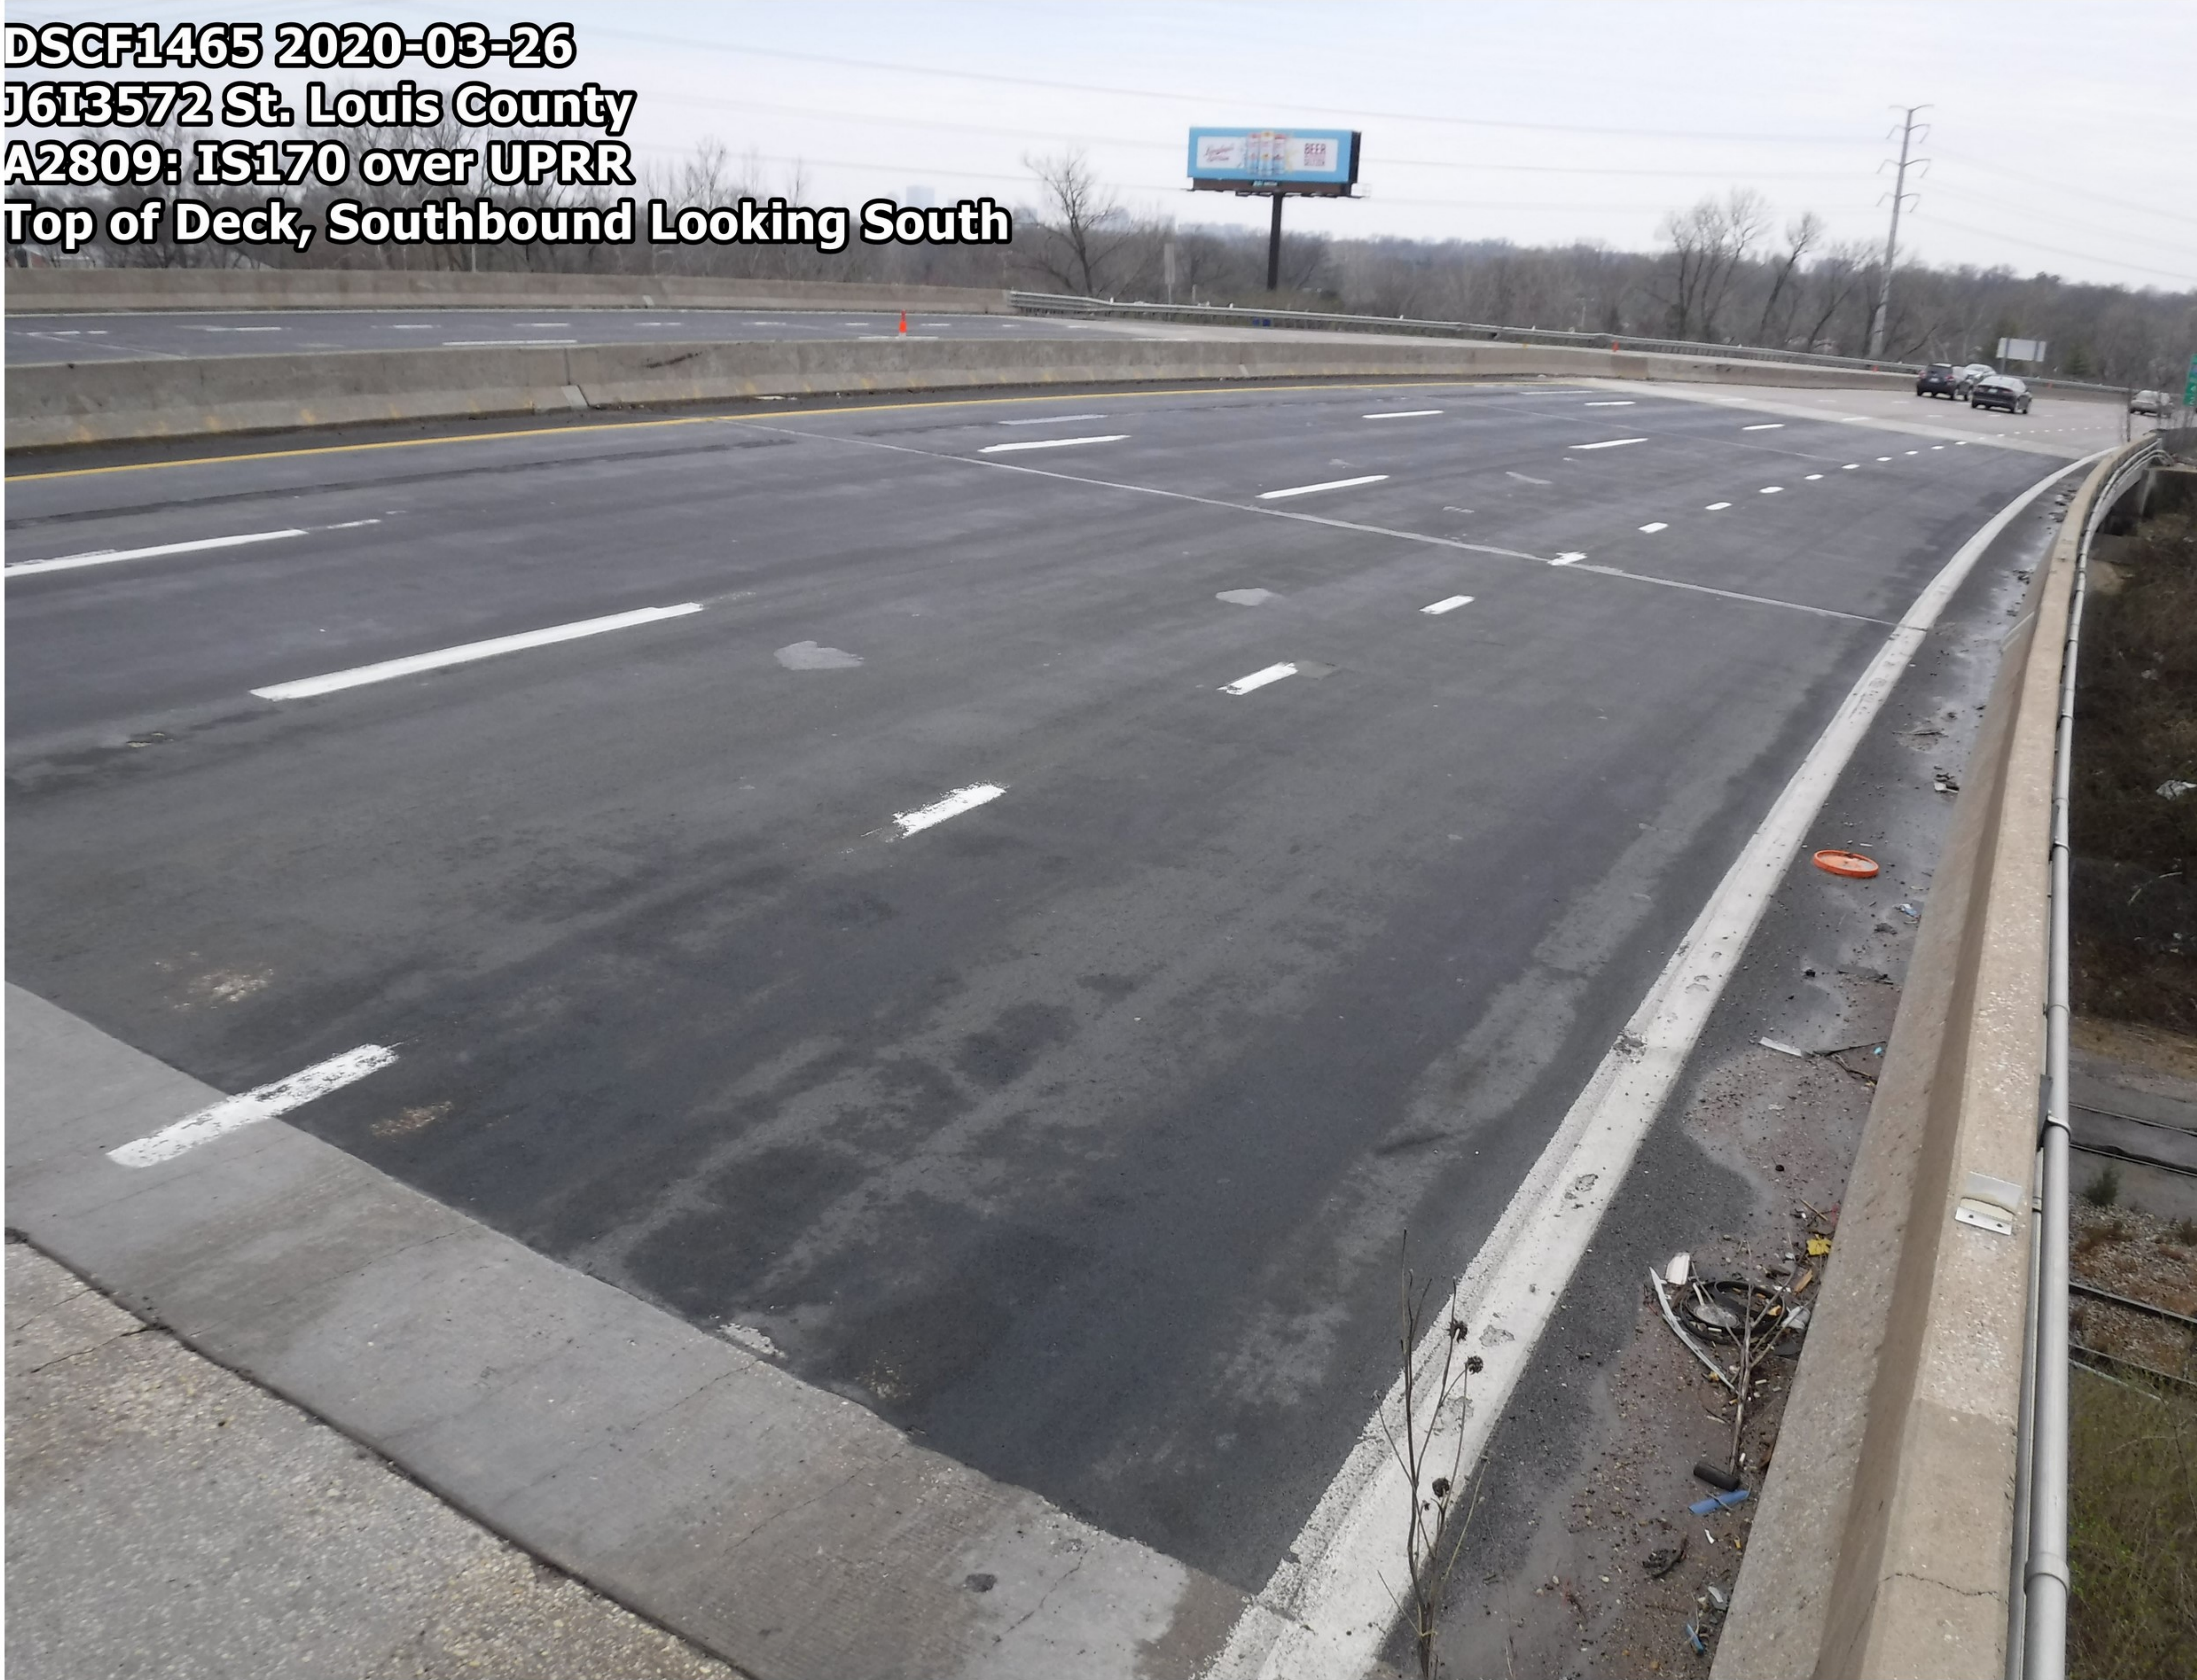
Bent	Formed Repair	Unformed Repair	Seal Concrete Beam Cap Bts.	Coat Exposed Pile @ Int. Pile Cap Bts.	Describe (Beam, Backwall, Wing, etc.)
<u>1</u>	_____ sq. ft.	<u>30</u> sq. ft.	<input type="checkbox"/> Yes <input checked="" type="checkbox"/> No	<input type="checkbox"/> Yes <input type="checkbox"/> No	<u>West Wing / Cap End</u>
<u>2</u>	_____ sq. ft.	<u>291</u> sq. ft.	<input checked="" type="checkbox"/> Yes <input type="checkbox"/> No	<input type="checkbox"/> Yes <input type="checkbox"/> No	<u>89SF at Cols, 202SF at Cap</u>
<u>3</u>	<u>24</u> sq. ft.	<u>154</u> sq. ft.	<input checked="" type="checkbox"/> Yes <input type="checkbox"/> No	<input type="checkbox"/> Yes <input type="checkbox"/> No	<u>46SF at Cols, 108SF UF at Cap, 24SF F at Cap</u>
<u>4</u>	_____ sq. ft.	<u>50</u> sq. ft.	<input type="checkbox"/> Yes <input checked="" type="checkbox"/> No	<input type="checkbox"/> Yes <input type="checkbox"/> No	<u>30Sf at Wings, 20SF at Cap End</u>

DSCF1466 2020-03-26
J6I3572 St. Louis County
A2809: IS170 over UPRR
Northwest Wing

* Notes: **End Cap Cantilever. REQUIRE shotcrete method for unformed repairs****Picture #** 1466, 1467, 1473-1480, 1482-1488, 1490-1497
