Missouri Department of Transportation

STRUCTURAL REHABILITATION CHECKLIST

Bridge No.: A2809 **Job No.:** J613572

Route: IS 170 **Over:** UP RR

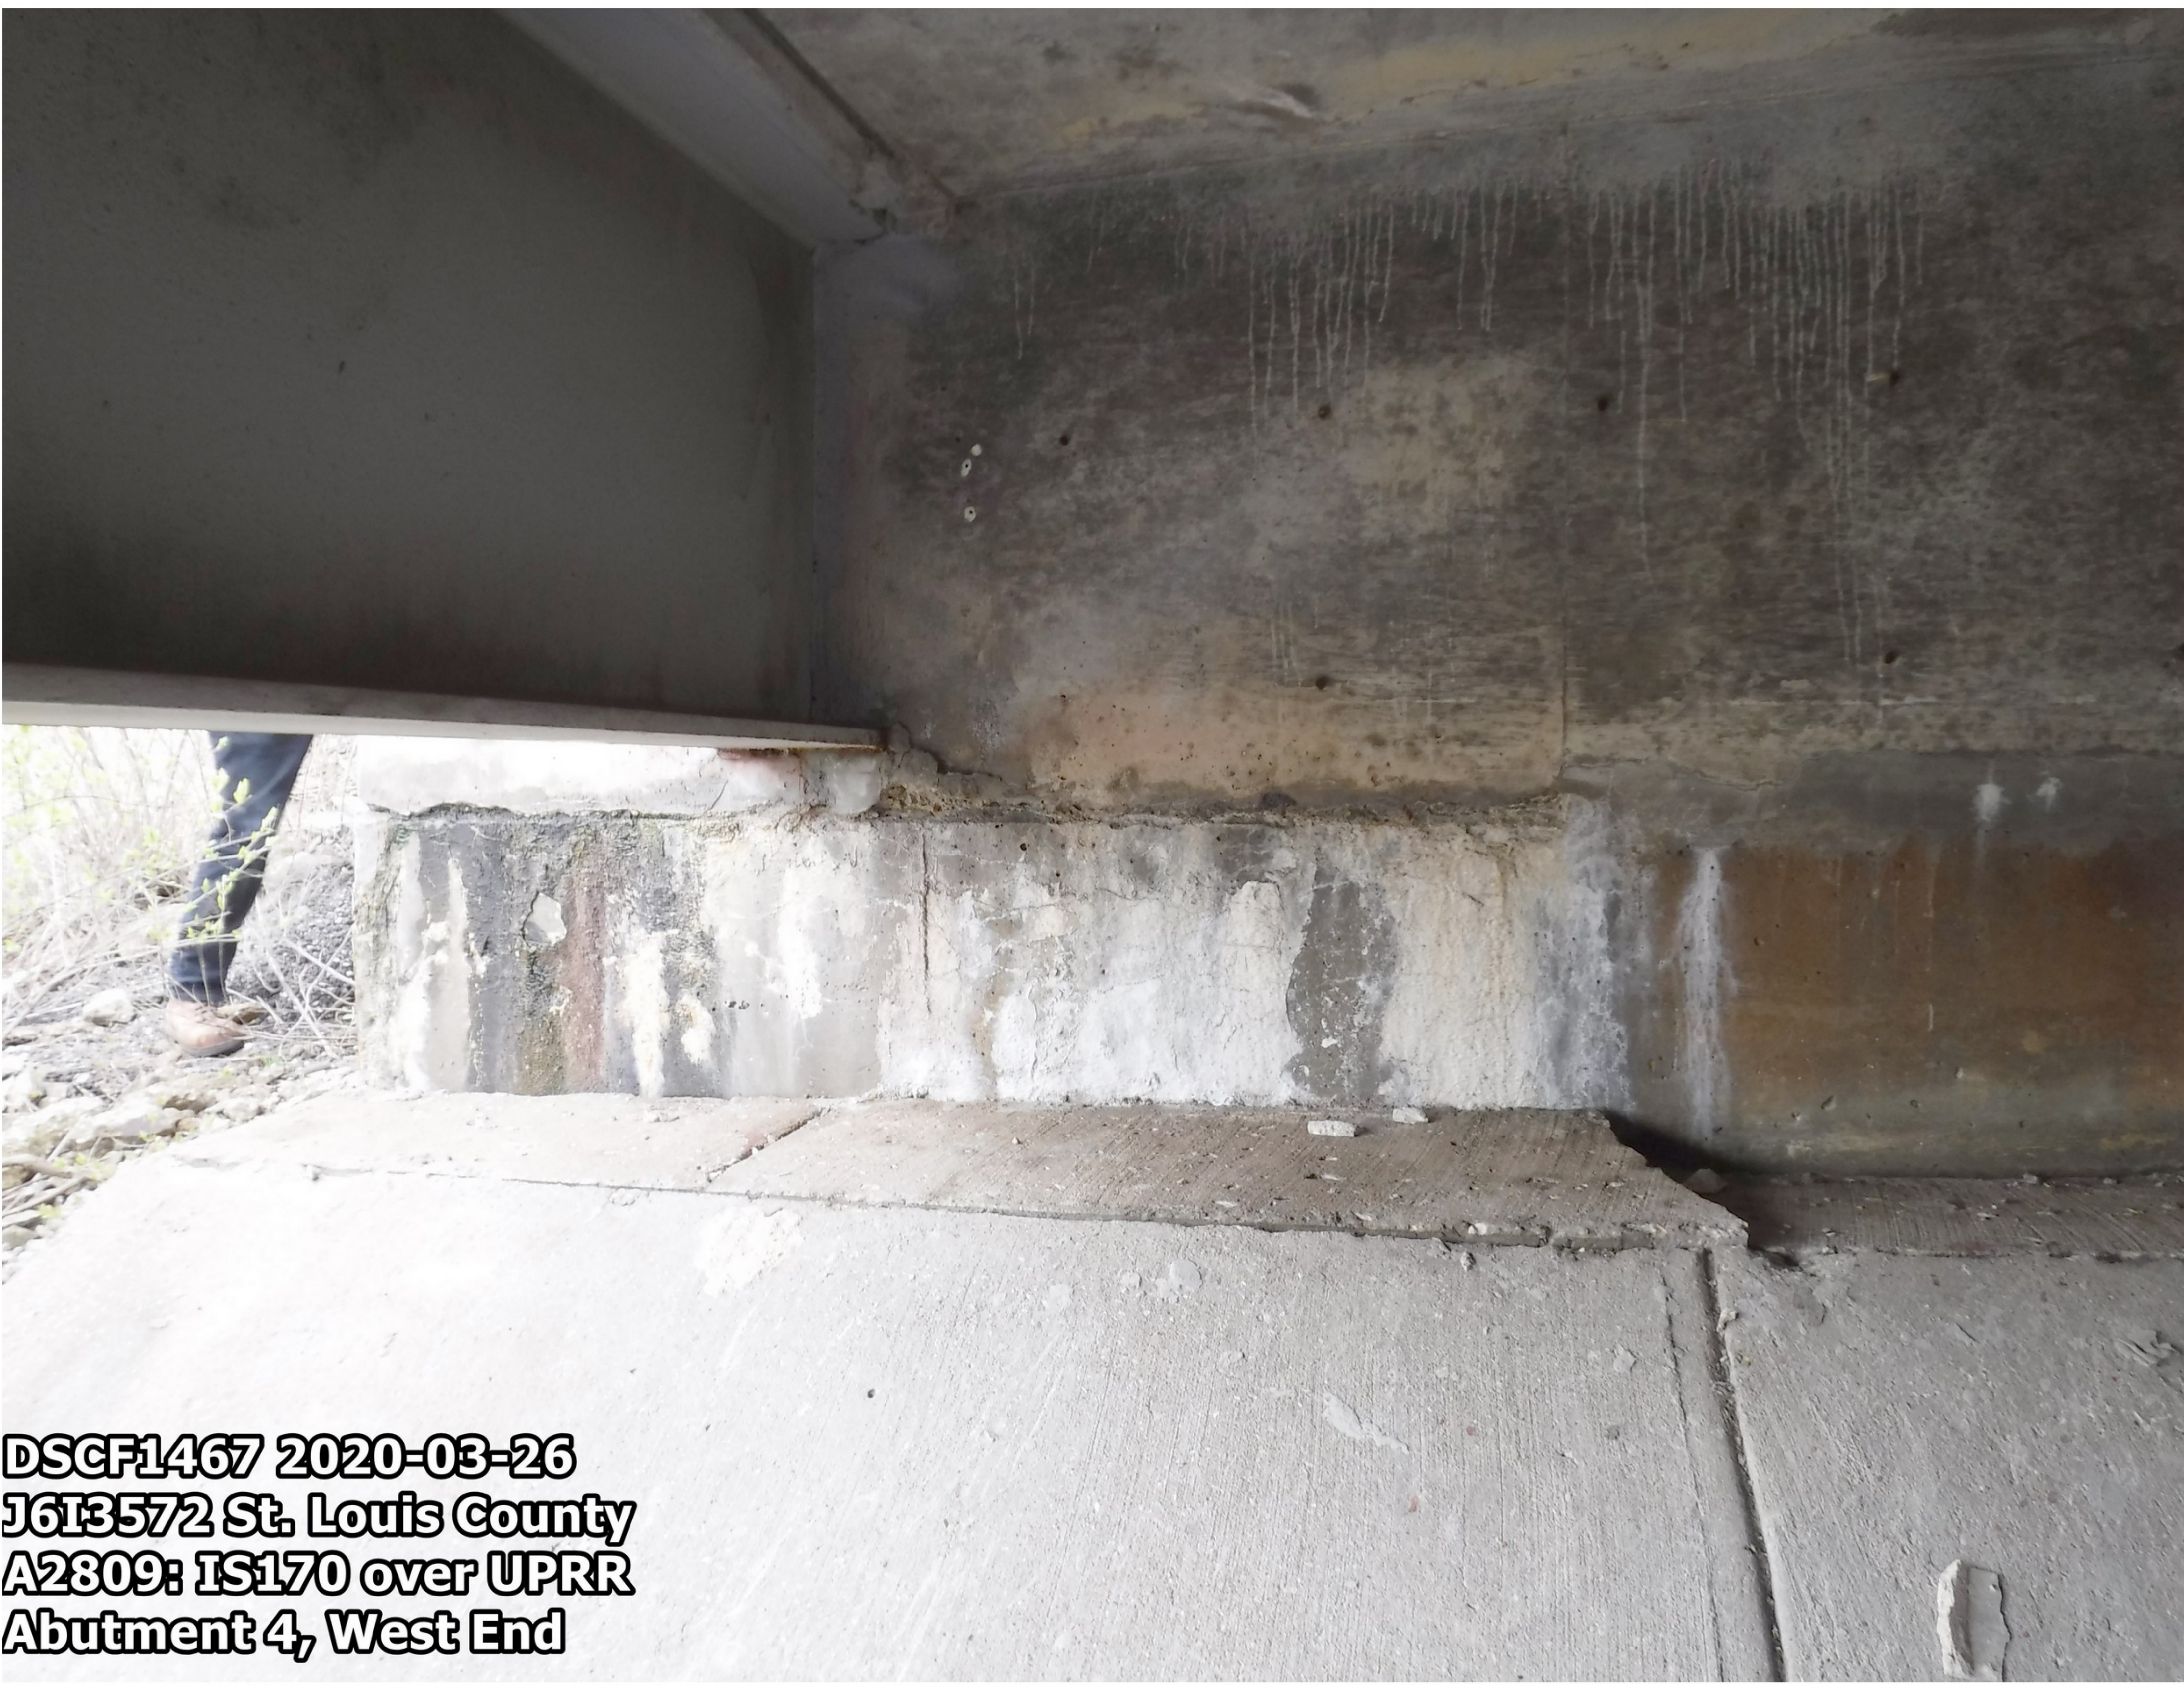
Bent	Formed Repair	Unformed Repair	Seal Concrete Beam Cap Bts.	Coat Exposed Pile @ Int. Pile Cap Bts.	Describe (Beam, Backwall, Wing, etc.)
<u>1</u>	_____ sq. ft.	<u>30</u> sq. ft.	<input type="checkbox"/> Yes <input checked="" type="checkbox"/> No	<input type="checkbox"/> Yes <input type="checkbox"/> No	<u>West Wing / Cap End</u>
<u>2</u>	_____ sq. ft.	<u>291</u> sq. ft.	<input checked="" type="checkbox"/> Yes <input type="checkbox"/> No	<input type="checkbox"/> Yes <input type="checkbox"/> No	<u>89SF at Cols, 202SF at Cap</u>
<u>3</u>	<u>24</u> sq. ft.	<u>154</u> sq. ft.	<input checked="" type="checkbox"/> Yes <input type="checkbox"/> No	<input type="checkbox"/> Yes <input type="checkbox"/> No	<u>46SF at Cols, 108SF UF at Cap, 24SF F at Cap</u>
<u>4</u>	_____ sq. ft.	<u>50</u> sq. ft.	<input type="checkbox"/> Yes <input checked="" type="checkbox"/> No	<input type="checkbox"/> Yes <input type="checkbox"/> No	<u>30Sf at Wings, 20SF at Cap End</u>

DSCF1467 2020-03-26
J6I3572 St. Louis County
A2809: IS170 over UPRR
Abutment 4, West End

* Notes: **End Cap Cantilever. REQUIRE shotcrete method for unformed repairs****Picture #** 1466, 1467, 1473-1480, 1482-1488, 1490-1497

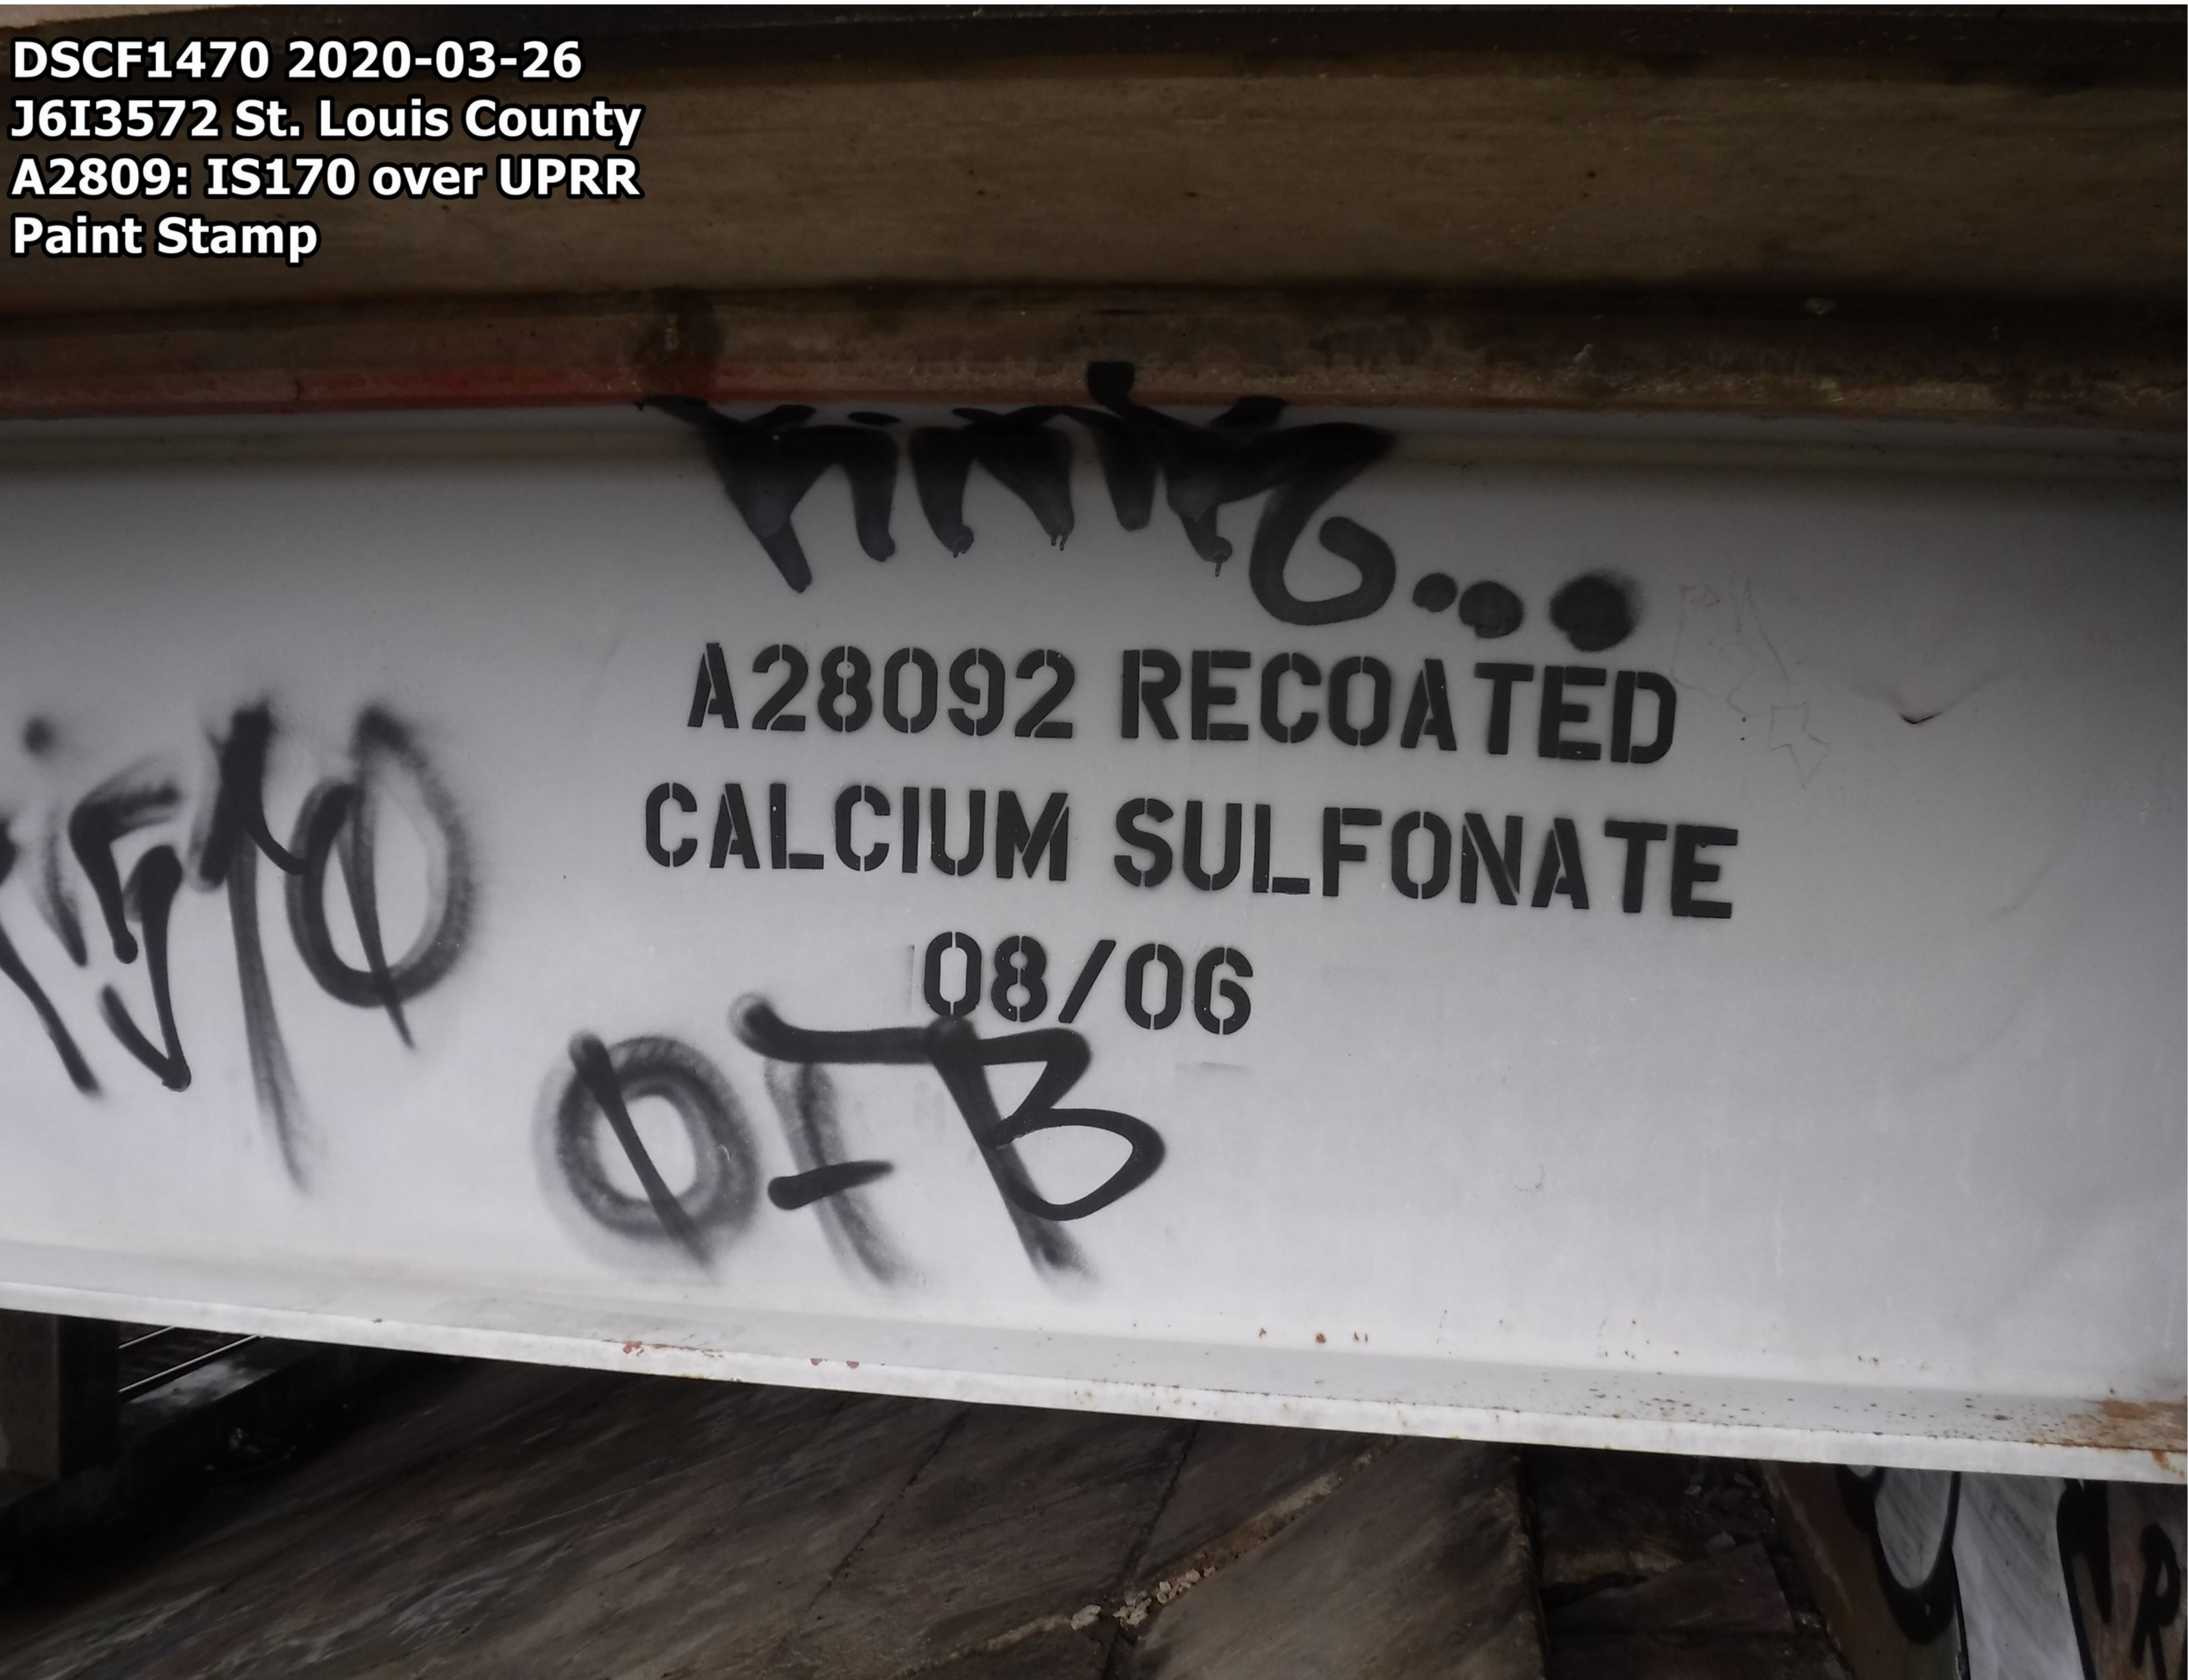
* Existing coating system: System S over System B ☐ green ☒ gray ☐ other _____

* Date last coated: 2006 * Is existing coating peeling? ☒ Yes (Overcoat is not an option) ☐ No

* Notes: Existing System B Paint contains Lead. See LBP Inspection Memo for more details.

DSCF1470 2020-03-26
J6I3572 St. Louis County
A2809: IS170 over UPRR
Paint Stamp

* Coating recommendation: ☒ Blast clean & recoat all steel ☐ Clean & overcoat all steel
☐ Blast clean & recoat only at joint locations ☐ Blast & recoat at joint locations and clean & overcoat all other steel

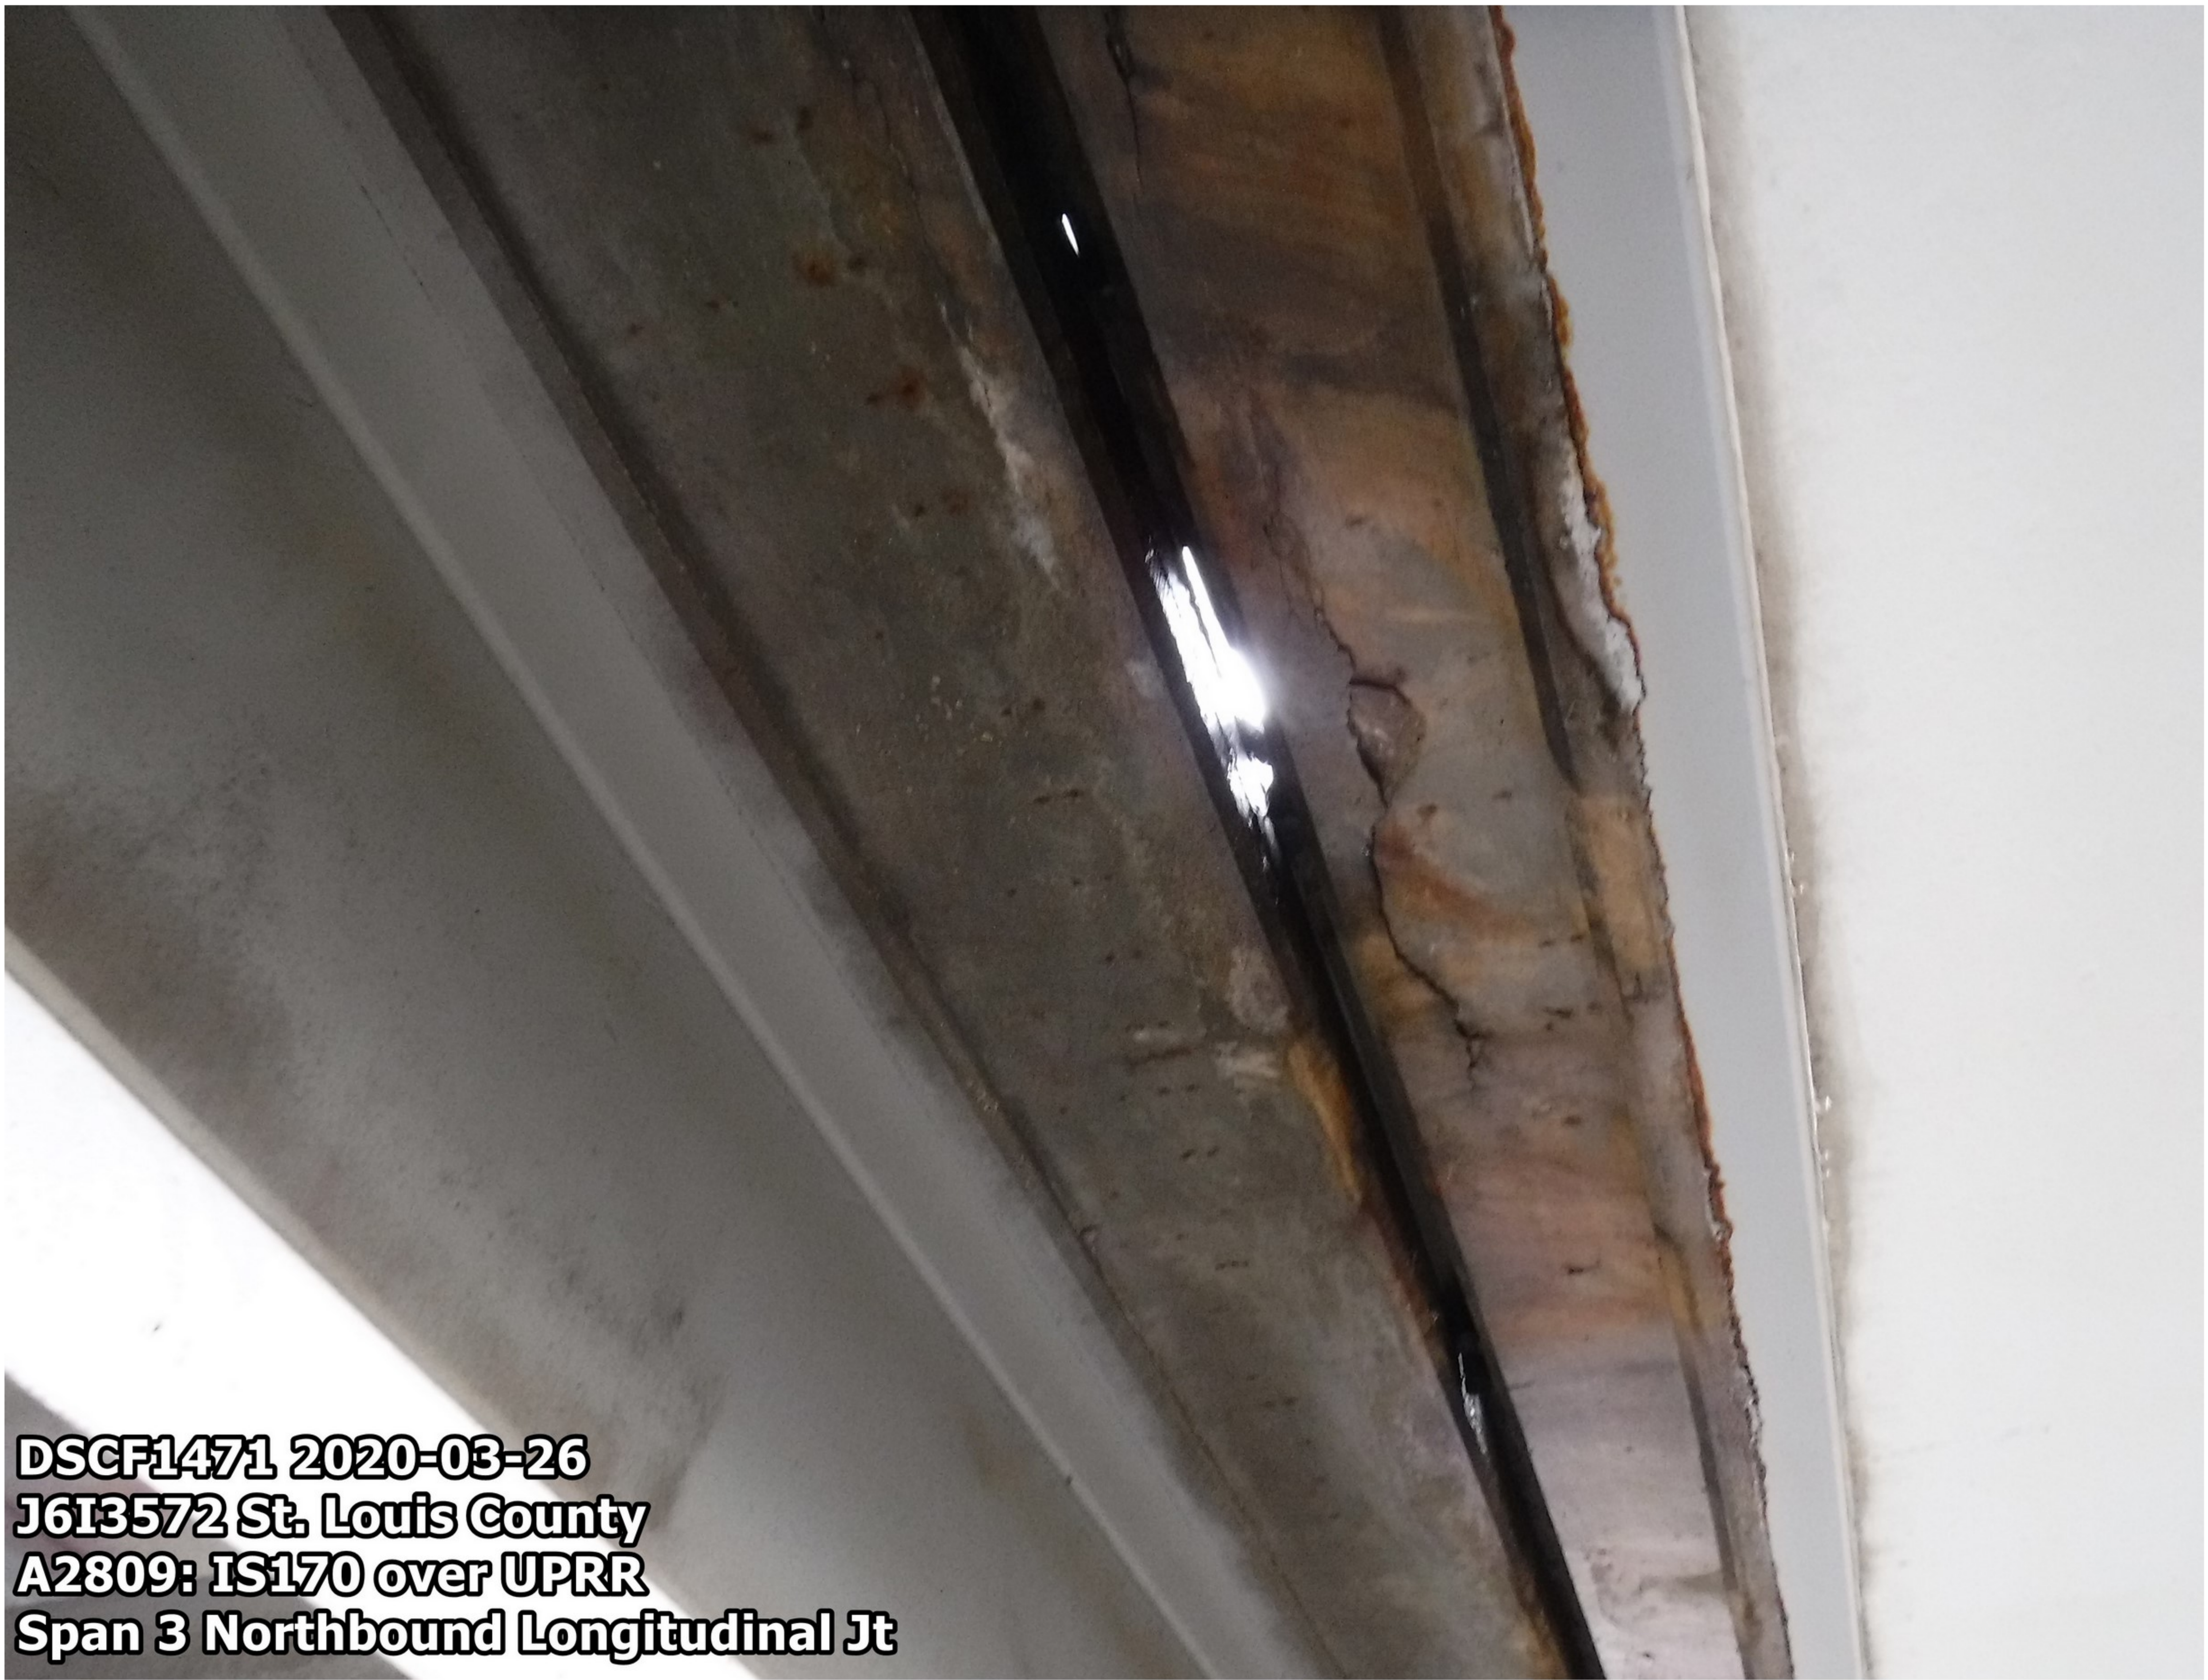
- * How were the quantities obtained? ☒ Visual ☐ Bridge Inspection Report ☐ Sounded ☐ Other _____
- * Notes: Make Deck Integral along full width by eliminating Longitudinal Joints. Estimating 10% Monolithic Repairs.

Full depth repair quantity includes L-joint removal. Consider consultant contract for GPR/IR deck sounding for refined quantities

DSCF1471 2020-03-26
J6I3572 St. Louis County
A2809: IS170 over UPRR
Span 3 Northbound Longitudinal Jt

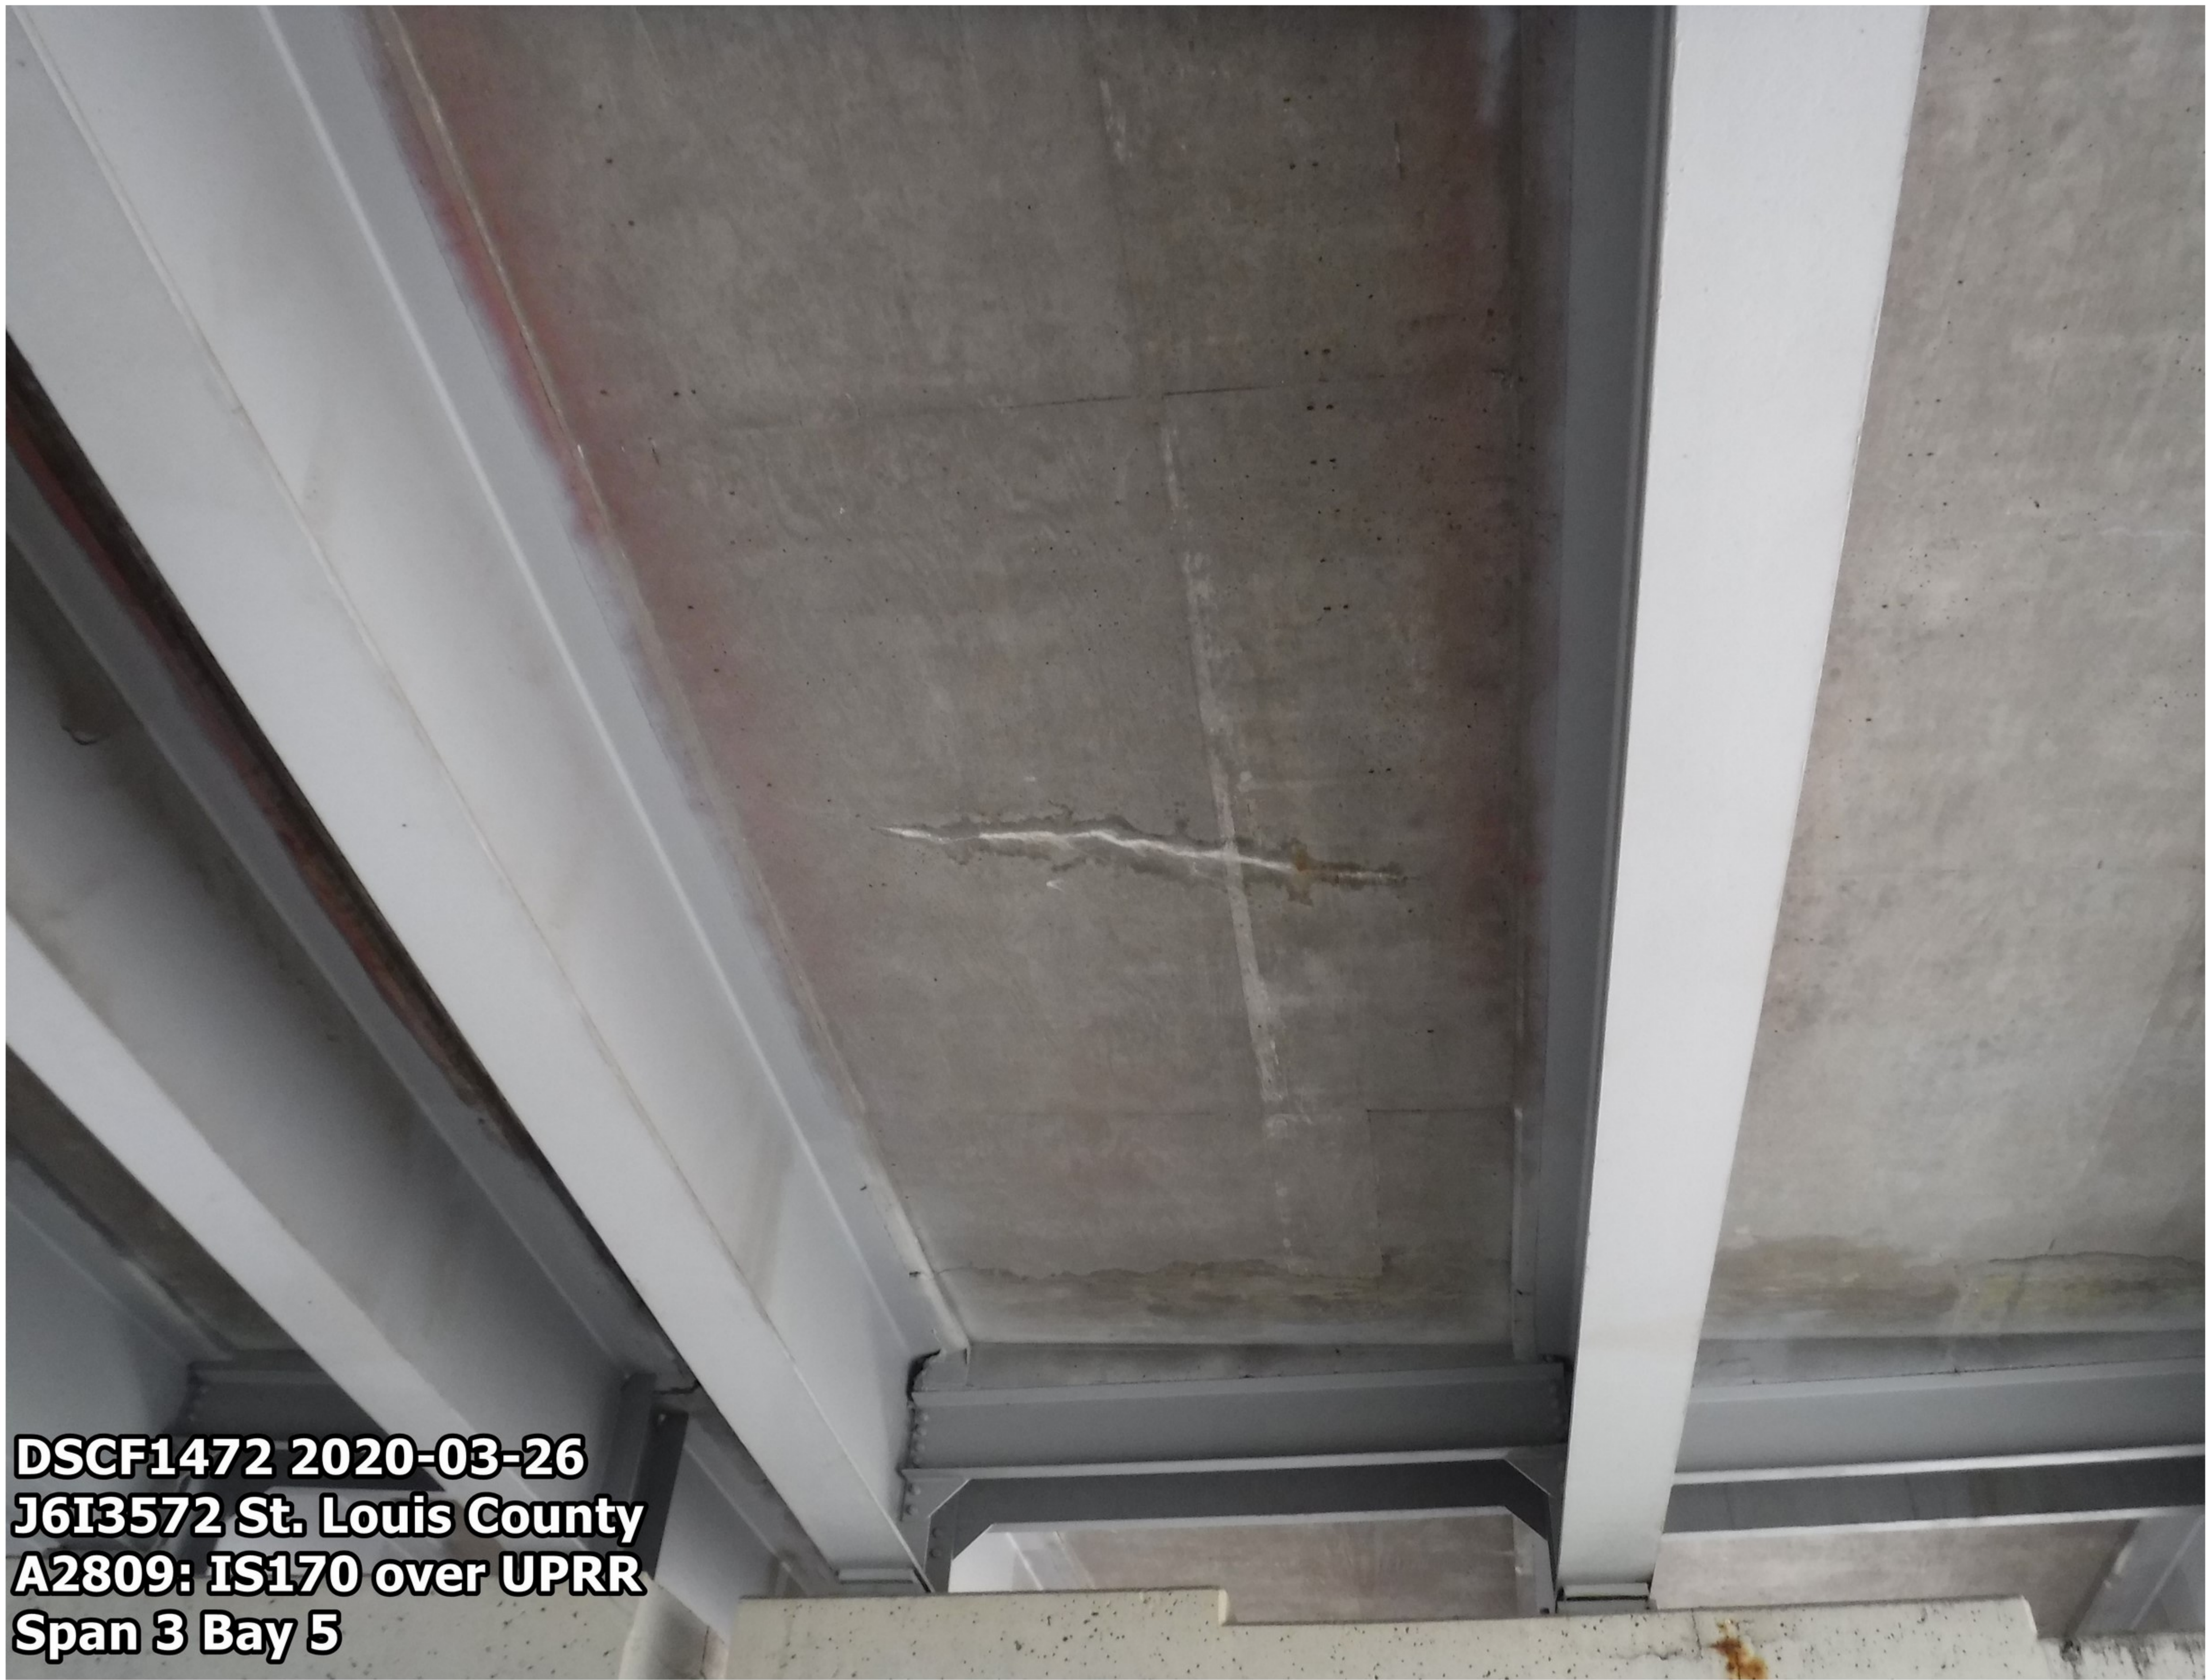
DSCF1472 2020-03-26
J6I3572 St. Louis County
A2809: IS170 over UPRR
Span 3 Bay 5

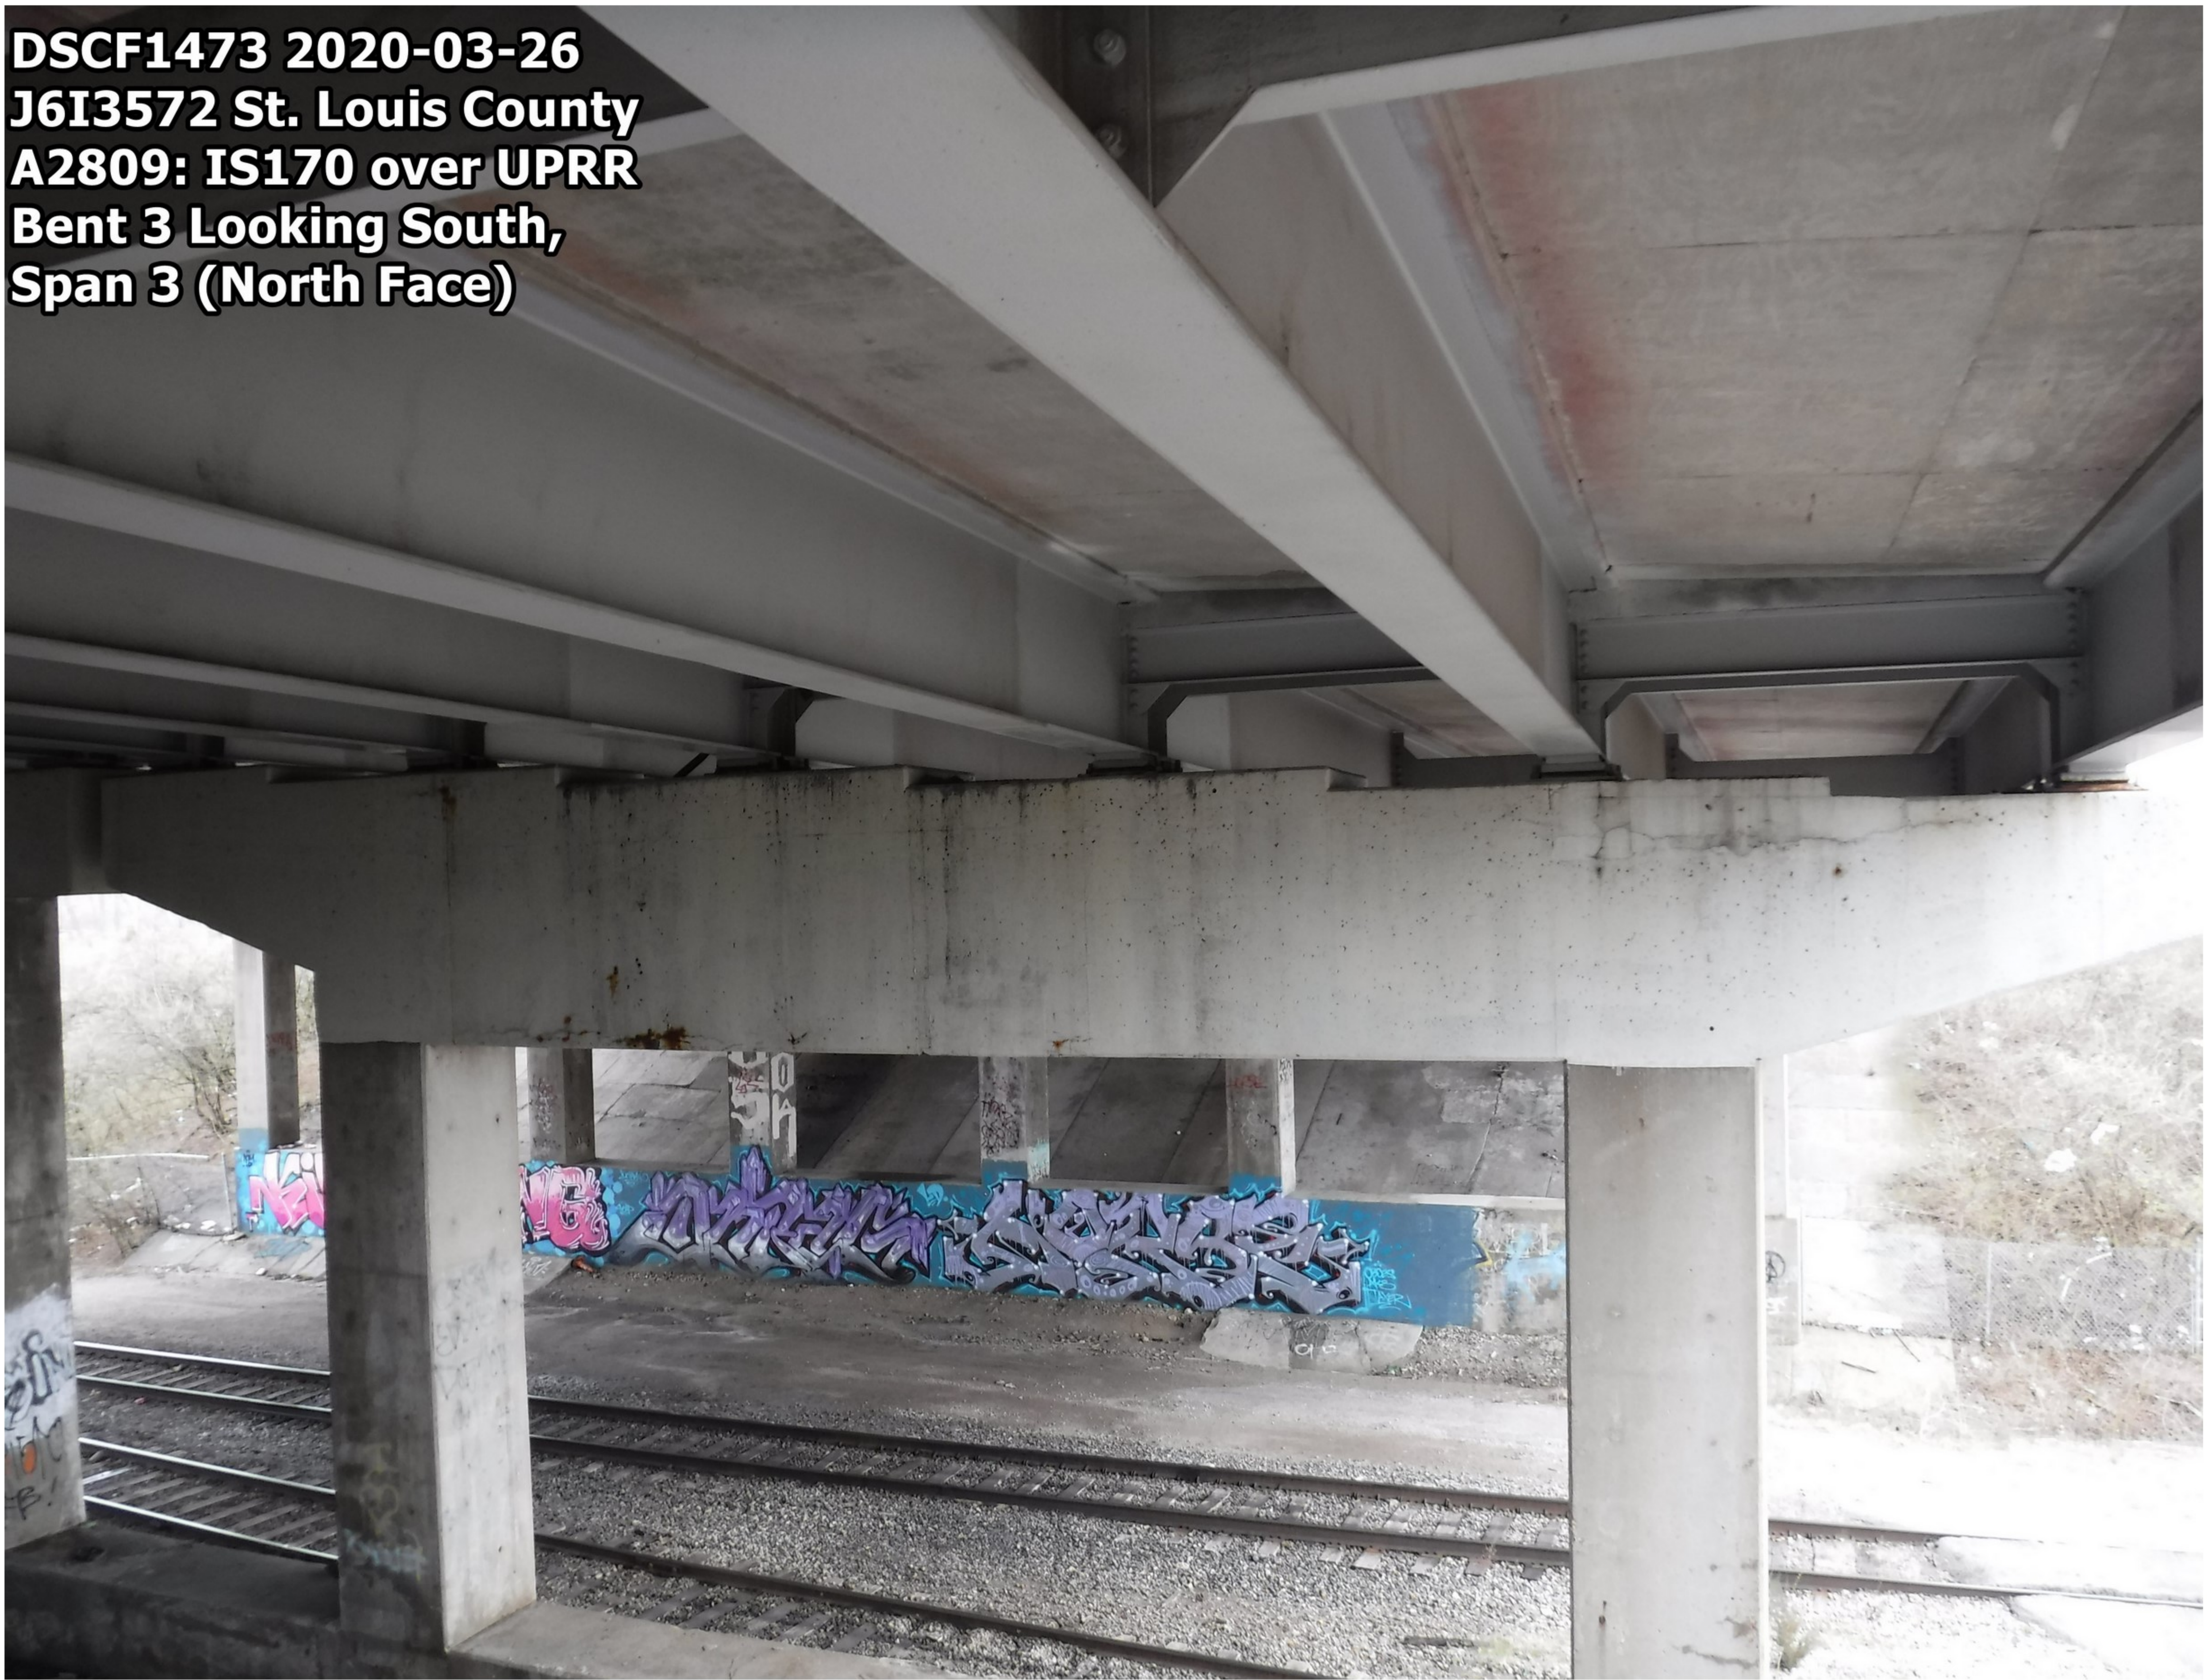
DSCF1473 2020-03-26
J6I3572 St. Louis County
A2809: IS170 over UPRR
Bent 3 Looking South,
Span 3 (North Face)

Seal Exterior Ends of Caps and Under Median after Repairs, 15LF each Intermediate Bent. May need to Fiber Wrap Bent 2 West
