Missouri Department of Transportation

STRUCTURAL REHABILITATION CHECKLIST

Bridge No.: A2809 **Job No.:** J613572

Route: IS 170 **Over:** UP RR

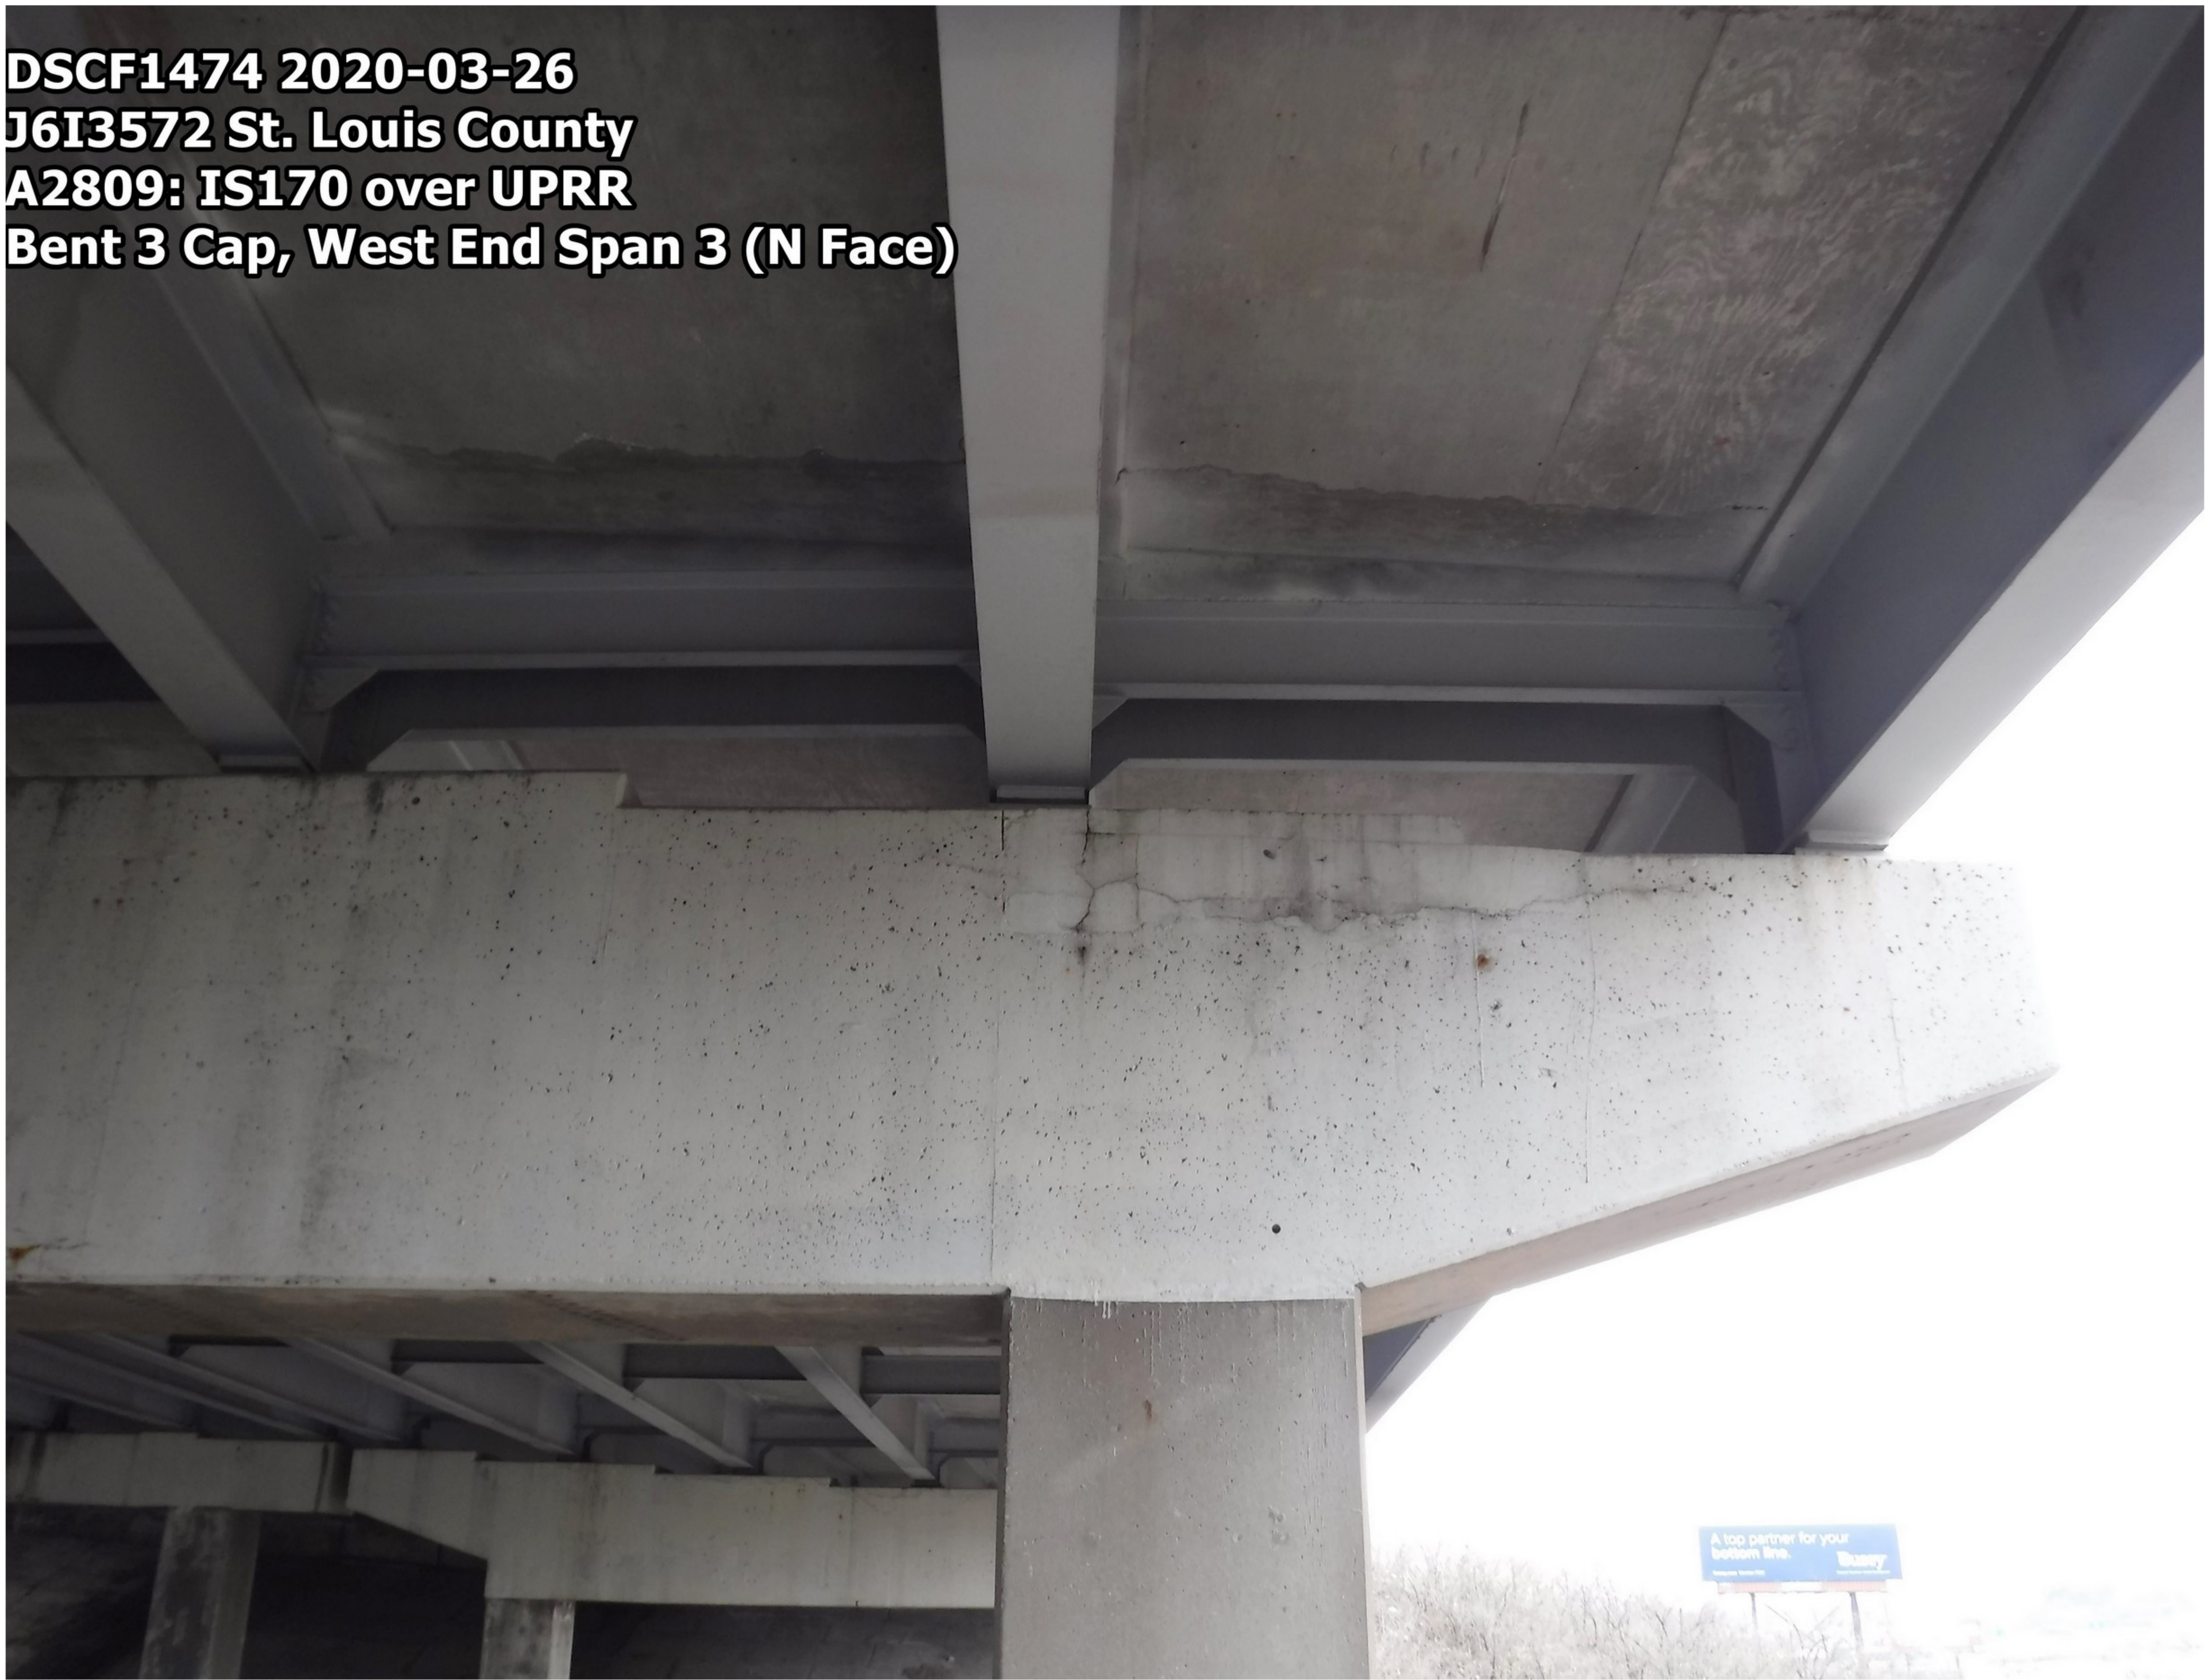
Bent	Formed Repair	Unformed Repair	Seal Concrete Beam Cap Bts.	Coat Exposed Pile @ Int. Pile Cap Bts.	Describe (Beam, Backwall, Wing, etc.)
<u>1</u>	_____ sq. ft.	<u>30</u> sq. ft.	<input type="checkbox"/> Yes <input checked="" type="checkbox"/> No	<input type="checkbox"/> Yes <input type="checkbox"/> No	<u>West Wing / Cap End</u>
<u>2</u>	_____ sq. ft.	<u>291</u> sq. ft.	<input checked="" type="checkbox"/> Yes <input type="checkbox"/> No	<input type="checkbox"/> Yes <input type="checkbox"/> No	<u>89SF at Cols, 202SF at Cap</u>
<u>3</u>	<u>24</u> sq. ft.	<u>154</u> sq. ft.	<input checked="" type="checkbox"/> Yes <input type="checkbox"/> No	<input type="checkbox"/> Yes <input type="checkbox"/> No	<u>46SF at Cols, 108SF UF at Cap, 24SF F at Cap</u>
<u>4</u>	_____ sq. ft.	<u>50</u> sq. ft.	<input type="checkbox"/> Yes <input checked="" type="checkbox"/> No	<input type="checkbox"/> Yes <input type="checkbox"/> No	<u>30Sf at Wings, 20SF at Cap End</u>

DSCF1474 2020-03-26
J6I3572 St. Louis County
A2809: IS170 over UPRR
Bent 3 Cap, West End Span 3 (N Face)

Seal Exterior Ends of Caps and Under Median after Repairs, 15LF each Intermediate Bent. May need to Fiber Wrap Bent 2 West

* Notes: **End Cap Cantilever. REQUIRE shotcrete method for unformed repairs****Picture #** 1466, 1467, 1473-1480, 1482-1488, 1490-1497

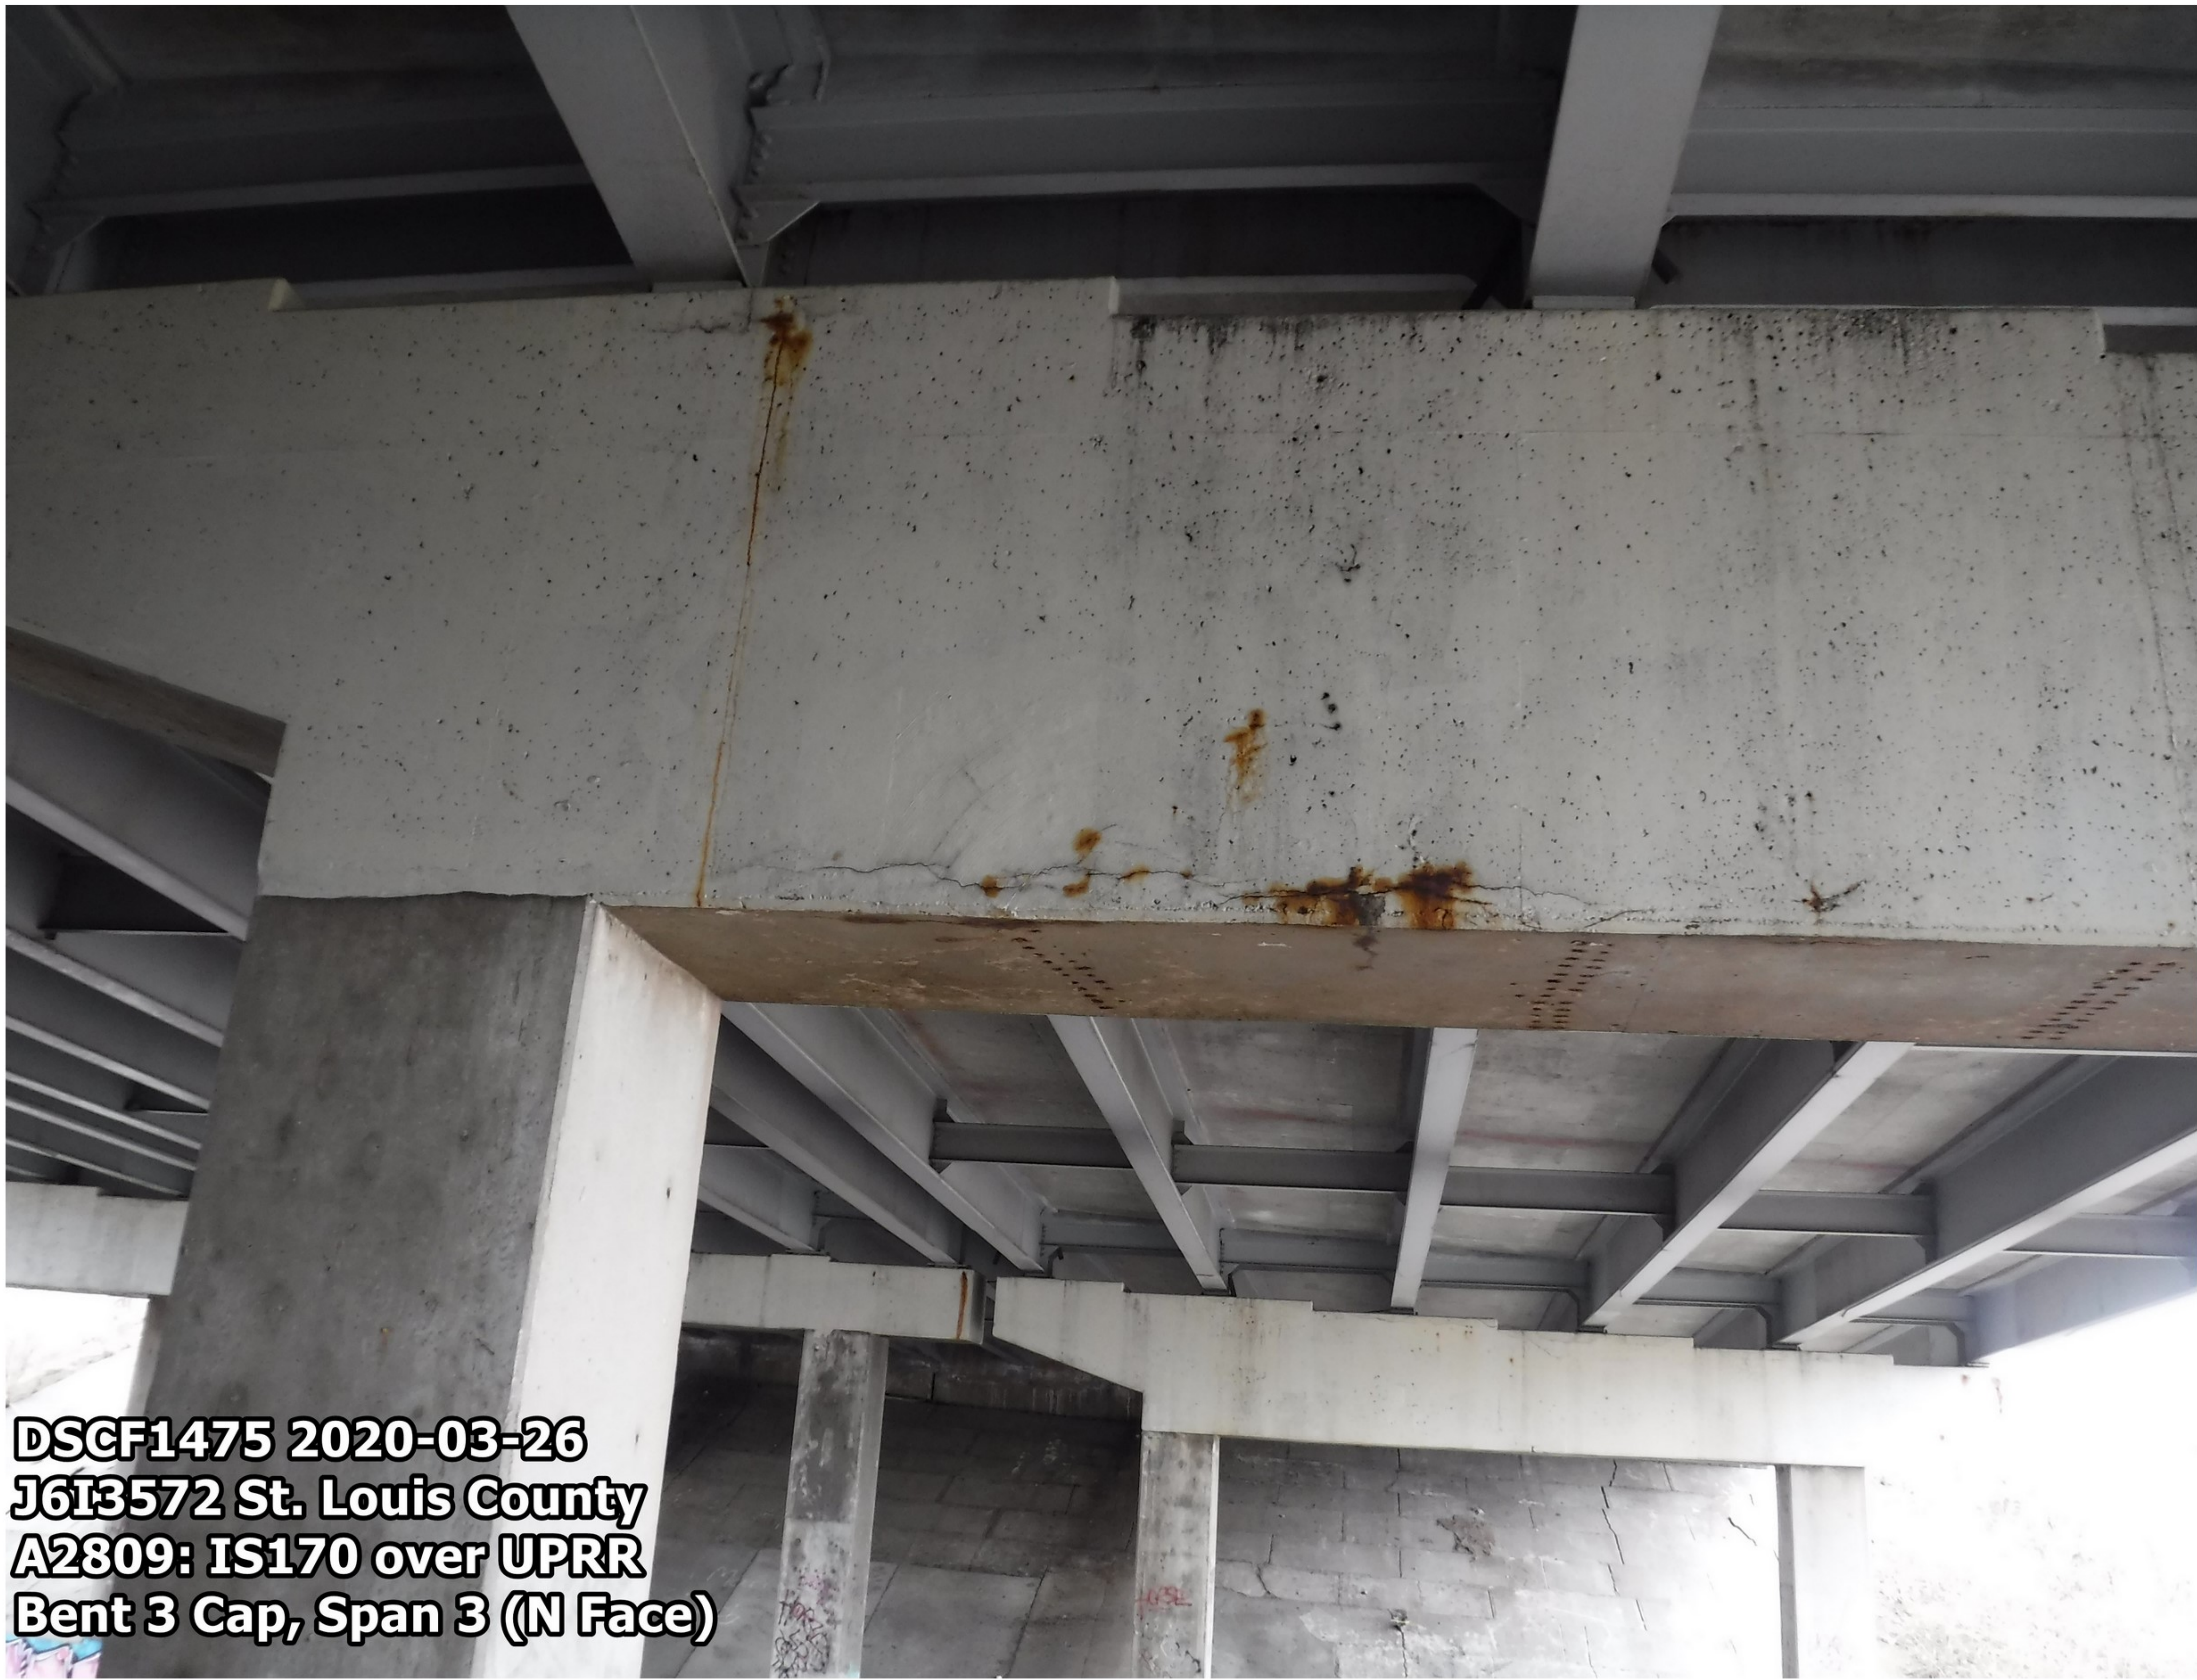
DSCF1475 2020-03-26
J6I3572 St. Louis County
A2809: IS170 over UPRR
Bent 3 Cap, Span 3 (N Face)

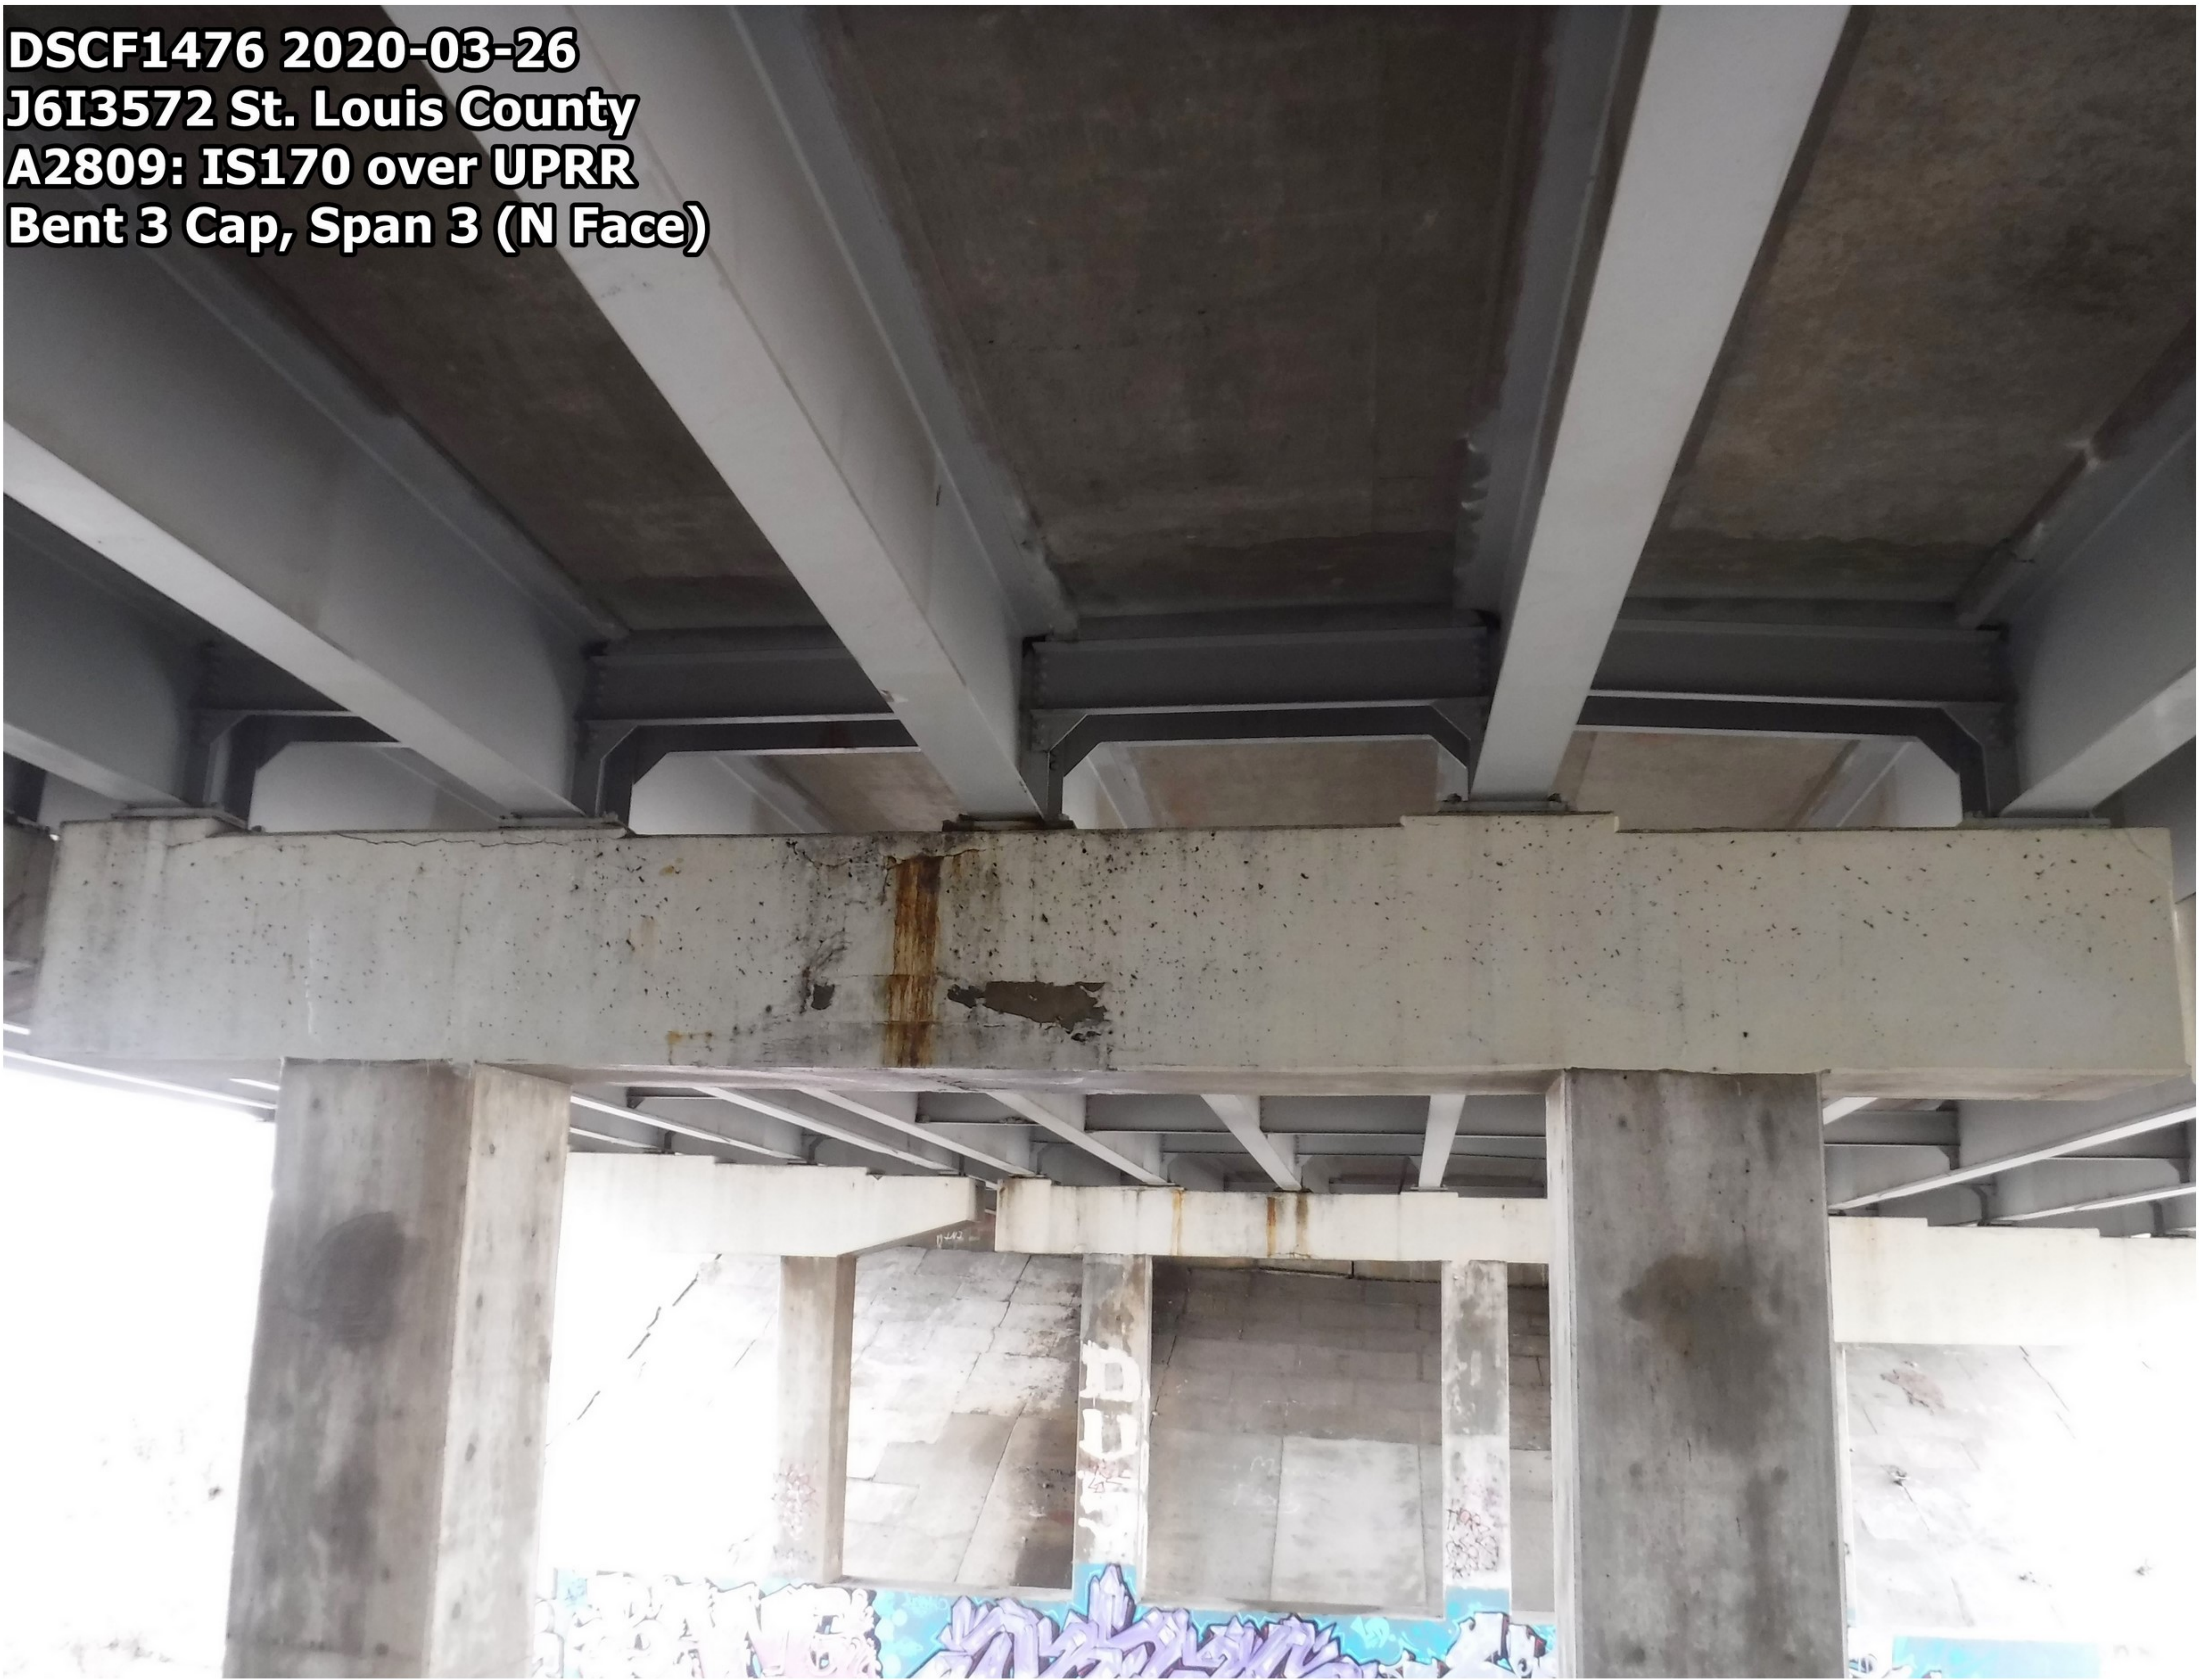
DSCF1476 2020-03-26
J6I3572 St. Louis County
A2809: IS170 over UPRR
Bent 3 Cap, Span 3 (N Face)

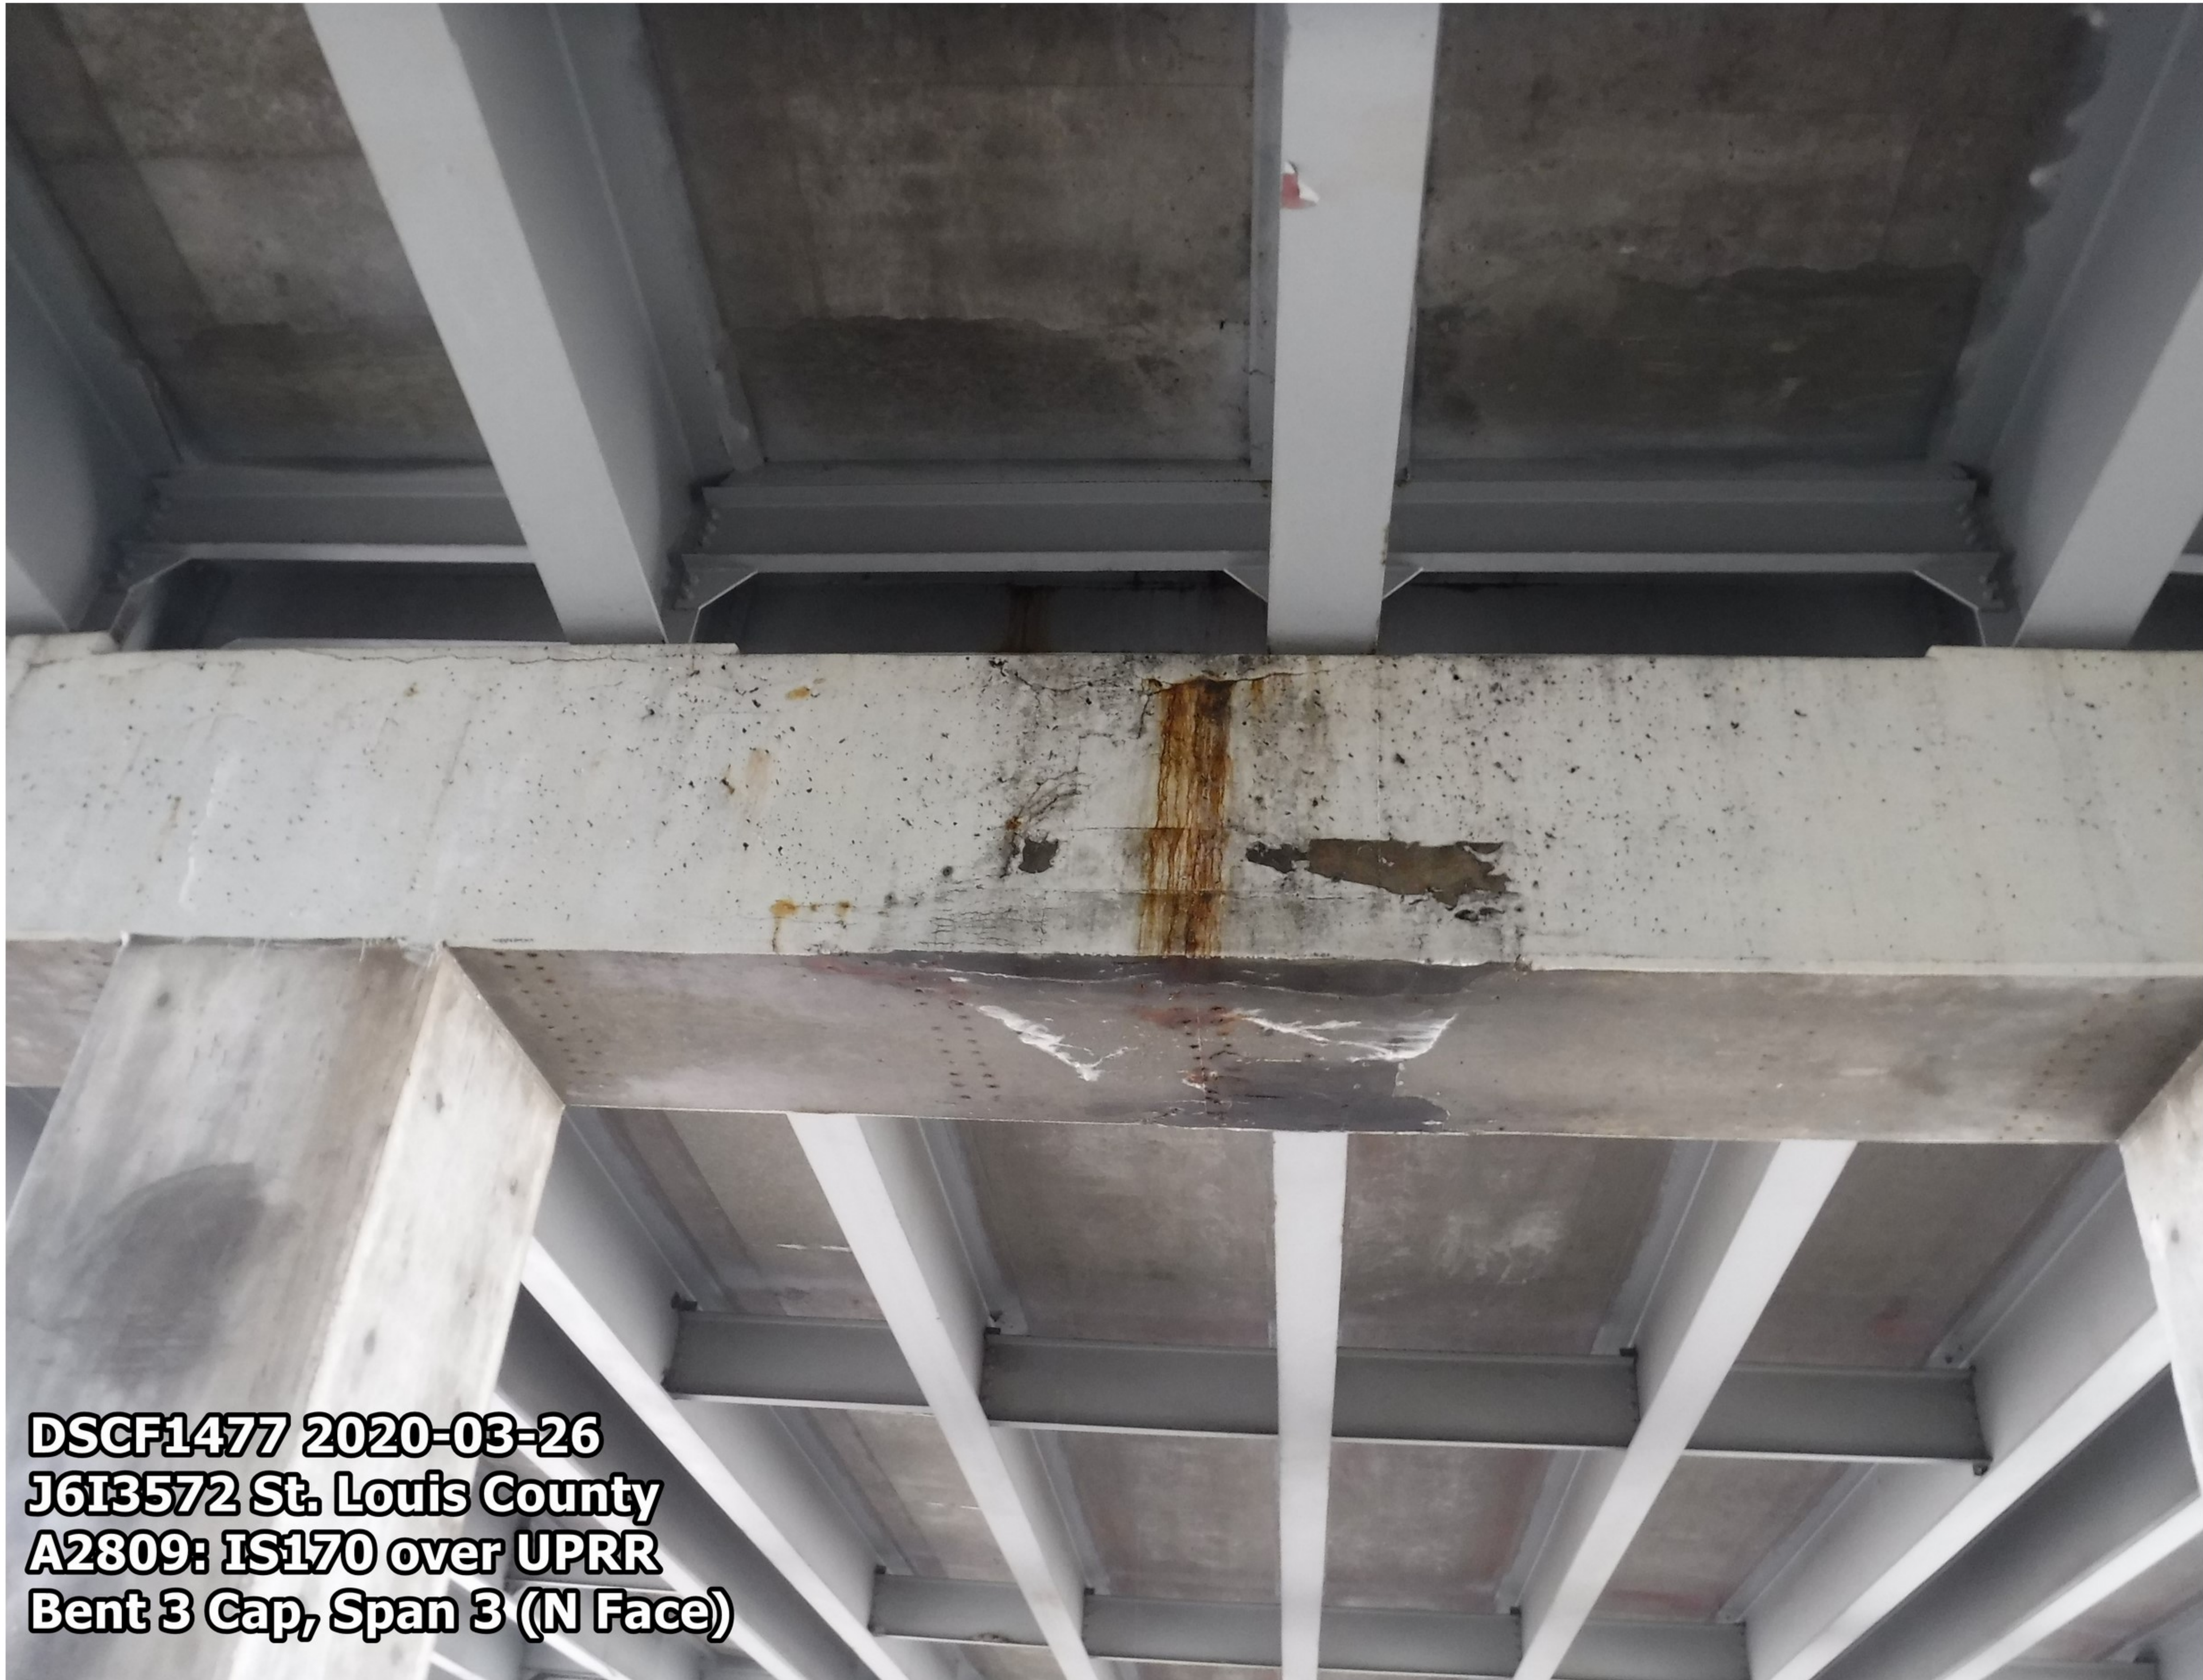
DSCF1477 2020-03-26
J6I3572 St. Louis County
A2809: IS170 over UPRR
Bent 3 Cap, Span 3 (N Face)

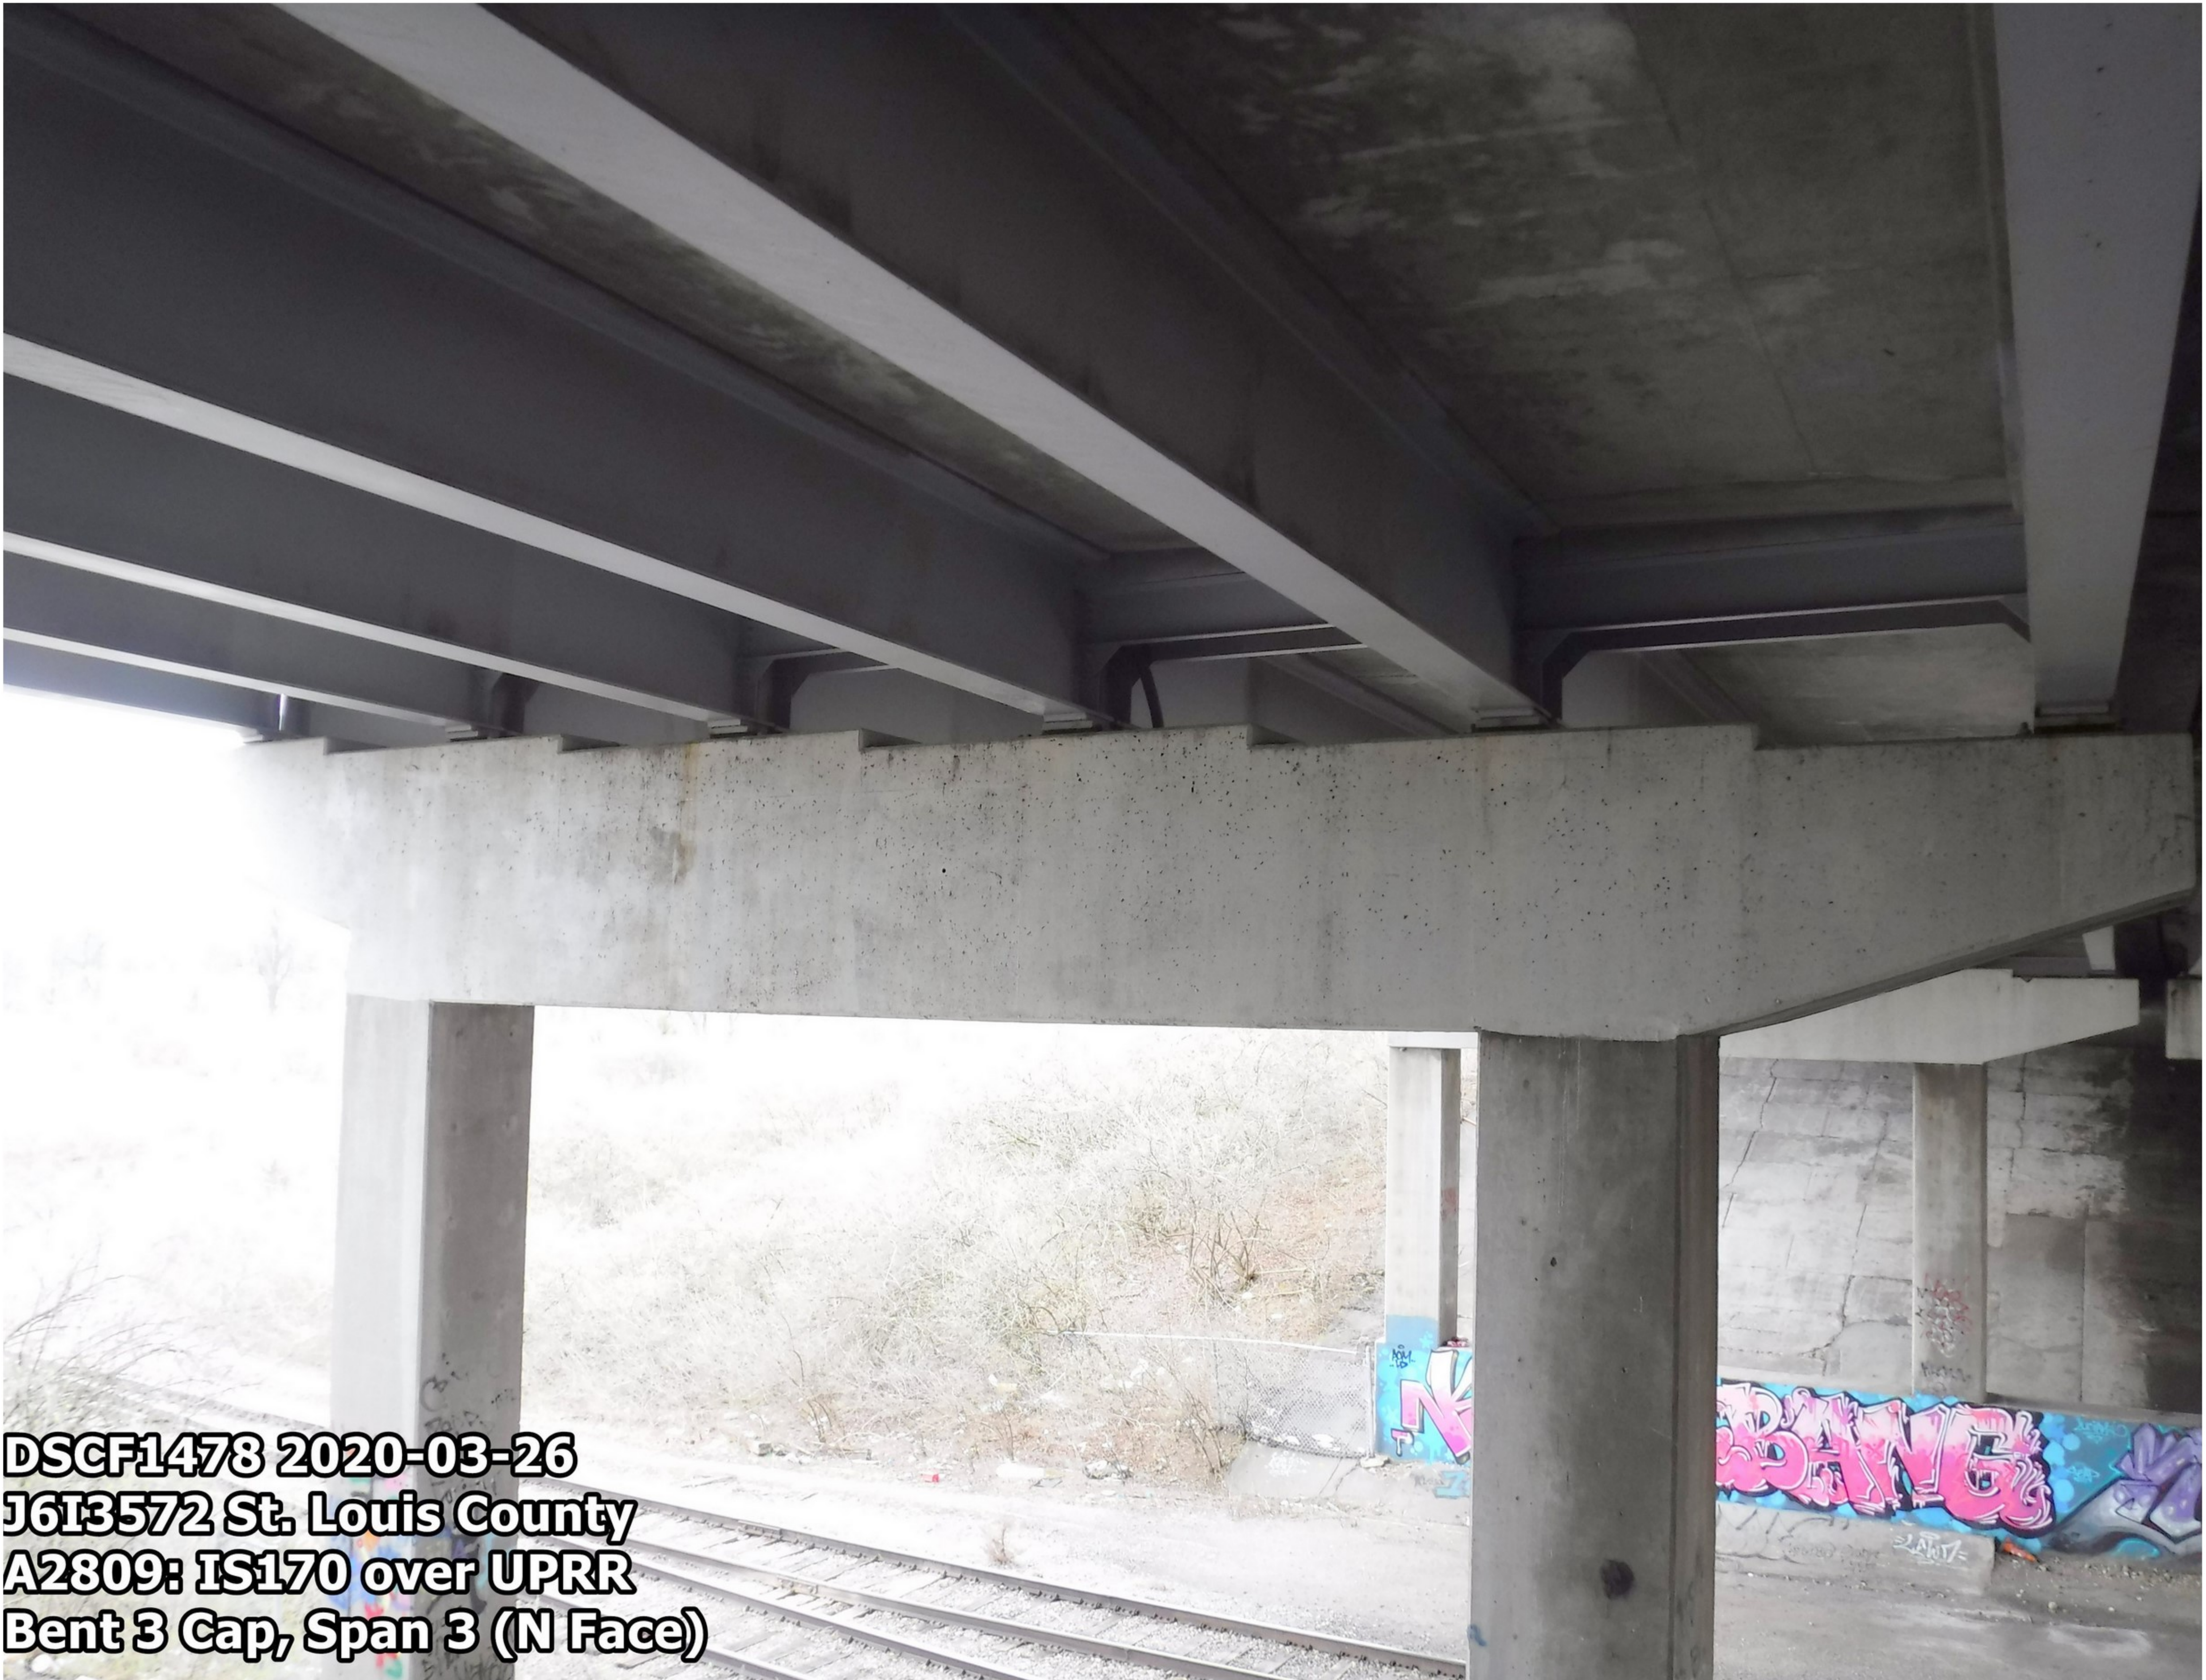
DSCF1478 2020-03-26
J6I3572 St. Louis County
A2809: IS170 over UPRR
Bent 3 Cap, Span 3 (N Face)

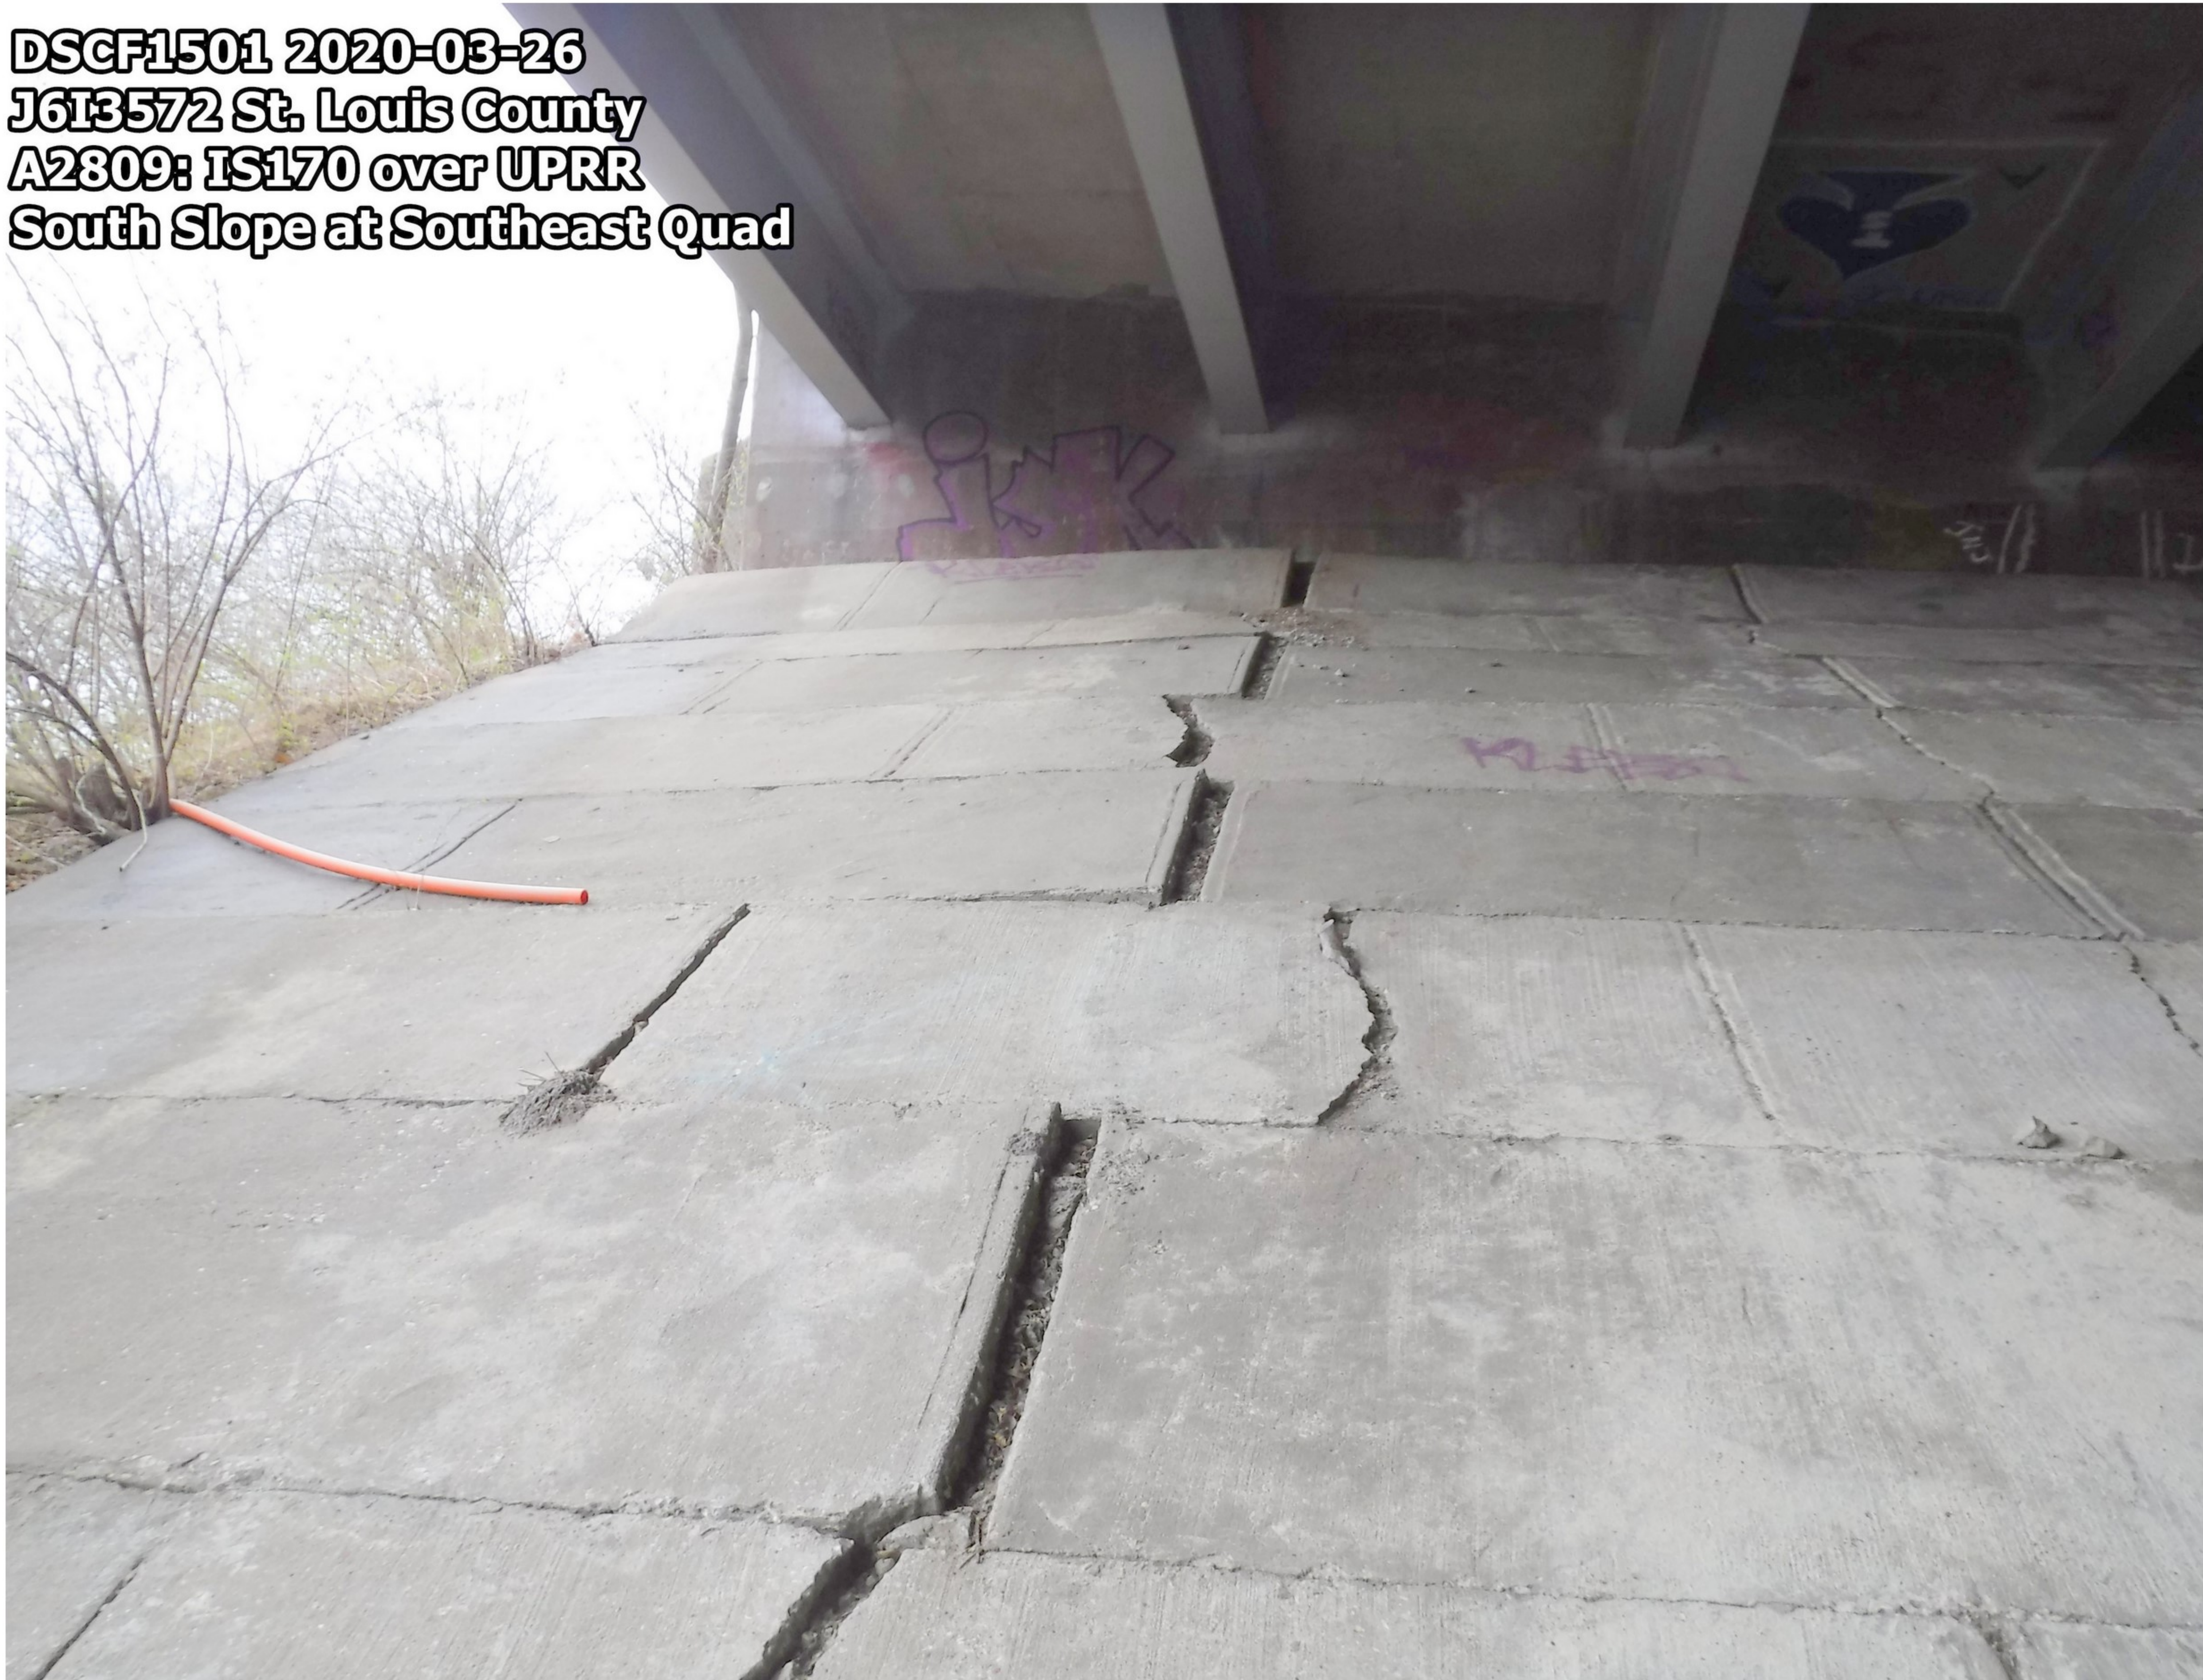
* Is erosion a problem? ☒ Yes ☐ No Describe & Locate Fill Settlement at Abutments

* Describe slope protection in place. Paved Slope Panel

* Describe needed work. Paved Slope Largely Functional

DSCF1501 2020-03-26
J6I3572 St. Louis County
A2809: IS170 over UPRR
South Slope at Southeast Quad
