Missouri Department of Transportation

STRUCTURAL REHABILITATION CHECKLIST

Bridge No.: A2809 **Job No.:** J613572

Route: IS 170 **Over:** UP RR

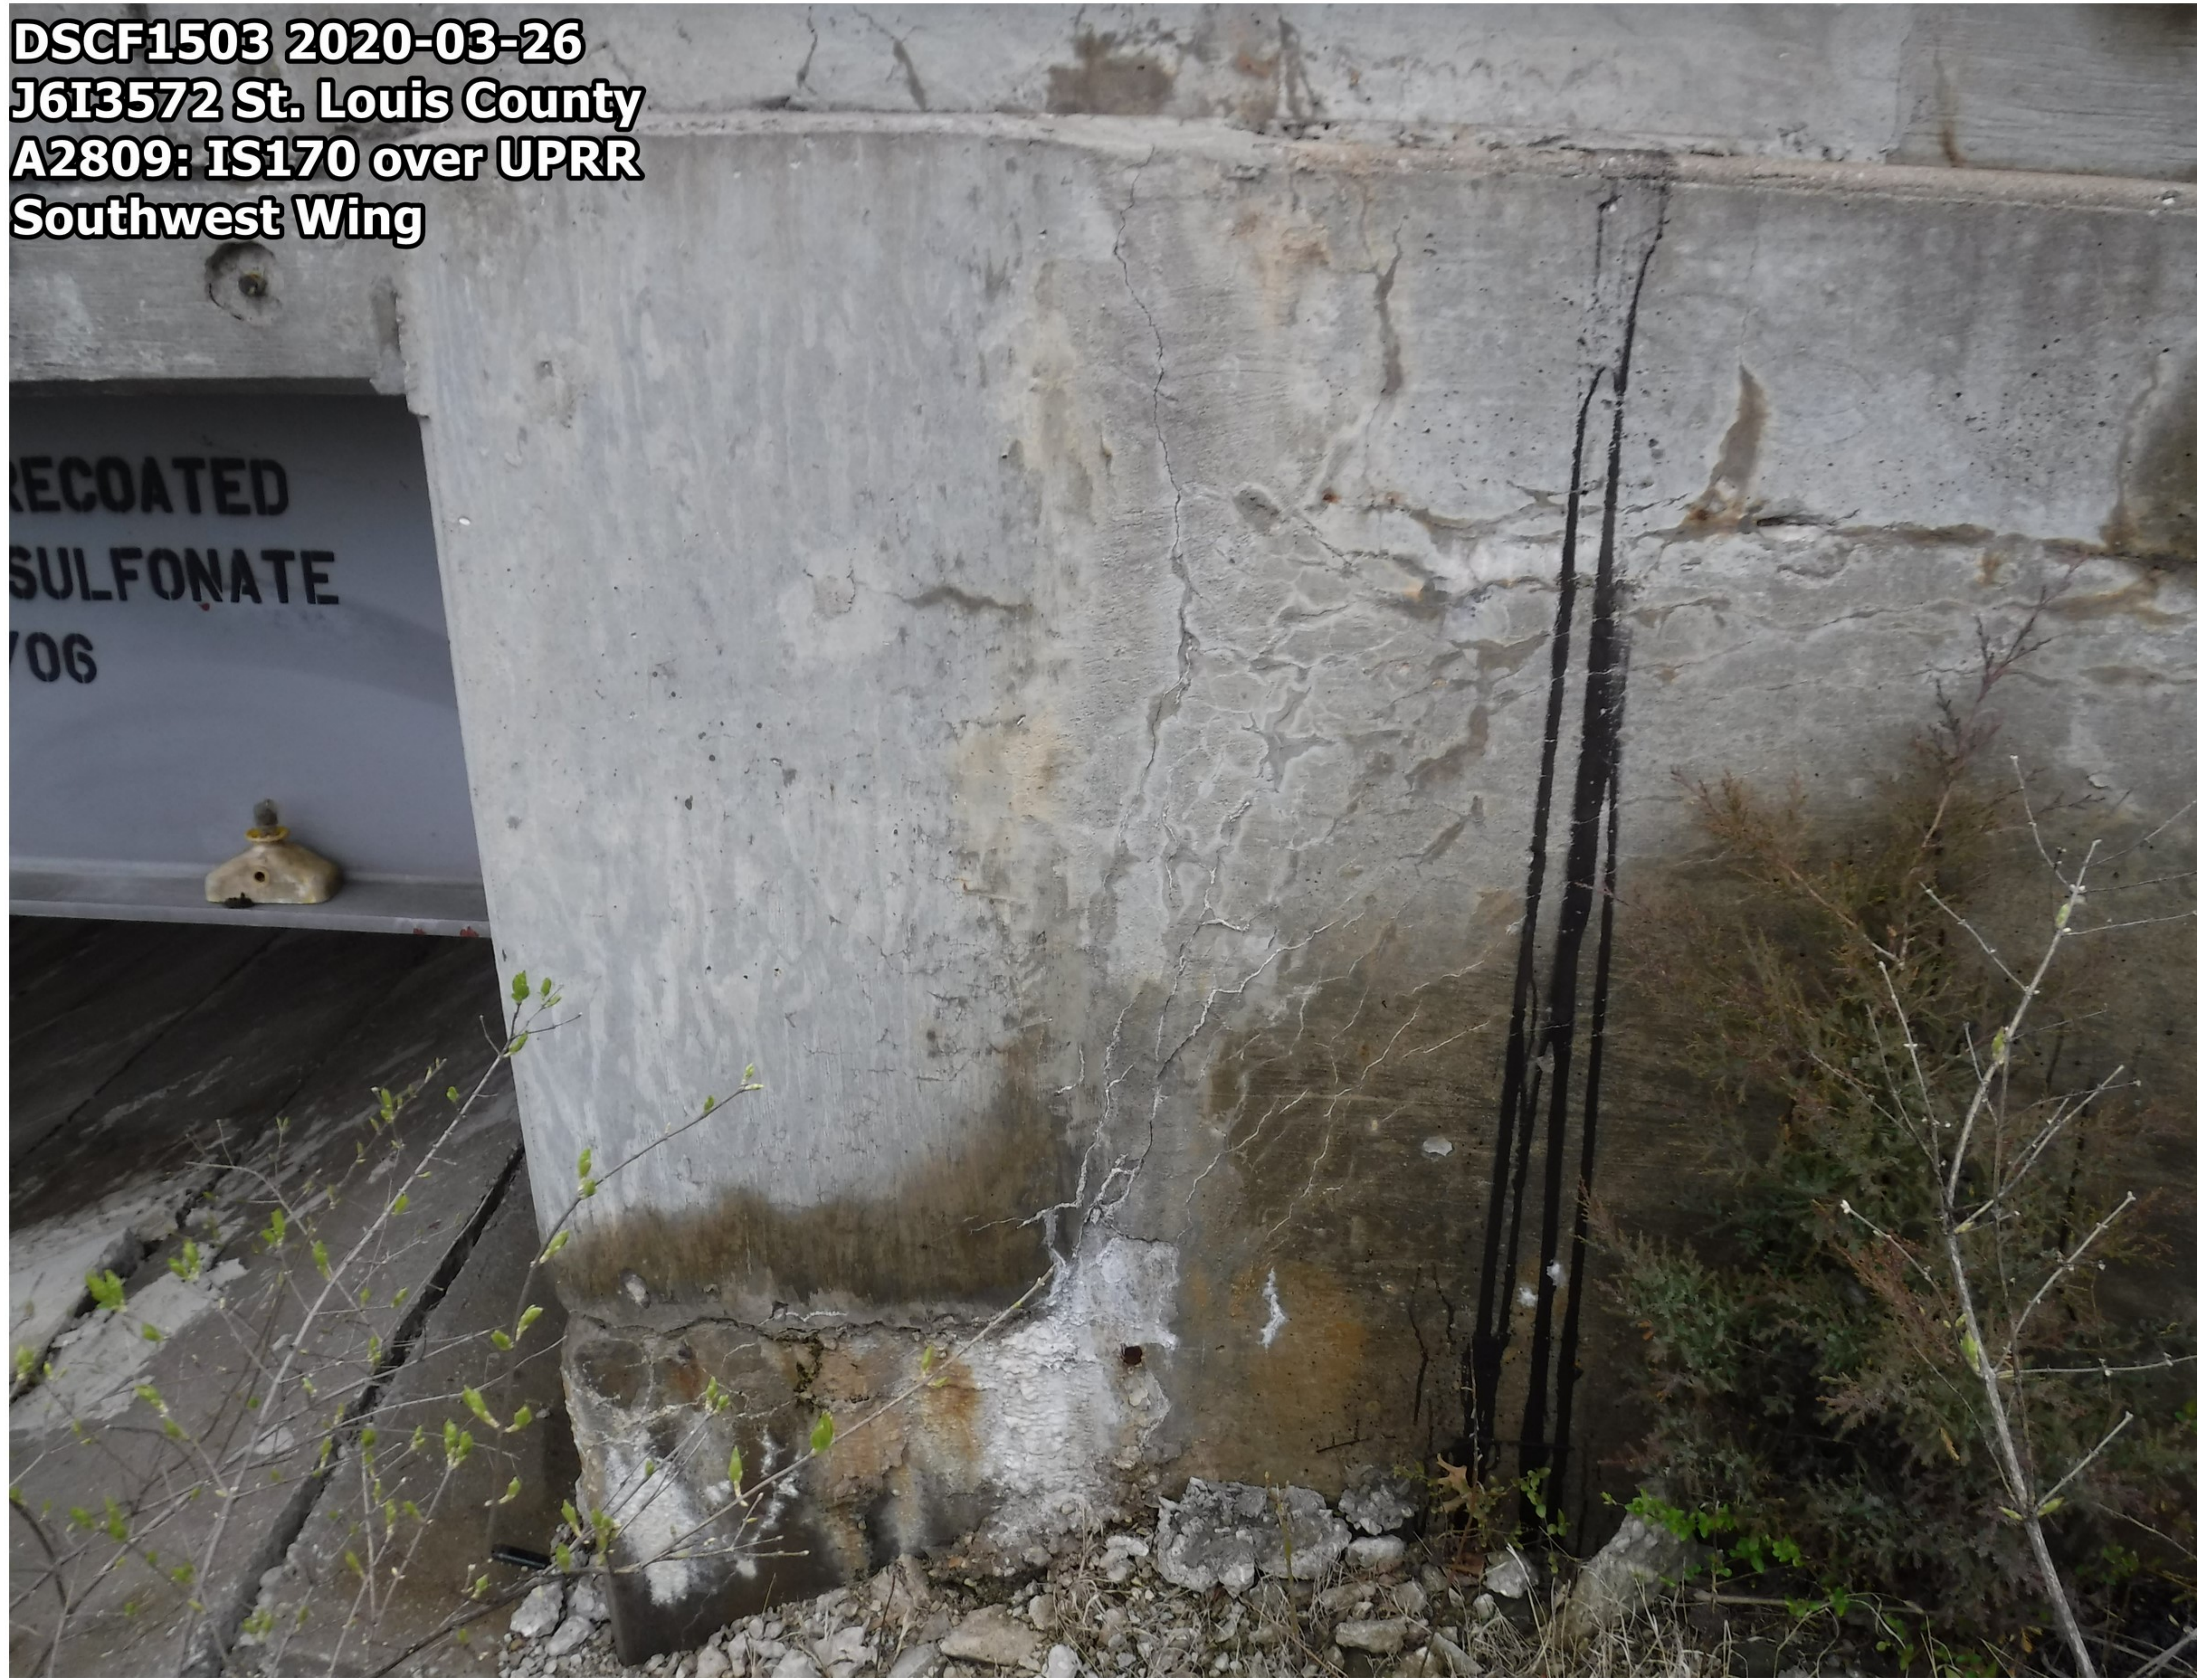
- * Is there a bridge approach slab in place? ☒ Yes ☐ No * Type: ☒ Concrete ☒ Asphalt ☐ Other _____
- * Is there a rdwy. approach pavement in place? ☒ Yes ☐ No * Type: ☒ Concrete ☐ Asphalt ☐ Other _____
- * Is the approach slab sinking at the end bent? ☐ N/A ☐ Yes ☒ No _____
- * Are repairs needed to the bridge approach slab driving surface? ☒ Yes ☐ No **105 SF at N Appr, 600 SF at S Appr.**
(Typically a roadway item but will be reported to district on the Bridge Memorandum.)
- * Full Replacement of Approach Slab? ☐ Yes ☒ No _____
- * Notes: **Include Approaches in Hydrodem/Overlay. Repairs can be accomplished monolithically.**

DSCF1504 2020-03-26
J6I3572 St. Louis County
A2809: IS170 over UPRR
Southbound South Approach Slab

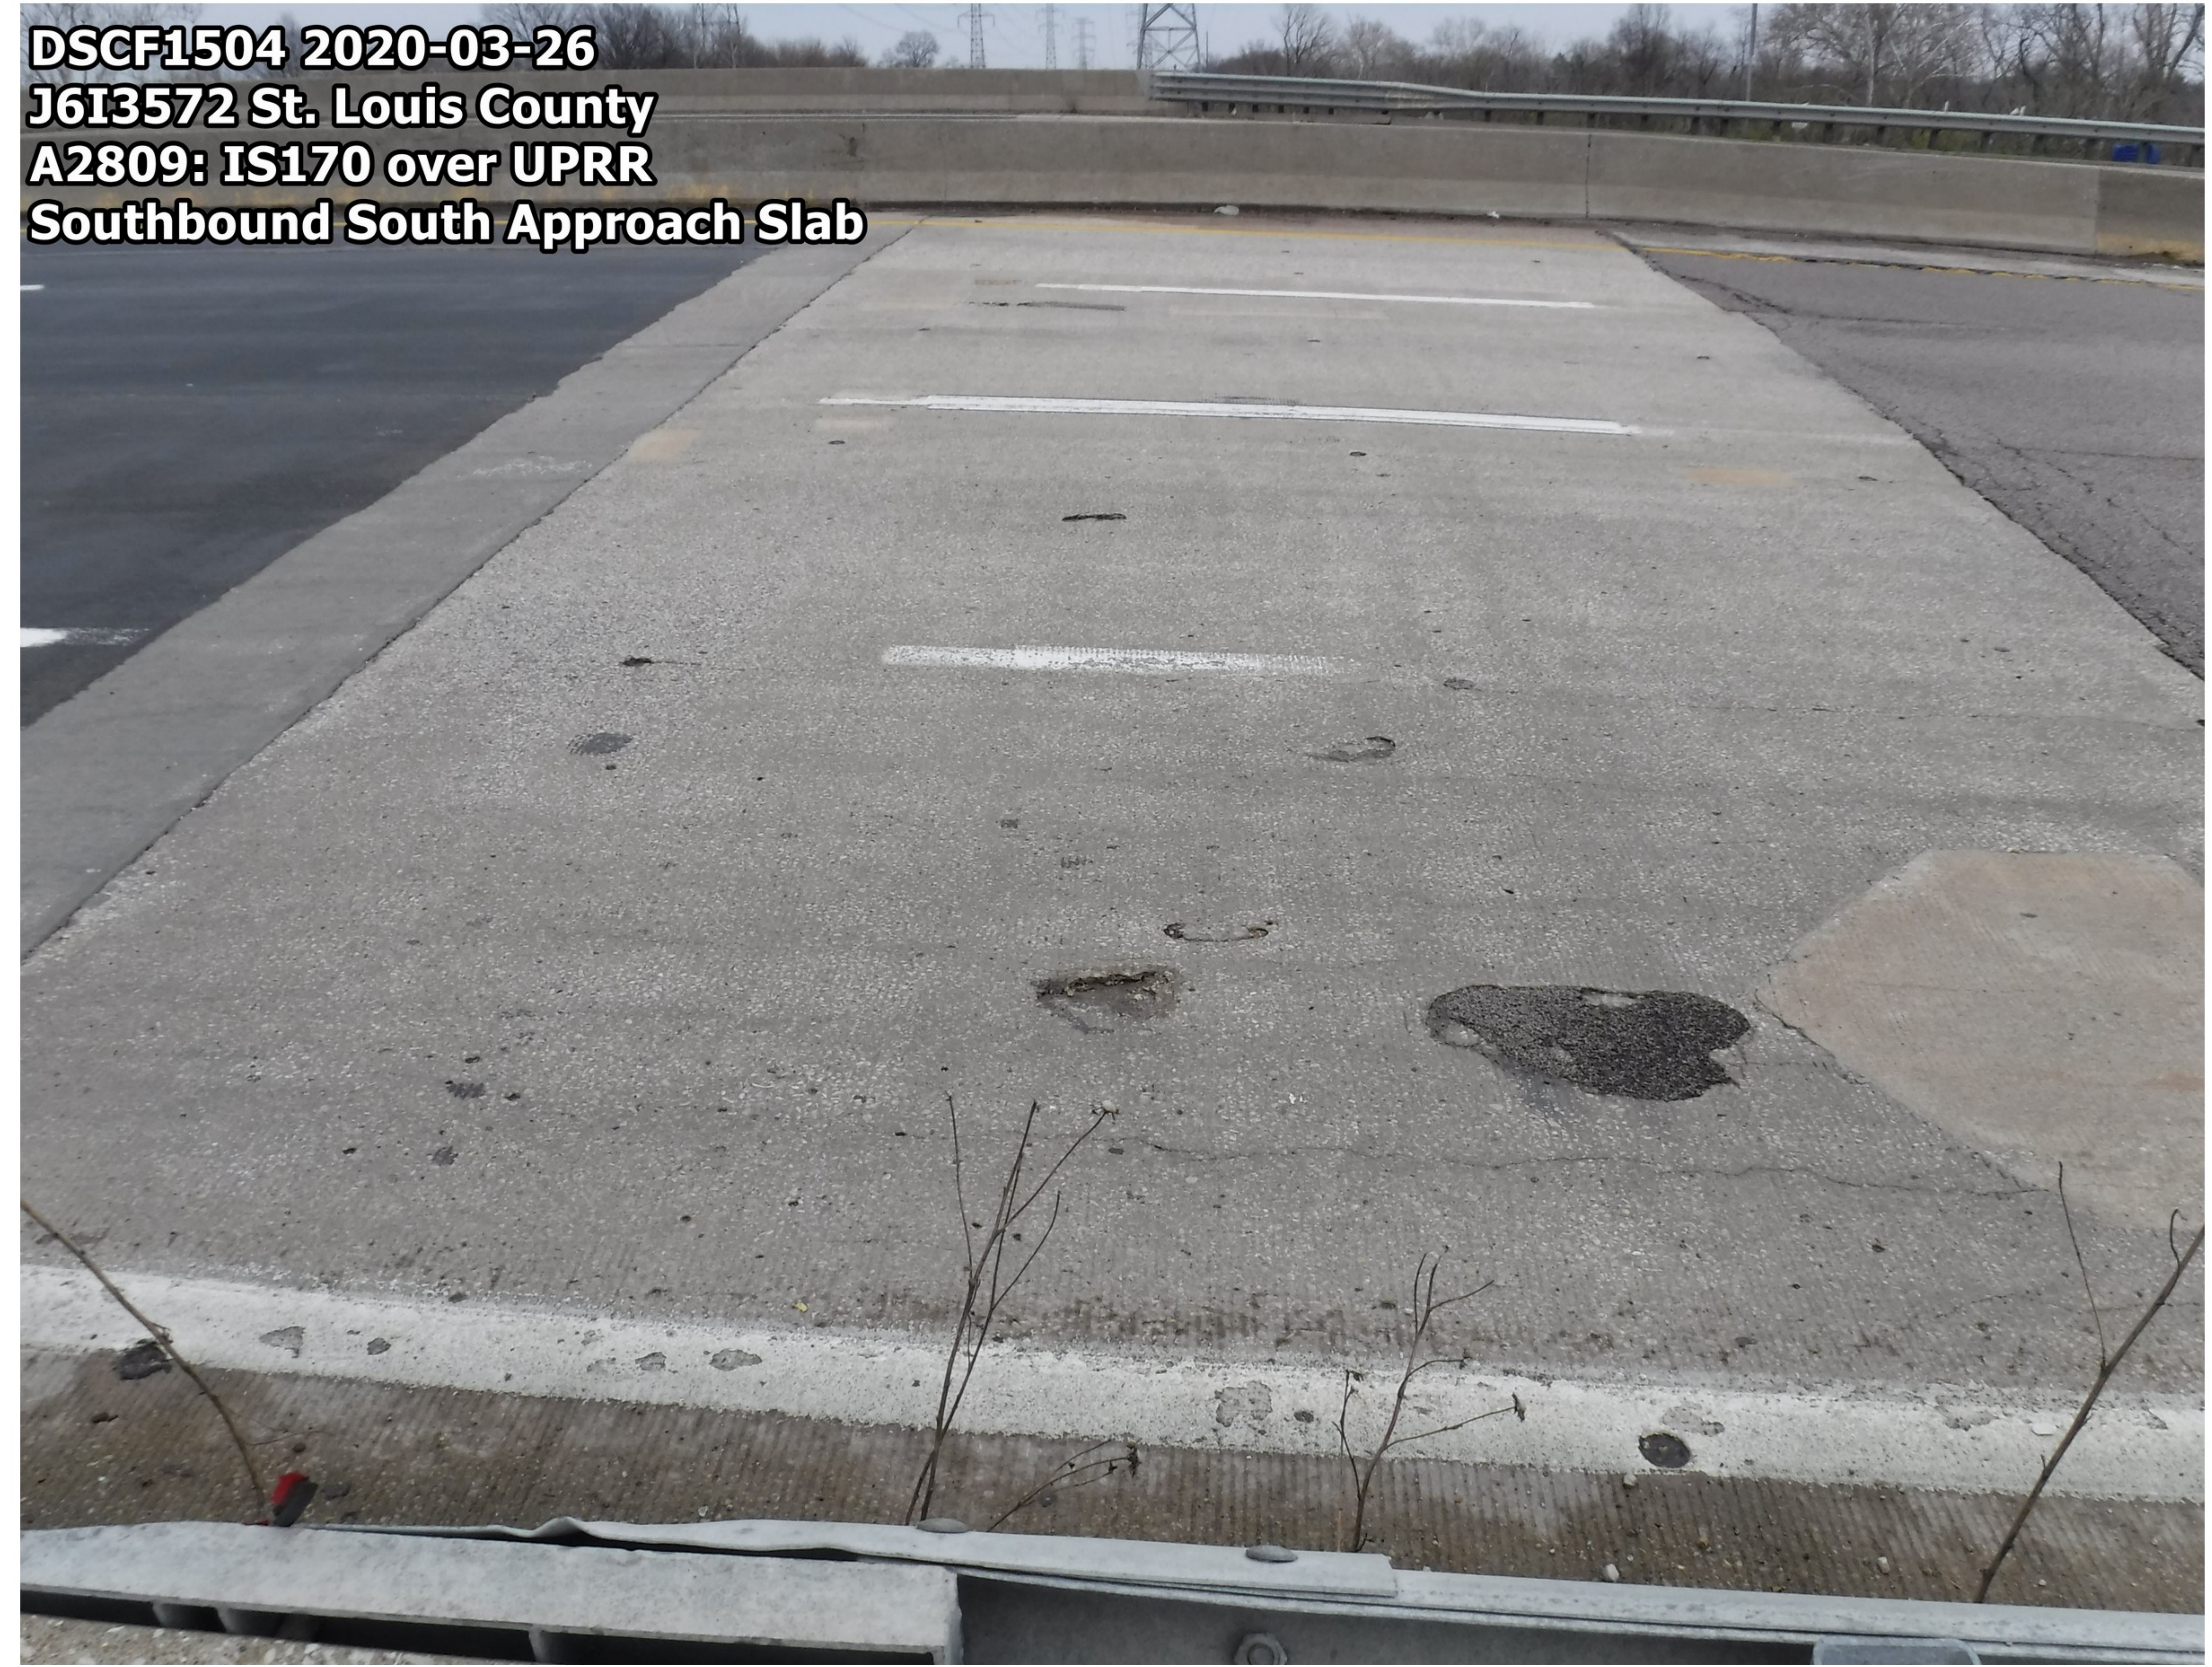
DSCF1505 2020-03-26
J6I3572 St. Louis County
A2809: IS170 over UPRR
Northbound South Approach Slab

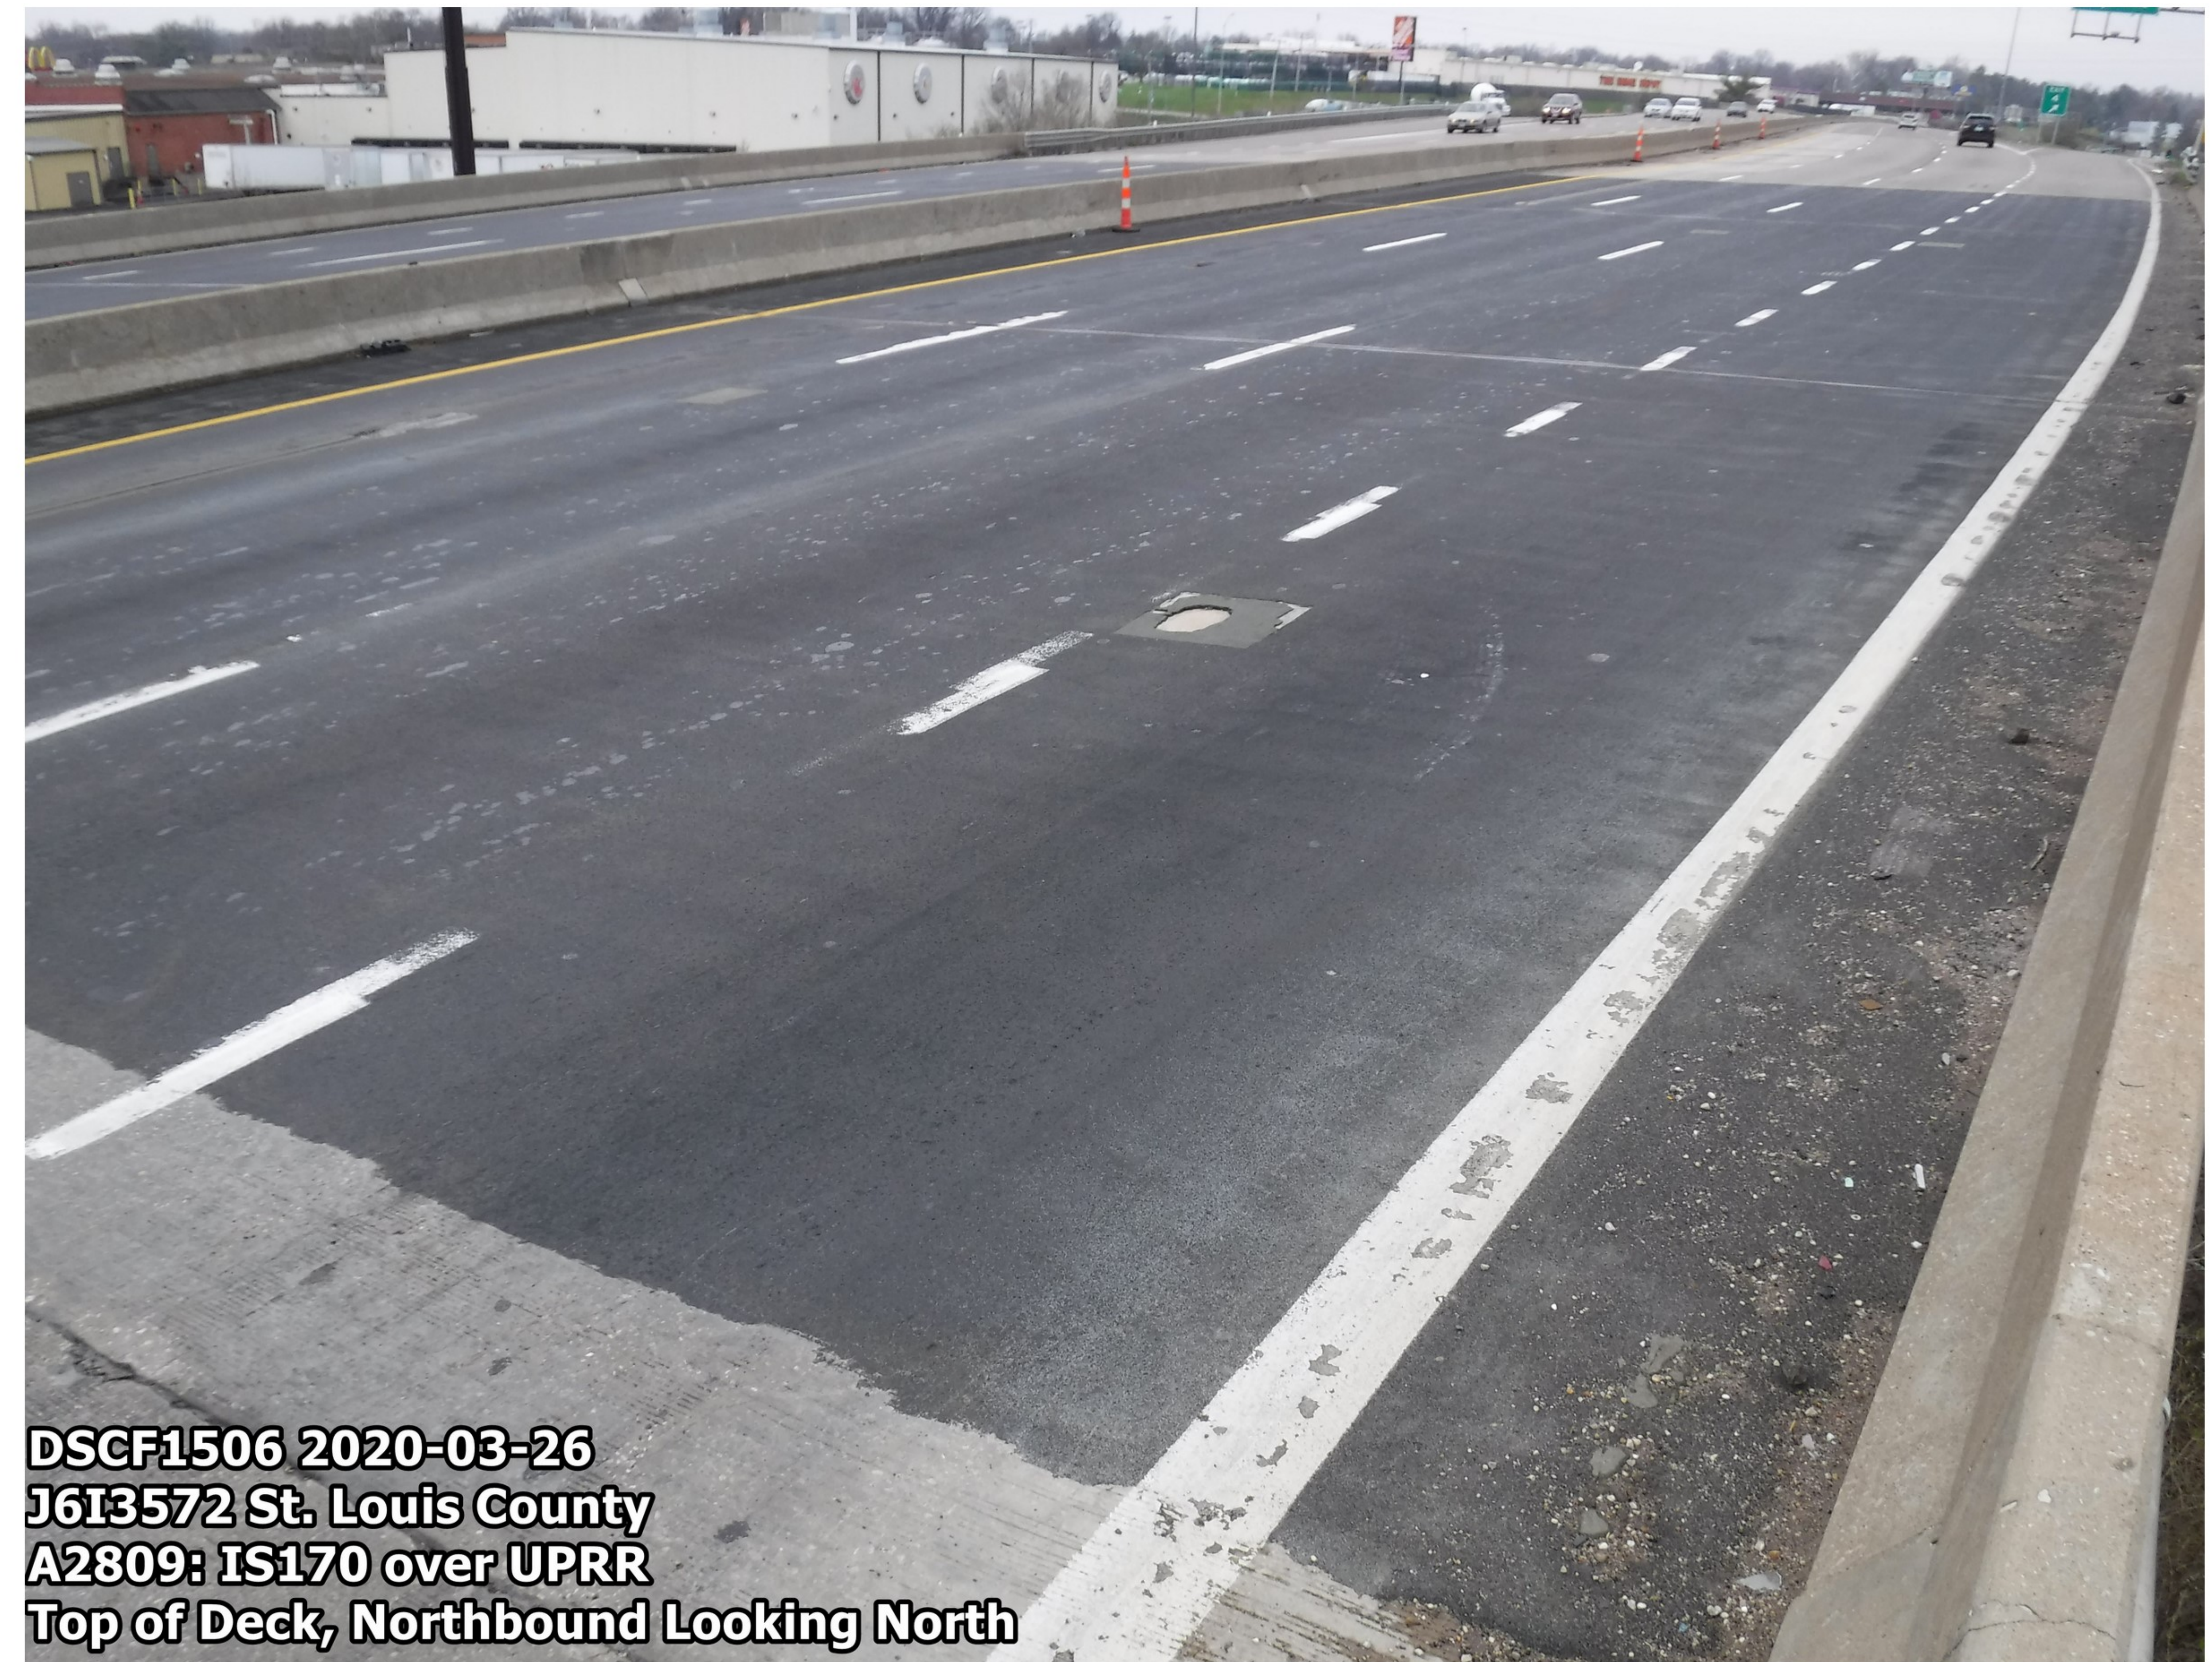
- * Type of existing overlay: ☐ None ☐ Asphalt ☐ Low Slump ☐ Silica Fume ☐ Latex ☒ Epoxy ☐ Other: _____
- * Existing overlay thickness: 3/8 " * Year overlay was applied: 2005 ☐ Unknown
- * % of overlay repaired or patched: _____ % * Replace overlay: ☒ Yes ☐ No
- * Notes: Place Latex Modified Concrete Overlay

DSCF1506 2020-03-26
J6I3572 St. Louis County
A2809: IS170 over UPRR
Top of Deck, Northbound Looking North

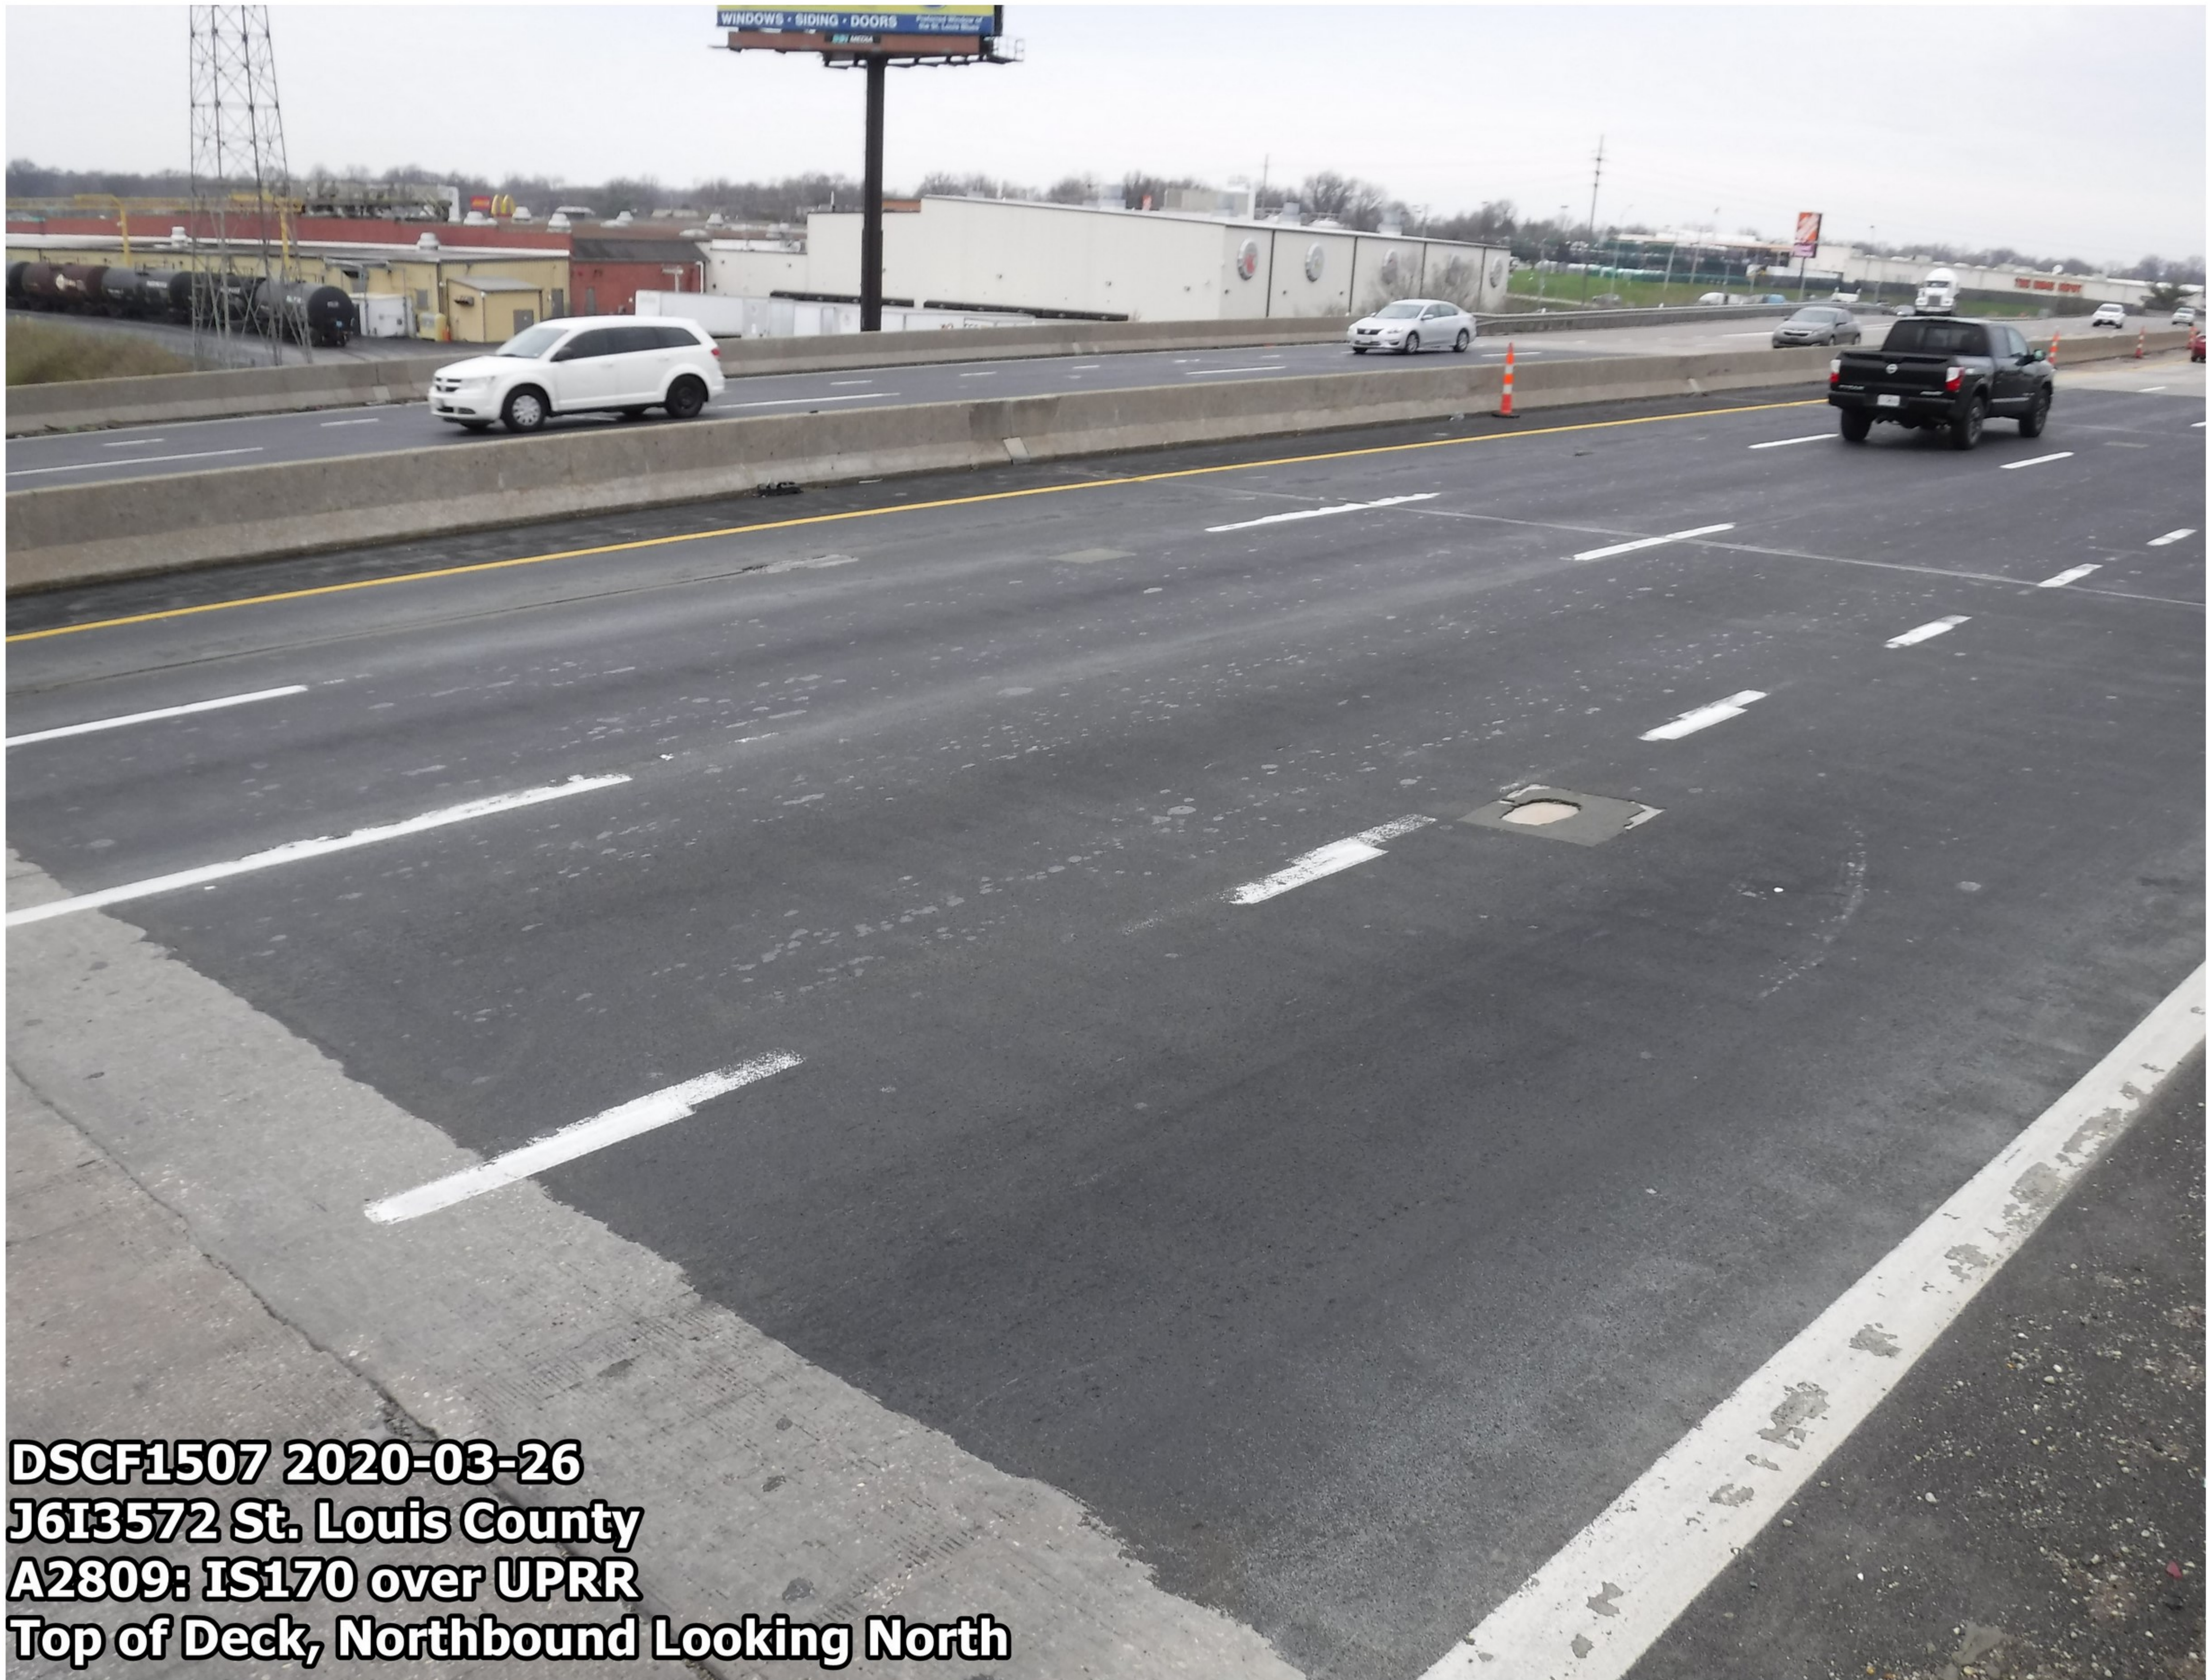
DSCF1507 2020-03-26
J6I3572 St. Louis County
A2809: IS170 over UPRR
Top of Deck, Northbound Looking North

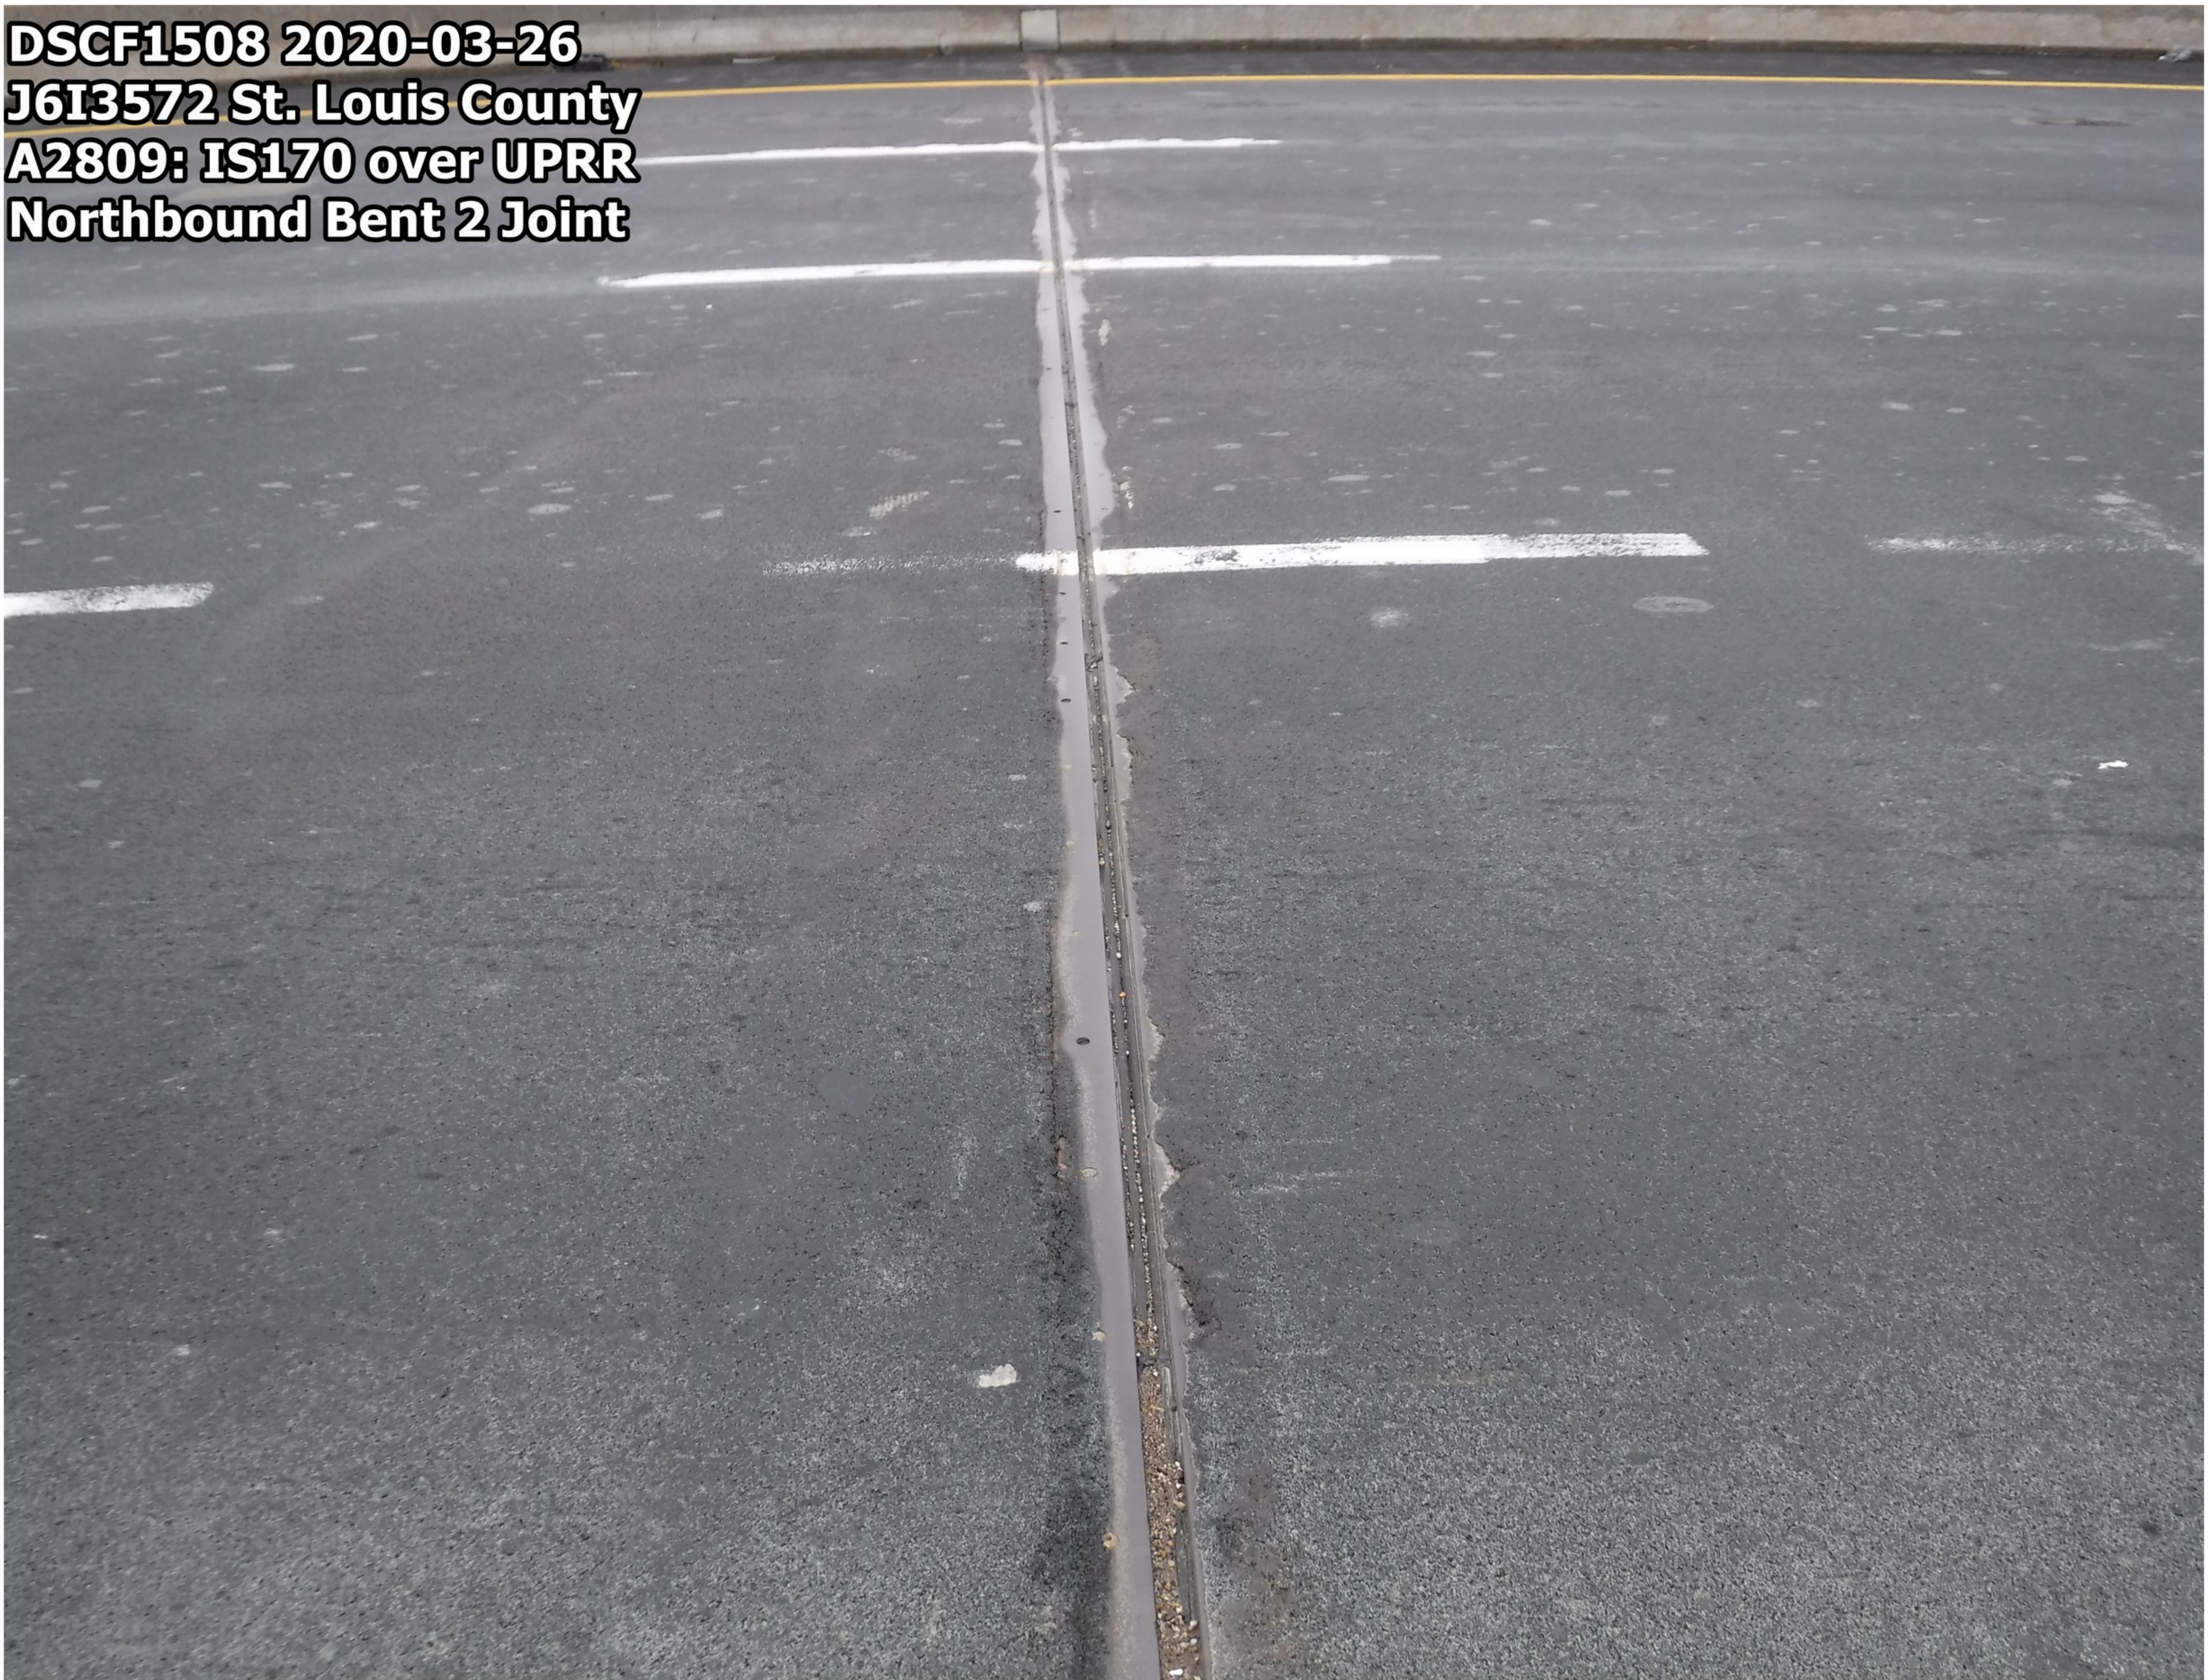
* Notes: Current Joint arrangement causing severe deterioration of intermediate bent cap under median curbline.

DSCF1508 2020-03-26
J6I3572 St. Louis County
A2809: IS170 over UPRR
Northbound Bent 2 Joint

Bent	Type	Recommendations			Gap Left	Gap Right	Temperature & Other Info
1	Filled Joint	<input type="checkbox"/>	<input type="checkbox"/>	<input checked="" type="checkbox"/>	"	"	Install Open Cell Foam JT
2	Armored Silicone	<input type="checkbox"/>	<input type="checkbox"/>	<input checked="" type="checkbox"/>	"	"	Replace with Armored strip seal
3	Armored Silicone	<input type="checkbox"/>	<input type="checkbox"/>	<input checked="" type="checkbox"/>	"	"	Replace with armored strip seal
4	Filled Joint	<input type="checkbox"/>	<input type="checkbox"/>	<input checked="" type="checkbox"/>	"	"	Install Open Cell Foam JT
NB L1	Long. JT	<input type="checkbox"/>	<input type="checkbox"/>	<input checked="" type="checkbox"/>	"	"	Eliminate Long. JT & Tie Deck
SB L1	Long. JT	<input type="checkbox"/>	<input type="checkbox"/>	<input checked="" type="checkbox"/>	"	"	Eliminate Long. JT & Tie Deck
