Missouri Department of Transportation

STRUCTURAL REHABILITATION CHECKLIST

Bridge No.: A2809 **Job No.:** J613572

Route: IS 170 **Over:** UP RR

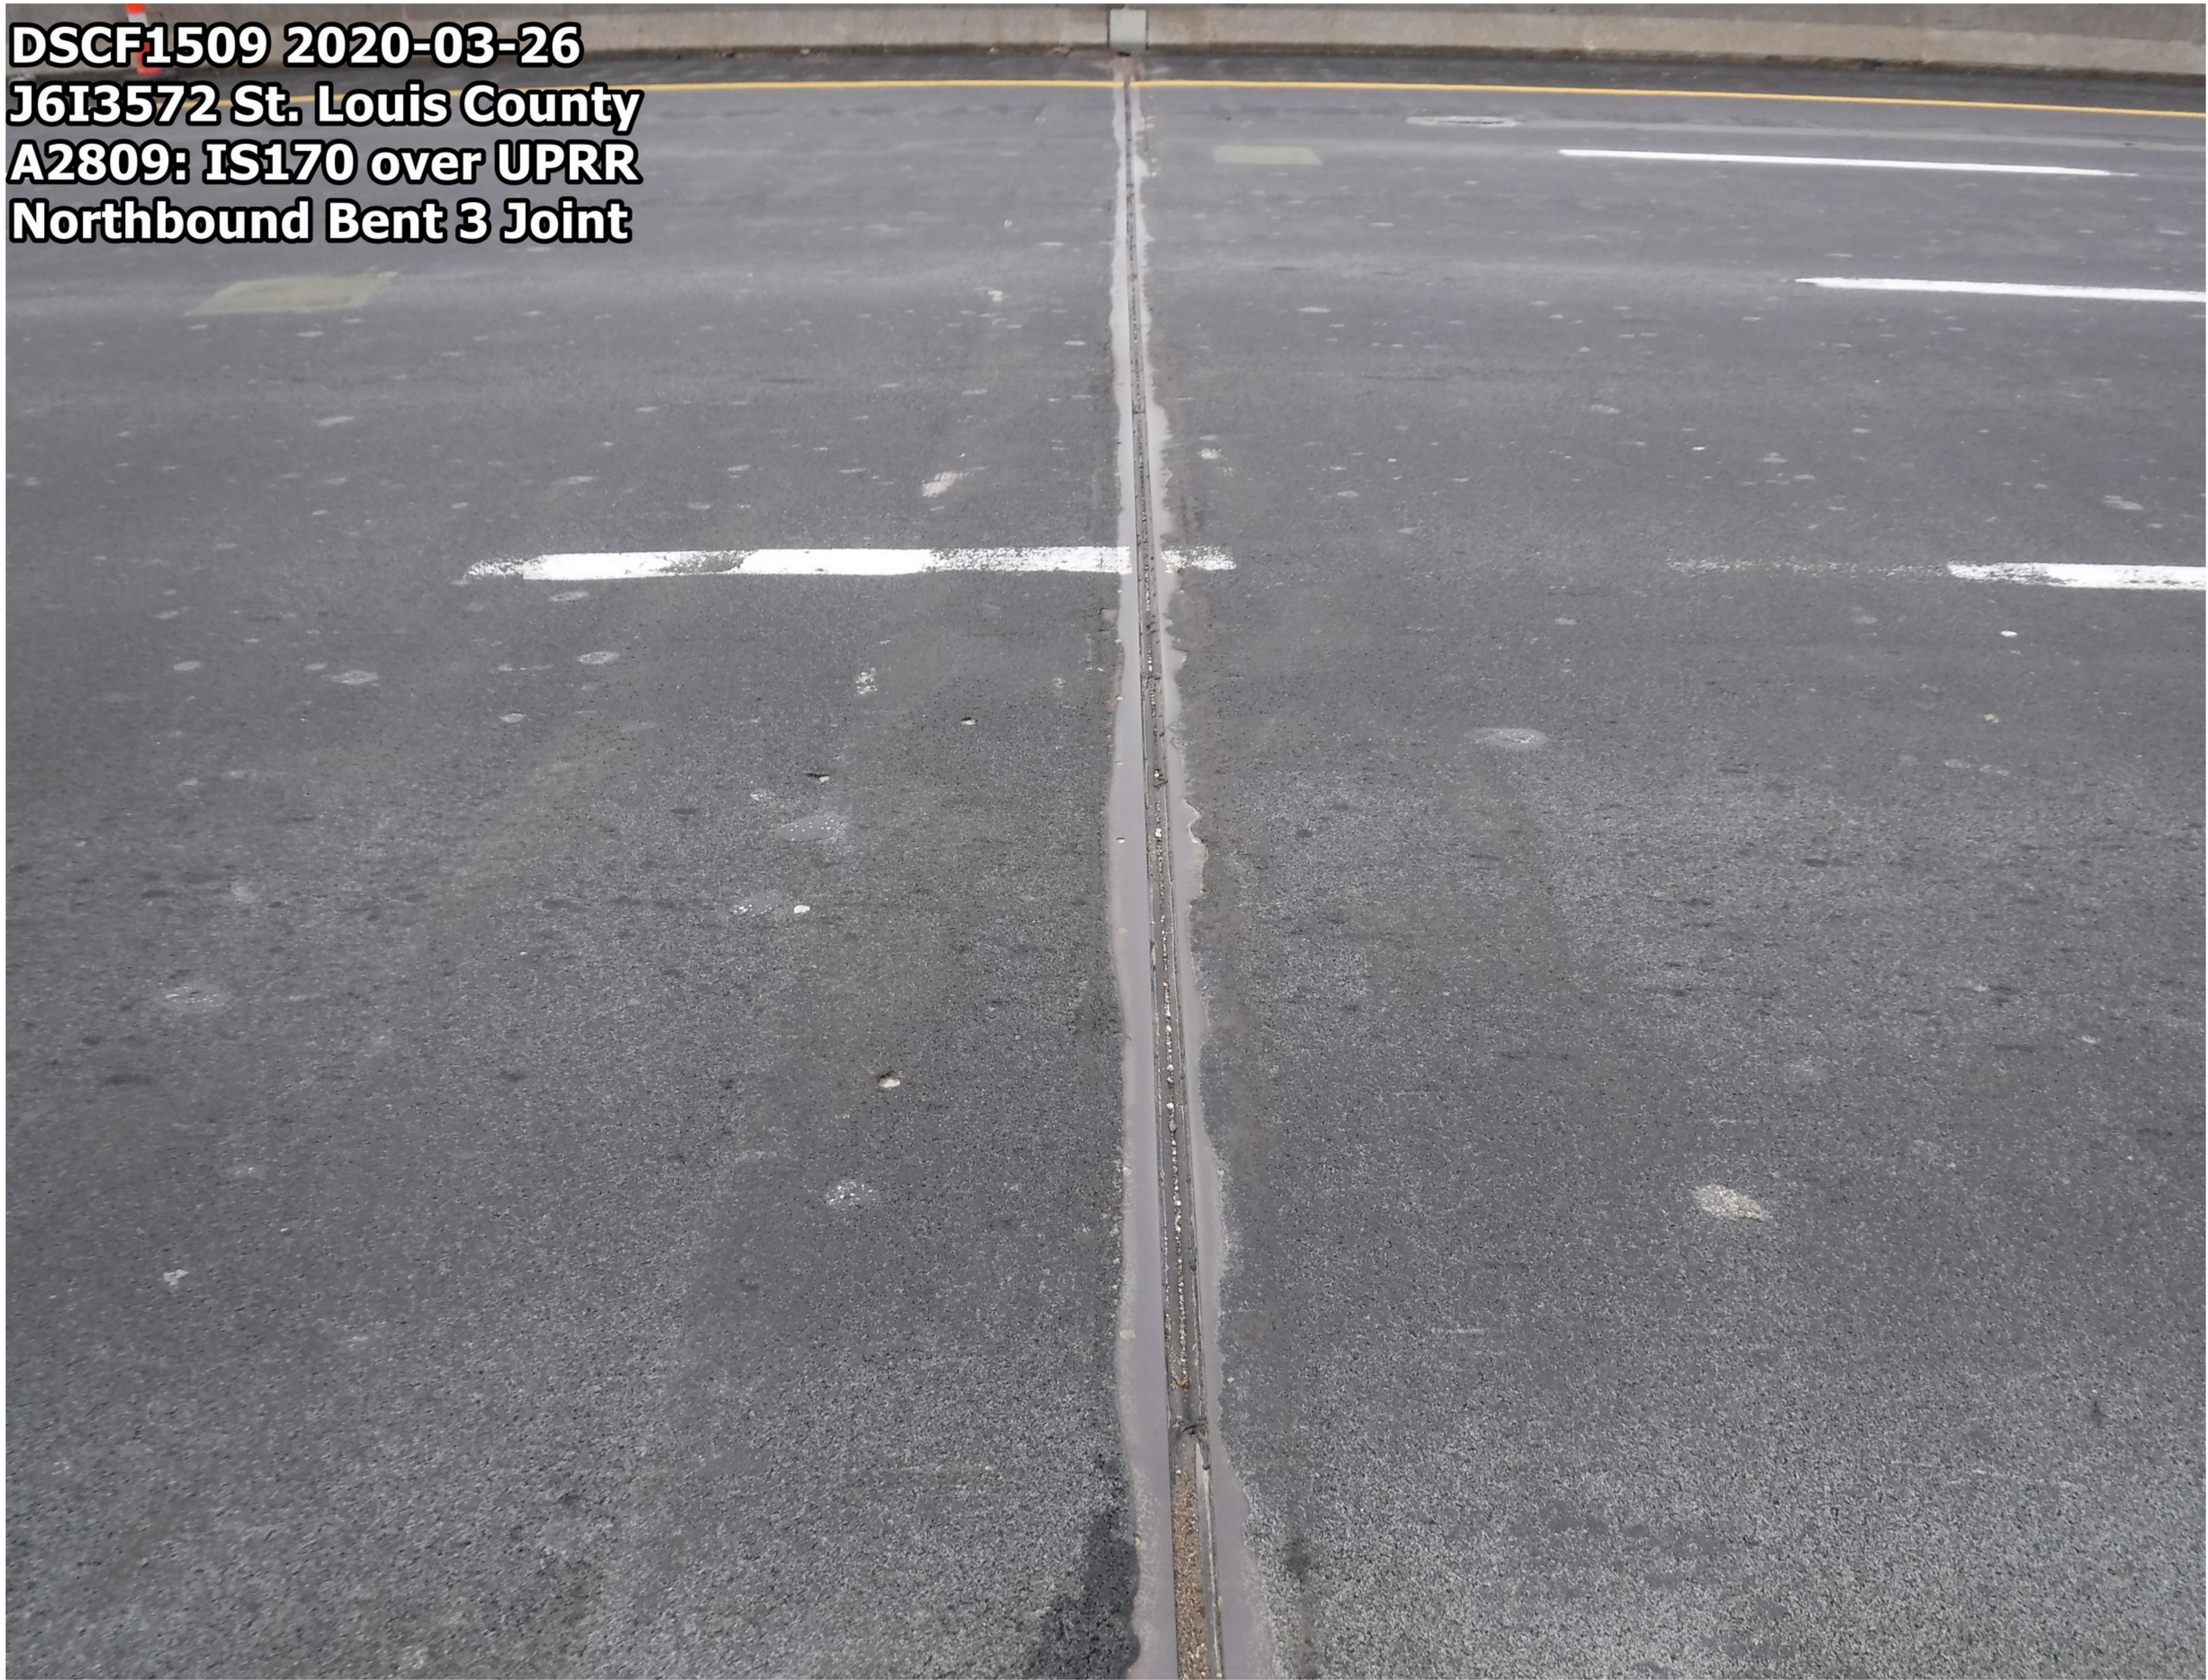
* Notes: Current Joint arrangement causing severe deterioration of intermediate bent cap under median curbline.

DSCF1509 2020-03-26
J6I3572 St. Louis County
A2809: IS170 over UPRR
Northbound Bent 3 Joint

Bent	Type	Recommendations			Gap Left	Gap Right	Temperature & Other Info
1	Filled Joint	<input type="checkbox"/>	<input type="checkbox"/>	<input checked="" type="checkbox"/>	"	"	Install Open Cell Foam JT
2	Armored Silicone	<input type="checkbox"/>	<input type="checkbox"/>	<input checked="" type="checkbox"/>	"	"	Replace with Armored strip seal
3	Armored Silicone	<input type="checkbox"/>	<input type="checkbox"/>	<input checked="" type="checkbox"/>	"	"	Replace with armored strip seal
4	Filled Joint	<input type="checkbox"/>	<input type="checkbox"/>	<input checked="" type="checkbox"/>	"	"	Install Open Cell Foam JT
NB L1	Long. JT	<input type="checkbox"/>	<input type="checkbox"/>	<input checked="" type="checkbox"/>	"	"	Eliminate Long. JT & Tie Deck
SB L1	Long. JT	<input type="checkbox"/>	<input type="checkbox"/>	<input checked="" type="checkbox"/>	"	"	Eliminate Long. JT & Tie Deck

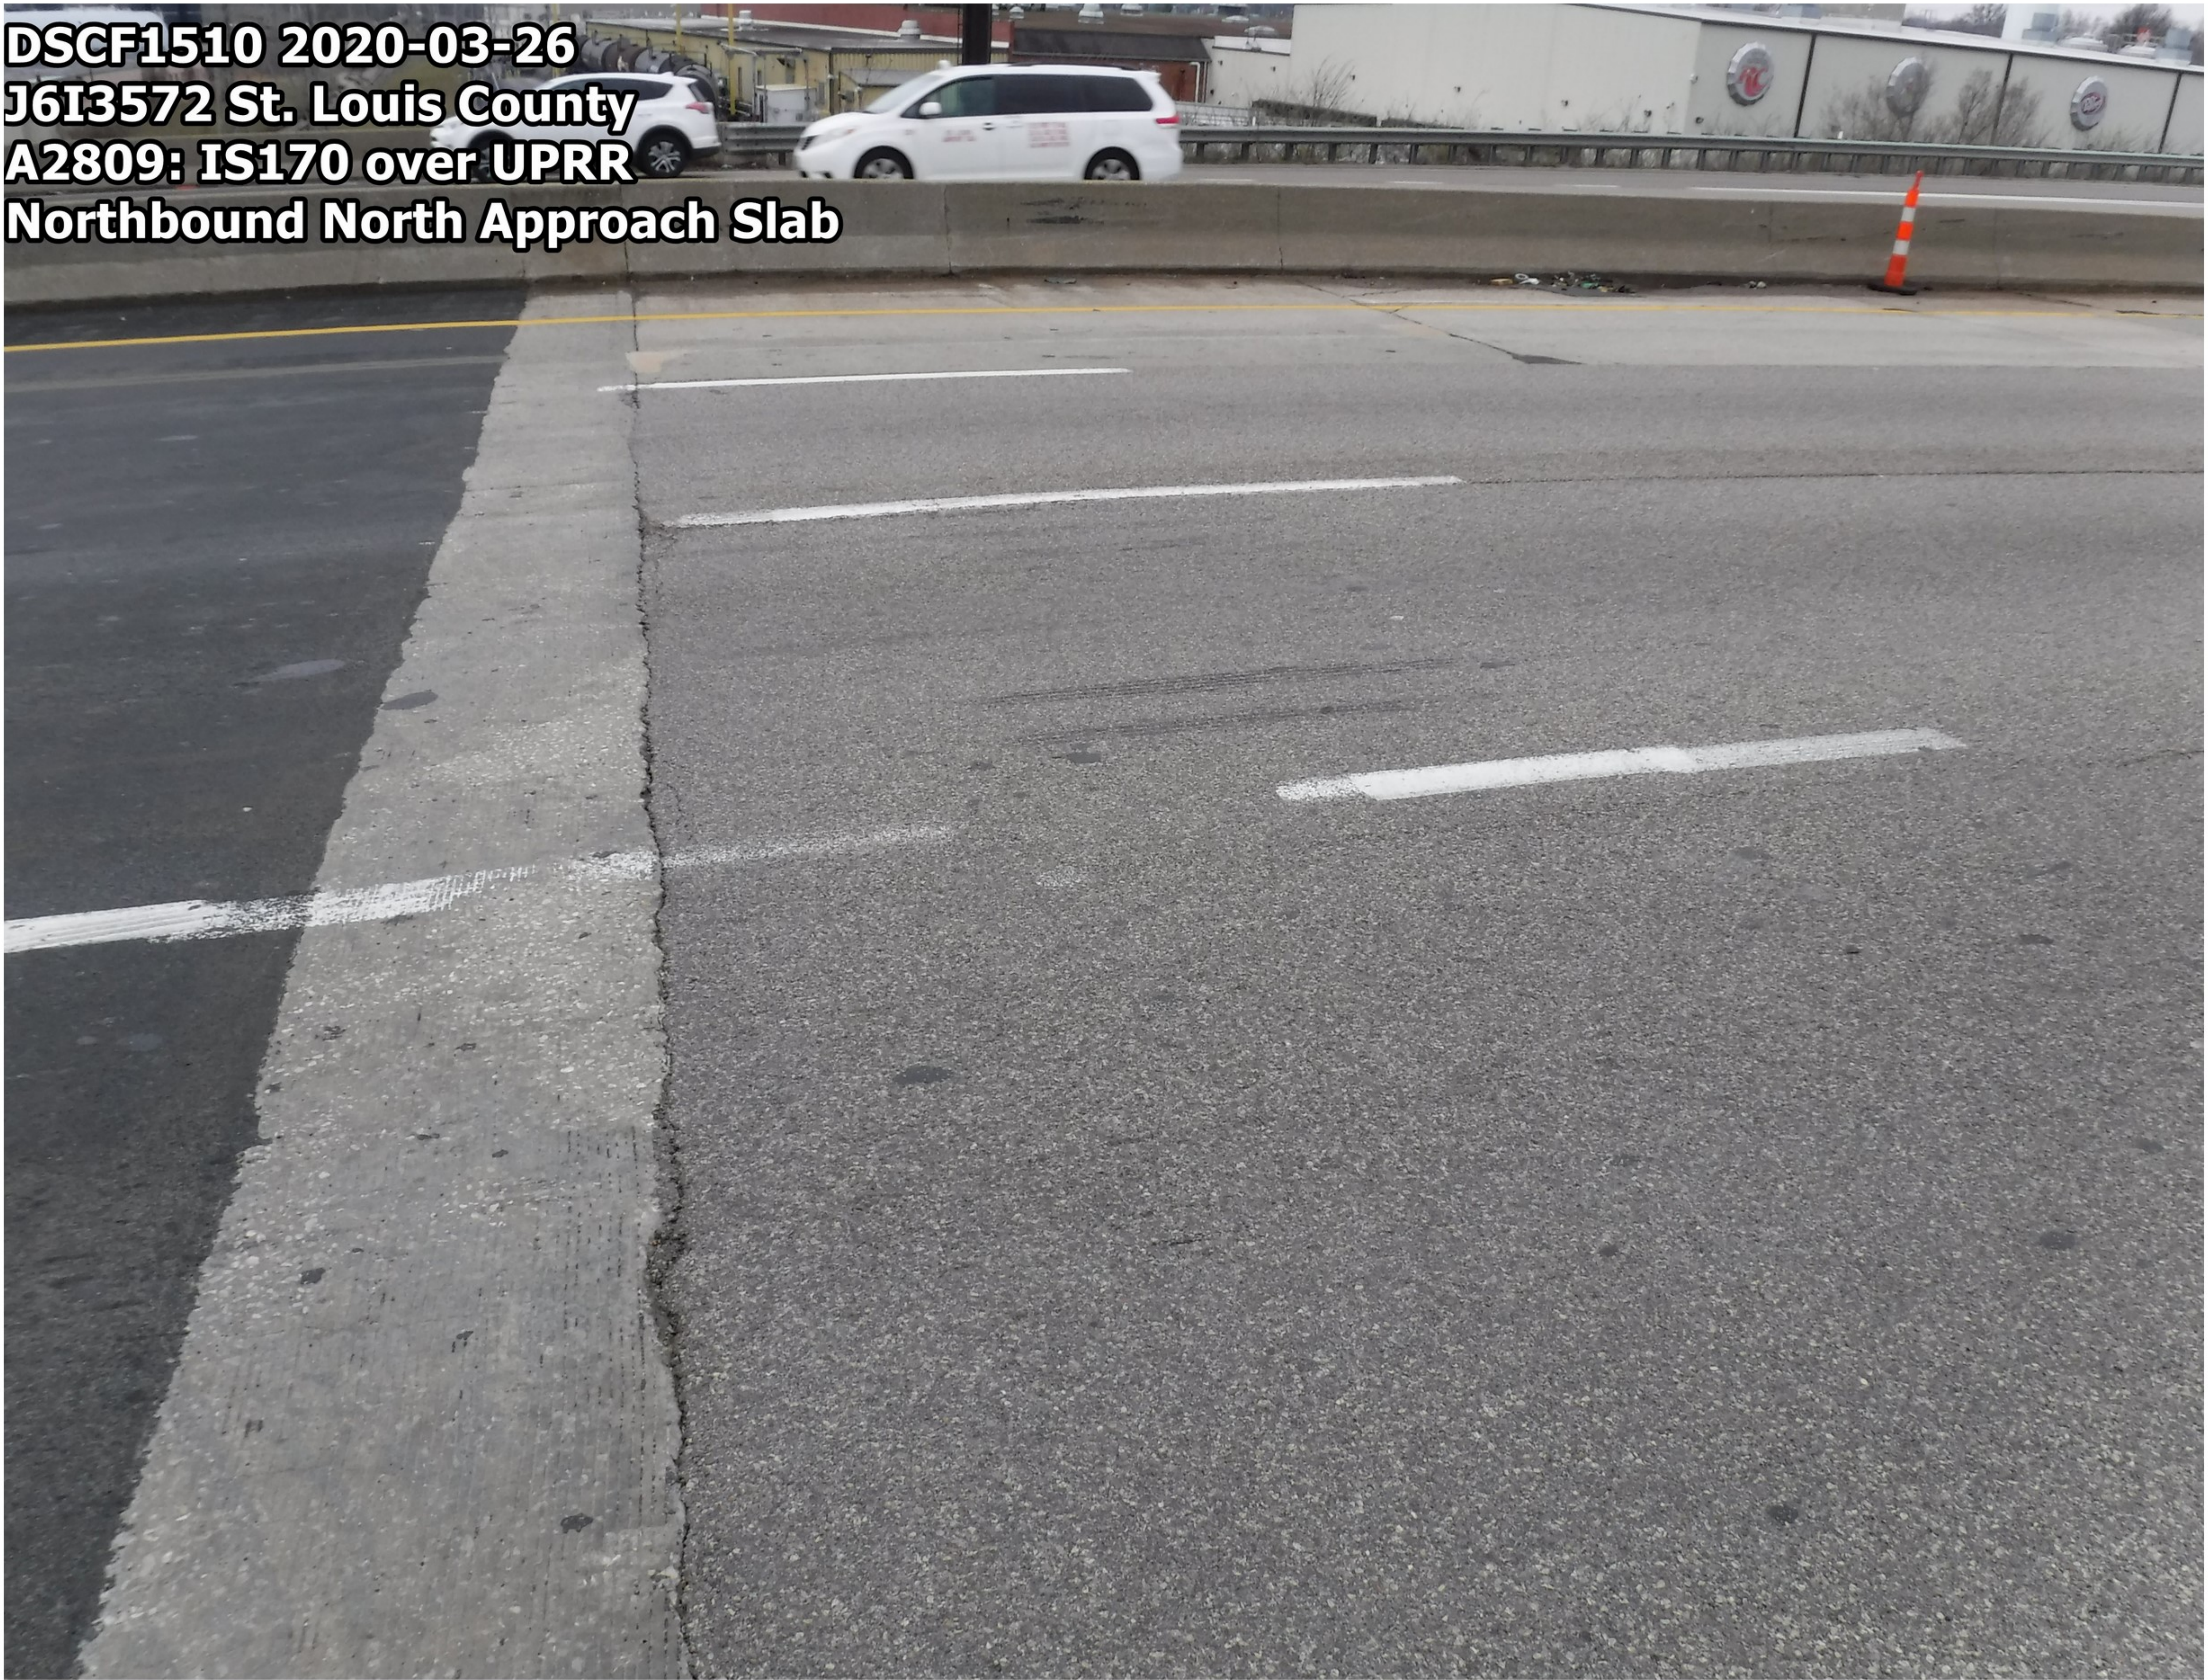
- * Is there a bridge approach slab in place? ☒ Yes ☐ No * Type: ☒ Concrete ☒ Asphalt ☐ Other _____
- * Is there a rdwy. approach pavement in place? ☒ Yes ☐ No * Type: ☒ Concrete ☐ Asphalt ☐ Other _____
- * Is the approach slab sinking at the end bent? ☐ N/A ☐ Yes ☒ No _____
- * Are repairs needed to the bridge approach slab driving surface? ☒ Yes ☐ No **105 SF at N Appr, 600 SF at S Appr.**
(Typically a roadway item but will be reported to district on the Bridge Memorandum.)
- * Full Replacement of Approach Slab? ☐ Yes ☒ No _____
- * Notes: **Include Approaches in Hydrodem/Overlay. Repairs can be accomplished monolithically.**

DSCF1510 2020-03-26
J6I3572 St. Louis County
A2809: IS170 over UPRR
Northbound North Approach Slab
