**Conceptual Study Report**  
**Route 100 (Manchester Road) Rehabilitation**  
**from Ballas Road to Route 141**

**February 5, 2018 (DRAFT)**  
**MoDOT Job No. 6P3274**

**SUBJECT:** District St. Louis – Design  
Route 100, St. Louis County  
Route 100 Rehabilitation  
From Ballas Road to Route 141  
Job No. 6P3274  
Conceptual Study Report

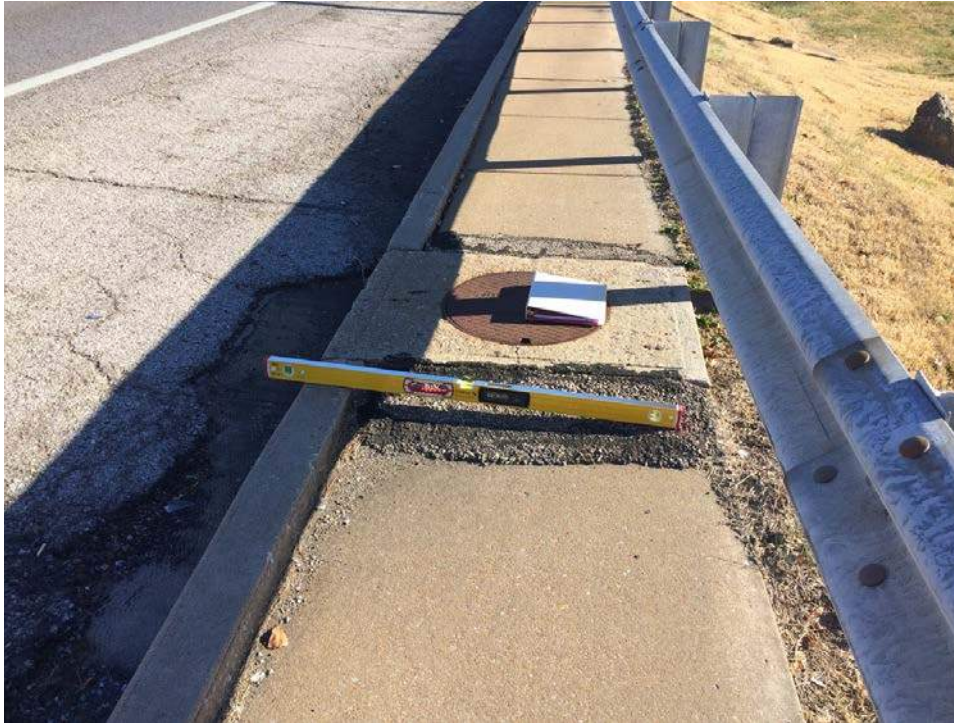
**Sidewalk width less than 4 feet and trip hazards.**

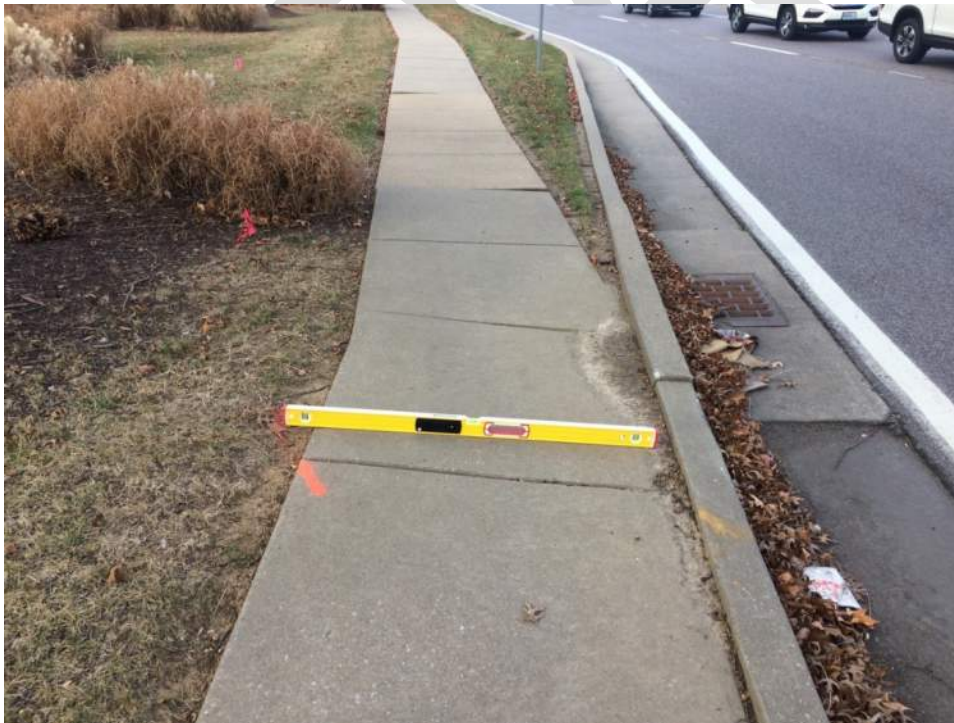
**Excessive cross slope and trip hazards.**

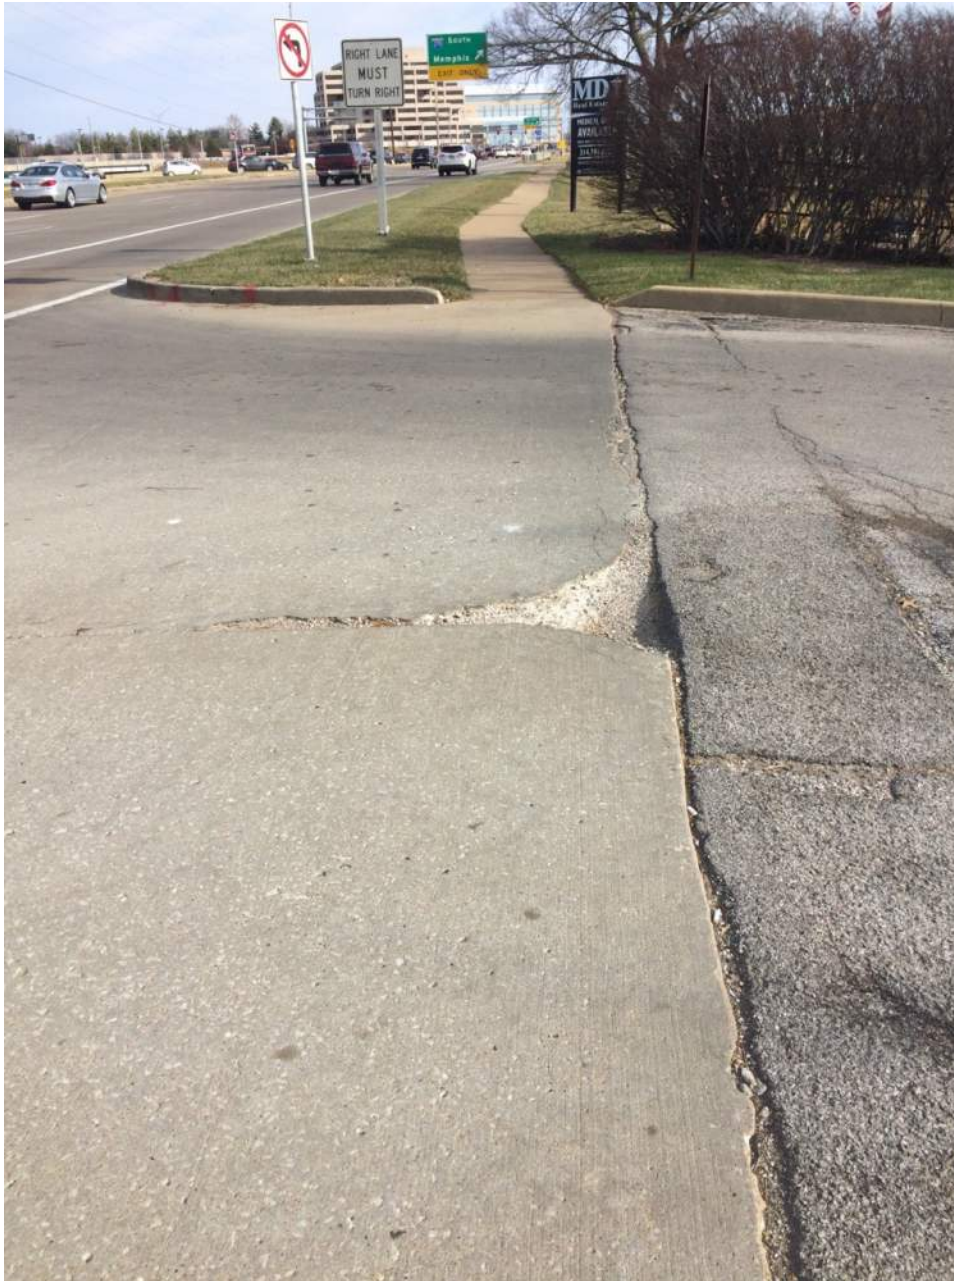
Entrance with large hole in the pedestrian access route.

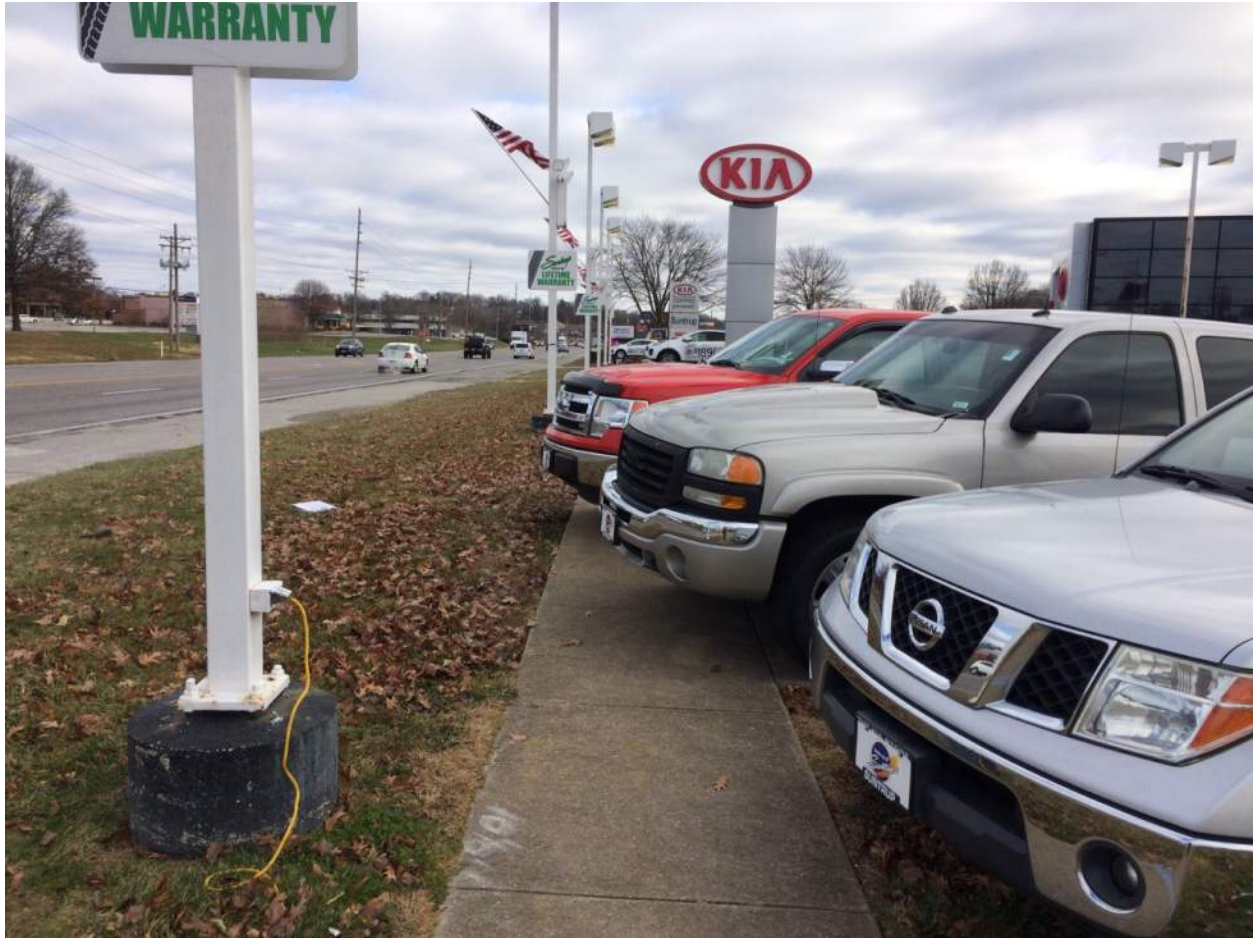
Horizontal encroachment on sidewalk by property owner.

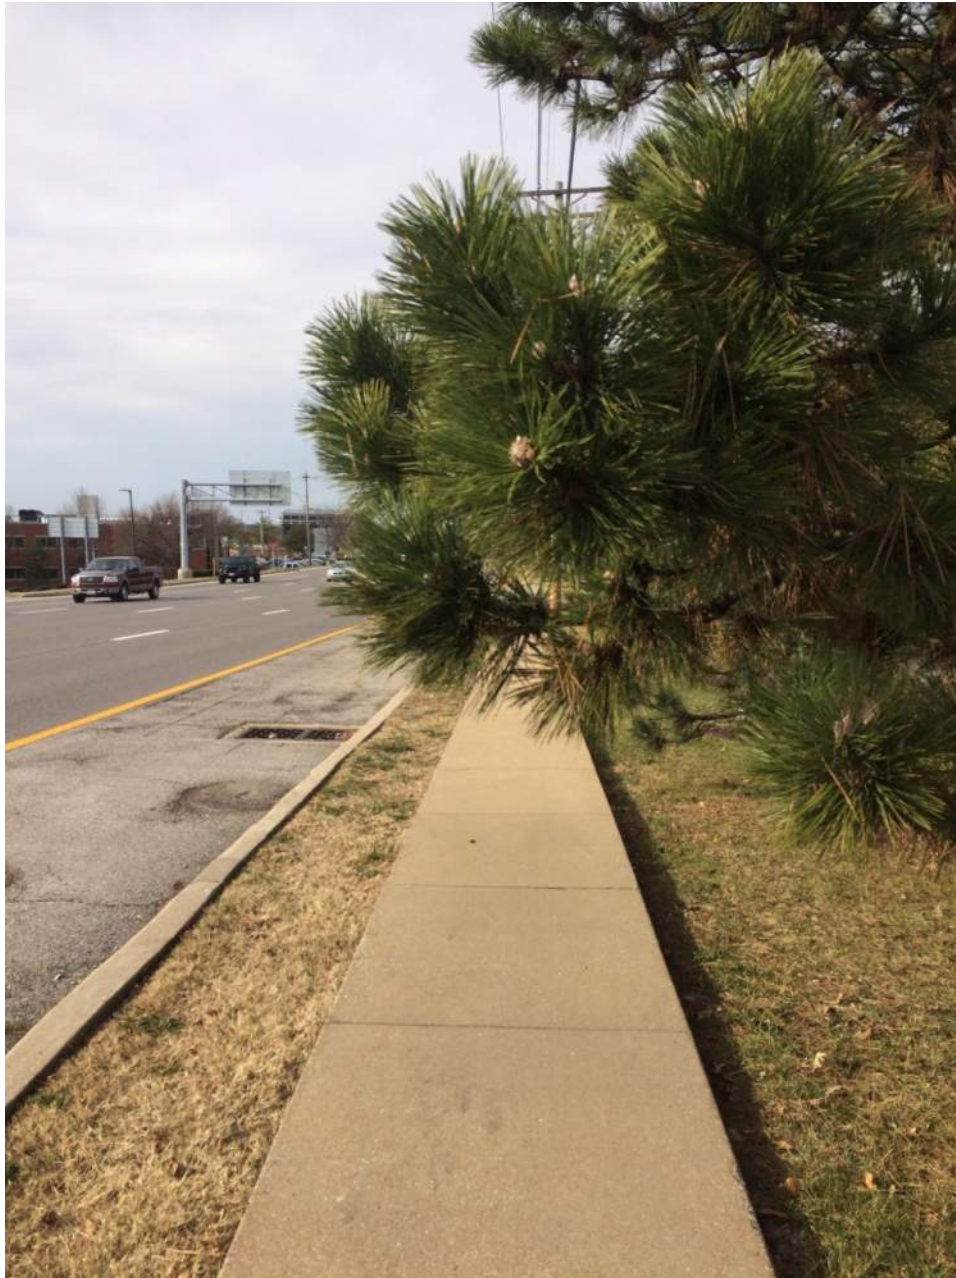
**Vertical encroachment due to vegetation.**

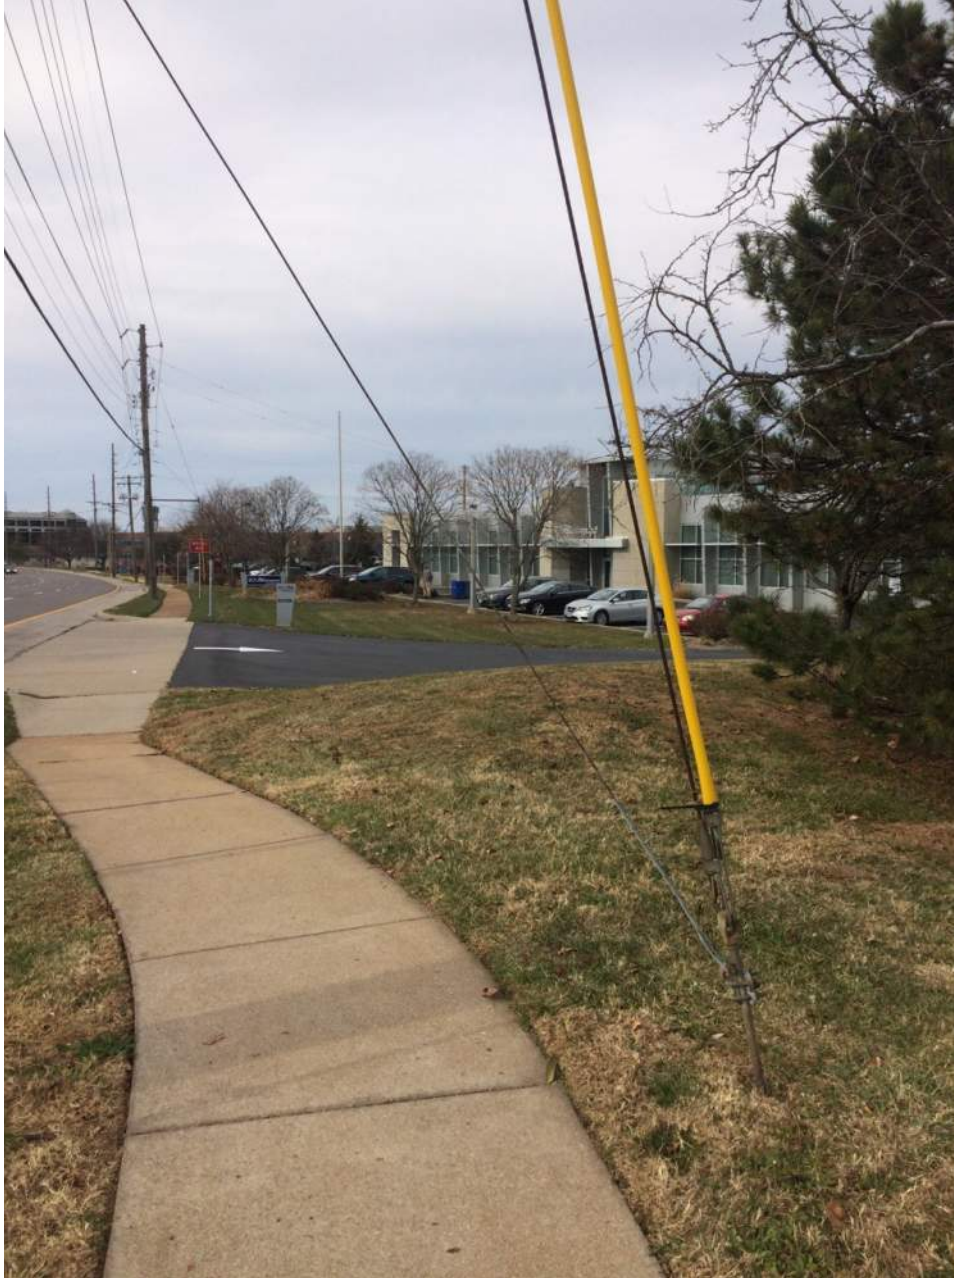
**Vertical encroachment due to guy wire.**

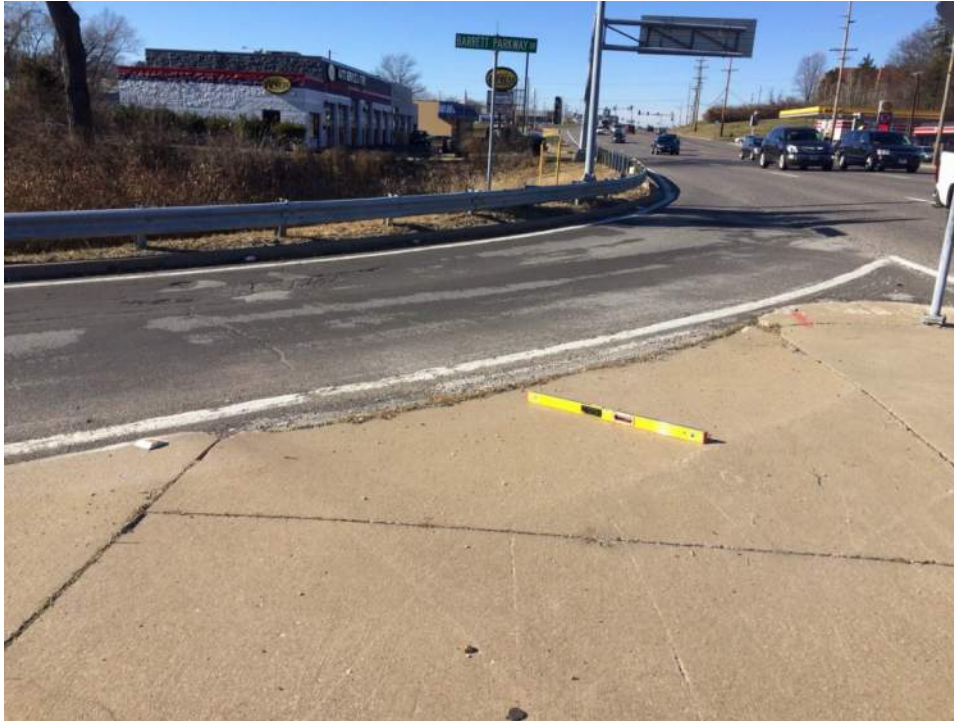
Sidewalk ramp with no warnings and no receiving ramp on opposite side.

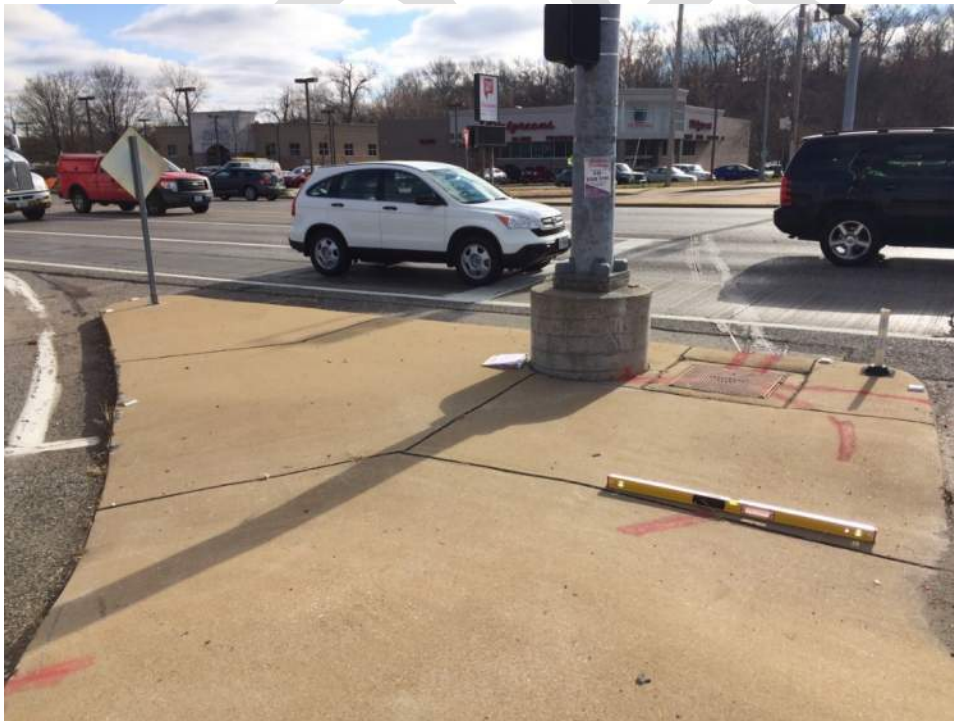
No detectable warnings or pedestrian buttons. Steep ramp grades.

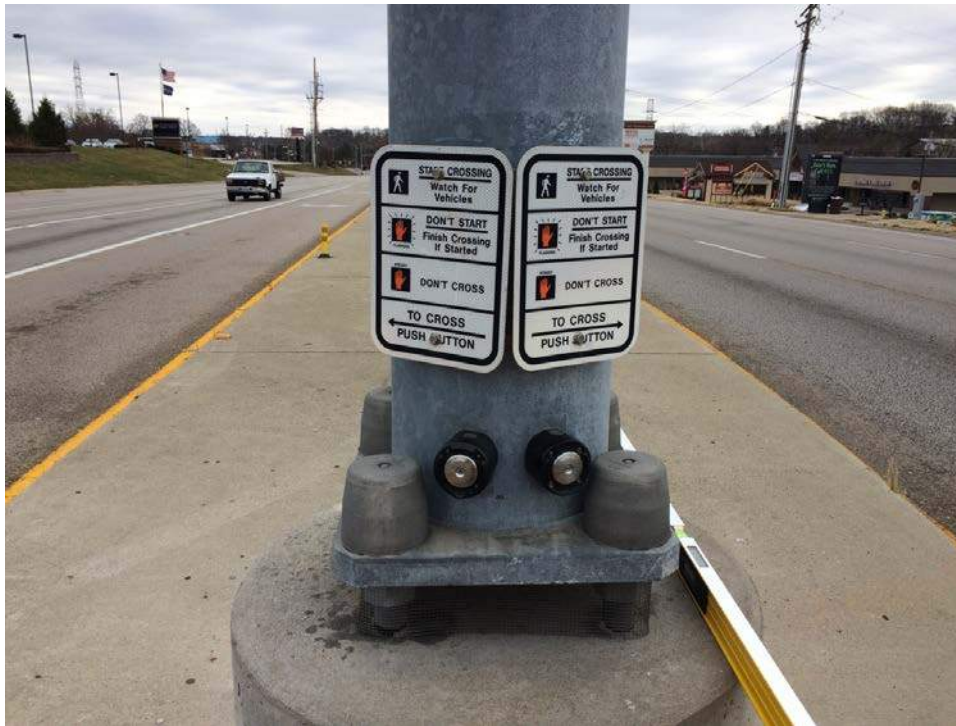
**Pedestrian buttons not 10 feet apart.**

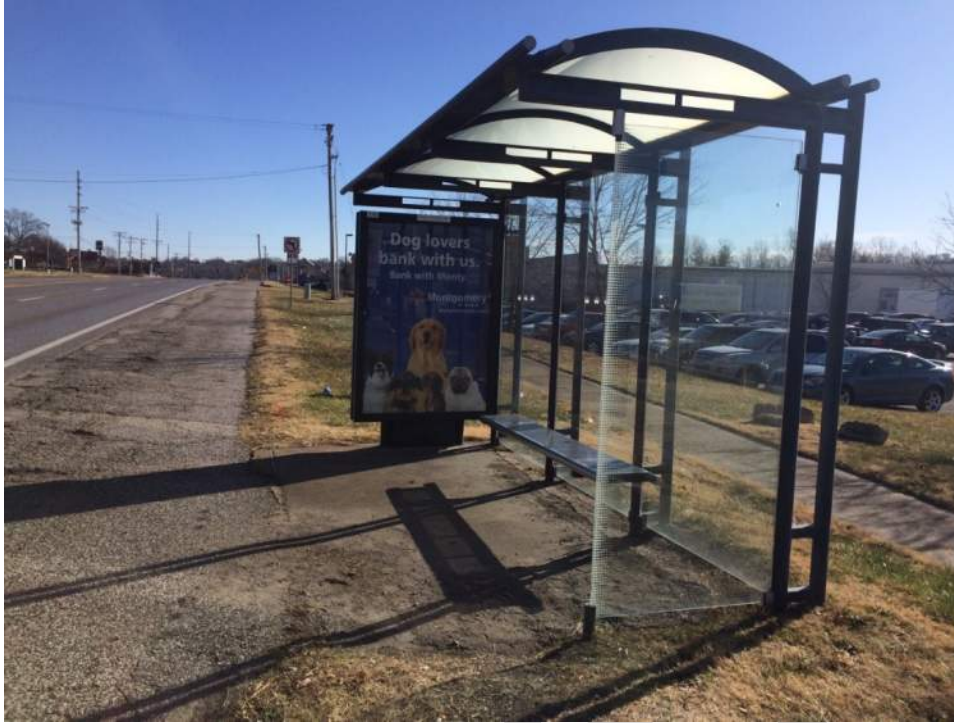
**Bus Shelter along shoulder. Sidewalk behind shelter but not connected up to shoulder.**

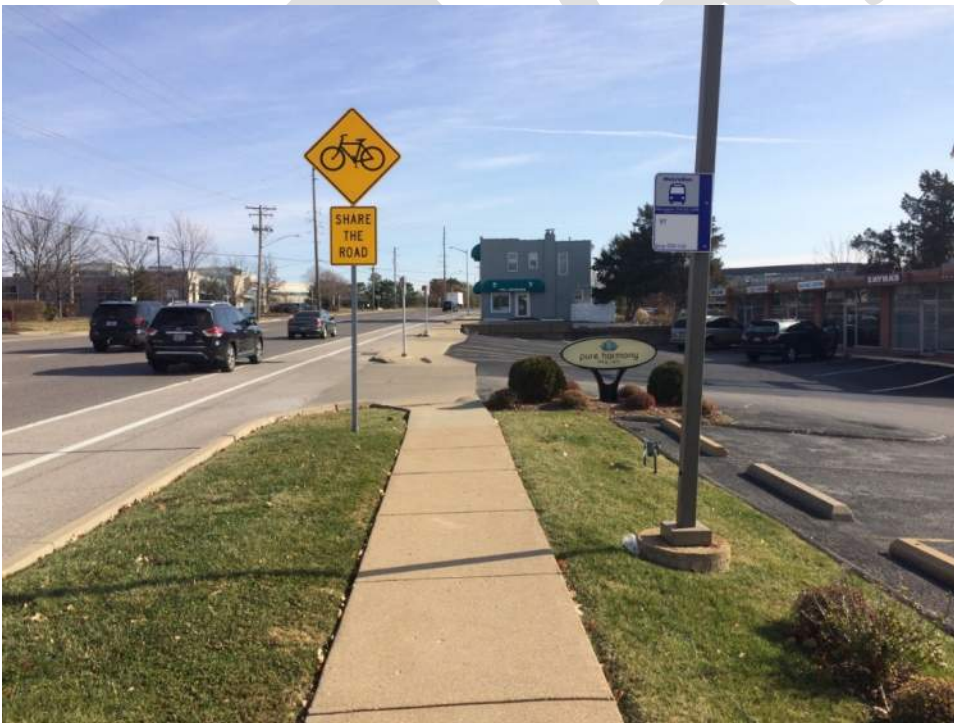
**Bus Stop Sign Only, sidewalk present but not connected to back of curb.**

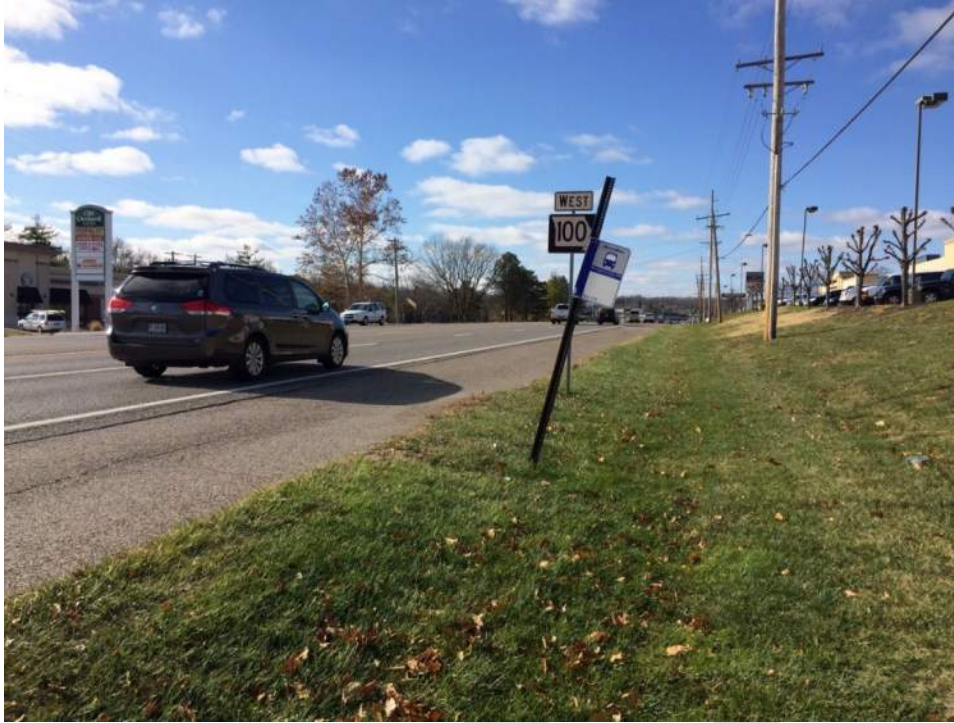
**Bus Stop Sign Only along shoulder, no sidewalk or space to wait.**

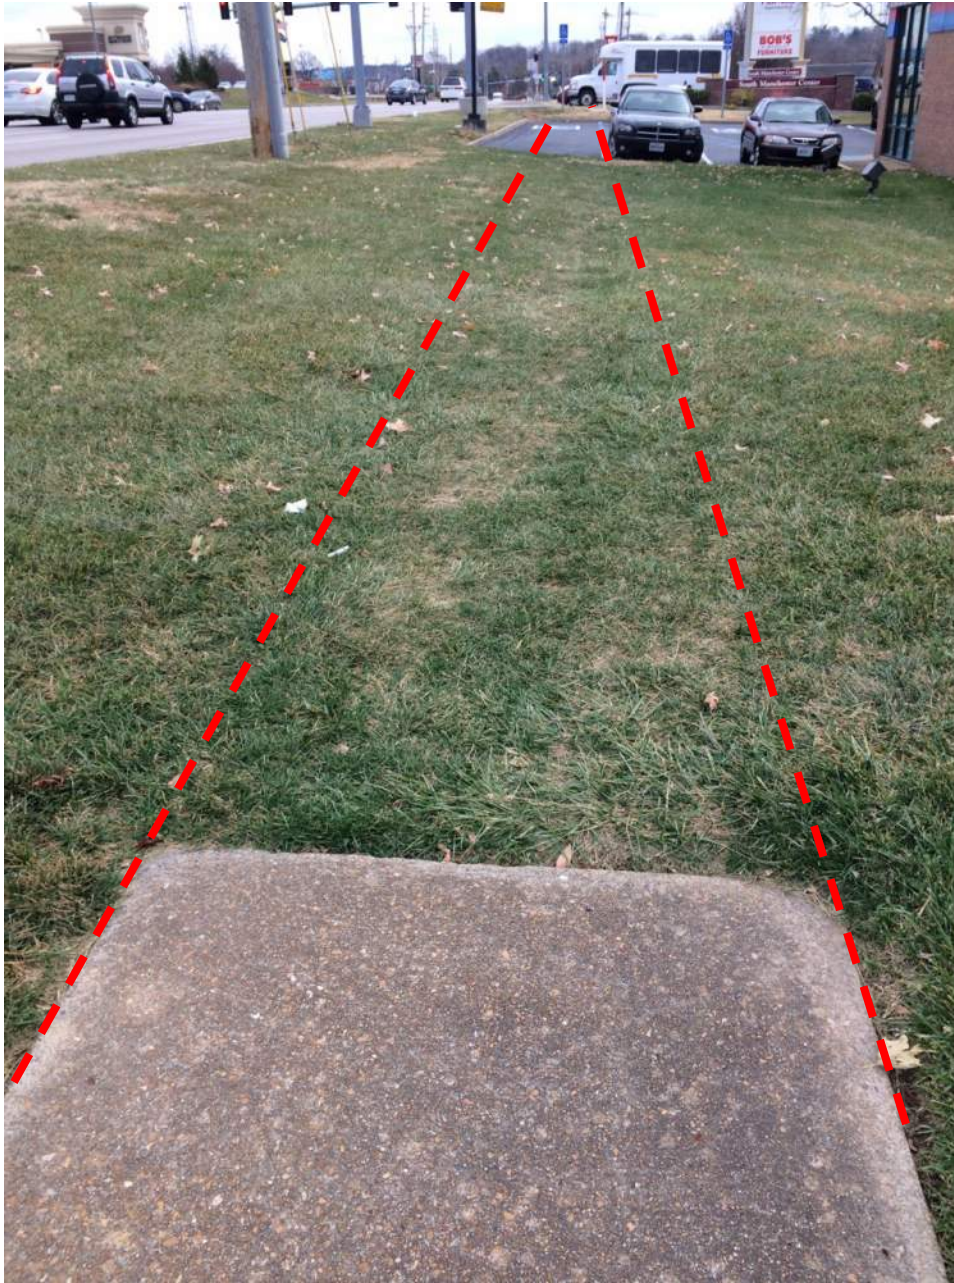
**Commercial property goes to back of curb, no room for sidewalk to continue.**

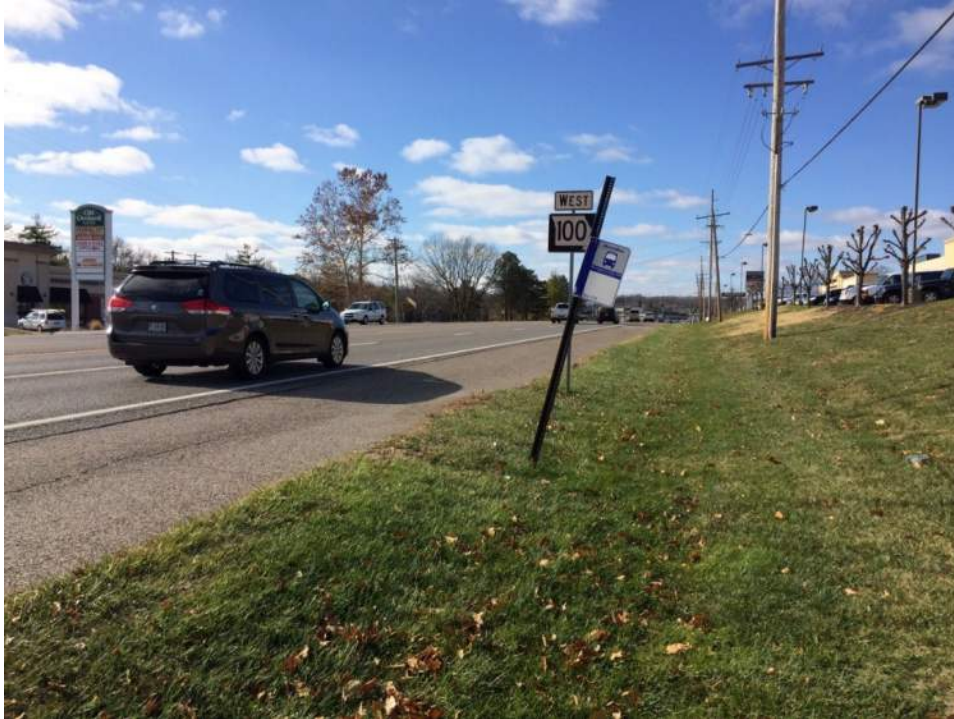
**Shoulders with open ditches and steep back slopes.**

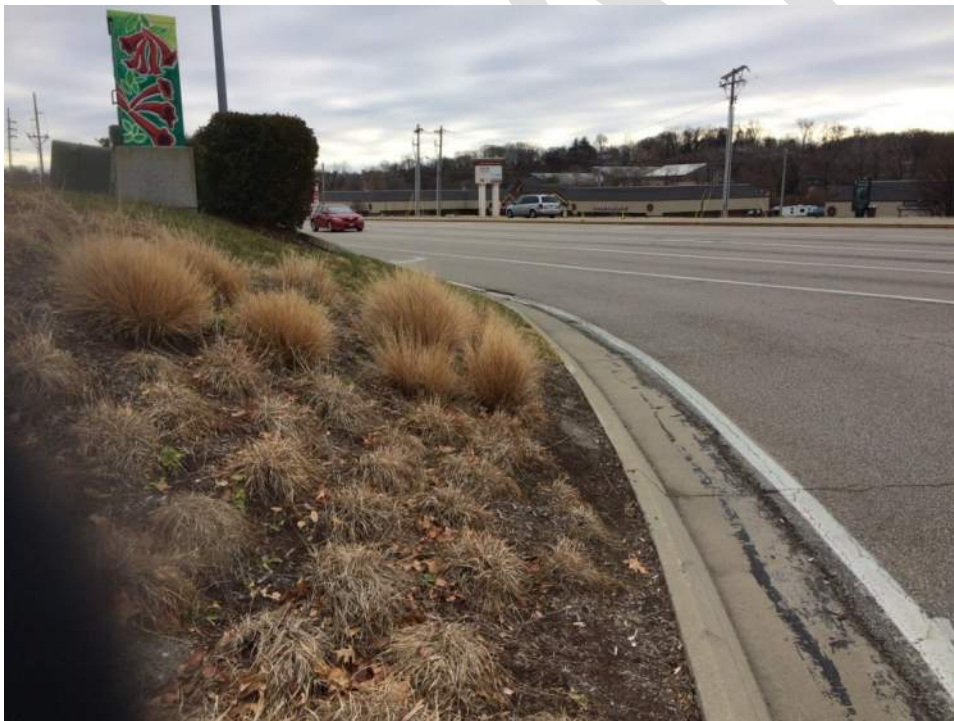
**Steep back slopes and landscaping**

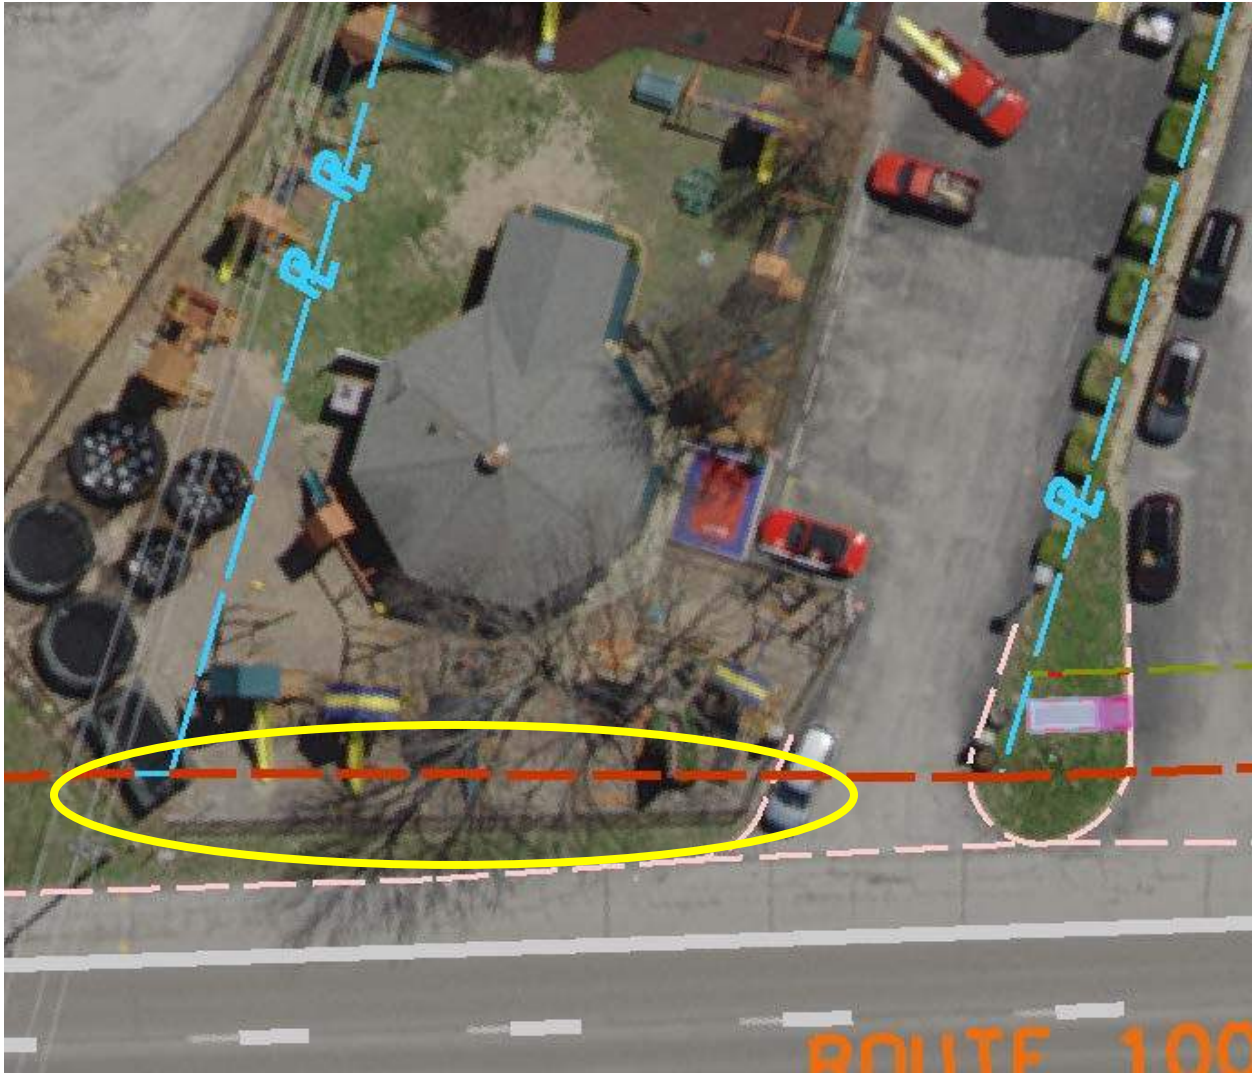
Owner improvements extend onto State owned right of way.
