Photo 1: 12/23/2019
A2942: Rte. 21 NB over Old Rte. 21
Looking south

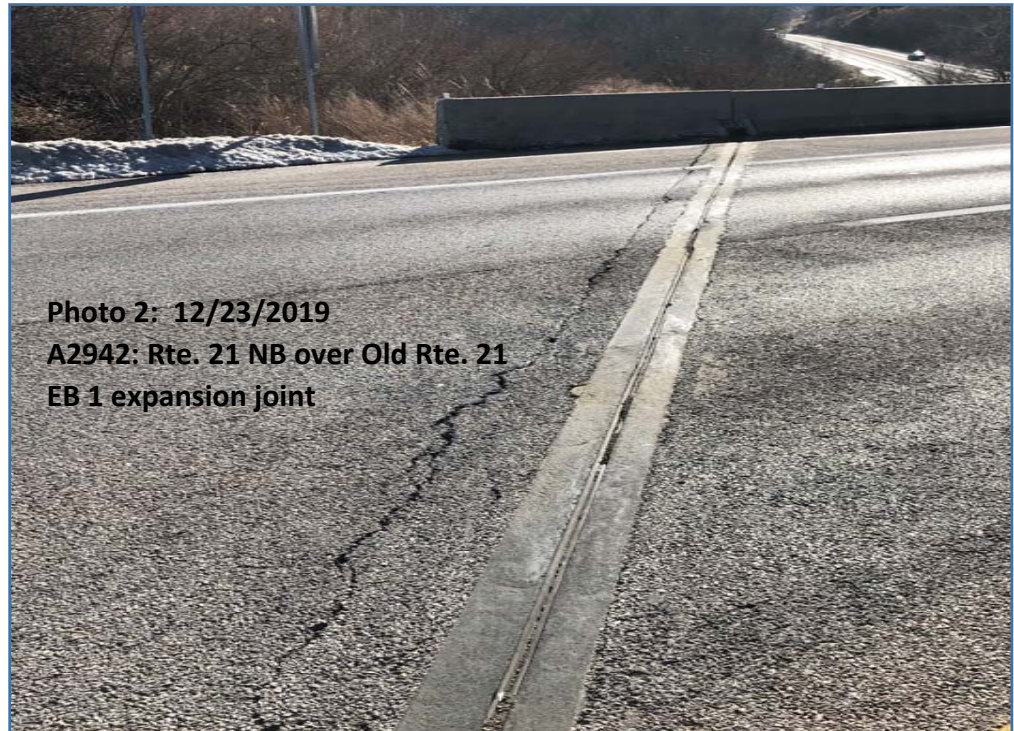
Photo 2: 12/23/2019
A2942: Rte. 21 NB over Old Rte. 21
EB 1 expansion joint

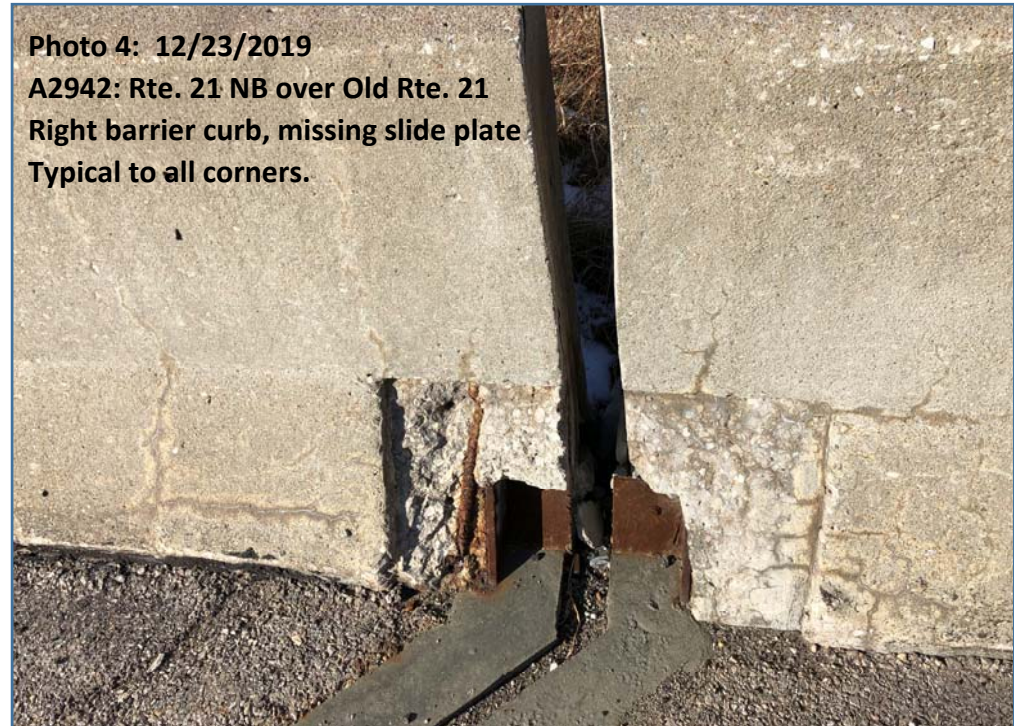
Photo 4: 12/23/2019
A2942: Rte. 21 NB over Old Rte. 21
Right barrier curb, missing slide plate
Typical to all corners.

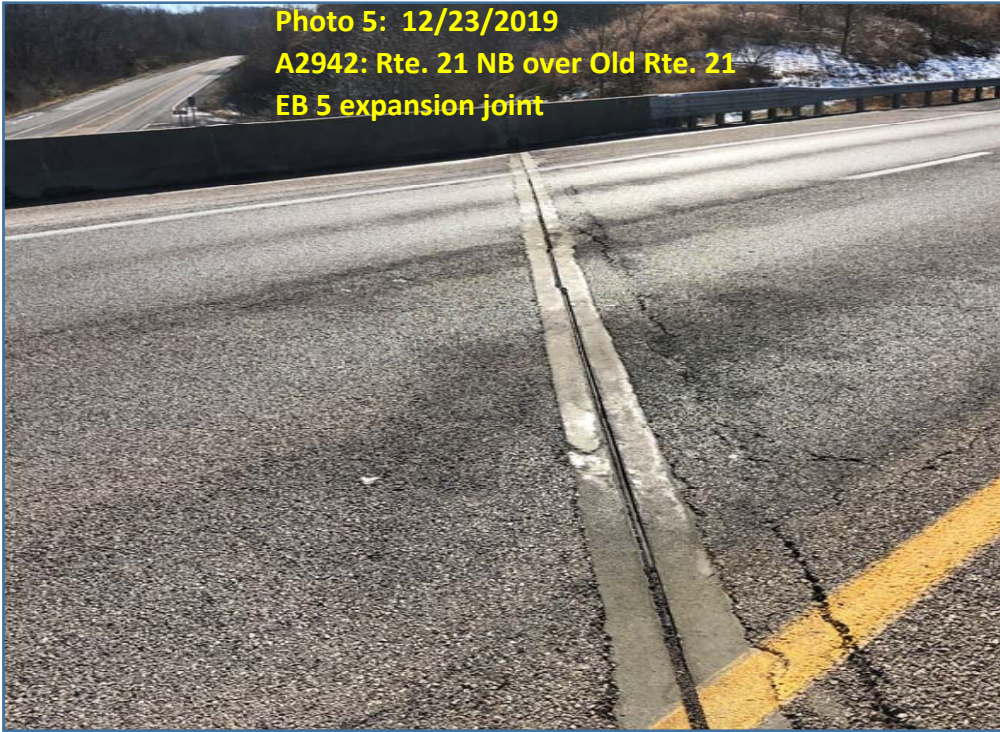
Photo 5: 12/23/2019
A2942: Rte. 21 NB over Old Rte. 21
EB 5 expansion joint

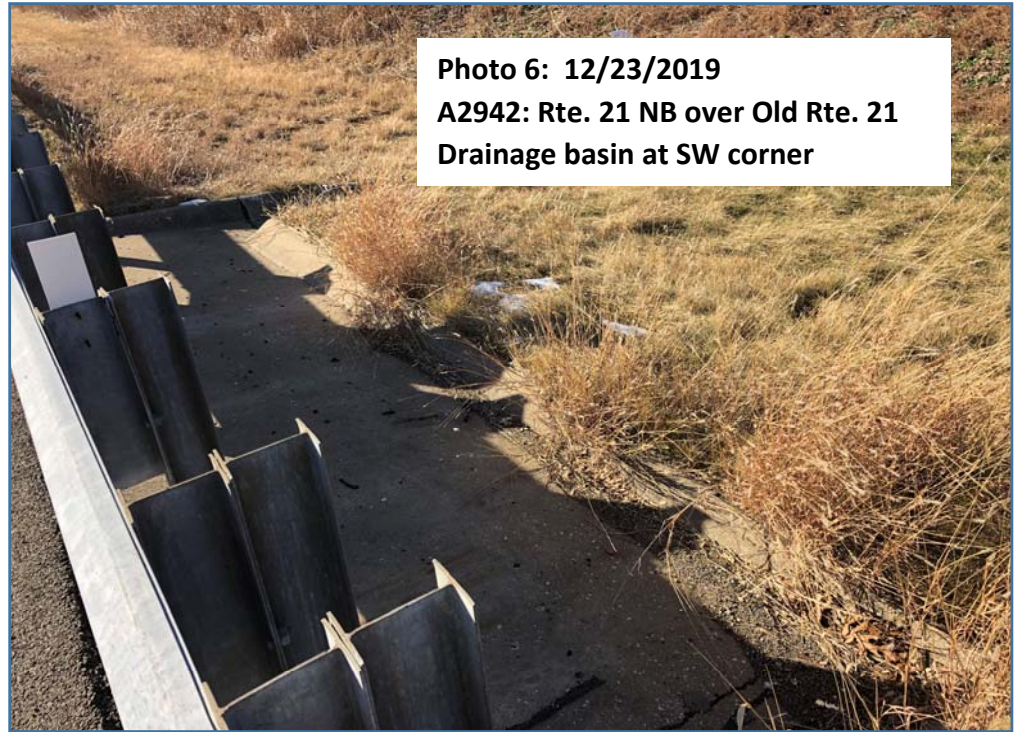
Photo 6: 12/23/2019
A2942: Rte. 21 NB over Old Rte. 21
Drainage basin at SW corner

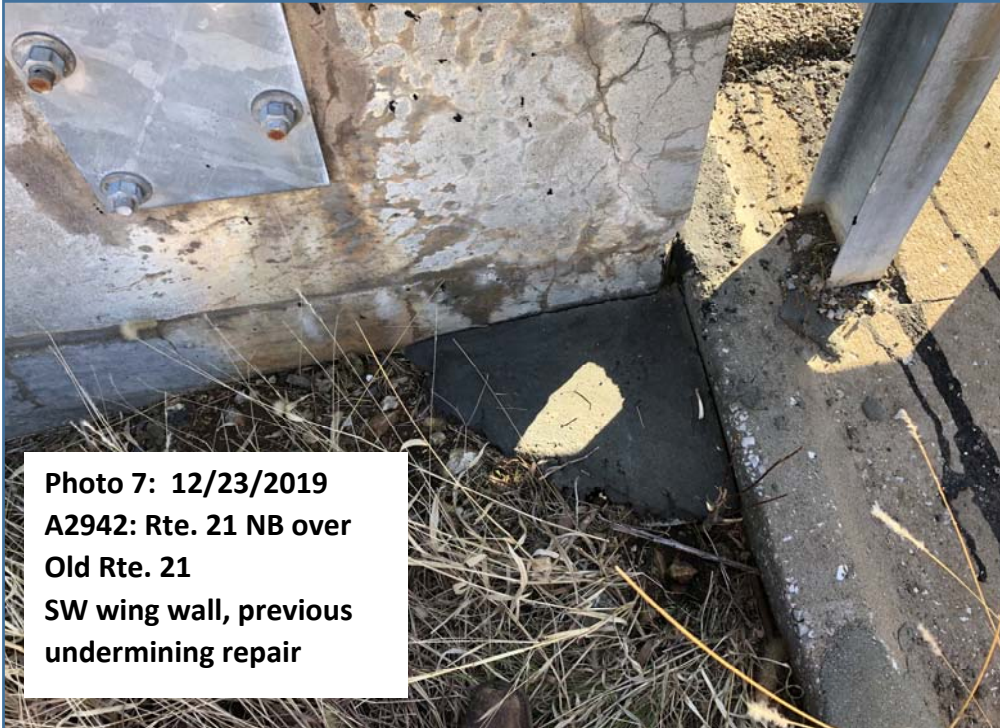
Photo 7: 12/23/2019
A2942: Rte. 21 NB over
Old Rte. 21
SW wing wall, previous
undermining repair

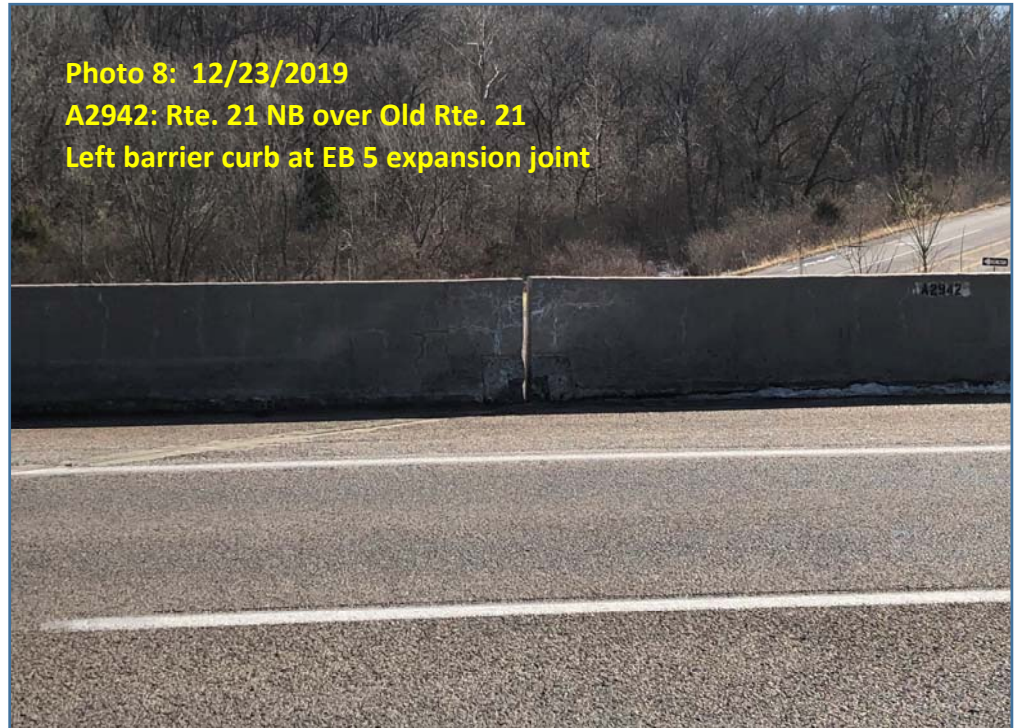
Photo 8: 12/23/2019
A2942: Rte. 21 NB over Old Rte. 21
Left barrier curb at EB 5 expansion joint

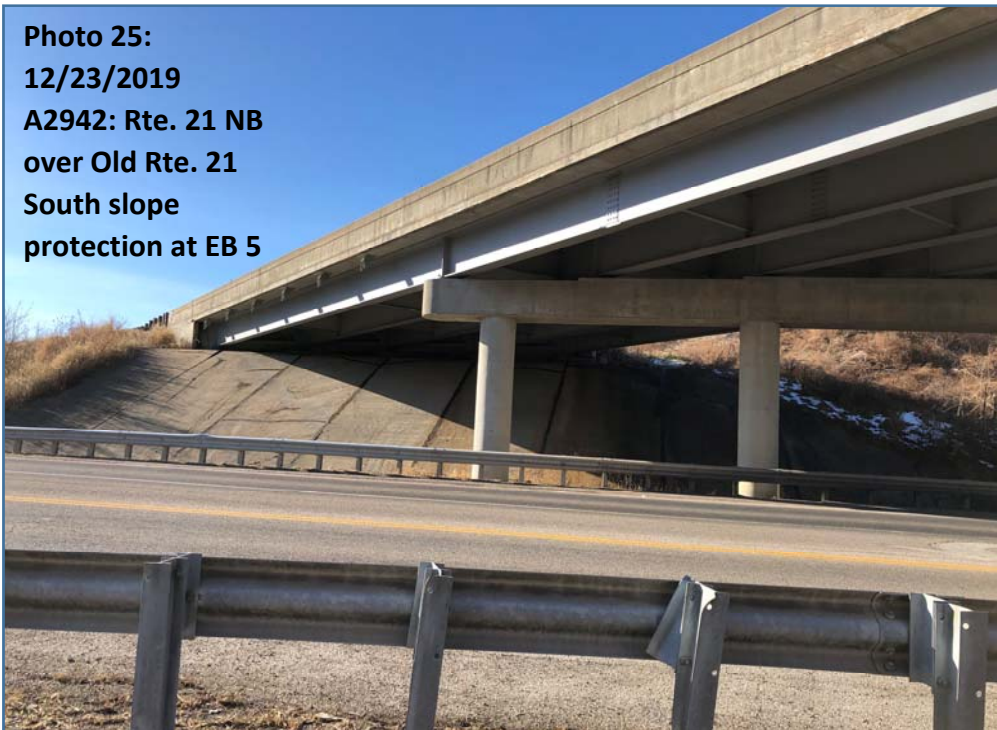
Photo 25:
12/23/2019
A2942: Rte. 21 NB
over Old Rte. 21
South slope
protection at EB 5

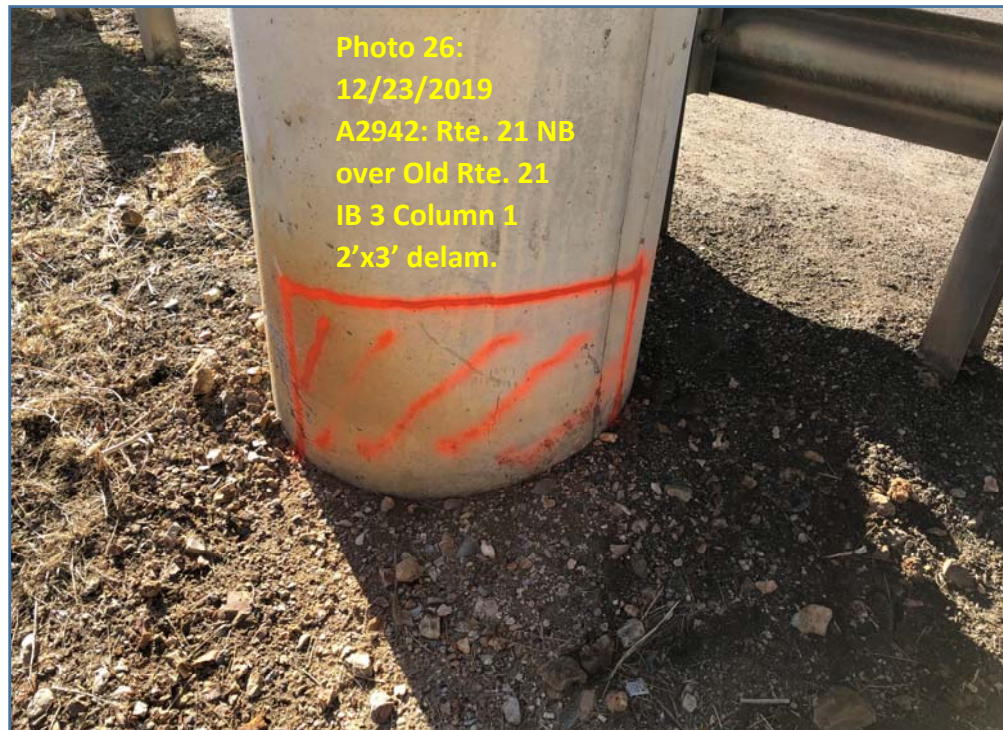
Photo 26:
12/23/2019
A2942: Rte. 21 NB
over Old Rte. 21
IB 3 Column 1
2'x3' delam.

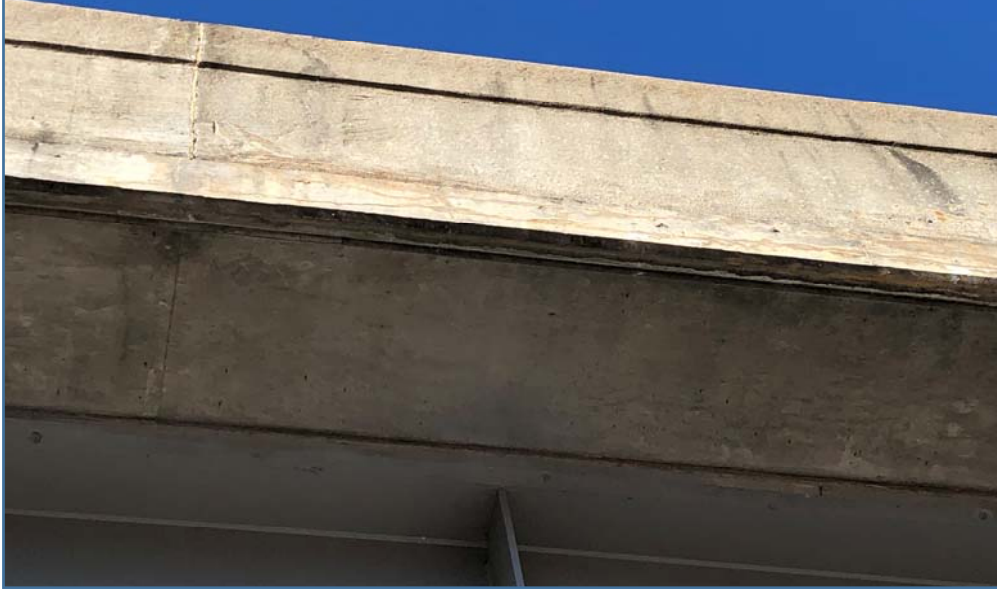
Photo 29: 12/23/2019
A2942: Rte. 21 NB over Old Rte. 21
Left barrier curb, horizontal cracking

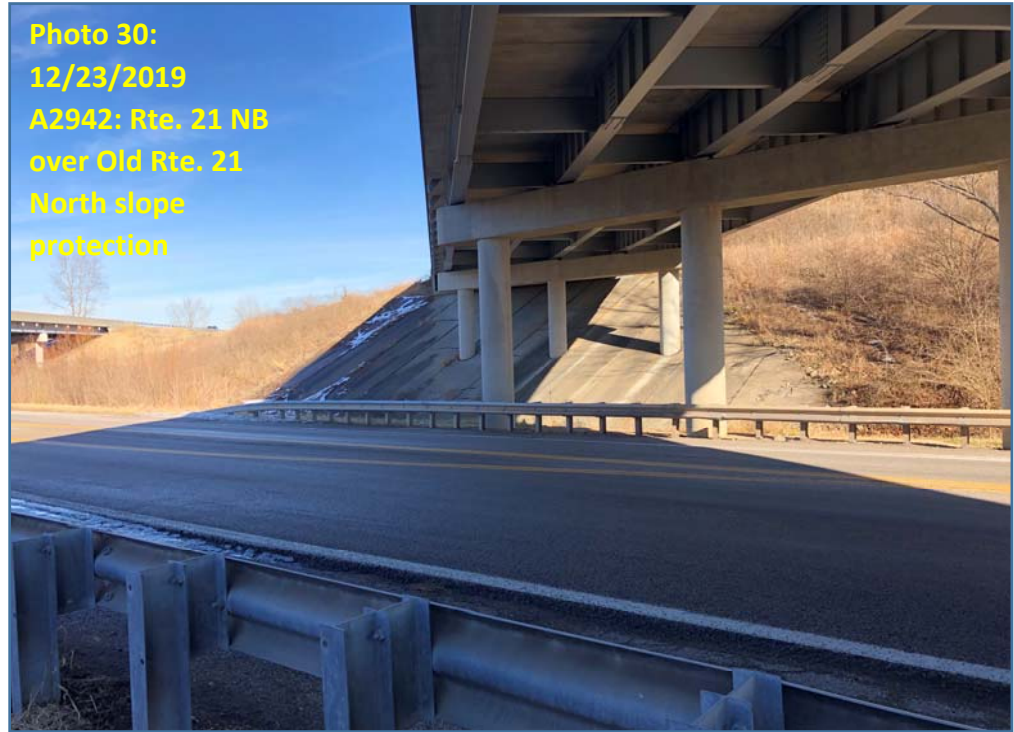
Photo 30:
12/23/2019
A2942: Rte. 21 NB
over Old Rte. 21
North slope
protection

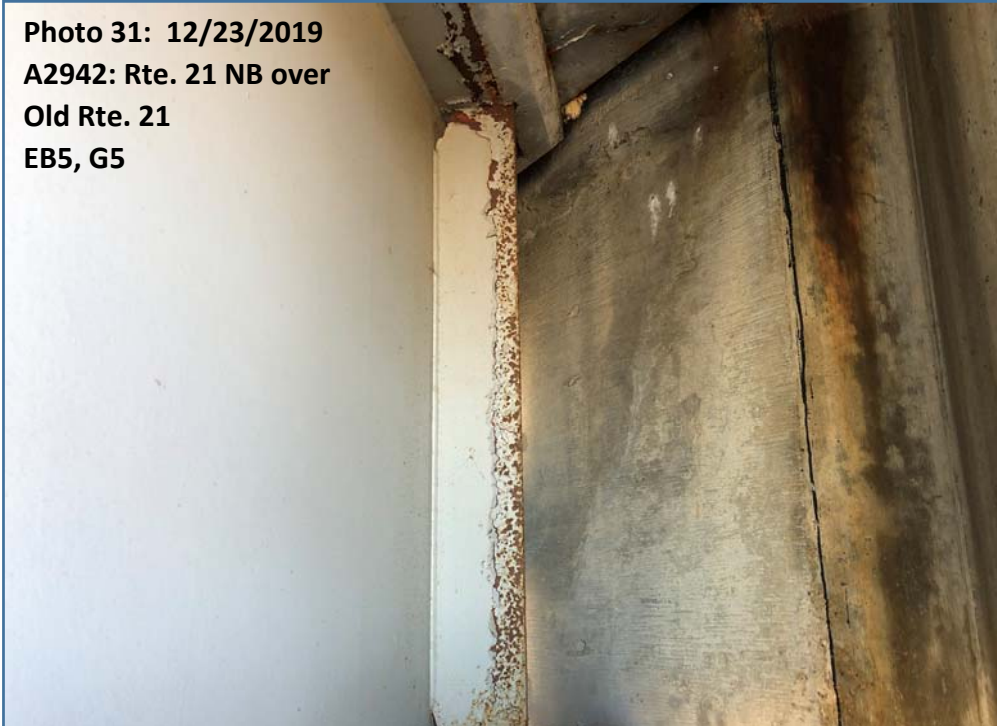
Photo 31: 12/23/2019
A2942: Rte. 21 NB over
Old Rte. 21
EB5, G5

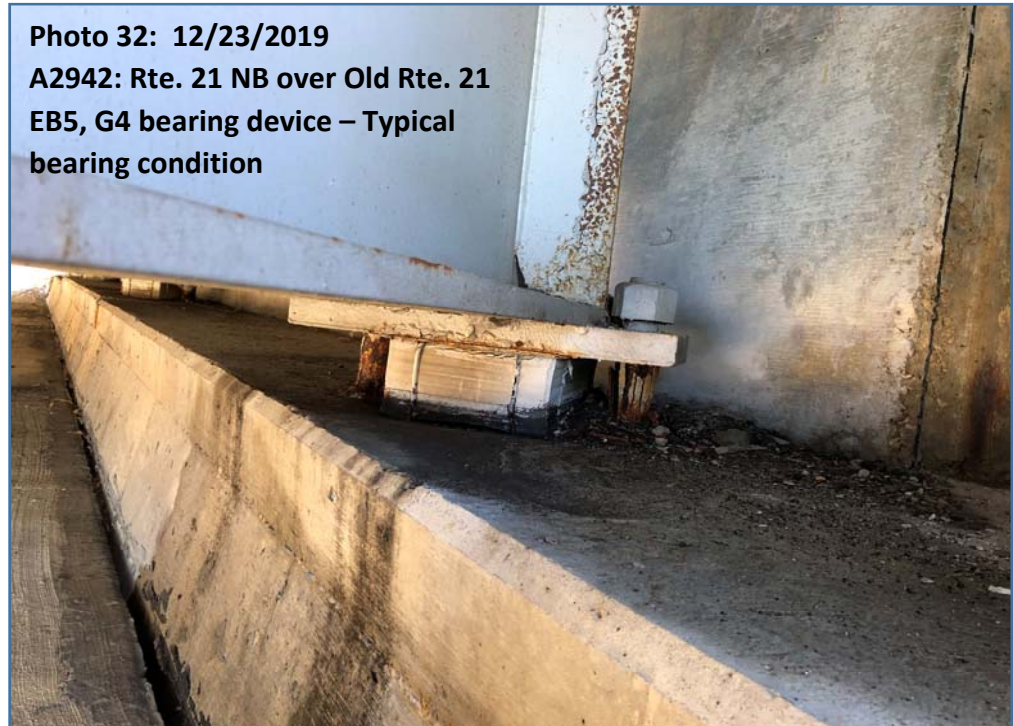
Photo 32: 12/23/2019
A2942: Rte. 21 NB over Old Rte. 21
EB5, G4 bearing device – Typical
bearing condition

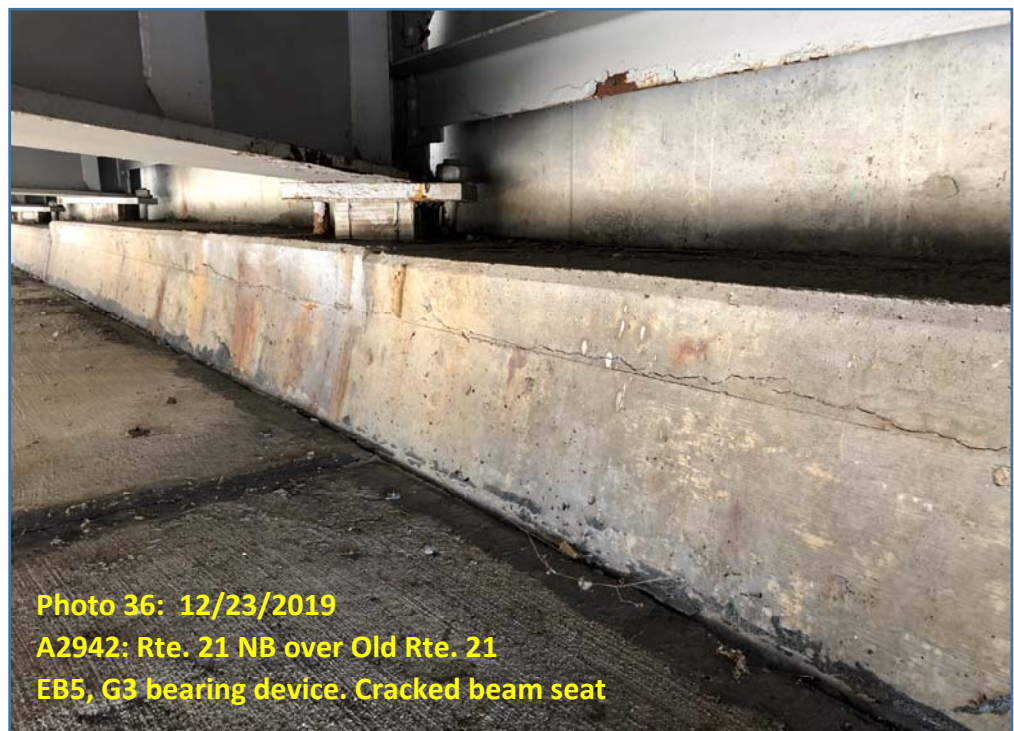
Photo 35: 12/23/2019
A2942: Rte. 21 NB over Old Rte. 21
EB5, G3 bearing device. Cracked beam seat
