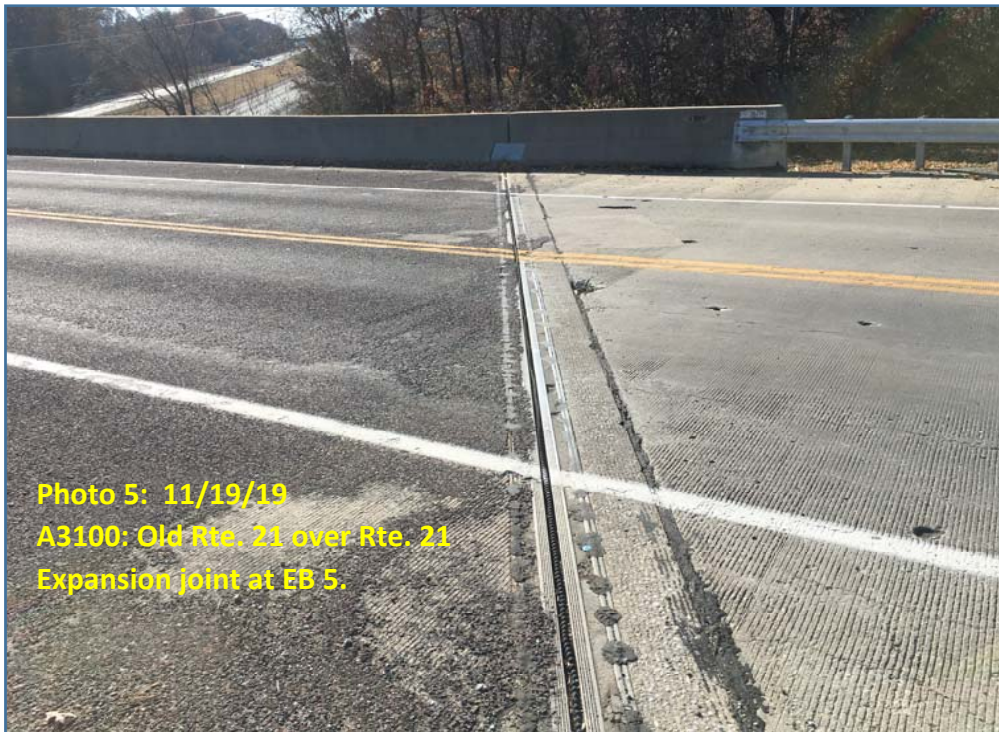
Photo 5: 11/19/19
A3100: Old Rte. 21 over Rte. 21
Expansion joint at EB 5.

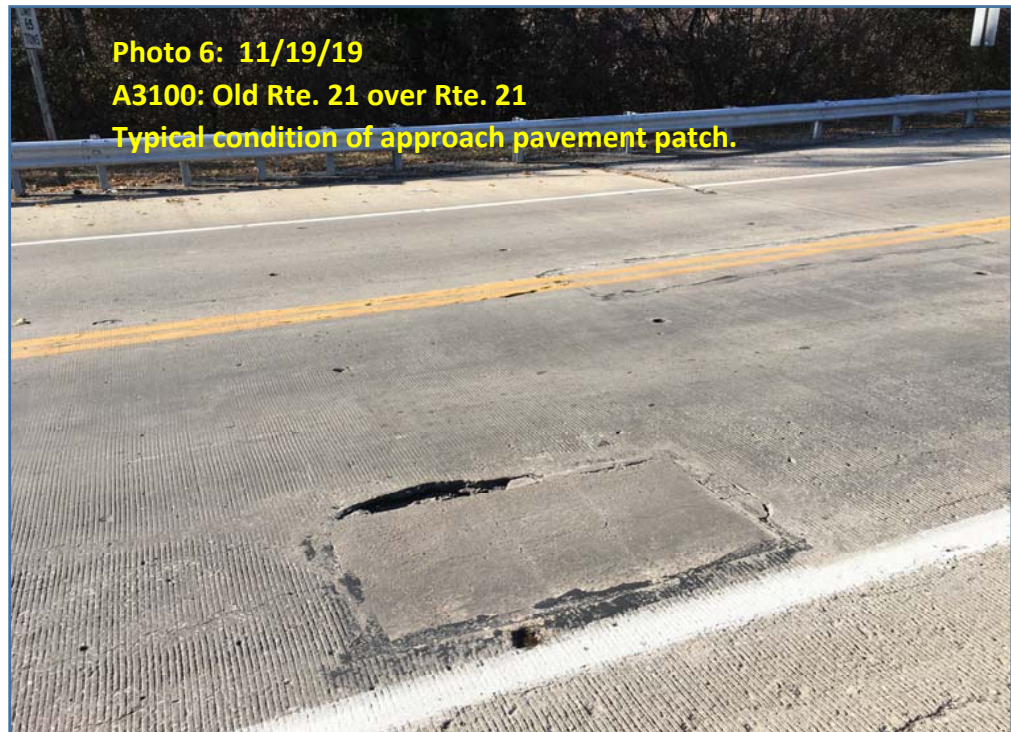
Photo 6: 11/19/19
A3100: Old Rte. 21 over Rte. 21
Typical condition of approach pavement patch.

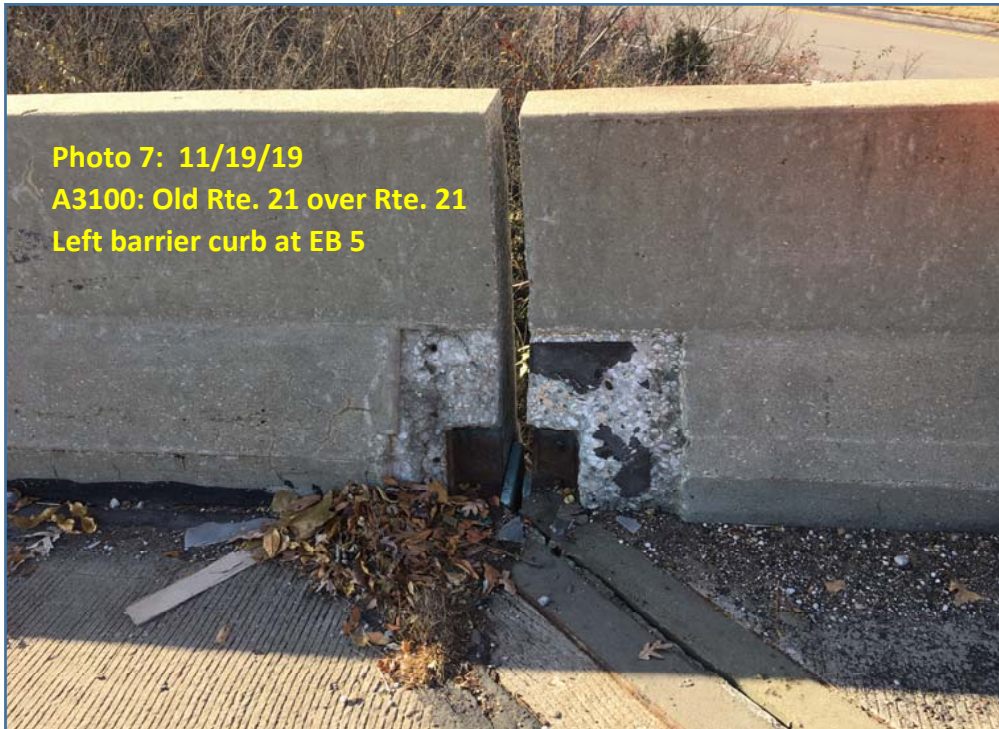
Photo 7: 11/19/19
A3100: Old Rte. 21 over Rte. 21
Left barrier curb at EB 5

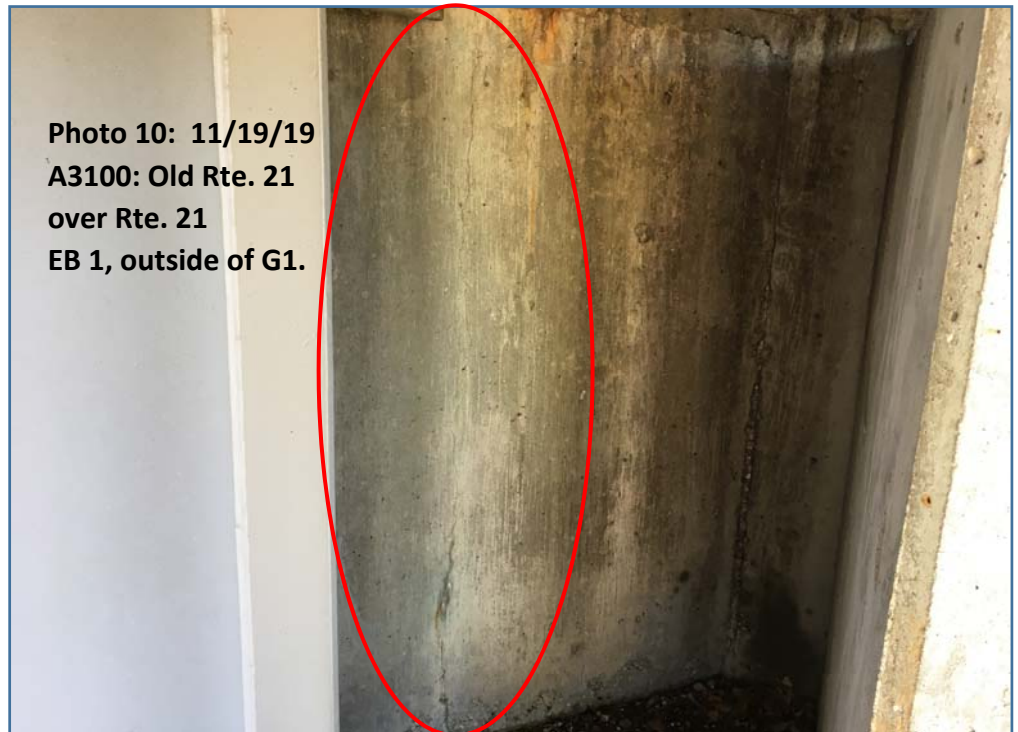
Photo 10: 11/19/19
A3100: Old Rte. 21
over Rte. 21
EB 1, outside of G1.

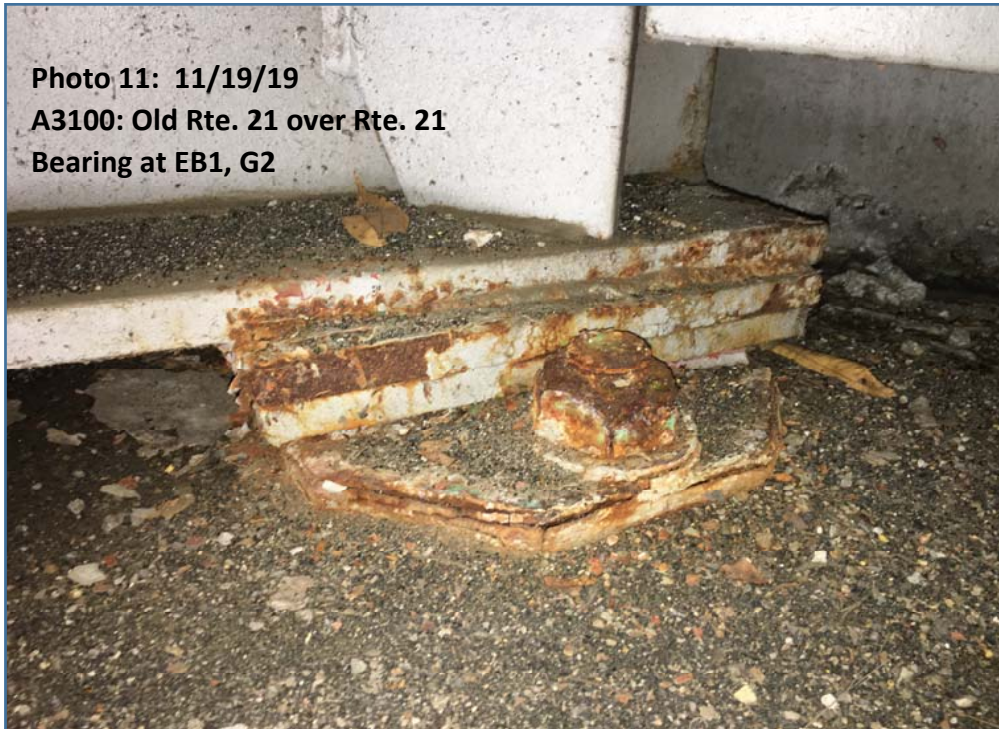
Photo 11: 11/19/19
A3100: Old Rte. 21 over Rte. 21
Bearing at EB1, G2

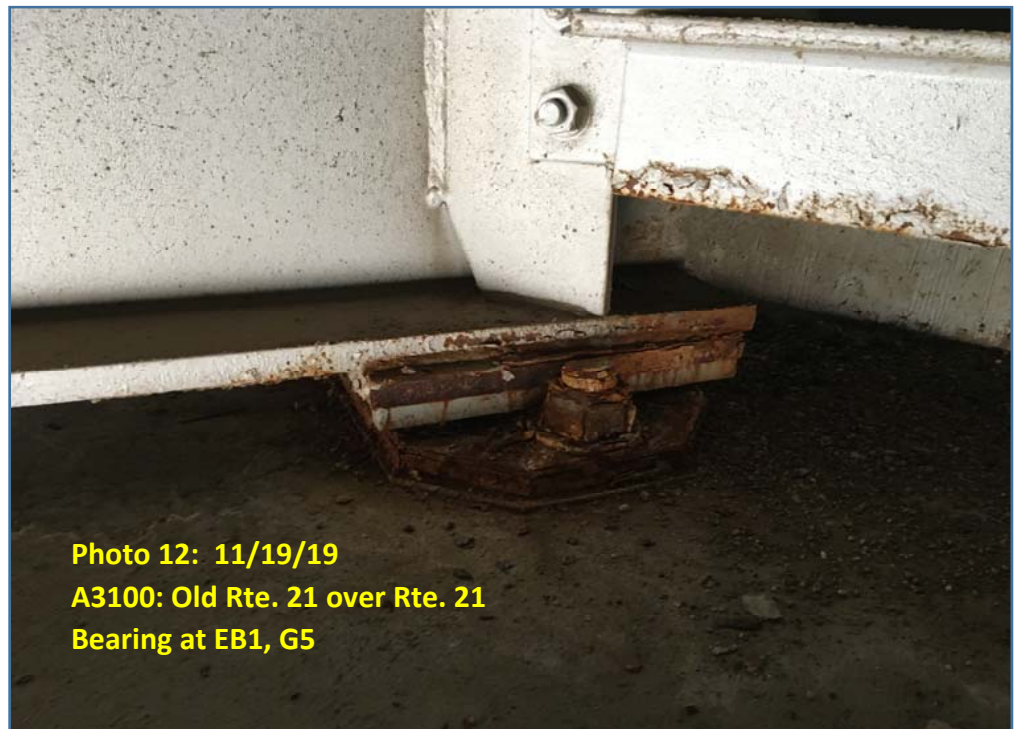
Photo 12: 11/19/19
A3100: Old Rte. 21 over Rte. 21
Bearing at EB1, G5

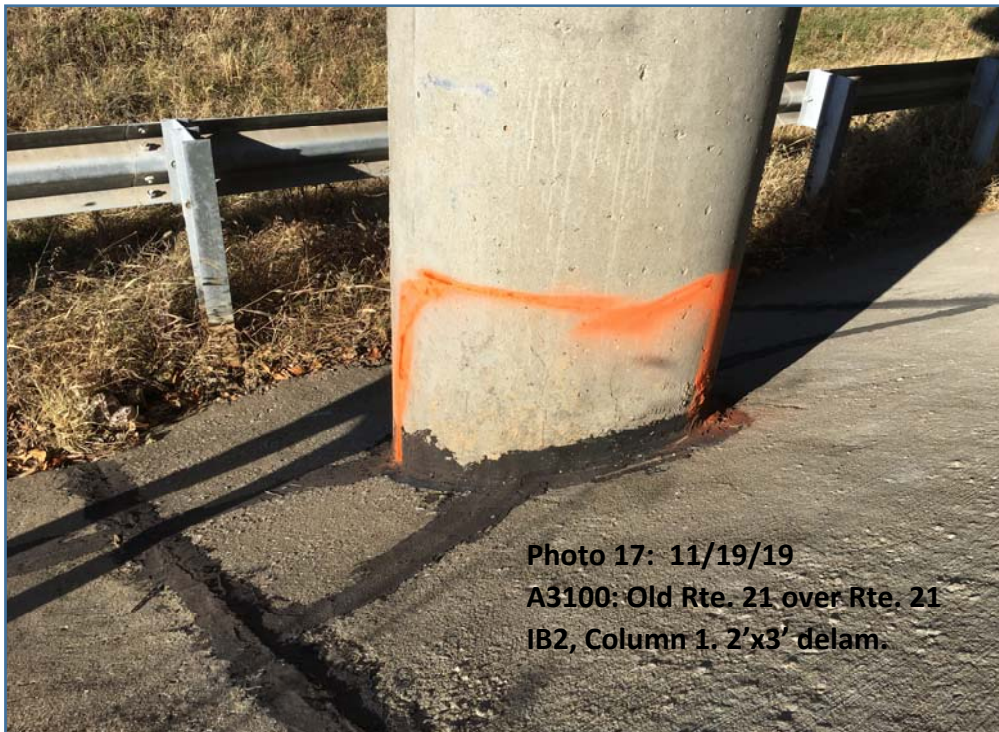
Photo 17: 11/19/19
A3100: Old Rte. 21 over Rte. 21
IB2, Column 1. 2'x3' delam.

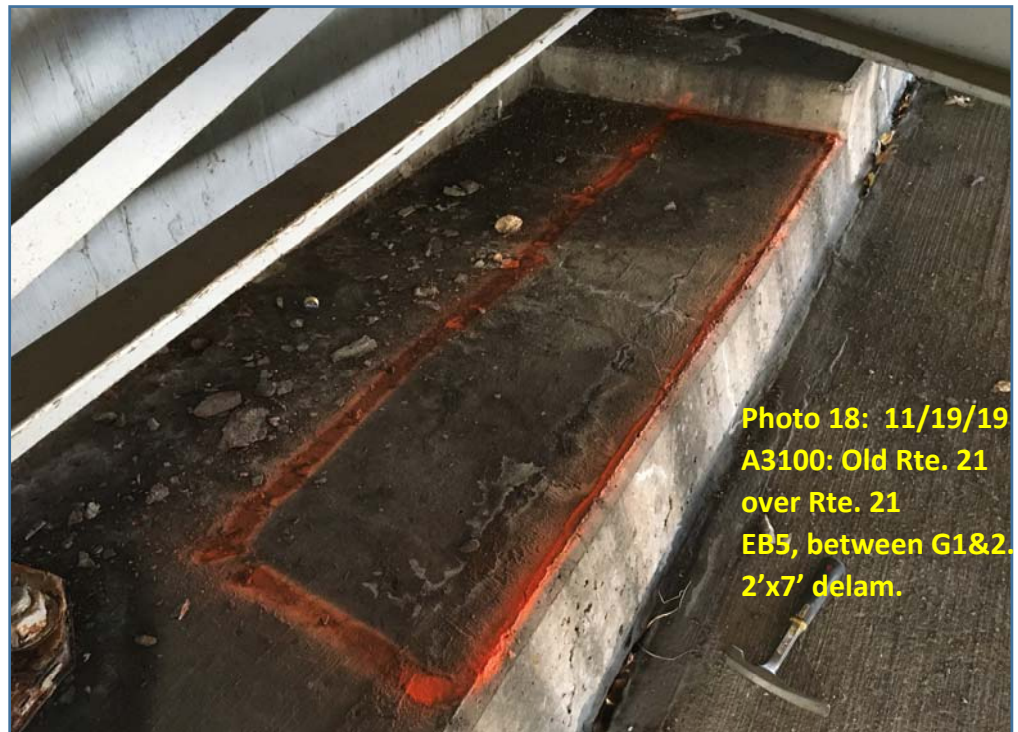
Photo 18: 11/19/19
A3100: Old Rte. 21
over Rte. 21
EB5, between G1&2.
2'x7' delam.

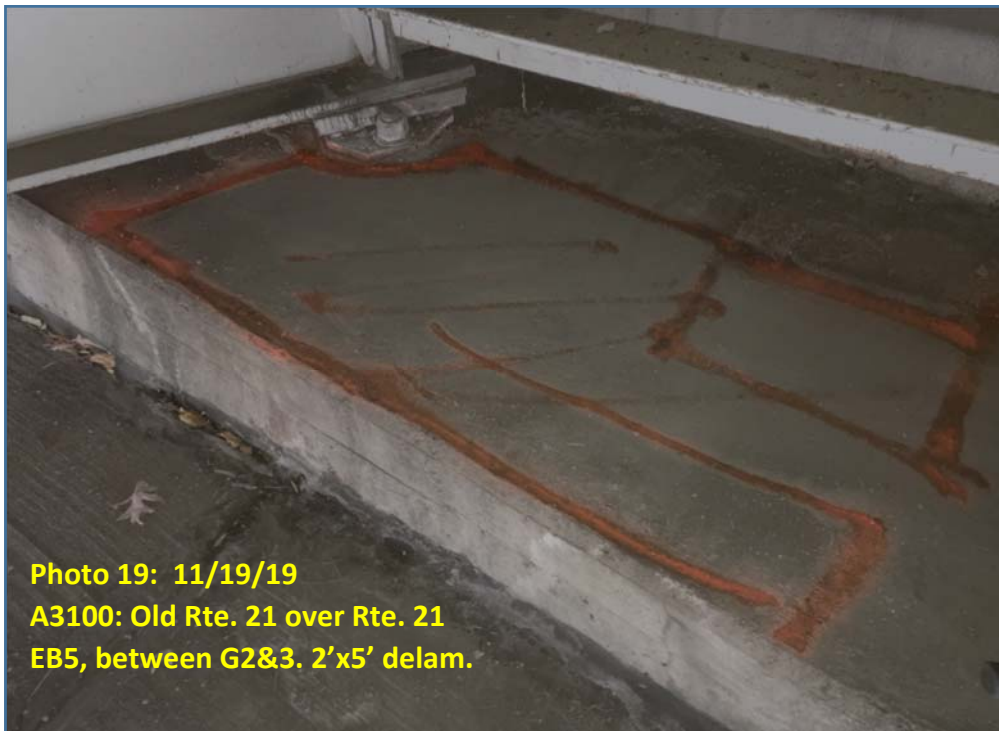
Photo 19: 11/19/19
A3100: Old Rte. 21 over Rte. 21
EB5, between G2&3. 2'x5' delam.

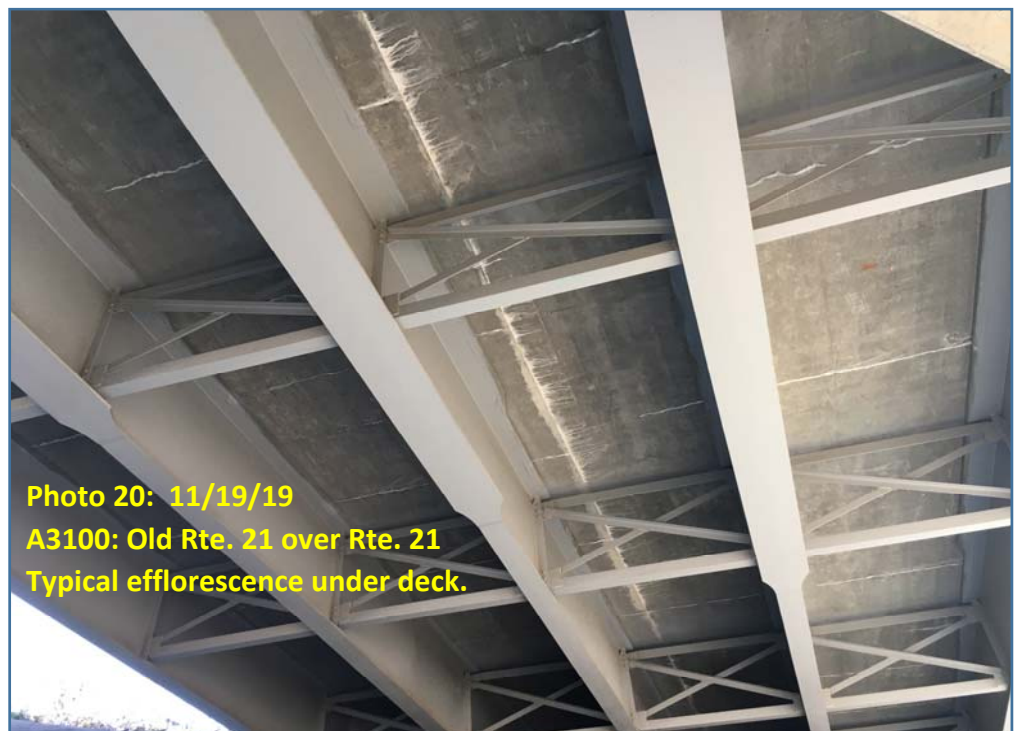
Photo 20: 11/19/19
A3100: Old Rte. 21 over Rte. 21
Typical efflorescence under deck.
